Building and Timber Pest Inspection Report

Inspection Date: Thu, 19 Mar 2026

Property Address: 6A Turner St, Gawler East SA 5118,
Australia

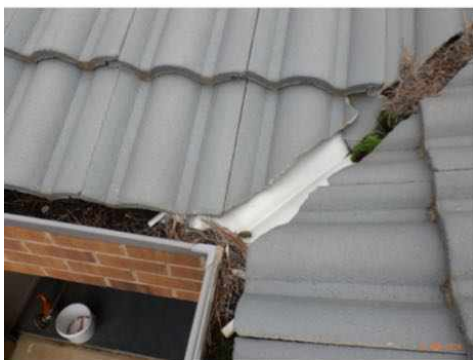
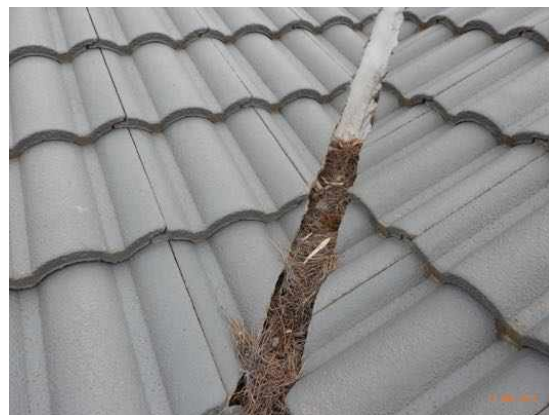
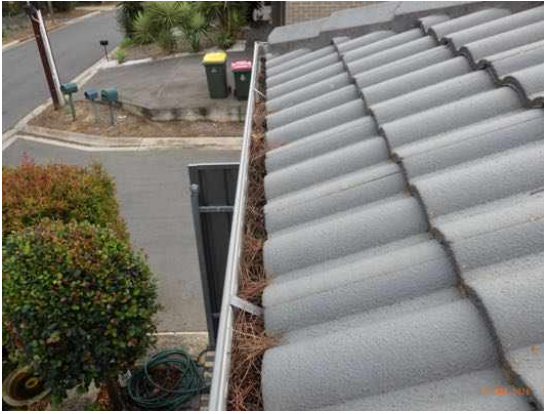
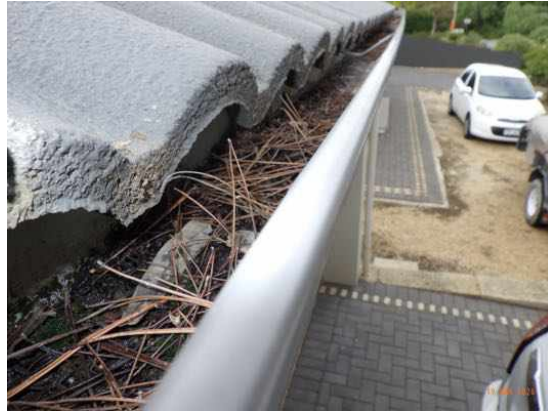
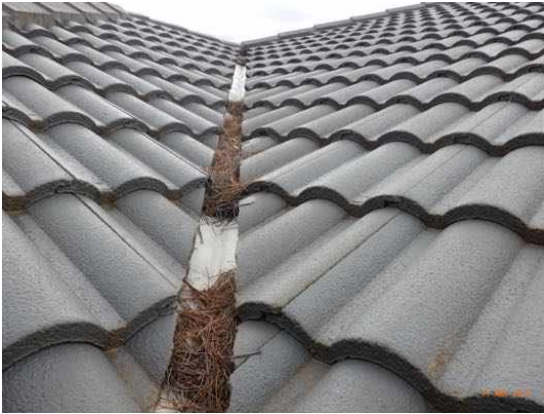
Blocked gutters are likely to lead to high levels of moisture in the affected areas. Such moisture will not only cause rust and decay of the associated building materials, but can also provide conditions that are conducive to termite and timber pest activity. Blockages in gutters should therefore be removed immediately to ensure dry conditions are maintained.

Removal of debris may expose currently concealed defects.

Consult a Licensed Plumber for further specific advice on remedial works that may be required. In the interim, it is highly advised that blocked gutters be removed by the homeowner or a general handyperson as a matter of urgency.

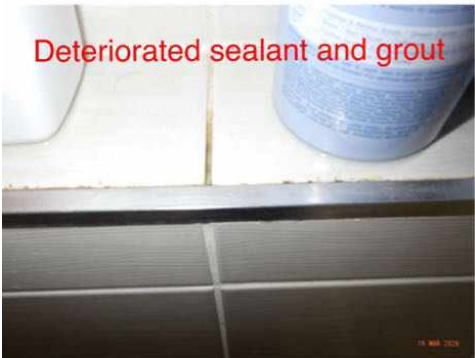
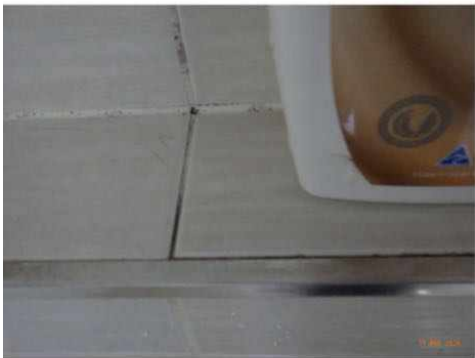
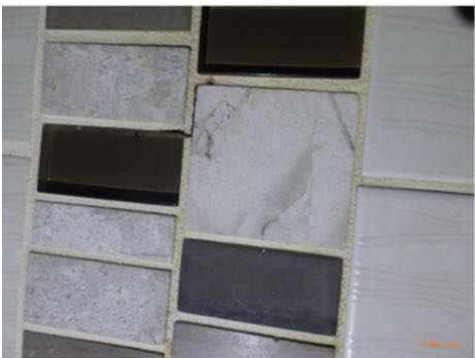
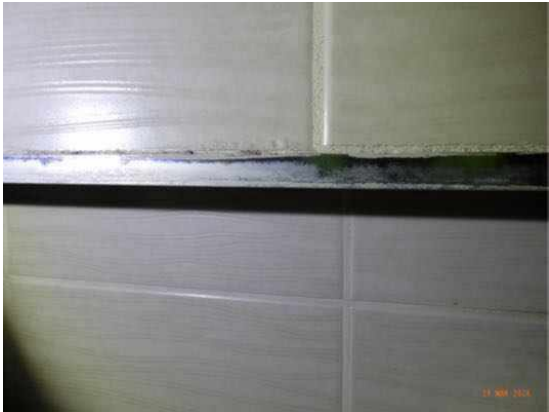
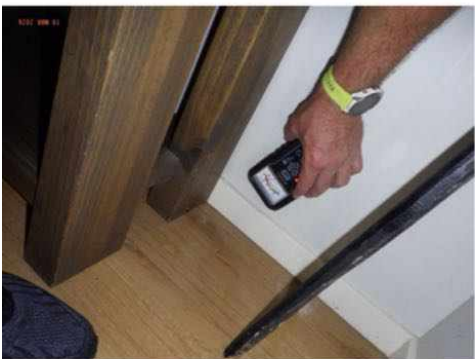
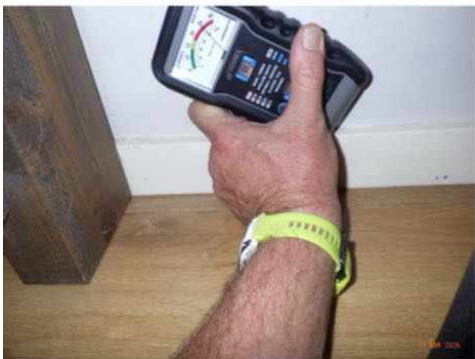
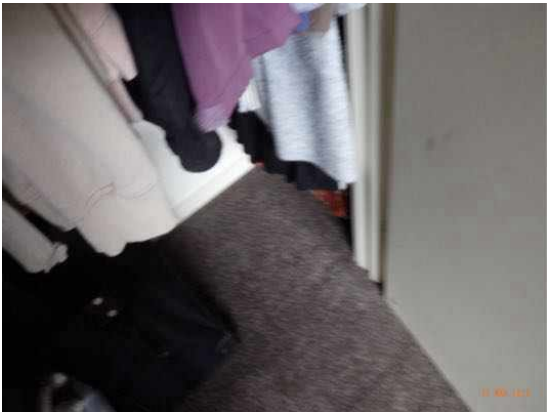
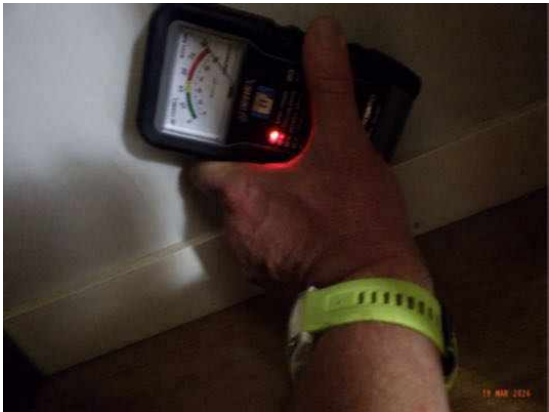
Finding 2.02

Building:	Building 1
Location:	Ensuite - Master
Finding:	Shower - Damp
Information:	Damp is evident to the walls to the shower alcove up to 1200mm high. There are small areas showing high readings transferring to the other side of the wall also.

This defect is quite common, and is suspected to have been caused by moisture permeating through the tiling, grouting and or sealant in this area, which shows evidence of deterioration. Leaking pipes within the adjoining wall is also a possible however appears unlikely as high readings were found on the non tap wall also.

Unmanaged damp in the shower recess is likely to facilitate the formation and development of mould and fungi growth, decaying associated building materials and compromising their structural integrity. High moisture around timber elements also creates an environment that is conducive to termite activity. Further investigation

Consultation with a qualified plumber is advised immediately to identify the cause of damp and to perform remedial works as required.

Always ensure that sealant and grout is in good condition to prevent any moisture issues occurring in the future.

Further investigate then repair sealant and grout to ensuite bathroom

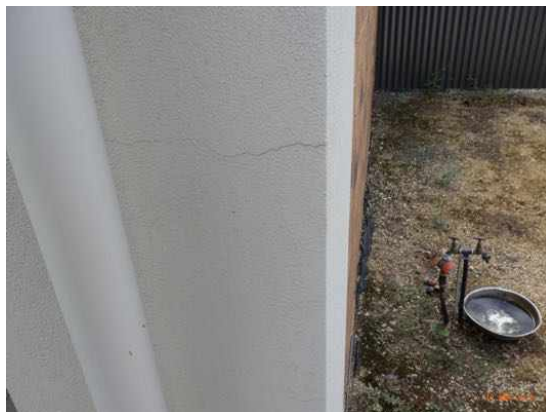
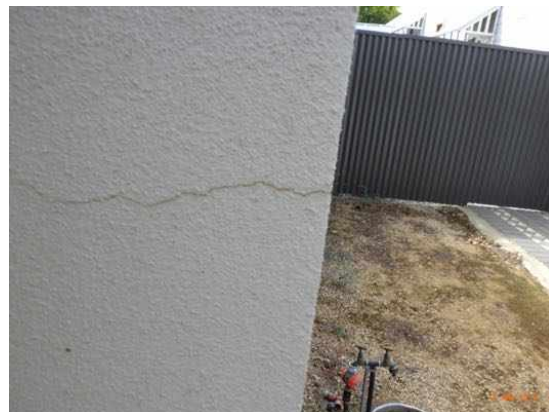
Finding 3.01

Building:	Building 1
Location:	Exterior walls
Finding:	Brickwork - Cracking [Fine]
Information:	There were fine cracks evident to the external brickwork at the time of inspection.

Although fine cracks are quite noticeable, they are often only considered to be an appearance defect and usually do not indicate any structural damage. Generally, the cause of a fine crack is indicative of a separation between brickwork and mortar throughout the structure, but single bricks may also show cracks of this nature.

Cracking of this nature can generally be repaired with minor filling and should be conducted by a qualified bricklayer.

Always contact a building inspector should cracks widen lengthen or become more numerous.

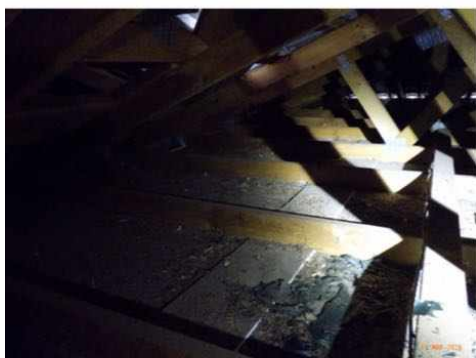
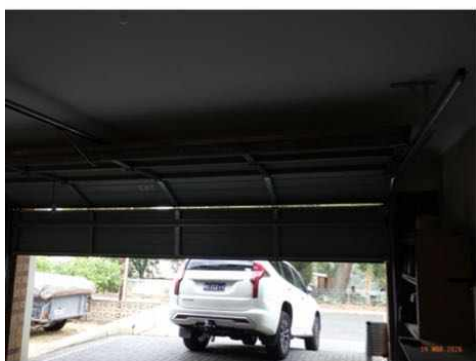
Information: A very common defect found in garages is that the ceiling can sag over time, due to their lack of insulation and or their susceptibility to moisture. Condensation builds up

in the roof and rests on the plasterboard softening it somewhat which makes it more likely to sag and release from its fixing points. Moisture evaporating from cars can also contribute to this issue.

Therefore we recommend that you insulate your garage and also apply a good coat of washable paint to the ceiling of the garage to prevent any moisture entering the plasterboard and creating issues in the future. A licensed building insulation installer and licensed painting contractor could be appointed to carry out these works at the discretion of the client.

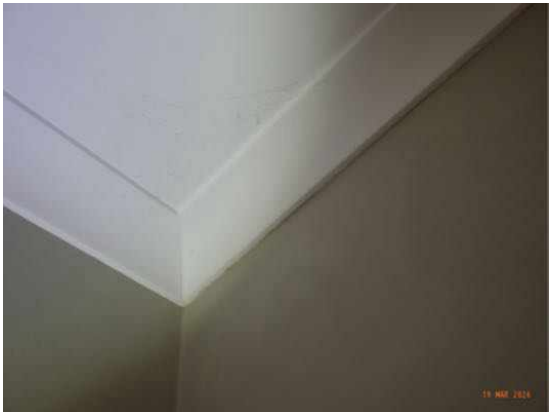
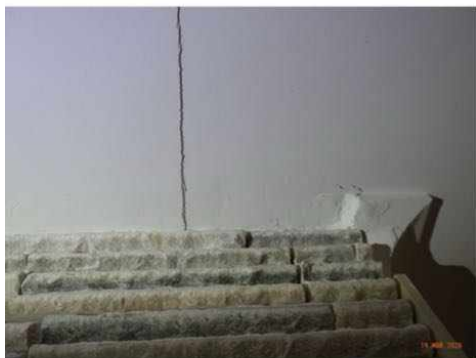
Finding 3.04

Building:	Building 1
Location:	All Internal Areas
Finding:	Cracking - Damage Category 1 - Fine (up to 1mm)
Information:	There were fine cracks evident to the walls and ceilings throughout the dwelling at the time of inspection.

Although fine cracks are quite noticeable, they are often only considered to be an appearance defect, and usually do not indicate any structural damage. Generally, the cause of a fine crack is indicative of a separation between building materials and finishes (e.g. paint, plaster, etc.) along joins.

Cracking of this nature can generally be repaired with minor sanding, filling and/or repainting. Such works should be performed by a qualified painter or a general handyman.

Monitoring of all cracking should be conducted frequently. Always contact a building inspector should cracks widen, lengthen, or become more numerous.

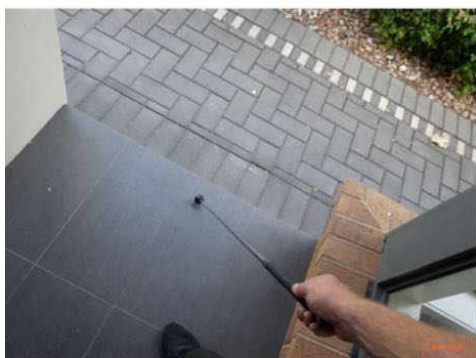
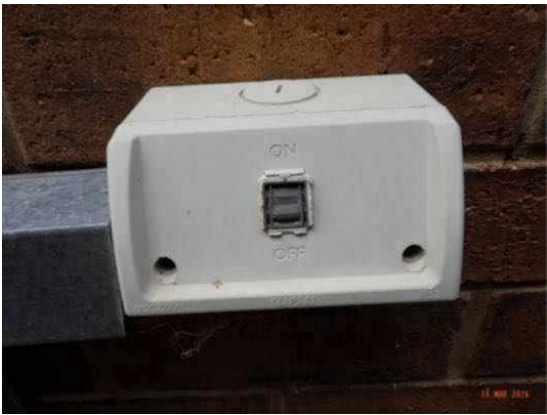
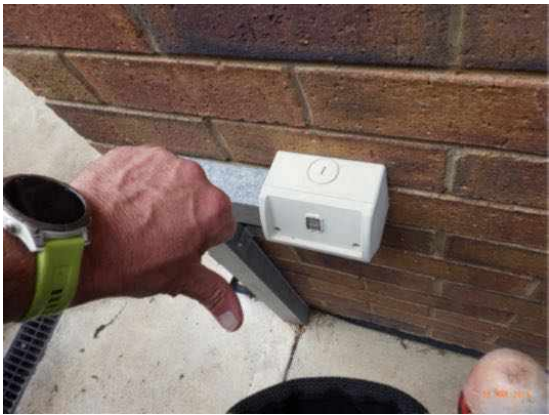
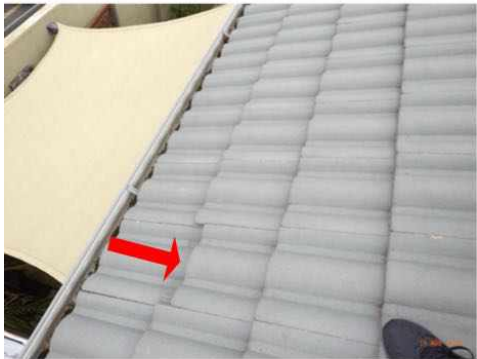
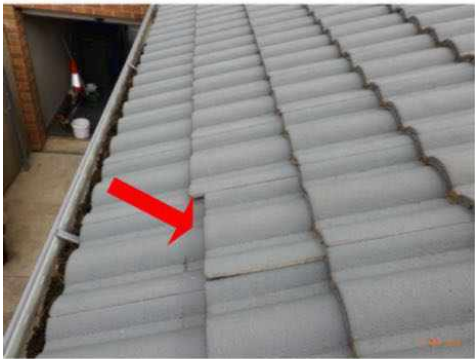
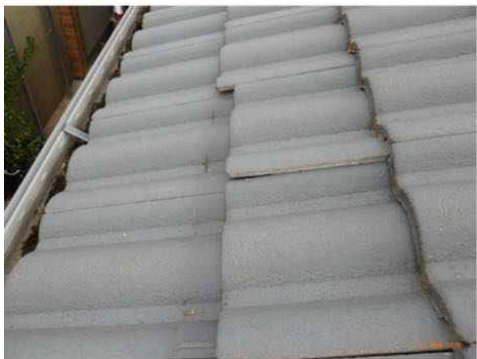
Finding 3.05

Building: Building 1
 Location: All Areas
 Finding: Minor defects present
 Information: There were several age and maintenance related defects evident to the dwelling at the time of inspection. These defects include but are not limited to

- approximately 20% of Porch tiles are drummy
- External power point missing its switch
- Roof tiles been pushed up and not returned onto place.
- Window winder is missing handle
- Several Fly screens are damaged
- Laundry tap is loose

Appropriate licensed trades people could be appointed to make repairs at the discretion of the client.

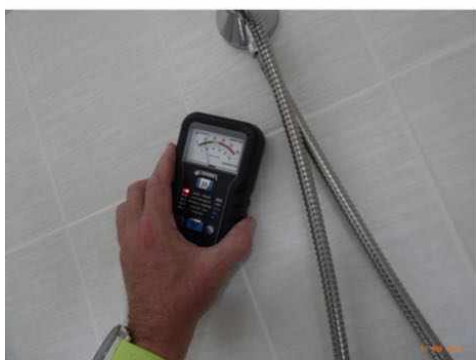
Building: Building 1
Location: Bathroom
Finding: Shower Head - Leaking
Information: The main shower head was found to be leaking at the time of inspection. There is no high moisture readings evident.

This is a common defect that is consistent with general ageing of the building element. However, it may be indicative of substandard plumbing workmanship if the tap is relatively new.

While this defect only seems minor, if left unmanaged, it is likely to result in the development of rust, water damage and/or extensive water usage.

It is advised that a licensed plumber be appointed immediately to perform remedial works on the affected fitting.

Repair leaking shower head

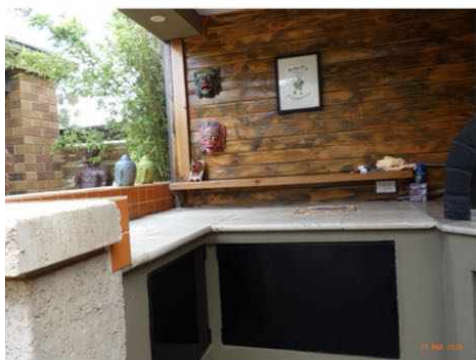
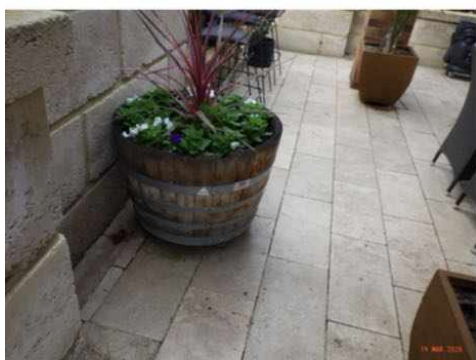
Finding 6.03

Building:	Building 1
Location:	All External Areas
Finding:	Untreated or non-durable timbers in a hazardous environment
Information:	To reduce the risk of timber pest attack it is essential that timber used in a hazardous environment (e.g. in direct contact with the ground or frequently exposed to damp conditions) is of sufficient durability and/or is adequately preservative treated. Additionally any timber lying around or timber stumps should be removed.

Untreated timbers in direct contact with the ground are likely to develop severe wood rot and/or fungal decay if left unattended creating attraction for subterranean termites to infest the timbers from surrounding areas.

If untreated or non-durable timbers are found to be in a hazardous environment it is highly advised that replacement of these building elements be performed as soon as possible to aid the protection of the property against termite / timber pest attack. Failing this close monitoring is recommended in an attempt to identify termite infestation at an early stage.

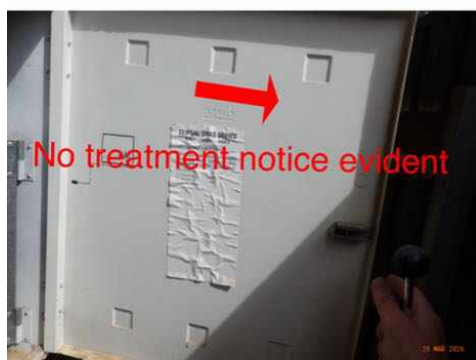
Finding 6.04

Building:	Building 1
Location:	All Areas
Finding:	Termite Management System - no evidence of a chemical installation
Information:	The application of a post-construction chemical termite barrier is highly recommended for all properties, particularly if live termite activity has been found on the site previously. Such barriers are highly effective in preventing termite attack on any timber building elements throughout the property.

At the time of inspection, it appeared as though no termite management system has been installed, with no evidence to suggest preventative works taking place.

The client may consider gaining further advice from a pest controller as to the costs and procedures involved with this application. It is recommended that obtaining such advice be a short-term priority.

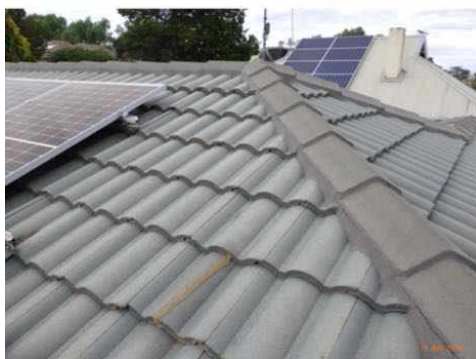
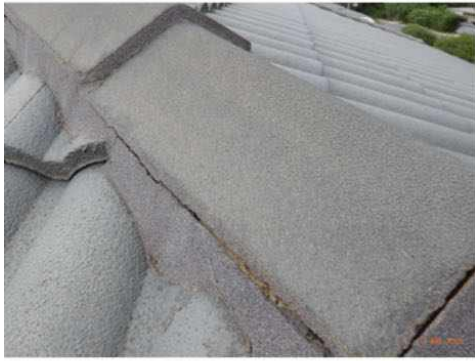
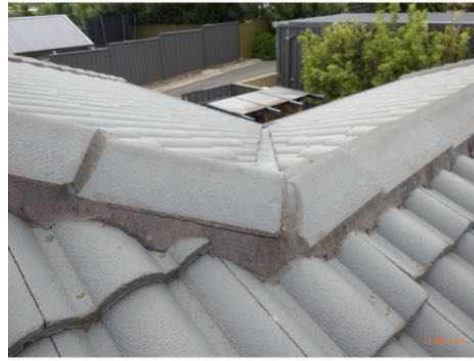
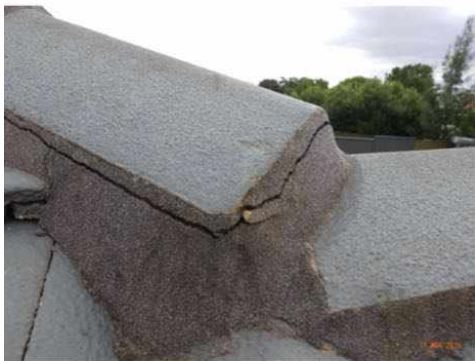
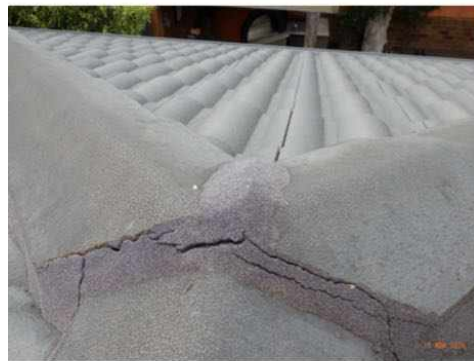
Finding 6.05

Building:	Building 1
Location:	Roof Exterior
Finding:	Mortar - Deterioration
Information:	Mortar, or 'bedding', is the material which fills joints and intersections between tiles and other building elements on the exterior roof covering, such as gable ends, hip capping and valleys. Upon inspection of the exterior roof, it was noted that sections of the mortar show varying levels of deterioration.

Mortar generally deteriorates as a result of frequent exposure to weather conditions over a prolonged period of time. Mortar that is deteriorating may allow water ingress into the roof void, putting associated building elements and roofing structures at risk of water damage.

Deteriorated mortar also detracts from the functionality of roof tiles and other roofing elements, potentially decreasing weather tightness and roof drainage.

Mortar deterioration can be attended to by a handyperson where areas of deterioration are localised and easily accessible. Otherwise, consultation with a roofing contractor is advised where greater works are required.

Small repairs to ridge mortar.
