# Building and Timber Pest Inspection Report

Inspection Date: Fri, 20 Mar 2026

Property Address: 81 Rumsey Dr, Raceview QLD 4305,  
Australia

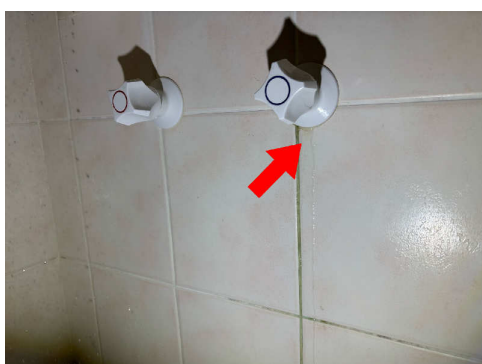
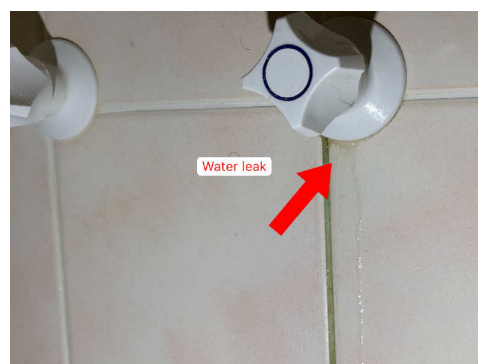
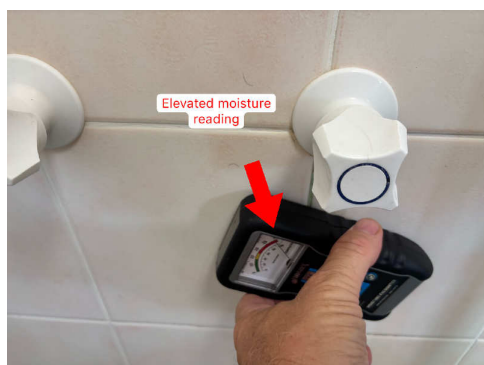
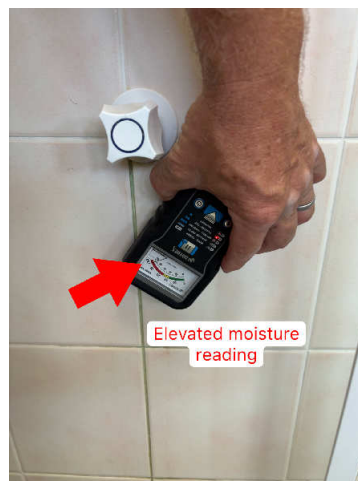
Finding: Ensuite - elevated moisture readings to shower wall

Information: At the time of the inspection, it was noted that there were elevated moisture readings recorded beneath the cold tap on the shower wall in the ensuite. It was found that water was leaking from the underside of the cold tap when turned on. The grout in this area is stained which suggests that moisture has been bleeding through the grout to get behind the tiles, resulting in the elevated moisture readings. Moisture behind the wall tiles may have a negative affect on the wall tile glue. This could result in loose tiles.

A licensed plumber should be engaged to repair the leaking tap. This should be done as a matter of urgency.

A bathroom specialist could be engaged to replace the grout and seal the floor and wall tiles in the shower cubicle. This will give longevity to the bathroom. This can be done at the clients discretion.

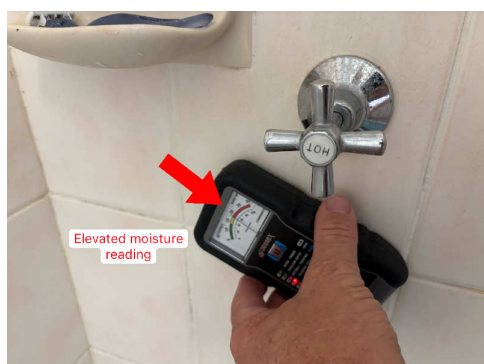
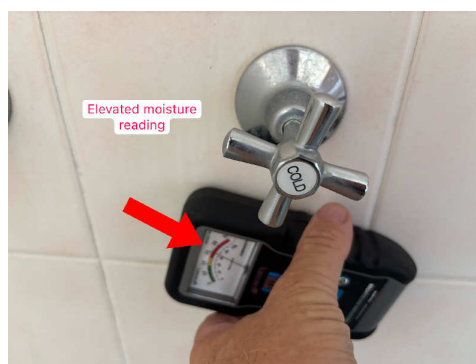
### Finding 3.02

Finding: Family bathroom - elevated moisture readings to shower wall

Information: At the time of the inspection, it was noted that there were elevated moisture readings recorded beneath the taps on the shower wall in the family bathroom.

This may be due to the age of the materials. Grout and certain tiles can be porous. Moisture behind the wall tiles may have a negative affect on the wall tile glue. This could result in loose tiles.

A bathroom specialist could be engaged to replace the grout and seal the floor and wall tiles in the shower cubicle. This will give longevity to the bathroom. This can be done at the clients discretion.

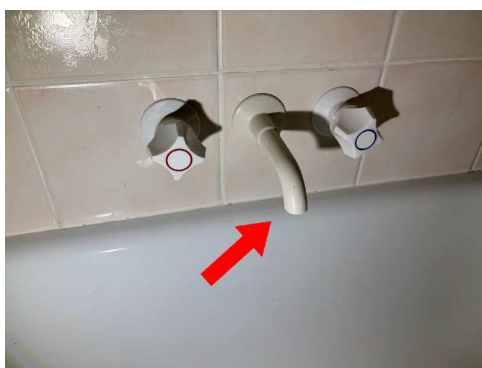
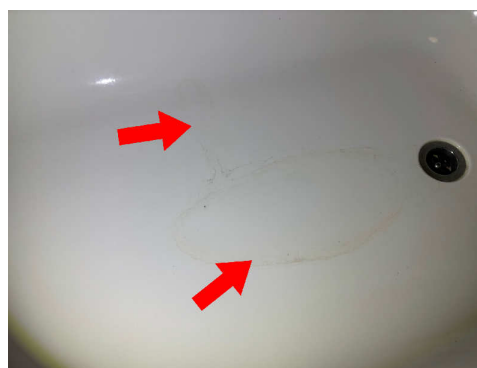
### Finding 3.03

Building:	Main Building
Location:	Family bathroom
Finding:	Family bathroom - bath tub taps leaking
Information:	<p>At the time of the inspection, it was noted that there was a slow leak from the bath tub taps when they are turned off. A stain can be seen in the bath tub. This may be due to general wear and tear of the tap seals.</p> <p>A licensed plumber should be engaged to replace the seals to the bath tub taps. This should be done as a short term priority.</p>

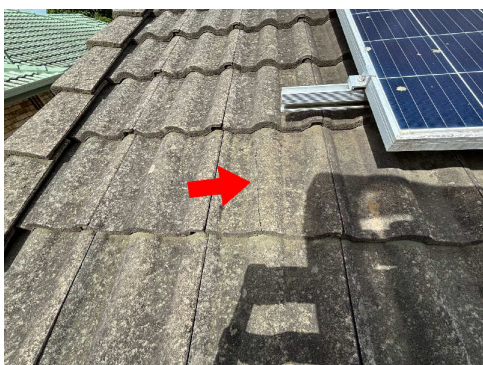
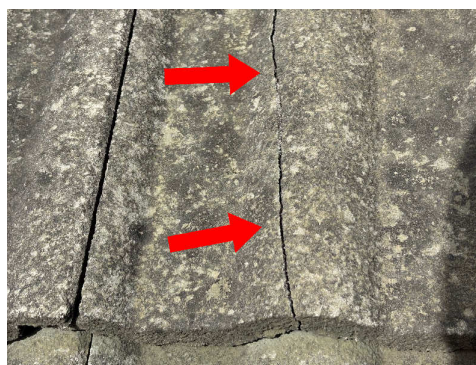
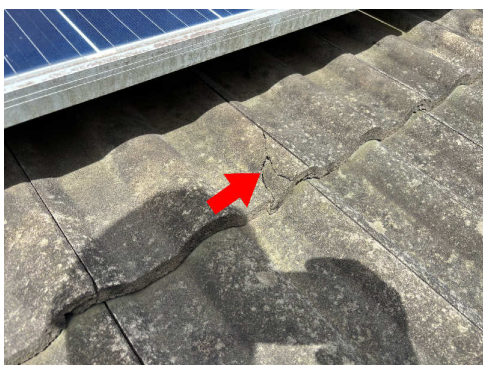
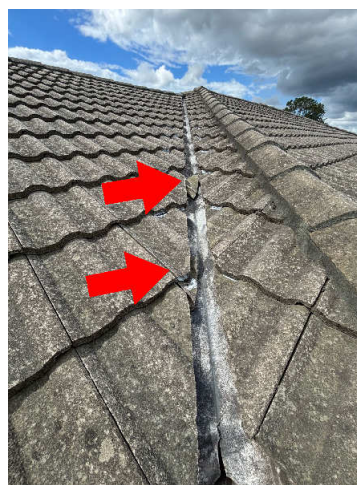
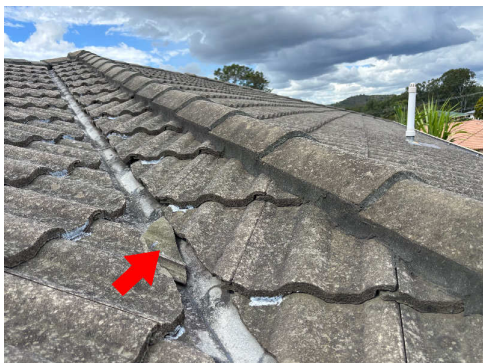
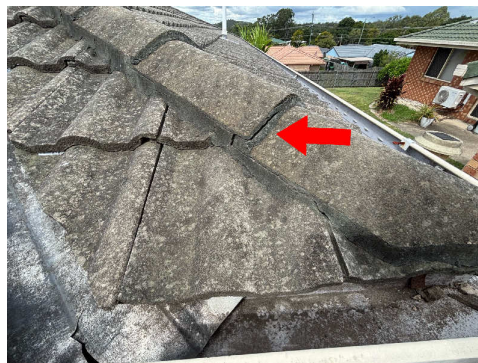
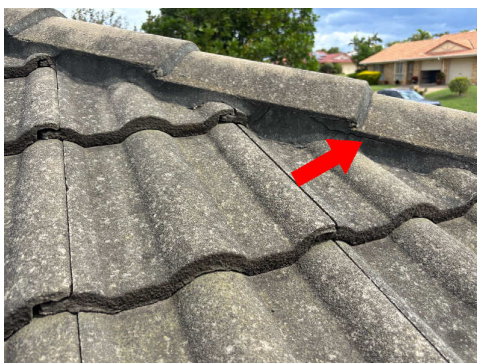
### Finding 3.04

Building:	Main Building
Location:	Roof Exterior
Finding:	Roof tiles - Weathered

Upon inspection of the exterior roofing, the majority of roof tiles were considered to be in a fair condition. While weathering of the tiles is consistent with the age of the property, maintenance works are required.

Cracked tiles were found at the front left hand side of the dwelling near the solar panels. Tiles were dislodged in the valleys and should be put back in place to avoid a dam like affect in the valleys. Minor cracking was found to some sections of the ridge cap mortar.

Where left unmanaged, deteriorating roof tiles are likely to lead to a number of secondary defects, including minor water leaks and weather exposure to internal roofing structures.

Consultation with a roofing contractor is highly advised to gain advice on cost of remedial works that may be required in the short to medium term. Remedial works are likely to increase the longevity of the exterior roofing structure. If left unaddressed, this minor defect may become a major defect.

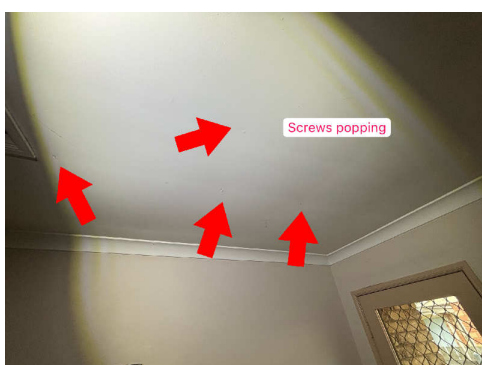
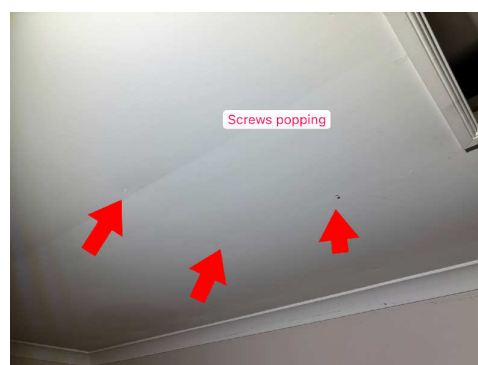
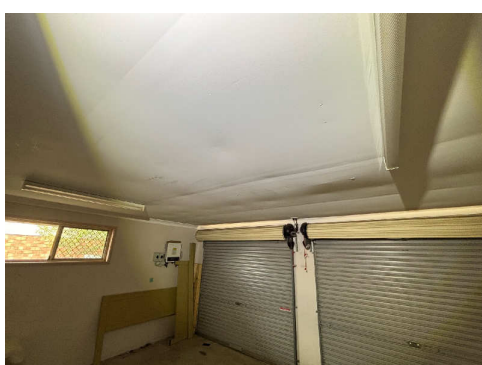
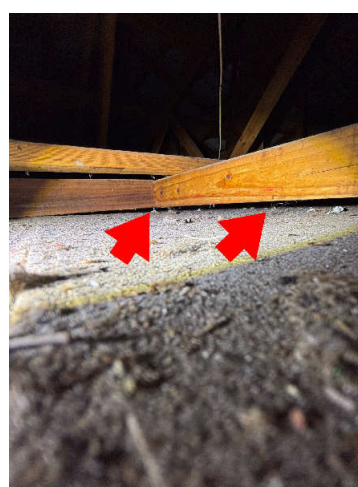
**Finding 3.05**

Building: Main Building  
Location: Garage  
Finding: Ceiling nails/screws - Popping

Nails and screws hold simply by the friction between them and the surface they are applied to. Over time, the nails and screws can back out, which is often a result of general ageing and deterioration of the building structure.

If left unmanaged, the ceiling sheets may become loose and unstable, increasing the rate of deterioration of the internal ceiling and creating potential for the development of secondary defects.

Re-fastening of popped nails will help to maintain the stability of the internal ceiling and associated building elements. Such minor works will also help to improve the appearance of the affected area and secure the ceiling sheets, so as to prevent the onset of ceiling sagging. These works should be performed by a qualified carpenter or plasterer at client discretion.

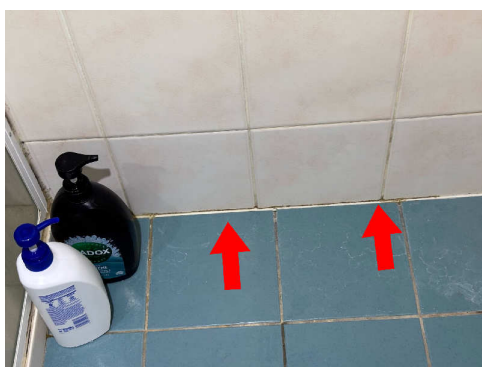
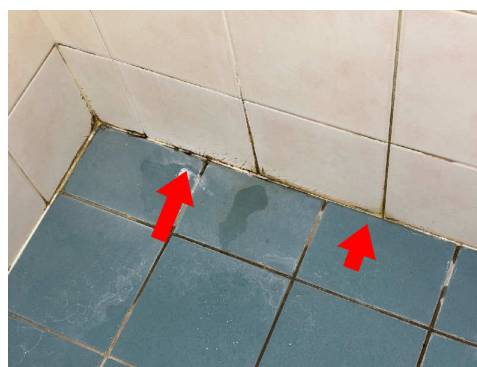
## Finding 3.06

Building:	Main Building
Location:	Ensuite
Finding:	Sealant deteriorating
Information:	At the time of the inspection it was noticed that the sealant in the shower in the ensuite was deteriorating.

Sealant is used in tiled areas to prevent moisture from entering the wall cavity and causing damage to the building elements. A moist environment in the wall cavity may also be a conducive condition for termite activity.

If it is not addressed, damage to building elements will occur and would require invasive works to rectify any damage.

A building maintenance professional or sealant applicator should be appointed to replace all sealant as a matter of urgency.

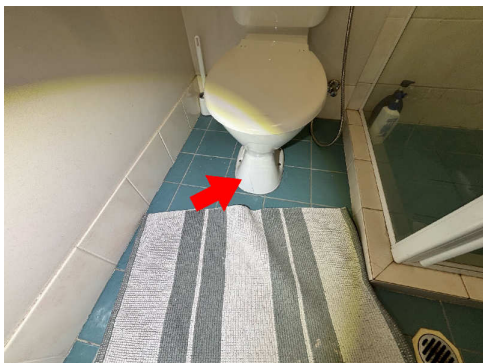
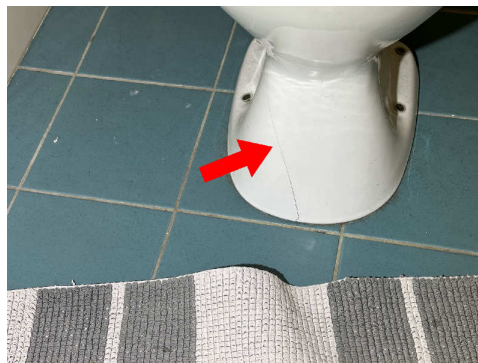
### Finding 3.07

Building:	Main Building
Location:	Ensuite
Finding:	Ensuite - toilet base cracked
Information:	At the time of the inspection, it was noted that the toilet base in the ensuite was cracked. This may be due to general wear and tear.

A licensed plumber could be engaged to replace the toilet. This can be done at the clients discretion.

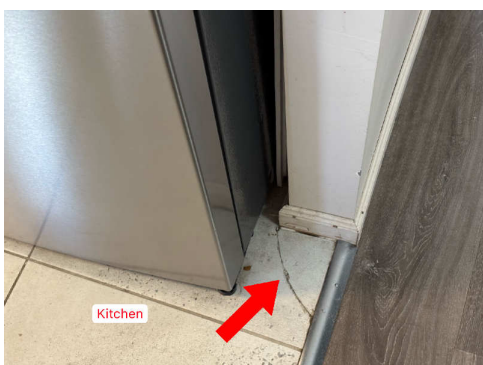
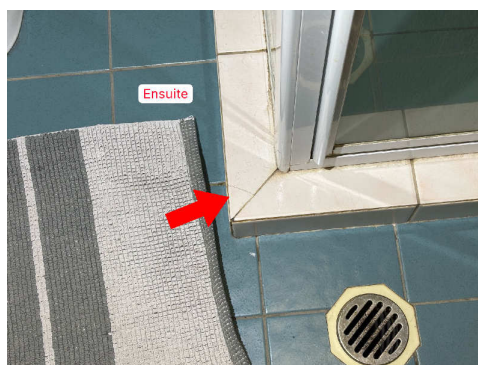
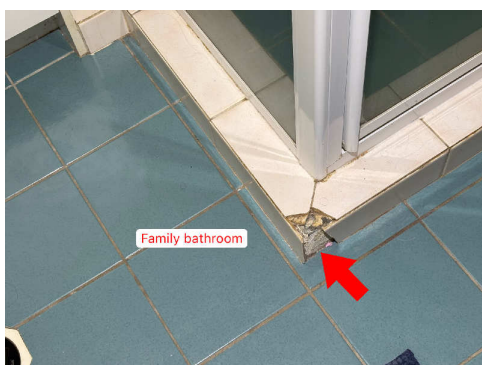
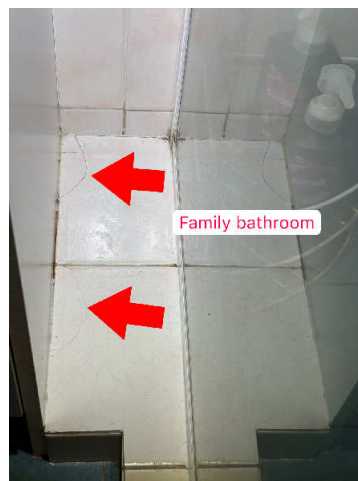
### Finding 3.08

Finding: Cracked tiles

Information: At the time of the inspection it was noted that several floor tiles were cracked in the dwelling. Examples were found in the kitchen, ensuite and family bathroom. These appear to be purely an aesthetic issues and could be attended to at the clients discretion. The tiles may have cracked because they are drummy and something has been dropped on them.

A tiler or building maintenance professional would be able to carry out the necessary works.

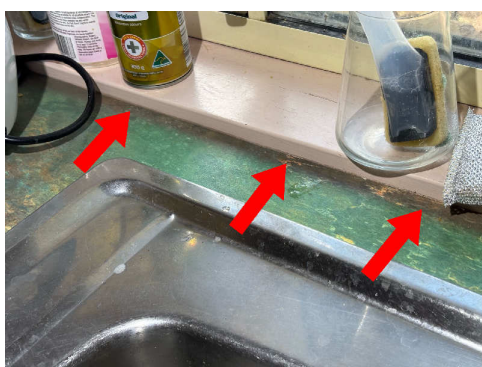
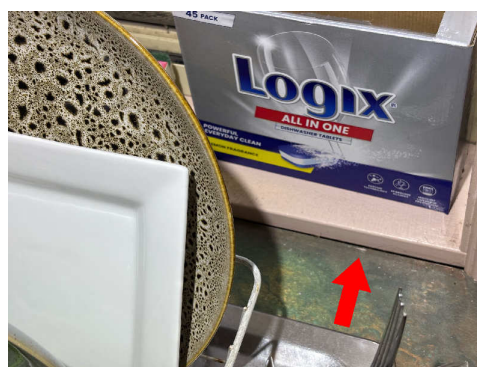
### Finding 3.09

Information: At the time of the inspection, it was noted that there was no sealant to the junction of the bench top and the window sill. This allows water from the sink to enter this junction and potentially penetrate the bench top which can cause deterioration.

A sealant application professional could be engaged to apply sealant to these junctions. This can be done at the clients discretion.

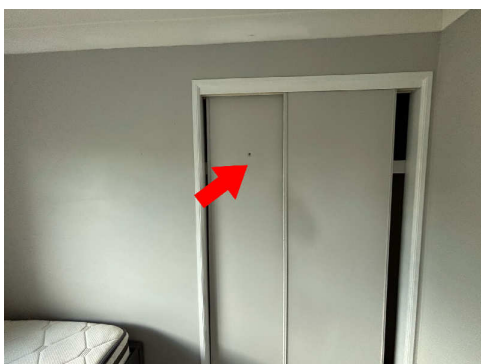
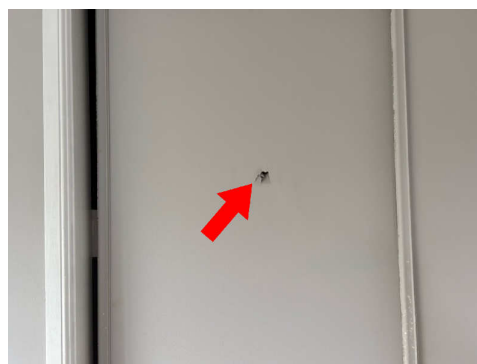
### Finding 3.10

- Finding: Bedroom 3 - damage to wardrobe door
- Information: At the time of the inspection, it was noted that there was some minor damage to the wardrobe door in bedroom 3.
- A building maintenance professional or painting contractor could be engaged to carry out this minor repair. This can be done at the clients discretion.

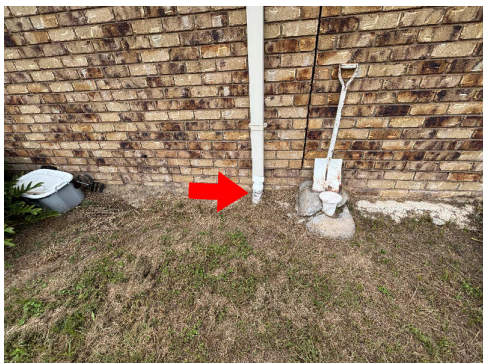
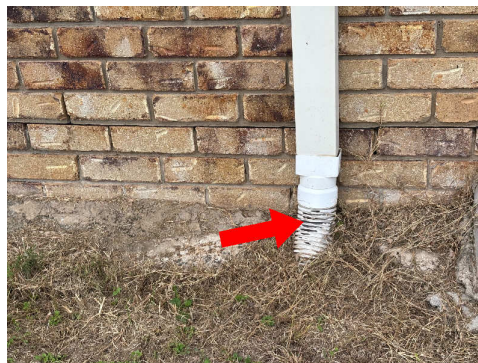
### Finding 3.11

- Building: Main Building
- Location: Rear Elevation
- Finding: Down pipe - damaged
- Information: At the time of the inspection, it was noted that the bottom section of the down pipe at the rear of the dwelling is damaged. This affects the functionality of the down pipe and allows water to escape near the foundation.
- Excessive moisture next the foundations of the dwelling creates a conducive environment for termite activity and can cause damage to the associated building materials.
- A licensed plumber should be engaged to carry out this repair. This should be done as a short term priority.

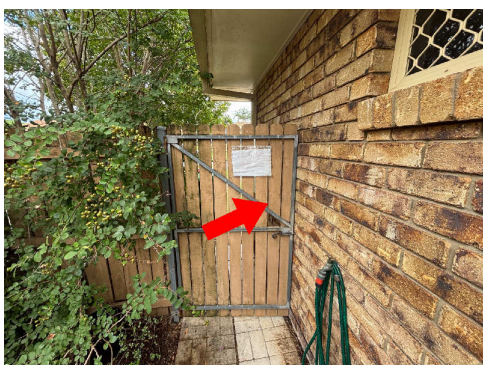
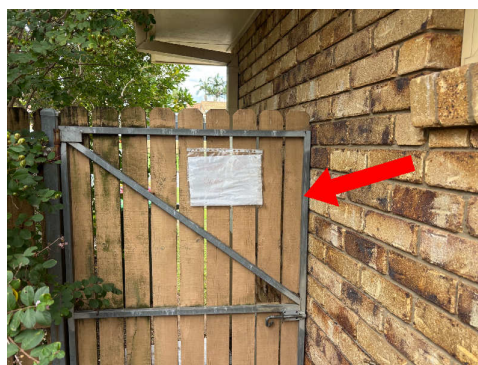
### Finding 3.12

Information: At the time of the inspection, it was noted that the side gate was binding on the brickwork. Movement of the fence may be causing the binding.

A building maintenance professional should be engaged to carry out the necessary repairs to restore functionality to the gate. This can be done at the clients discretion.

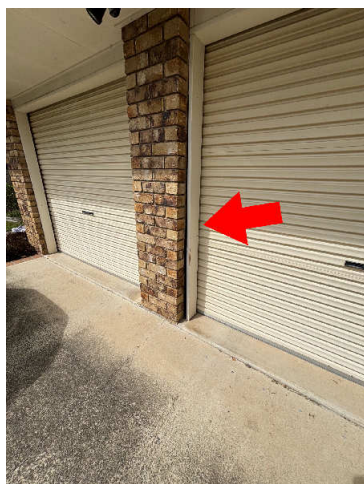
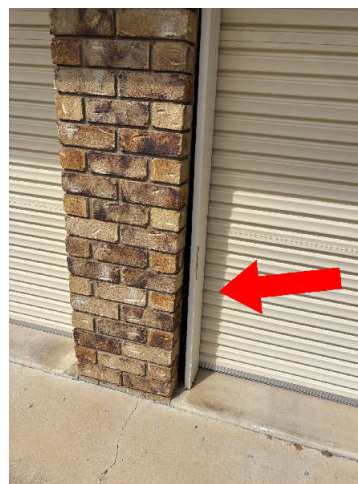
### Finding 3.13

Finding: Garage - door jamb loose

Information: At the time of the inspection, it was noted that one of the garage timber door jambs is loose. If left unaddressed, this jamb may fall off.

A building maintenance professional could be engaged to re-secure this timber door jamb. This can be done at the clients discretion.

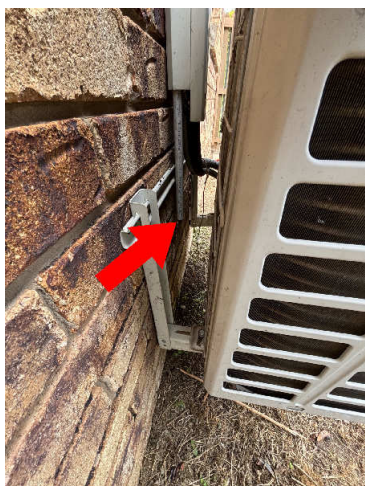
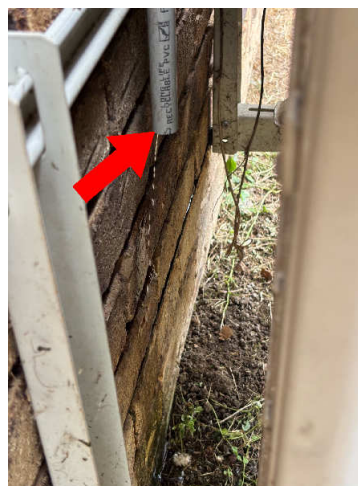
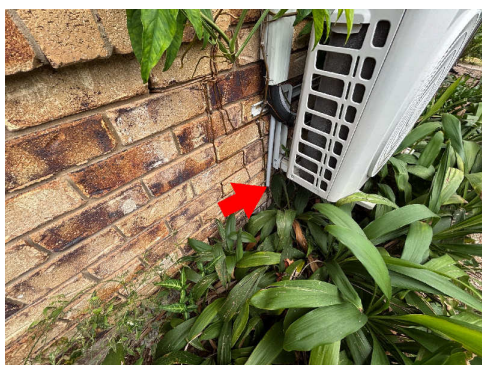
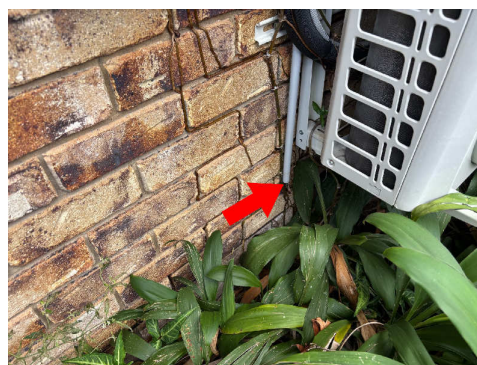
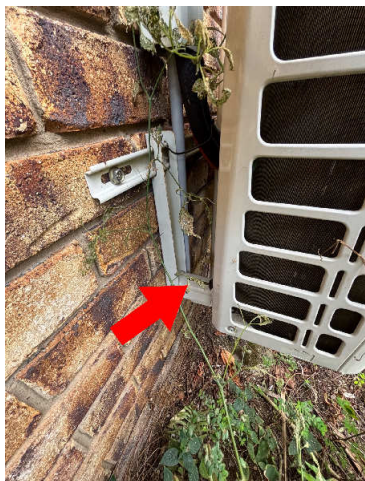
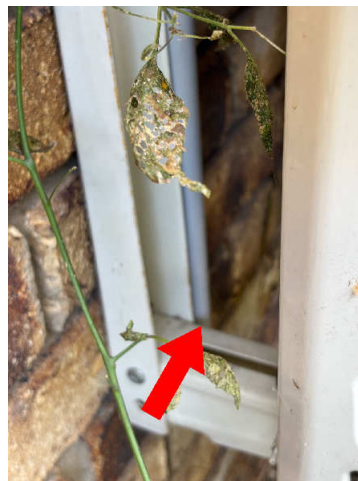
Finding: Air conditioner - Disconnected overflows

At the time of the inspection, it was noted that the air conditioner drain overflows to all the units were not connected to the storm water drainage and as a result are draining next to the foundations of the dwelling. The unit for the master bedroom is plumbed into the storm water.

Air conditioning overflows that are not connected to the storm water drainage and are draining near the foundation can create excessive moisture in the surrounding area.

Such leaking creates an environment which is conducive to an array of defects, including water damage to associated building elements and the attraction of termite or timber pest infestation.

It is highly recommended that a licensed plumber be appointed to connect the A/C overflow in order to prevent such an environment from being created. These minor works should be carried out as soon as possible.

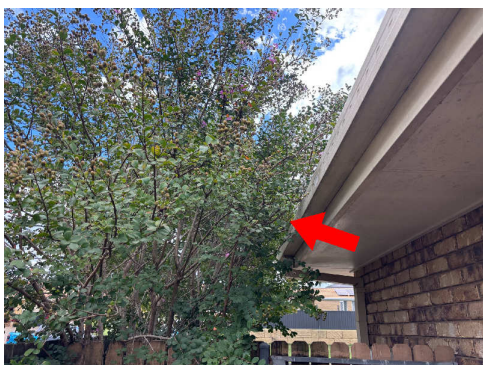
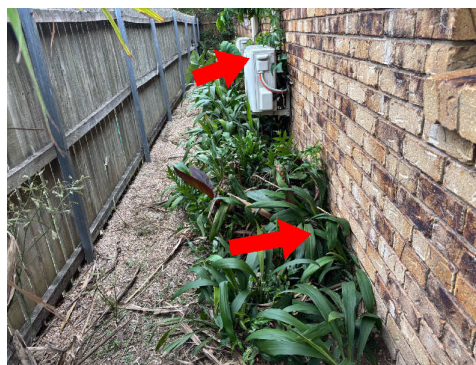
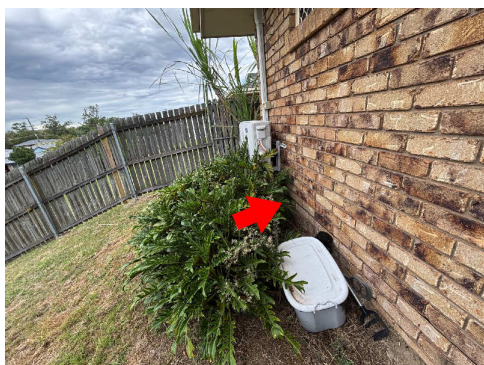
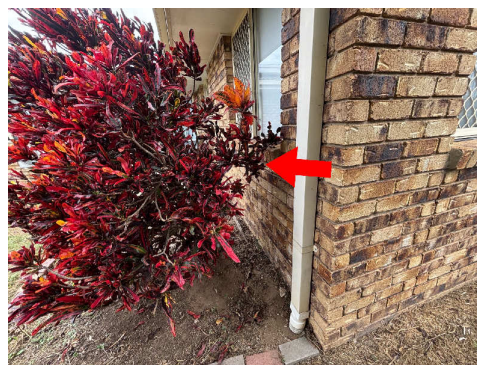
### Finding 6.02

Information: At the time of the inspection, it was noted that there was vegetation touching the building in several locations. This creates a potential access point for termites to enter the building undetected. This is a conducive condition for termite activity.

The client is to ensure that the vegetation is trimmed back to prevent undetected termite entry to the building. This should be done as a matter of urgency.

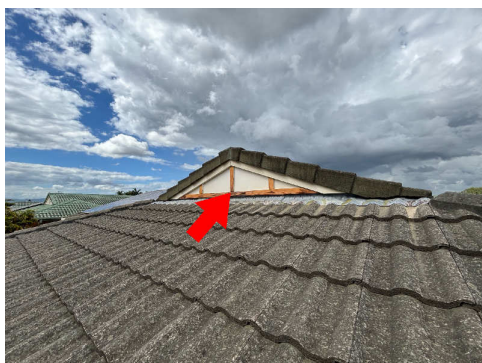
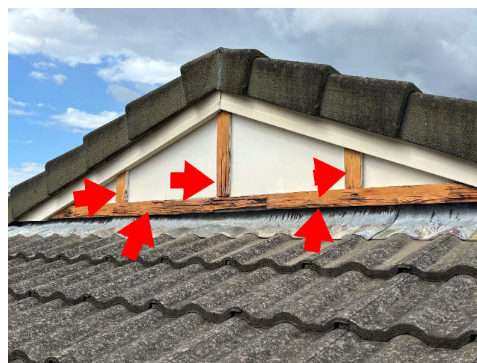
### Finding 7.01

Finding: Wood rot - decorative mouldings

Information: At the time of the inspection, it was noted that there was evidence of wood rot to the decorative timber mouldings on the front gable. This may be due to the age of the timber building elements and general weathering.

This building element shows evidence of wood rot. Wood rot, also known as Fungal Decay, occurs when timbers and other cellulose building materials are exposed to damp conditions on an ongoing basis.

Wood rot is often associated with general damp problems and is evidenced by a 'musty' smell or mould and mildew occurring on surfaces. If left unmanaged, damp conditions can lead to further health problems and the decay of timbers will continue.

Early intervention and regular maintenance, particularly of exterior timbers, will prolong the useful life of these building elements. Prior to any works being performed, the cause of the moisture that has created the visible wood rot should be identified and addressed in a suitable manner. Replacement of affected timbers may then be a necessary step in protecting surrounding building elements from such deterioration.

A qualified carpenter or registered builder may also be required to replace affected building materials.

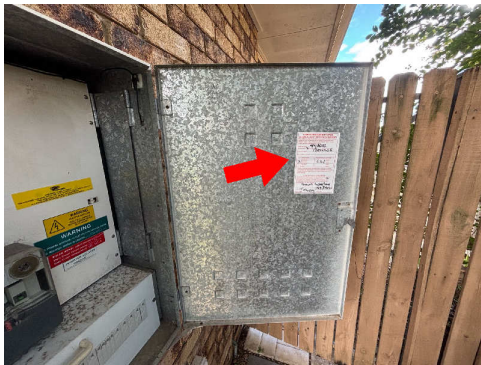
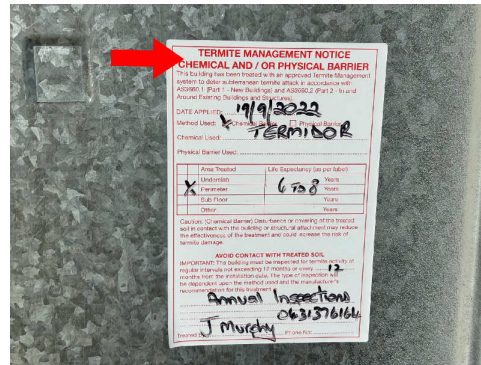
### Finding 9.01

Building:	Main Building
Location:	All External Areas
Finding:	Evidence of a current chemical termite management system was identified.
Information:	<p>At the time of the inspection, evidence of a current chemical termite management system was found by way of a durable notice in the electricity meter box.</p> <p>A chemical soil treatment was carried out to the perimeter of the dwelling on the 19/09/2022 with an expected life span of 6 - 8 years. This chemical treatment requires annual termite inspections.</p> <p>The client should have annual termite inspections carried out as per AS 3660.2 to help protect the dwelling.</p> <p>A termite treatment system and annual termite inspections are important parts of an ongoing termite management plan.</p>

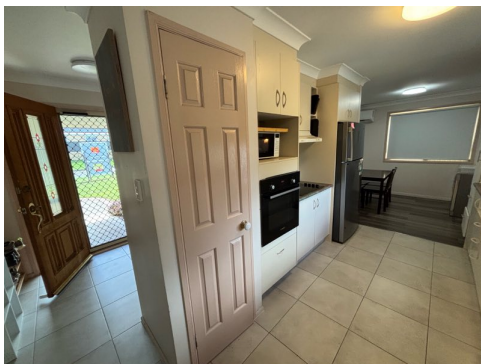
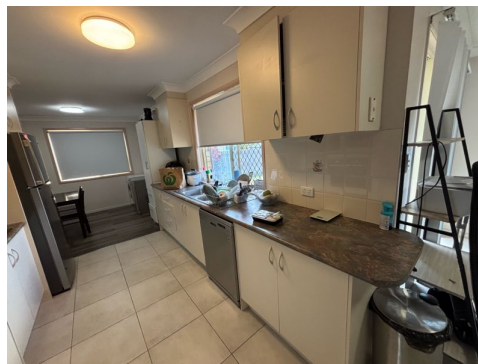
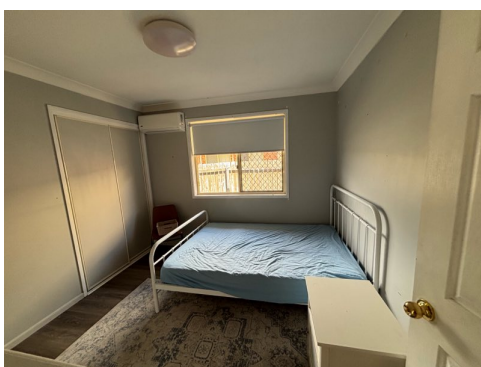
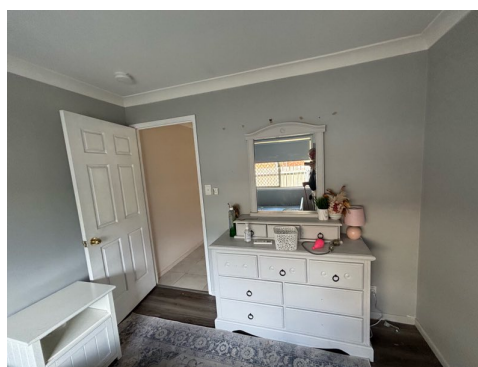
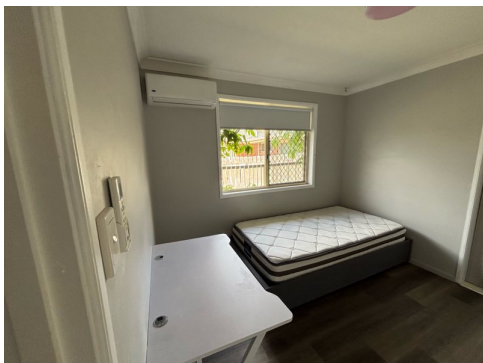
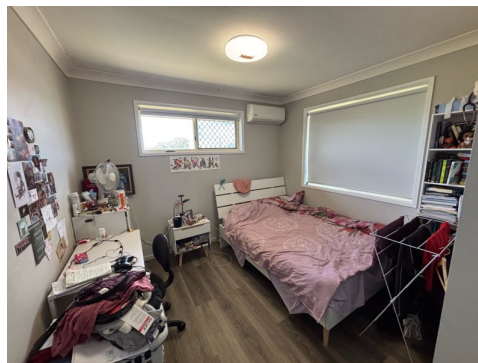
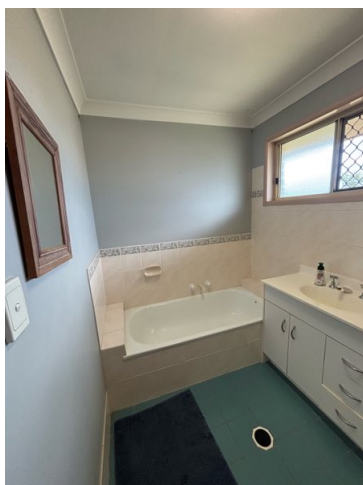
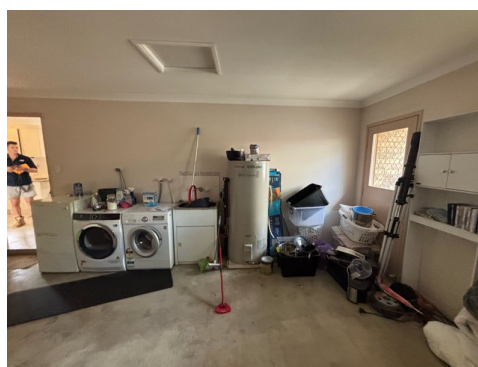
Finding: Obstructions and Limitations - Internal areas

Information: These photographs are an indication of the obstructions and limitations which impeded full inspection of the property of the internal areas at the time of inspection. These obstructions can hide an array of defects and should be removed to allow full inspection to be carried out. A re-inspection is recommended once the areas are made accessible.

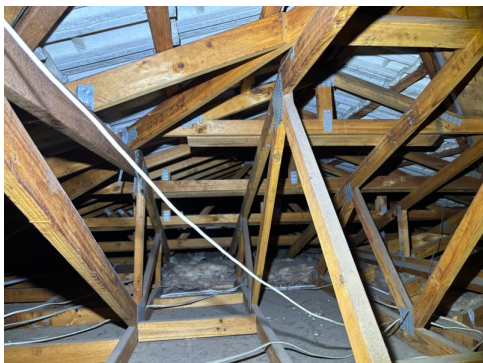
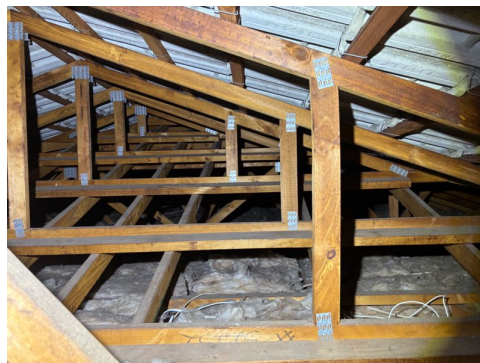
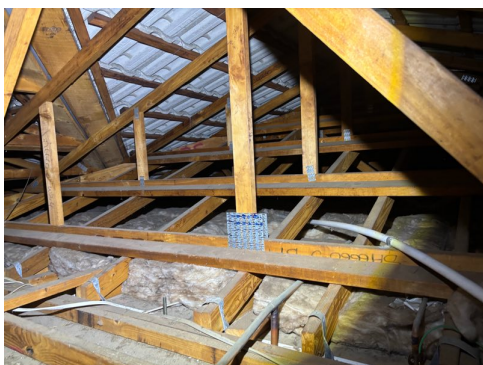
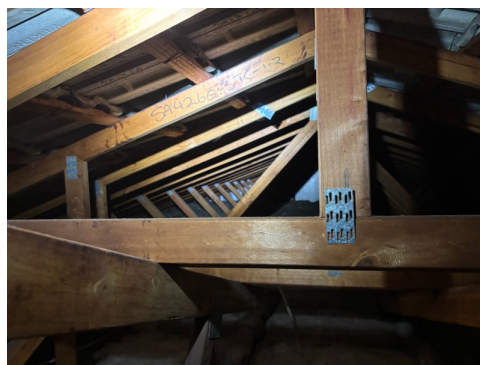
Finding: Obstructions and Limitations - Roof cavity

Information: These photographs are an indication of the obstructions and limitations which impeded full inspection of the property of the roof cavity at the time of inspection. These obstructions can hide an array of defects and should be removed to allow full inspection to be carried out. A re-inspection is recommended once the areas are made accessible.

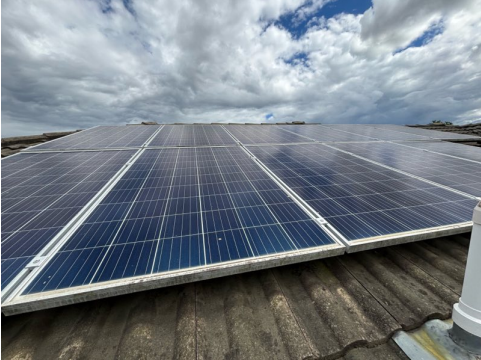
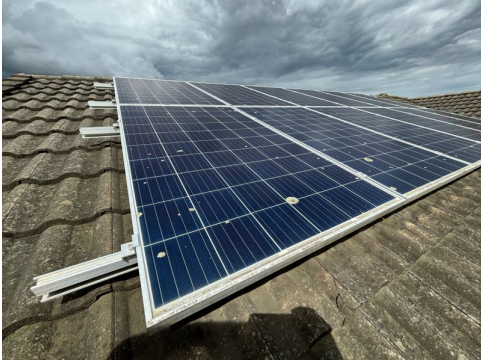
Finding: Obstructions and Limitations - Roof exterior

Information: These photographs are an indication of the obstructions and limitations which impeded full inspection of the property of the roof exterior at the time of inspection. These obstructions can hide an array of defects and should be removed to allow full inspection to be carried out. A re-inspection is recommended once the areas are made accessible.
