Building and Timber Pest Inspection Report

Inspection Date: Wed, 25 Mar 2026

Property Address: 18B Marara Rd, Caulfield South VIC 3162,
Australia

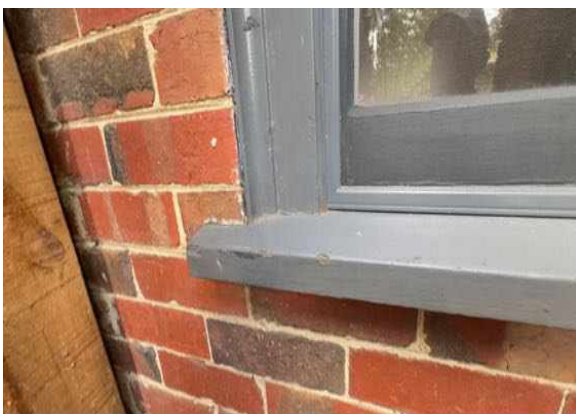
Building:	Main Building
Location:	All External Areas
Finding:	External Timber - Timber Rot
Information:	Timber elements including wall claddings, timber rails & posts, landscaping timbers, and other external timber surfaces were inspected and show signs of rot, decay and fungal attack in these areas. Softening, discoloration, splitting, and moisture penetration indicate ongoing timber degradation.

This is likely caused by prolonged moisture exposure, inadequate protective coatings or maintenance, direct contact with soil or water, or poor detailing that traps water or limits ventilation.

If left unaddressed, the affected timber may lose structural integrity, leading to progressive decay, potential collapse of walls, decks, or landscaping features, mould growth, and reduced durability and appearance of the building exterior.

A registered builder or timber specialist should inspect the affected areas immediately to determine the extent of damage. Damaged timbers should be repaired or replaced, protective treatments applied, and drainage or detailing corrected to prevent recurrence. Ongoing monitoring and urgent remedial action are required to prevent further deterioration.

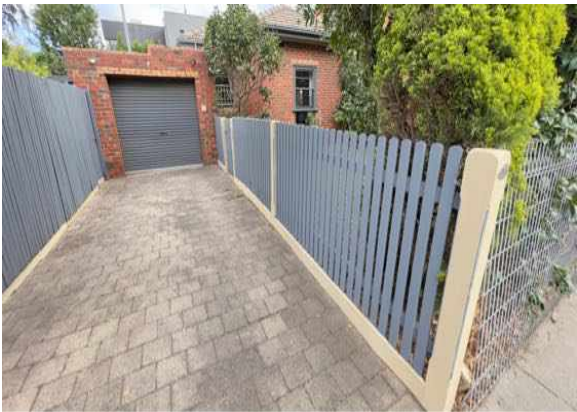
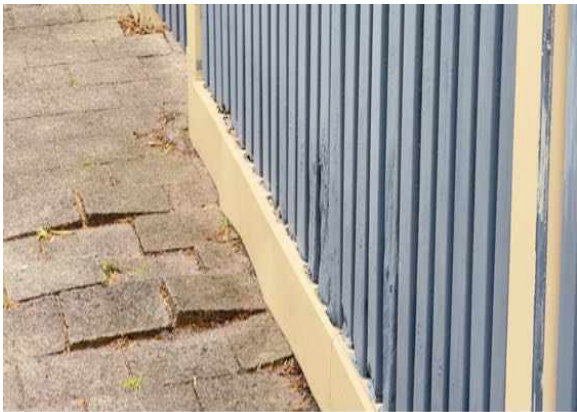
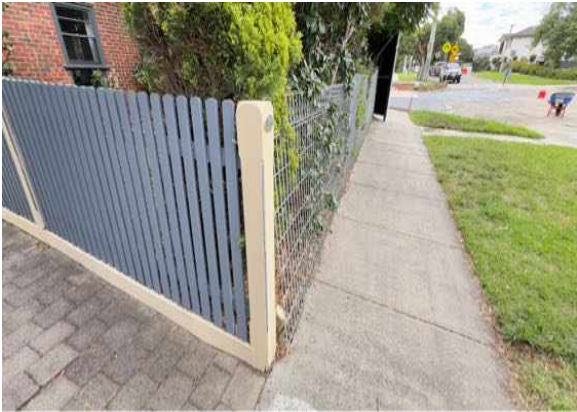
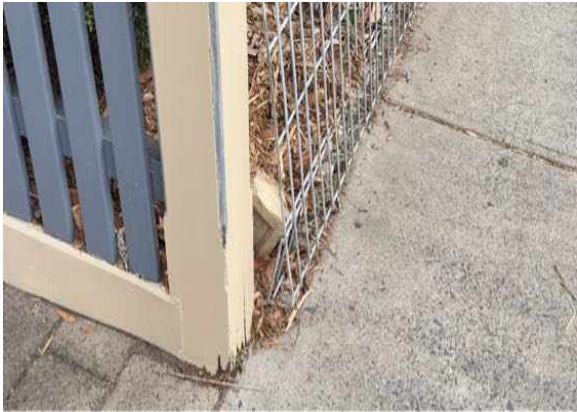
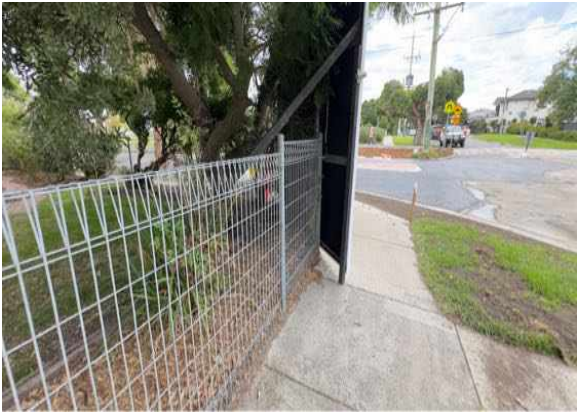
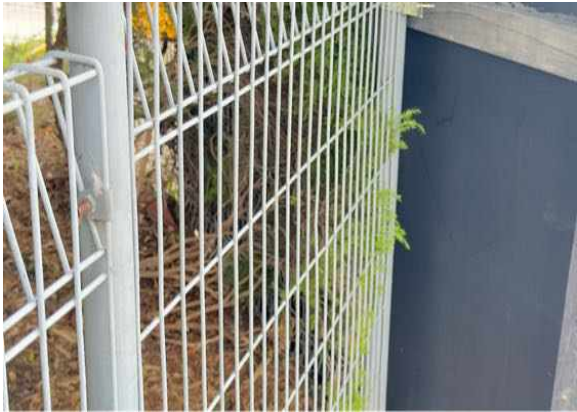
Building: Main Building
Location: Fencing All Areas
Finding: Fencing - Deteriated
Information: Timber fencing was inspected and deterioration was observed in this area. Deteriorated fencing can compromise structural stability, reduce privacy, and may allow pest ingress or accelerated decay if left unaddressed.

Possible causes include age-related timber decay, prolonged exposure to moisture or sunlight, poor maintenance, or impact damage.

When practical, a qualified carpenter or fencing specialist should be engaged to repair or replace affected sections, and a qualified painter should be engaged to restore protective finishes. Prompt rectification will maintain structural performance, improve appearance, and extend the lifespan of the fencing.

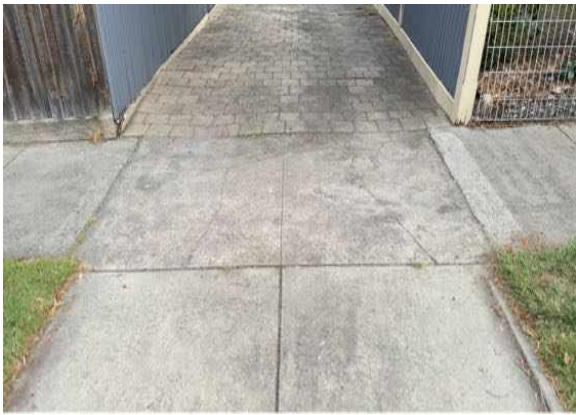
Building:	Main Building
Location:	Driveway >
Finding:	Driveway - Minor Cracking & Surface Imperfections
Information:	The external driveway was visually inspected. Minor cracking, surface settlement, and minor unevenness was observed in this area. While these defects do not currently compromise structural safety, they may affect long-term durability, appearance, and vehicle access.

These issues may be caused by age-related wear, soil movement or settlement beneath the driveway, possible tree root intrusion, or inadequate original construction or reinforcement.

A qualified concreter should be engaged when practical to repair or resurface affected areas. Prompt rectification will restore a smooth surface, improve appearance, and prevent further deterioration.

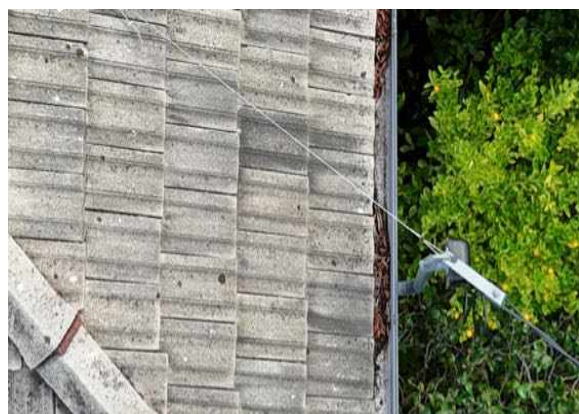
Building: Main Building
Location: Roof Exterior
Finding: Roof Plumbing - Roof Tiles Cracked
Information: Roof tiles in this area are cracked and may no longer provide full protection. The issue is observed across the roof surface where damaged tiles are present.

This has likely occurred due to impact, weathering, or poor installation. Cracked tiles may allow water to penetrate, causing leaks, water damage to internal structures, or deterioration of surrounding tiles.

A licensed roof plumber is required to inspect and repair or replace the cracked tiles in this area. This should be rectified immediately to prevent water ingress and further damage.

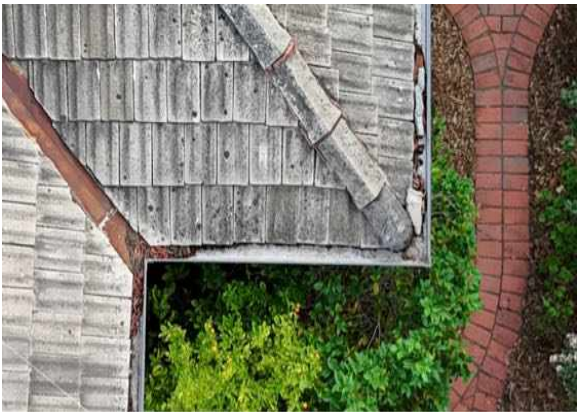
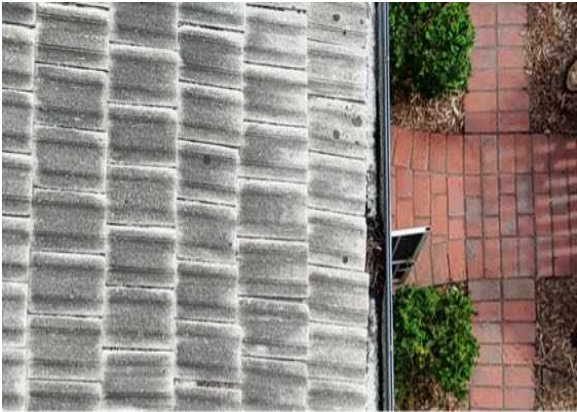
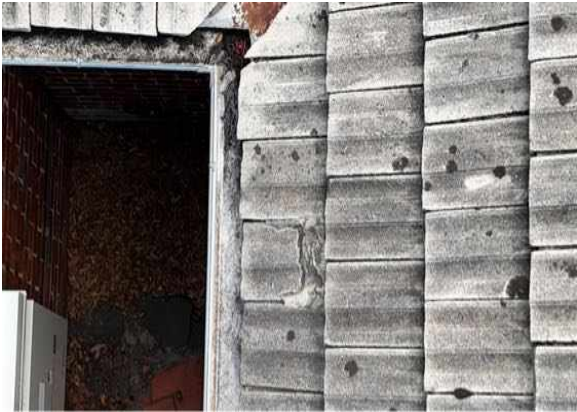
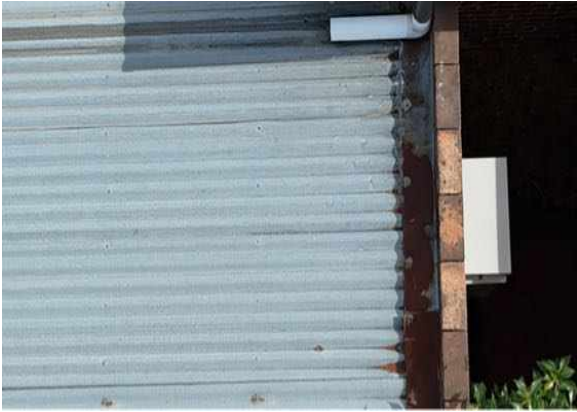
This has likely occurred due to long-term exposure to sunlight, rain, wind, frost, and environmental conditions. These combined issues increase the risk of water penetration, leaks, damage to the roof structure, and further deterioration of surrounding tiles.

A licensed roof plumber is required to inspect and repair or replace the affected tiles in this area. This should be rectified immediately, which may include removing moss, algae, and lichen, realigning or replacing damaged tiles, treating deteriorated tiles, and ensuring the roof covering is fully watertight to prevent further damage.

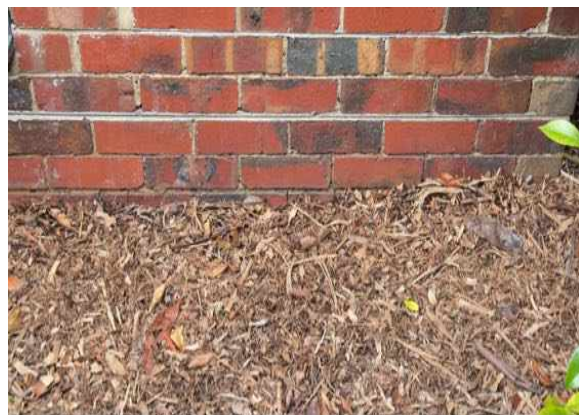
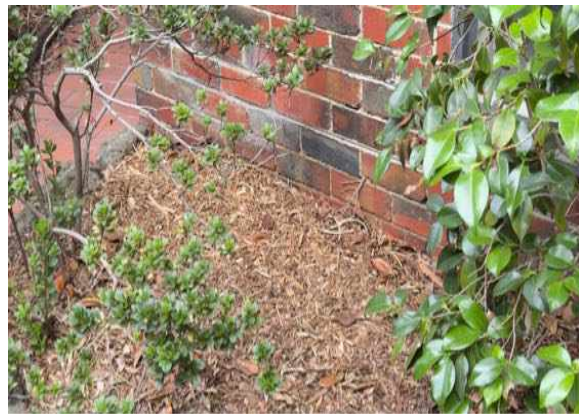
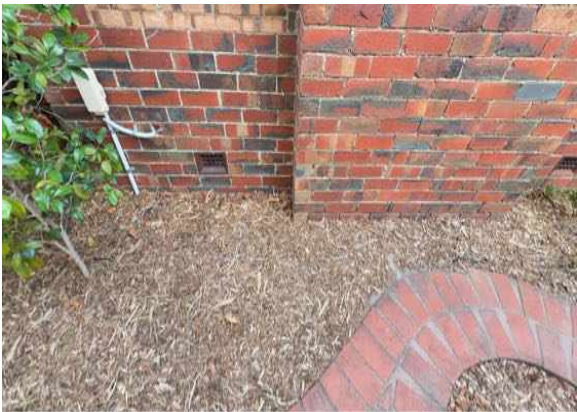
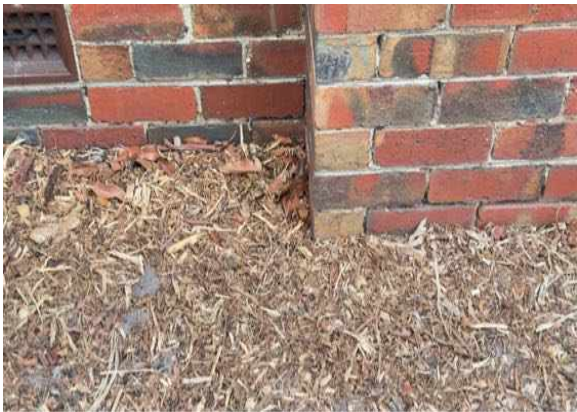
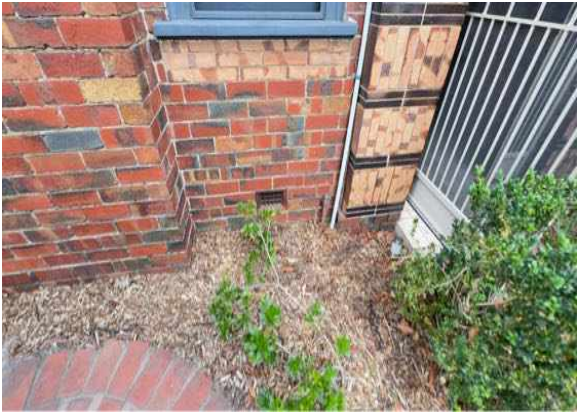
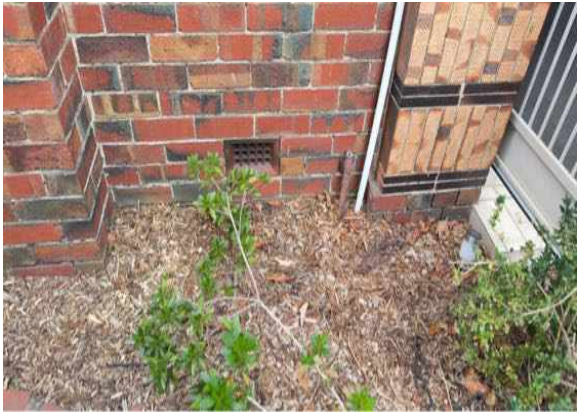
Finding 6.02

Building:	Main Building
Location:	All External Areas
Finding:	Timber Pests - Bridging Of Termite Barrier Found
Information:	During the inspection, bridging of the termite barrier was observed in certain areas. Bridging occurs when external elements, such as soil, vegetation, garden beds, or timber, make direct contact with the termite management system, effectively bypassing the barrier's protective function. This compromises the barrier's ability to prevent termites from accessing the building and can increase the risk of infestation.

It is strongly recommended that a licensed pest management specialist or termite professional be engaged immediately to assess the termite barrier and address the bridging issue. This may involve removal of bridging materials, adjustment or repair of the barrier, and ensuring that the area around the barrier is clear of any materials that could facilitate termite entry.

In addition to addressing the bridging issue, it is also crucial to inspect the property for signs of termite activity immediately and consider replacing or reapplying the termite barrier to ensure it is still effective. Regular maintenance and monitoring of the barrier are recommended to prevent future issues and ensure long-term protection against termites.

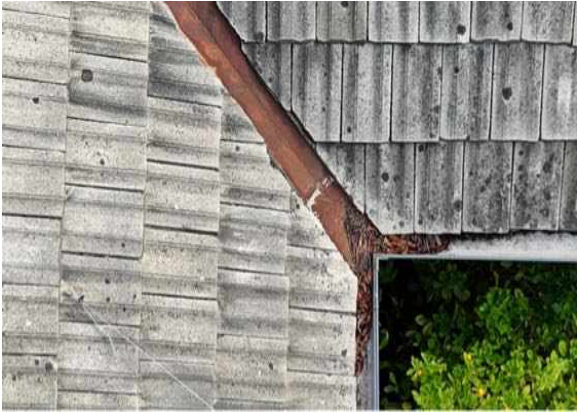
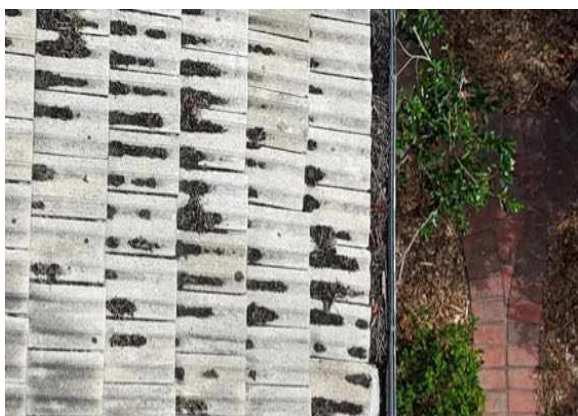
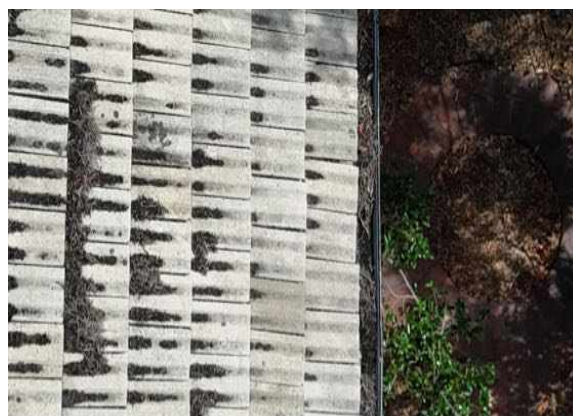
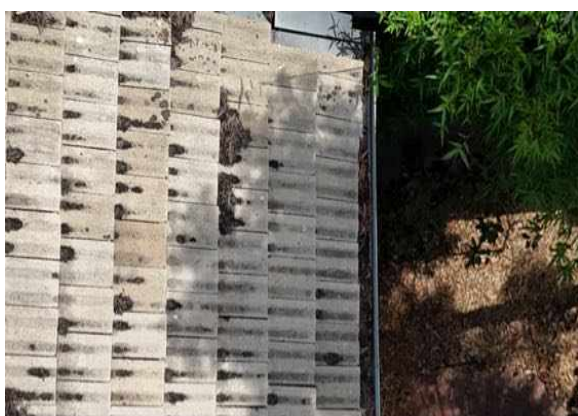
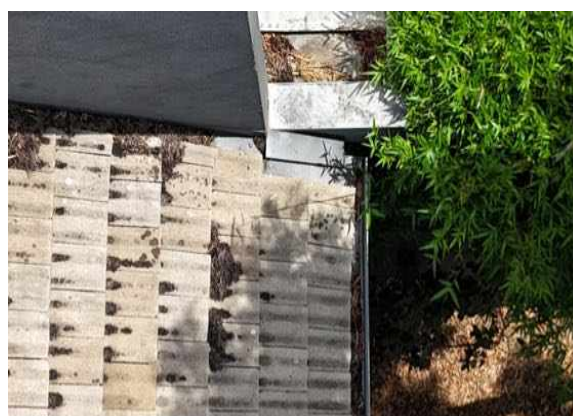
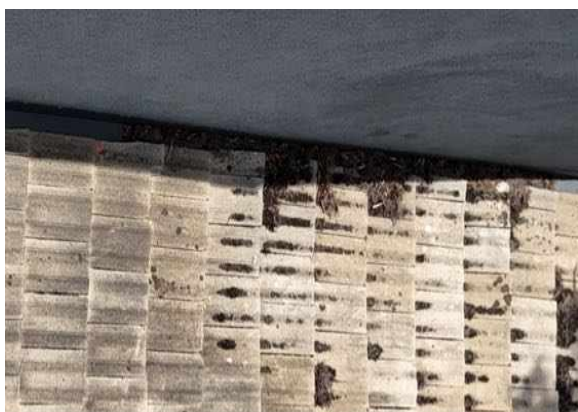
Finding 6.03

Building: Main Building
Location: All External Areas
Finding: Timber Pests - Conducive Conditions - Gutters Blocked
Information: During the inspection, gutters were observed to be blocked, resulting in water overflow and poor roof drainage. Blocked gutters are a significant concern as they can cause moisture to accumulate around roof edges, fascia boards, wall cavities, and subfloor areas. Persistent moisture in these locations creates conditions highly conducive to timber pest activity, including termites, borers, and fungal decay.

Moisture-related conditions of this nature substantially increase the risk of timber pest infestation and can accelerate deterioration of structural timbers if left unaddressed, potentially leading to progressive damage and higher repair costs.

It is recommended that a qualified roofing contractor or competent handyman be engaged promptly to clear and service all gutters and downpipes and ensure effective drainage away from the building. Ongoing gutter maintenance, in conjunction with regular timber pest inspections, is essential to reduce moisture-related risks and protect the long-term integrity of the structure.

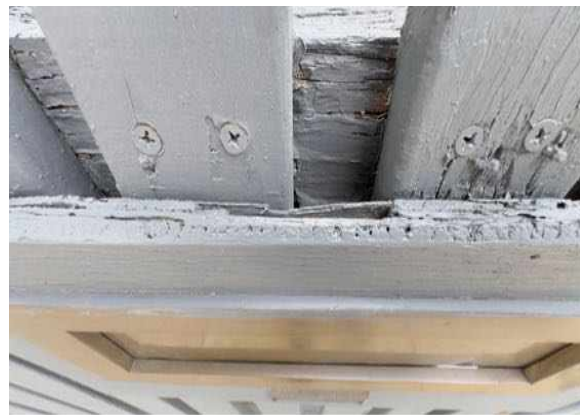
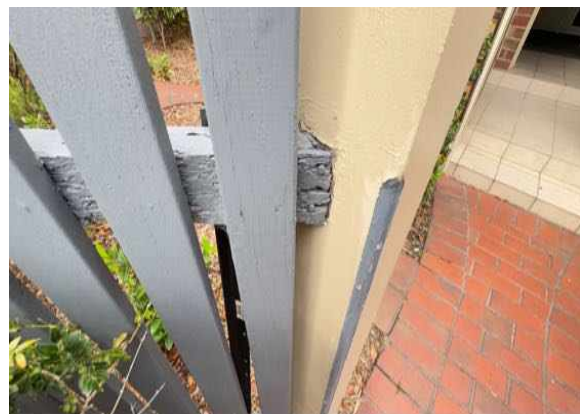
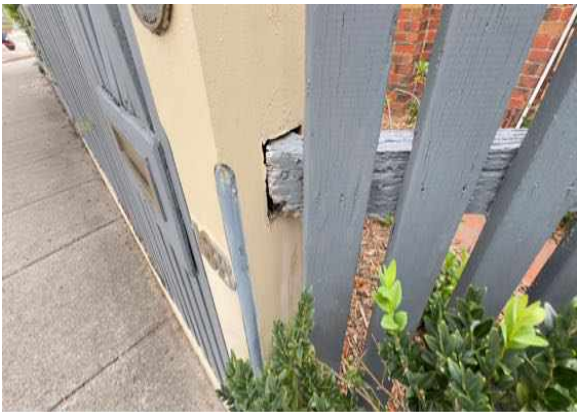
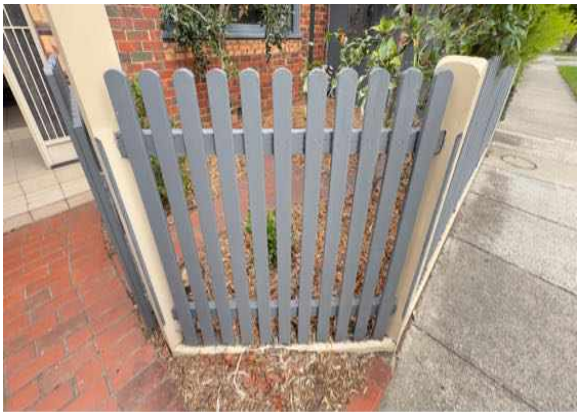
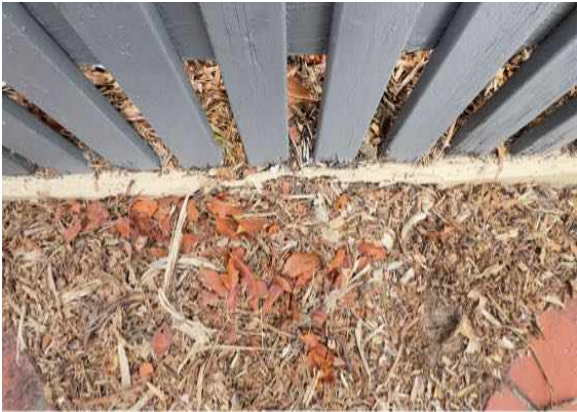
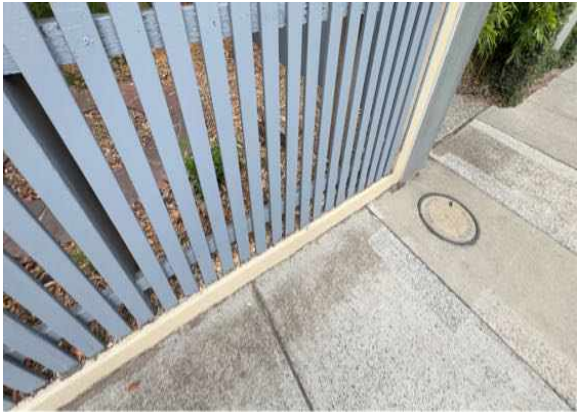
Finding 7.01

If left unaddressed, the affected timber may lose structural integrity, leading to progressive decay, potential collapse of walls, decks, or landscaping features, mould growth, and reduced durability and appearance of the building exterior.

A registered builder or timber specialist should inspect the affected areas immediately to determine the extent of damage. Damaged timbers should be repaired or replaced, protective treatments applied, and drainage or detailing corrected to prevent recurrence. Ongoing monitoring and urgent remedial action are required to prevent further deterioration.

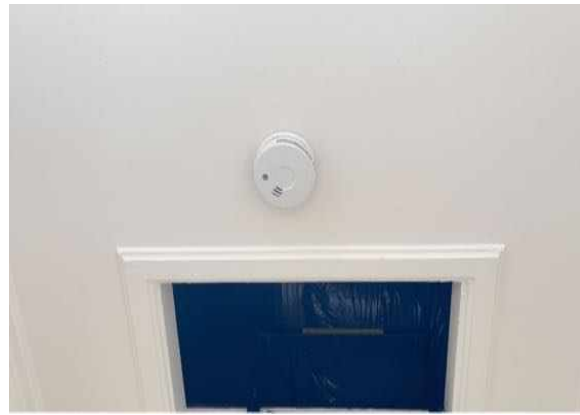
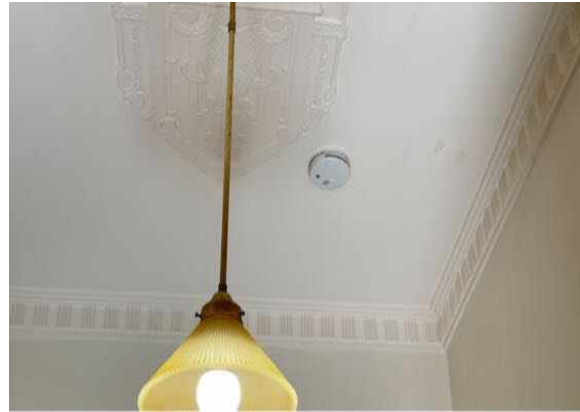
Smoke detectors are critical life-safety devices, and non-compliant, outdated, or non-operational units may not provide adequate warning in the event of a fire.

It is recommended that a licensed electrician be engaged immediately to test, service, and upgrade smoke detectors as required to ensure correct operation and compliance with current safety requirements.
