Building and Timber Pest Inspection Report

Inspection Date: Sat, 7 Mar 2026

Property Address: 102/19 Eve St, Erskineville NSW 2043,
Australia

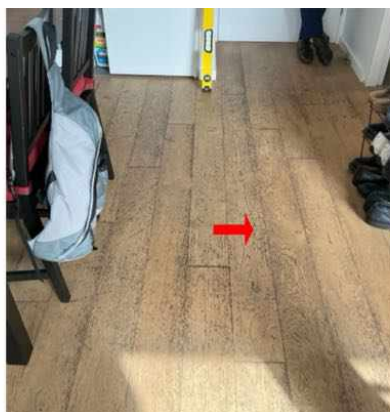
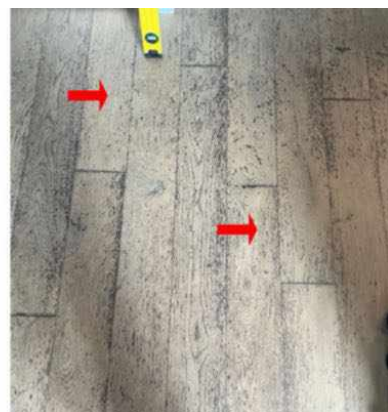
Finding 3.01

Building: Main Building
 Location: All Internal Areas
 Finding: Building element - Damaged - Flooring discolouration
 Information: flooring throughout the living, dining and circulation areas exhibits widespread surface wear, dark staining and deterioration of the protective finish. The damage appears scattered across multiple boards with more pronounced deterioration noted near the bathroom where moisture tracking may occur. The condition of the boards suggests long-term wear from foot traffic, possible moisture exposure and breakdown of the surface coating over time. While no significant deformation of the boards was evident, the degraded finish reduces protection of the timber surface and may allow further staining or deterioration if left untreated. It is recommended that the flooring be further assessed by a suitably qualified flooring contractor to determine the extent of deterioration and undertake appropriate remedial works.

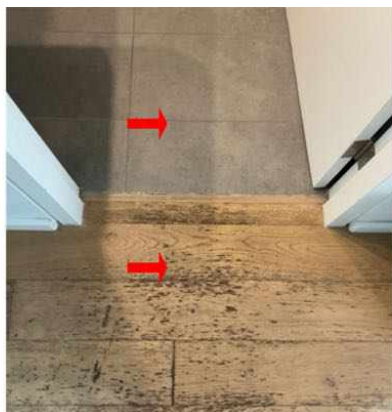
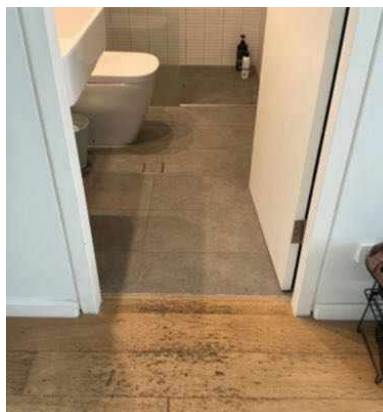
Finding 3.02

Building: Main Building
 Location: Bathroom
 Finding: Bathroom & external floor threshold

Information: The bathroom floor is at the same level as the adjoining timber flooring. This configuration is common in modern apartments where compliant waterproofing and floor falls have been installed; however, the performance and integrity of the concealed waterproofing system cannot be confirmed without invasive inspection. Evidence of wear and deterioration to the timber flooring adjacent to the bathroom doorway was observed, which may be consistent with moisture tracking from the wet area during use. Care should therefore be taken to minimise water migration beyond the bathroom, and the condition of the flooring should be monitored and maintained as required.

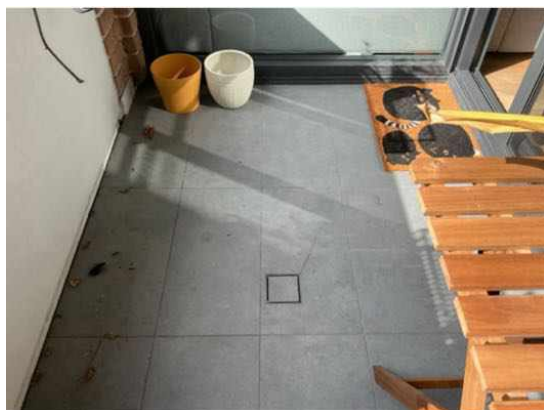
Finding 3.03

Building: Main Building
 Location: Balcony
 Finding: Balcony Elevated Moisture - Strata (No visual deterioration)
 Information: Elevated moisture was recorded at the base of the balcony and internal floor junction, no internal damage was visible at the time of inspection, balconies in multi-unit dwellings are high-risk areas for waterproofing failure, which can lead to leaks into adjoining units and significant rectification costs. Further investigation by a strata appointed licensed waterproofing contractor is recommended.

Depending on the strata plan, this area may form part of the common property, in which case remedial responsibility may rest with the owners corporation (strata). Purchasers should seek clarification from the strata manager and legal adviser prior to purchase.

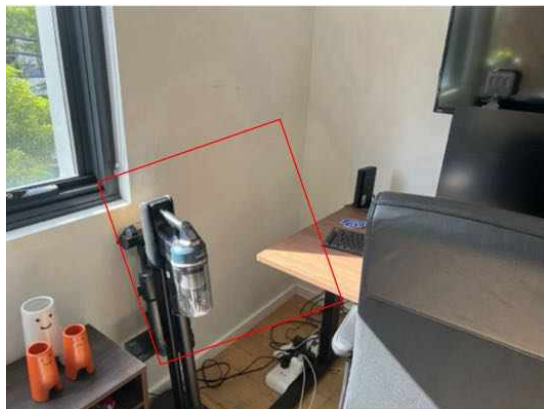
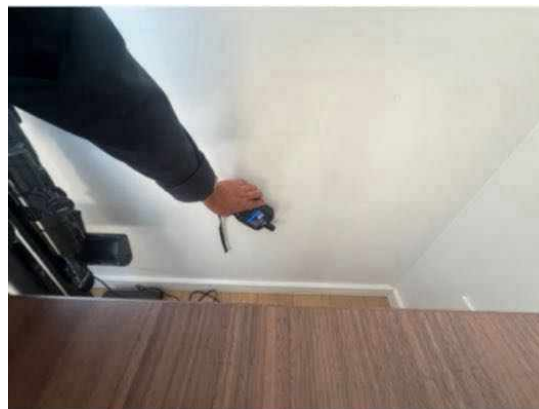
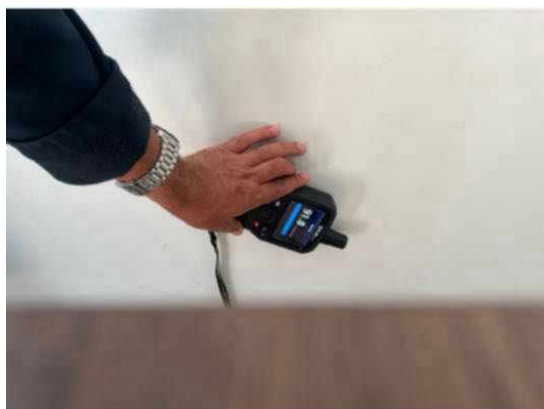
Finding 3.05

| Finding: | Elevated Moisture Detected |
| Information: | Slightly Elevated moisture levels were detected in wall in lounge area. The areas should be monitored for and changes to existing conditions e.g damp , paint bubbling of staining.Further invasive investigation by a licensed plumber or waterproofing specialist is recommended to confirm the source and extent of water ingress if condition persists. As this relates to a multi-residential building, the source of water ingress may involve common property, a suitably qualified waterproofing contractor is recommended to determine cause, responsibility, and scope if required. |

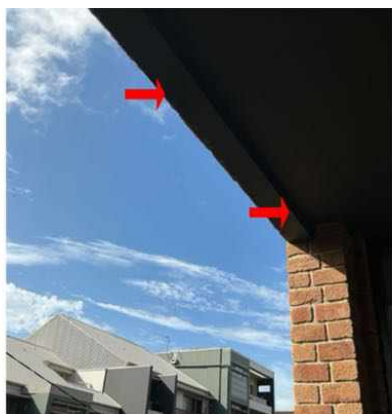
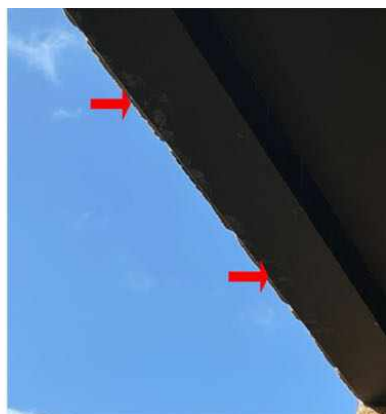
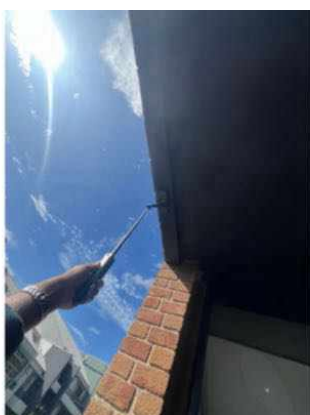
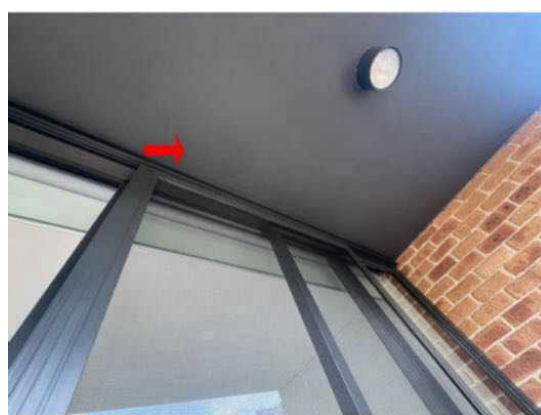
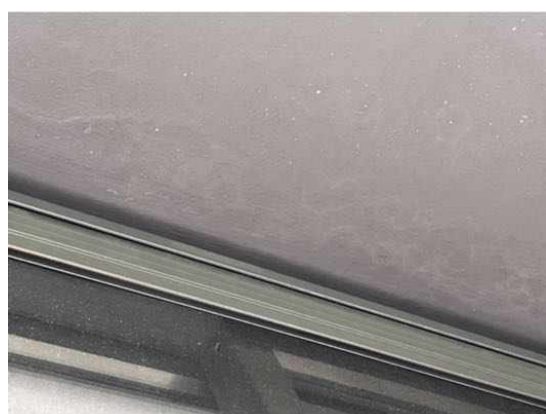
| Finding: | Water staining and elevated moisture |
| Information: | Water staining was evident in this area at the time of inspection. Water staining indicates that surfaces have been exposed to excessive moisture over time. The minerals and other elements in the water lead to staining, which may graduate to corrosion and deterioration if left unmanaged. |

External soffits are commonly affected by environmental exposure including moisture, condensation, dust accumulation and weathering of the painted surface. In areas near glazing and external openings, staining can also occur from condensation runoff, minor water tracking, or inadequate ventilation in enclosed eave spaces. Over time this can result in patchy paint deterioration or staining without necessarily indicating active leakage.

Elevated moisture above typical thresholds was also noted at the time of inspection.

While mostly an appearance defect, water staining can be indicative of more serious defects, which may be currently concealed by other building elements.

Where water staining is active, a licensed plumber must be consulted to identify the

cause of the staining and to provide advice on any reparation works that may be required.

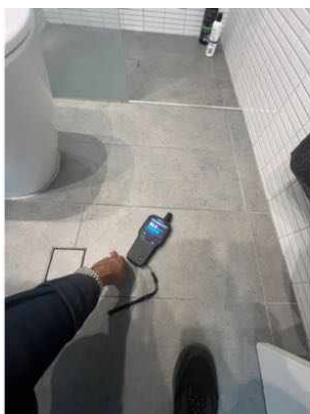
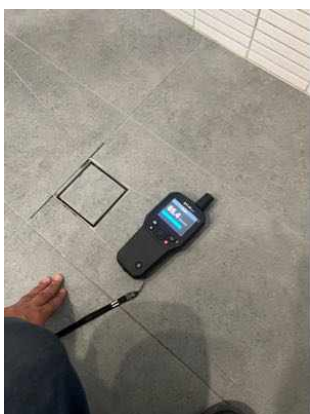
Finding 3.06

| Finding: | Elevated Moisture Bathroom (No visible deterioration noted) |
| Information: | Elevated moisture levels were detected to tiled surfaces in bathroom/shower areas. Persistent moisture ingress can lead to concealed damage, including timber rot and mould growth. |

Elevated moisture readings in tiled wet areas can occur from normal shower use, age/deterioration of waterproofing membranes, plumbing leaks or moisture absorption through grout lines. While no damage was visible, elevated readings may indicate moisture retention behind tiles, which can be a conducive condition for future deterioration if not monitored.

Monitor the area over time for signs of drumming, efflorescence, tile movement, or grout deterioration. If concerns arise, a licensed waterproofing specialist can perform further investigation (e.g., pressure testing, membrane assessment).

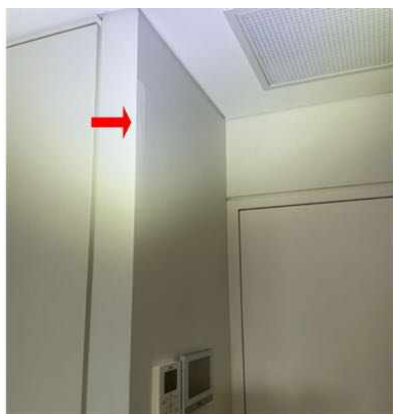
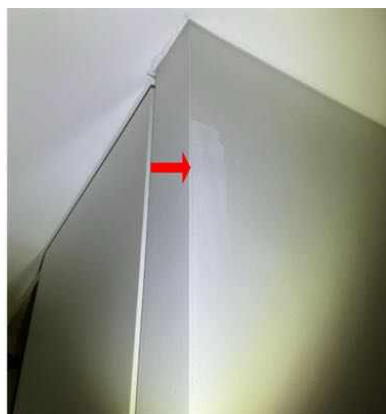
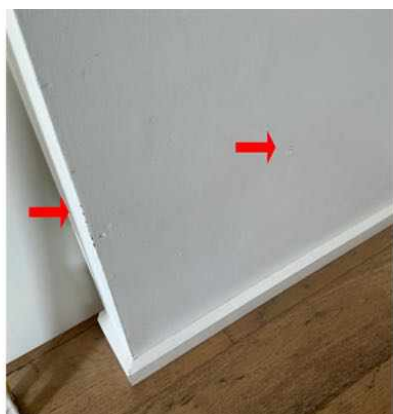
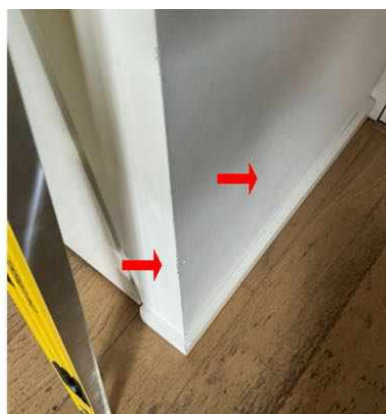
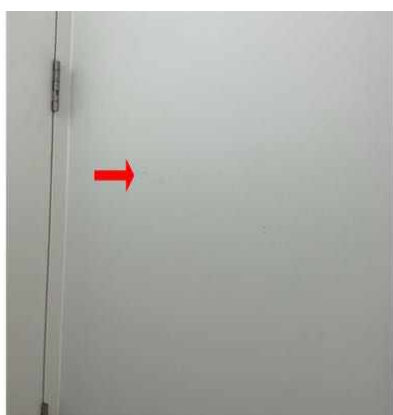
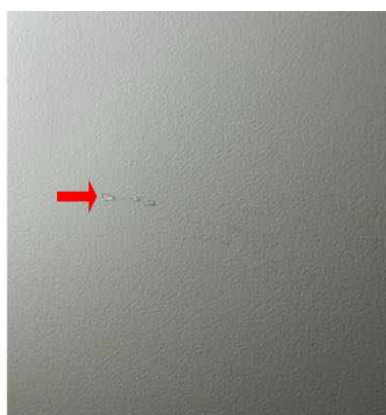
Finding 3.07

| Finding: | Paint finish and hairline cracking |
| Information: | The paint finish in this area was identified as being incomplete at the time of inspection including some hairline minor cracking. |

Whilst incomplete or missing paint finish is generally an appearance defect, it can also lead to the development of secondary building defects over time. Incomplete areas of paint finish expose the area to moisture, potentially accelerating the deterioration of underlying building materials.

Incomplete paint finishes should be sanded back, filled, leveled and painted, as applicable. Where inadequate or missing paint protection has led to the deterioration of the associated building element, repair and/or replacement of this building element may be required.

A painting contractor should be appointed as soon as possible to perform necessary works to aid the appearance of the affected area and to ensure the area is protected against further deterioration. Alternatively, the homeowner following manufacturer instructions may perform these works.

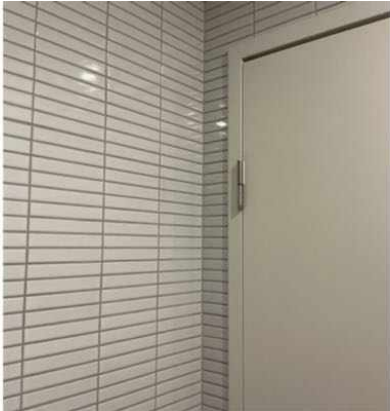
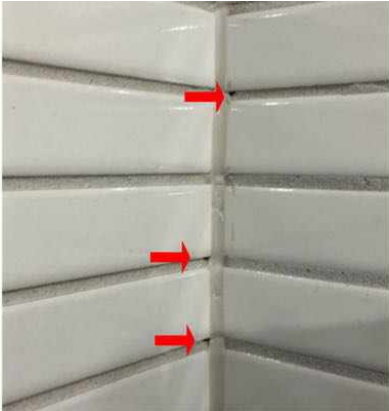
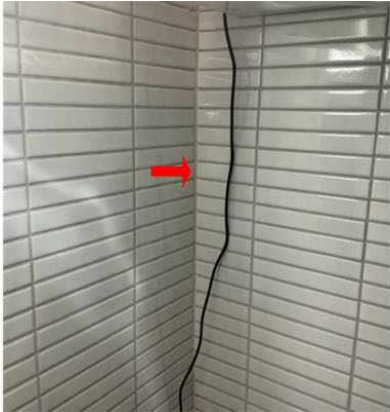
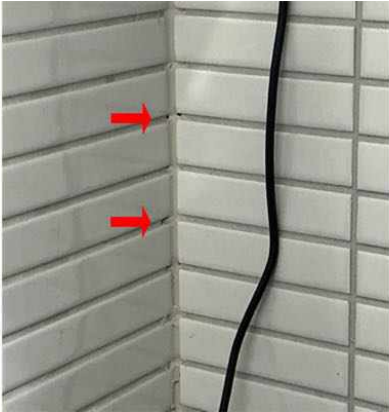
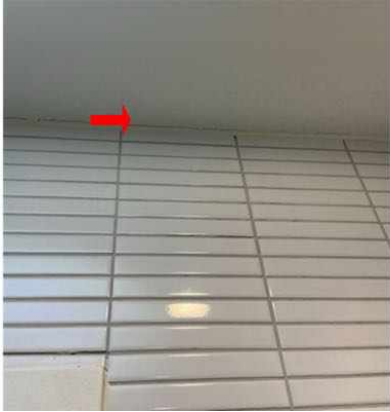
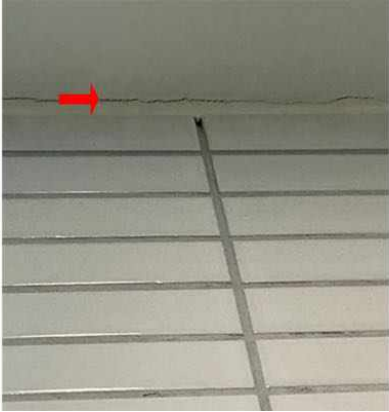
Finding 3.08

Building: Main Building
Location: All Internal Areas - Bath, Laundry , Balcony
Finding: Sealant and grouting - Missing or degraded
Information: It was noted on inspection that sealant or grout is degraded. There is also evidence of poor workmanship and excessive use of sealant. Silicone should never be used as a first line of defence against waterproofing.

Different materials and floor areas move at different rates, generally causing cracking to grout or sealant at this point. A flexible sealant is required to allow for expected expansion and contraction, while keeping the joint water tight and protective of all associated building materials.

Flexible and mould resistant materials should be applied to affected areas to prevent any subsequent water damage that is likely to occur. Regular maintenance and replacement of damage or missing or damaged sealant and grout is highly recommended to the wet areas, as this is a regular wear and tear defect. Sealant and grouting in areas that come into regular contact with water should be maintained for the long term care of your property.

A sealant specialist or tiling contractor should be appointed to complete these works as soon as possible
