## Building Inspection Report VR

Inspection Date: Tue, 20 Jan 2026

Property Address: 13 Yorkshire St, Pascoe Vale VIC 3044,  
Australia

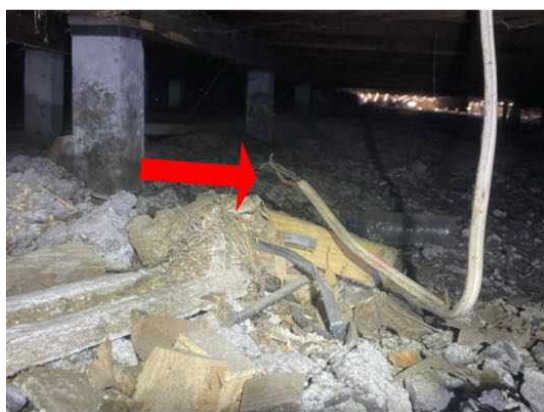
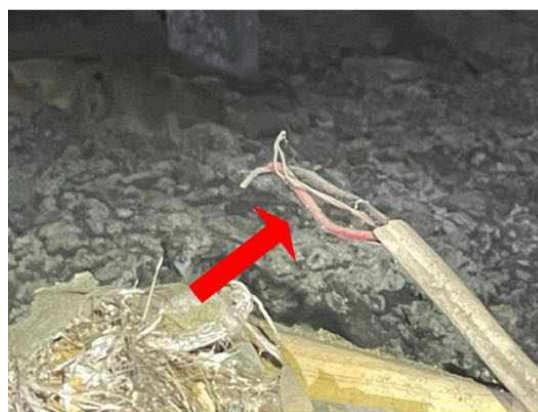
#### Defects 1.01

Building:	Main Building
Location:	Subfloor >
Finding:	Electrical - Exposed Wiring
Information:	Exposed electrical wiring was observed in this area. This condition presents a potential significant risk of electric shock, fire, or injury if left unattended.

Possible causes include previous incomplete or unlicensed electrical work, accidental damage during renovations or maintenance or relocation of fittings leaving wiring exposed.

Immediate inspection and rectification by a licensed electrician is strongly recommended. The wiring should be secured, protected, and made compliant with current electrical safety standards without delay.

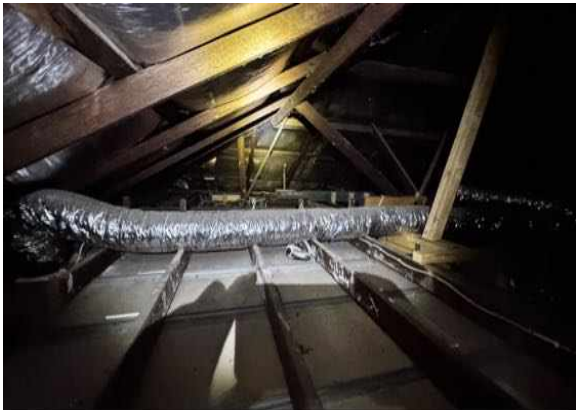
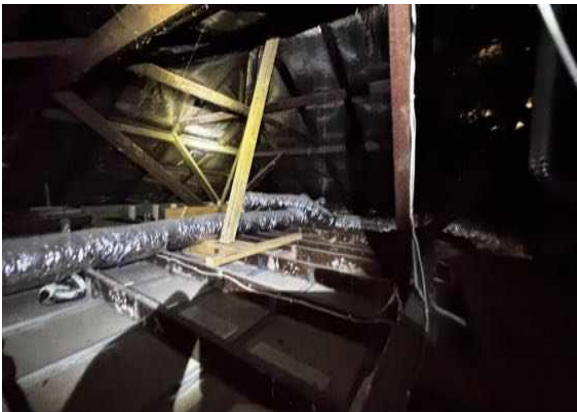
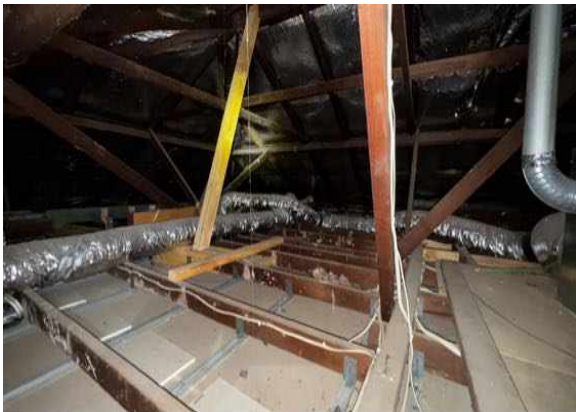
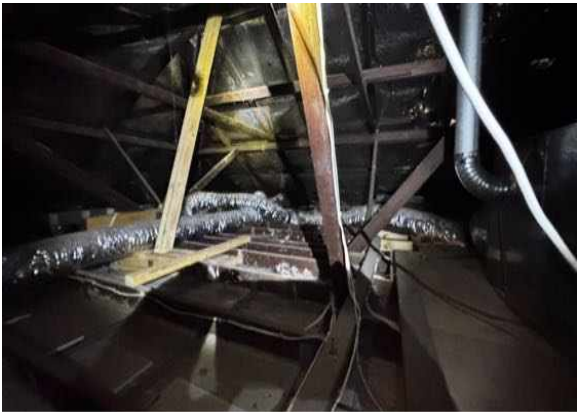
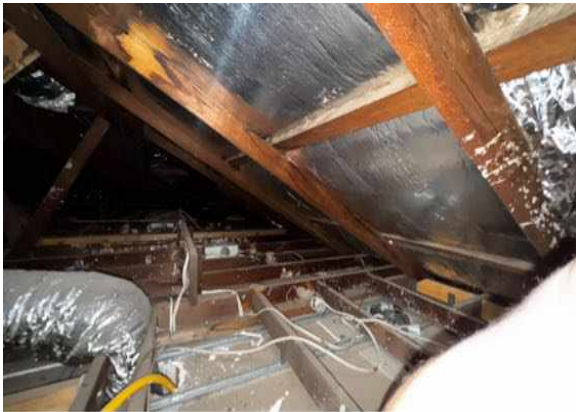
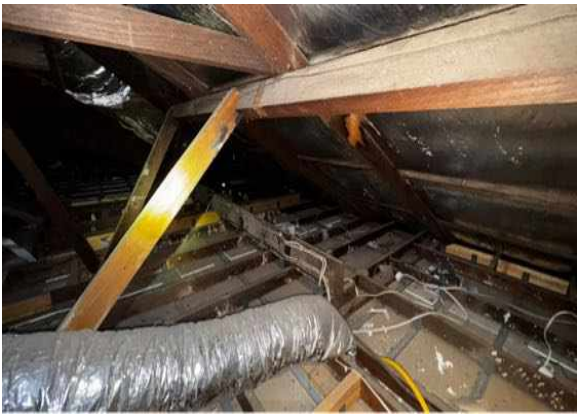
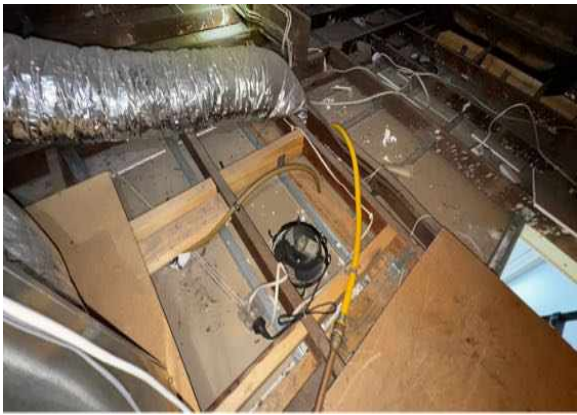
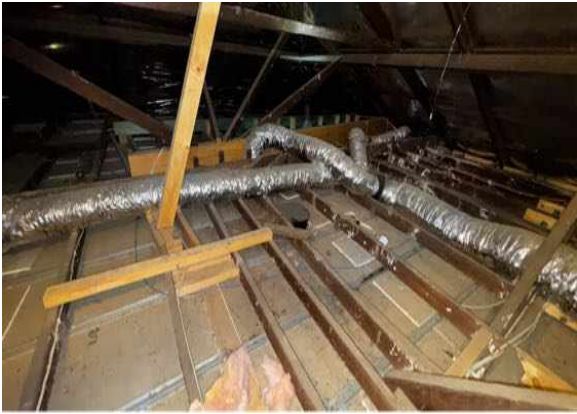
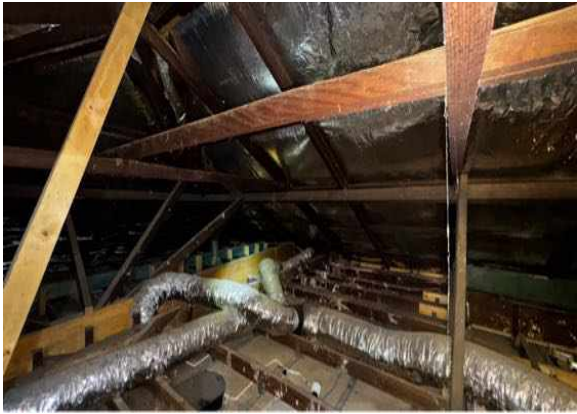
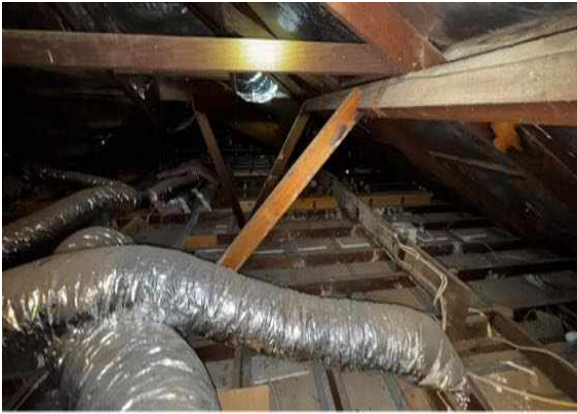
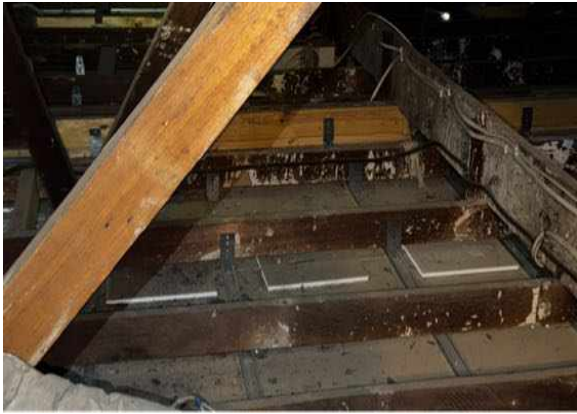
The issue may result from poor workmanship during installation or movement of insulation after installation. If not corrected, no insulation can increase heating and cooling costs and may create cold spots that lead to localized condensation or moisture issues.

A qualified insulation installer should be engaged promptly to assess the roof void and add insulation as needed to ensure full, even coverage without compression. Regular monitoring is recommended to maintain thermal performance.

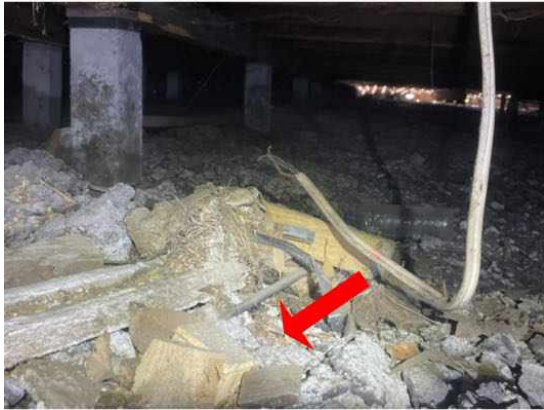
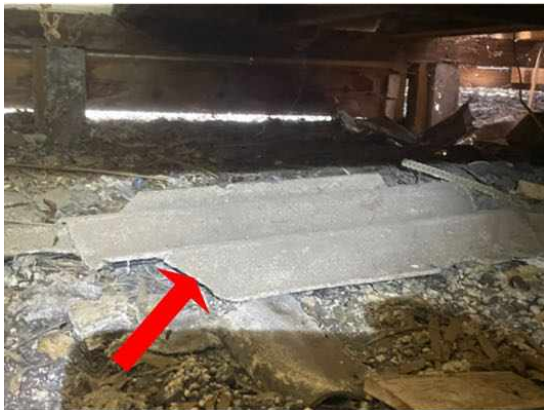
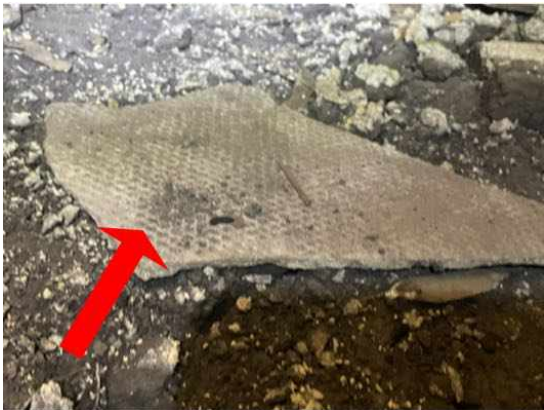
**Noted Item**

Building: Main Building  
Location: Subfloor  
Finding: Sub Floor - Limited Access  
Information: The subfloor area was observed to have restricted, limited and difficult access. The issue is present where limited space and obstacles prevent safe entry and movement beneath the building.

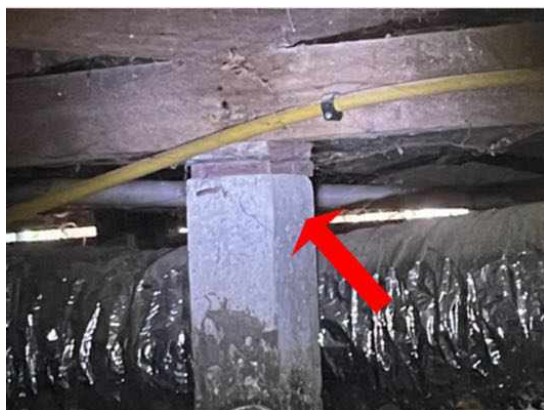
**Noted Item**

Building: Main Building  
 Location: Subfloor >  
 Finding: Sub Floor - Evidence of Historic Re-Stumping and Floor Level Deviations  
 Information: Evidence of historic re-stumping works was observed within the subfloor area at the time of inspection. Variations and deviations in floor levels were also noted, which may indicate movement, settlement, or uneven performance of the existing stumps.

It is recommended that a qualified and licensed re-stumping contractor be engaged immediately to assess the subfloor structure, verify the condition and adequacy of the existing stumps, and advise on any remedial works required to stabilise floor levels and prevent further movement.
