Building and Timber Pest Inspection Report

Inspection Date: Wed, 7 Jan 2026

Property Address: 91 Prince Edward Ave, Culburra Beach NSW
2540, Australia

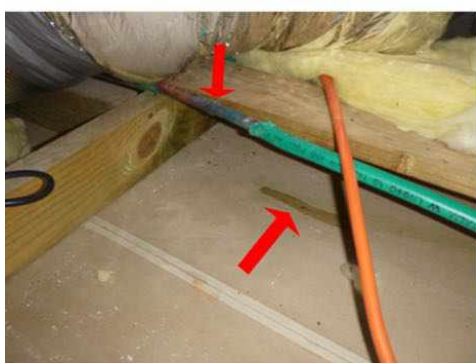
Finding: Water leak - Internal (This appears to be from a leaking water pipe join)

Information: A water leak was found in this area at the time of inspection. Internal water leaks can be detrimental to surrounding building elements; their potential causes include damage to plumbing fittings and fixtures, through to water damage and deterioration of associated building elements.

Rust, corrosion, decay and water damage are potential outcomes where a minor water leak is left unattended. More serious defects may also result, such as electrical hazards, or water damage to structural building elements.

In extreme cases, structural damage may develop due to a prolonged water leak. It is highly advised that internal water leaks be addressed by a licensed plumber as a matter of relative urgency.

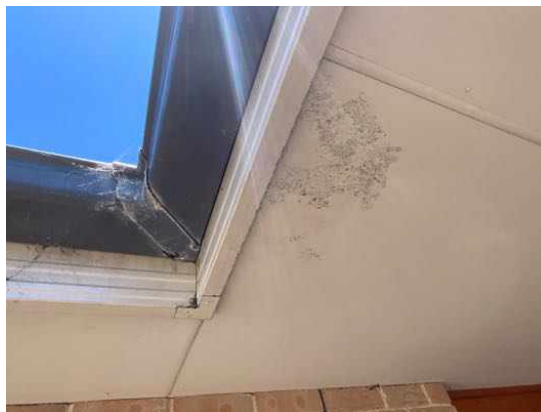
Finding 2.03

Building:	Main Building
Location:	Roof Exterior
Finding:	Eaves - Water stained (from blocked and overflowing guttering)
Information:	Water staining to eaves/ceiling linings in this area was evident at the time of inspection. Water staining indicates that surfaces have been exposed to excessive moisture over time. The minerals and other elements in the water lead to staining, which may graduate to corrosion and deterioration if left unmanaged.

While mostly an appearance defect, water staining can be indicative of more serious defects, which may be currently concealed by ceiling linings. Cleaning out of the guttering and roof valleys is highly recommended as priority to avoid water overflows into the eaves and potentially into the external walls of the house also.

It is highly advised that blocked gutters be cleaned out by a professional gutter cleaner, the homeowner or a general handyperson as a matter of urgency. The installation of a quality suitable gutter guard is also highly recommended to reduce blockages, however regular flushing out of the guttering is still recommended to avoid debris build up below the gutter guard.

Replacement of any damaged structures is advised.

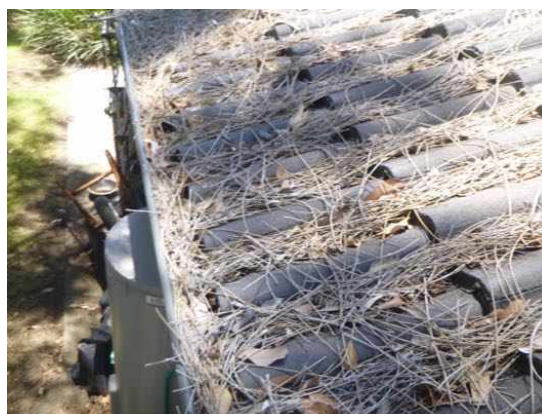
Gutters are a critical part of the building's management of storm water and rain. It is therefore important that they be kept clear to prevent secondary damage to associated building elements, including exterior and interior walls, ceiling linings and any adjoining building elements. Where gutters are blocked, pooling of rainwater is likely to occur, fast-tracking rust and corrosion of the roof plumbing elements.

Blocked gutters are likely to lead to high levels of moisture in the affected areas. Such moisture will not only cause rust and decay of the associated building materials, but can also provide conditions that are conducive to termite and timber pest activity. Blockages in gutters should therefore be removed immediately to ensure dry conditions are maintained.

Where gutter guard is installed, regular maintenance should include cleaning out any debris which may rest on top of or filter through the gutter guard. Regular flushing out of the guttering is still recommended to avoid debris build up below the gutter guard.

Consult a Licensed Plumber for further specific advice on remedial works that may be required. In the interim, it is highly advised that blocked gutters be removed by a professional gutter cleaner, the homeowner or a general handyperson as a matter of urgency. The installation of a suitable gutter guard is also highly recommended to reduce blockages, however regular flushing out of the guttering is still recommended to avoid debris build up below the gutter guard.

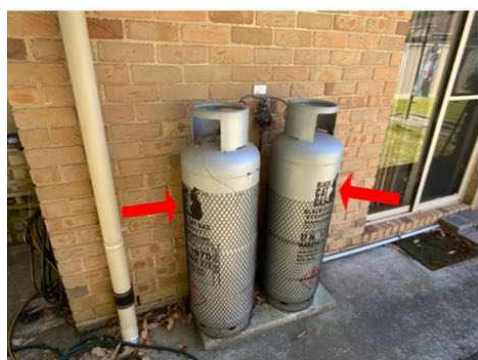
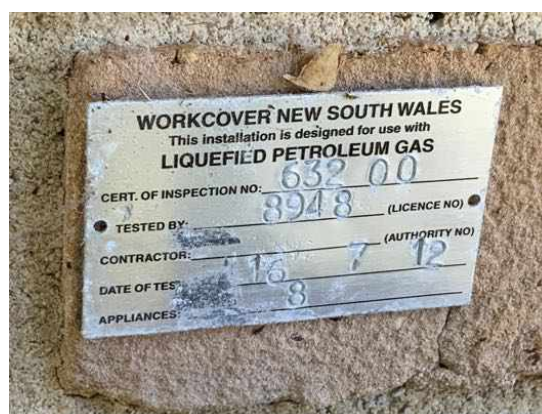
Finding 3.09

Building:	Main Building
Location:	Exterior walls - left side
Finding:	Gas Bottle - Non-compliant (secure chain missing)
Information:	In the opinion of the inspector, the gas bottle regulator is non compliant. However, in relation to gas and related gas plumbing, you should always consult a licensed plumber/gas fitter for further advice.

Unfinished and substandard building works are likely to degrade more quickly and may create potential for secondary defects to associated building elements, as well as a potential safety hazard in the case of gas service management.

The findings are that there appears to be no secure chain and the bottles are not securely fastened. Where installation is substandard and/or incomplete, the client should contact the responsible trade (gas plumber) to undertake rectification.

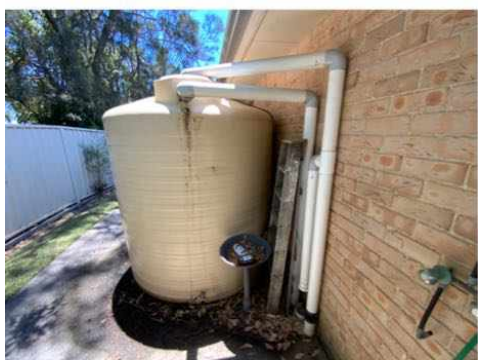
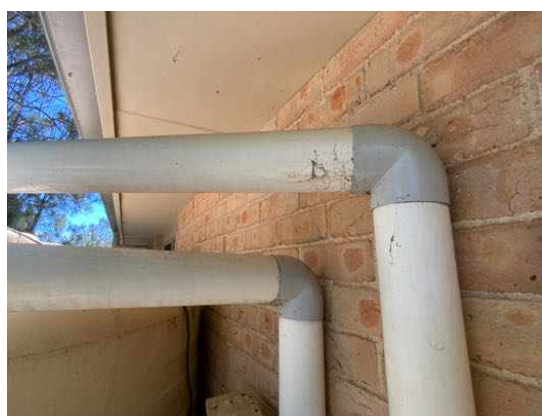
Finding 3.10

Building:	Main Building
Location:	Exterior walls - rear
Finding:	Paint finish - Incomplete to some areas (PVC pipes not painted - externally)
Information:	The paint finish in this area was identified as being incomplete at the time of

Incomplete paint finishes should be sanded back, filled, levelled and painted, as applicable. Where inadequate or missing paint protection has led to the deterioration of the associated building element, repair and/or replacement of this building element may be required.

A painting contractor should be appointed as soon as possible to perform necessary works to aid the appearance of the affected area and to ensure the area is protected against further deterioration. Alternatively, the homeowner following manufacturer instructions may perform these works.

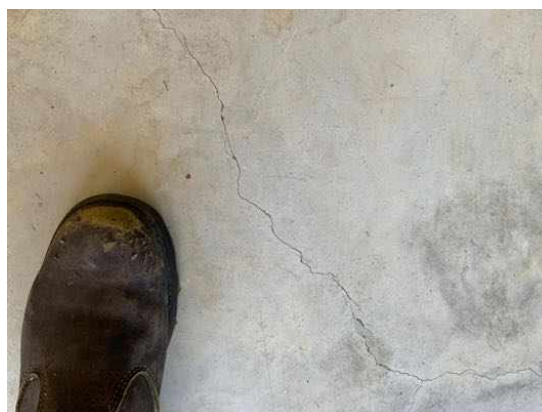
Finding: Cracks in concrete slab - Category 1

To be considered Category 1, the approximate width of the crack is less than 1.0mm, or a less than 10mm change in offset when a 3m straight edge is placed over the defect.

Category 1 cracks should be monitored for a period of 12 months. At the end of the monitoring period, identified cracks that are rated greater than Category 2 are considered defects, and require rectification.

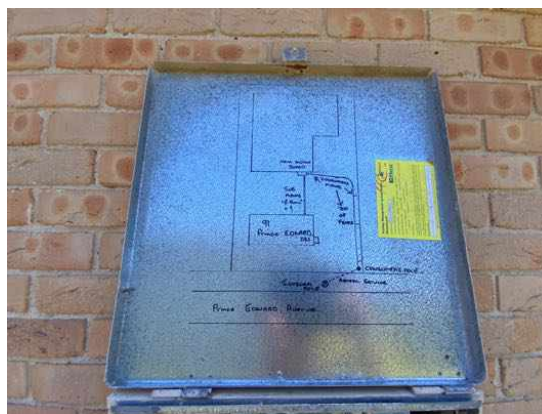
A durable notice should be placed in the switchboard unit to indicate current termite barriers. At the time of inspection, it appeared as though no termite management system has been installed, with no evidence to suggest preventative works taking place.

The client may consider gaining further advice from a pest controller as to the costs and procedures involved with this application. It is recommended that obtaining such advice be a short-term priority.

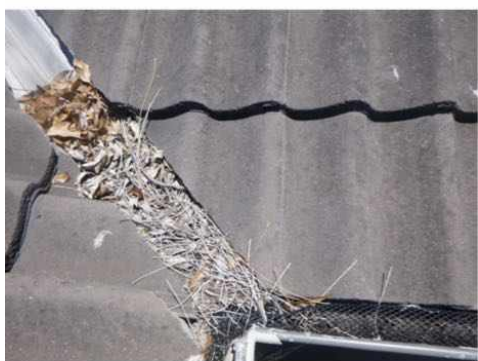
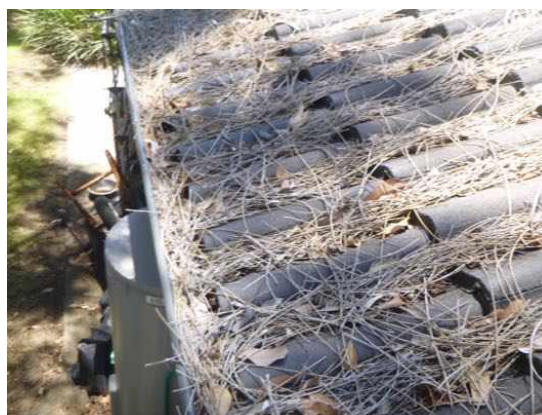
Finding 6.02

Building:	Main Building
Location:	Roof Exterior
Finding:	Gutters - Blocked
Information:	Roof plumbing structures, such as guttering and downpipes, should be free of all debris to prevent blockages. Blockages of the guttering and downpipes will lead to pooling and accumulated water overflows, which is likely to subsequently flood eaves and exterior walls.

Blocked gutters are likely to lead to high levels of moisture in the affected areas. Such moisture will not only cause rust and decay of the associated building materials, but can also provide conditions that are conducive to termite and timber pest activity. Blockages in gutters should therefore be removed immediately to ensure dry conditions are maintained.

Consult a Licensed Plumber for further specific advice on remedial works that may be required. In the interim, it is highly advised that blocked gutters be removed by the homeowner or a general handyperson as a matter of urgency.

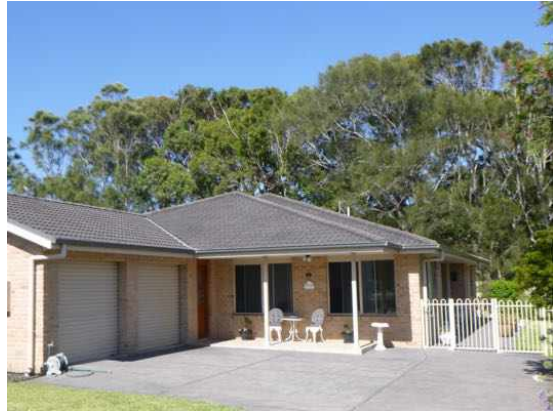
Finding 6.07

Building: Main Building
 Location: All Areas
 Finding: Trees within 50m of the property
 Information: Trees within 50m of the property can be conducive to termite activity. It is recommended an invasive inspection of all trees with 50m to the property be carried out by a qualified pest control expert.
