Building and Timber Pest Inspection Report VR

Inspection Date: Tue, 6 Jan 2026

Property Address: 23 Glen Sheather Dr, Nambucca Heads
NSW 2448, Australia

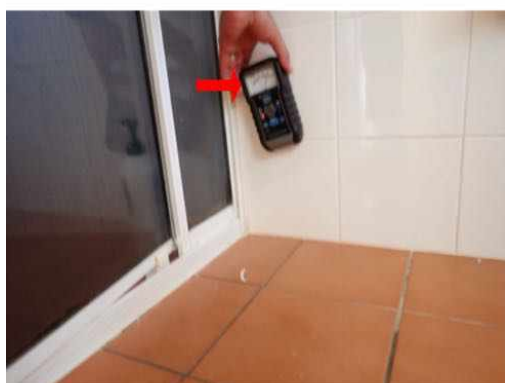
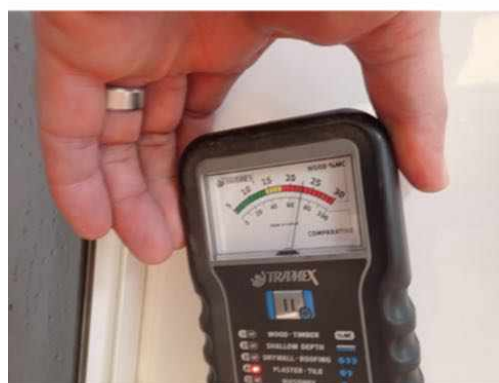
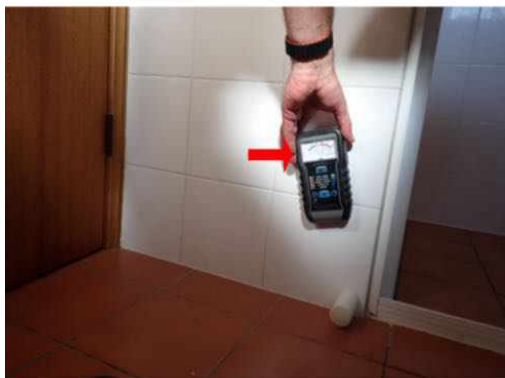
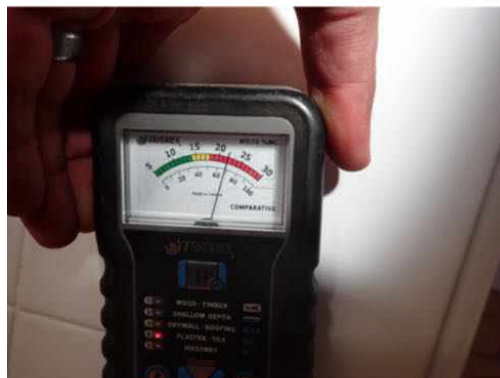
Finding 2.01

Building: Main Building
Location: Bathroom
Finding: Higher Than Normal Moisture Meter Readings To Bathroom Shower Area
Information: Higher than normal moisture meter readings were obtained to wall and/or floor surfaces within the bathroom shower area at the time of inspection. This may indicate moisture ingress associated with failed waterproofing, deteriorated grout or silicone, leaking shower plumbing, or inadequate sealing to penetrations. In plain terms, elevated moisture levels were detected around the shower which may suggest a leak or waterproofing issue. If left unaddressed, ongoing moisture exposure can result in concealed damage to wall framing, flooring, and promote mould growth. Preventative measures include maintaining grout and silicone seals and ensuring waterproofing systems remain intact. A licensed plumber is recommended to check for plumbing leaks and a qualified bathroom/waterproofing contractor should further assess and carry out repairs as deemed necessary. Prompt investigation and rectification is recommended at the owner's discretion to prevent further damage.

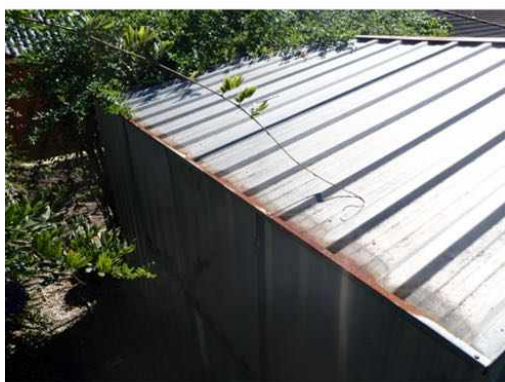
Finding 3.01

Building:	Shed
Location:	Shed at rear left hand corner of site
Finding:	Surface Rust Identified To Garden Shed
Information:	Surface rust was observed to the metal cladding and/or structural components of the garden shed. This condition is typically caused by prolonged exposure to moisture, weathering and age-related deterioration of protective coatings. In plain terms, the shed has areas of rust forming on the metal surfaces. While currently superficial, untreated rust can progress and lead to metal thinning, holes and structural weakening over time. Preventative maintenance includes cleaning affected areas and applying rust treatment and protective paint coatings. A qualified painter, handyman or shed specialist should assess and treat the rusted areas and repair or replace any severely deteriorated sections as deemed necessary. Repairs are recommended at the owner's discretion to prevent further corrosion and extend the life of the shed.

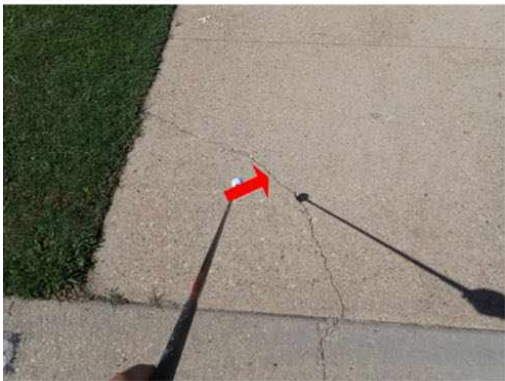
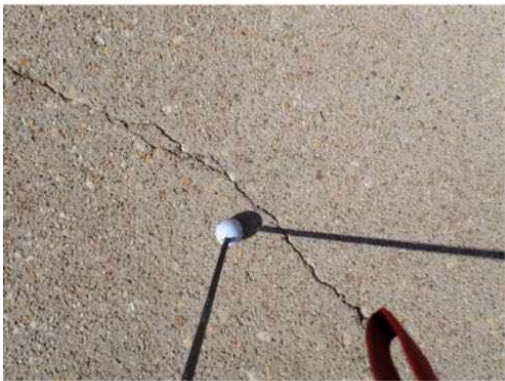
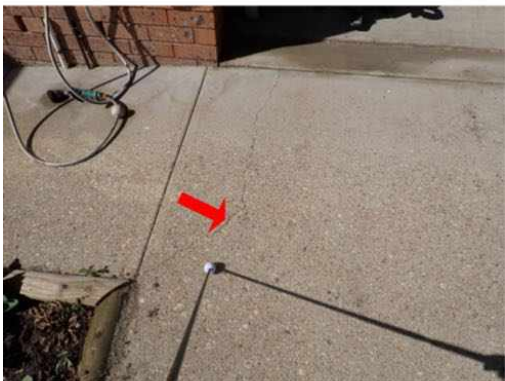
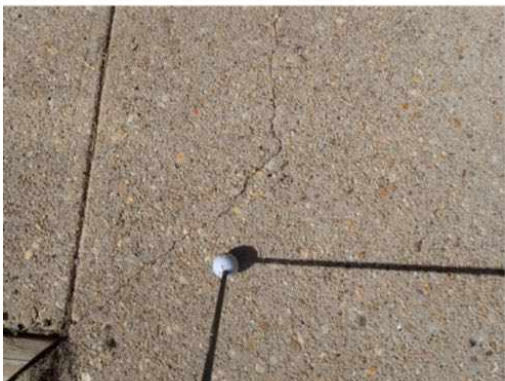
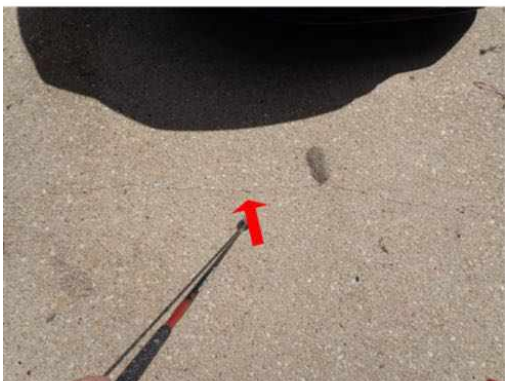
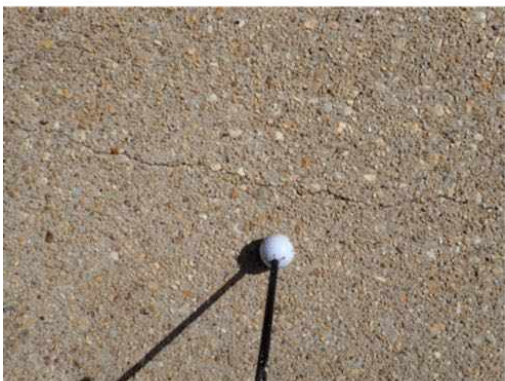
Finding 3.02

Building:	Not Applicable
Location:	Driveway

Several Minor Cracks To Concrete Driveway
Several minor cracks were identified within the concrete driveway surface. This is commonly caused by normal shrinkage during curing, minor ground movement, tree root activity or age-related wear and is considered a common defect in concrete of this type and age. In plain terms, the driveway has small cracks which are typical over time. While currently minor, cracks can allow water ingress which may lead to further deterioration if left unsealed. Preventative measures include sealing cracks and maintaining proper drainage away from the slab. A qualified concreter should assess and seal or repair the cracks as deemed necessary. Repairs are recommended at the owner's discretion to maintain durability and prevent further deterioration.

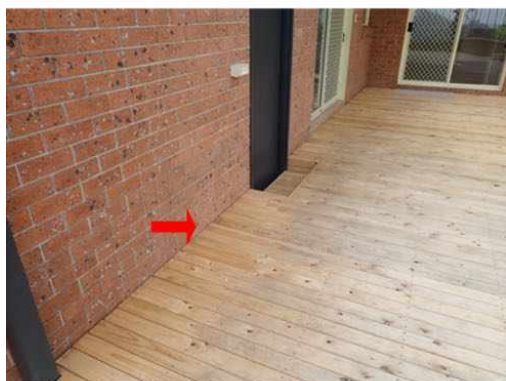
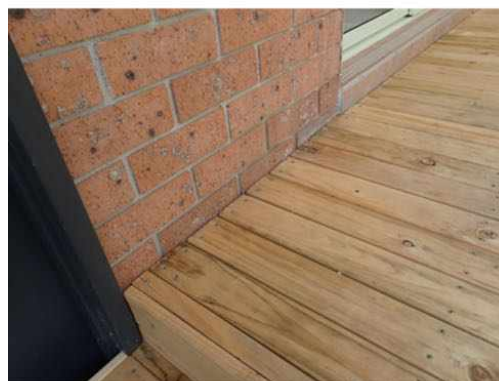
Finding 6.01

Building:	Main Building
Location:	Rear decked area
Finding:	Timber Deck Built Up to External Wall – No Termite Inspection Zone
Information:	The timber deck has been constructed against the external wall of the dwelling, which prevents an adequate visual termite inspection zone to the base of the wall. This condition may allow concealed termite entry into the building and is considered conducive to timber pest attack. It is generally recommended that a visible inspection zone be maintained around the perimeter of the building to allow for monitoring of termite activity. A licensed builder and/or pest control specialist should assess the area and carry out modifications if required to reinstate an appropriate inspection zone and reduce the risk of concealed termite entry. The pest control specialist should also provide recommendations for an appropriate timber pest management and protection plan to help reduce the risk of future termite activity.
