Building and Timber Pest Inspection Report

Inspection Date: Fri, 14 Nov 2025

Property Address: 8 Kitchener Ave, Earlwood NSW 2206,
Australia

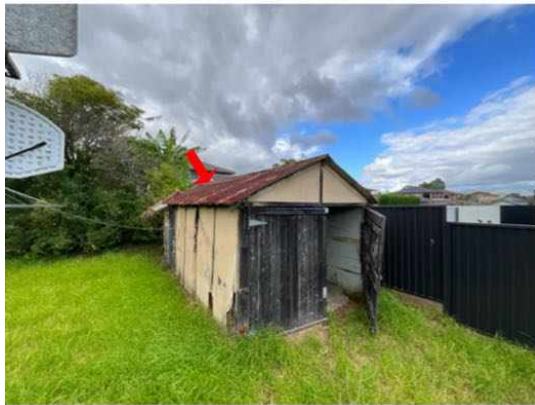
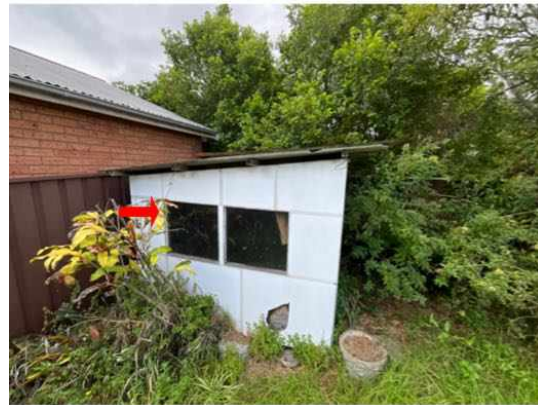
Finding 1.01

Building: Yard
Location: Garage & Shed
Finding: Deteriorated Structure
Information: It was identified that some elements have suffered from environmental effects with replacement required.

I would highly recommend appointing a builder to see what necessary works are required.

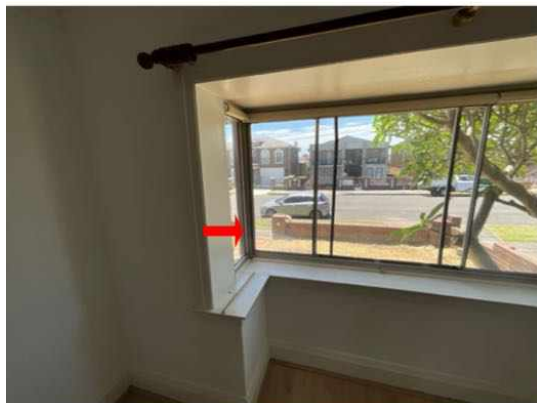
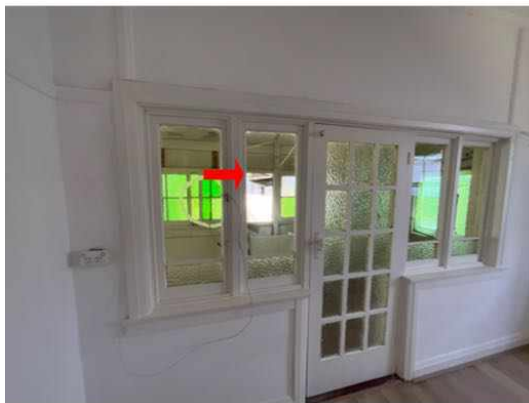
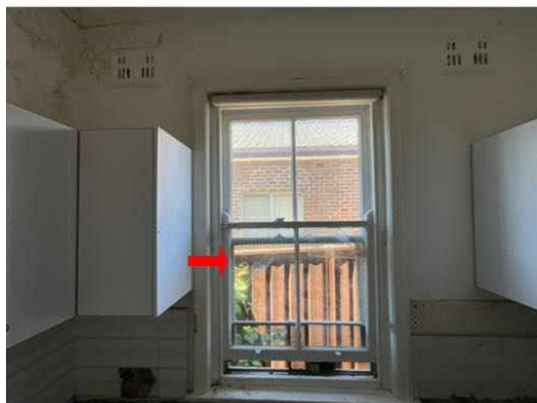
Finding 3.01

Building: Main Building
Location: Window
Finding: Glass - Cracked
Information: Cracks were identified in the glass in this area. Cracking in glass is generally the result of impact damage, and is likely to develop further when left unmanaged.

A qualified glazier is required to repair the glass.

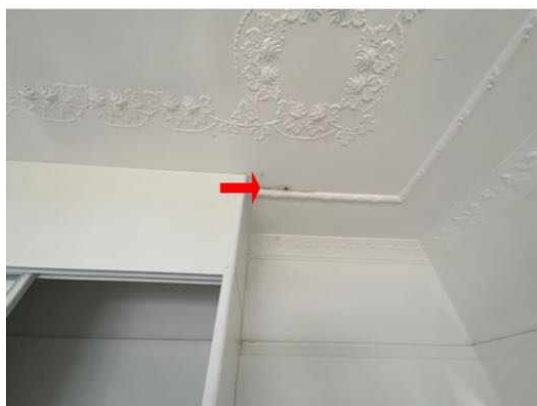
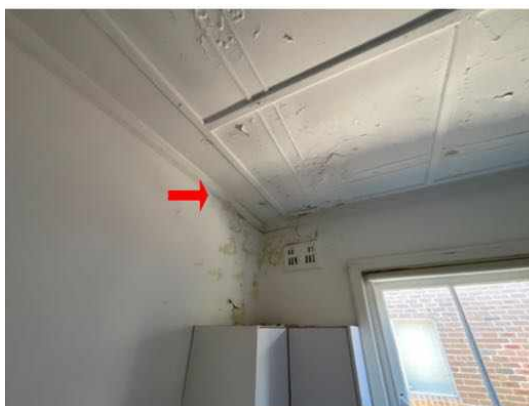
Finding 3.02

Building:	Main Building
Location:	Bedroom & Kitchen
Finding:	Ceiling - Water stained
Information:	Water staining to ceiling linings in this area was evident at the time of inspection. Water staining indicates that surfaces have been exposed to excessive moisture over time. The minerals and other elements in the water lead to staining, which may graduate to corrosion and deterioration if left unmanaged.

Although there was no moisture detected in the ceiling I would recommend monitoring and acting on one of the following.

Where water staining is active, a licensed plumber must be consulted to identify the cause of the staining and to provide advice on any reparation works that may be required. Replacement of any damaged structures is advised.

Conversely, where water staining is old and inactive, affected building materials may be repaired or replaced at client discretion.

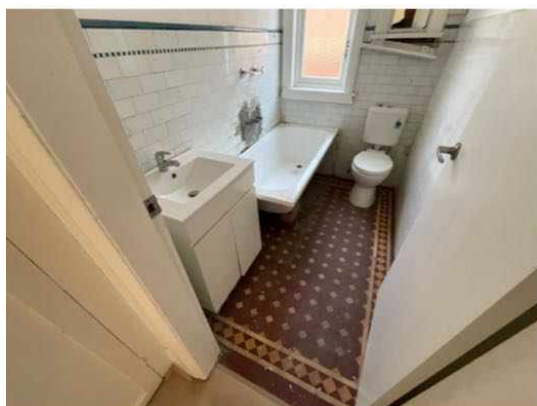
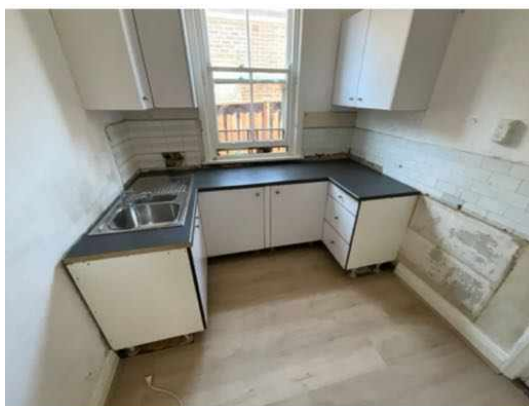
Finding 3.03

Building:	Main Building
Location:	Bathroom & Kitchen
Finding:	Unfinished construction
Information:	The construction of this structure appears to be incomplete. The safety of the structure can therefore not be ensured and the creation of secondary defects to surrounding building elements may be likely.

A Registered Builder should be appointed immediately to complete this construction process.

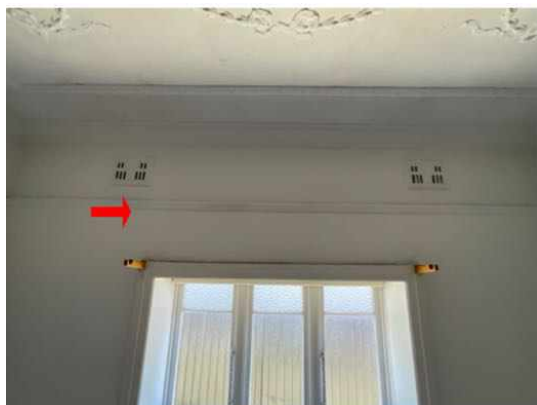
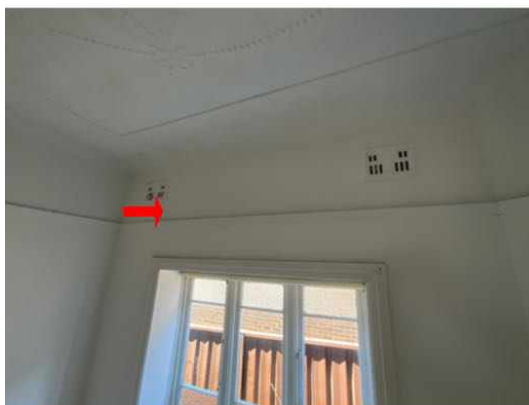
Finding 3.04

Building:	Main Building
Location:	Internal Areas
Finding:	Cracking - Damage Category 2 - Noticeable (up to 5mm)
Information:	Noticeable cracks are a common occurrence as a result of many primary defects. Such causes may include age, general wear and tear, expected building movement, general expansion/contraction of building materials in different weather conditions, and/or minor failings in the installation or application of building materials.

I recommend monitoring and if further cracking is evident appoint a bricklayer to see

what works are required.

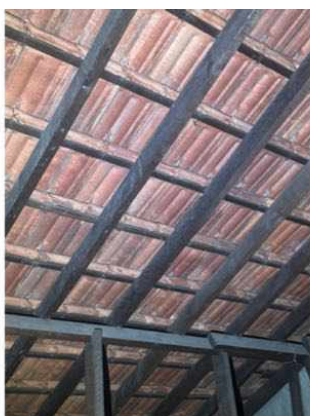
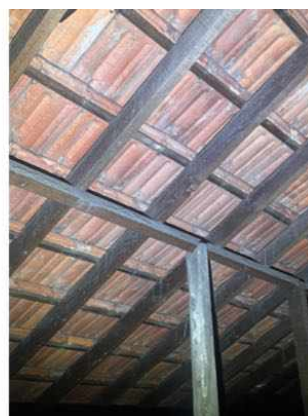
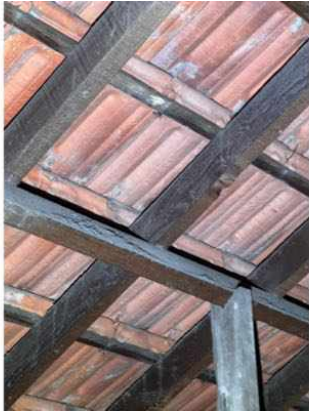
Finding 3.05

Building: Main Building

Location: Roof Void

Finding: Roof Tiles - Weathered

Information: Upon inspection of the interior roofing, sections of the tiles were beginning to deteriorate. While deteriorating of the tiles is consistent with the age of the property, replacement of the roof tiles may need to be carried out to prevent future defects to the property.

Where left unmanaged, deteriorating roof tiles may lead to a number of secondary defects, including minor water leaks and weather exposure to internal roofing structures.

Further consultation with a roofing contractor is height advised to gain advice of remedial works that may be required.

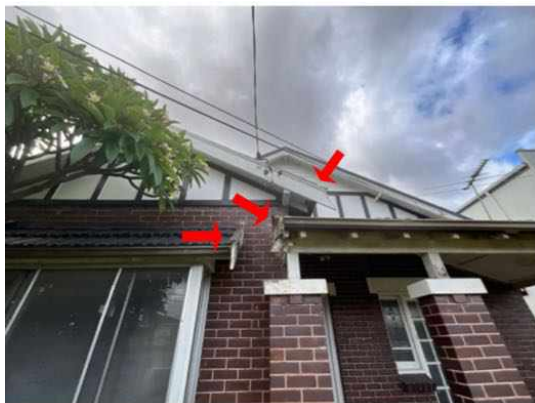
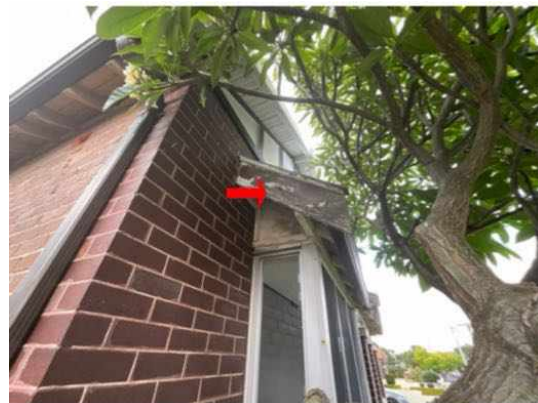
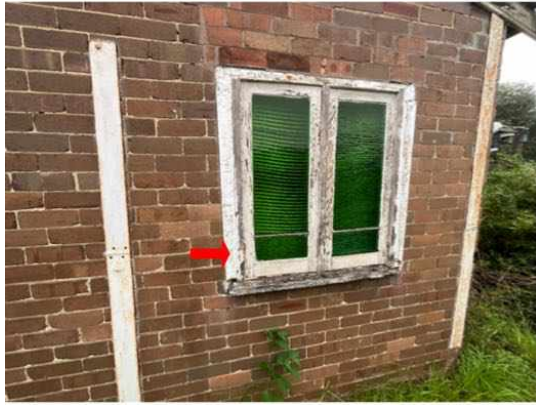
Finding 3.06

Building:	Main Building
Location:	External Areas
Finding:	Wood rot
Information:	This building element shows evidence of wood rot. Wood rot, also known as Fungal Decay, occurs when timbers and other cellulose building materials are exposed to damp conditions on an ongoing basis. This could be the result of exposure to weathering over a prolonged period of time, or the attraction of excessive moisture from other abutting building materials.

Early intervention and regular maintenance, particularly of exterior timbers, will prolong the useful life of these building elements. Prior to any works being performed, the cause of the moisture that has created the visible wood rot should be identified and addressed in a suitable manner. Replacement of affected timbers may then be a necessary step in protecting surrounding building elements from such deterioration.

A qualified carpenter or registered builder may also be required to replace affected building materials.

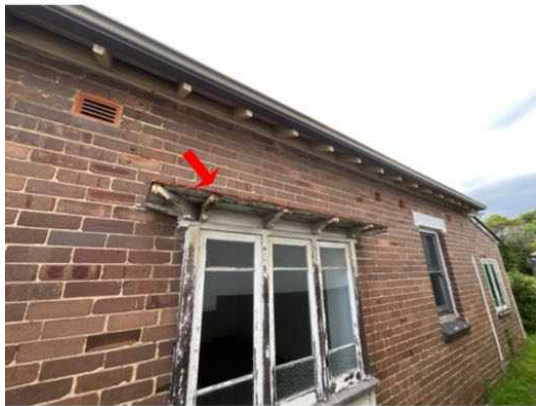
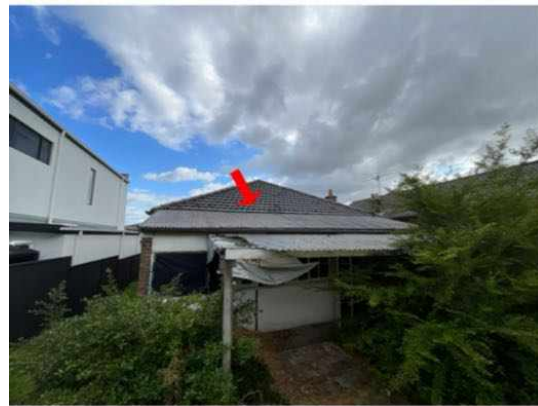
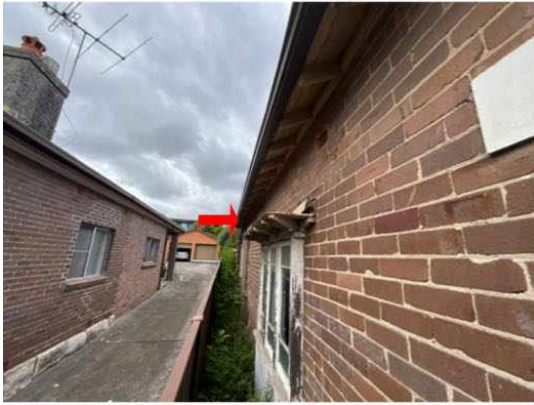
Finding 3.07

Building:	Main Building
Location:	Roof Exterior
Finding:	Roof sheets - Rusted
Information:	Metal roofs generally comprise numerous individual sheets, which join and overlap. These intersections are particularly prone to lift at the edge and consequently rust at these points.

Upon inspection of the exterior roofing structure, evidence of rust to these sections was identified.

A roofing contractor should be appointed to assess the damage to the roofing sheets and to perform remedial works as necessary.

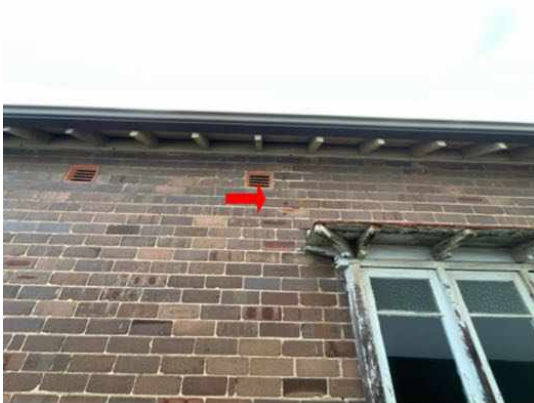
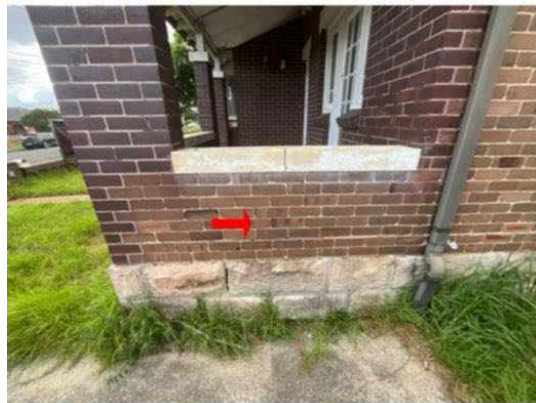
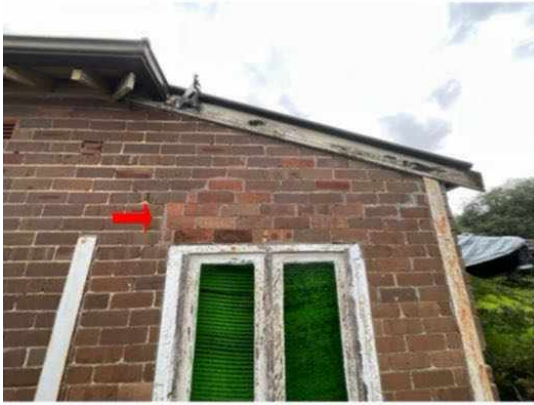
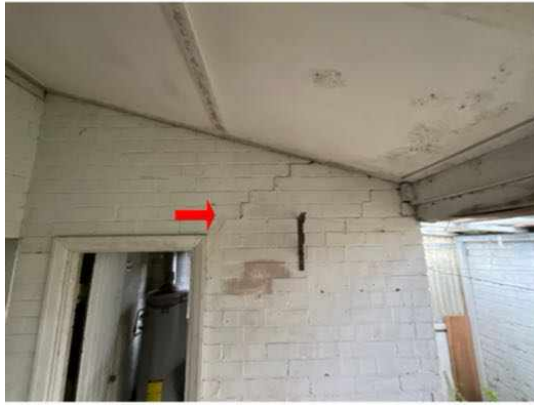
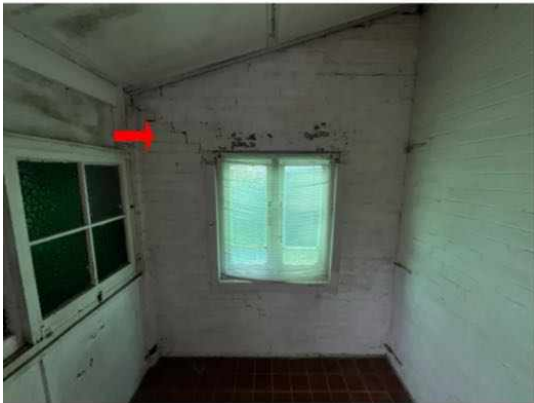
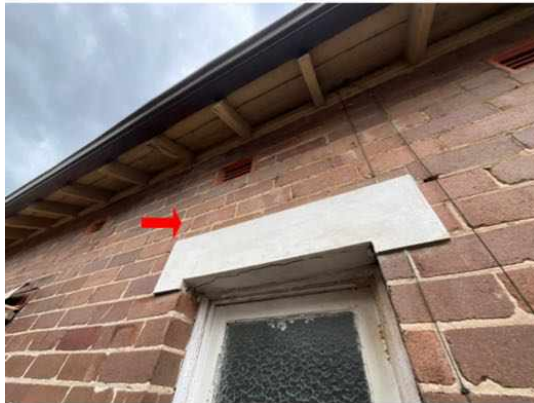
Finding 3.08

Building:	Main Building
Location:	Exterior walls
Finding:	Brickwork - Cracking noticeable
Information:	There were several cracks and or crack repairs evident to external brickwork.

Noticeable cracks are a common occurrence in external brickwork and are a likely result of age expected building movement, general expansion, and/or contraction of building materials in different weather conditions.

It is highly advised that a qualified bricklayer be appointed to provide necessary works to cracked brickwork to prevent any further damage.

Always monitor these cracks and contact a building inspector should cracks widen, lengthen, or become more numerous.

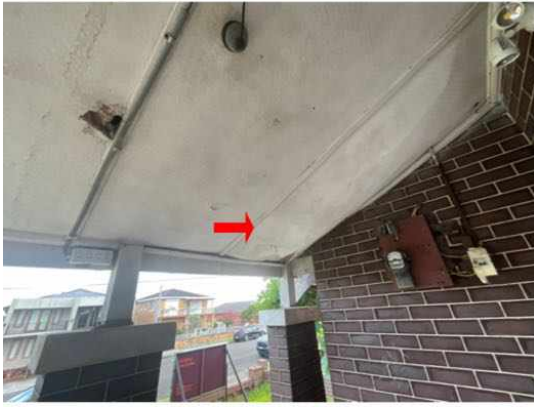
Finding 3.09

Building:	Main Building
Location:	Front Porch
Finding:	Ceiling - Water damaged
Information:	Water damage to the ceiling lining is generally an indication of excessive moisture being present in the roof void, usually via a leak to the roof covering.

Where water damage is evident to the ceiling, the primary requirement is to identify and rectify the source of the leak. A roofing plumber should be appointed as soon as possible to identify the leak and perform rectification works as necessary, ensuring the water damage is restricted.

Once the leak is repaired, consultation with relevant tradespeople, including plasterers and painters, is advised. Rectification works may include replacement of ceiling lining or minor repainting, depending on the extent of the damage.

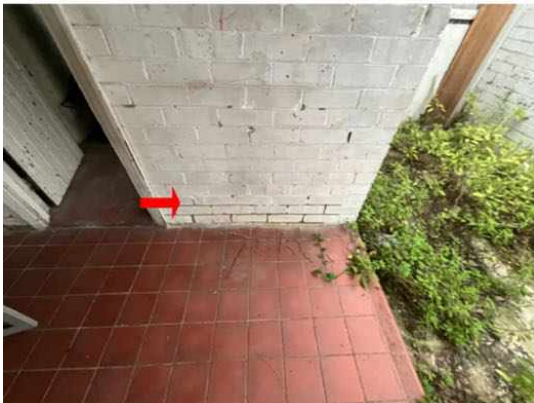
Finding 3.10

Building:	Main Building
Location:	Exterior walls
Finding:	Brickwork - Deteriorated mortar
Information:	Mortar, or 'bedding', is the material which fills joints and intersections between bricks in masonry walls and structures. Sections of mortar in this brickwork were identified as having deteriorated.

Mortar deterioration can be addressed by a bricklayer.

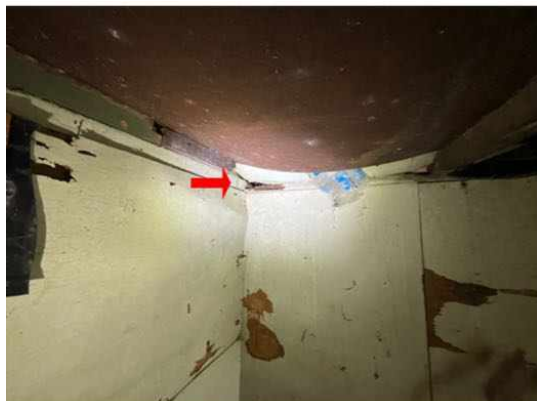
Finding 5.01

Building:	Garage
Location:	Garage
Finding:	Termite - damage identified

Information: Despite no live termite or timbered pest activity being indicated, termite damage was found to have affected this area.

A building contractor should be appointed to provide a further invasive inspection and to see what necessary works are required.

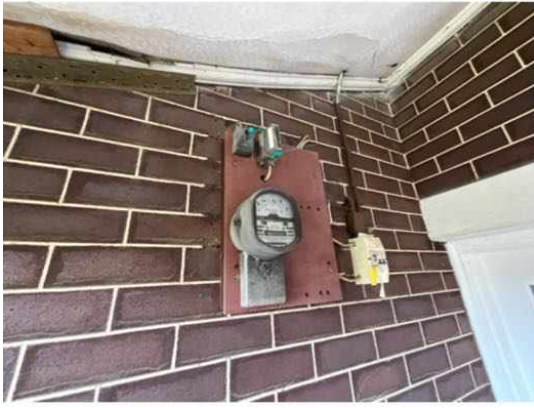
Finding 6.01

Building: Main Building
 Location: All Areas
 Finding: Termite Management System - no evidence of a chemical installation
 Information: The application of a post-construction chemical termite barrier is highly recommended for all properties, particularly if live termite activity has been found on the site previously. Such barriers are highly effective in preventing termite attack on any timber building elements throughout the property.

A durable notice should be placed in the switchboard unit to indicate current termite barriers. At the time of inspection, it appeared as though no termite management system has been installed, with no evidence to suggest preventative works taking place.

The client may consider gaining further advice from a pest controller as to the costs and procedures involved with this application. It is recommended that obtaining such advice be a short-term priority.

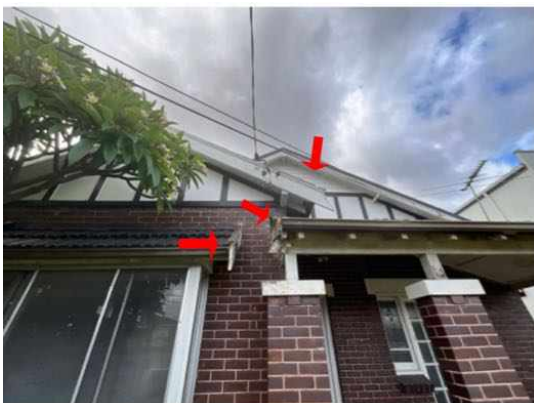
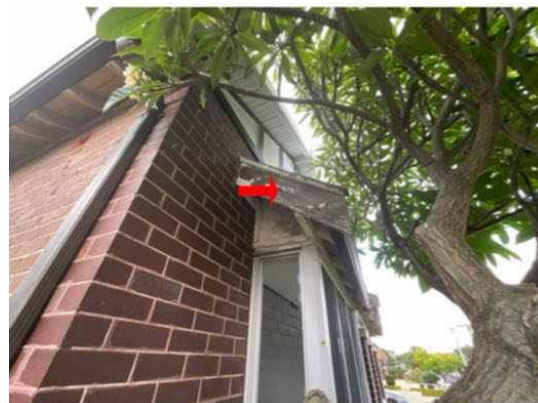
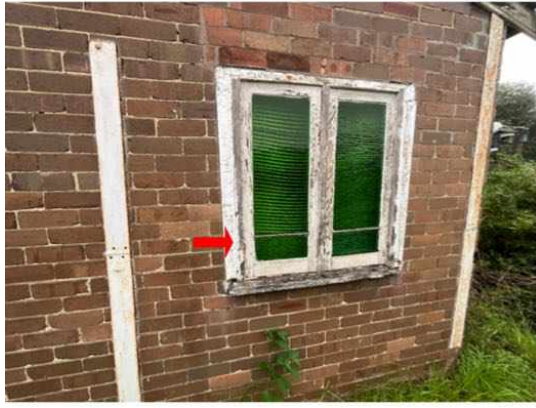
Finding 7.01

Building:	Main Building
Location:	External Areas
Finding:	Fungal decay - present (localised)
Information:	Fungal decay also known as wood decay or wood rot generally refers to the deterioration of timber elements when in contact with excessive levels of moisture for a prolonged period of time.

The development of fungal decay is accelerated by temperatures in the range of 5degreeC to 40degreeC as well as the presence of oxygen. Generally fungal decay develops on timber elements that are in use in an external environment which are exposed to rain penetration.

In this case although the affected timber element is in a decaying state the extent of any visible damage appears to be localised to a specific area and is yet to spread to other parts of the building element or affect adjoining structures. The fungal decay is therefore likely to be of a relatively superficial nature with minimal impact on the structural integrity or tensile strength of the timber element.

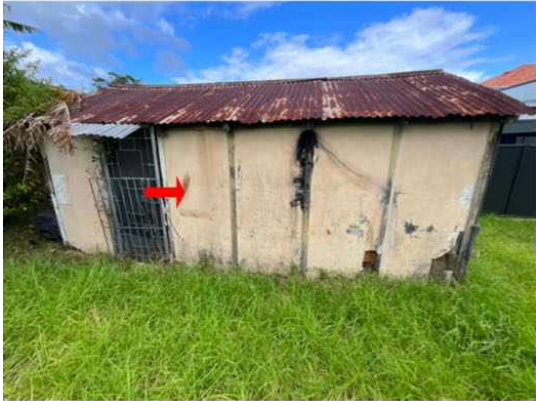
Building: Yard
 Location: Garage
 Finding: Asbestos - Suspected ACM Identified on Site
 Information: Reporting on Asbestos is outside the Scope of this Report. This suspected defect is highlighted as a caution only. We suspect, based on our experience in the building industry, that there is a higher risk of the identified building element containing asbestos.

As Asbestos Reporting is outside the scope of this report, we advise that you consider a separate Asbestos Inspection and Condition Audit, which can include the taking of

samples for definitive confirmation of the presence of Asbestos.

In the interim, the client is advised to act with caution, especially when considering any damage to building materials general wear and tear renovations extensions demolition and general maintenance activities due to the suspected presence of Asbestos.
