Building and Timber Pest Inspection Report

Inspection Date: Thu, 5 Feb 2026

Property Address: 4/23 Pye Rd, Quakers Hill NSW 2763,
Australia

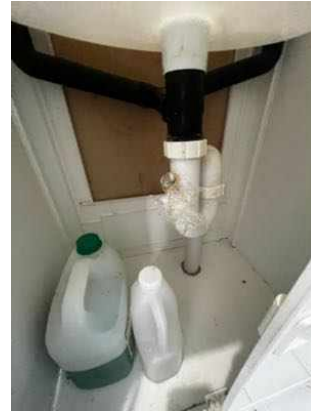
Building: Main Building
Location: Kitchen/ Laundry/ Ensuite/ Bathroom
Finding: Cabinetry Plumbing - Kitchen/ Laundry/Ensuite
Information: All cupboards where sinks and basins with drainage plumbing were inspected and no evidence of leaks were present at the time of inspection.

NOTE: Please be aware that although cupboards have had a thorough inspection, obstructions in cupboards may conceal potential water damage, prevent a full inspection and conditions can change after the initial inspection was carried out, therefore damage may be found after obstructions are removed.

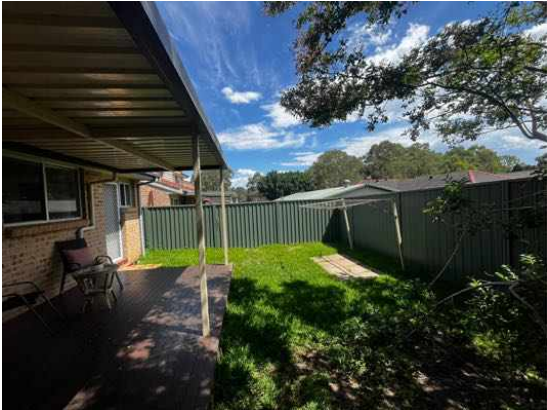
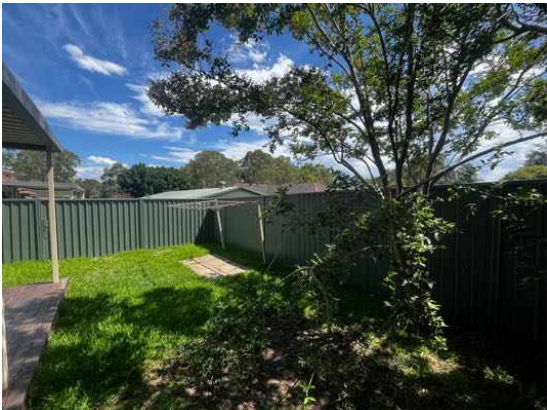
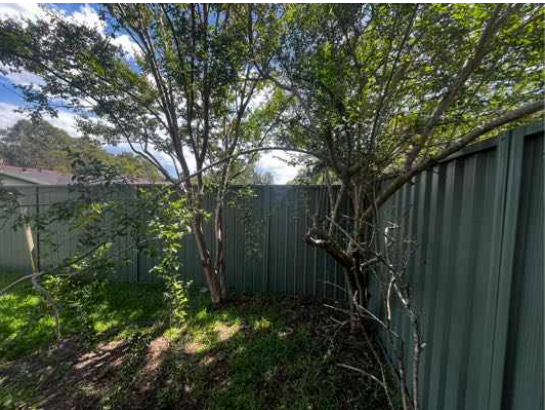
Finding 3.02

Building: Main Building
 Location: Yard
 Finding: Perimeter Fencing -
 Information: For your information photos taken at the time of inspection.

It was noted at the time of inspection that sections of the fencing throughout the property have deteriorated. Typically fencing deteriorates due to age and or wear, rot and or rust which is generally expected for a structure of this age, due to prolonged exposure to weather conditions. Sometimes inadequate installation or maintenance can be to blame.

If left unattended, it is likely that further damage will occur. It is suspected that repair of several elements of the fencing may be required however replacement may be a consideration of the client also.

A licensed fencing contractor should be appointed to provide further advice and perform rectification works as necessary.

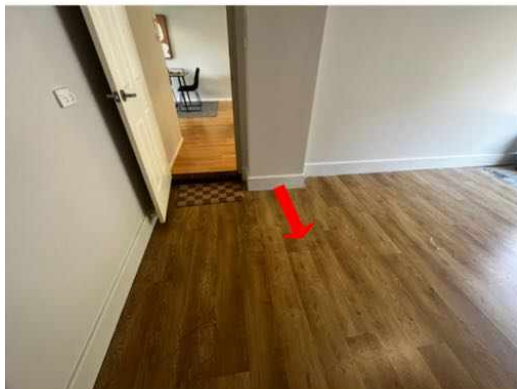
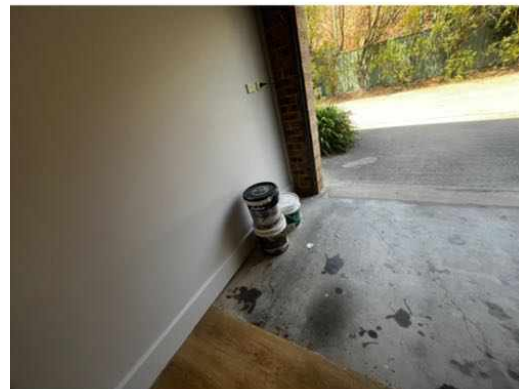
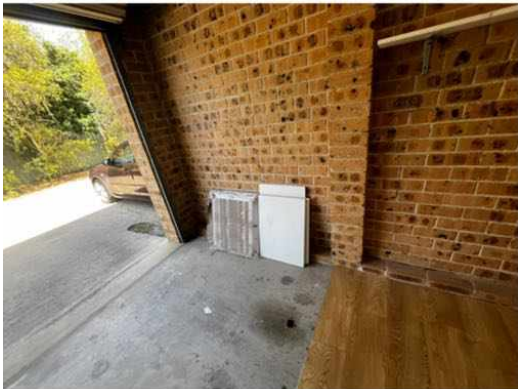
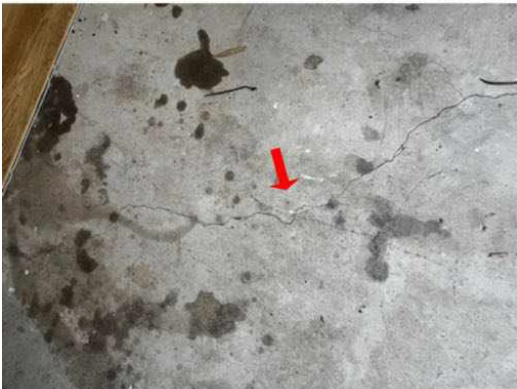
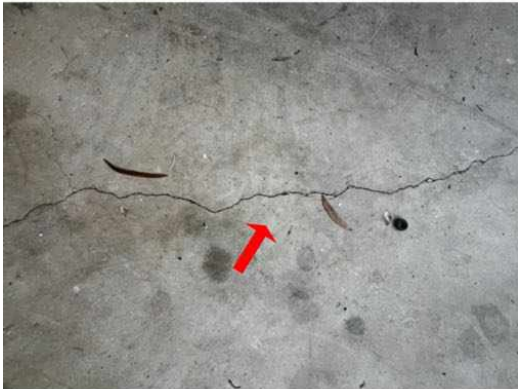
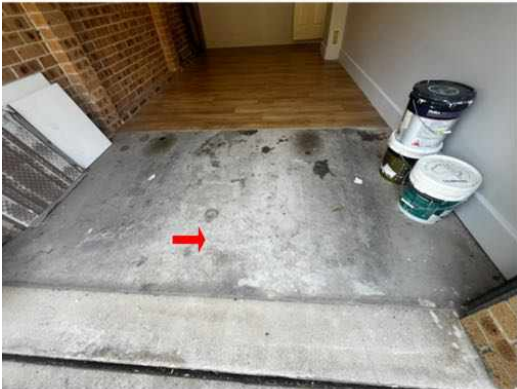
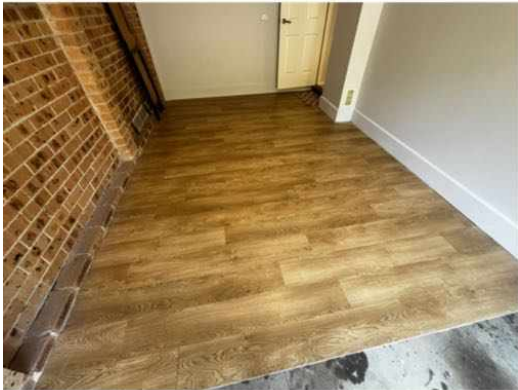
Finding 3.03

Finding: Crack in concrete slab - Category 2

Information: A crack coded as Category 2 was identified in the slab. A Category 2 crack is described as a distinct crack, with the slab being noticeably curved or changed in level.

To be considered Category 2, the approximate width of the crack is less than 2.0mm, or a change in offset of less than 15mm when a 3m straight edge is placed over the defect.

Category 2 cracks to slabs should be monitored for a period of 12 months. At the end of the monitoring period, cracks rated greater than Category 2 are considered defects that require rectification.

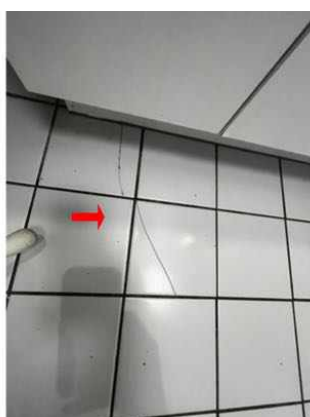
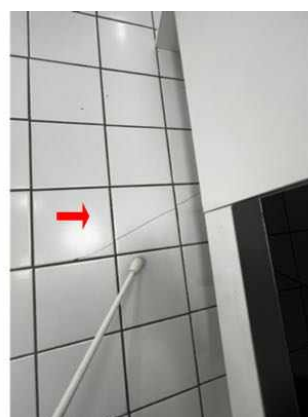
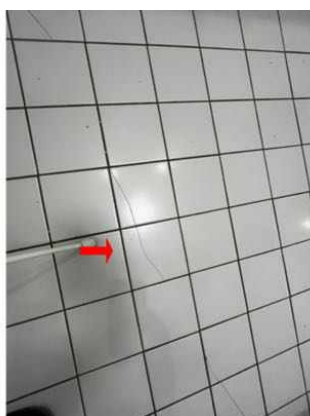
Finding 3.04

Building: Main Building
 Location: Kitchen
 Finding: Cracked floor tiles
 Information: Cracking in the floor tiles was evident in this area at the time of inspection. It is suspected that this cracking has occurred as a result of minor settlement or shrinkage of the slab.

Cracked tiles throughout the household detract from the overall appearance of the affected areas however it is unlikely to create or lead to any secondary defects.

While not considered a matter of urgency, replacement of cracked floor tiles is recommended at the clients discretion.

A tiling contractor may be appointed to perform these works. Where cracks become more numerous, contact a licensed building inspector for further investigation.

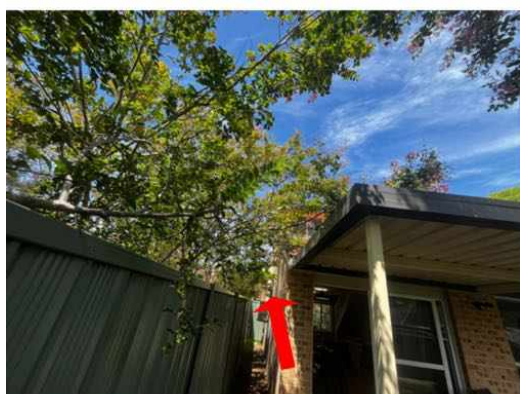
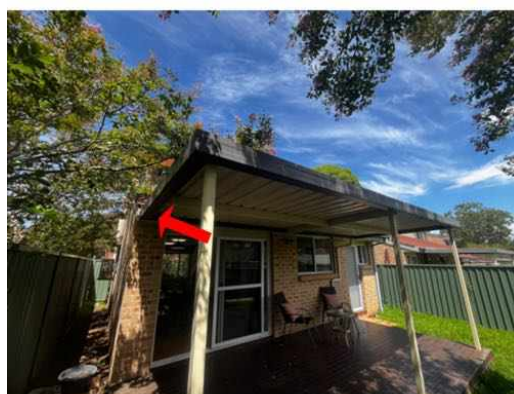
Gutters are a critical part of the building's management of storm water and rain. It is therefore important that they be kept clear to prevent secondary damage to associated building elements, including exterior and interior walls, ceiling linings and any adjoining building elements. Where gutters are blocked, pooling of rainwater is likely to occur, fast-tracking rust and corrosion of the roof plumbing elements.

It is highly advised that all overhanging tree branches be removed as soon as possible to prevent any further damage. Repair and/or replacement of sections of damaged guttering may also be required where the extent of the damage necessitates.

Such works should be performed by the homeowner; however, appointment of a landscape contractor or an arborist may be required. Consultation with a licensed roof plumber is required where guttering has been damaged.

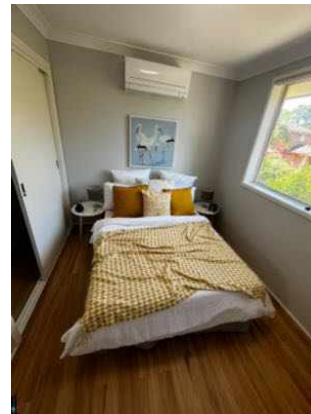
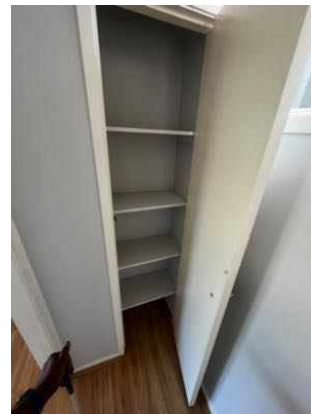
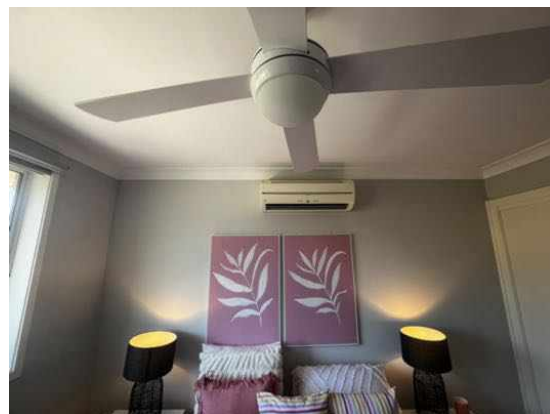
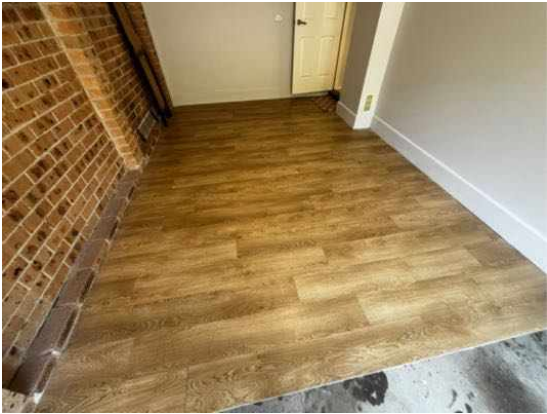
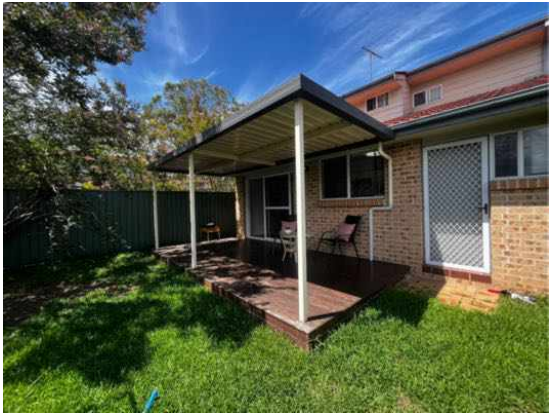
Finding: Additional Photos - Obstructions and Limitations

Information: These photographs are an indication of the obstructions and limitations which impeded full inspection of the property at the time of inspection. These obstructions can hide an array of defects and should be removed to allow full inspection to be carried out. A re-inspection is recommended once the areas are made accessible.

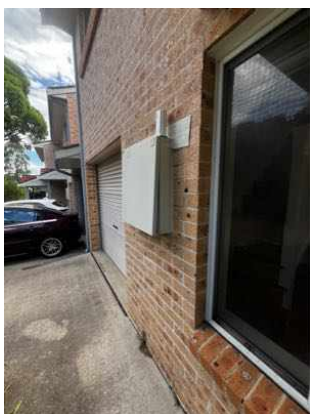
Finding 6.03

Building:	Main Building
Location:	All External Areas
Finding:	Slab Edge - Exposure
Information:	An inspection zone of at least 75mm in relation to the exposed slab edge, between the bottom brick and the perimeter pavement, is required. This inspection zone should be maintained in order to force termites into the open where they can be detected more readily during regular inspections. The slab edge should not be concealed by anything that may prevent inspection of the area, including render, landscaping, soil, turf, paving, concrete cladding or other structures.

If the slab edge is not properly exposed there is a high risk of termite attack. Sometimes, in order to determine the type of slab, a suitably qualified person such as an architect or builder may be required to consult the construction plans.

Where the slab edge cannot be properly inspected, it is highly recommended that termite or timber pest inspections be carried out every 6-12 months to aid protection of the property against infestation.

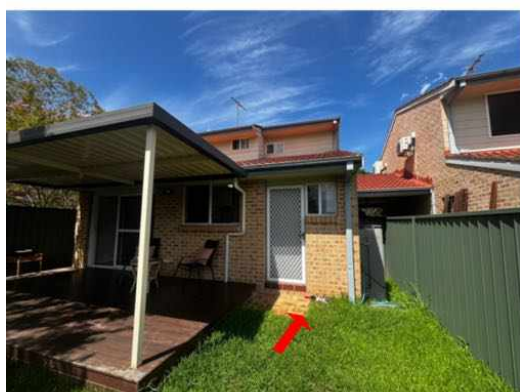
Finding 6.04

Building:	Main Building
Location:	Yard - Back

The risk of termite activity may be present. As they are likely to come into contact with weather conditions or excessive moisture wood rot is likely to develop on timbers that are not treated.

It is highly recommended that any stored timbers be immediately removed from areas in which they may attract any termite / timber pest attack. Minimisation of risk / prevention of termite attack is far more adequate than dealing with the presence of termite activity.

These obstructions can hide an array of defects and should be removed to allow full inspection to be carried out. A re-inspection is recommended once the areas are made accessible.

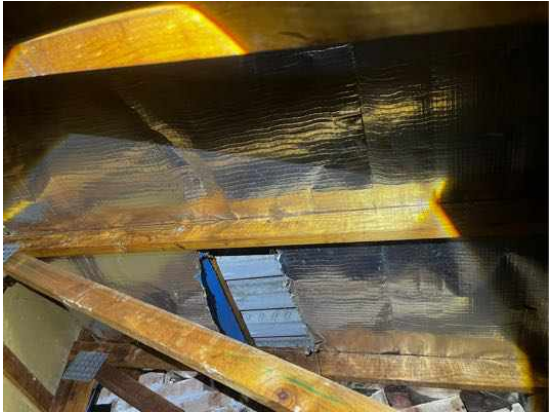
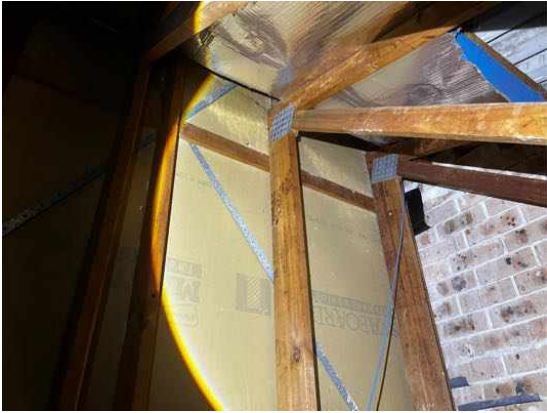
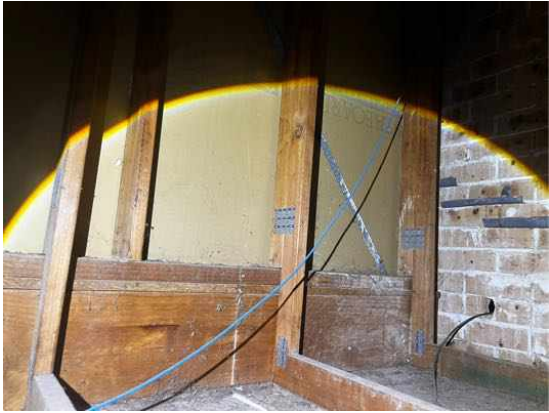
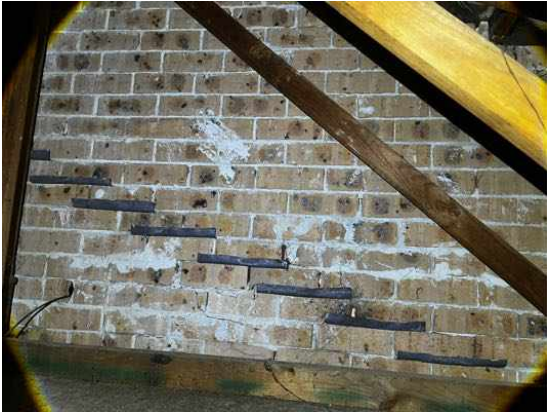
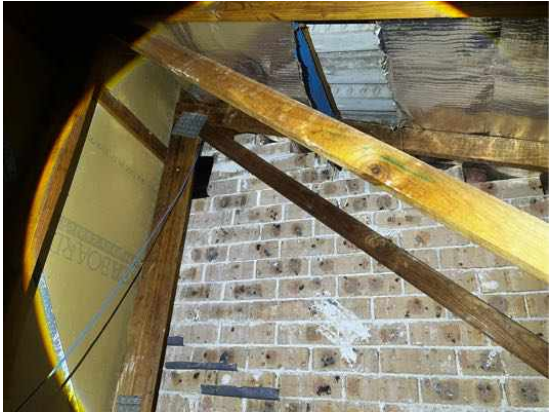
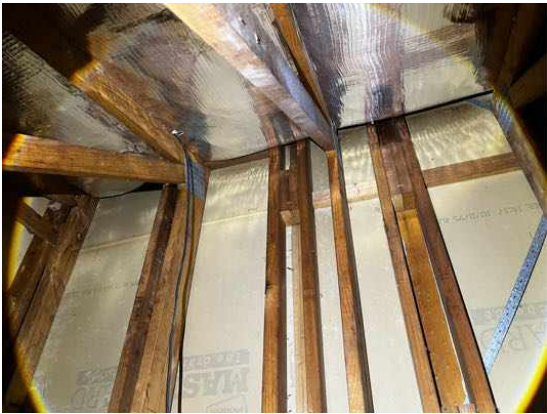
Building: Main Building
Location: Roof Void/garage/upstairs
Finding: Obstructions and Limitations - Roof space
Information: Upon Inspection of the Roof void upto the point safe for inspection These photographs are an indication of the obstructions and limitations which impeded full inspection of the Roof Space/Void at the time of inspection such as Stored items, Ducting, Electrical wires , insulation and cross beams, rafters, low clearance as of the pitch in the roof. These obstructions can hide an array of defects and should be removed to allow full inspection to be carried out.

A re-inspection is recommended once the areas are made accessible.

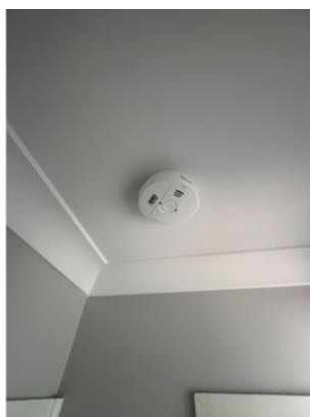
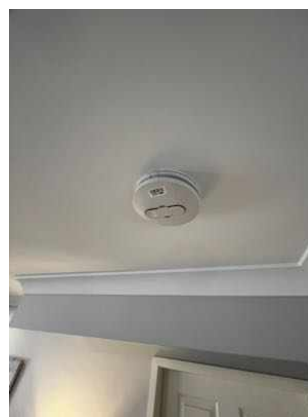
Building: Main Building
Location: All Internal Areas
Finding: Smoke Detector and Alarms
Information: Reporting on Smoke Detectors or Alarms, including hard wired smoke detection systems and their legislative requirements, is outside the Scope of this Report.

Additionally, it is advised that all smoke detectors be tested by the homeowner on a monthly basis.

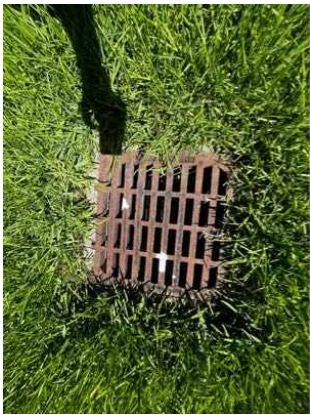
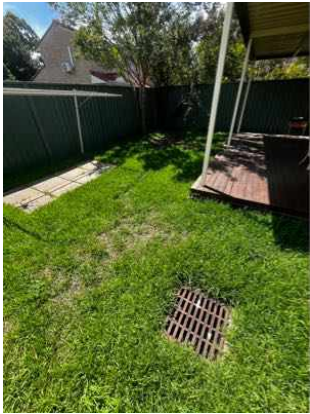
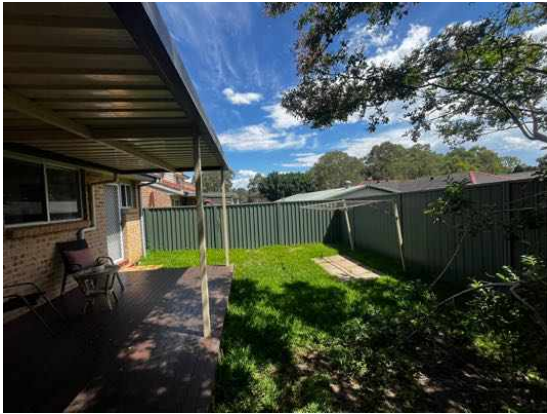
Building:	Main Building
Location:	Yard - Side
Finding:	Site drainage - For your Information
Information:	Site Drainage appears to be acceptable at the time of inspection, however, the site/ Yard should be monitored during heavy rain to determine whether the existing drains cope. If it appears that they cannot cope, then additional drains may be required.

The general adequacy of site drainage is not included in the standard property inspection report. Comments on surface water drainage are limited as where there may have been either little or no rainfall for the period of time, Surface water drainage may appear to be adequate during the inspection but then during periods of heavy rain, may be found to be inadequate.

Any comments made in the section are relevant only in light of the conditions present at the time of inspection. It is recommended that a smoke test be obtained to determine any illegal connections, blocked or broken drains.

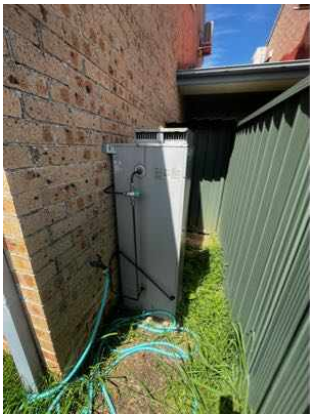
Building: Main Building
Location: Yard - Side
Finding: Hot Water Unit
Information: The HWS appeared to be in good condition at the time of inspection.

Water pressure appears to be normal, however, this is not an opinion of a licensed plumber. No water hammer was noted when taps are turned off fast.
