Building and Timber Pest Inspection Report VR

Inspection Date: Mon, 12 Jan 2026

Property Address: 13 Valley View Dr, West Albury NSW 2640, Australia

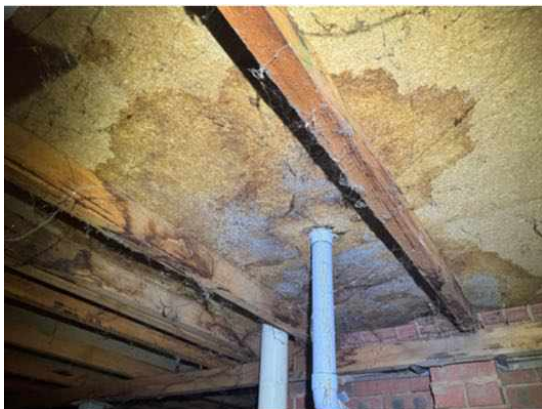
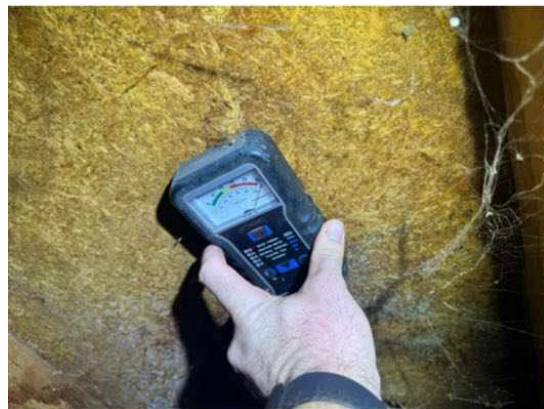
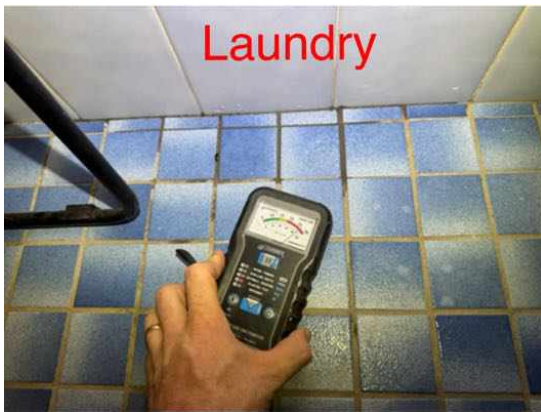
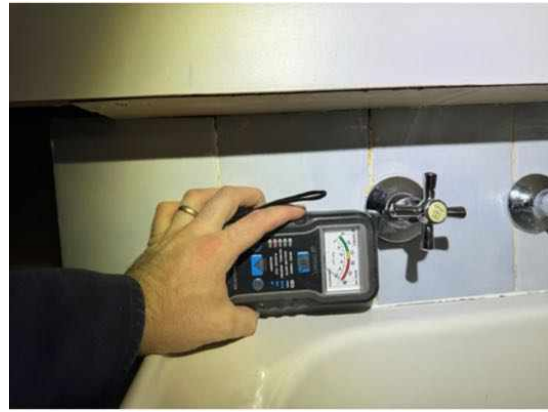
Finding 3.01

Building: Main Building
Location: Bath & Laundry Taps, Beneath Bathroom
Finding: Bath & Laundry Tap - High moisture
Information: It appears that high moisture is present at but not limited to, below the bath taps, the laundry floor beneath the taps (dripping tap) and in the subfloor beneath the bathroom/laundry area. Potential causes of leaking include loose or damaged plumbing fittings/ fixtures, and/or deteriorated seals or waterproofing.

Areas of leaking and high moisture create an environment conducive to termite activity & water damage to surrounding materials. Recommend engaging a licensed plumber promptly, to provide remedial works where necessary, to ensure no further water damage occurs.

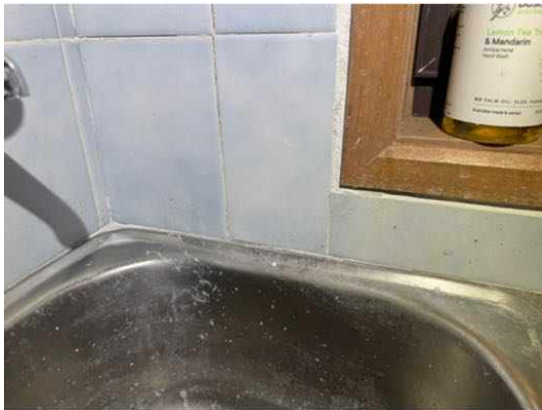
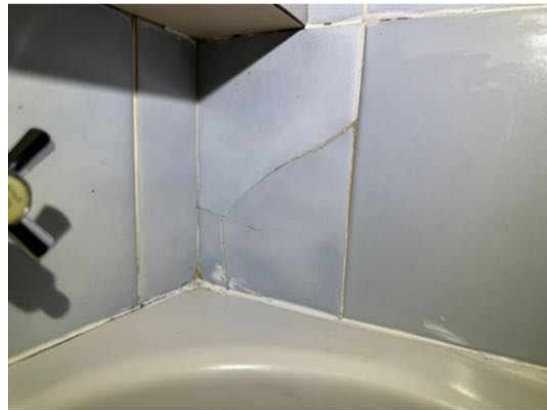
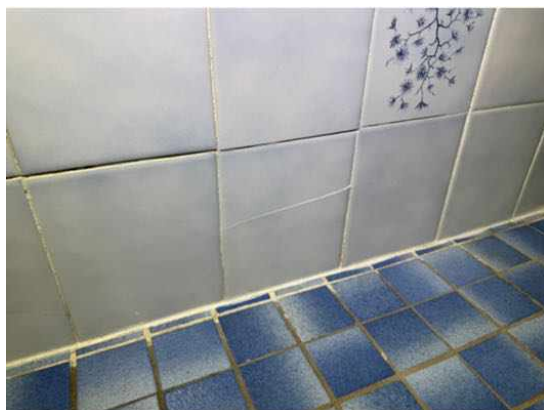
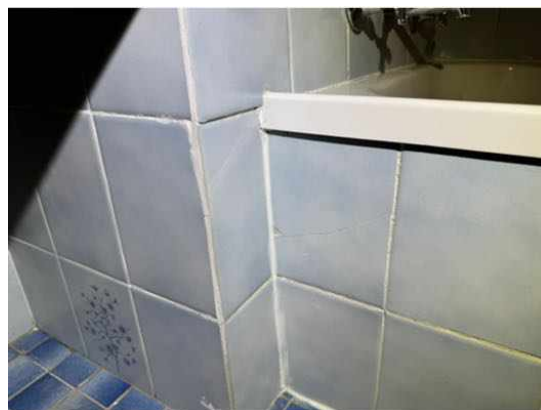
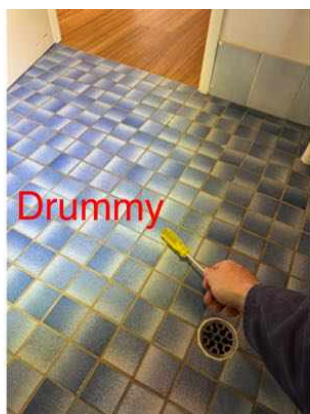
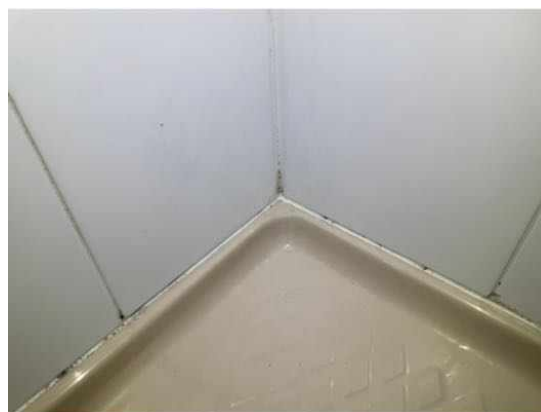
Finding 3.02

Building: Main Building

Location: Tiled Areas

Finding: Sealant / grouting - deteriorated or missing & Cracked Tiles

Information: It appears that the sealant and grout has deteriorated in some tiled areas, a common defect in buildings of a similar age. Some cracked tiles were also noted in the bathroom, which can allow for moisture ingress behind the tiles, if neglected.

Sealant and grouting in areas that come into regular contact with water should be maintained for the long term care of your property.

Recommend engaging a licensed tiling contractor in the short term, to provide maintenance works where necessary.

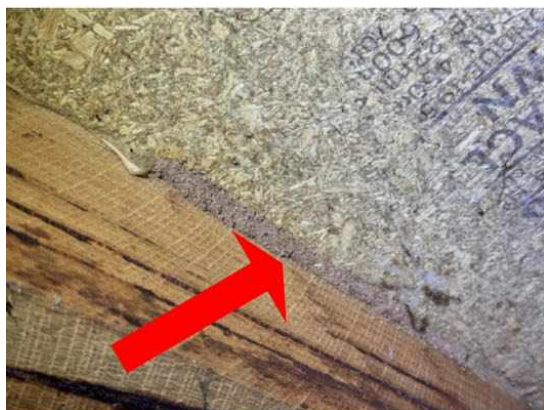
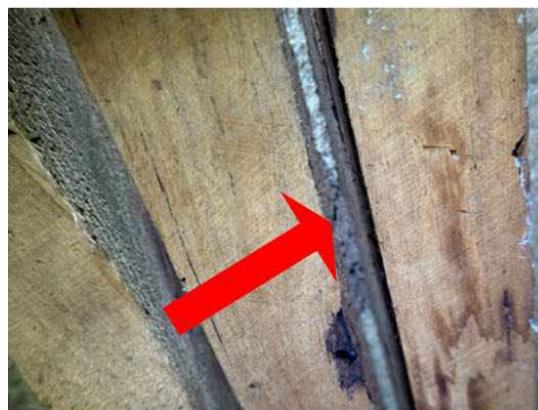
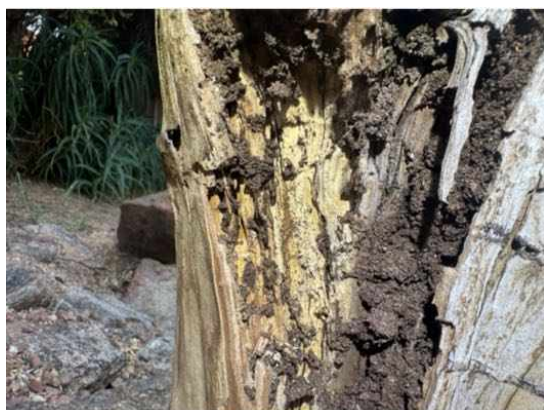
Finding 5.01

Building:	Main Building
Location:	Subfloor, Tree Stump
Finding:	Evidence of termite workings & damage
Information:	Evidence of termite damage & workings were identified at, but not limited to, some areas of the subfloor and to a tree stump.

The client should engage a licensed pest controller to provide further advice regarding installation of a termite treatment. 6 monthly termite inspections, conducted by a qualified termite inspector, are also recommended.

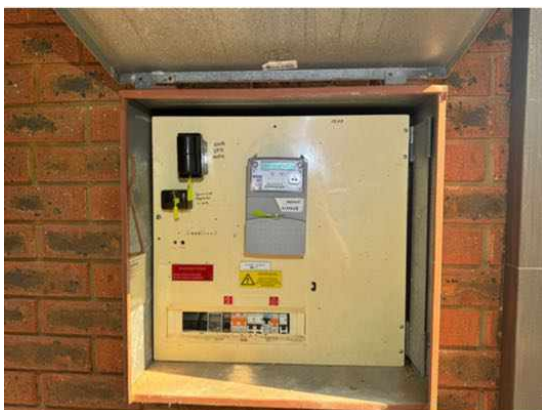
Finding 6.01

Building:	Main Building
Location:	Switchboard
Finding:	Termite Management System - no evidence of a chemical installation
Information:	The application of a termite barrier is strongly recommended, as it appears no termite management system has been installed, with no evidence or durable notice to suggest works taking place. Generally, a durable notice is placed in the meter box to indicate current termite barriers.

Such barriers are highly effective in preventing termite attack on the building and therefore should be installed.

Recommend seeking further advice from a licensed pest controller.

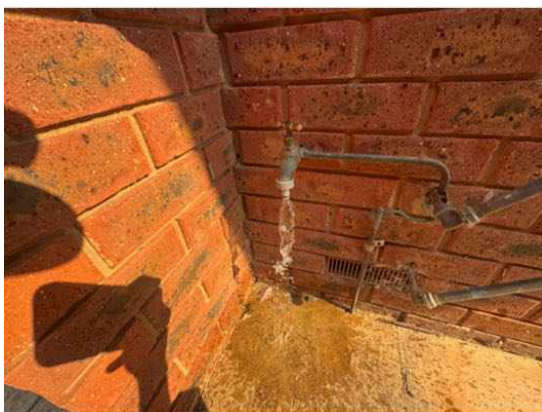
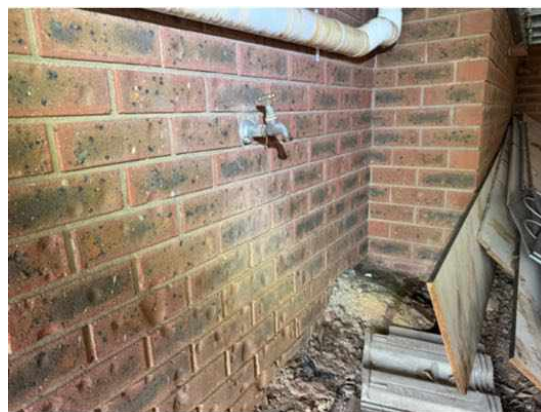
Finding 6.02

Building:	Main Building
Location:	External Taps
Finding:	Potential Water pooling - against property
Information:	It appears that there are potential areas around the perimeter of the property that could be susceptible to water pooling.

Where insufficient drainage of taps is present, water pooling is likely to occur, and can create areas conducive to timber pests and potential damage to the subfloor structure overtime, if neglected. Recommend consulting with a licensed plumber in the short term to provide remedial advice.

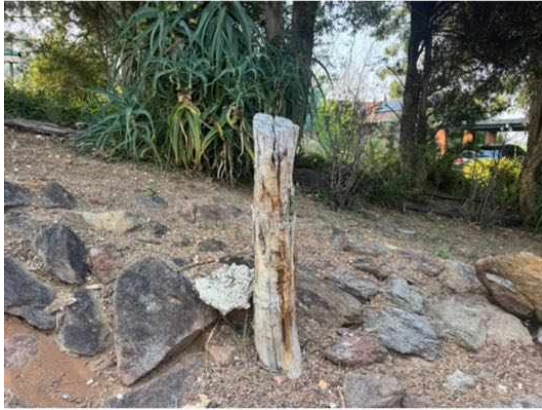
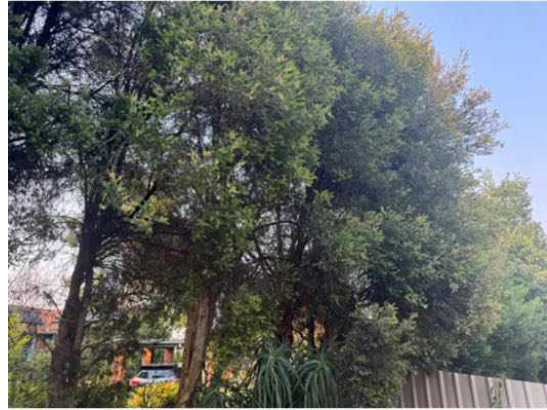
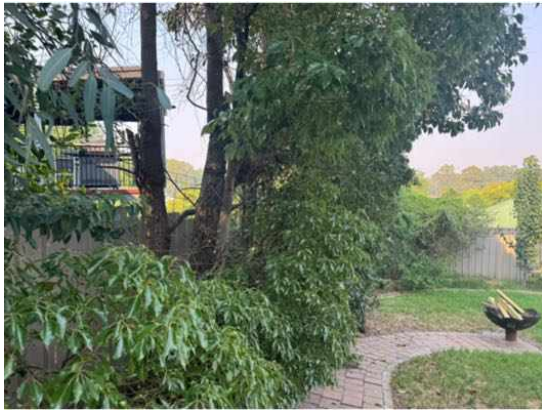
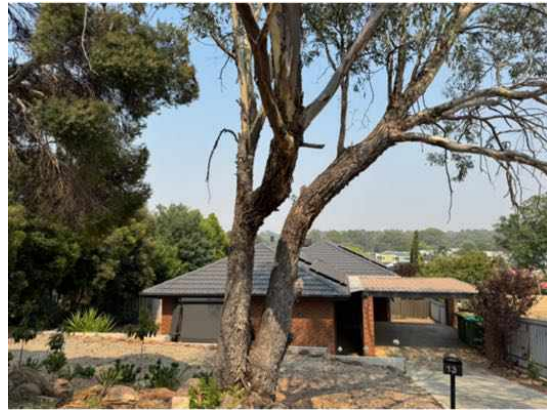
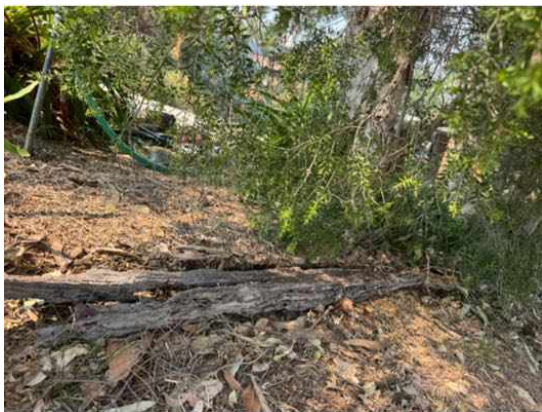
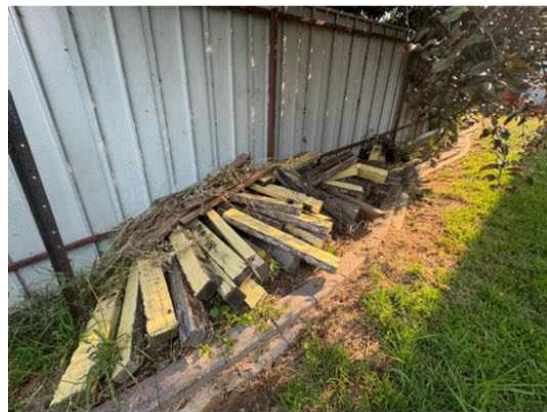
Finding 6.03

Building:	Main Building
Location:	All External Areas
Finding:	Timber in direct ground contact & trees - conducive to termites
Information:	Where timber materials are in direct contact with the ground and consequently moisture, they become conducive to termite activity. The tree stumps, timber debris in the subfloor, and trees surrounding the building create an environment conducive to termite infestation.

Where feasible, any timbers in direct contact with the ground should be removed and any trees in close proximity to the building should be removed or test drilled (inspected) at least annually to reduce the risk of termite infestation & detect any early signs of termite activity.

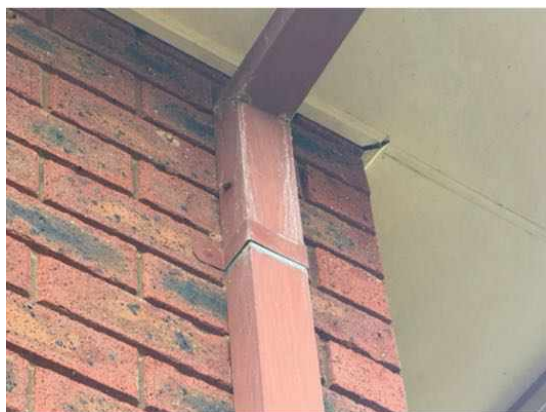
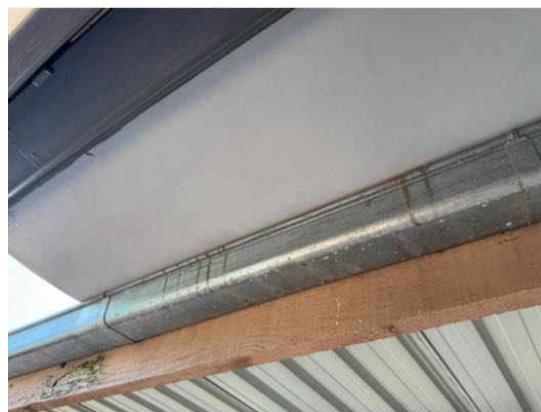
Finding 6.04

Building:	Main Building
Location:	Gutters, Down-pipes
Finding:	Roof Plumbing - Signs of Leaking
Information:	It appears that areas of the roof plumbing showed signs of leaking. Leaking can create water pooling at the base, creating an environment conducive to termite activity, if

neglected. Recommend engaging a licensed roof plumber in the short term, to provide maintenance works.

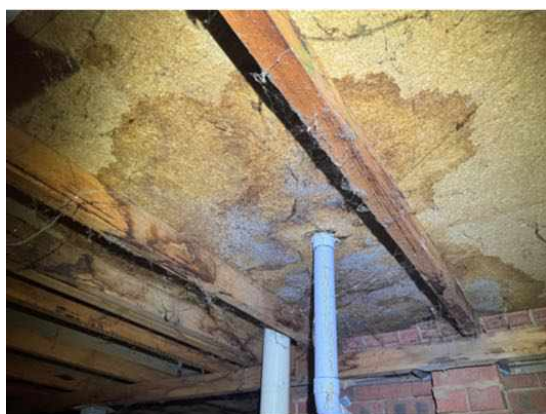
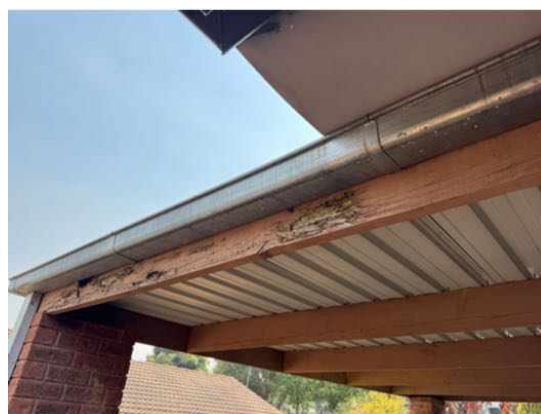
Finding 7.01

Building:	Main Building
Location:	Subfloor beneath bathroom, patio beam
Finding:	Fungal decay & weathering
Information:	Areas of fungal decay (wood rot) were identified at but not limited to the carport beam, and beneath the bathroom/laundry areas in the subfloor.

For areas of fungal decay, the client can engage a licensed carpenter at their discretion to replace affected materials. For areas of general weathering, it is advised the client engage a licensed painter to apply protective sealant or coating to areas of weathered external timbers.

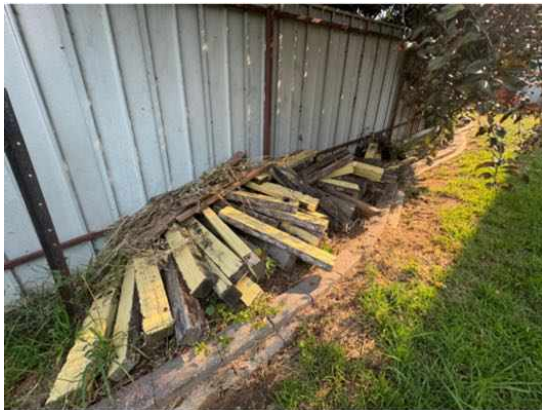
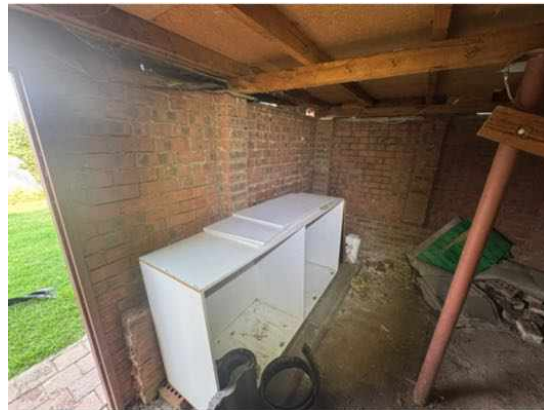
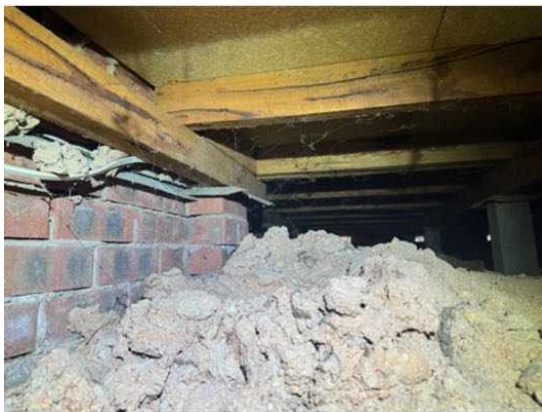
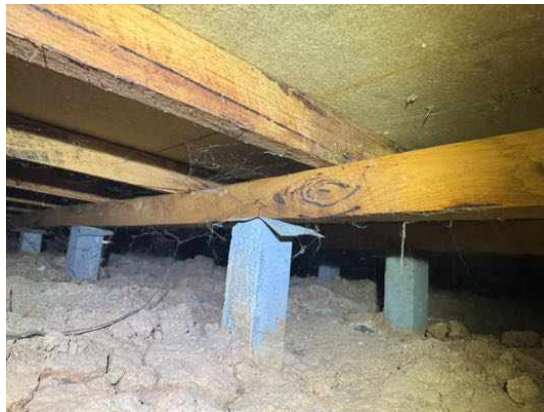
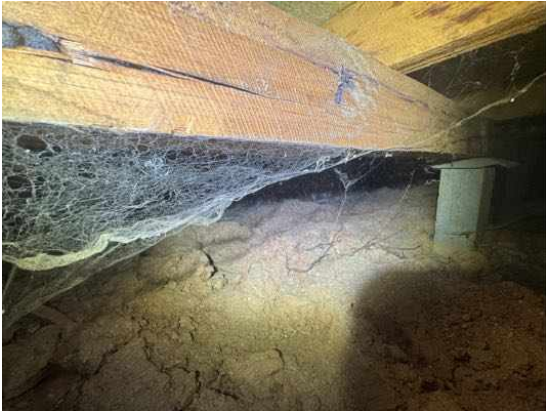
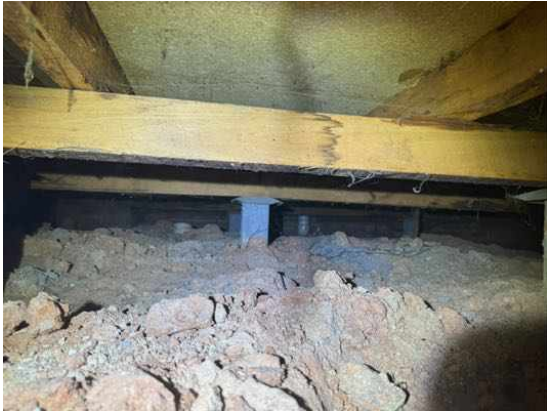
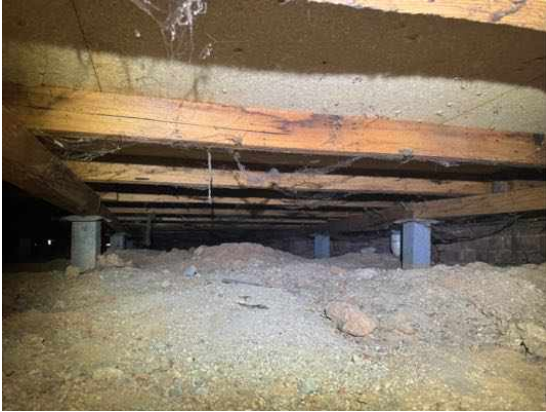
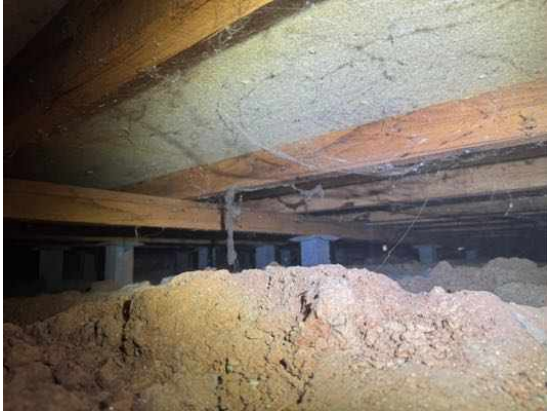
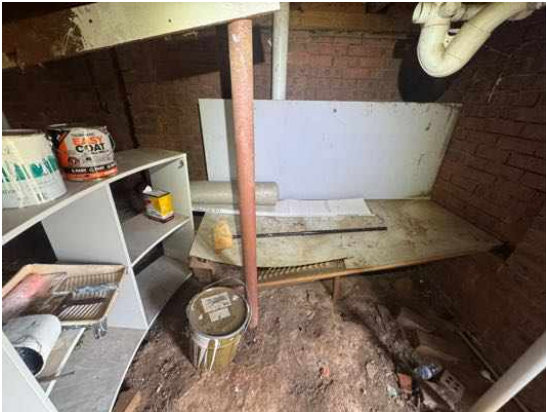
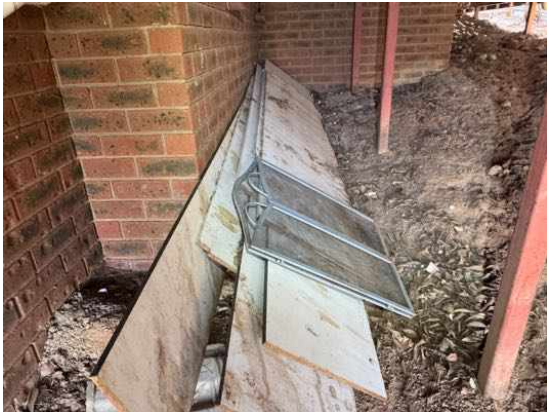
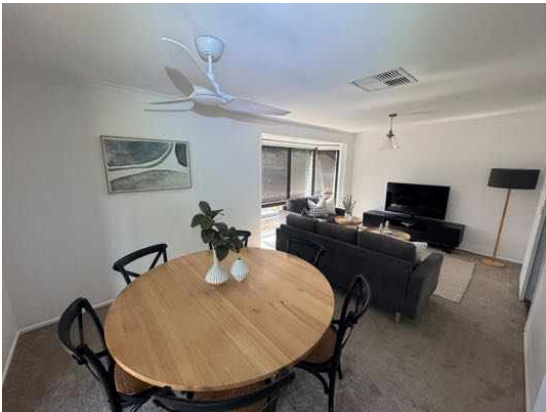
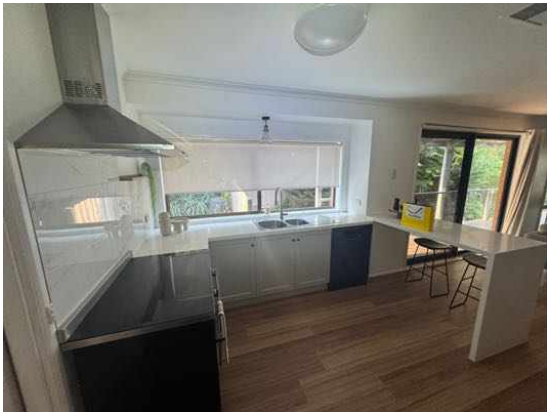
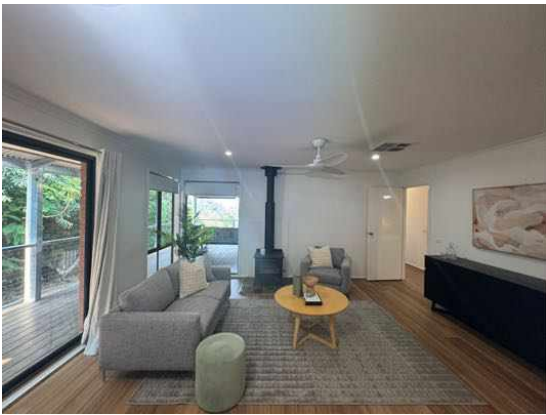
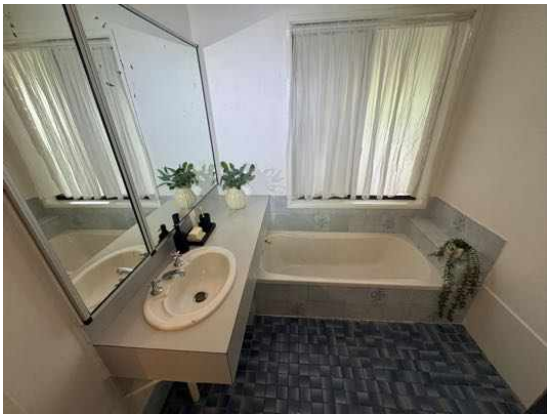
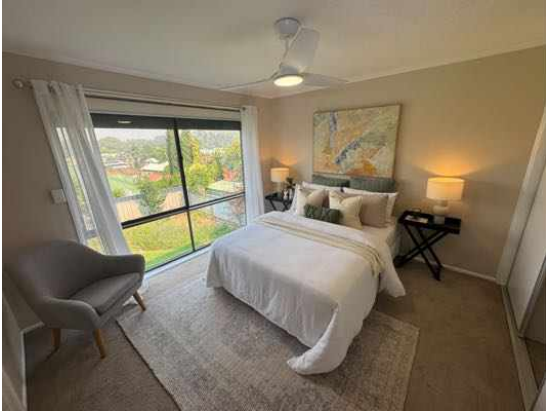
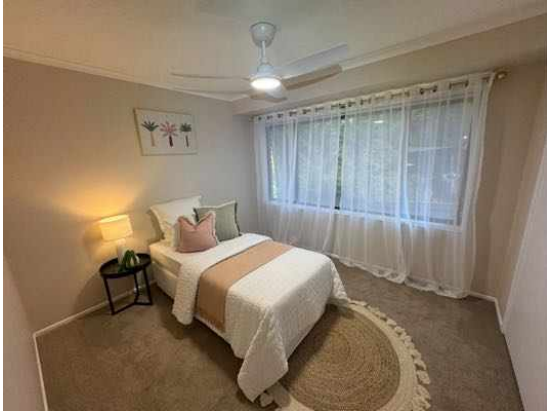
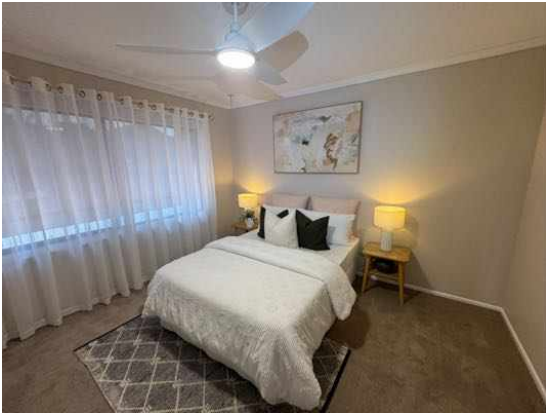
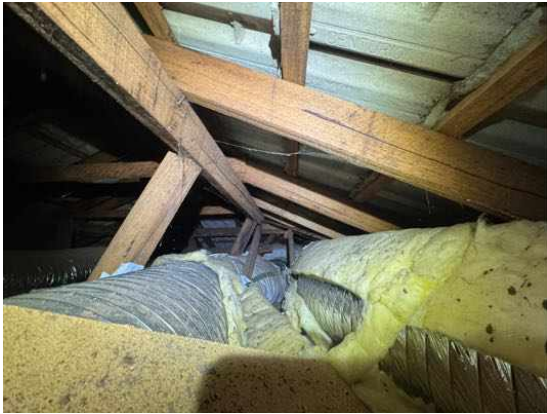
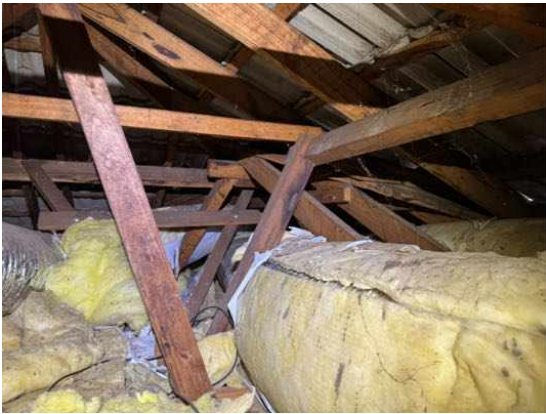
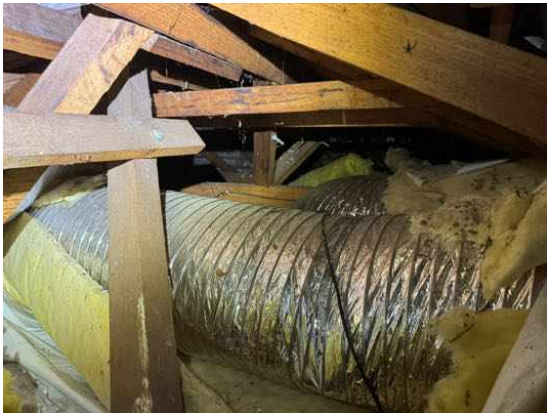
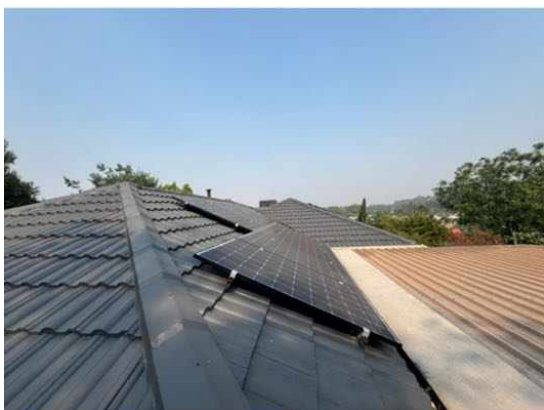
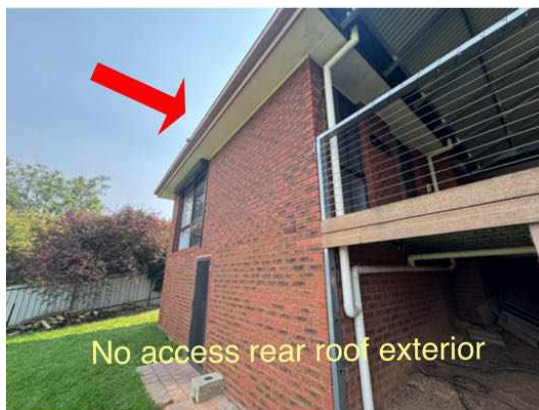
Building: Main Building
Location: All Areas
Finding: Additional Photos - Obstructions and Limitations
Information: These photographs are an indication of the obstructions and limitations which impeded full inspection of the property at the time of inspection. These obstructions can hide an array of defects and should be removed to allow full inspection to be carried out. A re-inspection is recommended once the areas are made accessible.

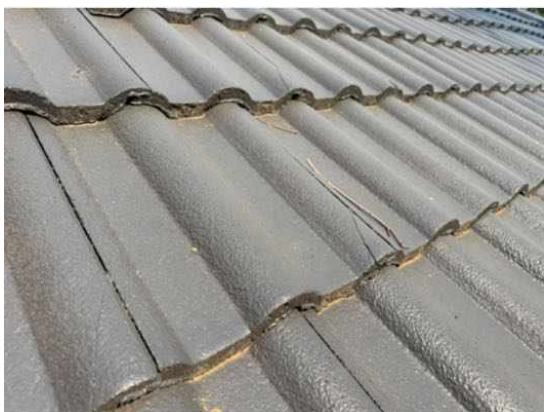
Building: Main Building
Location: Roof Exterior
Finding: Roof Exterior - Minor Chipping
Information: Although the roof exterior appeared to be in relatively good condition, areas of minor chipping were present to some roof tiles. While weathering of the tiles is consistent with the age of the property, it is advised that the client monitor the condition of the roof exterior.

Should further deterioration occur, a licensed roofing contractor should be engaged to provide maintenance works.

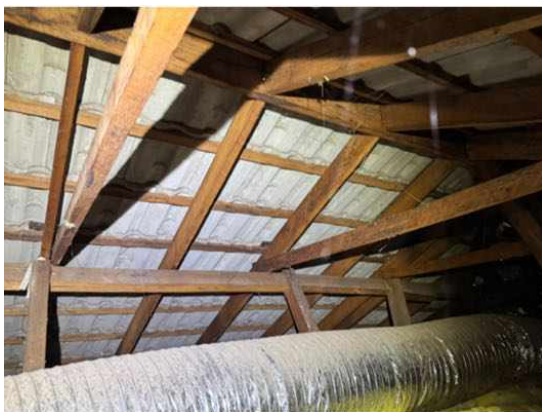
Building: Main Building
Location: Roof Void
Finding: Sarking - Not Present
Information: It is noted for your information that sarking has not been installed on the roof. Sarking is a laminated aluminium foil applied to the interior of the roof covering, assists in insulating the property and acting as a vapour-barrier to the roof void.

The client can consult with a licensed roofing contractor at their discretion, to provide

further advice.

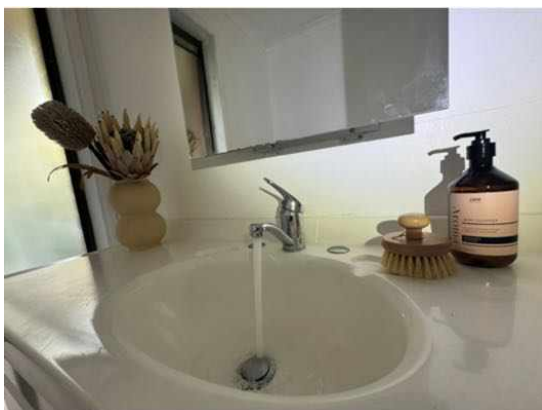
Building: Main Building
 Location: Ensuite Taps
 Finding: Taps - Water hammer
 Information: It appears that water hammer was present at, but not limited to the ensuite taps. Water hammer is a pressure surge resulting when water is forced to suddenly change direction. This is a common defect in plumbing fittings and is evidenced by a faint banging noise when operating the tap.

The client can consult with a licensed plumber at their discretion, to provide further advice.

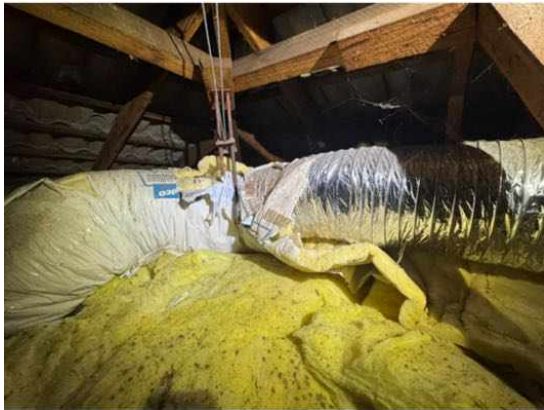
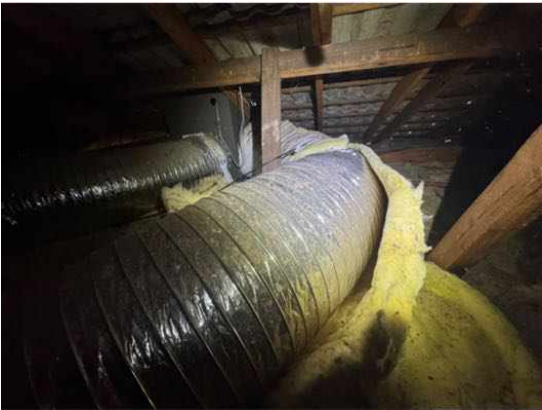
Building: Main Building
 Location: Roof void
 Finding: Heating / Cooling Ducts - deteriorated
 Information: It appears that areas of the heating/cooling ducts were found to be deteriorated at the time of inspection. The deterioration may detract from the functionality of the ductwork. Recommend engaging a heating/cooling specialist to provide further

advice, at clients discretion.

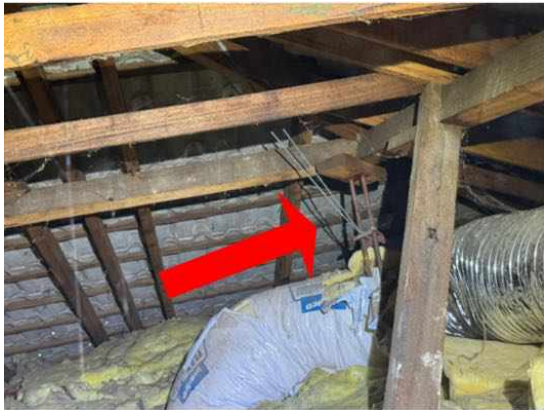
Building: Main Building

Location: Roof Void

Finding: BARAP Straps

Information: It is noted for the clients information that barap straps have been used in the construction of the roof framing. While this is a common construction method used in houses of a similar age, it is advised that the client get the straps inspected annually to ensure all nuts and bolts are tightened and haven't become loose.

Loosening of bolts may cause the roof framing to sag overtime, if neglected.
