Building and Timber Pest Inspection Report

Inspection Date: Mon, 30 Mar 2026

Property Address: U2 102 Central Rd, Unanderra NSW 2526, Australia

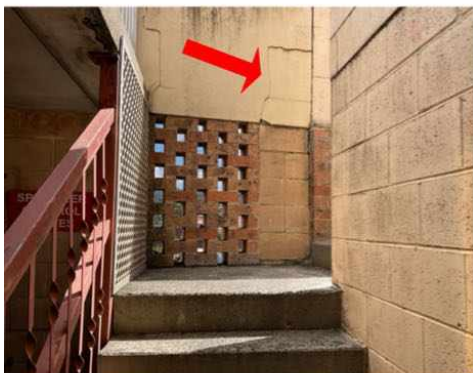
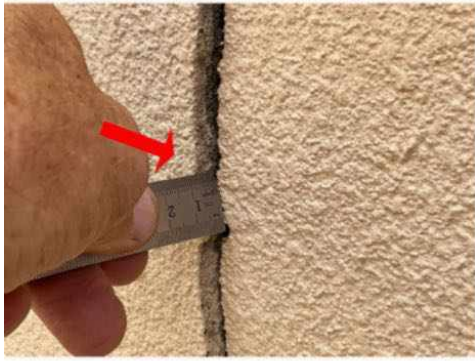
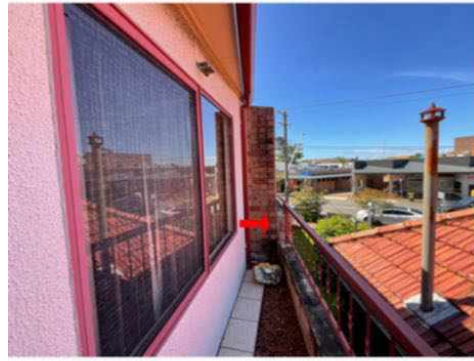
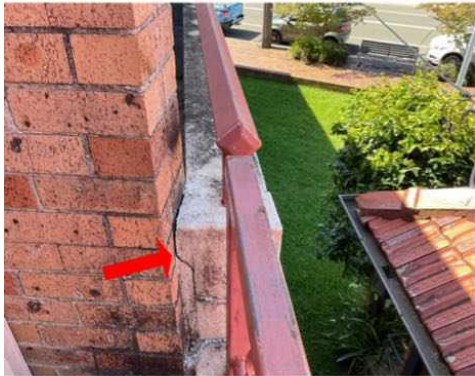
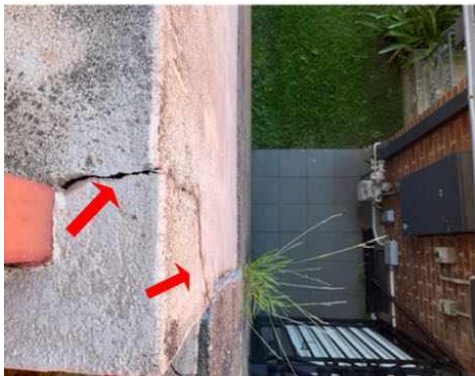
Building: Main Building
 Location: Garage stairs outside unit 1 and unit 2 north east balcony corner
 Finding: Step cracking to brickwork major
 Information: Step cracking of 7mm and 8mm respectively was identified to the brickwork in the external wall area outside unit 1 (bordering unit 2) and the unit 2 balcony corner

The NSW Standards and Tolerances 2017 states cracks over 5mm in width are a major defect requiring rectification work.

Step cracking, which is similar to other forms of cracking, has a variety of possible causes. However, the most common is the subsidence of adjacent footings.

Step cracking is a relatively common defect, and is most likely to occur adjacent to windows, doors and other openings. Mortar failure in the gaps between affected bricks indicates the stresses and tensions affecting the wall.

Where step cracking is extensive in this case, the client is advised to consult a structural engineer. Even minor step cracking can be used as a warning sign to address factors causing stress to the wall, which can include the effect of surrounding trees, water leaks, soil erosion, or even the presence of reactive soils in the surrounding area.

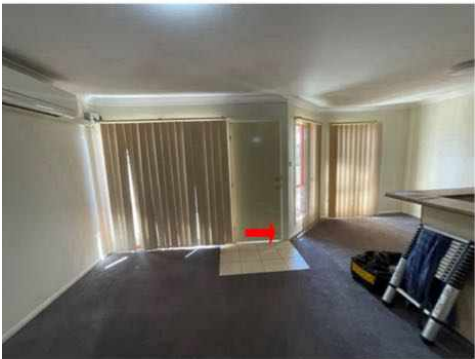
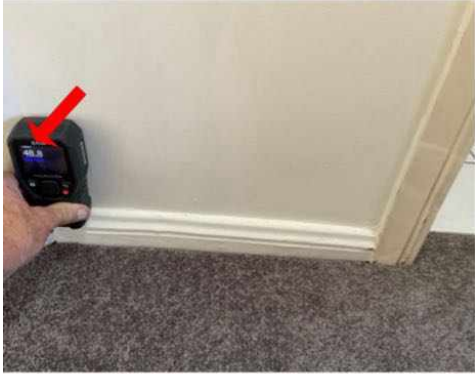
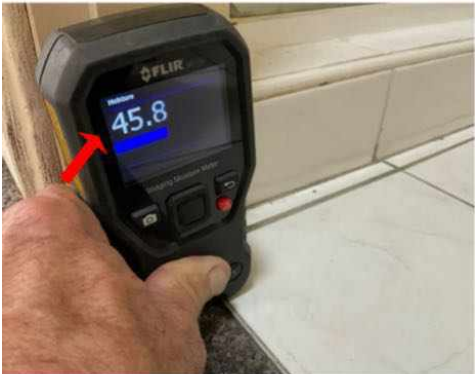
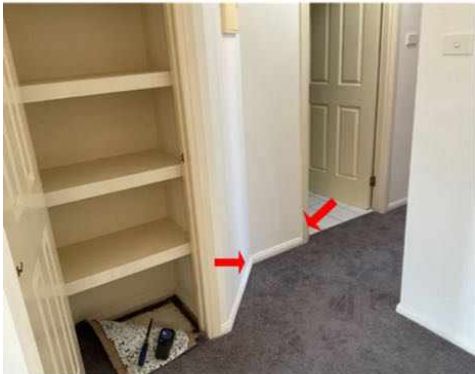
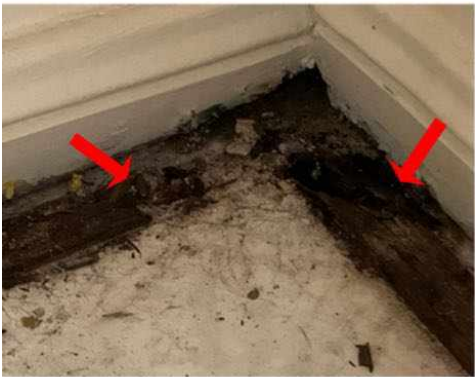
Finding 2.02

Building:	Main Building
Location:	Entry, hall behind shower and hall cupboard behind hit water system.
Finding:	Evidence of excessive moisture was present at the time of inspection
Information:	Excessive moisture was found in the unit entry door and bathroom door frames and hall wall. A high reading of 66.3 was recorded in the entry and up to 48.8 near the bathroom. All nearby areas had zero readings for reference. Old water damage was found in the hall cupboard behind the shower. Due to this current and old moisture damage, damage to internal wall framing is highly likely making the bathroom failed waterproofing membrane and wall damage a major defect and the entry moisture a minor defect. It is unclear if the damage in the hall cupboard originated from the

Excessive moisture can attract termites and produce conditions that promote termite attack and has all readily produced fungal growth and wood decay.

Excessive moisture is generally caused by deteriorated inadequate or missing roof drainage, failed waterproofing membranes, damaged sealant, leaking plumbing pipes or fixtures poorly plumbed HWS overflows or condenser units and poor site drainage.

It is highly recommended that all plumbing and drainage fixtures and fittings be maintained regularly in order to prevent excessive moisture being present in the external / internal property.

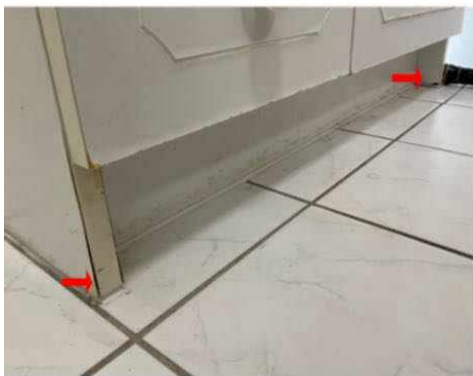
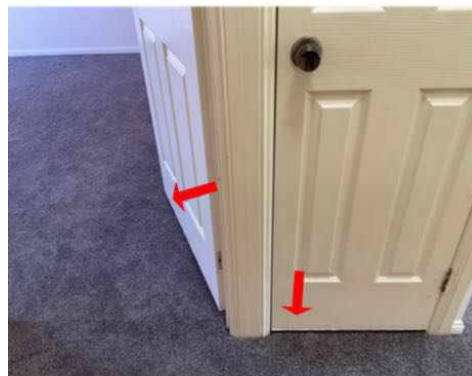
Finding 3.01

Building: Main Building
Location: Bathroom, entry,
Finding: Building elements - Swollen
Information: Swollen building elements generally indicate that the building materials have been affected by excessive moisture over a prolonged period of time, and have swollen as a result. The structural integrity of swollen building elements cannot be guaranteed, and further damage is possible if these areas are left unmanaged.

The north entry wall, hall wall and door frame all showed high moisture leading to swollen and damaged trim indicating water damage (see excessive moisture defect).

Repair or replacement of swollen building elements should be conducted by a qualified carpenter or cabinet maker after the cause if the leaks is rectified.

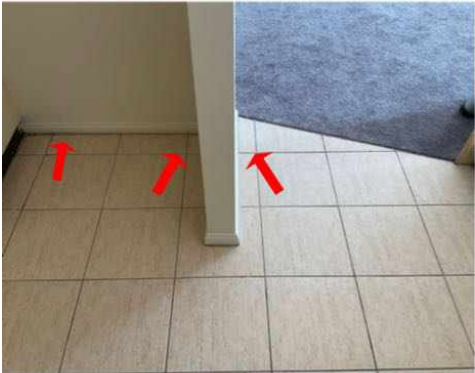
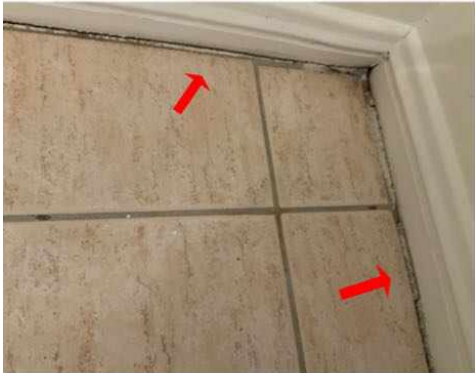
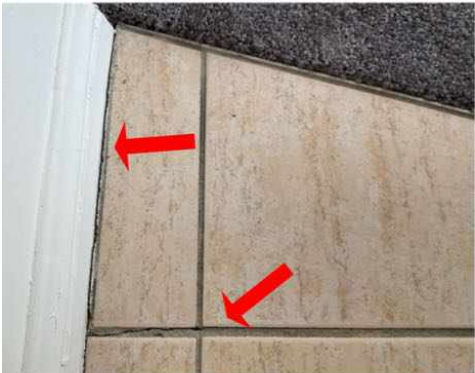
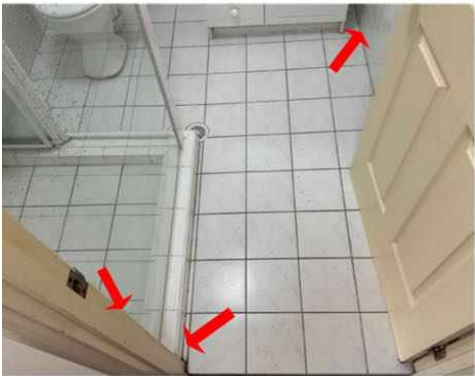
Finding 3.02

Building: Building 1
 Location: Pictured laundry and bathroom areas
 Finding: Sealant and grouting - Missing
 Information: It was noted on inspection that sealant or grout is missing to these pictured areas of the building.

Flexible and mould resistant materials should be applied to affected areas to prevent any subsequent water damage that is likely to occur.

This needs to be brought to the attention of the builder.

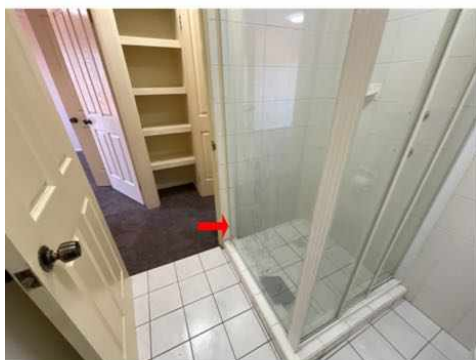
Finding 3.03

Building:	Main Building
Location:	Bathroom
Finding:	Shower screen - Leaking
Information:	<p>Leaking was evident to the shower screening at the time of inspection. It is suspected that the leaking has occurred as a result missing sealant. Leaking from the shower , where left unattended, is likely to lead to water damage to adjoining flooring and walls. Such damage can lead to water damage and necessitate extensive remedial works being required. Active water leaks may also create an environment that is susceptible to the formation and development of mould. This is not the leak found in the hall wall.</p> <p>Appointment of a sealant expert is required to repair or replace this missing sealant. Such works should be performed as soon as possible to ensure that no further damage occurs.</p>

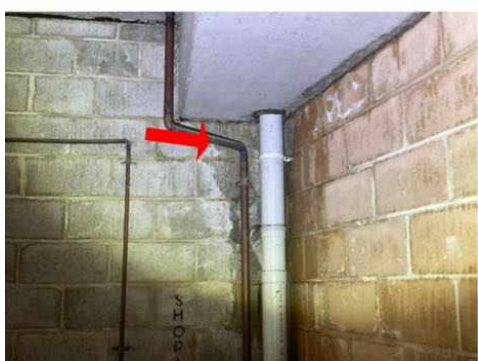
Building:	Main Building
Location:	Garage walls and above balcony areas
Finding:	Site drainage - Inadequate
Information:	The site drainage to most rear balconies was found to be inadequate at the time of inspection, creating potential for subsequent water damage to associated building elements. Garage wall water staining shows water from many balconys (some are garden beds) run down the internal garage southeast walls.

Water damage and secondary defects are likely to occur if left unmanaged.

Where site drainage is inadequate in these cases, some external waterproofing membranes need to be checked by a qualified plumber or waterproofing specialist.

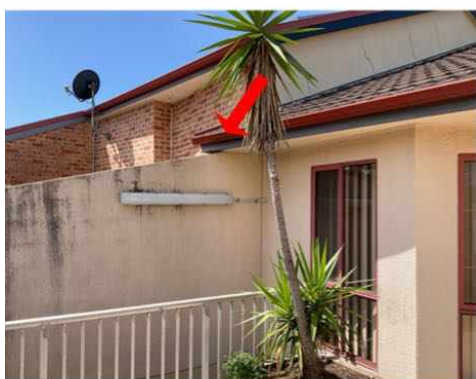
Finding 3.06

Building:	Building 1
Location:	Balcony
Finding:	Gutter - Insufficient fall
Information:	It was identified that there is insufficient fall or angle in the guttering at the front which is leading to pooling of water in the gutter and an array of secondary related building defects such as rust and fascia damage. Such defects are likely to include material deterioration, leaks and/or corrosion of associated building materials.

Over time, if this defect is not addressed, further building defects will develop.

Consultation with a roofing plumber or roofing restoration contractor is required for quotations regarding these works.

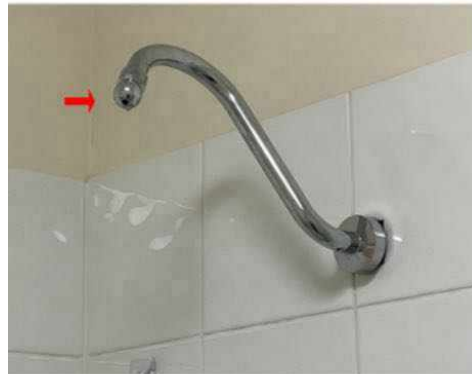
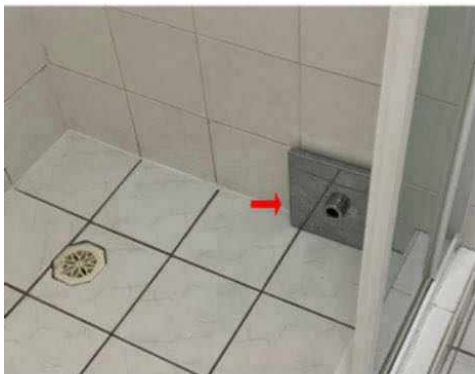
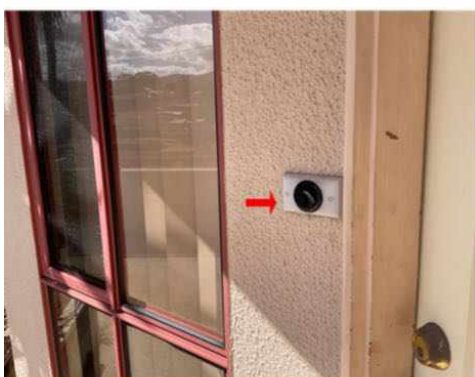
Finding 3.07

Building:	Building 1
Location:	Pictured Areas
Finding:	Building elements - Damaged
Information:	Evidence of damage was identified to the following areas -

1. The shower spout fell off when touched. Replacement is recommended.

2. The front flyscreen is binding and needs repair.

4. The front wall external push button light does not work.

A carpenter and electrician is required to repair this area and bring it back to full function.

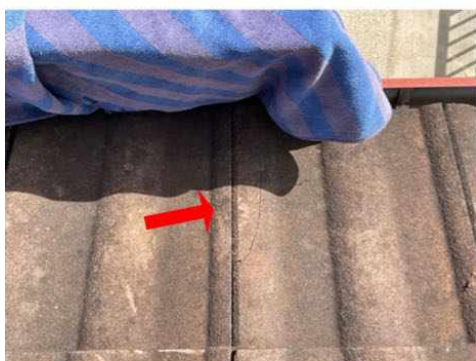
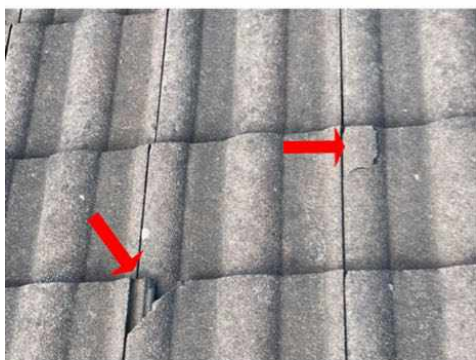
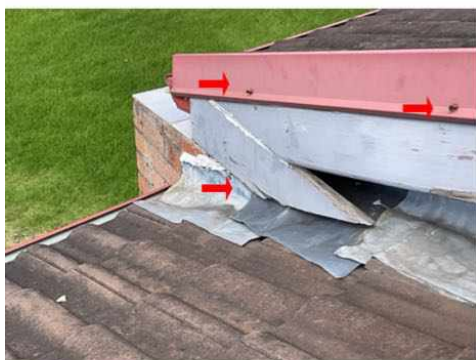
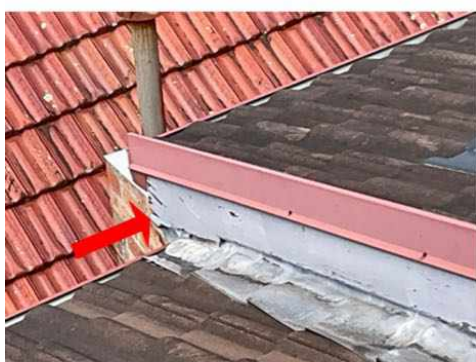
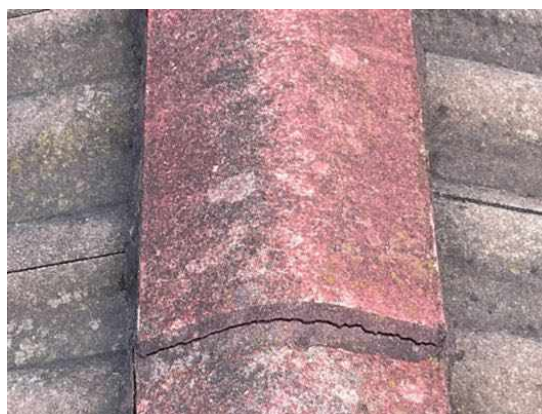
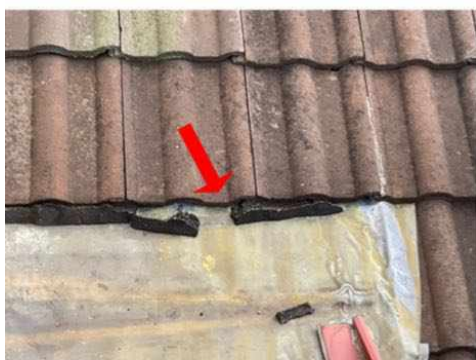
Finding 3.08

Location: Some roof areas
Finding: Roof areas (tiles, mortar, sealant)- weathered
Information: Upon inspection of the exterior roofing, the majority of roof tiles and mortar were considered to be in a good condition. The barges were in poor condition with wood rot and damaged paint. While weathering of the roofing areas is consistent with the age of the property, maintenance works are required.

Isolated areas of mortar and tiles show minor cracking is present. Re-pointing and re-sealing the may be considered as an interim solution by the client to help preserve and extend the life span of the tiles. Where left unmanaged, deteriorating roof mortar and tiles are likely to lead to a number of secondary defects, including minor water leaks and weather exposure to internal roofing structures.

Consultation with a roofing contractor is highly advised to gain advice on cost of remedial works that may be required in the short to medium term. Remedial works are likely to increase the longevity of the exterior roofing structure.

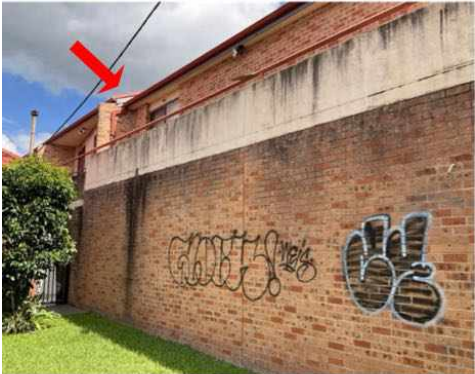
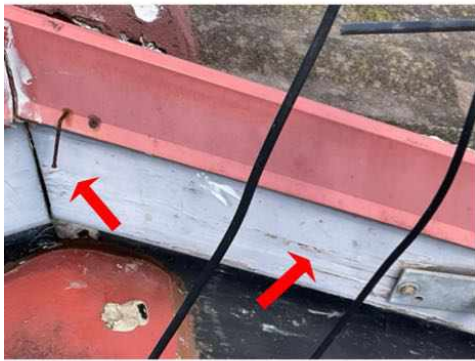
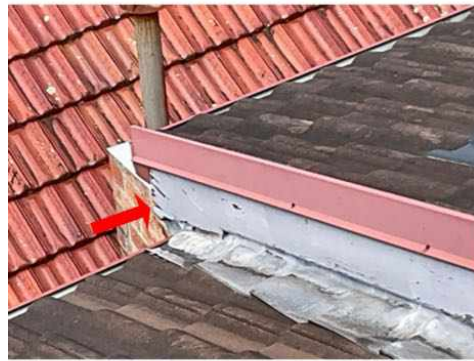
Finding 3.09

Building:	Main Building
Location:	Roof Exterior
Finding:	Fascias, barges, finials - Wood rot
Information:	Wood rot was found to be affecting fascias and barges on many roof areas. Wood rot, also known as Fungal Decay, occurs when timbers and other cellulose building materials are exposed to damp conditions on an ongoing basis.

It is likely that this wood rot has developed as a result of faults in the roof plumbing, creating excessive moisture in this areas. Frequent exposure to rain and other weather conditions also make fascias and barges susceptible to accelerated deterioration.

Early intervention and regular maintenance will prolong the useful life of these building elements. Prior to any works being performed, the cause of the moisture that has created the visible wood rot should be identified and addressed in a suitable manner.

It is advised that a roof plumber be appointed to inspect all roof plumbing and subsequently identify the cause of the wood rot. Replacement of affected fascias and bargeboards may then be a necessary step in protecting surrounding building elements from such deterioration.

A qualified carpenter or registered builder may also be required to replace affected building materials.

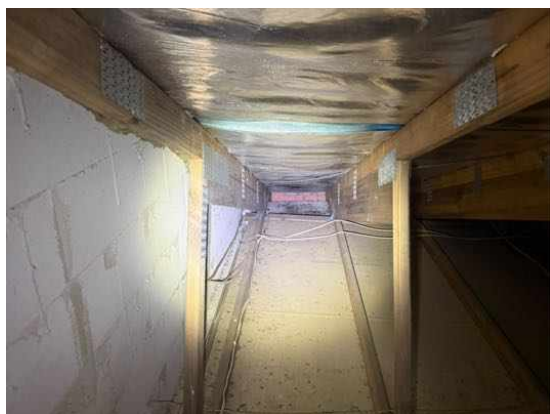
Finding 3.10

Building:	Main Building
Location:	Roof Void
Finding:	Insulation - Missing
Information:	Upon inspection of the roof void it was noted that insulation is not present.

Where insulation is absent, the area does not meet current Australian Standards. Installation of adequate insulation is required and should be conducted as soon as possible.

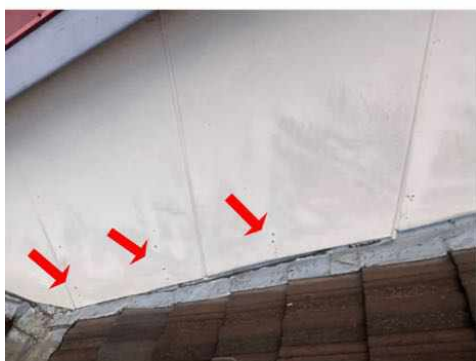
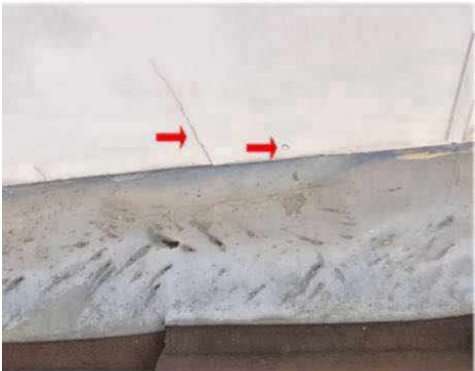
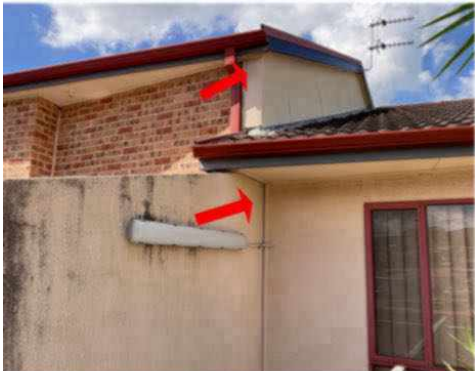
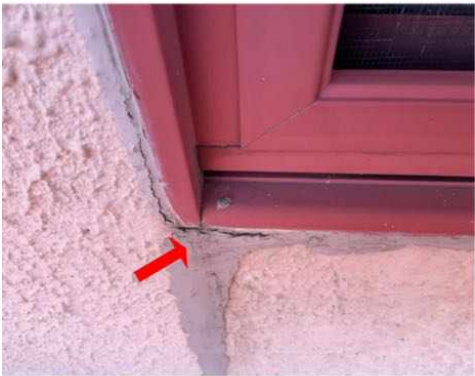
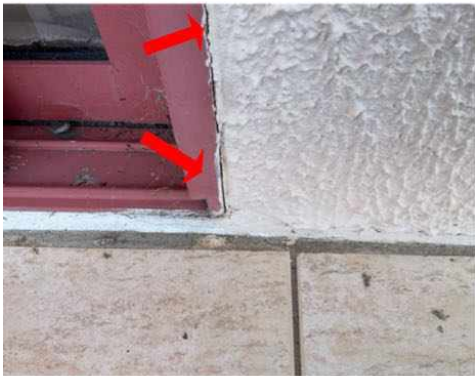
Finding 3.11

Building:	Main Building
Location:	Some External Areas
Finding:	Sealant (external) - Missing.
Information:	It was noted on inspection that areas of external sealant was missing to small areas of the external walls.

Very large gaps of 11mm and 13mm were found in the rear unit 2 balcony. See pages 7 & 8.

Flexible sealants should be applied to these affected areas to prevent any subsequent water damage that is likely to occur.

A sealant specialist or skilled handy person should be appointed to complete these works as soon as possible

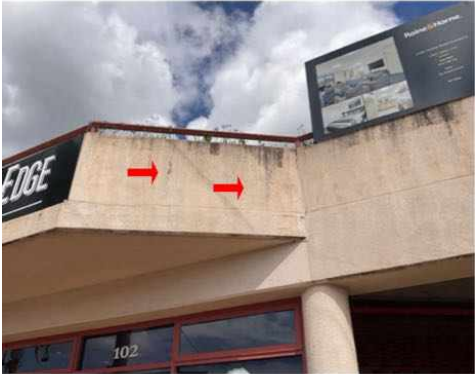
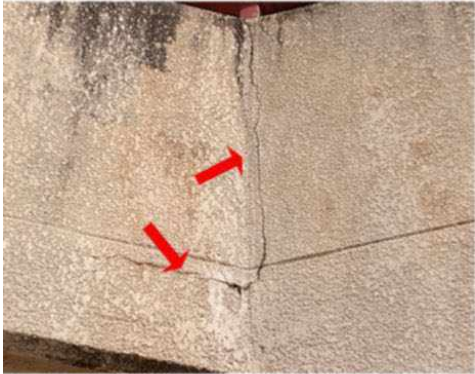
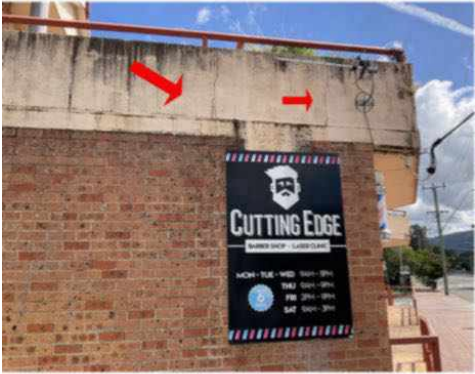
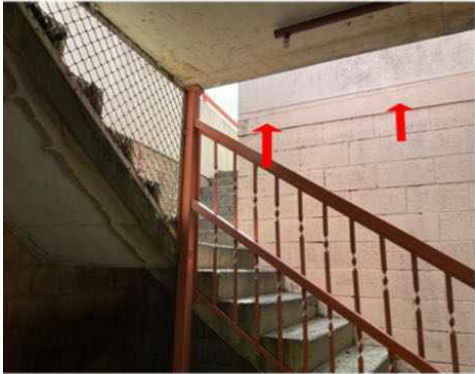
Finding 3.12

Building: Main Building
Location: Many external Areas
Finding: Render (external) cracking.
Information: It has been observed that cracking to many external rendered surfaces. The degree of most damage is described as “slight” noticeable cracks which are easily filled. Cracking of this size are generally less than 5mm in width.

Always contact your building inspector should cracks widen, lengthen, or become more numerous.

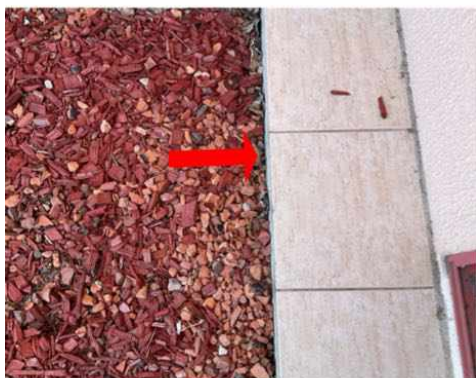
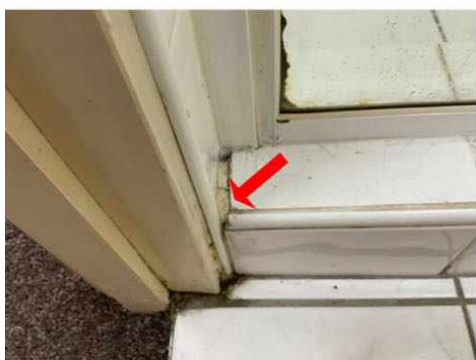
Finding 3.13

Building: Main Building
 Location: Pictured tiles
 Finding: Tiles - Cracked or damaged
 Information: Cracking was evident to the tiling in these areas at the time of inspection. While the cracking appears to be minor, this area is frequently exposed to water, allowing potential for water penetration into adjoining sections of walls or flooring.

If left unmanaged, water penetration to these areas may lead to subsequent water damage, which is likely necessitate repair work to affected building elements.

A tiling contractor should be appointed to ensure that no further water damage occurs. The re-application of silicone and grouting throughout remaining tile work is also advised, to further protect the area against water penetration.

Where water penetration has led to water damage, appointment of a relevant tradesperson may be required to repair damaged building elements.

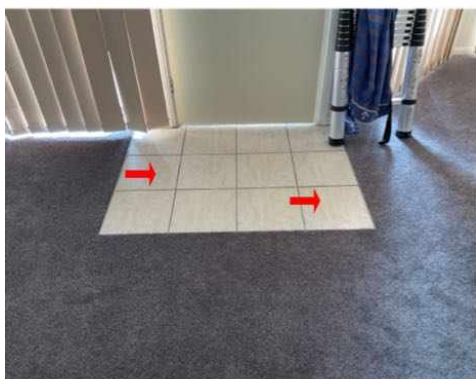
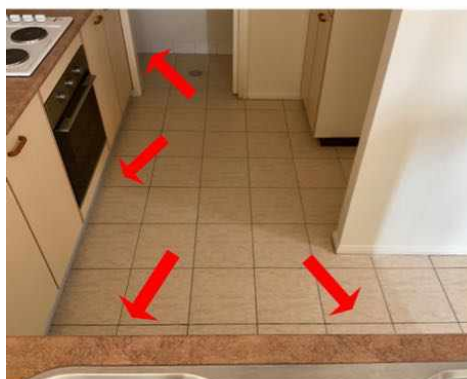
Finding 3.14

Building: Main Building
 Location: Pictured tiles
 Finding: Tiles - Drummy
 Information: Drummy tiled areas were identified at the time of inspection. The term 'drummy' refers

to tiles that have become detached from their fixing, despite otherwise being in relatively good condition. Such defects are generally caused by physical or moisture damage to the area. Drummy tiled areas may also be a direct result of poor workmanship during the construction process.

Tiled areas may swell and shrink with changes in air humidity if the area has sustained moisture damage. Any exposure to moisture is capable of causing tiled areas to become drummy and/or cracked over a prolonged period of time. Drummy tiled areas generally require removal and replacement of affected tiles, with adequate sealant and grouting.

Specialist trades are available for these types of services. A registered builder may be required to undertake works if damage is extensive or if secondary building defects have resulted. Otherwise, it is advised that a tiling contractor be appointed to perform works as necessary. Immediate action is recommended to ensure that no further damage is sustained in the affected area.

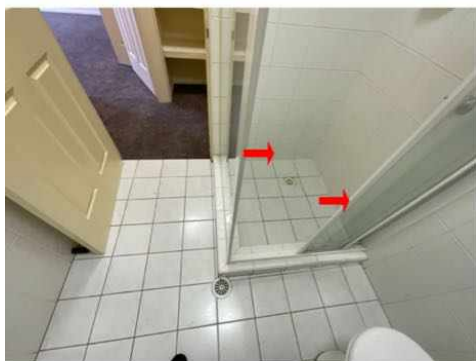
Finding 3.15

Building:	Main Building
Location:	Shower
Finding:	Tiles - crazing
Information:	Numerous damaged tiles were evident in the bathroom shower at the time of inspection.

Crazing is internal fracturing without a change of the surface texture. It might be seen when light transmits through transparent or translucent material and it can also exist in opaque plastics. Crazing can be a precursor to cracking if it extends to the surface, but even if it stops short of the surface, crazing still decreases the strength of the material.

These tiles may need replacement in the future and can be undertaken by a tiling contractor.

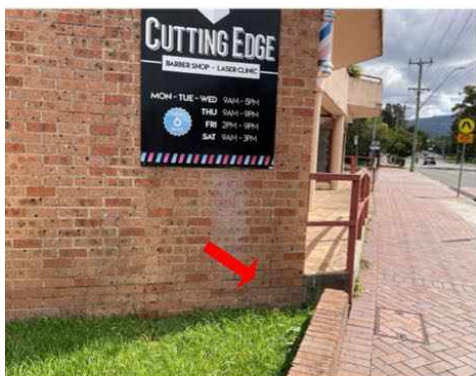
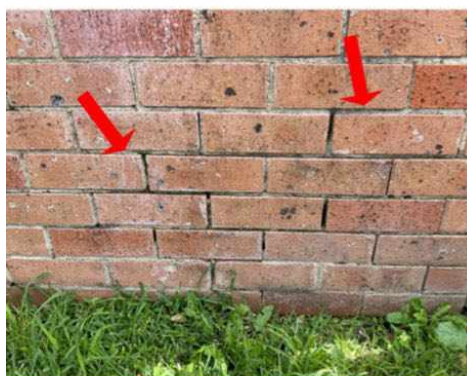
Finding 3.16

Building:	Main Building
Location:	Exterior walls - left side
Finding:	Brickwork mortar missing
Information:	Small areas of mortar was found to be missing at the time of the inspection. Mortar, or 'bedding', is the material which fills joints and intersections between bricks.

Mortar that is missing may allow water ingress into these areas, putting associated building elements at risk of water damage.

Missing mortar can be attended to by bricklayer as soon as possible.

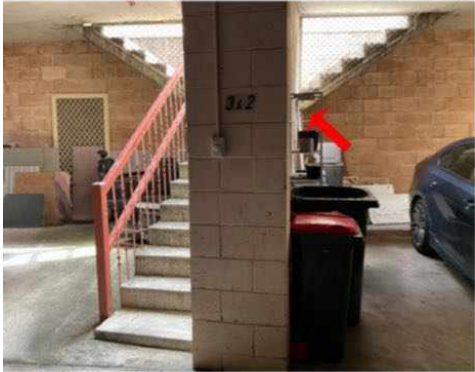
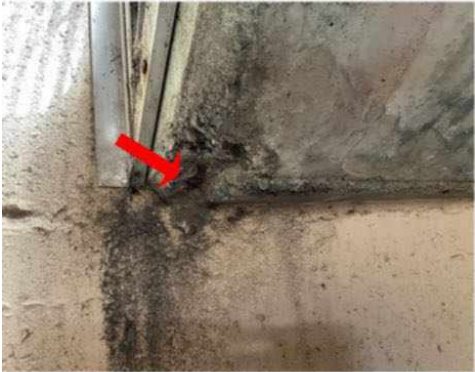
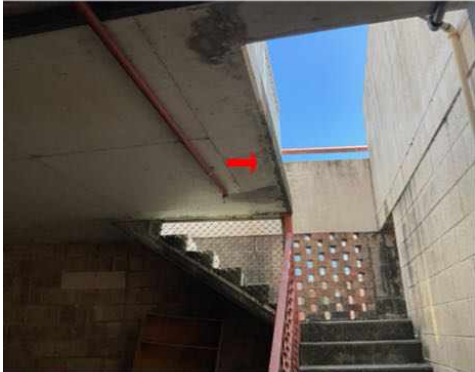
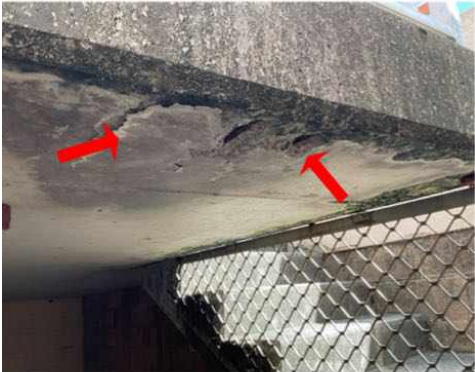
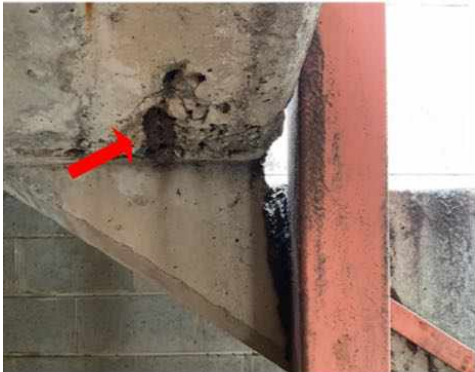
Finding 3.17

Building:	Main Building
Location:	Small areas of exterior walls and interior stairs
Finding:	Concrete spalling
Information:	These areas have suffered Concrete Spalling. This is the breakdown of concrete via natural weathering and/or chemical reaction that results in sections of cement chipping off the main body – often resulting in fractured, compromised concrete. Spalling looks like pitted acne scarring and breaks off in flecks which can expose rebar.

A concreting contractor can provide advice on repairs of this damaged concrete when convenient.

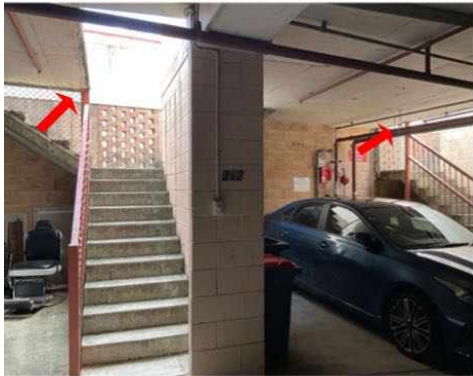
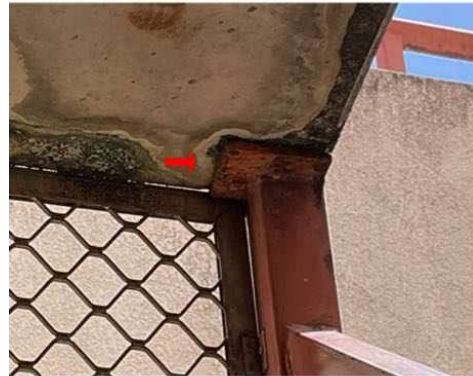
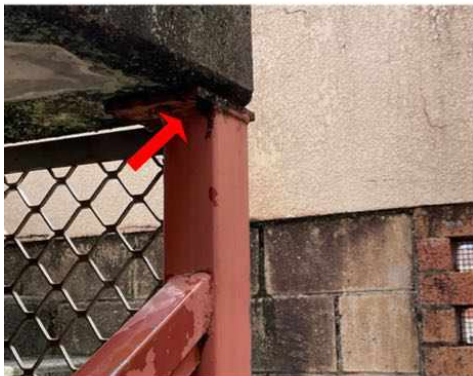
Finding 3.18

Building: Main Building
 Location: Interior garage stair posts
 Finding: Areas rusted or corroded
 Information: These posts show evidence of rusting and corrosion, which is likely to have developed as a result of excessive exposure to moisture and or inadequate coatings.

As surface rust provides no protection to the underlying iron, the deteriorating

condition is likely to worsen if not addressed in the short-term future.

Where possible, the use of galvanized (treated) metals or aluminium coated metals aid in rust prevention, as does regular general maintenance. Rust formation can be controlled with coatings, such as paint, that isolate the iron from the environment.

Rusting and corrosion should be managed by ideally removing or limiting the affected surface from exposure to moisture. A skilled handy person should be appointed immediately to rust treat these areas.

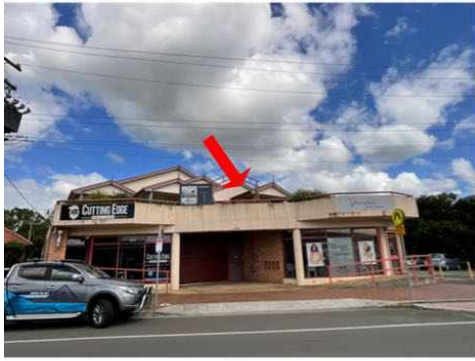
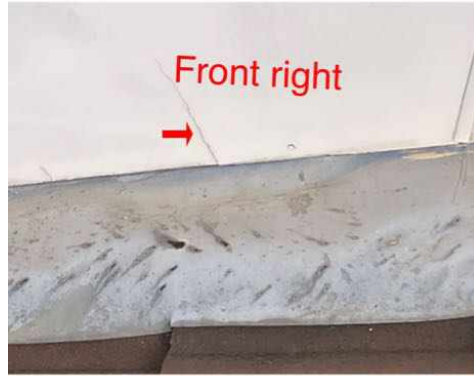
Finding 3.19

Building:	Main Building
Location:	Front Wall Area
Finding:	Cladding damaged
Information:	Evidence of damage was identified to the left side wall where the cladding has minor damage. A carpenter would be the trade responsible for rectification of this wall area.

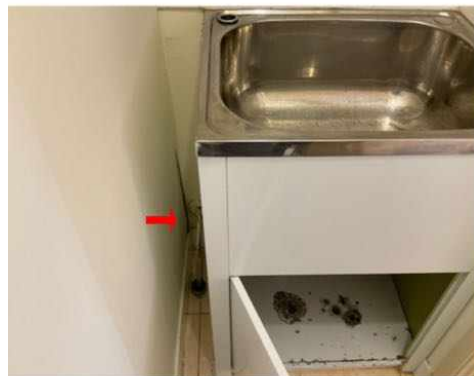
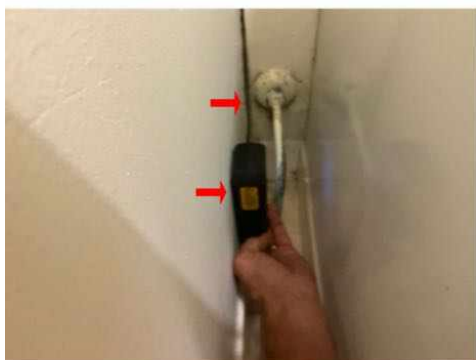
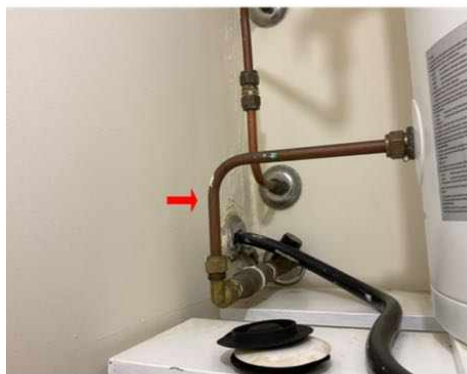
Finding 3.20

Building: Main Building
Location: Bathroom & Laundry
Finding: Building plaster damaged
Information: Evidence of minor plaster damage was identified to these areas. No moisture was evident after numerous tests.

A plasterer can repair these walls when convenient.

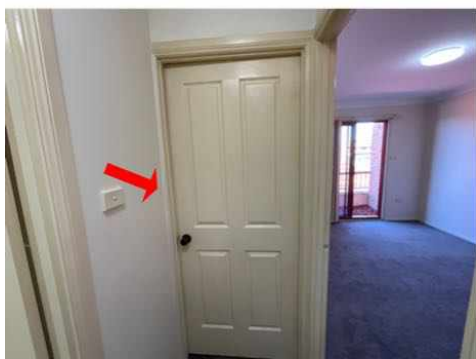
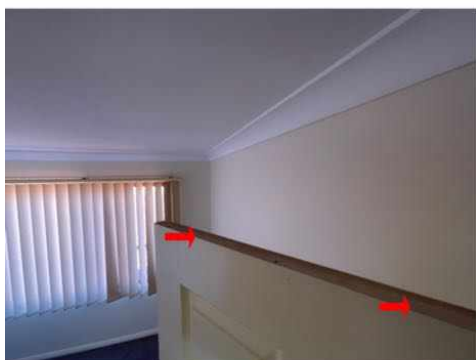
Finding 3.21

Building:	Main Building
Location:	Some doors
Finding:	Door - Binding/jamming and no paint protection
Information:	Binding and/or jamming of one bedroom door is evident during standard operation. All doors are also lacking paint top and bottom. These defects inhibits the functionality of the affected doors as well as creating potential for secondary defects to associated building elements, such as damage to the floor covering or swelling in wet areas.

A door that binds to flooring or to the associated door frame may have several causes, ranging from minor defects, such as poor installation of the door or deteriorated hinges, through to major structural issues, such as damage to subfloor structures.

Where door binding/jamming appears to indicate major structural issues, a registered builder specialising in re-stumping should be appointed to provide an estimate on the cost of rectification.

For minor causes, a qualified carpenter or general handyperson should be appointed to perform minor rectification works at client discretion.

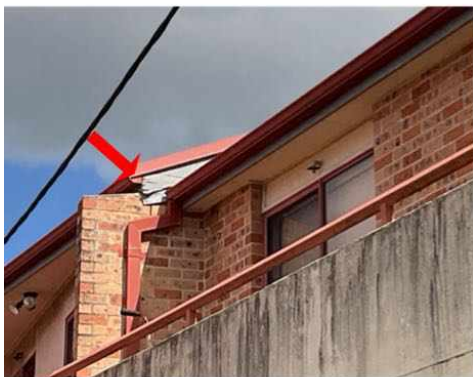
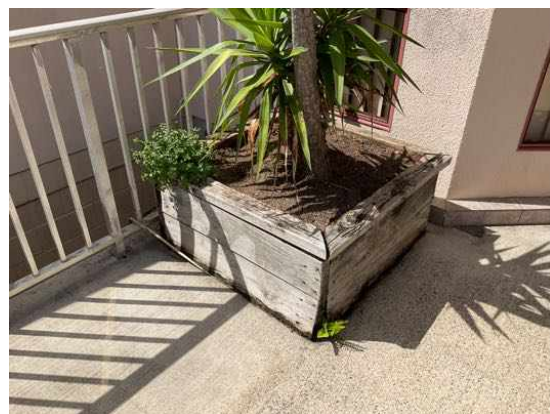
Building:	Main Building
Location:	Roof Exterior and rear yard areas
Finding:	Fungal decay - present (localised)
Information:	Fungal decay also known as wood decay or wood rot generally refers to the deterioration of timber elements when in contact with excessive levels of moisture for a prolonged period of time.

The development of fungal decay is accelerated by temperatures from 5degreeC to 40degreeC as well as the presence of oxygen. Generally fungal decay develops on timber elements that are in use in an external environment which are exposed to rain penetration.

In this case, the affected timber is decaying and attracting termites. This needs removal.

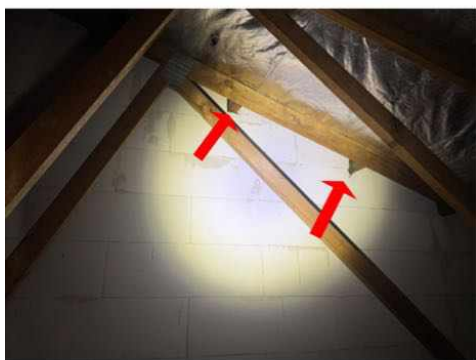
This wall has gaps at the top of the wall, appears to be crossed by timber and does not appear to be “packed with mineral fibre or other suitable fire-resisting material”.

This was not a requirement at the time of construction.
