Building and Timber Pest Inspection Report

Inspection Date: Tue, 17 Feb 2026

Property Address: 2 Grazier Cres, Werrington Downs NSW
2747, Australia

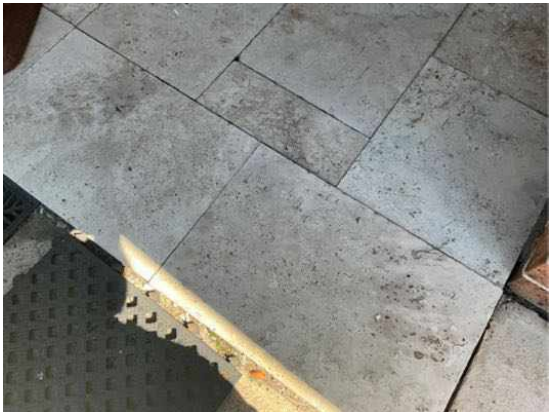
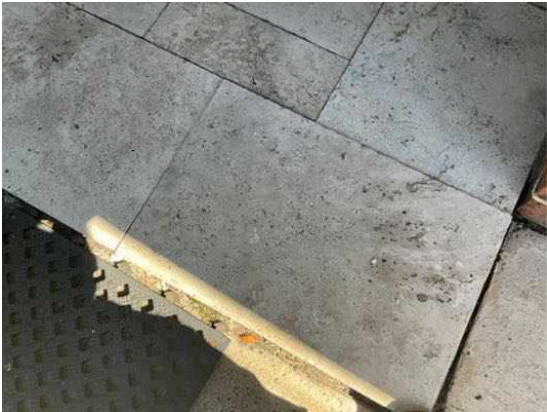
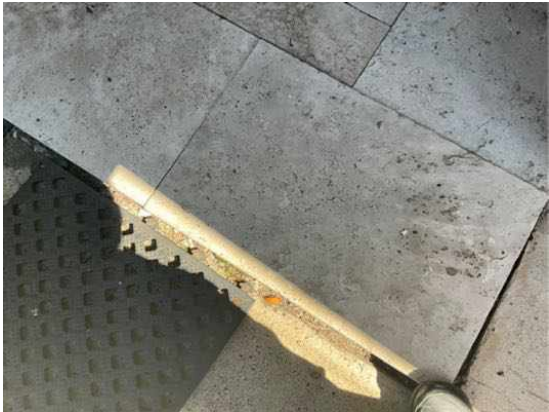
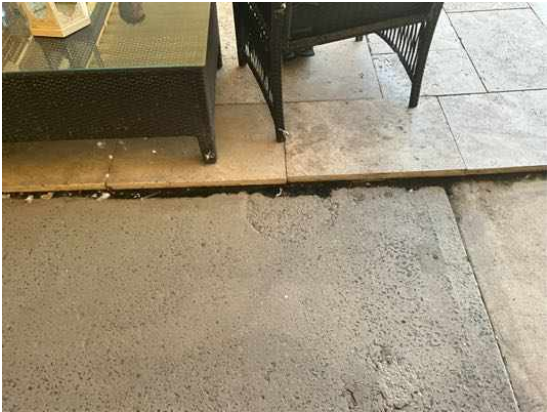
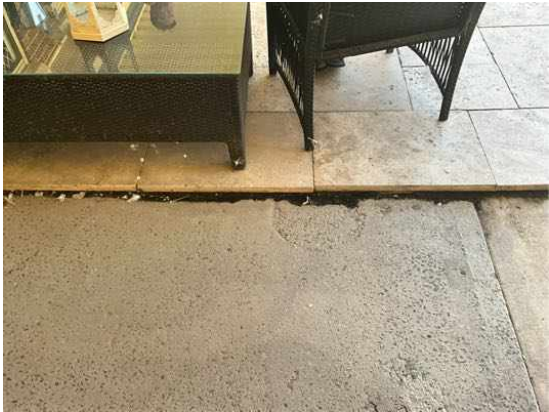
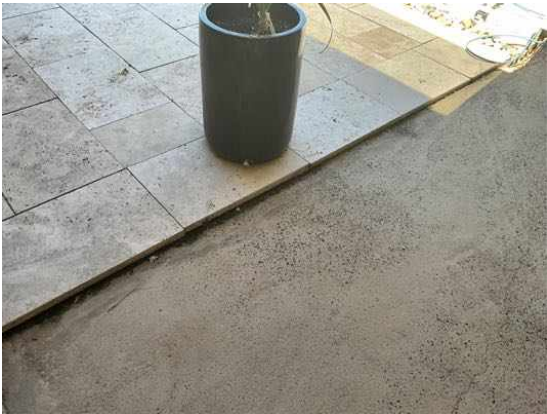
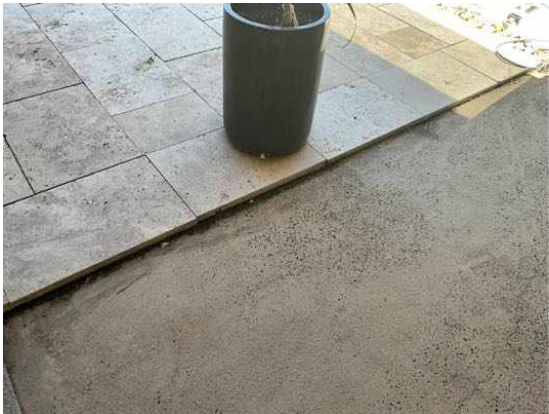
Building: Main Building
 Location: Yard - Back
 Finding: loose pavers and improper proper drainage

The side passageway of the property is obstructed by overgrown vegetation and uneven, loose pavers, which may impede proper drainage and access. The area shows signs of poor maintenance, potential water pooling, and trip hazards due to moss-covered, unstable surfaces.

Risk: Increased risk of personal injury due to slips and trips, mosquito breeding from stagnant water, and potential structural moisture damage from inadequate site drainage.

Recommended Action: A licensed landscaper or drainage specialist should be engaged to clear vegetation, regrade the area for proper water runoff, and relay or replace pavers to ensure a safe and accessible walkway.

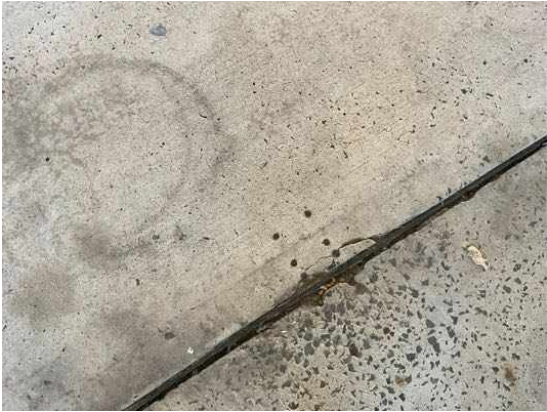
Finding 3.03

Building: Main Building
Location: Yard - Back
Finding: Concrete damaged
Information: The concrete pavement exhibits various forms of damage, including cracks, potholes, and spalling, compromising its integrity and smoothness.

Risk: Damaged concrete pavement poses several risks, including trip hazards, vehicle damage, and drainage issues. Cracks and potholes can cause pedestrians to trip and fall, leading to injuries, while vehicle damage may occur from driving over uneven surfaces. Additionally, poor drainage due to damaged pavement can result in water accumulation, leading to erosion, flooding, and further deterioration of the pavement over time.

A professional concrete contractor or pavement repair company should be engaged to assess the extent of the damage and determine the appropriate repair method. Depending on the severity of the damage, repairs may involve patching, resurfacing, or replacing sections of the concrete pavement to restore functionality and safety. Additionally, measures may be taken to address underlying issues such as poor drainage to prevent future damage.

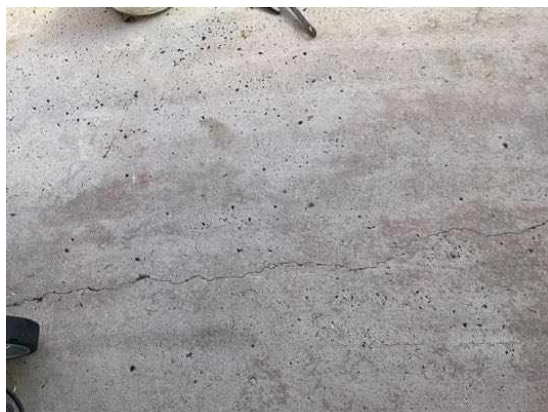
Finding 3.04

Building: Main Building
Location: All Areas
Finding: Crack in concrete slab - Category 0
Information: A crack coded as Category 0 was identified in the slab. A Category 0 crack is described as a hairline crack, representing insignificant movement of slab from level.

The approximate width of the crack to be considered Category 0 is 0.3mm, or change in offset of less than 8mm when a 3m straight edge is placed over the defect.

No rectification is required at this time. However, all cracking should be monitored over a 12 month period to identify any further damage in the area.

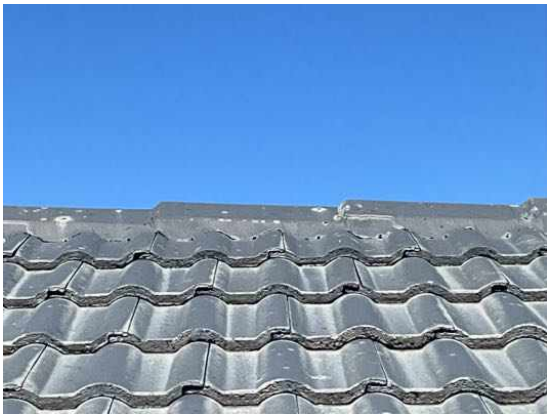
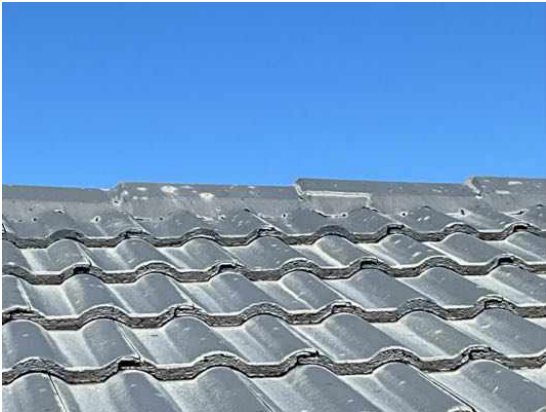
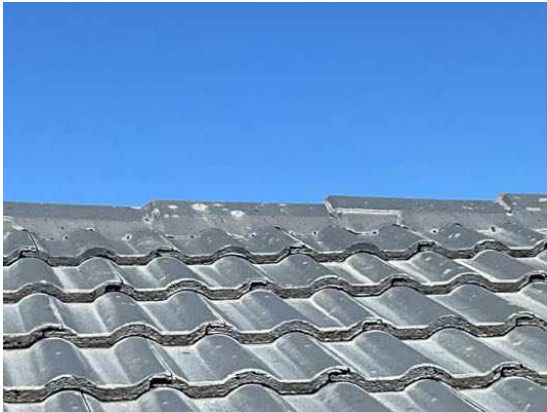
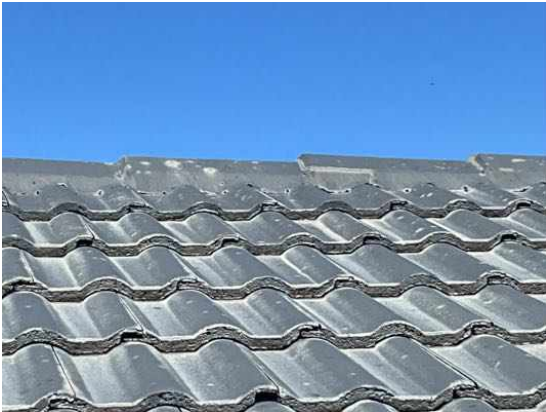
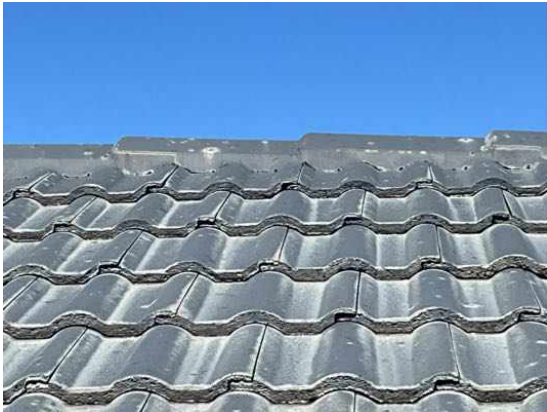
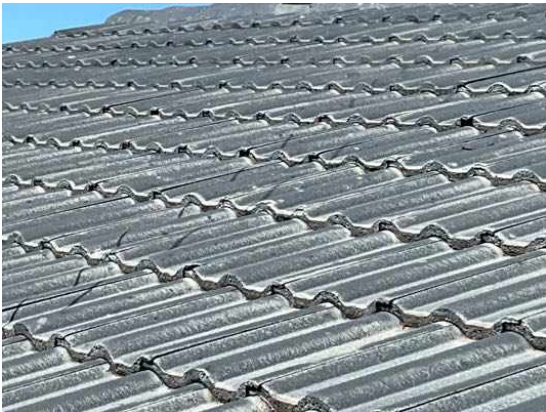
Finding 3.05

Information: Inspection of the roof revealed widespread weathering to the tiled roof surface. The tiles show loss of surface finish, colour fading, and age-related deterioration typical of older roof coverings. Although no significant cracking was noted, weathering can lead to increased porosity, reduced water-shedding capability, and a higher risk of future cracking or displacement during adverse weather conditions.

A licensed roofer should be engaged to undertake a closer inspection, carry out routine maintenance, and replace any tiles that may be compromised. Ongoing monitoring is recommended due to the age and condition of the roof covering.

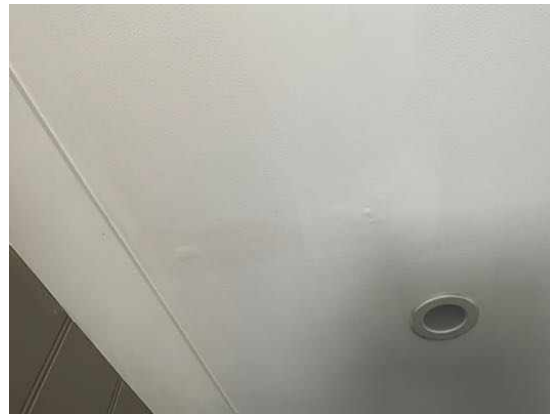
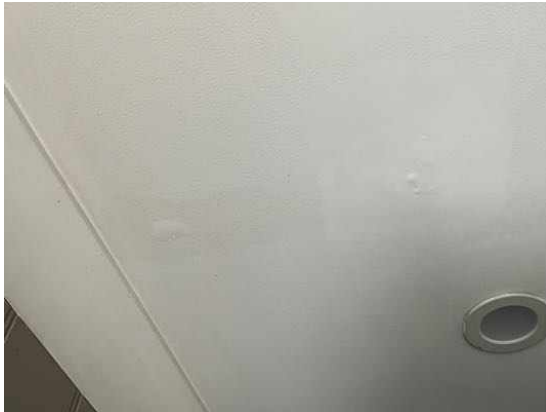
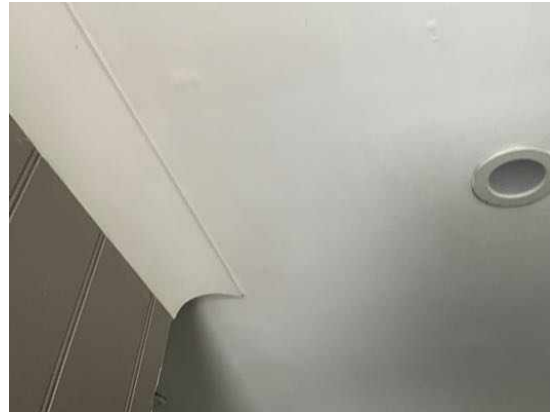
Information: A visible paint bubble (or blister) was identified on the surface. The deformation appears as a raised area in the paint film, typically resulting from adhesion failure between the paint and substrate, possibly due to moisture, poor surface preparation, or incompatible paint layers.

As per AS 4349.1-2007, this is considered a minor defect. However, if moisture is the cause, it may indicate an underlying issue such as water ingress or high humidity, which could worsen over time and lead to mould growth or plasterboard deterioration if left unattended.

Minor Defect — unless associated with active moisture ingress, in which case it may be upgraded depending on extent and cause.

A licensed painter or plasterer should assess the cause of the blister. If moisture is present, the source must be identified and rectified before repairs. Once dry, the affected area should be scraped back, sealed, patched, and repainted. Further investigation may be required if there is suspicion of plumbing or roofing leaks above the ceiling.

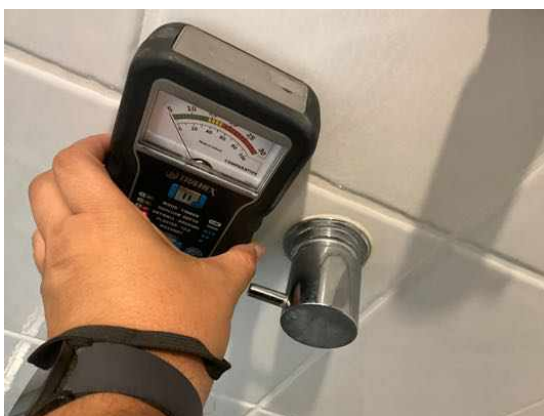
Building:	Main Building
Location:	Bathroom
Finding:	Shower - Damp
Information:	Damp is evident to the lower 300mm of wall to the shower alcove. This defect is quite common, and is suspected to have been caused by moisture permeating through the grouting in this area, which shows evidence of deterioration. Leaking pipes within the adjoining wall is also a possible cause.

Damp (or structural damp) refers to the presence of unwanted moisture in the structure of a building, either as the result of intrusion from outside, or condensation from within the structure. In the shower area, internal water leaks or other sources of excessive moisture are generally the cause of damp.

Unmanaged damp in the shower recess is likely to facilitate the formation and development of mould and fungi growth, decaying associated building materials and compromising their structural integrity. It is important to address damp conditions, as the World Health Organisation notes that excess moisture leads - on almost all indoor

Consultation with a qualified plumber or bathroom specialist is advised immediately to identify the cause of damp and to perform remedial works as required. Where excessive mould growth is present, further inspection by a specialist environmental health inspector should also be considered.

Always ensure that sealant and grout is in good condition to prevent any moisture issues occurring in the future.

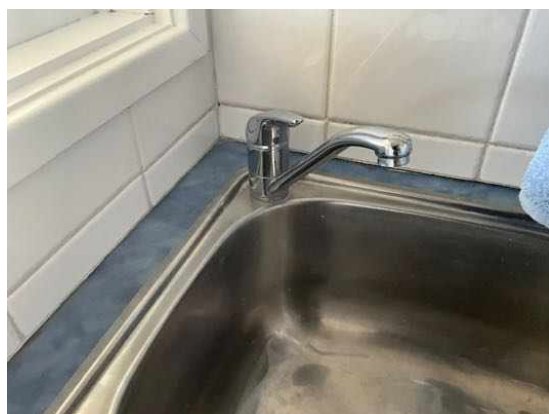
Building:	Main Building
Location:	Laundry
Finding:	Sealant and grouting - Missing or damaged
Information:	It was noted on inspection that sealant or grout is degraded to the tiled shower alcove and or other areas of the bathroom.

Different materials and floor areas move at different rates, generally causing cracking to grout or sealant at this point. A flexible sealant is required to allow for expected expansion and contraction, while keeping the joint water tight and protective of all associated building materials.

There appears to be excessive mould to the sealant and grout which will likely require scraping out and replacement.

Flexible and mould resistant materials should be applied to affected areas to prevent any subsequent water damage that is likely to occur. Regular maintenance and replacement of damage or missing or damaged sealant and grout is highly recommended to the wet areas, as this is a regular wear and tear defect. Sealant and grouting in areas that come into regular contact with water should be maintained for the long term care of your property.

A sealant specialist or tiling contractor should be appointed to complete these works as soon as possible

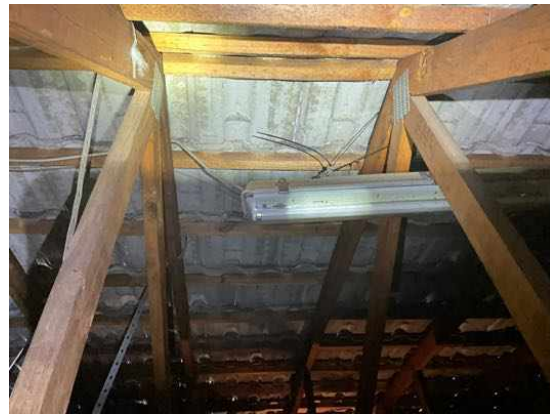
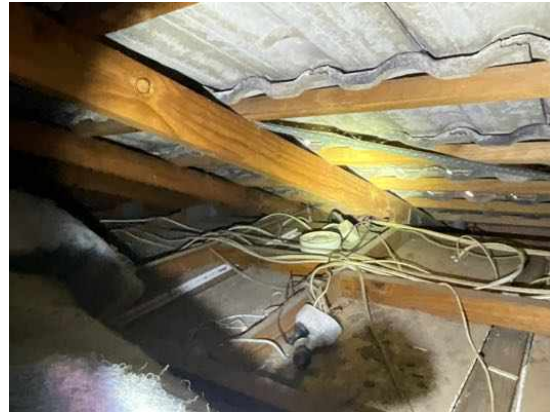
Building:	Main Building
Location:	Roof Void
Finding:	Sarking - Missing
Information:	Sarking is missing under the roof sheeting. Sarking acts as an insulator that helps with noise reduction and protects against water penetration. Sarking plays a key role in the operation and function of the overall roofing structure and its performance.

Although not a requirement at the time of construction, replacement of any missing building element is advisable (although this can be quite expensive to do after the time of construction). Where sarking is missing, regular inspections of the roof tiles for cracking and potential moisture penetration is required.

Sarking may be retrospectively fitted by a registered builder at the discretion of the client.

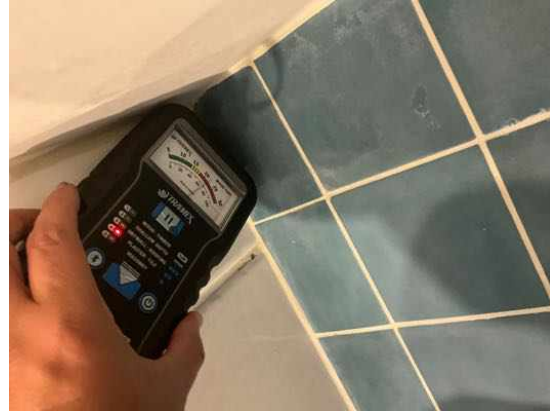
Building:	Main Building
Location:	Bathroom
Finding:	Excessive moisture - Conducive to Timber pest
Information:	Excessive moisture can attract termites and produce conditions that promote fungal growth and wood decay.

Excessive moisture is generally caused by deteriorated inadequate or missing roof drainage leaking plumbing pipes or fixtures poorly plumbed HWS overflows or condenser units and poor site drainage.

Prior to any remedial works being performed a qualified plumber should be appointed to further inspect the property and to identify the cause of the excessive moisture. Works to remove affected building elements may then be necessary and should be performed by an appropriate tradesperson.
