BEFORE YOU BUY
BEFORE YOU BUILD

Building and Timber Pest Inspection Report

Inspection Date: Fri, 13 Feb 2026

Property Address: 27 John Street, Hazlebrook NSW 2779

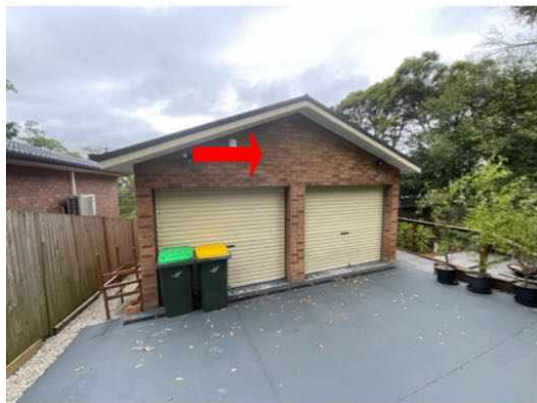
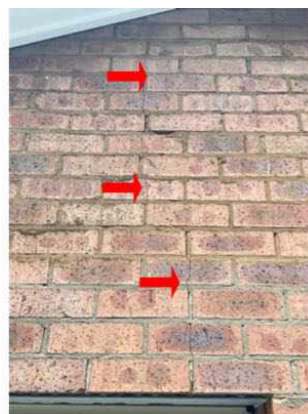
Finding 3.02

Building: Garage
Location: Exterior walls - front
Finding: Brickwork - Cracking
Information: Observation:

Fine cracking was observed in the brickwork. While visually noticeable, this type of cracking is generally considered to be cosmetic in nature and not indicative of structural damage.

These cracks are typically caused by minor separation between the mortar and brickwork or may appear within individual bricks due to natural thermal expansion, minor settlement, or general ageing of materials.

- Cracking is generally superficial and classed as an appearance defect
- Does not currently suggest structural instability
- May become more significant if widening, lengthening, or increasing in number

- Repair using minor filling or repointing carried out by a qualified bricklayer
- Although cracking appears minor and non-structural at this stage, it is recommended that the area be monitored
- For a more detailed assessment, consultation with a qualified Structural Engineer is advised to determine if movement is ongoing and whether any remedial action is necessary

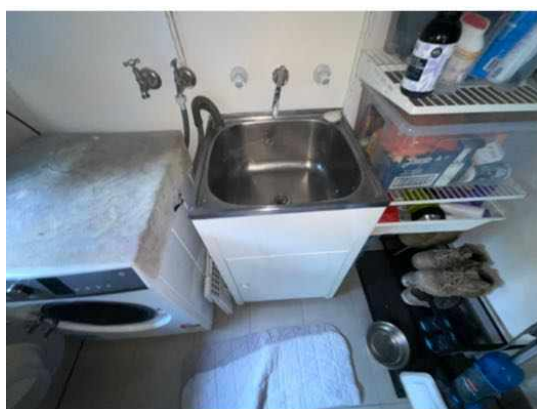
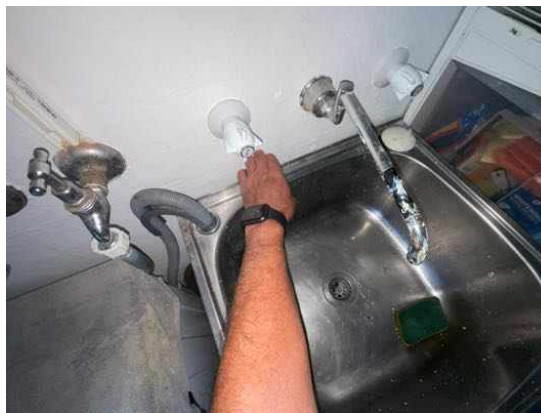
Finding 3.03

Building: Main Building
 Location: Laundry
 Finding: Laundry Tub Unit – Installation and Sealing Issues.
 Information: Findings:

- The laundry tub unit is not securely fixed to the wall, which presents a potential risk of movement.
- If left unattended, this movement could dislodge or strain the plumbing connections, potentially leading to leaks or water damage.
- Additionally, sealant is missing at the wall junctions around the unit, leaving gaps that may allow moisture ingress, promoting mould growth and damage to surrounding cabinetry or wall surfaces.
- The drainage plumbing pipes are leaking, rust or corrosion was noted to the bottom of the cabinetry indicating an ongoing maintenance issue.

- Unsecured fixtures can compromise the integrity of plumbing connections, potentially resulting in leaks or costly water damage.
- Lack of sealant may lead to ongoing moisture exposure, which can deteriorate cabinetry materials and create an environment conducive to mould and mildew.

- Apply appropriate waterproof sealant to all wall junctions and gaps around the unit to prevent moisture ingress.
- Repair leaking drainage pipe

The laundry tub unit requires immediate attention to secure its position and prevent further plumbing or moisture-related issues. Rectification by a suitably qualified tradesperson will help maintain the longevity and functionality of the laundry area.

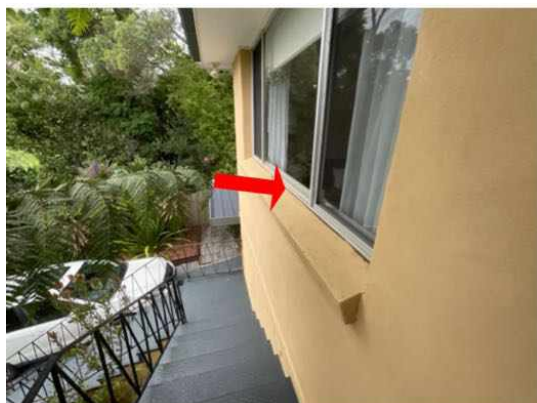
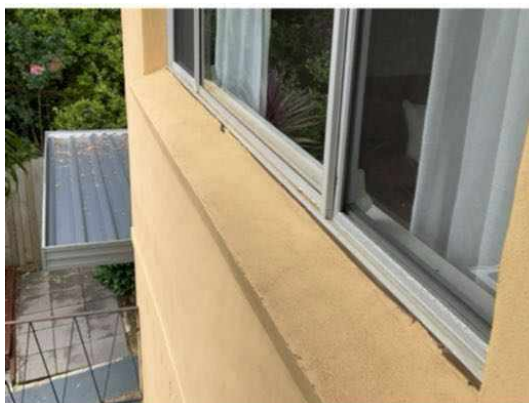
Finding 3.04

Building: Main Building
 Location: Front Elevation
 Finding: Window sill rubbers - Deteriorated
 Information: Observation:

The window sill rubber seals to window/s were observed to be deteriorated and in generally poor condition at the time of inspection. The rubber components appear aged, hardened and partially degraded, consistent with prolonged exposure to ultraviolet light and weather conditions over time. Deterioration of window seals is common in properties of this age and condition.

Where rubber seals have perished or lost elasticity, the window assembly is no longer fully weather-tight. This increases the likelihood of rainwater penetration during wind-driven rainfall events. Ongoing water ingress may result in damage to internal linings, window frames, surrounding wall materials and could contribute to concealed moisture issues if left unaddressed.

It is recommended that the deteriorated window rubber seals be replaced to restore the weather-tight integrity of the window assemblies. Alternatively, application of an appropriate external-grade waterproof sealant may provide a temporary improvement where full replacement is not immediately undertaken. Works should be carried out by a suitably qualified handyman or carpenter to ensure proper sealing and to prevent potential water-related damage.

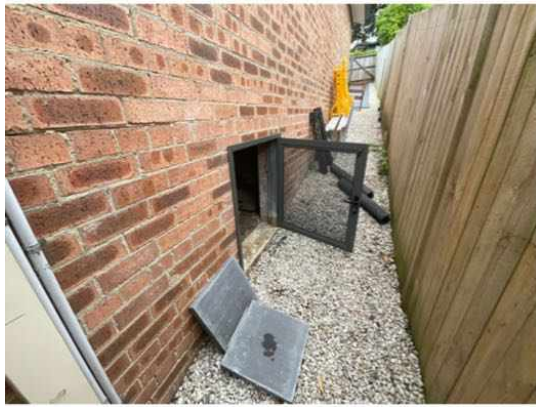
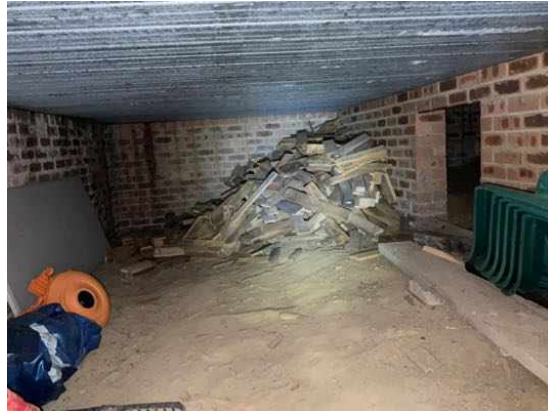
Conditions Conducive to Timber Pest Activity**Finding 6.01**

Building: Garage
 Location: Subfloor
 Finding: Subfloor - Stored timber
 Information: The storing of items including loose timbers or formwork in the subfloor space and around the yard increases the risk of undetected termite activity being present.

It is highly recommended that any stored timber items be immediately removed from areas in which any termite / timber pest attack is not visible.

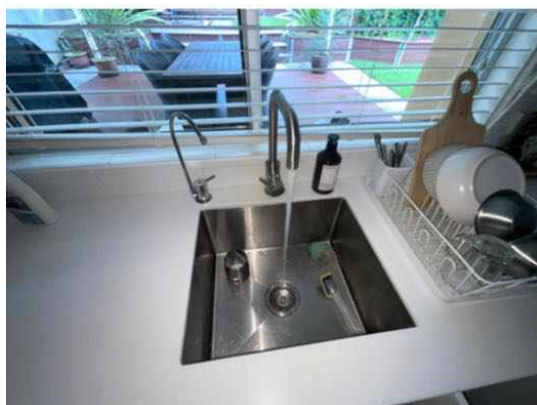
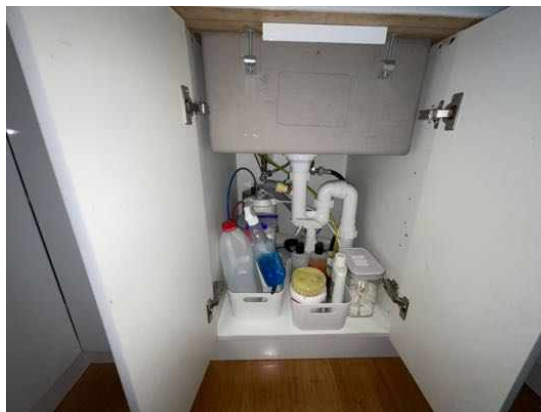
Building: Main Building
 Location: Kitchen
 Finding: Kitchen Sink – Overall Condition & Recommendations.
 Information: Observations:

- Further monitoring and testing are recommended once the tap(s) are in constant use, to identify any drainage issues or signs of slow leaks not evident during the limited inspection.
- For long-term property care, it is advised that sealant and grouting in water-exposed areas be regularly inspected and maintained.
- It is recommended that the stored items beneath the sink be removed to allow for a full re-inspection of the plumbing and cabinetry, ensuring no concealed defects are present.

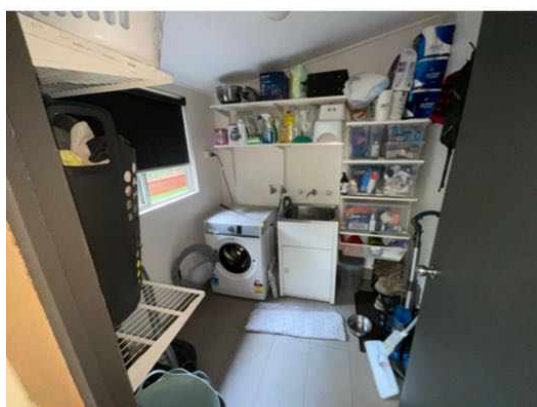
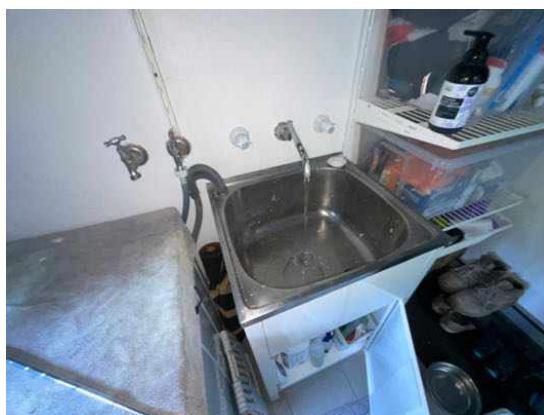
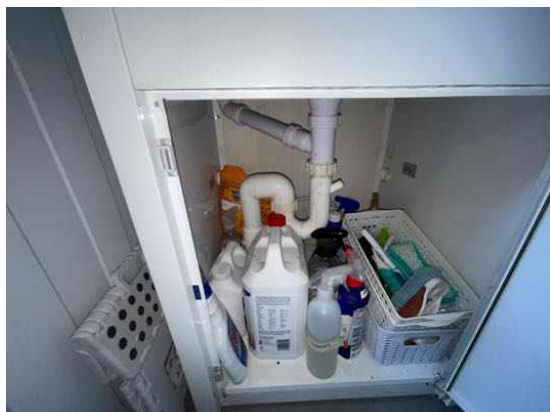
Building: Main Building
 Location: Laundry
 Finding: Laundry - Taps/Plumbing/Drainage.
 Information: Observation: Laundry Tub – Taps, Plumbing, and Cabinetry

- Flexible and mould-resistant sealant should be applied to junctions between the basin and the wall to prevent water ingress that may lead to damage.
- Regular maintenance and prompt replacement of missing or deteriorated sealant is highly recommended, as this is a common wear-and-tear issue.
- Sealant and grouting in wet areas should be maintained as part of the long-term care and upkeep of the property.
- Where required, a sealant specialist or qualified tiling contractor should be appointed to carry out remedial sealing works.
