# Building and Timber Pest Inspection Report

Inspection Date: Mon, 2 Mar 2026

Property Address: 11/30 Kings Rd, Ingleburn NSW 2565,  
Australia

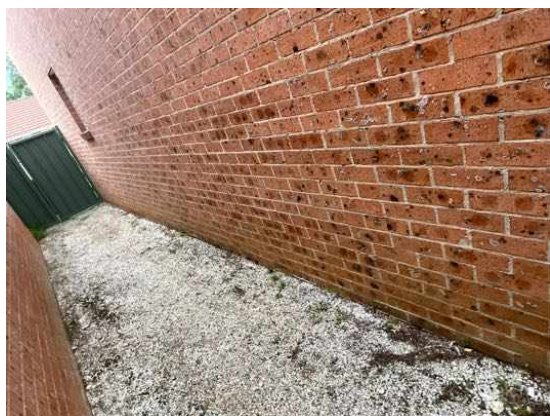
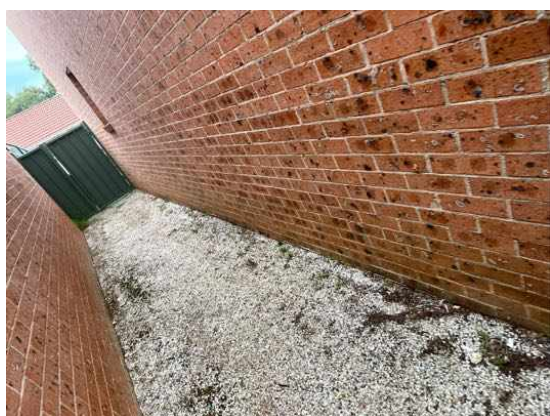
Building:	Main Building
Location:	All Areas
Finding:	Perimeter - Insufficient Fall
Information:	The perimeter ground levels were found to have an inadequate slope away from the adjoining building structure, creating potential for water pooling in this area.

Perimeter is required to fall from the building by a minimum of 25mm in the first metre and bare ground should fall away from the house by 50mm in the first meter. This standard ensures that excessive moisture does not pool around the base of building structures, which creates potential for water and structural damage, as well as making the area susceptible to termite and timber pest activity.

Where ground levels do not have adequate fall, a licensed paving contractor should be appointed to install or remove and re-level pavement.

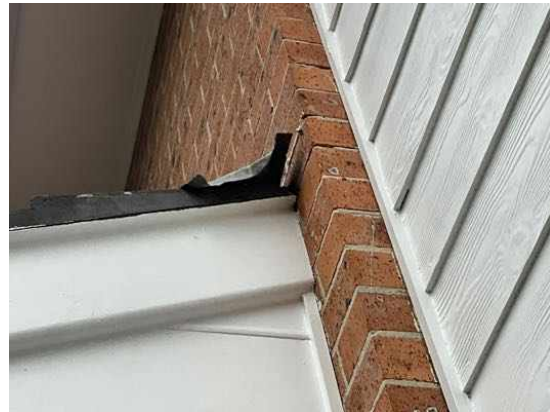
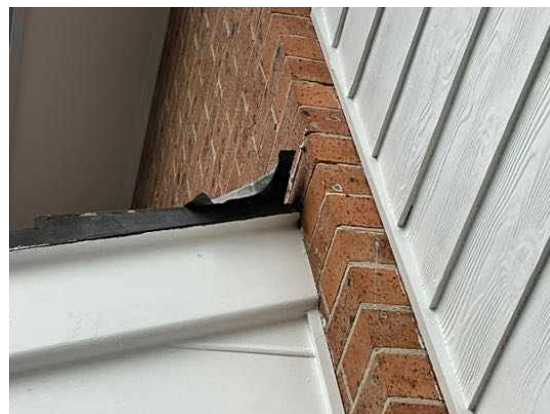
### Finding 3.02

Building:	Main Building
Location:	Front Elevation
Finding:	Flashing deteriorated
Information:	<p>The flashing installed between the timber frameworks and the panels of the building is deteriorated. This deterioration includes visible corrosion, gaps, and cracks, which compromise the effectiveness of the flashing in preventing water ingress.</p>
Risk:	<ol style="list-style-type: none"> <li>1. Water Ingress: Compromised flashing can lead to water penetration causing moisture to infiltrate the building envelope.</li> <li>2. Structural Damage: Continuous exposure to moisture can lead to timber rot, weakening the structural integrity of the timber framework and surrounding materials.</li> <li>3. Mold and Mildew Growth: Moist conditions promote mold and mildew growth, which can cause health issues for occupants and further damage building materials.</li> <li>4. Insulation Damage: Water ingress can damage insulation, reducing the building's energy efficiency and increasing heating and cooling costs.</li> <li>5. Aesthetic Issues: Water staining and damage can affect the building's appearance,</li> </ol>

potentially lowering property value and requiring costly repairs.

A licensed and qualified roofer with experience in flashing installation and repair should be engaged to address this issue. The contractor will:

1. Assess the extent of the deterioration.
2. Remove the damaged flashing.
3. Install new, properly sealed flashing to ensure water tightness.
4. Inspect adjacent areas for any signs of water damage and repair as needed.

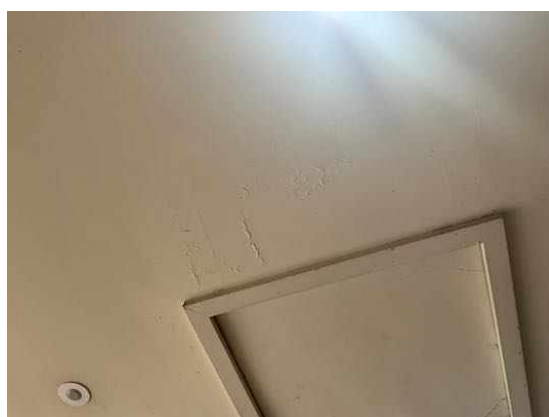
Information: A visible paint bubble (or blister) was identified on the surface. The deformation appears as a raised area in the paint film, typically resulting from adhesion failure between the paint and substrate, possibly due to moisture, poor surface preparation,

As per AS 4349.1-2007, this is considered a minor defect. However, if moisture is the cause, it may indicate an underlying issue such as water ingress or high humidity, which could worsen over time and lead to mould growth or plasterboard deterioration if left unattended.

Minor Defect — unless associated with active moisture ingress, in which case it may be upgraded depending on extent and cause.

A licensed painter or plasterer should assess the cause of the blister. If moisture is present, the source must be identified and rectified before repairs. Once dry, the affected area should be scraped back, sealed, patched, and repainted. Further investigation may be required if there is suspicion of plumbing or roofing leaks above the ceiling.

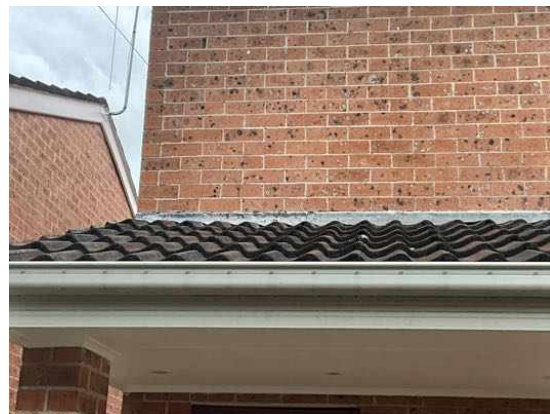
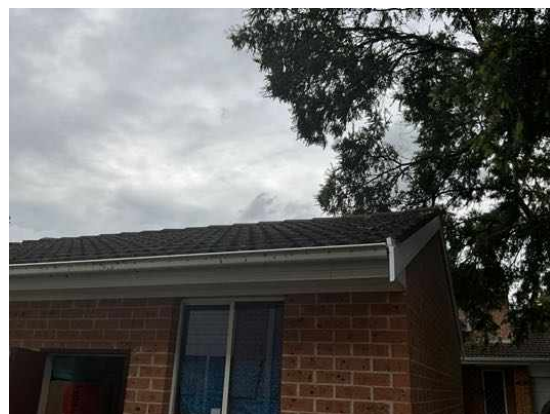
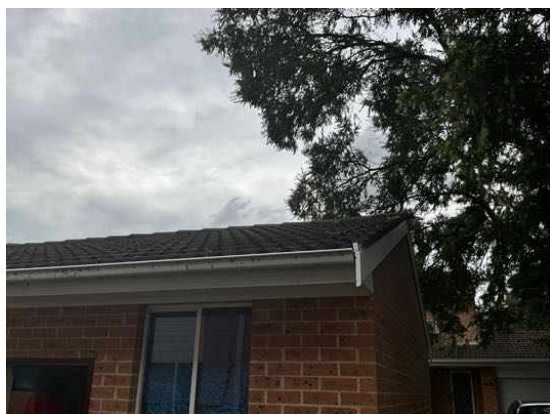
**Finding 3.07**

Building: Main Building  
Location: All Areas  
Finding: Roof Weathered  
Information: Upon inspection of the exterior roofing, the majority of roof was not in a fair condition. While weathering of the roof is consistent with the age of the property, maintenance works are required.

Isolated areas of mortar have come loose in the valleys and minor cracking is also present. Re-pointing and re-sealing the may be considered as an interim solution by the client to help preserve and extend the life span of the tiles.

Where left unmanaged, deteriorating roof are likely to lead to a number of secondary defects, including minor water leaks and weather exposure to internal roofing structures.

Consultation with a roofing contractor is highly advised to gain advice on cost of remedial works that may be required in the short to medium term. Remedial works are likely to increase the longevity of the exterior roofing structure.

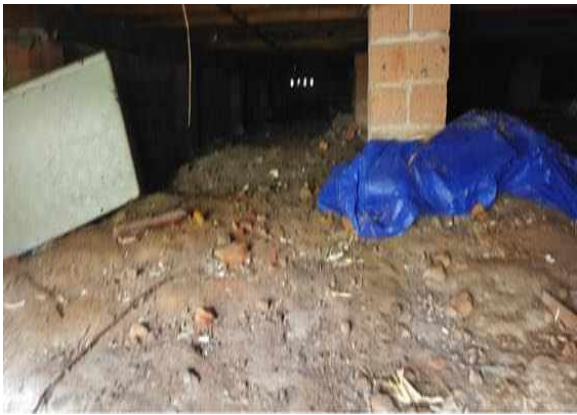
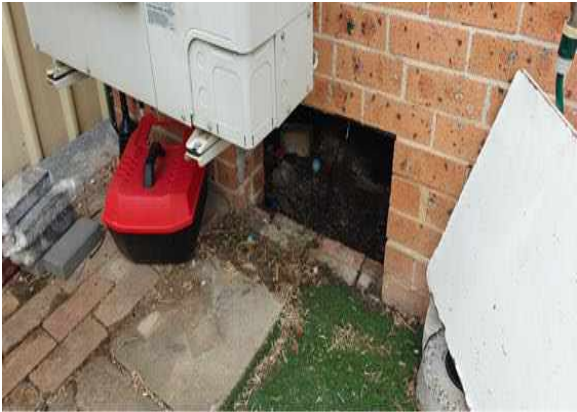
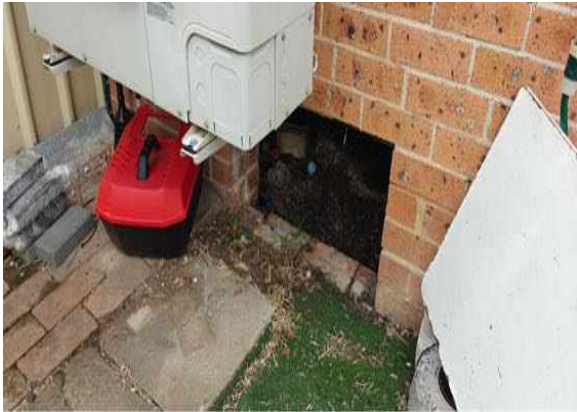
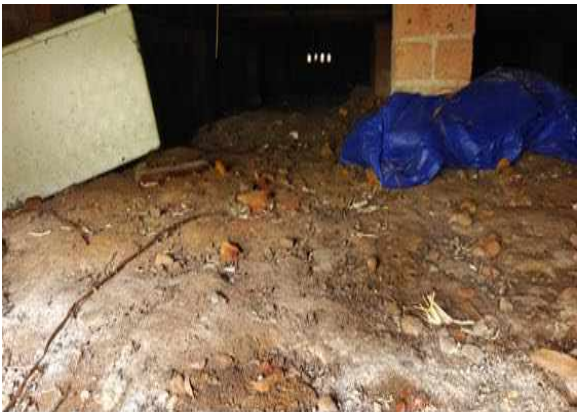
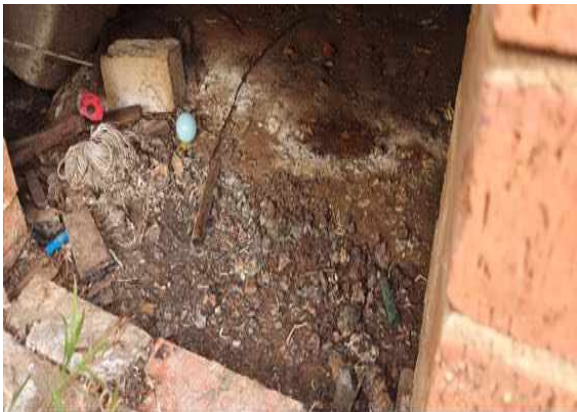
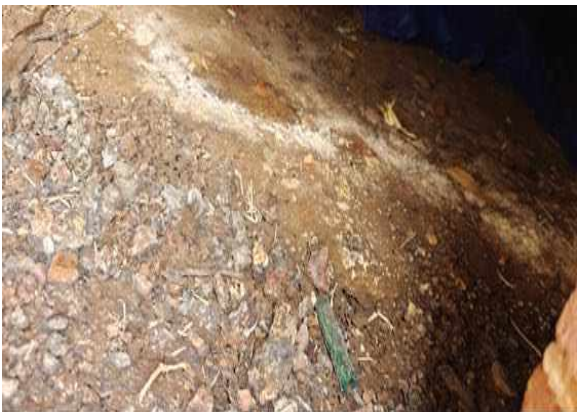
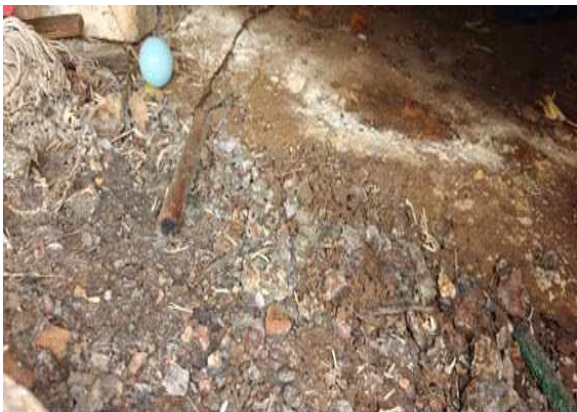
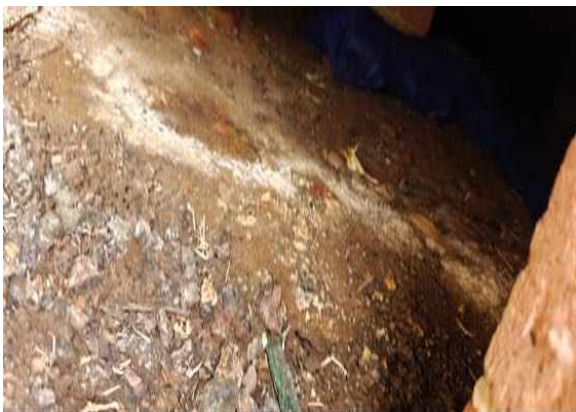
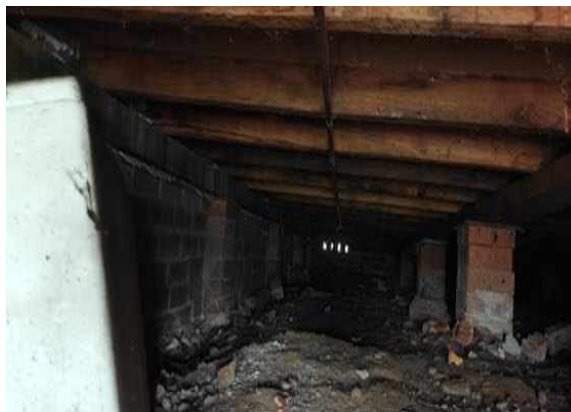
### Finding 3.08

Building: Main Building  
 Location: Subfloor  
 Finding: Subfloor - Site drainage - Inadequate  
 Information: The site exhibits poor drainage under the subfloor, leading to several critical issues. Water accumulates and does not properly drain away from the subfloor area, creating a hazardous condition.

1. Frequent water pooling and stagnation under the subfloor.
2. Risk of subfloor structural damage due to prolonged moisture exposure.
3. Potential for mold and mildew growth, compromising indoor air quality and a potential of Termite attack.
4. Safety hazard for occupants due to slippery surfaces and potential electrical hazards.

The poor site drainage under the subfloor poses a significant safety risk to the occupants, as it can lead to structural damage and health hazards.

This issue requires immediate attention and rectification. A licensed and experienced plumber or licensed builder specialising in drainage and foundation work should be engaged to assess the problem and implement necessary drainage solutions, such as improved grading, installation of drainage systems, and moisture barrier enhancements. Regular maintenance and inspections should also be scheduled to prevent future occurrences. Water damage and secondary defects are likely to occur if left unmanaged.

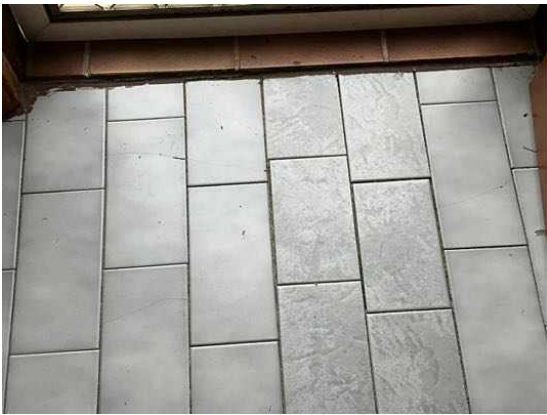
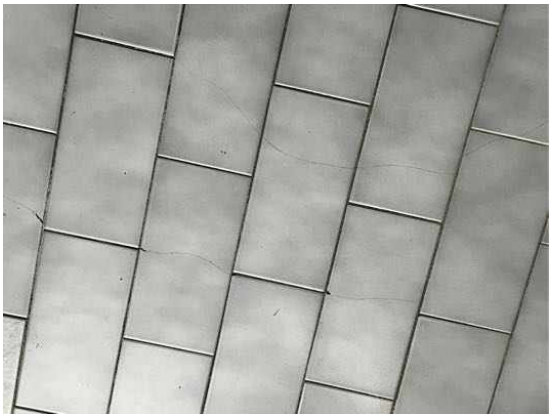
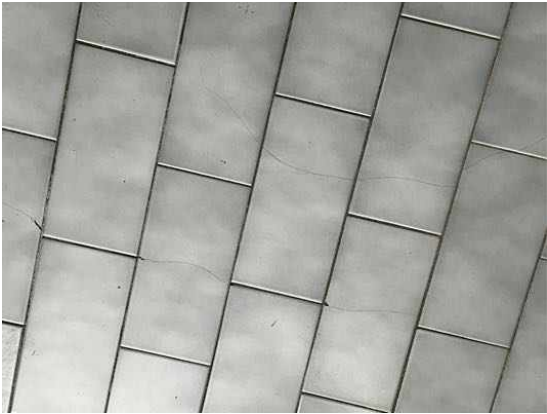
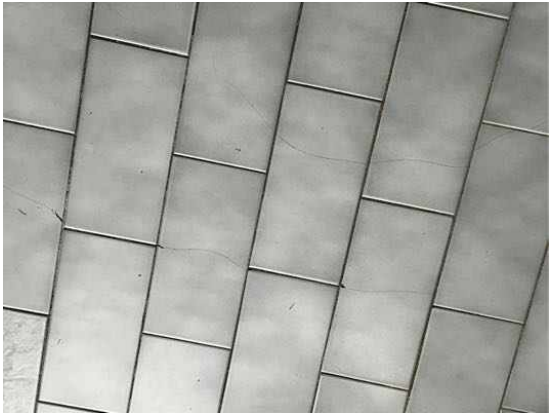
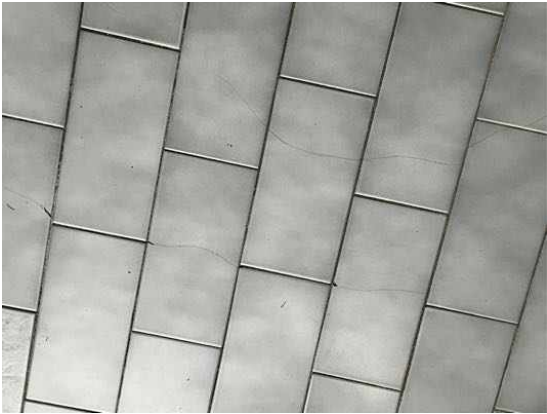
Building: Main Building  
 Location: Laundry  
 Finding: Floor Tile crack  
 Information: A floor tile has a visible crack on the surface.

The damaged tile presents a trip hazard, may lead to cuts if stepped on barefoot, and can allow moisture ingress into the substrate, which may cause further deterioration or loosening of adjacent tiles. It also affects the overall appearance of the floor.

A licensed tiler should be engaged to remove the damaged tile and install a matching replacement. If spare tiles are unavailable, additional remedial work may be required to blend the repair with surrounding finishes.

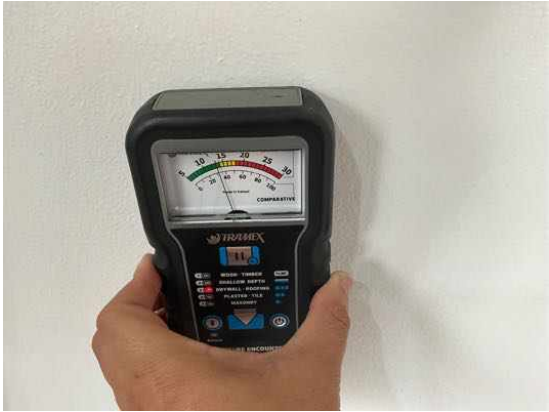
**Finding 3.11**

Building: Main Building  
Location: Laundry  
Finding: Evidence of excessive moisture - Drywall  
Information: Excessive moisture is present at the time of , indicating a potential water leakage issue within the wall.

The prolonged presence of moisture can lead to mold growth, deteriorate the structure, and create an environment conducive to health hazards. Additionally, it may compromise the adhesive holding the tiles, leading to their detachment.

A licensed plumber or a qualified contractor specializing in water damage remediation

should investigate the source of the moisture, fix any leaks, and address the damage. Additionally, replacing affected tiles and ensuring proper waterproofing are crucial to preventing future issues.

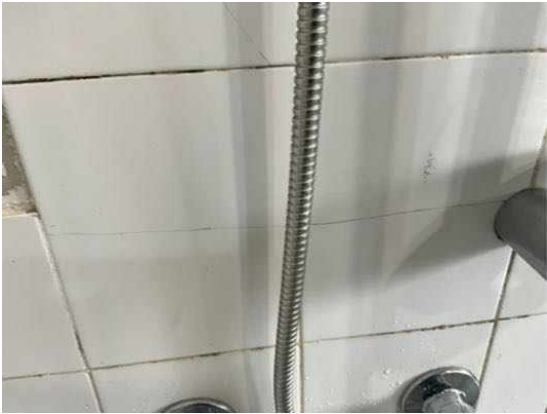
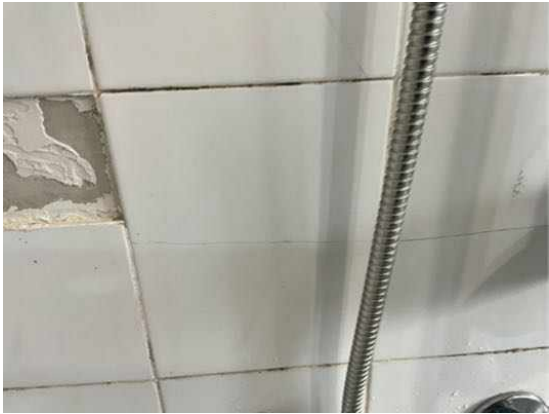
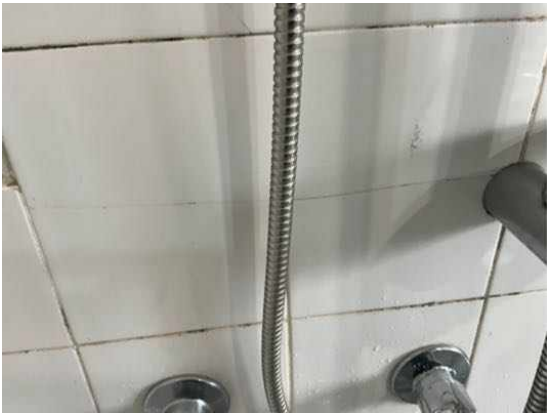
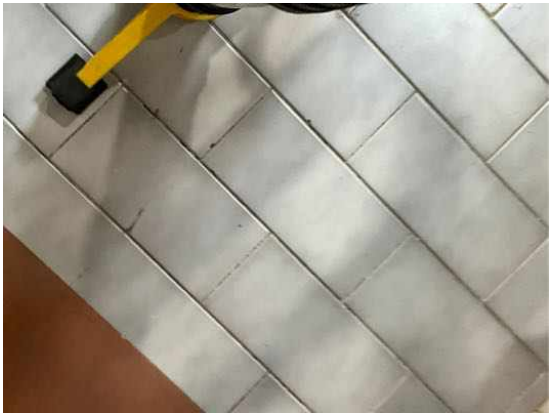
Finding: Tiles - Cracked or damaged

Information: Cracking was evident to the tiling in this area at the time of inspection. While the cracking appears to be minor, this area is frequently exposed to water, allowing potential for water penetration into adjoining sections of walls or flooring.

If left unmanaged, water penetration to these areas may lead to subsequent water damage, which is likely necessitate repair work to affected building elements.

A tiling contractor should be appointed to ensure that no further water damage occurs. The re-application of silicone and grouting throughout remaining tile work is also advised, to further protect the area against water penetration.

Where water penetration has led to water damage, appointment of a relevant tradesperson may be required to repair damaged building elements.

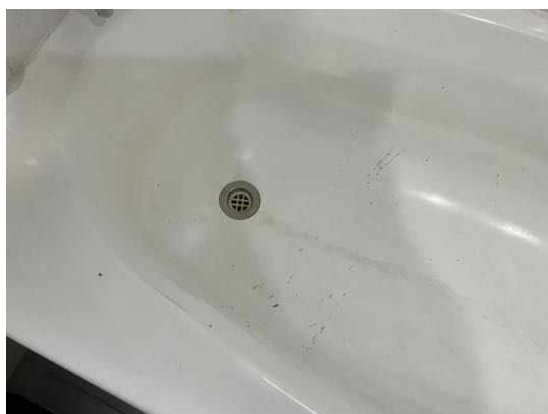
### Finding 3.14

Finding: Bathtub Stains

Information: This staining is indicative of long-term water exposure, possibly due to slow drainage, water quality issues, or the deterioration of materials in the bath.

- **Aesthetic Damage:** The stains detract from the visual appeal of the bathroom and may affect its overall cleanliness perception.
- **Material Degradation:** The source of the stains, such as rust or hard water, may eventually contribute to the deterioration of the bathtub's surface, leading to further damage if not addressed.
- **Plumbing Issues:** If the staining is caused by slow drainage or leaks, this may indicate a more significant issue with the plumbing that could worsen over time.

- **Professional Cleaner:** A professional cleaner specializing in bathroom or surface restoration can attempt to remove the stains using appropriate cleaning agents.

- Plumber: If the staining is caused by slow drainage, a plumber should inspect the drainage system for blockages or leaks.
- Bath Refinishing Specialist: If the staining is severe or has caused damage to the surface, a refinishing specialist can repair or recoat the bathtub.

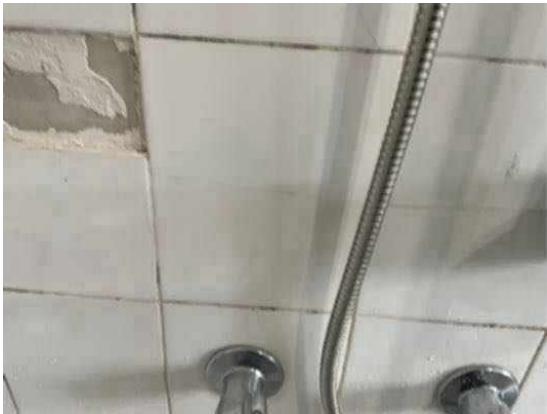
### Finding 3.15

Building:	Main Building
Location:	Bathroom
Finding:	Damaged Tile – Potential Waterproofing Risk
Information:	Damage was observed to a tile near the bath. The tile is chipped and cracked, exposing the substrate beneath. In wet areas, such damage may compromise the integrity of the waterproofing membrane underneath, which is essential for preventing water ingress.

Implication: Ongoing exposure to water in this area may result in membrane failure, water ingress, and deterioration of subfloor materials or adjoining finishes.

Recommendation: Engage a qualified tiler or waterproofing specialist to assess the extent of damage. An invasive inspection may be necessary to verify whether the waterproofing membrane has been breached and to undertake appropriate repairs to prevent future water damage.

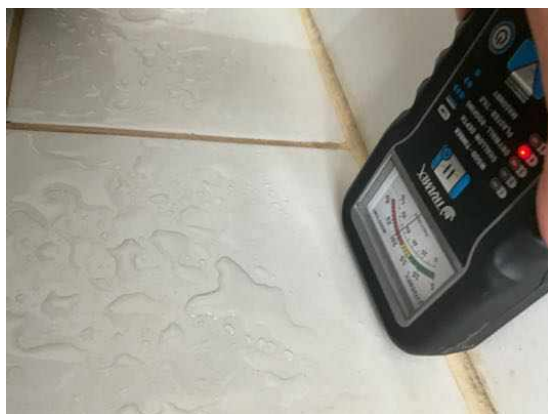
Finding 3.16

Building:	Main Building
Location:	Bathroom
Finding:	Shower - Damp
Information:	Damp is evident to the lower 300mm of wall to the shower alcove. This defect is quite common, and is suspected to have been caused by moisture permeating through the grouting in this area, which shows evidence of deterioration. Leaking pipes within the adjoining wall is also a possible cause.

Unmanaged damp in the shower recess is likely to facilitate the formation and development of mould and fungi growth, decaying associated building materials and compromising their structural integrity. It is important to address damp conditions, as the World Health Organisation notes that excess moisture leads - on almost all indoor materials - to growth of microbes such as moulds, fungi and bacteria, which subsequently emit spores and other matter into the indoor air. Exposure to these contaminants is associated with a wide range of respiratory and other health-related problems.

Consultation with a qualified plumber or bathroom specialist is advised immediately to identify the cause of damp and to perform remedial works as required. Where excessive mould growth is present, further inspection by a specialist environmental health inspector should also be considered.

Always ensure that sealant and grout is in good condition to prevent any moisture issues occurring in the future.

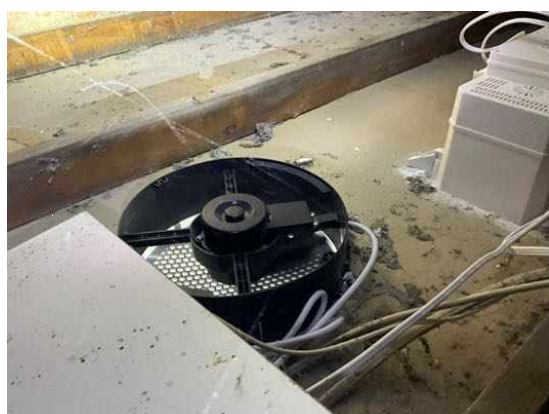
### Finding 3.17

Building: Main Building  
 Location: Roof Void  
 Finding: Exhaust fan not vented out  
 Information: The exhaust fan located within the roof void is not appropriately ducted to the external atmosphere and is currently discharging moist air directly into the roof space. This is considered a defect under AS 4349.1, as it does not meet the minimum standard of residential building performance expected under normal residential building practices.

This condition may lead to excessive condensation within the roof void, increasing the

risk of mould growth, deterioration of insulation, timber decay, and overall reduced durability of building elements. It may also result in poor indoor air quality, potentially affecting occupant health.

It is recommended that the exhaust fan be modified by a licensed HVAC contractor or qualified builder, ensuring it is properly ducted to discharge externally in accordance with manufacturer specifications, the National Construction Code (NCC), and applicable Australian Standards.

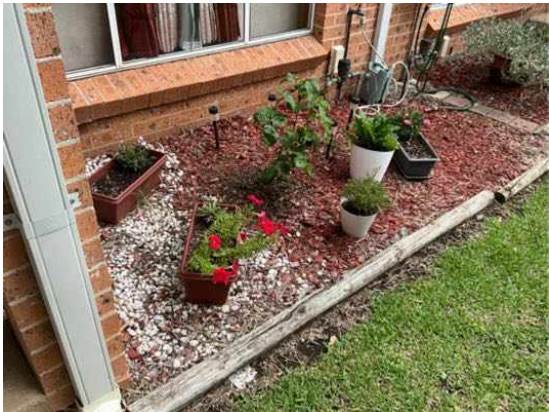
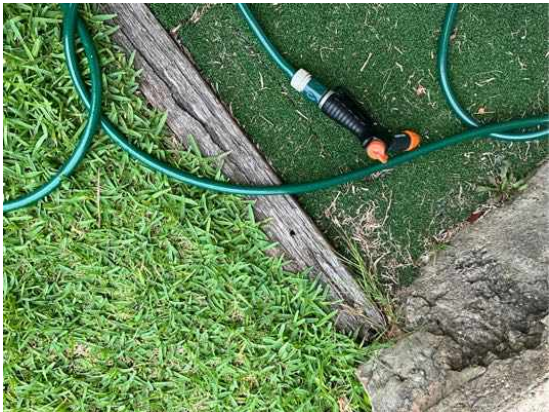
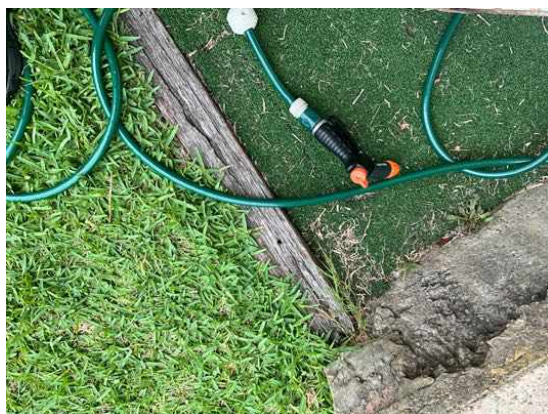
thrive in moist environments, and wood in contact with soil or moisture is more susceptible to infestation.

To prevent this, it's important to keep timber elevated and away from direct ground contact. Regular inspections and proper termite control measures are also essential to protect your wooden structures from termite damage.

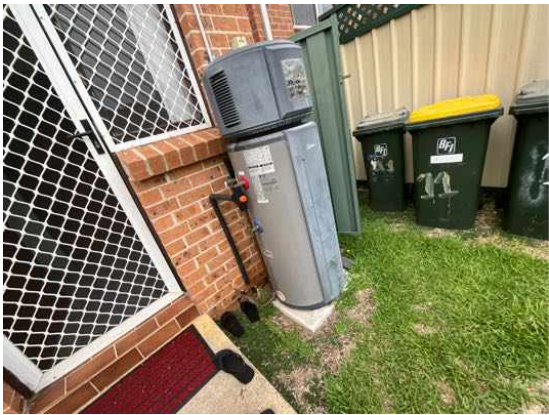
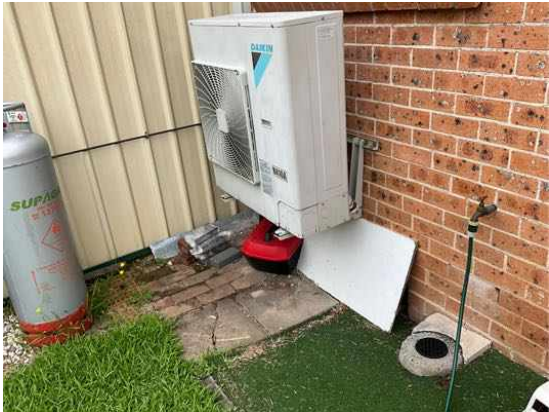
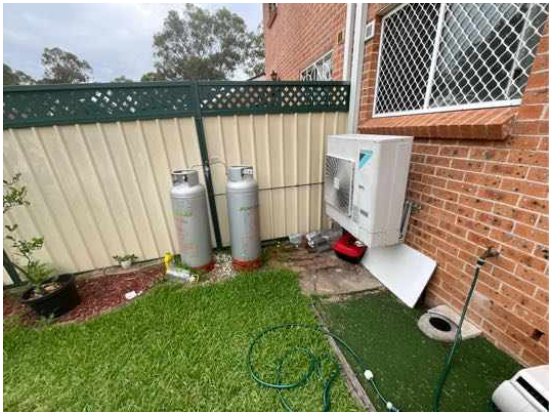
Where bridging has occurred full inspection is prevented and termites may enter a property in a concealed or undetected manner.

Recommended moving obstructions away from the external walls for further and future inspections.

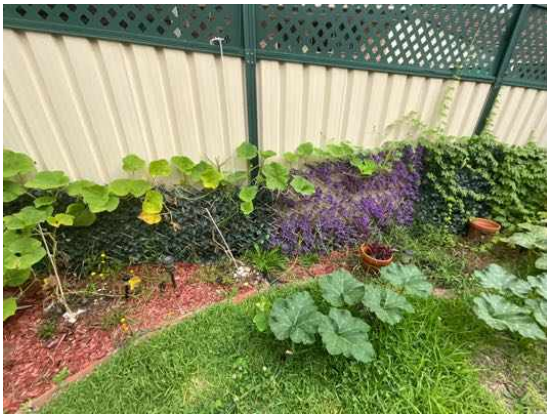
### Finding 6.05

Building:	Main Building
Location:	All Areas
Finding:	Dense vegetation around a property can increase the risk of termite infestation
Information:	The presence of dense vegetation around a property can increase the risk of termite infestation, as it provides a conducive environment for them. To address this, consider maintaining a clear space between the vegetation and your home. If you suspect a termite issue, it's advisable to consult with a licensed pest control professional for inspection and treatment.

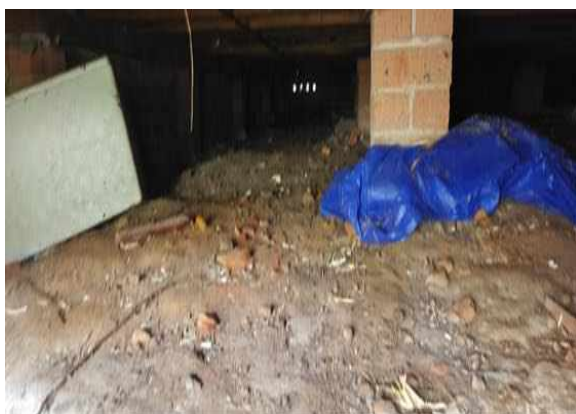
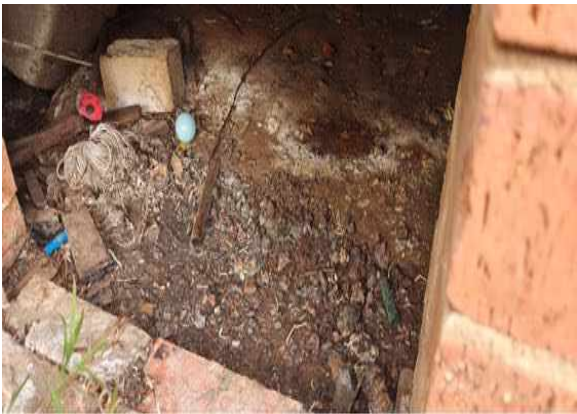
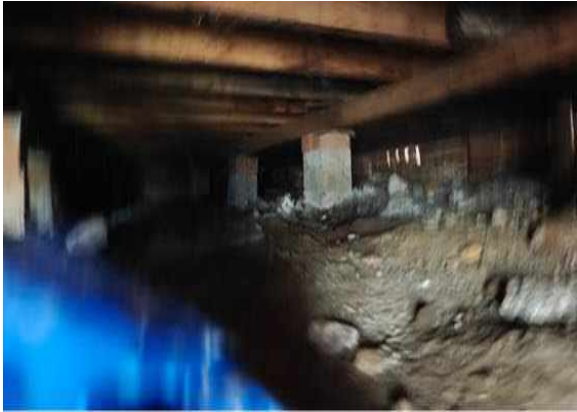
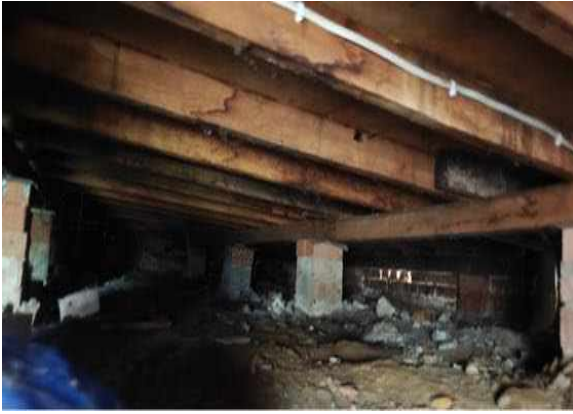
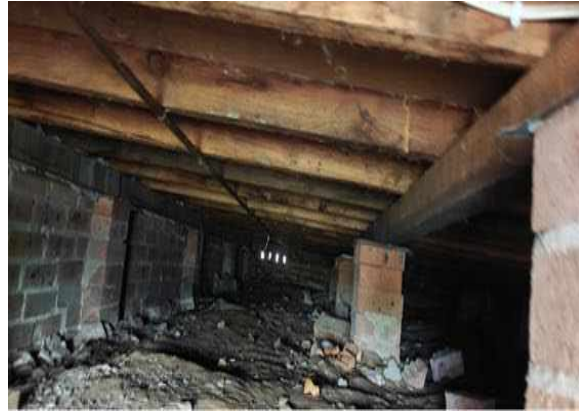
Finding 6.06

Building:	Main Building
Location:	Subfloor
Finding:	Subfloor - poor ventilation, inadequate site drainage, water stains
Information:	The subfloor lacks adequate ventilation, suffers from inadequate site drainage, exhibits water stains, creating conducive conditions for timber pests such as termites.

Risk: The combination of poor ventilation, inadequate drainage, water stains significantly increases the risk of timber pest infestations. Termites are attracted to moist environments and can thrive in subfloors with high humidity levels and water damage. The lack of proper ventilation and drainage exacerbates moisture retention, providing an ideal habitat for timber pests to establish colonies and cause extensive damage to the subfloor structure. Additionally, water stains indicate previous or ongoing moisture issues, which further attract timber pests and contribute to the deterioration of timber materials.

A licensed pest control professional specializing in timber pest management should be consulted to assess the extent of the infestation and develop a comprehensive treatment plan. They can implement strategies to eliminate existing timber pests, such as termites and prevent future infestations by addressing underlying moisture issues. Additionally, a qualified plumber or builder may be needed to improve subfloor ventilation, enhance site drainage, repair water-damaged areas. Regular inspections and maintenance are essential to ensure ongoing protection against timber pests and maintain the structural integrity of the subfloor.

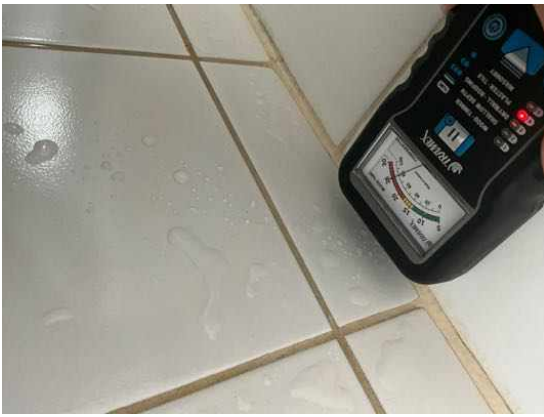
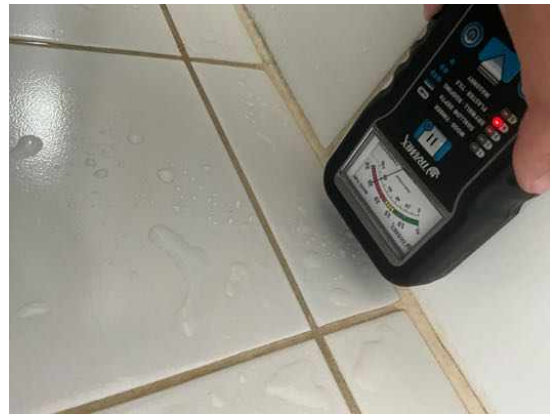
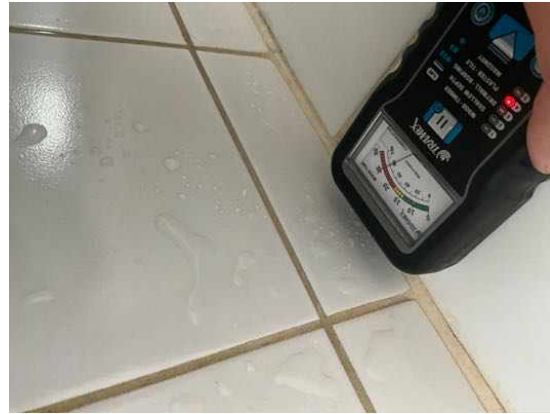
### Finding 6.07

Building:	Main Building
Location:	Laundry
Finding:	Excessive moisture - Conducive to Timber pest
Information:	Excessive moisture can attract termites and produce conditions that promote fungal growth and wood decay.

Prior to any remedial works being performed a qualified plumber should be appointed to further inspect the property and to identify the cause of the excessive moisture. Works to remove affected building elements may then be necessary and should be performed by an appropriate tradesperson.
