Building and Timber Pest Inspection Report

Inspection Date: Thu, 19 Feb 2026

Property Address: 19 Shorthorn Avenue, Glenmore Park NSW
2745

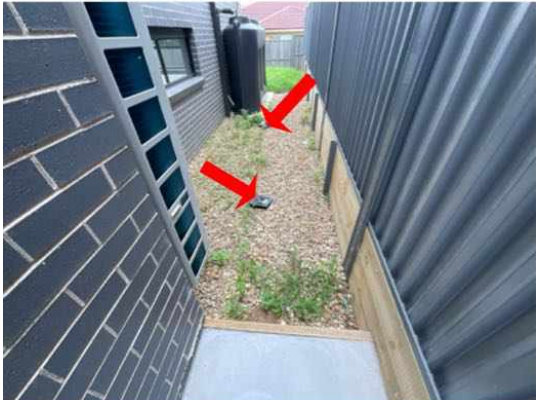
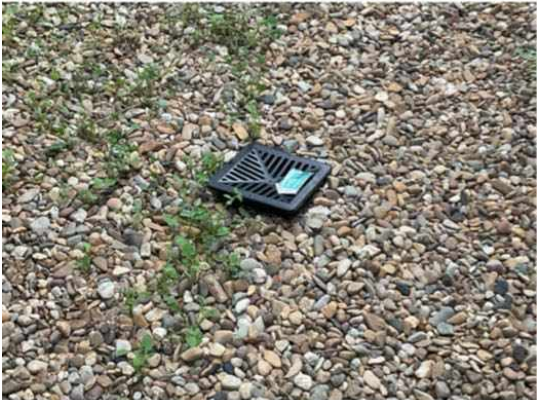
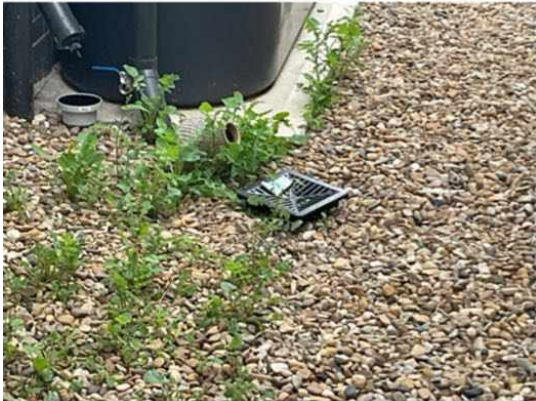
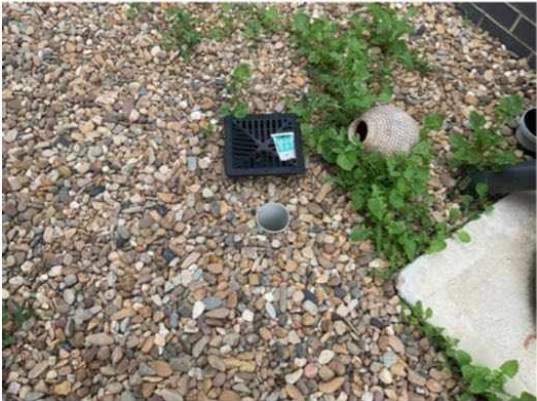
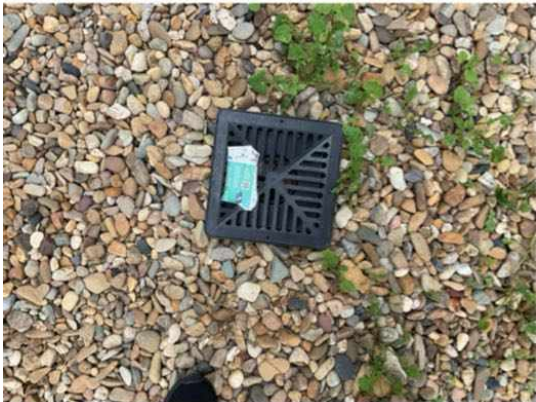
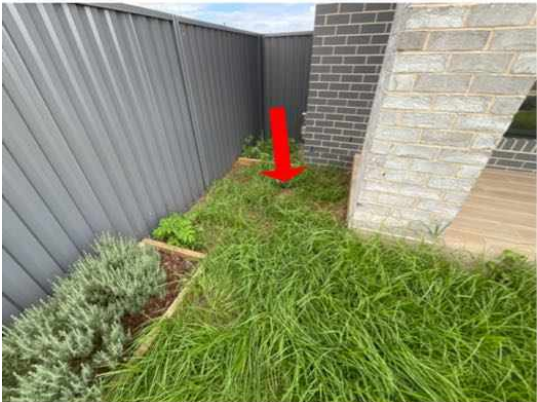
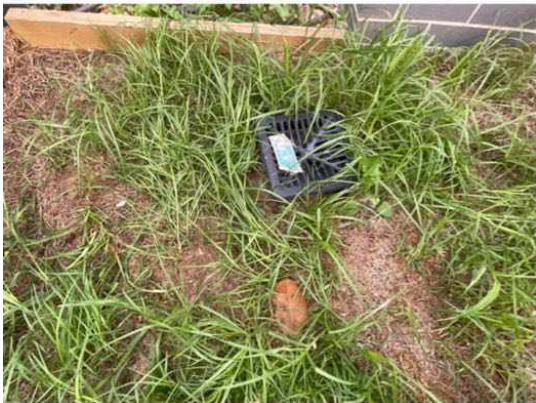
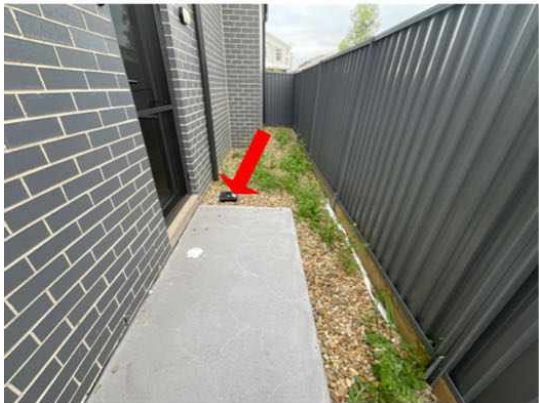
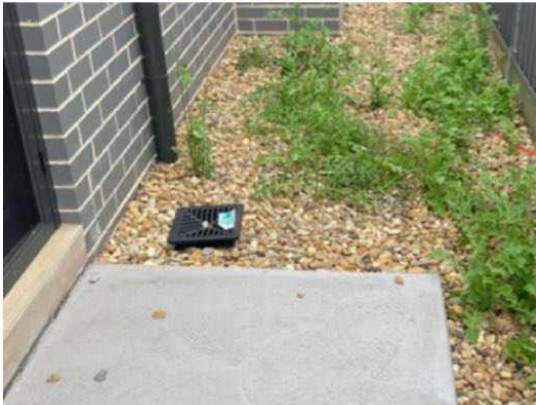
Building:	Main Building
Location:	All External Areas
Finding:	Site/Yard drainage - Inadequate (Surface drain too high).
Information:	Site Drainage – Substandard landscaping and drainage

Improper drainage in this location can lead to:

- Surface water pooling near the building, increasing the risk of moisture ingress to subfloor or lower wall areas
- Slip hazards along the path due to standing water
- Long-term degradation of paving, concrete, or building footings if drainage issues persist

It is recommended that a qualified drainage plumber or landscaping contractor be

- Assess the extent of the issue
- Lower or reinstall the drain at the correct level
- Regrade the surrounding path or surface as needed to ensure positive drainage

Timely rectification will help prevent water pooling and associated moisture-related issues around the property.

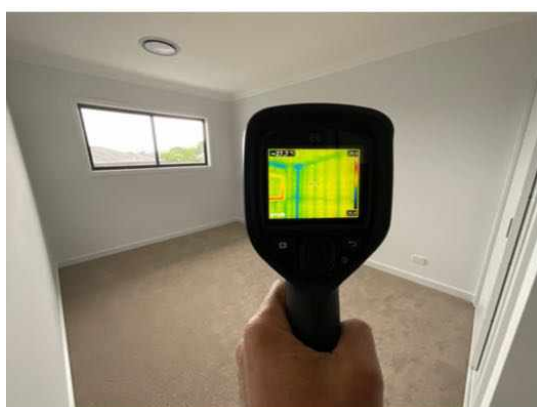
At the time of the inspection, no abnormalities indicating live termite activity were observed. However, it's important to note that various factors—such as obstructions, ambient temperature, and wall material/thickness—can impact the accuracy of thermal readings. In cases where surfaces are visually restricted or obstructed, a comprehensive thermal scan may not always be feasible.

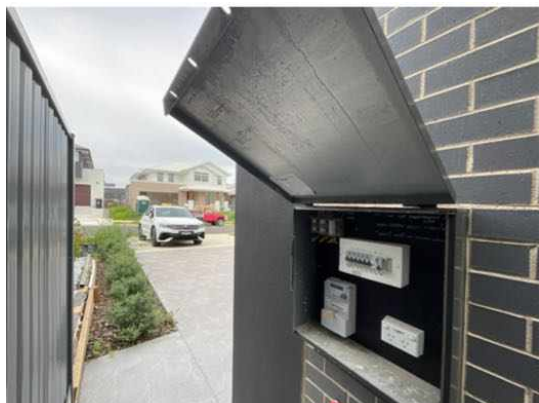
Building:	Main Building
Location:	All Areas
Finding:	Termite Management System - Missing Durable Notice..

At the time of inspection, no durable notice or sticker was found within the switchboard unit or other accessible areas to indicate the presence or type of termite management system currently installed.

It is strongly recommended that a durable notice be affixed within the main electrical switchboard or another prominent location (e.g. meter box or inside garage) to clearly identify:

- The type of termite management system installed (e.g. chemical barrier, physical barrier, reticulation system, baiting system)
- The installation date
- The installer's contact information
- Ongoing maintenance or inspection requirements
- If no reliable information can be obtained, or if the existing system is found to be outdated or non-functional, it is recommended that a new termite management system be installed by a licensed pest control professional.

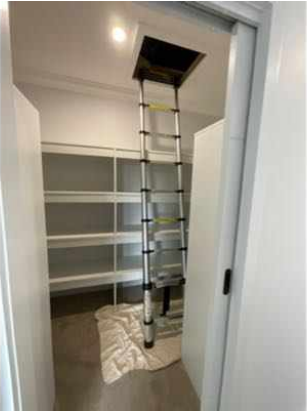
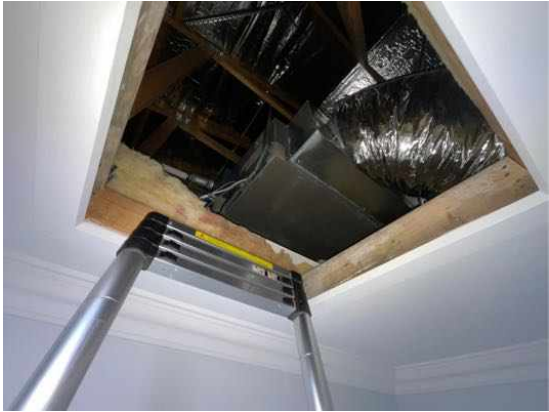
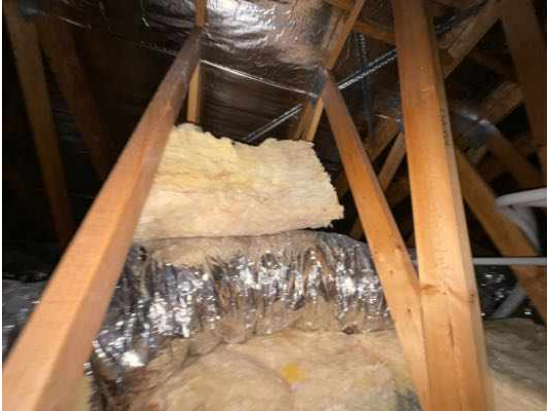
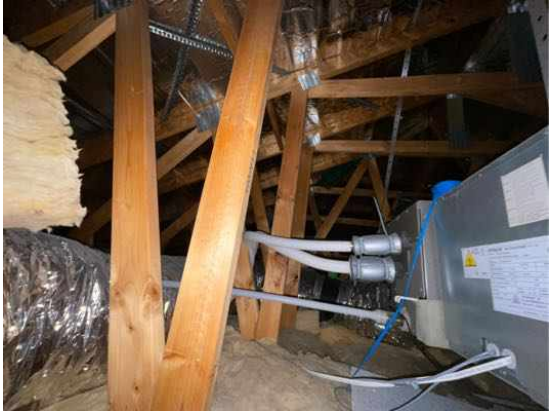
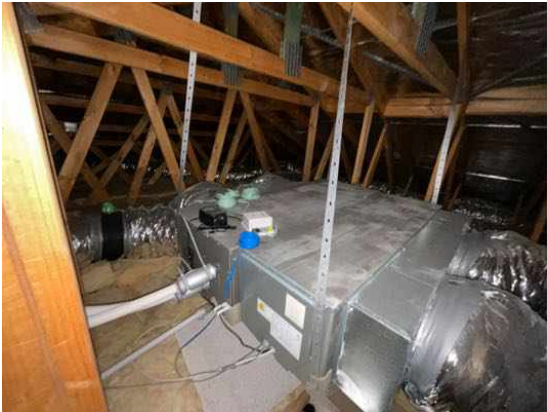
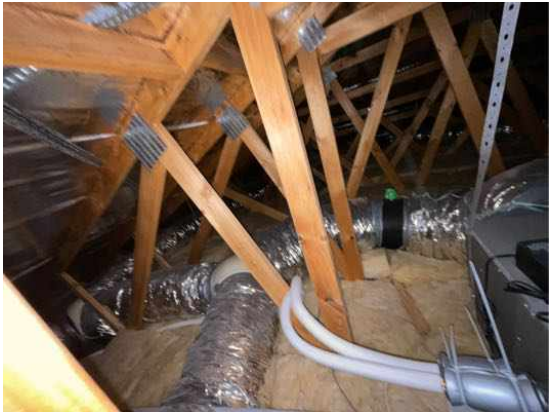
A full inspection of the roof space is not achievable unless all obstructions—including insulation and restricted access points—are removed, and full, safe access is provided. Termite activity or timber pest damage may go undetected in concealed or inaccessible areas.

Installation of an additional manhole is recommended to facilitate a re-inspection and enable a more thorough assessment of the roof void in the future. This will help ensure that all structural elements and concealed areas are properly evaluated.

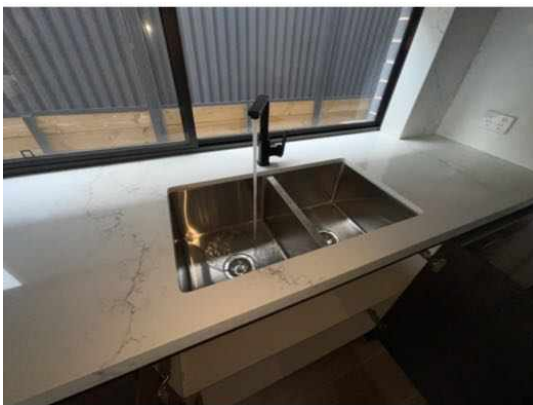
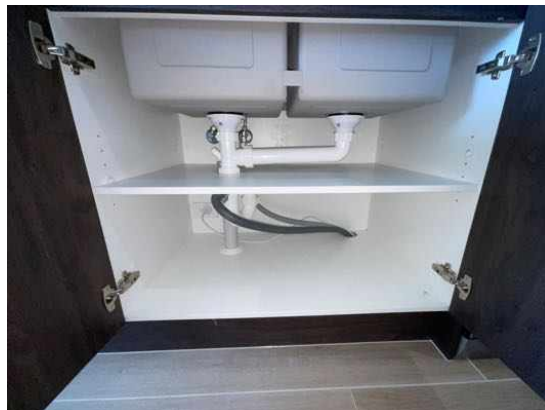
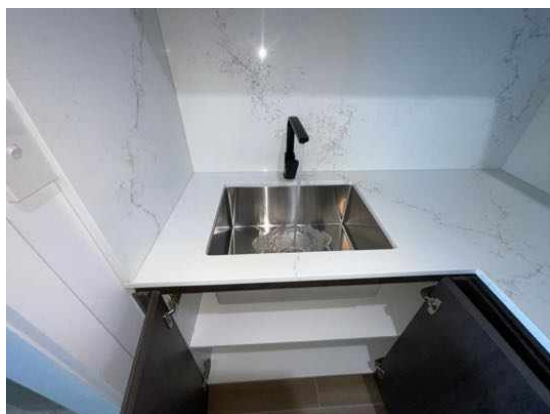
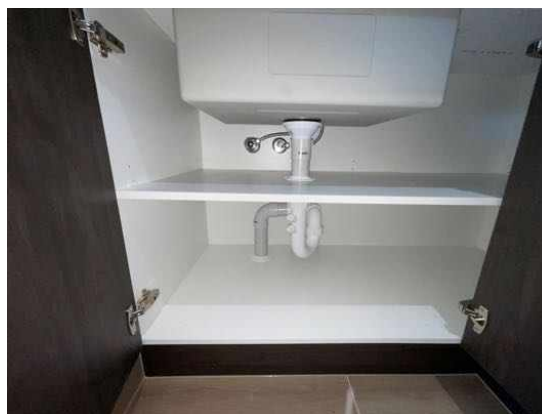
Building: Main Building
 Location: Kitchen
 Finding: Kitchen Sink – Overall Condition & Recommendations.
 Information: Observations:

- The kitchen sink tap(s) were water tested at the time of inspection, with no evidence of leaks or blockages observed in the visible plumbing or drainage.
- No significant water damage was observed to the cabinetry/unit;

- Further monitoring and testing are recommended once the tap(s) are in constant use, to identify any drainage issues or signs of slow leaks not evident during the limited inspection.
- For long-term property care, it is advised that sealant and grouting in water-exposed areas be regularly inspected and maintained.

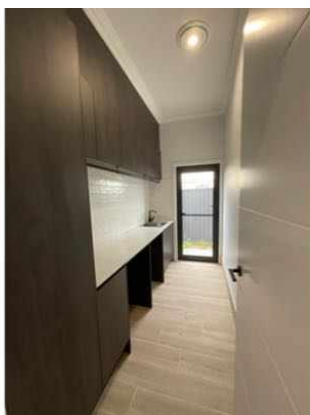
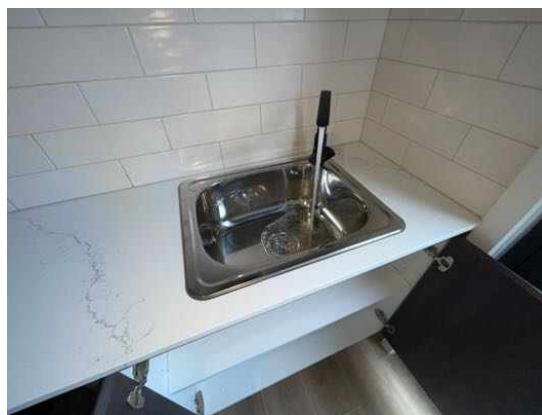
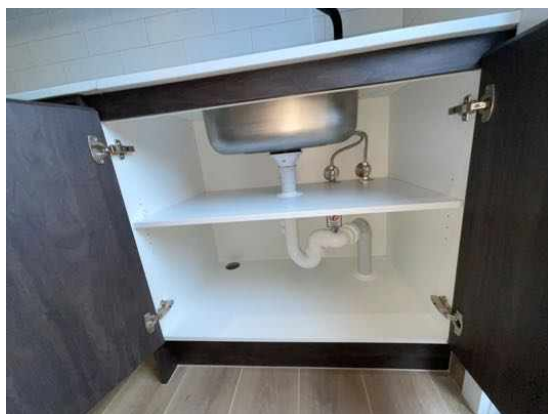
Building: Main Building
 Location: Laundry
 Finding: Laundry - Taps/Plumbing/Drainage.
 Information: Observation: Laundry Tub – Taps, Plumbing, and Cabinetry

- The taps to the laundry tub were water tested and inspected, with no evidence of plumbing or drainage leaks observed at the time of inspection.
- No visible signs of water damage, rust, or corrosion were noted to the cabinetry or surrounding unit during the inspection.

- Further monitoring or testing is recommended once the taps are placed into regular use, to ensure no leaks develop over time and that the drainage system continues to perform adequately.
- Sealant and grouting in wet areas should be maintained as part of the long-term care and upkeep of the property.
