Building and Timber Pest Inspection Report

Inspection Date: Wed, 11 Feb 2026

Property Address: 120 Sir John Jamison Cct Glenmore Park
NSW 2745

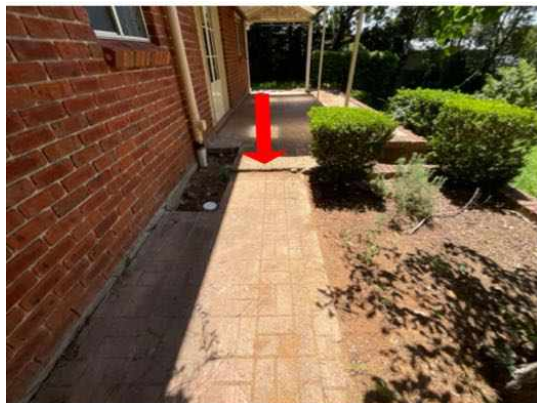
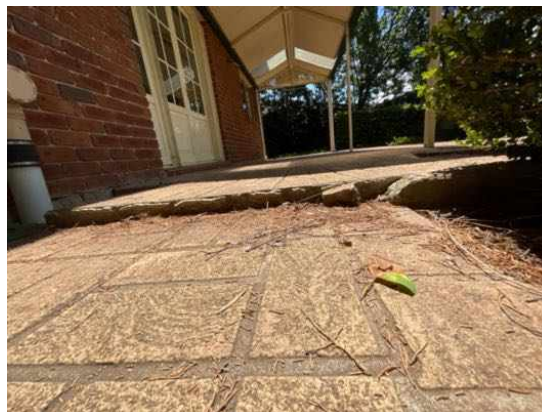
Building:	Main Building
Location:	Exterior - rear
Finding:	Paving - Uneven.
Information:	Sections of the external paved area were observed to be uneven and irregular, with noticeable height variations between adjoining pavers. This condition appears consistent with either rough or substandard installation practices, possible soil movement, or settlement of the underlying base material over time.

Uneven paving poses a significant trip and fall hazard, particularly in areas of regular pedestrian use such as paths, patios, or entryways. The risk of personal injury increases if individuals are unaware of the uneven surface or during periods of low visibility or wet conditions. From a safety perspective, this issue requires timely attention to ensure compliance with general building and accessibility standards.

In addition to safety concerns, uneven paved areas can also negatively affect surface drainage. Poorly graded or uneven sections may allow water to pond or flow back toward the building's foundation, contributing to moisture accumulation, potential dampness issues, and premature surface deterioration. Over time, these conditions can lead to further instability of the paving and may necessitate more extensive repair works.

It is recommended that the affected sections be re-laid or re-paved to achieve an even and stable finish. Works should include assessment and correction of the underlying substrate to prevent recurrence of movement or settlement. Ensuring appropriate compaction, grading, and drainage will improve both the functionality and longevity of the surface.

A qualified concreter or paving specialist should be consulted to inspect the area, determine the extent of remediation required, and carry out the necessary works in accordance with relevant building and safety standards. Prompt rectification will help eliminate potential safety hazards and preserve the overall condition and presentation of the property.

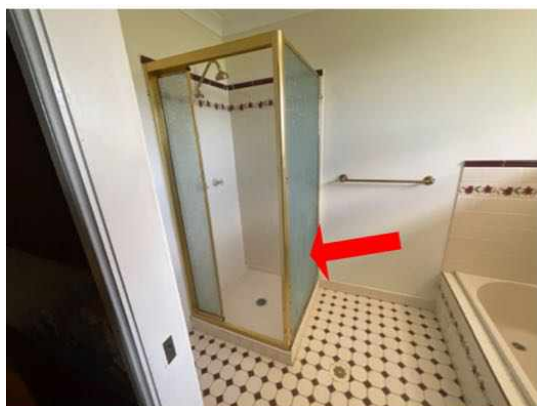
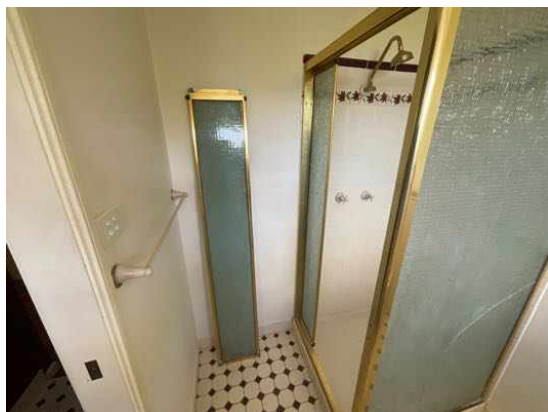
Finding 1.02

Building:	Main Building
Location:	Bathroom
Finding:	Damaged Shower Screen Glass Panel.
Information:	Major Defect – Bathroom Shower Screen (Cracked Glass Panel)

During the inspection of the bathroom, the shower screen glass panel was observed to have sustained visible and significant cracking. Also noted the two sliding doors have been removed and will need to be replaced. The cracking is clearly evident and extends through the glass panel, indicating that the integrity of the glass has been compromised. Based on the condition observed at the time of inspection, the damage is considered major. Any additional stress, vibration, or minor impact may cause the crack to propagate further or result in sudden and complete failure of the glass panel.

Cracked shower screen glass presents a serious safety hazard. Tempered or toughened glass, when compromised, can fail without warning and shatter into multiple fragments, creating a high risk of personal injury to occupants. Continued use of the shower in its current condition significantly increases the likelihood of glass failure. In addition, deterioration of the crack over time is likely, which will ultimately require full replacement of the shower screen assembly rather than minor repair.

It is strongly recommended that a qualified glazier be engaged as a matter of urgency to assess the extent of the damage. The cracked glass panel should be repaired or, more likely, fully replaced to restore the shower screen to a safe and compliant condition. Until appropriate remedial works are completed, occupants should exercise extreme caution and avoid using or coming into contact with the affected shower screen to minimise the risk of injury.

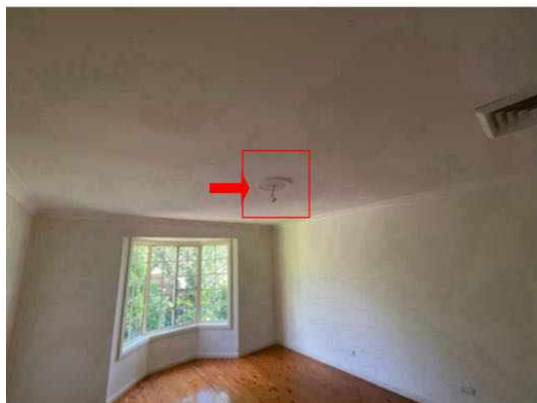
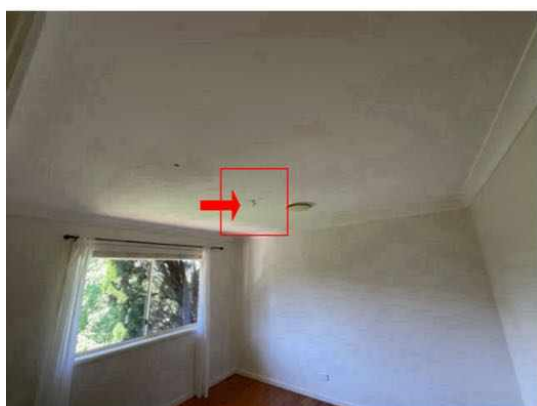
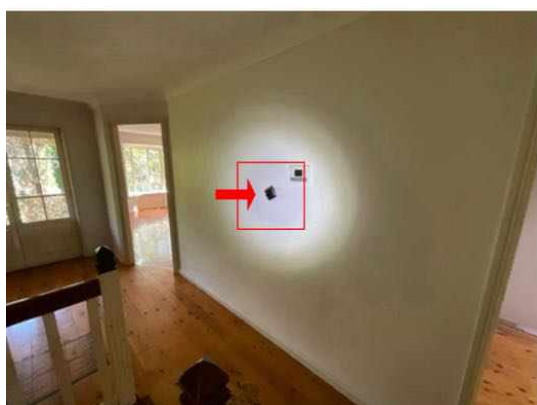
Finding 1.03

Building:	Main Building
Location:	Bedrooms
Finding:	Electrical – Exposed Wiring (Safety Hazard)
Information:	Exposed electrical wiring was identified within the bedroom ceiling areas where light fittings have been removed and not reinstated. The absence of enclosed light fixtures has left active wiring accessible at the ceiling lining interface. This condition is not considered safe and does not meet acceptable electrical safety standards.

In addition, a light switch located in the hallway was observed to be loose within its mounting. The switch plate was not securely fixed, and internal wiring was visible. Loose fittings can place strain on conductors and terminations, increasing the likelihood of short-circuiting, arcing, or overheating.

Exposed or inadequately protected electrical wiring represents a significant safety hazard. Risks include electric shock through direct contact, increased fire risk due to arcing or poor connections, and potential non-compliance with relevant electrical safety regulations.

This matter requires urgent attention. It is strongly recommended that a licensed electrician be engaged without delay to undertake a comprehensive inspection of the affected circuits, safely terminate or reinstall compliant light fittings, secure the loose switch, and ensure all wiring is properly enclosed and compliant with current electrical

standards. The area should be treated as a safety hazard until rectification has been completed.

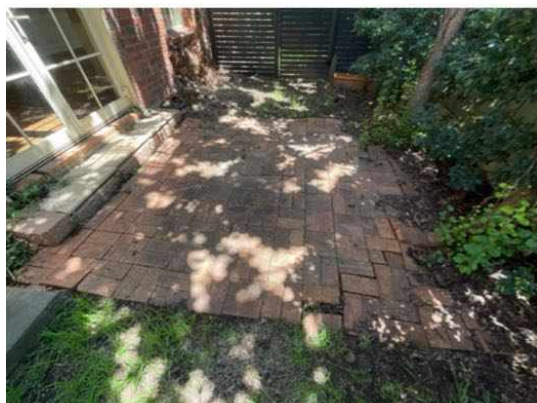
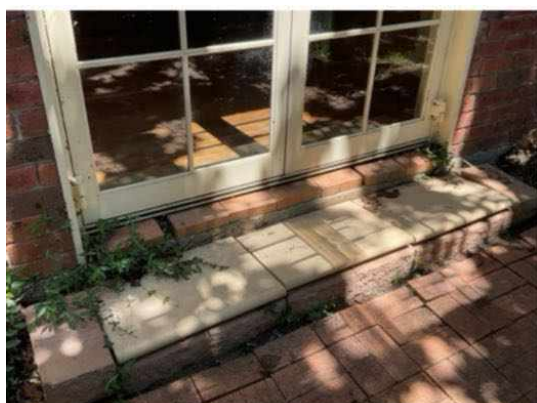
Finding 1.04

Building:	Main Building
Location:	Exterior - left side
Finding:	External Paved Area and Stair Access – Potential Safety Hazard
Information:	The paved surface leading to the side external doors was observed to be uneven and out of level at the time of inspection. Differential movement and/or subsidence of the paving has resulted in an irregular walking surface, which presents a foreseeable trip hazard to occupants and visitors. In addition, the uneven grading may allow water to

Tiles installed to the stair tread and threshold area were noted to be loose and/or not bonded. Loose tiles present a direct slip and trip hazard and may further deteriorate with continued use or exposure to weather conditions.

In its current condition, this area is not considered safe for regular foot traffic. Prompt rectification is recommended. Works should include lifting and reinstating affected paving to achieve a stable and adequately drained surface, stabilising or reconstructing the stair tread as required, and securely re-fixing or replacing loose tiles. All repairs should be carried out by a suitably qualified tradesperson to ensure safe and durable access to the external doors.

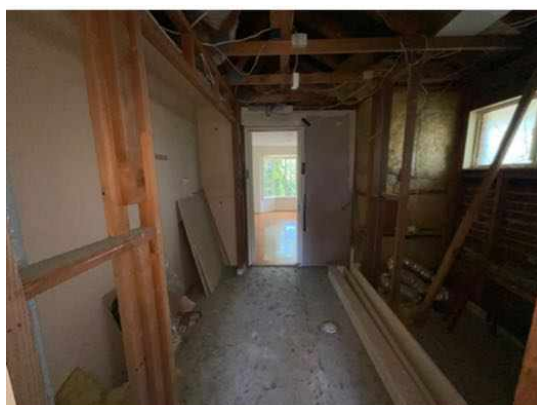
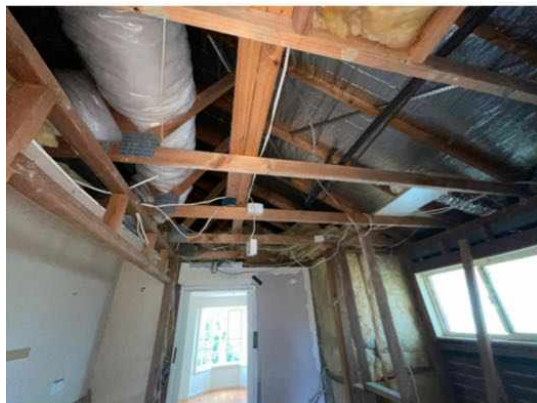
Finding 2.01

Location: Ensuite
Finding: Major Defect – Incomplete Ensuite Renovation
Information: The ensuite has been partially demolished in preparation for renovation works. Wall, floor and ceiling linings, including tiles and associated fixtures and fittings, have been removed. At the time of inspection, renovation works had ceased and the area remains incomplete.

As a result of the demolition stage, building elements are exposed, including structural framing and electrical cabling. Exposed electrical wiring presents a safety hazard and increases the risk of electric shock, mechanical damage to cables and potential fire risk if not properly protected and terminated. In addition, the removal of waterproofing, linings and floor finishes leaves surrounding building materials vulnerable to moisture ingress, deterioration and possible secondary damage if the area is inadvertently exposed to water.

An incomplete wet area renovation is considered a major defect in the context of a pre-purchase inspection. The bathroom is currently non-functional and cannot be used for its intended purpose. Furthermore, unfinished works may conceal additional defects, non-compliant work practices, or incomplete plumbing and electrical installations that cannot be fully assessed at this stage.

It is recommended that a suitably qualified and licensed bathroom renovation specialist or registered builder be appointed to assess the current condition of the works, verify compliance of any installed services, and complete the renovation in accordance with current Building Code requirements and relevant Australian Standards, including compliant waterproofing and certified electrical and plumbing installations. Any exposed electrical components should be made safe as a priority.

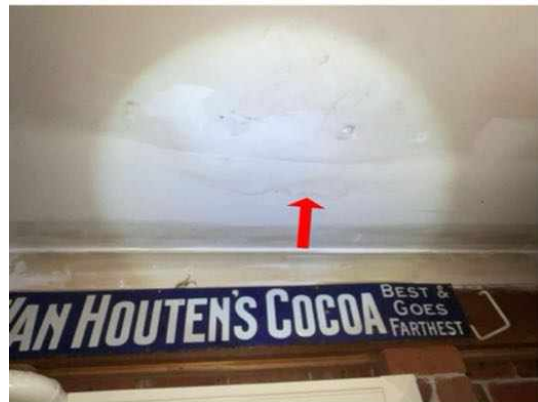
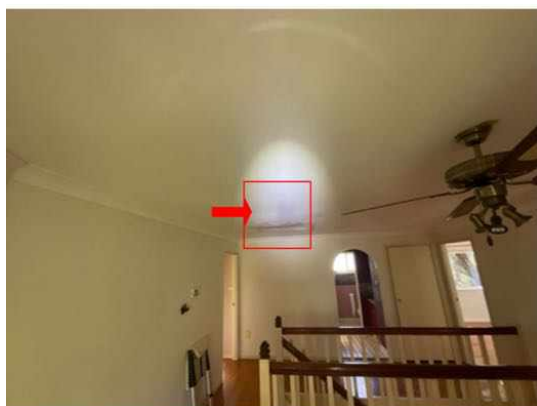
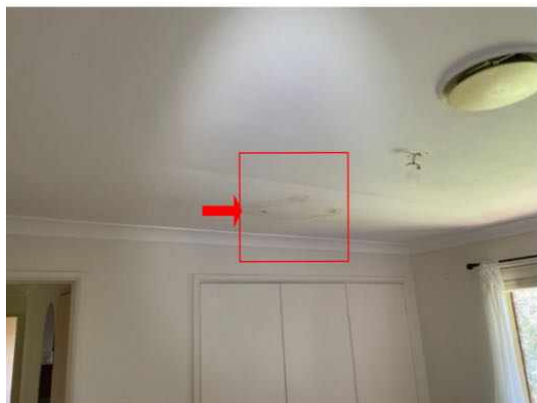
Finding 2.02

Building:	Main Building
Location:	Garage & Upstairs
Finding:	Ceiling - Water damaged
Information:	Observation:

Water staining and damage was noted to ceiling linings in the inspected area(s) at the time of the inspection. These stains present as discoloured or patchy areas and may suggest a history of moisture ingress, most commonly associated with roof leaks.

Water staining is typically the result of prolonged exposure to moisture, which allows minerals and other contaminants carried by the water to accumulate on surfaces, leaving visible marks. If ongoing or left untreated, moisture ingress can lead to more serious issues such as:

- Where the staining is active or suspected to be active during wet weather, a qualified roofing specialist should be engaged to conduct a more detailed inspection. Their investigation should focus on identifying the exact source of moisture ingress and advising on necessary repairs to the roof coverings, flashings, penetrations, or

- Where the staining appears to be historical (i.e., dry and showing no recent progression), reparation of affected ceiling materials (such as repainting or patching) may be carried out at the client's discretion, subject to confirmation that the source of the leak has been effectively addressed.

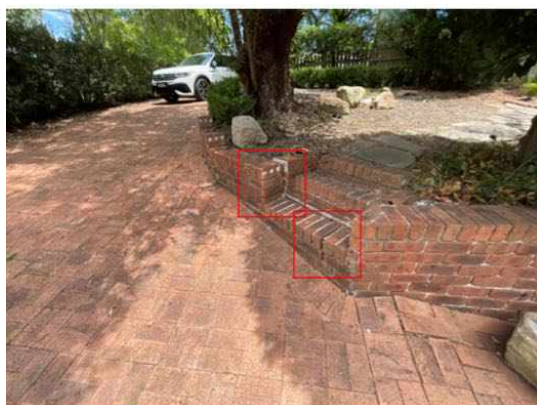
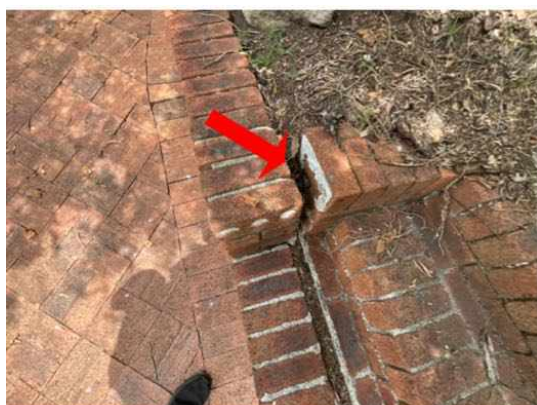
Finding 3.01

Building: Yard
 Location: Yard - Front
 Finding: Minor Defect – Masonry Retaining Wall.
 Information: Observation:

A section of the masonry retaining wall was noted to be defective at the time of inspection, showing signs of deterioration.

Defects in retaining walls are often due to factors such as age, poor drainage, or original construction methods. While no immediate safety hazard was identified, deterioration may continue if not addressed and could become a concern over time.

Monitoring is advised. If movement or further deterioration becomes evident, the client may consider:

- Engaging a landscaper or retaining wall contractor to carry out repairs or replacement
- Where the wall is considered structural, consulting a qualified structural engineer or building surveyor is recommended to assess and advise on appropriate remedial works.

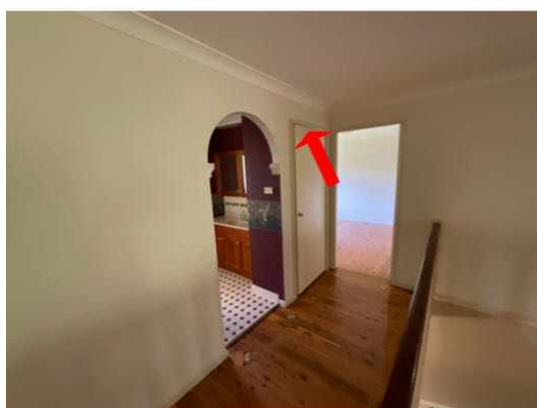
Finding 3.04

Building: Main Building
Location: Linen Cupboard
Finding: Door - Binding and/or Jamming.
Information: Functional Defect Identified

- If the issue appears to be related to major structural movement, it is recommended that a registered builder with experience in re-stumping or subfloor repairs be engaged to assess the extent of the movement and provide a quotation for necessary remedial works.
- Where the issue is minor in nature, a qualified carpenter or general handyperson may be appointed to carry out corrective works at the client's discretion.

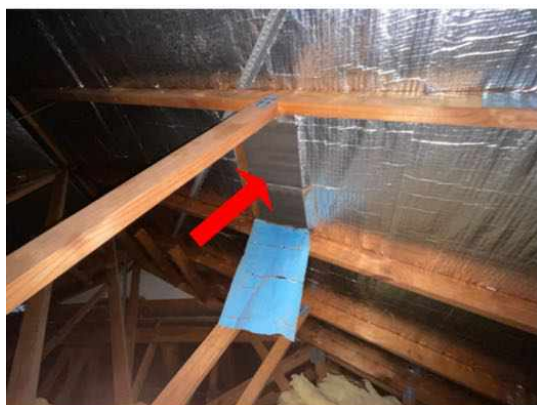
Finding 3.07

Building: Main Building
 Location: Roof Void
 Finding: Sarking was found to be damaged in this area.
 Information: Damaged Roof Sarking

Any holes or damaged sections of sarking should be repaired or replaced to restore full functionality. These works should be completed by a roofing contractor or other suitably qualified tradesperson.

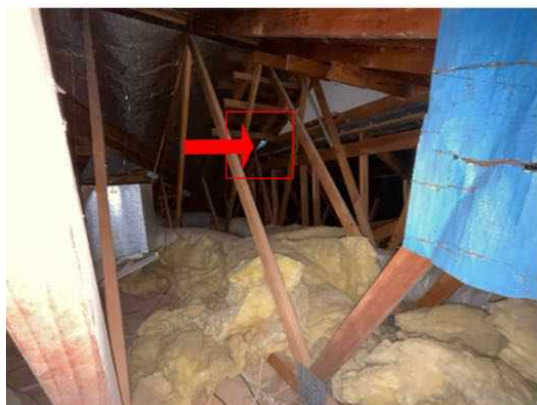
Finding 3.08

Building:	Main Building
Location:	Roof Void
Finding:	Roof flashing - Deteriorated or loose
Information:	Observation:

It is recommended that a licensed roofing plumber or suitably qualified roofing contractor be engaged as soon as practicable to carry out a detailed assessment of the Dutch gable flashings. Any deteriorated or defective flashing materials should be repaired or replaced as necessary to restore effective weatherproofing. Prompt remedial action is advised to minimise the risk of ongoing water ingress and to prevent the development of further internal damage or consequential defects.

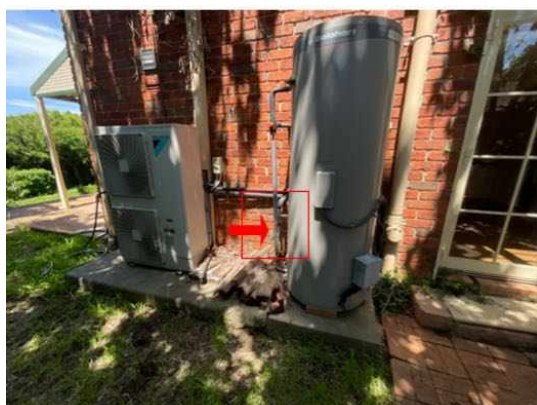
Finding 6.03

Building:	Main Building
Location:	All External Areas
Finding:	Overflow Management – Risk of Termite Activity..
Information:	Observation: Water Pooling from HWS and Air Conditioning Overflows

It is highly recommended that all overflows from the HWS and air conditioning units be redirected away from the building, preferably via fixed drainage or extension piping, to prevent water accumulation near the structure.

These minor corrective works should be undertaken promptly to minimise the risk of both termite ingress and potential structural damage due to ongoing moisture exposure.

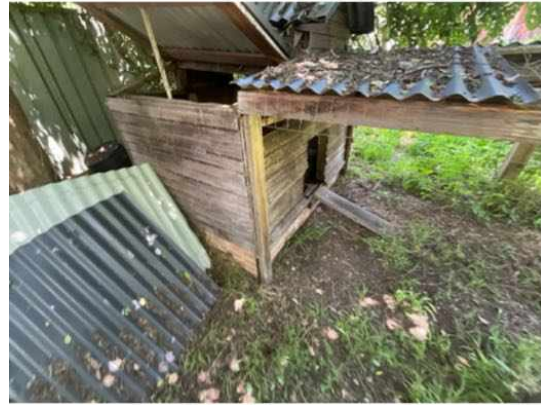
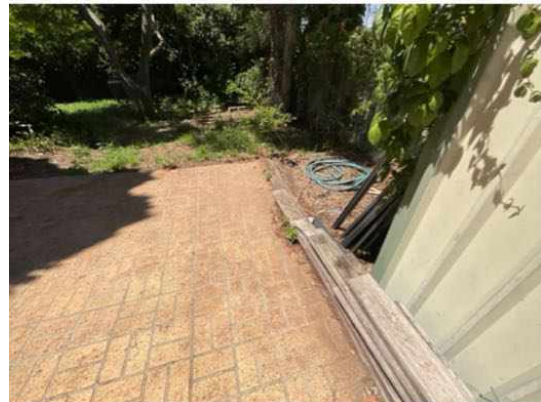
**Finding 6.04**

Building: Main Building
Location: Yard
Finding: Conducive Conditions – Timber and Firewood Storage Near the Structure..
Information: During the inspection, it was noted that timber and/or firewood is being stored against the house including around the external areas of the property. This practice is considered a conducive condition for timber pest activity, particularly termites.

It is strongly recommended that all firewood, off-cuts, untreated timber, and similar cellulose materials be immediately removed from direct ground contact and relocated away from the building's perimeter (ideally stored on a raised, well-ventilated platform at least several metres from the structure). This significantly reduces the likelihood of attracting termites and helps maintain an environment that is less favourable for timber pest activity.
