Building and Timber Pest Inspection Report

Inspection Date: Tue, 3 Feb 2026

Property Address: 5/9-11 Veron St, Fairfield East NSW 2165,
Australia

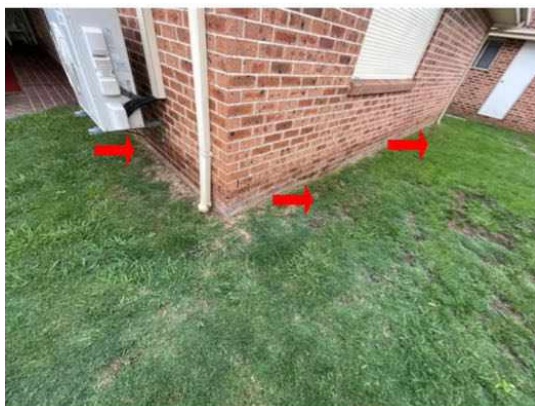
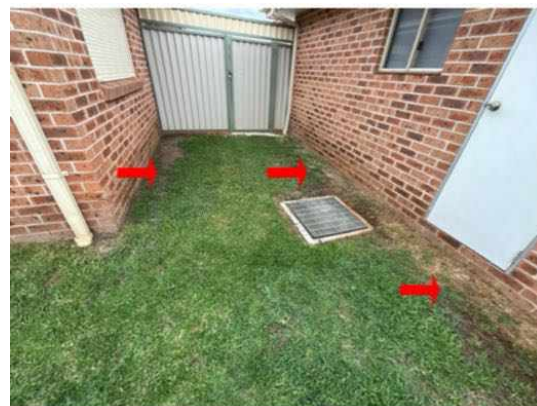
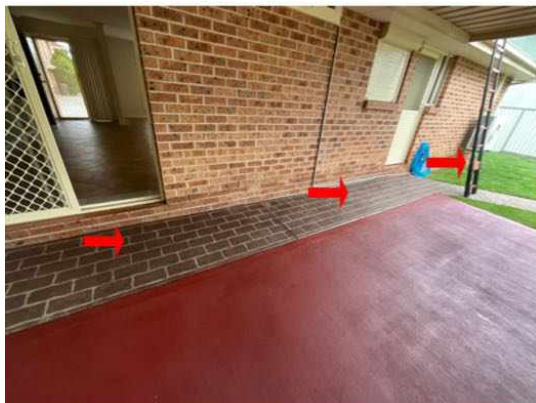
Building: Main Building
Location: Yard
Finding: Site drainage— Inadequate
Information: The site drainage in this area was found to be inadequate at the time of inspection, creating potential for subsequent water damage to associated building elements. This is additionally conducive to termite activity.

It is important that water does not lie against the base of walls; surrounding paths and ground levels should be sloped to drain water away from walls. Downpipes should not discharge stormwater onto lower walls or plinths. Stormwater should be carried away by large, regularly cleaned drains. Ground levels may need to be lowered to expose a buried DPC.

Where site drainage is inadequate, installation of an Agricultural (Aggie) Drain may be required. A licensed plumber should be appointed to further inspect the property and perform any remedial works as necessary. Water damage and secondary defects are likely to occur if left unmanaged.

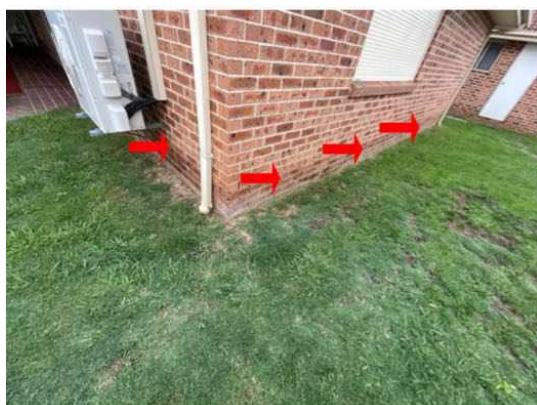
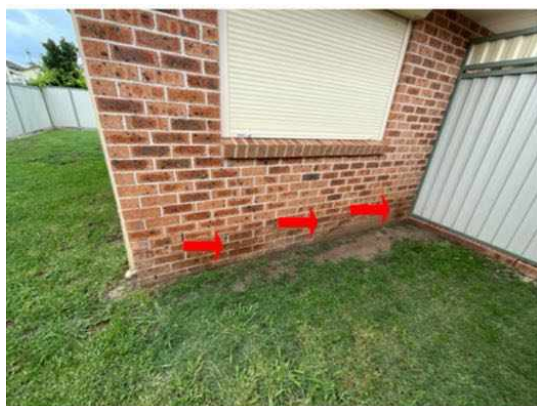
Finding 3.02

Building:	Main Building
Location:	Lower sections of external walls
Finding:	Brickwork and Mortar - Deteriorated (Erosion)
Information:	Lower sections of walls were found to be deteriorated. Mortar, or 'bedding', is the material which fills joints and intersections between bricks in masonry walls and structures.

Commonly referred to as corrosion or erosion, the bricks and mortar are aged and likely to have been affected by a variety of factors, including moisture, salt-based deterioration, and more.

Regular monitoring must be carried out as the conditions are currently not severe. A licensed plumber must be appointed urgent to ensure site drainage is addressed adequately.

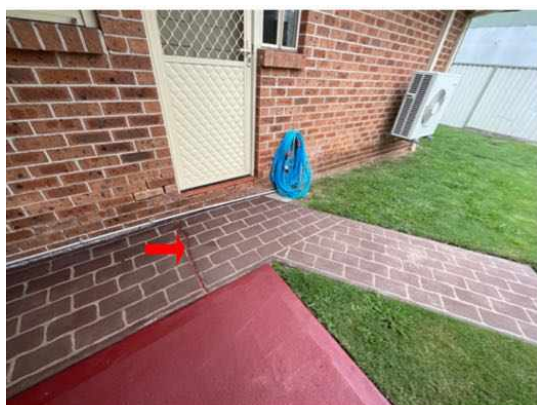
Finding 3.03

Building:	Main Building
Location:	Alfresco
Finding:	Cracking - External Concrete Paving Damage Category 3 - Wide Cracks (2mm - 4mm)
Information:	Wide cracks were identified in external concrete paving. Wide cracks are significant and are likely to lead to the development of safety hazards and secondary defects if left unmanaged.

General age and expected deterioration of the paved areas is a common cause of this type of cracking. However, expansion and contraction of the slab may also have occurred due to environmental factors. Such factors include variable moisture and weather conditions, the presence of trees and their roots having a settling or lifting affect on the soil, or the effect of load bearing, e.g. heavy vehicles over a sustained period of time.

Cracking to this degree may also be due to poor original installation of the concrete. Factors such as poor compaction of the sub surface and/or inadequate reinforcing of the slab may create cracking and other secondary defects. Wide cracks may also have a more significant structural cause, such as subsidence of soils.

Where the crack is located adjacent to structural elements of the building, the advice of a Structural Engineer is advisable before undertaking repairs.

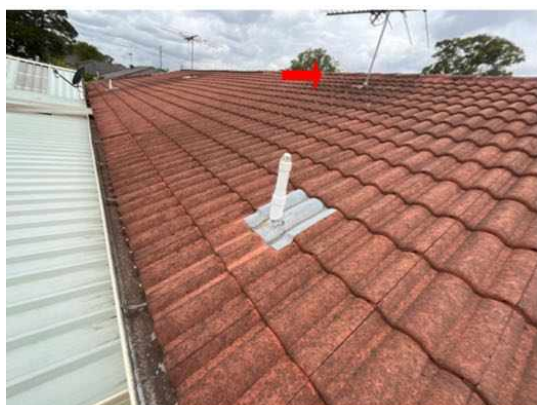
Finding 3.04

Building:	Main Building
Location:	Roof Exterior
Finding:	Roof tiles - Weathered
Information:	Upon inspection of the exterior roofing, the majority of roof tiles were considered to be in a fair condition. While weathering of the tiles is consistent with the age of the property, maintenance works are required.

Isolated areas of mortar have come loose and minor cracking is also present. Re-pointing and re-sealing the may be considered as an interim solution by the client to help preserve and extend the life span of the tiles.

Where left unmanaged, deteriorating roof tiles are likely to lead to a number of secondary defects, including minor water leaks and weather exposure to internal roofing structures.

Consultation with a licensed roofing contractor is highly advised to gain advice on cost of remedial works that may be required in the short to medium term. Remedial works are likely to increase the longevity of the exterior roofing structure.

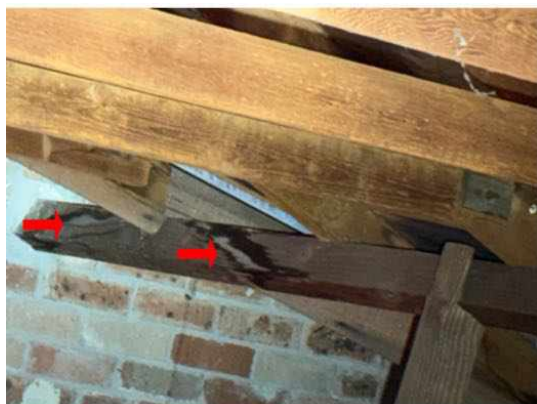
Finding 3.05

Building:	Main Building
Location:	Roof Void
Finding:	Water staining
Information:	Water staining was evident in this area at the time of inspection. Water staining indicates that surfaces have been exposed to excessive moisture over time. The minerals and other elements in the water lead to staining, which may graduate to corrosion and deterioration if left unmanaged.

While mostly an appearance defect, water staining can be indicative of more serious defects, which may be currently concealed by other building elements.

Where water staining is active, a licensed roof plumber must be consulted to identify the cause of the staining and to provide advice on any reparation works that may be required. Replacement of any broken or damaged structures is advised.

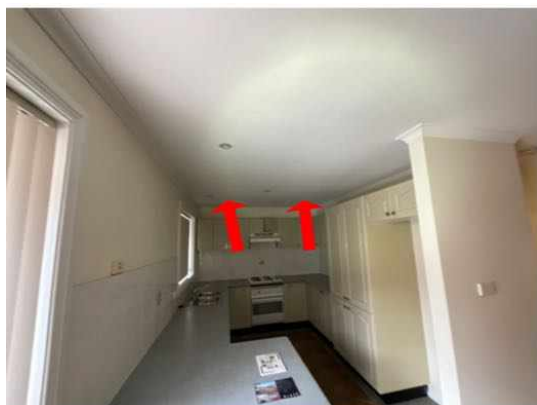
Finding 3.06

Information: Sections of the ceiling were found to be sagging at the time of inspection. Sagging to the fixed ceiling structure generally indicates that the building materials have swollen, due to contact with water, or that fixings (e.g. nails or glue) have become loose and require reattachment.

Where minor sagging is evident, comparatively minor works, such as re-gluing of ceiling sheets, may be required. Such works may be performed by relevant tradespeople, such as plasterers and painters. Where excessive moisture has caused the roofing structure to swell and sag, the source of the water leak should primarily be identified prior to any remedial works being performed.

The appropriate action should be taken by the client as soon as possible to ensure that any potential further damage is limited.

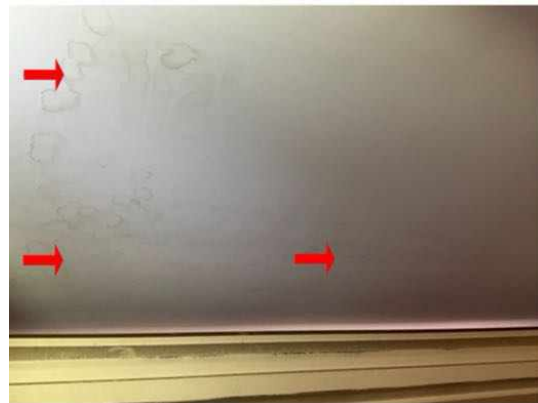
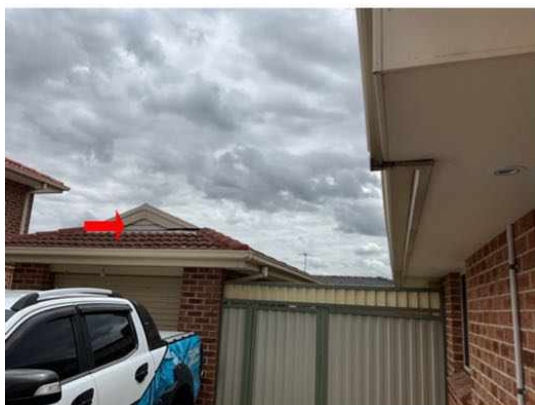
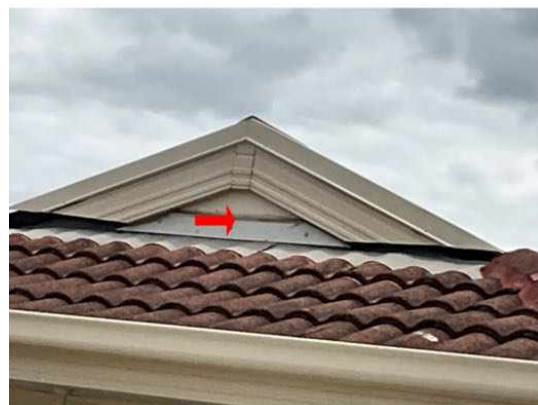
Finding 3.07

Finding: Water leak - Inactive

Information: Water leaks generally occur when a particular area of the property is not weather- or water-tight. Repair work was identified to the roof flashing above this point. While the damage in this area appears to be from an old inactive water leak, the area should be monitored frequently for the recurrence of any dampness.

Repair and / or replacement of previously affected building elements is at client discretion. Consider a further invasive inspection: removal of obstructions around the damaged area may reveal further damage which has been concealed. A more significant or major defect may be identified at this time.

Where recurrence of an active water leak is identified, a licensed roof plumber should be appointed immediately to rectify the leak and advise on any further preventative works as necessary.

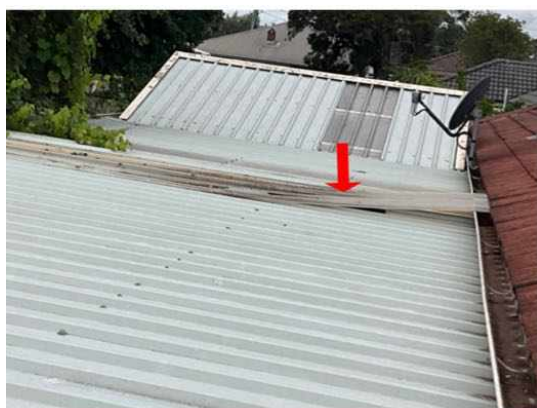
Finding 3.08

Works that have not been completed to a satisfactory level create potential for the development of building defects and may impede on the safety and integrity of the overall structure.

It is highly recommended that the relevant trades be appointed to complete these works and ensure the safety of the area and the longevity of all associated building elements.

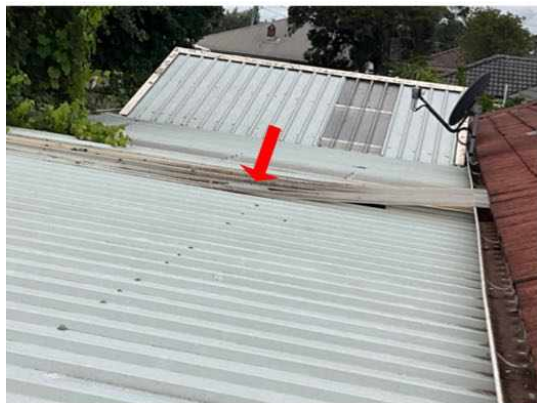
Finding 3.09

Building: Main Building
 Location: Alfresco
 Finding: Roof sheets - Water pooling
 Information: The roof drainage in sections of the exterior roof appears to be poor, evidenced by water pooling on the roof sheets. This is generally caused by either inadequate roof plumbing or roof structures not effectively draining due to the construction method.

Where water is pooling, rust and deterioration of the roof sheets is imminent if left unattended, which may necessitate major repair works.

Consultation with a roofing plumber is recommended as soon as possible to provide advice on rectification options. Additional works to rectify structural issues with the roof may also be required.

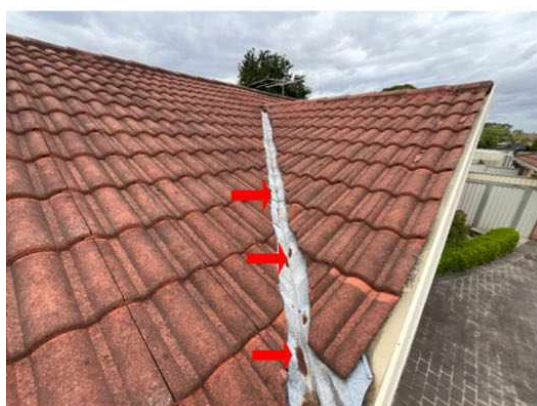
Finding 3.10

Building: Main Building
 Location: Front Elevation
 Finding: Valley - Rusted
 Information:

The valley on the roof were found with rust and corrosion. Rusted roof plumbing will generally develop holes and leaks that can affect other building elements with poor drainage of storm water. Poorly drained roof areas will also lead to damp conditions surrounding the base perimeter of the building which, if left unmanaged, can lead to a range of secondary building defects.

Repair and/or replacement of rusted roof plumbing is highly required in order to reinstate the roof drainage system to a fully operational level. To further maintain these areas, gutters should be cleaned frequently, allowing the avoidance of any partial blockages.

A licensed roofing specialist should be engaged for rectification as soon as possible.

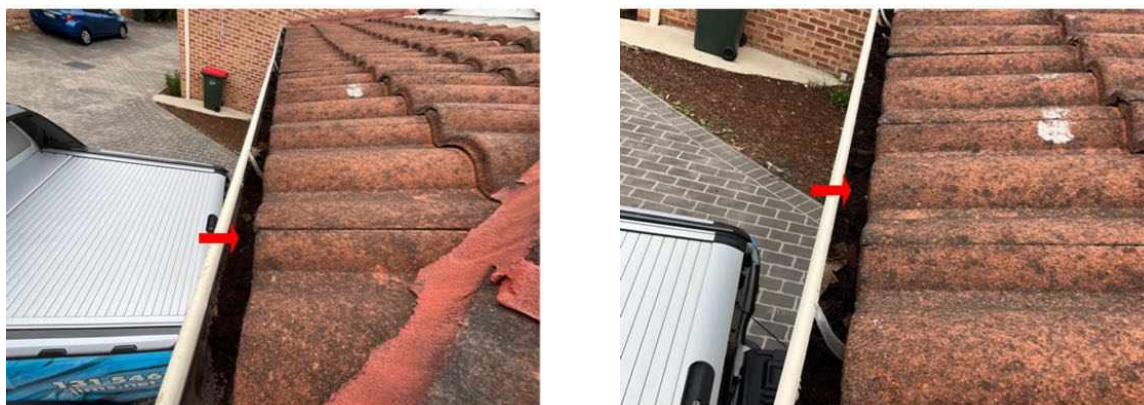
Finding 3.11

Building: Main Building
 Location: Garage >
 Finding: Gutters - Debris

Blocked gutters are likely to lead to high levels of moisture in the affected areas. Such moisture will not only cause rust and decay of the associated building materials, but can also provide conditions that are conducive to termite and timber pest activity. Blockages in gutters should therefore be removed immediately to ensure dry conditions are maintained.

Consult a Licensed Plumber for further specific advice on remedial works that may be required. In the interim, it is highly advised that blocked gutters be removed by the homeowner or a general handyperson as a matter of urgency.

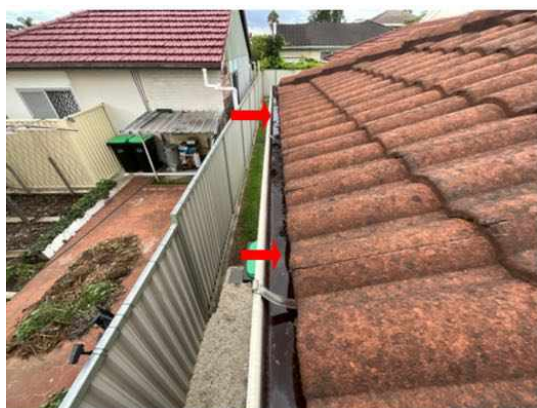
Finding 3.12

Building: Main Building
 Location: Garage
 Finding: Gutters - Water pooling
 Information: Water was found to be pooling in sections of the roof guttering. This is generally a secondary defect caused by blocked or partially blocked gutters. Furthermore inadequate fall to the adjacent downpipe could also be the underlying cause.

Water pooling is likely to lead to rust and water damage to associated structures if left unattended. This excess dampness is additionally conducive to termite activity.

Any areas of guttering that shows evidence of water pooling should be checked for partial or full blockages or otherwise appropriate fall to the downpipe must be applied accordingly. Any secondary damage that may have occurred as a result must be rectified. Depending on the extent of the damage, building elements may require repair and/or replacement to ensure adequate roof drainage and function of exterior

plumbing system.

A roofing plumber must be appointed as soon as possible if inadequate fall to downpipe is deemed to be the cause. It is highly advised that all gutters be maintained on a frequent basis to ensure the condition of roof plumbing.

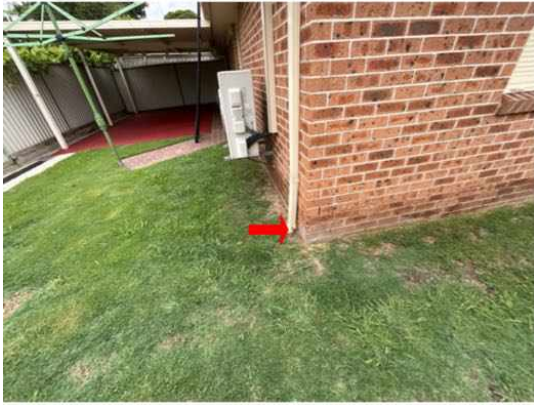
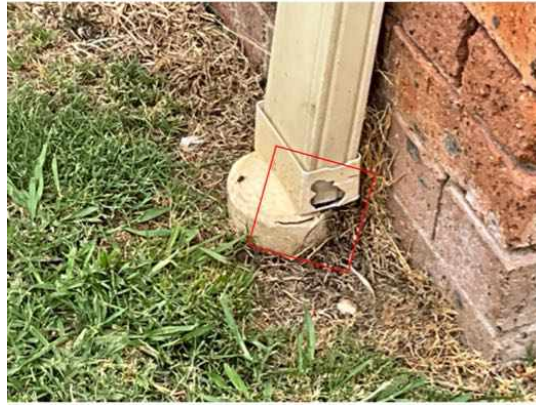
Finding 3.13

Building:	Main Building
Location:	Rear left corner
Finding:	Stormwater drain - Damaged
Information:	The roof plumbing is not adequately connected to stormwater drainage on the site. This disconnection negatively impacts the functional capacity of the roof plumbing.

Where roof plumbing doesn't drain adequately, the area at the base perimeter can become excessively damp, potentially creating an environment that is susceptible to rust and corrosion of surrounding building elements, as well as attracting termites and other pests.

It is highly recommended that a plumber be appointed to further inspect the area and to install adequate drainage equipment where necessary.

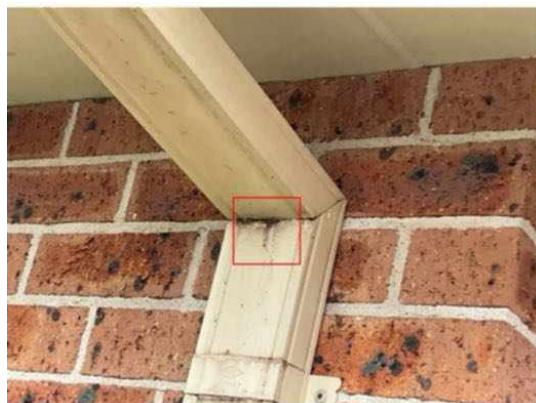
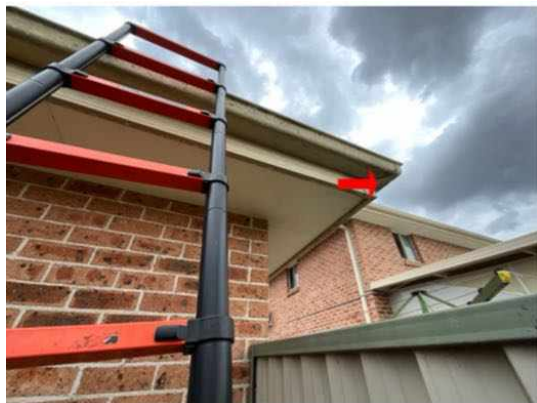
Finding 3.14

Building:	Main Building
Location:	Multiple areas
Finding:	Water leak - External
Information:	Water leaks were found to be present to exterior plumbing work. Leaks are generally caused by deterioration of the plumbing elements over time, due to exposure to weather conditions, but may have also been caused by minor impact damage.

Such leaking creates damp conditions in the affected area, causing potential for water pooling and subsequent water damage if left unattended. These conditions may also attract termite attack, particularly if the area is subject to minimal levels of sun throughout daylight hours.

It is highly advised that a licensed plumber be appointed to rectify any water leaks that may be present. Areas of repair and replacement of plumbing fittings and fixtures may be required and, as such, a quotation should be sought.

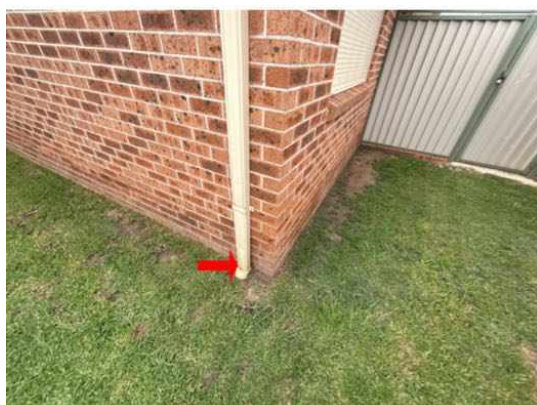
Finding 3.15

Building:	Main Building
Location:	Rear right corner
Finding:	Plumbing - Point of connection non-compliant
Information:	At the time of inspection it was noted that connections between above ground pipe work and below ground sewer/storm water systems were incomplete.

Additionally, where sewer pipes are concerned, gases can escape from unsealed connections which can pose a serious health risk.

Engagement of a certified plumber is strongly recommended to ensure all connection points are sealed in accordance with the plumbing construction guidelines.

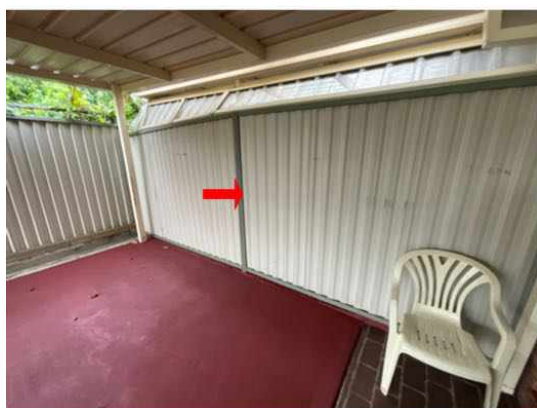
Finding 3.16

Building:	Main Building
Location:	Fencing
Finding:	Fencing - Deteriorated
Information:	It was noted at the time of inspection that sections of the fencing in this area has

deteriorated. Typically fencing deteriorates due to age and or wear, rot and or rust which is generally expected for a structure of this age, due to prolonged exposure to weather conditions. Sometimes inadequate installation or maintenance can be to blame.

If left unattended, it is likely that further damage will occur. It is suspected that repair of several elements of the fencing may be required however replacement may be a consideration of the client also.

A licensed fencing contractor should be appointed to provide further advice and perform rectification works as necessary.

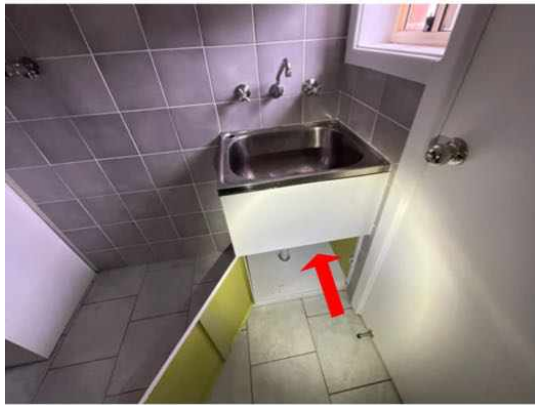
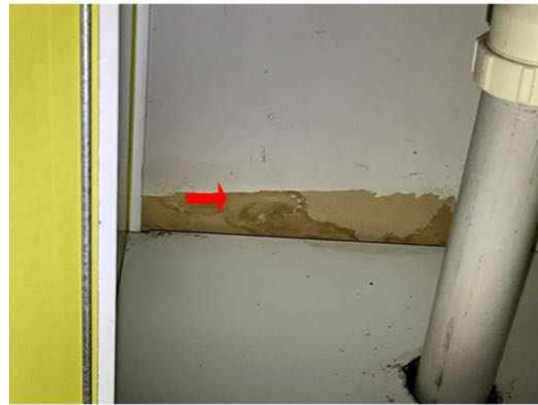
Finding 3.17

Building:	Main Building
Location:	Laundry
Finding:	Walls - Water stained
Information:	Water staining to sections of the walls in this area was evident at the time of inspection. Water staining indicates that surfaces have been exposed to excessive moisture over time. The minerals and other elements in the water lead to staining, which may graduate to corrosion and deterioration if left unmanaged.

While mostly an appearance defect, water staining can be indicative of more serious defects, which may be currently concealed by wall linings.

Where water staining is active, a licensed plumber must be consulted to identify the cause of the staining and to provide advice on any reparation works that may be required. Replacement of any broken or damaged structures is advised.

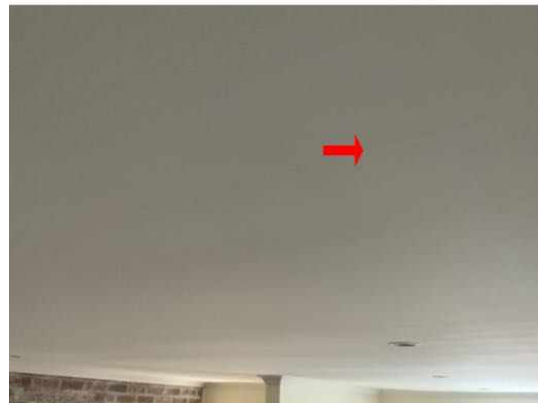
Finding 3.18

Building:	Main Building
Location:	Lounge Room
Finding:	Cracking - Damage Category 0 - Hairline (less than 1mm)
Information:	Hairline cracks are very minor in nature and generally are only ever an appearance defect. While such cracking may be noticeable in some cases, it is quite common and does not indicate any structural damage.

Cracking of this nature can generally be repaired with minor sanding, filling and/or repainting. Such works should be performed by a qualified painter or a general handyman.

Monitoring of all cracking should be conducted frequently. Always contact a building inspector should cracks widen, lengthen, or become more numerous.

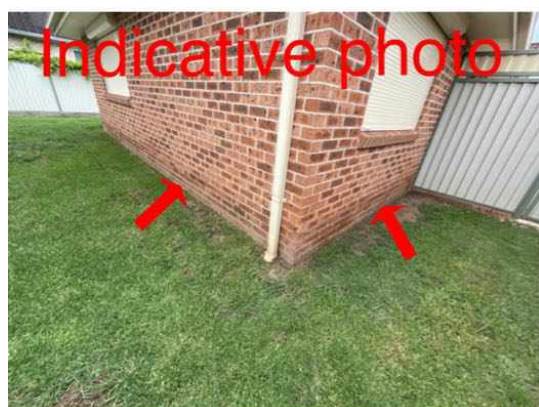
Building:	Main Building
Location:	
Finding:	Termite Management System - no evidence of installation
Information:	The application of a post-construction chemical termite barrier is highly recommended for all properties, particularly if live termite activity has been found on the site previously. Such barriers are highly effective in preventing termite attack on any timber building elements throughout the property.

The client may consider gaining further advice from a pest controller as to the costs and procedures involved with this application. It is recommended that obtaining such advice be a short-term priority.

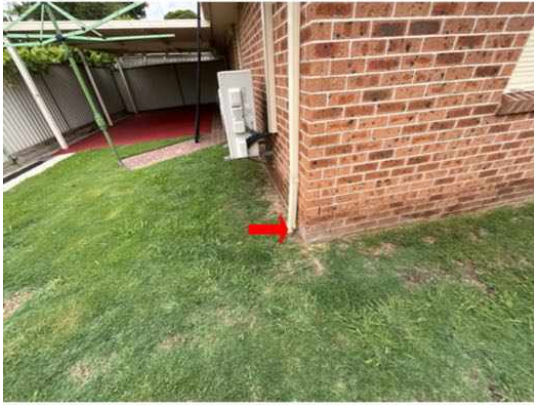
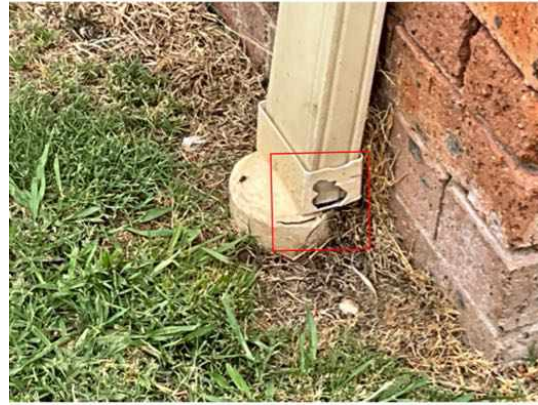
Building:	Main Building
Location:	Rear left corner
Finding:	Stormwater drain - Damaged
Information:	The roof plumbing is not adequately connected to stormwater drainage on the site. This disconnection negatively impacts the functional capacity of the roof plumbing.

Where roof plumbing doesn't drain adequately, the area at the base perimeter can become excessively damp, potentially creating an environment that is susceptible to rust and corrosion of surrounding building elements, as well as attracting termites and other pests.

It is highly recommended that a plumber be appointed to further inspect the area and to install adequate drainage equipment where necessary.

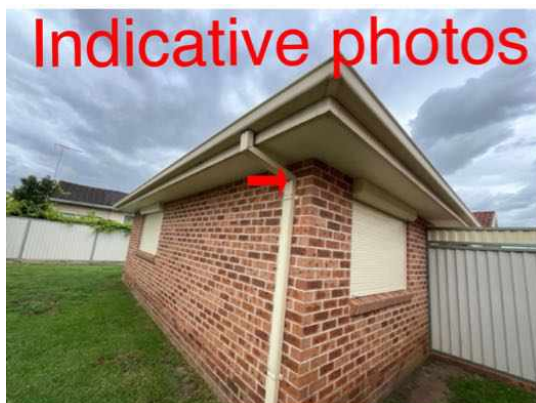
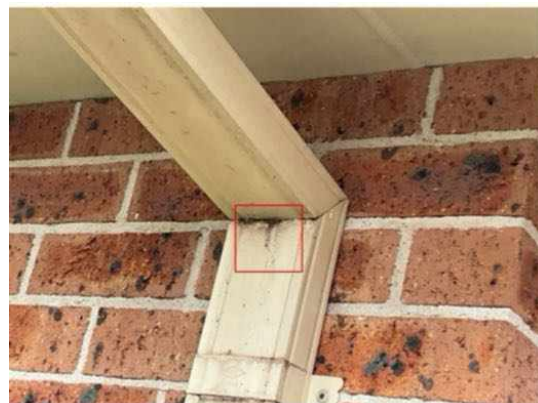
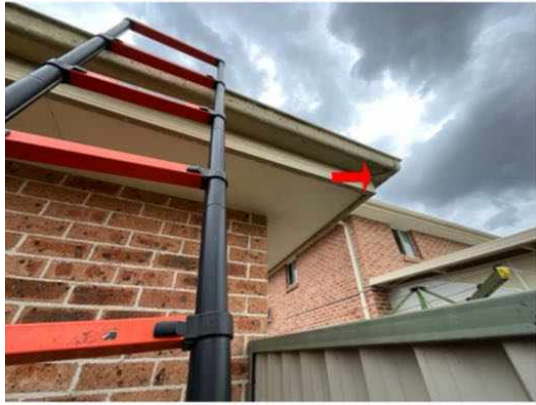
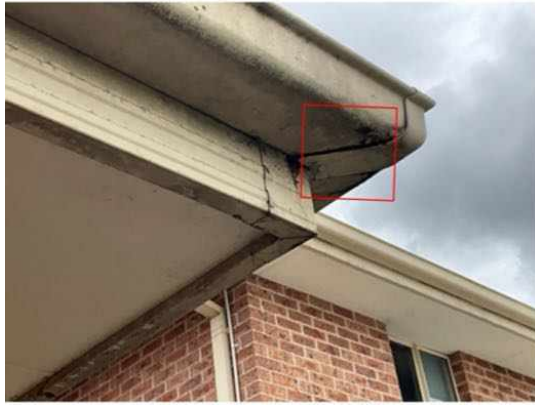
Finding 6.06

Building:	Main Building
Location:	Multiple areas
Finding:	Water leak - External
Information:	Water leaks were found to be present to exterior plumbing work. Leaks are generally caused by deterioration of the plumbing elements over time, due to exposure to weather conditions, but may have also been caused by minor impact damage.

Such leaking creates damp conditions in the affected area, causing potential for water pooling and subsequent water damage if left unattended. These conditions may also attract termite attack, particularly if the area is subject to minimal levels of sun throughout daylight hours.

It is highly advised that a licensed plumber be appointed to rectify any water leaks that may be present. Areas of repair and replacement of plumbing fittings and fixtures may be required and, as such, a quotation should be sought.

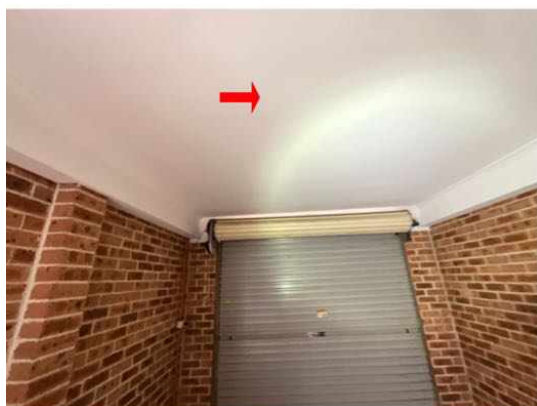
Building: Main Building
 Location: Garage
 Finding: Roof void - Access not possible
 Information:

It is highly advised a licensed carpenter be appointed immediately to install an appropriate access panel for maintenance purposes.
