Building and Timber Pest Inspection Report

Inspection Date: Tue, 27 Jan 2026

Property Address: 20 Forman Ave, Glenwood NSW 2768,
Australia

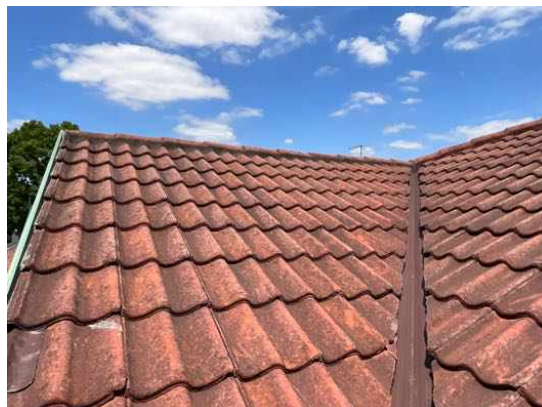
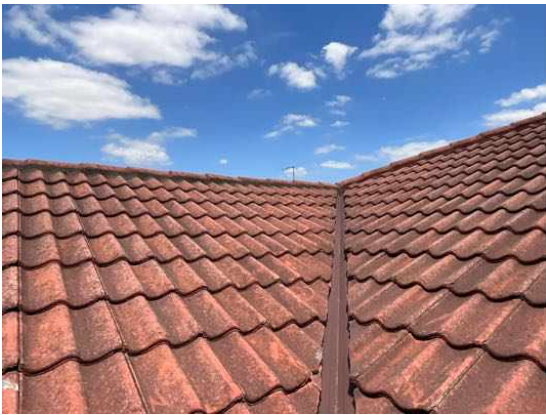
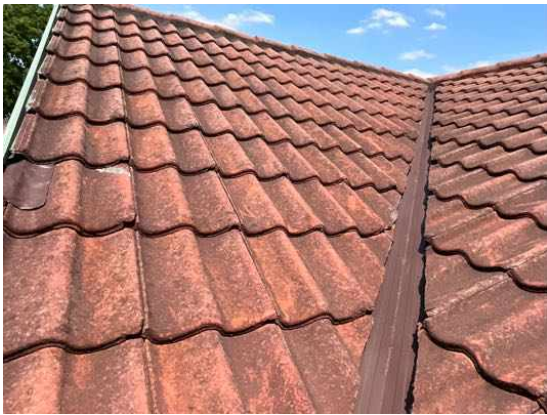
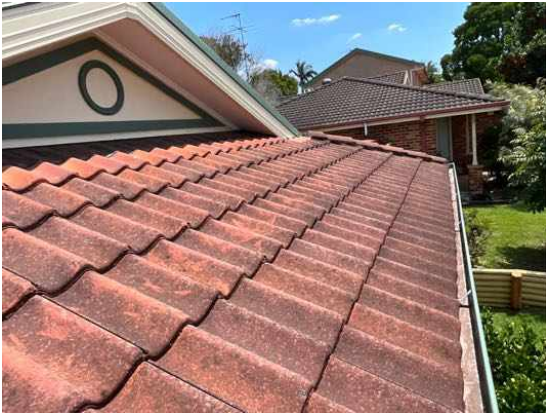
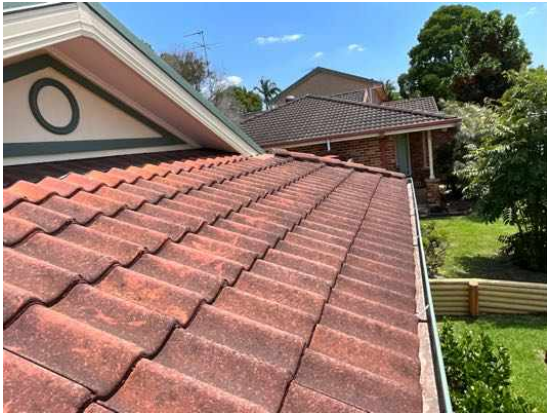
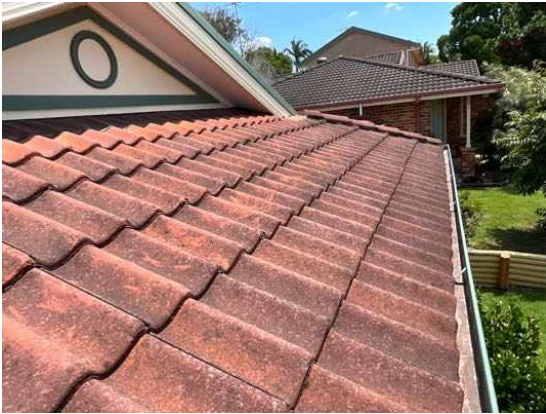
Information: Inspection of the roof revealed widespread weathering to the tiled roof surface. The tiles show loss of surface finish, colour fading, and age-related deterioration typical of older roof coverings. Although no significant cracking was noted, weathering can lead to increased porosity, reduced water-shedding capability, and a higher risk of future cracking or displacement during adverse weather conditions.

A licensed roofer should be engaged to undertake a closer inspection, carry out routine maintenance, and replace any tiles that may be compromised. Ongoing monitoring is recommended due to the age and condition of the roof covering.

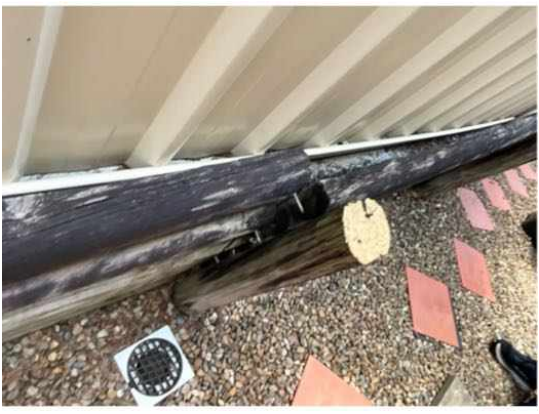
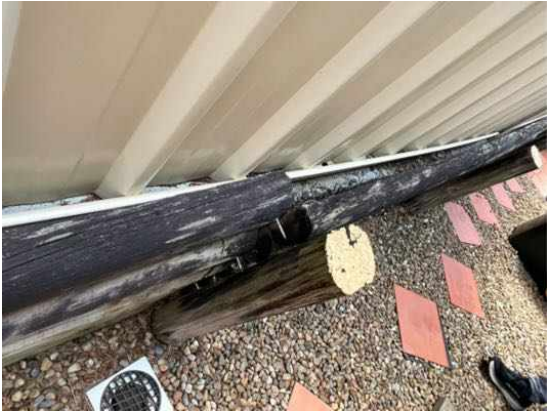
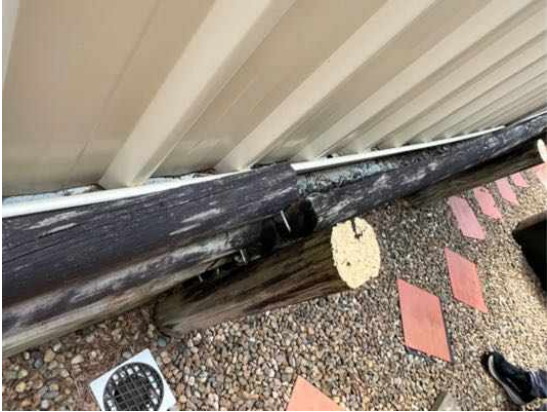
Finding: Retaining wall - Defective

Information: The retaining wall in this area was found to be defective at the time of inspection. Generally, defective retaining walls are caused by poor original design or material use. However, deteriorated retaining walls may also be a result of substandard construction, poor site drainage or unmanaged stormwater flows.

If left unmanaged, the retaining wall may become a safety hazard if it continues to destabilise. Where retaining walls further rot and decay, an environment is created that is conducive to termite and pest infestation.

Significant repair and replacement should be expected. Where retaining walls are considered structural walls, a structural engineer / surveyor should be consulted regarding required remedial works. Otherwise, a landscaper or retaining wall installer may be appointed to repair or replace the wall, at the discretion of the client.

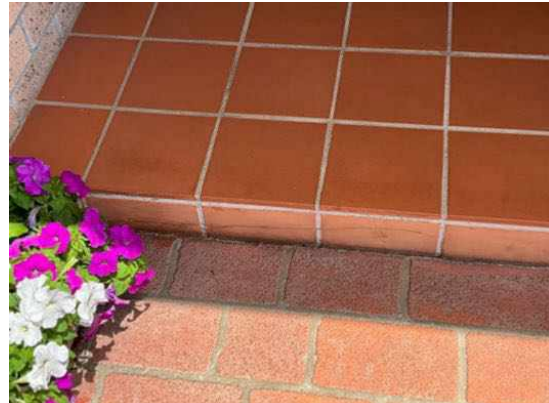
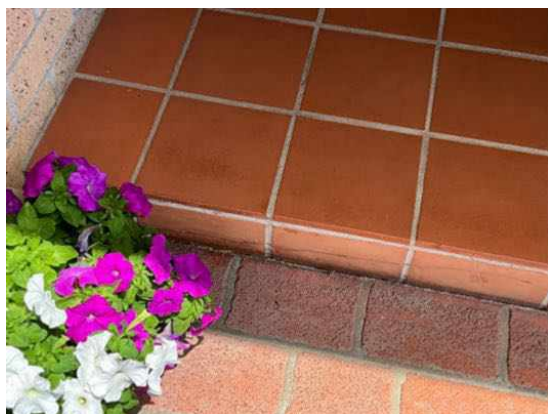
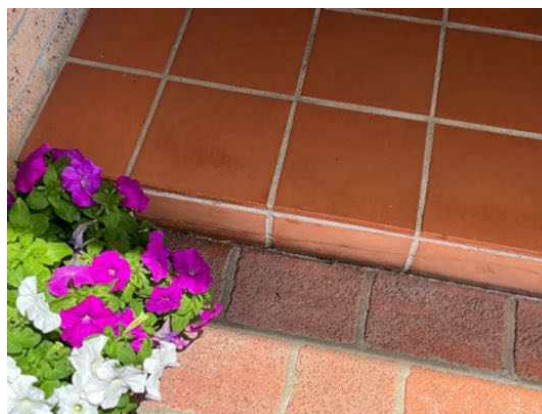
Building: Main Building
 Location: Front porch
 Finding: Floor Tile crack
 Information: A floor tile has a visible crack on the surface.

The damaged tile presents a trip hazard, may lead to cuts if stepped on barefoot, and can allow moisture ingress into the substrate, which may cause further deterioration or loosening of adjacent tiles. It also affects the overall appearance of the floor.

A licensed tiler should be engaged to remove the damaged tile and install a matching replacement. If spare tiles are unavailable, additional remedial work may be required to blend the repair with surrounding finishes.

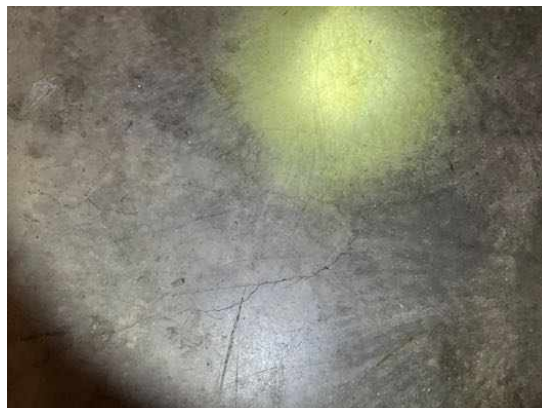
Finding 3.06

Building: Main Building
 Location: Garage
 Finding: Crack in concrete slab - Category 0
 Information: A crack coded as Category 0 was identified in the slab. A Category 0 crack is described as a hairline crack, representing insignificant movement of slab from level.

The approximate width of the crack to be considered Category 0 is 0.3mm, or change in offset of less than 8mm when a 3m straight edge is placed over the defect.

No rectification is required at this time. However, all cracking should be monitored over a 12 month period to identify any further damage in the area.

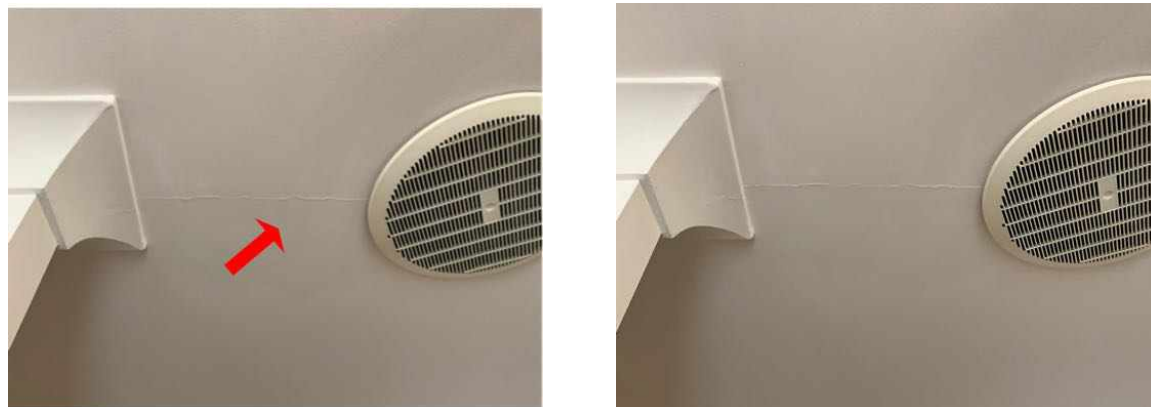
Finding 3.07

Building: Main Building
 Location: Ensuite
 Finding: Ceilings gyprock - Crack (Fine)
 Information: Fine cracks have appeared in the gyprock of the ceiling, suggesting potential issues with settling or structural movement.

The fine cracks in the gyprock ceiling pose a risk of further widening, compromising the aesthetic appeal of the space, and potentially indicating underlying structural

problems.

A skilled plasterer or a contractor specializing in drywall repairs should assess the extent of the cracks and address them promptly. Identifying and fixing the root cause of the issue, whether related to settling or structural concerns, is essential to prevent further damage and maintain the integrity of the ceiling.

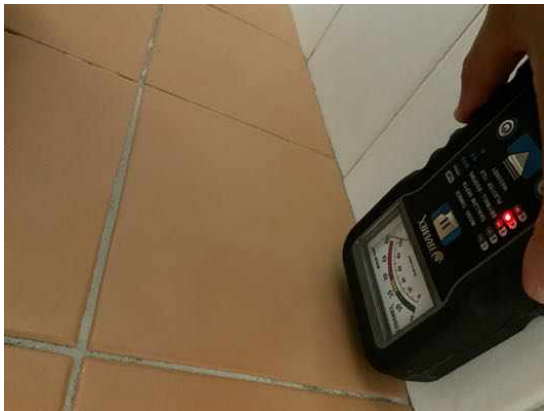
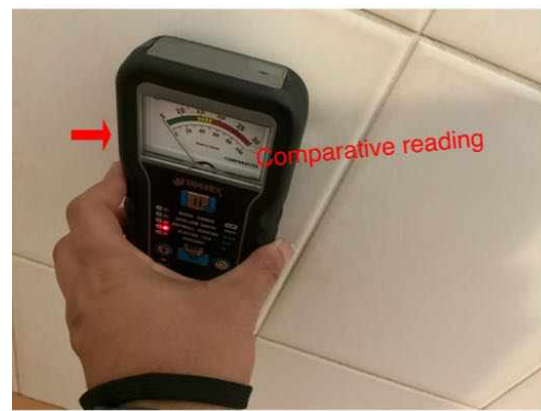
Finding 3.08

Information: Damp is evident to the lower 300mm of wall to the shower alcove. This defect is quite common, and is suspected to have been caused by moisture permeating through the grouting in this area, which shows evidence of deterioration. Leaking pipes within the adjoining wall is also a possible cause.

Damp (or structural damp) refers to the presence of unwanted moisture in the structure of a building, either as the result of intrusion from outside, or condensation from within the structure. In the shower area, internal water leaks or other sources of excessive moisture are generally the cause of damp.

Unmanaged damp in the shower recess is likely to facilitate the formation and development of mould and fungi growth, decaying associated building materials and compromising their structural integrity. It is important to address damp conditions, as the World Health Organisation notes that excess moisture leads - on almost all indoor materials - to growth of microbes such as moulds, fungi and bacteria, which subsequently emit spores and other matter into the indoor air. Exposure to these contaminants is associated with a wide range of respiratory and other health-related problems.

Consultation with a qualified plumber or bathroom specialist is advised immediately to identify the cause of damp and to perform remedial works as required. Where excessive mould growth is present, further inspection by a specialist environmental health inspector should also be considered.

Always ensure that sealant and grout is in good condition to prevent any moisture issues occurring in the future.

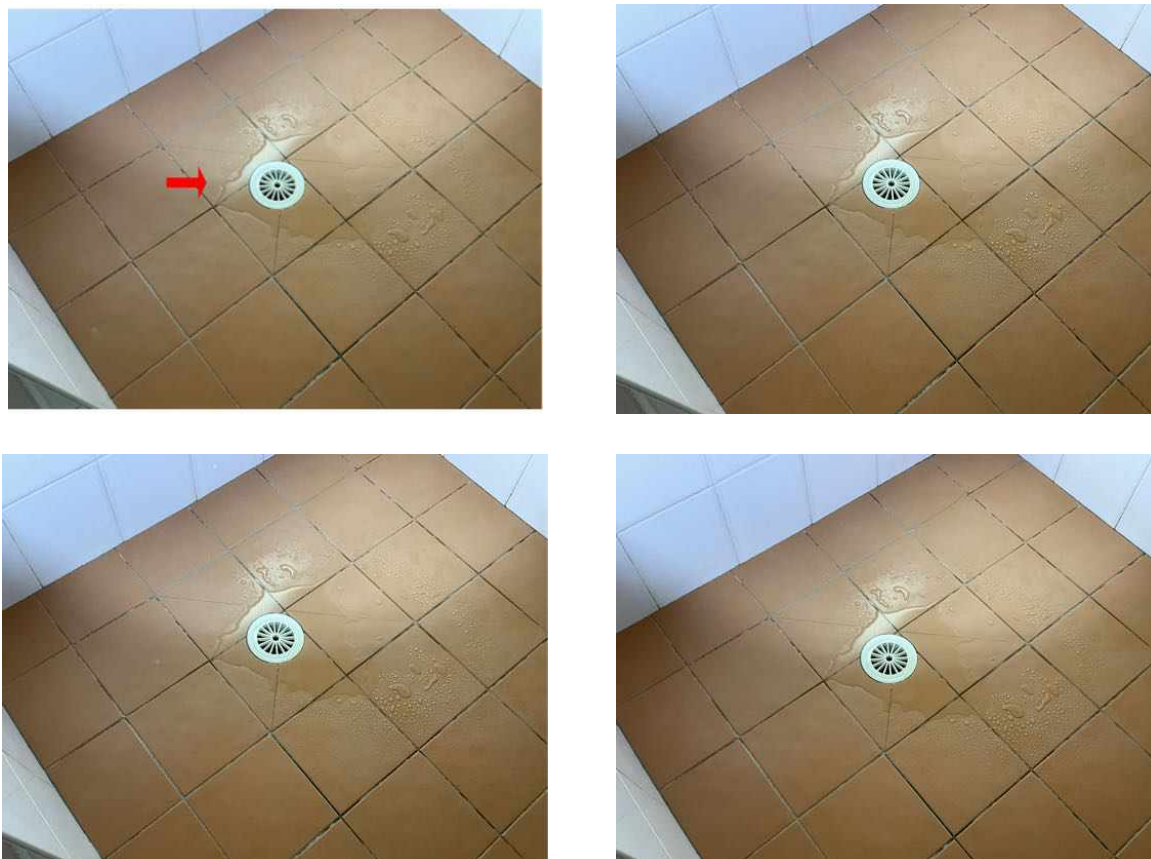
Finding 3.09

Building:	Main Building
Location:	Ensuite
Finding:	Shower base - Water pooling
Information:	Evidence of water pooling around the floor waste in the shower recess was noticed at the time of inspection. It is suspected that this excessive moisture is attributed to insufficient fall in the shower floor tiles.

This pooling is minor overall but is still considered unsatisfactory, as standard tiling practices would not permit this situation to occur. Pooling water around floor wastes can create a slip hazard in extreme cases and create conditions that are conducive to mould growth over time. Where left unmanaged, the degradation of sealant and grouting is also likely to occur, possibly necessitating further repair works.

Remedial works may involve some sections of tiling and flooring repair and replacement. A tiling contractor or bathroom specialist should be appointed to provide further advice on reparation options and to perform works as necessary.

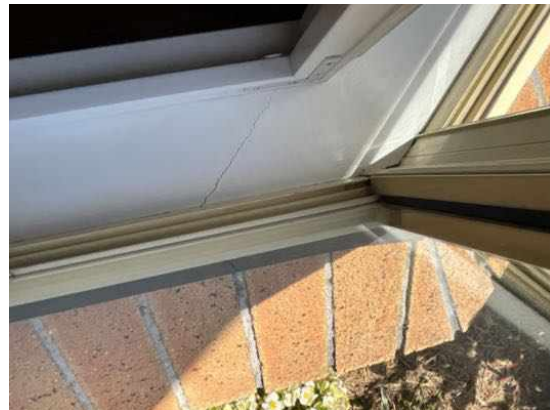
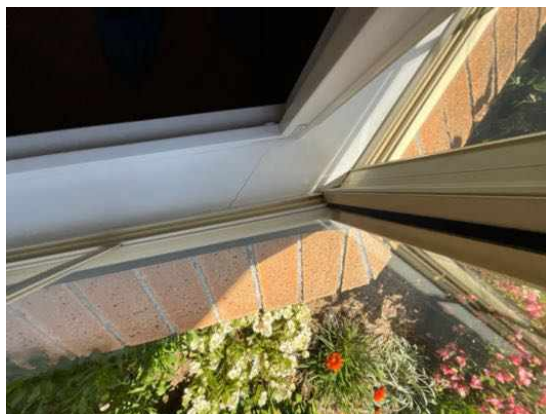
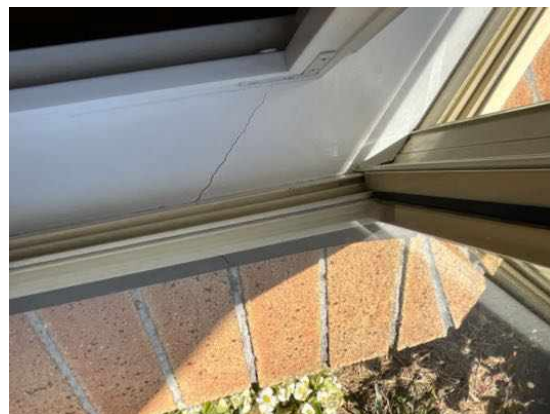
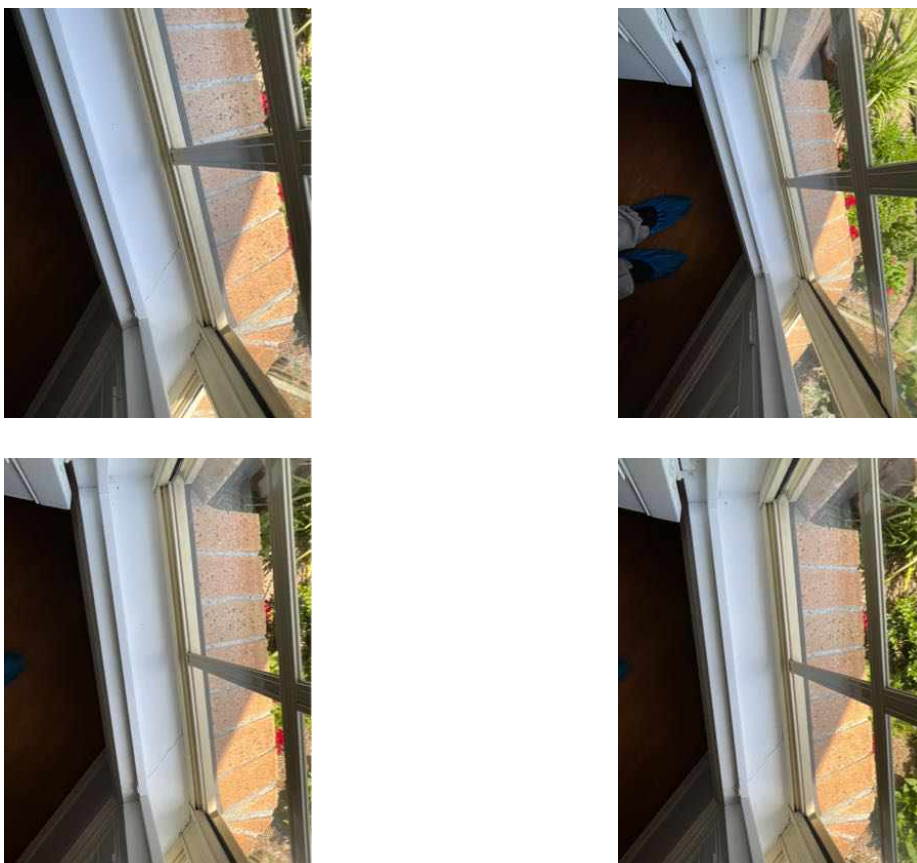
Finding 3.10

Building: Main Building
 Location: Living Room
 Finding: Window Frame Crack
 Information: A crack near a window frame,. This crack may indicate movement or settling in the structure, poor finishing work, or thermal expansion.

- Structural Movement: If the crack is caused by structural movement, it could worsen over time, leading to more significant structural issues.
- Water Ingress: Cracks around window frames can allow moisture to seep into the

wall cavity, potentially leading to water damage, mold growth, or decay.

- Aesthetic Concerns: The crack detracts from the aesthetic appearance of the wall and may worsen without proper repair.

- Builder or Structural Engineer: If there is concern about structural movement, a structural engineer should assess the crack to determine the cause and ensure the stability of the area.
- Handyman or Painter: If the crack is minor and not related to structural movement, a handyman or painter can fill and repair the crack, followed by repainting to restore the wall's appearance.
- Window Installer: If the crack is related to improper window installation, a window installer may need to inspect and adjust or replace the window.

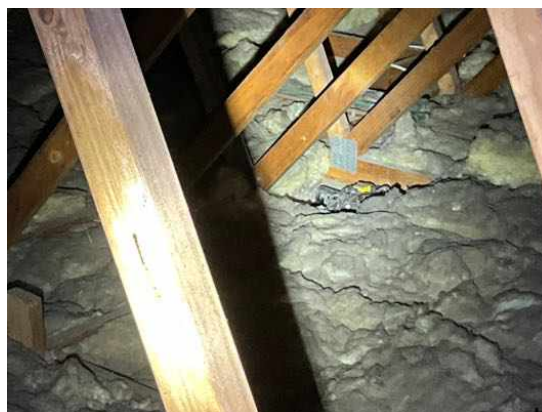
Finding 3.11

Building: Main Building
 Location: Roof Void
 Finding: Exhaust fan not vented out
 Information: The exhaust fan located within the roof void is not appropriately ducted to the external atmosphere and is currently discharging moist air directly into the roof space. This is considered a defect under AS 4349.1, as it does not meet the minimum standard of residential building performance expected under normal residential building practices.

This condition may lead to excessive condensation within the roof void, increasing the risk of mould growth, deterioration of insulation, timber decay, and overall reduced durability of building elements. It may also result in poor indoor air quality, potentially affecting occupant health.

It is recommended that the exhaust fan be modified by a licensed HVAC contractor or qualified builder, ensuring it is properly ducted to discharge externally in accordance with manufacturer specifications, the National Construction Code (NCC), and applicable Australian Standards.

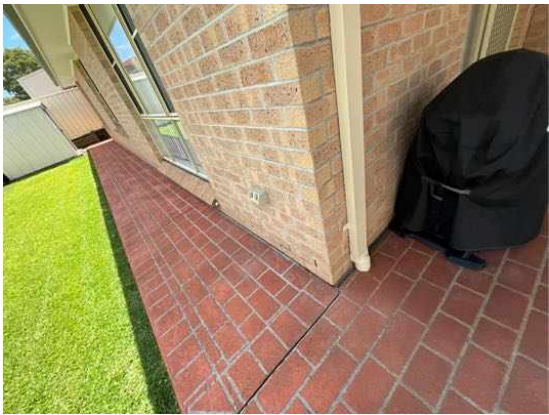
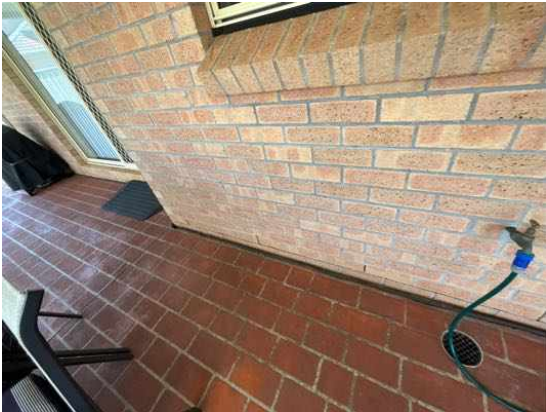
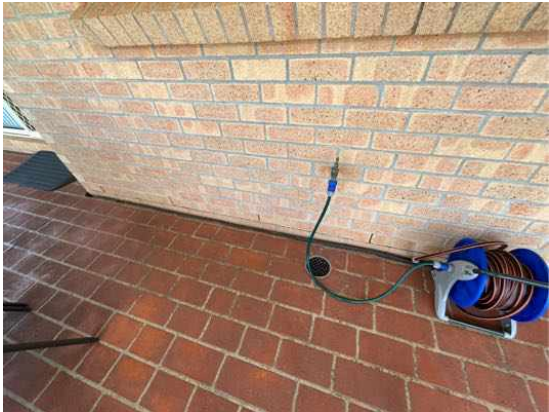
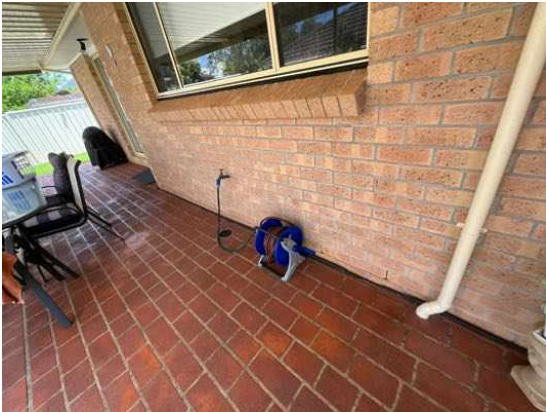
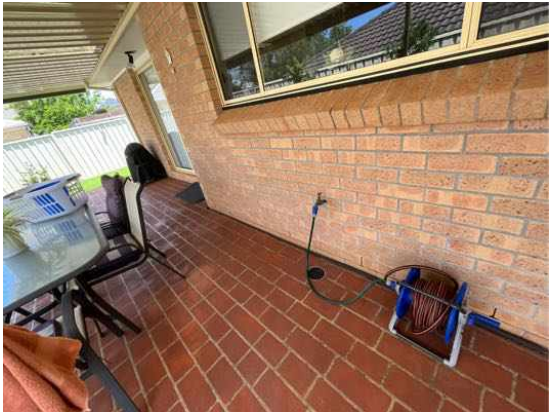
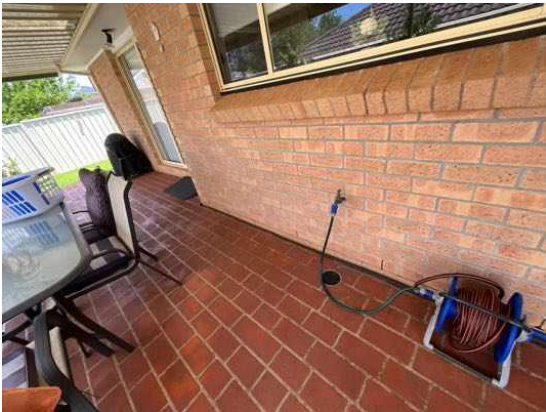
If the slab edge is not properly exposed there is a high risk of termite attack. Sometimes, in order to determine the type of slab, a suitably qualified person such as an architect or builder may be required to consult the construction plans.

Where the slab edge cannot be properly inspected, it is highly recommended that termite or timber pest inspections be carried out every 6-12 months to aid protection of the property against infestation.

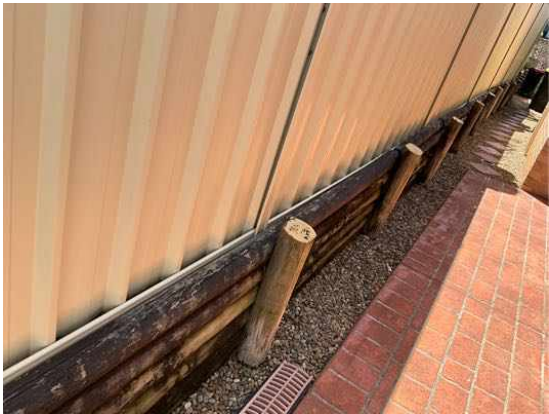
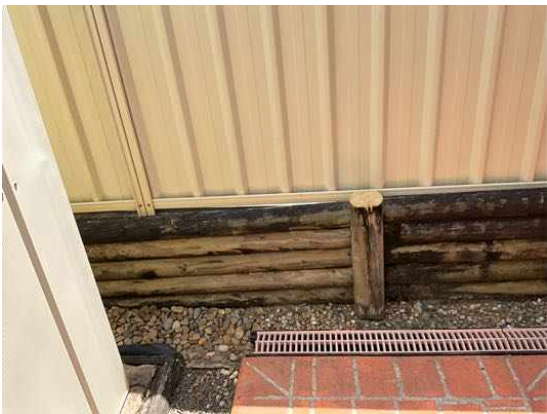
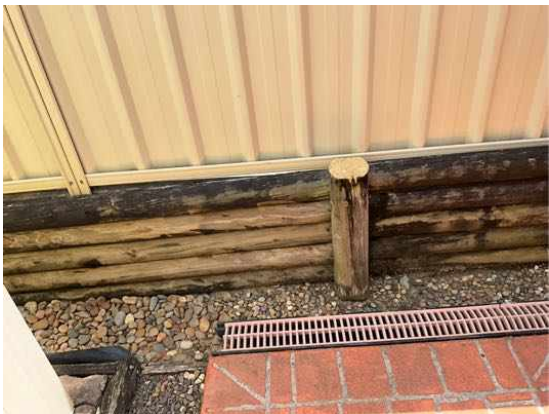
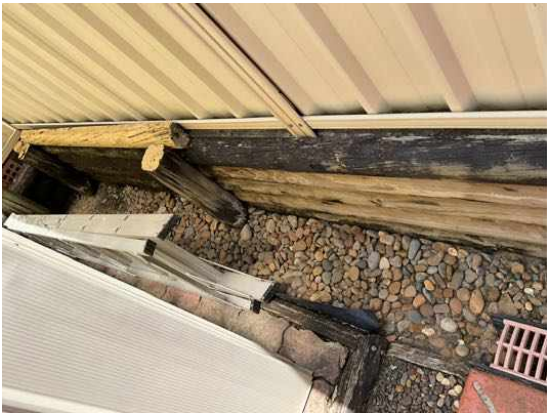
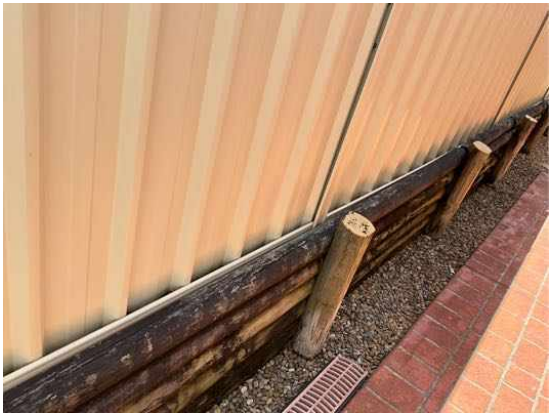
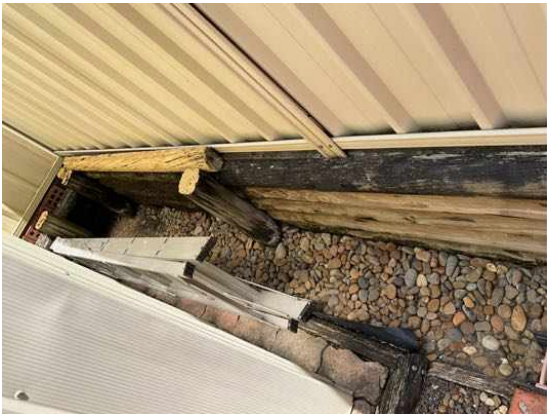
Finding 6.02

Building:	Main Building
Location:	All Areas
Finding:	Timber on ground / conducive conditions to termite damage
Information:	Timber on the ground is indeed conducive to termite damage. Termites are known to thrive in moist environments, and wood in contact with soil or moisture is more susceptible to infestation.

To prevent this, it's important to keep timber elevated and away from direct ground contact. Regular inspections and proper termite control measures are also essential to protect your wooden structures from termite damage.

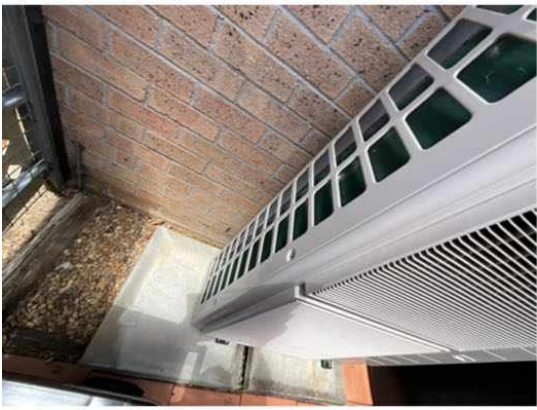
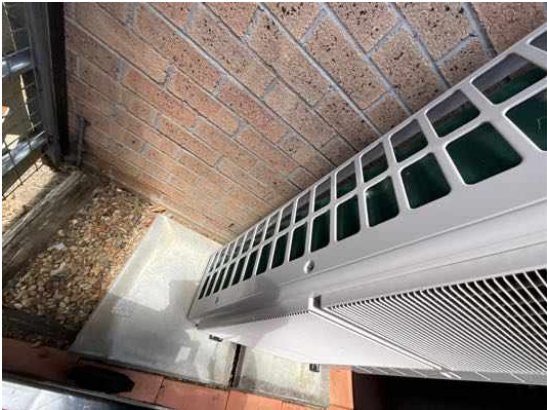
Where bridging has occurred full inspection is prevented and termites may enter a property in a concealed or undetected manner.

Recommended moving obstructions away from the external walls for further and future inspections.

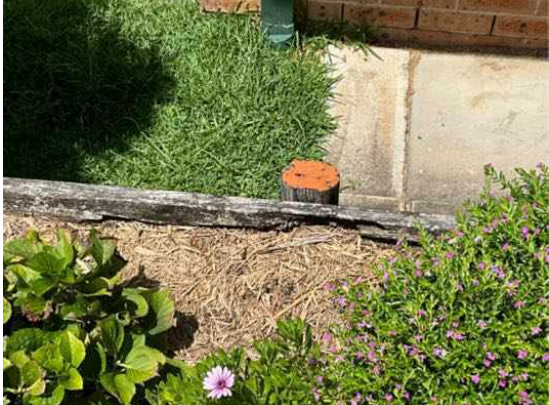
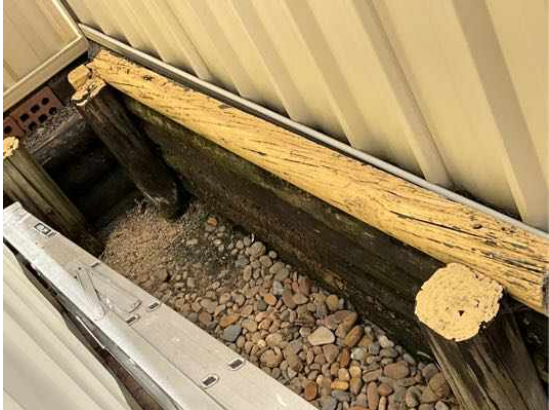
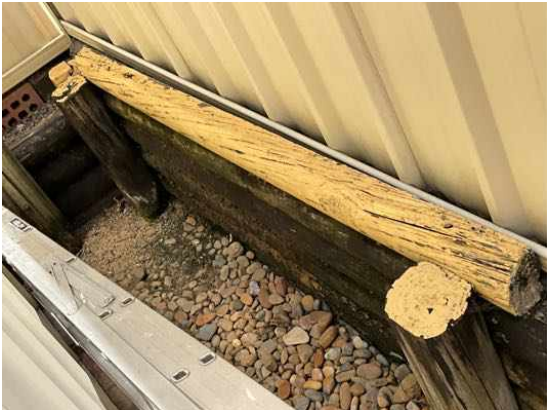
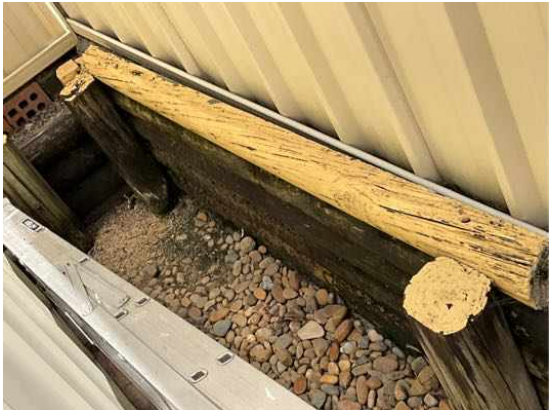
Finding: Wood rot

Information: This building element shows evidence of wood rot. Wood rot, also known as Fungal Decay, occurs when timbers and other cellulose building materials are exposed to damp conditions on an ongoing basis. This could be the result of exposure to weathering over a prolonged period of time, or the attraction of excessive moisture from other abutting building materials. Contributing factors also include poor air ventilation in the area.

Wood rot is often associated with general damp problems and is evidenced by a 'musty' smell or mould and mildew occurring on surfaces. If left unmanaged, damp conditions can lead to further health problems and the decay of timbers will continue.

Early intervention and regular maintenance, particularly of exterior timbers, will prolong the useful life of these building elements. Prior to any works being performed, the cause of the moisture that has created the visible wood rot should be identified and addressed in a suitable manner. Replacement of affected timbers may then be a necessary step in protecting surrounding building elements from such deterioration.

A qualified plumber may be appointed to assess the cause of excessive moisture and to provide advice on any remedial works as required. A qualified carpenter or registered builder may also be required to replace affected building materials.
