Building Inspection Report

Inspection Date: Wed, 11 Feb 2026

Property Address: 310/8 Aviators Way, Penrith NSW 2750

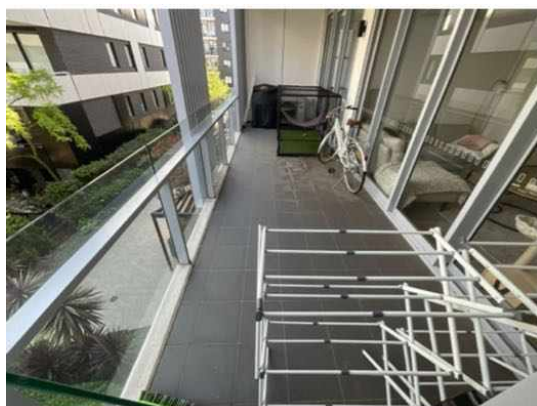
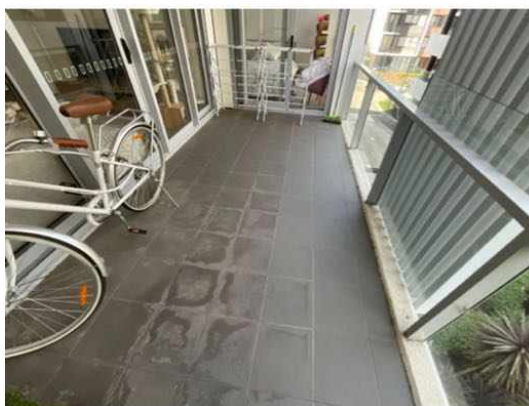
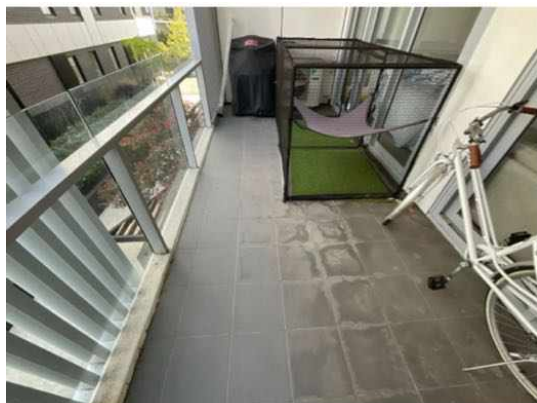
Building: Main Building
Location: Balcony
Finding: Observation – Balcony Drainage
Information: During the inspection, the floor drainage to the enclosed balcony area was assessed and no floor waste was found. The balcony is fully enclosed, effectively creating a vessel-like space in which water cannot freely escape. No primary floor waste was visible to facilitate effective water removal. It is possible that stored items, mats etc. may be concealing the floor waste, and further investigation is advised to confirm whether one exists.

Additionally, no overflow or alternative drainage provisions were observed along the external balustrade. In the absence of adequate drainage, water may accumulate and pool on the balcony floor. This can present a slip hazard and due to current floor level differences, may also increase the risk of moisture ingress into adjoining internal living areas.

Effective drainage is critical to preventing water buildup, protecting structural elements, and maintaining the long-term integrity of internal finishes.

- Floor waste may be covered by mats, recommend further investigation to confirm appropriate drainage to the balcony area in accordance with relevant building codes and waterproofing standards.
- At the client's discretion, this matter may be referred to the Owners Corporation should issues arise, as balcony drainage design and performance may fall under strata responsibility depending on the registered strata plan.

Ensuring compliant and functional balcony drainage will assist in mitigating future water-related defects and maintaining the property's overall condition.

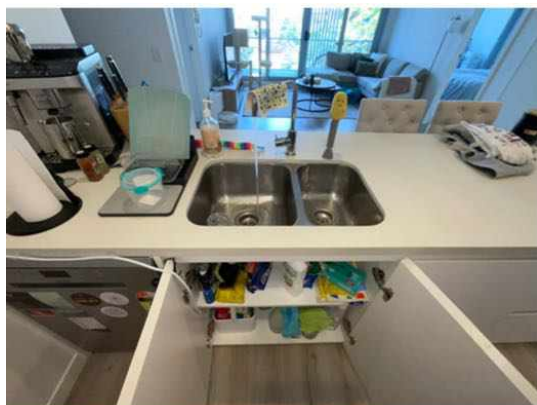
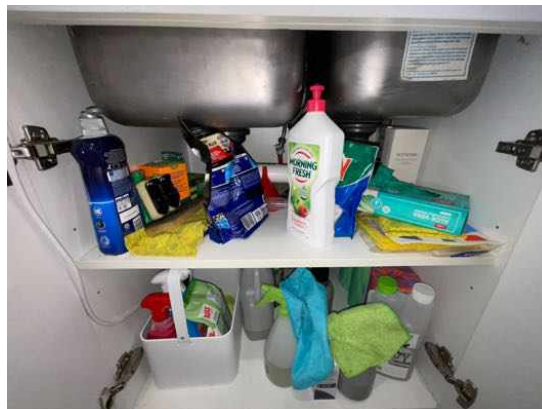
Building: Main Building
 Location: Kitchen
 Finding: Kitchen Sink – Overall Condition & Recommendations.
 Information: Observations:

- The kitchen sink tap(s) were water tested at the time of inspection, with no evidence of leaks or blockages observed in the visible plumbing or drainage.
- No significant water damage was observed to the cabinetry/unit
- Stored items under the sink obstructed access, limiting a full inspection of the plumbing and internal cabinetry.

- Further monitoring and testing are recommended once the tap(s) are in constant use, to identify any drainage issues or signs of slow leaks not evident during the limited inspection.
- It is recommended that the stored items beneath the sink be removed to allow for a full re-inspection of the plumbing and cabinetry, ensuring no concealed defects are

present.

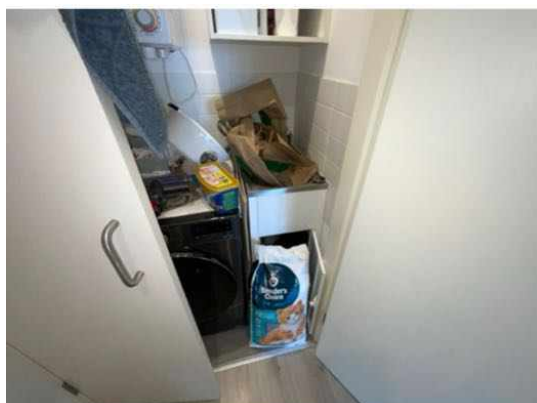
Building: Main Building
 Location: Laundry
 Finding: LaundryTub - Obstructions and Limitations.
 Information: Photographic Evidence – Obstructions & Limitations

The following photographs illustrate obstructions and limitations that impeded a full inspection of certain areas of the property at the time of assessment.

These obstructions—such as stored items, fixed structures, or restricted access areas—may conceal defects, including issues with tap fittings, plumbing, or drainage systems.

It is strongly advised that these obstructions be removed to enable a complete inspection of the affected areas. Once access is granted, a re-inspection—particularly of tap fittings and drainage components—is recommended to ensure no concealed defects or leaks are present.

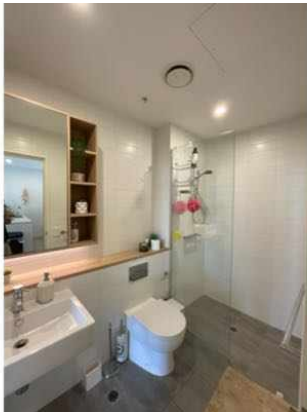
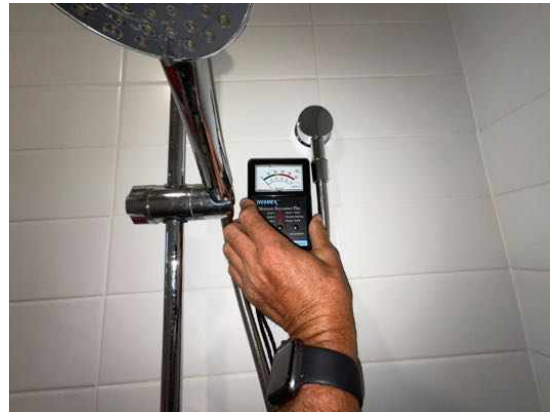
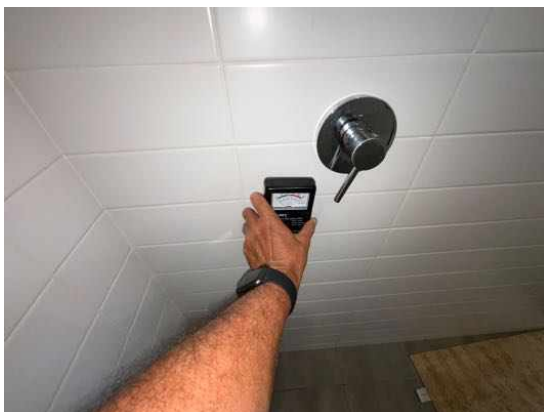
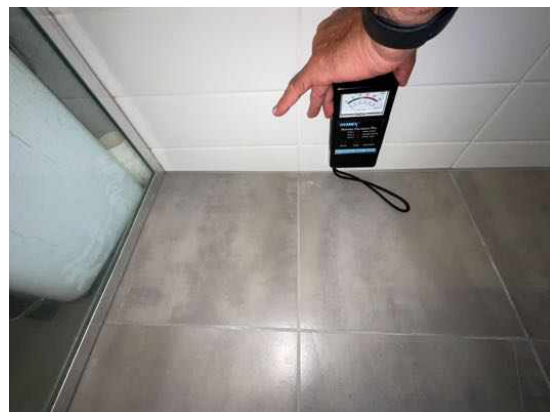
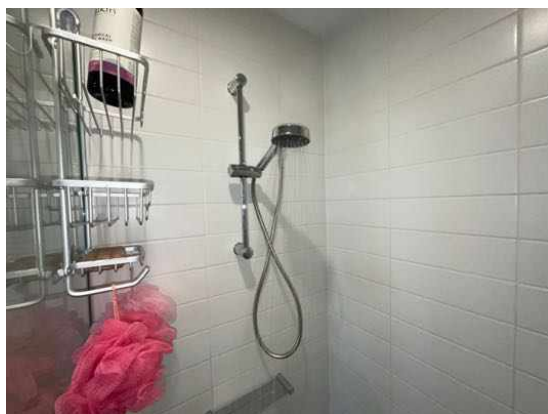
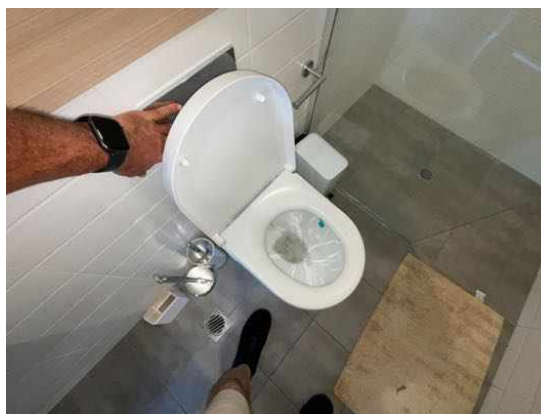
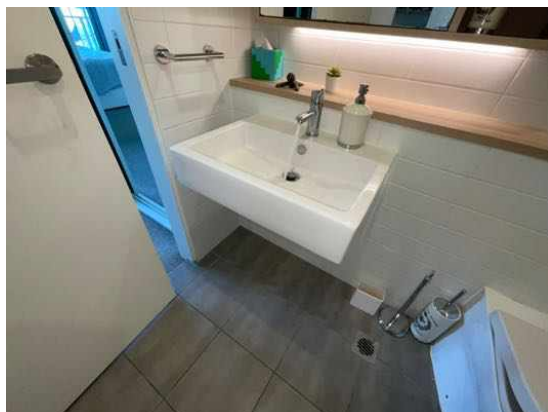
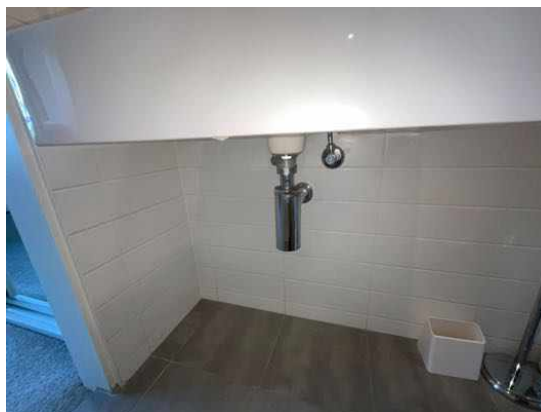
Building: Main Building
Location: Bathroom
Finding: Wet Areas - Bathroom(s) - Overall Condition & Recommendations.
Information: Overall Condition & Recommendations

- Water appeared to drain slowly towards the shower floor waste at the time of inspection, indicating minimal fall. This may result in water pooling or ponding during regular use. Rectification is at the client's discretion.

- Floor waste was found to be clear and free of blockages at the time of inspection. Further monitoring is advised after consistent use to identify any drainage issues or buildup requiring cleaning.

- No elevated moisture readings were detected around the tap fittings or behind the shower walls (as viewed from adjacent rooms), suggesting no active plumbing leaks at the time of inspection.

- Sealing of grout and tiles is recommended to prevent moisture buildup and mould growth in damp areas such as showers.
- The condition of grout and sealant appeared to be good.

- The exhaust fan appeared to be operational, which supports moisture control in the bathroom.

- No leaks were observed during flushing. The toilet operated normally, and the toilet pan appeared to be securely fixed to the floor.

- Basin(s) were water tested and inspected, with no leaks or blockages identified in the plumbing or drainage system at the time of inspection.

- Flood testing of the shower recess is recommended. This may reveal inadequacies in the waterproofing or shower screens, which could lead to water damage in surrounding areas.

- Further monitoring is recommended after the basin(s) are placed under regular use to confirm ongoing performance and cleanliness.

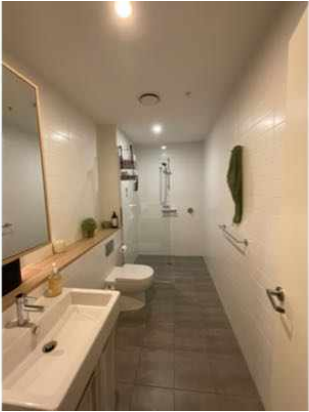
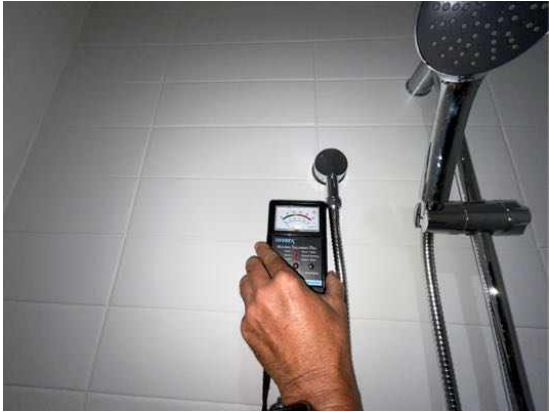
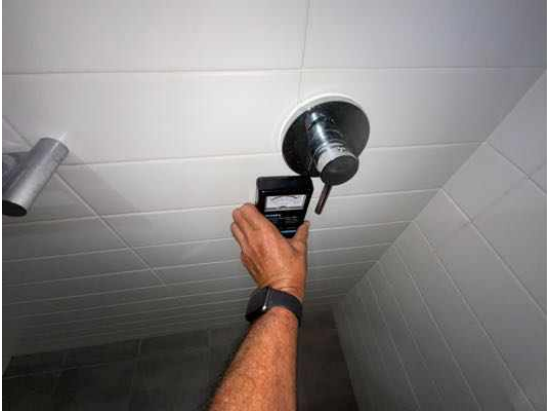
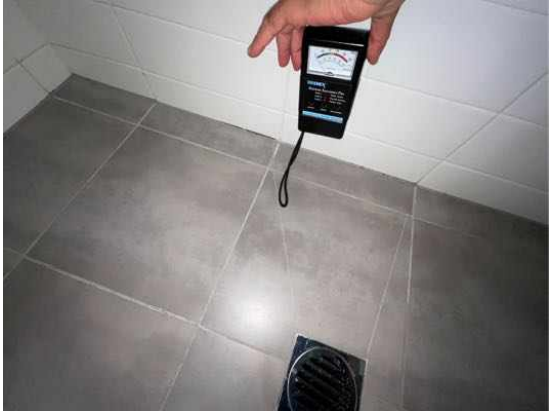
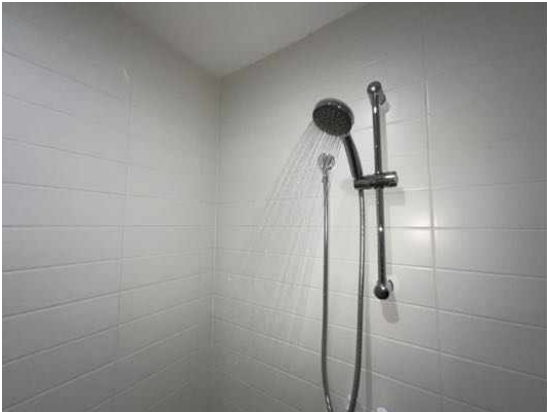
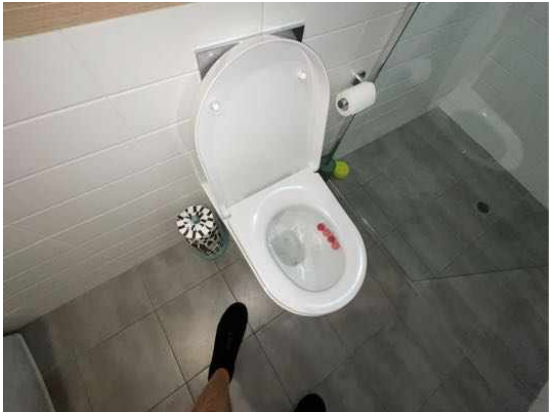
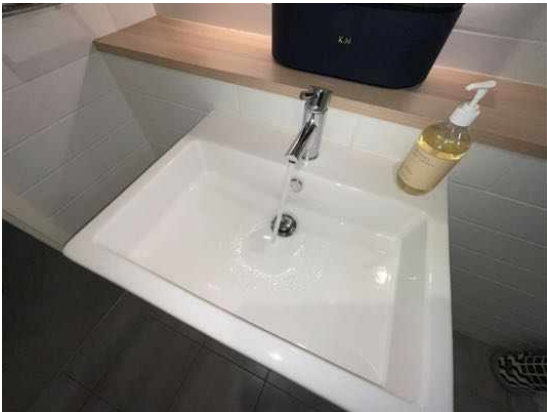
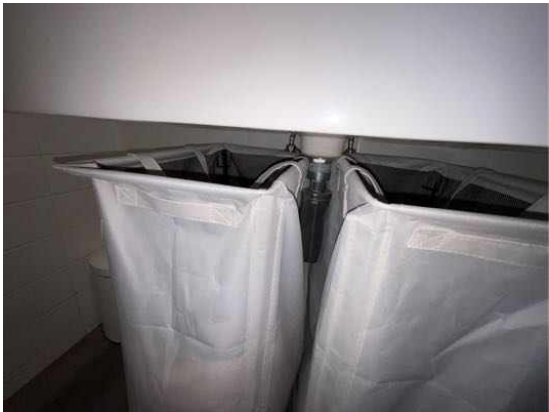
Building: Main Building
 Location: Ensuite
 Finding: Wet Areas - Bathroom(s) - Overall Condition & Recommendations.
 Information: Overall Condition & Recommendations

- Water appeared to drain slowly towards the shower floor waste at the time of inspection, indicating minimal fall. This may result in water pooling or ponding during regular use. Rectification is at the client's discretion.
- Flood testing of the shower recess is recommended. This may reveal inadequacies in the waterproofing or shower screens, which could lead to water damage in surrounding areas.
- Floor waste was found to be clear and free of blockages at the time of inspection. Further monitoring is advised after consistent use to identify any drainage issues or buildup requiring cleaning.
- No elevated moisture readings were detected around the tap fittings or behind the shower walls (as viewed from adjacent rooms), suggesting no active plumbing leaks at

the time of inspection.

- Sealing of grout and tiles is recommended to prevent moisture buildup and mould growth in damp areas such as showers.
- The condition of grout and sealant appeared to be good.
- The exhaust fan appeared to be operational, which supports moisture control in the bathroom.

- No leaks were observed during flushing. The toilet operated normally, and the toilet pan appeared to be securely fixed to the floor.

- Basin(s) were water tested and inspected, with no leaks or blockages identified in the plumbing or drainage system at the time of inspection.
- Further monitoring is recommended after the basin(s) are placed under regular use to confirm ongoing performance and cleanliness.
