Building and Timber Pest Inspection Report

Inspection Date: Fri, 20 Mar 2026

Property Address: 67 Illaroo Rd, North Nowra NSW 2541,
Australia

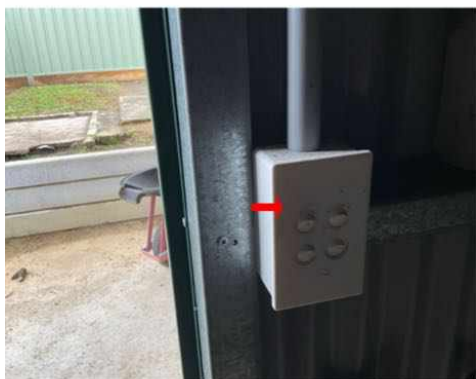
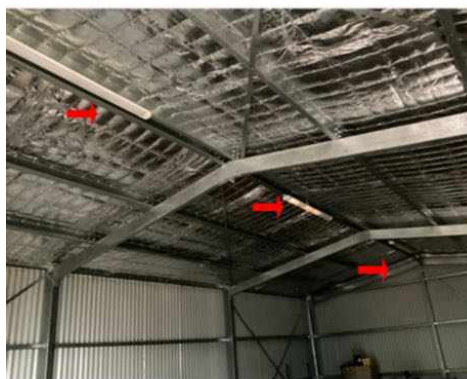
Building:	Building 3
Location:	Pictured switch and lighting
Finding:	Lights - Damaged
Information:	The light fitting in this garage area was found to be damaged emitting unusual noises at the time of inspection. The lights were not working and it is suspected rainwater has damaged the wiring. Left unmanaged, the fitting may cause injury if there is potential contact with persons in the area.

A Licensed electrician should be appointed to investigate further.

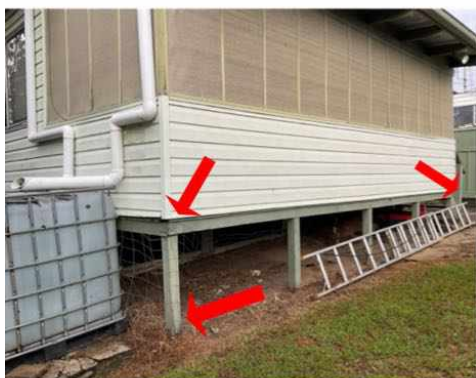
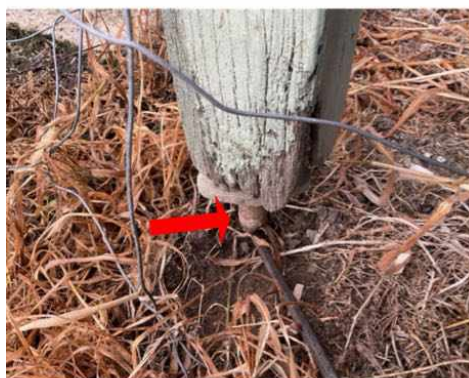
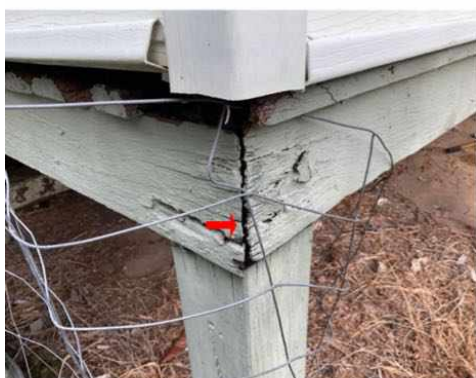
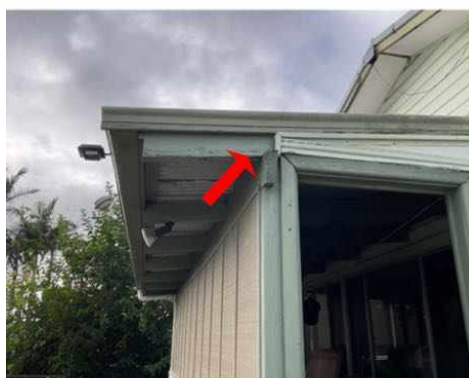
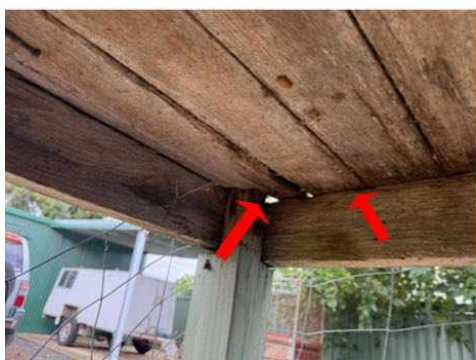
Finding 2.01

Building:	Building 1
Location:	Rear deck northeast corner
Finding:	Lack of support
Information:	These rear verandah areas shows a lack of support which is highly likely to result in further defects over time. The post support has rusted and become detached.

The verandah rear areas also have severe wood rot. Additional support is required by a carpenter to urgently add a new post support.

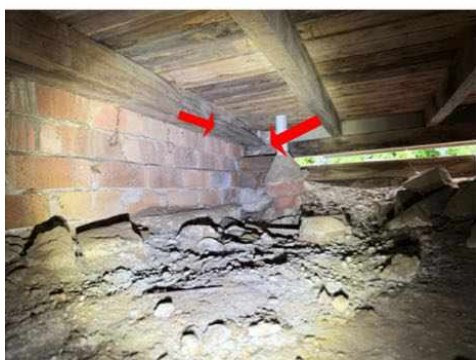
Finding 2.02

Building:	Building 1
Location:	Subfloor under kitchen/ bathroom wall
Finding:	Subfloor structure - Wood rot
Information:	The subfloor structure here is showing severe wood rot (fungal decay) of the timbers. It is suspected that this defect has developed as a result of damp conditions in the subfloor from a bathroom leak.

Damp conditions cause the timbers to fail, resulting in the subfloor structures failing to bear the load (or weight) of the building as originally intended. Without repairs and maintenance, including potential replacement of affected elements, it is likely that serious structural faults will result, as well as an array of minor defects.

The presence of wood rot to the subfloor structure is also conducive to termite infestation. As timber stumps are in direct contact with the ground, concealed termite is made possible. Such entry is made easier if the timbers become non-durable due to even slight wood rot.

Where wood rot is present to any structural timber, rectification or replacement of the affected timber building element is required. The adequate timeframe for such works are dependent on the severity of the rot. This area was inspected from 1 meter away due to tight safe access. A builder or carpenter is required to urgently restrengthen or replace these damaged timbers.

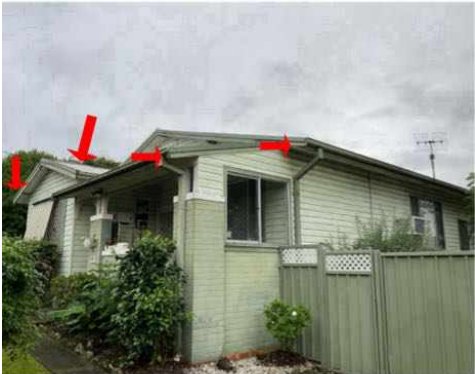
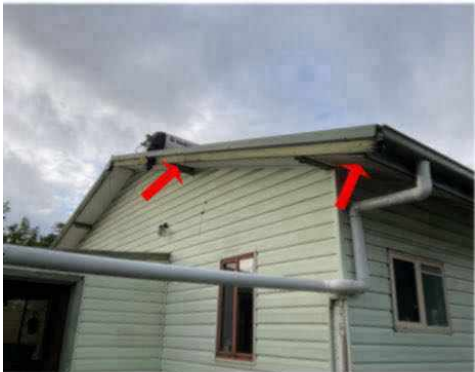
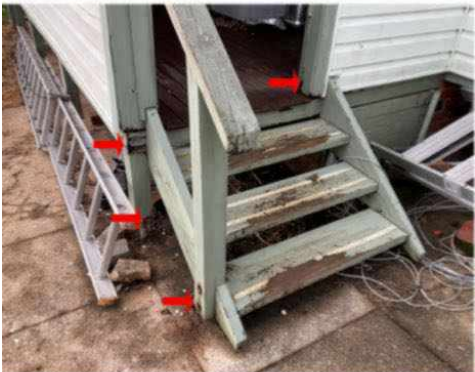
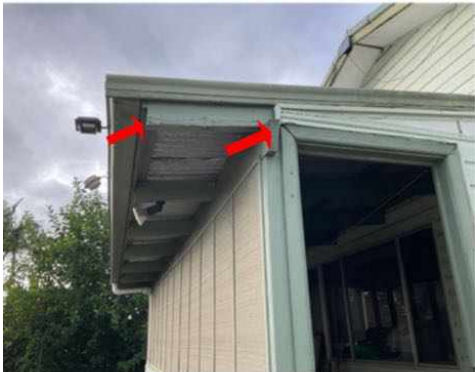
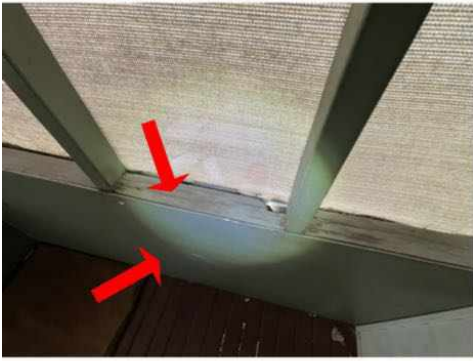
Finding 3.01

Building:	Building 1
Location:	Pictured areas
Finding:	Wood rot
Information:	The building shows evidence of wood rot. Wood rot, also known as Fungal Decay, occurs when timbers and other cellulose building materials are exposed to damp conditions on an ongoing basis. This could be the result of exposure to weathering

over a prolonged period of time, or the attraction of excessive moisture from other abutting building materials.

Early intervention and regular maintenance, particularly of exterior timbers, will prolong the useful life of these building elements. Prior to any works being performed, the cause of the moisture that has created the visible wood rot should be identified and addressed in a suitable manner. Replacement of affected timbers may then be a necessary step in protecting surrounding building elements from such deterioration.

A qualified carpenter or registered builder may also be required to replace affected building materials.

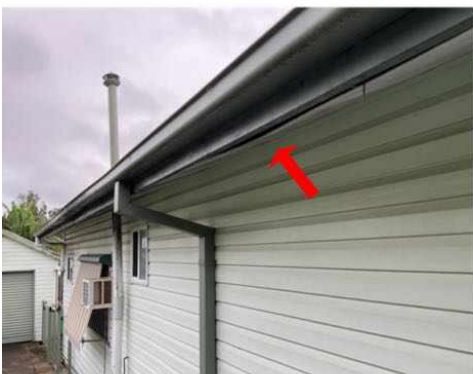
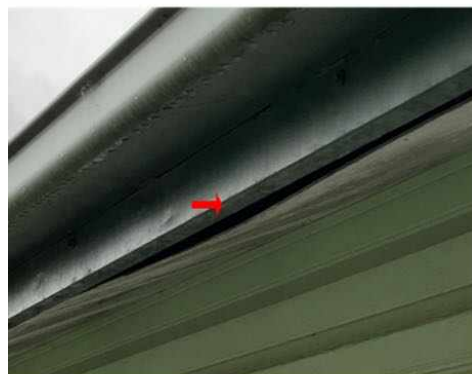
Finding 3.02

Building:	Building 1
Location:	Pictured driveway area
Finding:	Eaves - Sagging
Information:	Sagging to the eaves was evident in this area at the time of inspection. This type of defect is generally consistent with older properties, where the eave sheeting has worn over time.

Eaves are important in preventing water ingress to associated walls by promoting adequate water run-off from roofing structures. Their secondary function is to prevent shelter to adjoining structures from excessive moisture and hence prevent water damage to these areas.

Sagging eaves are susceptible to the attraction of excessive moisture, and are therefore considered non-functional. This defect also detracts from the overall appearance and condition of the roofing structure and any associated structures.

A carpenter is required to perform rectification works immediately before this eave sheet(s) falls.

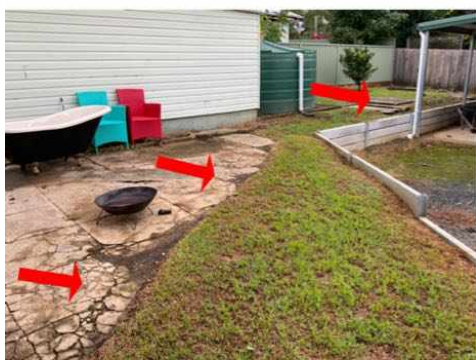
Finding 3.03

Location: Yard - rear
 Finding: Cracks in concrete slab - Category 3
 Information: A crack coded as Category 3 was identified in these slabs. A Category 3 crack is described as a wide crack with obvious curvature or change in level, affecting the slab.

The approximate width of the crack to be considered Category 3 is greater than 2.0mm, or a change in offset of 15-25mm when a 3m straight edge is placed over the defect.

Category 3 cracks to slabs exceed allowable Standards and Tolerances, and are considered defects requiring rectification.

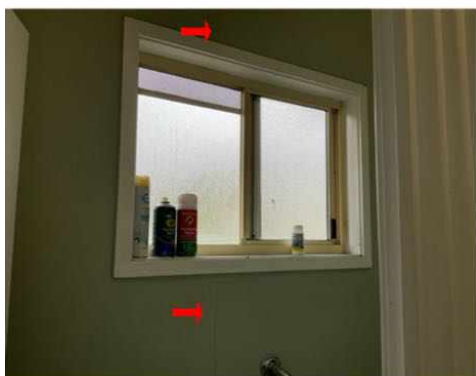
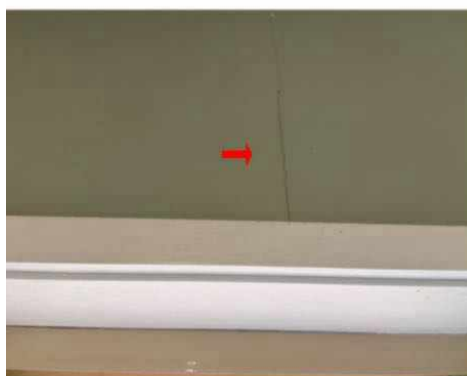
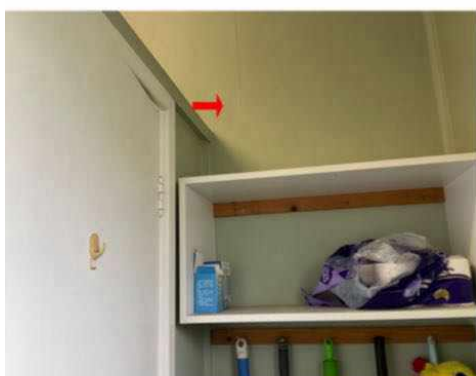
Finding 3.04

Building: Building 1
 Location: Laundry
 Finding: Cracking - Damage Category 1 - Fine (up to 1mm)
 Information: Although fine cracks are quite noticeable, they are often only considered to be an appearance defect, and usually do not indicate any structural damage. Generally, the cause of a fine crack is indicative of a separation between building materials and finishes (e.g. paint, plaster, etc.) along joins.

Cracking of this nature can generally be repaired with minor sanding, filling and/or repainting. Such works should be performed by a qualified painter or a general handyman.

Monitoring of all cracking should be conducted frequently. Always contact a building inspector should cracks widen, lengthen, or become more numerous.

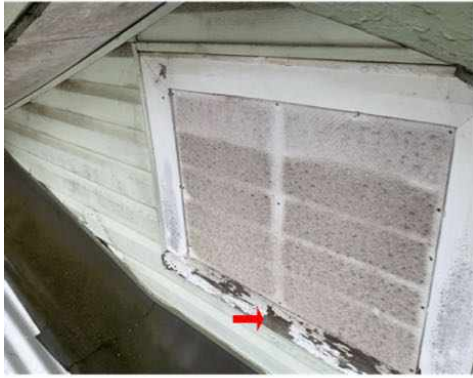
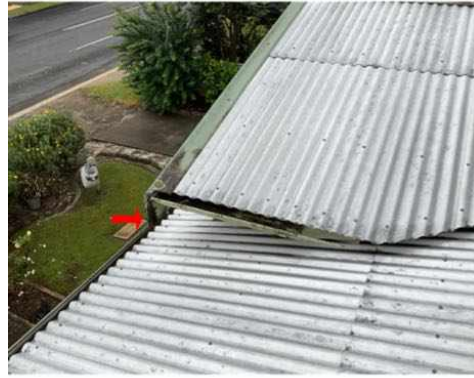
Building:	Building 1
Location:	Roof Exterior
Finding:	Roofing areas - Weathered
Information:	Upon inspection of the exterior roofing, the majority of the roof sheets areas were considered to be in a good condition. The timber areas was in fair condition.

Re-sealing old sealant and painting may be considered as an interim solution by the client to help preserve and extend the life span of these roofing areas. Some timber fascia and barges require repair/ replacement. Where left unmanaged, deteriorating roofing materials are likely to lead to a number of secondary defects, including minor water leaks and weather exposure to internal roofing structures.

Remedial works are likely to increase the longevity of the exterior roofing structure.

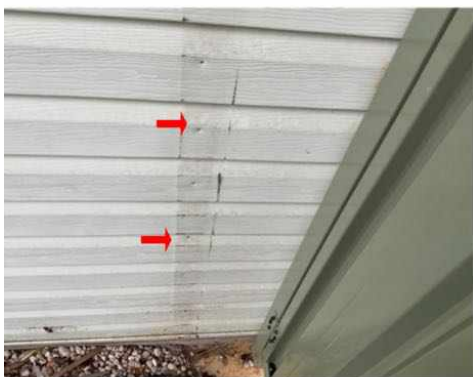
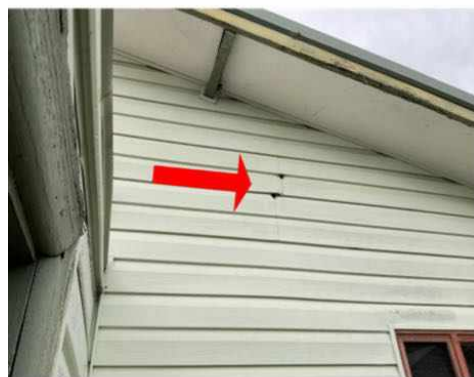
Finding 3.07

Building:	Building 1
Location:	Pictured Areas
Finding:	Sealant (external) - Missing.
Information:	It was noted on inspection that small areas of external sealant was missing to the external walls.

Flexible sealants should be applied to these affected areas to prevent any subsequent water damage that is likely to occur.

A sealant specialist or skilled handy person should be appointed to complete these works as soon as possible

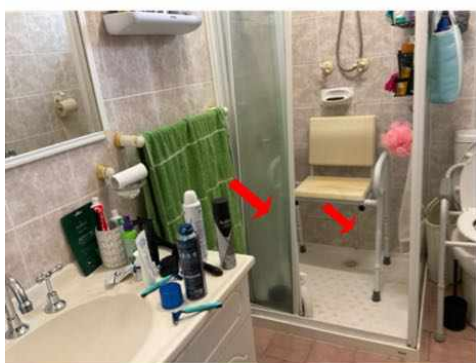
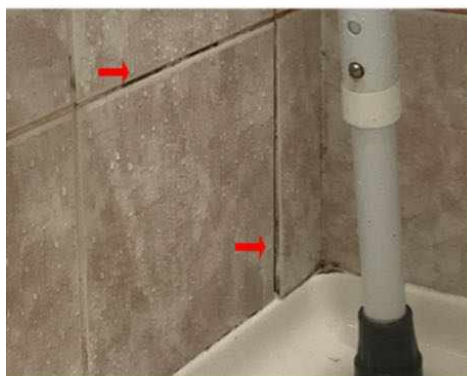
Finding 3.08

Building:	Building 1
Location:	Kitchen and bathroom
Finding:	Sealant and grouting - Missing or damaged
Information:	It was noted on inspection that sealant or grout is degraded to these pictured wet areas.

Different materials and floor areas move at different rates, generally causing cracking to grout or sealant at this point. A flexible sealant is required to allow for expected expansion and contraction, while keeping the joint water tight and protective of all associated building materials.

Flexible and mould resistant materials should be applied to affected areas to prevent any subsequent water damage that is likely to occur. Regular maintenance and replacement of damage or missing or damaged sealant and grout is highly recommended to the wet areas, as this is a regular wear and tear defect. Sealant and grouting in areas that come into regular contact with water should be maintained for the long term care of your property.

A sealant specialist or tiling contractor should be appointed to complete these works as soon as possible

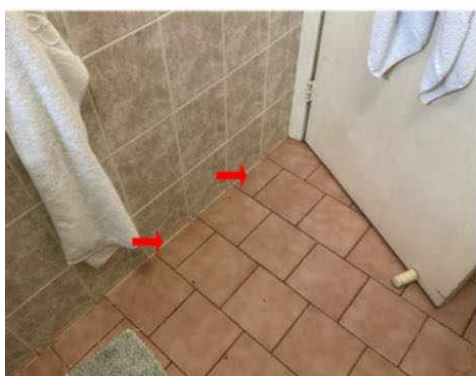
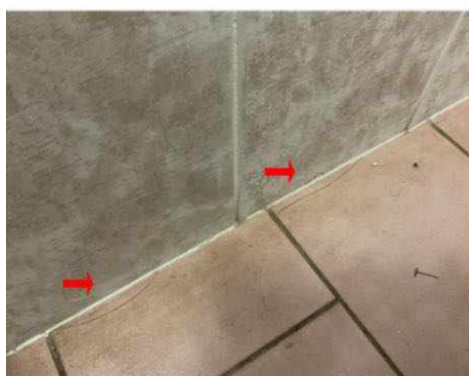
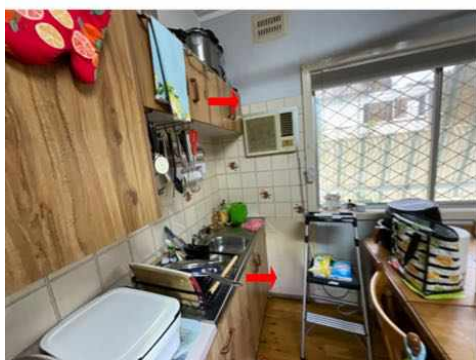
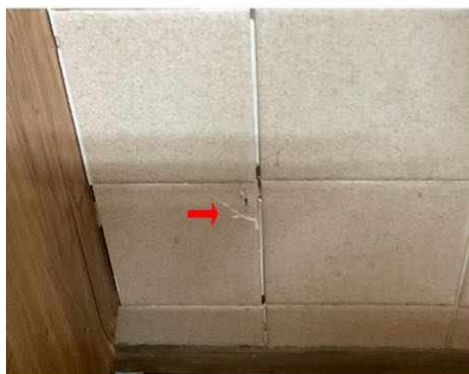
Finding 3.09

Building:	Building 1
Location:	Bathroom, kitchen
Finding:	Tiles cracked
Information:	Cracked tiles were evident in these pictured areas at the time of inspection. It is suspected that this cracking has occurred as a result of minor settlement or impact damage.

Cracked tiles throughout the household detract from the overall appearance of the affected areas. In wet areas of kitchens and bathrooms, it can lead to water damage of adjoining walls and floors.

Replacement of cracked tiles is recommended as soon as possible. A tiling contractor may be appointed to perform these works. Where cracks become more numerous, contact a licensed building inspector for further investigation.

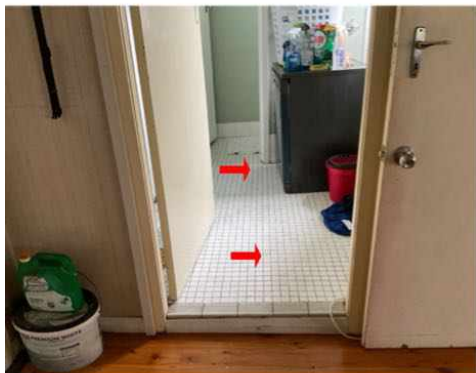
Finding 3.10

Information: Drummy tiled areas were identified at the time of inspection. The term 'drummy' refers to tiles that have become detached from their fixing, despite otherwise being in relatively good condition. Such defects are generally caused by physical or moisture damage to the area. Drummy tiled areas may also be a direct result of poor workmanship during the construction process.

Tiled areas may swell and shrink with changes in air humidity if the area has sustained moisture damage. Any exposure to moisture is capable of causing tiled areas to

become drummy and/or cracked over a prolonged period of time. Drummy tiled areas generally require removal and replacement of affected tiles, with adequate sealant and grouting.

Specialist trades are available for these types of services. A registered builder may be required to undertake works if damage is extensive or if secondary building defects have resulted. Otherwise, it is advised that a tiling contractor be appointed to perform works as necessary. Immediate action is recommended to ensure that no further damage is sustained in the affected area.

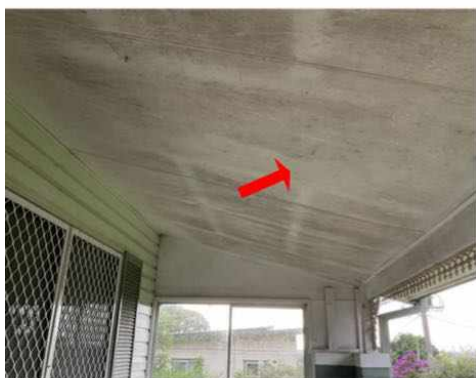
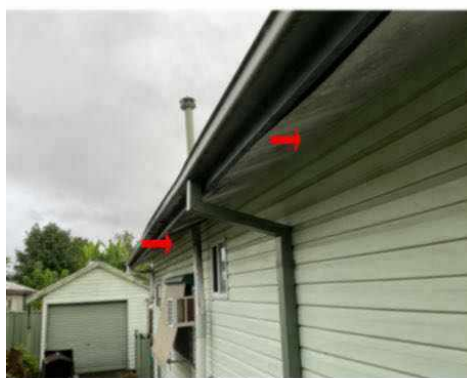
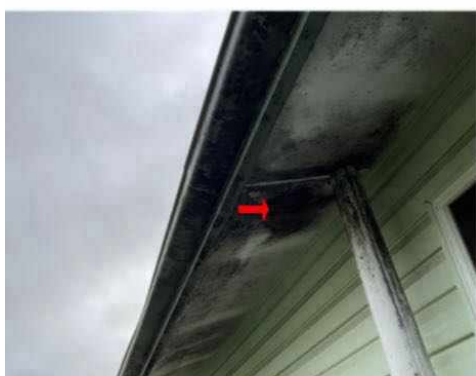
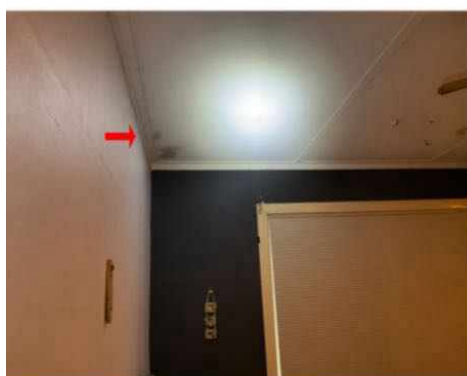
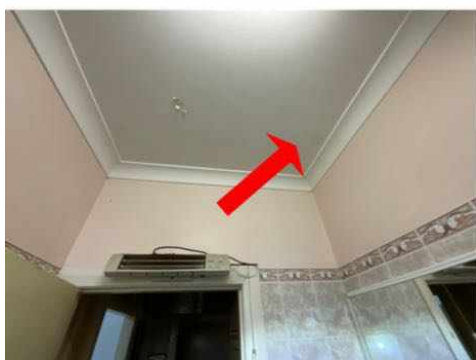
Finding 3.11

Building:	Building 1
Location:	Pictured Areas
Finding:	Mould - Present
Information:	Where evidence of mould growth was noted, there may be environmental, biological or health issues associated with the report. A specialist inspection by a suitably qualified environmental health inspector is warranted, where mould is extensive or where any queries regarding air quality spores or other related issues apply.

Generally, the client is advised to ensure that the general environment is free of moisture and humidity to aid in the prevention of mould formation and development. Any mould found during the inspection should be cleaned immediately by a cleaning contractor or the homeowner as applicable.

Please note that severely affected building elements may require replacement by a registered builder or qualified carpenter.

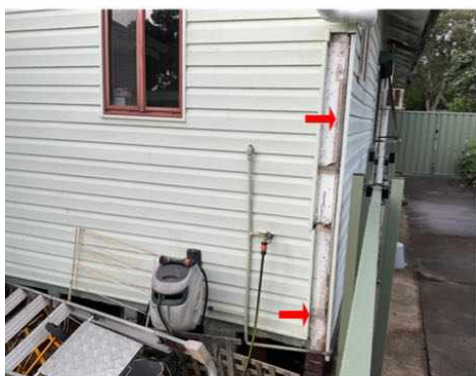
Finding 3.14

Building:	Building 1
Location:	Pictured wall area
Finding:	Cladding missing / damaged
Information:	Evidence of damage was identified to the left side wall where the cladding has minor

damage. A carpenter would be the trade responsible for rectification of this wall area.

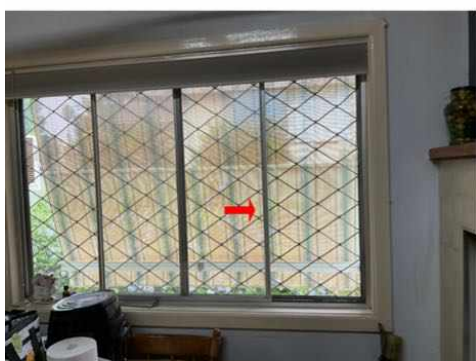
Finding 3.15

Finding: Lock - missing

Information: The lock to this window was missing at the time of inspection. Where locks are missing the security of the property is immediately compromised.

Replacement of the lock is highly recommended. Consultation with a locksmith or general handyman is required to gain further advice on any added security that may be available for the area.

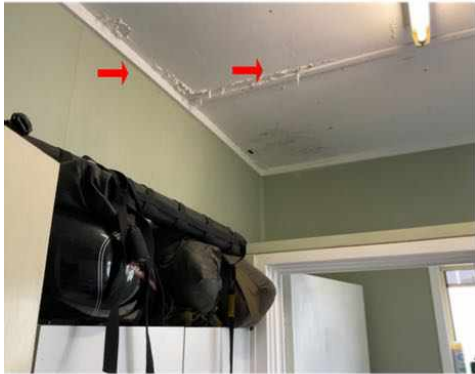
Finding 3.16

Finding: Paint damaged

Information: The paint finish throughout the house was found to be damaged. Damaged painting is generally classified as an appearance defect. However, the appearance may also be indicative of poor surface preparation and substandard workmanship. Damaged paint finishes in areas exposed to moisture,

e.g. external areas or wet areas, could lead to deterioration of underlying building materials. Damaged paint finishes should be sanded back, filled, leveled and repainted, as applicable.

A painting contractor should be appointed as soon as possible to perform necessary works to aid the appearance of the affected area and to ensure that the area is protected against further deterioration. Alternatively, the homeowner following manufacturer instructions may be able to provide this service.

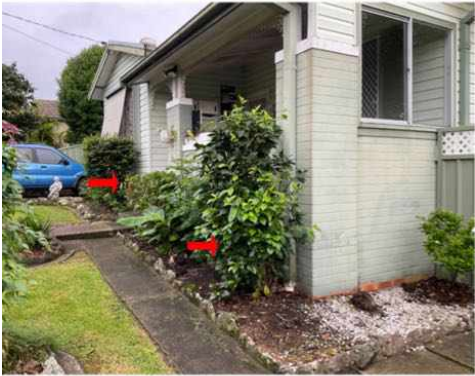
Finding 6.02

Building:	Building 1
Location:	Yard - front
Finding:	Bridging - Vegetation and decking
Information:	Where vegetation and decking obstructs inspection of building elements, also known as bridging as it provides a bridging point for the access of termites, full inspection can not be achieved. Consequently moisture or dampness may be present and the areas becomes conducive to termite activity. Plants and decks against or very close to buildings provide cover, shade and can provide an environment that is attractive to termite infestation.

The removal of any such stored building or plant materials that may be conducive to termite activity should be carried out as soon as possible and arrange re inspection to minimize the risk of termite attack.

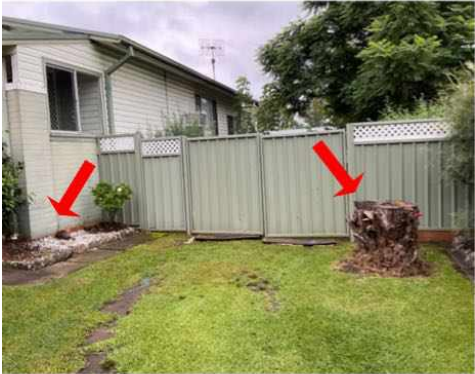
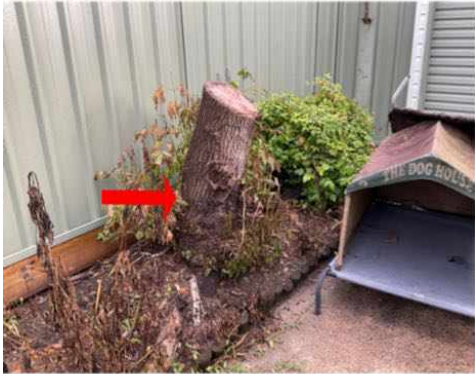
Finding 6.03

Building: Building 1
Location: Pictured yard area
Finding: Tree stumps - left in ground
Information: Tree stumps left in ground provide opportunity for termite attack as they are likely to be subject to rot and decay providing an attractive food source. Treatment and/or Removal of the stump is highly recommended. A pest controller and tree removalist should be engaged to perform such works.

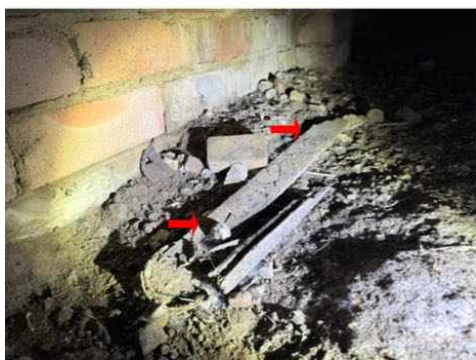
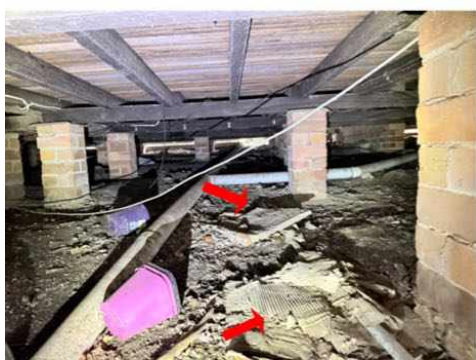
Finding 6.04

Building:	Building 1
Location:	Subfloor
Finding:	Subfloor - Debris
Information:	An array of debris was found in the subfloor area at the time of inspection. Debris in this area restricts subfloor ventilation and creates potential for concealed pest entry. Stored timbers and other materials may also make the area susceptible to termite activity and wood rot.

Debris in the subfloor should be removed as soon as possible. Depending on the location and amount of debris and stored items, the homeowner may elect to undertake this task. Alternatively there are a large number of rubbish removal subcontractors that could undertake these works.

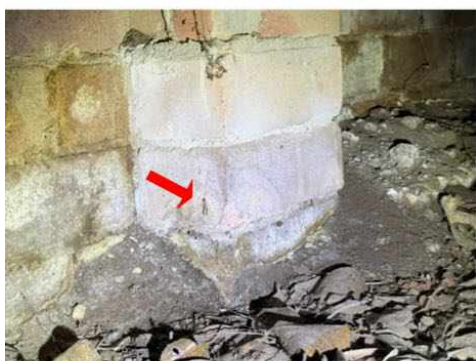
Finding 6.05

Building:	Building 1
Location:	Subfloor
Finding:	Damp - Rising
Information:	Rising damp describes the upward movement of water in low sections of building

Consultation with a qualified plumber is advised immediately to identify the cause of the damp and perform remedial works as required.

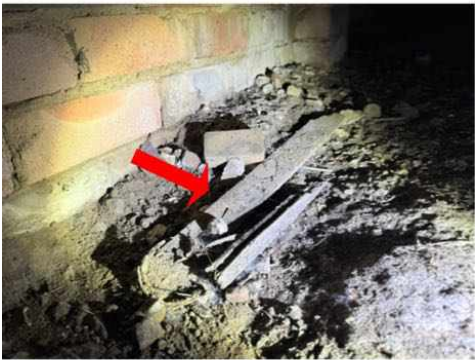
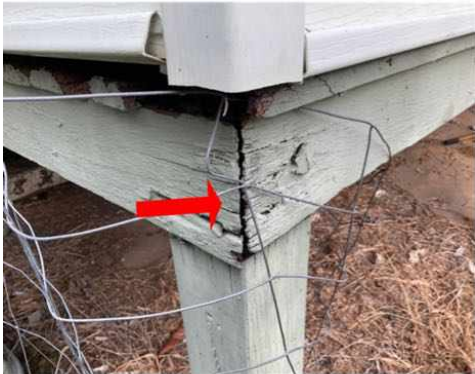
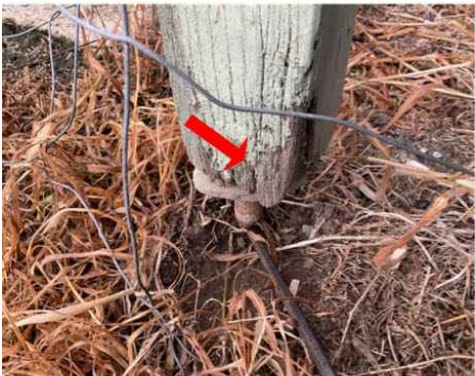
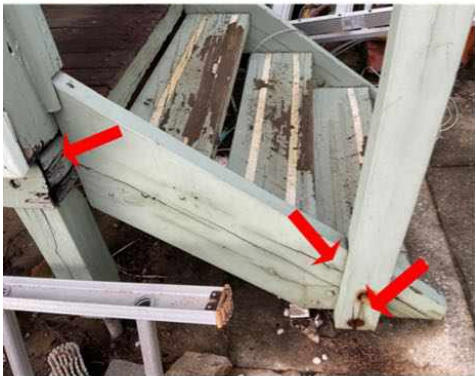
Finding 7.01

Note - See ALL wood rot photos, all these show fungal decay.

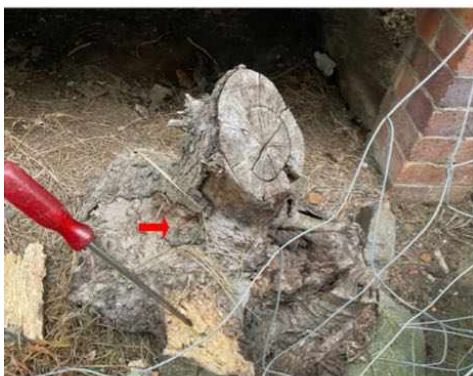
As no live wood borer activity was identified treatment is not required at this time.

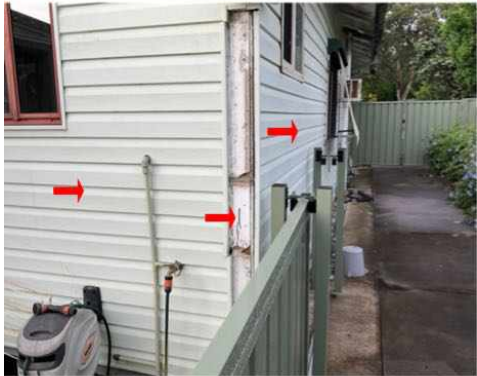
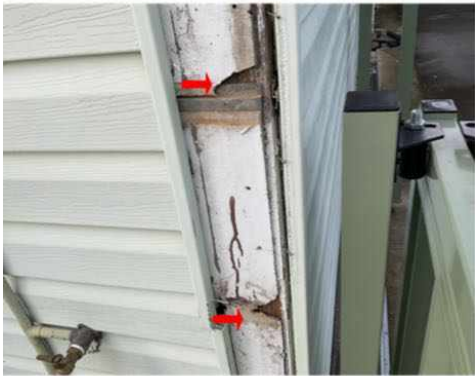
Building: Building 1
Location: Pictured wall area
Finding: Asbestos - ACM Identified on Site
Information: Reporting on Asbestos is outside the Scope of this Report. This defect is highlighted as a caution only. We suspect the house has asbestos present due to its age.

Contact this inspector for Asbestos Report and testing.
