# Building and Timber Pest Inspection Report

Inspection Date: Thu, 5 Feb 2026

Property Address: 118 Vary St, Morwell VIC 3840, Australia

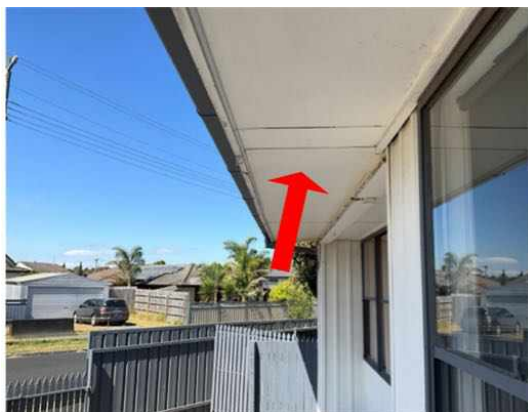
Building:	Main Building
Location:	Eaves
Finding:	Asbestos - Suspected ACM Identified on Site
Information:	Eaves were suspected to contain asbestos at the time of inspection. Reporting on Asbestos is outside the Scope of this Report. This suspected defect is highlighted as a caution only. We suspect, based on our experience in the building industry, that there is a higher risk of the identified building element containing asbestos.

As Asbestos Reporting is outside the scope of this report, we advise that you consider a separate Asbestos Inspection and Condition Audit, which can include the taking of samples for definitive confirmation of the presence of Asbestos.

In the interim, the client is advised to act with caution, especially when considering any damage to building materials general wear and tear renovations extensions demolition and general maintenance activities due to the suspected presence of Asbestos.

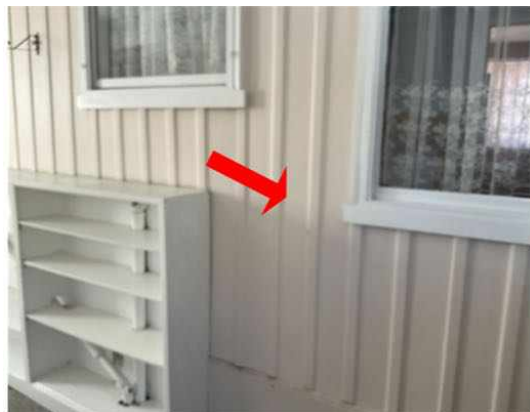
#### Finding 1.02

Building:	Main Building
Location:	Sunroom
Finding:	Asbestos - Suspected ACM Identified on Site
Information:	Internal cladding was suspected to contain asbestos at the time of inspection. Reporting on Asbestos is outside the Scope of this Report. This suspected defect is highlighted as a caution only. We suspect, based on our experience in the building industry, that there is a higher risk of the identified building element containing asbestos.

a separate Asbestos Inspection and Condition Audit, which can include the taking of samples for definitive confirmation of the presence of Asbestos.

In the interim, the client is advised to act with caution, especially when considering any damage to building materials general wear and tear renovations extensions demolition and general maintenance activities due to the suspected presence of Asbestos.

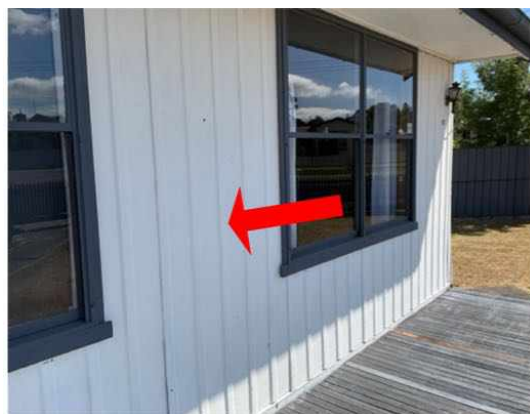
### Finding 1.03

Building:	Main Building
Location:	All Areas
Finding:	Asbestos - Suspected ACM Identified on Site
Information:	External cladding was suspected to contain asbestos at the time of inspection. Reporting on Asbestos is outside the Scope of this Report. This suspected defect is highlighted as a caution only. We suspect, based on our experience in the building industry, that there is a higher risk of the identified building element containing asbestos.

As Asbestos Reporting is outside the scope of this report, we advise that you consider a separate Asbestos Inspection and Condition Audit, which can include the taking of samples for definitive confirmation of the presence of Asbestos.

In the interim, the client is advised to act with caution, especially when considering any damage to building materials general wear and tear renovations extensions demolition and general maintenance activities due to the suspected presence of Asbestos.

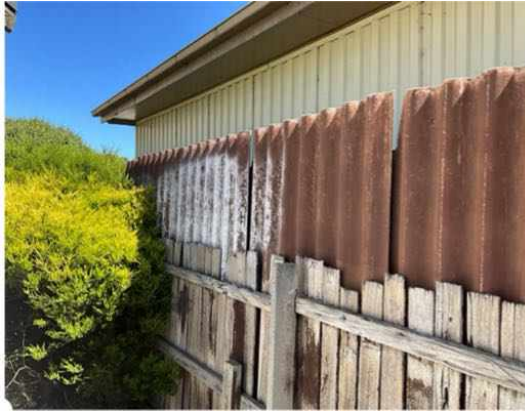
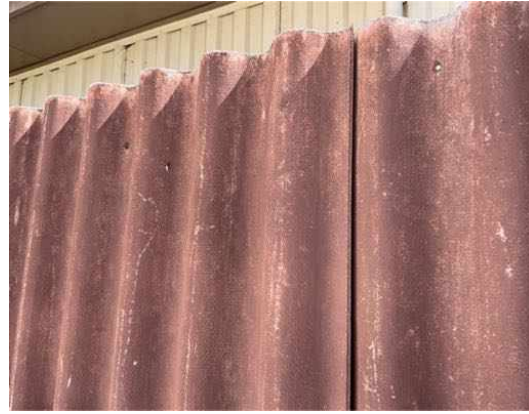
### Finding 1.04

Building:	Main Building
Location:	Fencing
Finding:	Asbestos - Suspected ACM Identified on Site
Information:	Fencing of adjacent property was suspected to contain asbestos at the time of inspection. Reporting on Asbestos is outside the Scope of this Report. This suspected defect is highlighted as a caution only. We suspect, based on our experience in the building industry, that there is a higher risk of the identified building element containing asbestos.

As Asbestos Reporting is outside the scope of this report, we advise that you consider a separate Asbestos Inspection and Condition Audit, which can include the taking of samples for definitive confirmation of the presence of Asbestos.

In the interim, the client is advised to act with caution, especially when considering any damage to building materials general wear and tear renovations extensions demolition and general maintenance activities due to the suspected presence of Asbestos.

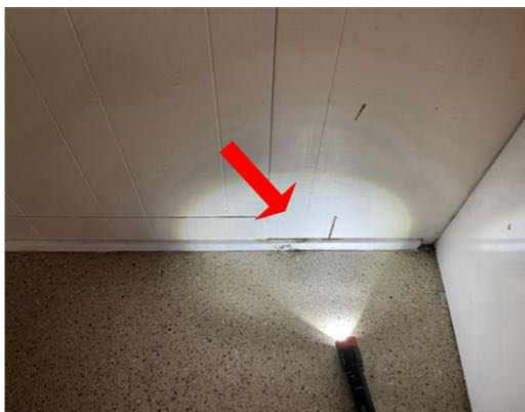
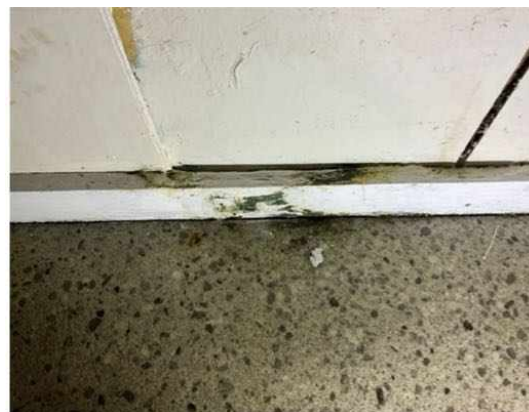
### Finding 2.01

Building:	Main Building
Location:	Laundry
Finding:	Timber Skirting Decay with Elevated Moisture Levels
Information:	Timber decay was observed to the skirting board at the time of inspection. Elevated moisture levels were also recorded in this area, indicating ongoing moisture exposure. Based on the location and condition of the affected materials, an ongoing water leak within the adjoining wall is suspected.

If left unaddressed, continued moisture ingress may result in further deterioration of the skirting board and potential spread of decay to concealed timber framing, wall linings, and other adjoining building elements. Ongoing moisture may also increase the risk of mould growth and damage to internal finishes.

It is recommended that an invasive inspection be carried out to confirm the source and extent of moisture ingress. A suitably qualified plumber and/or registered builder should be engaged to investigate the suspected leak and undertake necessary repairs, including replacement of any decayed timber and remediation of affected areas.

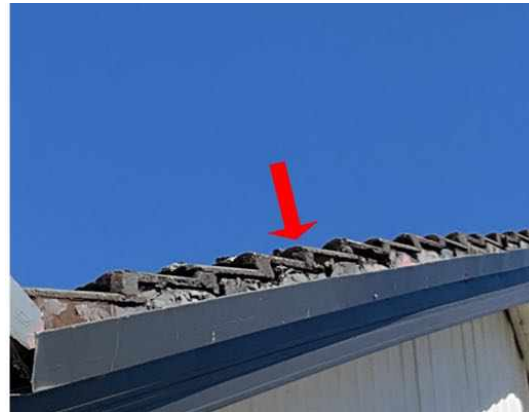
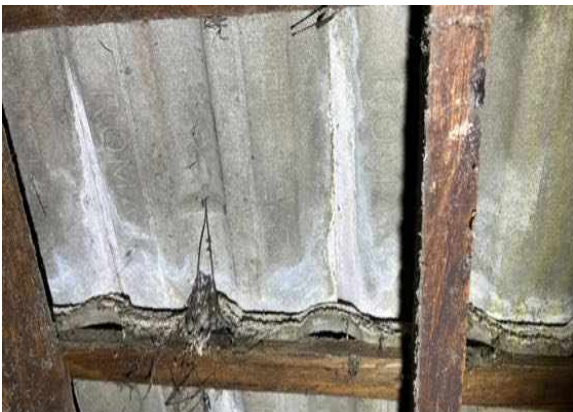
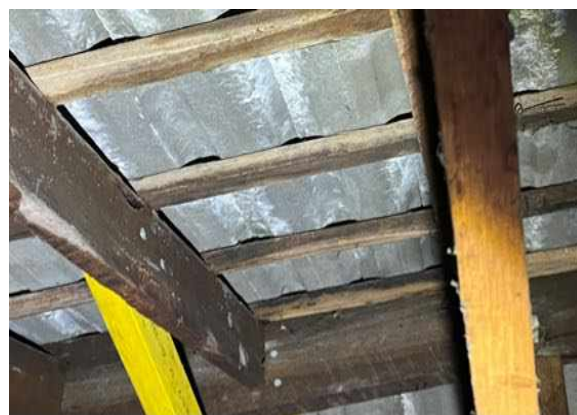
**Finding 2.02**

Building: Main Building  
 Location: Roof Exterior  
 Finding: Roof Tile and Mortar Deterioration  
 Information: Edge deterioration and surface wear were observed to the roof tiles during the inspection of the roof void. In addition, deterioration of the mortar bedding and pointing was noted along the edges of the gable roof. These defects are commonly associated with natural ageing, prolonged exposure to weather conditions, and general wear and tear over time.

If left unaddressed, the deterioration of roof tiles and mortar may compromise the

roof's ability to provide a watertight barrier, potentially leading to water ingress and damage to the roof space and interior of the dwelling. Deteriorated mortar may also reduce the stability of roof tiles, increasing the risk of tile movement or dislodgement during strong winds or storm events.

It is recommended that a licensed roof plumber or registered roofing contractor be engaged to assess the extent of tile and mortar deterioration and carry out any necessary repairs, repointing, or replacement works. Prompt rectification will help ensure the roof remains weatherproof and structurally sound.

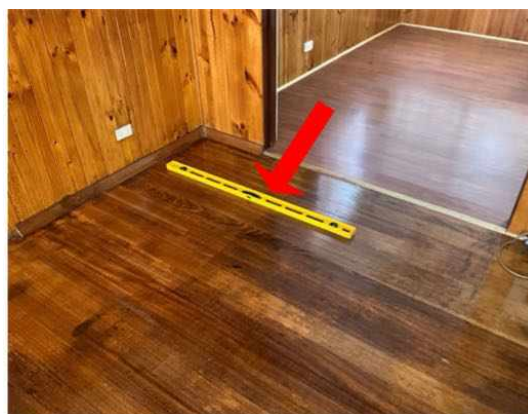
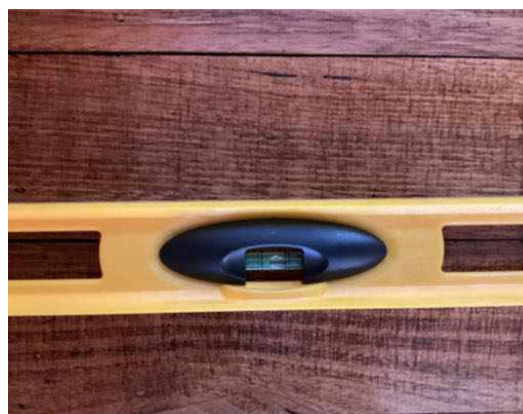
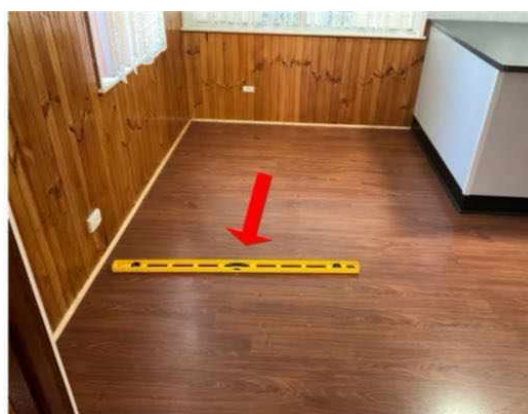
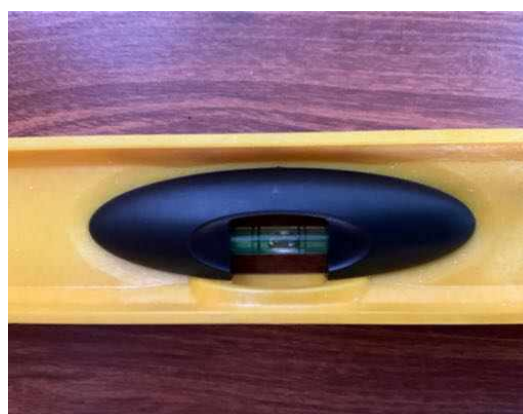
### Finding 3.01

Information: The internal flooring in this area is out of level and uneven. Uneven flooring is likely to indicate minor defects such as expected movement of the foundations of the property, but may also indicate subsidence of the associated subfloor stumps.

It is advised that the flooring be closely monitored to identify any further movement. Where flooring remains relatively unchanged for an extended period of time (i.e. several months), it is likely that this defect has been caused by expected movement of the foundations of the property.

However, where flooring is uneven further, potentially invasive inspection of the subfloor structures and stumps in this area is required. In this case, works to repair are likely to be required, and would be carried out by a registered builder specialising in re-stumping.

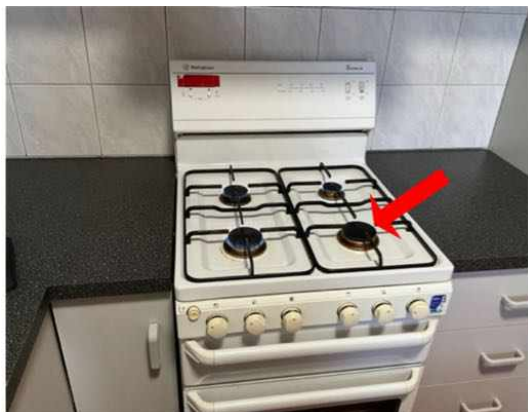
### Finding 3.02

**Finding:** Non-Functioning Cooktop Burner  
**Information:** One burner was found not to be functioning at the time of inspection. This condition may be related to an appliance fault, ignition issue, or gas supply component malfunction.

If left unaddressed, a non-functioning burner may limit the safe and effective use of the appliance and could indicate an underlying issue requiring attention.

It is recommended that a licensed gas plumber or authorised appliance technician be engaged to assess the cooktop and carry out any necessary repairs or servicing.

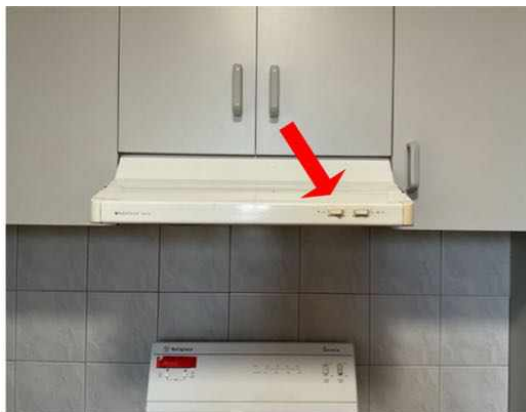
### Finding 3.03

**Building:** Main Building  
**Location:** Kitchen  
**Finding:** Non-Functioning Rangehood Light  
**Information:** The rangehood light was found not to be operating at the time of inspection. This may be due to a failed globe, wiring issue, or an internal fault within the rangehood unit.

If left unaddressed, inadequate lighting may affect the safe and effective use of the cooking area and could indicate an underlying electrical issue.

It is recommended that the rangehood light be repaired or replaced as required by a suitably qualified electrician or authorised appliance technician.

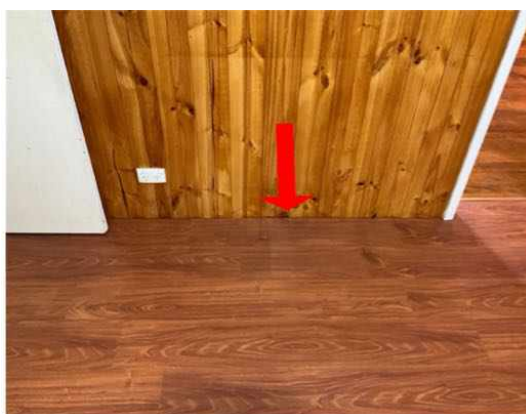
### Finding 3.04

Building:	Main Building
Location:	All Internal Areas
Finding:	Gaps to Timber Flooring Edges
Information:	Gaps were observed along the edges of the timber flooring at the time of inspection. This condition is commonly associated with natural timber movement due to changes in temperature and humidity, shrinkage, or installation tolerances.

If the gaps increase over time, they may affect the appearance of the flooring and allow debris or moisture to enter, potentially leading to further deterioration or movement of the flooring.

It is recommended that the affected areas be monitored for any changes. If the gaps widen or cause functional concerns, a suitably qualified flooring contractor should be engaged for further assessment and advice.

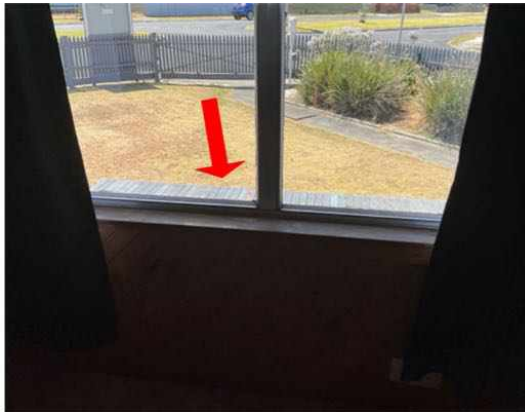
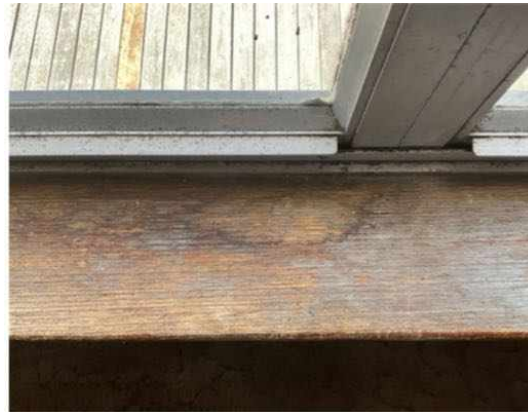
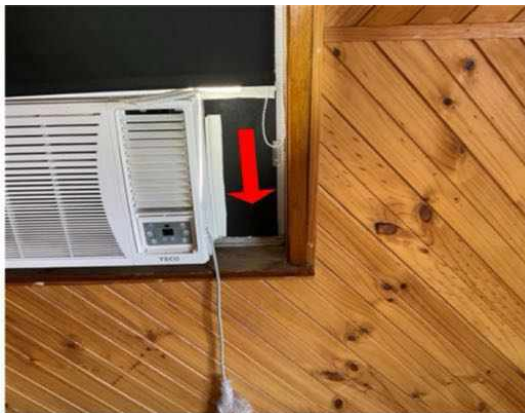
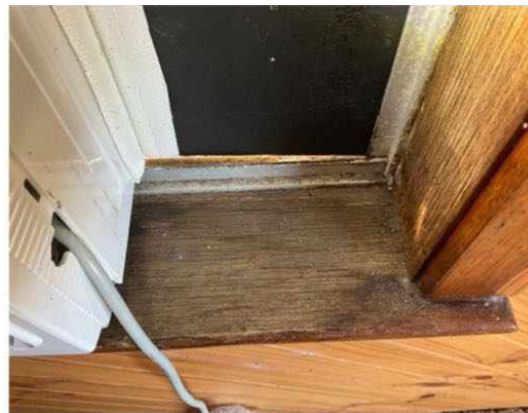
### Finding 3.05

Building:	Main Building
Location:	All Internal Areas
Finding:	Weathered Window Reveal
Information:	A weathered reveal was observed in this area at the time of inspection. This

deterioration is minor in nature and may be due to age, sun exposure, or intermittent moisture contact.

If left unmanaged, continued weathering may allow moisture to penetrate the surrounding materials, potentially leading to staining, decay, or further deterioration of the window frame and adjoining wall surfaces.

It is recommended that this area be regularly monitored for any signs of water ingress. If deterioration progresses or moisture is detected, a qualified carpenter or painter should be engaged to repair and reseal the affected section to prevent further damage.

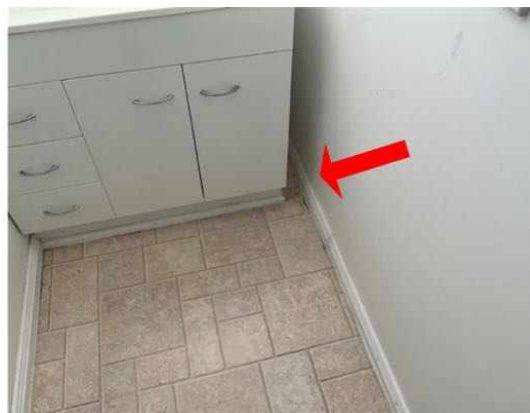
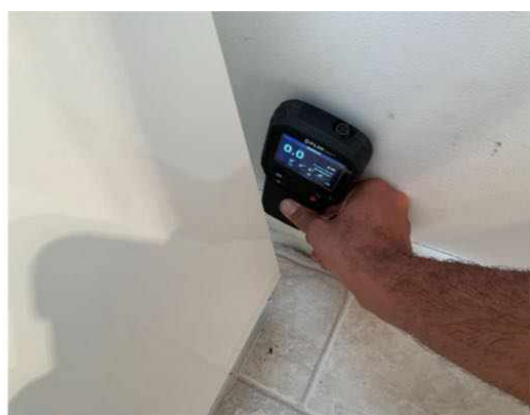
### Finding 3.06

Building:	Main Building
Location:	Bathroom
Finding:	Uneven Vinyl Flooring to Bathroom
Information:	The vinyl flooring in the bathroom was found to be uneven at the time of inspection. This condition may be associated with substrate irregularities, installation issues, or general wear over time.

If left unaddressed, uneven flooring may worsen, affect the appearance and serviceability of the bathroom floor, and in some cases present a minor trip hazard.

Elevated moisture levels were not recorded in this area during the inspection. It is recommended that the flooring be monitored, and if the condition deteriorates or causes concern, a suitably qualified flooring contractor should be engaged for further assessment and advice.

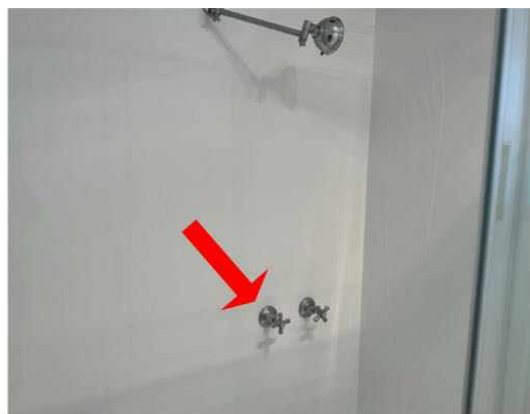
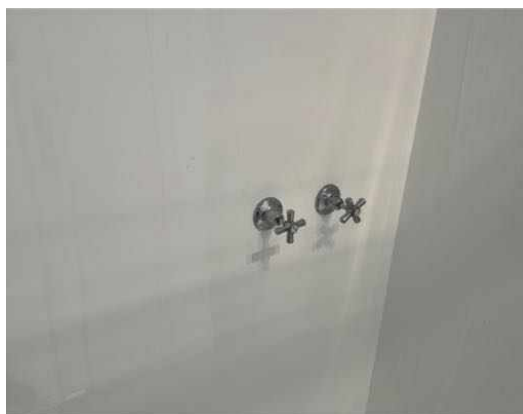
### Finding 3.07

Information: This tap shows evidence of water hammer being present. Water hammer, a pressure surge resulting when a fluid is forced to suddenly change direction, is a common defect in plumbing fittings, particularly those that are aged and not frequently maintained. Water hammer is generally caused by factors that create high water pressure in the affected plumbing fixture, usually evidenced by a faint banging noise during operation of the affected tap.

Although water hammer is generally considered to be a minor defect, subsequent damage such as erosion of tap hardware and/or water damage to associated building elements is likely to occur if left unmanaged.

A licensed plumber should be appointed as soon as possible to replace any affected tap hardware and perform any remedial works as necessary. Please be advised that

the appointment of a cabinet maker or qualified carpenter may be necessary if water damage to associated building elements has occurred.

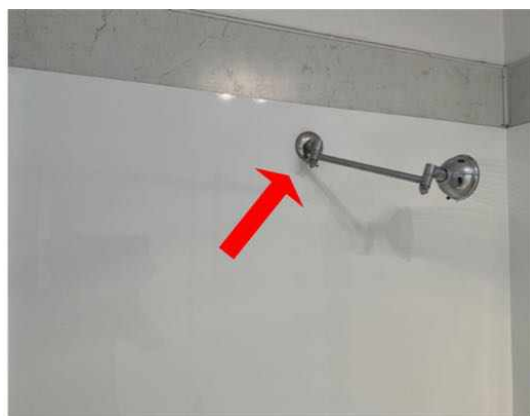
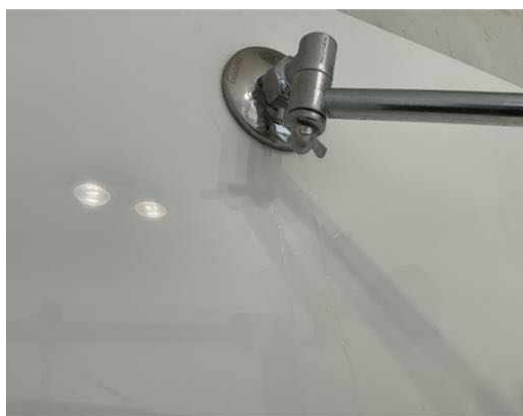
### Finding 3.08

Building: Main Building  
Location: Bathroom  
Finding: Shower head - Leaking  
Information: The shower head in this area was found to be leaking at the time of inspection. This is a common defect that is consistent with general ageing of the building element. However, it may be indicative of substandard plumbing workmanship if the shower is relatively new.

While this defect only seems minor, if left unmanaged, it is likely to result in the development of rust, water damage and/or extensive water usage.

It is advised that a handyman or licensed plumber be appointed to perform remedial works on the affected tap. Such works should be performed prior to the development of secondary defects to ensure adequate functionality of all associated building elements.

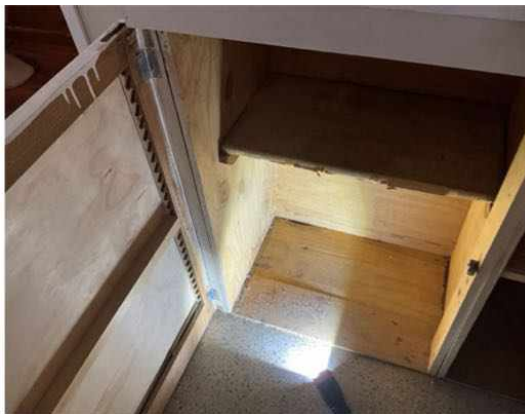
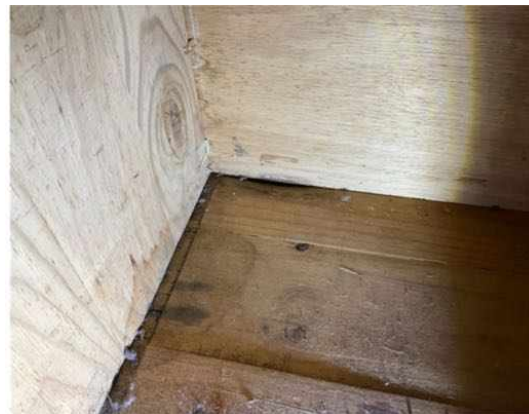
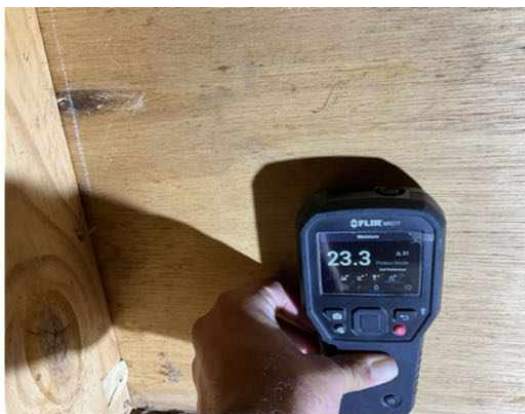
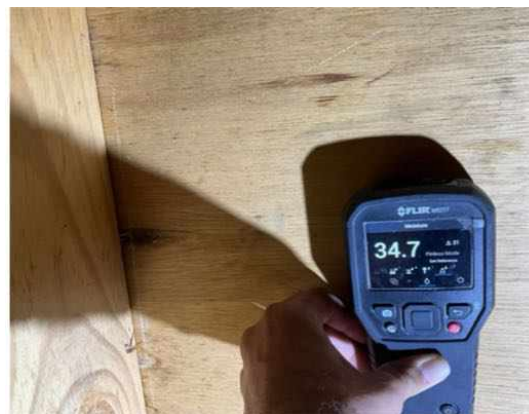
### Finding 3.09

Building:	Main Building
Location:	Laundry
Finding:	Elevated Moisture Levels Behind Shower Area
Information:	Elevated moisture levels were recorded behind the shower area at the time of inspection. This condition indicates moisture ingress within the wall cavity and is commonly associated with waterproofing failure, plumbing leaks, or deterioration of seals and finishes within the shower area.

If left unaddressed, ongoing moisture ingress may lead to deterioration of wall linings, framing, and adjoining building elements, as well as mould growth and potential health concerns. Prolonged moisture exposure can also result in more extensive and costly repairs.

It is recommended that an invasive inspection be undertaken to determine the source and extent of moisture ingress. A suitably qualified plumber and/or registered builder should be engaged to investigate and carry out any necessary repairs and remediation works.

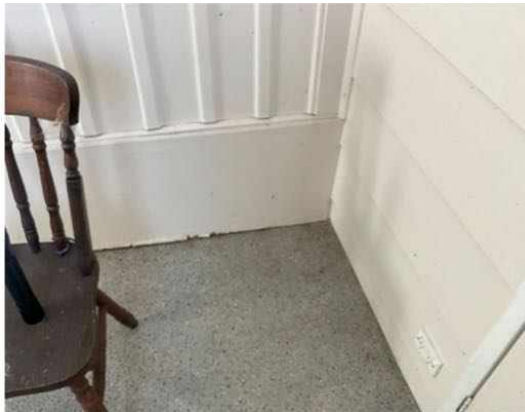
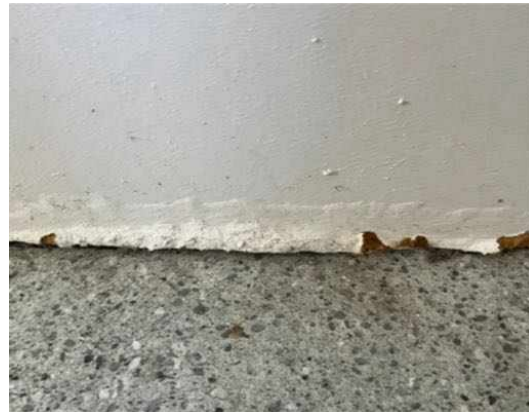
### Finding 3.10

Building:	Main Building
Location:	Sunroom
Finding:	Rising Damp to Timber Skirting

Information: Rising damp was observed affecting the timber skirting in the sub room at the time of inspection. This condition is typically associated with moisture migration from the ground through masonry or slab elements and may indicate an ineffective or deteriorated damp-proof course.

If left unaddressed, rising damp may lead to continued moisture exposure, resulting in deterioration of timber skirting, damage to adjoining wall linings, mould growth, and potential long-term impacts on internal finishes and air quality.

It is recommended that a suitably qualified contractor or damp specialist be engaged to further assess the extent and cause of the rising damp and provide appropriate remedial measures.

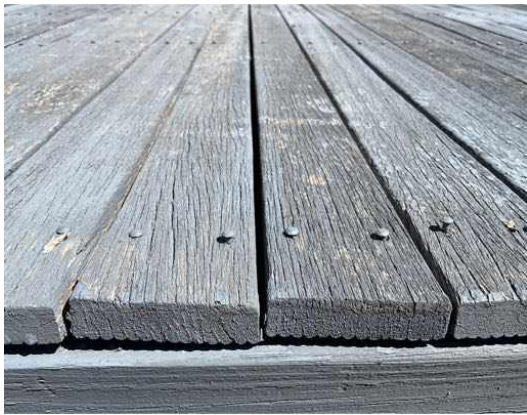
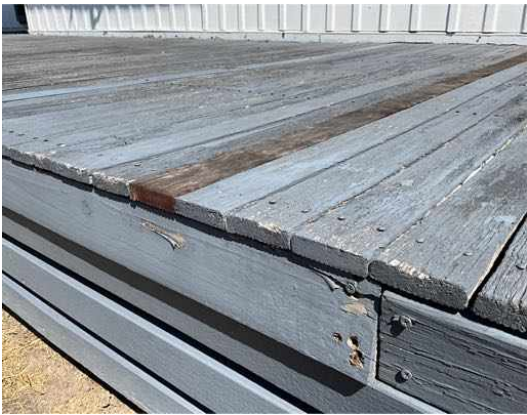
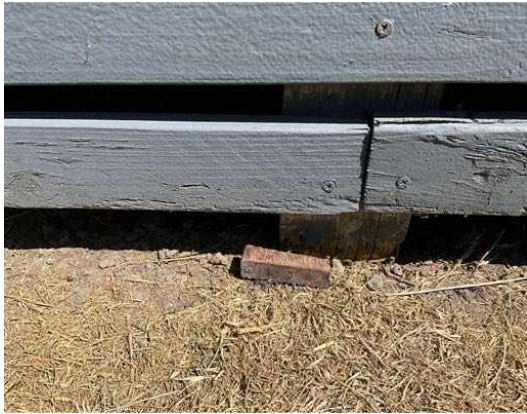
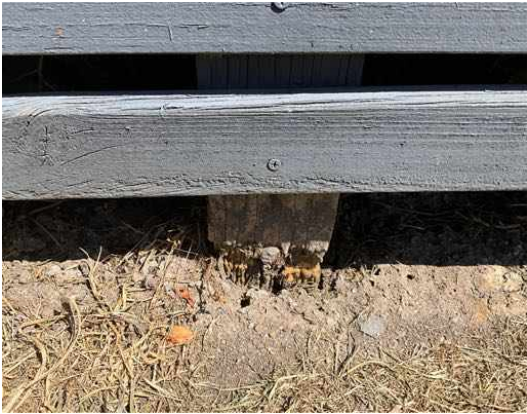
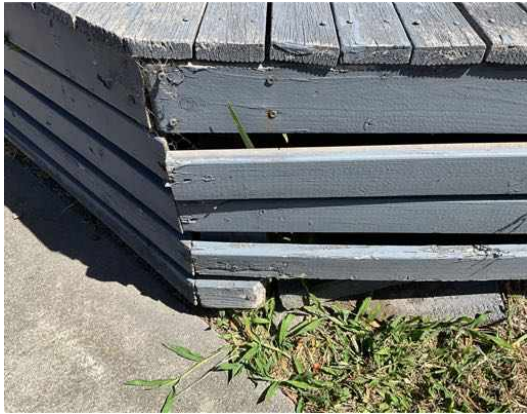
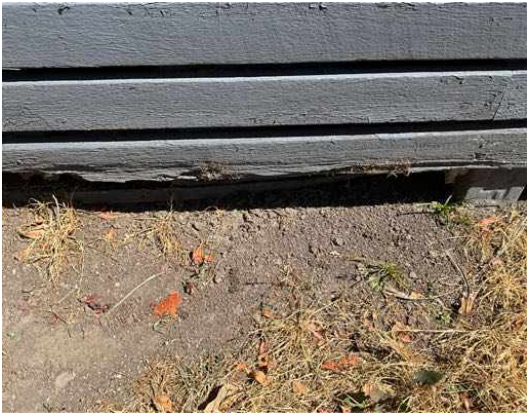
### Finding 3.11

Building: Main Building  
 Location: Deck  
 Finding: Weathered Timber Decking  
 Information: The timber decking in the deck area was observed to be weathered at the time of inspection. Surface deterioration, fading, and general wear were noted. Weathered Timber Decking, consistent with prolonged exposure to external weather conditions and a lack of recent maintenance.

Weathered timber can become more susceptible to moisture absorption, decay, and splintering. If left untreated, the deterioration may progress, potentially leading to structural weakening of the decking boards, safety hazards, and reduced overall lifespan of the deck.

It is recommended that a qualified contractor or carpenter be engaged to assess the condition of the decking and undertake appropriate maintenance. This may include cleaning, sanding, repairing any damaged sections, and applying a suitable protective coating or sealant to prolong the durability and appearance of the timber. Regular ongoing maintenance is advised.

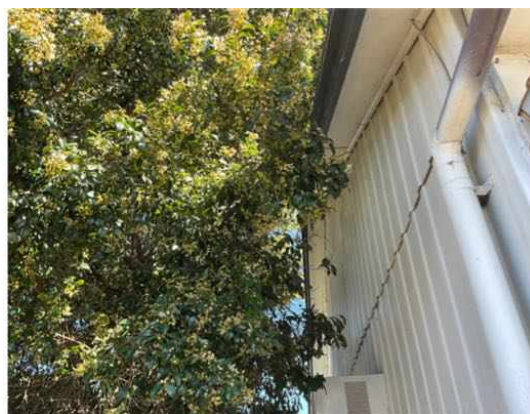
**Finding 3.12**

Building: Main Building  
Location: Exterior walls - right side  
Finding: Trees - Overhanging and filling gutters  
Information: Overhanging trees often result in excessive amounts of leaf debris accumulating in gutters.

Such works should be performed by the homeowner; however, appointment of a landscape contractor or an arborist may be required. Consultation with a licensed roof plumber is required where guttering has been damaged.

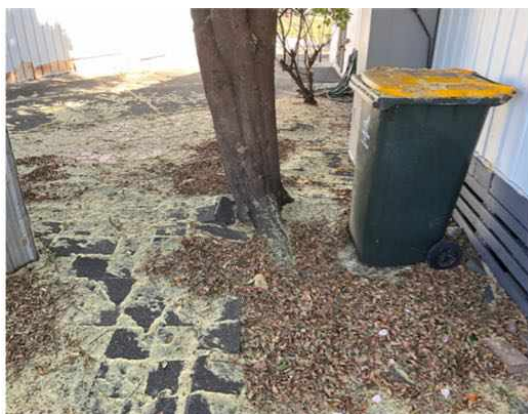
### Finding 3.13

Building:	Main Building
Location:	Exterior walls - right side
Finding:	Tree Root Growth Adjacent to Dwelling
Information:	Tree roots were observed growing close to the dwelling and were noted to be damaging sections of the surrounding paving at the time of inspection. The proximity of established tree roots to the structure increases the risk of ongoing ground movement and subsurface interference.

It is recommended that a suitably qualified arborist or contractor be engaged to assess the extent of root growth and advise on appropriate management or removal. Ongoing monitoring is also recommended to reduce the risk of future structural damage.

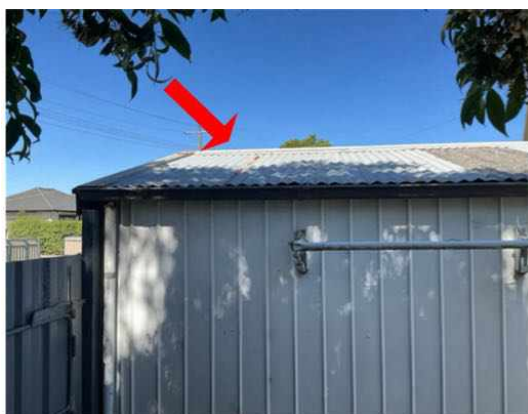
### Finding 3.14

Building:	Shed
Location:	Roof Exterior
Finding:	Corrugated Iron Roof - rusting
Information:	Rusting was observed on the corrugated iron roof in this area. The affected sections show signs of corrosion, which may be due to prolonged exposure to moisture, weathering, or inadequate drainage. Factors such as pooling water, debris accumulation, or previous damage to protective coatings could have accelerated the rusting process.

It is recommended to engage a registered roofing contractor to assess the extent of the rust and take appropriate remedial action. Minor surface rust may be treated with rust inhibitors and protective coatings to prevent further corrosion. If rust has penetrated deeper, sections of the roofing may require repair or replacement. Regular maintenance, including clearing debris and ensuring proper water drainage, can help extend the lifespan of the roof and prevent further rust development.

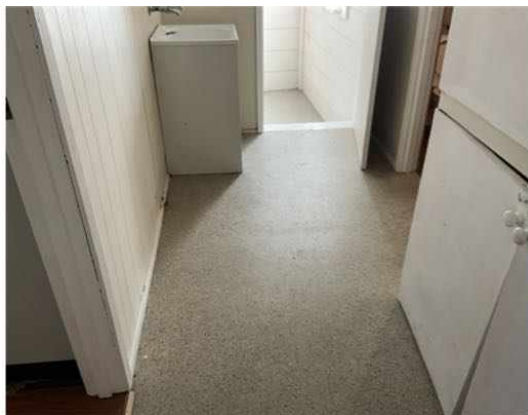
### Finding 3.15

Building: Main Building  
 Location: All Areas  
 Finding: Bouncy floor  
 Information:

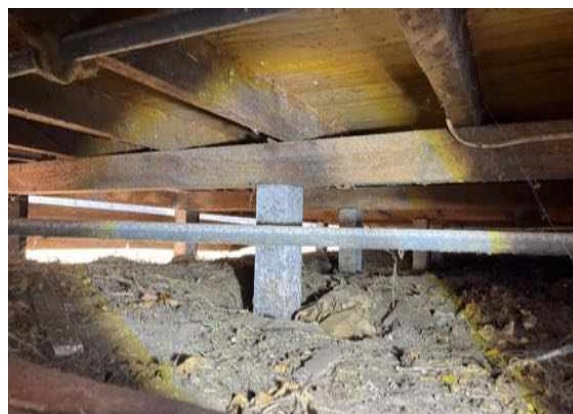
### Finding 3.16

Building: Main Building  
 Location: Subfloor  
 Finding: Backfill substandard for stumps  
 Information: Backfill was not completed around several stumps, leaving gaps and depressions in the surrounding soil. This issue is present in areas where the stumps were installed but not properly backfilled after excavation. The likely cause of this condition is inadequate soil replacement during or after the stump installation process, potentially due to time constraints, oversight, or soil compaction issues.

To address this issue, it is recommended to properly backfill the affected areas with well-compacted soil to eliminate depressions and improve drainage. Ensuring adequate grading around the stumps will help direct water away from the structure, reducing the risk of moisture-related damage. If necessary, additional drainage solutions should be considered to prevent future water accumulation. Regular monitoring of moisture levels and termite activity is also advised to protect the structural components.

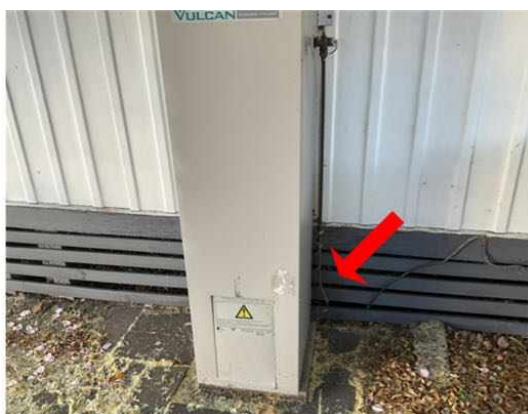
### Finding 6.02

Building: Main Building  
 Location: All External Areas  
 Finding: HWS Overflow - Not Connected  
 Information: The Hot Water System (HWS) overflow was found to be disconnected from storm water drainage and is creating excessive moisture in the surrounding area.

It is highly recommended that a licensed plumber be appointed to connect the HWS overflow in order to prevent such an environment from being created. These minor works should be carried out as soon as possible.

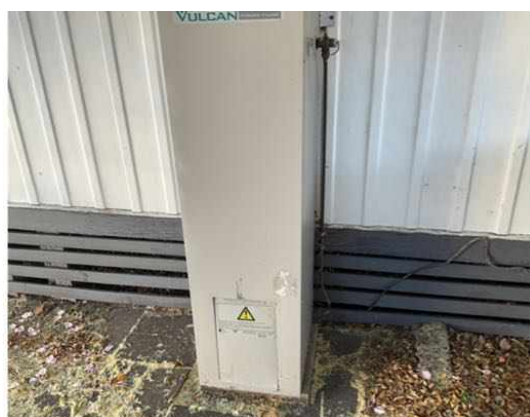
### Finding 6.03

Building: Main Building  
 Location: All External Areas  
 Finding: Bridging - Attachments to Buildings  
 Information: Bridging occurs when items against a building provide a concealed entry point for

Building attachments of this nature need to be frequently inspected for termite activity by a qualified inspector.

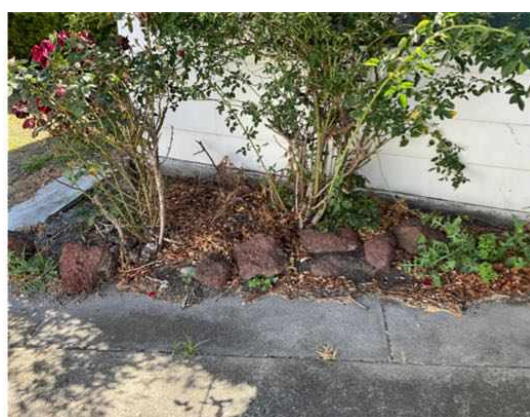
#### Finding 6.04

Building:	Main Building
Location:	All External Areas
Finding:	Garden Beds - Conditions Conducive to Termites
Information:	Garden beds were found to be evident in the garden area. These garden beds can include untreated timber, and with a combination of moisture from watering hosing can make conditions conducive to termite activity and termite ingress.

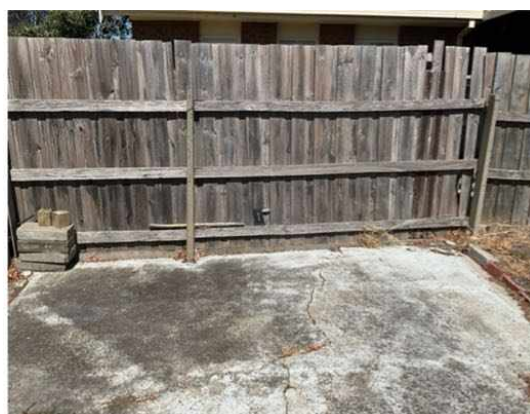
#### Finding 6.05

Building:	Main Building
Location:	All External Areas

The removal of any such materials that may be conducive to termite activity should be removed as soon as possible to minimise the risk of termite attack.

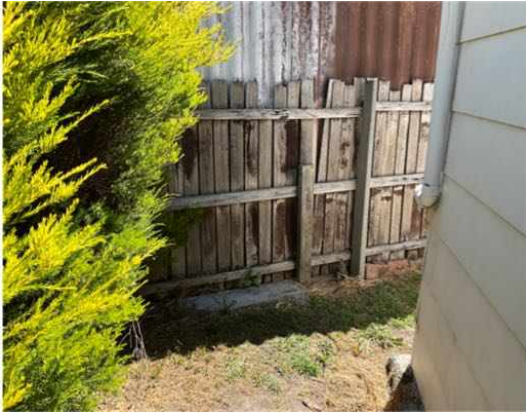
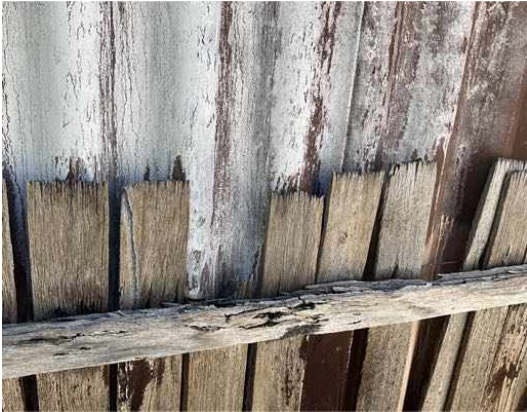
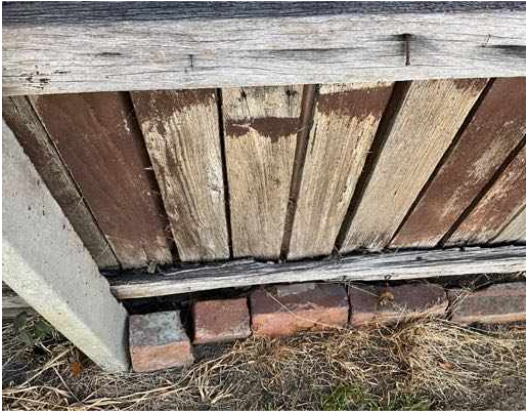
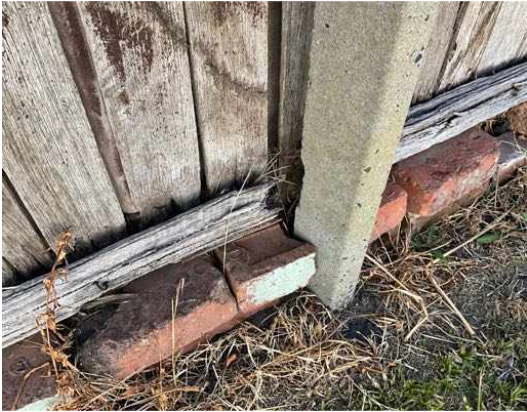
## Finding 7.02

Finding: Wood rot - Fence

building materials.

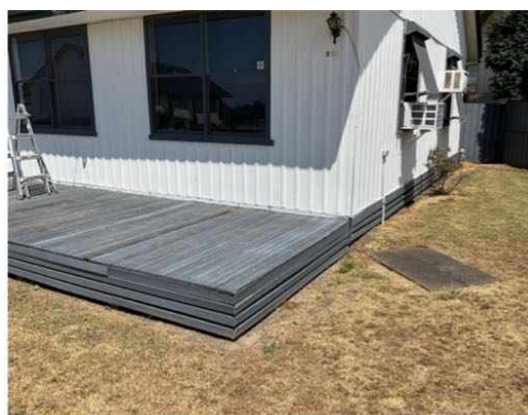
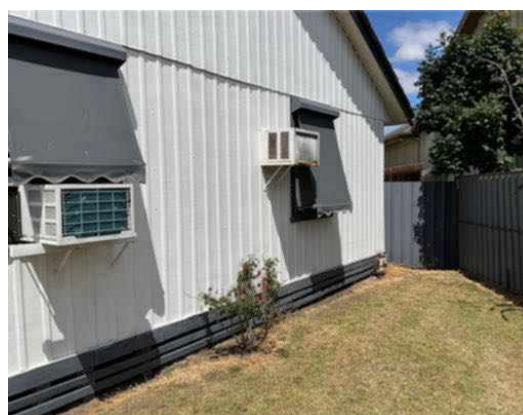
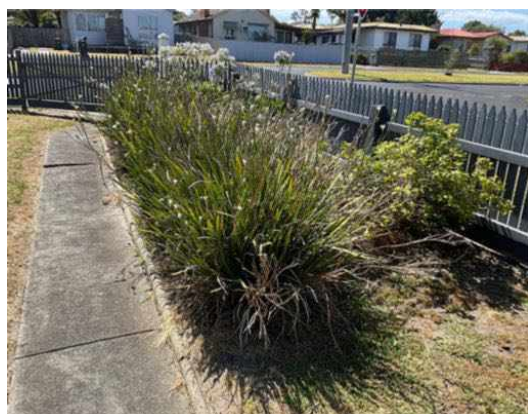
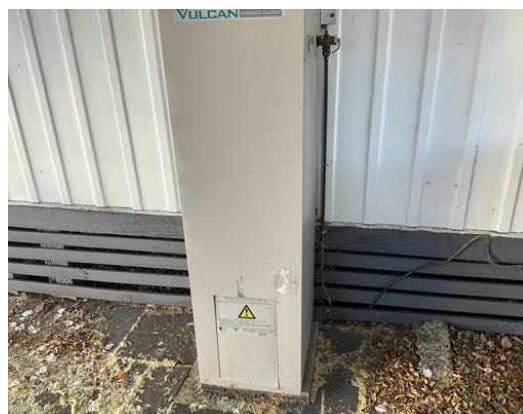
Building:	Main Building
Location:	All External Areas
Finding:	Obstructions and Limitations - External areas
Information:	These photographs are an indication of the obstructions and limitations which impeded full inspection of the external areas of the property at the time of inspection. These obstructions can hide an array of defects and should be removed to allow full inspection to be carried out. A re-inspection is recommended once the areas are made accessible.

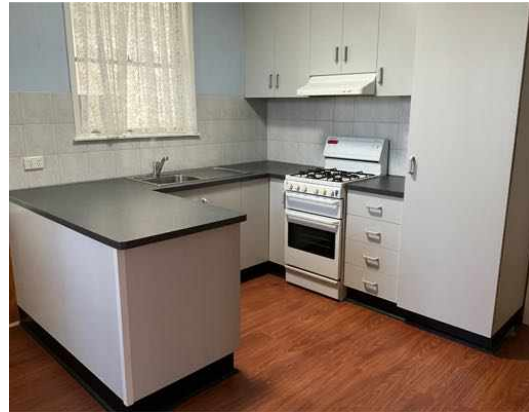
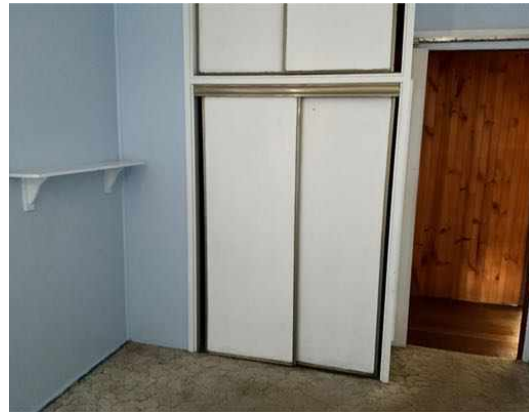
#### Noted Item

These obstructions can hide an array of defects and should be removed to allow full inspection to be carried out. A re-inspection is recommended once the areas are made accessible.

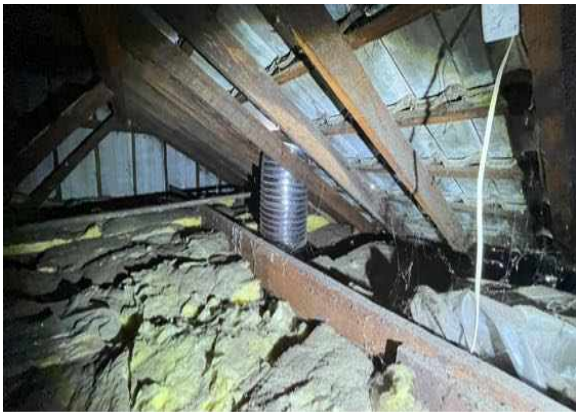
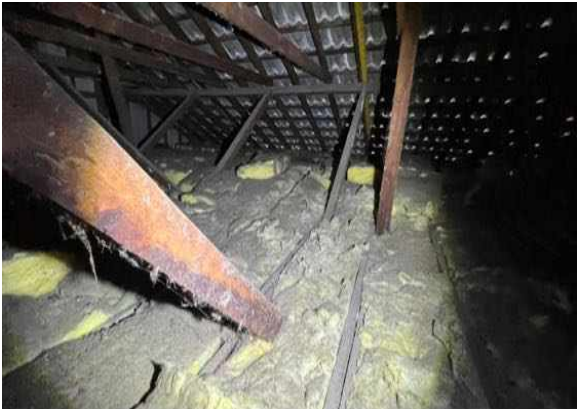
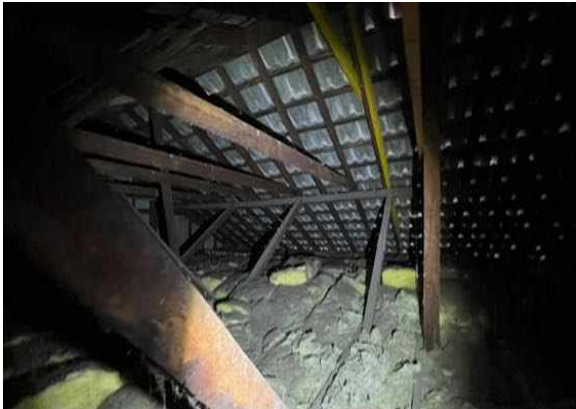
### Noted Item

Building:	Main Building
Location:	Roof Void
Finding:	Obstructions and Limitations - Roof Cavity
Information:	These photographs are an indication of the obstructions and limitations which impeded full inspection of the roof cavity of the main building at the time of inspection. These obstructions can hide an array of defects and should be removed to allow full inspection to be carried out. A re-inspection is recommended once the areas are made accessible.

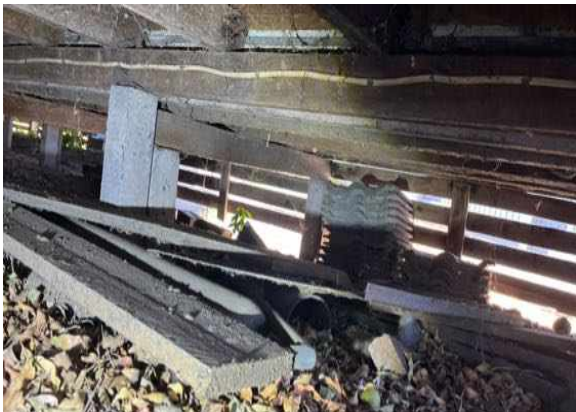
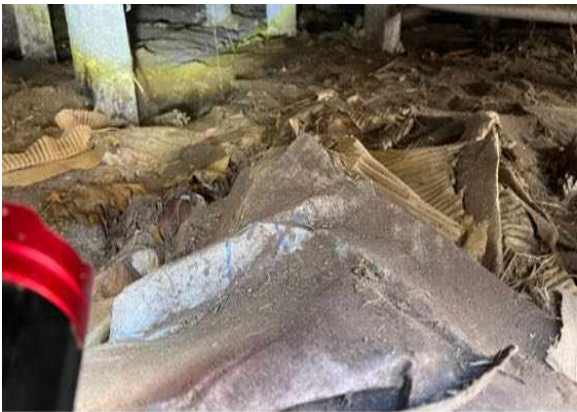
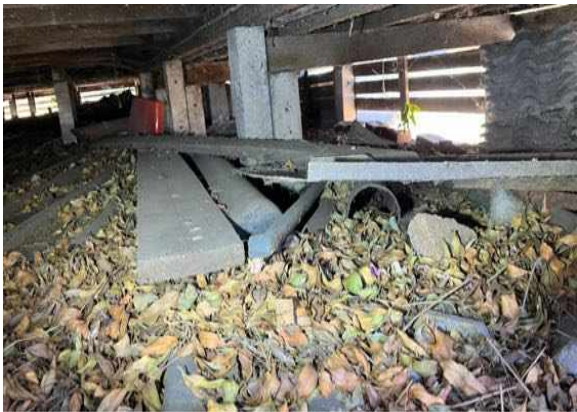
**Noted Item**

Building: Main Building  
Location: Subfloor  
Finding: Obstructions and Limitations - Subfloor  
Information: These photographs are an indication of the obstructions and limitations which impeded full inspection of the subfloor of the main building at the time of inspection. These obstructions can hide an array of defects and should be removed to allow full inspection to be carried out. A re-inspection is recommended once the areas are made accessible.
