Building and Timber Pest Inspection Report

Inspection Date: Mon, 12 Jan 2026

Property Address: 6 Frederick St, Point Frederick NSW 2250,
Australia

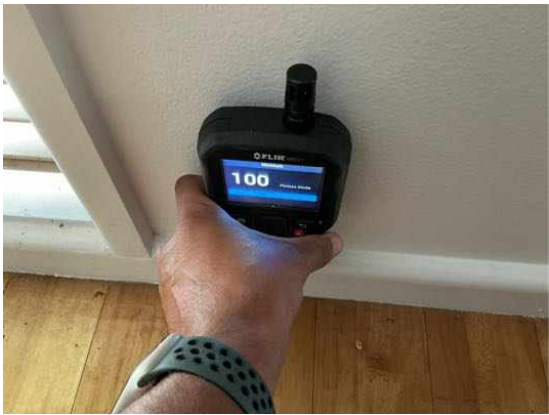
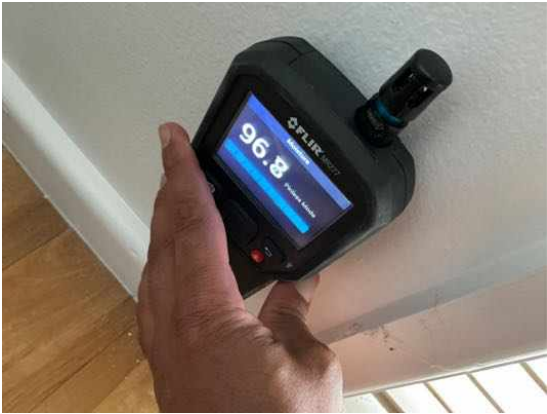
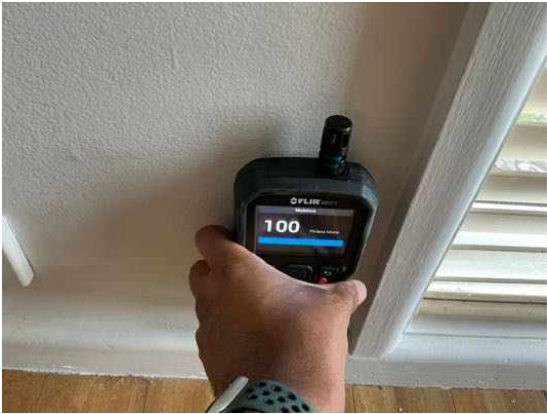
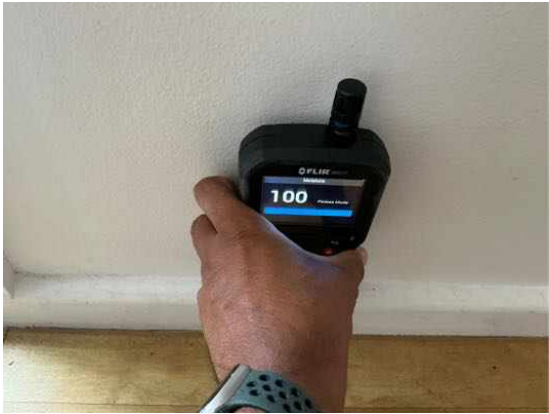
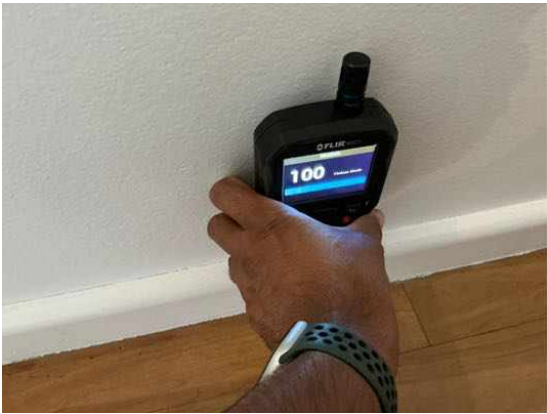
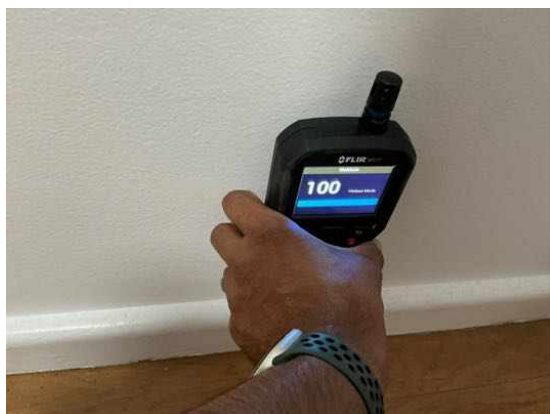
Building:	Main Building
Location:	Lounge Room, Bedroom 2
Finding:	Excessive Moisture - Walls
Information:	Excessive moisture was observed in the walls at the time of inspection, indicating potential underlying issues that could be contributing to this condition.

One possible cause is rising damp, where moisture from the ground seeps up through the brickwork due to a compromised or missing damp-proof course. Another potential factor could be water ingress from faulty or blocked gutters and downpipes, which may be allowing water to overflow and penetrate the wall. Additionally, poor drainage around the property can lead to water pooling near the base of the wall, increasing the likelihood of moisture absorption. Inadequate ventilation in the affected area could also exacerbate the problem, as it would prevent moisture from properly evaporating, leading to persistent dampness. It is essential to investigate these potential causes thoroughly to identify the source of the moisture and implement appropriate remedial actions to prevent further damage to the wall and the building's structural integrity.

The client is advised to engage services of a professional plumber to fix the issue.

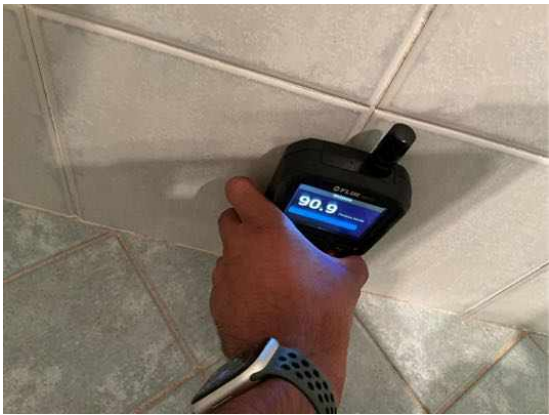
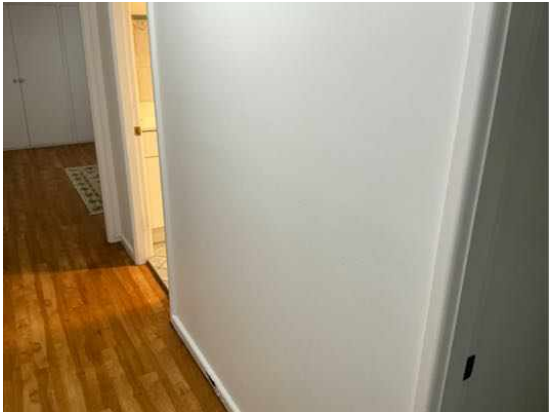
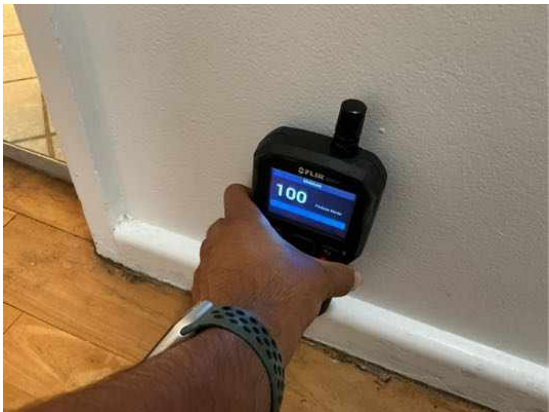
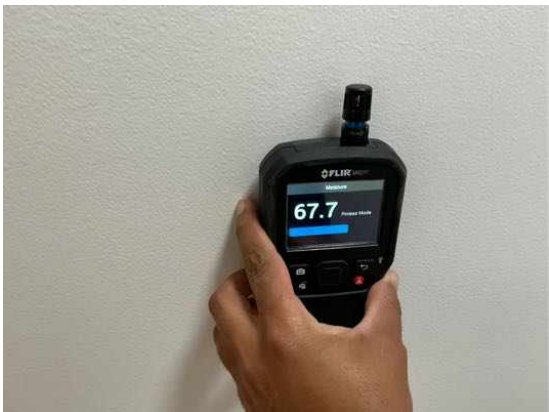
Finding 2.04

Building:	Main Building
Location:	Bathroom
Finding:	Excessive Moisture on Walls (Adjacent Bathroom) - Major Defect
Information:	A major defect was identified during the inspection, with evidence of moisture penetration noted on the walls adjoining the bathroom and shower area. These walls are shared with the bedrooms on either side of the bathroom. The presence of moisture raises serious concerns about the integrity of the waterproofing system, which is a critical component in preventing water ingress into adjoining structures.

The moisture penetration is likely due to a failure or inadequacy in the waterproofing membrane beneath the tiled surfaces in the bathroom and shower area. Waterproofing systems are designed to act as a barrier, and any breach can result in water escaping into adjacent walls. This could also be exacerbated by inadequate sealing around fixtures, joints, or tiles, which are common entry points for water. Additionally, the defect may be attributed to substandard installation practices or the natural wear and tear of waterproofing materials over time, both of which can compromise the membrane's effectiveness.

If left unaddressed, this issue could lead to significant consequences. Persistent moisture can weaken the structural integrity of the walls, resulting in costly repairs or replacement. Damp conditions also create an ideal environment for mould growth, which poses health risks and further compromises the interior condition of the property. Moreover, unresolved waterproofing issues can adversely impact the property's value and marketability.

The client is advised to use services of a professional waterproofing specialist as soon as possible.

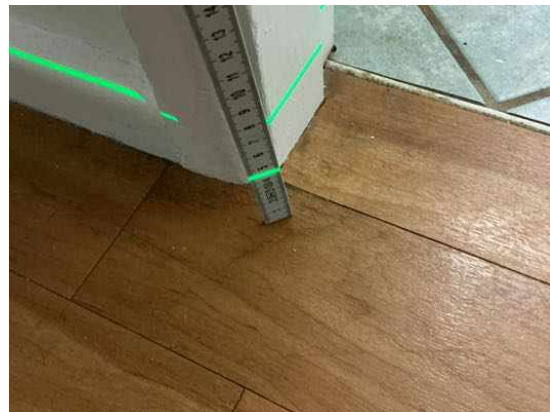
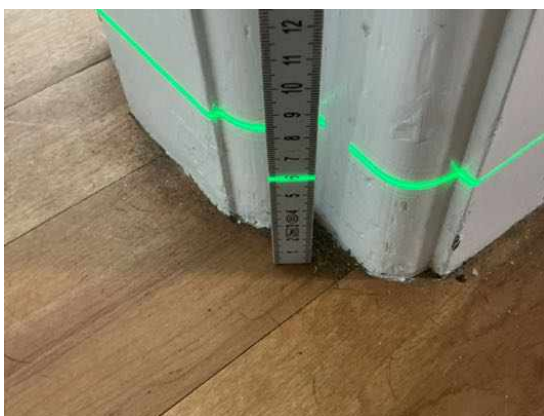
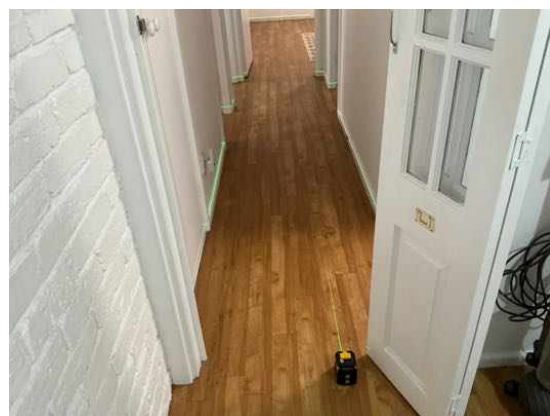
Finding 3.06

Building: Main Building
Location: Living Room, Hallway
Finding: Flooring - Uneven (Monitoring)
Information: At the time of inspection, the floor was noted to be uneven. This may be due to general movement, moisture changes, or natural settling. Uneven flooring can create trip hazards, affect how furniture sits, and may lead to further deterioration over time. The area should be monitored, and if any cracking, shifting, or worsening unevenness is observed, a builder may be required to assess and carry out any necessary rectification works at the client's discretion.

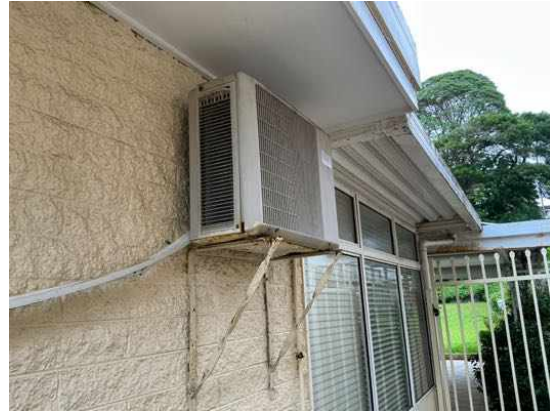
Building attachments of this nature need to be frequently inspected for termite activity by a qualified inspector.

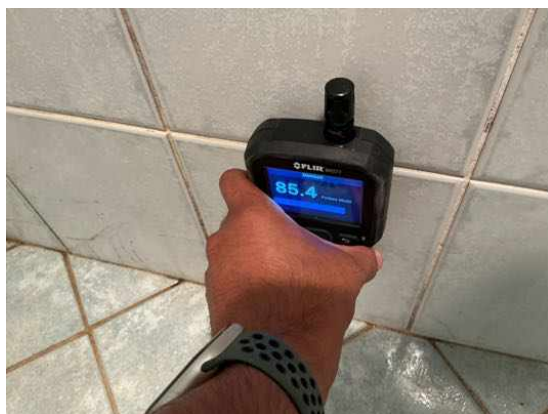
Finding: Excessive Moisture - Shower Damp

However, persistently damp conditions may act as conducive conditions for termite activity, as termites are strongly attracted to moisture-rich environments. It is recommended that the client ensures regular use of the exhaust fan and maintains adequate ventilation after shower use to promote drying and reduce long-term moisture build-up, thereby also reducing the risk of attracting termites.
