Building and Timber Pest Inspection Report

Inspection Date: Tue, 6 Jan 2026

Property Address: 17 Sharyn St, Cranbourne West VIC 3977,
Australia

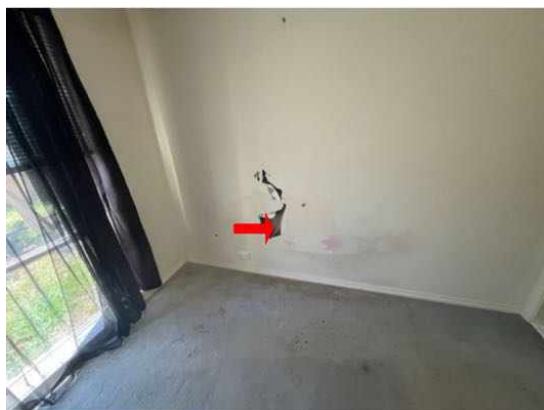
Building: Main Building
Location: Master Bedroom and Bedroom 4
Finding: Electrical TPS Cable - Unprotected
Information: Whilst inspection of electrical services and installation is outside the scope of the report, at the time of inspection an exposed TPS electrical cable was observed, due to damaged plaster including a GPO that was not fixed leaving terminals exposed, which is considered a significant safety hazard.

The likely causes appear to be due to physical damage to the wall linings which was observed in numerous locations throughout the property.

The implications of this defect include increased risk of electrical shock, cable deterioration from exposure, and potential non-compliance with relevant electrical standards..

A licensed electrician should be engaged to install suitable mechanical protection, such as conduit, and/or wall surfaces should be repaired to ensure the wiring is compliant and safe. Rectification should be undertaken as a matter of urgency due to the heightened electrical risks associated with exposed cabling and GPO terminals.

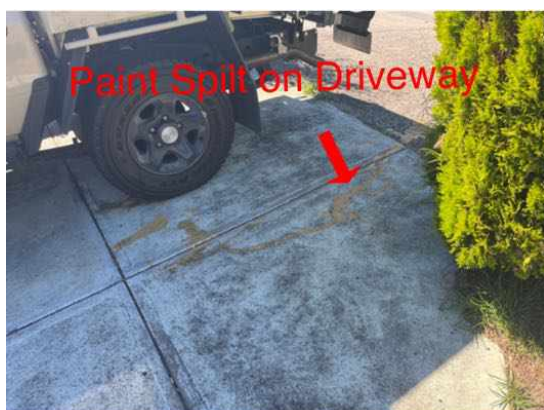
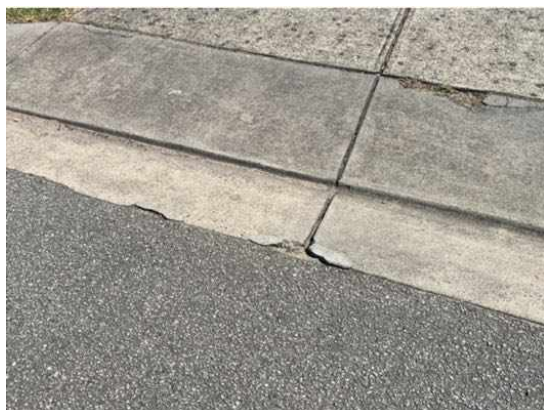
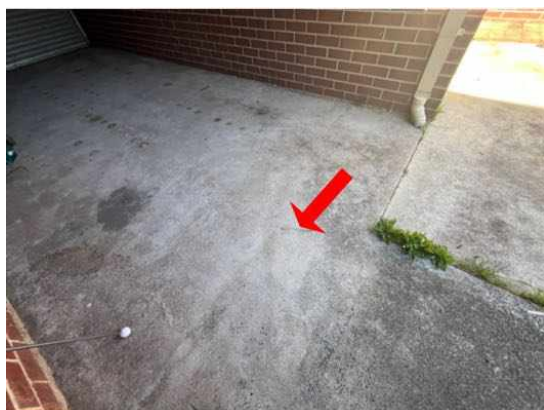
Building:	Yard
Location:	External Front & Rear
Finding:	External Concrete Paving Damage - Cracking, chipped and spilt paint
Information:	Various cracks and damage were identified in the external concrete including hairline cracks, chips and spilt paint was evident in the highlighted locations. Cracks and chips are generally found in older concrete paving, and may also present as a trip hazard where there is uneven, stepped or curved surfaces.

General age and expected deterioration of the paved areas is a common cause of this type of cracking. However, poor ground preparation, poor installation, expansion and contraction of the slab may also have occurred due to environmental factors. Such factors include variable moisture and weather conditions, the presence of trees and their roots having a settling or lifting affect on the soil, or the effect of load bearing, e.g. heavy vehicles over a sustained period of time.

Monitoring of all cracking should be conducted frequently. Always contact a building inspector should cracks inexplicably widen, lengthen, or become more numerous.

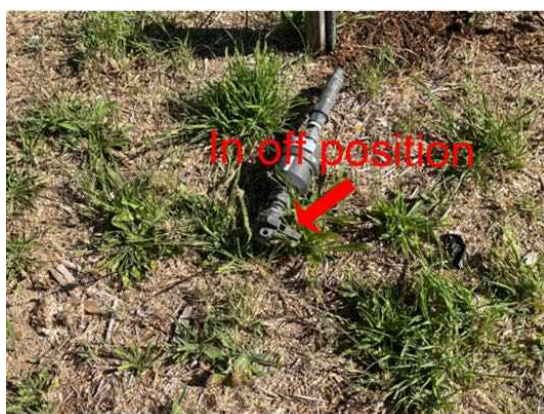
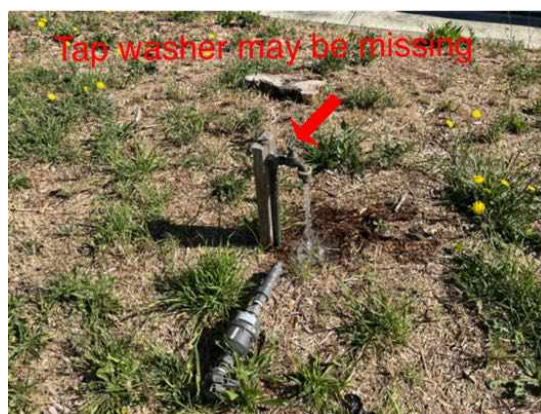
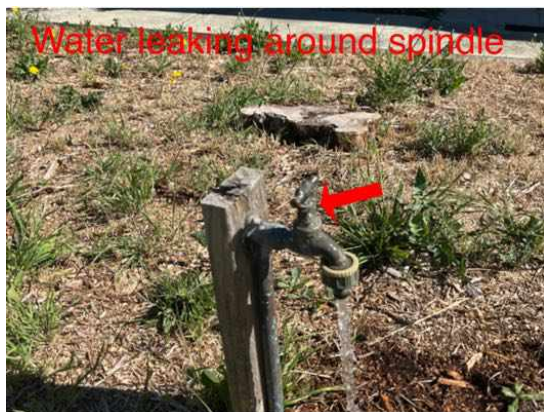
Finding 3.02

Building:	Yard
Location:	External Front
Finding:	Front Tap - Unable to control water flow
Information:	The front garden tap was observed to be unable to be fully turned off, with water control ineffective. Based on the condition and operation of the tap, the defect is suspected to be due to a missing or deteriorated internal tap washer or worn valve components or possibly the complete removal of the washer to discourage turning on of water to the property. At the time of inspection, the water supply to the property had been turned off, which prevented confirmation of active leakage at other plumbing fixtures throughout the property.

The likely causes of this defect include general wear and tear of the tap washer, age-related deterioration of internal components, removal of the washer by the vendor or poor-quality fittings. Prolonged exposure to weather and frequent use can also contribute to premature failure of external taps.

If left unrectified, this defect may result in uncontrolled water loss if the supply is turned on, increased water charges, potential water damage to surrounding structures or landscaping, and an inability to isolate water at the fixture. The inability to test the plumbing system also means any existing leaks or faults elsewhere in the property may remain undetected.

A licensed plumber should be engaged to replace the tap washer or tap assembly as required and to restore water supply so that all plumbing fixtures and pipework can be properly tested for leaks and correct operation.

Rectification should be carried out promptly and prior to occupation or normal use of the property, as the defect affects water control and prevents adequate assessment of the plumbing system.

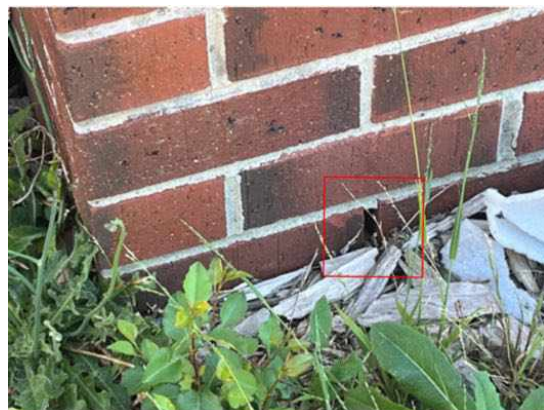
Finding 3.03

Building:	Main Building
Location:	External Front
Finding:	Weep holes blocked - Landscaping levels established at an unsuitable height
Information:	The weep holes to the brickwork are blocked due to the landscaping levels in the highlighted areas.

Weep holes are designed to allow water to escape the cavity from leaks or seepages in brickwork before the water enters in or damages the wall cavity and in particular to windows and doorways. Weep holes should be kept clean and free of debris or blockages and landscaping and paving should be installed below the bottom of the weep holes in compliance with the NCC.

The landscaping to the areas highlighted will require re-establishing in compliance with the NCC. A landscaper, builder or handy-person should be engaged to perform these works immediately to prevent any possible further damage.

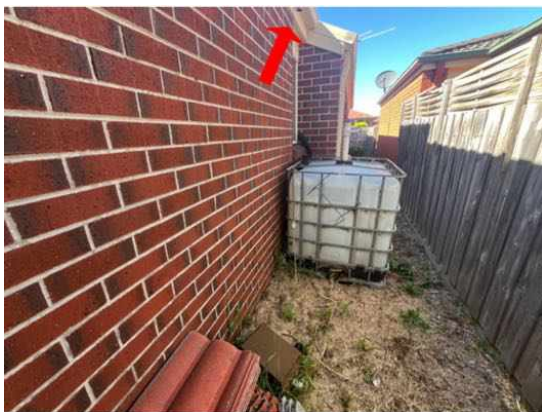
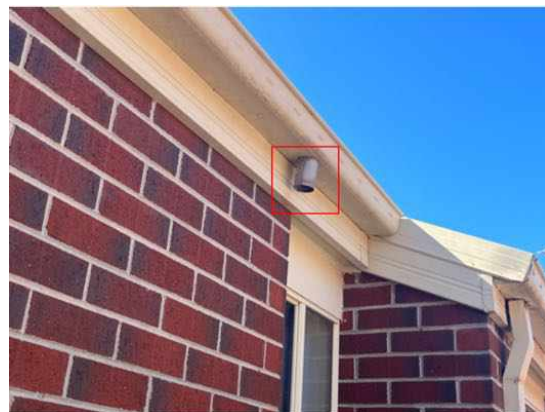
This allows stormwater to inundate the area and creates an environment conducive to timber pest activity.

Recommend engaging a plumber to rectify as a matter of urgency.

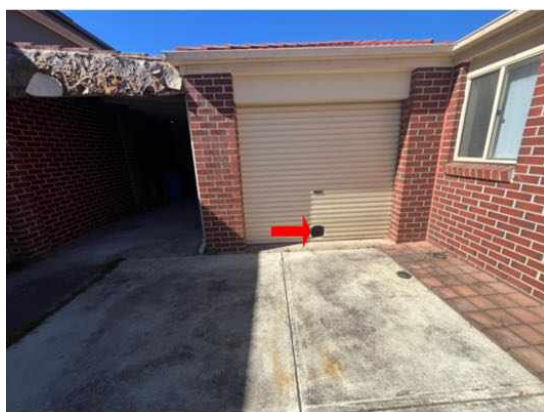
Finding 3.07

Building: Garage
 Location: External Rear

Finding: Garage Door - Hole
Information: The garage roller shutter door was observed to have a hole cut through the door curtain. The opening appears to have been deliberately created and is suspected to have been for pet access into the garage, resulting in damage to the door and loss of its original form and function.

The likely causes of this defect include unauthorised modification of the roller shutter door after installation, with the panel being cut to allow animal access without consideration for the door's design or structural integrity.

This defect compromises the security of the garage, reduces weatherproofing, and may allow vermin, pests, or unauthorised access into the garage space. The modification may also affect the operation, strength, and longevity of the roller shutter door and detract from the overall presentation of the property.

A qualified garage door contractor or suitably licensed tradesperson should be engaged to assess the damage and either repair the affected panel or replace the roller shutter door as necessary to reinstate security and proper operation.

Rectification should be undertaken in the short term, particularly if the garage forms part of the home's security envelope or provides internal access to the dwelling.

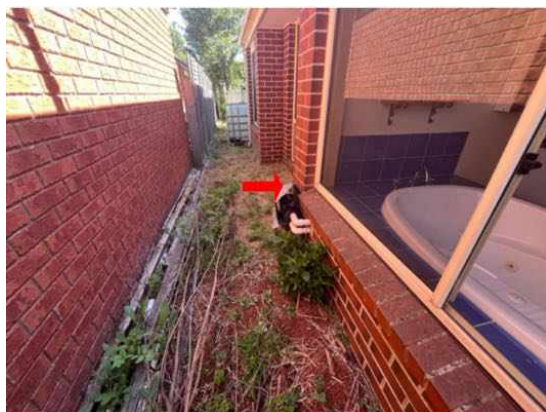
Finding 3.08

Building: Main Building
Location: External LHS
Finding: Spa Pump - Cover Detached
Information: The external spa pump motor cover was observed to have detached from the adjacent brickwork and is no longer securely fixed in place. This has left the pump motor and associated components partially exposed to the elements and potential physical damage.

The likely causes of this defect include failure or corrosion of fixings, inadequate original installation, vibration from the operating pump, or general deterioration due to prolonged exposure to weather conditions.

If left unrectified, the detached cover may allow water ingress, debris accumulation, and increased risk of electrical or mechanical damage to the spa pump motor. There is also a potential safety hazard if the loose cover falls or allows unintended access to moving or electrical components, and it may shorten the service life of the equipment.

A handy-person or qualified carpenter should be engaged to refix or replace the motor cover and ensure it is securely and appropriately mounted to the brickwork.

Rectification should be carried out in the short term to protect the equipment, maintain safe operation, and prevent further damage.

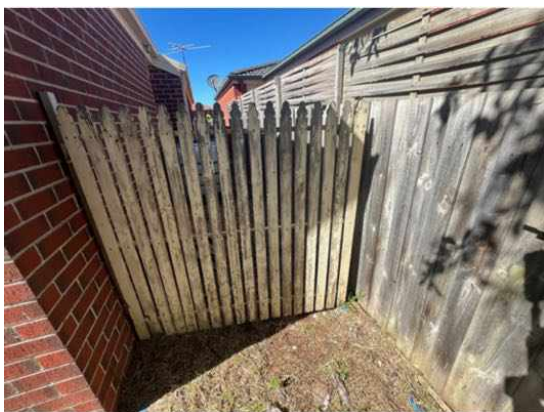
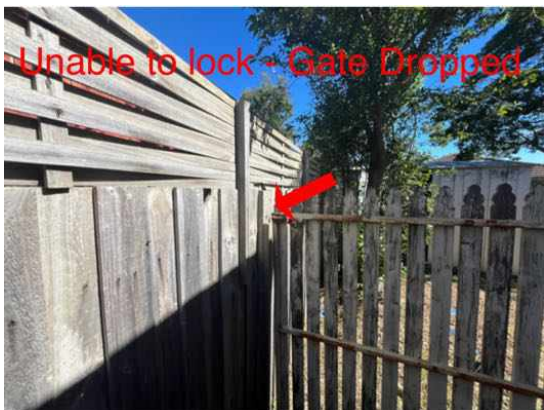
Finding 3.09

Building:	Yard
Location:	External Rear LHS
Finding:	Gates - Non-Professional construction and require repair
Information:	The gates as observed were of poor construction, were binding and not closing properly at the time of inspection.

Poor construction methodology generally indicates non-professional construction and installation that can attribute to the poor functionality and subsequent damage to fittings. Binding gates can also be attributed to seasonal variations, ground movement, poor construction & installation, and/or lack of maintenance.

Gates that do not function correctly can impact the adjoining fencing and cause nuisance and inconvenience for the occupants.

Recommend engaging a qualified fencing contractor to rectify and provide further advice at the clients discretion.

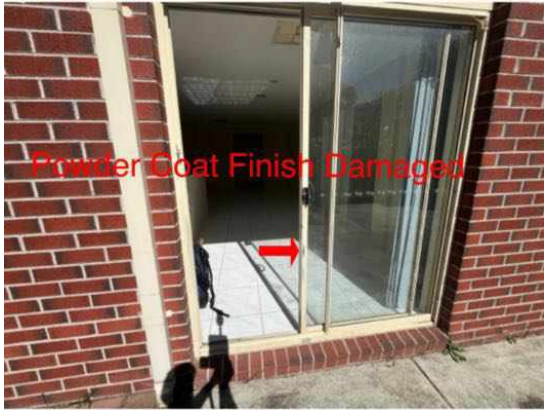
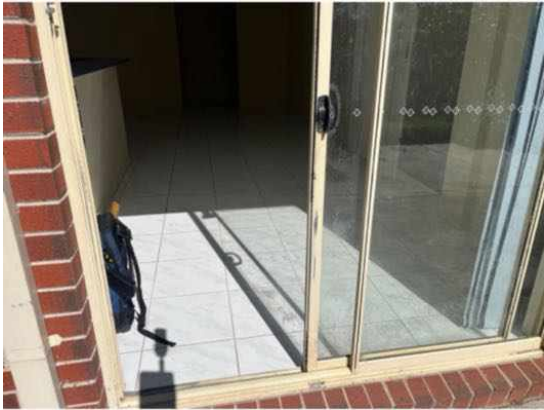
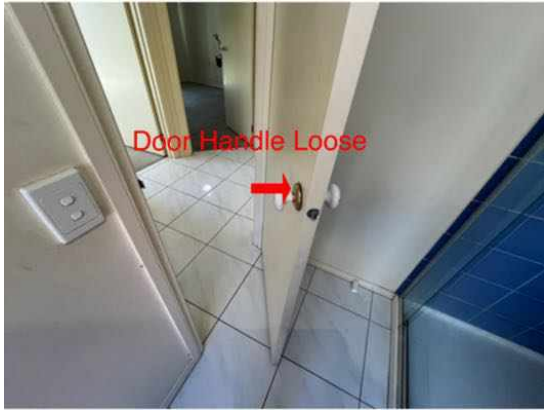
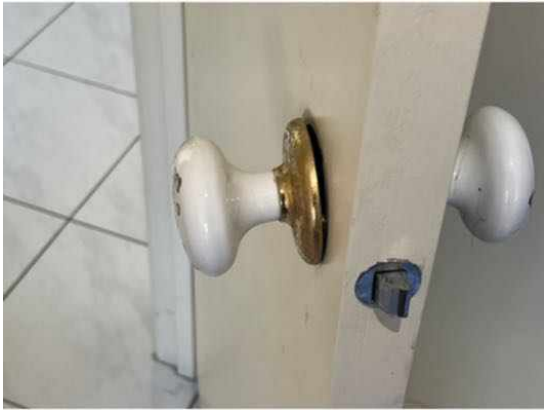
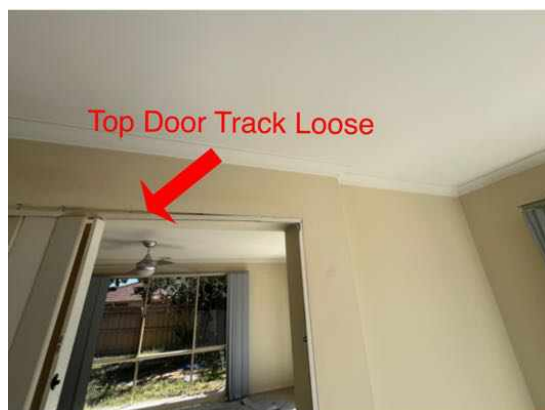
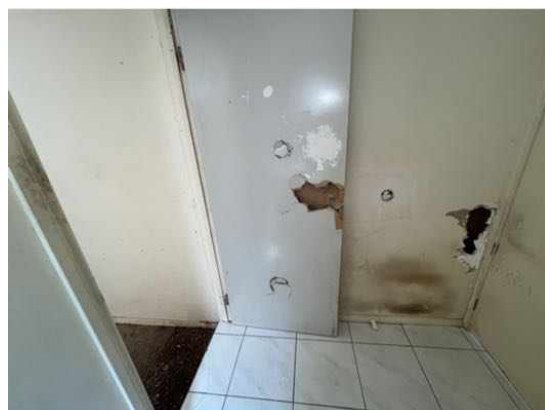
Building:	Main Building
Location:	All Internal Areas
Finding:	Doors & Flyscreen - Require general maintenance, replacement and repairs
Information:	Several doors throughout the property and a flyscreen to the bathroom were identified as requiring maintenance due to poor operation, damage and reduced functionality. Issues observed include loose hardware, misalignment, degraded seals, damaged flyscreens, moisture damage, physical damage and difficulty opening, closing, or locking.

These conditions reduce the building's energy efficiency, security, and ventilation, and may worsen and cause damage to adjoining building elements over time if not managed promptly.

We recommend that a qualified maintenance carpenter or handy-person is engaged to assess and carry out necessary repairs, replacement or maintenance to ensure all windows and doors operate smoothly, seal correctly, and meet relevant performance and safety standards.

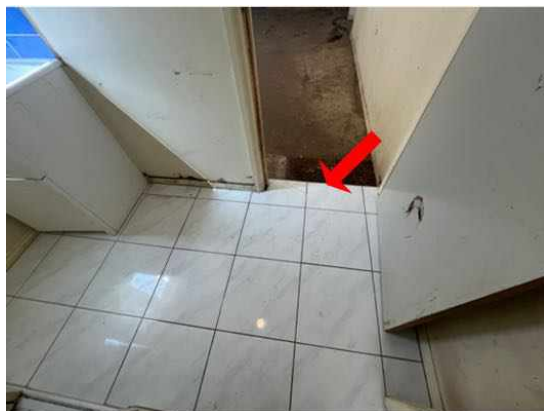
If left unmanaged, water penetration to this area may lead to subsequent further water damage.

A tiling contractor should be appointed in a timely manner to ensure that no further water damage occurs. The re-application of silicone and grouting throughout remaining tile work and around the fixtures is also advised, to further protect the area against water penetration.

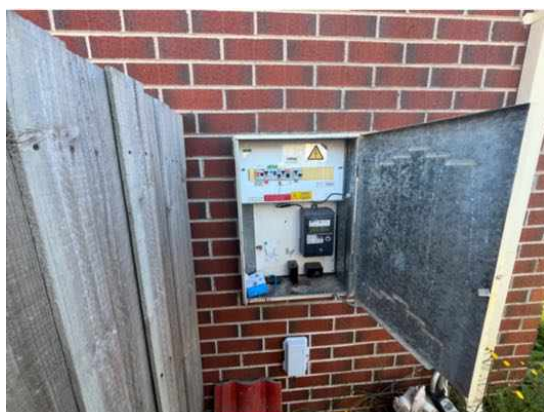
A durable notice should be placed in the switchboard unit to indicate current termite barriers. At the time of inspection, it appeared as though no termite management system has been installed, with no evidence to suggest preventative works taking place.

The client may consider gaining further advice from a pest controller as to the costs and procedures involved with this application. It is recommended that obtaining such advice be a short-term priority.

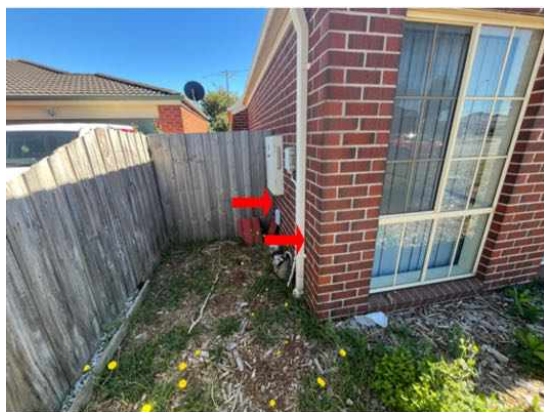
Finding 6.02

Where any part of an attachment to a building is not isolated and is not provided with a clear gap of not less than 25mm from the building, bridging occurs. Attachments to buildings such as hot water services, downpipes, verandahs, decks, steps, fences, service conduits and the like provide the opportunity for concealed entry.

Building attachments of this nature need to be frequently inspected for termite activity by a qualified inspector.

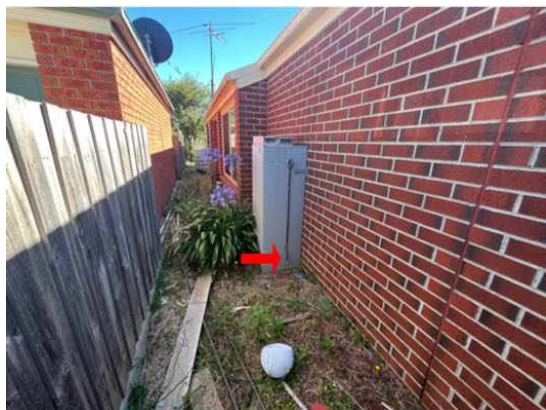
Finding 6.03

Building:	Main Building
Location:	External LHS
Finding:	Hot Water Service TPRV Drain - Discharging against the building
Information:	The hot water service temperature and pressure relief valve (TPRV) drain was found to be installed in a manner that will discharge against the building and may create excessive moisture in the surrounding area.

termite activity to this area.

It is highly recommended that a licensed plumber be appointed to connect the TPRV drain to stormwater in order to prevent such an environment from being created. These works should be carried out as soon as possible.

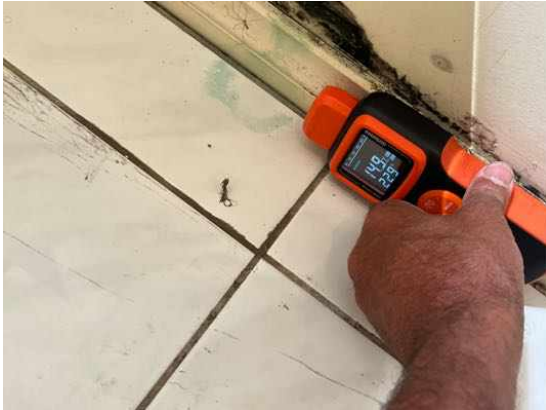
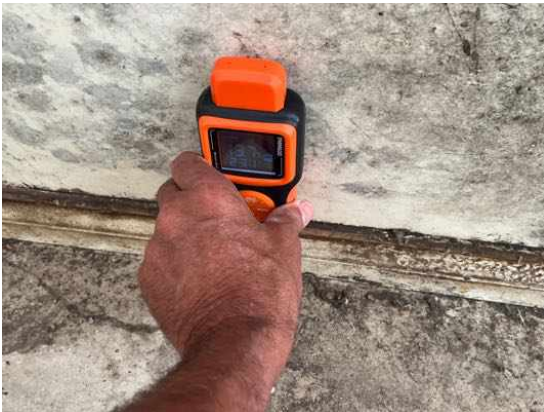
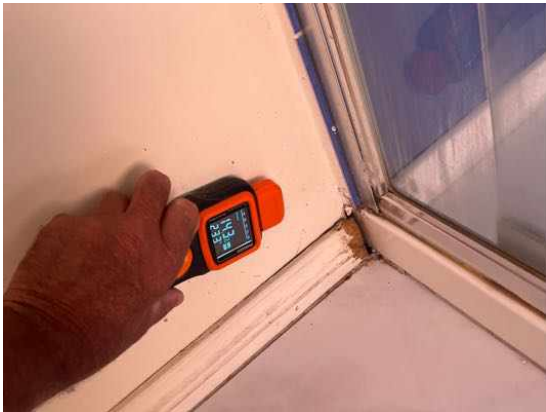
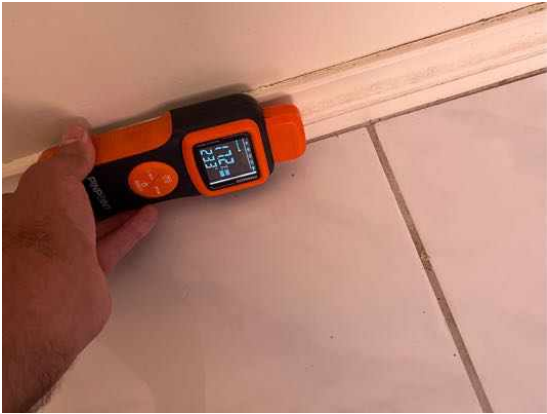
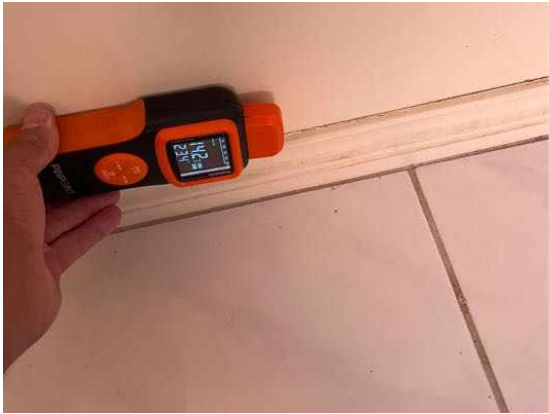
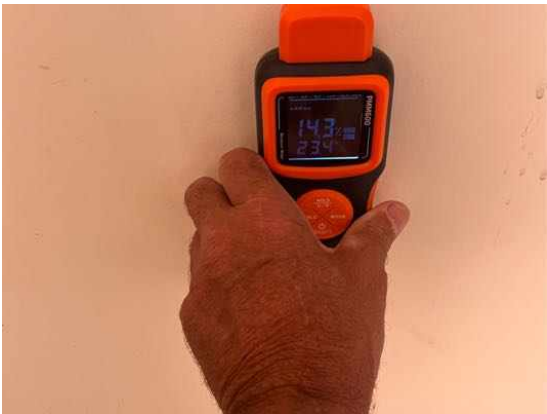
Building: Main Building
Location: All Internal Areas
Finding: Additional Photos - Moisture readings - Vacant Property
Information: Additional photos of some of the relative moisture readings taken around the wet areas. Whilst there were some indications of slightly elevated moisture readings, it was evident that the wet areas have not been used recently and the water was turned off to the property. It is recommended that the wet areas and any adjoining walls outside these areas are regularly monitored during occupation and use, and if an increase is observed a further building inspection should be performed immediately to provide further advice.
