Building and Timber Pest Inspection Report

Inspection Date: Mon, 23 Mar 2026

Property Address: 1/4-5 Dean Cres, ERMINGTON, NSW,
2115, Australia

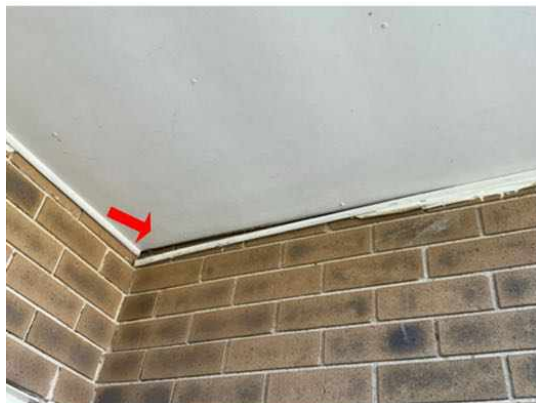
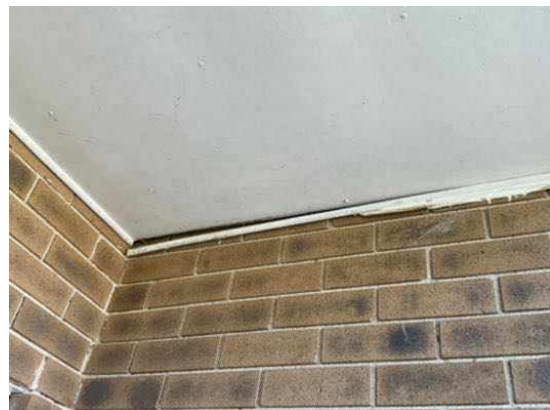
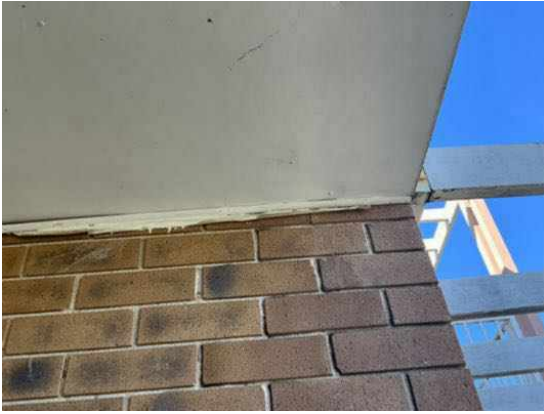
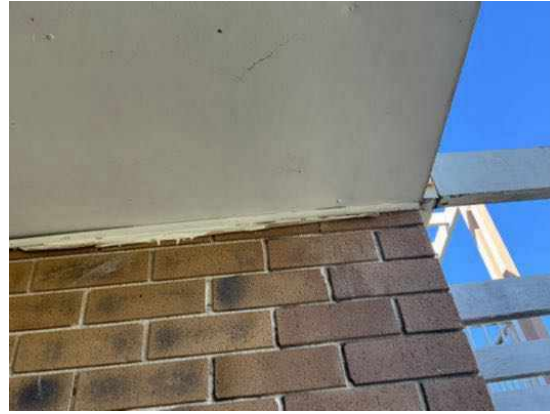
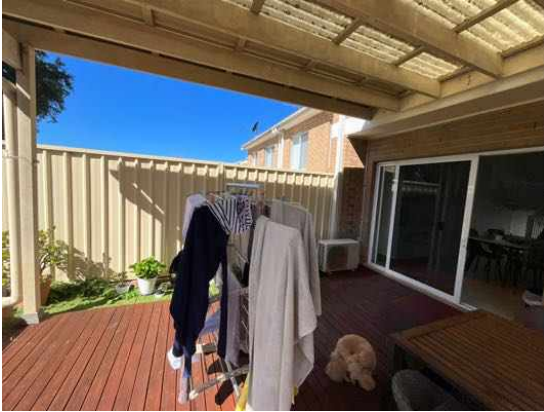
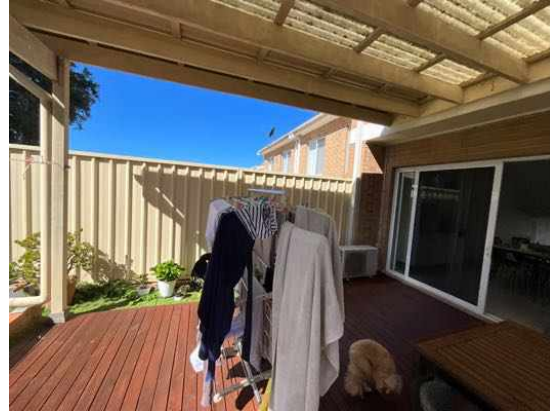
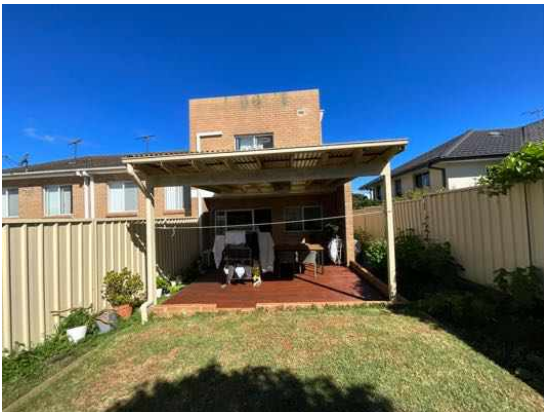
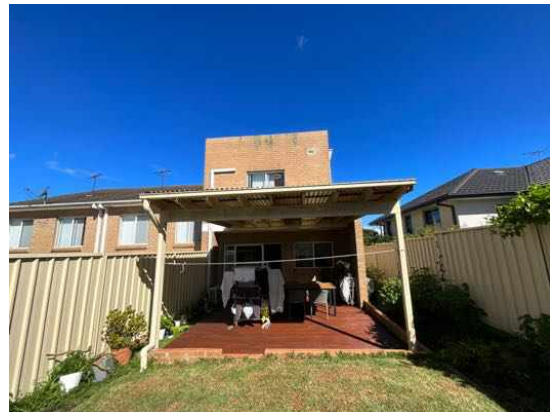
Finding 3.01

Building: Main Building
Location: Front porch
Finding: Timber - exposed to weather
Information: External timbers that are frequently exposed to harsh weather conditions require adequate protection in order to maintain their condition. Where timbers have not been painted or treated adequately, general deterioration is likely to occur at an accelerated rate.

If left unattended, replacement of these timbers is likely to be necessary in the short-term future. Adequate treatment of these timbers is required as soon as possible by a painting contractor or general handyman.

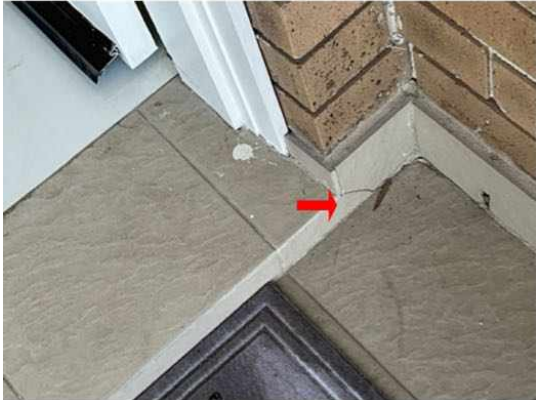
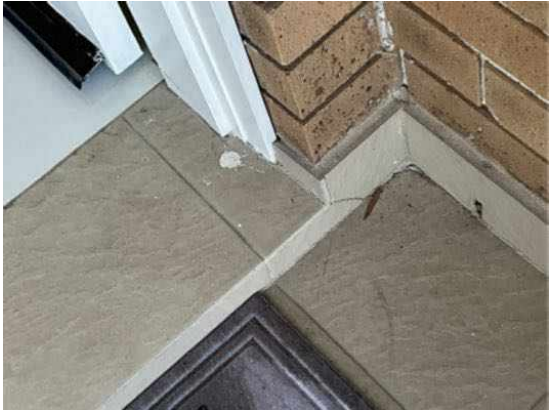
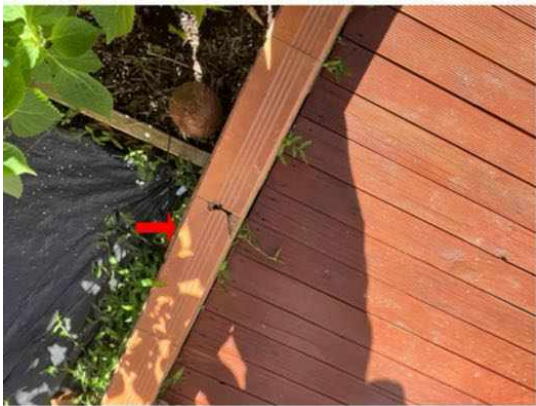
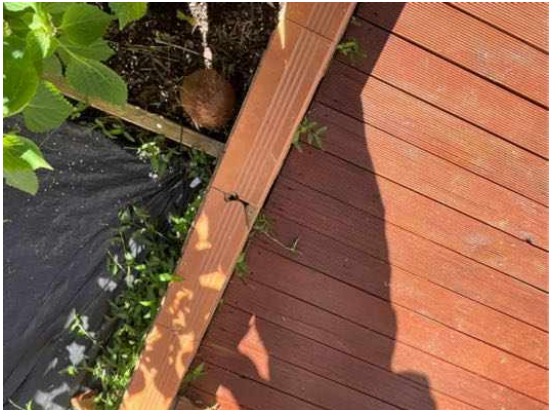
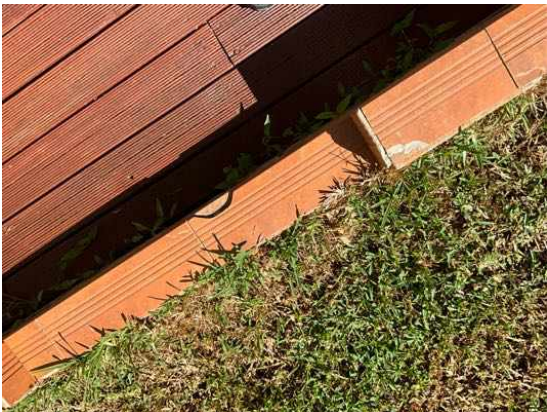
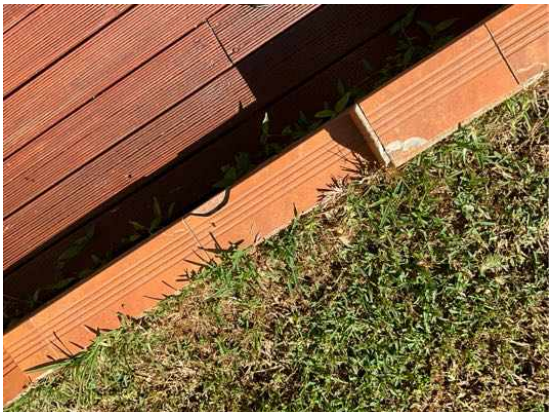
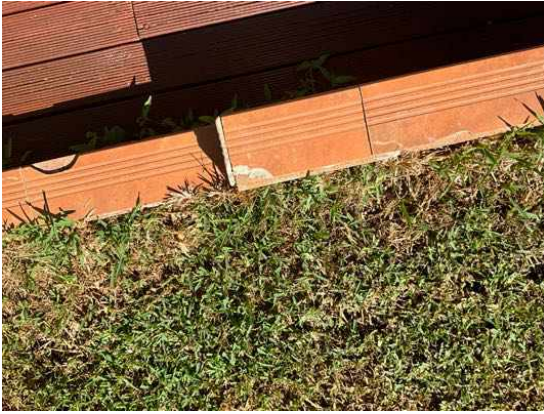
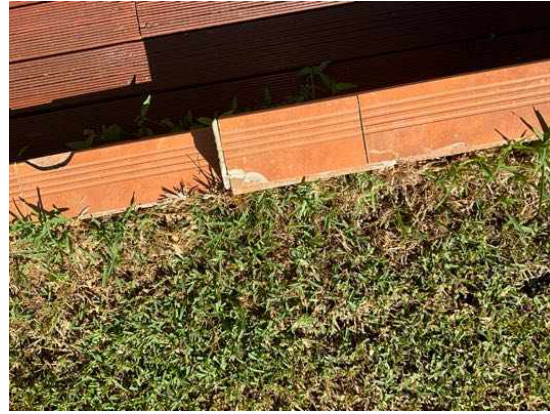
Finding 3.02

Building: Main Building
Location: All Areas
Finding: Floor Tile crack
Information: A floor tile has a visible crack on the surface.

The damaged tile presents a trip hazard, may lead to cuts if stepped on barefoot, and can allow moisture ingress into the substrate, which may cause further deterioration or loosening of adjacent tiles. It also affects the overall appearance of the floor.

A licensed tiler should be engaged to remove the damaged tile and install a matching replacement. If spare tiles are unavailable, additional remedial work may be required to blend the repair with surrounding finishes.

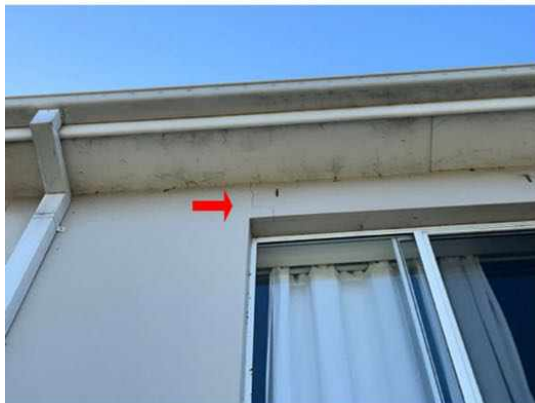
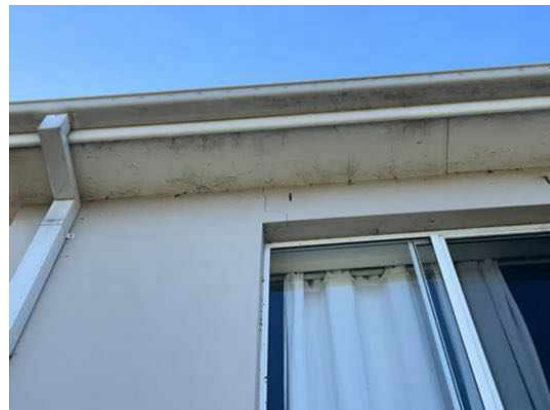
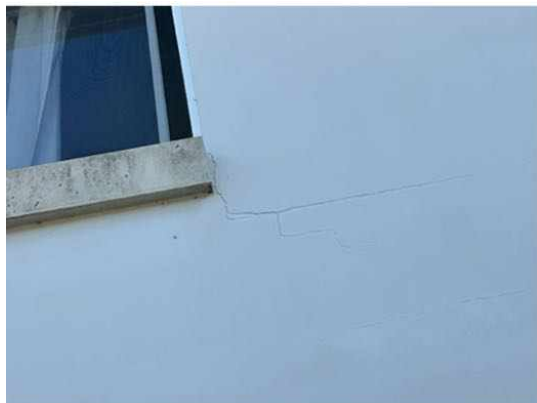
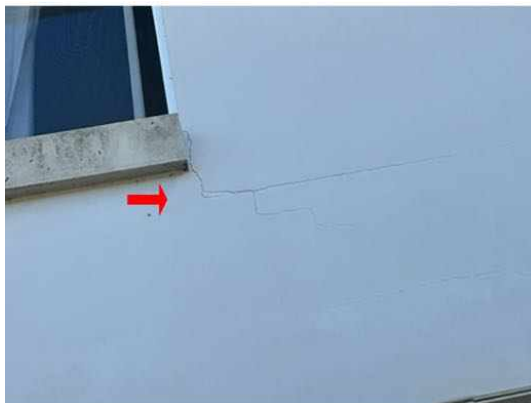
Finding 3.03

Location: Front Elevation

Finding: Brickwork - Cracking [Fine]

Information: Although fine cracks are quite noticeable, they are often only considered to be an appearance defect and usually do not indicate any structural damage. Generally, the cause of a fine crack is indicative of a separation between brickwork and mortar throughout the structure, but single bricks may also show cracks of this nature.

Cracking of this nature can generally be repaired with minor filling and should be conducted by a qualified bricklayer.

Always contact a building inspector should cracks widen lengthen or become more numerous.

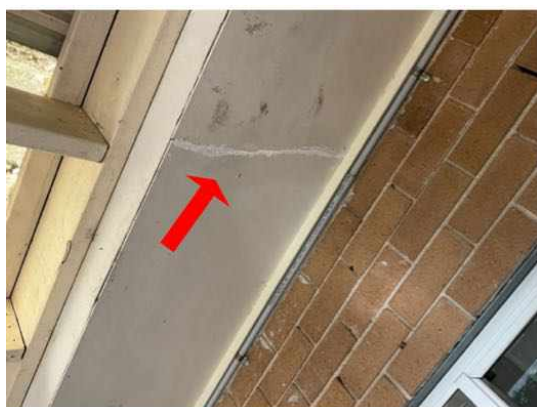
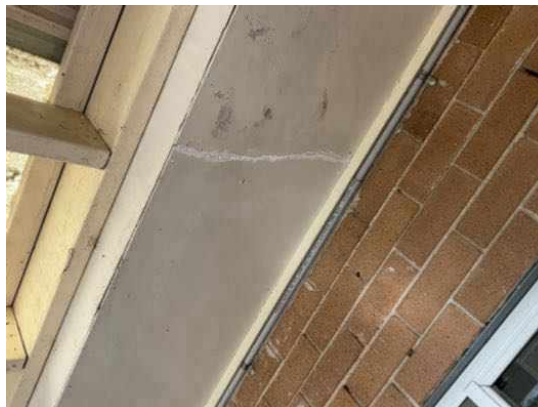
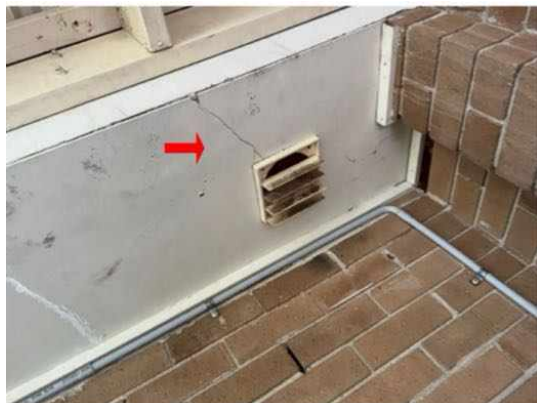
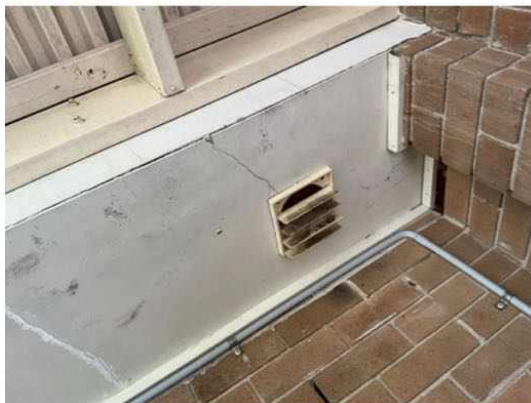
Finding 3.04

Building:	Main Building
Location:	Exterior walls - rear
Finding:	Cracking - Damage Category 1 - Fine (up to 1mm)
Information:	Although fine cracks are quite noticeable, they are often only considered to be an appearance defect, and usually do not indicate any structural damage. Generally, the cause of a fine crack is indicative of a separation between building materials and finishes (e.g. paint, plaster, etc.) along joins.

Cracking of this nature can generally be repaired with minor sanding, filling and/or repainting. Such works should be performed by a qualified painter or a general handyman.

Monitoring of all cracking should be conducted frequently. Always contact a building inspector should cracks widen, lengthen, or become more numerous.

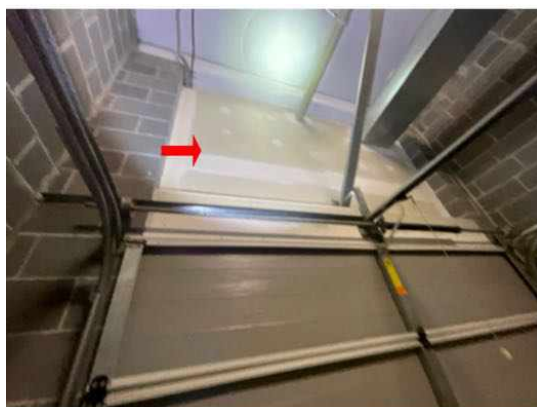
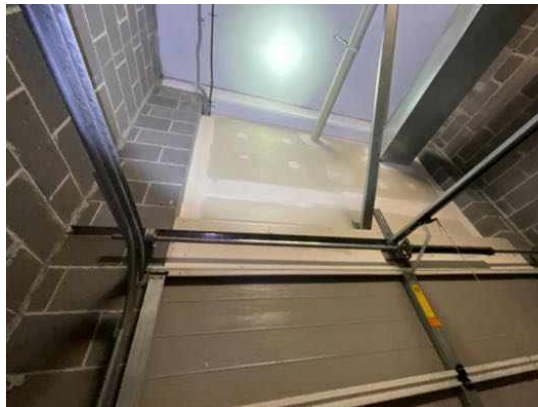
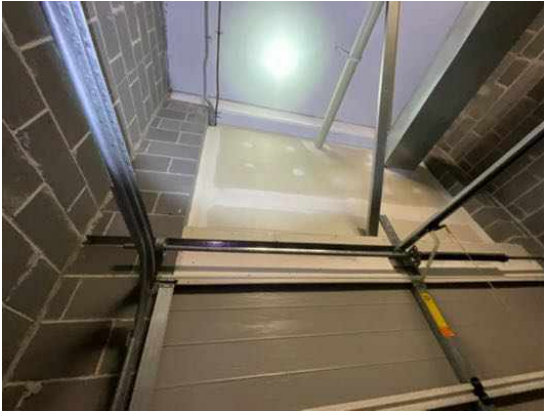
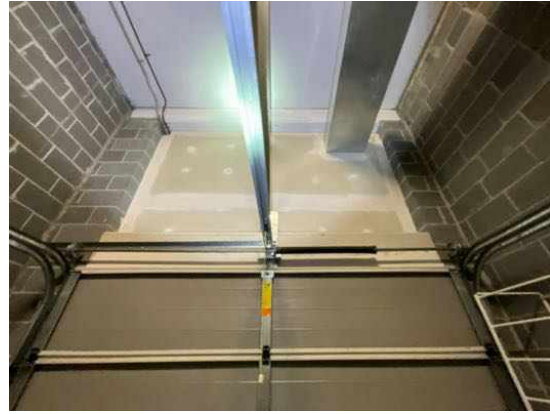
Finding 3.05

Location: Garage

Finding: Paint - Substandard

Information: Areas were identified where the surface finish of the painting is substandard and this is considered a defect.

Defective surface finish of paintwork is marked with an arrow to the below photos in the following locations.

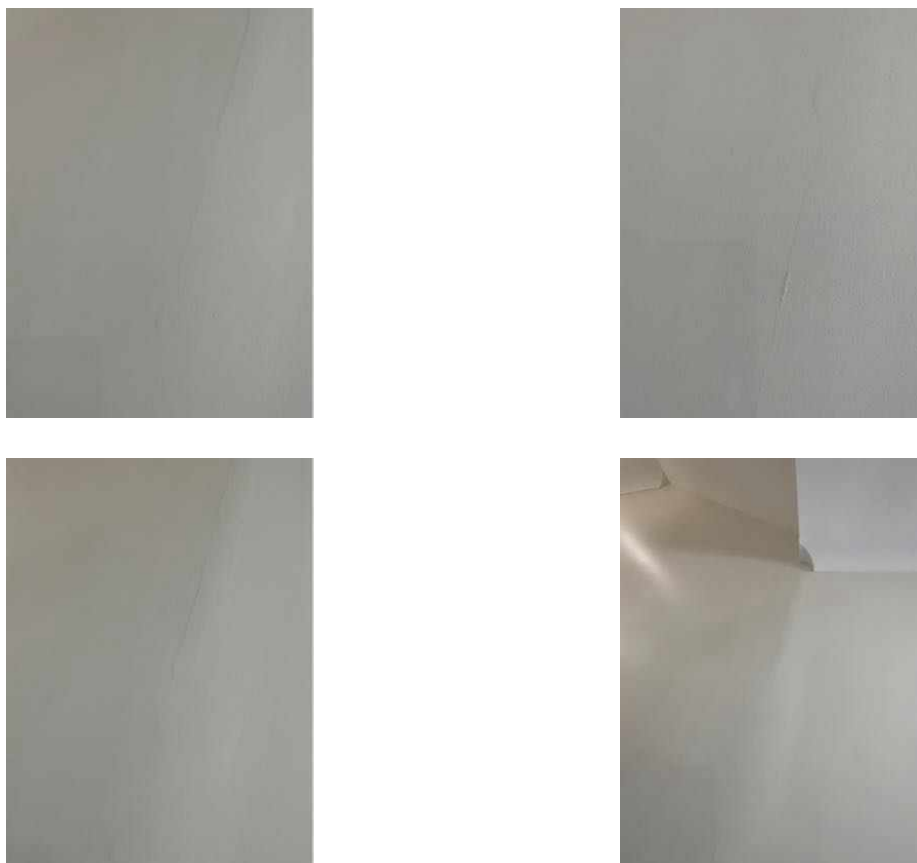
Finding 3.07

Location: Living Room

Finding: Gyprock - Fine Cracking

Information: Fine cracks were observed in the plasterboard wall. These cracks are likely due to minor building movement or settlement and are generally considered cosmetic in nature.

- Primarily aesthetic, but may worsen over time with further movement.
- No immediate structural concerns.

- A licensed plasterer or painter can fill the cracks with a flexible compound and repaint the affected area.

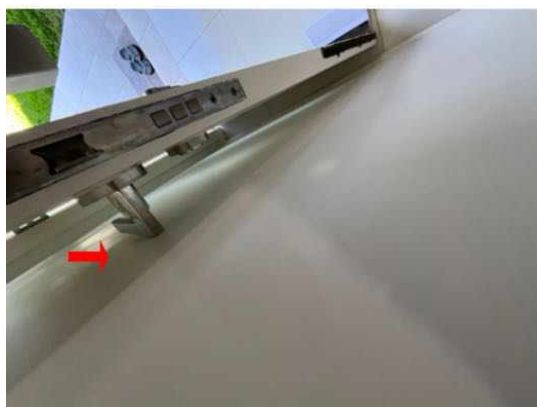
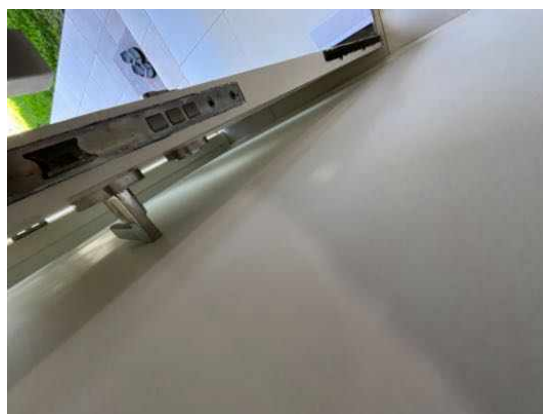
Finding 3.08

Building: Main Building
 Location: Front door
 Finding: Missing Door Stopper
 Information: The door lacks a stopper, which is essential to prevent the door from swinging too far and potentially damaging the wall or the door handle. The absence of a door stopper increases the likelihood of impact damage to both the door and surrounding surfaces over time.

- **Damage Risk:** Moderate risk of damage to the door handle, wall, or door itself from repeated impacts when the door is opened forcefully or by a gust of wind.
- **Wear and Tear Risk:** Increased wear on door hardware and hinges due to the potential for abrupt stops without a dedicated stopper.

This issue is a minor defect but should be addressed to prevent potential damage and

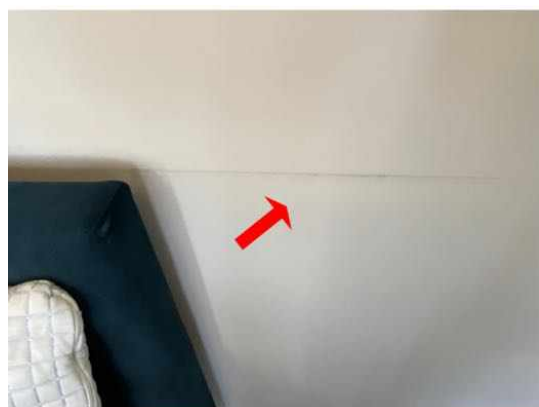
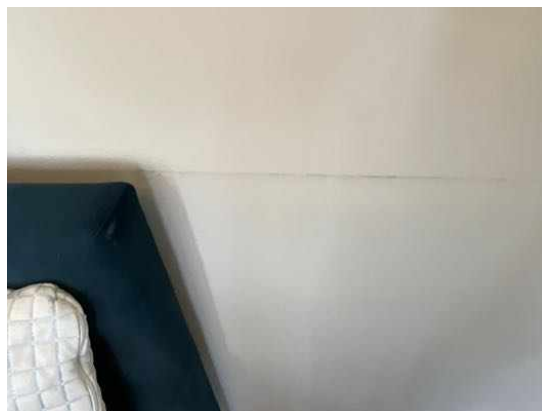
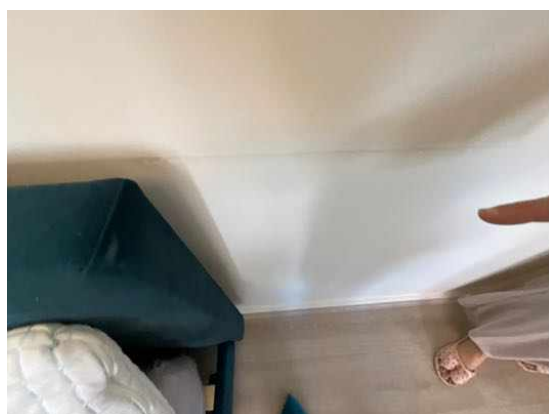
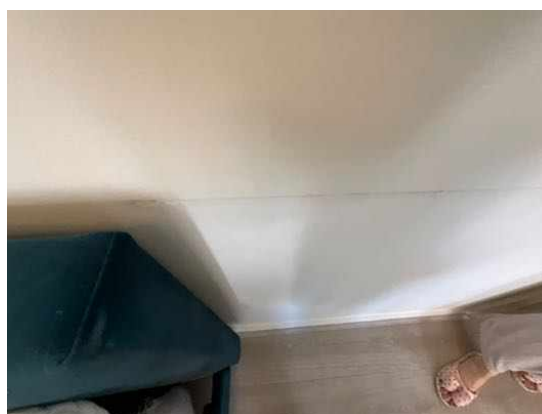
Finding 3.09

Building: Main Building
 Location: Bedroom
 Finding: Paint surface - Scratches
 Information: Scratches have been identified on the paint surface, detracting from the overall appearance and quality of the painted surface.

1. Aesthetic Degradation: Scratches mar the appearance of the painted surface, diminishing its visual appeal and potentially lowering property value.
2. Corrosion Vulnerability: Exposed areas of bare metal due to scratched paint are susceptible to corrosion, leading to structural damage and compromised durability.
3. Environmental Hazards: Scratched paint can release hazardous chemicals into the environment, posing risks to both human health and the ecosystem.

A qualified painter should address the issue promptly to repair the scratched paint. Depending on the severity of the scratches, repair options may include sanding, priming, and repainting the affected area to restore the integrity and appearance of the paint surface.

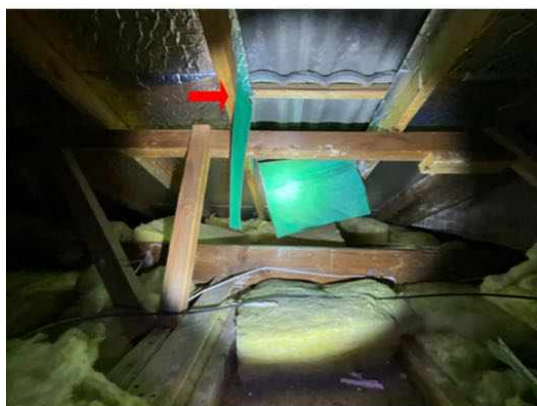
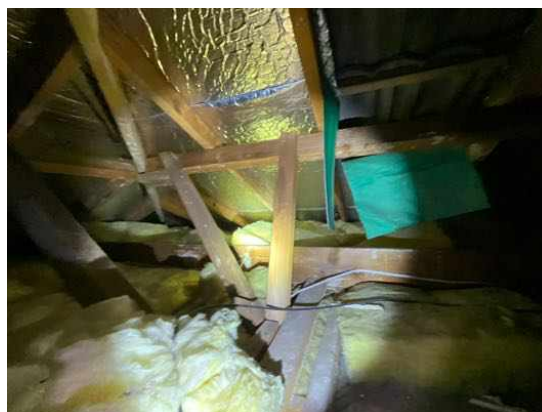
Building:	Main Building
Location:	Roof Void
Finding:	Sarking - Damaged
Information:	Sarking, a laminated aluminium foil applied to the interior of the roof covering, assists in insulating the property and acting as a vapour-barrier to the roof void and, subsequently, to the household.

Where sarking is damaged, both insulation and moisture protection of the property are inhibited. This creates a loss of energy and thus negatively impacts the energy efficiency of the property, allowing potential for moisture ingress from condensation or leaking roof tiles.

It is important to repair any holes or damaged sections of sarking to ensure that the building material is fully functional. A registered builder or qualified carpenter should be consulted to provide further advice on this defect and to perform rectification works at client discretion.

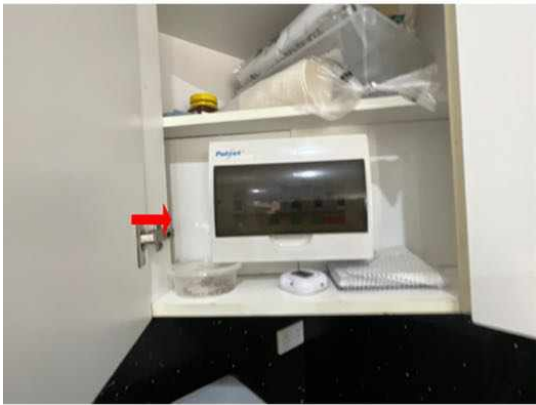
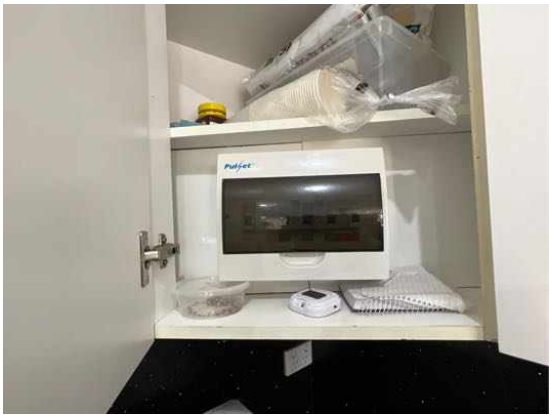
Finding 6.02

Building: Main Building
 Location: Kitchen
 Finding: No Evidence of Termite Management System - Durable notice / Legible Sticker
 Information: The application of a pre & post-construction chemical termite barrier is highly recommended for all properties. Such barriers are highly effective in preventing termite attack on any timber building elements throughout the property.

A durable notice was not placed in the switchboard unit to indicate current termite barriers is legible at the time of inspection.

Client must seek further information from the vendor or real estate agent if the conditions of termite management systems were maintained.

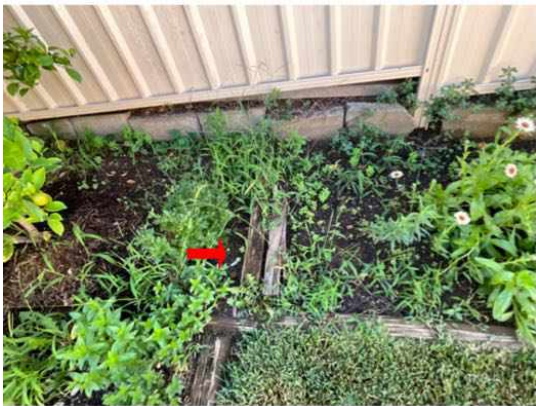
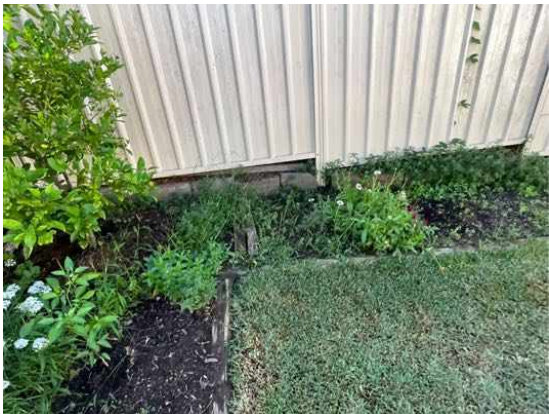
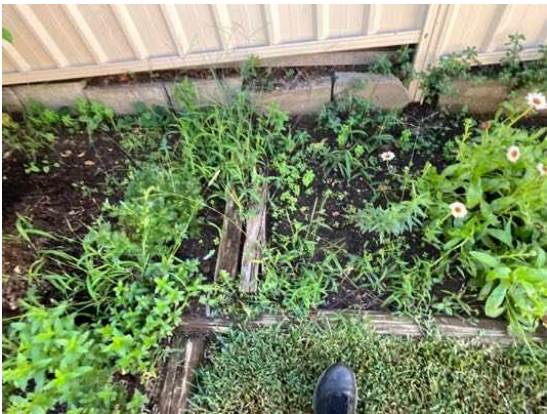
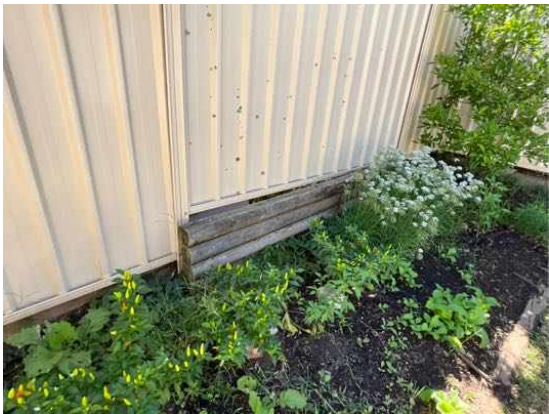
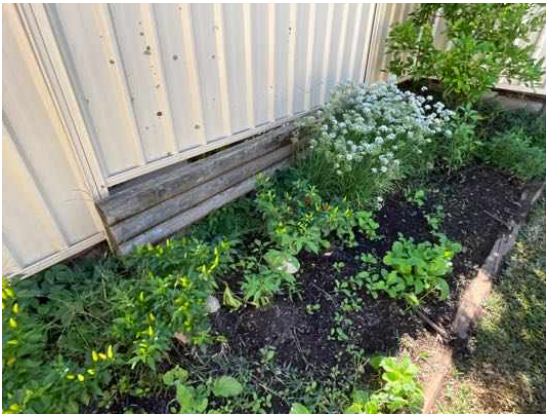
Finding 6.03

Building: Main Building
 Location: All Areas
 Finding: Timber on ground / conducive conditions to termite damage
 Information: Timber on the ground is indeed conducive to termite damage. Termites are known to thrive in moist environments, and wood in contact with soil or moisture is more susceptible to infestation.

To prevent this, it's important to keep timber elevated and away from direct ground contact. Regular inspections and proper termite control measures are also essential to protect your wooden structures from termite damage.

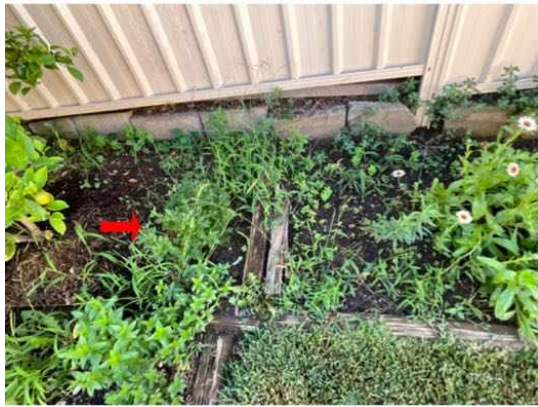
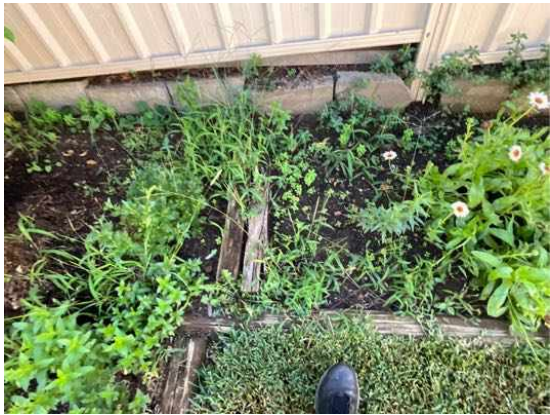
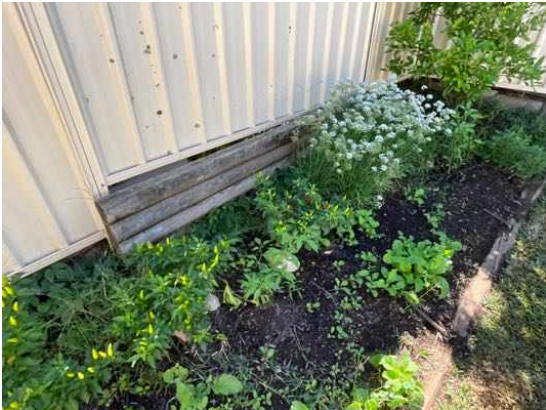
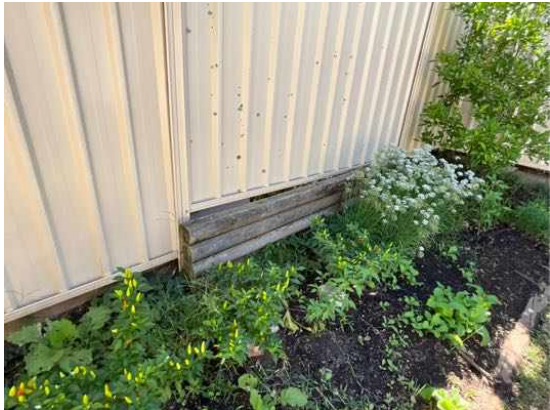
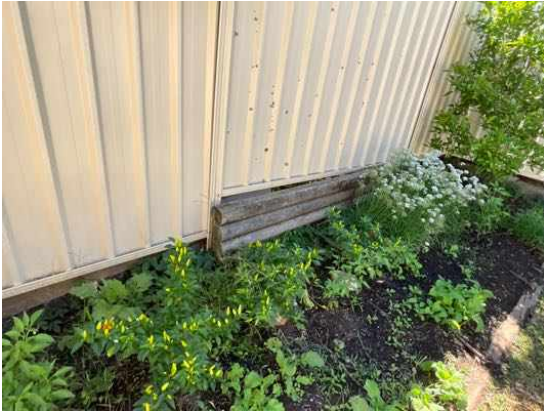
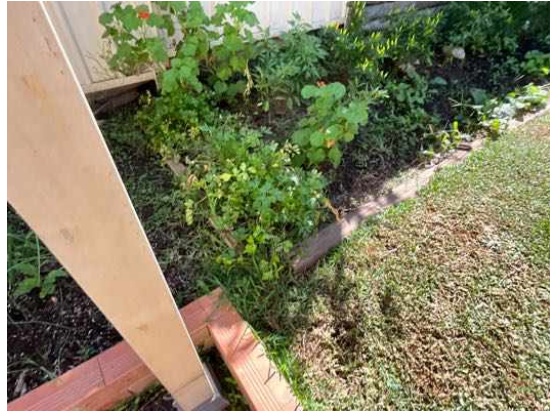
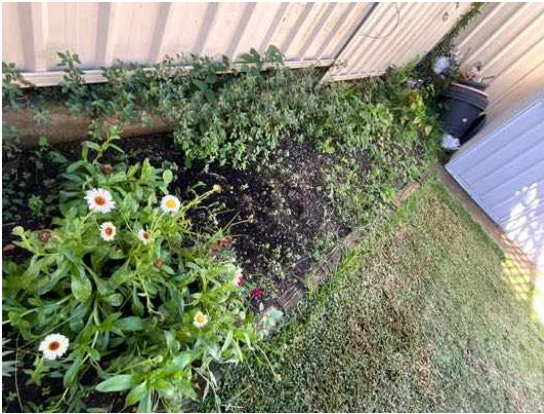
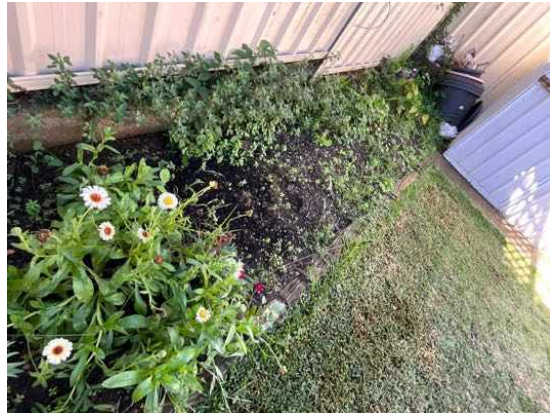
Building: Main Building
Location: All Areas
Finding: vegetation around a property can increase the risk of termite infestation
Information: The presence of vegetation around a property can increase the risk of termite infestation, as it provides a conducive environment for them. To address this, consider maintaining a clear space between the vegetation and your home. If you suspect a termite issue, it's advisable to consult with a licensed pest control professional for inspection and treatment.
