Building and Timber Pest Inspection Report

Inspection Date: Mon, 16 Feb 2026

Property Address: 113 Douglas McInnes Dr, Laidley QLD 4341,
Australia

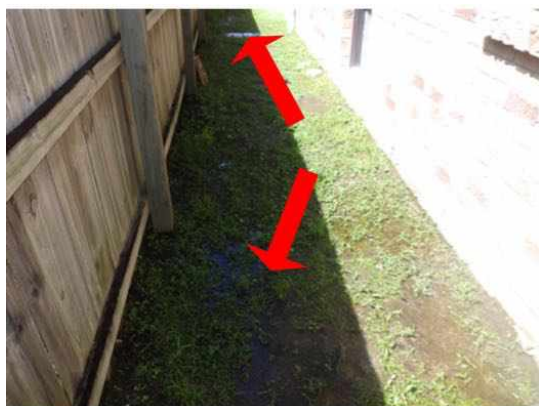
Information: At the time of inspection it was noted there was water ponding to ground areas on the left side of the property. Water pooling near foundations and footings is a serious concern with the potential to adversely impact on the longevity of the dwelling.

If left unattended damp or wet conditions may have many consequences including the development of fungal decay and/or wood rot as well as providing an environment that may be conducive to termite or timber pest attack.

Additionally a licensed plumber should be consulted regarding drainage options for the area.

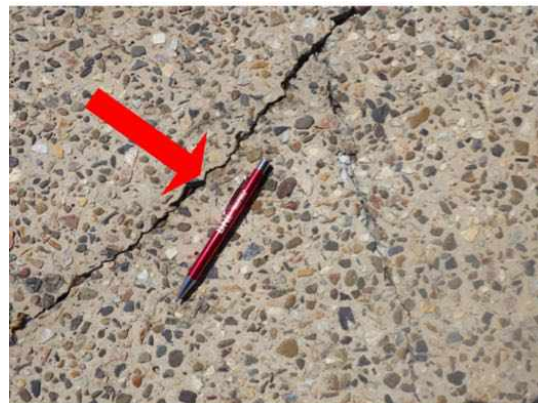
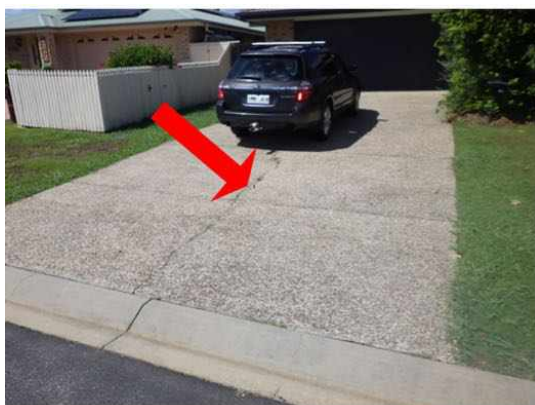
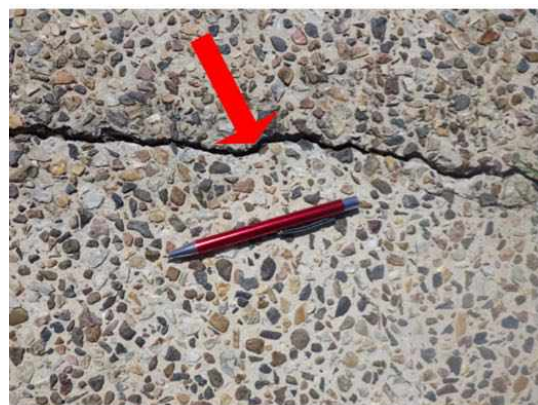
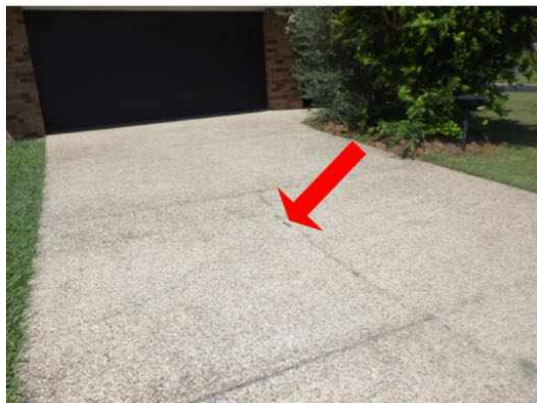
Building:	Main Building
Location:	Driveway > Ground Level
Finding:	Cracking in concrete slab - Category 1 - 2
Information:	Cracking coded as Category 1 -2 was identified in the driveway concrete slab. A Category 1 crack is described as a fine but noticeable crack, with the slab at an otherwise reasonable level.

To be considered Category 1, the approximate width of the crack is less than 1.0mm, or a less than 10mm change in offset when a 3m straight edge is placed over the defect.

Category 1 cracks should be monitored for a period of 12 months. At the end of the monitoring period, identified cracks that are rated greater than Category 2 are considered defects, and require rectification.

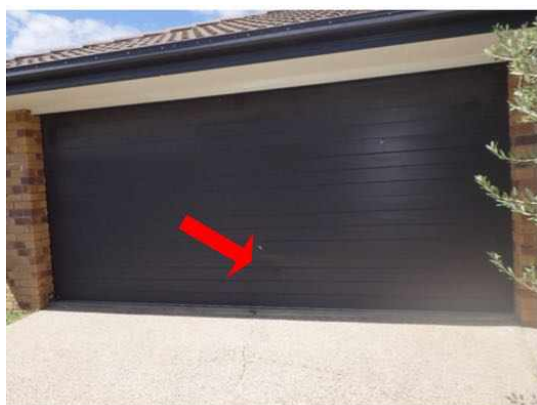
Finding 3.02

Building:	Main Building
Location:	Garage > Front
Finding:	Garage door - dent
Information:	The garage door has a dent likely to have resulted from impact damage be it accidental or deliberate impact at sometime.

Repair and/or replacement of the garage door would improve the condition of the garage but certainly not an urgent item

A qualified sectional door installer or supplier could be engaged to check out the operation and overall condition of the door to determine if repair is an option otherwise replacement may need to be considered.

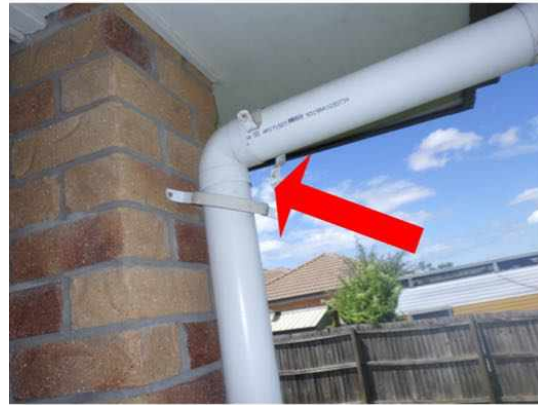
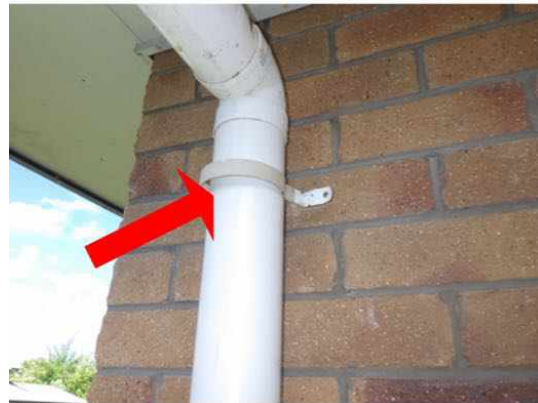
Finding 3.03

Building:	Main Building
Location:	Exterior walls - sides > Existing
Finding:	Downpipes fixing - defective
Information:	It was observed that a number of downpipes to the exterior walls are not securely

fixed.

A general handyman could be engaged to undertake rectification work.

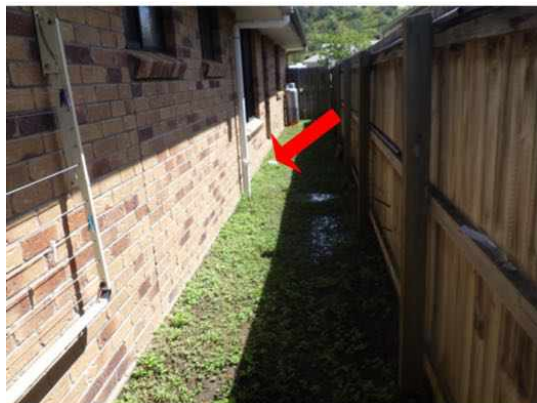
Finding 3.04

Building:	Main Building
Location:	Yard - Side > Ground Level
Finding:	Sewer line - Caps Missing
Information:	At the time of inspection it was noted the sewer line inspection cap on the left side of the property was missing.

It is assumed the cap has been previously removed (reason unknown). The missing sewer line cap creates potential for sewer line blockages.

A licensed plumber or general handyman could be engaged to replace the sewer line cap..

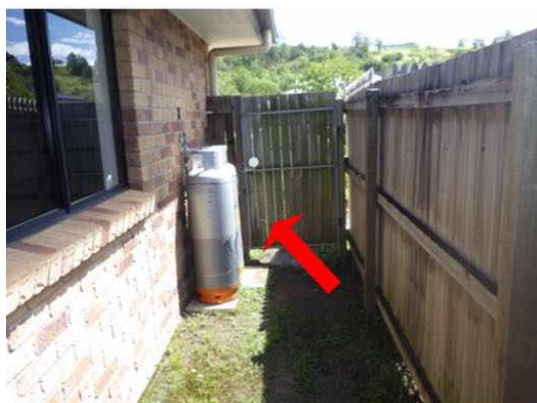
Finding 3.05

Building: Main Building
 Location: Yard > All Areas
 Finding: Fencing - Deteriorated
 Information: It was noted at the time of inspection that sections of the fencing and gates throughout the property have deteriorated. Typically fencing deteriorates due to age and or wear, rot and or rust which is generally expected for a structure of this age, due to prolonged exposure to weather conditions. Sometimes inadequate installation or maintenance can be to blame.

If left unattended, it is likely that further damage will occur. It is suspected that repair of several elements of the fencing may be required however replacement may be a consideration of the client also.

A licensed fencing contractor should be appointed to provide further advice and perform rectification works as necessary.

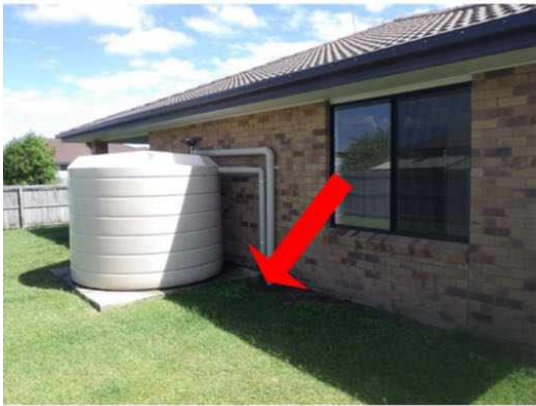
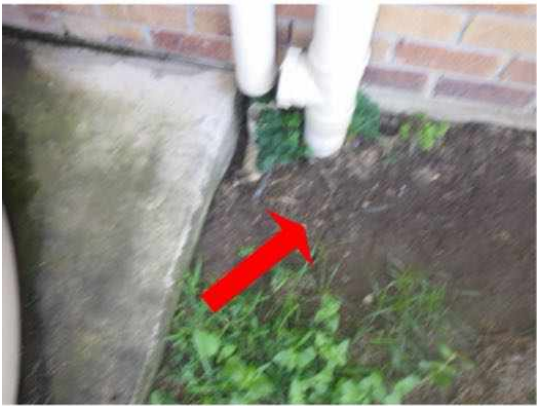
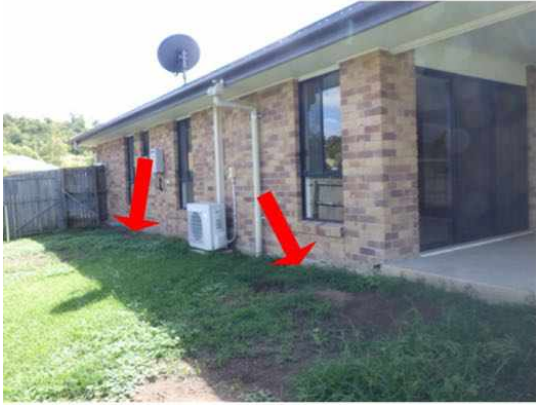
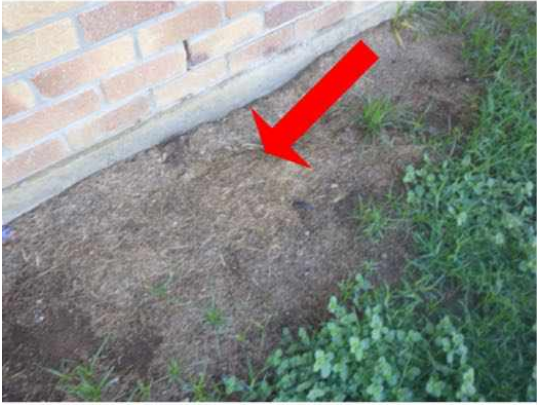
Finding 3.06

At the time of inspection it was noted there is ground subsidence to areas around the perimeter of the building. The erosion appears to be the result of water coursing or ponding. The continued ground erosion may in turn compromise the structural integrity of the concrete footings.

A landscaper should be engaged to remove the existing grass clippings type debris, fill and pack the eroded areas with a suitable soil or base material.

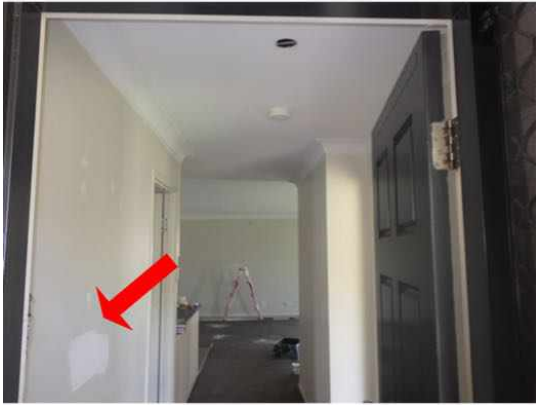
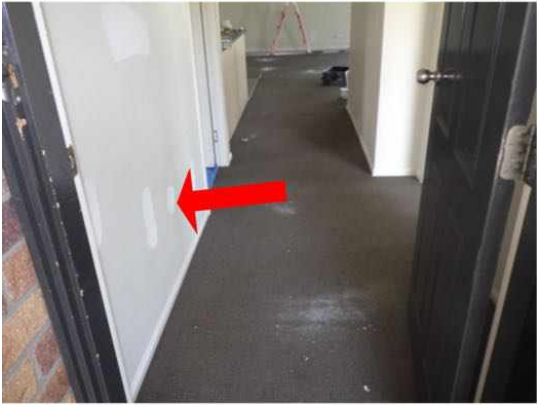
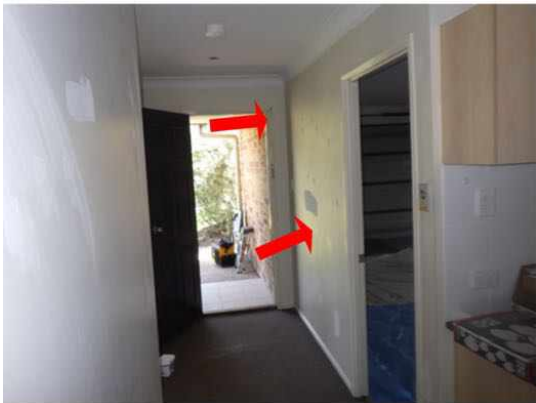
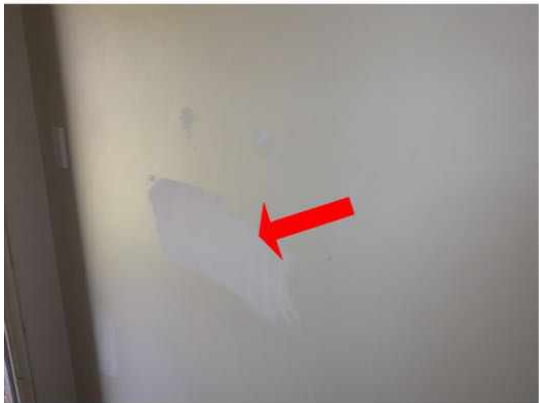
Finding 3.07

Building: Main Building
Location: Hallway > Existing
Finding: Wear and Tear
Information: At the time of inspection the hallway interior showed signs of existing repair works and/or scuffing to internal wall & ceiling linings and timber trims.

The level of damage appears consistent with general deterioration and/or wear and tear.

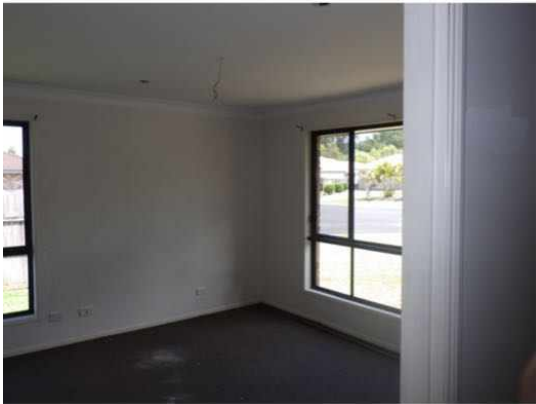
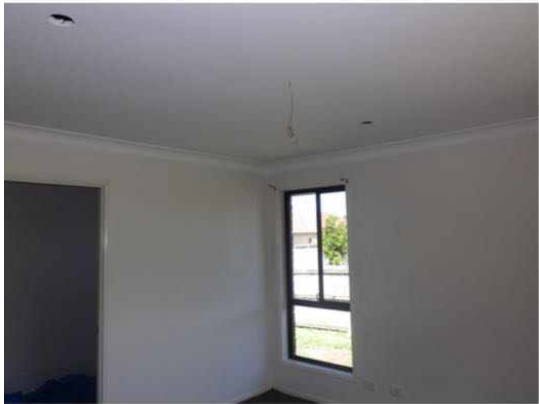
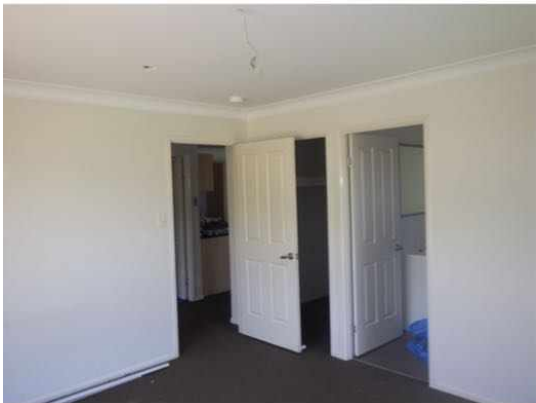
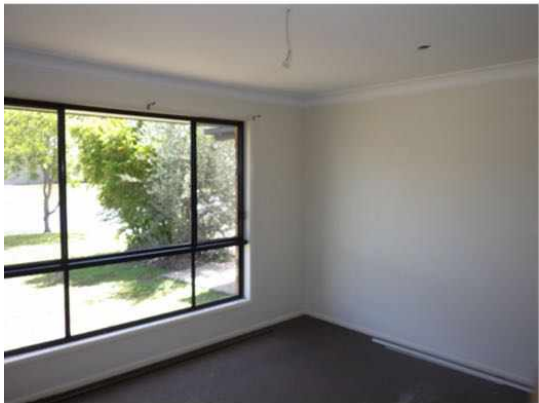
Finding 3.08

Building: Main Building
Location: Bedroom - Master > Existing
Finding: Wear and Tear
Information:

At the time of inspection the main bedroom interior showed signs of existing repair/renovation work, and/or scuffing to internal wall & ceiling linings and timber trims.

The level of damage appears consistent with general deterioration and/or wear and tear.

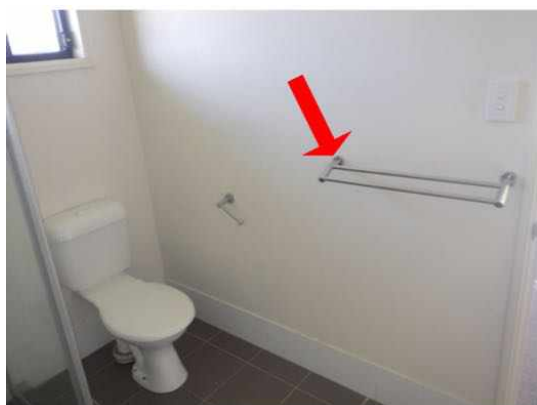
Finding 3.09

Building:	Main Building
Location:	Ensuite > Front Right
Finding:	Fitting or fixture - Loose towel rail
Information:	The ensuite towel rail is loose and requires adjustment to tighten.

If left unmanaged, the fitting may further deteriorate, causing potential for the development of other minor secondary defects.

A general handyman could be appointed to perform these rectification works at discretion of the client.

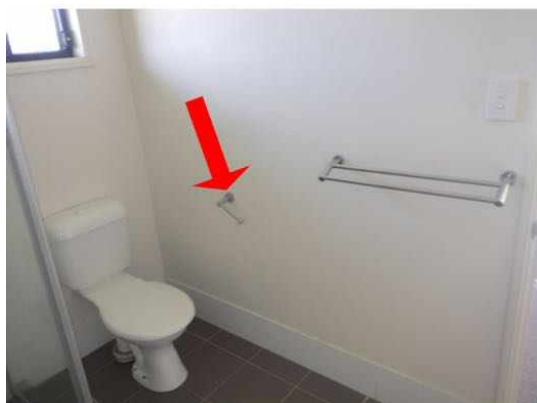
Finding 3.10

Building:	Main Building
Location:	Ensuite > Centre Right
Finding:	Toilet roll holder - Loose
Information:	The ensuite area toilet roll holder was found to be loose at the time of inspection. While not a major operational defect, function can deteriorate if the problem is left unmanaged.

It is advised that the homeowner performs remedial works to re-attach the toilet roll holder to its original fixing. A general handyperson may be required to perform these works.

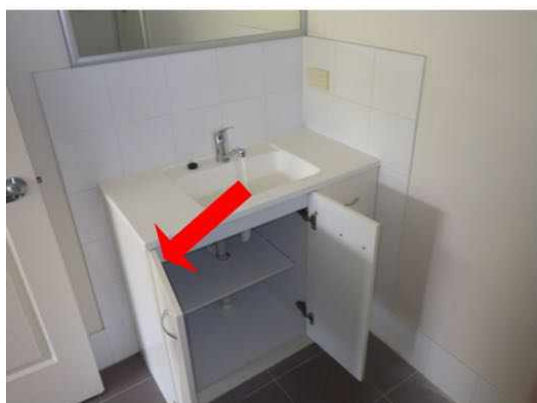
Finding 3.11

Building:	Main Building
Location:	Ensuite > Centre Left
Finding:	Cabinetry - Loose hinges
Information:	At the time of inspection, it was noted that the top hinge to the ensuite vanity cupboard door has deteriorated over time and, as a result, has come loose from it's original fixing. To improve operation of the affected cupboard doors, a general handyman may be appointed to replace the faulty hinges. Such works should be completed at discretion of the client.

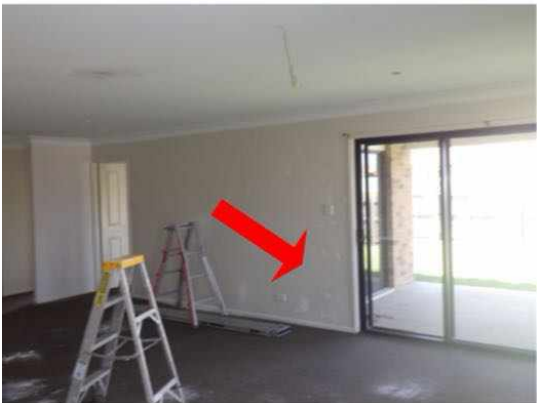
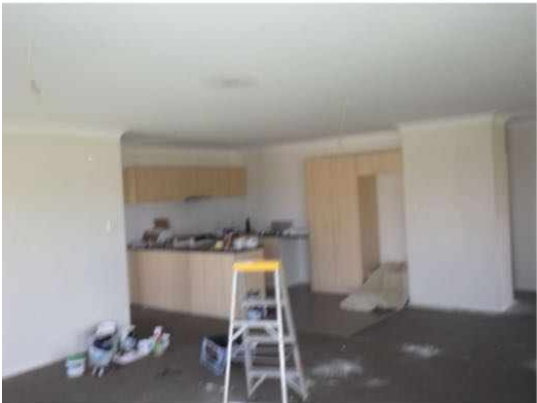
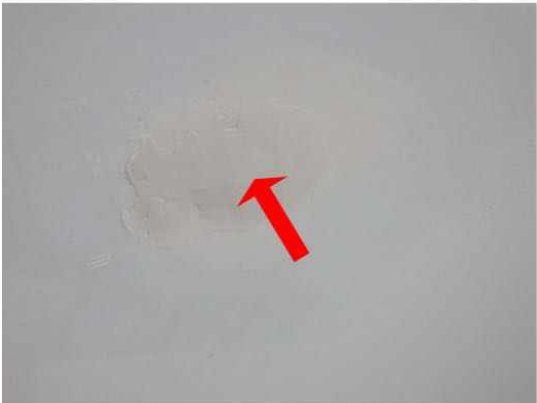
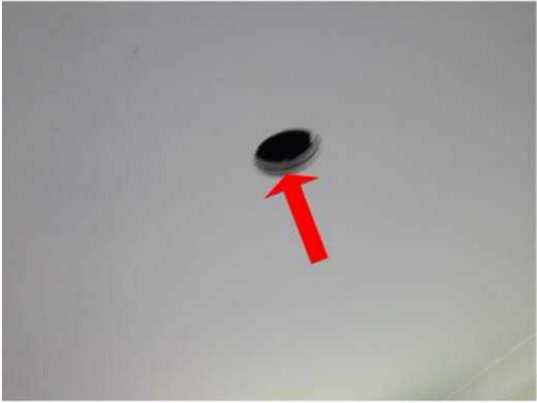
Finding 3.12

Building:	Main Building
Location:	Living/Dining Room > Existing
Finding:	Wear and Tear
Information:	At the time of inspection the living/dining room interior showed signs of existing repair/renovation work, and/or scuffing or cracking to internal wall & ceiling linings and timber trims. The level of damage appears consistent with general deterioration and/or wear and tear.

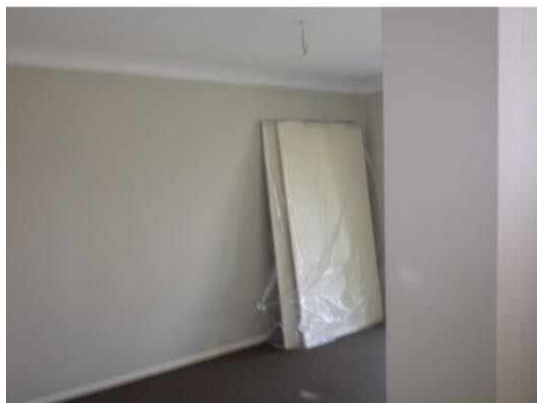
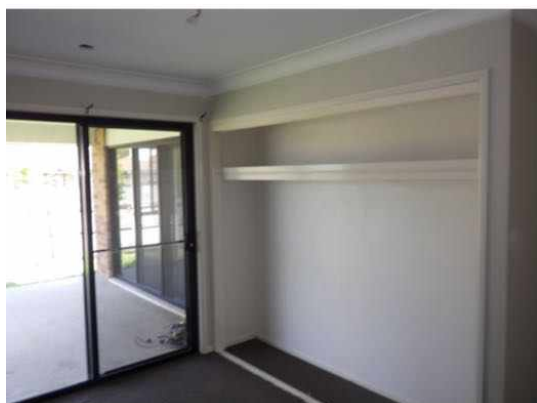
Finding 3.13

Building: Main Building
 Location: Bedroom 2 > Existing
 Finding: Wear and Tear
 Information: At the time of inspection the bedroom 2 interior showed signs of existing repair/renovation work, and/or scuffing to internal wall & ceiling linings and timber trims.

The level of damage appears consistent with general deterioration and/or wear and tear.

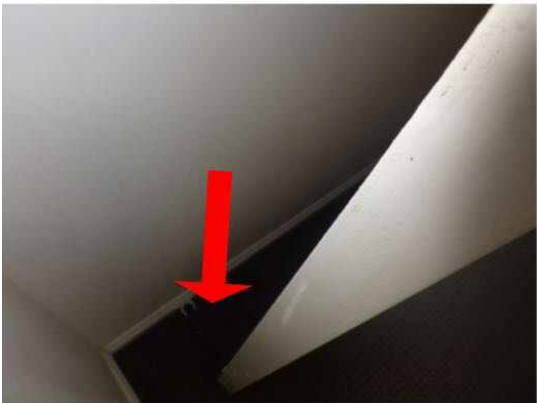
Finding 3.14

Building: Main Building
 Location: Bedroom 3 > Front
 Finding: Door stop - Missing
 Information: The door stop is missing or is inadequate to stop the door handle from damaging the wall.

Re-installation or replacement of the door stop is advised to prevent any subsequent damage to the wall linings or associated structures.

A general handyman may be appointed to perform these works at client discretion.

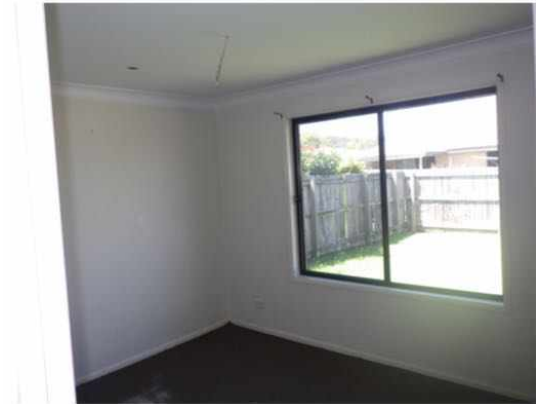
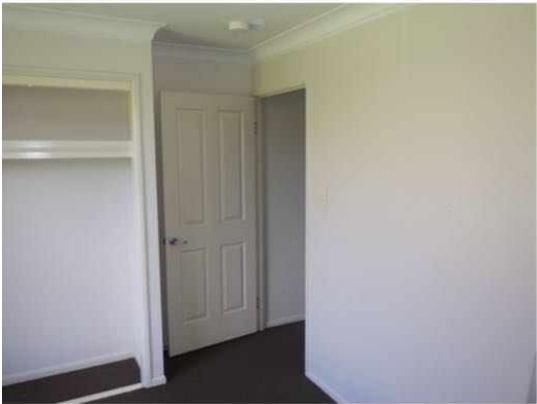
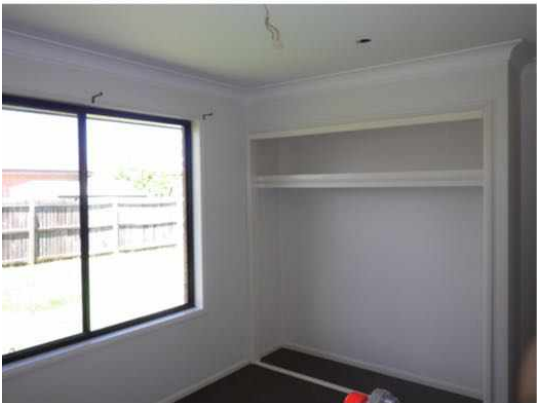
Finding 3.15

Building: Main Building
Location: Bedroom 3 > Existing
Finding: Wear and Tear
Information: At the time of inspection the bedroom 3 interior showed signs of existing repair/renovation work, and/or scuffing to internal wall & ceiling linings and timber trims.

The level of damage appears consistent with general deterioration and/or wear and tear.

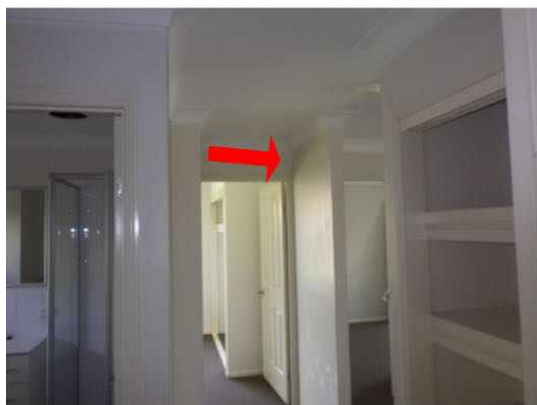
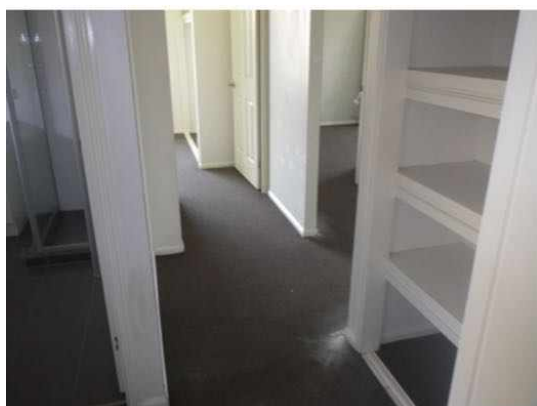
Finding 3.16

Building:	Main Building
Location:	Hallway 2 > Existing
Finding:	Wear and Tear
Information:	At the time of inspection the hallway 2 interior showed signs of existing repair/renovation work, and/or scuffing to internal wall & ceiling linings and timber trims.
	The level of damage appears consistent with general deterioration and/or wear and tear.

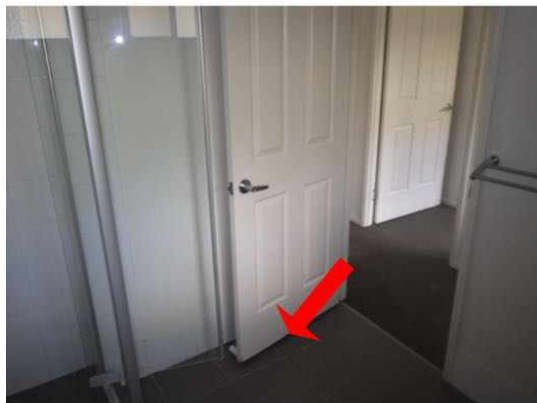
Finding 3.17

Building:	Main Building
Location:	Bathroom > Front
Finding:	Damaged Door
Information:	The door leading into the bathroom has suffered damage to the bottom edge.

Damage occurs generally when the building materials have aged and decayed, but in this instance the damage appears to be the result of exposure to moisture, possibly from the bottom and/or top edges of the door not being sealed with a suitable paint or sealant at the time of construction.

A qualified carpenter or general handyman could be appointed to repair/replace the door at the clients discretion.

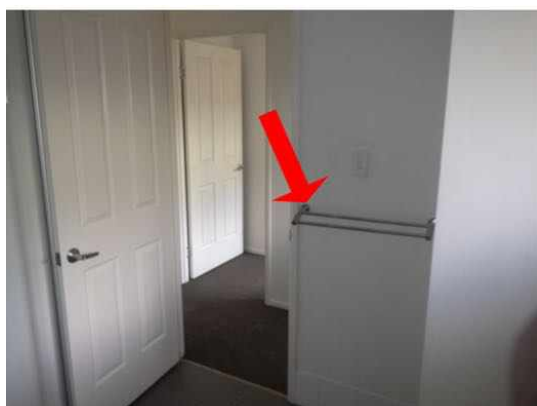
Finding 3.18

Building: Main Building
 Location: Bathroom > Centre Left
 Finding: Fitting or fixture - Loose towel rail
 Information: The bathroom towel rail is loose and requires adjustment to tighten.

If left unmanaged, the fitting may further deteriorate, causing potential for the development of other minor secondary defects.

A general handyman could be appointed to perform these rectification works at discretion of the client.

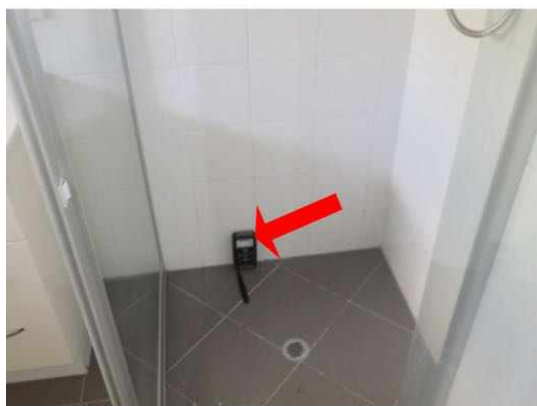
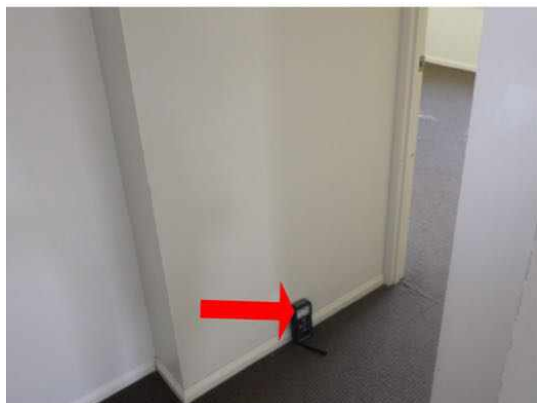
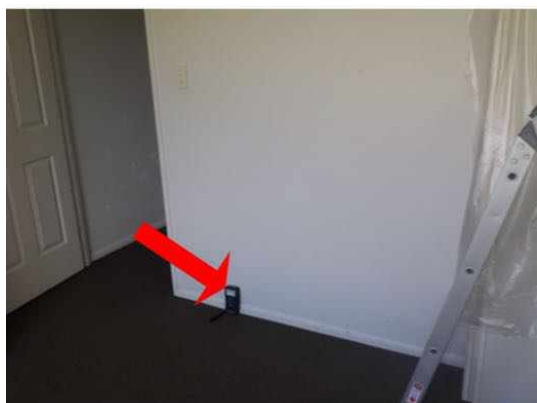
Finding 3.19

Building: Main Building
 Location: Bathroom > Rear Right
 Finding: Shower - Monitor
 Information: Elevated moisture level readings were recorded to the lower 200mm of wall to the bathroom shower alcove at the time of inspection. There was no elevated moisture

level readings around the tap area, and no elevated readings transferring to the other side of the wall in the areas where moisture readings were able to be obtained. Both sealant and grout appear in good condition at present.

This defect is quite common, and is suspected to have been caused by moisture permeating or leaching through the grouting and perhaps gaps in the sealant.

Monitoring the area is advised and if any visual signs of excessive moisture appear (peeling paint, mould) then consultation with a qualified plumber or bathroom specialist would be advised to identify the cause of damp and to perform remedial works as required.

Always ensure that sealant and grout is in good condition to prevent any moisture issues occurring in the future.

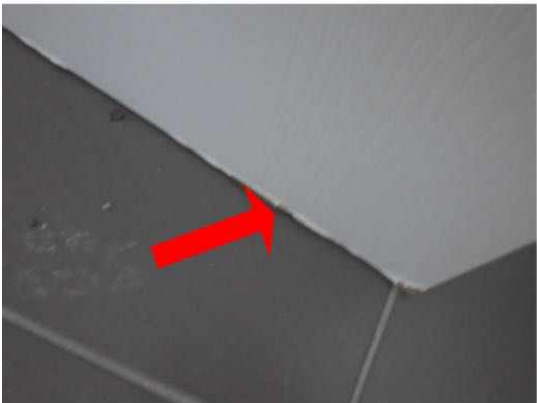
Finding 3.20

Building:	Main Building
Location:	Toilet (WC) > Front
Finding:	Damaged Door
Information:	The door leading into the WC area has suffered damage to the bottom edge.

Damage occurs generally when the building materials have aged and decayed, but in this instance the damage appears to be the result of exposure to moisture, possibly from the bottom and/or top edges of the door not being sealed with a suitable paint or sealant at the time of construction.

A qualified carpenter or general handyman could be appointed to repair/replace the

door at the clients discretion.

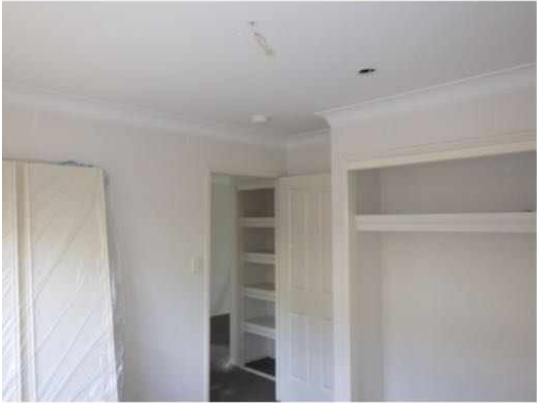
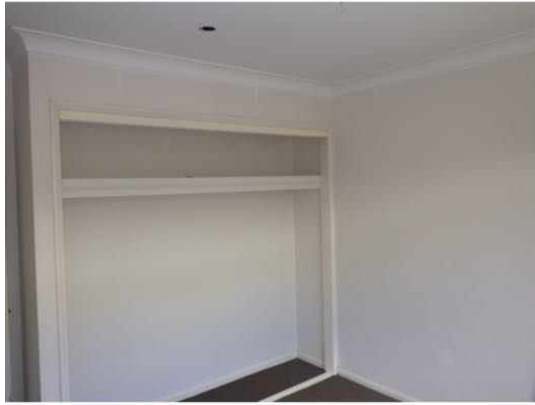
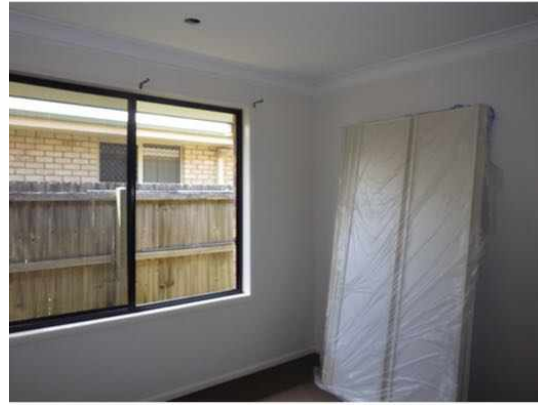
Finding 3.21

Building: Main Building
Location: Bedroom 4 > Existing
Finding: Wear and Tear
Information: At the time of inspection the bedroom 4 interior showed signs of existing repair/renovation work, and/or scuffing to internal wall & ceiling linings and timber trims.

The level of damage appears consistent with general deterioration and/or wear and tear.

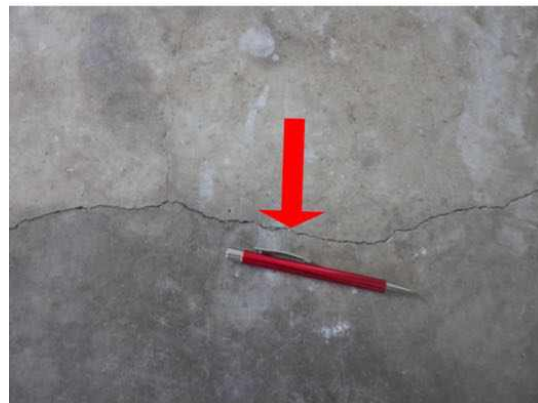
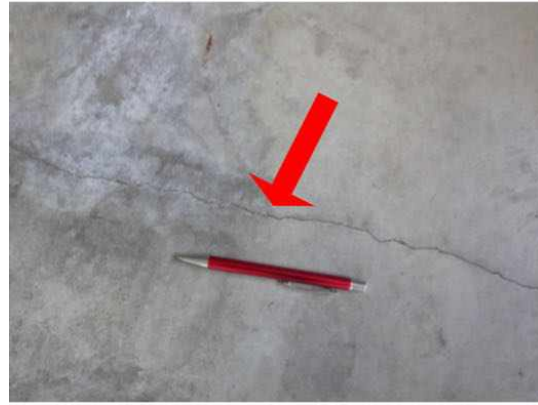
Finding 3.22

Building: Main Building
 Location: Garage > Ground Level
 Finding: Cracking in concrete slab - Category 1
 Information: Cracking coded as Category 1 was identified in the garage floor concrete slab (as per example photos). A Category 1 crack is described as a fine but noticeable crack, with the slab at an otherwise reasonable level.

To be considered Category 1, the approximate width of the crack is less than 1.0mm, or a less than 10mm change in offset when a 3m straight edge is placed over the defect.

Category 1 cracks should be monitored for a period of 12 months. At the end of the monitoring period, identified cracks that are rated greater than Category 2 are considered defects, and require rectification.

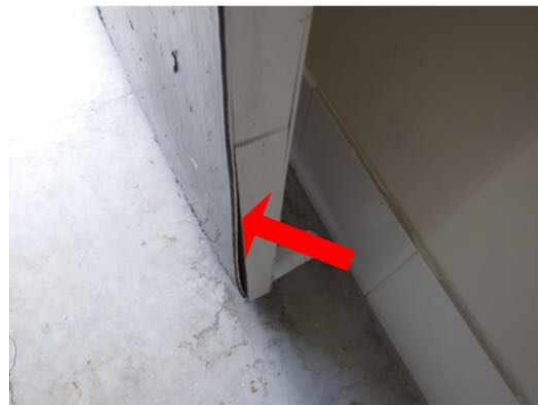
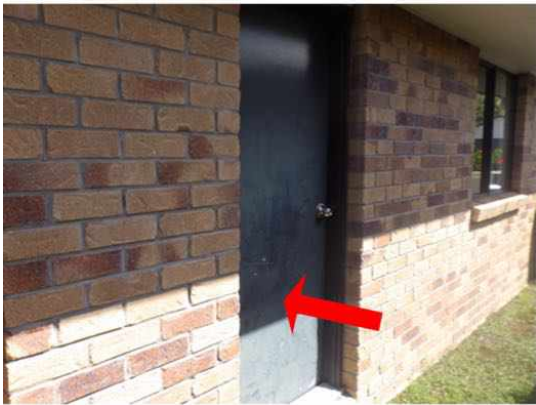
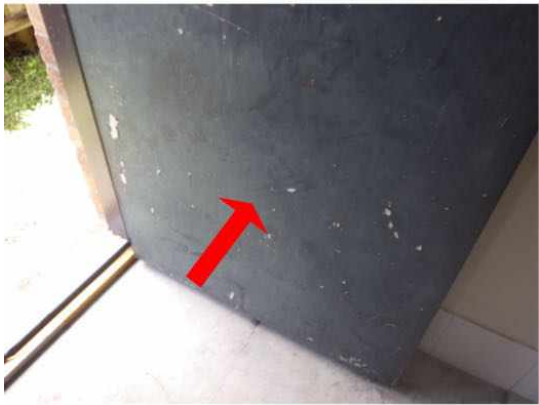
Finding 3.23

Building: Main Building
Location: Garage > Rear Left
Finding: Damaged Door
Information: The garage area exterior door has suffered damage to the front and back panels or surface.

Damage occurs generally when the building materials have aged and decayed, but appears to be indicative of exposure to moisture or impact damage.

A qualified carpenter or general handyman could be appointed to repair/replace the door at the clients discretion.

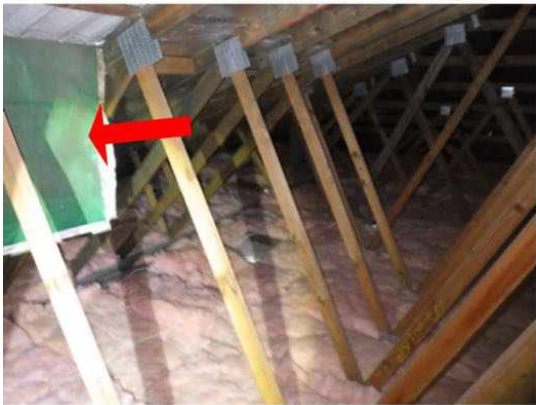
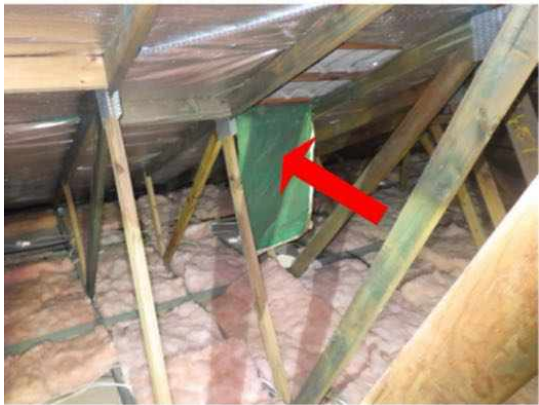
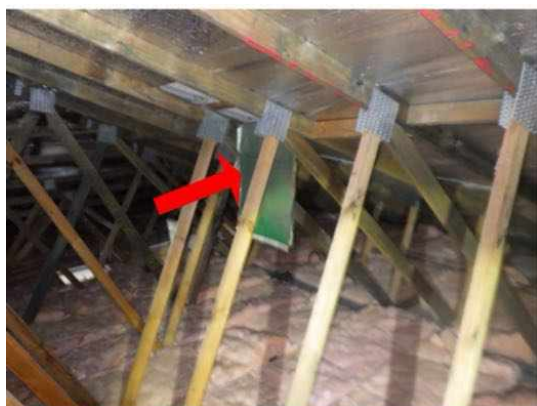
Finding 3.24

Building: Main Building
Location: Attic > Existing
Finding: Sarking - Damaged
Information: At the time of inspection there was loose roof sarking observed in the ceiling space area.

Where sarking is damaged, both insulation and moisture protection of the property are inhibited. This creates a loss of energy and thus negatively impacts the energy efficiency of the property, allowing potential for moisture ingress from condensation or leaking roof tiles.

It is important to repair any holes or damaged sections of sarking to ensure that the building material is fully functional. A general handyman could be engaged to perform rectification works at client discretion.

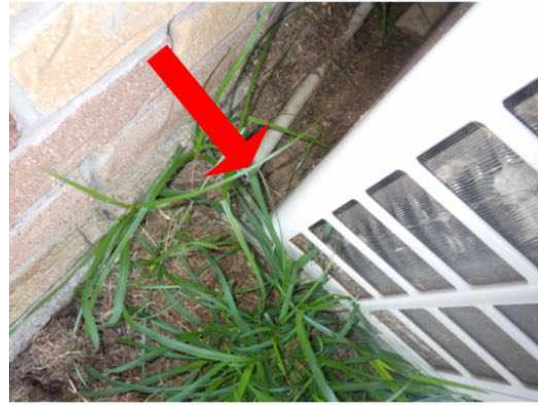
Building:	Main Building
Location:	Exterior walls - right side > Centre Right
Finding:	Overflow - Not plumbed for drainage
Information:	The air conditioning unit overflow is not plumbed or connected to suitable drainage, which can result in the surrounding area becoming excessively damp. These damp conditions can lead to secondary defects such as rot, rust or corrosion of associated building elements, the formation of fungal decay, or even the creation of potential slip hazards. When coupled with poor site drainage, pooling of water may also attract termite activity to this area. It is highly recommended that a qualified plumber be appointed to install adequate drainage to the overflow. These works will ensure that the area remains dry and free of any secondary defects.

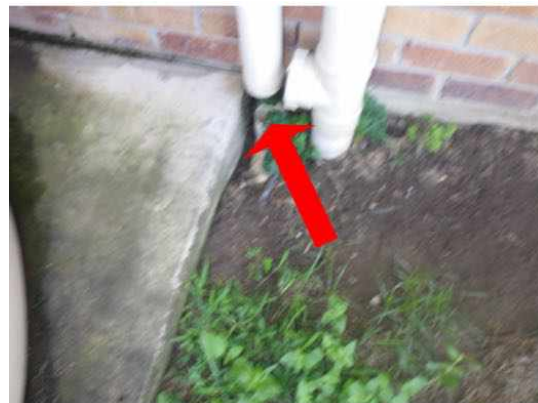
Finding 6.02

Building:	Main Building
Location:	Exterior walls - rear > Centre,Rear
Finding:	Stormwater pipe
Information:	The overflow down pipe to the water tank at the rear of the building finishes short of the stormwater drainage on the site. This disconnection negatively impacts the functional capacity of the down pipe.

Where roof plumbing doesn't drain adequately, the area at the base perimeter can become excessively damp, potentially creating an environment that is susceptible to rust and corrosion of surrounding building elements, as well as attracting termites and other pests.

It is recommended that a plumber or handyman be appointed to further inspect and to extend the down pipe as necessary.
