# Building and Timber Pest Inspection Report

Inspection Date: Thu, 8 Jan 2026

Property Address: 29 Scott St, Euroa VIC 3666, Australia

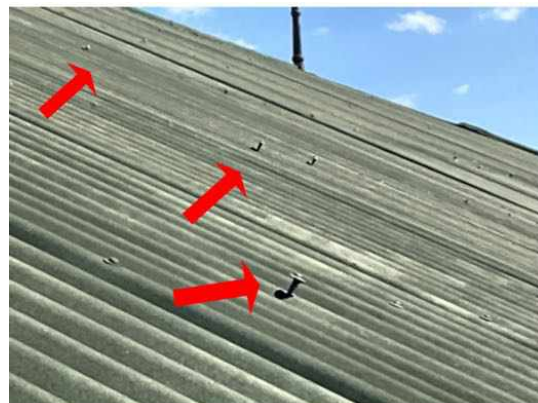
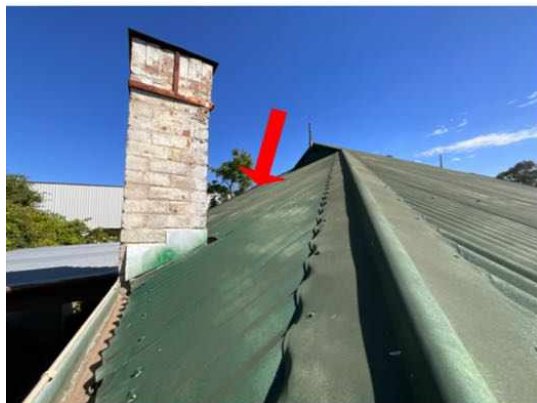
Building: Building 1  
Location: Roof Exterior  
Finding: Roof sheets - Loose  
Information: Upon inspection of the exterior roof covering, it was noted that numerous roof sheets have become loose from their original fixings. It is suspected that this defect has developed as a result of a lack of adequate maintenance, but may also have been caused by inappropriate fixings being used in the construction process.

Loose roof sheeting detracts from the weather tightness of the roof covering, making the internal roofing structure susceptible to water penetration and subsequent damage. If left unaddressed, it is likely that secondary damage to associated building elements will develop, potentially necessitating remedial works to these structures.

A roofing restoration contractor should be appointed to advise on rectification options and on the cost of repair. It is advised that remedial works be performed as soon as possible to prevent any further damage.

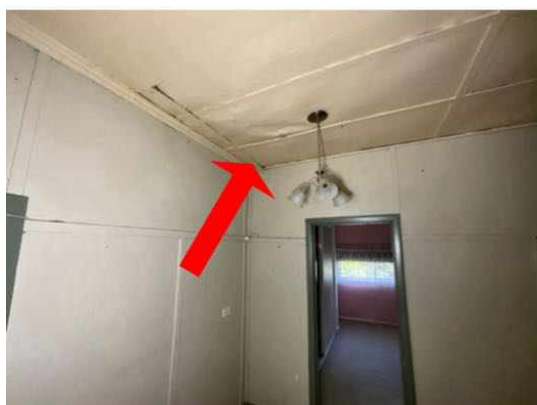
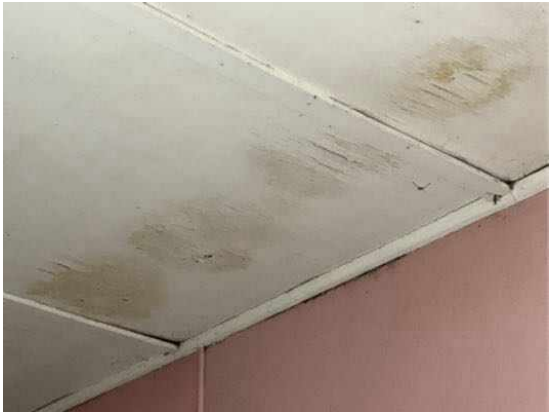
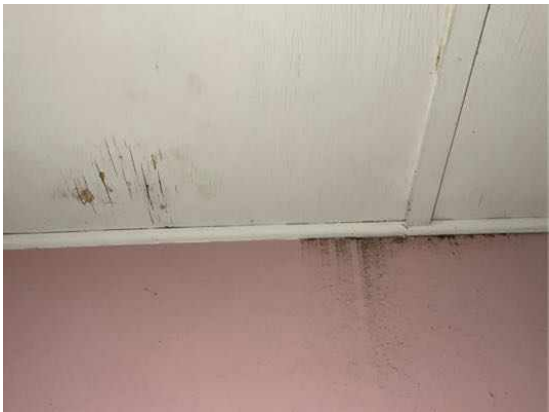
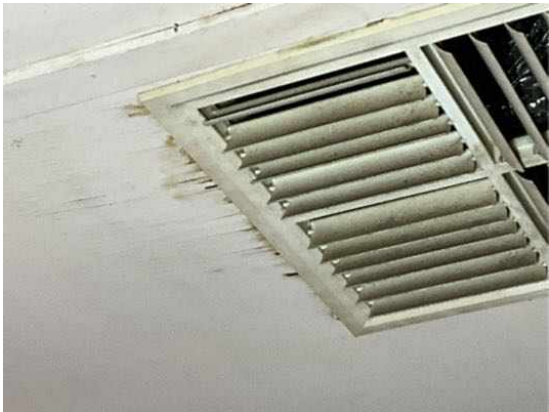
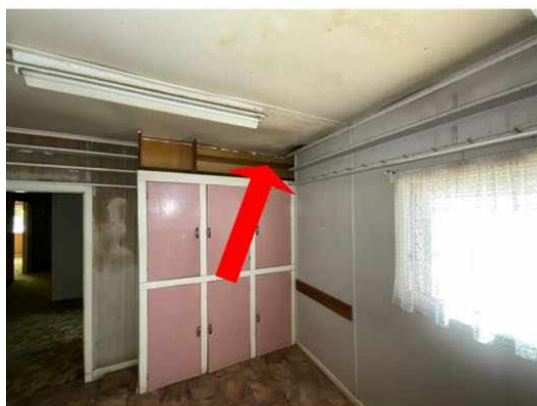
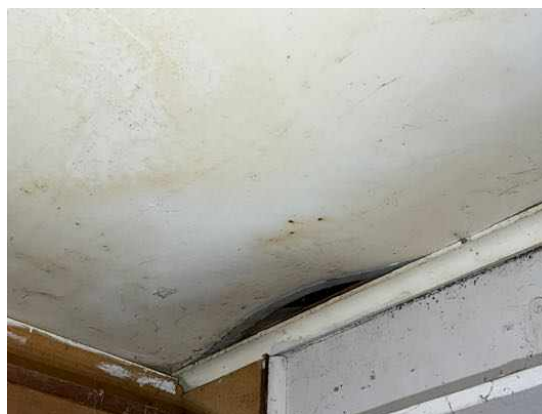
### Finding 3.02

Building:	Building 1
Location:	Hall, bed 2, dining, laundry area,
Finding:	Ceiling - Water damaged
Information:	Water damage to the ceiling lining is generally an indication of excessive moisture being present in the roof void, usually via a leak to the roof covering.

Where water damage is evident to the ceiling, the primary requirement is to identify and rectify the source of the leak. A roofing plumber should be appointed as soon as possible to identify the leak and perform rectification works as necessary, ensuring the water damage is restricted.

Once the leak is repaired, consultation with relevant tradespeople, including plasterers and painters, is advised. Rectification works may include replacement of ceiling lining or minor repainting, depending on the extent of the damage.

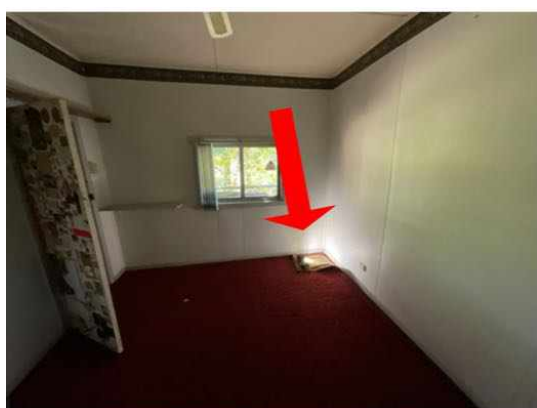
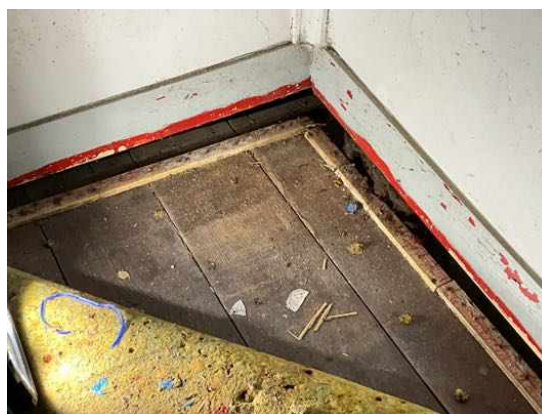
### Finding 3.03

Building:	Building 1
Location:	All Internal Areas
Finding:	Flooring - Uneven
Information:	The internal flooring in this area is out of level and uneven. Uneven flooring is likely to indicate minor defects such as expected movement of the foundations of the property, but may also indicate subsidence of the associated subfloor stumps.

It is advised that the flooring be closely monitored to identify any further movement. Where flooring remains relatively unchanged for an extended period of time (i.e. several months), it is likely that this defect has been caused by expected movement of the foundations of the property.

However, where flooring is uneven further, potentially invasive inspection of the subfloor structures and stumps in this area is required. In this case, works to repair are likely to be required, and would be carried out by a registered builder specialising in re-stumping.

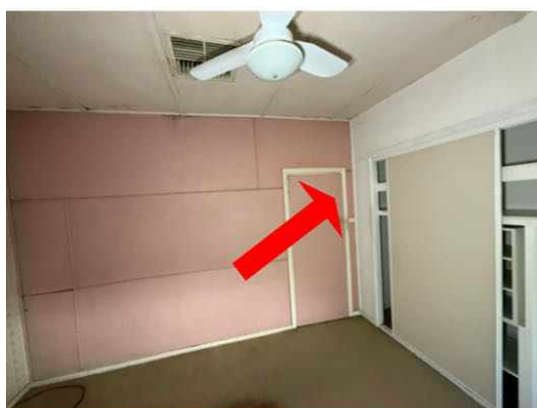
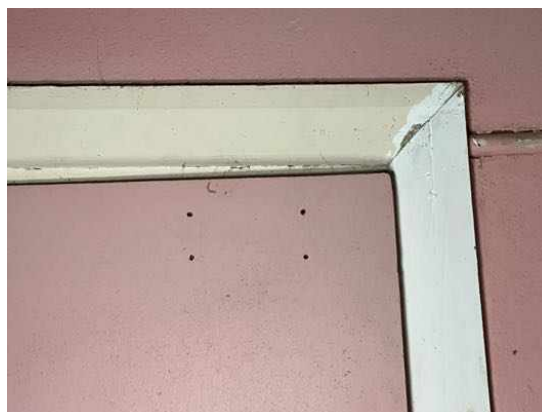
### Finding 3.04

Building:	Building 1
Location:	Bedroom 2

Finding: Door- Binding/jamming  
 Information: Binding and/or jamming of this door is evident during standard operation. This defect inhibits the functionality of the affected door as well as creating potential for secondary defects to associated building elements, such as damage to the floor covering.

A door that binds to flooring or to the associated door frame may have several causes, ranging from minor defects, such as poor installation of the door or deteriorated hinges, through to major structural issues, such as damage to subfloor structures.

A qualified carpenter or general handyperson should be appointed to perform minor rectification works at client discretion.

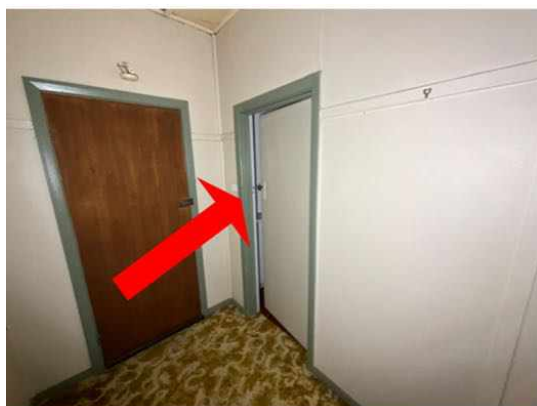
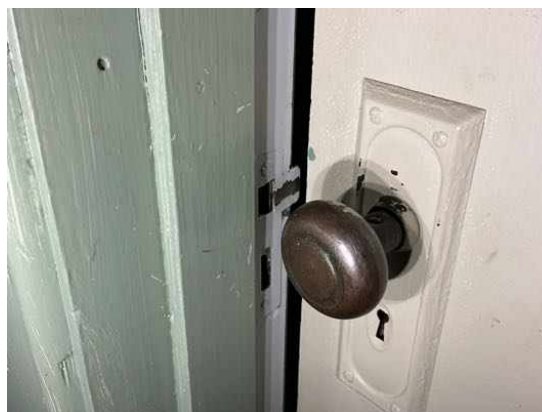
### Finding 3.05

Building: Building 1  
 Location: Bedroom 1  
 Finding: Door - Striker plate misaligned  
 Information: The striker plate to this door appears to have become misaligned and has consequently resulted in the door's operation being compromised.

This is a common defect and is expected in a property of this age, whether being due to substandard installation or general deterioration of the door hardware.

Readjustment of the striker plate is recommended at client discretion. Works such as these can be completed by a general handyman or qualified carpenter.

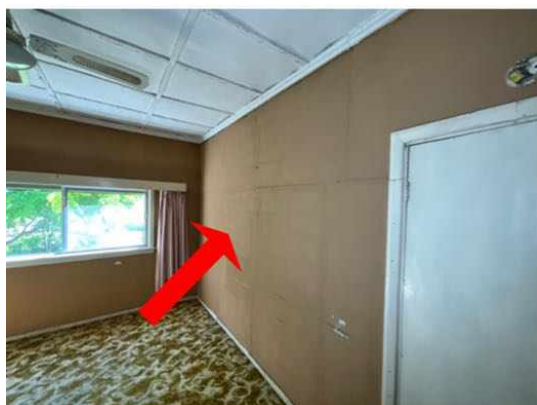
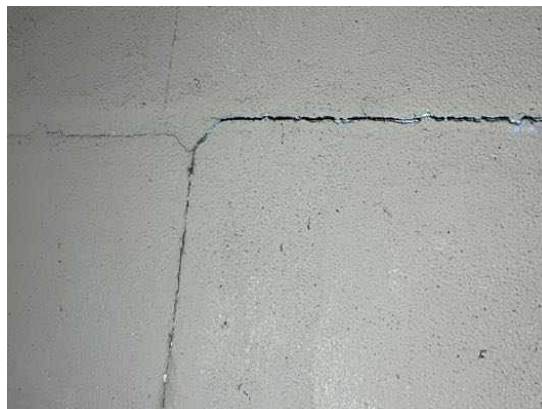
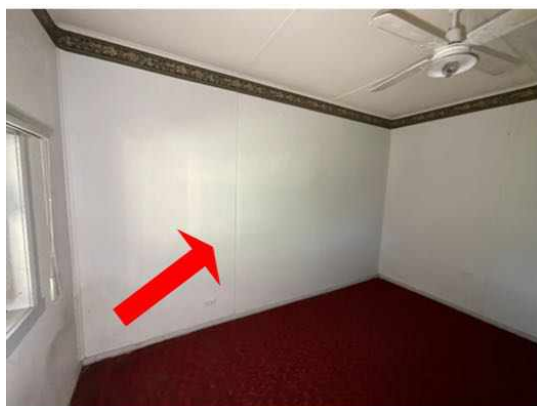
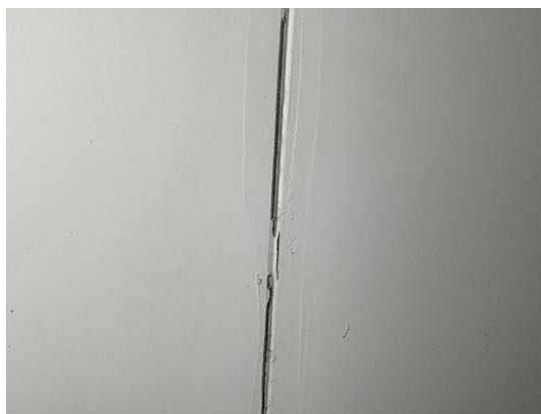
### Finding 3.06

Building:	Building 1
Location:	Living Room, bed 1
Finding:	Cracking - Damage Category 2 - Noticeable (up to 5mm)
Information:	Noticeable cracks are a common occurrence as a result of many primary defects. Such causes may include age, general wear and tear, expected building movement, general expansion/contraction of building materials in different weather conditions, and/or minor failings in the installation or application of building materials.

Noticeable cracks may result in minor sticking or jamming of associated doors and windows, which require easement. However, noticeable cracks are easily filled and repaired. A plasterer can be consulted to install an expansion joint at this point to allow for this movement during different weather conditions.

Monitoring of all cracking should be conducted frequently. Always contact a building inspector should cracks widen, lengthen, or become more numerous. Additionally, your building inspector should also be contacted if associated building elements such as doors and windows become more difficult to operate over time.

Relevant tradespeople, such as carpenters, painters and plasterers, should be appointed to perform remedial works, as deemed necessary.

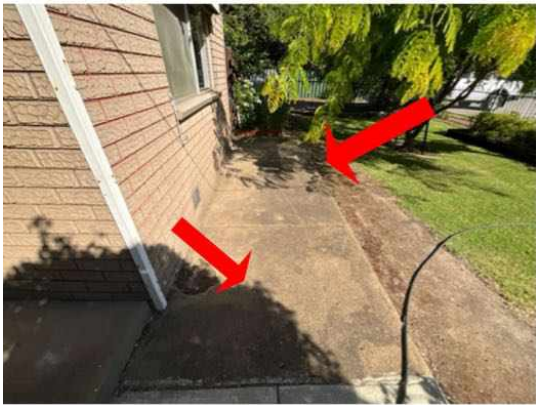
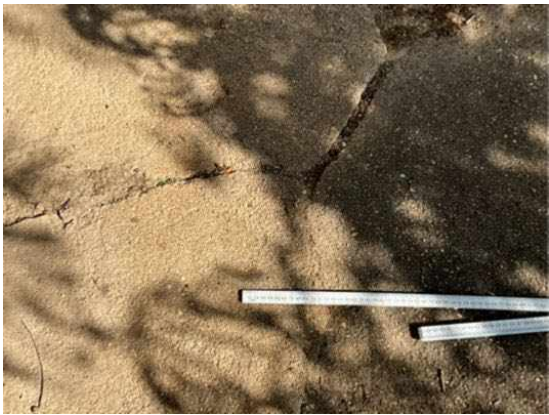
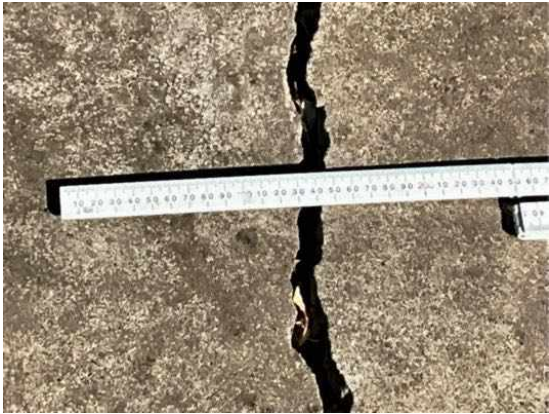
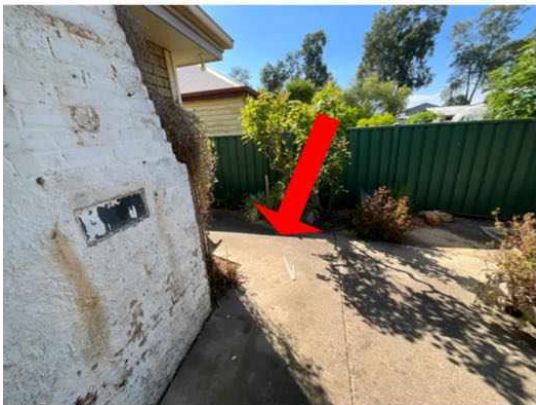
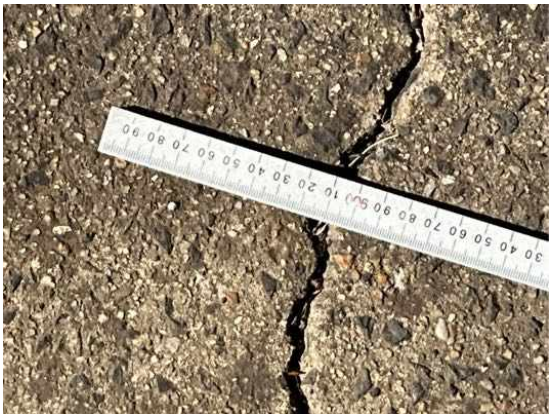
### Finding 3.07

Building:	Building 1
Location:	Yard - Front, side
Finding:	Cracking - External Concrete Paving Damage Category 4 - Gaps in Slab (4mm - 10mm +)
Information:	Gaps in the slab were identified in external concrete paving. Gaps in the slab are significant and are likely to lead to the development of safety hazards and secondary defects if left unmanaged, such as the creation of a trip hazard.

General age and expected deterioration of the paved areas is a common cause of this type of cracking. However, expansion and contraction of the slab may also have occurred due to environmental factors. Such factors include variable moisture and weather conditions, the presence of trees and their roots having a settling or lifting affect on the soil, or the effect of load bearing, e.g. heavy vehicles over a sustained period of time.

Cracking to this degree may also be due to poor original installation of the concrete. Factors such as poor compaction of the sub surface and/or inadequate reinforcing of the slab may create cracking and other secondary defects. Gaps in the concrete paving may also have a more significant structural cause, such as subsidence of soils.

Where gaps in the concrete paving are adjacent to structural elements of the building, the advice of a Structural Engineer is advisable before undertaking repairs. Significant repair and likely replacement of the concrete paving is probable.

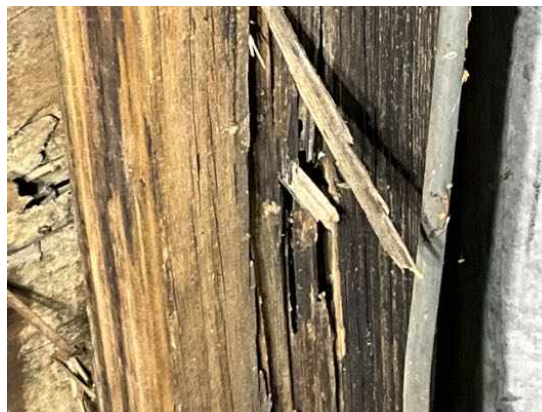
Building: Building 1  
Location: Shed  
Finding: Evidence of termite damage - minor

**Information:** Despite no live termite or timber pest activity being indicated, previous termite damage was found to have affected this area. This damage is considered to be inactive and is minor in nature.

It is advised that the area be visually inspected frequently to ensure that the condition of affected building materials does not worsen. At the time of inspection, damage is not structural and is only considered to be superficial.

A building contractor may be appointed to provide a further invasive inspection if further damage is evident.

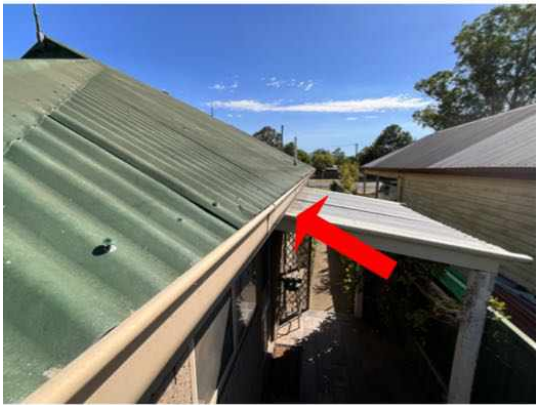
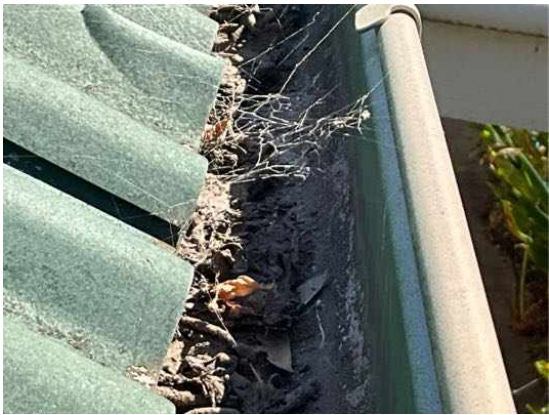
### Finding 6.01

Blocked gutters are likely to lead to high levels of moisture in the affected areas. Such moisture will not only cause rust and decay of the associated building materials, but can also provide conditions that are conducive to termite and timber pest activity.

Blockages in gutters should therefore be removed immediately to ensure dry conditions are maintained.

Consult a Licensed Plumber for further specific advice on remedial works that may be required. In the interim, it is highly advised that blocked gutters be removed by the homeowner or a general handyperson as a matter of urgency.

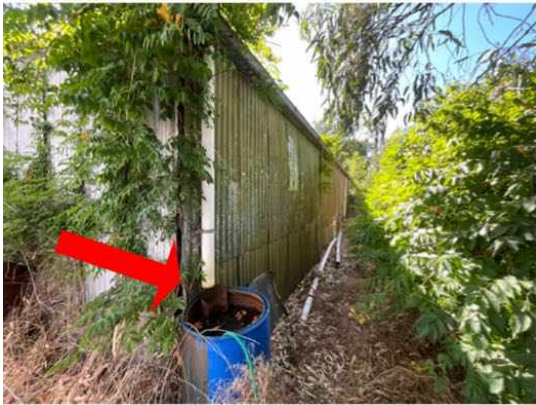
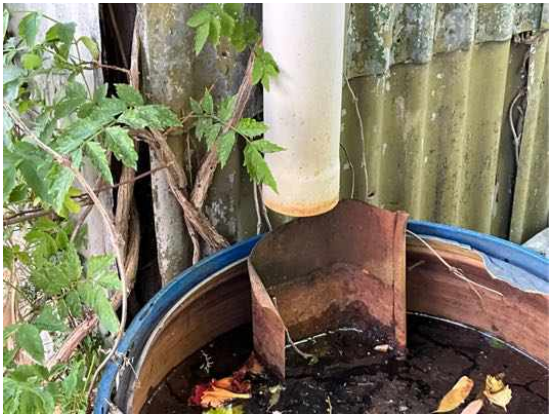
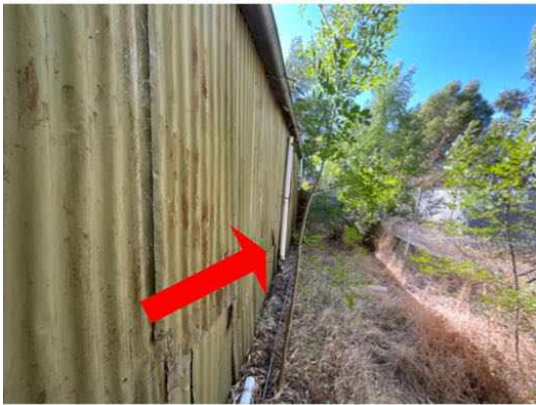
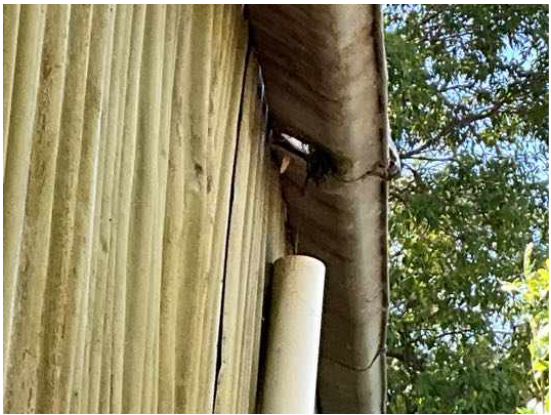
**Finding 6.02**

Building: Building 1  
Location: Shed  
Finding: Stormwater drain - Not connected  
Information: The roof plumbing is not adequately connected to stormwater drainage on the site. This disconnection negatively impacts the functional capacity of the roof plumbing.

Where roof plumbing doesn't drain adequately, the area at the base perimeter can become excessively damp, potentially creating an environment that is susceptible to rust and corrosion of surrounding building elements, as well as attracting termites and other pests.

It is highly recommended that a plumber be appointed to further inspect the area and to install adequate drainage equipment where necessary.

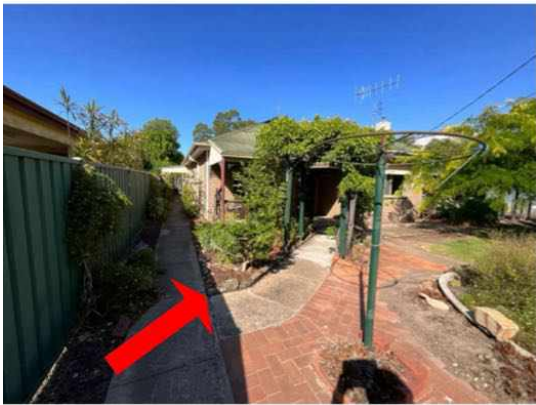
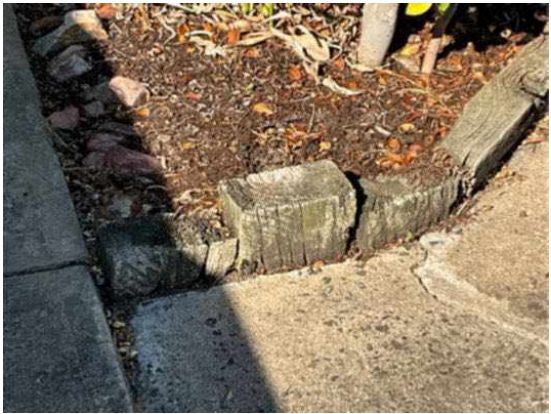
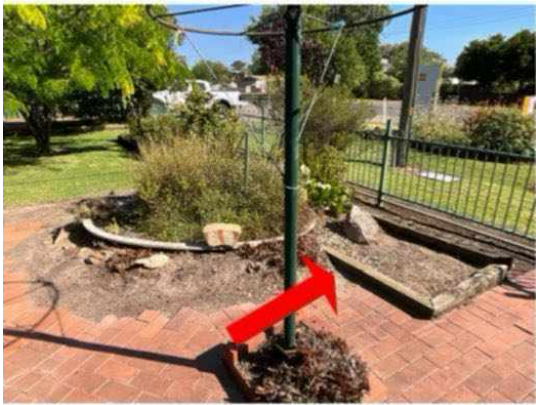
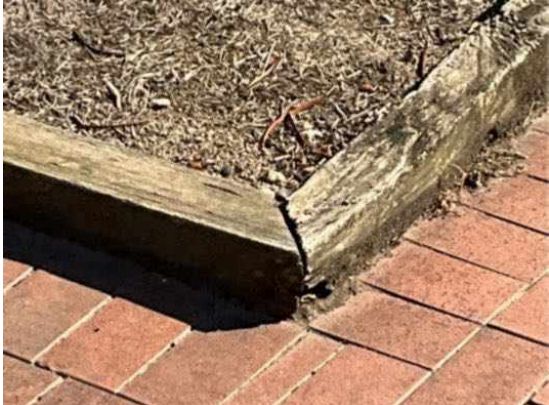
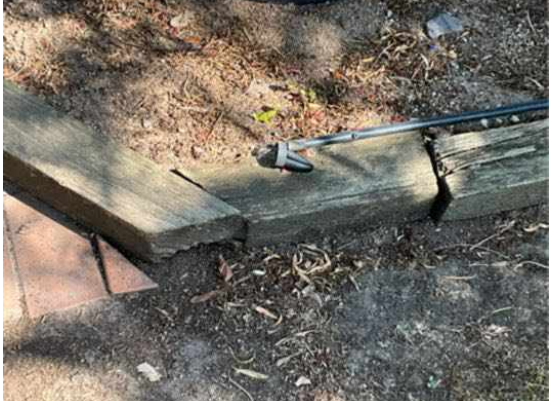
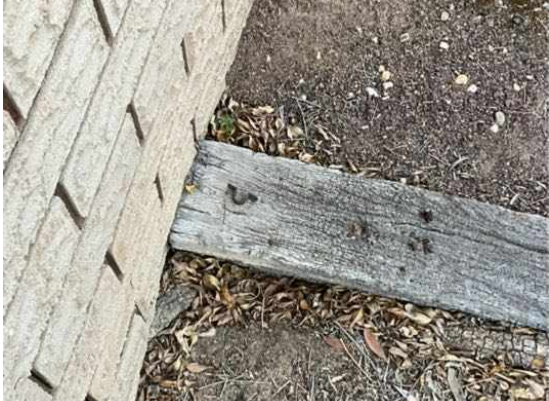
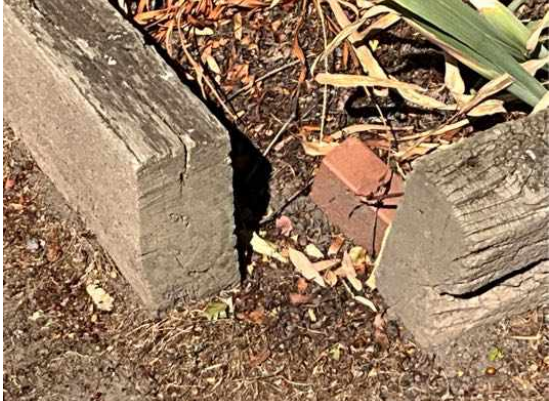
**Finding 6.03**

Building: Building 1  
 Location: Yard - Front, side, back  
 Finding: Untreated or non-durable timbers in a hazardous environment  
 Information: To reduce the risk of timber pest attack it is essential that timber used in a hazardous environment (e.g. in direct contact with the ground or frequently exposed to damp conditions) is of sufficient durability and/or is adequately preservative treated.

Untreated timbers in direct contact with the ground are likely to develop severe wood rot and/or fungal decay if left unattended creating attraction for subterranean termites to infest the timbers from surrounding areas.

If untreated or non-durable timbers are found to be in a hazardous environment it is highly advised that replacement of these building elements be performed as soon as possible to aid the protection of the property against termite / timber pest attack.

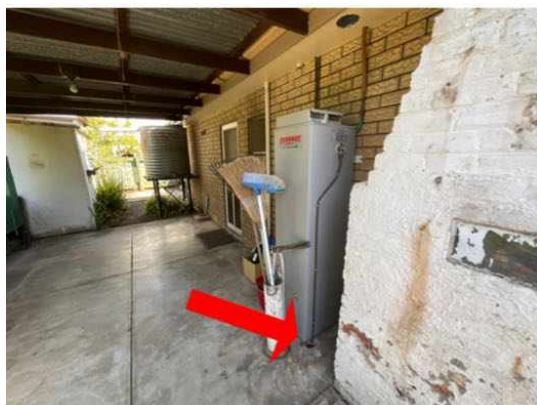
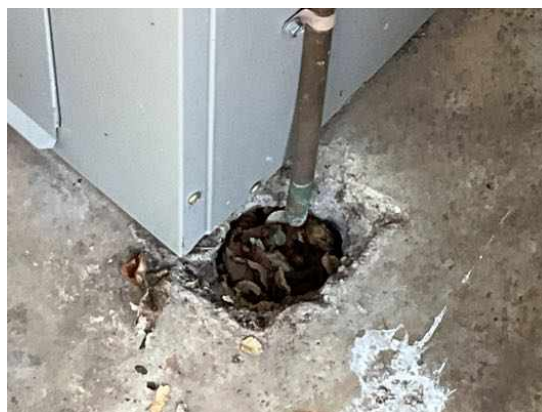
Finding 6.04

Building: Building 1  
 Location: Alfresco  
 Finding: HWS Overflow - Not Connected  
 Information: The Hot Water System (HWS) overflow was found to be disconnected from storm water drainage and is creating excessive moisture in the surrounding area.

These damp conditions can lead to secondary defects such as rot, rust or corrosion of associated building elements, the formation of fungal decay, or even the creation of potential slip hazards. When coupled with poor site drainage, pooling of water may also attract termite activity to this area.

It is highly recommended that a licensed plumber be appointed to connect the HWS overflow in order to prevent such an environment from being created. These minor works should be carried out as soon as possible.

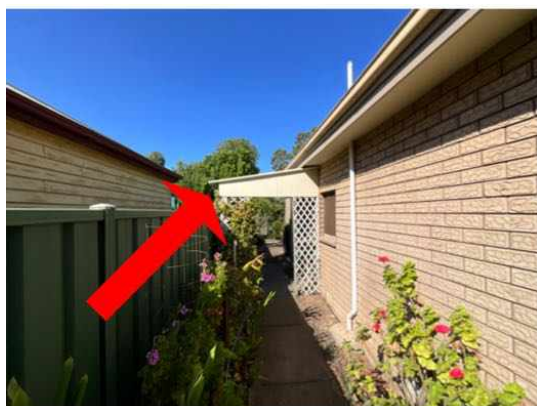
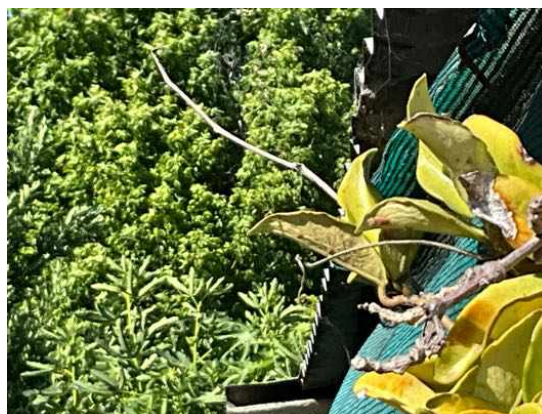
### Finding 6.05

Building: Building 1  
 Location: Back door  
 Finding: Guttering Missing  
 Information: The Guttering in this area was missing at the time of inspection. Guttering, Downpipes and Stormwater drainage are vital to protect the integrity of the structure and to prevent an environment conducive to Timber Pest attack.

A Plumber should be contacted as soon as possible to replace and connect to drainage the missing Guttering.

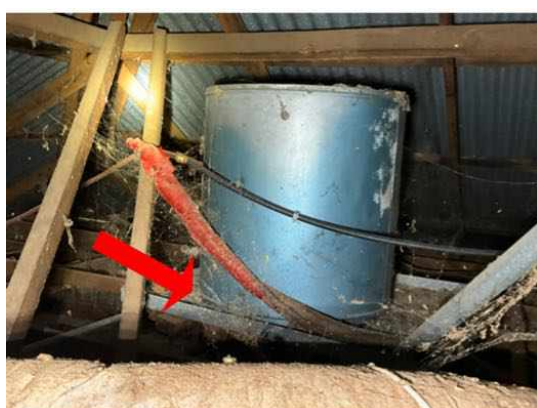
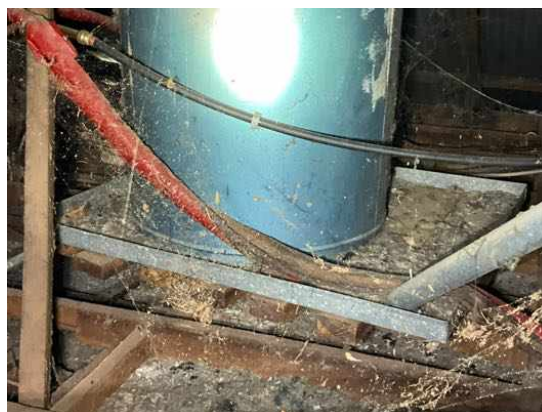
### Finding 6.06

Building:	Building 1
Location:	Roof Void
Finding:	Gravity-Fed HWS - Disconnected
Information:	It was noted at the time of inspection that a disconnected gravity-fed hot water system (HWS) remains in this area.

Despite this plumbing structure being unused, it is likely to be storing residual water, and is therefore susceptible to rust and corrosion. If allowed to continue, rust and corrosion is likely to lead to damage to adjoining building elements, and may also make the area susceptible to termite or timber pest activity.

While it is a costly exercise to remove the disused gravity-fed HWS, it is advisable in the short-term future to prevent any further damage to the area. Further consultation with a licensed plumber is required to gain further advice on removal of the structure.

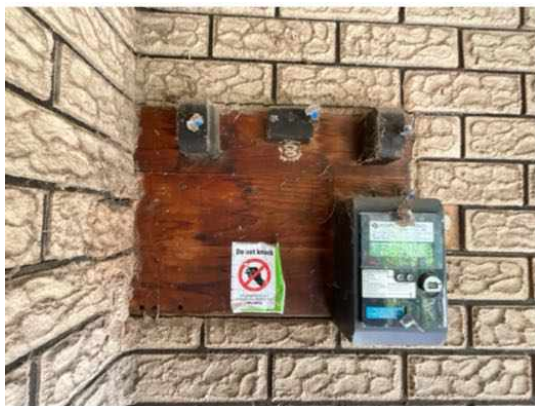
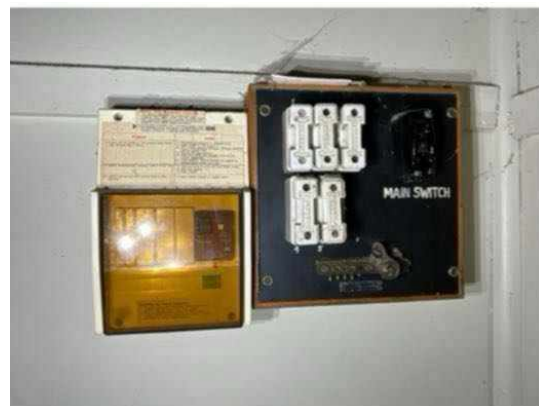
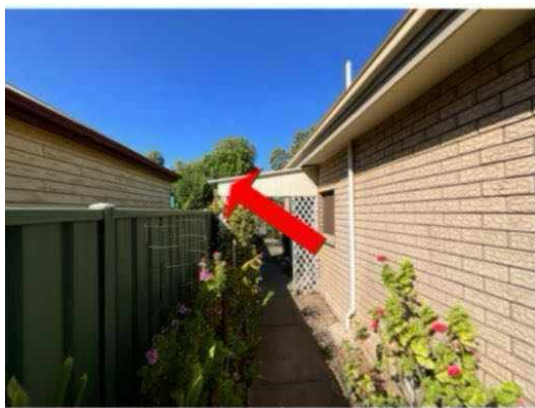
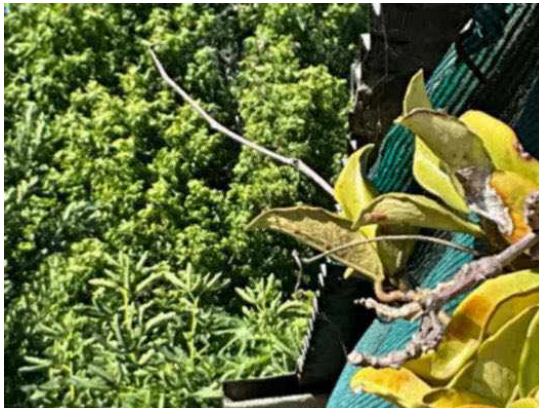
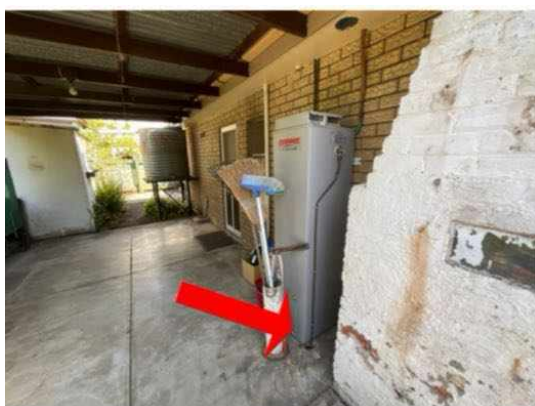
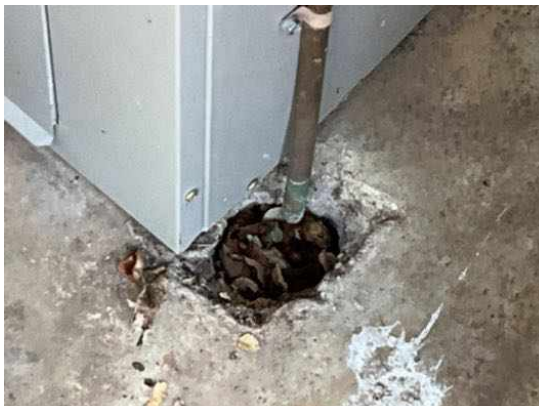
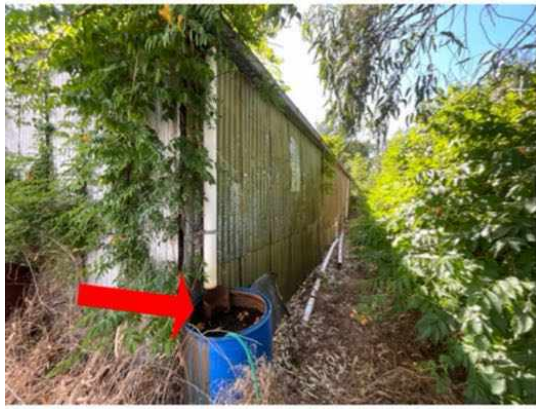
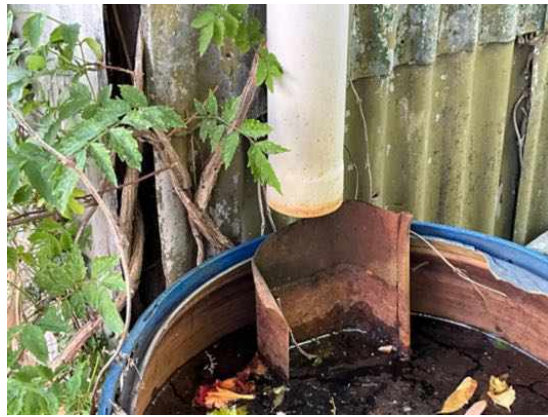
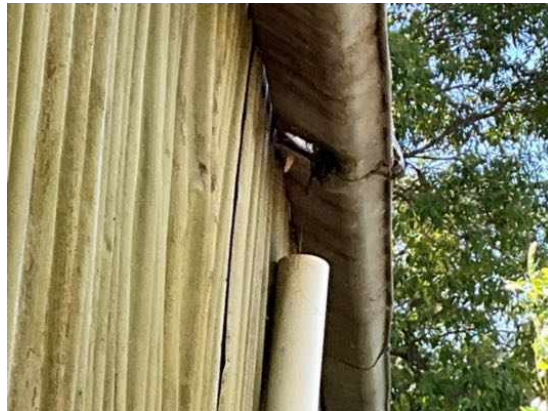
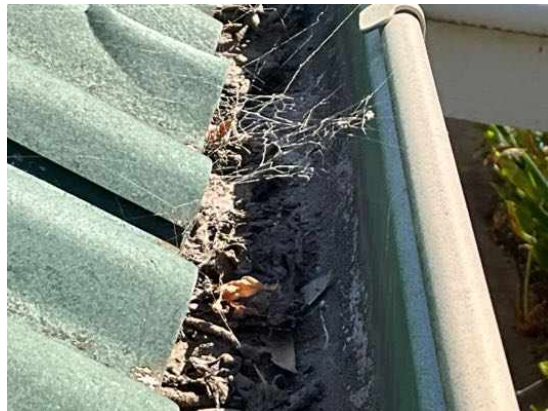
### Finding 6.07

Building:	Building 1
Location:	All External Areas
Finding:	Termite Management System - no evidence of a chemical installation
Information:	The application of a post-construction chemical termite barrier is highly recommended

for all properties, particularly if live termite activity has been found on the site previously. Such barriers are highly effective in preventing termite attack on any timber building elements throughout the property.

A durable notice should be placed in the switchboard unit to indicate current termite barriers. At the time of inspection, it appeared as though no termite management system has been installed, with no evidence to suggest preventative works taking place.

The client may consider gaining further advice from a pest controller as to the costs and procedures involved with this application. It is recommended that obtaining such advice be a short-term priority.

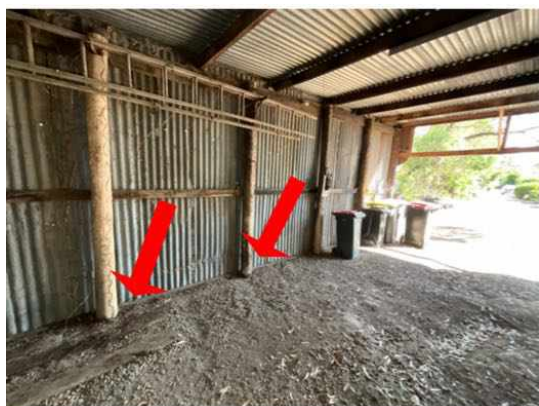
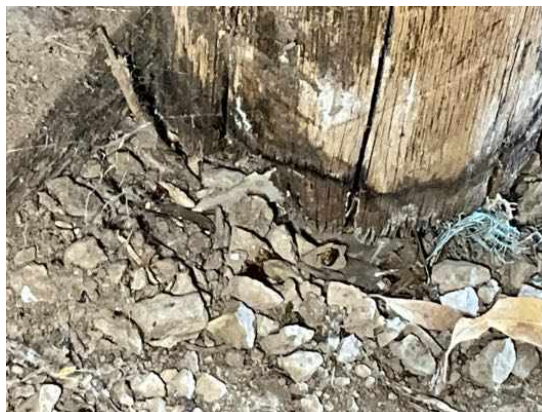
### Finding 7.01

Building:	Building 1
Location:	Shed
Finding:	Fungal decay - present
Information:	Fungal decay is also known as wood decay or wood rot generally refers to the deterioration of timber elements when in contact with excessive levels of moisture for a prolonged period of time.

The development of fungal decay is accelerated by temperatures in the range of 5degreeC to 40degreeC as well as the presence of oxygen. Generally fungal decay develops on timber elements that are in use in an external environment which are exposed to rain penetration.

In this case, fungal decay appears to have become extensive enough to damage timber elements of the shed and adjoining timber elements/structures. The widespread development of fungal decay is likely to have impacted the structural integrity and tensile strength of the affected timber elements and the associated structure.

Timbers affected by widespread fungal decay should be replaced immediately. The cause of the moisture that has led to the development of such decay should also be identified and dealt with in an appropriate manner.

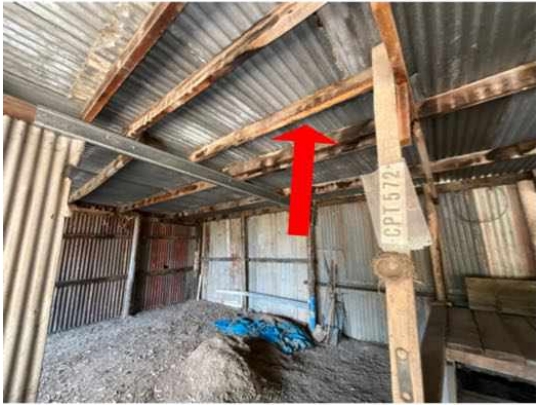
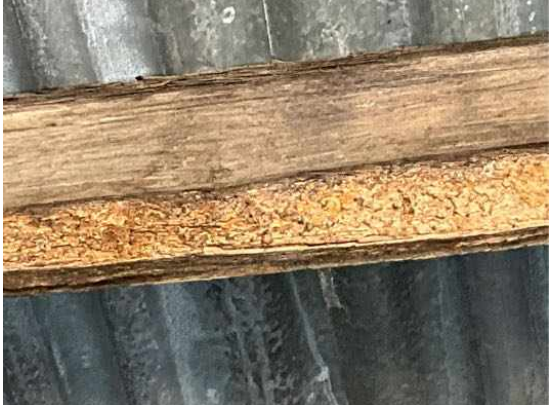
### Finding 8.01

Building: Building 1  
 Location: Shed  
 Finding: Evidence of wood borer activity identified  
 Information: Wood borers small beetles that colonise in exposed timber elements are a common timber pest that are regularly mistaken for termites. Although wood borer activity is generally not detrimental to the affected timber they may lead to serious damage and necessitate replacement of certain building elements if left unattended.

The other commonly known borer the Anobium borer is more likely to attack floorboards and may cause severe structural damage to flooring areas.

As no live wood borer activity was identified treatment is not required at this time.

Replacement of affected timbers may be considered by the client for superficial reasons.

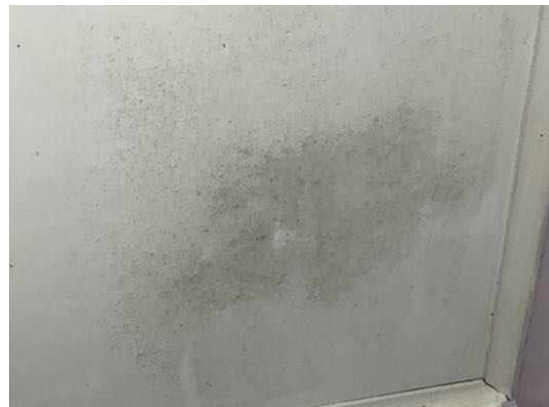
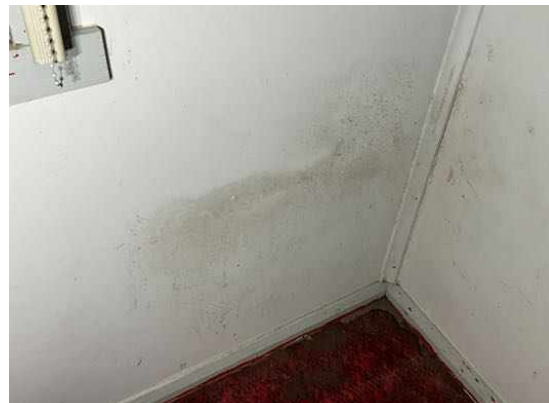
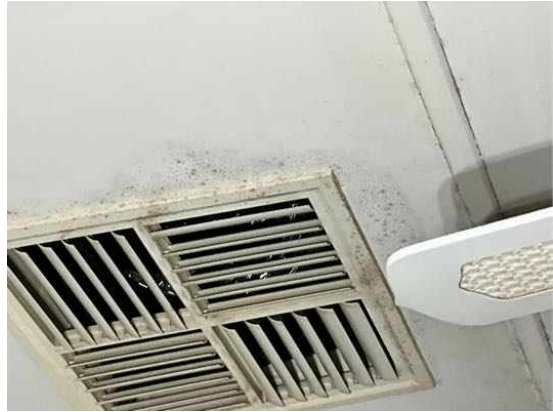
Information: Where evidence of mould growth was noted, there may be environmental, biological or health issues associated with the report. A specialist inspection by a suitably qualified environmental health inspector is warranted, where mould is extensive or where any queries regarding air quality spores or other related issues apply.

Generally, the client is advised to ensure that the general environment is free of moisture and humidity to aid in the prevention of mould formation and development. Any mould found during the inspection should be cleaned immediately by a cleaning contractor or the homeowner as applicable.

Please note that severely affected building elements may require replacement by a registered builder or qualified carpenter.

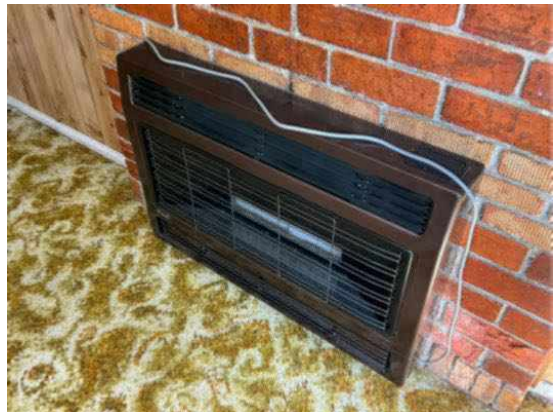
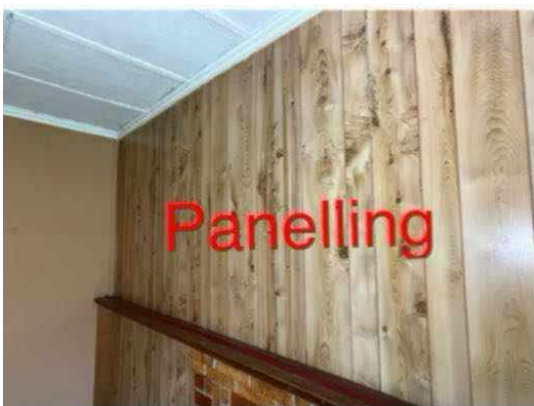
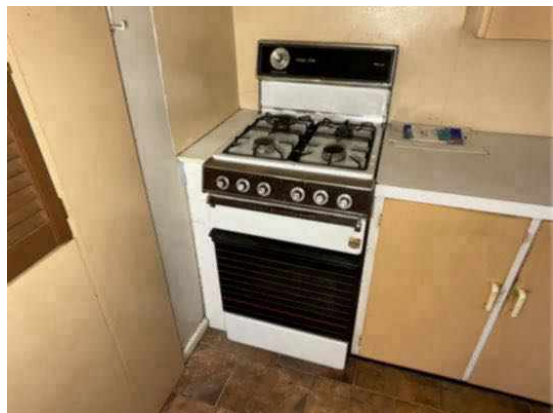
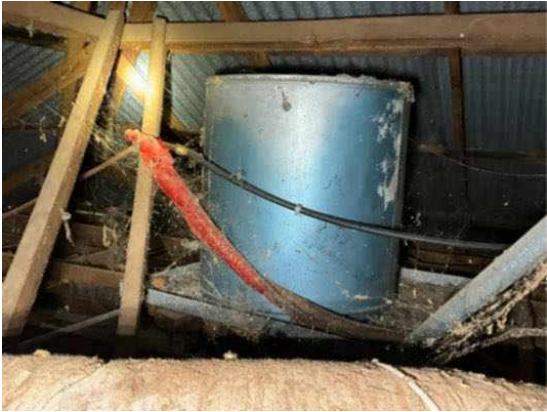
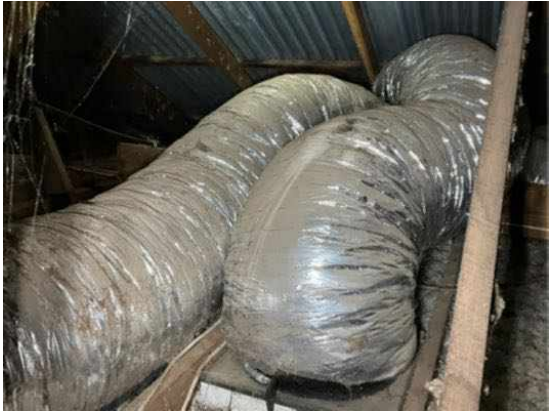
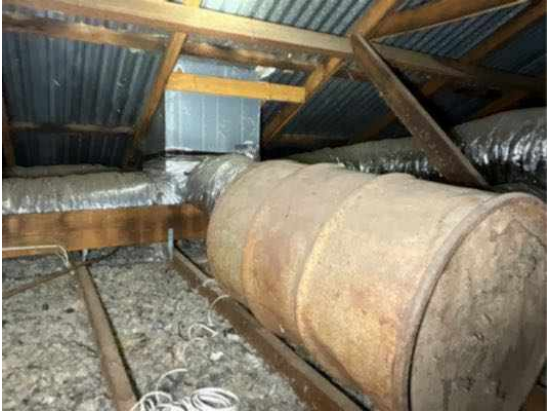
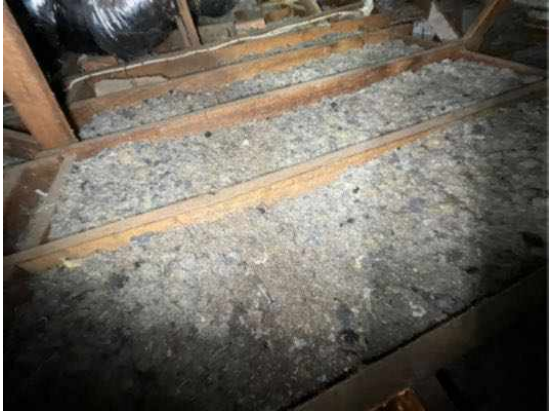
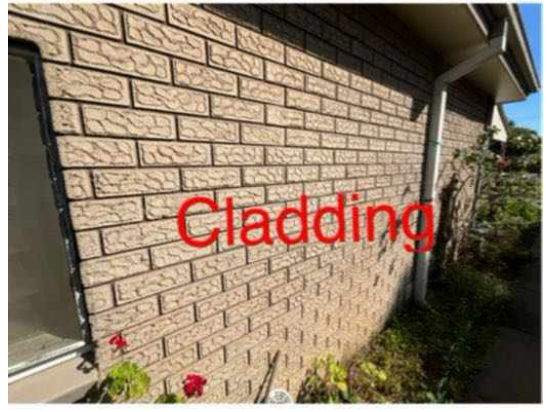
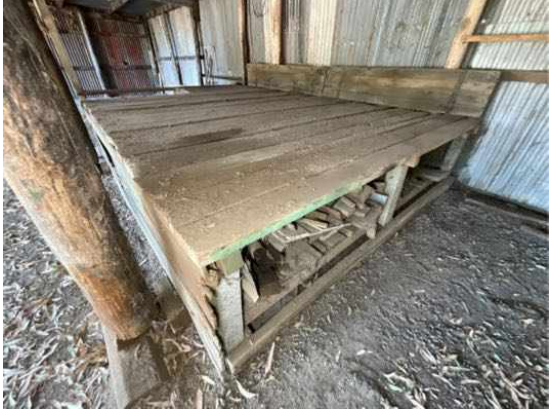
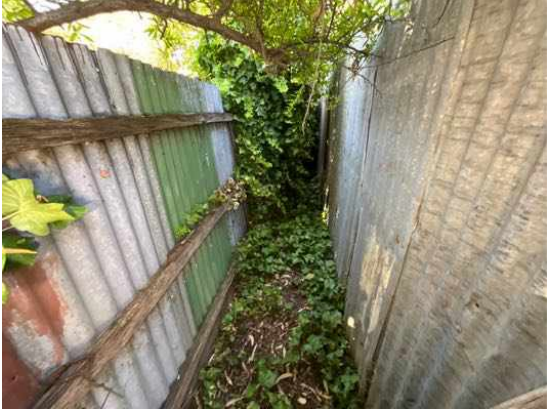
Finding: Additional Photos - Obstructions and Limitations

Information: These photographs are an indication of the obstructions and limitations which impeded full inspection of the property at the time of inspection. These obstructions can hide an array of defects and should be removed to allow full inspection to be carried out. A re-inspection is recommended once the areas are made accessible.
