Building and Timber Pest Inspection Report

Inspection Date: Wed, 4 Mar 2026

Property Address: 45 Francis St, Rochester VIC 3561, Australia

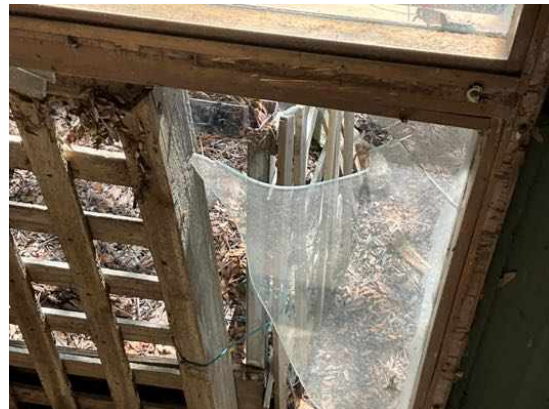
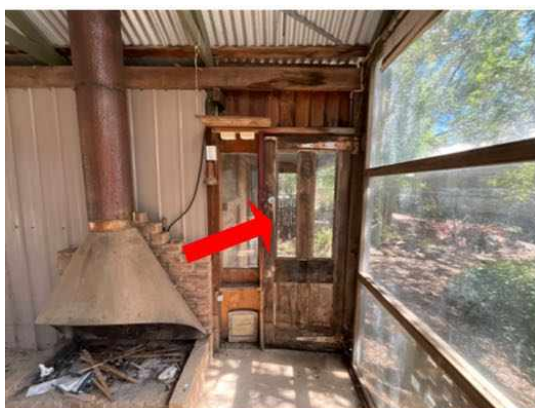
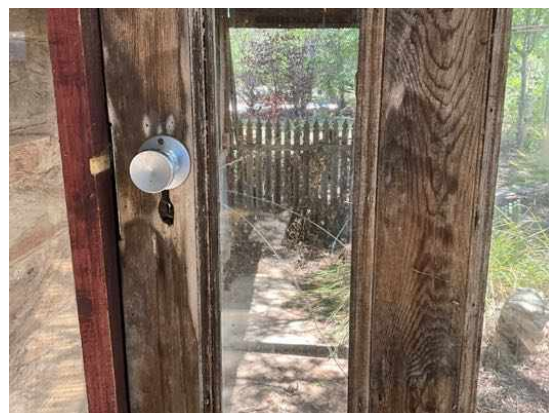
Building: Building 1
Location: Carport
Finding: Window - Cracked
Information: Cracks were identified in the window in this area. Cracking in windows is generally the result of impact damage, and is likely to develop further when left unmanaged.

The likelihood of this windowpane further cracking and shattering is increased exponentially, providing a safety hazard in the area. The cracked window also impairs the weather tightness of the building, creating potential for minor water leaks.

A safety hazard is noted. There is cracking evident in the carport windows. A glazier should be contacted immediately to restore the area and prevent potential injury.

A qualified glazier is required to repair the window as soon as possible. Depending on the extent of the cracking, replacement of the window may be required. Please be advised that any persons coming into contact with the cracked window should do so with due caution to avoid any personal injury that may ensue.

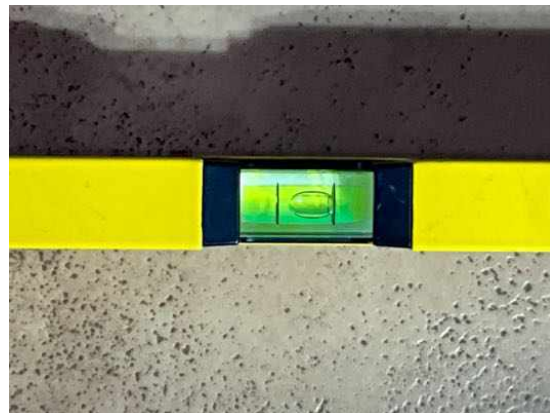
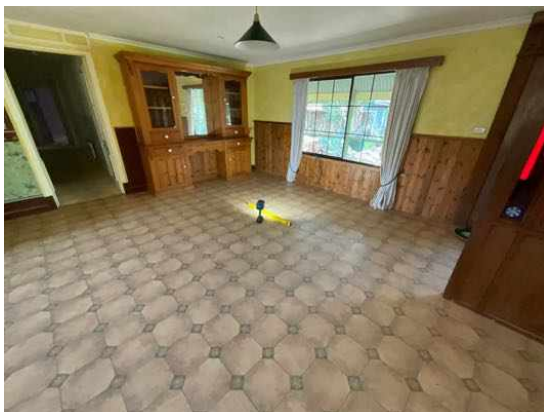
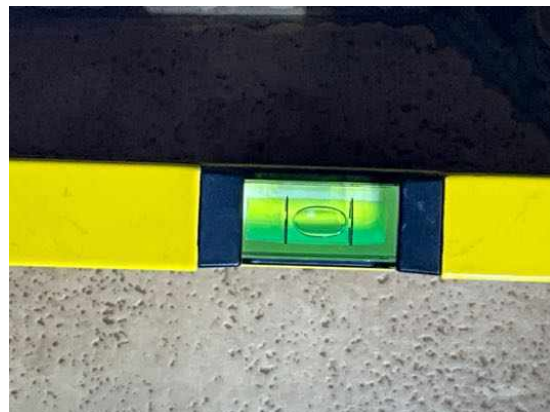
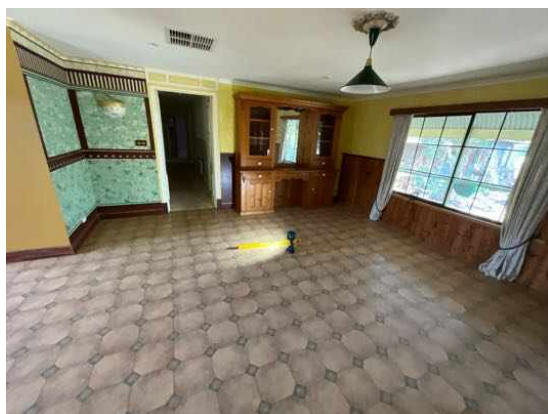
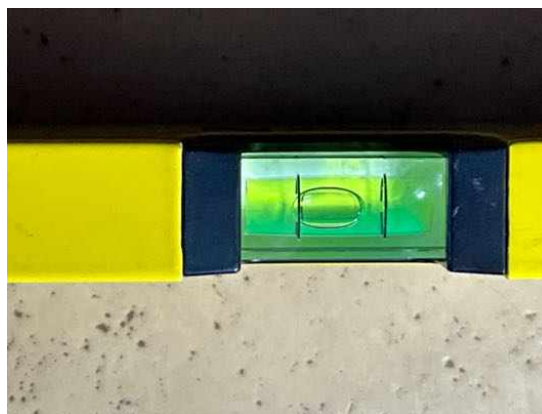
Information: The internal flooring in this area is out of level and uneven. Uneven flooring is likely to indicate minor defects such as expected movement of the foundations of the property, but may also indicate subsidence of the associated subfloor stumps.

It is advised that the flooring be closely monitored to identify any further movement. Where flooring remains relatively unchanged for an extended period of time (i.e. several months), it is likely that this defect has been caused by expected movement of the foundations of the property.

However, where flooring is uneven further, potentially invasive inspection of the subfloor structures and stumps in this area is required. In this case, works to repair are likely to be required, and would be carried out by a registered builder specialising in re-stumping.

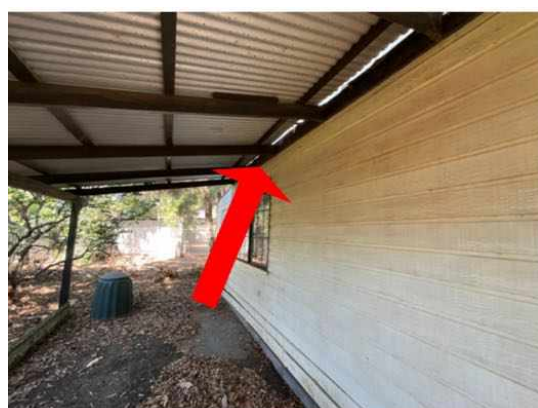
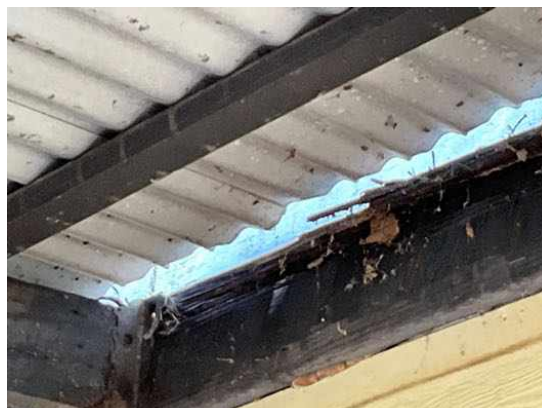
Finding 3.02

Building:	Building 1
Location:	Verandah > Rear
Finding:	Flashing - missing
Information:	Flashing is required to be installed wherever walls are interrupted by openings within the cavity where the roof abuts a cavity wall or the like at the base of cavities and where masonry chimney's abut the roof. Instances where flashing is missing in locations nominated by BCA3.3.4.7 this should be reinstated.

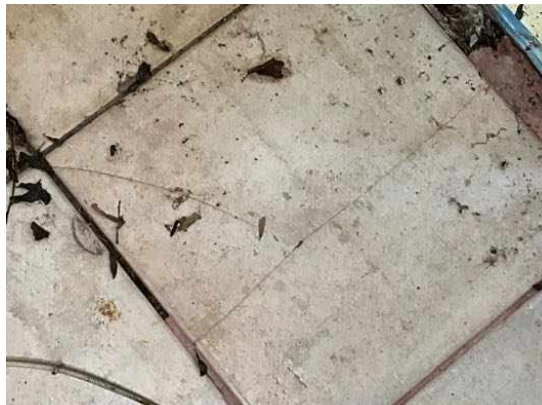
Finding 3.03

Building:	Building 1
Location:	Verandah
Finding:	Cracked floor tiles
Information:	Cracking in the floor tiles was evident in this area at the time of inspection. It is suspected that this cracking has occurred as a result of minor settlement or impact damage.

Cracked tiles throughout the household detract from the overall appearance of the affected areas however it is unlikely to create or lead to any secondary defects.

While not considered a matter of urgency, replacement of cracked floor tiles is

recommended at the clients discretion. A tiling contractor may be appointed to perform these works. Where cracks become more numerous, contact a licensed building inspector for further investigation.

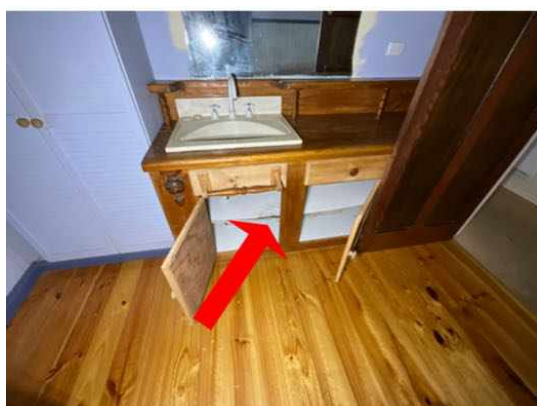
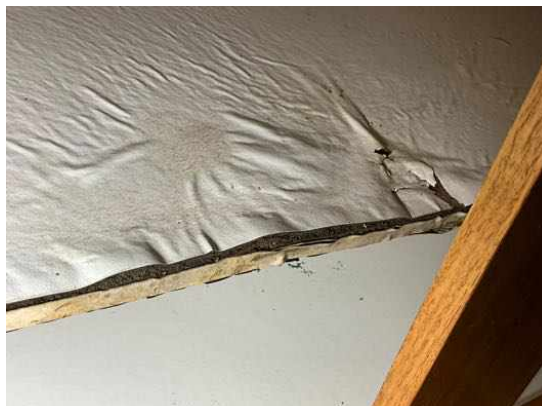
Finding 3.04

Building: Building 1
 Location: Bathroom
 Finding: Cabinets- moisture affected.
 Information: The structure of the Cabinets in this area was found to be deteriorating due to the effects of excessive moisture. Replacement of any damaged board materials is recommended. Parts of the Cabinetry not badly damaged or swollen may be re-sealed or painted.

The source of the moisture must be identified and rectified before repairs and replacement is carried out. The services of a Cabinet maker or General Handy Person should be sought at the discretion of the owner.

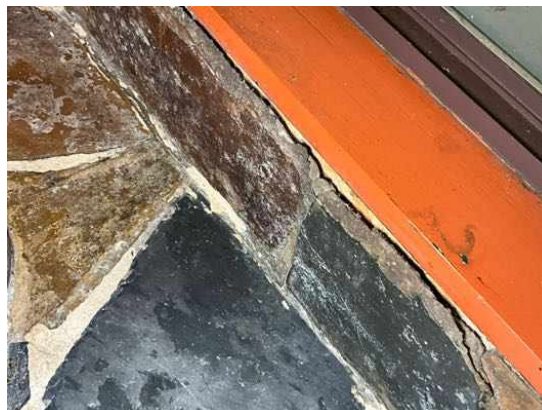
Finding 3.05

Building: Building 1
 Location: Kitchen
 Finding: Tiles - Drummy

Information: Drummy tiled areas were identified at the time of inspection. The term 'drummy' refers to tiles that have become detached from their fixing, despite otherwise being in relatively good condition. Such defects are generally caused by physical or moisture damage to the area. Drummy tiled areas may also be a direct result of poor workmanship during the construction process.

Tiled areas may swell and shrink with changes in air humidity if the area has sustained moisture damage. Any exposure to moisture is capable of causing tiled areas to become drummy and/or cracked over a prolonged period of time. Drummy tiled areas generally require removal and replacement of affected tiles, with adequate sealant and grouting.

Specialist trades are available for these types of services. A registered builder may be required to undertake works if damage is extensive or if secondary building defects have resulted. Otherwise, it is advised that a tiling contractor be appointed to perform works as necessary. Immediate action is recommended to ensure that no further damage is sustained in the affected area.

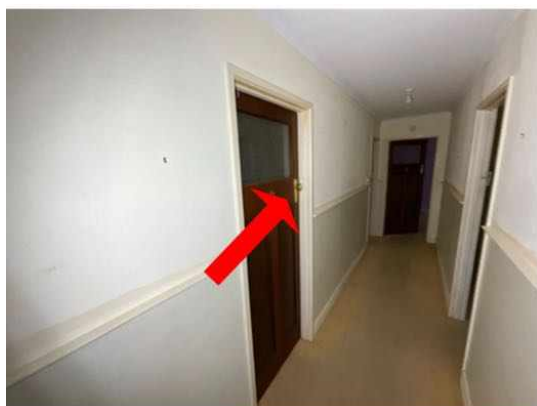
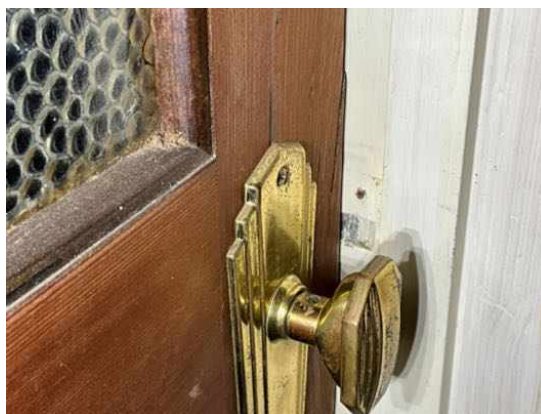
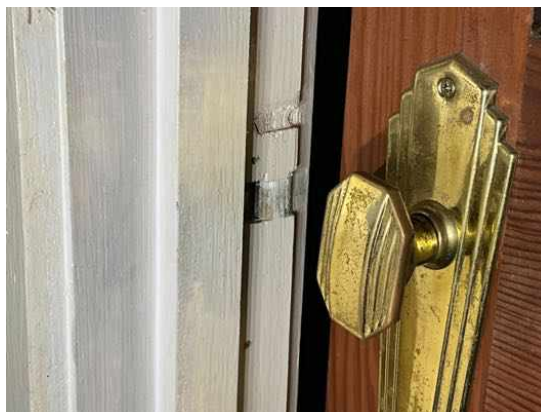
Finding 3.06

Building: Building 1
 Location: Bedroom 1, 2
 Finding: Door - Striker plate misaligned
 Information: The striker plate to this door appears to have become misaligned and has consequently resulted in the door's operation being compromised.

This is a common defect and is expected in a property of this age, whether being due to substandard installation or general deterioration of the door hardware.

Readjustment of the striker plate is recommended at client discretion. Works such as these can be completed by a general handyman or qualified carpenter.

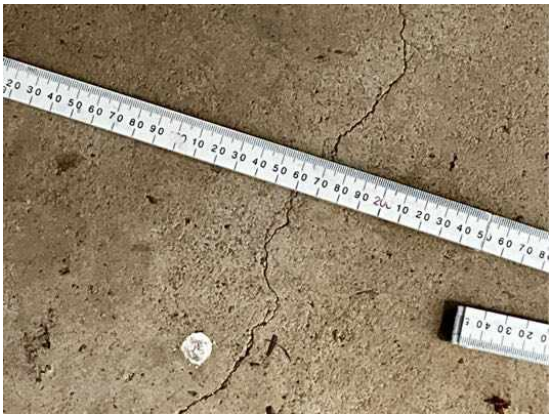
Finding 3.07

Building: Building 1
 Location: Carport
 Finding: Crack in concrete slab - Category 1
 Information: A crack coded as Category 1 was identified in the slab. A Category 1 crack is described as a fine but noticeable crack, with the slab at an otherwise reasonable level.

To be considered Category 1, the approximate width of the crack is less than 1.0mm, or a less than 10mm change in offset when a 3m straight edge is placed over the defect.

Category 1 cracks should be monitored for a period of 12 months. At the end of the monitoring period, identified cracks that are rated greater than Category 2 are considered defects, and require rectification.

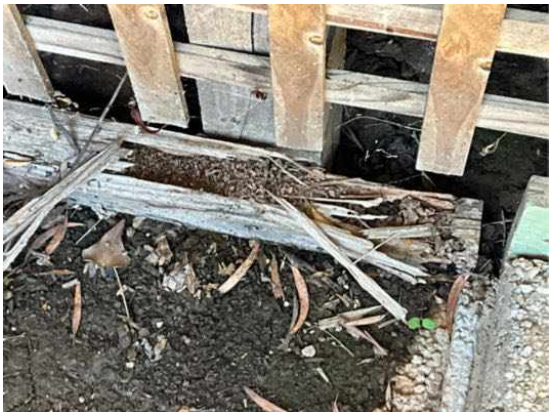
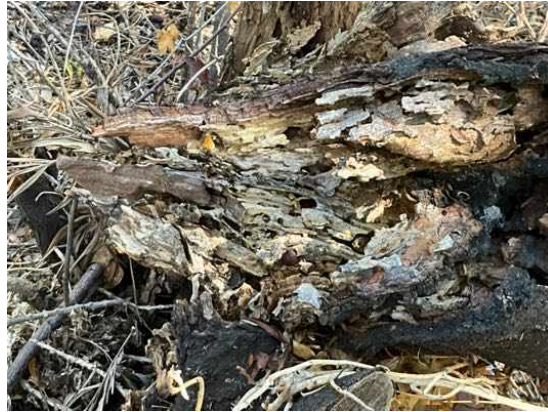
Building: Building 1
 Location: Yard - Side
 Finding: Evidence of termite damage- minor
 Information: Despite no live termite or timber pest activity being indicated, previous termite damage was found to have affected this area. This damage is considered to be inactive and is minor in nature.

It is advised that the area be visually inspected frequently to ensure that the condition of affected building materials does not worsen. At the time of inspection, damage is not structural and is only considered to be superficial.

A building contractor may be appointed to provide a further invasive inspection if further damage is evident.

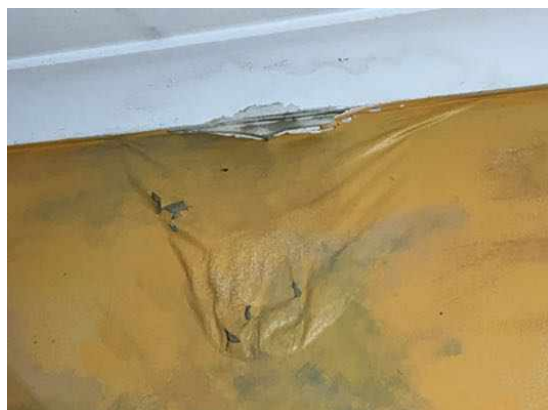
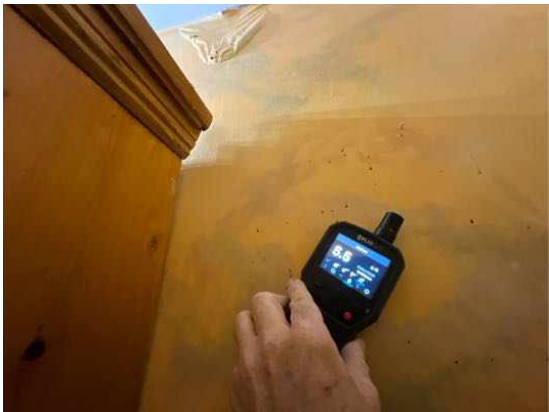
Finding 6.01

Finding: Water leak - Inactive

Information: Water leaks generally occur when a particular area of the property is not weather- or water-tight. While the damage in this area appears to be from an old inactive water leak, the area should be monitored frequently for the recurrence of any dampness.

Repair and / or replacement of previously affected building elements is at client discretion. Consider a further invasive inspection: removal of obstructions around the damaged area may reveal further damage which has been concealed. A more significant or major defect may be identified at this time.

Where recurrence of an active water leak is identified, a qualified plumber should be appointed immediately to rectify the leak and advise on any further preventative works as necessary.

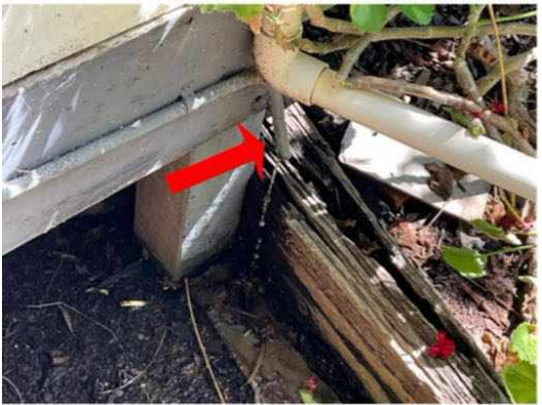
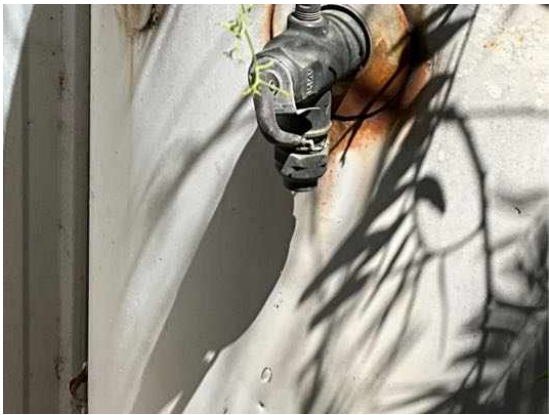
Finding 6.02

Building: Building 1
Location: Yard - Side, back
Finding: HWS Overflow - Not Connected
Information: The Hot Water System (HWS) overflow was found to be disconnected from storm water drainage and is creating excessive moisture in the surrounding area.

These damp conditions can lead to secondary defects such as rot, rust or corrosion of associated building elements, the formation of fungal decay, or even the creation of potential slip hazards. When coupled with poor site drainage, pooling of water may also attract termite activity to this area.

It is highly recommended that a licensed plumber be appointed to connect the HWS overflow in order to prevent such an environment from being created. These minor works should be carried out as soon as possible.

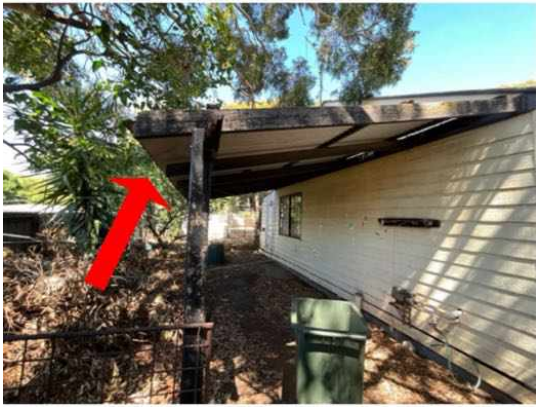
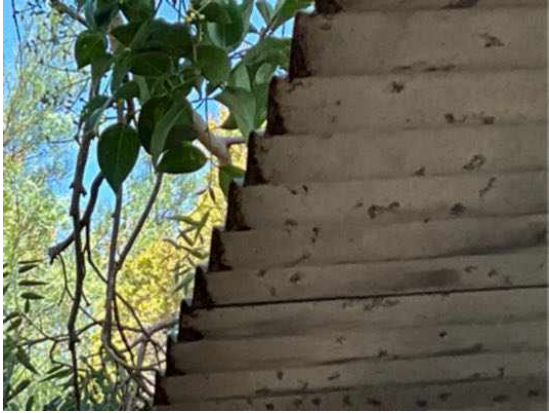
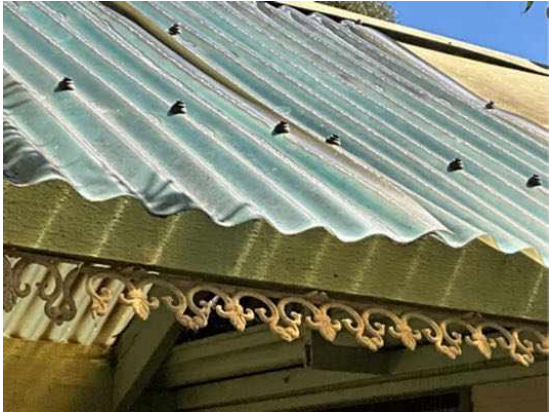
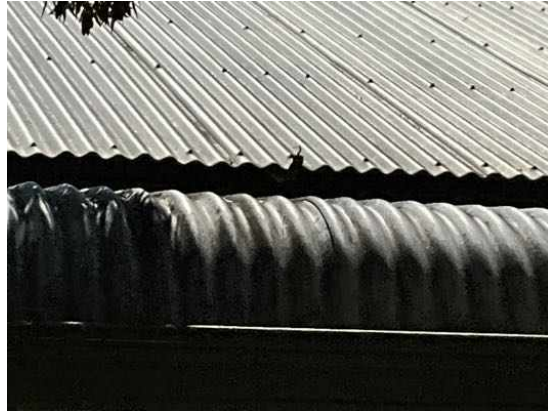
Finding 6.03

Building: Building 1
 Location: Verandah, upper roof >
 Finding: Guttering Missing
 Information: The Guttering in this area was missing at the time of inspection. Guttering, Downpipes and Stormwater drainage are vital to protect the integrity of the structure and to prevent an environment conducive to Timber Pest attack.

A Plumber should be contacted as soon as possible to replace and connect to drainage the missing Guttering.

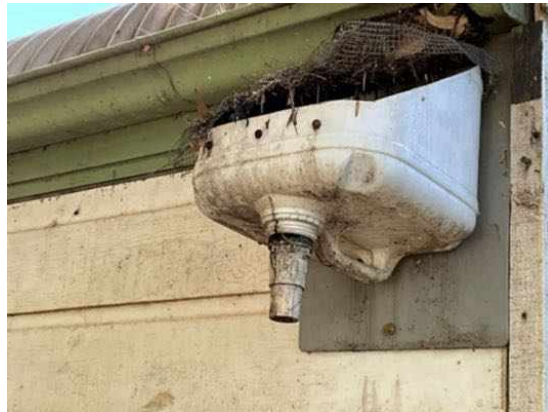
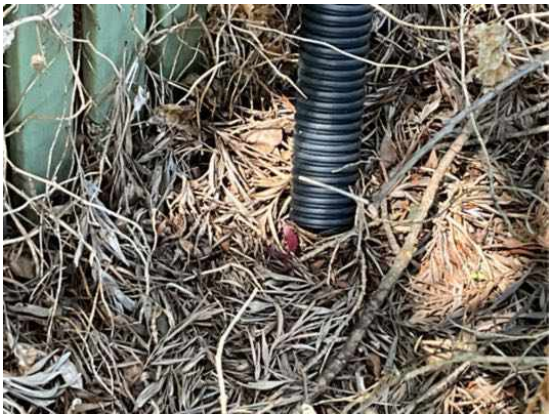
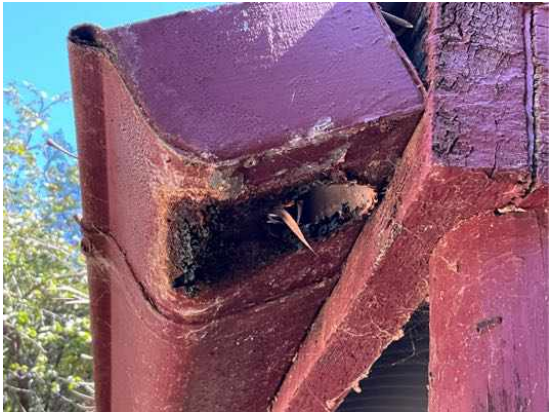
Finding 6.04

Building:	Building 1
Location:	Yard - Side, carport
Finding:	Stormwater drain - Not connected
Information:	The roof plumbing is not adequately connected to stormwater drainage on the site. This disconnection negatively impacts the functional capacity of the roof plumbing.

Where roof plumbing doesn't drain adequately, the area at the base perimeter can become excessively damp, potentially creating an environment that is susceptible to rust and corrosion of surrounding building elements, as well as attracting termites and other pests.

It is highly recommended that a plumber be appointed to further inspect the area and to install adequate drainage equipment where necessary.

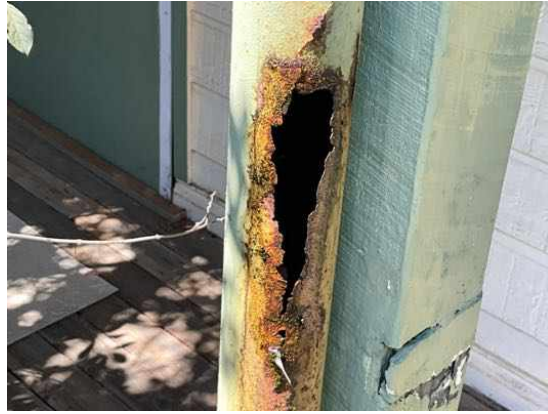
Finding 6.05

Building: Building 1
Location: Yard - Side
Finding: Downpipe/ Stormwater pipe Damaged
Information: The Stormwater element was found to be damaged at the time of inspection.

Downpipes ensure excess water is directed away from the structure to prevent damage. This damage includes Fungal timber decay, Termite attack and sinking of the stumps that support the floor. All of this type of damage may lead to costly repairs.

A Plumber should be contacted to make repairs as soon as possible to prevent deterioration of the Structure.

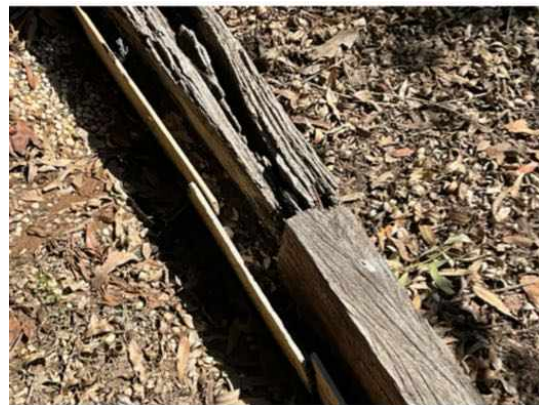
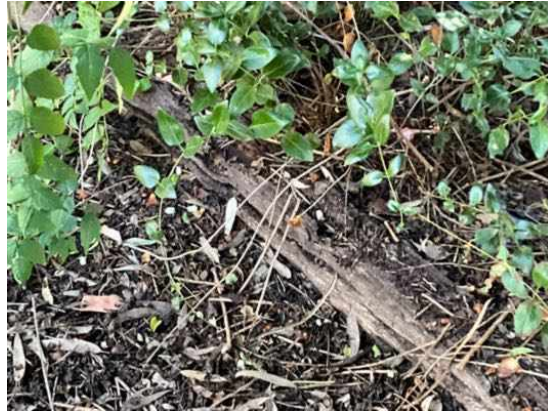
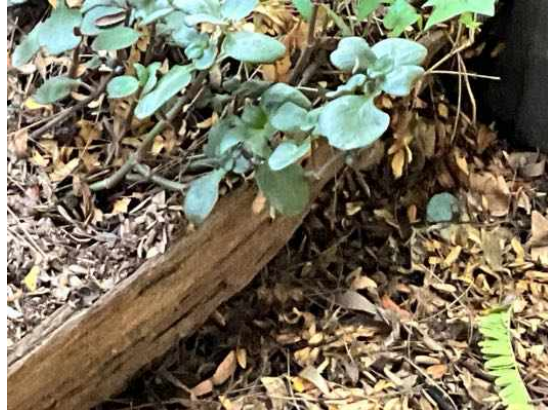
Finding 6.06

Building:	Building 1
Location:	Yard - Side, verandah
Finding:	Untreated or non-durable timbers in a hazardous environment
Information:	To reduce the risk of timber pest attack it is essential that timber used in a hazardous environment (e.g. in direct contact with the ground or frequently exposed to damp conditions) is of sufficient durability and/or is adequately preservative treated.

Untreated timbers in direct contact with the ground are likely to develop severe wood rot and/or fungal decay if left unattended creating attraction for subterranean termites to infest the timbers from surrounding areas.

If untreated or non-durable timbers are found to be in a hazardous environment it is highly advised that replacement of these building elements be performed as soon as possible to aid the protection of the property against termite / timber pest attack.

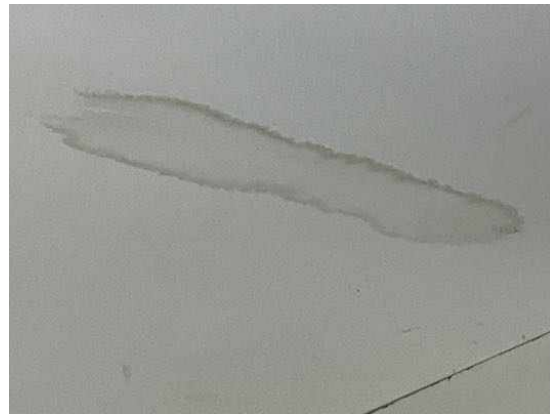
Finding 6.07

Building:	Building 1
Location:	Walk in robe
Finding:	Ceiling - Water stained
Information:	Water staining to ceiling linings in this area was evident at the time of inspection. Water staining indicates that surfaces have been exposed to excessive moisture over time. The minerals and other elements in the water lead to staining, which may graduate to corrosion and deterioration if left unmanaged.

While mostly an appearance defect, water staining can be indicative of more serious defects, which may be currently concealed by interior ceilings.

Where water staining is active, a licensed plumber must be consulted to identify the cause of the staining and to provide advice on any reparation works that may be required. Replacement of any damaged structures is advised.

Conversely, where water staining is old and inactive, affected building materials may be repaired or replaced at client discretion.

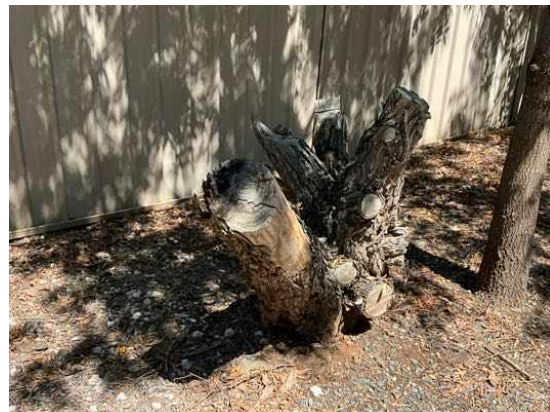
Finding 6.08

Building:	Building 1
Location:	Yard - Back
Finding:	Tree Stump in Ground
Information:	Any tree stumps in the yard not removed during the tree removal process provides the opportunity for Termite infestation and is likely to be subject to decay from damp conditions against the stump.

Services for tree stump removal should be contacted as soon as possible to reduce the risk of timber pest attack.

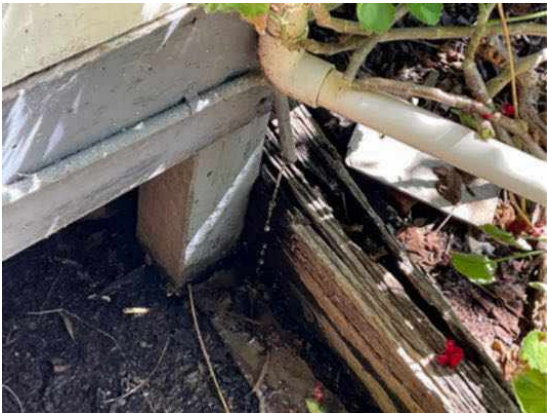
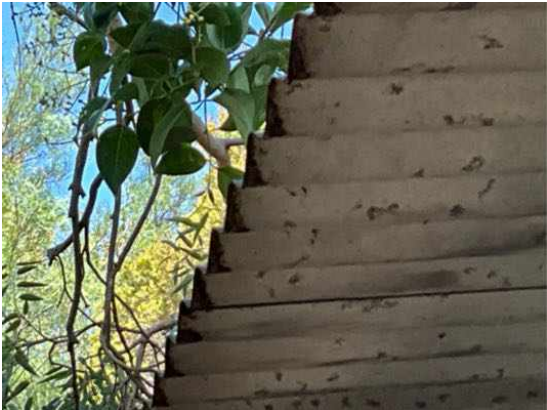
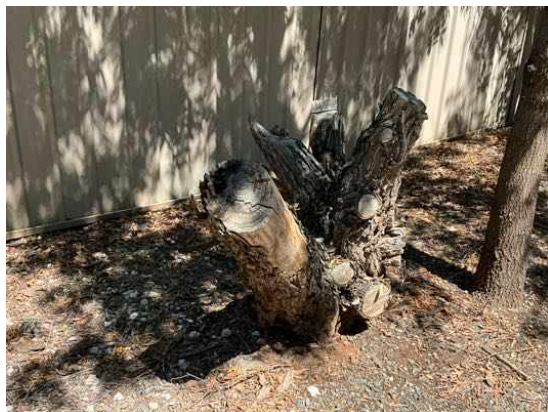
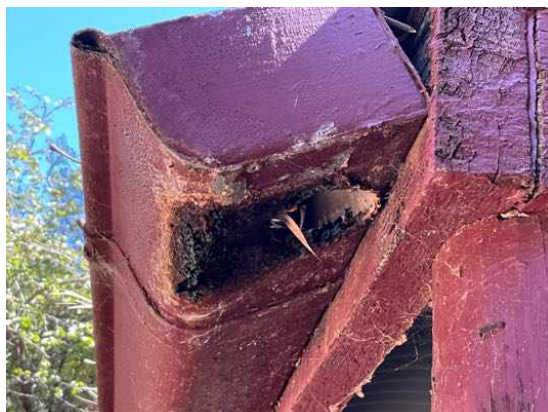
Finding 6.09

Building:	Building 1
Location:	All External Areas
Finding:	Termite Management System - no evidence of a chemical installation
Information:	The application of a post-construction chemical termite barrier is highly recommended for all properties, particularly if live termite activity has been found on the site

There is no evidence of previous Termite Management services. The property has factors that are conducive to Termite attack. A Licensed Pest controller should be contacted soon to advise on a Termite Management Plan and avoid potentially costly repairs.

The client may consider gaining further advice from a pest controller as to the costs and procedures involved with this application. It is recommended that obtaining such advice be a short-term priority.

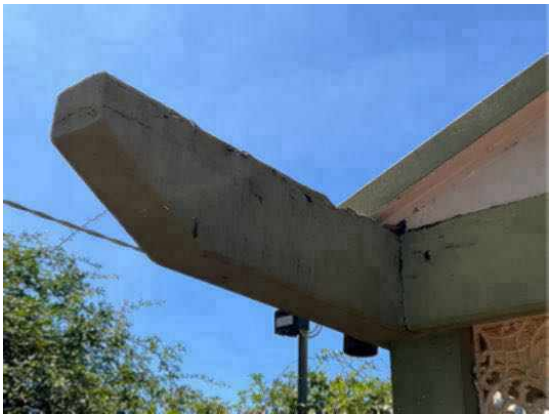
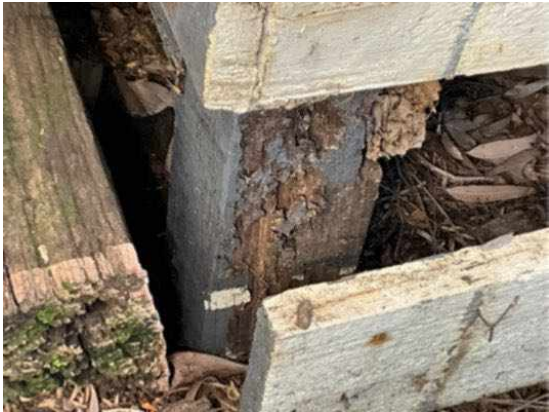
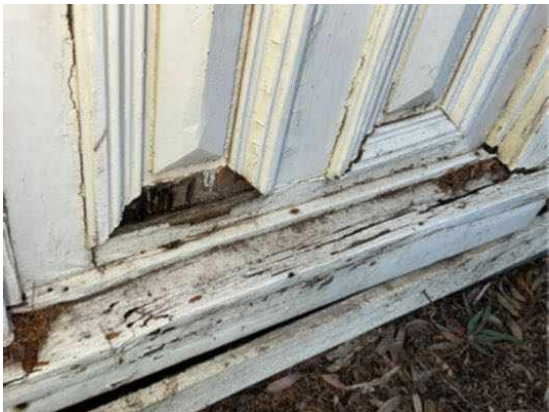
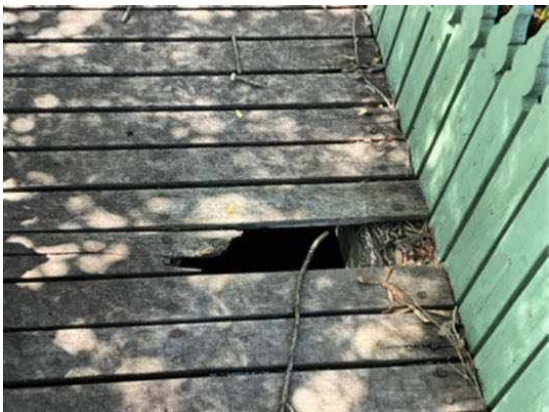
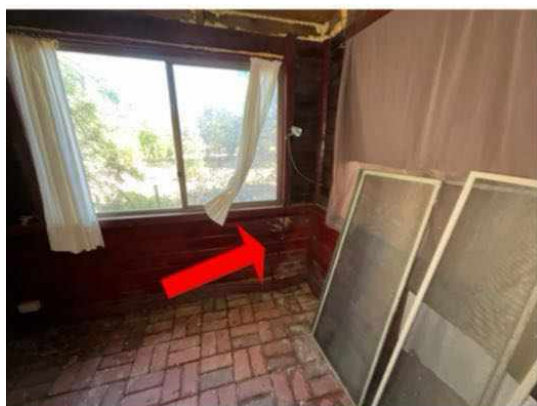
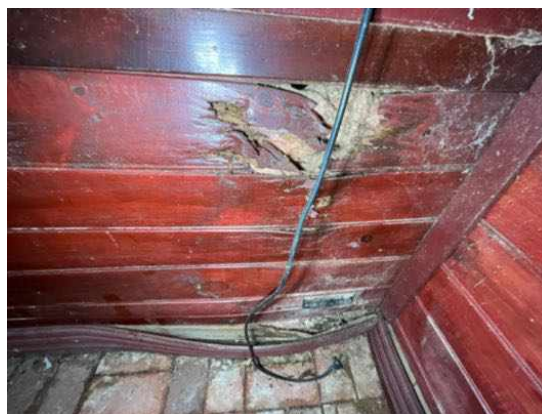
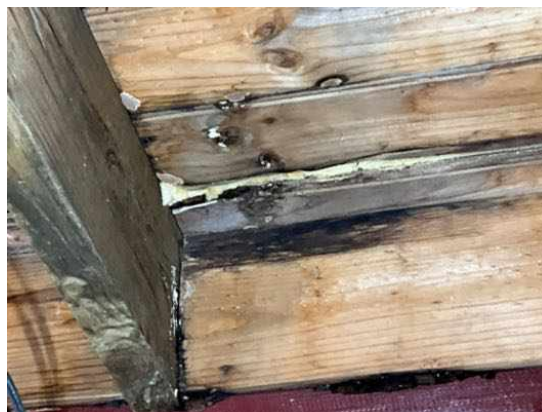
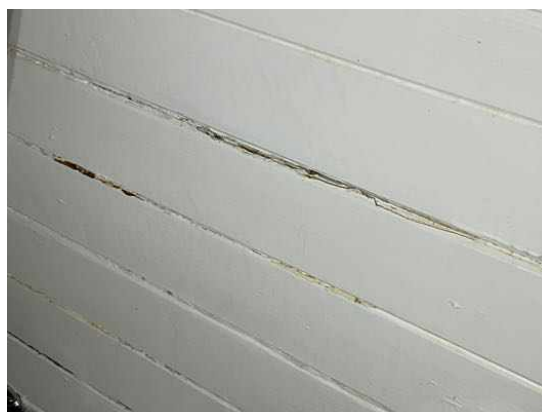
Finding 7.01

Building:	Building 1
Location:	Entry, back yard, carport, spa
Finding:	Fungal decay - present (localised)
Information:	Fungal decay also known as wood decay or wood rot generally refers to the deterioration of timber elements when in contact with excessive levels of moisture for a prolonged period of time.

The development of fungal decay is accelerated by temperatures in the range of 5degreeC to 40degreeC as well as the presence of oxygen. Generally fungal decay develops on timber elements that are in use in an external environment which are exposed to rain penetration.

In this case although the affected timber element is in a decaying state the extent of any visible damage appears to be localised to a specific area and is yet to spread to other parts of the building element or affect adjoining structures. The fungal decay is therefore likely to be of a relatively superficial nature with minimal impact on the structural integrity or tensile strength of the timber element.

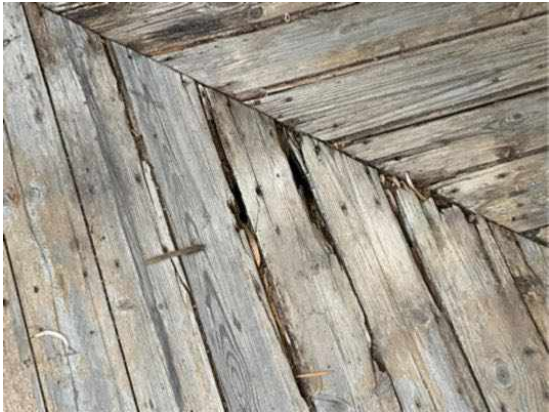
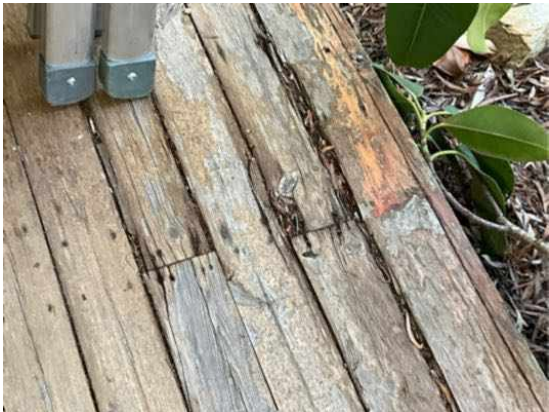
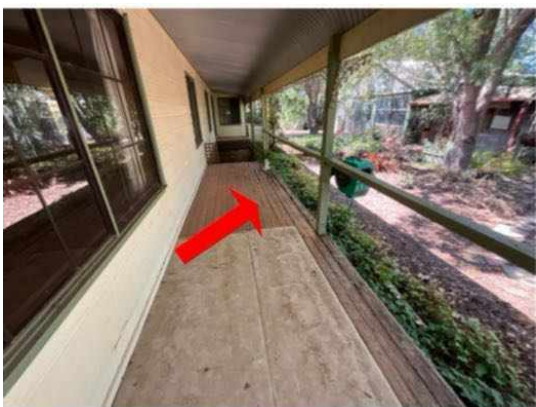
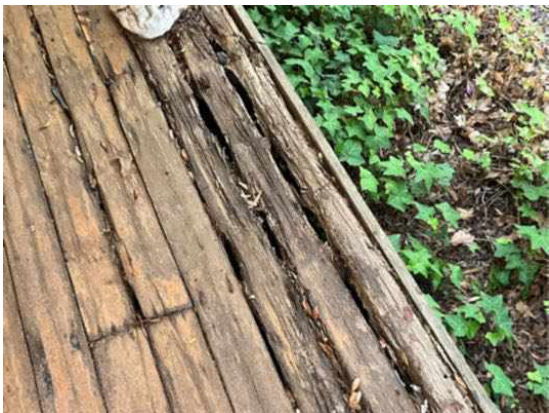
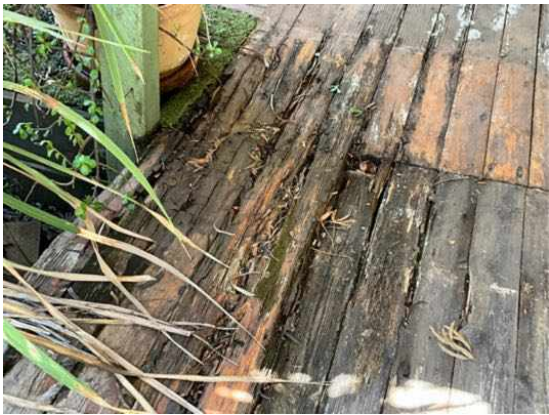
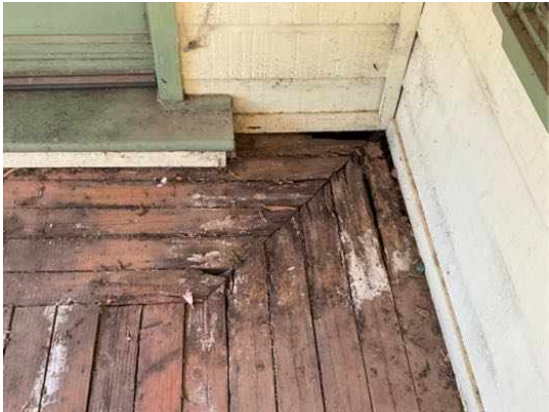
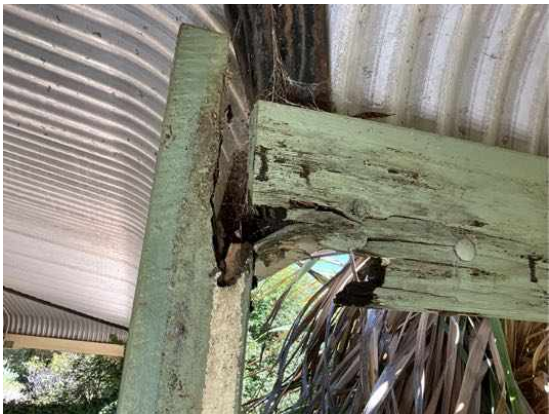
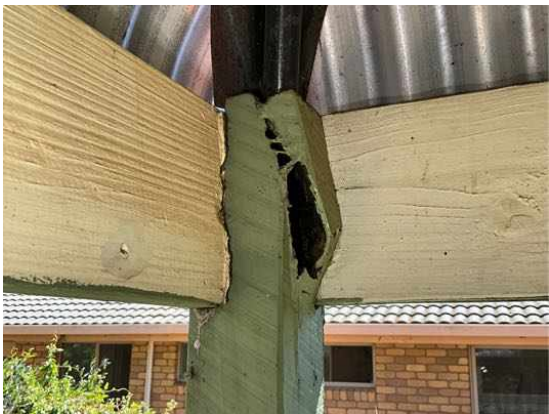
Finding 7.02

Building:	Building 1
Location:	Verandah
Finding:	Fungal decay - present (widespread)
Information:	Fungal decay is also known as wood decay or wood rot generally refers to the deterioration of timber elements when in contact with excessive levels of moisture for a prolonged period of time.

The development of fungal decay is accelerated by temperatures in the range of 5degreeC to 40degreeC as well as the presence of oxygen. Generally fungal decay develops on timber elements that are in use in an external environment which are exposed to rain penetration.

In this case, fungal decay appears to have become widespread and is likely to have affected any adjoining timber elements/structures. The widespread development of fungal decay is likely to have heavily impacted the structural integrity and tensile strength of the affected timber elements and the associated structure.

Timbers affected by widespread fungal decay should be replaced immediately. The cause of the moisture that has led to the development of such decay should also be identified and dealt with in an appropriate manner.

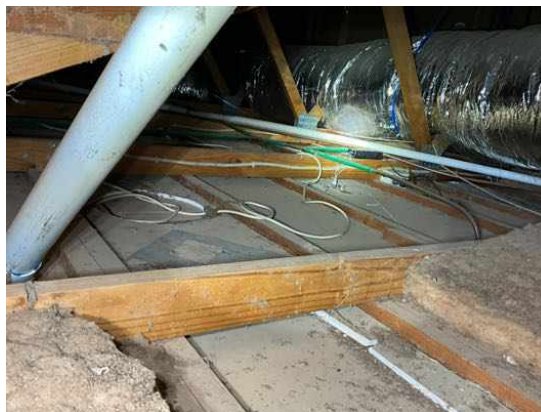
Building: Building 1
 Location: Roof Void
 Finding: Insulation - Inadequate
 Information: Upon inspection of the roof void it was noted that there is a lack of adequate insulation.

Caution should be exercised when accessing the roof void. Do not attempt to stand on the framework to the underside of the trusses and be aware there is a potential for electric shock if contact is made with exposed or faulty electrical wiring.

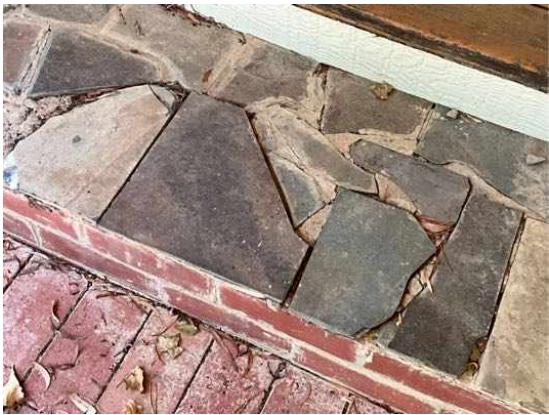
Building: Building 1
 Location: Verandah entry
 Finding: Tiles - Cracked or damaged
 Information: Cracking and removal was evident to the tiling in this area at the time of inspection. This area is frequently exposed to water, allowing potential for water penetration into adjoining sections of walls or flooring.

If left unmanaged, water penetration to these areas may lead to subsequent water damage, which is likely necessitate repair work to affected building elements.

A tiling contractor should be appointed to ensure that no further water damage occurs. The re-application of silicone and grouting throughout remaining tile work is also advised, to further protect the area against water penetration.

Where water penetration has led to water damage, appointment of a relevant tradesperson may be required to repair damaged building elements.

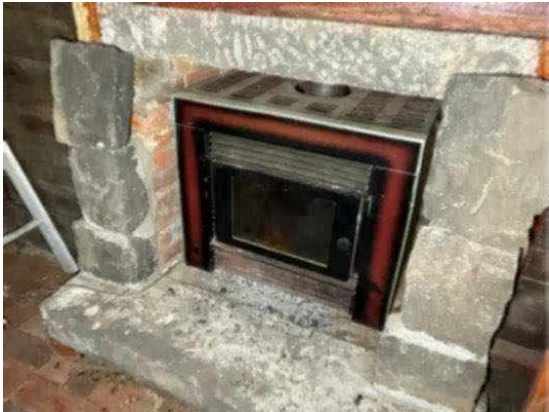
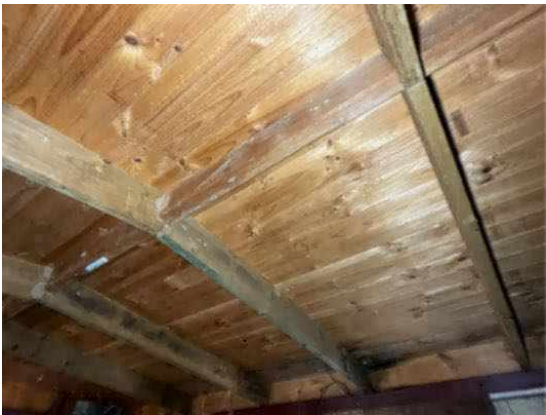
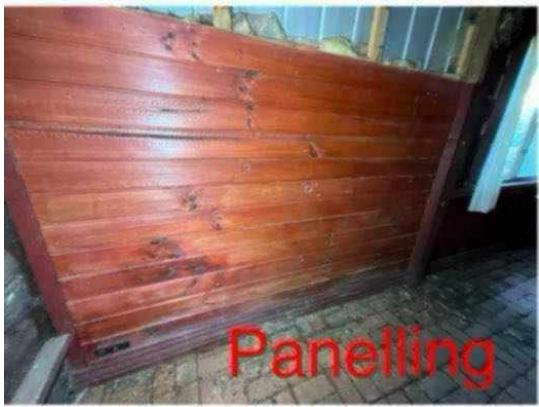
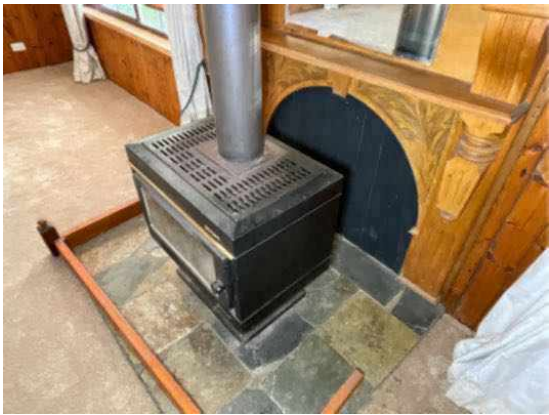
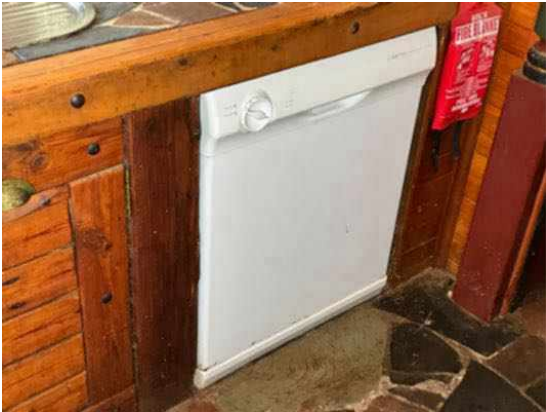
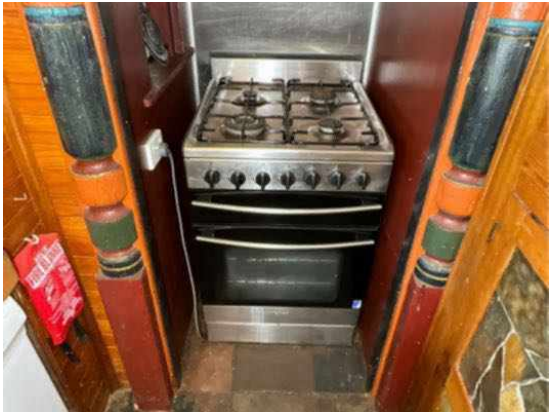
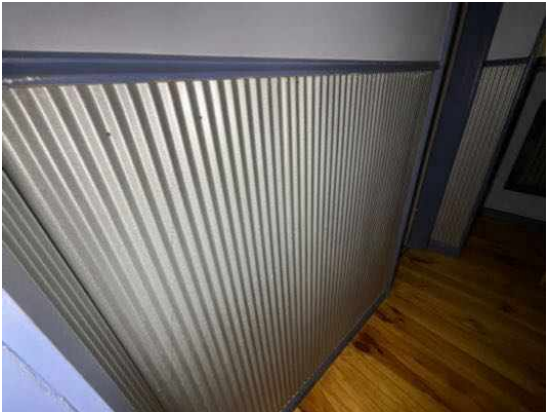
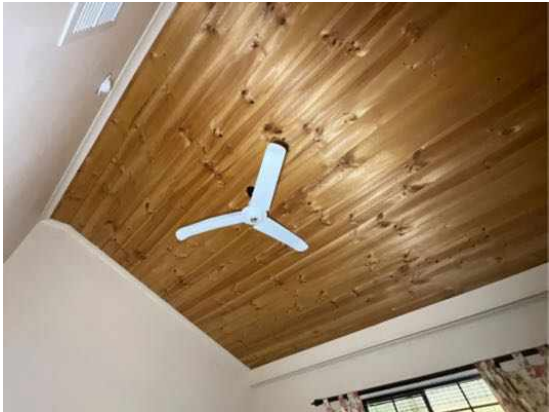
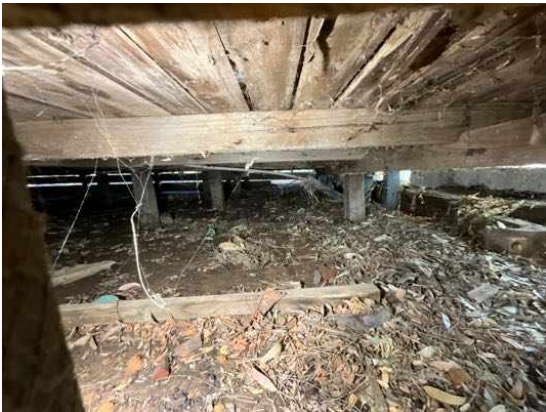
Building: Building 1
 Location: All Areas
 Finding: Additional Photos - Obstructions and Limitations
 Information: These photographs are an indication of the obstructions and limitations which impeded full inspection of the property at the time of inspection. These obstructions can hide an array of defects and should be removed to allow full inspection to be carried out. A re-inspection is recommended once the areas are made accessible.
