Building and Timber Pest Inspection Report

Inspection Date: Thu, 5 Feb 2026

Property Address: 25 merrigum crescent , Clarinda ,3169

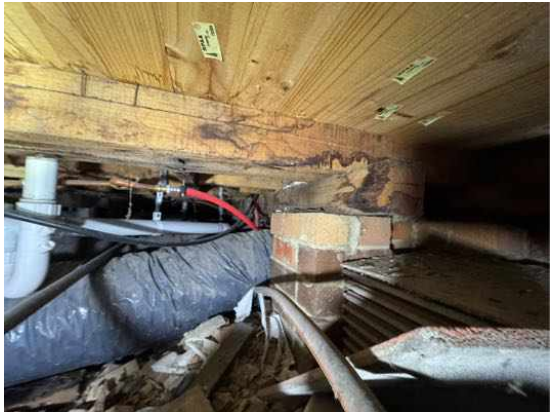
Building: Main Building
Location: Subfloor
Finding: Subfloor (Below Bathroom) – Water Leakage & Moisture Damage to Bearer (Potential Major Defect)

Information: Evidence of water leakage was observed within the subfloor area located beneath the bathroom, with visible moisture staining and dampness noted to a section of a structural bearer. This condition is consistent with ongoing or previous water escape from bathroom plumbing or waterproofing-related components.

Prolonged moisture exposure to structural timber beneath wet areas may result in timber deterioration, reduced bearing capacity, and progressive structural movement if not addressed. Moist conditions in this location are conducive to timber deterioration and create conditions conducive to termite activity. If the source of water ingress remains unresolved, this condition may develop into a major structural defect over time.

This issue should be investigated and assessed as soon as practicable (ASAP) by a suitably qualified structural engineer, in conjunction with an appropriately licensed plumber to identify and rectify the source of water leakage. Further investigation may be required to determine the extent of timber impact and any necessary remedial works.

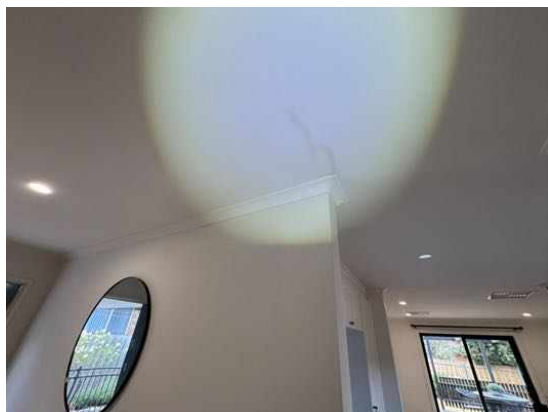
Building:	Main Building
Location:	All Areas
Finding:	Internal Walls – Surface Imperfections
Information:	Sections of the internal walls show visible dents and surface imperfections. These marks are consistent with general wear, minor impact, or previous patching that was not finished to a high standard.

If left unrectified, the imperfections may remain visible through new paintwork and affect the overall presentation of the interior surfaces.

Rectification should be carried out as soon as practicable by a qualified painter or plasterer to properly sand, patch, and repaint the affected areas for a smooth and consistent finish.

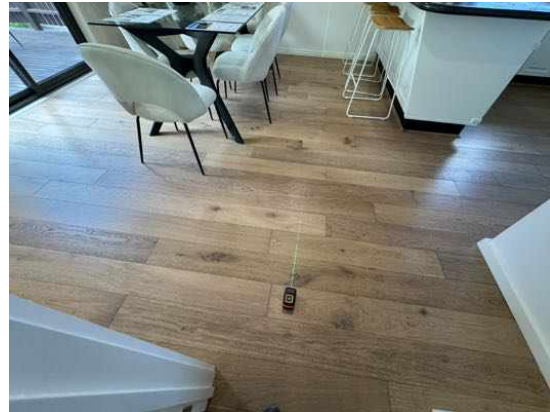
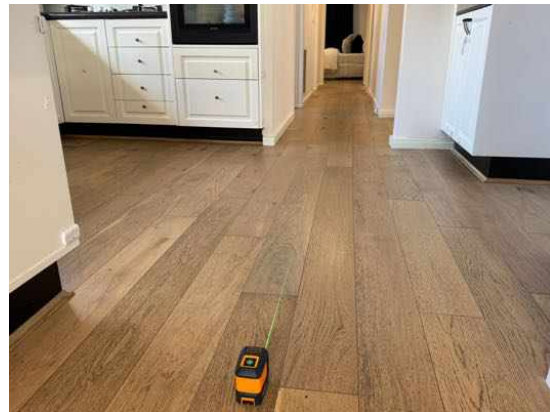
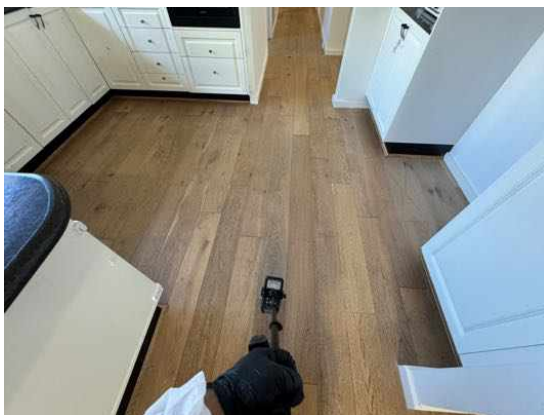
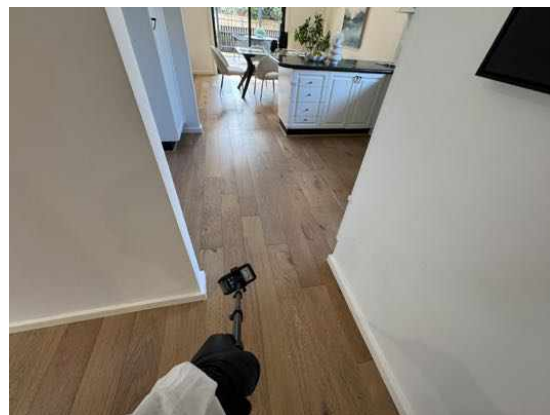
Finding 3.03

Building:	Main Building
Location:	All Areas
Finding:	Timber Flooring – Suspected Unevenness & Movement (Potential Major Defect)
Information:

A section of the timber flooring was observed to exhibit unevenness and possible movement when traversed. Laser levelling checks indicate variations that may exceed normal expectations for floor performance, suggesting potential issues within the underlying support system.

Due to limited access to the subfloor at the time of inspection, the condition of bearers, joists, and supporting elements could not be fully assessed. Possible contributing factors may include subfloor movement, inadequate support, settlement, or moisture-related effects. If left unaddressed, this condition may worsen and develop into a major structural issue. Any moisture affecting timber is conducive to deterioration and creates conditions conducive to termite activity where timber elements may be present.

This matter should be assessed as soon as practicable (ASAP) by a suitably qualified structural engineer. Further access to the subfloor is likely required to determine the cause, extent, and appropriate remedial action to prevent progressive structural damage.

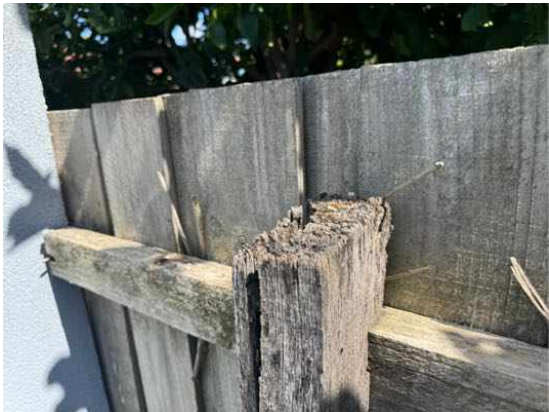
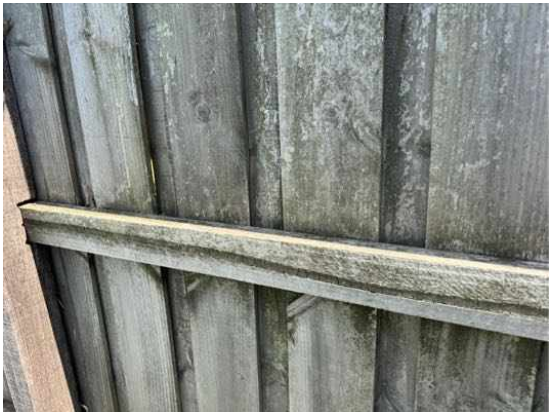
Finding 3.04

Building: Main Building
 Location: All Areas
 Finding: Timber Fence – Deterioration and Weathering
 Information:

A section of the timber fencing shows visible signs of deterioration and weathering. This may be due to age, exposure to moisture, or reduced structural support affecting the stability and condition of the fence.

If not addressed, the deterioration may worsen and lead to further weakening of the

fence structure. Any moisture in contact with timber is conducive to termite activity, so this condition should be attended to as soon as practicable to reduce the risk of further damage.

Assessment and rectification should be carried out by a licensed carpenter or builder to repair or replace affected sections and ensure the fence is structurally sound.

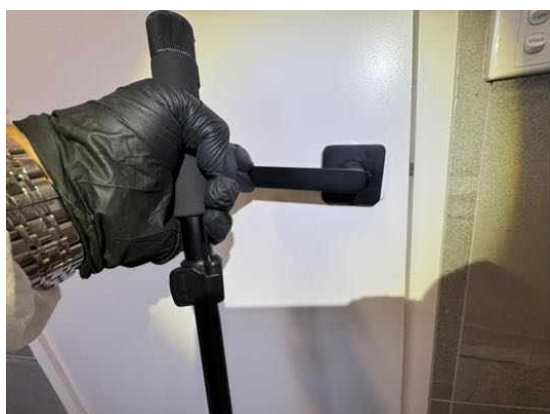
Finding 3.05

Building: Main Building
Location: All Areas
Finding: Door Hardware – Loose Handle Mechanisms

Information: A section of the internal door hardware shows loose handle mechanisms during normal operation. This condition may be due to worn fixings or general use over time.

If left unattended, the looseness may worsen and affect the correct operation of the door hardware. To prevent further deterioration, this minor issue should be addressed as soon as practicable.

Rectification should be carried out by a qualified handyman or licensed carpenter, who can tighten or replace the affected hardware as required.

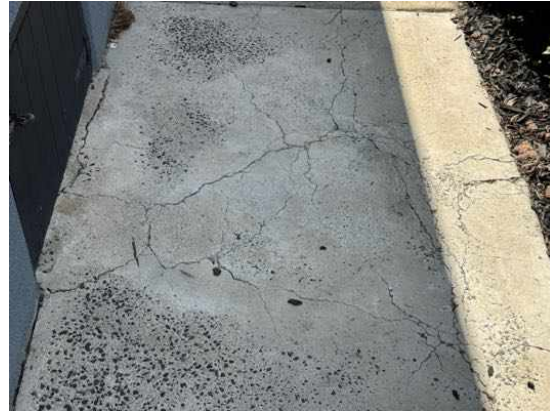
Building: Main Building
 Location: All Areas
 Finding: Concrete Elements – Fine Cracking Observed
 Information:

Fine cracking was observed across sections of the concrete elements around the property. These cracks may be related to normal shrinkage, thermal movement, or minor settlement of the substrate beneath the concrete.

Although minor at this stage, if left unattended the cracks may widen and allow moisture to penetrate the concrete, potentially leading to deterioration of reinforcement or surrounding building elements. This condition should be addressed as soon as practicable to prevent further progression.

Rectification should be carried out by a licensed builder or concreter, who can seal and repair the affected areas. A structural engineer may be required if any signs of ongoing movement or structural impact are suspected.

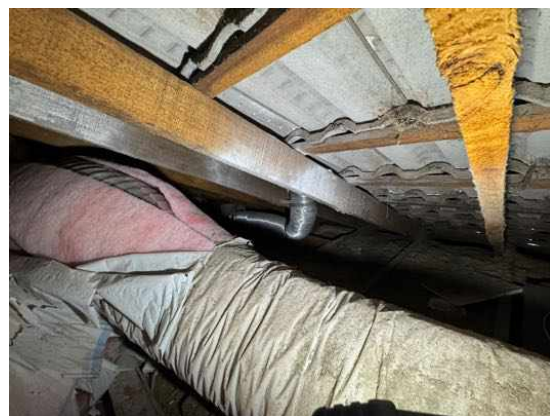
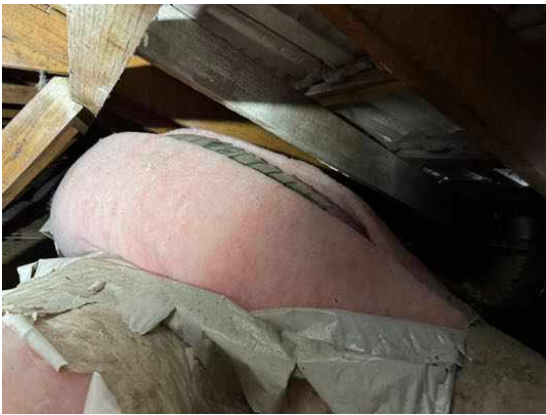
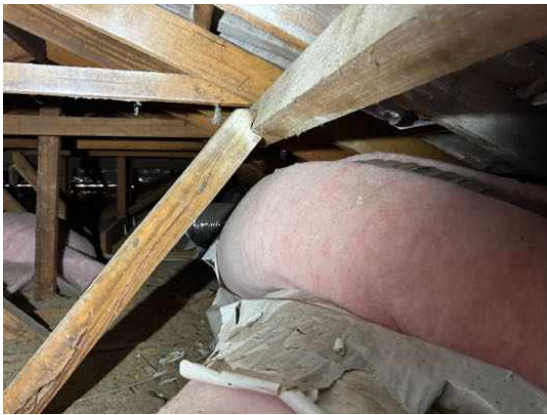
Finding 3.08

Building: Main Building
 Location: Roof Void
 Finding: Bathroom Exhaust Fan Ducting – Deteriorated / Venting into Roof Void
 Information:

The bathroom exhaust fan ducting within the roof void was observed to be in poor condition, with signs of deterioration and wear. The duct appears to discharge moist air into the roof space rather than being fully sealed and vented to the external atmosphere.

This condition allows warm, moisture-laden air to accumulate within the roof void, increasing the risk of condensation, mould growth, and deterioration of roof timbers, insulation, and other building elements. Ongoing moisture within the roof space is conducive to deterioration and creates conditions conducive to termite activity where timber elements are present.

This issue should be rectified as soon as practicable. Replacement of the deteriorated ducting and proper connection to an external vent should be carried out by a licensed electrician or suitably qualified contractor to ensure compliant and effective ventilation.

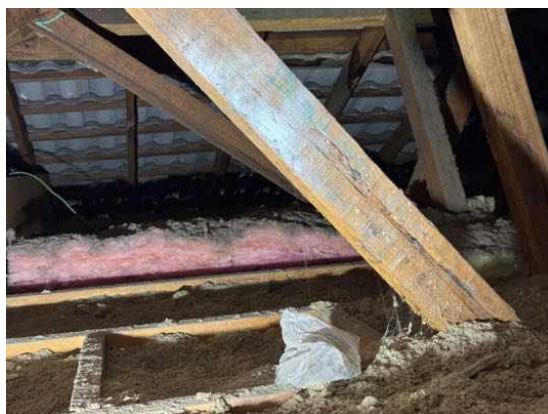
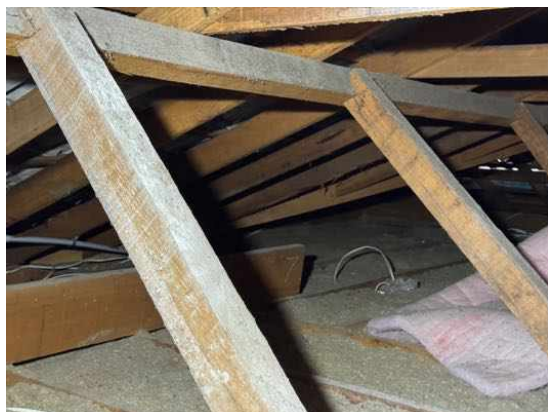
Building: Main Building
 Location: Roof Exterior
 Finding: Roof Structure – Cracked Hip & Rafter (Structural Concern)
 Information:

Cracking was observed to a section of the roof hip and associated rafter within the roof structure. This condition indicates possible structural stress, movement, or overloading affecting the roof framing members.

If left unaddressed, cracking to primary roof elements may progress and adversely affect the structural performance and load distribution of the roof system over time.

This issue should be assessed as soon as practicable (ASAP) by a suitably qualified structural engineer. Further access and investigation are likely required to determine the cause, extent, and structural significance of the cracking and to specify appropriate remedial works.

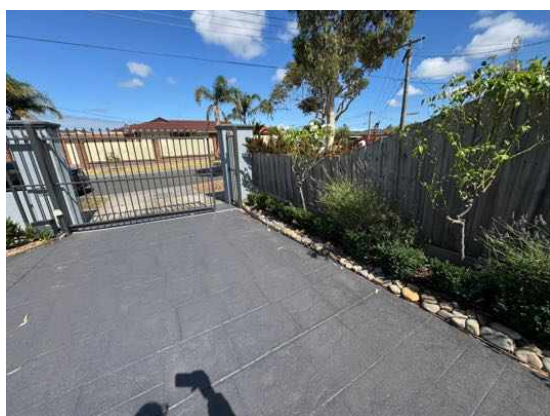
Building: Main Building
 Location: All External Areas
 Finding: Trees Around Property – Conducive Conditions
 Information: Vegetation and trees positioned close to the property were observed around sections of the external areas. The proximity of foliage, roots, and organic debris creates conditions that are conducive to timber decay and termite activity. Moisture retention around walls and footings is also increased in these areas.

These conditions may lead to deterioration of external elements, encourage fungal growth, and provide concealed pathways for termites. Any moisture in contact with

timber is considered highly conducive, and if not addressed, this issue may escalate into a more significant concern.

Rectification should be carried out as soon as practicable by a qualified gardener or arborist to trim vegetation away from the structure and improve airflow. A pest technician may also be needed to reassess conducive conditions once vegetation is cleared.

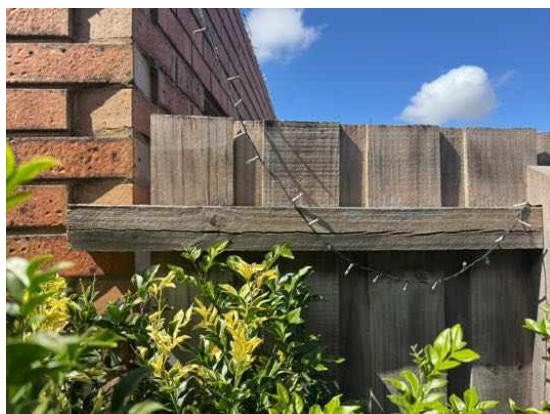
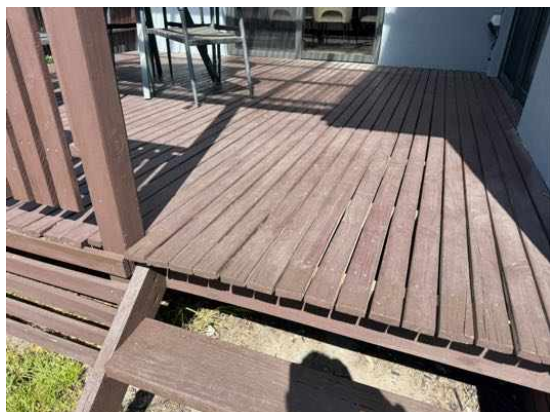
Building:	Main Building
Location:	All External Areas
Finding:	Timber No Protective Sealer – Moisture-Related Deterioration (Conductive Conditions)
Information:	Timber elements in the inspected area were noted to have no protective sealer or coating applied. Exposed raw timber is more vulnerable to moisture absorption, surface deterioration, and fungal growth. Moisture in contact with timber is conducive to termite activity, and unsealed surfaces increase this risk.

If left unprotected, the timber may warp, deteriorate, or weaken over time, especially in areas exposed to humidity, water splashes, or outdoor weathering. Continued exposure may escalate the condition into a more significant maintenance or structural concern.

Rectification should be carried out as soon as practicable by a qualified carpenter or painter to apply an appropriate timber sealer or protective coating. A pest technician may also be required if signs of moisture-related conducive conditions persist.

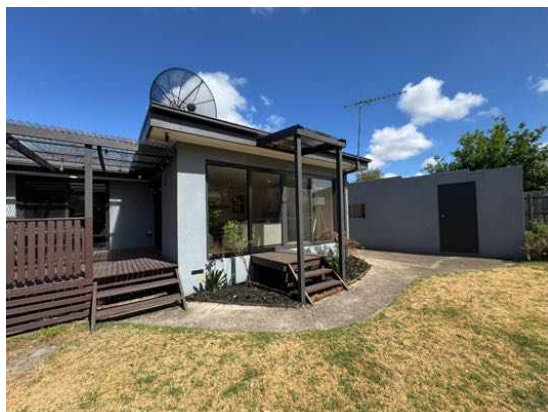
Finding 6.04

Building:	Main Building
Location:	All External Areas
Finding:	Timber in Contact With Soil – Conductive Conditions
Information:	Timber elements were observed in direct contact with soil around the property. This condition is conducive to termite activity and moisture absorption, as soil contact keeps the timber damp and provides concealed access points for termites.

Rectification should be carried out as soon as practicable by a qualified carpenter or builder to separate the timber from soil and install an appropriate barrier.

A licensed termite management technician is also recommended to inspect the area and advise on suitable termite management system options once conducive conditions are reduced.

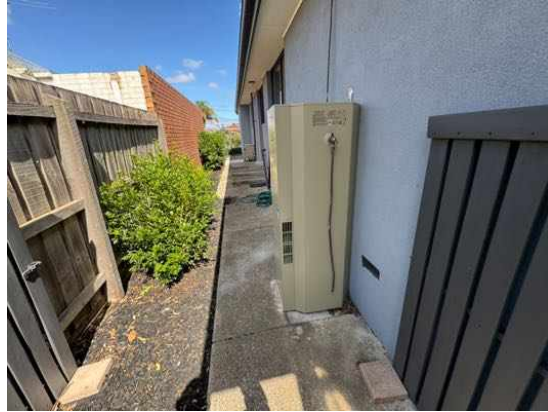
Finding 6.05

Building: Main Building
 Location: All Areas
 Finding: Air Conditioner Overflow – Disconnected
 Information: The air conditioner overflow pipe was found disconnected from the stormwater drainage system, resulting in excess moisture around the external wall.

This moisture can create conditions conducive to timber decay and termite activity if not managed.

A licensed plumber should reconnect the overflow to prevent ongoing dampness as soon as practicable.

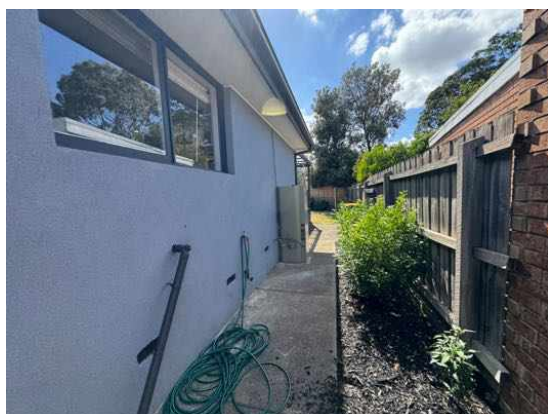
Bridging occurs when fixtures such as posts, downpipes, decks, or steps are not separated from the structure and do not maintain a minimum 25mm inspection gap. These conditions increase the risk of undetected termite activity.

This area should be regularly monitored for signs of termite activity by a licensed termite management technician, and steps should be taken to maintain clear access for future inspections.

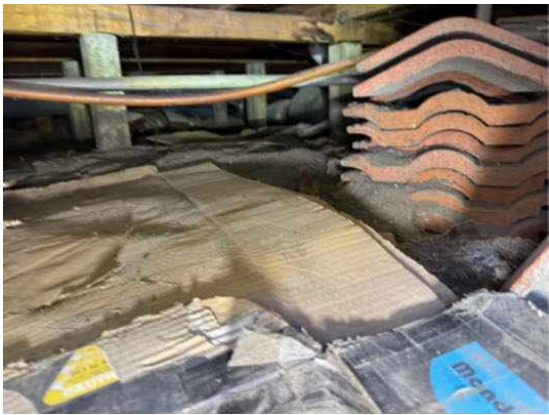
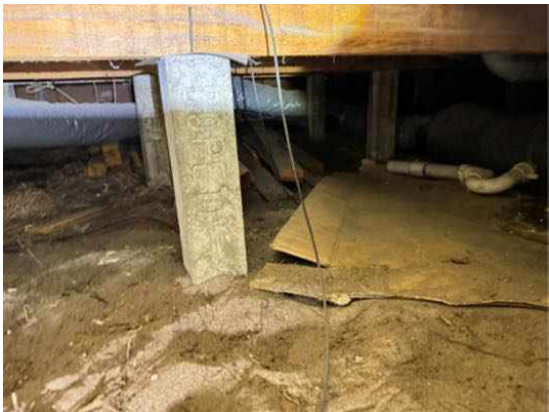
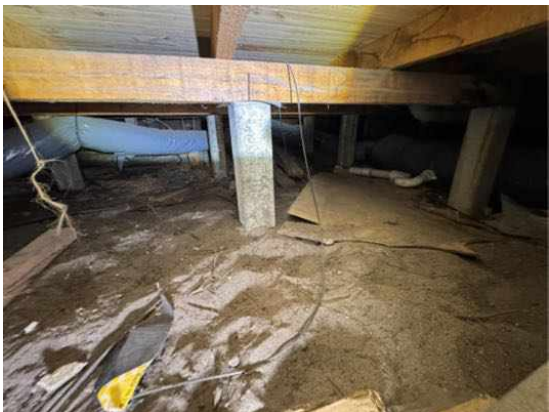
Timber and cardboard can hold moisture and attract termites. They also make it harder to see parts of the subfloor clearly during inspection.

These materials must be removed by a qualified person, and the area must be kept under regular monitoring by a licensed termite management technician as soon as practicable.

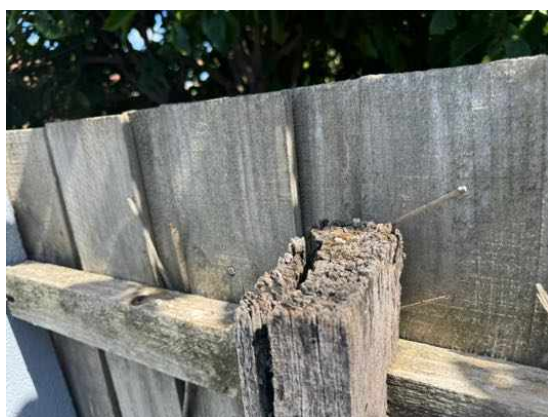
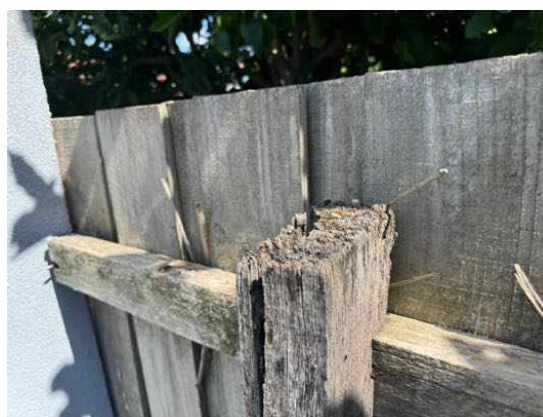
Finding 7.01

If not attended to, deterioration may progress and affect the performance of the surrounding building materials. Any moisture in contact with timber is conducive to termite activity, so this matter should be addressed as soon as practicable to avoid further damage.

Rectification should be carried out by a licensed carpenter or builder, who can repair or replace affected sections and ensure all exposed timber is properly sealed and protected. A licensed structural engineer may be required if any structural impact is suspected.

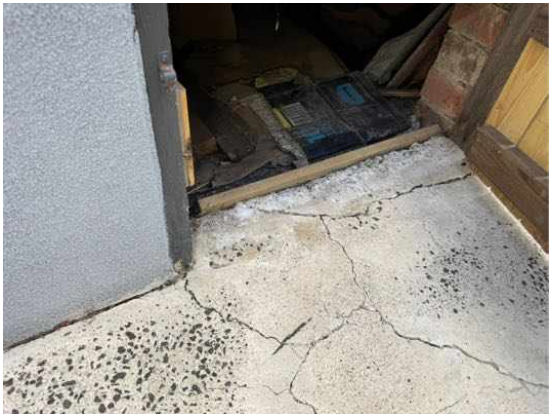
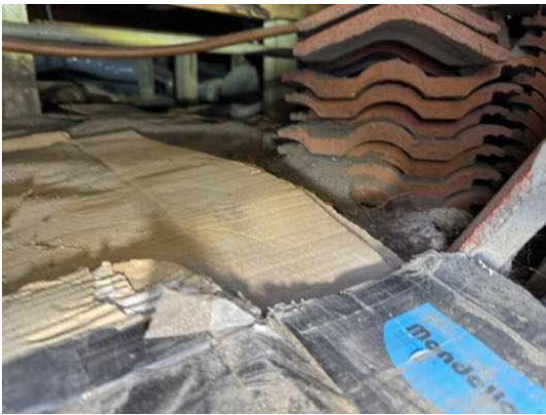
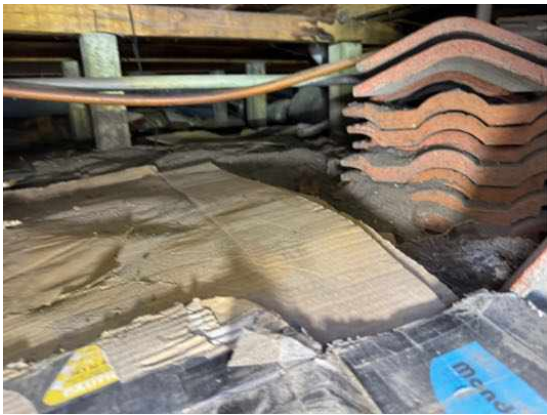
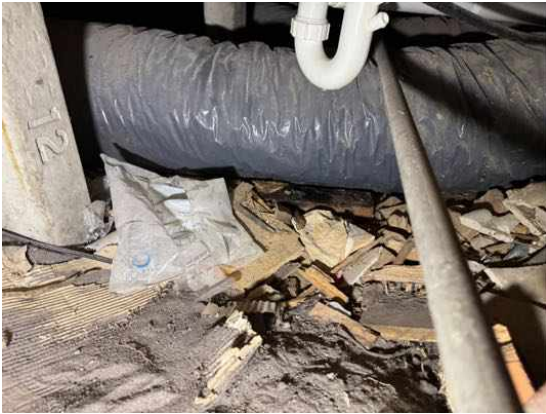
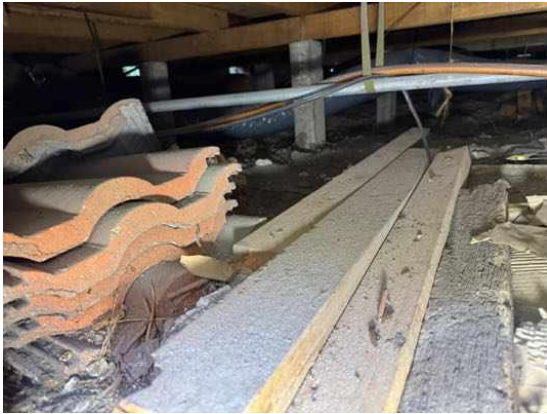
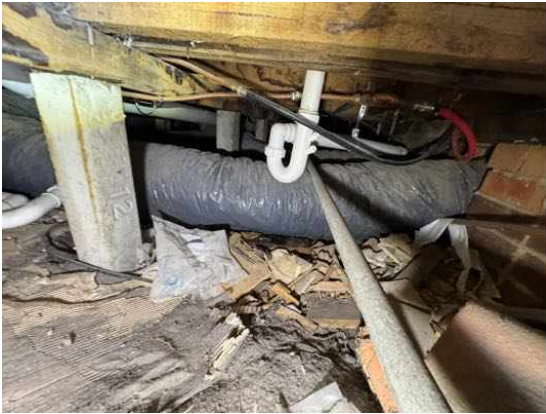
Building: Main Building
Location: All Areas
Finding: Subfloor – Limited Access for Termite Inspection
Information: Access to the subfloor area was restricted due to inadequate clearance and physical obstructions, preventing full visual assessment of the internal timbers and perimeter areas.

This condition increases the risk of concealed termite activity or damage, as these areas cannot be fully inspected.

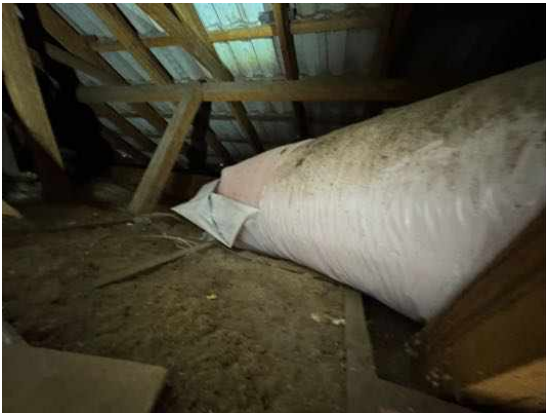
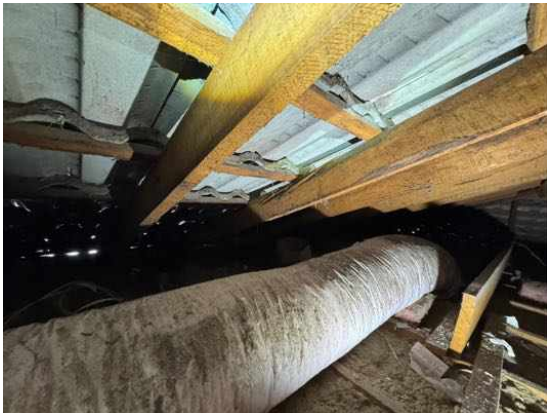
Building: Main Building
Location: Roof Void
Finding: Roof Void – Limited Access
Information: Access to the roof void was limited due to restricted clearance, structural obstructions, or safety constraints. This reduced visibility may prevent a full assessment of roof framing, insulation, services, and potential moisture-related conditions within the space.

Limited access can result in sections of the roof void remaining uninspected, meaning concealed defects such as leaks, timber deterioration, or conducive moisture conditions may not be fully identifiable during the inspection.

Further assessment should be carried out as soon as practicable by a licensed builder, roofer, or pest technician if safe access becomes available, or if any signs of moisture or structural concerns appear elsewhere in the property.
