Building and Timber Pest Inspection Report

Inspection Date: Mon, 19 Jan 2026

Property Address: 25 Wattle St, Rydalmere NSW 2116,
Australia

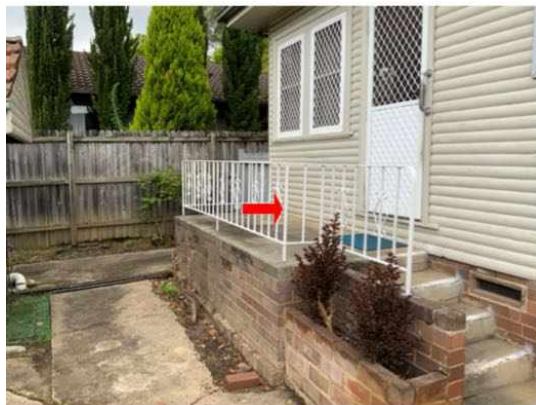
| Information: | The balustrade was measured and found to be less than the present building regulation requirement of 1000mm high. Additionally the gaps between the balustrade cladding were found to be greater than the present building regulation requirement of 125mm. |

This defect creates a potential safety hazard and should be rectified as soon as possible to ensure the safety of the area and to meet present building standards and regulations.

A registered builder should be contacted to discuss possible rectification solutions.

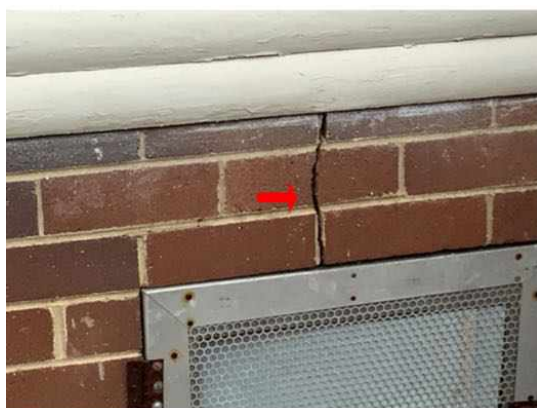
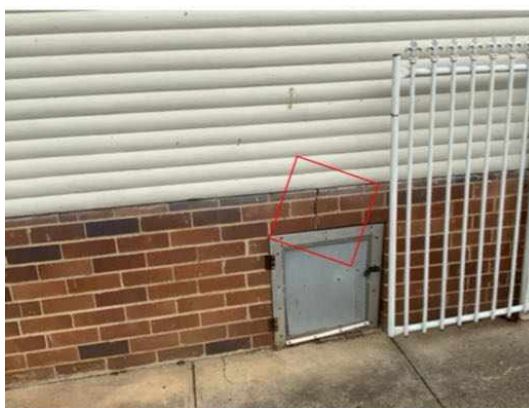
Finding 2.01

Information: It appears that the wall structure structure has been affected by movement of the foundations, often referred to as sinking or subsidence. Whilst a degree of movement is expected in subfloors over time, especially as environmental conditions change and buildings 'settle' after construction, this degree of subfloor movement requires attention.

General subsidence is usually initiated by changes in soil moisture content. The most critical factor is identifying the specific causes, and identifying if this is a recurring or ongoing problem, or one that has been resolved by previous works in the past.

Subsidence can have complex and varying causes, which will influence the required remedial works. It is advised to begin by consulting a structural engineer to determine the required scope of works. This generally includes some form of underpinning, as well as addressing the underlying cause. Consultation with a geotechnical engineer may also be necessary where changes to soil moisture content is apparent.

A Registered Builder specialising in re-stumping would then generally carry out works as advised by an Engineer.

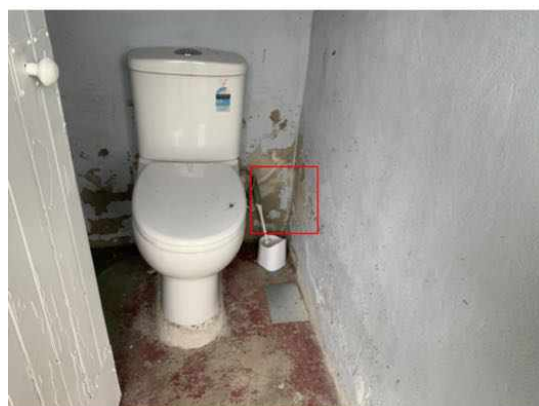
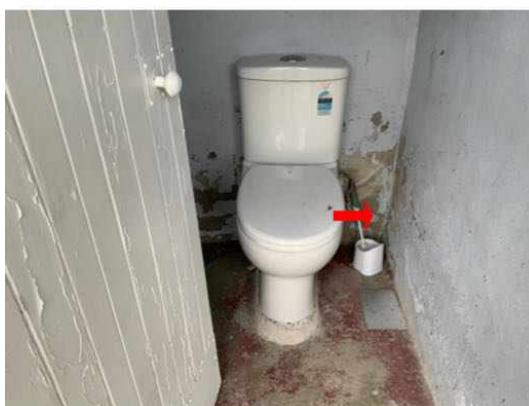
Finding 2.02

Building: Main Building
 Location: Toilet (WC)
 Finding: Damp - Rising
 Information: Rising damp describes the upward movement of water in low sections of building elements (e.g. walls) by capillary action - the movement of water through porous materials such as bricks, sandstone or mortar.

Rising damp is generally managed by the installation of a damp proof course during construction. A Damp Proof Course (DPC) is an impermeable barrier at the base of the wall above ground level. However, many 19th Century buildings have no damp course installed, or the materials have failed. The DPC may have been omitted as a consequence of poor workmanship, or it may have been bridged where materials built up against the side of the house allow moisture ingress above the DPC level.

The first step in addressing rising damp is to diagnose the cause. The identified cause should be addressed first before addressing the appearance and other defects which have resulted from the rising damp. If the original cause is not resolved, further cases of damp are likely to ensue, resulting in secondary defects.

Consultation with a qualified plumber is advised immediately to identify the cause of the damp and perform remedial works as required.

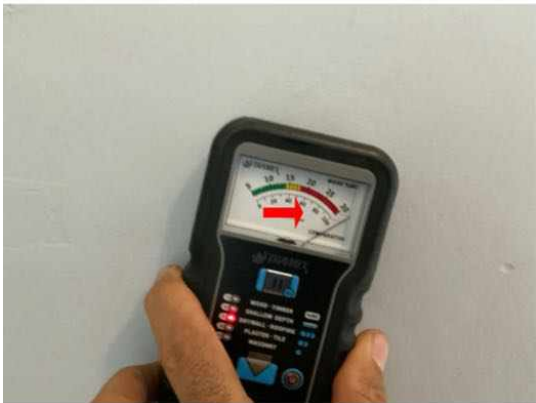
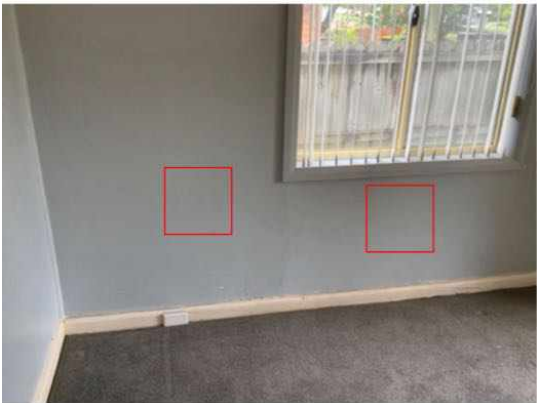
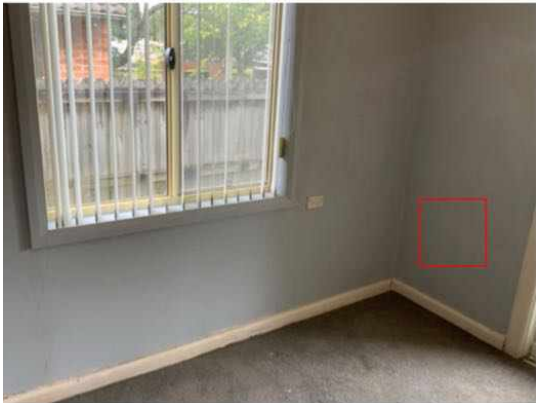
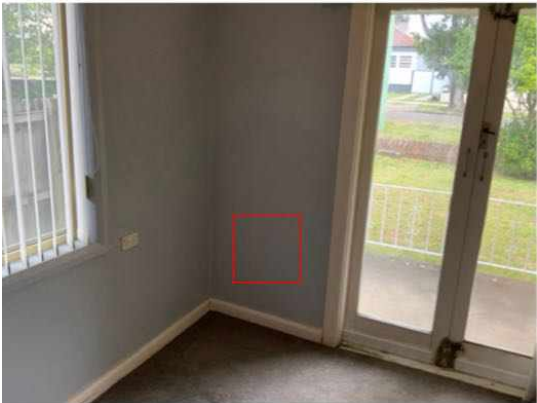
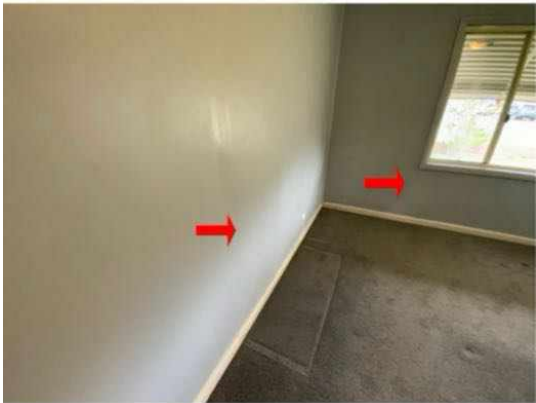
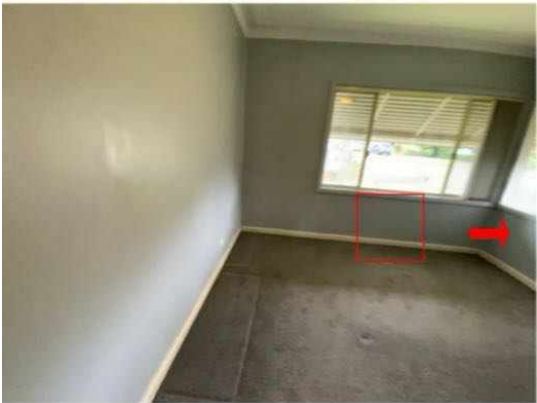
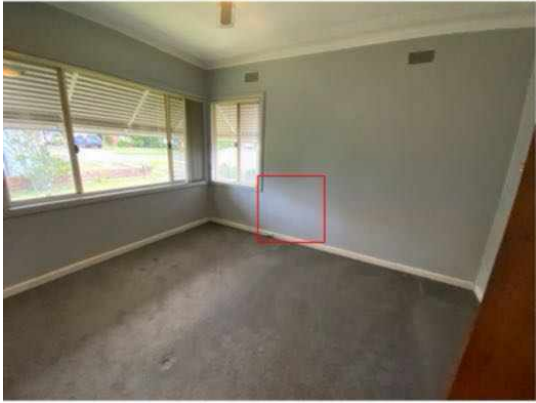
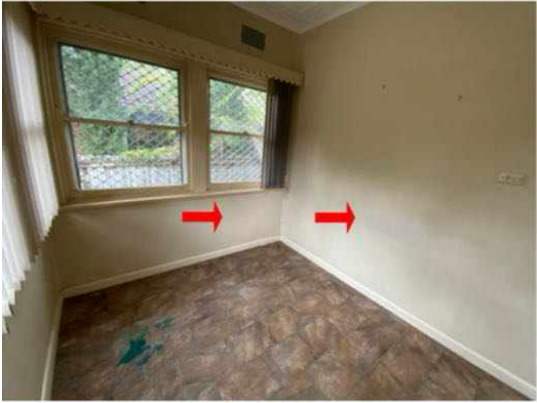
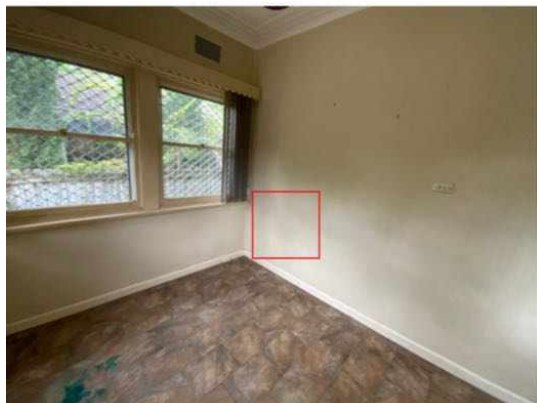
Finding 2.03

| Finding: | Excessive moisture - identified |
| Information: | Excessive moisture can attract termites and produce conditions that promote fungal growth and wood decay. |

Excessive moisture is generally caused by deteriorated, inadequate or missing roof drainage, leaking plumbing pipes or fixtures, poorly plumbed HWS overflows or condenser units and poor site drainage.

Prior to any remedial works being performed a qualified plumber should be appointed to further inspect the property and to identify the cause of the excessive moisture. Works to remove affected building elements may then be necessary and should be performed by an appropriate tradesperson.

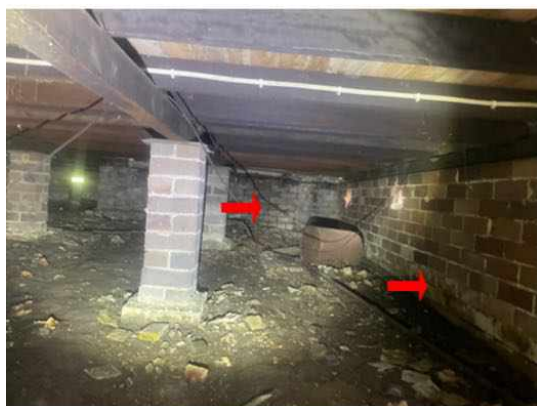
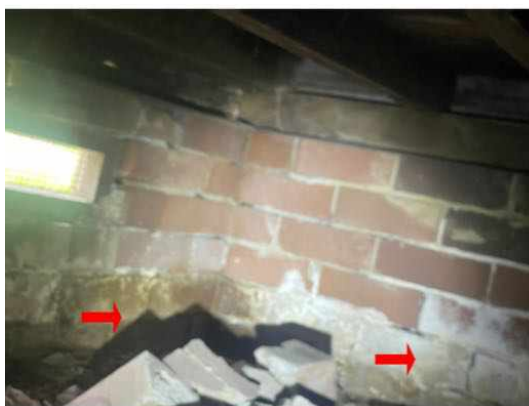
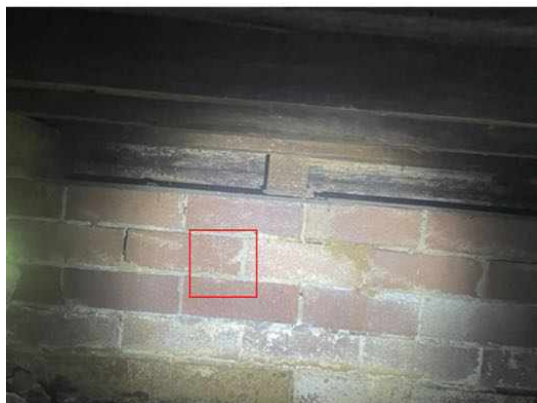
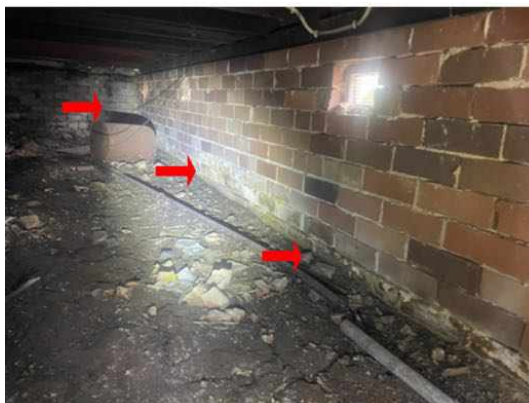
Finding 2.04

Rising damp is generally managed by the installation of a damp proof course during construction. A Damp Proof Course (DPC) is an impermeable barrier at the base of the wall above ground level. However, many 19th Century buildings have no damp course installed, or the materials have failed. The DPC may have been omitted as a consequence of poor workmanship, or it may have been bridged where materials built up against the side of the house allow moisture ingress above the DPC level.

The first step in addressing rising damp is to diagnose the cause. The identified cause should be addressed first before addressing the appearance and other defects which have resulted from the rising damp. If the original cause is not resolved, further cases of damp are likely to ensue, resulting in secondary defects.

Consultation with a qualified plumber is advised immediately to identify the cause of the damp and perform remedial works as required.

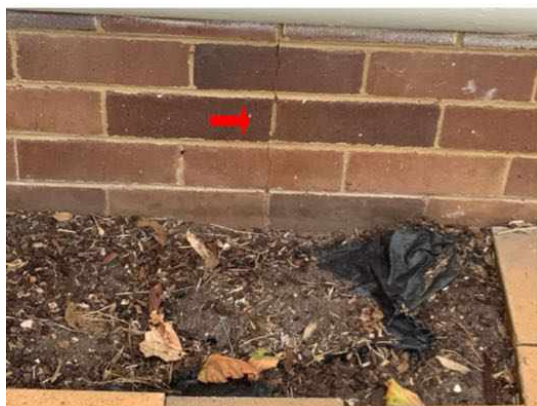
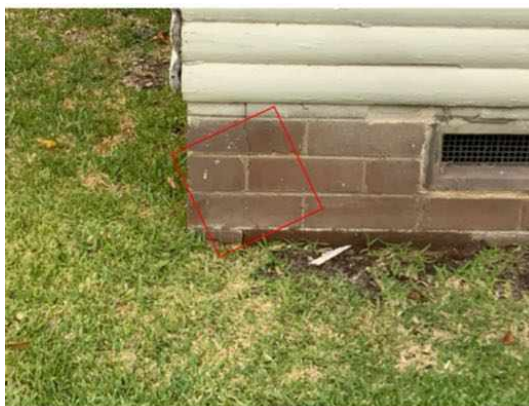
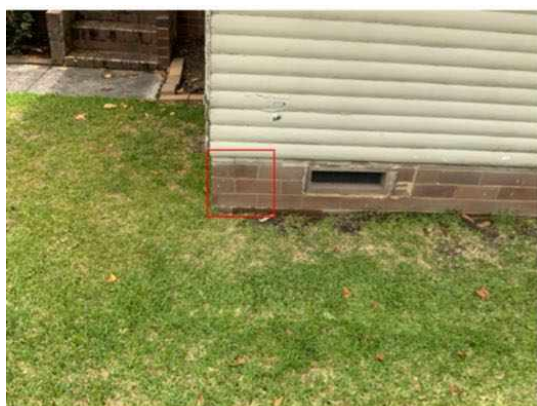
Finding 3.01

| Information: | It appears that the subfloor structure has been affected by movement of the foundations, often referred to as sinking or subsidence. A degree of movement is expected in subfloors over time, especially as environmental conditions change and buildings settle after construction. |

The apparent subsidence is evidenced by some of the following, gaps and cracks to brickwork.

General subsidence is usually initiated by changes in soil moisture content. The most critical factor is identifying the specific causes, and identifying if this is a recurring or ongoing problem, or one that has been resolved by previous works in the past.

Subsidence can have complex and varying causes, which will influence the required remedial works. If movement continues It is advised to consult a structural engineer to determine if repair works are warranted. Works may include some form of underpinning, as well as addressing the underlying cause. Consultation with a

geotechnical engineer may also be necessary where changes to soil moisture content is apparent.

A Registered Builder would then generally carry out works as advised by an Engineer.

At this point it is recommended to contain storm water flows, ensure pavements flow away from the building to lessen any excessive wetting and drying effects.

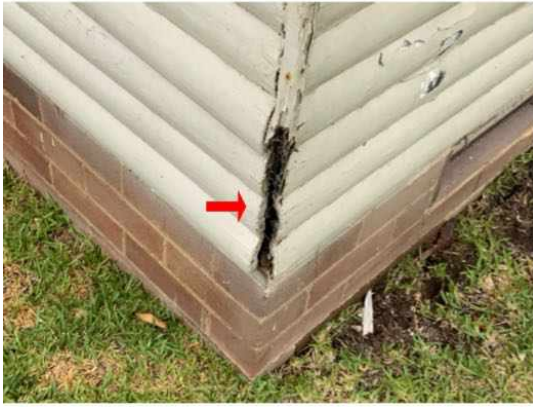
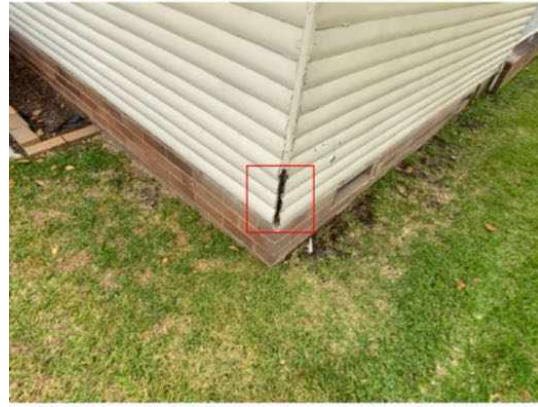
Finding 3.02

| Information: | Holes in surfaces are generally indicative of impact damage, whether accidental or deliberate, or a failing of the surface material. |

Where holes are apparent in the surface of a building material, the surface is no longer sealed against water penetration or further impact damage, which may lead to additional damage to the surrounding surface.

Repair or replacement of the affected building element is recommended as soon as possible to ensure that any secondary defects are minimised. A qualified carpenter or general handyperson should be appointed to perform these works.

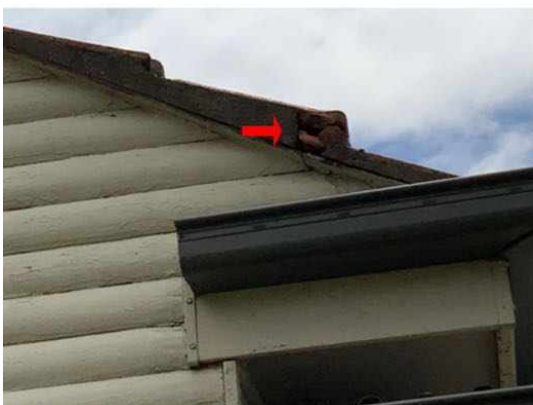
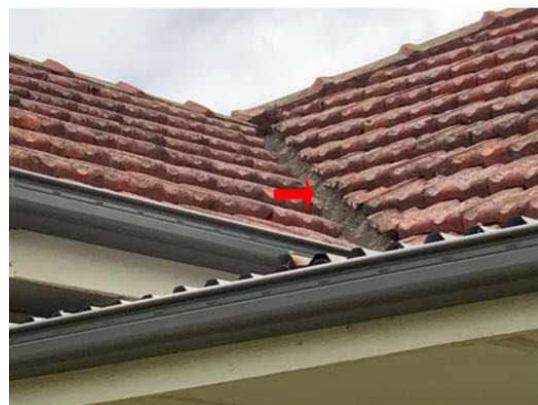
Finding 3.03

| Information: | Upon inspection of the exterior roofing, the majority of roof tiles were considered to be in a fair condition. While weathering of the tiles is consistent with the age of the property, maintenance works are required. |

Isolated areas of mortar have come loose in the valleys and minor cracking is also present. Re-pointing and re-sealing the may be considered as an interim solution by the client to help preserve and extend the life span of the tiles.

Where left unmanaged, deteriorating roof tiles are likely to lead to a number of secondary defects, including minor water leaks and weather exposure to internal roofing structures.

Consultation with a roofing contractor is highly advised to gain advice on cost of remedial works that may be required in the short to medium term. Remedial works are likely to increase the longevity of the exterior roofing structure.

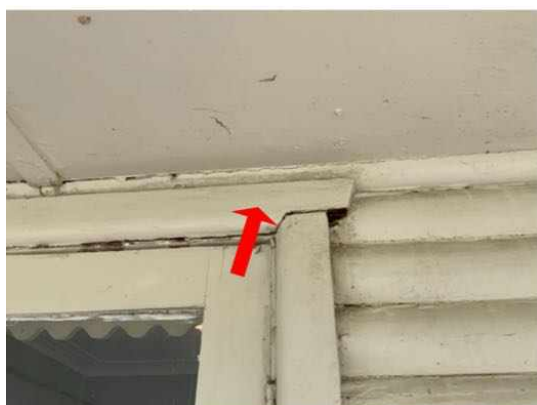
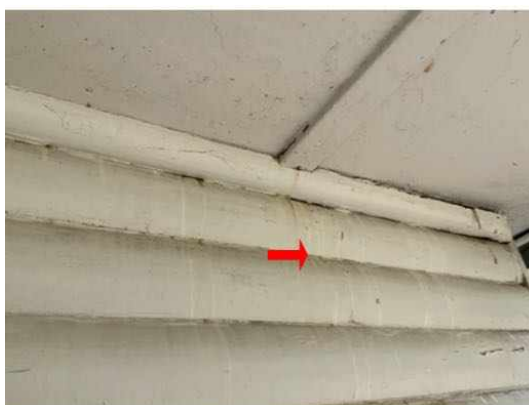
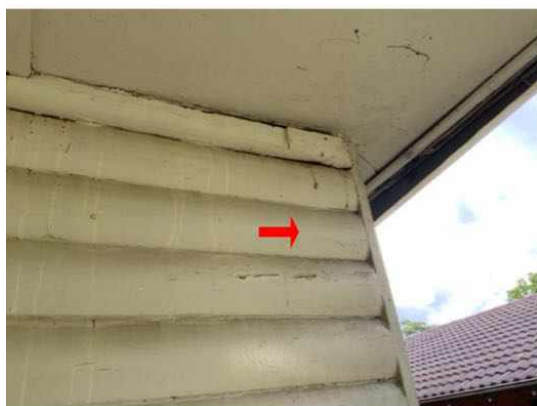
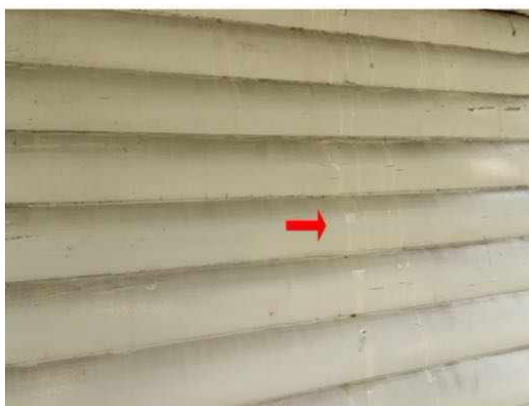
Finding 3.04

| Finding: | Exterior roof - Leaking |
| Information: | Active roof leaks were evident at the time of inspection. Roof leaks can have a number of causes, including damage to roof coverings, deterioration of roof fixtures and fittings, or loosely associated materials (fascias etc.). |

Where water leaks are active, rain penetration is likely to cause water damage to associated structures and building elements in this area, which can have a range of implications. If left unmanaged, the development of major structural damage to the roofing and associated structures may occur.

A roof plumber should be appointed as soon as possible to primarily identify the cause of the leak, and to provide subsequent repair works as necessary. Depending on the extent of the damage, replacement of sections of the roof covering and/or roofing structures may be required, and may be performed by a registered builder or qualified carpenter.

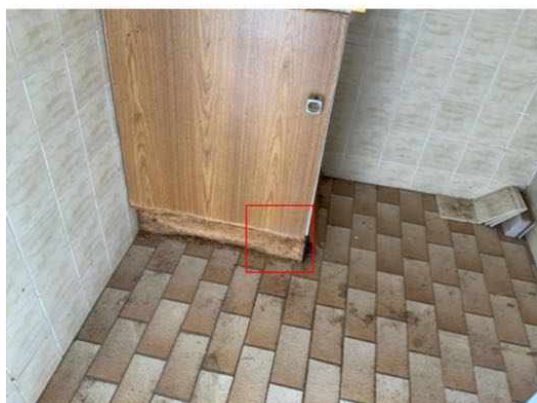
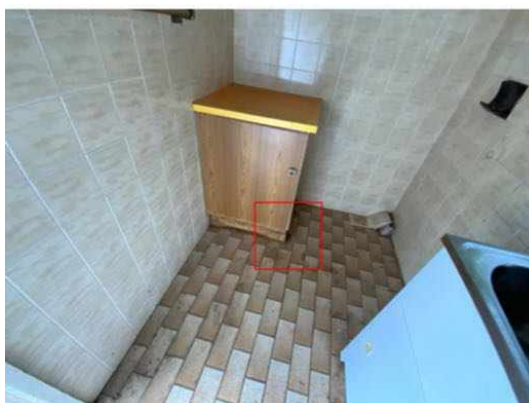
Finding 3.05

Finding: Vanity/Deterioration

Information: It was noted that the vanity was damaged due to exposure to water and moisture. This could be due to low quality of the vanity itself, or the misuse by the occupant or the excessive exposure to steam and lack of ventilation.

A qualified plumber should be contacted to make good vanity or replace it.

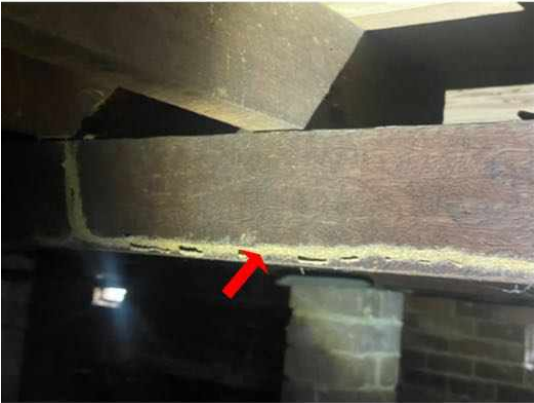
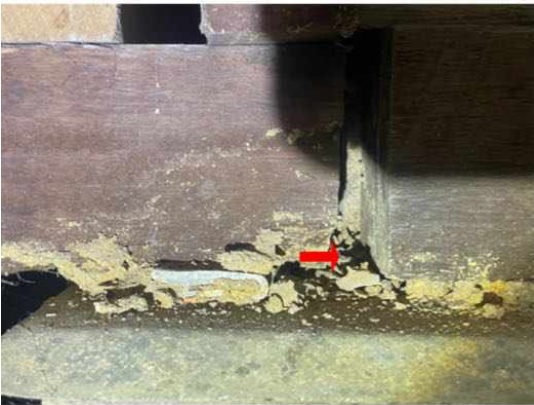
Information: Despite no live termite or timber pest activity being indicated, previous termite damage was found to have affected this area. This damage is considered to be inactive and is minor in nature.

It is advised that the area be visually inspected frequently and also invasive inspection is required to determine the extent of damage if there is an in the walls .

A building contractor may be appointed to provide a further invasive inspection if further damage is evident.

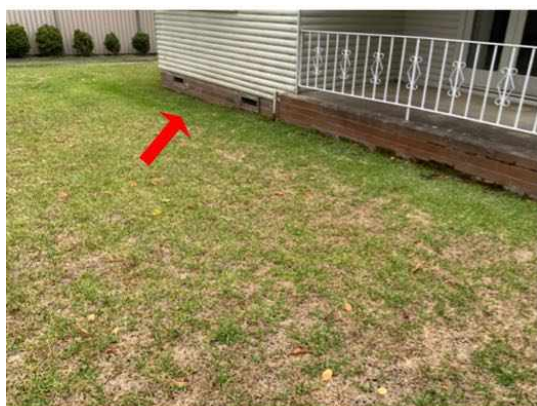
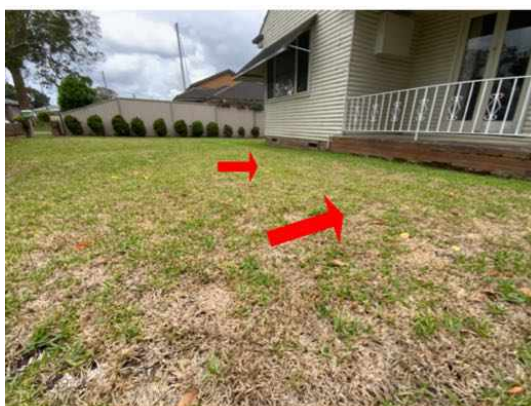
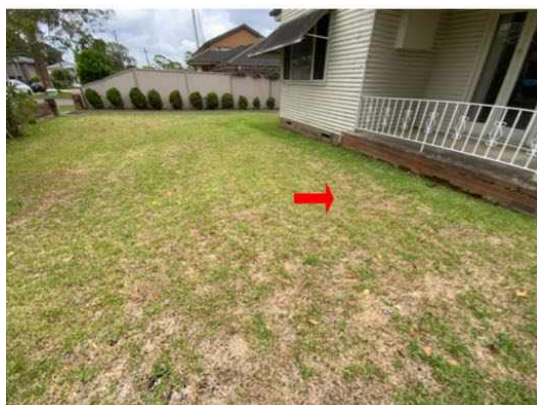
Finding 6.01

Building: Main Building
 Location: Exterior walls - front
 Finding: Site drainage - Inadequate
 Information: The site drainage in this area was found to be inadequate at the time of inspection, creating potential for subsequent water damage to associated building elements.

It is important that water does not lie against the base of walls; surrounding paths and ground levels should be sloped to drain water away from walls. Downpipes should not discharge stormwater onto lower walls or plinths. Stormwater should be carried away by large, regularly cleaned drains. Ground levels may need to be lowered to expose a buried DPC.

Where site drainage is inadequate, installation of an Agricultural (Aggie) Drain may be required. A qualified plumber should be appointed to further inspect the property and perform any remedial works as necessary. Water damage and secondary defects are likely to occur if left unmanaged.

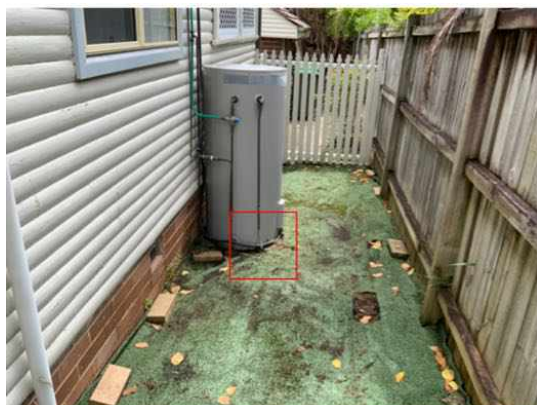
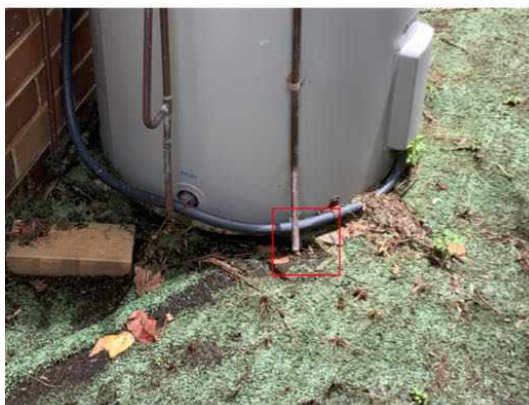
Finding 6.02

Finding: HWS Overflow - Not Connected
 Information: The Hot Water System (HWS) overflow was found to be disconnected from storm water drainage and is creating excessive moisture in the surrounding area.

These damp conditions can lead to secondary defects such as rot, rust or corrosion of associated building elements, the formation of fungal decay, or even the creation of potential slip hazards. When coupled with poor site drainage, pooling of water may also attract termite activity to this area.

It is highly recommended that a licensed plumber be appointed to connect the HWS overflow in order to prevent such an environment from being created. These minor works should be carried out as soon as possible.

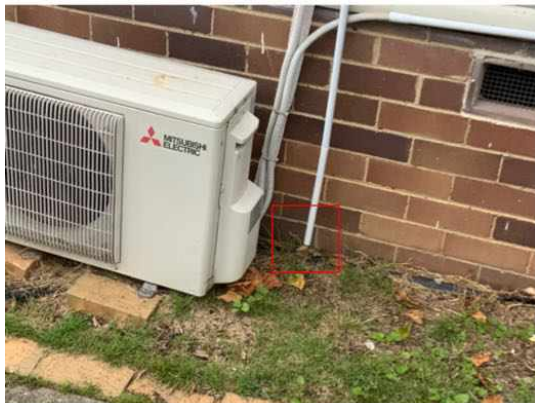
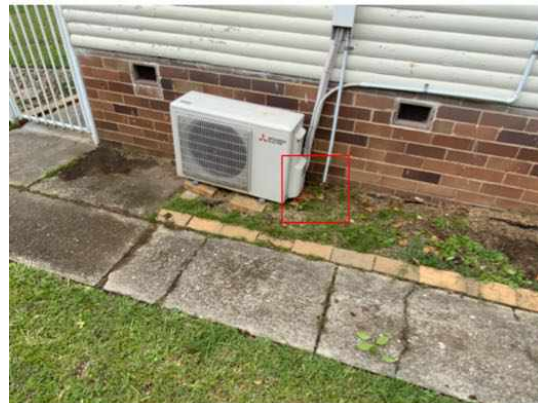
| Finding: | Air conditioner - Disconnected overflow |
| Information: | The Air Conditioner (A/C) overflow was found to be disconnected from storm water drainage and is creating excessive moisture in the surrounding area. |

Such leaking creates an environment which is conducive to an array of defects, including water damage to associated building elements and the attraction of termite or timber pest infestation.

It is highly recommended that a licensed plumber be appointed to connect the A/C overflow in order to prevent such an environment from being created. These minor works should be carried out as soon as possible.

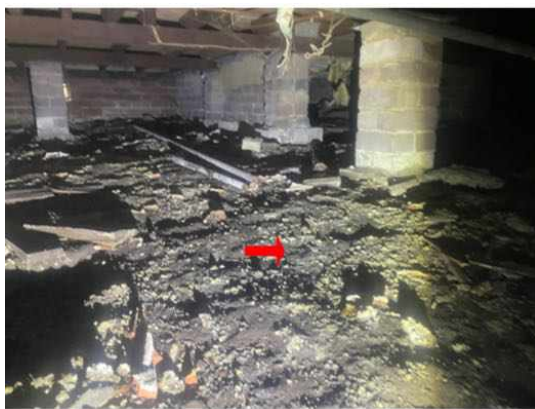
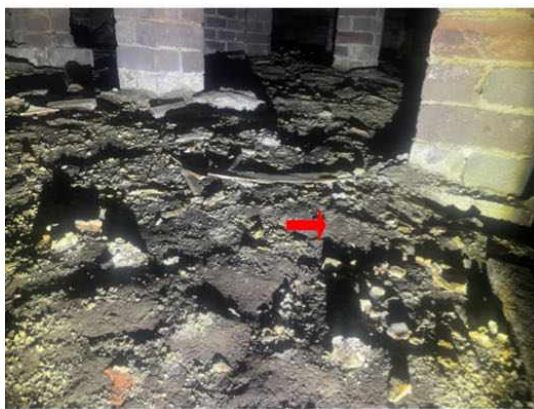
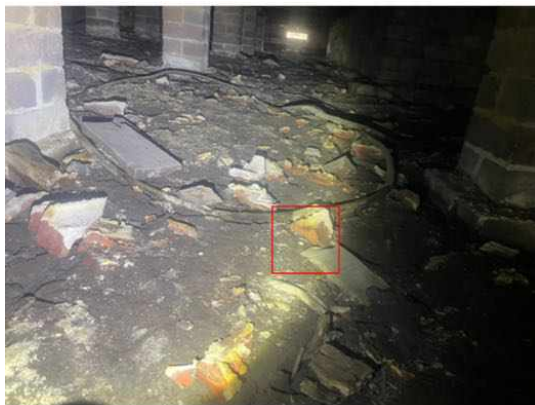
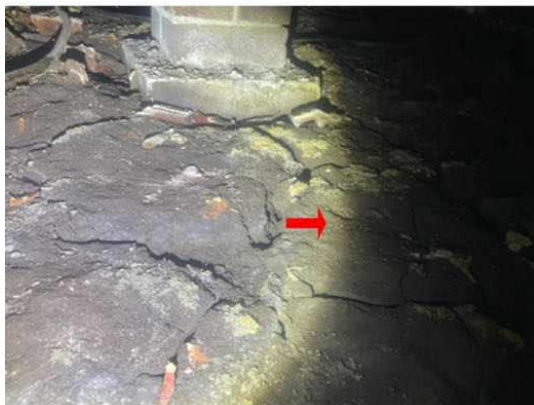
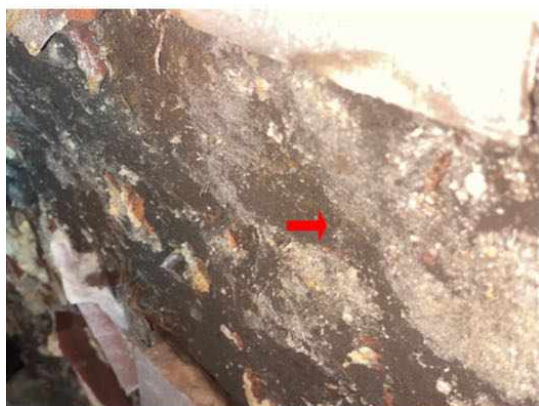
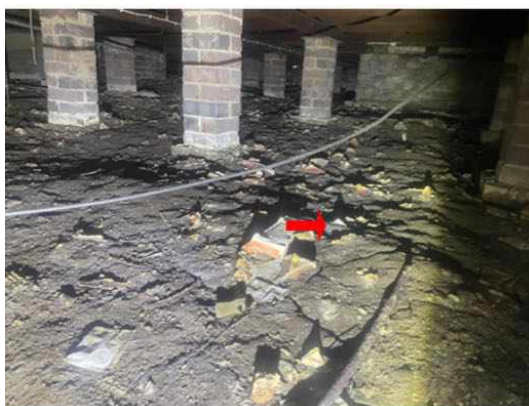
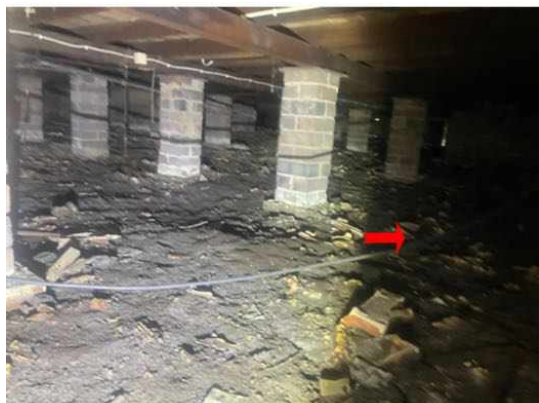
Finding 6.05

| Finding: | Sub-floor excessive moisture |
| Information: | Excessive moisture can attract termites and produce conditions that promote termite attack fungal growth in wood decay. |

Excessive moisture is generally caused by inadequate subfloor ventilation and poor site drainage.

There appear to be inadequate vents installed to the perimeter of the building and I would suggest that further solar powered fans or the like be installed to improve crossflow ventilation and aid in keeping the subfloor area relatively dry.

The installation of additional surface drainage to the front of the property would also be beneficial to keeping the subfloor dry.

It is highly recommended that subfloor ventilation and site drainage be improved and maintained regularly in order to prevent excessive moisture being present in the external/internal property.

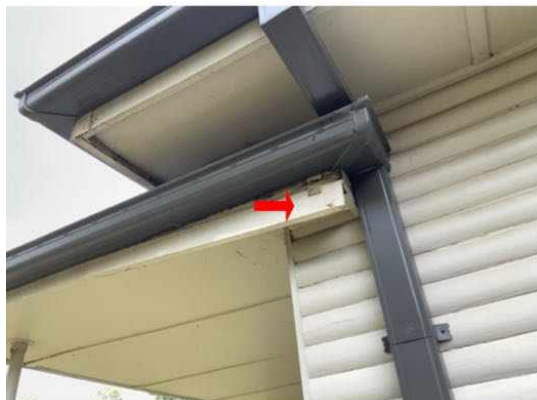
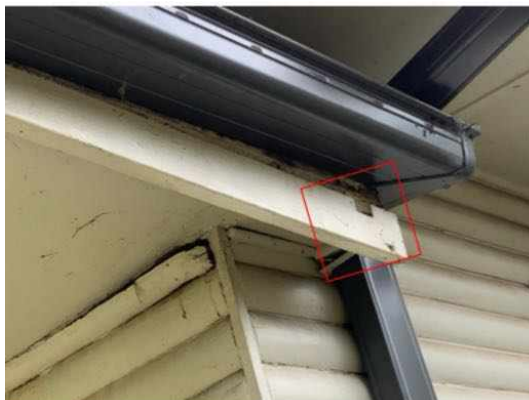
Finding 7.01

| Finding: | Fascias - Wood rot |
| Information: | Wood rot was found to be affecting fascias and barges in this area, evidenced by the presence of mould on the surface in some areas. Wood rot, also known as Fungal Decay, occurs when timbers and other cellulose building materials are exposed to damp conditions on an ongoing basis. |

It is likely that this wood rot has developed as a result of faults in the roof plumbing, creating excessive moisture in this areas. Frequent exposure to rain and other weather conditions also make fascias and barges susceptible to accelerated deterioration.

Early intervention and regular maintenance will prolong the useful life of these building elements. Prior to any works being performed, the cause of the moisture that has created the visible wood rot should be identified and addressed in a suitable manner.

It is advised that a roof plumber be appointed to inspect all roof plumbing and subsequently identify the cause of the wood rot. Replacement of affected fascias and barges may then be a necessary step in protecting surrounding building elements from

such deterioration.

A qualified plumber may be appointed to assess the cause of excessive moisture and to provide advice on any remedial works as required. A qualified carpenter or registered builder may also be required to replace affected building materials.

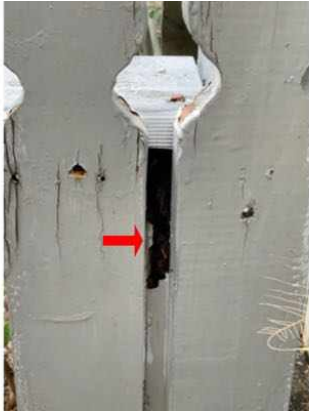
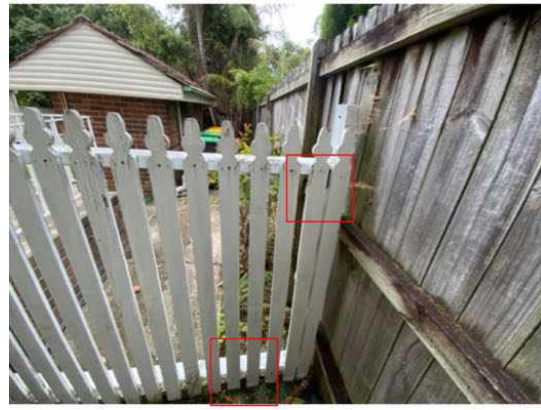
Finding 7.02

| Finding: | Wood rot |
| Information: | The timber post shows evidence of wood rot. Wood rot, also known as Fungal Decay, occurs when timbers and other cellulose building materials are exposed to damp conditions on an ongoing basis. This could be the result of exposure to weathering over a prolonged period of time, or the attraction of excessive moisture from other abutting building materials. Contributing factors also include poor air ventilation in the area. |

Early intervention and regular maintenance, particularly of exterior timbers, will prolong the useful life of these building elements. Prior to any works being performed, the cause of the moisture that has created the visible wood rot should be identified and addressed in a suitable manner. Replacement of affected timbers may then be a necessary step in protecting surrounding building elements from such deterioration.

A qualified plumber may be appointed to assess the cause of excessive moisture and to provide advice on any remedial works as required. A qualified carpenter or registered builder may also be required to replace affected building materials.

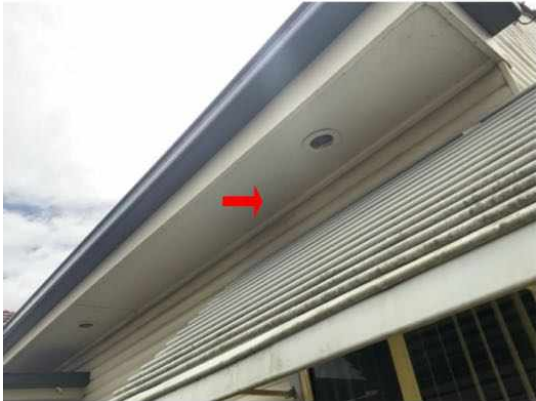
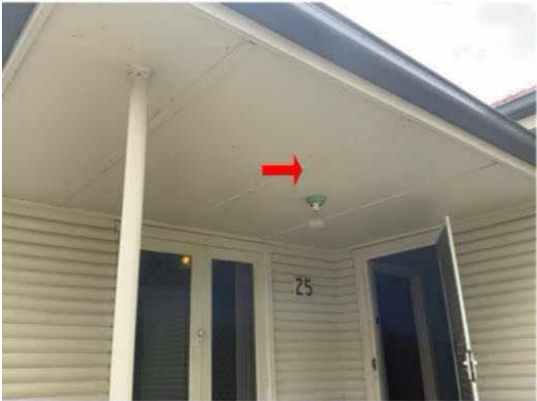
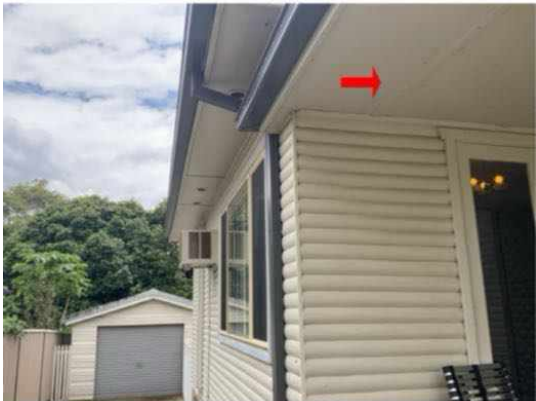
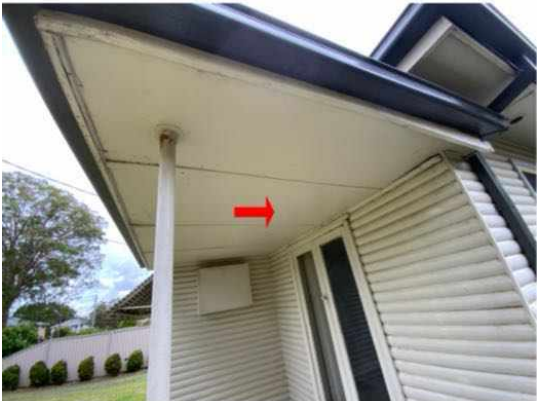
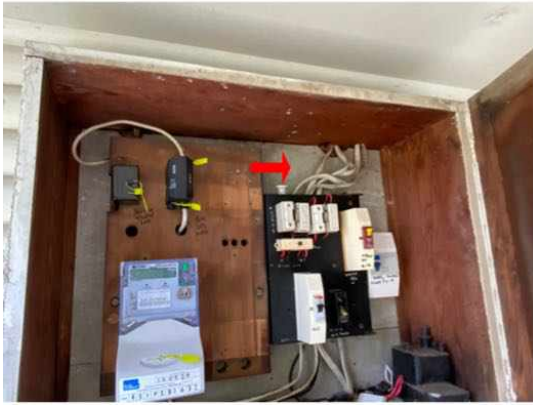
Building: Main Building
Location: Exterior walls - front
Finding: Asbestos - Suspected ACM Identified on Site
Information: Reporting on Asbestos is outside the Scope of this Report. This suspected defect is highlighted as a caution only. We suspect, based on our experience in the building industry, that there is a higher risk of the identified building element containing asbestos.

As Asbestos Reporting is outside the scope of this report, we advise that you consider a separate Asbestos Inspection and Condition Audit, which can include the taking of samples for definitive confirmation of the presence of Asbestos.

In the interim, the client is advised to act with caution, especially when considering any damage to building materials general wear and tear renovations extensions demolition and general maintenance activities due to the suspected presence of Asbestos.

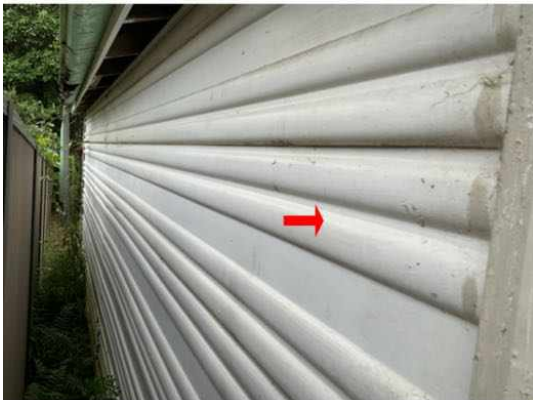
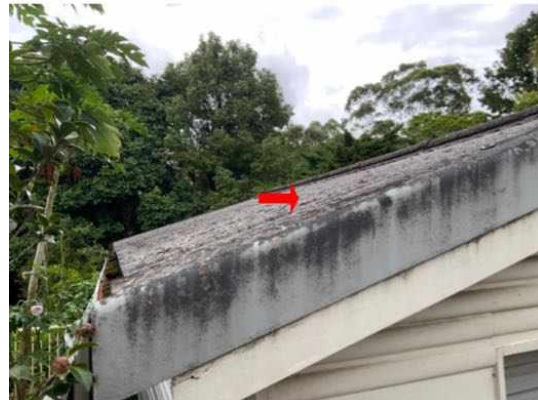
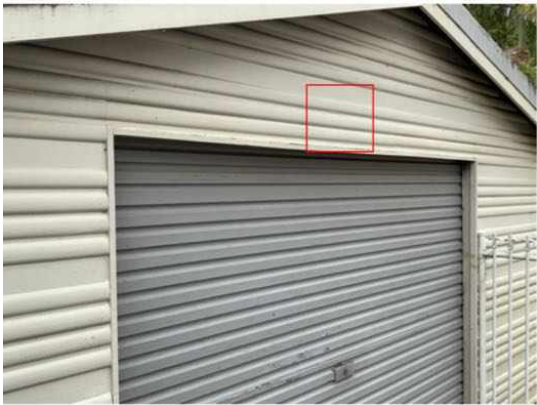
| Information: | Reporting on Asbestos is outside the Scope of this Report. This suspected defect is highlighted as a caution only. We suspect, based on our experience in the building industry, that there is a higher risk of the identified building element containing asbestos. |

As Asbestos Reporting is outside the scope of this report, we advise that you consider a separate Asbestos Inspection and Condition Audit, which can include the taking of samples for definitive confirmation of the presence of Asbestos.

In the interim, the client is advised to act with caution, especially when considering any damage to building materials general wear and tear renovations extensions demolition and general maintenance activities due to the suspected presence of Asbestos.
