Building and Timber Pest Inspection Report

Inspection Date: Mon, 2 Mar 2026

Property Address: 1 Clydesdale Ct, Mooroopna VIC 3629,
Australia

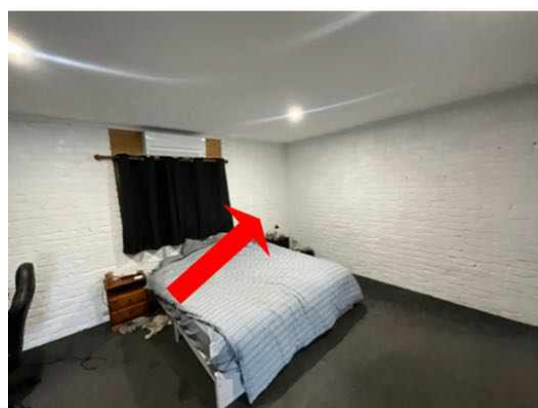
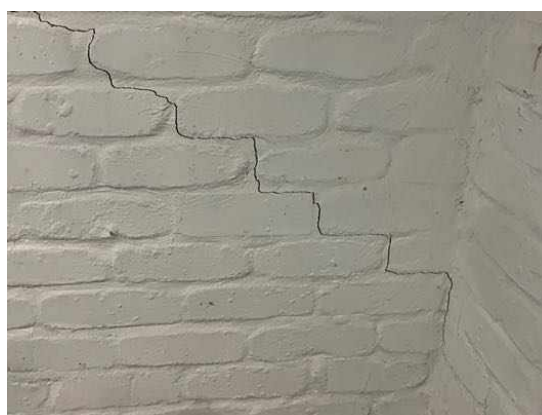
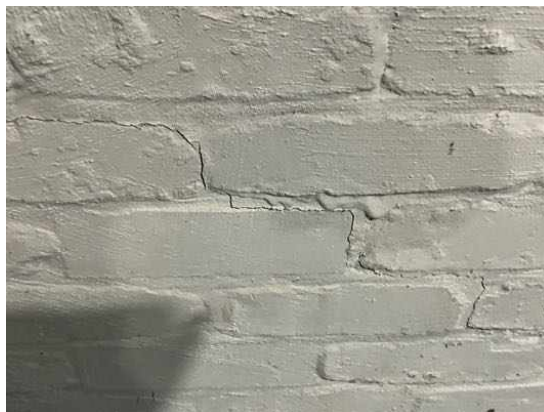
Building: Building 1
Location: Bed 1
Finding: Brickwork- Step cracking
Information: Step cracking was identified to the brickwork in this area at the time of inspection. Step cracking, which is similar to other forms of cracking, has a variety of possible causes. However, the most common is the subsidence of adjacent footings.

Step cracking is a relatively common defect, and is most likely to occur adjacent to windows, doors and other openings. Mortar failure in the gaps between affected bricks indicates the stresses and tensions affecting the wall.

Minor step cracking can be used as a warning sign to address factors causing stress to the wall, which can include the effect of surrounding trees, water leaks, soil erosion, or even the presence of reactive soils in the surrounding area.

If cracks increase in size or number contact a Licensed builder immediately to make all needed repairs.

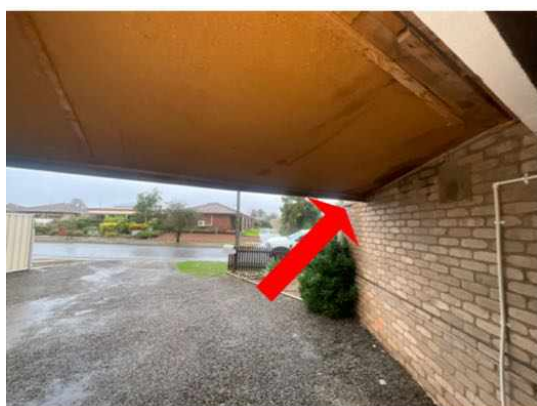
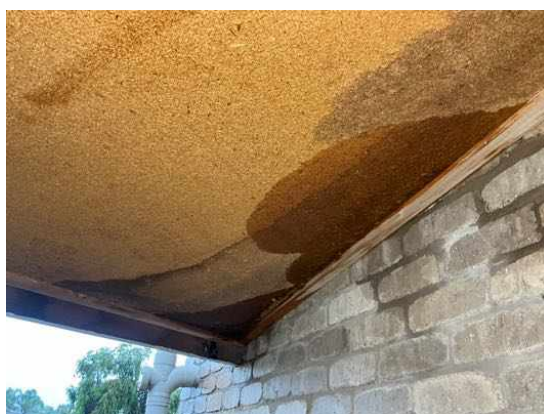
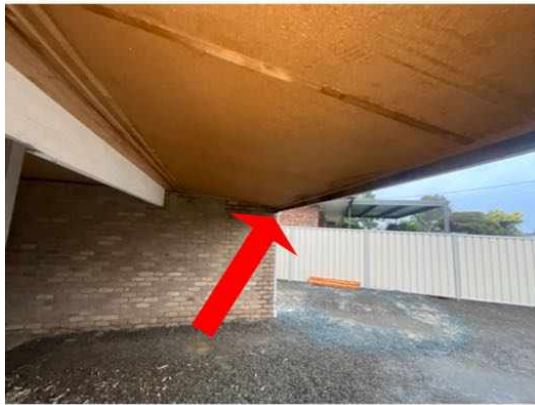
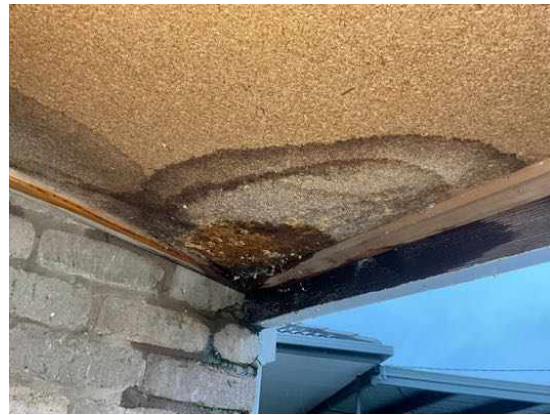
Finding 3.02

Building:	Building 1
Location:	Carport
Finding:	Ceiling - Water damaged
Information:	Water damage to the ceiling lining is generally an indication of excessive moisture being present in the roof void, usually via a leak to the roof covering.

In this case it may be overflowing gutters causing water to flow into the ceiling space.

Where water damage is evident to the ceiling, the primary requirement is to identify and rectify the source of the leak. A roofing plumber should be appointed as soon as possible to identify the leak and perform rectification works as necessary, ensuring the water damage is restricted.

Once the leak is repaired, consultation with relevant tradespeople, including plasterers and painters, is advised. Rectification works may include replacement of ceiling lining or minor repainting, depending on the extent of the damage.

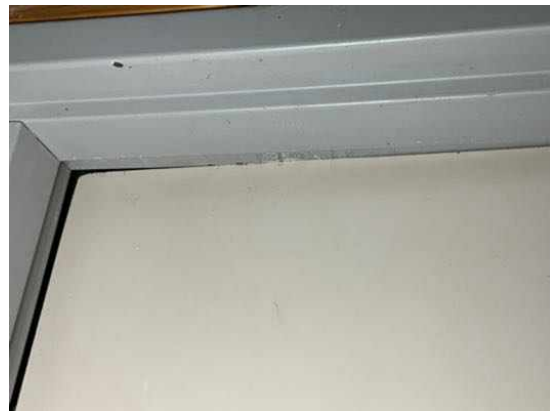
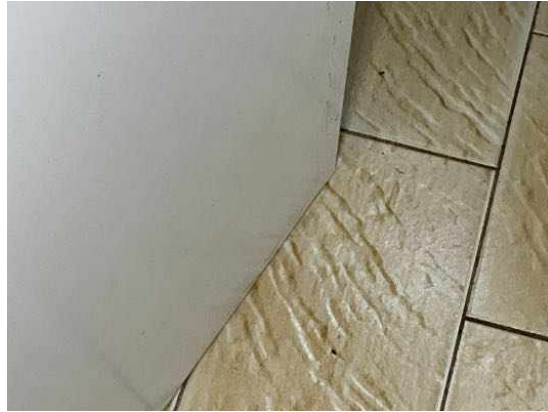
Finding 3.03

Building:	Building 1
Location:	Laundry, Wc
Finding:	Door- Binding/jamming
Information:	Binding and/or jamming of this door is evident during standard operation. This defect inhibits the functionality of the affected door as well as creating potential for secondary defects to associated building elements, such as damage to the floor covering.

A door that binds to flooring or to the associated door frame may have several causes, ranging from minor defects, such as poor installation of the door or deteriorated hinges, through to major structural issues, such as damage to subfloor structures.

A qualified carpenter or general handyperson should be appointed to perform minor rectification works at client discretion.

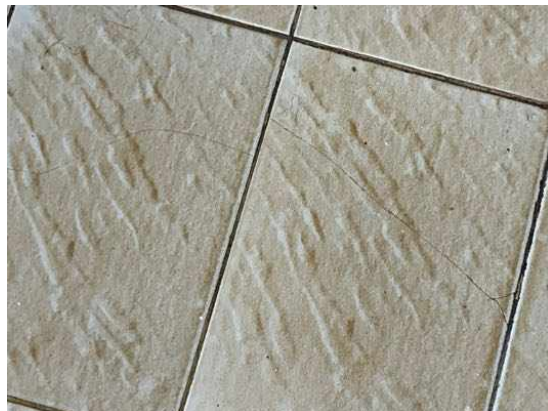
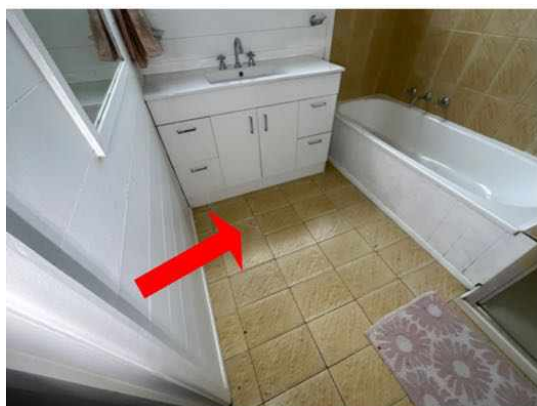
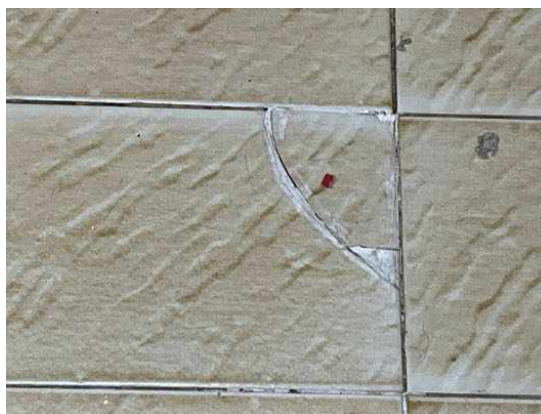
Finding 3.04

Building:	Building 1
Location:	Bathroom > Level 1
Finding:	Cracked floor tiles
Information:	Cracking in the floor tiles was evident in this area at the time of inspection. It is suspected that this cracking has occurred as a result of minor settlement or impact damage.

Cracked tiles throughout the household detract from the overall appearance of the affected areas however it is unlikely to create or lead to any secondary defects.

While not considered a matter of urgency, replacement of cracked floor tiles is recommended at the clients discretion. A tiling contractor may be appointed to perform these works. Where cracks become more numerous, contact a licensed building inspector for further investigation.

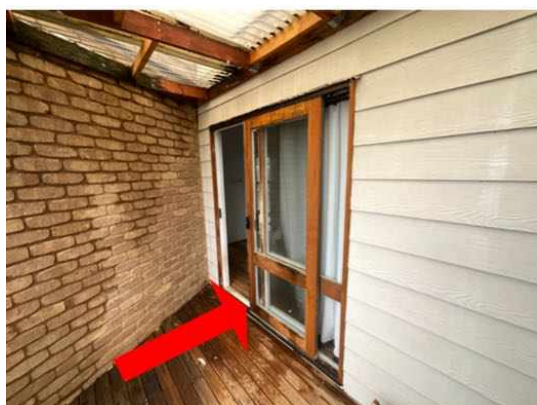
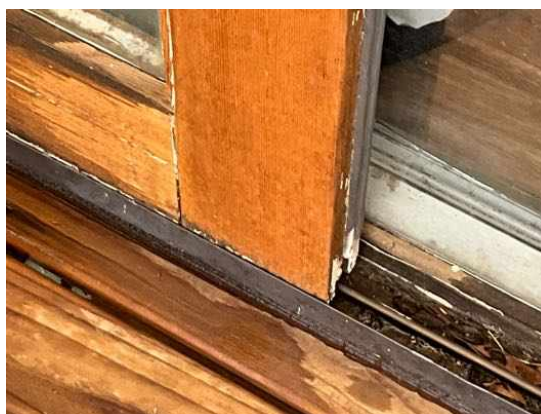
Finding 3.05

Building:	Building 1
Location:	Deck > Level 1
Finding:	Door- Stiff to slide
Information:	The door in this area was jammed and difficult to slide along the associated tracks at the time of the inspection. Restricted function of the affected door may pose as a potential safety hazard if required for emergency egress from the building.

Generally, factors such as general age of the building element and a lack of maintenance are the usual causes for this type of defect.

Replacement of door hardware or tracks may be required, as well as minor repairs and cleaning. A registered builder or general handy person will be required to repair the affected doors.

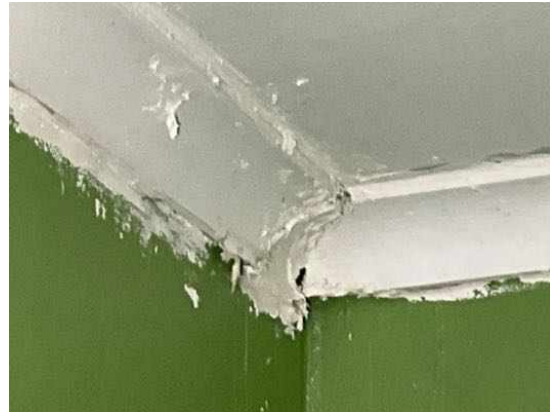
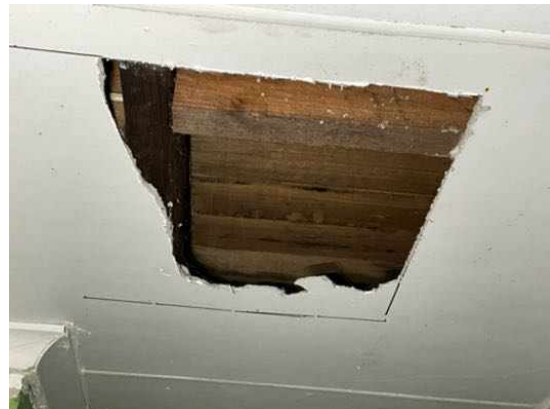
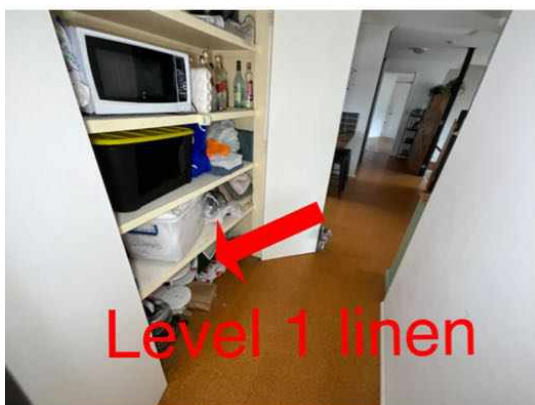
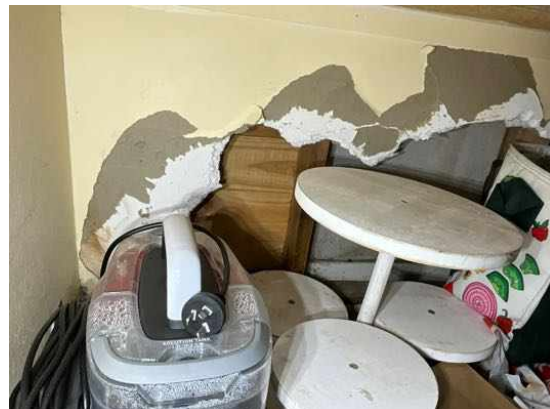
Finding 3.06

Building:	Building 1
Location:	Laundry
Finding:	Water leak - Inactive
Information:	Water leaks generally occur when a particular area of the property is not weather- or water-tight. While the damage in this area appears to be from an old inactive water

leak, the area should be monitored frequently for the recurrence of any dampness.

Repair and / or replacement of previously affected building elements is at client discretion. Consider a further invasive inspection: removal of obstructions around the damaged area may reveal further damage which has been concealed. A more significant or major defect may be identified at this time.

Where recurrence of an active water leak is identified, a qualified plumber should be appointed immediately to rectify the leak and advise on any further preventative works as necessary.

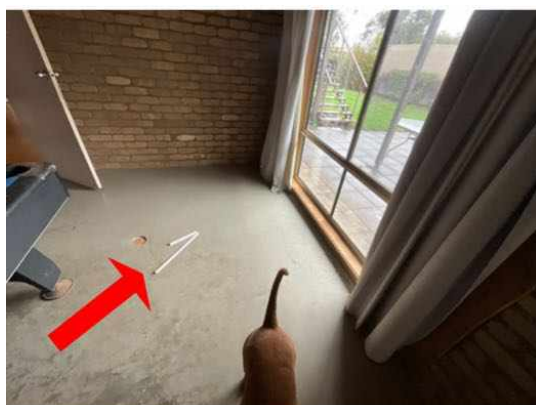
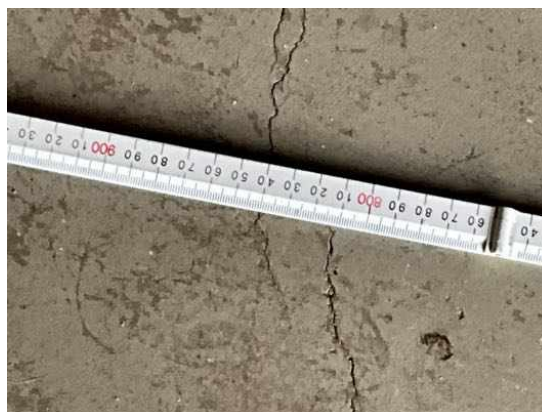
Finding 3.07

Building: Building 1
 Location: Pool room
 Finding: Crack in concrete slab - Category 1
 Information: A crack coded as Category 1 was identified in the slab. A Category 1 crack is described as a fine but noticeable crack, with the slab at an otherwise reasonable level.

To be considered Category 1, the approximate width of the crack is less than 1.0mm, or a less than 10mm change in offset when a 3m straight edge is placed over the defect.

Category 1 cracks should be monitored for a period of 12 months. At the end of the monitoring period, identified cracks that are rated greater than Category 2 are considered defects, and require rectification.

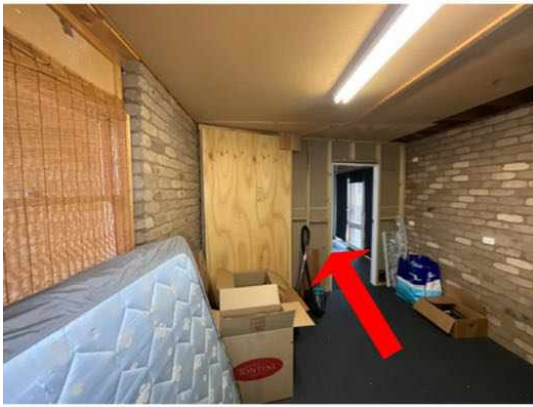
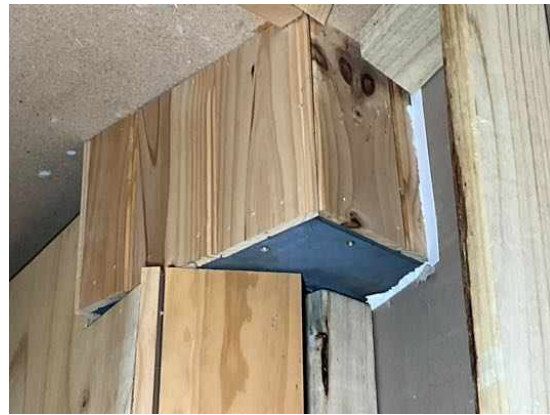
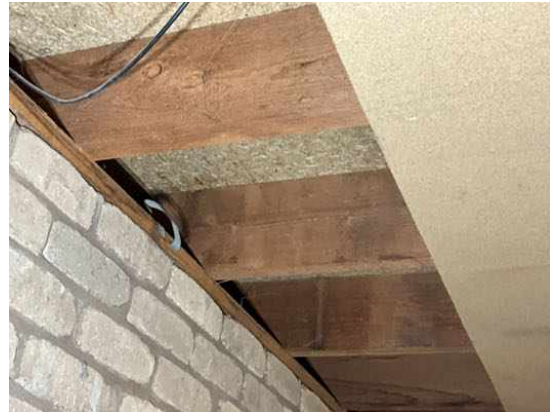
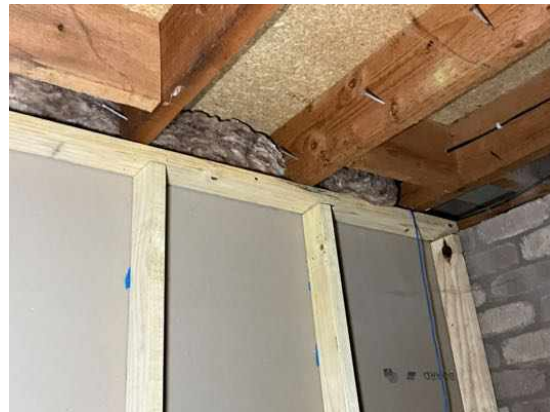
Finding 3.08

Building: Building 1
 Location: Ground floor
 Finding: Installation - substandard or incomplete
 Information: The installation of this building element appears to have been completed to a substandard level of workmanship or is incomplete. Generally substandard repairs or installation are related to poor workmanship, the use of inappropriate materials, or a failure to complete installation to a suitable standard.

Where installation is substandard and/or incomplete, the client should contact the responsible trade to undertake rectification. Unfinished and substandard building works are likely to degrade more quickly and may create potential for secondary defects to associated building elements.

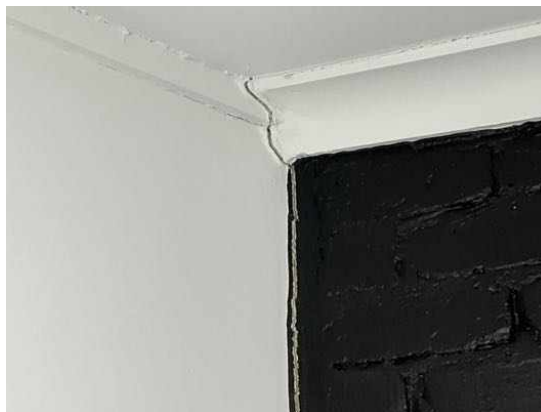
Finding 3.09

Building: Building 1
 Location: Living > Level 1
 Finding: Cracking - Damage Category 2 - Noticeable (up to 5mm)
 Information: Noticeable cracks are a common occurrence as a result of many primary defects. Such causes may include age, general wear and tear, expected building movement, general expansion/contraction of building materials in different weather conditions, and/or minor failings in the installation or application of building materials.

Noticeable cracks may result in minor sticking or jamming of associated doors and windows, which require easement. However, noticeable cracks are easily filled and repaired. A plasterer can be consulted to install an expansion joint at this point to allow

for this movement during different weather conditions.

Monitoring of all cracking should be conducted frequently. Always contact a building inspector should cracks widen, lengthen, or become more numerous. Additionally, your building inspector should also be contacted if associated building elements such as doors and windows become more difficult to operate over time.

Relevant tradespeople, such as carpenters, painters and plasterers, should be appointed to perform remedial works, as deemed necessary.

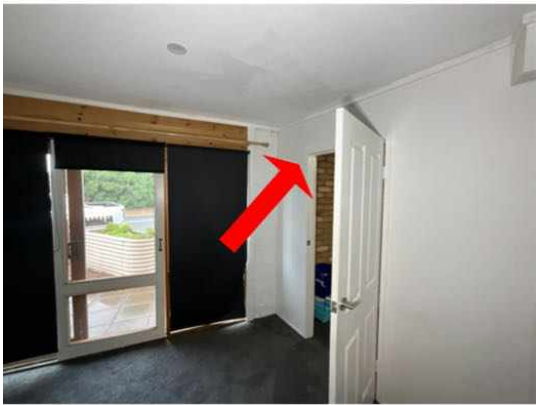
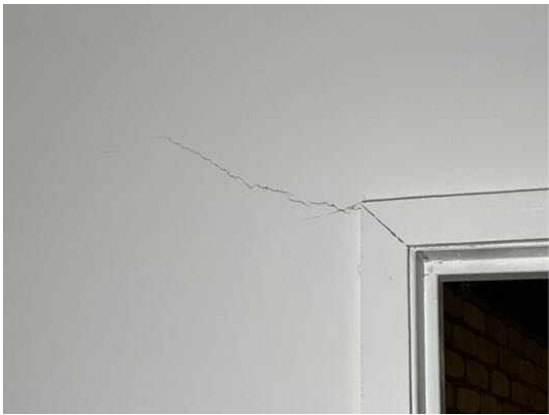
Finding 3.10

Building:	Building 1
Location:	Bed 1
Finding:	Cracking - Damage Category 1 - Fine (up to 1mm)
Information:	Although fine cracks are quite noticeable, they are often only considered to be an appearance defect, and usually do not indicate any structural damage. Generally, the cause of a fine crack is indicative of a separation between building materials and finishes (e.g. paint, plaster, etc.) along joints.

Cracking of this nature can generally be repaired with minor sanding, filling and/or repainting. Such works should be performed by a qualified painter or a general handyman.

Monitoring of all cracking should be conducted frequently. Always contact a building inspector should cracks widen, lengthen, or become more numerous.

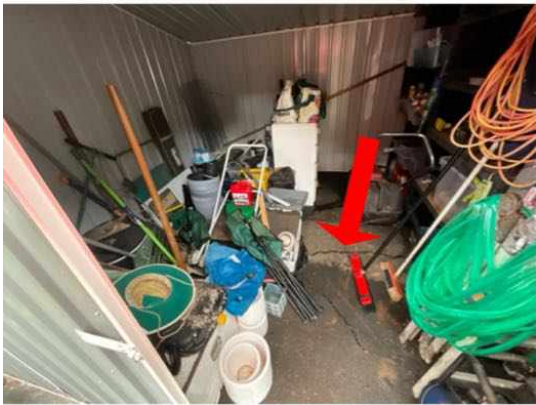
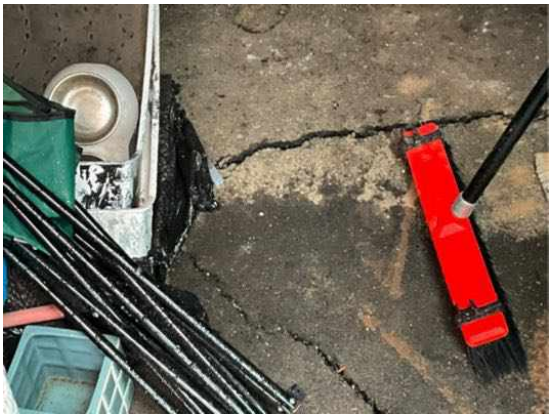
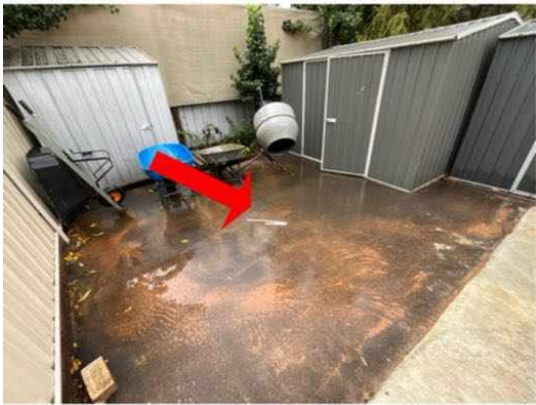
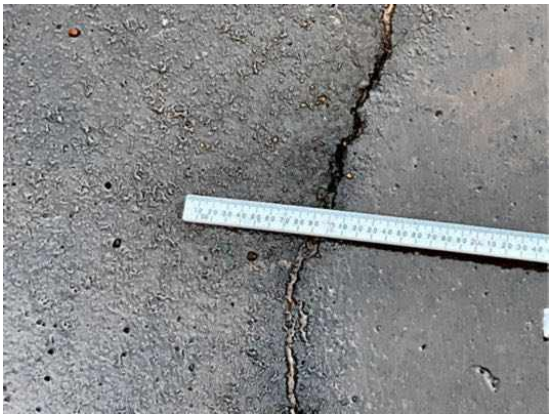
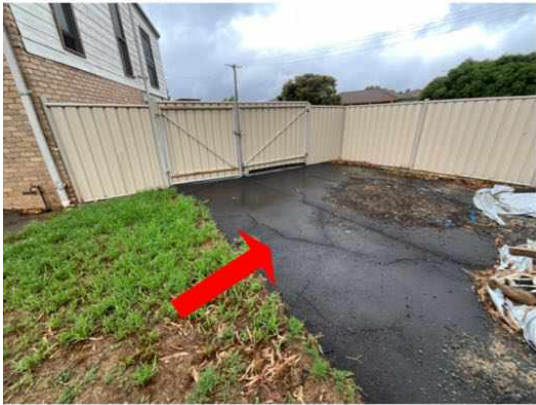
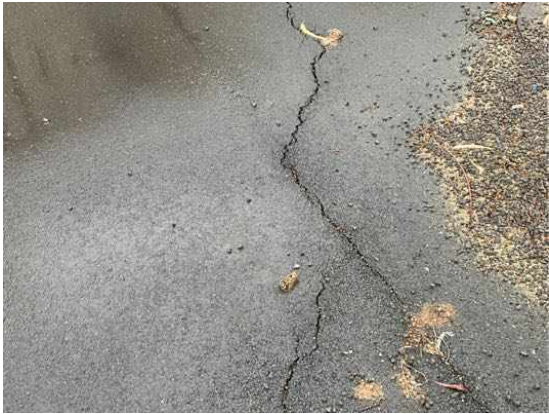
Finding 3.11

Building: Building 1
Location: Yard - Back
Finding: Cracking - External Bitumen Paving Damage
Information: Distinct cracks were identified in external paving. Distinct cracks are generally found in older bitumen paving and may also present as a trip hazard as consequence of an uneven or curved surface.

Cracking to this degree may also be due to poor original installation. Factors such as poor compaction of the sub surface and/or inadequate preparation may create cracking and other secondary defects.

Repairs are likely to be required to prevent further cracking and to reduce hazards associated with cracking, such as tripping. Monitoring of all cracking should be conducted frequently. Always contact a building inspector should cracks widen, lengthen, or become more numerous.

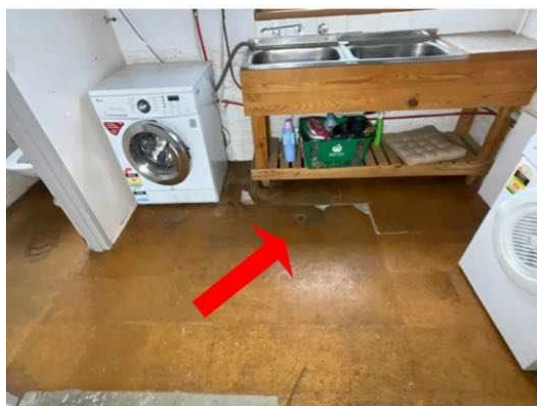
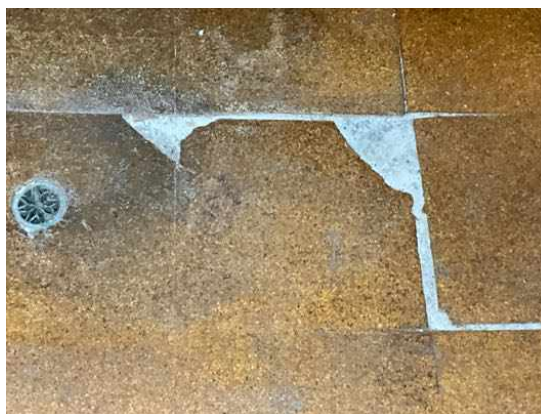
Finding 3.12

Building: Building 1
Location: Laundry
Finding: Cork floor lifting
Information:

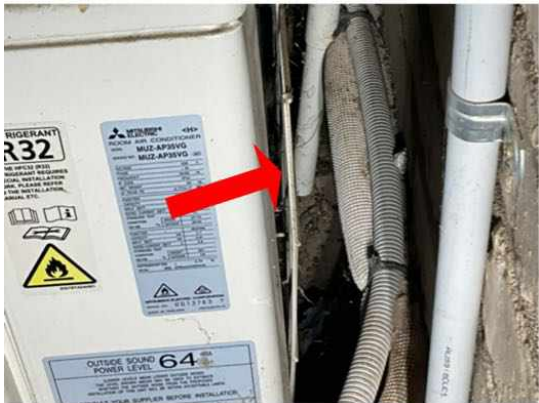
Building:	Building 1
Location:	Carport
Finding:	Air conditioner - Disconnected overflow
Information:	The Air Conditioner (A/C) overflow was found to be disconnected from storm water drainage and is creating excessive moisture in the surrounding area.

Such leaking creates an environment which is conducive to an array of defects, including water damage to associated building elements and the attraction of termite or timber pest infestation.

It is highly recommended that a licensed plumber be appointed to connect the A/C overflow in order to prevent such an environment from being created. These minor works should be carried out as soon as possible.

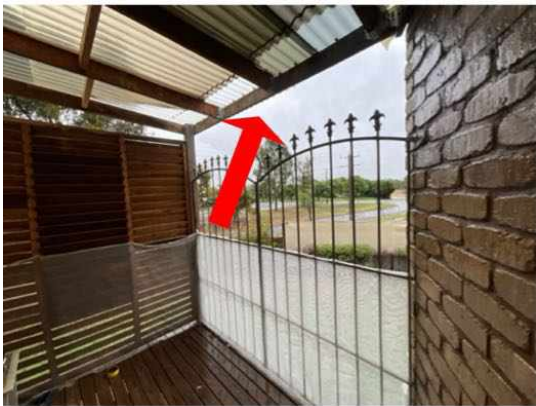
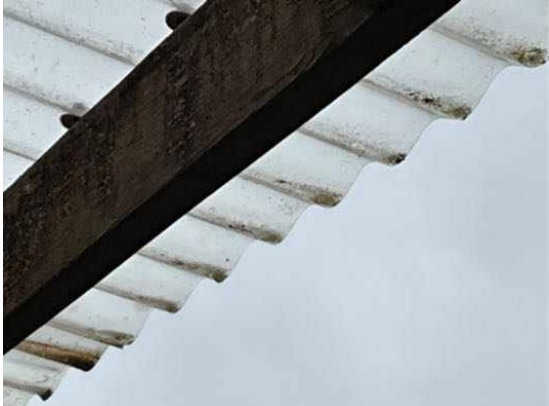
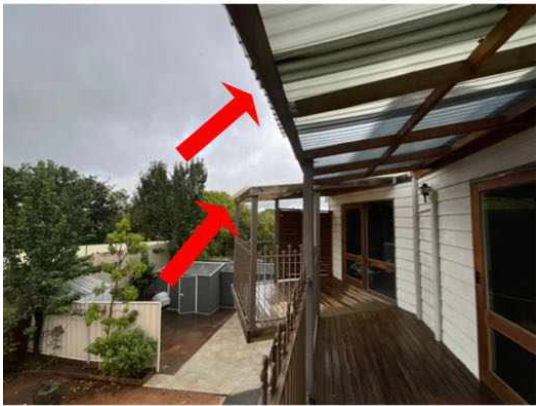
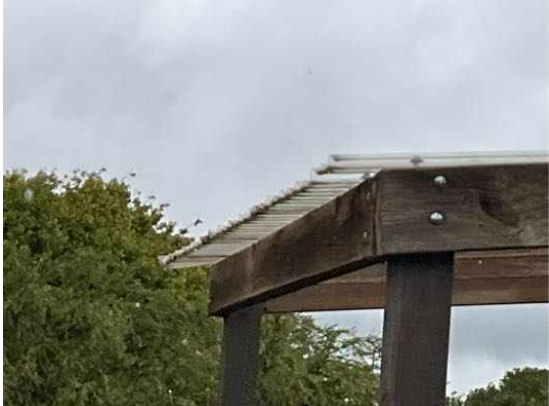
Finding 6.02

Building: Building 1
 Location: Deck > Level 1
 Finding: Guttering Missing
 Information: The Guttering in this area was missing at the time of inspection. Guttering, Downpipes and Stormwater drainage are vital to protect the integrity of the structure and to prevent an environment conducive to Timber Pest attack.

A Plumber should be contacted as soon as possible to replace and connect to drainage the missing Guttering.

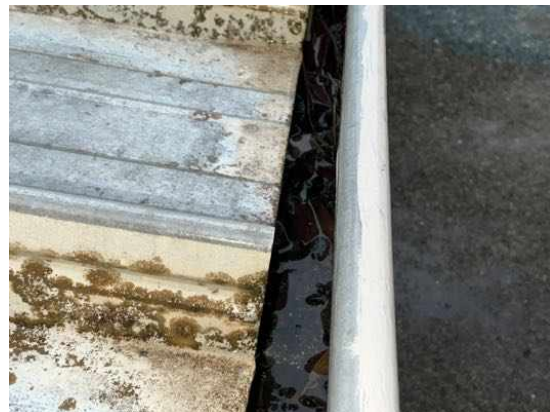
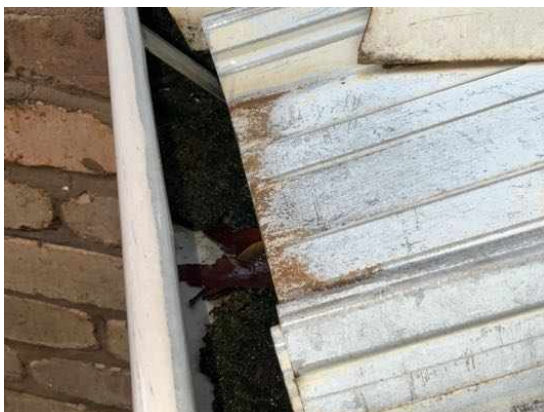
Finding 6.03

Building:	Building 1
Location:	Carport
Finding:	Gutters- Blocked
Information:	Roof plumbing structures, such as guttering and downpipes, should be free of all debris to prevent blockages. Blockages of the guttering and downpipes will lead to pooling and accumulated water overflows, which is likely to subsequently flood eaves and exterior walls.

Blocked gutters are likely to lead to high levels of moisture in the affected areas. Such moisture will not only cause rust and decay of the associated building materials, but can also provide conditions that are conducive to termite and timber pest activity. Blockages in gutters should therefore be removed immediately to ensure dry conditions are maintained.

Consult a Licensed Plumber for further specific advice on remedial works that may be required. In the interim, it is highly advised that blocked gutters be removed by the homeowner or a general handyperson as a matter of urgency.

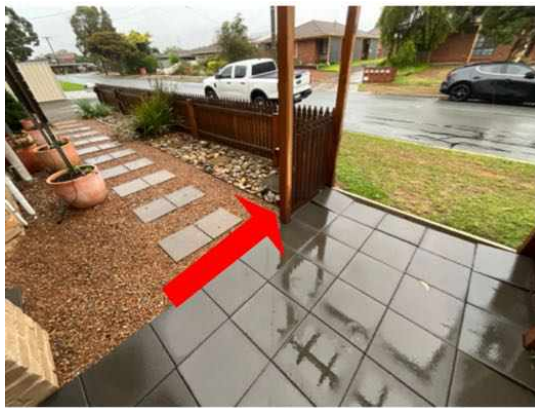
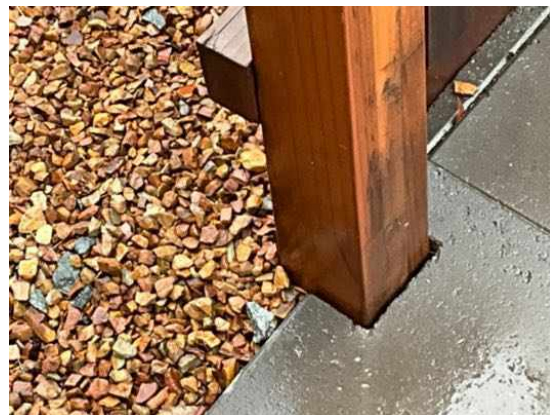
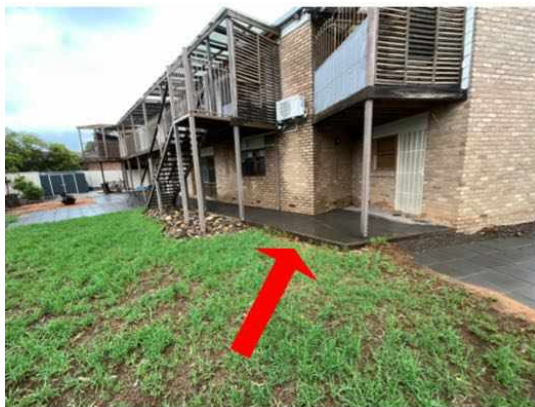
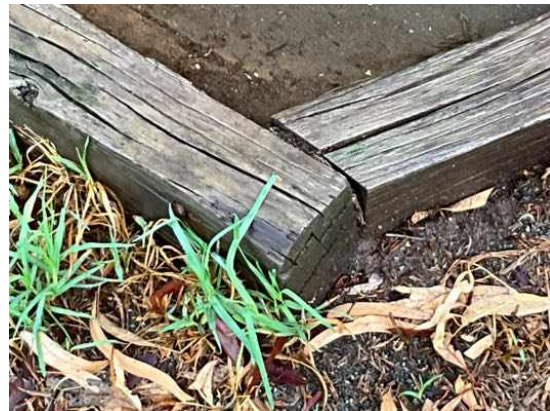
Finding 6.04

Location: Yard - Front, back
 Finding: Untreated or non-durable timbers in a hazardous environment
 Information: To reduce the risk of timber pest attack it is essential that timber used in a hazardous environment (e.g. in direct contact with the ground or frequently exposed to damp conditions) is of sufficient durability and/or is adequately preservative treated.

Untreated timbers in direct contact with the ground are likely to develop severe wood rot and/or fungal decay if left unattended creating attraction for subterranean termites to infest the timbers from surrounding areas.

If untreated or non-durable timbers are found to be in a hazardous environment it is highly advised that replacement of these building elements be performed as soon as possible to aid the protection of the property against termite / timber pest attack.

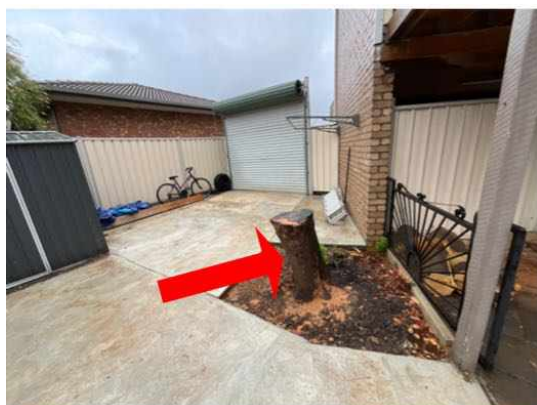
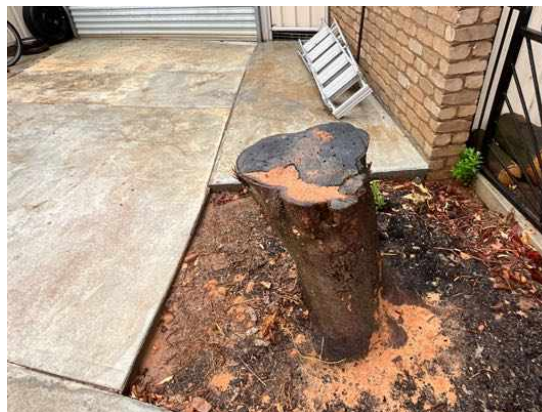
Finding 6.05

Building: Building 1
 Location: Yard - Back
 Finding: Tree Stump in Ground
 Information: Any tree stumps in the yard not removed during the tree removal process provides the opportunity for Termite infestation and is likely to be subject to decay from damp conditions against the stump.

All tree stumps should be removed by professional tree removal services where possible. Meanwhile regular inspections are advised to identify any termite activity in the areas identified.

Services for tree stump removal should be contacted as soon as possible to reduce the risk of timber pest attack.

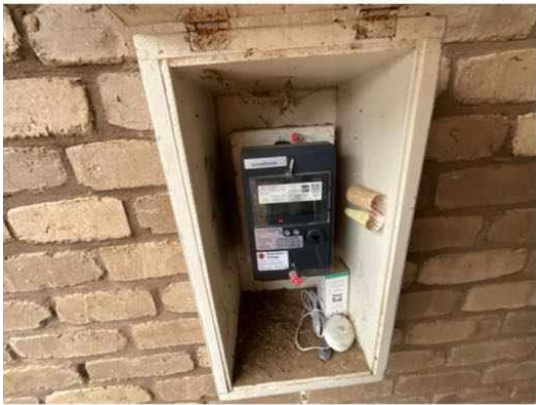
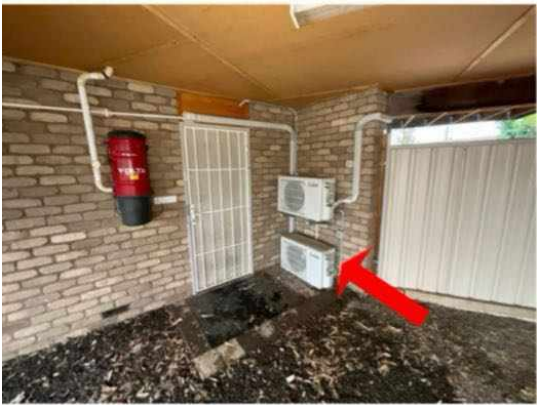
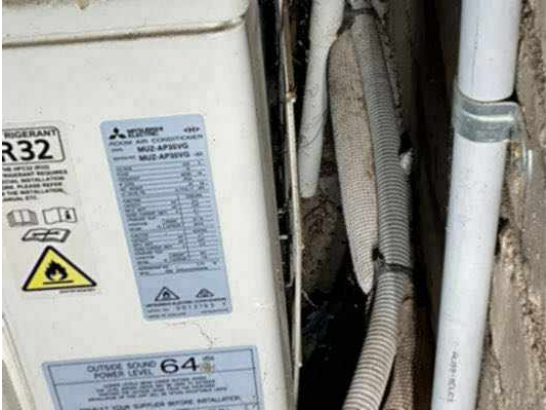
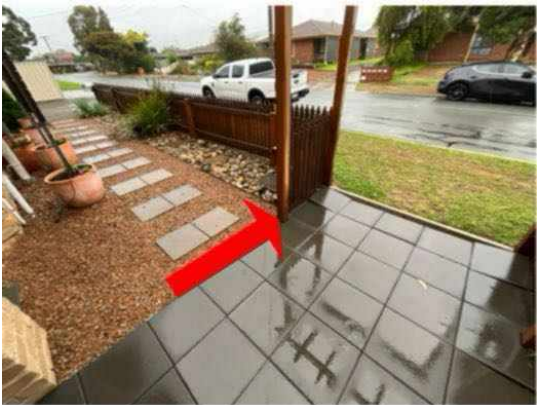
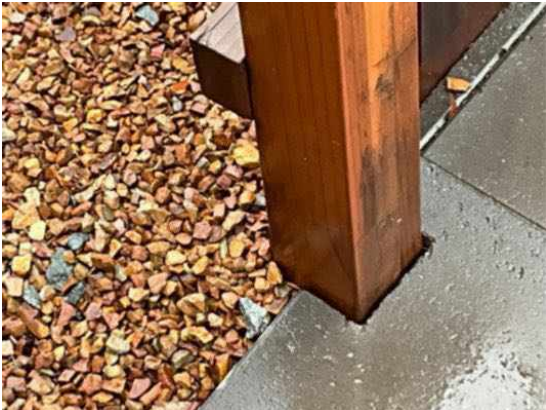
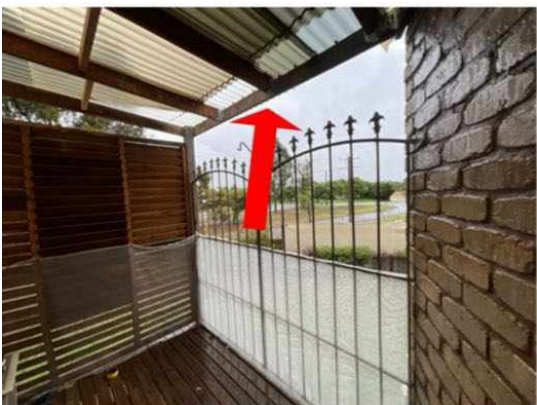
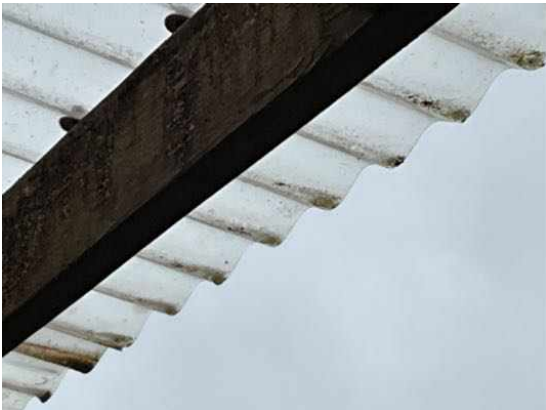
Finding 6.06

Building:	Building 1
Location:	All External Areas
Finding:	Termite Management System - no evidence of a chemical installation
Information:	The application of a post-construction chemical termite barrier is highly recommended for all properties, particularly if live termite activity has been found on the site previously. Such barriers are highly effective in preventing termite attack on any timber building elements throughout the property.

A durable notice should be placed in the switchboard unit to indicate current termite barriers. At the time of inspection, it appeared as though no termite management system has been installed, with no evidence to suggest preventative works taking place.

The client may consider gaining further advice from a pest controller as to the costs and procedures involved with this application. It is recommended that obtaining such advice be a short-term priority.

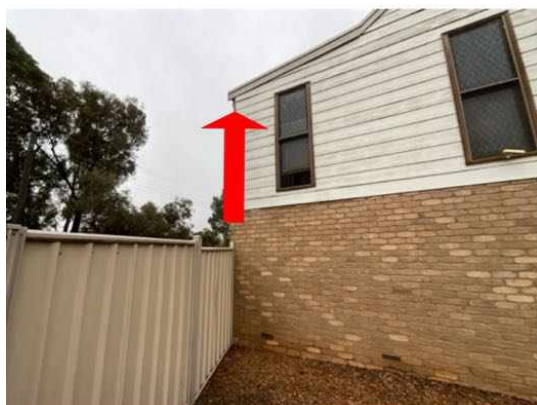
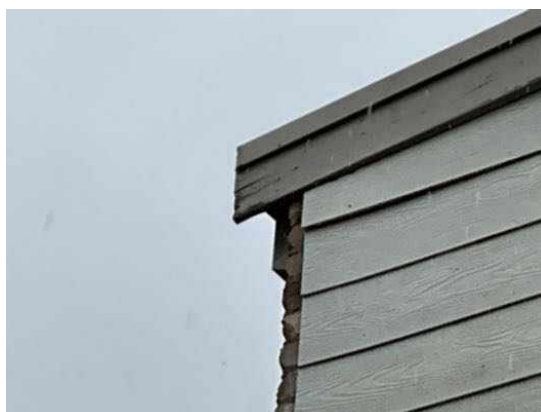
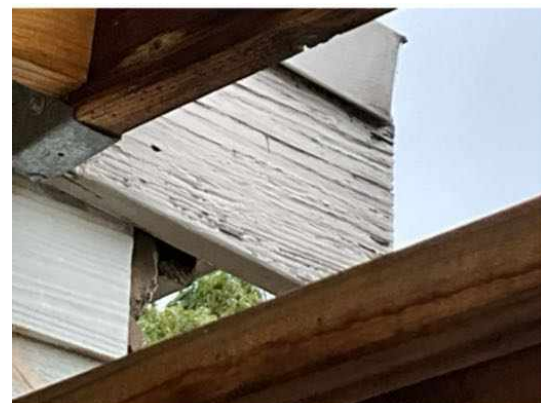
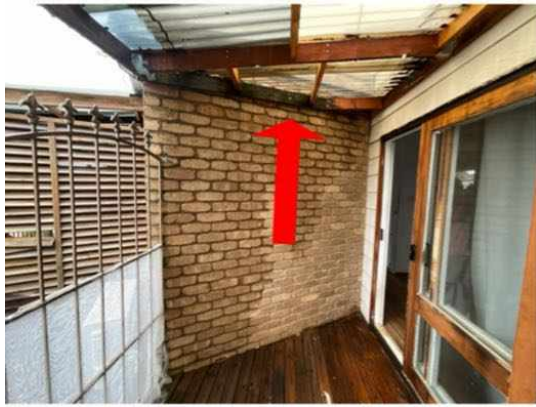
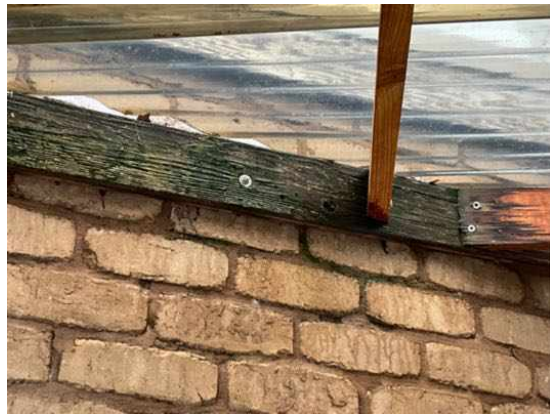
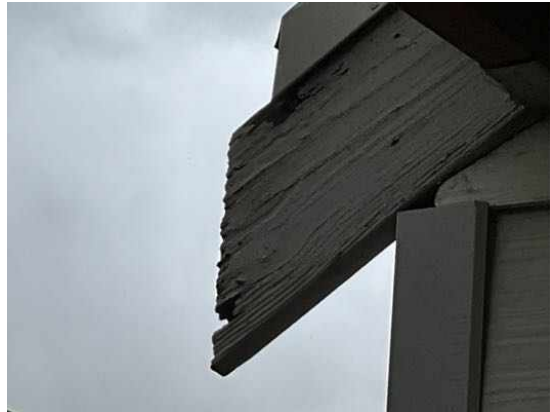
Finding 7.01

Building: Building 1
Location: Eaves
Finding: Fungal decay - present (localised)
Information: Fungal decay also known as wood decay or wood rot generally refers to the deterioration of timber elements when in contact with excessive levels of moisture for a prolonged period of time.

The development of fungal decay is accelerated by temperatures in the range of 5degreeC to 40degreeC as well as the presence of oxygen. Generally fungal decay develops on timber elements that are in use in an external environment which are exposed to rain penetration.

In this case although the affected timber element is in a decaying state the extent of any visible damage appears to be localised to a specific area and is yet to spread to other parts of the building element or affect adjoining structures. The fungal decay is therefore likely to be of a relatively superficial nature with minimal impact on the structural integrity or tensile strength of the timber element.

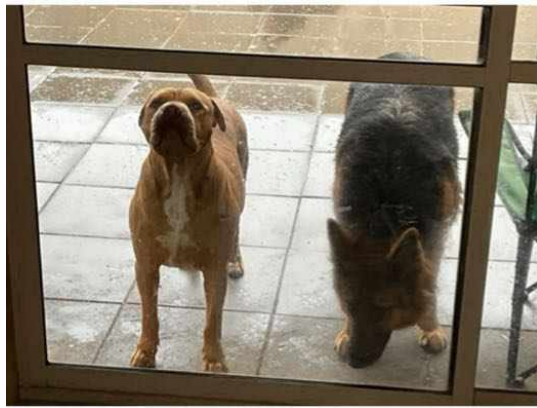
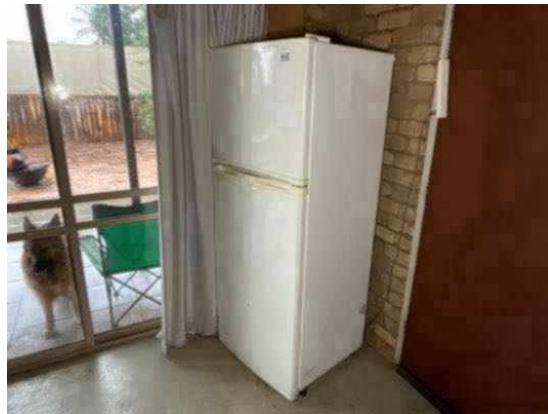
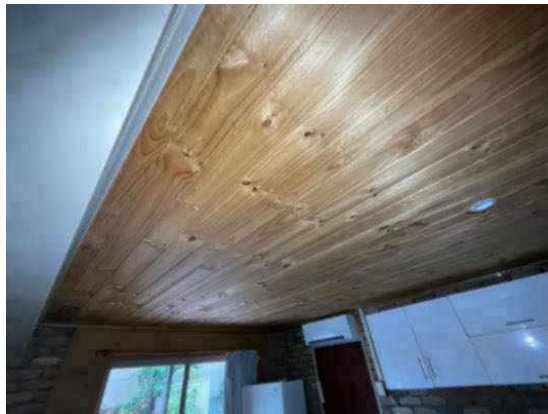
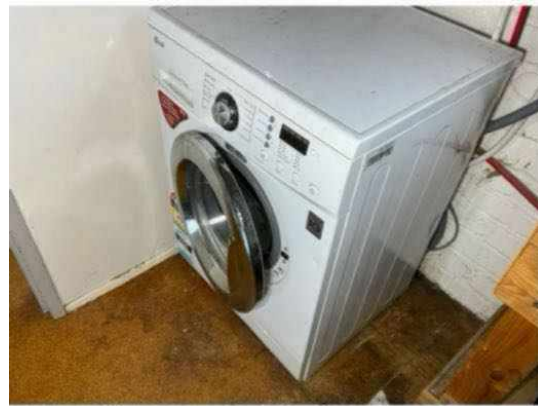
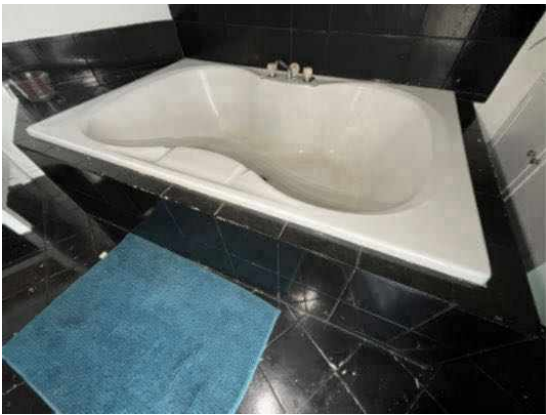
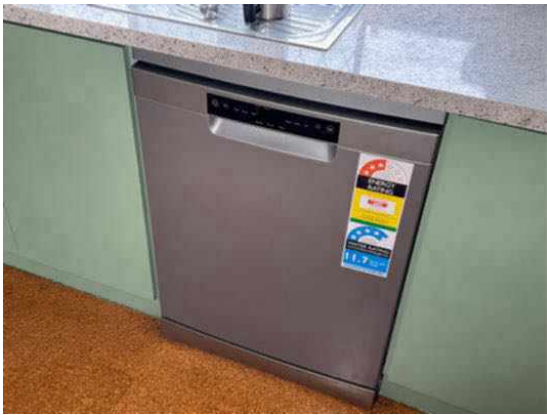
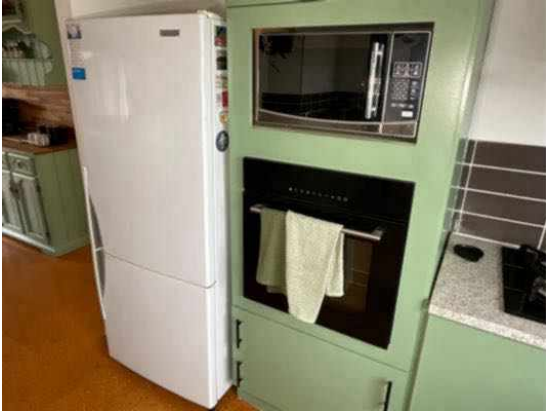
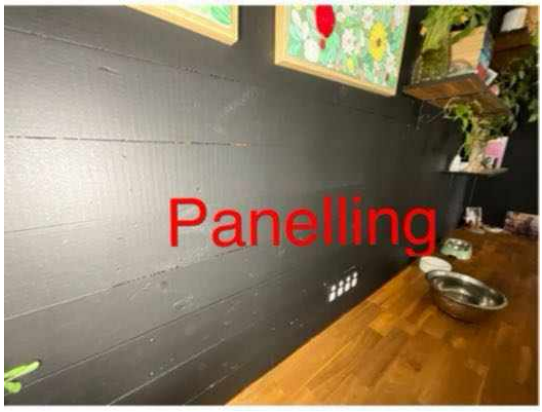
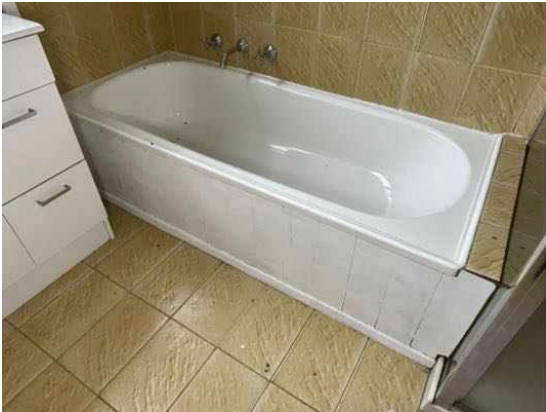
Building: Building 1
Location: All Areas
Finding: Additional Photos - Obstructions and Limitations
Information: These photographs are an indication of the obstructions and limitations which impeded full inspection of the property at the time of inspection. These obstructions can hide an array of defects and should be removed to allow full inspection to be carried out. A re-inspection is recommended once the areas are made accessible.
