Building Inspection Report

Inspection Date: Mon, 2 Feb 2026

Property Address: 2/43-45 Neil St, Merrylands NSW 2160,
Australia

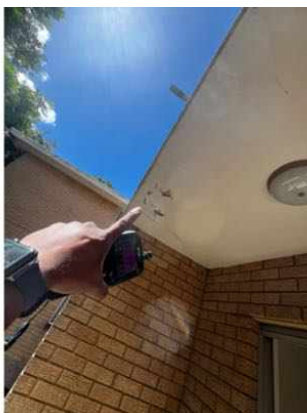
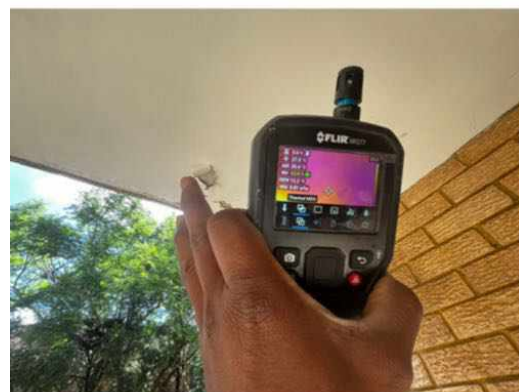
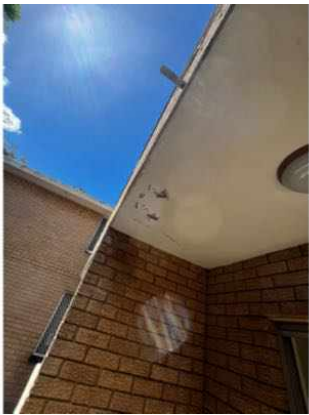
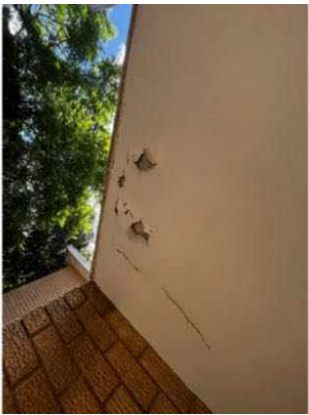
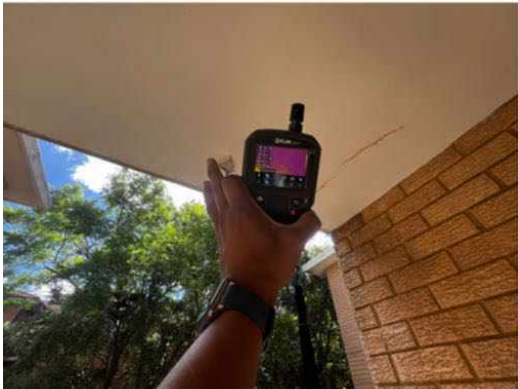
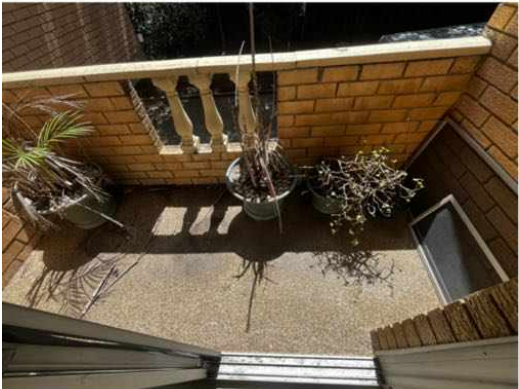
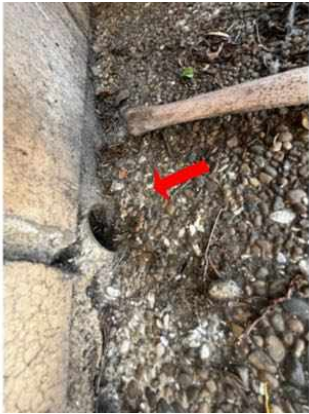
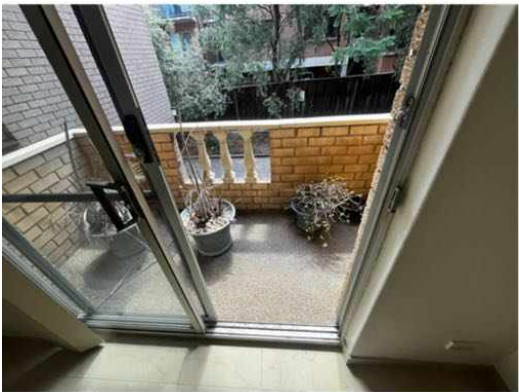
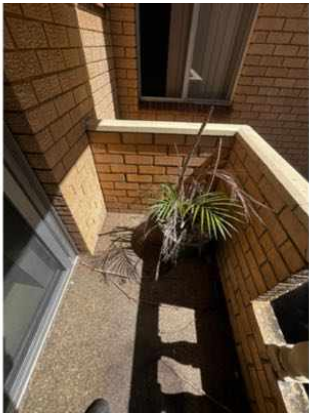
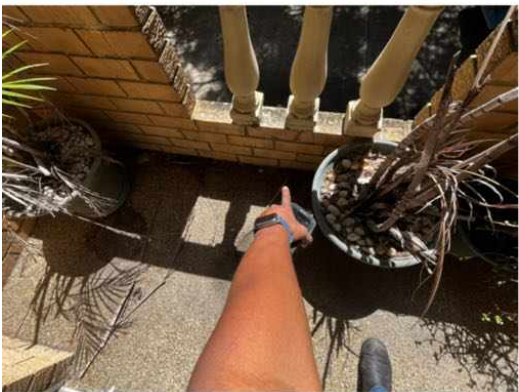
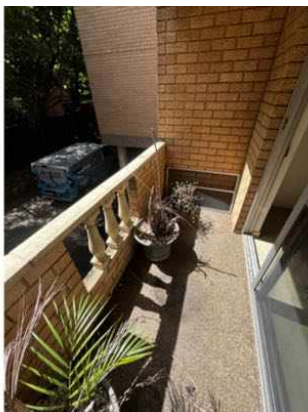
Defects 2.01

Building: Main Building
Location: Bedroom Balcony
Finding: Balcony Area - Ceiling Damage
Information: Upon Inspection The gradients of the Balcony floor levels are checked and found to be ok.

Upon inspection of the ceiling Evidence of Previous Water Leak was found during Inspection in the ceiling of the Balcony.

Missing roof drainage, leaking plumbing pipes or fixtures, poorly plumbed HWS overflows or condenser units and poor site drainage are generally the causes of the leakage.

It is highly recommended that all plumbing and drainage fixtures and fittings be maintained regularly in order to prevent excessive moisture being present in the external / internal property.

Suggest to Take the advise of the Licensed Plumber to inspect and verify the cause of the leak and remedy the situation.

Suggest to always keep the area clear of rubbish and leaves, for the free flow of water/ rainwater to go through the downpipes.

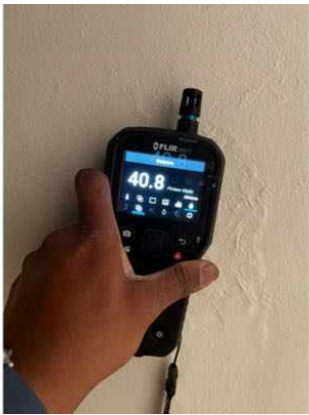
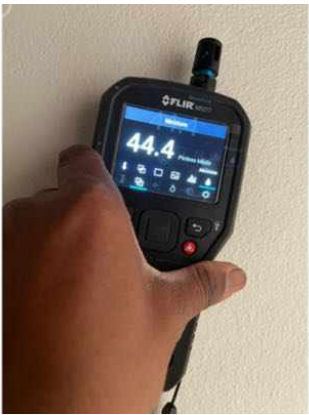
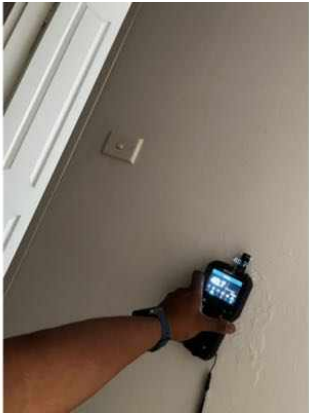
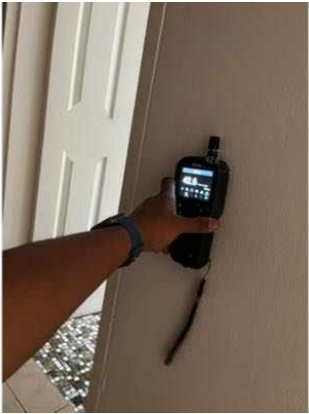
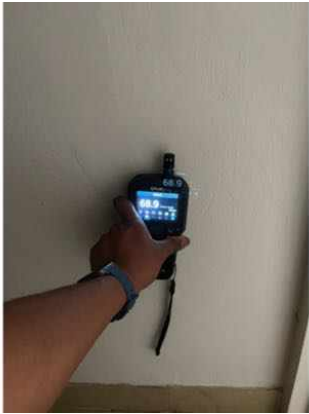
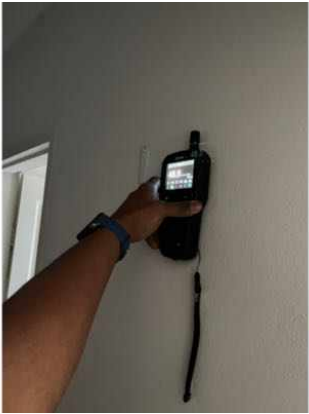
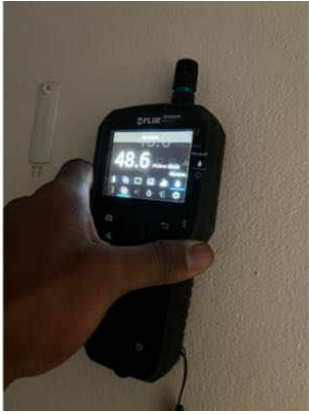
Defects 2.02

Building:	Main Building
Location:	Bathroom wall/ behind shower area.
Finding:	High Moisture Readings - Evidence of high moisture was present during Inspection.
Information:	All areas of dwellings are checked with particular attention paid to wet areas which were closely assessed to check for moisture levels of moisture and temperature anomalies.

High readings for moisture were found in the walls adjacent the showers in the bathroom and the laundry plumbing area at the time of inspection.

Excessive moisture is generally caused by deteriorated, inadequate or missing roof drainage, leaking plumbing pipes or fixtures, poorly plumbed HWS overflows or condenser units and poor site drainage.

It is highly recommended that all plumbing and drainage fixtures and fittings be maintained regularly in order to prevent excessive moisture being present in the external / internal property.

It is highly advised to consult a Licensed Plumber to inspect and remedy the situation.

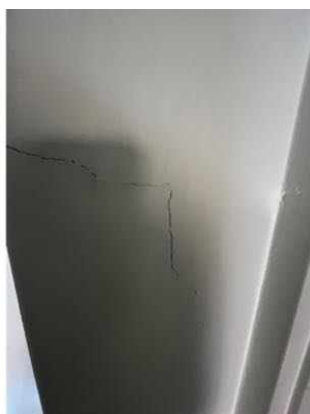
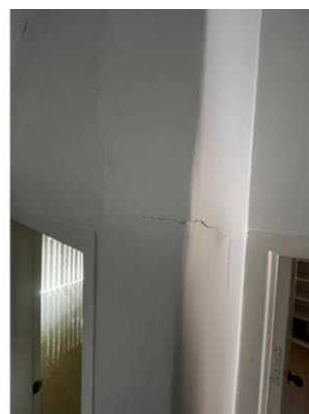
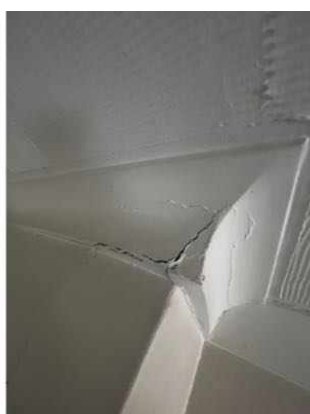
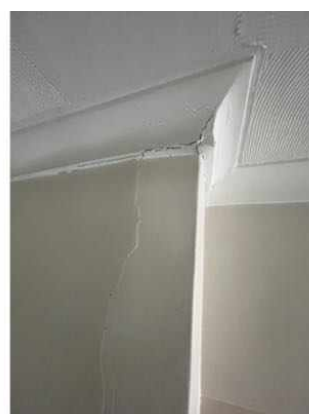
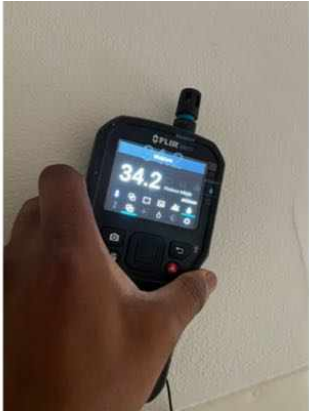
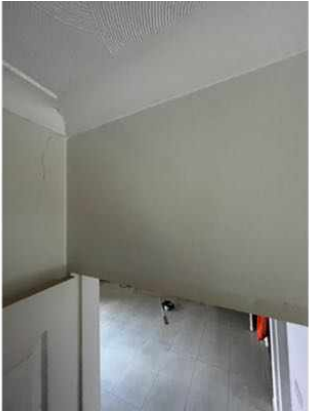
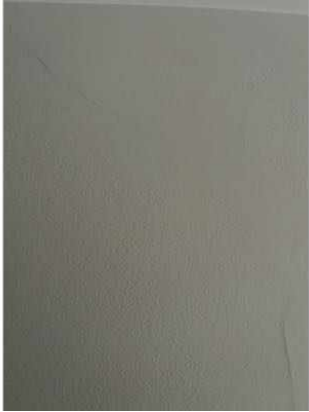
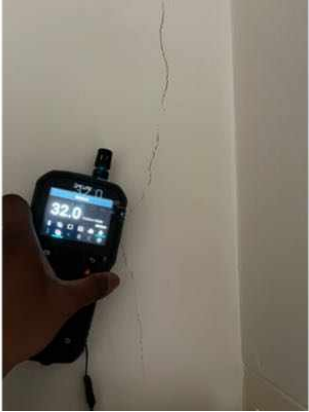
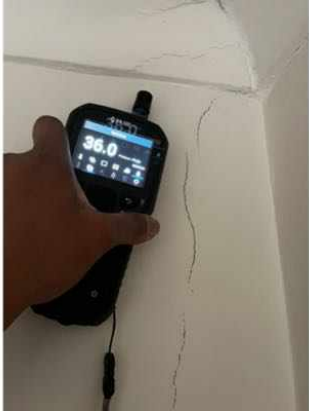
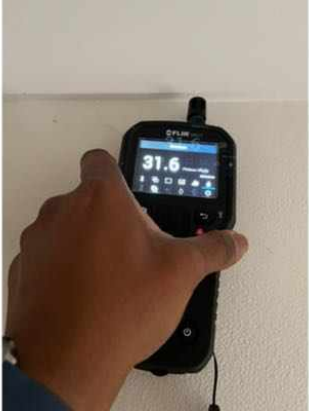
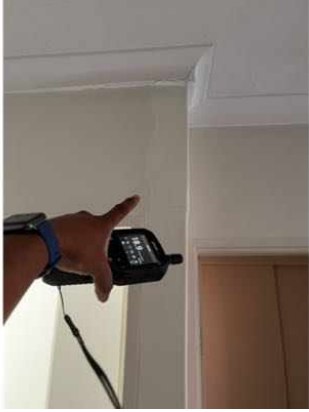
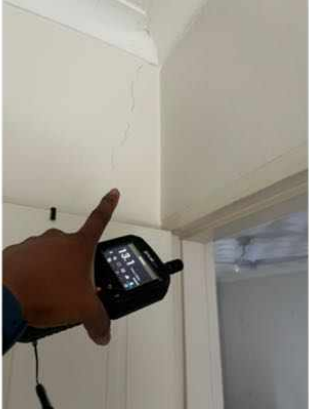
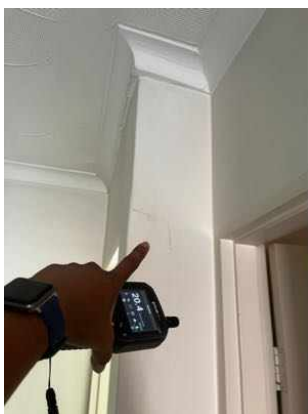
Defects 2.03

Building: Main Building
Location: Bedroom entrance wall
Finding: Render Cracking - Damage in Internal Render - Noticeable
Information: Noticeable cracks are a result of many primary defects. Such causes may include age, general wear and tear, expected building movement, general expansion/contraction of building materials in different weather conditions, and/or minor failings in the installation or application of building materials.

The most important cause for the crack of render could be the moisture being trapped between the render and the wall. It could be also be due to poor application and also the sub standard matériels being used.

Extreme heat and cold weather could have also impacted the settlement of applied render. It can also be the cause of Base coat being expanded more than the Top coat being applied.

Relevant tradespeople, Licensed Renderer , Licensed Builder should be consulted before arriving at a decision to take action as they can further do an invasive inspection and remedy the situation.

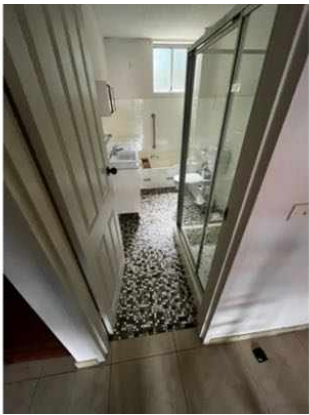
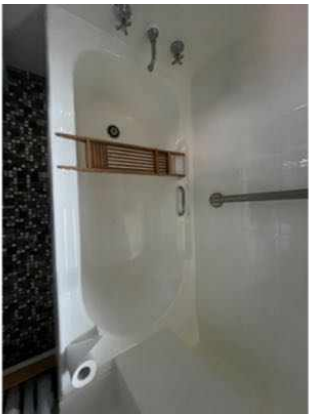
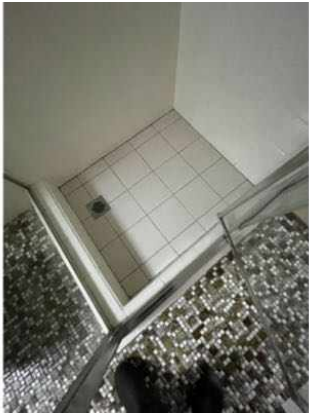
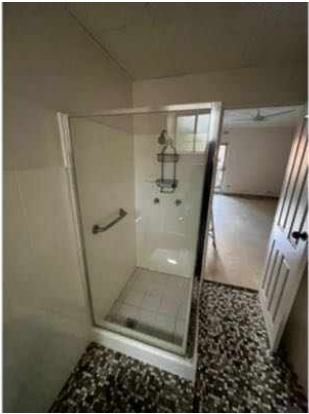
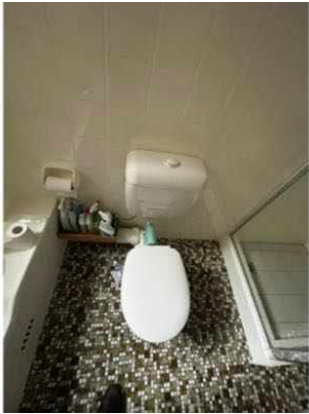
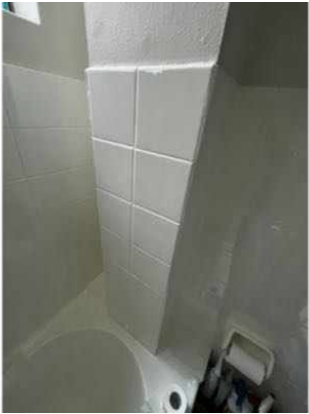
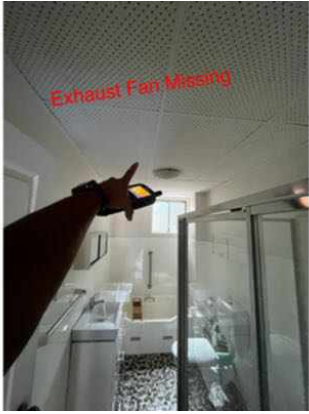
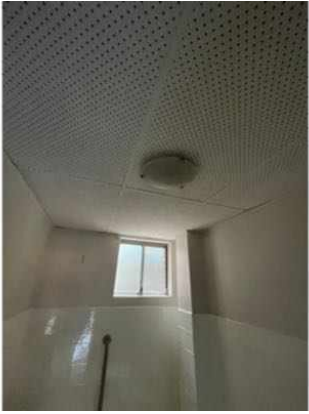
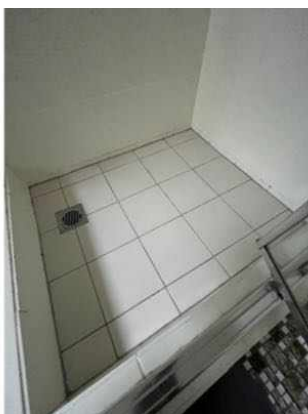
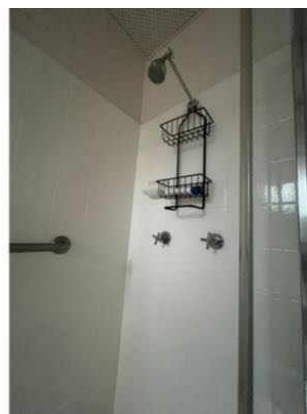
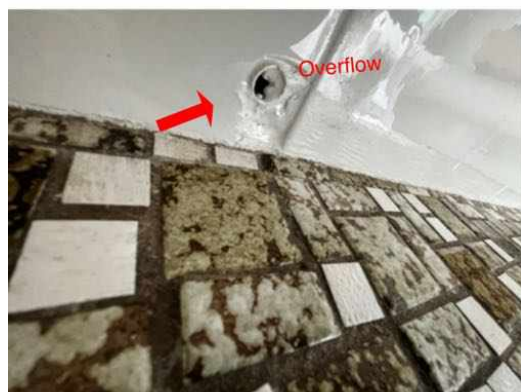
Defects 3.01

Building:	Main Building
Location:	Bathroom >
Finding:	Sealant Deterioration in - Bathroom
Information:	During the time of inspection it was evident that the shower recess, needs to be silicone sealed in the edges.

This defect is quite common, and is suspected to have been caused by moisture permeating or leaching through the grouting and sealant in this area, which shows evidence of missing sealant .

Different materials and floor areas move at different rates, generally causing cracking to grout or sealant at this point. A flexible sealant is required to allow for expected expansion and contraction, while keeping the joint water tight and protective of all associated building materials.

However grout and silicone is missing from wall to floor tiled junctions. These areas of missing grout should be re- instated and silicone applied to all internal corners to maintain a good overall seal and to prevent water from penetrating under the tiled surface.

The purchaser may wish to re-seal the showers with a professional epoxy seal to ensure a watertight seal into the future.

A sealant specialist or tiling contractor should be appointed to complete these works as soon as possible. Also if any further issues persist please do consult a Licensed Plumber.

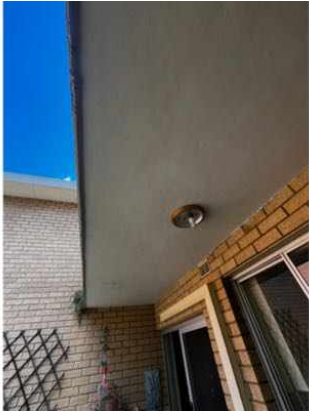
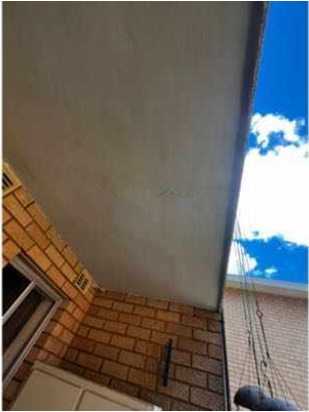
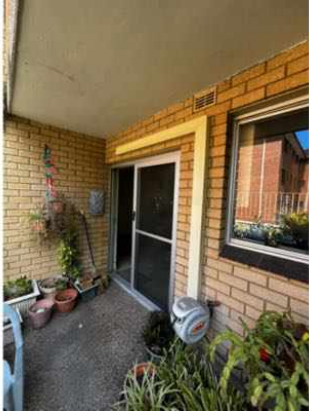
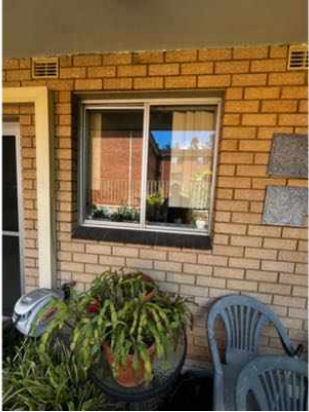
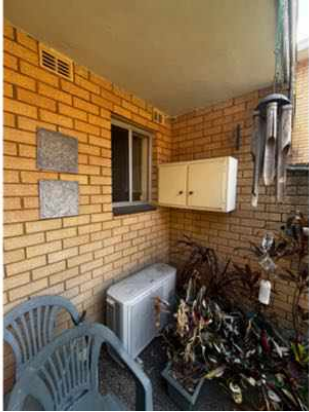
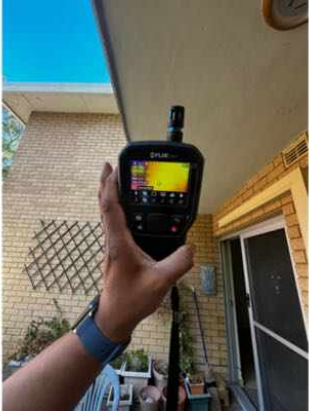
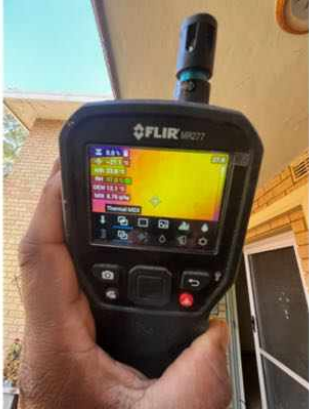
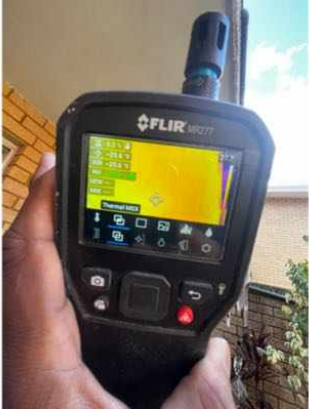
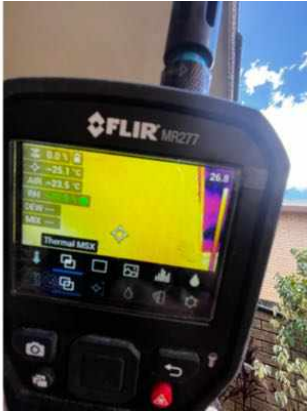
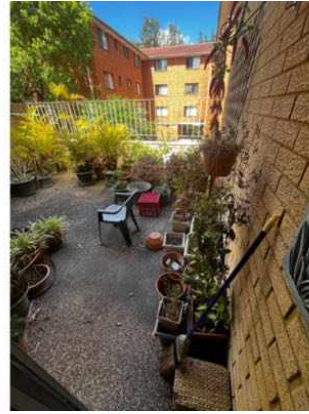
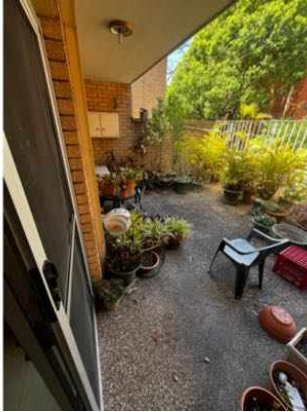
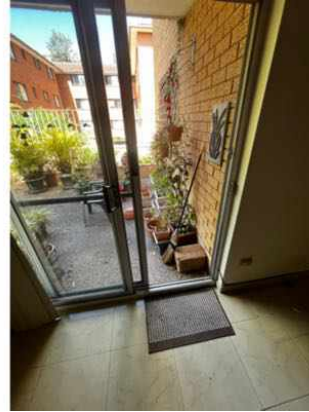
Defects 3.02

Building:	Main Building
Location:	Main Balcony
Finding:	Balcony - Floor
Information:	Upon Inspection The gradients of the Balcony floor levels are checked and found decrease in many points in floor gradient.

During the time of inspection it was evident that the balcony floor needs to be grouted and epoxy silicone sealed in the edges suitable for exterior use, This defect is quite common, and is suspected to have been caused by moisture permeating or leaching through the grouting and sealant in this area, which shows evidence of grout penetration.

The area being exposed to different weather is also a Cause for the grout/ silicone to dry up. Regular maintenance and replacement of damage or missing or damaged sealant and grout is highly recommended to the wet areas, as this is a regular wear and tear defect. Sealant and grouting in areas that come into regular contact with water should be maintained for the long term care of your property.

Suggest to always keep the area clear of rubbish and leaves, for the free flow of water/ rainwater to go through the downpipes.

A sealant specialist or tiling contractor should be appointed to complete these works

as soon as possible.

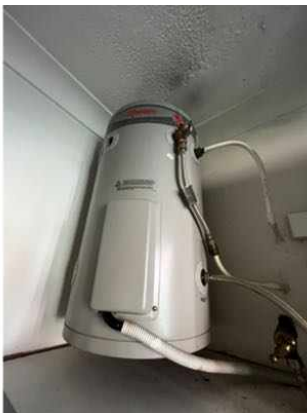
Defects 3.03

Building: Main Building
 Location: Laundry
 Finding: Hot Water Unit
 Information: The Hot Water Unit could not be inspected as there was no power at the property.

Water pressure appears to be normal, however, this is not an opinion of a licensed plumber. No water hammer was noted when taps are turned off fast.

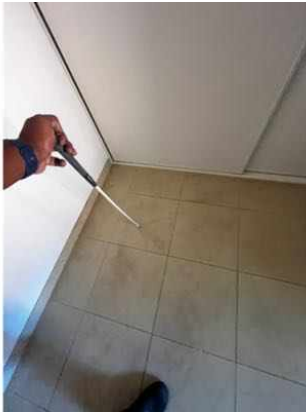
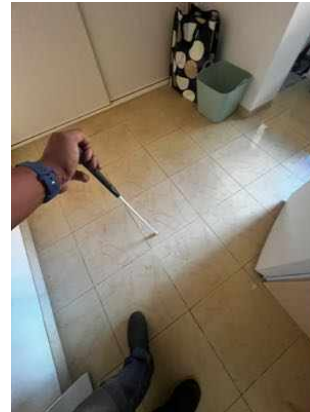
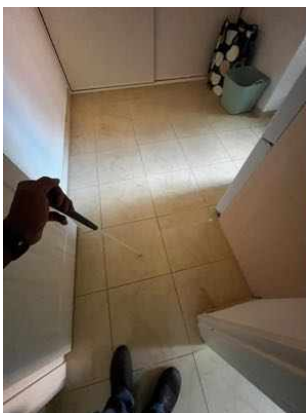
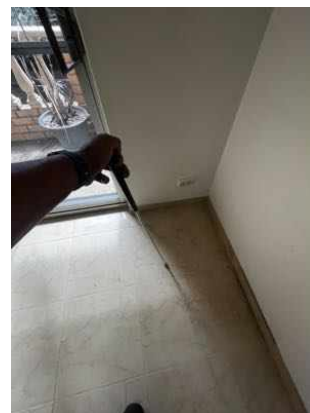
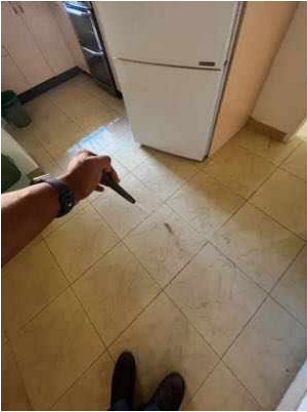
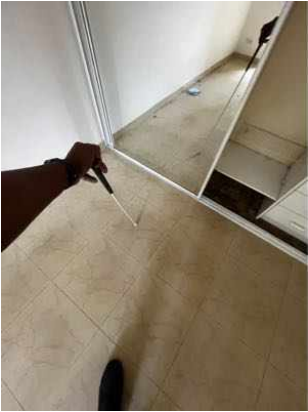
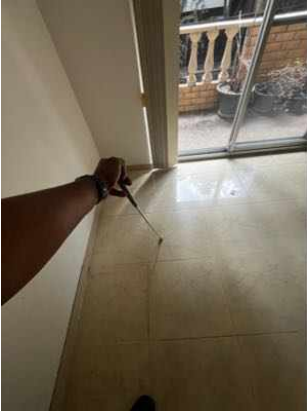
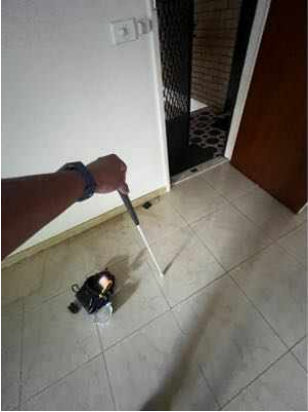
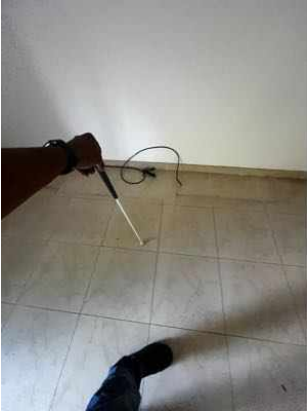
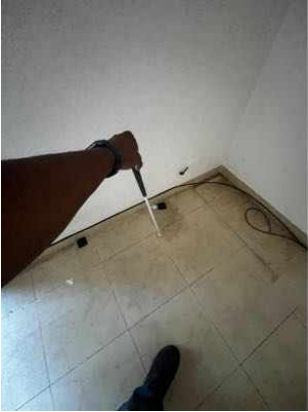
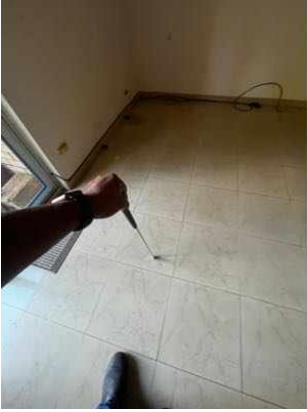
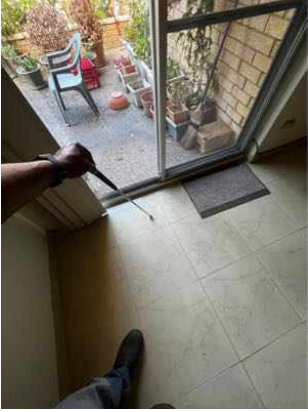
Defects 3.04

Building: Main Building
Location: Kitchen/ Lounge
Finding: Tiles - Drummy
Information: Drummy tiled areas were identified at the time of inspection. The term 'drummy' refers to tiles that have become detached from their fixing, despite otherwise being in relatively good condition. Such defects are generally caused by physical or moisture damage to the area. Drummy tiled areas may also be a direct result of poor workmanship during the construction process.

Tiled areas may swell and shrink with changes in air humidity if the area has sustained moisture damage. Any exposure to moisture is capable of causing tiled areas to become drummy and/or cracked over a prolonged period of time. Drummy tiled areas generally require removal and replacement of affected tiles, with adequate sealant and grouting.

Specialist trades are available for these types of services. A registered builder may be required to undertake works if damage is extensive or if secondary building defects have resulted. Otherwise, it is advised that a tiling contractor be appointed to perform works as necessary. Immediate action is recommended to ensure that no further damage is sustained in the affected area.

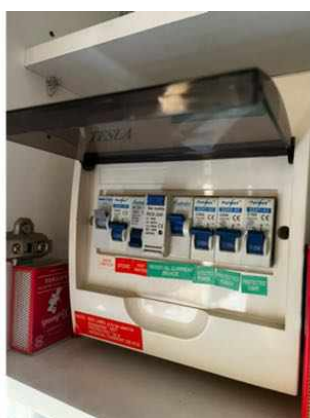
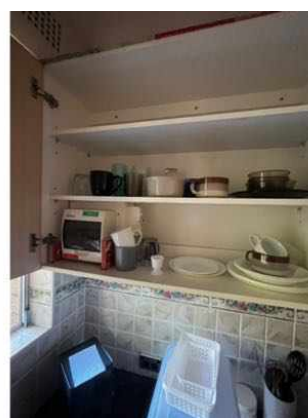
Noted Item

Building: Main Building
 Location: Electrical Switchboard
 Finding: Electrical Sub board
 Information: Upon Inspection there was no power at the property.

It is highly advised to the buyer to consult a Licensed Electrician to check the reason for no power at the property.
