# Building and Timber Pest Inspection Report

Inspection Date: Wed, 1 Apr 2026

Property Address: 76 Firetail St, South Nowra NSW 2541, Australia

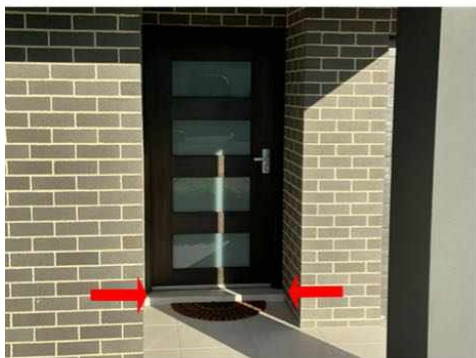
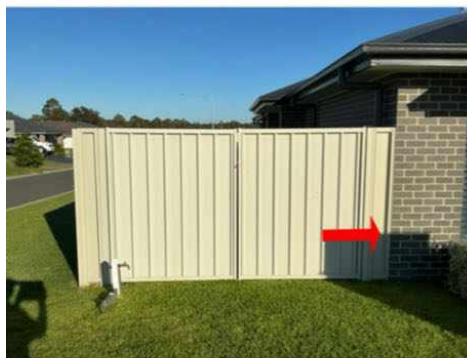
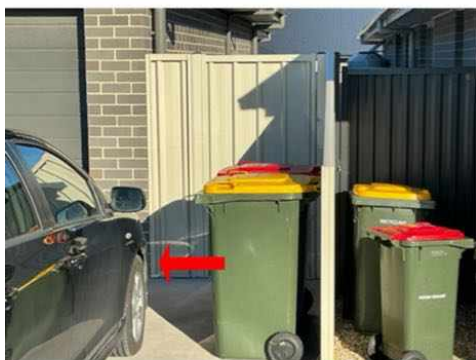
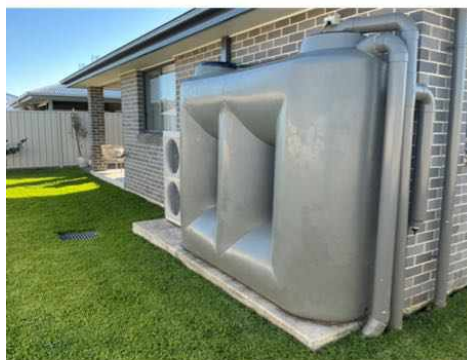
### Finding 6.01

Building:	Main Building
Location:	All Areas
Finding:	Bridging of Termite Management System
Information:	Bridging of termite management system occurs when a termite management system or inspection zone are covered by exterior objects where termites can enter a structure undetected. Due to the bridging this property it is considered High Risk for concealed termite ingress which should be treated and inspected every 6-12 months.

Generally this takes the form of finished ground levels external paving, concrete, fencing posts, gardens, vegetation, plumbing, stored items etc being retrospectively installed above the ant cap level or weep and ventilation holes.

Where bridging of the termite management system has occurred full inspection is prevented and termites may enter a property in a concealed or undetectable manner.

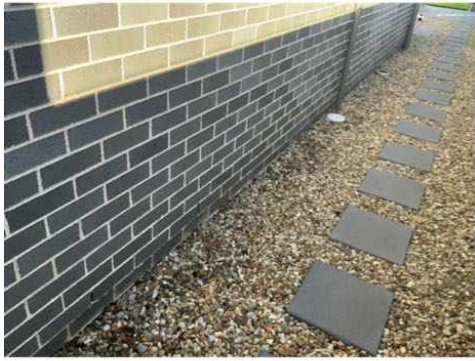
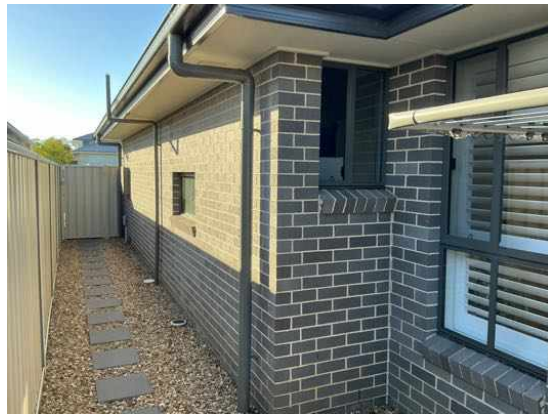
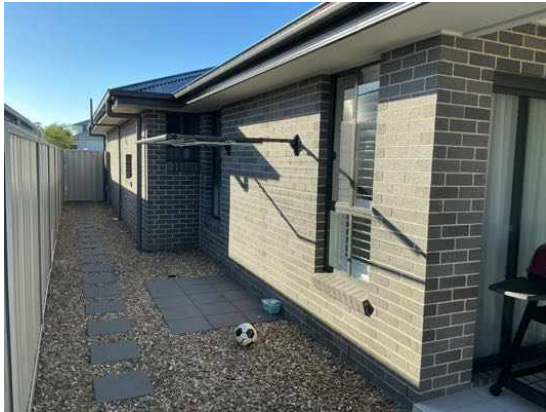
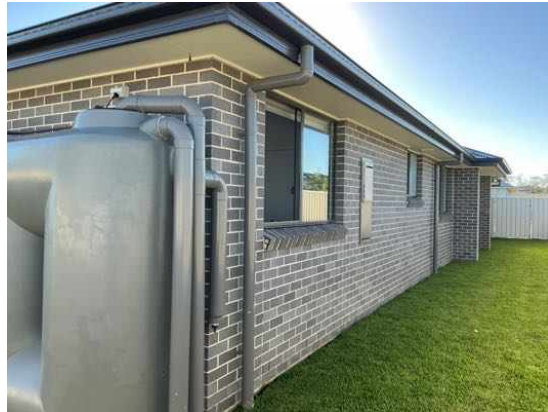
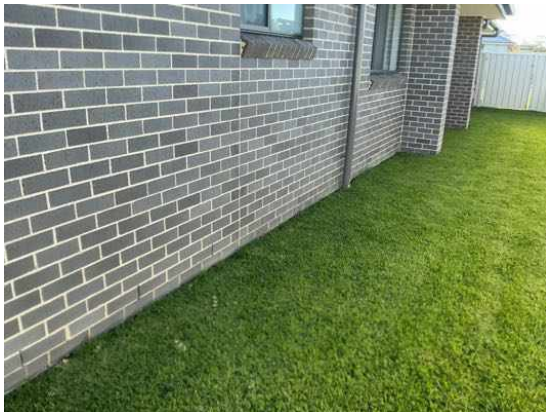
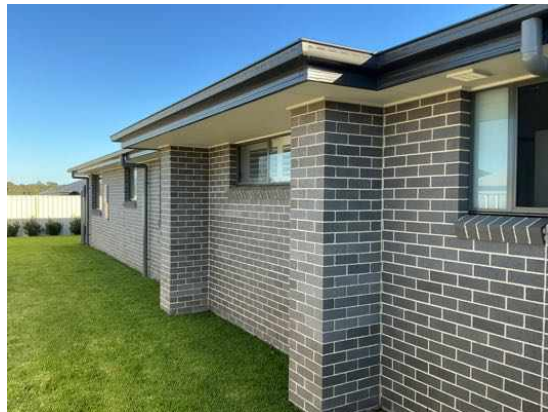
## Finding 6.02

Building:	Main Building
Location:	External Walls
Finding:	Slab Edge - Exposure
Information:	An inspection zone of at least 75mm in relation to the exposed slab edge, between the bottom brick and the perimeter pavement, is required. This inspection zone should be maintained in order to force termites into the open where they can be detected more readily during regular inspections. The slab edge should not be concealed by anything that may prevent inspection of the area, including render, landscaping, soil, turf, paving, concrete cladding or other structures.

If the slab edge is not properly exposed there is a high risk of termite attack. Sometimes, in order to determine the type of slab, a suitably qualified person such as an architect or builder may be required to consult the construction plans.

Where the slab edge cannot be properly inspected, it is highly recommended that termite or timber pest inspections be carried out every 6-12 months to aid protection of the property against infestation.

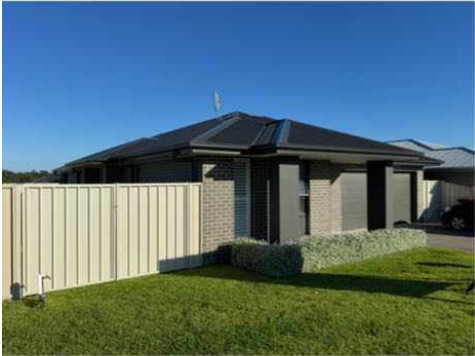
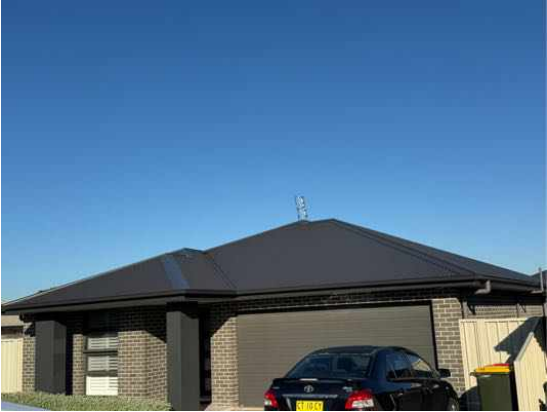
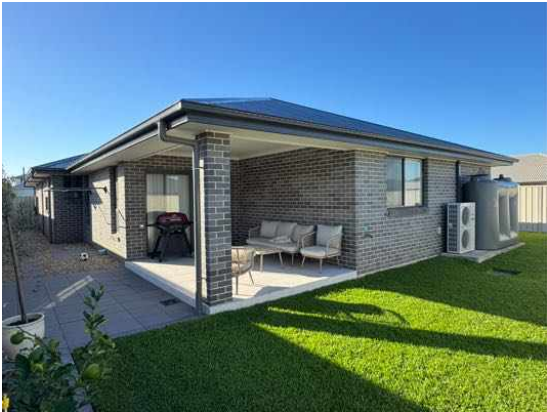
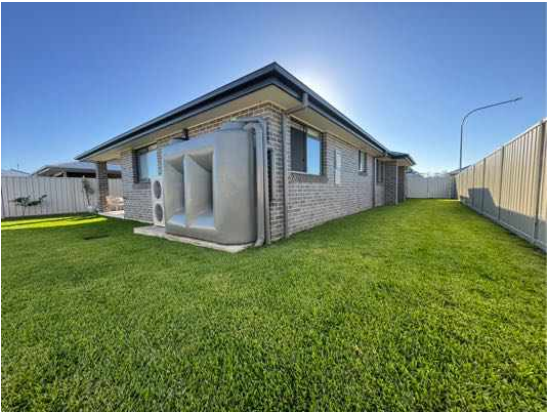
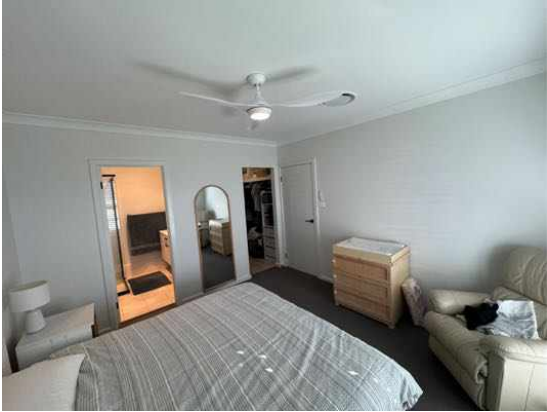
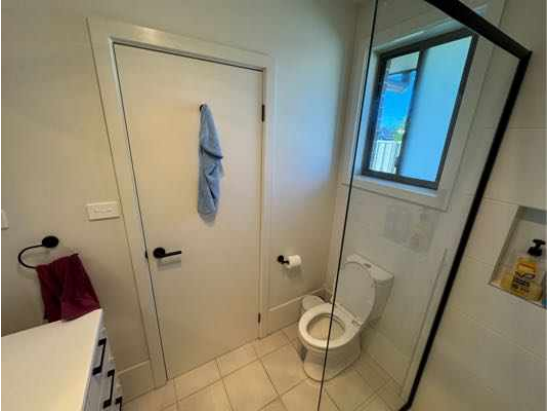
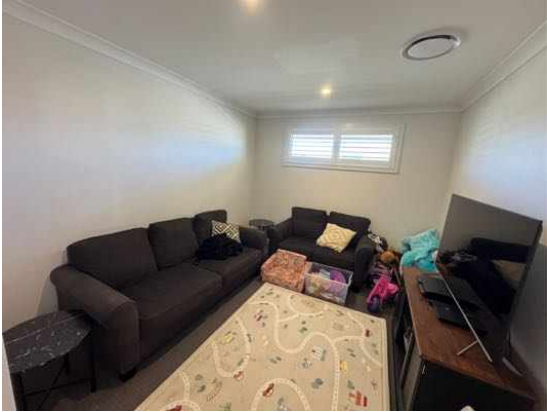
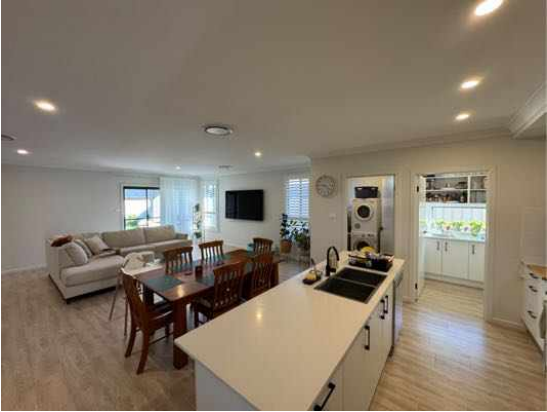
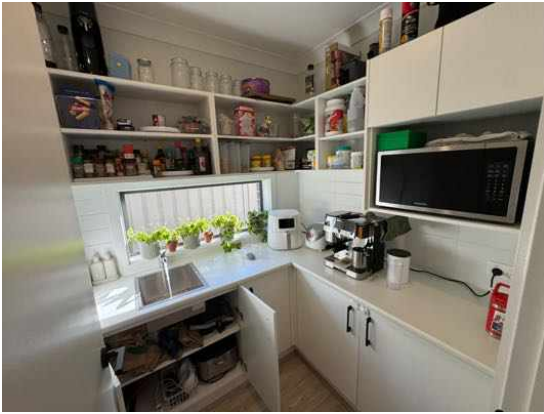
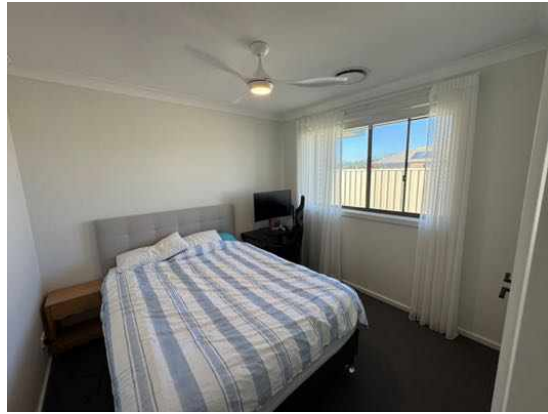
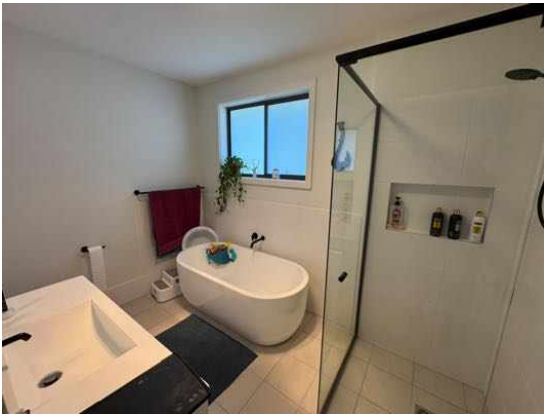
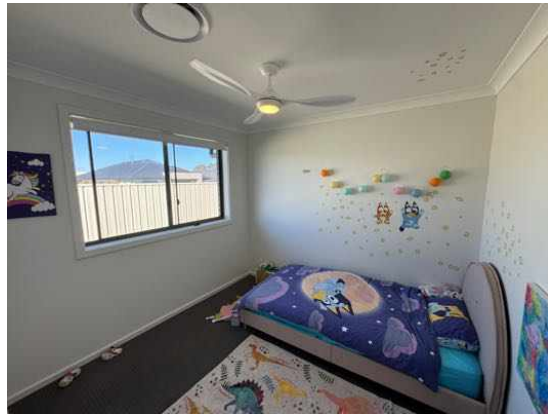
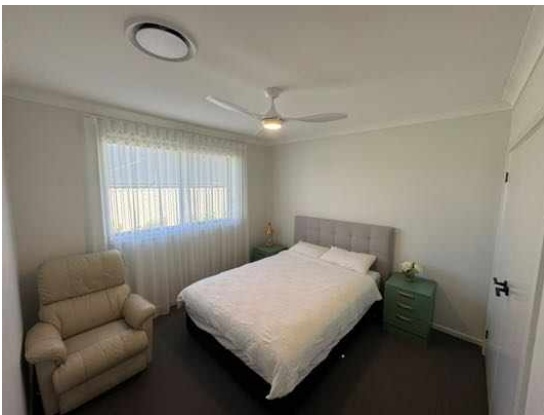
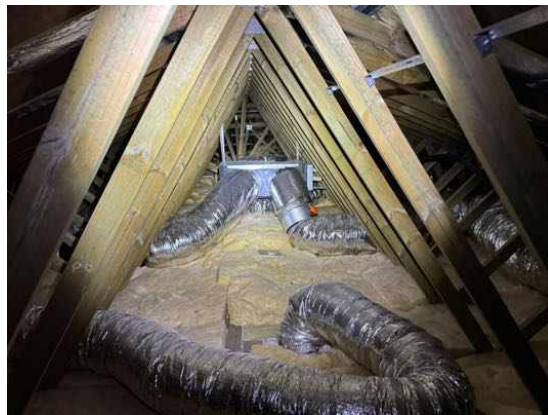
#### Noted Item

Building: Main Building  
 Location: All Areas  
 Finding: Additional Photos - Obstructions and Limitations  
 Information: These photographs are an indication of the obstructions and limitations which impeded full inspection of the property at the time of inspection. These obstructions can hide an array of defects and should be removed to allow full inspection to be carried out. A re-inspection is recommended once the areas are made accessible.

A further invasive inspection is recommended to these areas immediately.

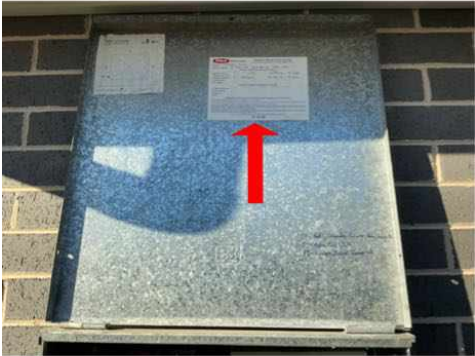
### Noted Item

Building:	Main Building
Location:	Meter Box
Finding:	Evidence of a previous termite management system was identified
Information:	There are a number of factors which indicate the presence of a previously installed or applied termite barrier. The most common are a durable notice (to the inside of your

meter box) observable physical barriers installed to building perimeter and in ground reticulation systems. Flick 131 440 installed their product on 4/4/23.

Flick Anticimex		TERMITE PROTECTION NOTICE	
In accordance with BCA 1.1.3 & AS 3660.1:2014			
BUILDER	Amsterton Homes	South Nowra	2561 NSW
PROPERTY ADDRESS	76 Firehailg		
PHYSICAL TERMITE MANAGEMENT SYSTEMS			
SLAB PENETRATION	<input checked="" type="checkbox"/>	corners	16/3/23 50 years
CONSTRUCTION JOINTS	<input type="checkbox"/>		
EXTERNAL PERIMETER	<input checked="" type="checkbox"/>	Spilcoquid	4/4/23 50 years
RETAINING WALL	<input type="checkbox"/>		
ANT CAPPING	<input type="checkbox"/>		
CHEMICAL TERMITE MANAGEMENT SYSTEMS			
EXTERNAL PERIMETER	<input type="checkbox"/>		
SUB FLOOR AREA	<input type="checkbox"/>		
UNDER SLAB	<input type="checkbox"/>		
OTHER	<input type="checkbox"/>		
<p><b>WARNING: To the owner of the building about inspection and maintenance</b></p> <p>This termite management system needs to be maintained on a regular basis. The Australian Standard for termite protection (AS3660.1) recommends regular, competent INSPECTIONS of the building for termite activity at least every twelve months, or high termite risk areas more frequent inspections may be required as defined by your inspector. It is needed to ensure that any termite have not brought or breached the system and may render the structure liable to termite attack. Do not be careless parties or make any alterations or additions (including porches, awnings, verandahs etc) adjacent to the protected areas until the installing company has been notified. Additional treatment may be required in these areas. Failure to have additional treatment will compromise the effectiveness of the management system and any warranty offered.</p> <p><b>ADDITIONAL WARNING:</b> Failure to have annual inspections may void the warranty obligations of the builder and the installing company will not provide a warranty to a building inspected or treated by another party.</p> <p>Ensure you ring Flick Anticimex to arrange your regular follow-up inspection.</p>

Where a Termite Management System has been identified you should refer to the type of barrier date of installation warranty conditions and any documentation provided by a builder or past owner. Consult the company who installed the barrier to confirm whether the system is still under warranty.
