Building and Timber Pest Inspection Report

Inspection Date: Tue, 17 Mar 2026

Property Address: 58 Faulconbridge St, The Ponds NSW 2769, Australia

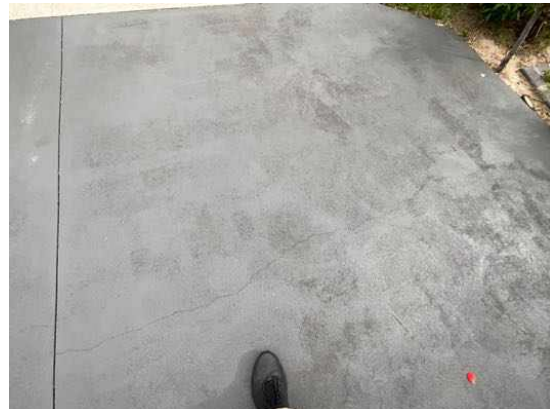
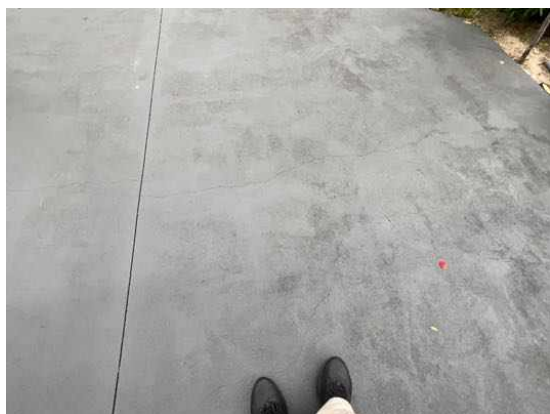
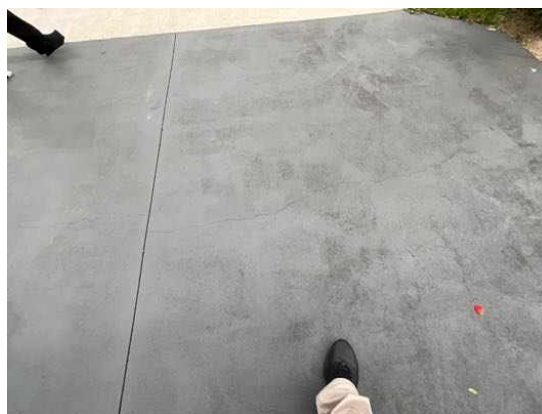
Building: Main Building
Location: All Areas
Finding: Crack in concrete slab - Category 0
Information: A crack coded as Category 0 was identified in the slab. A Category 0 crack is described as a hairline crack, representing insignificant movement of slab from level.

The approximate width of the crack to be considered Category 0 is 0.3mm, or change in offset of less than 8mm when a 3m straight edge is placed over the defect.

No rectification is required at this time. However, all cracking should be monitored over a 12 month period to identify any further damage in the area.

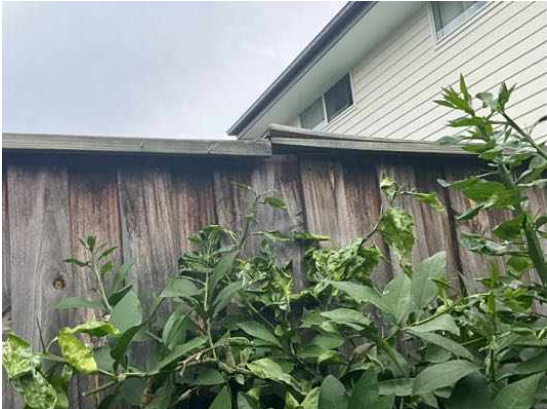
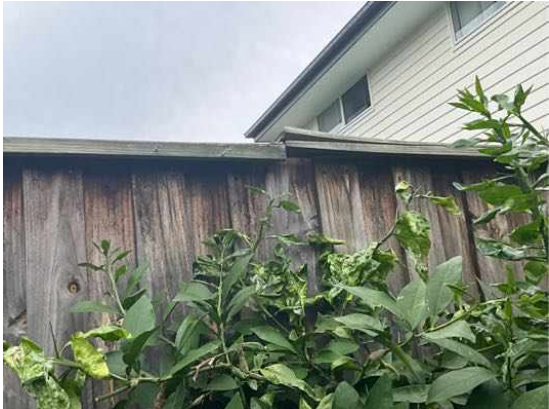
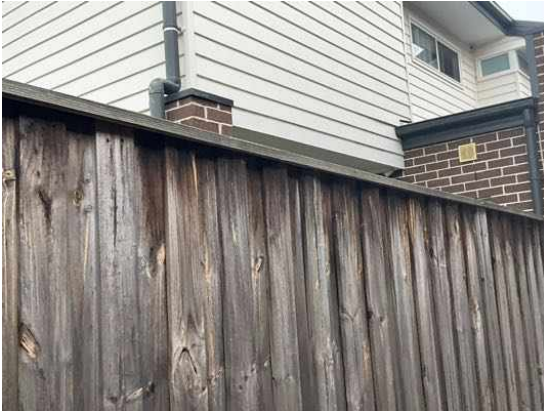
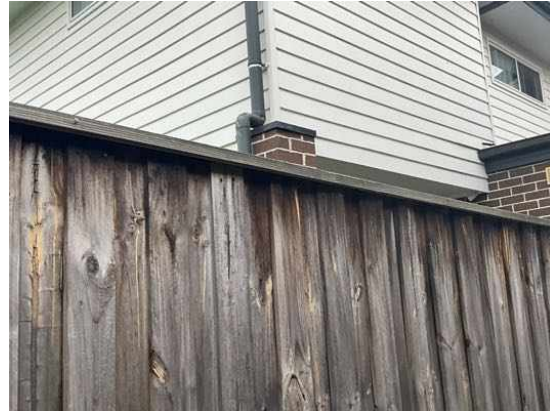
Finding 3.02

Building:	Main Building
Location:	All Areas
Finding:	Deteriorated fence
Information:	The fence along the property boundary has deteriorated significantly, showing signs of rot, rust, and structural weakness. Several sections are leaning or have become detached, compromising the integrity of the fence and its ability to perform its intended function.

The deteriorated fence poses multiple risks:

1. ****Safety Hazard:**** The unstable fence may collapse, posing a risk of injury to residents, visitors, and passersby.
2. ****Security Concern:**** The compromised fence may allow unauthorized access to the property, increasing the risk of theft, vandalism, or trespassing.
3. ****Property Damage:**** Falling sections of the fence could damage nearby structures, plants, or other property features.

- ****Licensed Fencing Contractor:**** A professional fencing contractor should be hired to assess the extent of the damage and either repair or replace the deteriorated sections.
- ****Handyman Services:**** For minor repairs, a qualified handyman could be engaged to reinforce or repair specific sections of the fence.
- ****Landscaper (if the fence is part of a larger garden feature):**** If the fence is integrated into the landscape design, a landscaper with experience in fencing could be involved in the repair or replacement process.

It's important to ensure that whoever is hired is experienced and qualified to ensure the fence is restored to a safe and functional condition, compliant with local regulations.

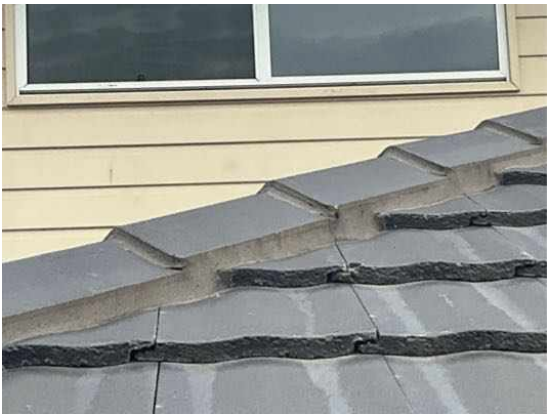
Finding 3.03

Information: Inspection of the roof revealed widespread weathering to the tiled roof surface. The tiles show loss of surface finish, colour fading, and age-related deterioration typical of older roof coverings. Although no significant cracking was noted, weathering can lead to increased porosity, reduced water-shedding capability, and a higher risk of future cracking or displacement during adverse weather conditions.

A licensed roofer should be engaged to undertake a closer inspection, carry out routine maintenance, and replace any tiles that may be compromised. Ongoing monitoring is recommended due to the age and condition of the roof covering.

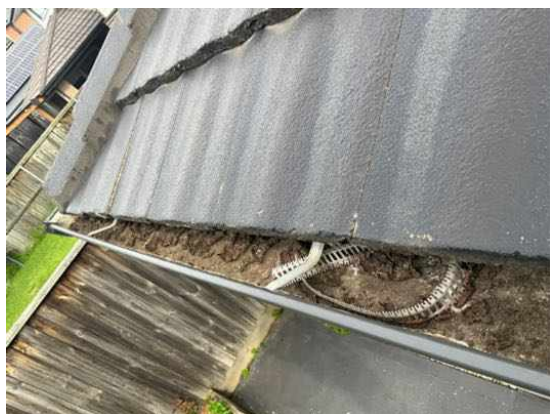
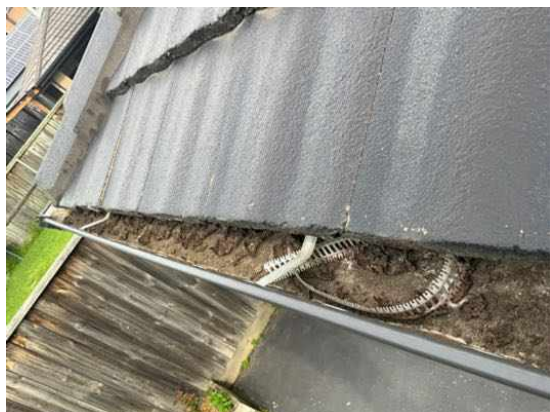
Finding 3.04

Building: Main Building
Location: Roof Exterior
Finding: Blocked Gutters
Information: Blocked gutters , advised gutter to be cleaned.

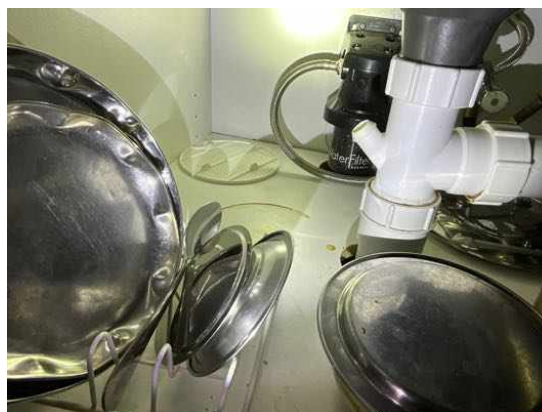
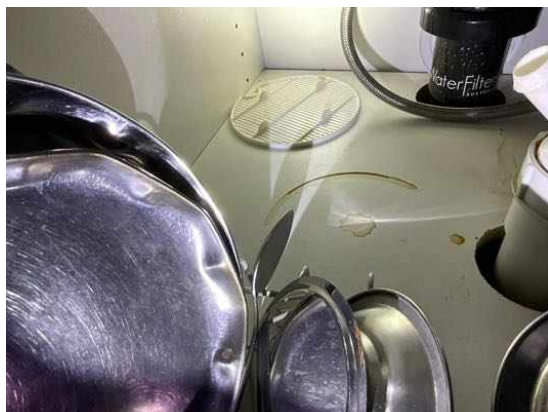
Finding 3.05

Building:	Main Building
Location:	Kitchen
Finding:	Water damage / Vanity
Information:	"The vanity in the shower area has sustained water damage, resulting in swelling and discoloration of the wood, as well as potential structural issues. This damage compromises both the aesthetic and functional aspects of the vanity."

1. **Carpenter or Woodworker:** They can assess and repair the damage to the vanity, potentially replacing any irreparable parts.
2. **Plumber:** If the water damage is due to plumbing issues, a plumber can fix leaks and ensure there are no further water-related problems.
3. **General Contractor:** If the damage is extensive and affects the surrounding area, a general contractor can coordinate the repair work, including both the vanity and any related structural or cosmetic repairs.

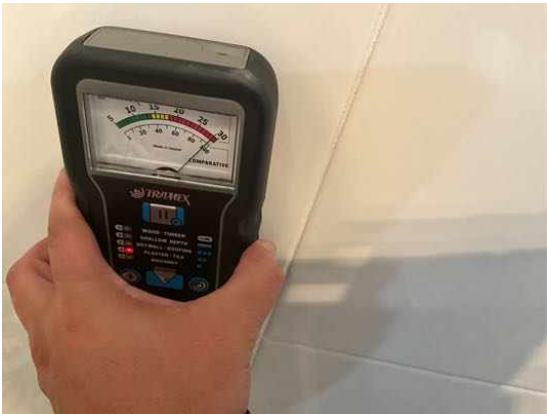
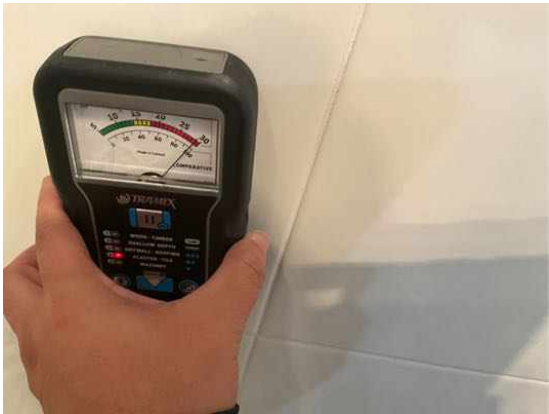
Building:	Main Building
Location:	Bathroom downstairs
Finding:	Shower - Damp
Information:	Damp is evident to the lower 300mm of wall to the shower alcove. This defect is quite common, and is suspected to have been caused by moisture permeating through the grouting in this area, which shows evidence of deterioration. Leaking pipes within the adjoining wall is also a possible cause.

Unmanaged damp in the shower recess is likely to facilitate the formation and development of mould and fungi growth, decaying associated building materials and compromising their structural integrity. It is important to address damp conditions, as the World Health Organisation notes that excess moisture leads - on almost all indoor materials - to growth of microbes such as moulds, fungi and bacteria, which subsequently emit spores and other matter into the indoor air. Exposure to these contaminants is associated with a wide range of respiratory and other health-related problems.

Consultation with a qualified plumber or bathroom specialist is advised immediately to identify the cause of damp and to perform remedial works as required. Where excessive mould growth is present, further inspection by a specialist environmental health inspector should also be considered.

Always ensure that sealant and grout is in good condition to prevent any moisture issues occurring in the future.

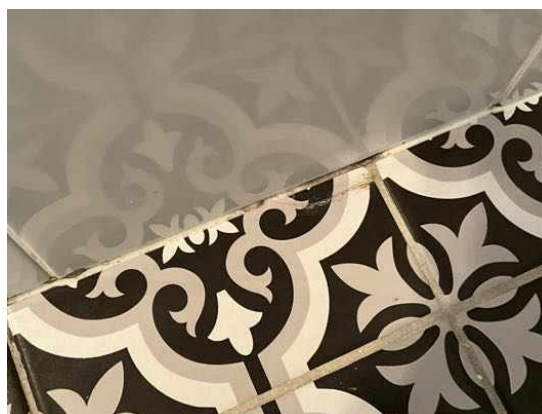
Finding 3.08

Finding:	Tiles - Cracked or damaged
Information:	Cracking was evident to the tiling in this area at the time of inspection. While the cracking appears to be minor, this area is frequently exposed to water, allowing potential for water penetration into adjoining sections of walls or flooring. If left unmanaged, water penetration to these areas may lead to subsequent water damage, which is likely necessitate repair work to affected building elements. A tiling contractor should be appointed to ensure that no further water damage occurs. The re-application of silicone and grouting throughout remaining tile work is also advised, to further protect the area against water penetration. Where water penetration has led to water damage, appointment of a relevant tradesperson may be required to repair damaged building elements.

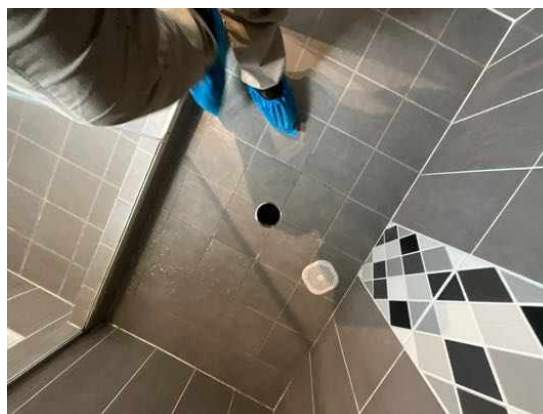
Building:	Main Building
Location:	Ensuite
Finding:	Floor waste drain cover missing
Information:	The floor waste drain cover in the bathroom is missing, exposing the open pipe and surrounding debris. Accumulated hair and organic matter are visible, indicating poor maintenance and posing hygiene concerns.

- **Injury Hazard:** The open drain presents a risk of foot injury, especially in a wet environment.
- **Health & Hygiene:** Unsealed drains can emit foul odours and allow pests or gases to enter from the sewer system.
- **Drainage Issues:** Loose debris or hair may obstruct water flow, leading to blockages or slow drainage.

- **Licensed Plumber:** To clean and clear the drain and install a compliant, sealed floor waste cover to prevent recurrence.
- **Handyman (for minor cleaning and cover replacement only):** If no deeper plumbing or sealing issues exist.

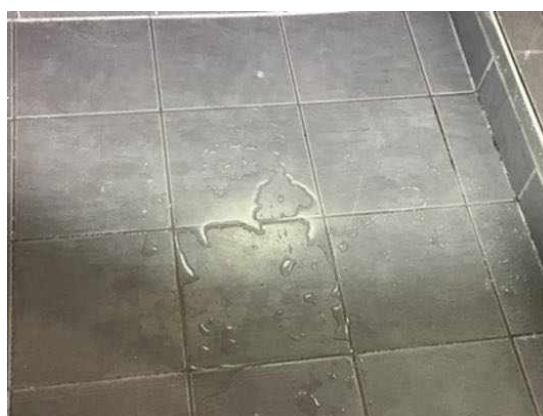
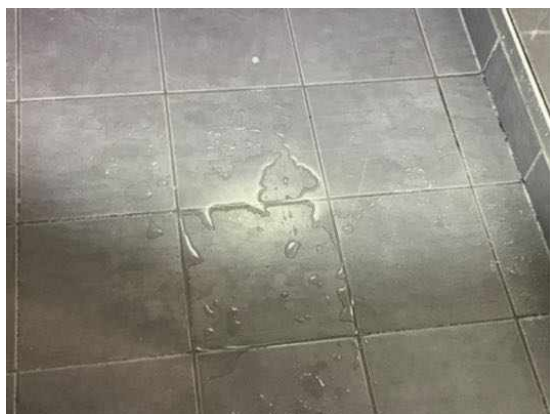
Finding 3.12

Building:	Main Building
Location:	Ensuite
Finding:	Shower base - Water pooling
Information:	Evidence of water pooling around the floor waste in the shower recess was noticed at the time of inspection. It is suspected that this excessive moisture is attributed to insufficient fall in the shower floor tiles.

This pooling is minor overall but is still considered unsatisfactory, as standard tiling practices would not permit this situation to occur. Pooling water around floor wastes can create a slip hazard in extreme cases and create conditions that are conducive to mould growth over time. Where left unmanaged, the degradation of sealant and grouting is also likely to occur, possibly necessitating further repair works.

Remedial works may involve some sections of tiling and flooring repair and replacement. A tiling contractor or bathroom specialist should be appointed to provide further advice on reparation options and to perform works as necessary.

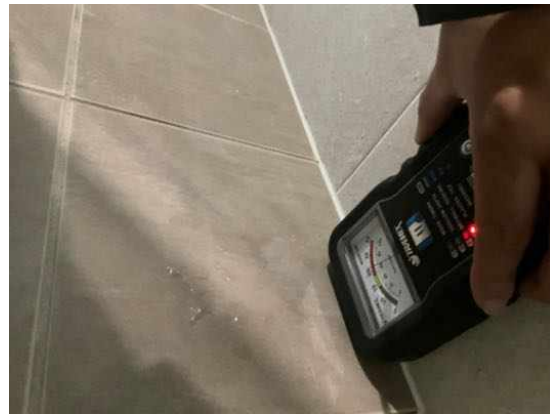
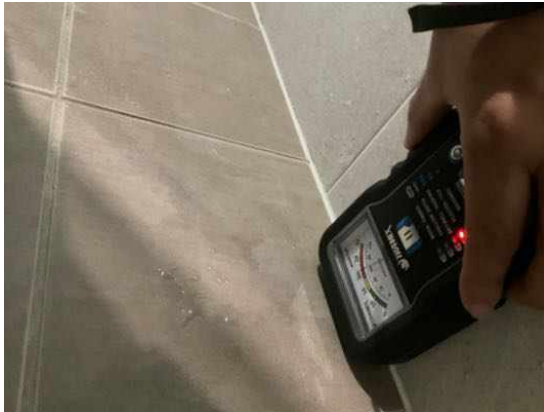
Finding 3.13

Building:	Main Building
Location:	Bathroom upstairs
Finding:	Shower - Damp
Information:	Damp is evident to the lower 300mm of wall to the shower alcove. This defect is quite common, and is suspected to have been caused by moisture permeating through the grouting in this area, which shows evidence of deterioration. Leaking pipes within the adjoining wall is also a possible cause.

Unmanaged damp in the shower recess is likely to facilitate the formation and development of mould and fungi growth, decaying associated building materials and compromising their structural integrity. It is important to address damp conditions, as the World Health Organisation notes that excess moisture leads - on almost all indoor materials - to growth of microbes such as moulds, fungi and bacteria, which subsequently emit spores and other matter into the indoor air. Exposure to these contaminants is associated with a wide range of respiratory and other health-related problems.

Consultation with a qualified plumber or bathroom specialist is advised immediately to identify the cause of damp and to perform remedial works as required. Where excessive mould growth is present, further inspection by a specialist environmental health inspector should also be considered.

Always ensure that sealant and grout is in good condition to prevent any moisture issues occurring in the future.

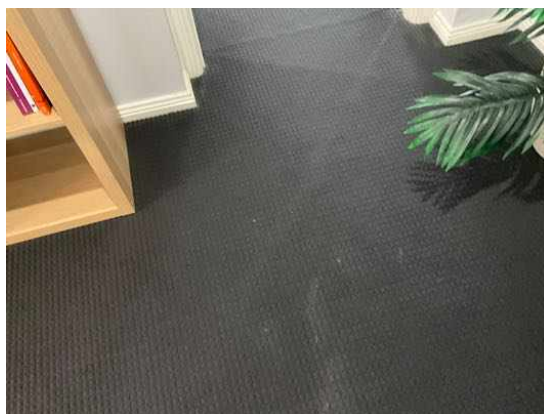
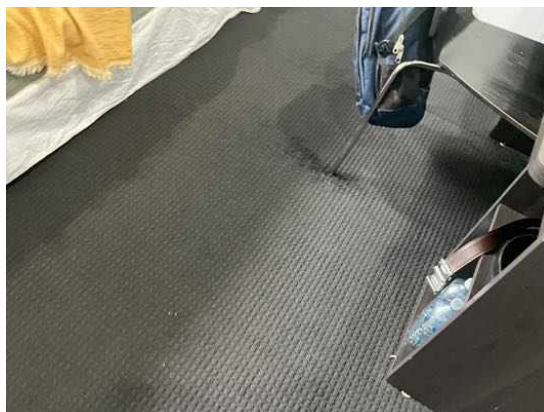
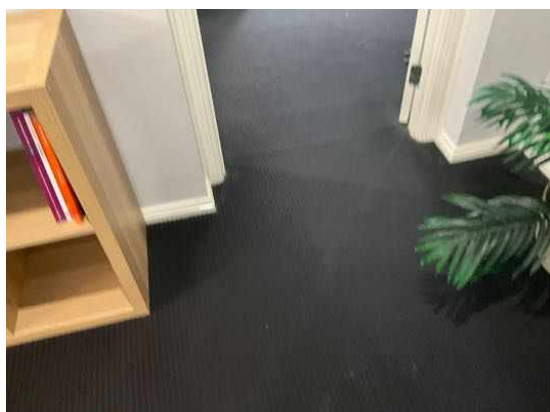
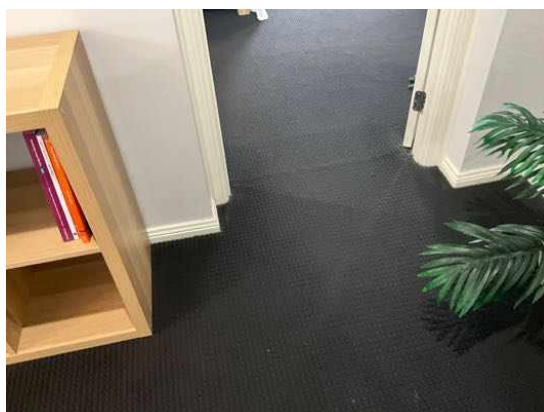
Finding 3.14

Building:	Main Building
Location:	All Areas
Finding:	carpet exhibits visible signs of aging
Information:	Carpets are exhibiting visible signs of aging, including fraying edges, faded colors, and flattened fibers, diminishing their aesthetic appeal and functional quality.

The risk associated with aging carpets includes diminished appearance, decreased comfort, potential tripping hazards due to frayed edges, and a negative impact on indoor air quality if fibers begin to degrade and release particles into the air.

Professional carpet cleaning and restoration services can address issues such as deep cleaning to rejuvenate colors, repairing frayed edges, and restoring fibers. Additionally, replacing the carpets entirely may be necessary in severe cases of aging or damage beyond repair.

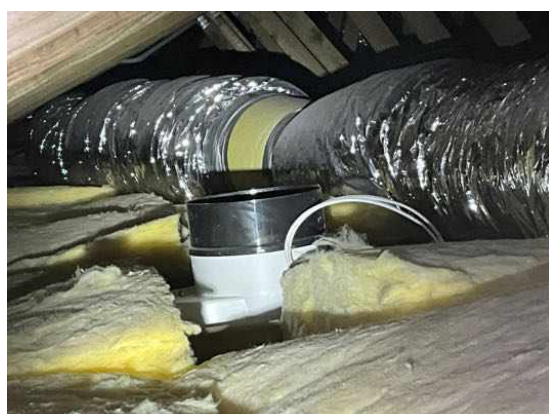
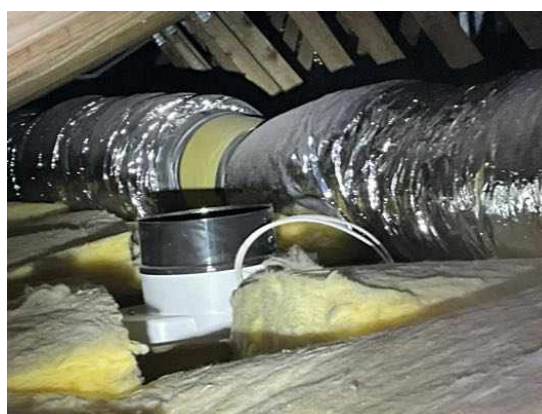
Finding 3.15

Information: The exhaust fan located within the roof void is not appropriately ducted to the external atmosphere and is currently discharging moist air directly into the roof space. This is considered a defect under AS 4349.1, as it does not meet the minimum standard of residential building performance expected under normal residential building practices.

This condition may lead to excessive condensation within the roof void, increasing the

risk of mould growth, deterioration of insulation, timber decay, and overall reduced durability of building elements. It may also result in poor indoor air quality, potentially affecting occupant health.

It is recommended that the exhaust fan be modified by a licensed HVAC contractor or qualified builder, ensuring it is properly ducted to discharge externally in accordance with manufacturer specifications, the National Construction Code (NCC), and applicable Australian Standards.

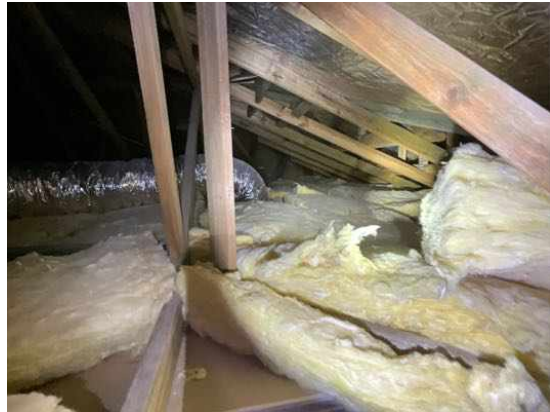
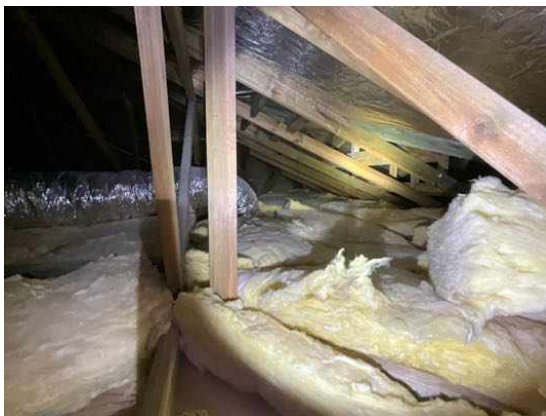
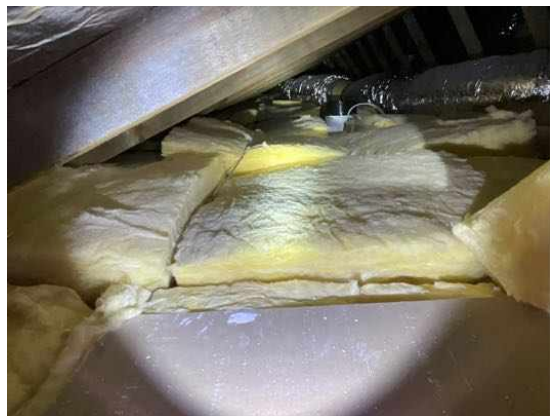
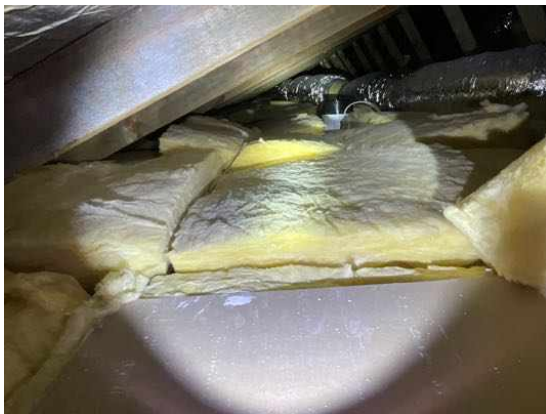
Finding 3.16

Building:	Main Building
Location:	Roof Void
Finding:	Insulation - Covering downlights
Information:	Sections of insulation in the roof void have been poorly installed or moved from their original position and are covering down light fittings. While the down lights have been fitted with appropriate protective covers, the presence of this insulation creates a potential fire hazard.

Any insulation within the vicinity of down light fixtures should be moved and re-applied to more appropriate sections of the roof void, thus ensuring the area is fire-safe. An insulation contractor should be appointed as soon as possible to perform any

necessary works as required.

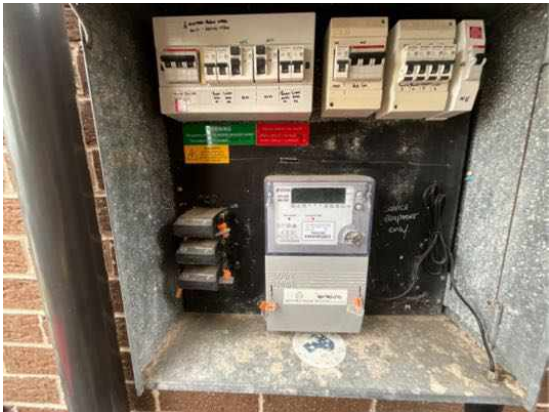
Building: Main Building
Location: Exterior walls - right side
Finding: No Evidence of Termite Management System - Durable notice / Legible Sticker
Information: The application of a pre & post-construction chemical termite barrier is highly recommended for all properties. Such barriers are highly effective in preventing termite attack on any timber building elements throughout the property.

A durable notice was not placed in the switchboard unit to indicate current termite barriers is legible at the time of inspection.

Client must seek further information from the vendor or real estate agent if the conditions of termite management systems were maintained.

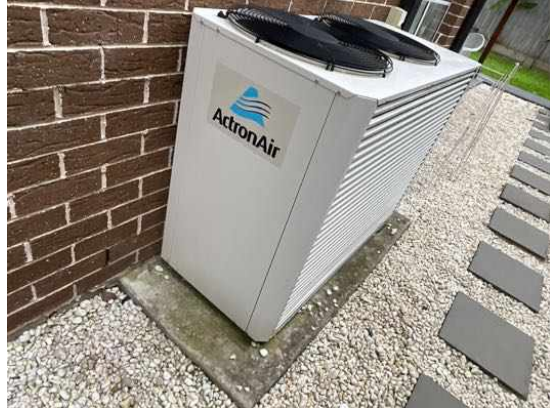
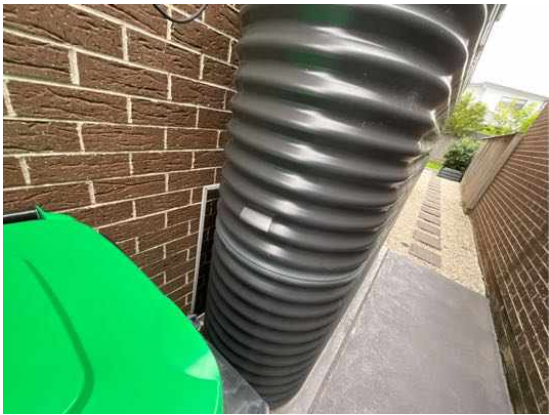
Finding 6.03

Building: Main Building
 Location: All Areas
 Finding: Bridging or Obstruction Conducive environment for Termites
 Information: Bridging of termite barriers occurs when termites bridge (usually by building a mud tunnel) a termite barrier or inspection zone or where termites have a passage, allowing them to bridge the barrier.

Recommended moving obstructions away from the external walls for further and future inspections.

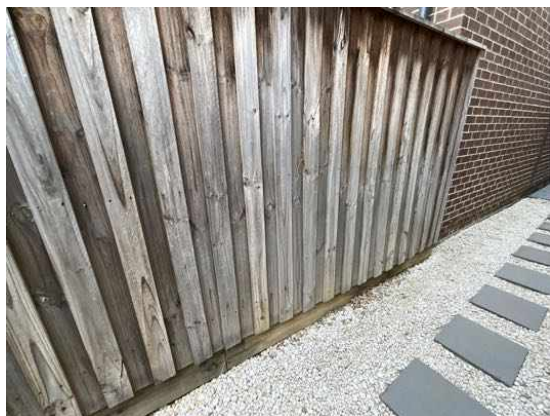
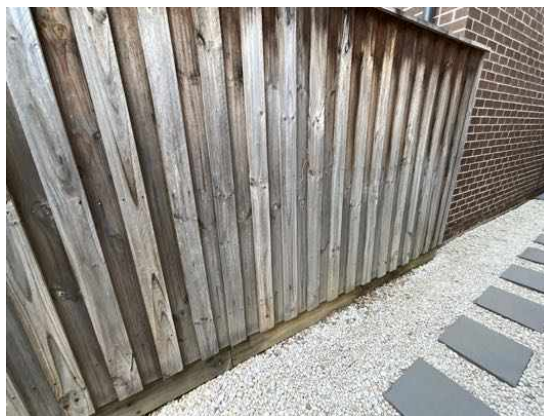
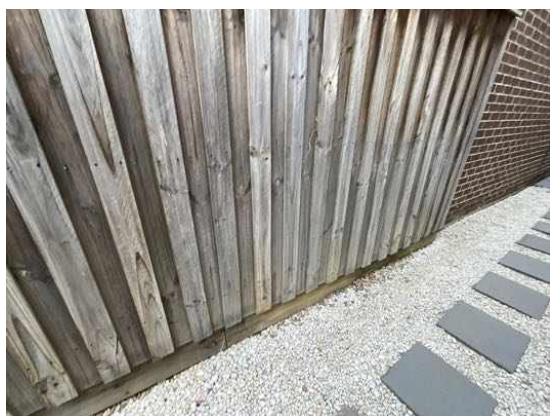
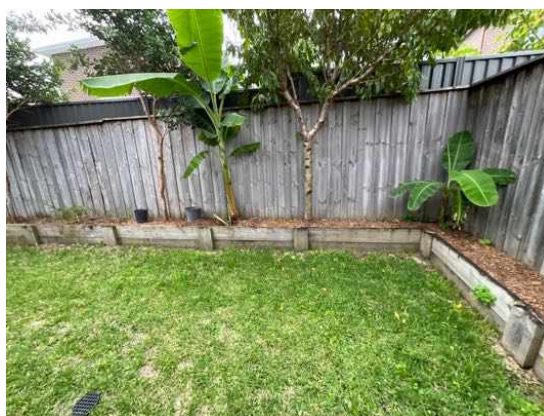
Finding 6.04

Building: Main Building
 Location: All Areas
 Finding: Timber on ground / conducive conditions to termite damage
 Information: Timber on the ground is indeed conducive to termite damage. Termites are known to thrive in moist environments, and wood in contact with soil or moisture is more susceptible to infestation.

To prevent this, it's important to keep timber elevated and away from direct ground contact. Regular inspections and proper termite control measures are also essential to protect your wooden structures from termite damage.

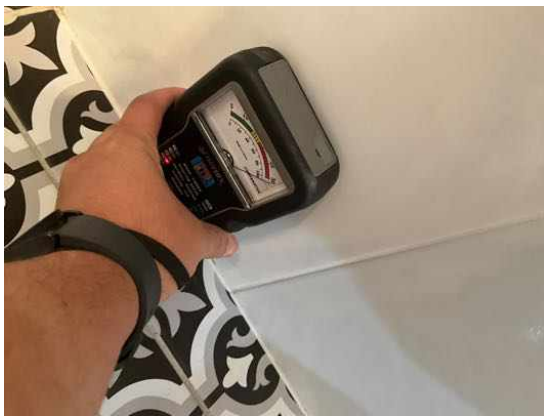
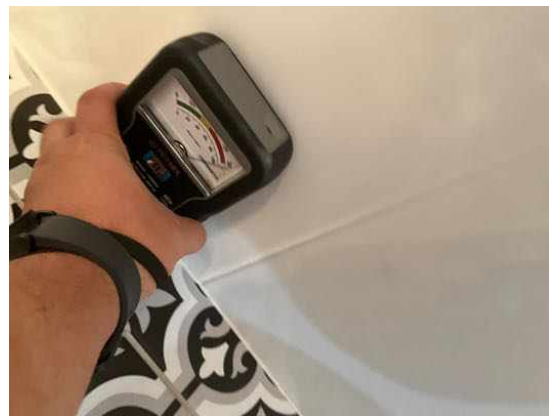
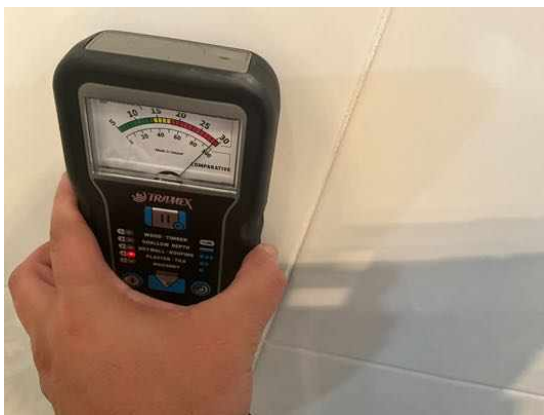
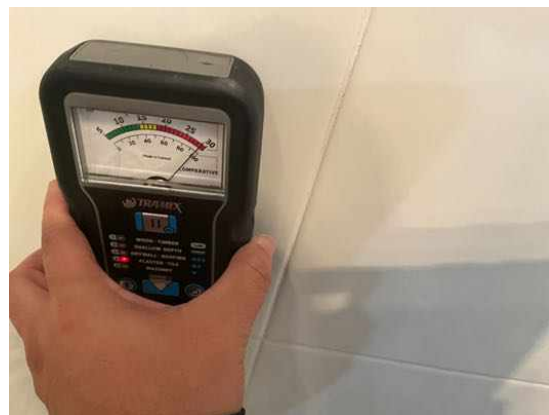
Building:	Main Building
Location:	Bathroom downstairs
Finding:	Excessive moisture - Conducive to Timber pest
Information:	Excessive moisture can attract termites and produce conditions that promote fungal growth and wood decay.

Excessive moisture is generally caused by deteriorated inadequate or missing roof drainage leaking plumbing pipes or fixtures poorly plumbed HWS overflows or condenser units and poor site drainage.

Prior to any remedial works being performed a qualified plumber should be appointed to further inspect the property and to identify the cause of the excessive moisture. Works to remove affected building elements may then be necessary and should be performed by an appropriate tradesperson.

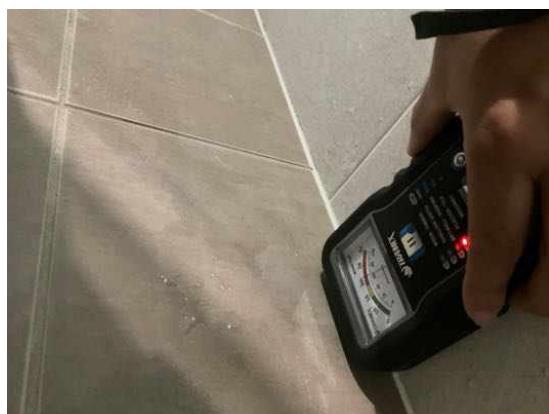
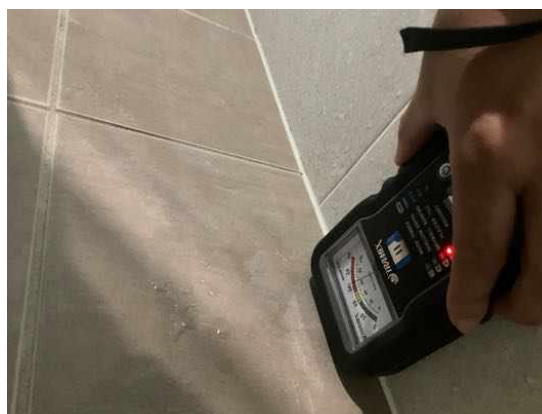
Finding 6.07

Building:	Main Building
Location:	Bathroom upstairs
Finding:	Excessive moisture - Conducive to Timber pest
Information:	Excessive moisture can attract termites and produce conditions that promote fungal growth and wood decay.

Excessive moisture is generally caused by deteriorated inadequate or missing roof drainage leaking plumbing pipes or fixtures poorly plumbed HWS overflows or condenser units and poor site drainage.

Prior to any remedial works being performed a qualified plumber should be appointed to further inspect the property and to identify the cause of the excessive moisture. Works to remove affected building elements may then be necessary and should be performed by an appropriate tradesperson.
