Building Inspection Report

Inspection Date: Fri, 30 Jan 2026

Property Address: 2/23 Wallace Ave, Toorak VIC 3142,
Australia

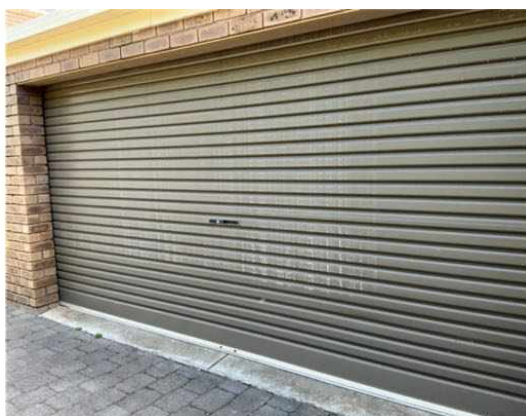
Defects 3.01

Building:	Garage
Location:	Front elevation
Finding:	Garage door - Superficial markings
Information:	The garage roller door has a number of marks and dents likely to have resulted from impact damage be it accidental or deliberate impact at sometime.

Garage roller doors can fail when the building materials have aged but may be indicative of impact damage (accidental or deliberate). While superficial markings detract from the aesthetics of the building element, the functionality has not been hindered in any way.

Repair and/or replacement of the two garage doors would improve the condition of the garage but certainly not an urgent item

A qualified roller door installer or supplier should be engaged to check out the operation and overall condition of the doors to determine if repair is an option otherwise replacement may need to be considered.

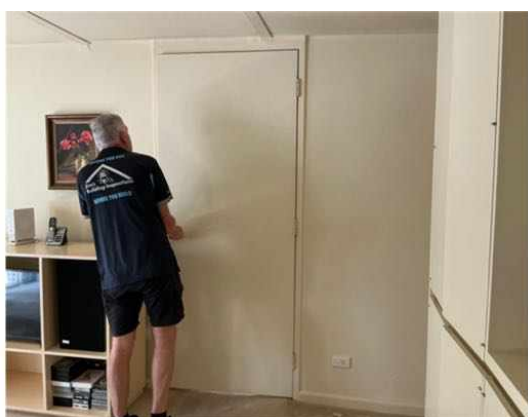
Defects 3.02

Building:	Main Building
Location:	Lounge Room
Finding:	Sticking or jamming
Information:	Building elements which are sticking or jamming are difficult to operate and don't function as intended. There are a variety of causes for sticking and jamming.

The most usual causes are swelling of timbers due to moisture, bulging or bowing of metal frames, or general material deterioration. Generally, sticking and jamming building elements indicate that their frames are uneven or out of level, generally as result of movement to surrounding walls and floors.

Easement will be required, which usually depends on the building materials used. This may involve some sanding and/or application of a lubricant. It will almost always include ensuring the areas are cleaned and free of any debris that may be detrimental to their operational state.

Appointment of a carpenter or general handyman is recommended to rectify any sticking/jamming building elements.

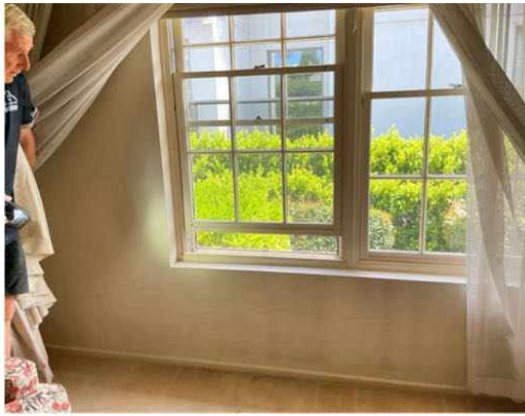
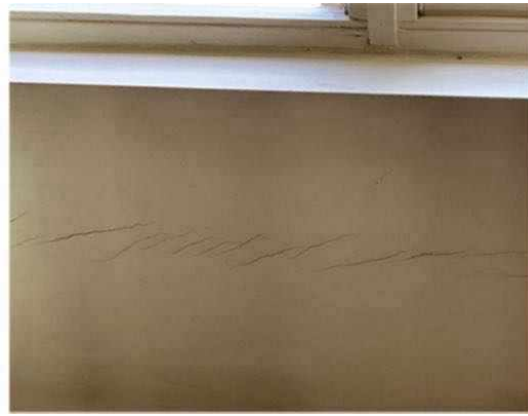
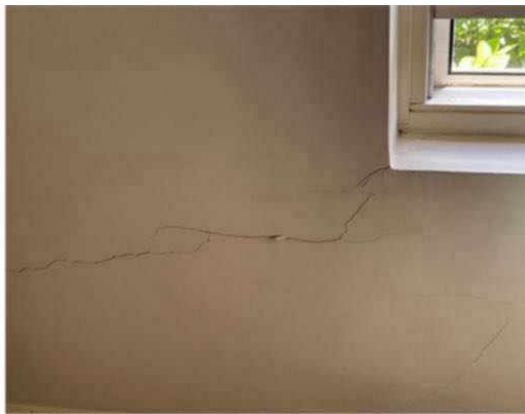
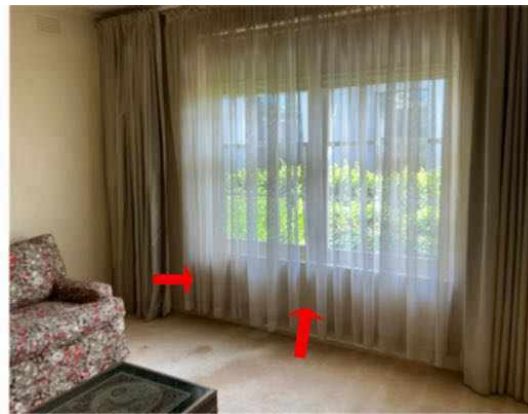
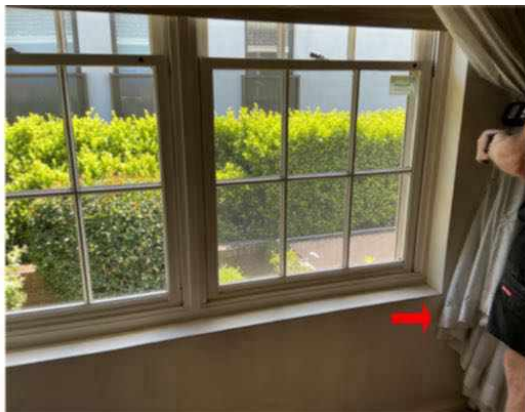
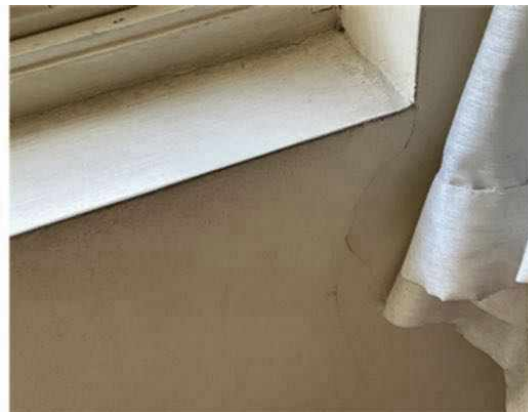
Defects 3.03

Building:	Main Building
Location:	Bedrooms
Finding:	Cracks to internal render - Category 2
Information:	It has been observed that cracking to internal rendered surfaces has occurred. The degree of damage falls within Category 2, described as noticeable cracks which are easily filled. Cracking of this size are generally less than 5mm in width.

Category 2 damage is required to be monitored for a period of 12 months. After the monitoring period, a crack rated at Category 2 or above is considered a defect requiring rectification.

Always contact your building inspector should cracks widen, lengthen, or become more numerous.

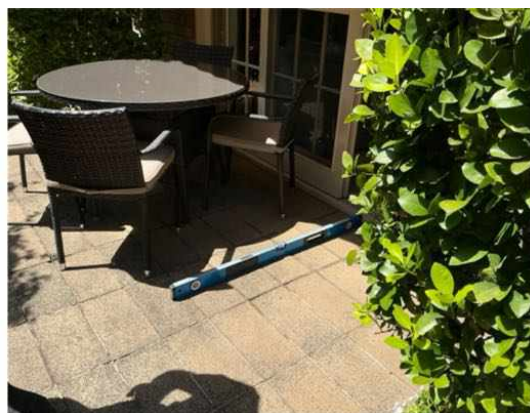
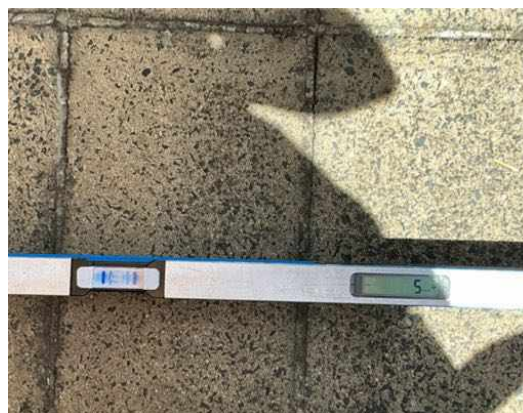
Defects 3.04

Building:	Main Building
Location:	Rear
Finding:	Perimeter Paving - Insufficient Fall
Information:	The perimeter paving or ground levels were found to have an inadequate slope away from the adjoining building structure, creating potential for water pooling in this area.

Perimeter paving is required to fall from the building by a minimum of 25mm in the first metre and bare ground should fall away from the house by 50mm in the first meter. This standard ensures that excessive moisture does not pool around the base of building structures, which creates potential for water and structural damage, as well

as making the area susceptible to termite and timber pest activity.

Where paving or ground levels do not have adequate fall, a licensed paving contractor should be appointed to install or remove and re-level pavement.

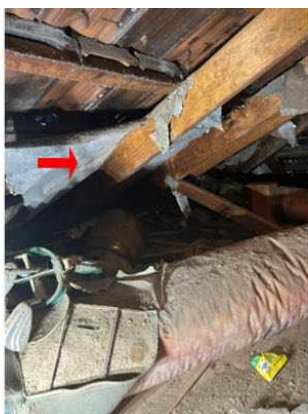
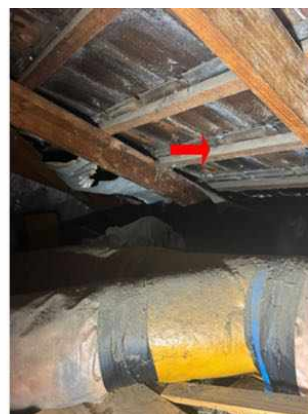
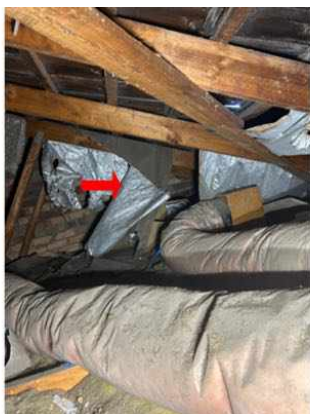
Defects 3.05

Building:	Main Building
Location:	All Areas
Finding:	Sarking - Damaged
Information:	Sarking, a laminated aluminium foil applied to the interior of the roof covering, assists in insulating the property and acting as a vapour-barrier to the roof void and, subsequently, to the household.

Where sarking is damaged, both insulation and moisture protection of the property are inhibited. This creates a loss of energy and thus negatively impacts the energy efficiency of the property, allowing potential for moisture ingress from condensation or leaking roof tiles.

It is important to repair any holes or damaged sections of sarking to ensure that the building material is fully functional. A registered builder or qualified carpenter should be consulted to provide further advice on this defect and to perform rectification works at client discretion.

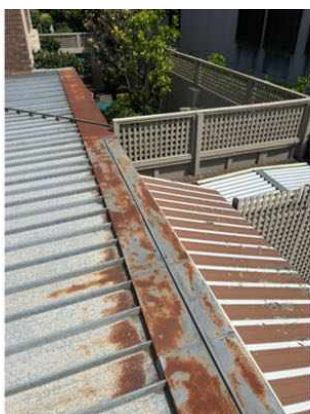
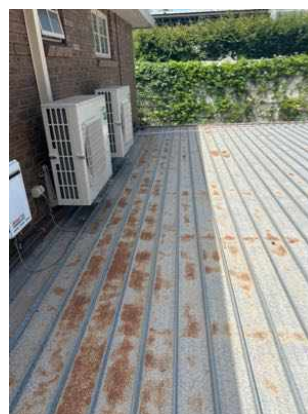
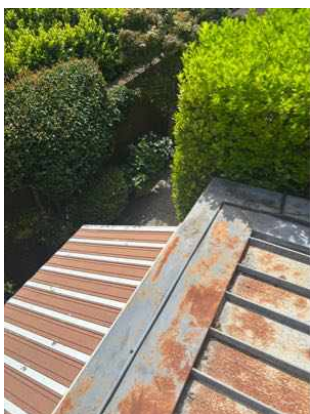
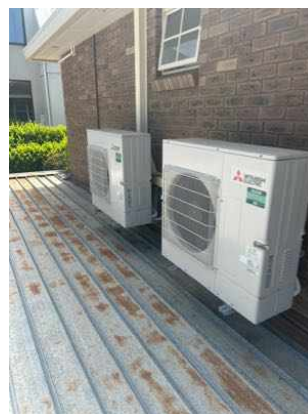
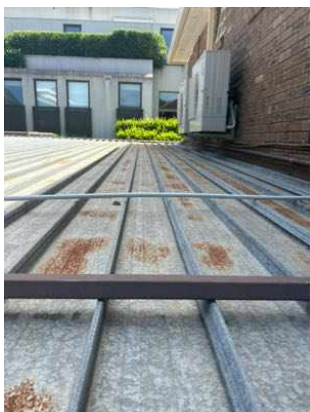
Defects 3.06

Building:	Garage
Location:	All Areas
Finding:	Roof sheets - Rusted
Information:	Metal roofs generally comprise numerous individual sheets, which join and overlap. These intersections are particularly prone to lift at the edge and consequently rust at these points.

Upon inspection of the exterior roofing structure, evidence of rust to these sections was identified. If left unmanaged, these degrading joins can allow water ingress to the internal roofing structures, potentially leading to secondary damage of building elements. Accelerated deterioration of the roofing sheets and any associated building elements is also likely to occur.

A roofing contractor should be appointed immediately to assess the damage to the roofing sheets and to perform remedial works as necessary. Works may include replacement of severely affected roofing sheets or minor works such as the application of rust-retardant surface protectors.

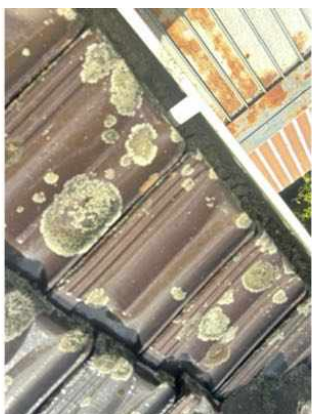
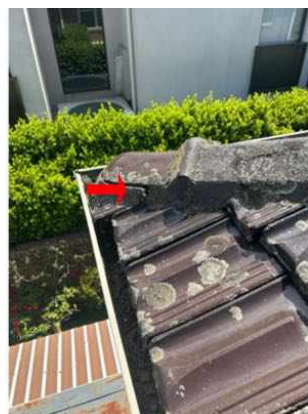
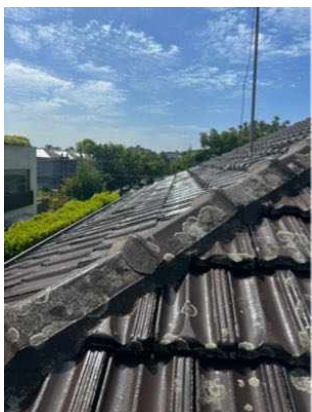
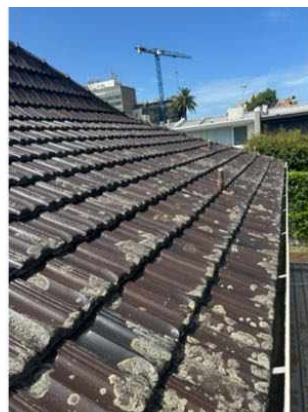
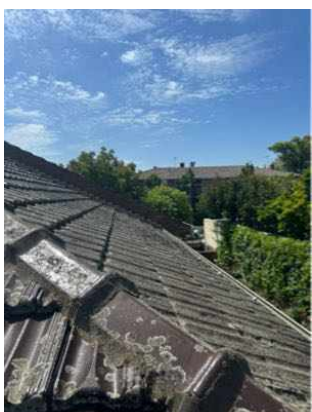
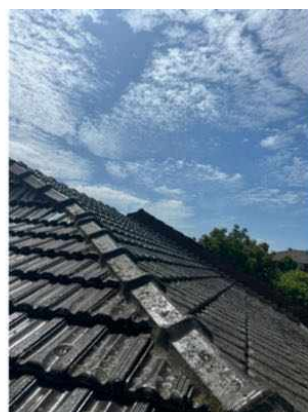
Defects 3.07

Building:	Main Building
Location:	All Areas
Finding:	Roof tiles - Weathered
Information:	Upon inspection of the exterior roofing, the majority of roof tiles were considered to be in a fair condition. While weathering of the tiles is consistent with the age of the property, maintenance works are required.

Isolated areas of mortar have come loose in the valleys and minor cracking is also present. Re-pointing and re-sealing the may be considered as an interim solution by the client to help preserve and extend the life span of the tiles.

Where left unmanaged, deteriorating roof tiles are likely to lead to a number of secondary defects, including minor water leaks and weather exposure to internal roofing structures.

Consultation with a roofing contractor is highly advised to gain advice on cost of remedial works that may be required in the short to medium term. Remedial works are likely to increase the longevity of the exterior roofing structure.

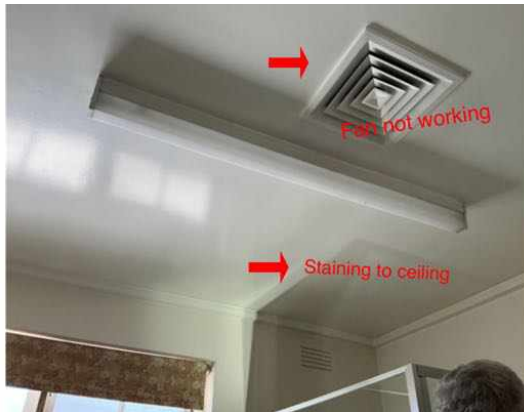
Defects 3.08

Building:	Main Building
Location:	Bathroom 2
Finding:	Exhaust fan - Not operating
Information:	The exhaust fan in this area appears to be damaged or blocked and is not operating as intended. If left unmanaged, a lack of general maintenance is likely to lead to the development of more significant defects, such as water damage to surrounding building materials from inadequate ventilation. If left unattended for a prolonged period of time, poor ventilation in this area may also be conducive to the development of mould.

Where no secondary damage has developed, the Homeowner may undertake minor

cleaning of the area and consider replacement of the exhaust fan. Alternatively, consultation with a Licensed Electrician is required to check for any secondary or concealed damage and consider repair or replacement.

Please be advised that a cabinet maker or qualified carpenter may also be required if water damage has occurred and that an additional specialist mould inspection may be required if severe mould has resulted.

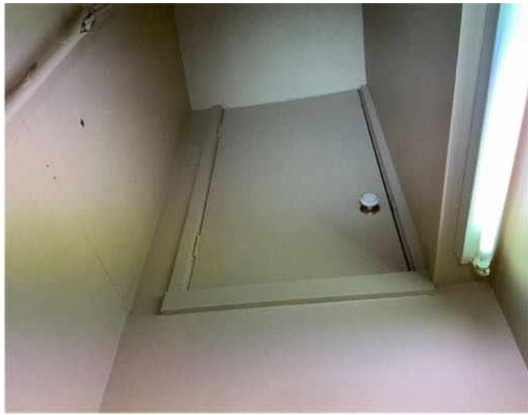
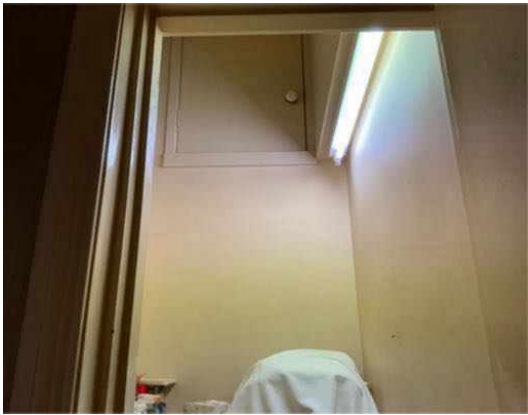
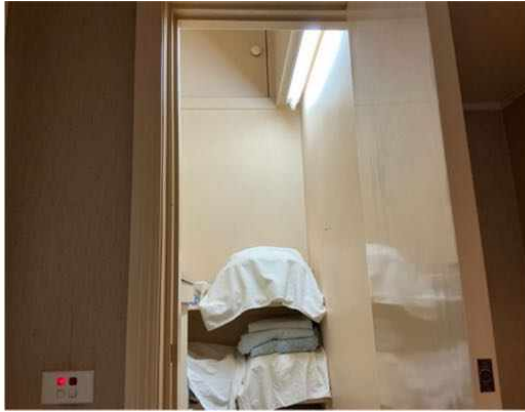
Building: Main Building
Location: Roof Void
Finding: Roof void access limitations
Information: No access to the roof void was available due to fact that the current owner denied entry, for this reason access to the roof void was not available.

Condition of the roof void, insulation and structure could not be inspected.

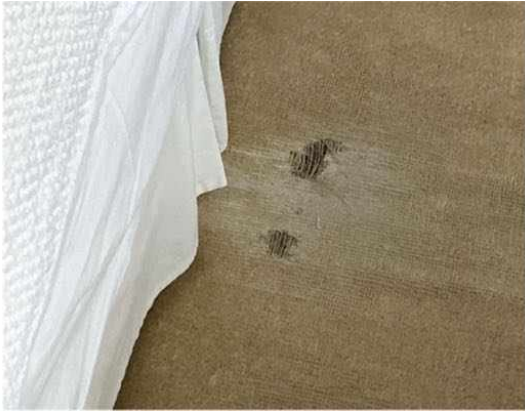
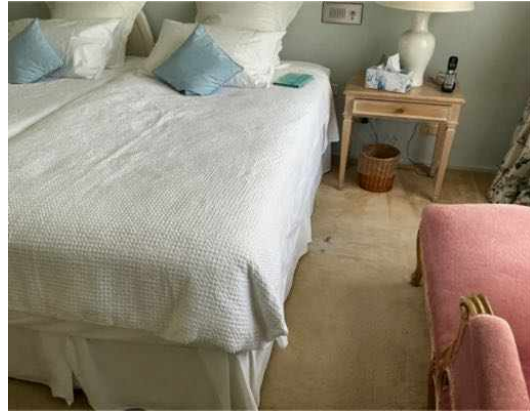
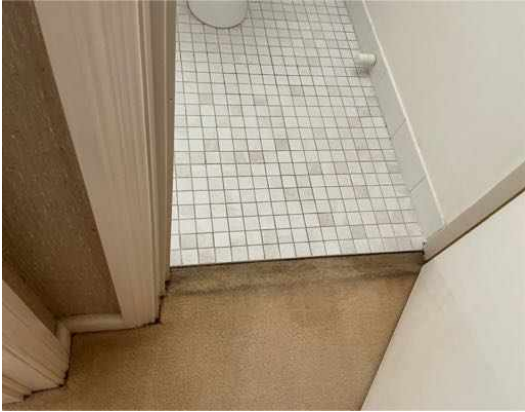
Building: Main Building
Location: All Areas
Finding: Carpet - Deteriorated
Information: Sections of the carpet floor covering throughout were worn and stained, these carpets may be replaced at the clients convenience.

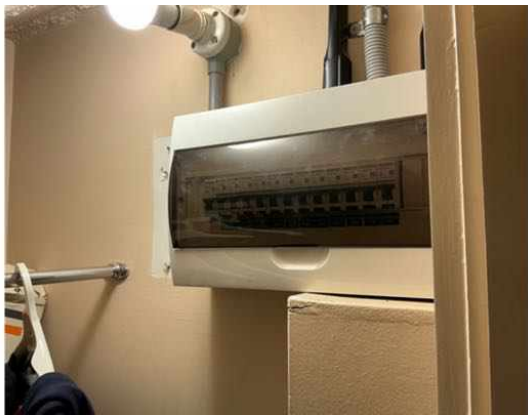
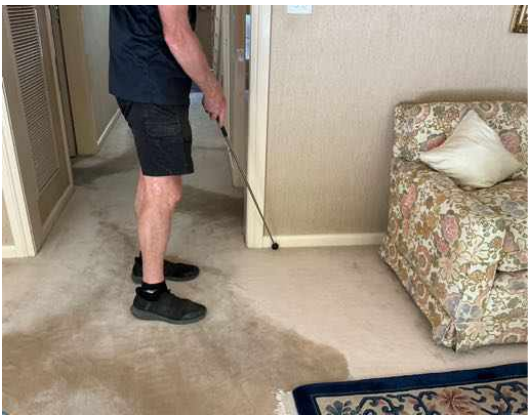
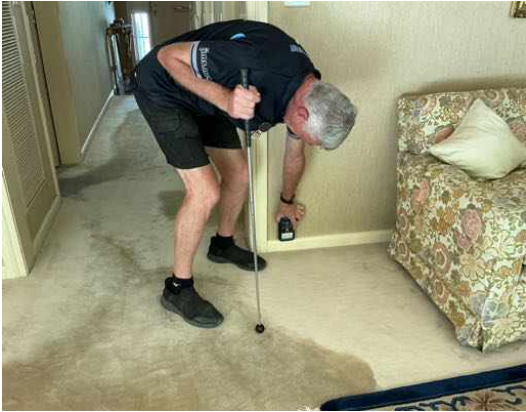
Building: Main Building
 Location: All Areas
 Finding: Termite Management System - no evidence of a chemical installation
 Information: The application of a post-construction chemical termite barrier is highly recommended for all properties, particularly if live termite activity has been found on the site previously. Such barriers are highly effective in preventing termite attack on any timber building elements throughout the property.

A durable notice should be placed in the switchboard unit to indicate current termite barriers. At the time of inspection, it appeared as though no termite management system has been installed, with no evidence to suggest preventative works taking place.

The client may consider gaining further advice from a pest controller as to the costs and procedures involved with this application. It is recommended that obtaining such advice be a short-term priority.
