Building and Timber Pest Inspection Report

Inspection Date: Fri, 30 Jan 2026

Property Address: 61 Tindale Rd, Artarmon NSW 2064,
Australia

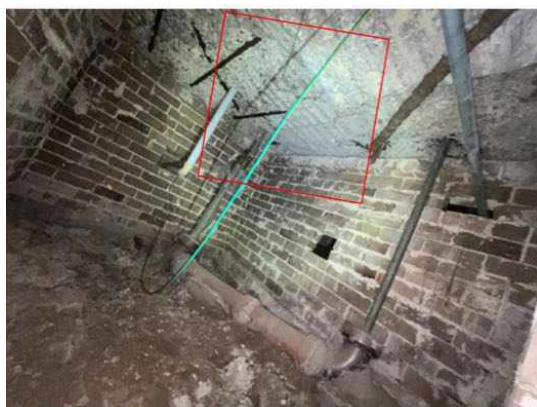
Building:	Main Building
Location:	Bathroom
Finding:	Concrete - Cancer
Information:	Concrete cancer is the common term used to describe a number of factors which cause concrete construction to deteriorate. Generally, water penetration causes the concrete reinforcement to rust and expand, creating stresses on the surrounding concrete and in turn causing it to spall (or break away). Alternatively, if the cement component is too alkaline, reactions with the general atmosphere occurs and star-shaped cracks appear which allow rainwater to penetrate. Concrete cancer may also

In some instances, repairs are possible; however, repair works will generally involve extensive works, including removal of affected concrete and the treatment or replacement of any exposed steel. Some injection of resins or special mortars may also be possible, however this depends on the size and extent of consequent damage.

Ultimately, the cause of the concrete cancer (e.g. poor water proofing) must also be addressed, otherwise the problem is likely to recur. Treatment of concrete cancer can be expensive and, left unmanaged, the problem is likely to worsen over time, potentially leading to the development of major structural defects or safety hazards.

The client is advised to exercise caution and to prepare for the potential cost of remedial and / or replacement works. A structural engineer should be appointed to provide estimates on the required works.

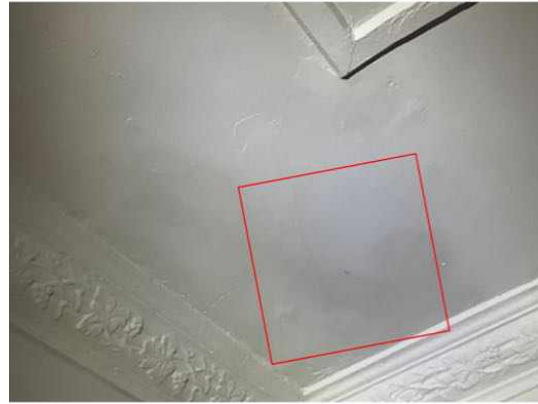
Finding 3.01

Building:	Main Building
Location:	Bedroom 2
Finding:	Ceiling - Water stained
Information:	Water staining to ceiling linings in this area was evident at the time of inspection. Water staining indicates that surfaces have been exposed to excessive moisture over time. The minerals and other elements in the water lead to staining, which may graduate to corrosion and deterioration if left unmanaged.

While mostly an appearance defect, water staining can be indicative of more serious defects, which may be currently concealed by interior ceilings.

Where water staining is active, a licensed plumber must be consulted to identify the cause of the staining and to provide advice on any reparation works that may be

required. Replacement of any damaged structures is advised.

Conversely, where water staining is old and inactive, affected building materials may be repaired or replaced at client discretion.

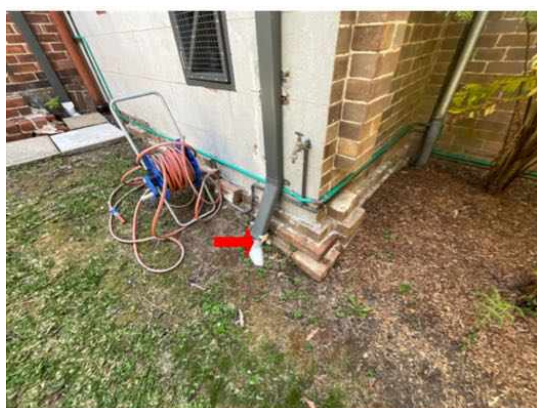
Building:	Main Building
Location:	Yard - LHS
Finding:	Stormwater drain - Damaged
Information:	The roof plumbing is not adequately connected to stormwater drainage on the site. This disconnection negatively impacts the functional capacity of the roof plumbing.

Where roof plumbing doesn't drain adequately, the area at the base perimeter can become excessively damp, potentially creating an environment that is susceptible to rust and corrosion of surrounding building elements, as well as attracting termites and other pests.

It is highly recommended that a plumber be appointed to further inspect the area and to install adequate drainage equipment where necessary.

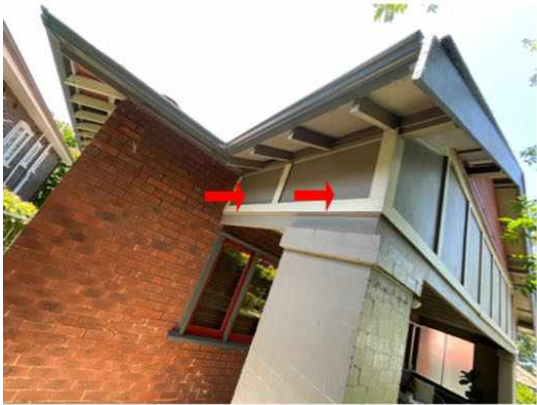
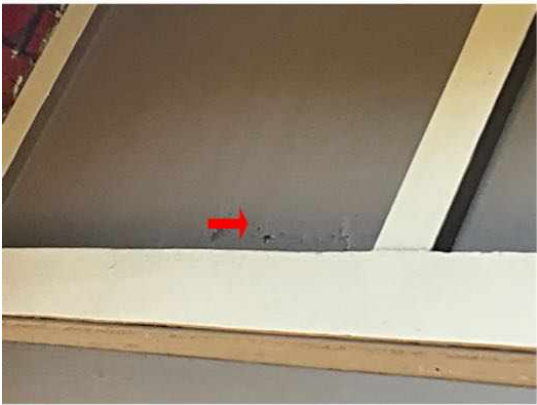
Building:	Main Building
Location:	Multiple areas
Finding:	Paint cracking and peeling
Information:	Cracking and ultimately flaking of paint can occur for a variety of reasons. Often these failures are due to the fact that the paint has inadequate adhesion and flexibility, both common problems with lower quality exterior flat paints.

When timber is involved, moisture intrusion results in swelling of the wood surface followed by contraction as the wood dries. The expansion and contraction cycles, can result in cracking and subsequent paint failure by flaking and peeling.

Cracking and flaking can also result when paint is applied too thinly due to overspreading (higher-than-recommended spread rate) or excessive thinning. These practices tend to diminish the paint's final film thickness, so that it is more vulnerable to cracking and flaking.

Inadequate surface preparation can also cause these failures, especially when paint is applied to bare wood or a very porous surface without first applying a primer.

A qualified painter should be appointed to rectify the problem.

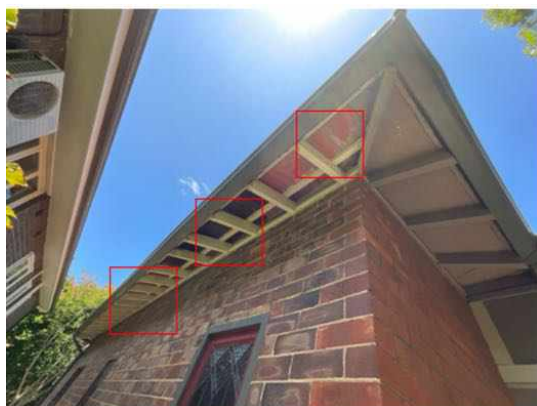
Building:	Main Building
Location:	Walls
Finding:	External painting deteriorated
Information:	The external paintwork to multiple external areas have been neglected and require attention to prepare and re-paint.

Whilst incomplete or missing paint finish is generally an appearance defect, it can also lead to the development of secondary building defects over time. Incomplete areas of paint finish expose the area to moisture, potentially accelerating the deterioration of underlying building materials.

Degraded paint finishes should be sanded back, filled, leveled and painted, as applicable. Where inadequate or missing paint protection has led to the deterioration of the associated building element, repair and/or replacement of this building element may be required.

A painting contractor should be appointed as soon as possible to perform necessary works to aid the appearance of the affected area and to ensure the area is protected against further deterioration. Alternatively, the homeowner following manufacturer instructions may perform these works.

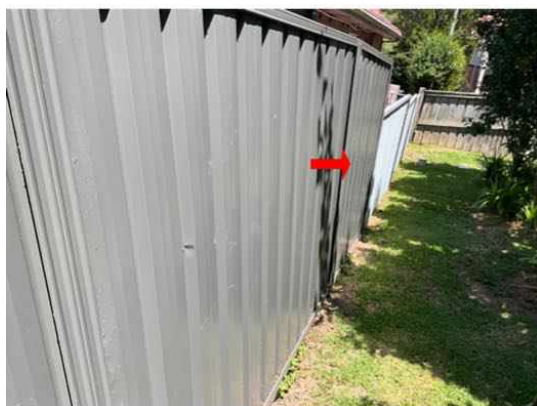
Finding 3.08

Finding: Fencing - Deteriorated

Information: It was noted at the time of inspection that sections of the fencing in this area has deteriorated. Typically fencing deteriorates due to age and or wear, rot and or rust which is generally expected for a structure of this age, due to prolonged exposure to weather conditions. Sometimes inadequate installation or maintenance can be to blame.

If left unattended, it is likely that further damage will occur. It is suspected that repair of several elements of the fencing may be required however replacement may be a consideration of the client also.

A licensed fencing contractor should be appointed to provide further advice and perform rectification works as necessary.

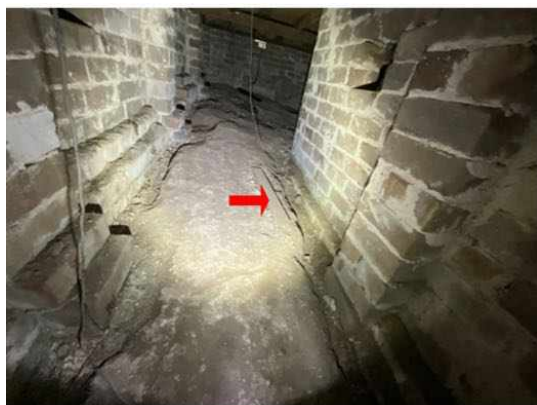
Finding 3.09

Building:	Main Building
Location:	Subfloor
Finding:	Stored timbers - subfloor space or external area
Information:	The storing of timbers in the subfloor space or around the external property increases the risk of termite activity being present. As they are likely to come into contact with weather conditions or excessive moisture wood rot is likely to develop on timbers that are not treated.

It is highly recommended that any stored timbers be immediately removed from areas in which they may attract any termite / timber pest attack. Minimisation of risk / prevention of termite attack is far more adequate than dealing with the presence of termite activity.

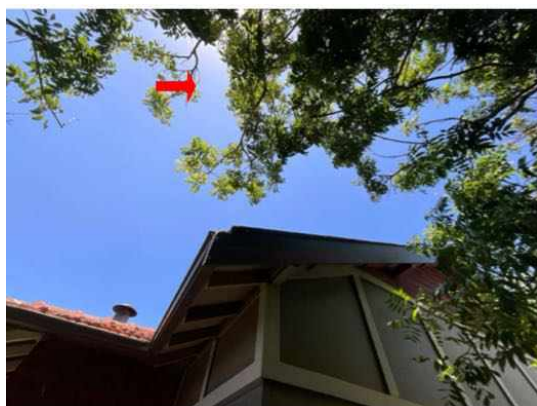
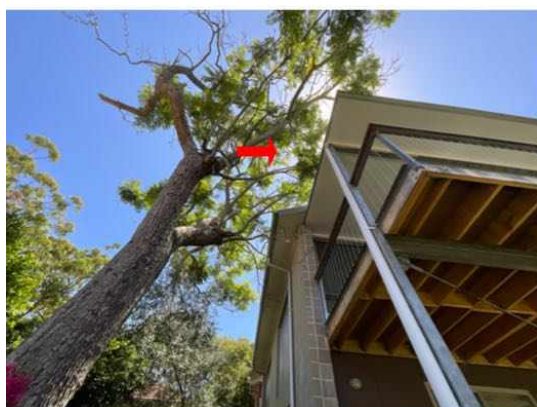
Finding 3.10

Building:	Main Building
Location:	Roof Exterior
Finding:	Trees - Overhanging and filling gutters
Information:	Overhanging trees often result in excessive amounts of leaf debris accumulating in gutters.

Gutters are a critical part of the building's management of storm water and rain. It is therefore important that they be kept clear to prevent secondary damage to associated building elements, including exterior and interior walls, ceiling linings and any adjoining building elements. Where gutters are blocked, pooling of rainwater is likely to occur, fast-tracking rust and corrosion of the roof plumbing elements.

It is highly advised that all overhanging tree branches be removed as soon as possible to prevent any further damage. Repair and/or replacement of sections of damaged guttering may also be required where the extent of the damage necessitates.

Such works should be performed by the homeowner; however, appointment of a landscape contractor or an arborist may be required. Consultation with a licensed roof plumber is required where guttering has been damaged.

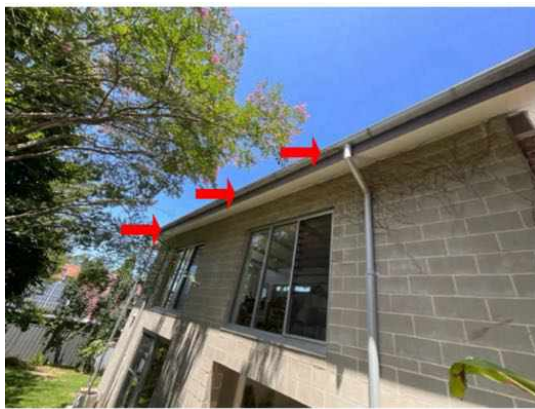
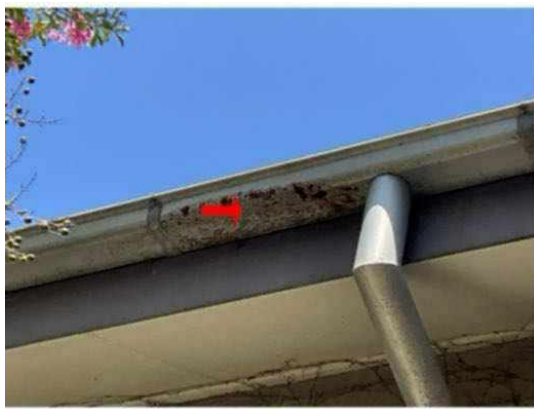
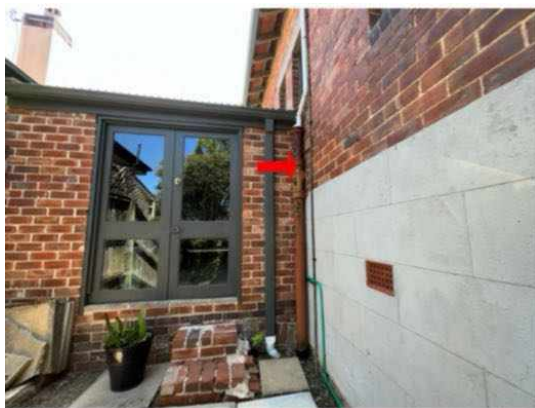
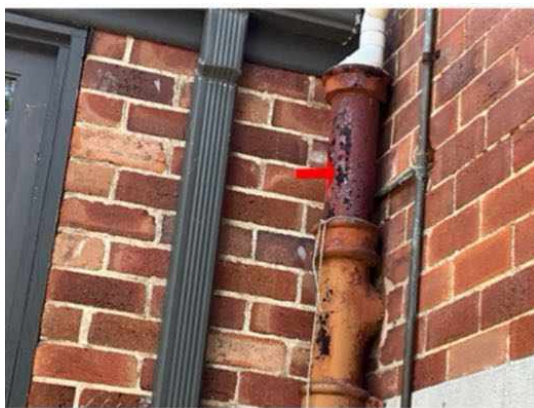
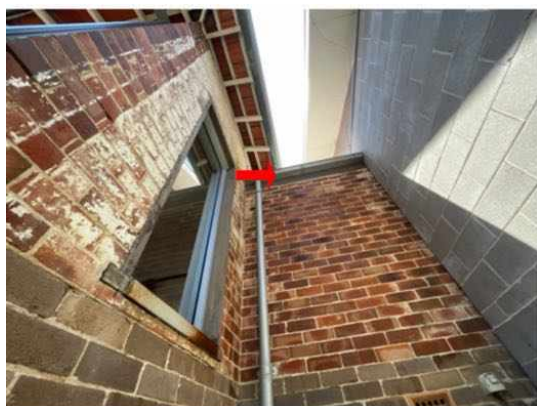
Finding 3.11

Building:	Main Building
Location:	Multiple areas of plumbing
Finding:	Roof plumbing - Rusted or corroded
Information:	The roof plumbing has areas of rust and corrosion. It is suspected that this has been caused by blockages, resulting in pooling or standing water, that have prematurely rusted elements of the roof plumbing.

Rusted roof plumbing will generally develop holes and leaks that can affect other building elements with poor drainage of storm water. Poorly drained roof areas will also lead to damp conditions surrounding the base perimeter of the building which, if left unmanaged, can lead to a range of secondary building defects.

Repair and/or replacement of rusted roof plumbing is highly required in order to reinstate the roof drainage system to a fully operational level. To further maintain these areas, gutters should be cleaned frequently, allowing the avoidance of any partial blockages.

A licensed plumber or specialist roof restoration company should be appointed to undertake these works. It is advised that such works be completed as soon as possible to prevent any further damage and deterioration.

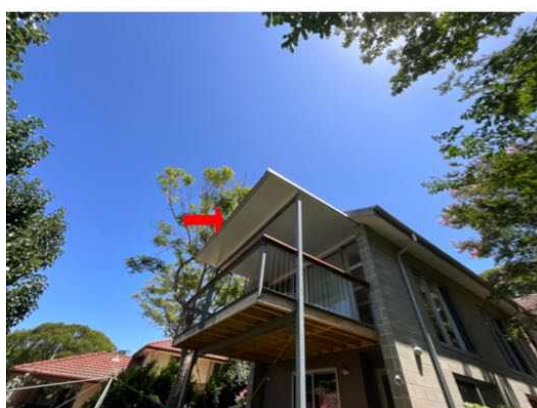
Finding 3.12

Building:	Main Building
Location:	Rear Elevation
Finding:	Roof plumbing - Missing
Information:	Some sections of the roof are not adequately drained via gutters and downpipes. Gutters and downpipes that are not installed adequately are likely to result in excessively damp conditions against the exterior surfaces and around the base perimeter of the building.

Excessive moisture creates an environment which accelerates the deterioration of building elements in the area, as well as being conducive to termite and pest infestation. Such an environment is likely to necessitate repair and/or replacement of building elements, which are prone to sustaining wood rot, rust or corrosion.

A roofing plumber should be appointed as soon as possible to install relevant roof plumbing materials. Depending on the extent of the damage, repair and/or replacement of damaged building elements may be required.

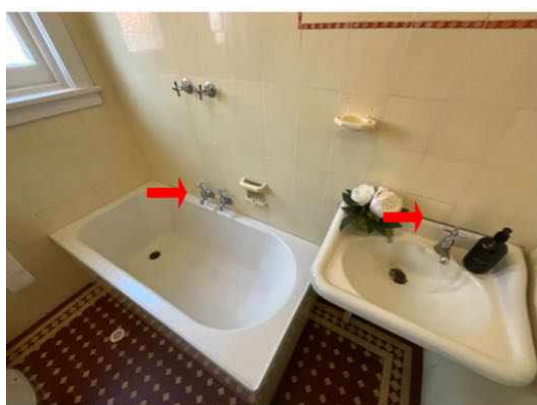
Finding 3.13

Finding: Sealant and grouting - Missing or damaged

It was noted on inspection that sealant or grout is degraded to this area.

Different materials and floor areas move at different rates, generally causing cracking to grout or sealant at this point. A flexible sealant is required to allow for expected expansion and contraction, while keeping the joint water tight and protective of all associated building materials.

Flexible and mould resistant materials should be applied to affected areas to prevent any subsequent water damage that is likely to occur. Regular maintenance and replacement of damage or missing or damaged sealant and grout is highly recommended to the wet areas, as this is a regular wear and tear defect. Sealant and grouting in areas that come into regular contact with water should be maintained for the long term care of your property.

A sealant specialist should be appointed to complete these works as soon as possible.

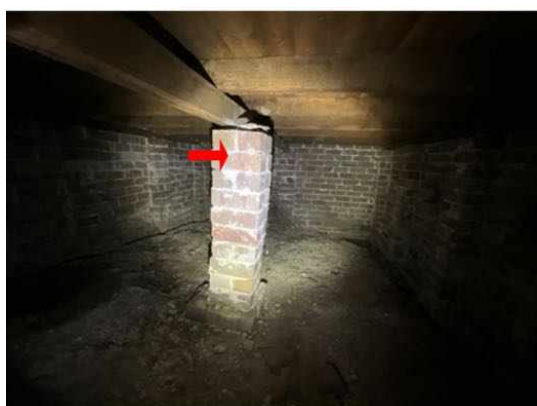
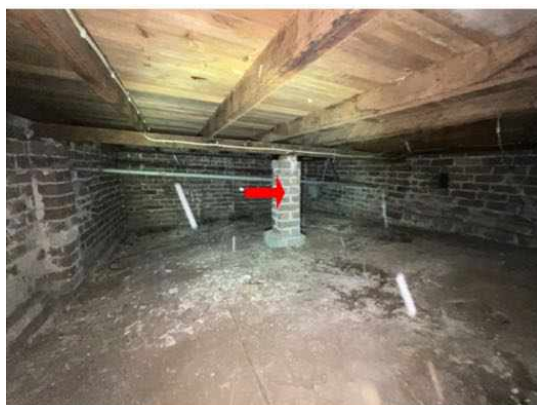
Finding 3.14

Building: Main Building
 Location: Subfloor
 Finding: Piers - Leaning

Information: Pier to the subfloor structure is leaning, indicating that its structural integrity may have been affected. The cause of this instability is likely to be caused by movement / minor subsidence of the pier due to moisture.

If further movement is evident appointment of a structural engineer is advised to assess the condition of the piers and provide advice on remedial works that may be required.

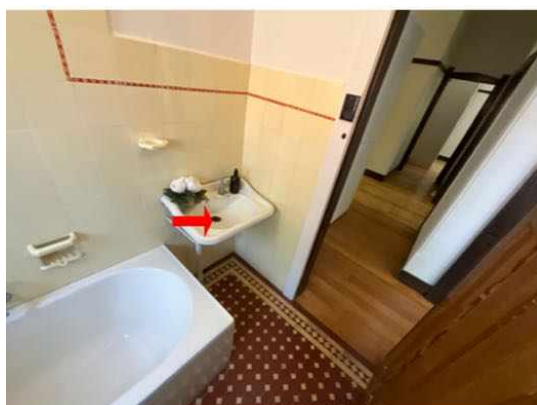
Finding 3.15

Building: Main Building
 Location: Bathroom
 Finding: Building element - Rusted or corroded
 Information: This building element shows evidence of rusting and corrosion, which is likely to have developed as a result of excessive exposure to moisture and or inadequate coatings.

As surface rust provides no protection to the underlying iron, the deteriorating condition is likely to worsen if not addressed in the short-term future.

A licensed plumber be appointed to replace the wash basin.

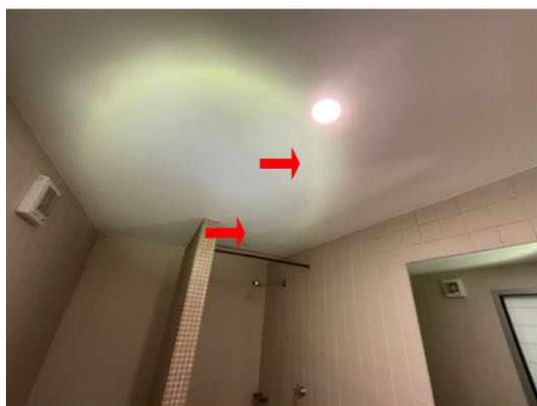
Finding 3.16

Building:	Main Building
Location:	Multiple areas
Finding:	Paint cracking and peeling
Information:	Cracking and ultimately flaking of paint can occur for a variety of reasons. Often these failures are due to the fact that the paint has inadequate adhesion and flexibility, both common problems with lower quality exterior flat paints.

Inadequate surface preparation can also cause these failures, especially when paint is applied to bare wood or a very porous surface without first applying a primer.

A qualified painter should be appointed to rectify the problem.

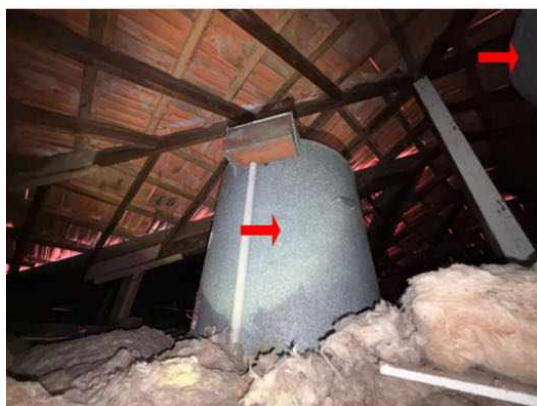
Finding 6.09

Building:	Main Building
Location:	Roof Void
Finding:	Gravity-Fed HWS - Disconnected
Information:	It was noted at the time of inspection that a disconnected gravity-fed hot water system (HWS) remains in this area.

While it is a costly exercise to remove the disused gravity-fed HWS, it is advisable in the short-term future to prevent any further damage to the area. Further consultation with a licensed plumber is required to gain further advice on removal of the structure.

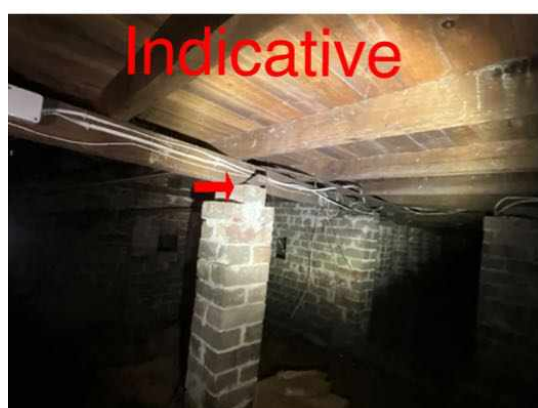
Finding 6.10

Building:	Main Building
Location:	Subfloor
Finding:	Ant caps - Not installed
Information:	Ant caps have not been installed to multiple areas of the subfloor structure at the time of inspection. Generally, ant caps are installed to the intersection between the top of the stumps (or piers) and the subfloor structures.

A licensed builder must be appointed urgently to replace any missing ant caps.

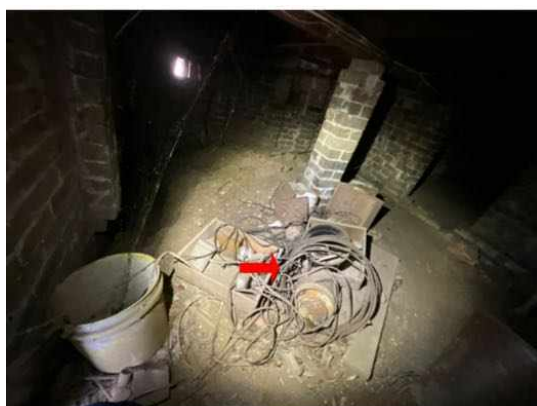
Finding 6.11

Building:	Main Building
Location:	Subfloor
Finding:	Subfloor - Debris
Information:	An array of debris was found in the subfloor area at the time of inspection. Debris in this area restricts subfloor ventilation and creates potential for concealed pest entry.

Debris in the subfloor should be removed as soon as possible. Depending on the location and amount of debris and stored items, the homeowner may elect to undertake this task. Alternatively there are a large number of rubbish removal subcontractors that could undertake these works.
