Building Inspection Report

Inspection Date: Tue, 10 Feb 2026

Property Address: 105 Campbell Hill Rd,CHESTER
HILL,NSW,2162,Australia

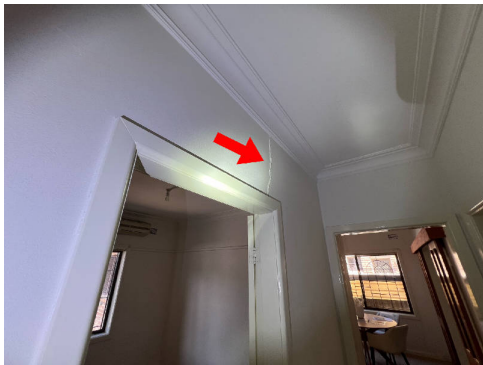
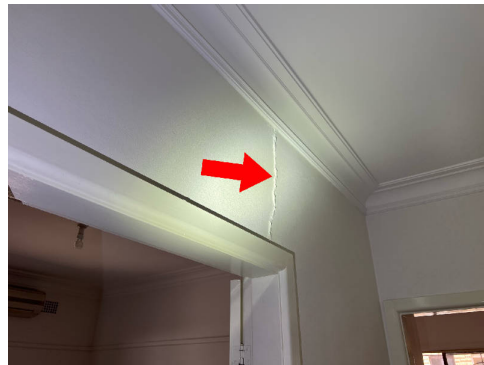
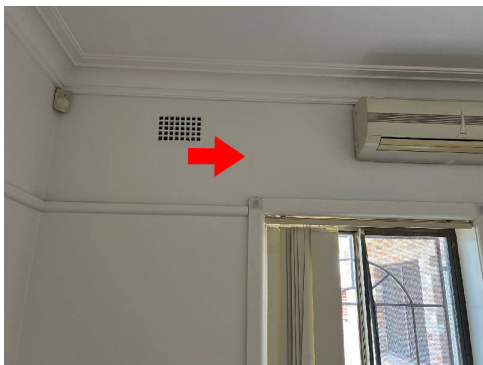
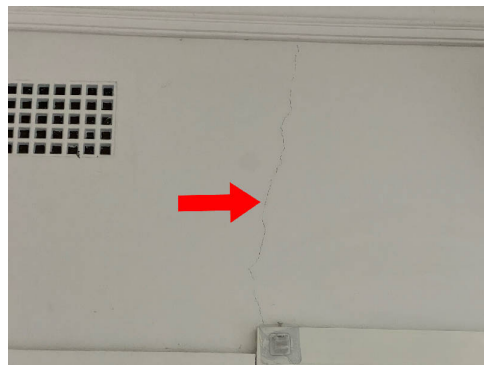
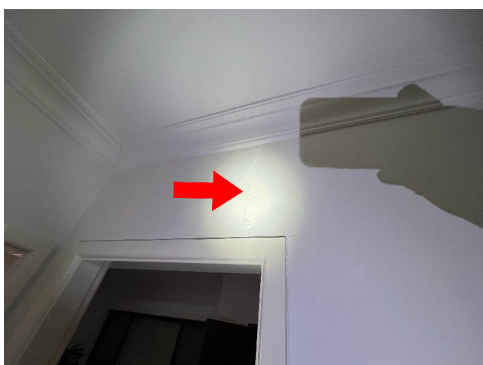
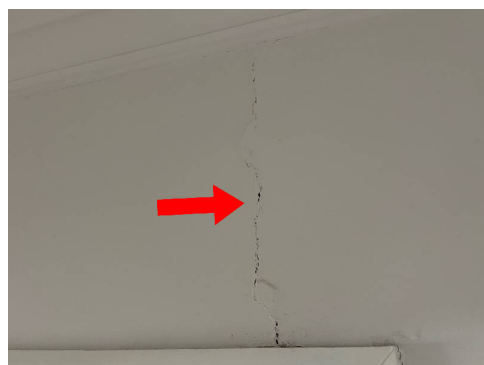
Defects 2.01

Finding: Internal Wall Cracking – Multiple Locations

Information: Multiple vertical and stepped cracks were observed to the internal masonry walls throughout the dwelling, including walls adjacent to door openings and areas near the ceiling line. The cracking appears to extend through the internal wall finishes and is consistent across several internal locations within the double brick structure.

Cracking of this nature may be associated with building movement, differential settlement, or age-related deterioration of wall materials. While the dwelling is of double brick construction, internal wall cracking can indicate ongoing or past movement and may affect the long-term performance and serviceability of the structure if left unaddressed. The extent and pattern of cracking warrant further assessment to determine whether the movement is progressive or historic.

It is recommended that a suitably qualified structural engineer be engaged to further assess the cracking, determine the underlying cause, and provide advice regarding any necessary rectification works. This assessment should be undertaken prior to settlement or as soon as practicable.

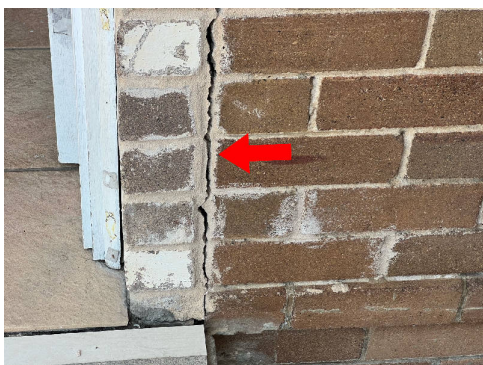
Defects 2.02

Building:	Main Building
Location:	Exterior walls - rear
Finding:	Cracking and Poor Workmanship to External Brickwork Adjacent to Doorway
Information:	Cracking and separation were observed to the external brickwork adjacent to the doorway opening, including stepped and vertical cracking through the mortar joints and along the junction between the brickwork and the door frame. Evidence of patch repairs and inconsistent mortar finishes was also noted, indicating prior rectification attempts.

Cracking of this nature around openings can be associated with building movement, inadequate articulation detailing, or poor workmanship during construction or subsequent repairs. Separation at the brickwork-to-frame interface may allow moisture ingress and can contribute to ongoing deterioration of masonry, internal finishes, and door framing if left unaddressed. The visible repairs suggest the issue may be recurrent rather than isolated.

It is recommended that a suitably qualified structural engineer or experienced brickwork contractor be engaged to further assess the cracking, determine whether the movement is ongoing, and provide appropriate repair recommendations. Any rectification works should ensure adequate movement control and weather sealing. This matter should be addressed as a priority.

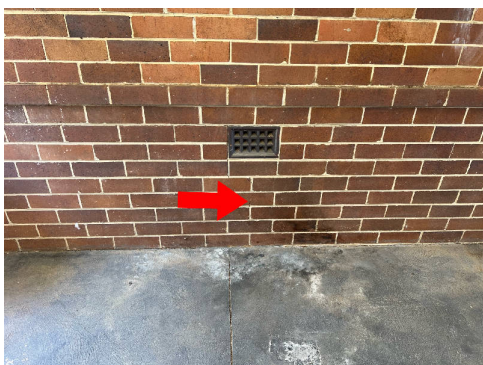
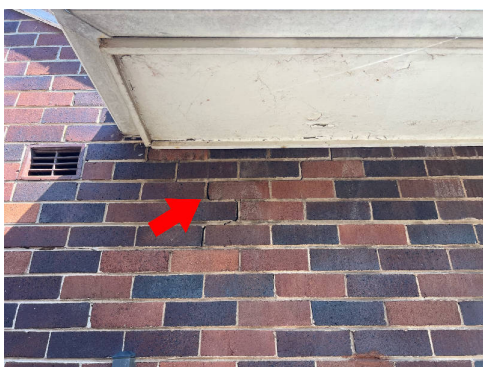
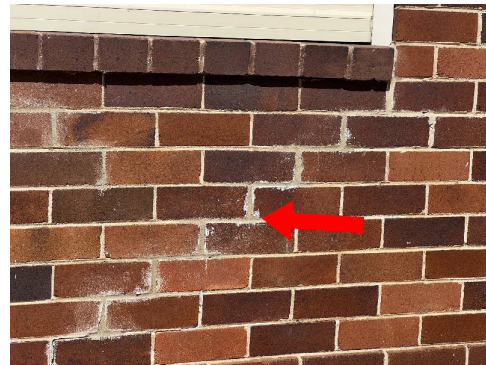
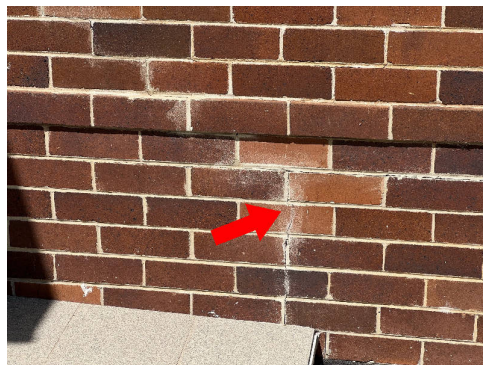
Defects 2.03

Building: Main Building
Location: All External Areas
Finding: Brickwork - Step cracking

Step cracking was identified to the brickwork in this area at the time of inspection. Step cracking, which is similar to other forms of cracking, has a variety of possible causes. However, the most common is the subsidence of adjacent footings.

Step cracking is a relatively common defect, and is most likely to occur adjacent to windows, doors and other openings. Mortar failure in the gaps between affected bricks indicates the stresses and tensions affecting the wall.

Where step cracking is extensive or severe, the client is advised to consult a structural engineer. Minor step cracking can be used as a warning sign to address factors causing stress to the wall, which can include the effect of surrounding trees, water leaks, soil erosion, or even the presence of reactive soils in the surrounding area.

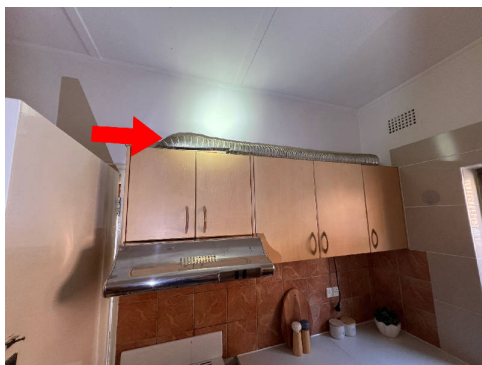
Defects 3.01

Information: The kitchen rangehood exhaust ducting was observed to be exposed above the overhead cupboards, rather than being concealed within cabinetry, ceiling space, or a purpose-built bulkhead. The flexible metal ducting was visible along its length within the kitchen area.

Exposed ducting of this nature detracts from the finish of the kitchen and may be more susceptible to grease accumulation, damage, or dislodgement over time. In addition, flexible ducting that is not adequately supported or concealed may be less effective in maintaining airflow efficiency and can contribute to increased noise or reduced performance of the rangehood system.

It is recommended that a suitably qualified contractor be engaged to assess the ducting installation and consider enclosing or rerouting the ducting to improve durability, performance, and overall presentation. This should be addressed as part of general maintenance or during future kitchen upgrades.

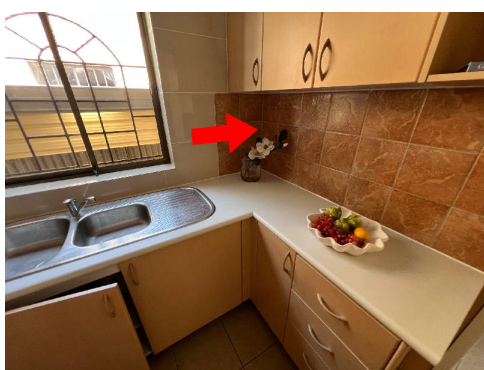
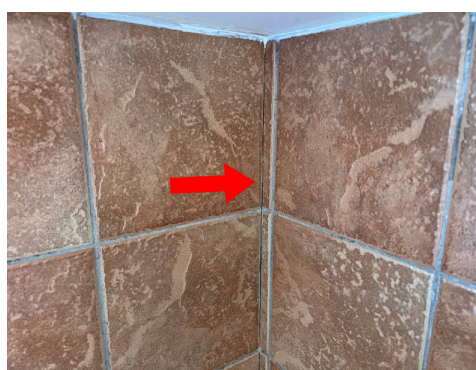
Defects 3.02

Building: Main Building
Location: Kitchen
Finding: Minor Cracking to Kitchen Splashback Grout

Information: Minor cracking was observed to the grout line at the internal corner junction of the tiled kitchen splashback. The cracking was localised and limited to the grout, with no loose tiles noted at the time of inspection.

Minor cracking in tiled grout at internal corners can occur due to normal building movement, age-related shrinkage, or thermal expansion of materials. While not considered structurally significant, cracked grout can allow moisture penetration over time if left unsealed.

It is recommended that the affected grout be monitored and resealed or repaired as part of routine maintenance to maintain the integrity and appearance of the splashback.

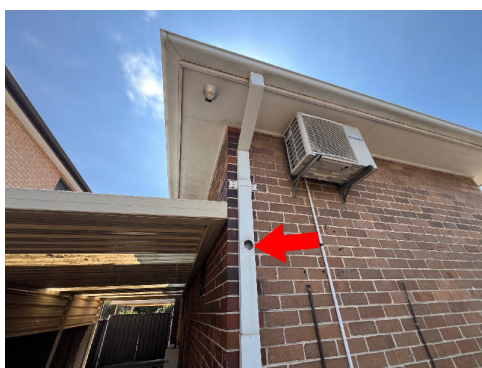
Defects 3.04

Location:	Exterior walls - rear
Finding:	Damaged Downpipe
Information:	The external downpipe was observed to be damaged and incomplete, with an open section and missing connection preventing effective conveyance of roof water to the stormwater drainage system. The downpipe was not fully functional at the time of inspection.

A damaged or incomplete downpipe can result in uncontrolled discharge of roof water at the base of the dwelling. This can contribute to moisture issues, erosion, and potential foundation movement over time, particularly in reactive soil conditions. Ineffective roof drainage also increases the risk of dampness to adjacent walls and footings.

It is recommended that the downpipe be repaired or replaced and properly connected to an appropriate stormwater discharge point by a suitably qualified contractor. This should be addressed in the short term to ensure effective roof water management.

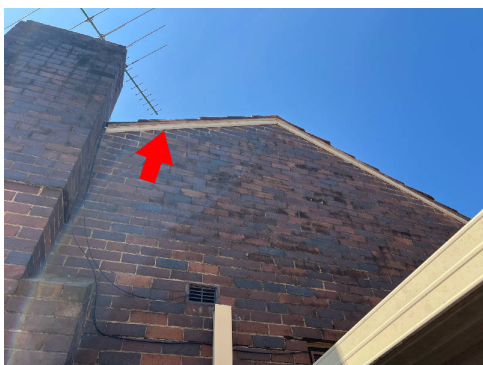
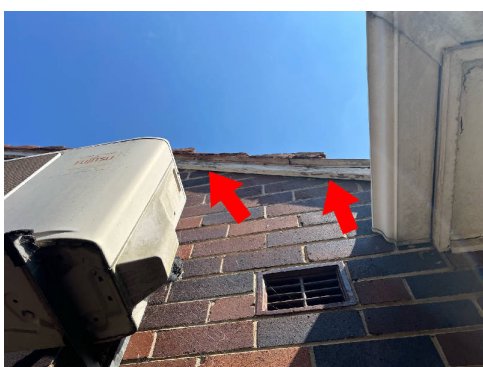
Defects 3.05

Building:	Main Building
Location:	Exterior walls - Sides
Finding:	Fascia wood rot

Sections of the fascia board were noted to be affected by timber rot and deterioration. The damage appears to be associated with prolonged exposure to moisture, likely from roof or gutter overflows in this area. Rotting timber can weaken structural integrity, compromise the support for gutters, and provide entry points for pests.

If left untreated, the decay may spread to adjoining timber elements and result in more extensive repairs being required. It is recommended that the affected sections be removed and replaced with new, treated timber, and that the source of moisture ingress (such as leaking or overflowing gutters) be identified and rectified.

Repairs should be carried out by a licensed carpenter or builder, with further inspection of roof plumbing by a roof plumber if leaks are contributing to the issue.

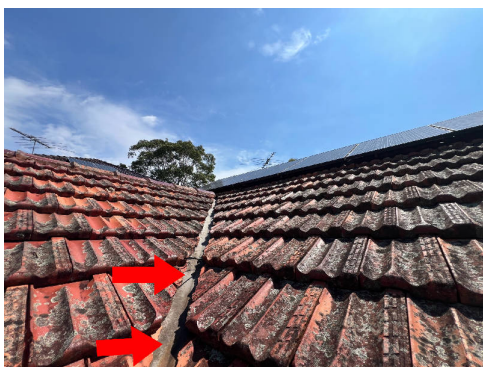
**Defects 3.06**

Finding: Corroded Valley Flashing

Information: At the time of inspection, corrosion was observed along the metal valley flashing, indicating prolonged moisture exposure and inadequate protective coating. The rust has begun to compromise the flashing's durability and may lead to water ingress during heavy rainfall, particularly where debris accumulation is also present.

It is recommended that a licensed roofing contractor remove debris, assess the extent of corrosion, and repair or replace the affected valley flashing to restore proper water management and prevent further deterioration.

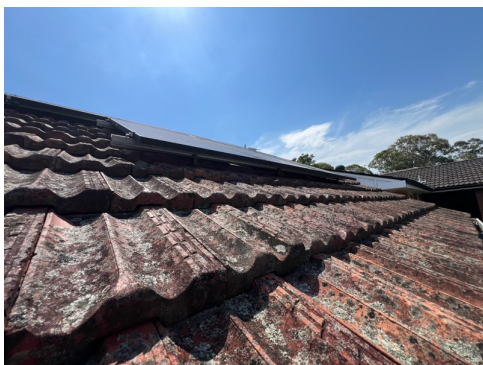
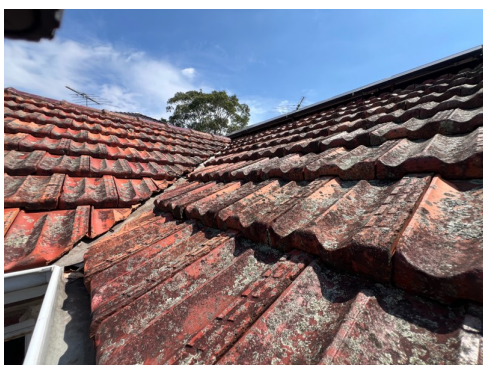
Defects 3.07

The exterior tiled roof covering was generally observed to be in fair condition for its apparent age; however, isolated deterioration was noted to the mortar bedding and pointing, particularly within valley areas. Minor cracking and areas of loose or degraded mortar were evident at the time of inspection, indicating that previous pointing materials have begun to break down due to age and weather exposure.

Deteriorated or cracked mortar within roof valleys can compromise the weatherproofing performance of the roof covering and may allow water ingress during heavy rainfall. If left unaddressed, this condition may lead to secondary defects such as minor roof leaks and moisture exposure to internal roofing components. Re-pointing and re-sealing of affected areas may be considered as an interim maintenance measure to assist in preserving and extending the service life of the existing roof tiles. It is recommended that a suitably qualified roofing contractor assess the roof and provide advice regarding appropriate remedial works required in the short to medium term.

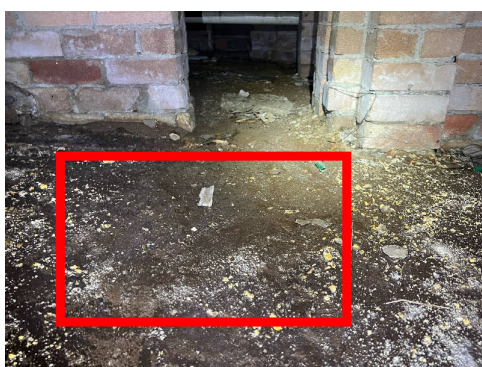
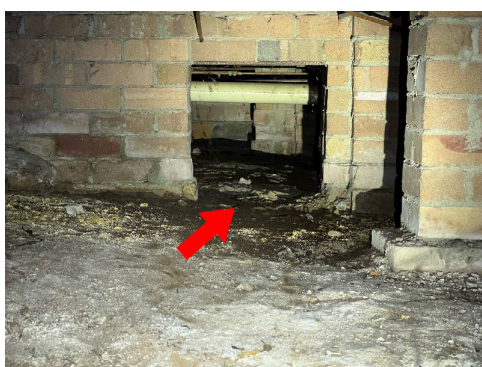
**Defects 3.08**

Information: Dampness to localised sections of the subfloor area was identified. While no active leaks were observed at the time of inspection, the pattern of moisture suggests that leaking pipes in this area may have been the source, potentially worsened by poor site drainage and inadequate subfloor ventilation.

This level of dampness is likely to lead to wood rot and general deterioration of structural elements within the subfloor space. Elevated moisture also creates conditions conducive to termite activity and other pest infestation.

A licensed plumber should be appointed immediately to assess and repair any pipes that may be leaking. Addressing plumbing issues promptly will help ensure a dry subfloor environment and improve the overall water efficiency of the property.

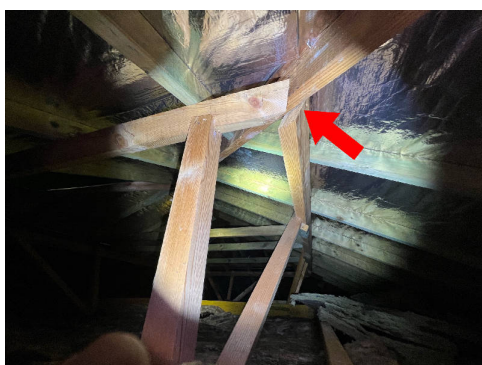
Defects 3.09

Building:	Granny-Flat
Location:	Roof Void
Finding:	Inadequate Fixing to Roof Framing Member
Information:	<p>A roof framing member was observed to be fixed by face-nailing only, with limited bearing and no visible structural support or connector at the junction. The fixing method appeared minimal and not consistent with best practice for roof framing connections.</p>

Inadequate fixing and limited bearing at framing junctions can reduce the load-carrying capacity of the roof structure and may lead to movement or loosening of the connection over time. While the member was fixed at the time of inspection, the adequacy of the connection could not be confirmed and may not meet current structural standards.

It is recommended that a suitably qualified structural engineer or experienced carpenter be engaged to assess the connection and provide advice regarding strengthening or rectification if required. This should be addressed as part of ongoing maintenance or prior to future roof works.

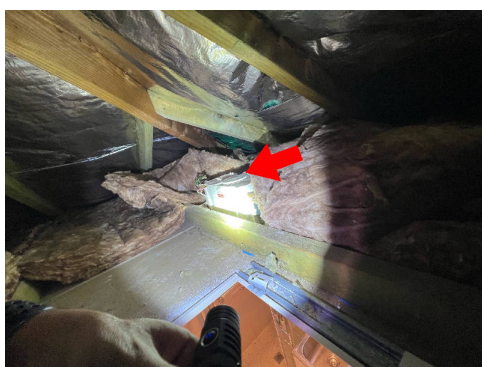
Defects 3.10

Building:	Granny-Flat
Location:	Roof Void
Finding:	Bathroom Exhaust Fan Discharging Into Roof Space

Information: The bathroom exhaust fan unit was observed installed within the roof space. No clear evidence was observed of the fan being ducted to discharge externally from the dwelling, and insulation was noted surrounding the fan housing.

Bathroom exhaust fans are intended to vent moist air to the exterior of the building. Where moist air is discharged into the roof space, it can contribute to increased humidity, condensation, and moisture accumulation. Over time, this may lead to deterioration of roof timbers, insulation, and ceiling linings, and can increase the risk of mould growth within the roof space.

It is recommended that a suitably qualified contractor be engaged to assess the installation and ensure the exhaust fan is correctly ducted to an appropriate external discharge point. This should be addressed in the short term to reduce the risk of moisture-related issues.

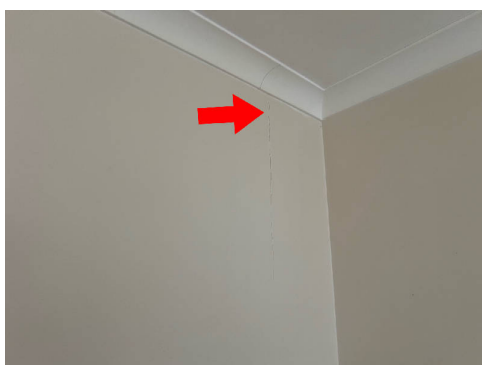
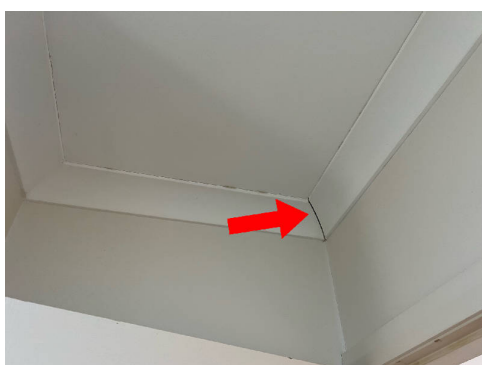
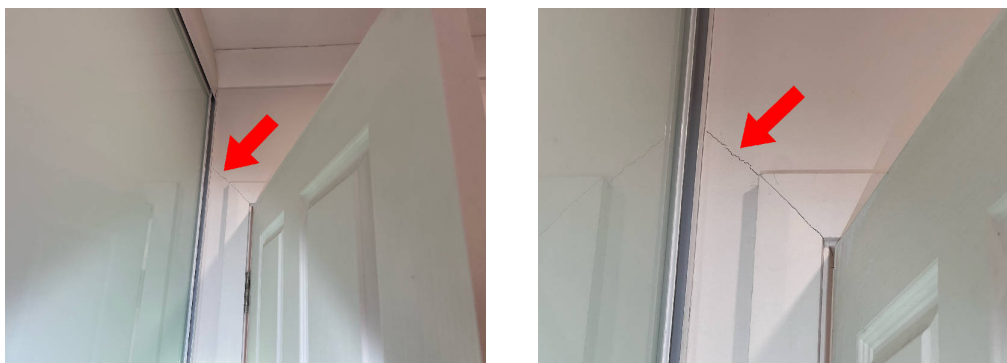
Defects 3.11

Building: Granny-Flat
Location: Living rooms 1 & 2
Finding: Cracking to Internal Walls and Ceiling Junctions – Living Room

Cracking was observed to the internal wall and ceiling junctions within the living room, including fine vertical cracking extending down the wall and cracking through cornice lines and ceiling joints. The cracking was present in multiple areas within the room and was not isolated to a single location.

Cracking of this nature may be associated with building movement, differential settlement, or age-related movement of materials. While some minor cracking can be common in older dwellings, the repeated pattern and distribution of cracking within the living area indicate movement that may affect internal finishes over time if ongoing. Cracking at cornice and ceiling junctions may also reoccur following cosmetic repairs if the underlying cause is not addressed.

It is recommended that the cracking be monitored for any signs of progression and that a suitably qualified structural engineer or building professional be engaged to assess whether the movement is ongoing and to provide advice regarding appropriate rectification. This should be considered prior to undertaking cosmetic repairs.

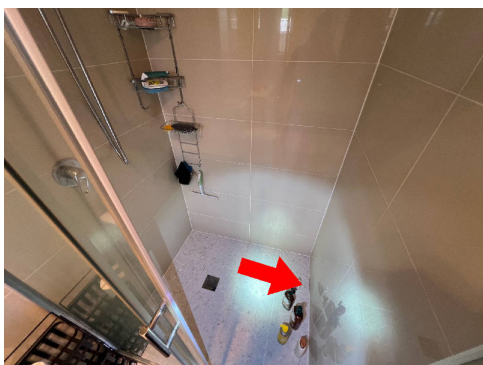
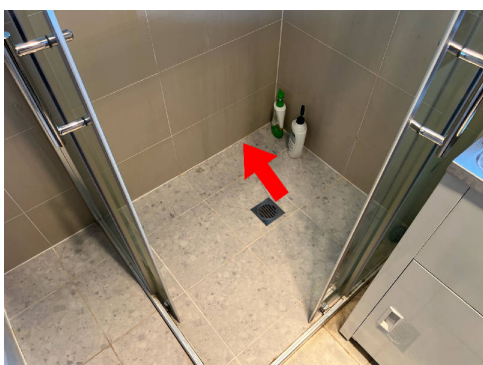
Defects 3.12

Building:	Granny-Flat
Location:	Bathroom 1 & 2
Finding:	Sealant and grouting - Missing or damaged
Information:	It was noted on inspection that sealant or grout is degraded to the tiled shower alcove and or other areas of the bathroom.

Different materials and floor areas move at different rates, generally causing cracking to grout or sealant at this point. A flexible sealant is required to allow for expected expansion and contraction, while keeping the joint water tight and protective of all associated building materials.

There appears to be excessive mould to the sealant and grout which will likely require scraping out and replacement.

Flexible and mould resistant materials should be applied to affected areas to prevent any subsequent water damage that is likely to occur. Regular maintenance and replacement of damage or missing or damaged sealant and grout is highly recommended to the wet areas, as this is a regular wear and tear defect. Sealant and grouting in areas that come into regular contact with water should be maintained for the long term care of your property.

A sealant specialist or tiling contractor should be appointed to complete these works as soon as possible

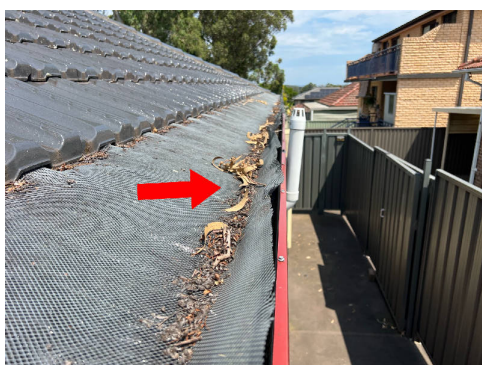
Defects 3.14

Where debris accumulates, gutters may not function effectively, potentially leading to restricted water flow, overflow during rainfall, and increased moisture exposure to fascia boards, eaves, and external walls. Gutter guards do not eliminate the need for ongoing maintenance and can still allow debris build-up, particularly in areas with overhanging vegetation.

It is recommended that the gutters and gutter guards be cleaned and maintained regularly and that the suitability and effectiveness of the existing gutter guard system be reviewed. This should be addressed as part of routine property maintenance to reduce the risk of water-related issues.

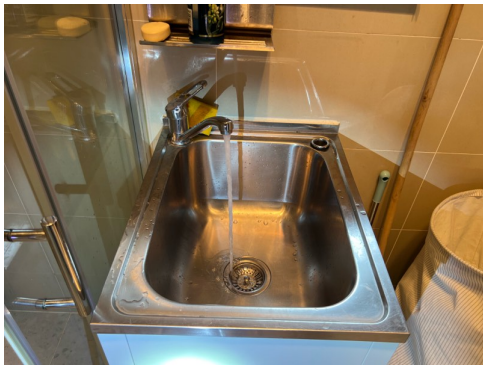
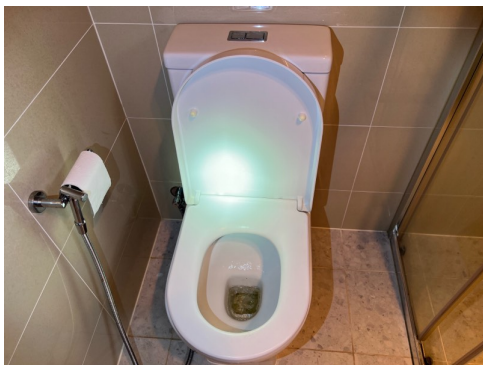
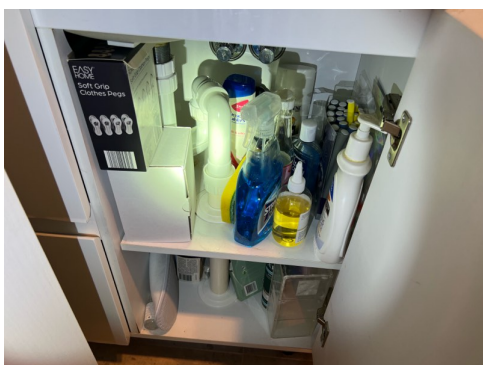
Based on the above observations, there is no conclusive evidence to suggest the presence of an active shower recess leak at the time of inspection, other than any issues already identified elsewhere in this report. It is therefore reasonable to assume that the shower waterproofing is currently performing as intended. However, it should be noted that if the shower has not been used for an extended period prior to the inspection, moisture readings may not accurately reflect underlying conditions and may result in misleading outcomes. As this inspection is limited to visual and noninvasive methods in accordance with pre-purchase inspection standards, it is not possible to definitively confirm the absence of leaks. If a higher level of certainty is required, a specialist invasive inspection is recommended.
