# Building and Timber Pest Inspection Report

Inspection Date: Wed, 21 Jan 2026

Property Address: 3 Bushing St, Wynnum West QLD 4178,  
Australia

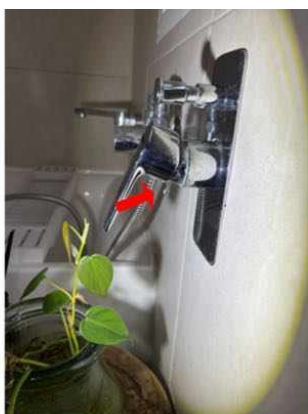
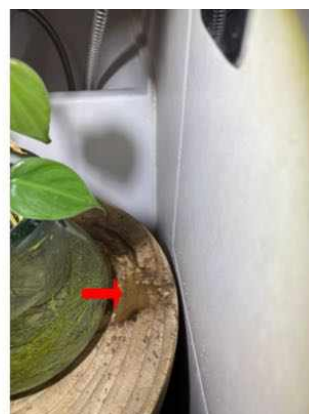
#### Finding 3.01

Building: Main Building  
 Location: Bathroom/laundry  
 Finding: Bathroom/laundry - mixer tap leaking  
 Information: At the time of the inspection, it was noted that the bathtub mixer tap is leaking when turned on. Moisture can be seen on the piece of furniture next to the bathtub. This may be due to general wear and tear of the seals in the mixer tap.

A licensed plumber should be engaged to repair the leak from the mixer tap. This should be done as a short term priority.

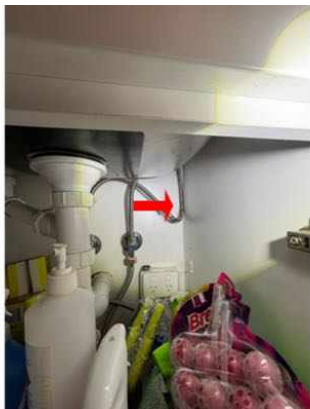
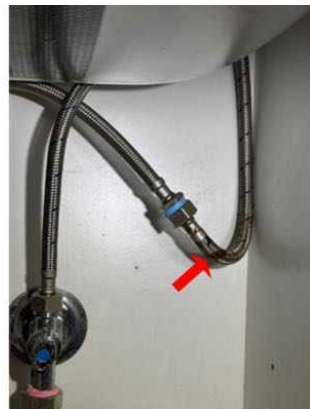
#### Finding 3.02

Building: Main Building  
 Location: Bathroom/laundry  
 Finding: Laundry tub - flexible hose has signs of rust  
 Information: At the time of the inspection, it was noted that a flexible hose to the laundry tub mixer had signs of rusting. This may be due to the age of the hose. Flexible hoses typically have a 5 - 10 year lifespan. It is recommended that they be changed if they have signs of bulging, fraying, kinking or rust.

A licensed plumber should be engaged to replace both the flexible hoses to the laundry tub mixer. This should be done as a matter of urgency.

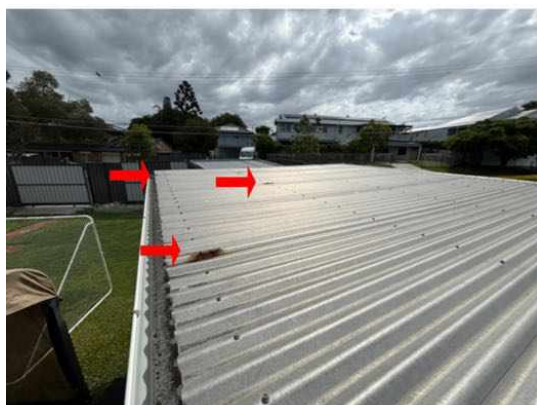
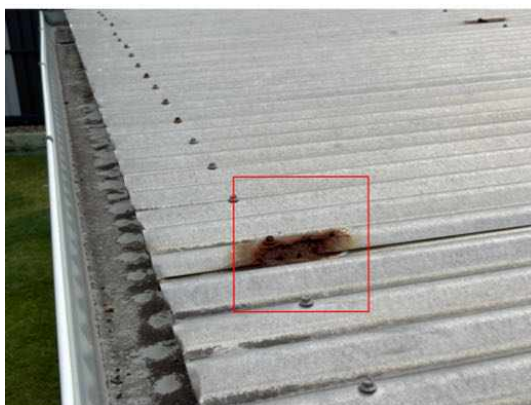
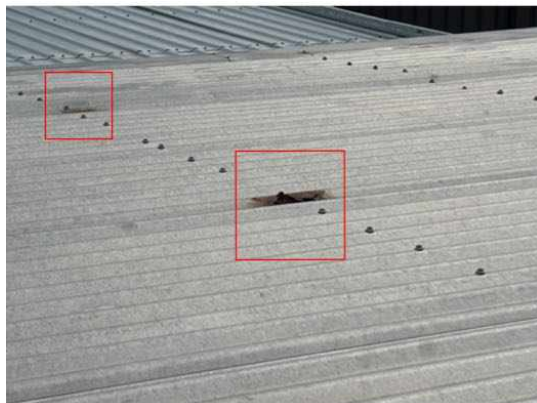
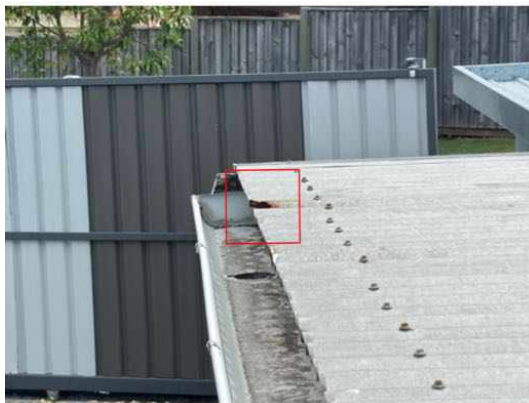
### Finding 3.03

Finding: Garage/shed - metal roof rusting

Information: At the time of the inspection, it was noted that there were several rust spots with holes on the metal roof of the garage/shed. This is due to the age of the materials.

If left unaddressed, damage may occur to the roof framing and ceiling linings.

A roofing contractor should be engaged to replace the affected roof sheets. This should be done as a matter of urgency.

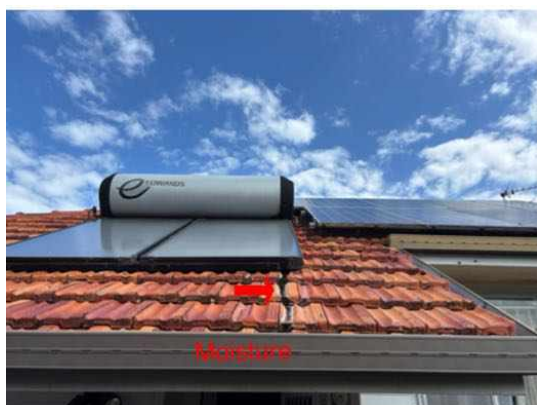
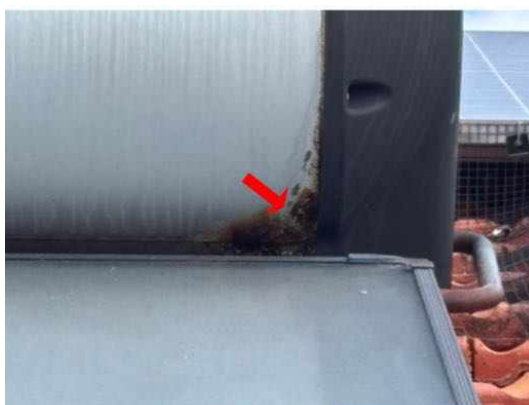
### Finding 3.04

Building:	Main Building
Location:	Roof Exterior
Finding:	Roof exterior - solar hot water system has evidence of a potential leak
Information:	At the time of the inspection, it was noted that there is signs of rusting to the solar hot water system on the roof. Moisture can be seen on the roof tiles below the solar panel which indicates that the unit may be leaking. The overflow drain for the unit can be seen on the left hand side of the unit.

Due to the delicate nature of the terracotta roof tiles, a closer inspection of the unit was not undertaken.

A solar hot water specialist should be engaged to assess the unit and determine if there is a leak. This should be done as a short term priority.

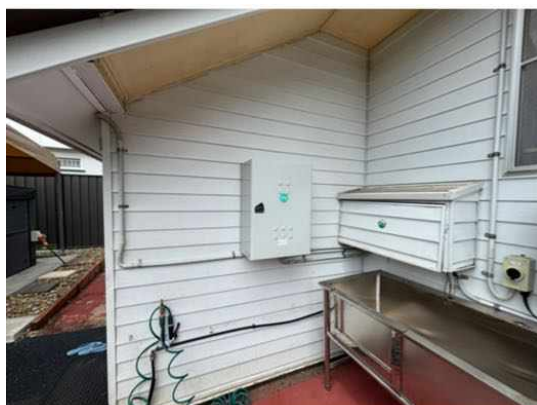
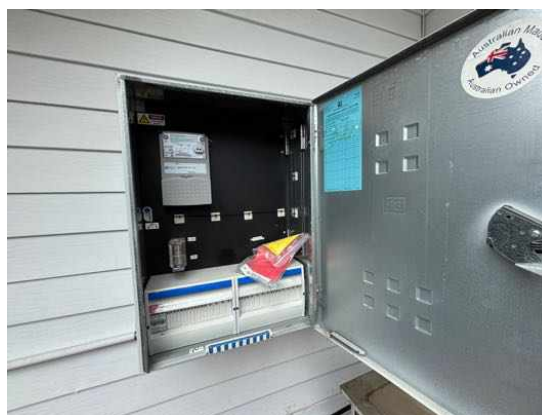
### Finding 6.01

Building:	Main Building
Location:	All External Areas
Finding:	Termite Management System - no evidence of a chemical installation
Information:	At the time of the inspection, no evidence of a chemical termite management system was found. There is no durable notice in the meter box.

A durable notice should be placed in the switchboard unit to indicate current termite barriers. At the time of inspection, it appeared as though no termite management system has been installed, with no evidence to suggest preventative works taking place.

The application of a post-construction chemical termite barrier is highly recommended for all properties, particularly if live termite activity has been found on the site previously. Such barriers are highly effective in preventing termite attack on any timber building elements throughout the property.

The client may consider gaining further advice from a pest controller as to the costs and procedures involved with this application. It is recommended that obtaining such advice be a short-term priority.

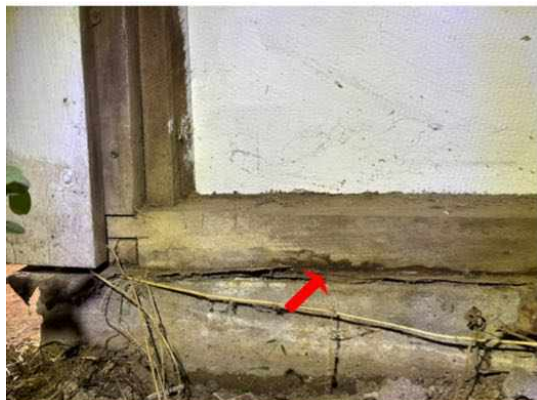
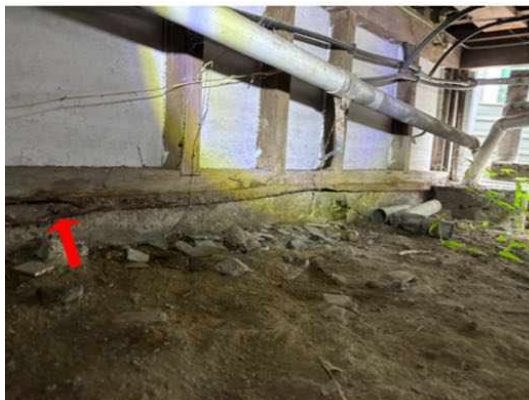
### Finding 6.02

Building:	Main Building
Location:	Subfloor
Finding:	Subfloor - metal ant caps rusted
Information:	At the time of the inspection, it was noted that sections of the metal ant caps in the subfloor were rusted and as a result, the effectiveness of the metal ant caps is

compromised. It would be difficult to replace the metal ant caps.

A termite and timber pest technician should be engaged to carry out annual termite inspections. They would pay closer attention to areas that are of a conducive nature for termite activity. This can be done at the clients discretion.

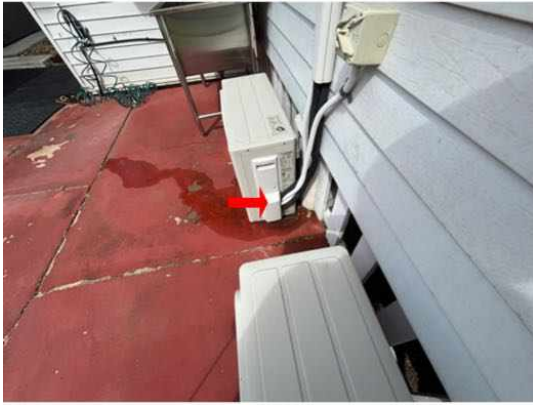
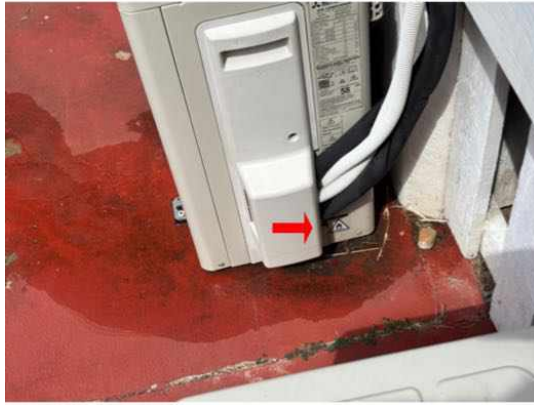
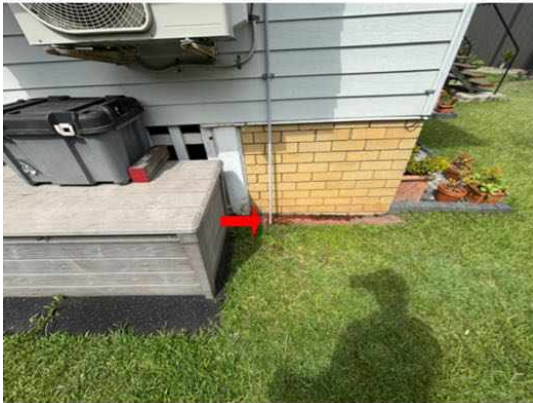
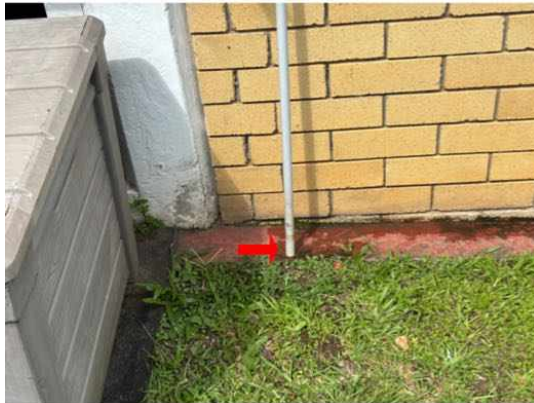
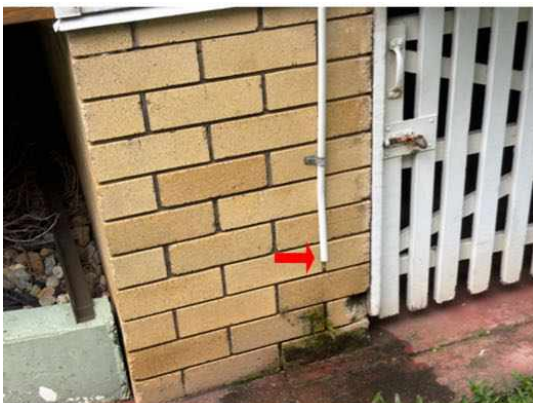
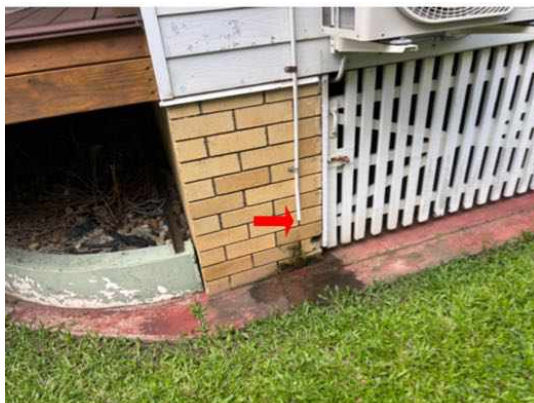
### Finding 6.03

Building:	Main Building
Location:	All External Areas
Finding:	Air conditioner - Disconnected overflows
Information:	At the time of the inspection, it was noted that the air conditioner drain overflows to all the units were not connected to the storm water drainage and as a result are draining next to the foundations of the dwelling.

Air conditioning overflows that are not connected to the storm water drainage and are draining near the foundation can create excessive moisture in the surrounding area.

Such leaking creates an environment which is conducive to an array of defects, including water damage to associated building elements and the attraction of termite or timber pest infestation.

It is highly recommended that a licensed plumber be appointed to connect the A/C overflow in order to prevent such an environment from being created. These minor works should be carried out as soon as possible.

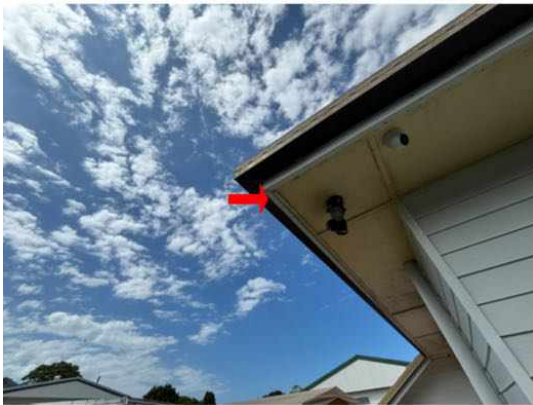
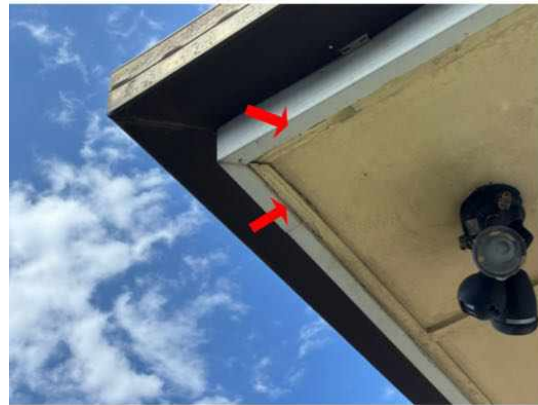
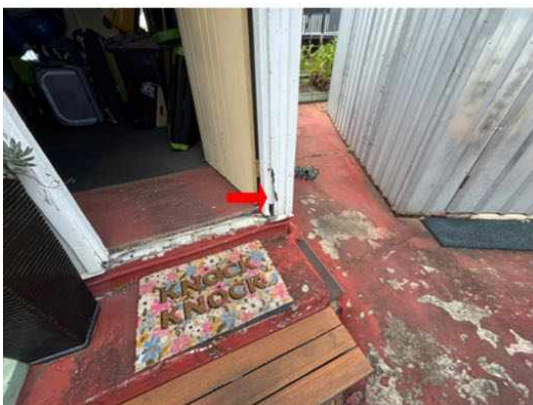
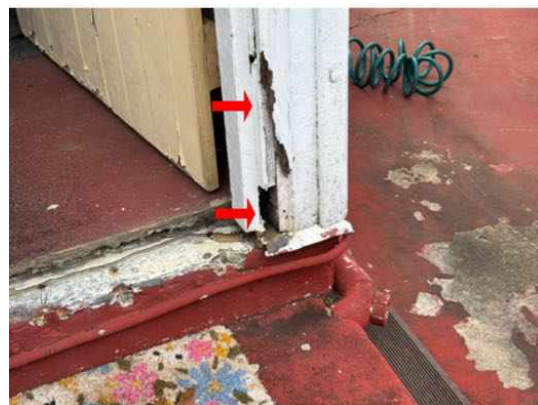
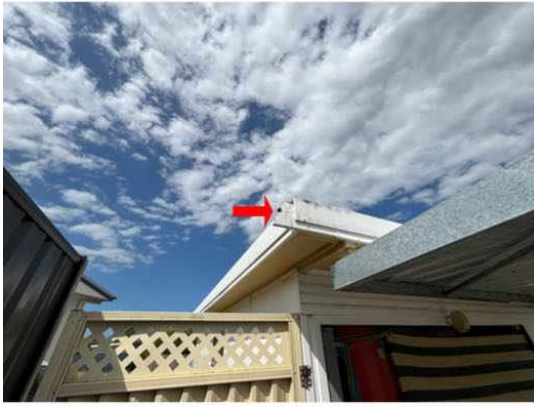
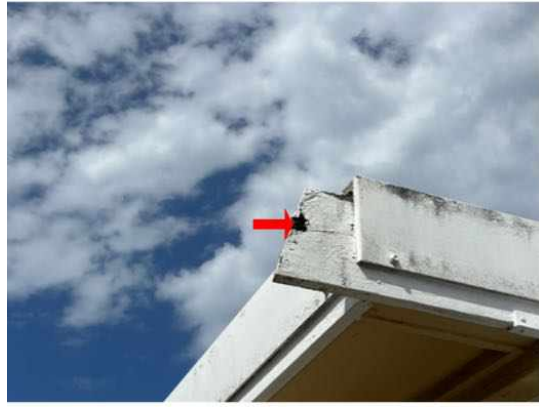
### Finding 7.01

Finding: Wood rot

Information: At the time of the inspection, it was noted that there was evidence of wood rot to several timber building elements around the dwelling. This may be due to the age of the timber building elements and general weathering.

This building element shows evidence of wood rot. Wood rot, also known as Fungal Decay, occurs when timbers and other cellulose building materials are exposed to damp conditions on an ongoing basis.

Early intervention and regular maintenance, particularly of exterior timbers, will prolong the useful life of these building elements. Prior to any works being performed, the cause of the moisture that has created the visible wood rot should be identified and addressed in a suitable manner. Replacement of affected timbers may then be a necessary step in protecting surrounding building elements from such deterioration.

A qualified carpenter or registered builder may also be required to replace affected building materials.

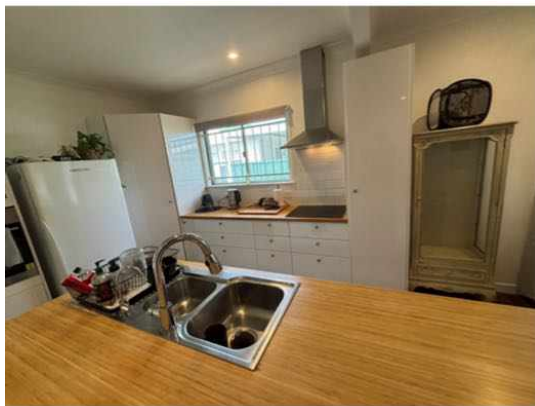
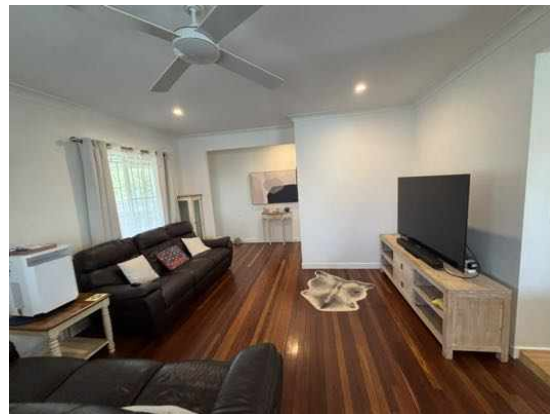
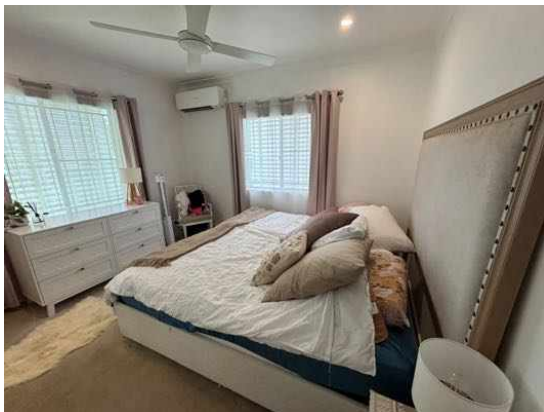
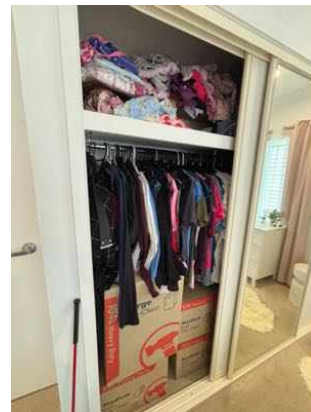
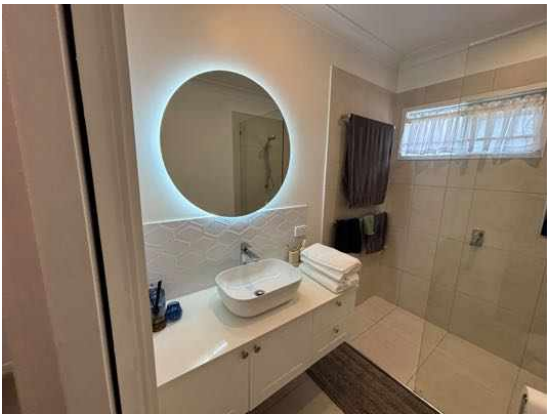
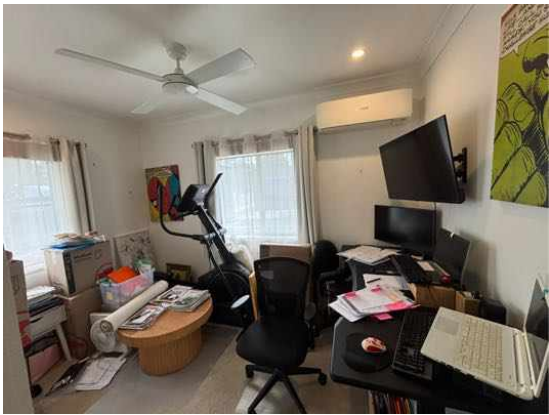
Building: Main Building  
Location: All Internal Areas  
Finding: Obstructions and Limitations - Internal areas  
Information: These photographs are an indication of the obstructions and limitations which impeded full inspection of the property of the internal areas at the time of inspection. These obstructions can hide an array of defects and should be removed to allow full inspection to be carried out. A re-inspection is recommended once the areas are made accessible.

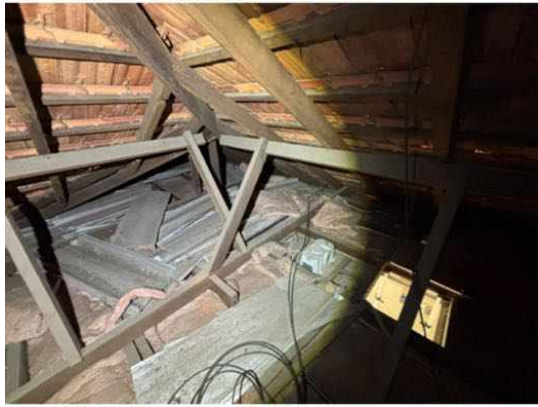
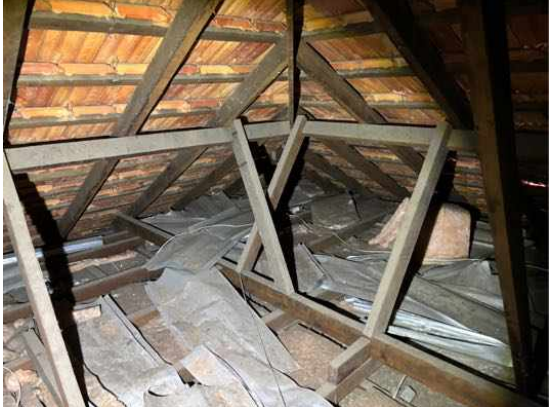
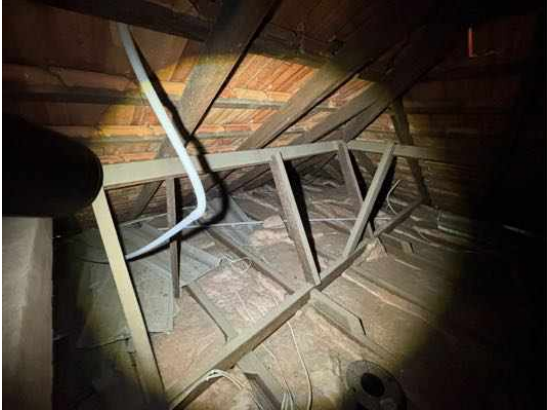
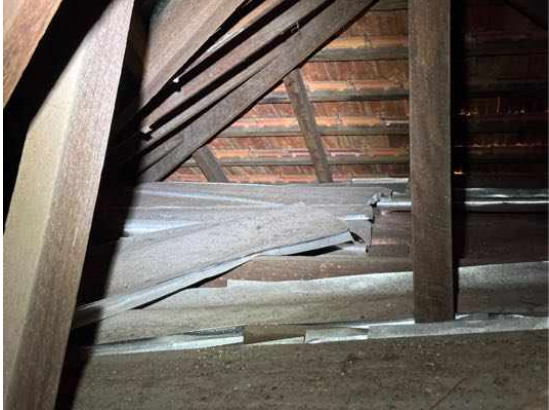
Building: Main Building  
Location: Roof Void  
Finding: Obstructions and Limitations - Roof cavity  
Information: These photographs are an indication of the obstructions and limitations which impeded full inspection of the property of the roof cavity

at the time of inspection. These obstructions can hide an array of defects and should be removed to allow full inspection to be carried out. A re-inspection is recommended once the areas are made accessible.

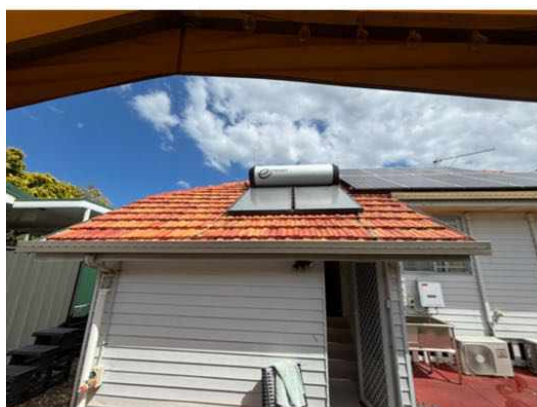
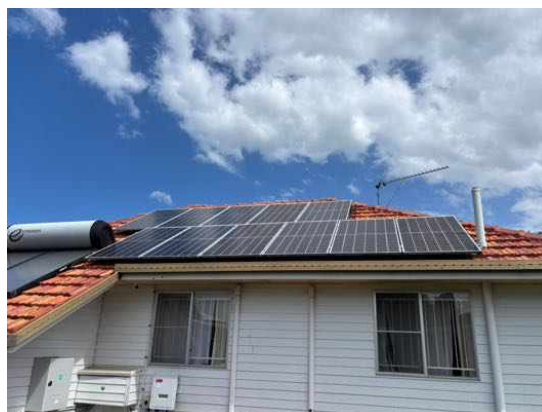
Building:	Main Building
Location:	Roof Exterior
Finding:	Obstructions and Limitations - Roof exterior
Information:	These photographs are an indication of the obstructions and limitations which impeded full inspection of the property of the roof exterior

at the time of inspection. These obstructions can hide an array of defects and should be removed to allow full inspection to be carried out. A re-inspection is recommended once the areas are made accessible.

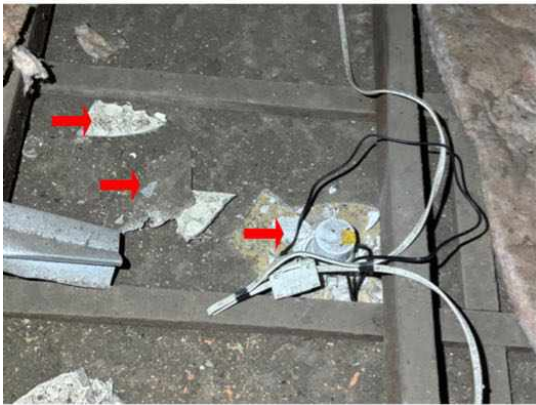
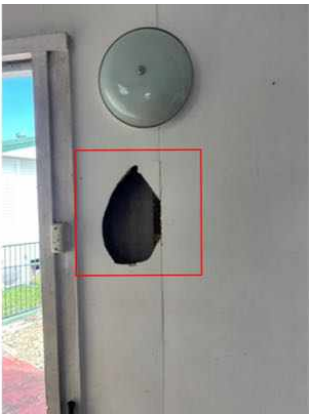
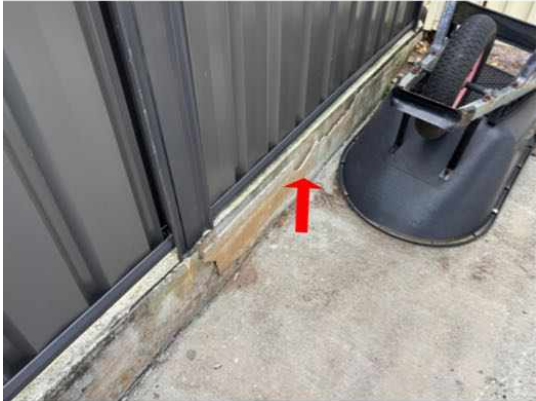
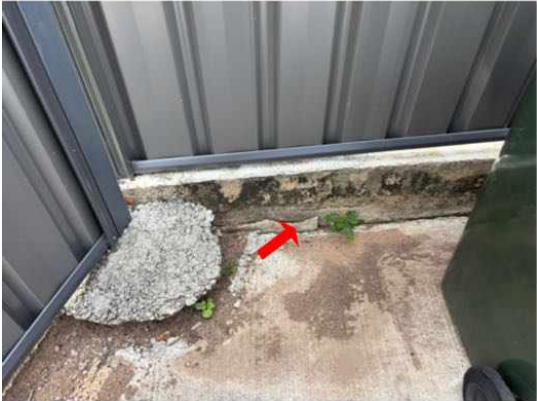
Building:	Main Building
Location:	All Areas
Finding:	Suspected Asbestos
Information:	At the time of the inspection, it was noted that there were fibre cement style products found around the dwelling that are suspected to be Asbestos Containing Material. Care should be taken when dealing with these products until testing can be done for Asbestos.

An Asbestos inspection should be carried out to determine the full extent of any suspected Asbestos Containing Materials.

Any damaged products that are suspected as Asbestos Containing Material should be sealed to encapsulate the fibres.
