Building and Timber Pest Inspection Report

Inspection Date: Tue, 10 Mar 2026

Property Address: 6 Stuart Mould Cres, Lalor Park NSW 2147,
Australia

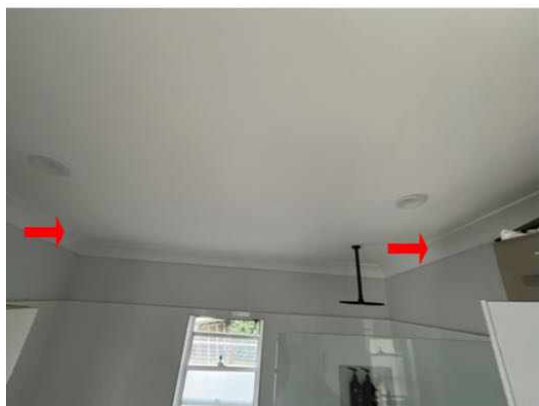
Building:	Main Building
Location:	Laundry
Finding:	Mould present - Ventilation
Information:	Evidence of mould growth was noted, which is believed to have grown due to lack of ventilation to the area.

Generally, the client is advised to ensure that the general environment is free of moisture and humidity to aid in the prevention of mould formation and development. Any mould found during the inspection should be cleaned immediately by a cleaning contractor or the homeowner as applicable.

Although the exhaust fan was found to be working at the time of inspection, however a licensed electrician May be appointed to ensure the full exhaust fan operation.

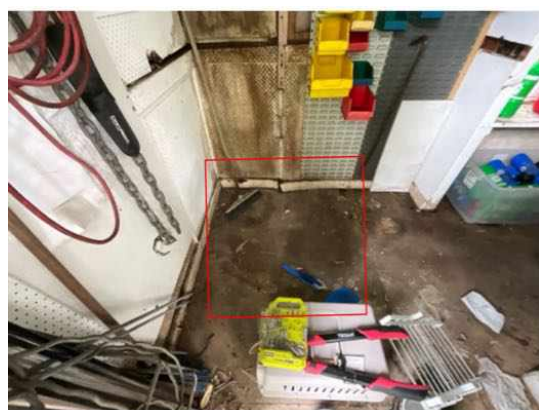
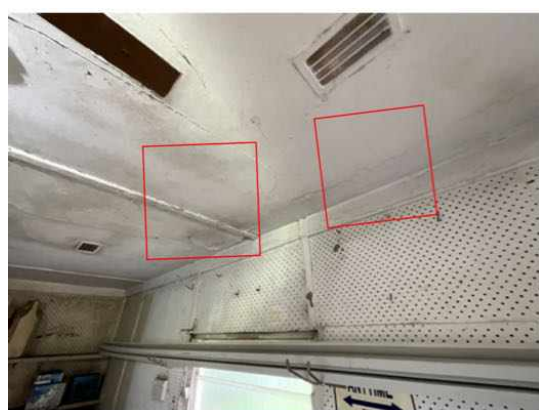
Finding 2.01

Common causes include faulty or missing flashing, cracked tiles, degraded pointing, lack of sealant and blocked weep holes. Rain penetration can also occur when water tracks horizontally under the lip of eaves and roof linings with insufficient angles, or by tracking across wall ties.

The cause of the water leak should be addressed immediately to prevent further damage. It is recommended that the water leak be resolved prior to any repairs of the damaged area, which may require localised replacement of building materials and refinishing.

Trades responsible for such works may include licensed builder, licensed plumber, roof restoration specialist and landscaper.

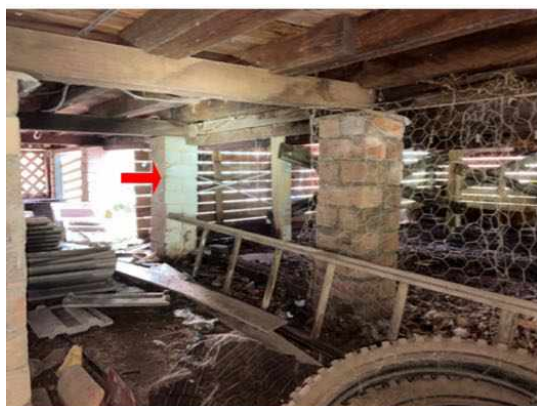
Building: Main Building
Location: Subfloor
Finding: Piers -- Leaning (major)
Information: Some piers to the subfloor are not supporting the suspended structure adequately, indicating that their structural integrity have been affected. The cause of this instability is likely to be caused by movement / subsidence of the pier due to moisture.

Inadequate support is likely to lead to a range of other secondary major and minor defects and hence immediate rectification to this pier is required by a registered builder. Monitoring and when required improving site drainage is recommended to avoid further movement / subsidence of the affected piers.

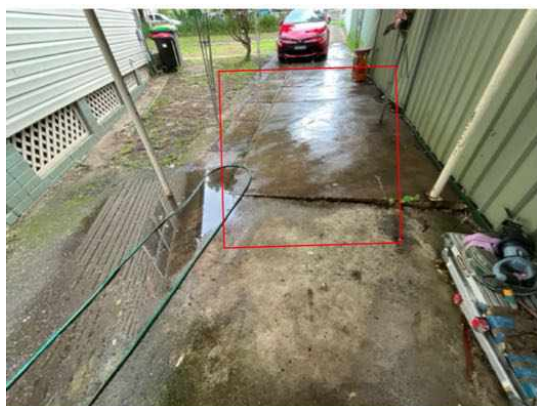
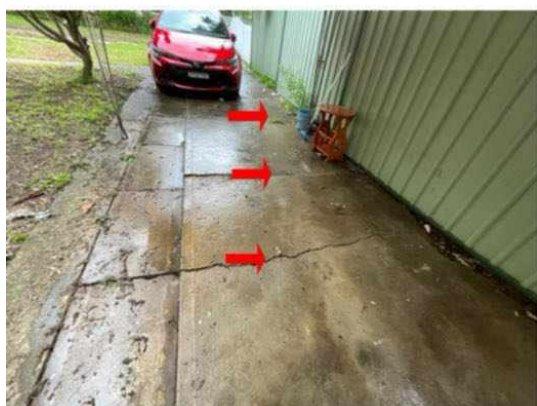
Finding 2.05

Building:	Main Building
Location:	Carport & driveway
Finding:	Subsidence - Local trees and vegetation
Information:	Trees and other vegetation can have a significant local effect on drying of soils. Over a number of years, especially during drought conditions, adjacent trees and vegetation may draw excessive moisture from the soils. The opposite may also occur, where swelling of the soil results when the trees decline or are removed.

As the cumulative moisture deficient is reversed, the surface level around the tree (and adjoining subfloor) will rise and expand laterally. This is often damaging to structures unless the foundations have been strengthened or designed to cope with the effect.

Subsidence can have complex and varying causes, which will influence the required remedial works. It is advised to begin by consulting a structural engineer to determine the required scope of works. This generally includes some form of underpinning, as well as addressing the underlying cause. Consultation with a geotechnical engineer may also be necessary.

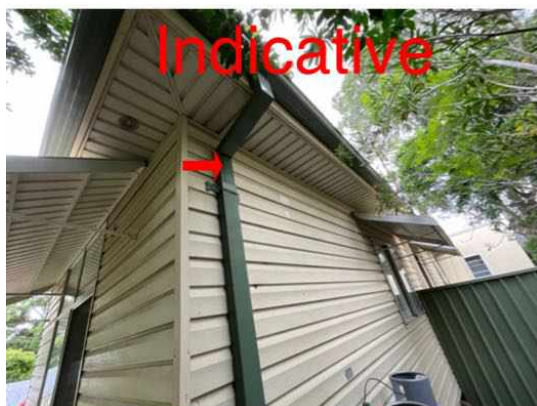
Building:	Main Building
Location:	Multiple areas of roof plumbing
Finding:	Water leak - External
Information:	Water leaks were found to be present to exterior plumbing work. Leaks are generally caused by deterioration of the plumbing elements over time, due to exposure to weather conditions, but may have also been caused by minor impact damage.

Such leaking creates damp conditions in the affected area, causing potential for water pooling and subsequent water damage if left unattended. These conditions may also attract termite attack, particularly if the area is subject to minimal levels of sun throughout daylight hours.

It is highly advised that a licensed plumber be appointed to rectify any water leaks that may be present. Areas of repair and replacement of plumbing fittings and fixtures may be required and, as such, a quotation should be sought.

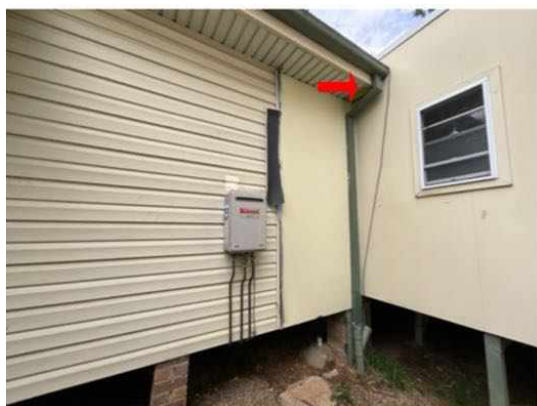
Finding 3.03

Building:	Main Building
Location:	Multiple areas
Finding:	Building element - Damaged
Information:	Breakage occurs generally when the building materials have either aged and decayed, or as a result of damage (accidental or deliberate).

Repair and/or replacement of broken elements is advised to ensure that additional secondary defects do not arise as a consequence. Such works are necessary, as all building elements play a key role in the operation and function of the overall structure and its performance.

A relevant tradesperson should be appointed to repair or replace the affected building element prior to any subsequent damage being caused.

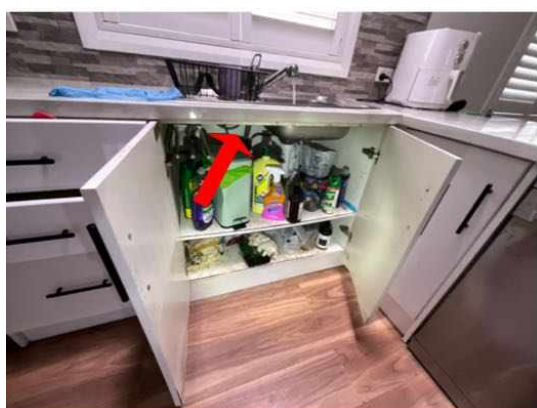
Finding 3.04

Finding: Water leak - Active

Information: Generally, water leaks occur when a particular area of the property is not weather or water tight. As the surrounding area was found to be damp at the time of inspection, the leak is considered ongoing and hence requires urgent action.

Regardless of the location, even minor leaks that are left unmanaged can lead to serious damage of associated building elements and result in the need for replacement of building materials. Mould and other hazards such as electrical hazards may also arise if the leak is left to develop.

It is highly advised that the cause of the leak be identified and resolved immediately by a licensed plumber to prevent any further damage. Depending on the extent of the damage previously sustained, repair and/or replacement of any affected building materials may be required.

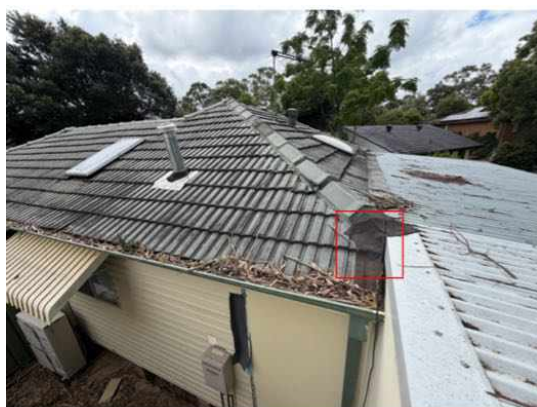
Premature ageing and secondary building defects are imminent where roof plumbing is missing or inadequately installed. Additionally, water pooling also creates an environment that is susceptible to termite and pest infestation.

A roofing plumber should be appointed as soon as possible to install relevant roof plumbing materials, ensuring that no further damage is sustained.

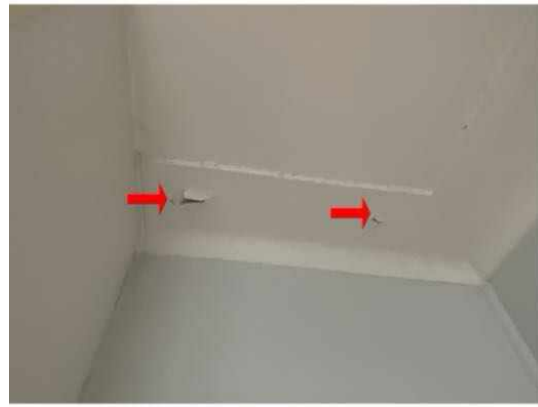
Inadequate surface preparation can also cause these failures, especially when paint is applied to bare wood or a very porous surface without first applying a primer.

A qualified painter should be appointed to rectify the problem.

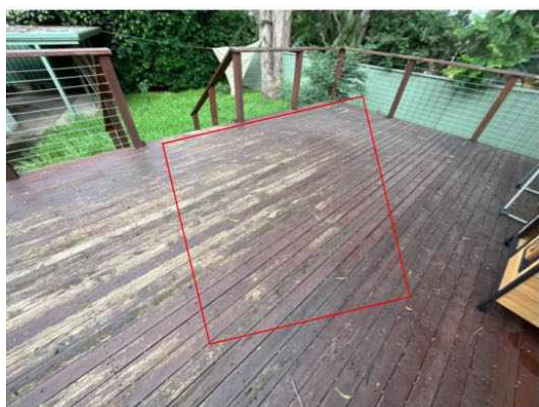
Building:	Main Building
Location:	Deck
Finding:	Timber - exposed to weather
Information:	External timbers that are frequently exposed to harsh weather conditions require adequate protection in order to maintain their condition. Where timbers have not been painted or treated adequately, general deterioration is likely to occur at an accelerated rate.

If left unattended, replacement of these timbers is likely to be necessary in the short-term future. Adequate treatment of these timbers is required as soon as possible by a painting contractor or general handyman.

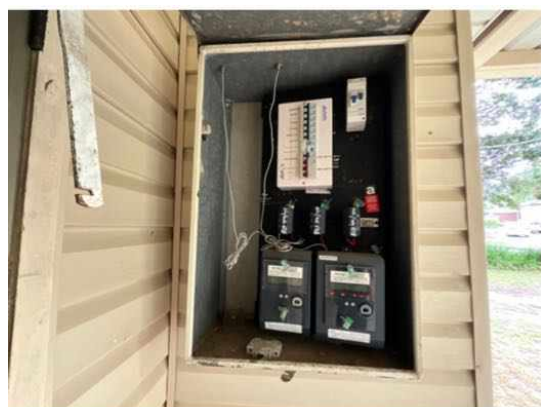
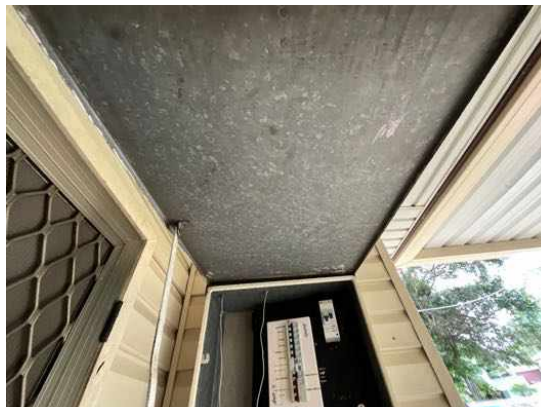
A durable notice should be placed in the switchboard unit to indicate current termite barriers. At the time of inspection, it appeared as though no termite management system has been installed, with no evidence to suggest preventative works taking place.

The client may consider gaining further advice from a pest controller as to the costs and procedures involved with this application. It is recommended that obtaining such advice be a short-term priority.

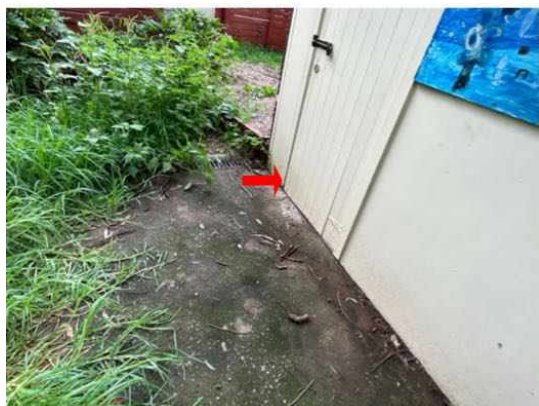
Early intervention and regular maintenance, particularly of exterior timbers, will prolong the useful life of these building elements. Prior to any works being performed, the cause of the moisture that has created the visible wood rot should be identified and addressed in a suitable manner. Replacement of affected timbers may then be a necessary step in protecting surrounding building elements from such deterioration.

A licensed plumber may be appointed to assess the cause of excessive moisture and to provide advice on any remedial works as required. A licensed carpenter may also be required to replace affected building materials.
