Building and Timber Pest Inspection Report

Inspection Date: Thu, 22 Jan 2026

Property Address: 13 Durali Road, Glenmore Park NSW 2745

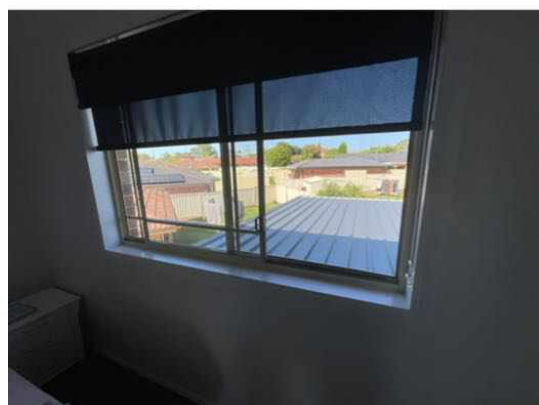
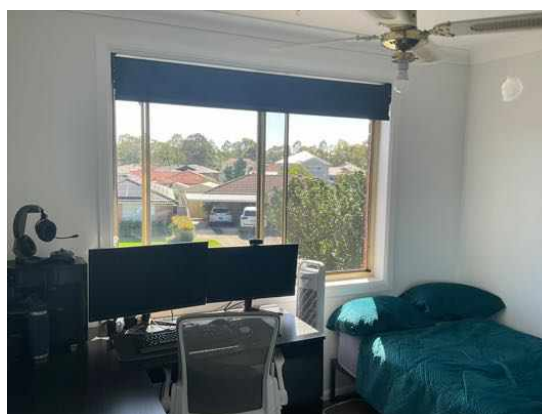
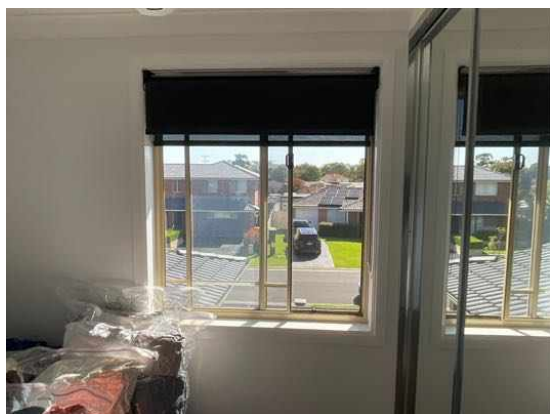
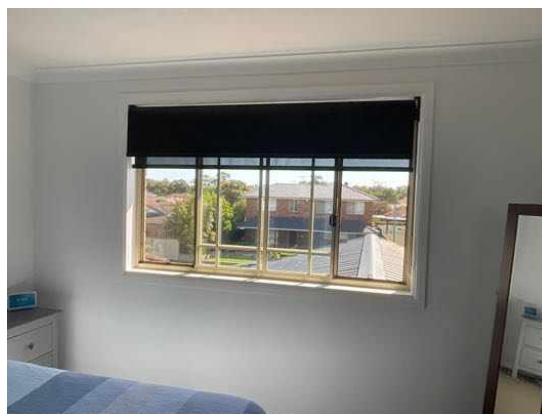
Building:	Main Building
Location:	All Areas > Upstairs
Finding:	Caution: Missing Window Restriction Devices.
Information:	Please note that this is highlighted as a caution only.

It has been noted that window restriction devices are either missing or not installed on the affected windows.

It is strongly recommended that window restrictors be installed to mitigate this safety hazard. A qualified window specialist should be appointed to fit the appropriate safety devices as soon as possible to comply with safety standards and ensure the protection of occupants.

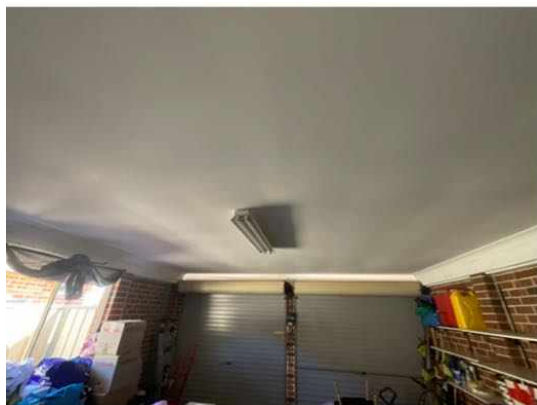
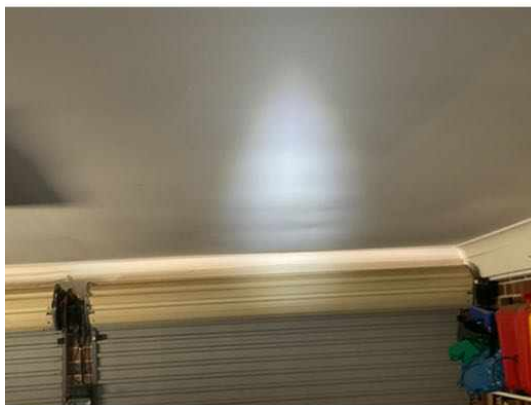
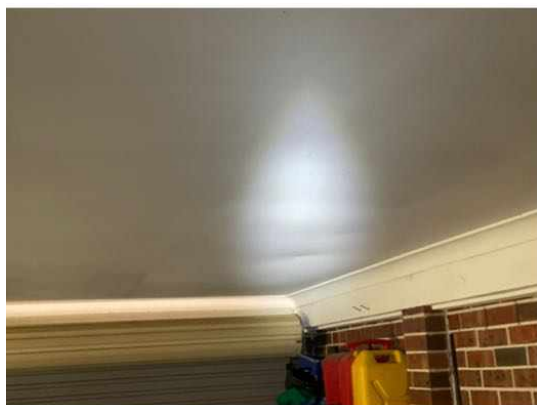
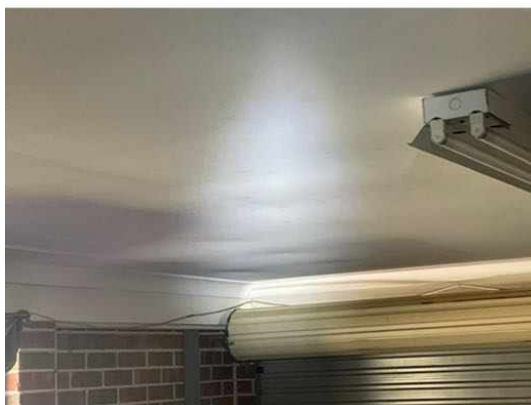
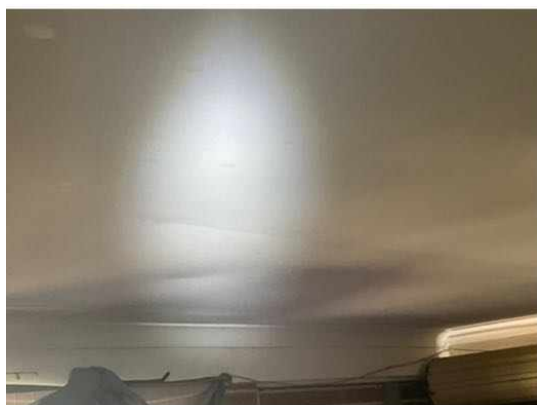
Building:	Main Building
Location:	Garage
Finding:	Ceiling lining - Ceiling Sagging
Information:	During the inspection, the ceiling lining in the garage were found to be uneven or slightly sagging. This type of defect is commonly observed in garage areas and is typically attributed to general wear over time.

- Age-related deterioration of ceiling fixings (e.g. nails, screws, or adhesive/glue)
- Moisture exposure or humidity-related expansion, often exacerbated by incorrect or low-grade paint coatings that fail to protect the ceiling surface adequately

While the defect is currently considered minor and does not appear to compromise the structural integrity of the ceiling, it may worsen over time if left untreated. Early signs such as minor sagging may eventually lead to partial detachment of ceiling sheets or visible cracking along joins or edges.

Repairs may involve re-gluing and re-fixing the ceiling sheets to the joists, a task generally undertaken by qualified plasterers or general interior trades. In some cases, repainting with moisture-resistant coatings may also be appropriate, particularly in garages where humidity levels can fluctuate.

It is recommended that buyers allow for maintenance or minor repair costs in the

medium to long term and engage a relevant trade professional to assess and carry out works as needed. Timely intervention will help prevent further deterioration and maintain the visual and functional condition of the ceiling.

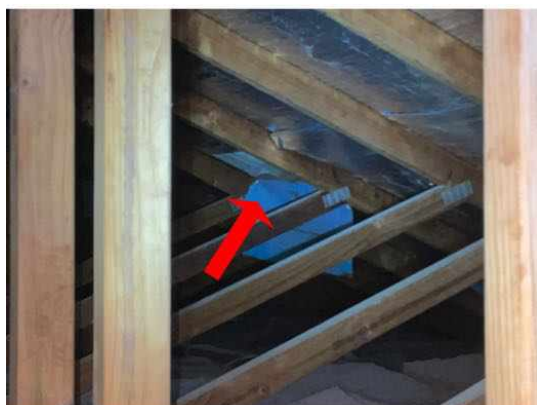
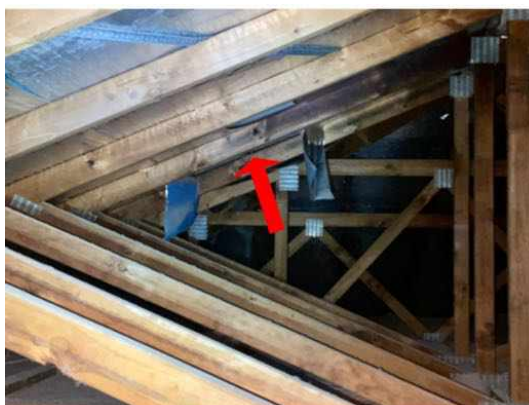
Finding 3.02

Building: Main Building
Location: Roof Void
Finding: Sarking was found to be damaged in this area.
Information: Damaged Roof Sarking

Defect Classification: Minor Defect / Maintenance Item

Where sarking is damaged, its ability to insulate and prevent moisture ingress is compromised. This may reduce the property's energy efficiency and increase the risk of moisture penetration, particularly from condensation or leaking roof tiles.

Any holes or damaged sections of sarking should be repaired or replaced to restore full functionality. These works should be completed by a roofing contractor or other suitably qualified tradesperson.

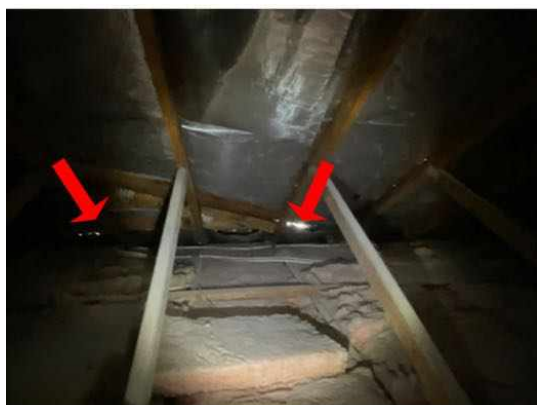
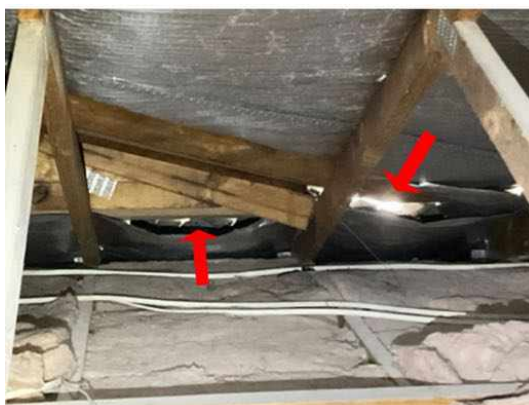
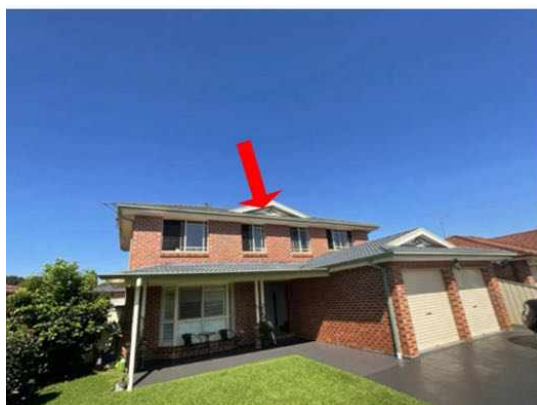
Finding 3.03

Building:	Main Building
Location:	Roof Void
Finding:	Roof flashing - Deteriorated
Information:	Observation:

The roof flashings associated with the Dutch gable were observed to be deteriorated and in poor condition at the time of inspection. This condition was noted from within the roof space, where corrosion, ageing, and general degradation of the flashing materials were evident. Roof flashings are critical components of the roof system and are typically constructed from lead, metal, or other waterproof materials. They are installed at junctions where the roof covering meets adjoining elements, such as walls or gable ends, to form a weatherproof seal and prevent water ingress.

Where roof flashings have deteriorated, failed, or become damaged, their ability to provide effective weatherproofing is significantly reduced. This increases the risk of

water penetration into the roof space and internal areas of the dwelling, particularly during periods of heavy rainfall or wind-driven rain. Ongoing moisture ingress can contribute to premature deterioration of roof framing and other building materials, and may lead to secondary defects such as internal water staining, mould growth, decay of timber elements, and potential structural issues if left unaddressed.

It is recommended that a licensed roofing plumber or suitably qualified roofing contractor be engaged as soon as practicable to carry out a detailed assessment of the Dutch gable flashings. Any deteriorated or defective flashing materials should be repaired or replaced as necessary to restore effective weatherproofing. Prompt remedial action is advised to minimise the risk of ongoing water ingress and to prevent the development of further internal damage or consequential defects.

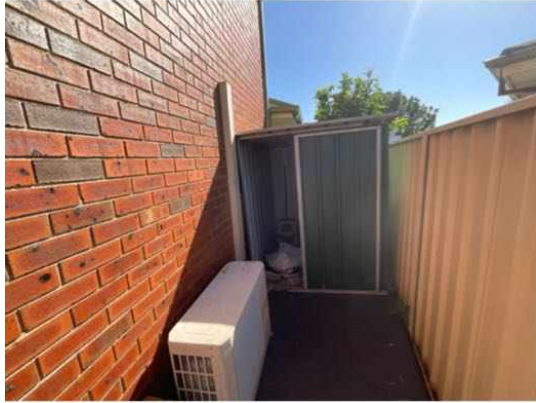
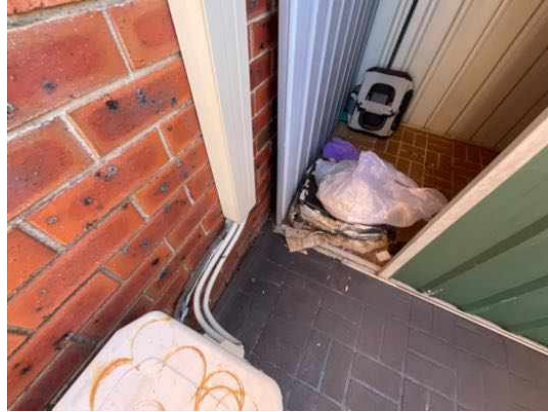
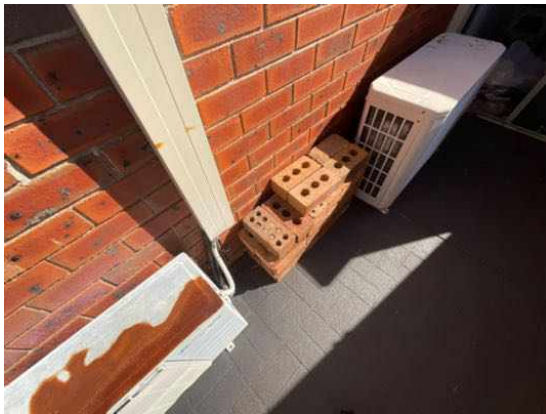
At the time of inspection, it was noted that the weep holes in the external brickwork of the property are concealed by adjacent shed and stored masonry. This creates a bridging point for termites, allowing undetected access over or around the termite barrier system and into the structure. As a result, a full inspection of this area could not be achieved.

- Concealed termite entry becomes possible when weep holes are obstructed by the shed and stored masonry.
- These obstructions also provide moist, shaded environments that are attractive to termite activity.
- Moisture build-up due to covered weep holes further increases the risk of timber pest infestation and wood decay.

- All weep holes should remain exposed and unobstructed across the entire property to allow for effective drainage and visual termite inspections.
- It is strongly advised that any material or structure covering weep holes be removed promptly, and a re-inspection carried out to ensure termite entry is not occurring undetected.
- Where removal of obstructions is not feasible, it is recommended that the area be inspected regularly, ideally every 3 to 6 months, to monitor for signs of termite activity or moisture-related damage.

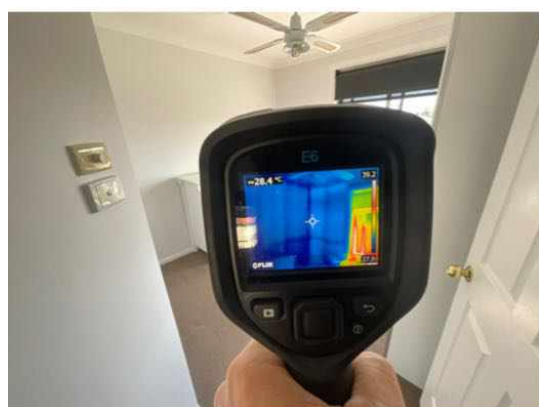
Termites release heat in the form of carbon dioxide and build mud tubes with high moisture content, which can create irregular heat patterns on surfaces such as walls, ceilings, and floors.

At the time of the inspection, no abnormalities indicating live termite activity were observed. However, it's important to note that various factors—such as obstructions, ambient temperature, and wall material/thickness—can impact the accuracy of thermal readings. In cases where surfaces are visually restricted or obstructed, a comprehensive thermal scan may not always be feasible.

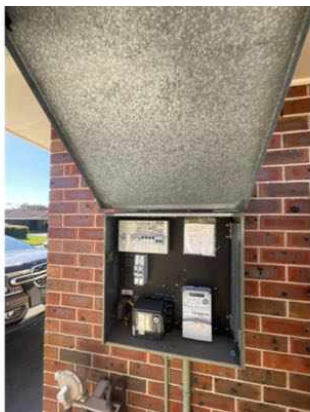
Building:	Main Building
Location:	All Areas
Finding:	Termite Management System - Missing Durable Notice..

Proper maintenance and documentation are essential to ensure continued protection. Without a visible durable notice, there is no clear indication of what system (if any) is in place, which may limit the effectiveness of future termite inspections and hinder warranty claims.

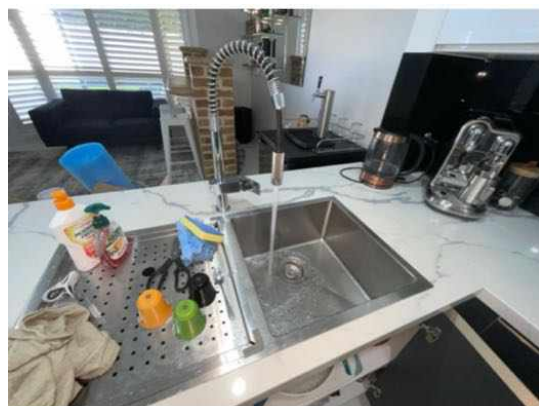
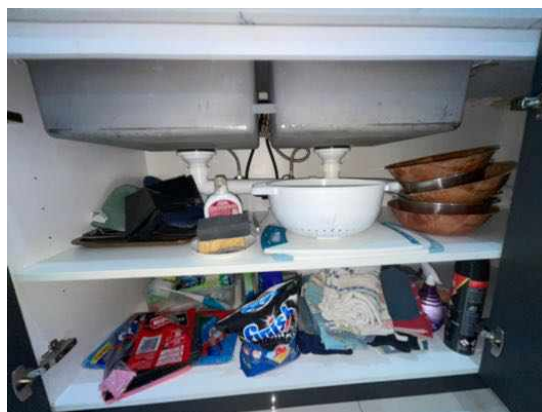
Building: Main Building
 Location: Kitchen
 Finding: Kitchen Sink – Overall Condition & Recommendations.
 Information: Observations:

- Further monitoring and testing are recommended once the tap(s) are in constant use, to identify any drainage issues or signs of slow leaks not evident during the limited inspection.
- It is recommended that the stored items beneath the sink be removed to allow for a

full re-inspection of the plumbing and cabinetry, ensuring no concealed defects are present.

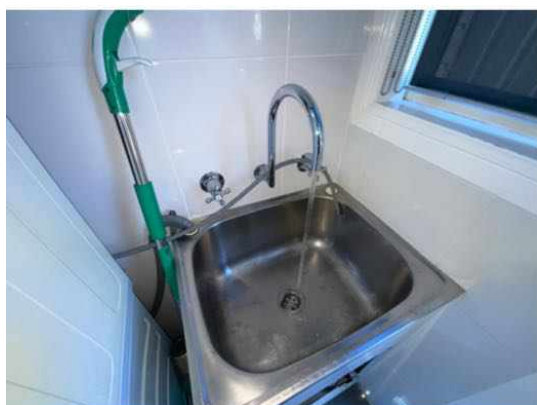
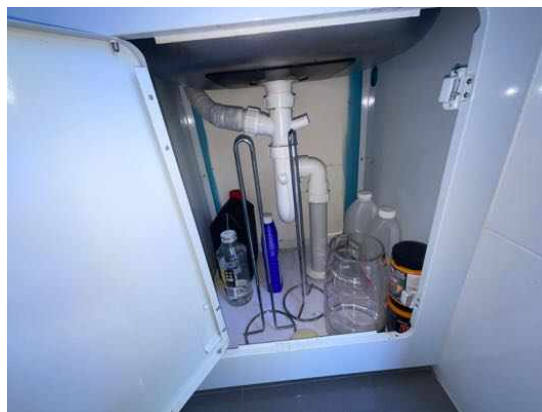
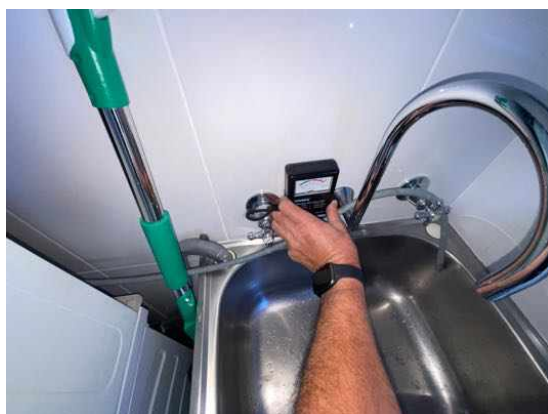
Building: Main Building
 Location: Laundry
 Finding: Laundry - Taps/Plumbing/Drainage.
 Information: Observation: Laundry Tub – Taps, Plumbing, and Cabinetry

- Further monitoring or testing is recommended once the taps are placed into regular use, to ensure no leaks develop over time and that the drainage system continues to perform adequately.
- Flexible and mould-resistant sealant should be applied to junctions between the basin and the wall to prevent water ingress that may lead to damage. Grout in wall junctions may crack and deteriorate over time. It is recommended to remove any rigid grout from junctions and replace with flexible, mould-resistant sealant in accordance with best building practices.
- Regular maintenance and prompt replacement of missing or deteriorated sealant is highly recommended, as this is a common wear-and-tear issue.
- Sealant and grouting in wet areas should be maintained as part of the long-term

care and upkeep of the property.

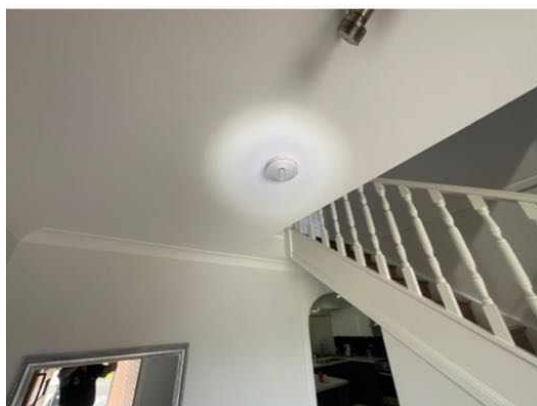
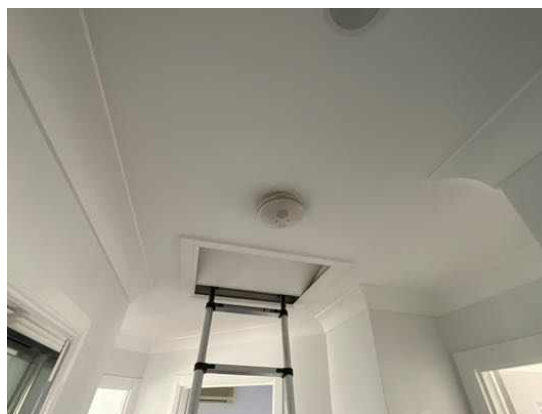
Building:	Main Building
Location:	All Areas
Finding:	Smoke Detectors / Alarms.
Information:	Reporting on the presence, type, location, or compliance of smoke detectors or alarms, including hard-wired smoke detection systems and their legislative requirements, is outside the scope of this inspection report.

- All smoke detectors be tested monthly by the homeowner.
- All systems comply with the requirements of AS 3786 and any applicable state-based legislation.

Failure to comply with these requirements may pose a serious risk to occupant safety.
