Building and Timber Pest Inspection Report

Inspection Date: Tue, 20 Jan 2026

Property Address: 251 Gundurimba Rd, Monaltrie NSW 2480, Australia

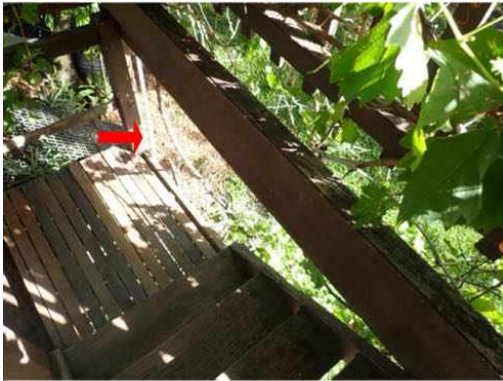
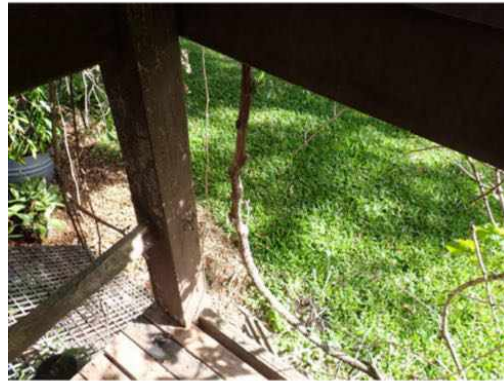
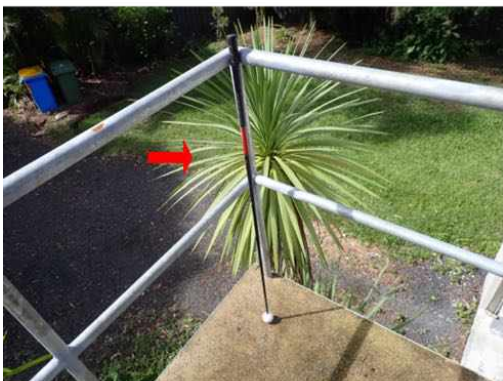
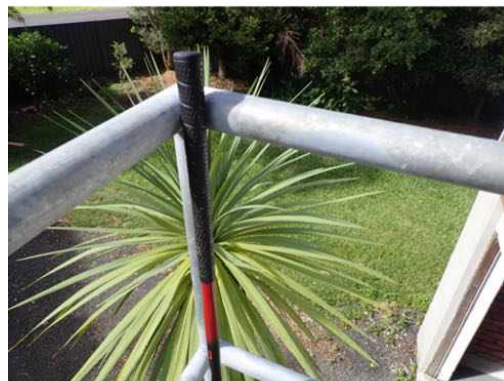
Finding 1.01

Building:	Main Building
Location:	Stairs front and rear
Finding:	Front and Rear Staircases – Insufficient Fall Protection to Balustrades
Information:	The balustrades to the front and rear staircases were found to have inadequate fall protection at the time of inspection. This presents a potential safety risk, particularly for occupants and visitors, and does not provide sufficient protection against falls. It is recommended that a suitably qualified carpenter or builder install compliant balustrades or handrails as deemed necessary to improve safety and meet current standards.

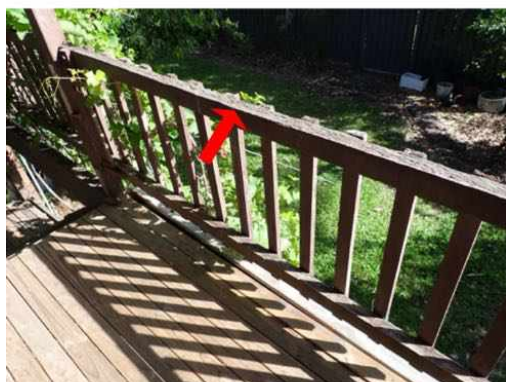
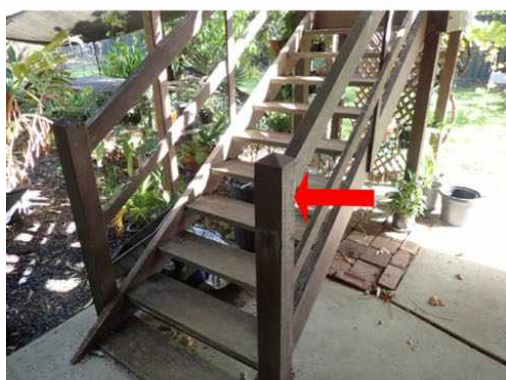
Finding 2.01

Building:	Main Building
Location:	Side decked area

Finding: Side Decked Area – Timber Stairs and Balustrade Age-Related Deterioration

Information: The timber stairs and balustrade to the side decked area were found to show age-related deterioration at the time of inspection. This may affect the structural integrity, safety, and appearance of the area if left unaddressed. It is recommended that a suitably qualified carpenter carry out repairs, maintenance, or replacement of affected components as deemed necessary to ensure the stairs and balustrade remain safe and serviceable.

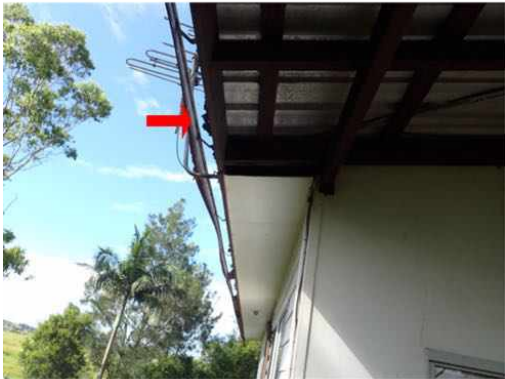
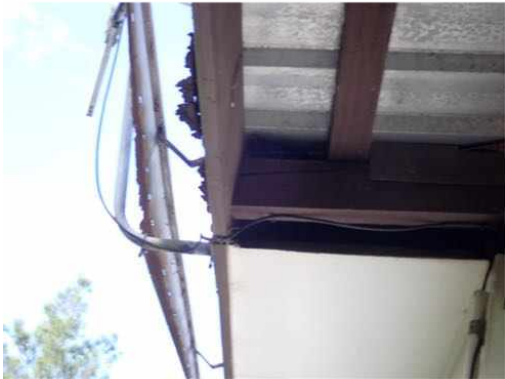
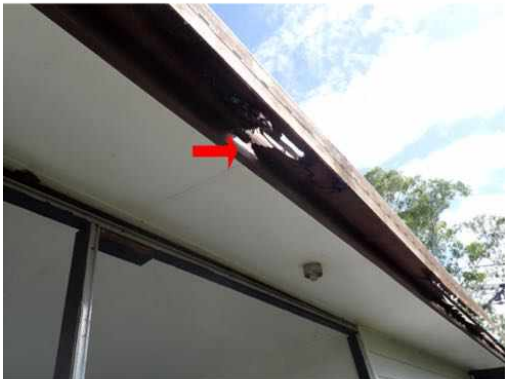
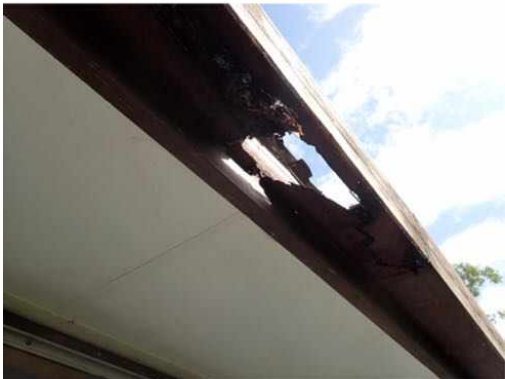
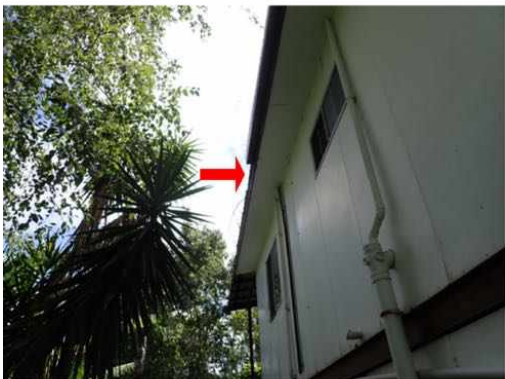
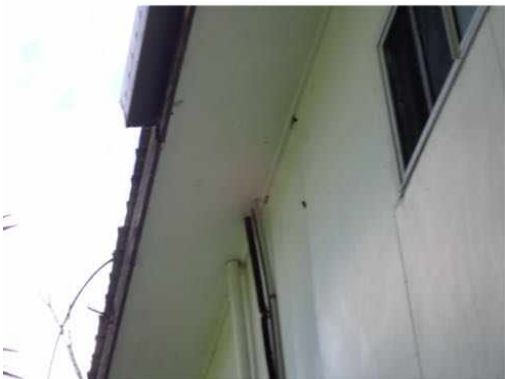
Finding 2.02

Building: Main Building

Location: Roof

Finding: Gutters – Rusted and Require Replacement

Information: The roof gutters were found to be rusted at the time of inspection, indicating age-related deterioration. Rusted gutters may leak and fail to effectively direct rainwater away from the building, potentially causing water damage to walls, foundations, and other building elements. It is recommended that a suitably qualified plumber or roofing contractor replace the affected gutters as deemed necessary to ensure proper drainage and prevent further deterioration.

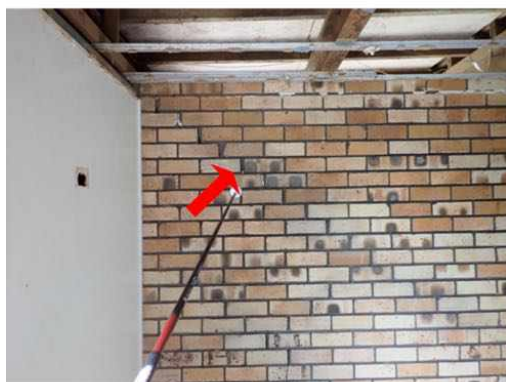
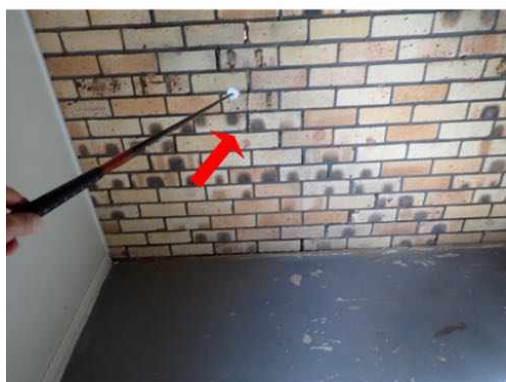
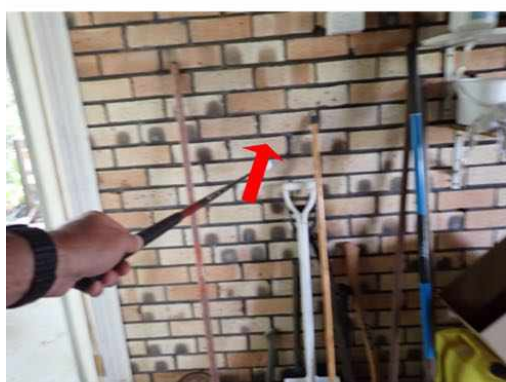
Finding 2.03

Building: Main Building
Location: Brick wall in middle of building
Finding: Brick Wall – Structural Cracks Identified
Information: Several cracks were identified to the brick wall in the middle of the building, and the cracking is considered to be structural in nature. This may indicate underlying movement or stress within the building structure. If left unaddressed, further deterioration and structural issues may occur. It is recommended that a suitably qualified structural engineer or builder assess the cracking and carry out any necessary repairs or remedial works as deemed necessary.

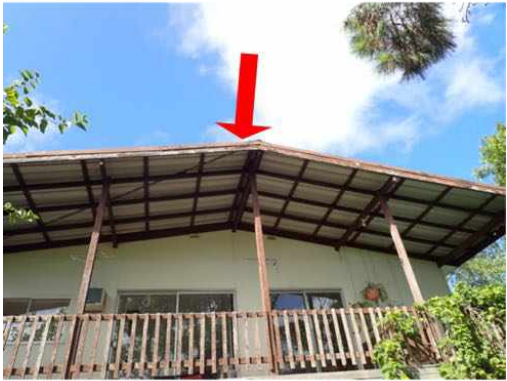
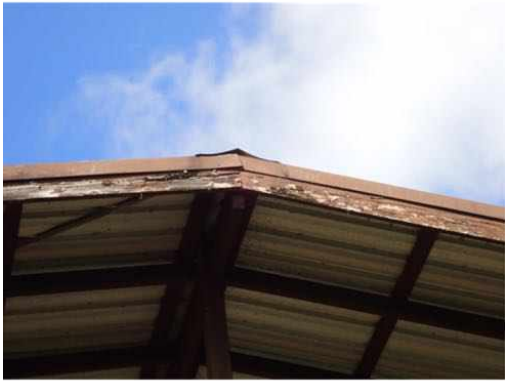
Finding 2.04

Building:	Main Building
Location:	Fascia boards
Finding:	Fascia Boards – Wood Rot Identified
Information:	Wood rot was identified to the fascia boards at the time of inspection. This is likely due to prolonged exposure to moisture and weathering. If left unaddressed, the deterioration may lead to further damage to the roof edge and associated building materials. It is recommended that a suitably qualified carpenter or builder repair or replace the affected fascia boards as deemed necessary to prevent further deterioration.

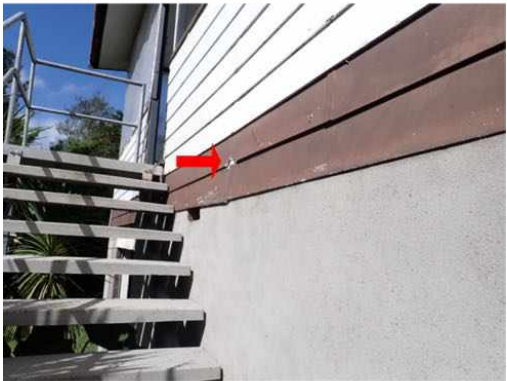
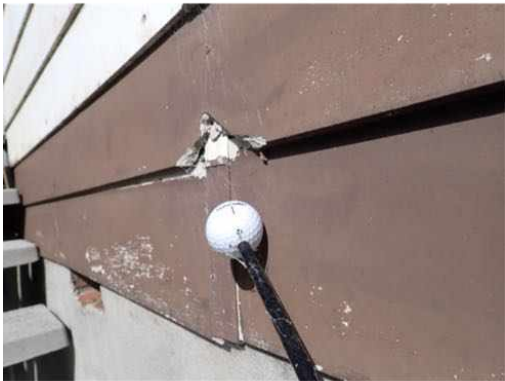
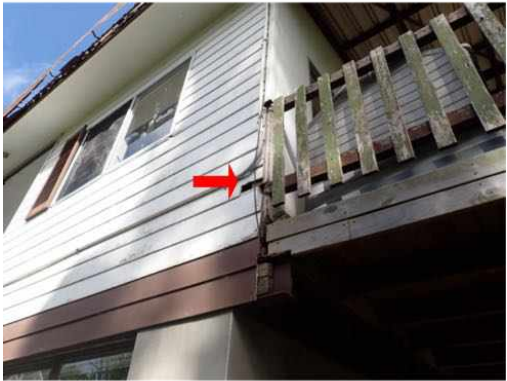
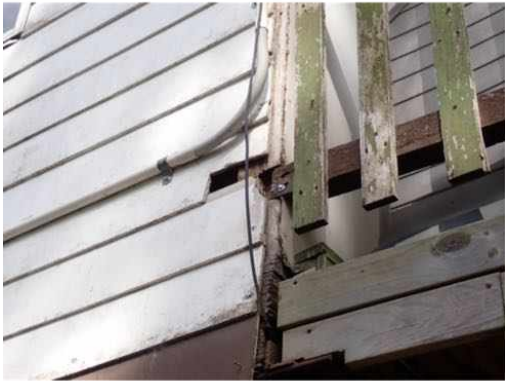
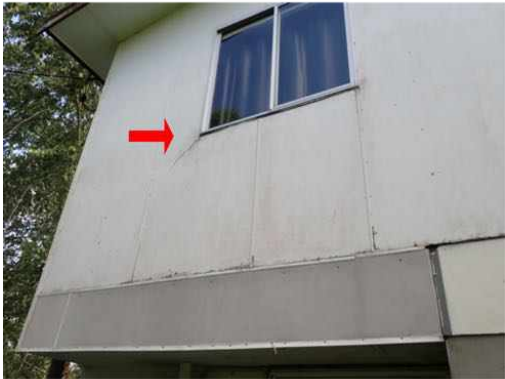
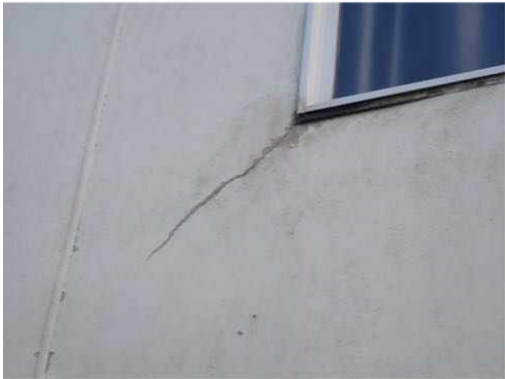
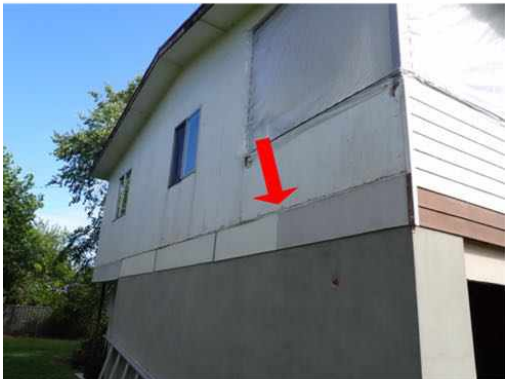
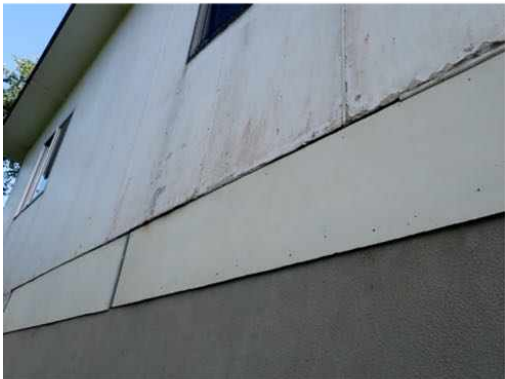
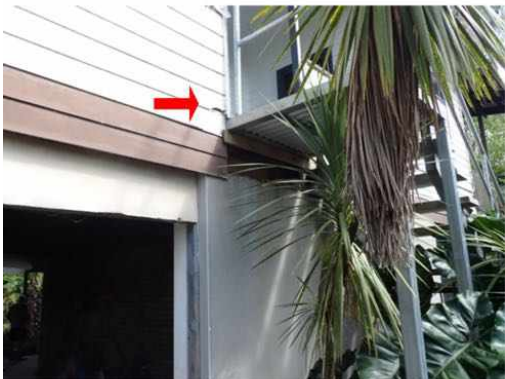
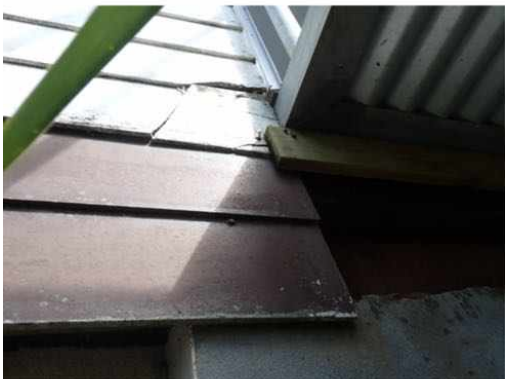
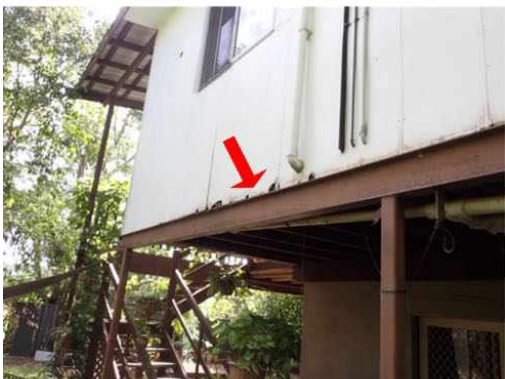
Finding 2.05

Building: Main Building
Location: External walls
Finding: External Cladding – Damage at Multiple Locations
Information: Damage was identified to the external cladding at multiple locations at the time of inspection. This may allow moisture ingress and lead to further deterioration of the building materials if left unaddressed. It is recommended that a suitably qualified carpenter or builder repair or replace the affected cladding as deemed necessary to maintain the integrity of the building exterior.

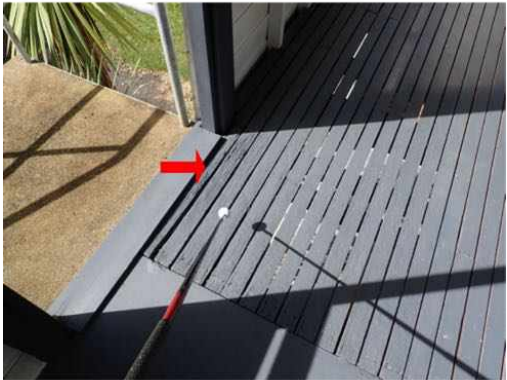
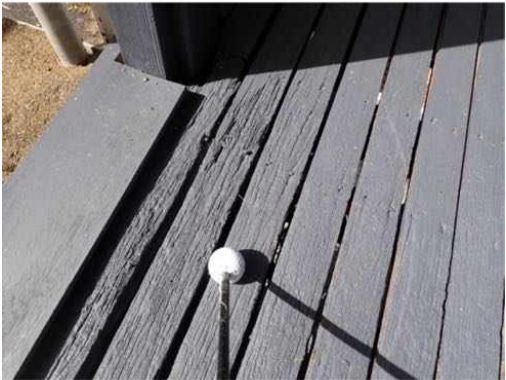
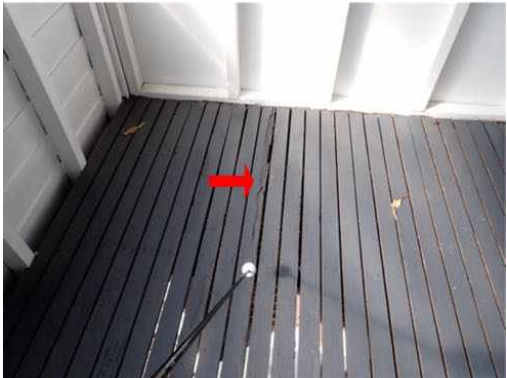
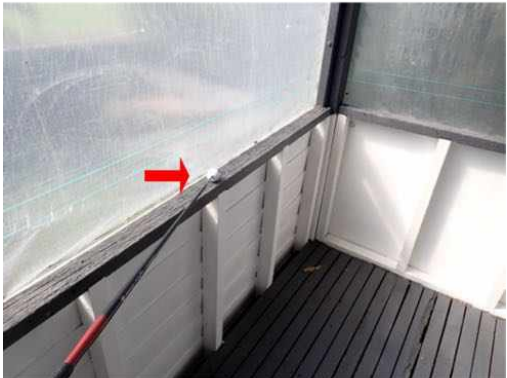
Finding 2.06

Building: Main Building
Location: Front decked area
Finding: Front Timber Decked Area – Age-Related Deterioration to Decking and Handrail/Balustrade
Information: Age-related deterioration was identified to the front timber decking and the handrail/balustrade at the time of inspection. This is consistent with prolonged exposure to weathering over time. If left unaddressed, the condition may continue to deteriorate and affect the safety and serviceability of the deck. It is recommended that a suitably qualified carpenter carry out maintenance, repairs, or replacement of affected components as deemed necessary.

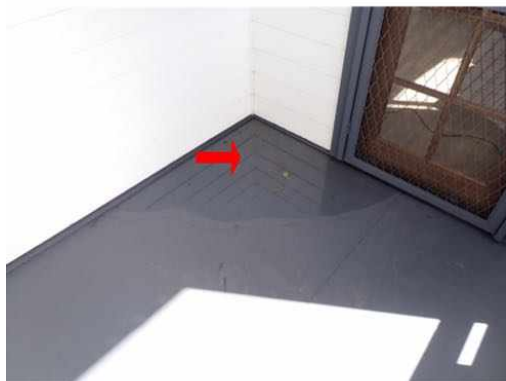
Finding 2.07

Building:	Main Building
Location:	Front decked area
Finding:	Top Floor Entry Area – Water Pooling
Information:	Water pooling was observed in the top floor entry area at the time of inspection. This may be due to poor drainage, surface levels, or inadequate fall away from the building. If left unaddressed, ongoing moisture exposure may lead to deterioration of surrounding building materials. It is recommended that a suitably qualified tradesperson assess the area and carry out drainage or surface repairs as deemed necessary to prevent further water accumulation.

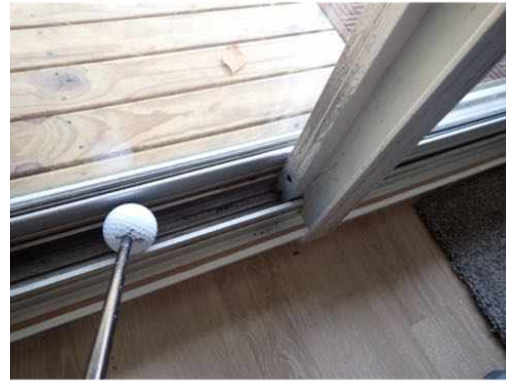
Finding 3.01

Building:	Main Building
Location:	Side door out to decked area
Finding:	Sliding Door to Deck Area – Difficult to Operate
Information:	The side sliding door providing access to the decked area was hard to open and close at the time of inspection. This is likely due to worn rollers, debris in the track, or poor alignment. It is recommended that a suitably qualified carpenter, glazier, or general handyman inspect and repair the door as deemed necessary to restore smooth operation.

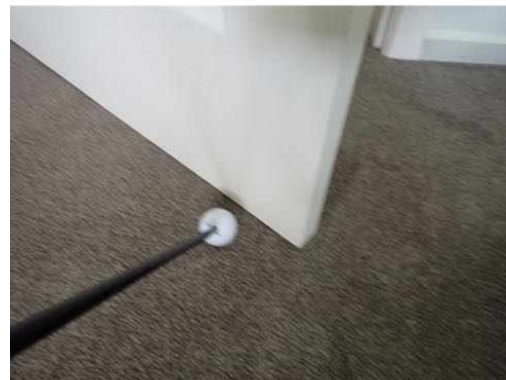
Finding 3.02

Building:	Main Building
Location:	Bedroom
Finding:	Bedroom Door – Catching on Carpet
Information:	The bedroom door was observed to be catching on the carpet when opening and closing at the time of inspection. This is likely due to carpet height, poor door clearance, or minor door/frame misalignment. It is recommended that a suitably qualified carpenter or general handyman adjust or trim the door as deemed necessary to allow smooth operation and prevent further wear to the door or floor coverings.

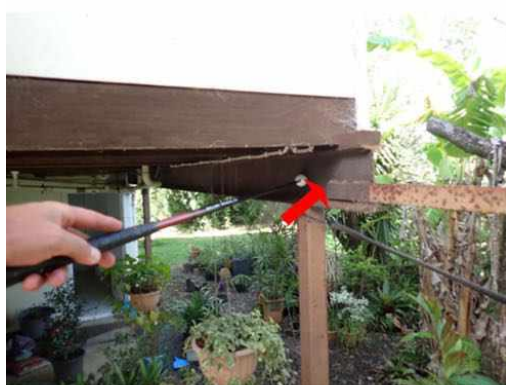
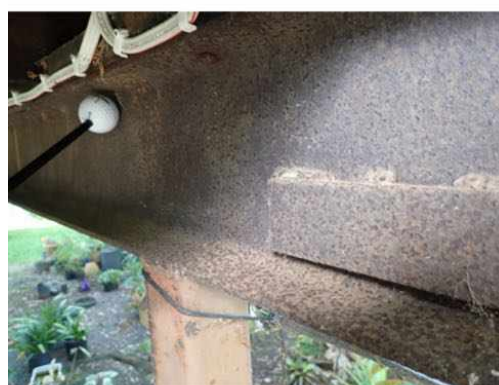
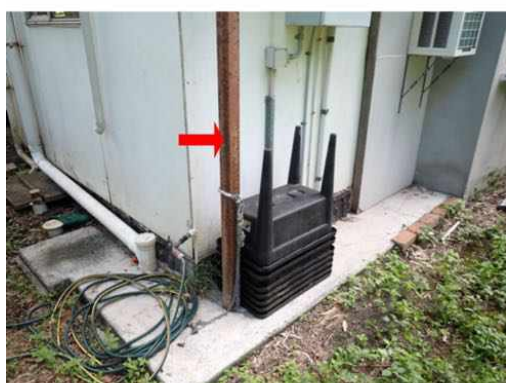
Finding 3.06

Building:	Main Building
Location:	Rear of building
Finding:	Rear of Building – Surface Rust to Steel Post and Beam
Information:	Surface rust was observed on the steel post and beam at the rear of the building at the time of inspection. While the rust appeared to be superficial, ongoing corrosion may lead to deterioration of the steel over time if left unaddressed. It is recommended that a suitably qualified tradesperson clean, treat, and protect the affected steelwork as deemed necessary to prevent further corrosion.

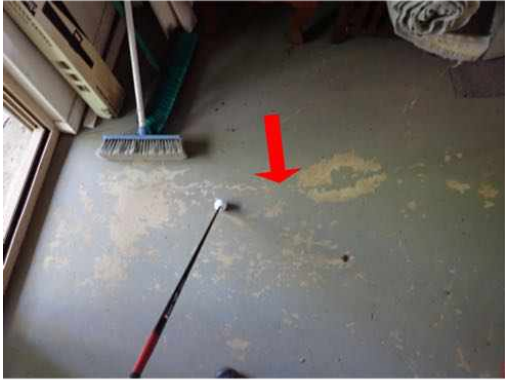
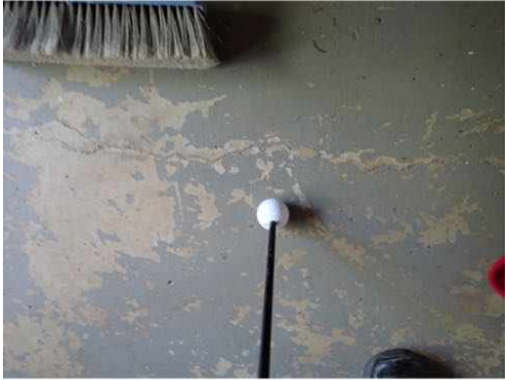
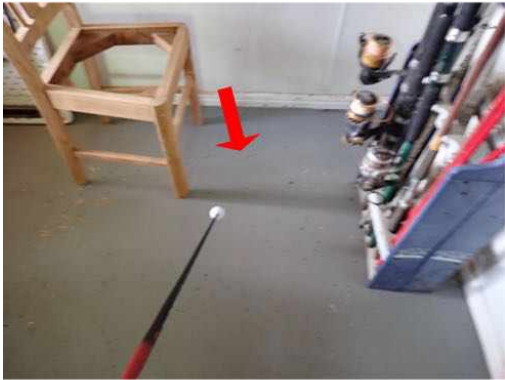
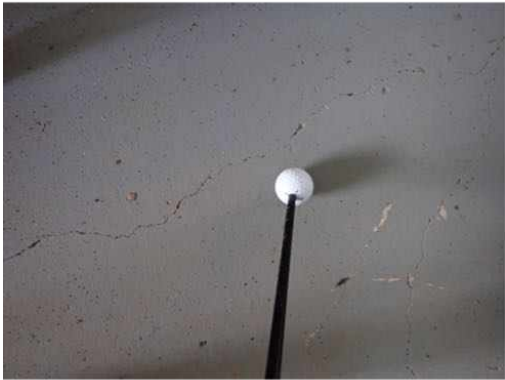
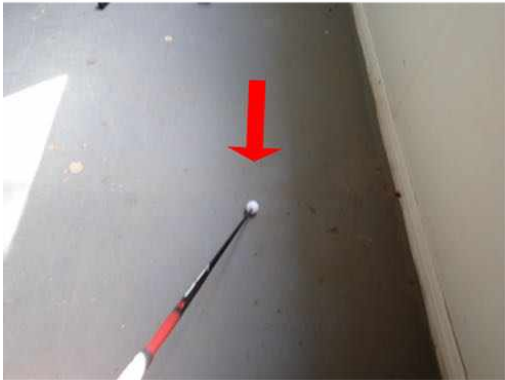
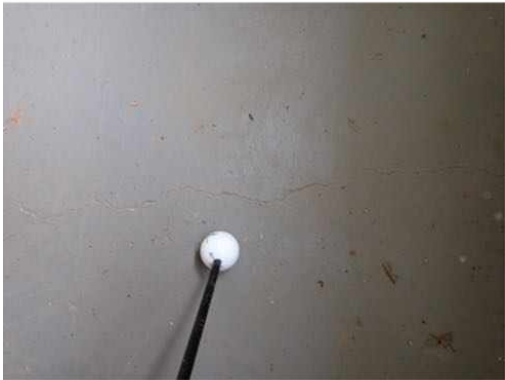
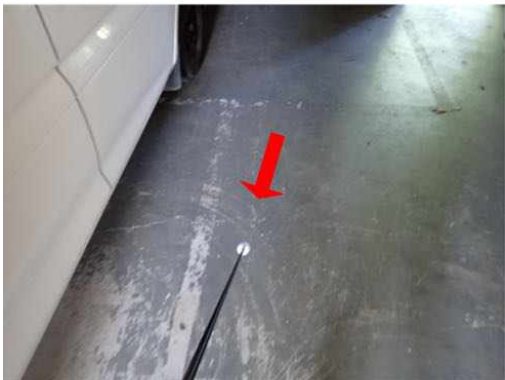
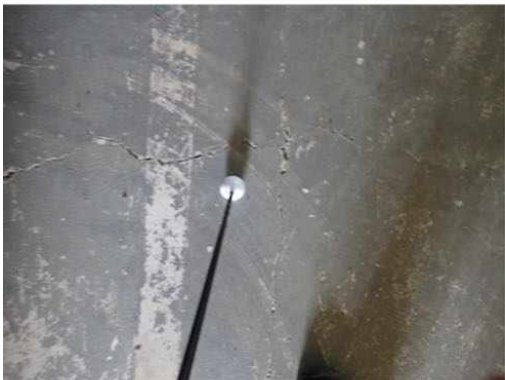
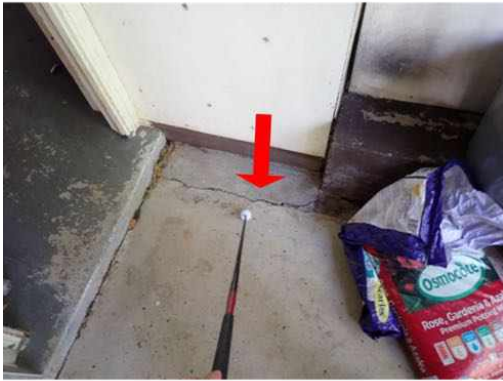
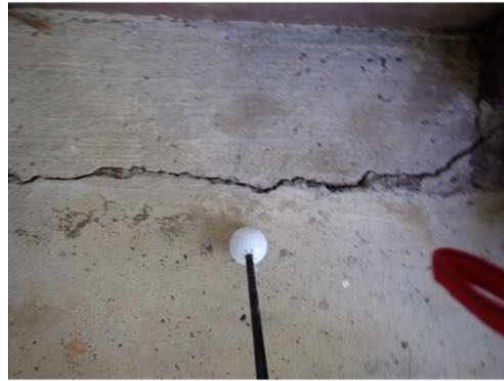
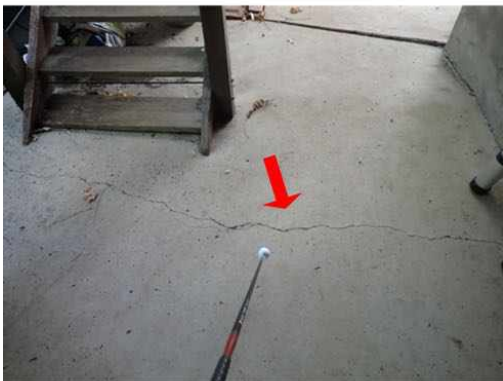
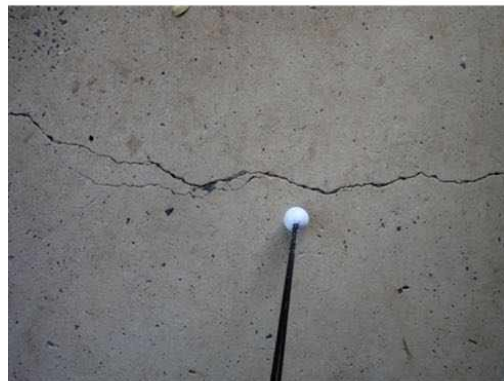
Finding 3.07

Building:	Main Building
Location:	Ground floor concrete
Finding:	Ground Floor Concrete – Multiple Minor Cracks
Information:	Multiple minor cracks were observed in the ground floor concrete at the time of inspection. These appear to be consistent with general shrinkage, age-related movement, or minor settlement. While not considered structurally significant at this time, ongoing movement may lead to further deterioration if left unaddressed. It is recommended that the cracks be monitored and repaired as deemed necessary by a suitably qualified tradesperson to help prevent moisture ingress and future damage.

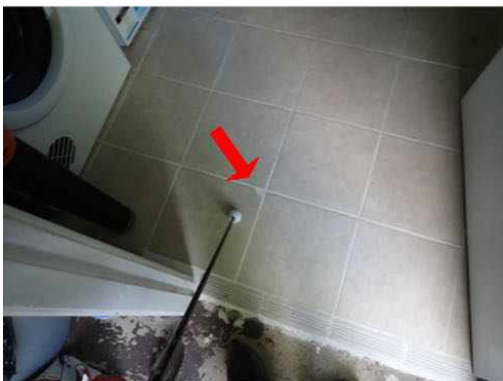
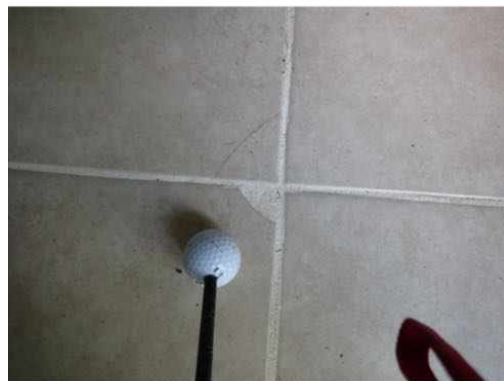
Finding 3.08

Location: Laundry

Finding: Laundry – Cracked Floor Tile

Information: A cracked floor tile was identified in the laundry at the time of inspection. It is recommended that a suitably qualified tiler repair or replace the affected tile as deemed necessary to maintain a durable floor surface.

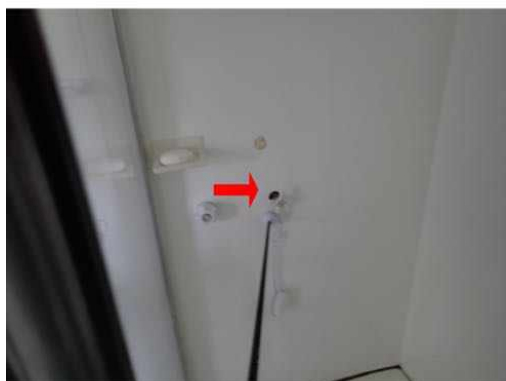
Finding 3.09

Location: Laundry

Finding: Shower Tap Wall Penetrations – Not Sealed

Information: The wall penetrations around the shower taps were not sealed at the time of inspection. This may allow moisture to enter the wall cavity and cause damage to internal building materials over time. It is recommended that a suitably qualified tradesperson seal the penetrations with appropriate waterproofing materials as deemed necessary to prevent further deterioration.

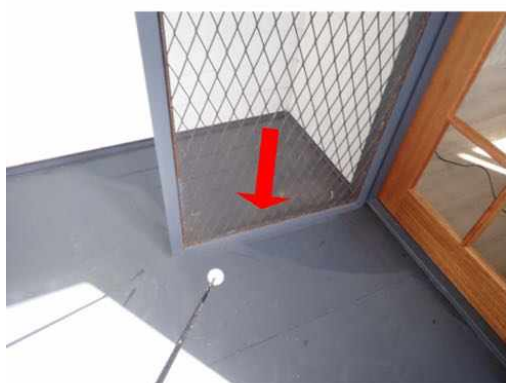
Finding 3.10

Location: Front decked area

Finding: Security Screen Door – Rusted

Information: The security screen door was found to be rusted at the time of inspection, indicating age-related deterioration and exposure to weathering. If left unaddressed, the corrosion may worsen and affect the door's operation and appearance. It is recommended that a suitably qualified tradesperson repair, treat, or replace the door as deemed necessary to prevent further deterioration.

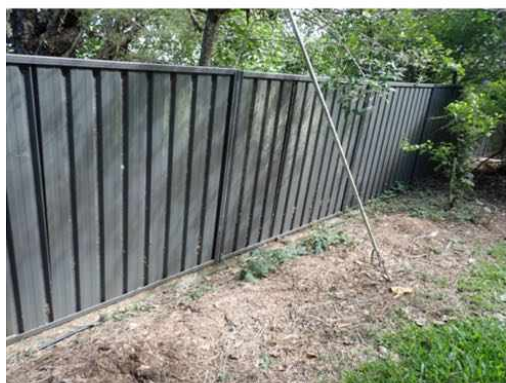
Finding 3.11

Building: Yard

Location:	Rear fence
Finding:	Rear Colourbond Fence – Leaning Out of Plumb
Information:	The rear Colourbond fence was observed to be leaning out of plumb at the time of inspection. This may be due to ground movement, deteriorated footings, or impact damage. If left unaddressed, the fence may continue to lean and lose stability. It is recommended that a suitably qualified fencing contractor or general handyman realign, repair, or replace the fence as deemed necessary to restore stability.

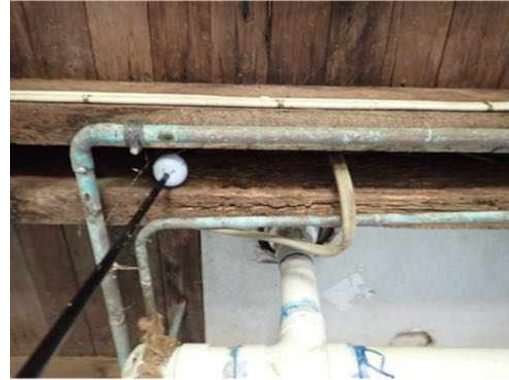
Finding 7.01

Building:	Main Building
Location:	Flooring system below bathroom
Finding:	Bathroom Subfloor – Wood Rot to Timber Flooring Beam
Information:	Wood rot was identified to a timber flooring beam below the bathroom, although the area was dry at the time of inspection. This is likely due to past moisture exposure from previous water leaks. If left unaddressed, the deterioration may compromise the structural integrity of the floor. It is recommended that a suitably qualified carpenter or builder investigate the cause, repair or replace the affected timber, and carry out any necessary remedial works as deemed necessary to prevent further deterioration.

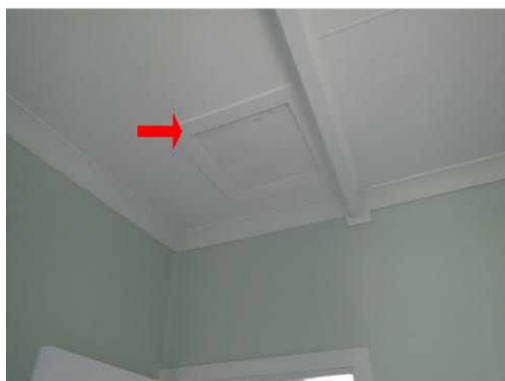
Noted Item

Building:	Main Building
Location:	Bedroom
Finding:	Ceiling Manhole – Sealed Shut
Information:	The ceiling manhole was found to be sealed shut at the time of inspection, restricting access to the roof void. This prevents proper inspection, maintenance, and monitoring of the roof space. It is recommended that a suitably qualified tradesperson make the manhole accessible as deemed necessary to allow safe and proper access to the roof void.

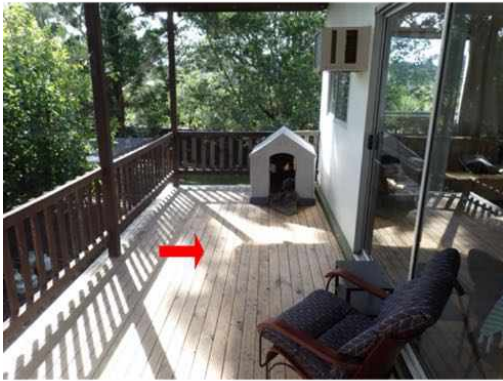
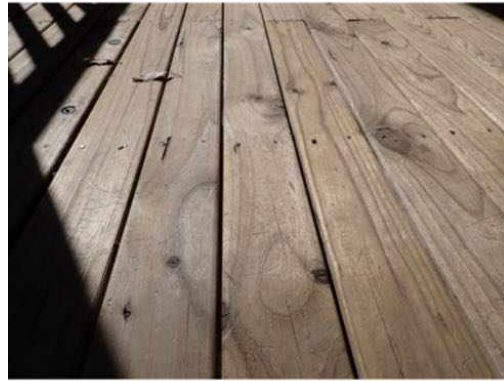
Noted Item

Building:	Main Building
Location:	Side decked area
Finding:	Side Decked Area – General Maintenance Required
Information:	The side decked area was found to be in need of general maintenance at the time of inspection. This may include cleaning, re-coating, tightening fixings, and minor repairs to address weathering and deterioration. It is recommended that a suitably qualified carpenter or general handyman carry out maintenance works as deemed necessary to maintain the safety, appearance, and durability of the deck.

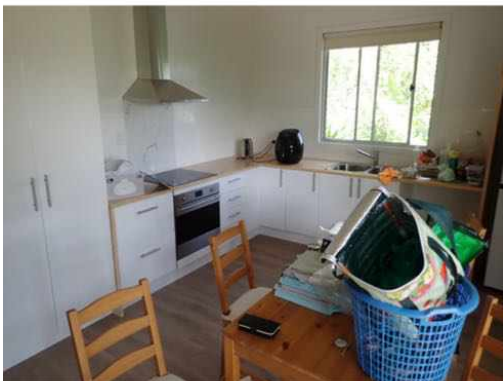
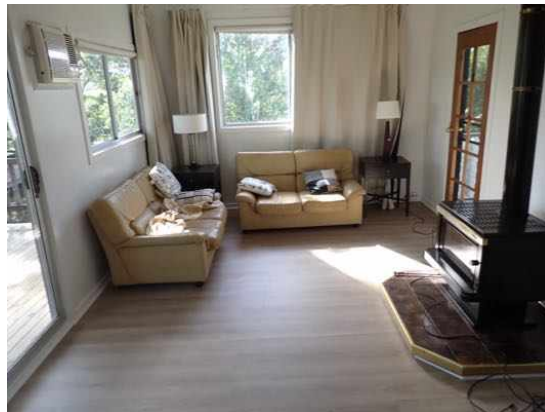
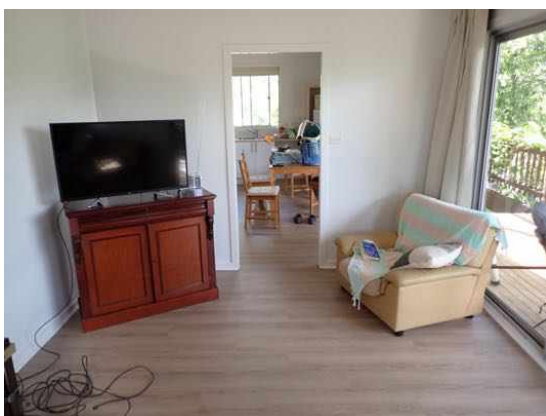
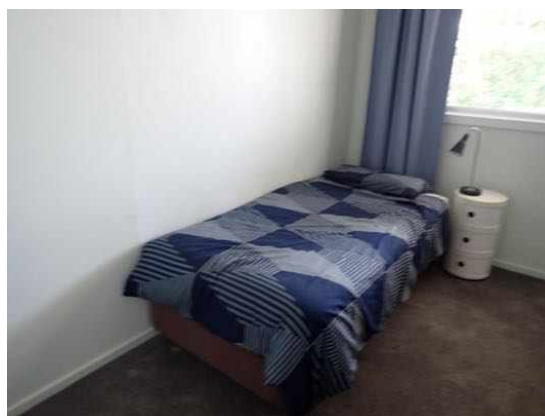
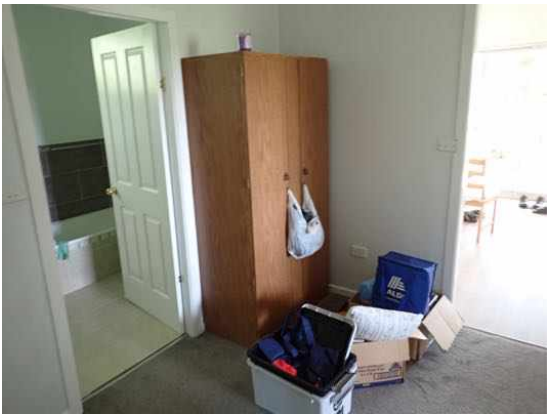
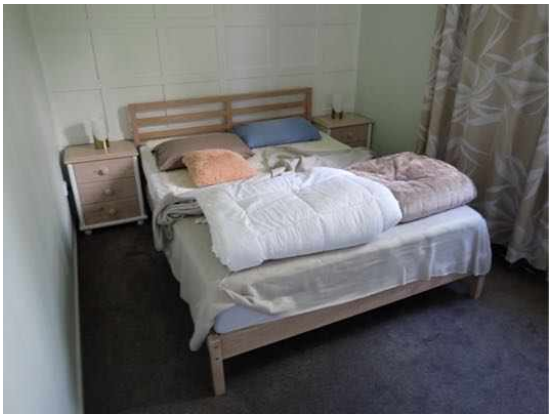
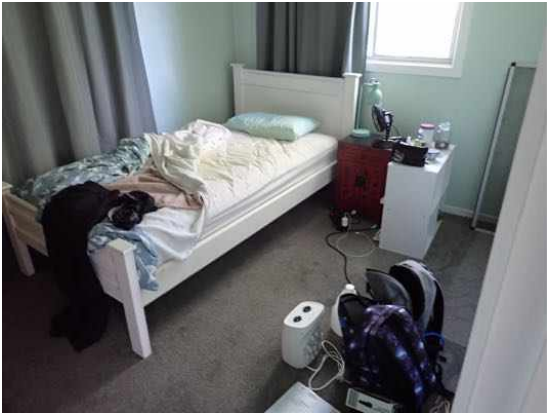
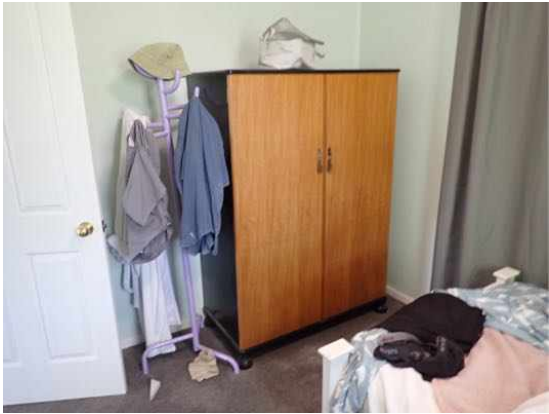
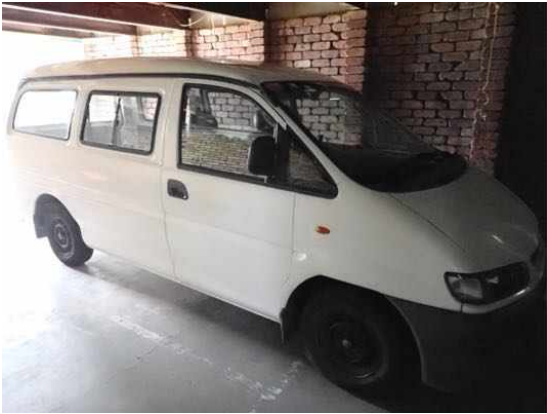
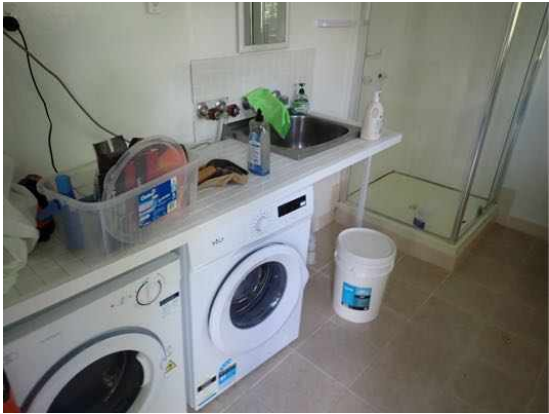
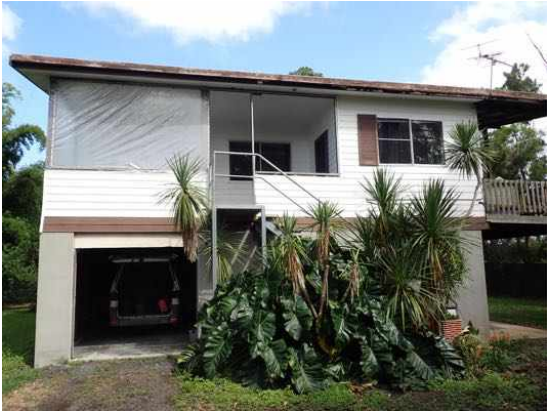
Noted Item

Finding: Additional Photos - Obstructions and Limitations

Information: These photographs are an indication of the obstructions and limitations which impeded full inspection of the area at the time of inspection. These obstructions can hide an array of defects and should be removed to allow full inspection to be carried out. A re-inspection is recommended once the areas are made accessible.
