Building and Timber Pest Inspection Report

Inspection Date: Sat, 17 Jan 2026

Property Address: 12 Michie St, Elmore VIC 3558, Australia

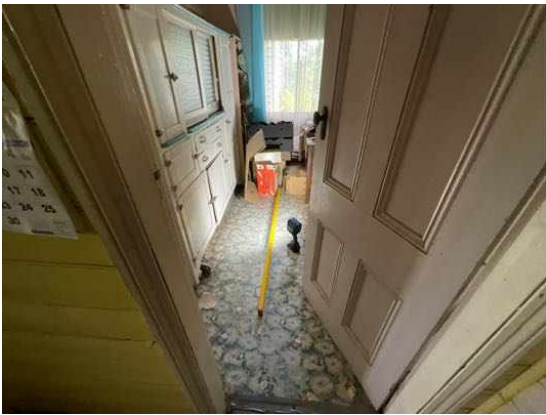
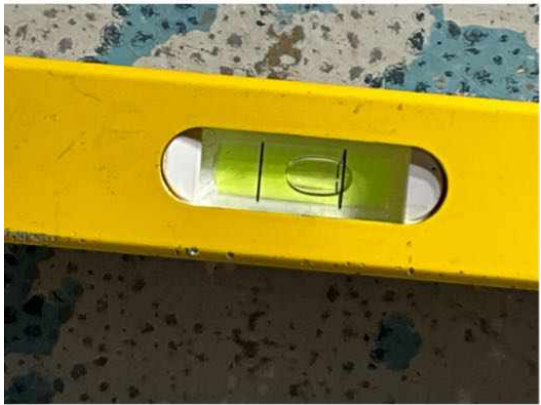
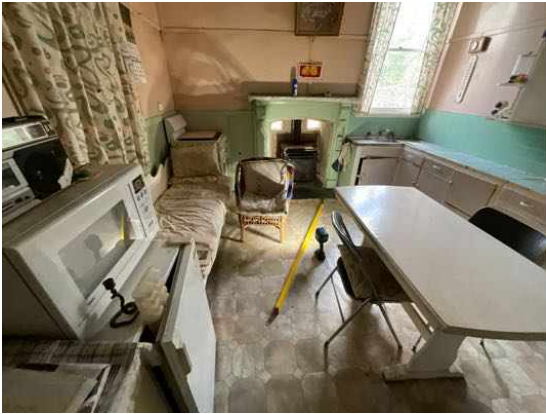
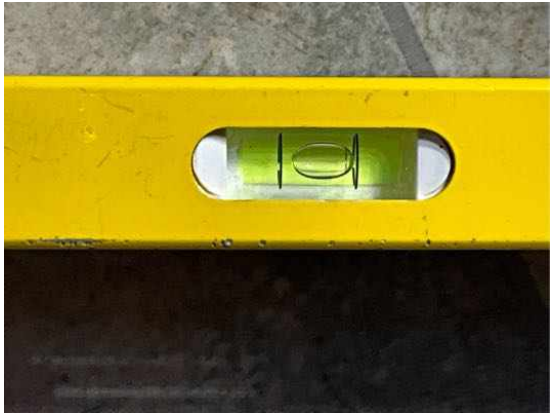
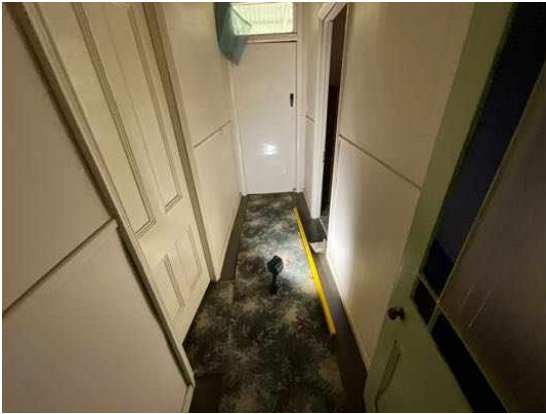
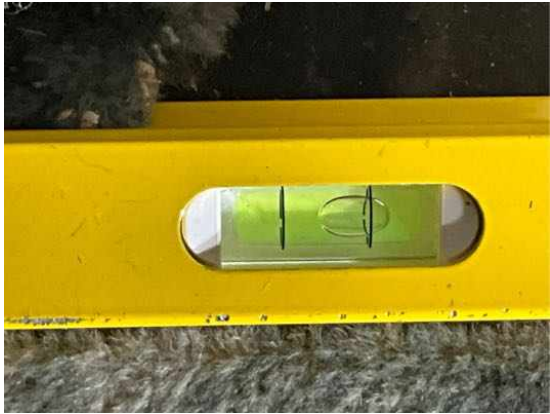
Building: Building 1
Location: All Internal Areas
Finding: Flooring - Uneven
Information: The internal flooring in this area is out of level and uneven. Uneven flooring is likely to indicate minor defects such as expected movement of the foundations of the property, but may also indicate subsidence of the associated subfloor stumps.

It is advised that the flooring be closely monitored to identify any further movement. Where flooring remains relatively unchanged for an extended period of time (i.e. several months), it is likely that this defect has been caused by expected movement of the foundations of the property.

However, where flooring is uneven further, potentially invasive inspection of the subfloor structures and stumps in this area is required. In this case, works to repair are likely to be required, and would be carried out by a registered builder specialising in re-stumping.

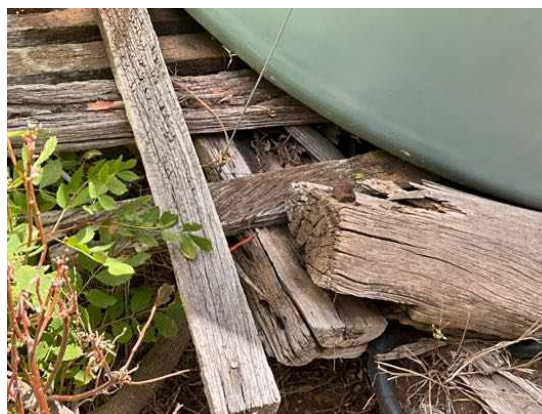
Finding 2.02

Building: Building 1
Location: Yard - Side
Finding: Tank leaning
Information: The water tank in this area is poorly supported. This has caused the tank to lean over. This instability could become dangerous if left unattended.

A plumber or tank specialist should be contacted as soon as possible to improve the support and prevent potential damage.

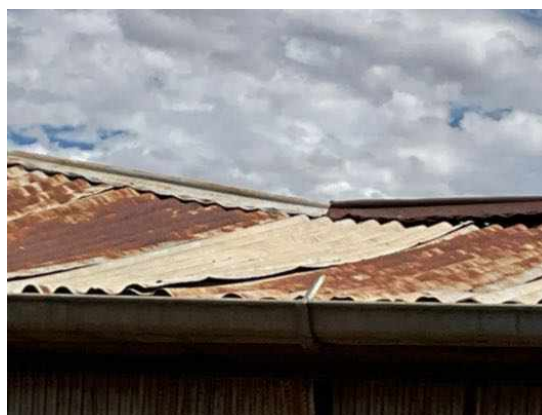
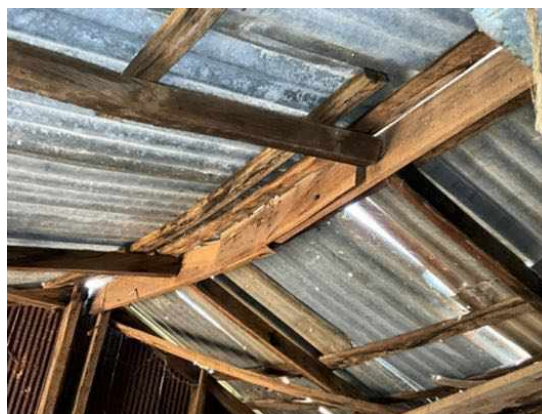
Finding 2.03

Information: The roofing structure was found to be sagging in sections at the time of inspection. This sagging is likely due to the lack of support to the roof members (rafters). These support members are referred to as under purlins and struts. While this type of construction is common for the era of building, additional support may be required.

Sagging roof structures are likely to create strain on associated building elements, creating potential for secondary damage including the deterioration of roof coverings. The roof is also unlikely to have sufficient support, which may lead to further sagging if left unmanaged.

It is advised that a Registered Builder be appointed to provide remedial advice and pricing for any necessary work.

While it would appear that this defect has been present for a long period of time repair is recommended in the short term to ensure the longevity and structural integrity of the dwelling.

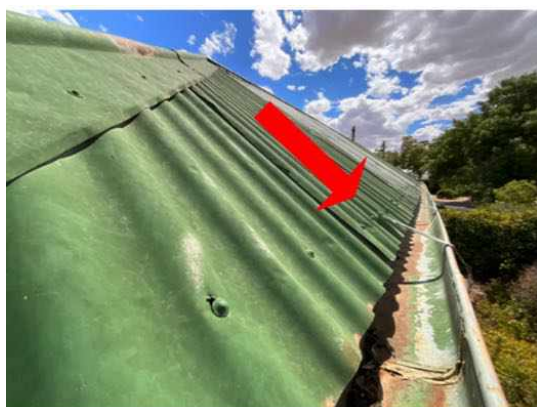
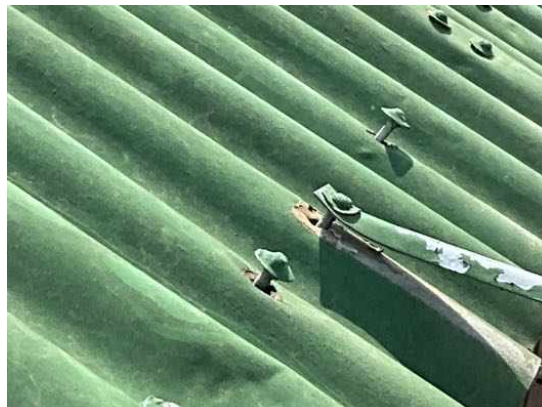
Finding 3.01

Building:	Building 1
Location:	Roof Exterior
Finding:	Roof sheets - Loose
Information:	Upon inspection of the exterior roof covering, it was noted that numerous roof sheets have become loose from their original fixings. It is suspected that this defect has developed as a result of a lack of adequate maintenance, but may also have been caused by inappropriate fixings being used in the construction process.

Loose roof sheeting detracts from the weather tightness of the roof covering, making the internal roofing structure susceptible to water penetration and subsequent damage. If left unaddressed, it is likely that secondary damage to associated building elements will develop, potentially necessitating remedial works to these structures.

A roofing restoration contractor should be appointed to advise on rectification options and on the cost of repair. It is advised that remedial works be performed as soon as possible to prevent any further damage.

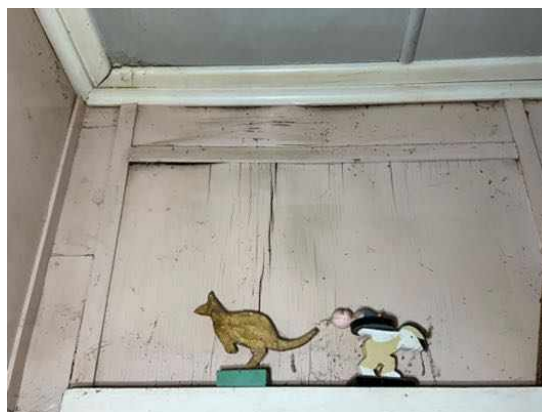
Finding 3.02

Building:	Building 1
Location:	Kitchen
Finding:	Wall- Water damaged
Information:	Water damage to the wall lining is generally an indication of excessive moisture being present in the roof void, usually via a leak to the roof covering.

Where water damage is evident to the wall, the primary requirement is to identify and rectify the source of the leak. A roofing plumber should be appointed as soon as possible to identify the leak and perform rectification works as necessary, ensuring the water damage is restricted.

Once the leak is repaired, consultation with relevant tradespeople, including painters, is advised. Rectification works may include replacement of lining board or minor repainting, depending on the extent of the damage.

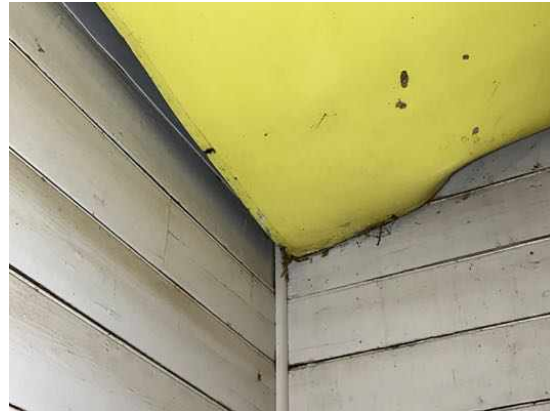
Finding 3.03

Building:	Building 1
Location:	Hallway 2
Finding:	Ceiling - Sagging
Information:	Sections of the ceiling were found to be sagging at the time of inspection. Sagging to the fixed ceiling structure generally indicates that the building materials have swollen, due to contact with water, or that fixings (e.g. nails or glue) have become loose and require reattachment.

Where minor sagging is evident, comparatively minor works, such as re-gluing of ceiling sheets, may be required. Such works may be performed by relevant tradespeople, such as plasterers and painters. Where excessive moisture has caused the roofing structure to swell and sag, the source of the water leak should primarily be identified prior to any remedial works being performed.

The appropriate action should be taken by the client as soon as possible to ensure that any potential further damage is limited.

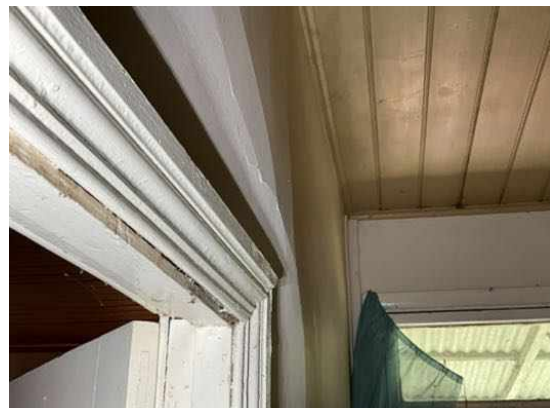
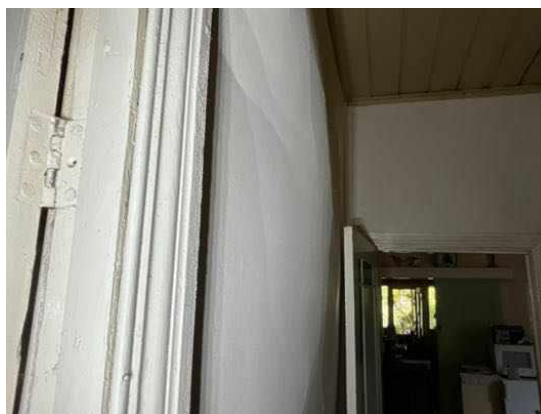
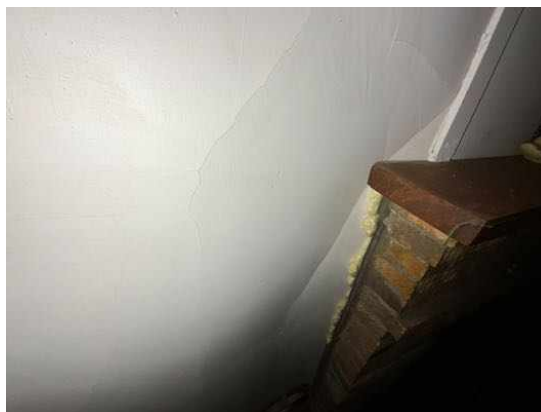
Finding 3.04

Information: Sagging and uneven surfaces generally indicate that the building materials have swollen, due to contact with water, or that fixings (e.g. nails or glue) have become loose and require reattachment. In some cases, sagging and uneven surfaces may also indicate that there are structural issues causing surfaces to warp, twist, or sag.

Where sagging appears to be major, appointment of a structural engineer is advised to further inspect the property. Otherwise, minor works such as re-gluing of wall/ceiling sheets may be required and should be performed by an aptly qualified plasterer or carpenter.

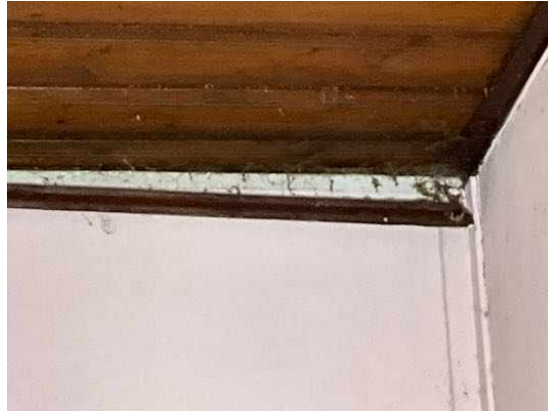
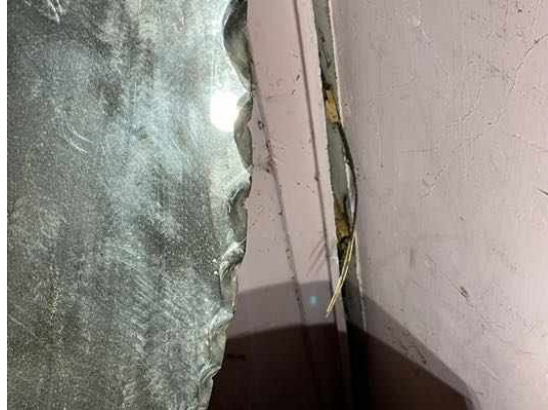
Finding 3.05

Building:	Building 1
Location:	Bedroom - Master
Finding:	Cracking - Damage
Information:	Noticeable cracks are a common occurrence as a result of many primary defects. Such causes may include age, general wear and tear, expected building movement, general expansion/contraction of building materials in different weather conditions, and/or minor failings in the installation or application of building materials.

Noticeable cracks may result in minor sticking or jamming of associated doors and windows, which require easement. However, noticeable cracks are easily filled and repaired. A plasterer can be consulted to install an expansion joint at this point to allow for this movement during different weather conditions.

Monitoring of all cracking should be conducted frequently. Always contact a building inspector should cracks widen, lengthen, or become more numerous. Additionally, your building inspector should also be contacted if associated building elements such as doors and windows become more difficult to operate over time.

Relevant tradespeople, such as carpenters, painters and plasterers, should be appointed to perform remedial works, as deemed necessary.

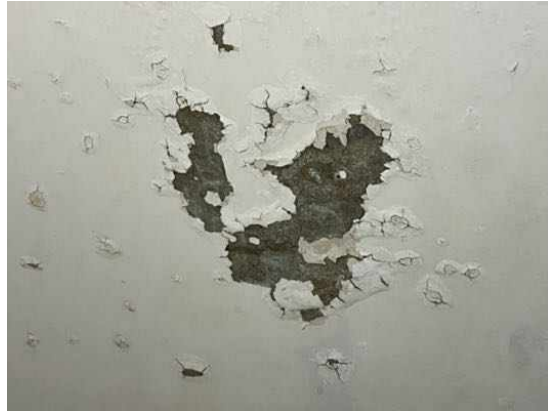
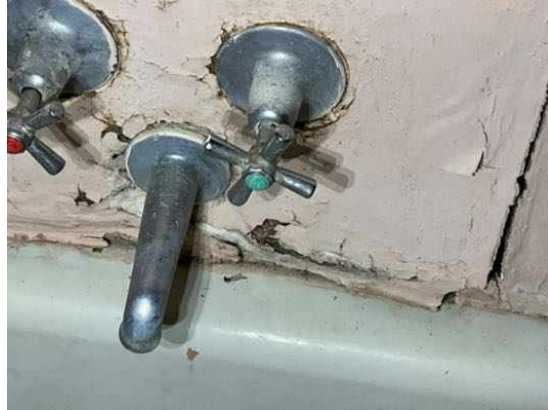
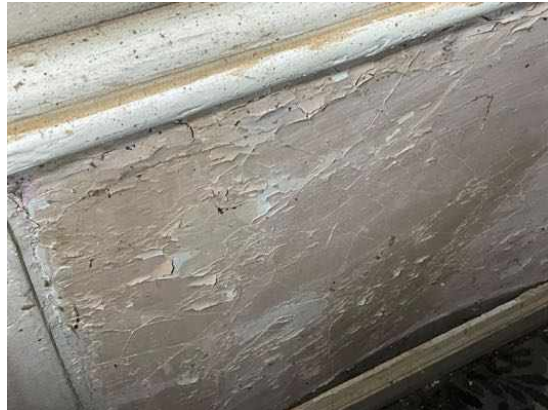
Finding 3.06

Building: Building 1
 Location: Bathroom, bed 1
 Finding: Paint- Flaking
 Information:

Sections of paint in this area was found to have deteriorated. Paint flaking is generally an indication of excessive moisture in the area, that is currently hidden by the painted surface.

The presence of excessive moisture can have major implications on associated building elements if left unattended. While only seemingly minor at this stage, the damage cannot be determined due to the paint obstructing any further inspection of the damage.

A qualified Painter should be contacted at the Owner's discretion to re-paint the area.

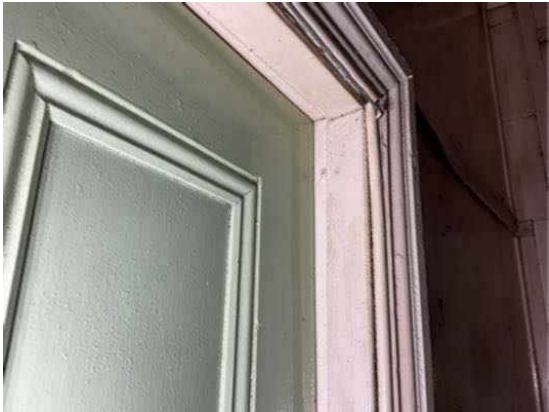
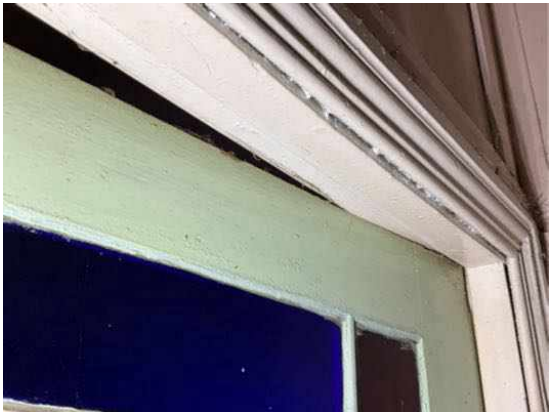
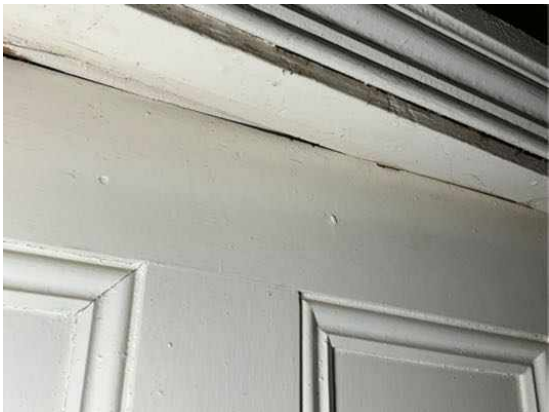
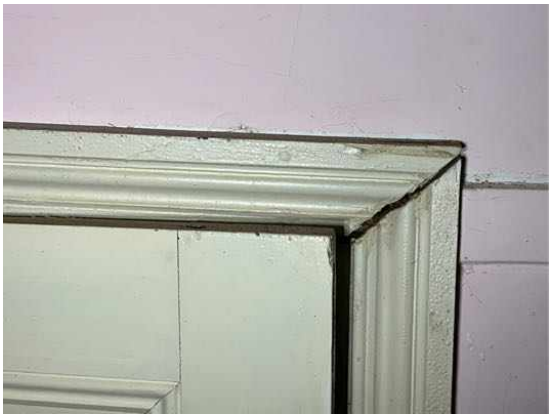
Finding 3.07

Building: Building 1
 Location: Bedroom 1, 2, hall, living
 Finding: Door- Binding/jamming
 Information: Binding and/or jamming of this door is evident during standard operation. This defect inhibits the functionality of the affected door as well as creating potential for secondary defects to associated building elements, such as damage to the floor covering.

A door that binds to flooring or to the associated door frame may have several causes, ranging from minor defects, such as poor installation of the door or deteriorated hinges, through to major structural issues, such as damage to subfloor structures.

A qualified carpenter or general handyperson should be appointed to perform minor rectification works at client discretion.

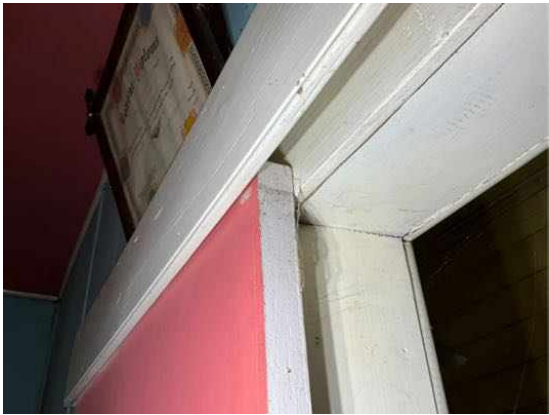
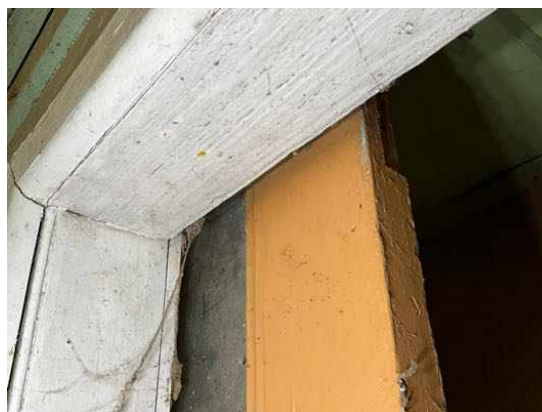
Finding 3.08

Building: Building 1
Location: Bedroom 2, Wc
Finding: Door- Stiff to slide
Information: The door in this area was jammed and difficult to slide along the associated tracks at the time of the inspection. Restricted function of the affected door may pose as a potential safety hazard if required for emergency egress from the building.

Generally, factors such as general age of the building element and a lack of maintenance are the usual causes for this type of defect.

Replacement of door hardware or tracks may be required, as well as minor repairs and cleaning. A registered builder or general handy person will be required to repair the affected doors.

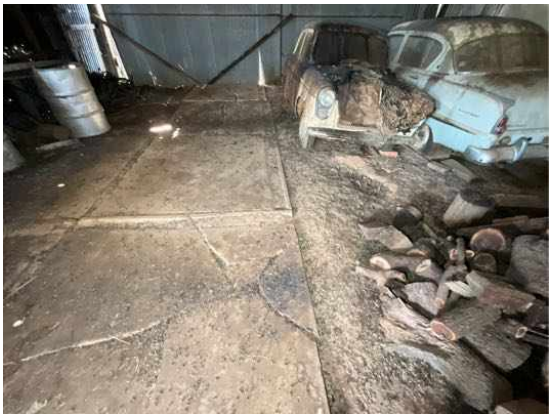
Finding 3.09

Building:	Building 1
Location:	Garage 2
Finding:	Cracking - External Concrete Paving Damage Category 4 - Gaps in Slab (4mm - 10mm +)
Information:	Gaps in the slab were identified in external concrete paving. Gaps in the slab are significant and are likely to lead to the development of safety hazards and secondary defects if left unmanaged, such as the creation of a trip hazard.

General age and expected deterioration of the paved areas is a common cause of this type of cracking. However, expansion and contraction of the slab may also have occurred due to environmental factors. Such factors include variable moisture and weather conditions, the presence of trees and their roots having a settling or lifting affect on the soil, or the effect of load bearing, e.g. heavy vehicles over a sustained period of time.

Cracking to this degree may also be due to poor original installation of the concrete. Factors such as poor compaction of the sub surface and/or inadequate reinforcing of the slab may create cracking and other secondary defects. Gaps in the concrete paving may also have a more significant structural cause, such as subsidence of soils.

Where gaps in the concrete paving are adjacent to structural elements of the building, the advice of a Structural Engineer is advisable before undertaking repairs. Significant repair and likely replacement of the concrete paving is probable.

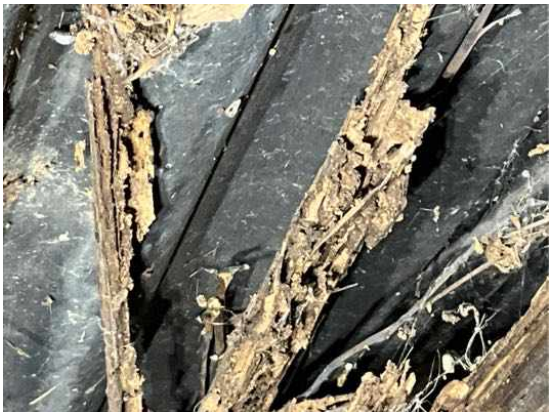
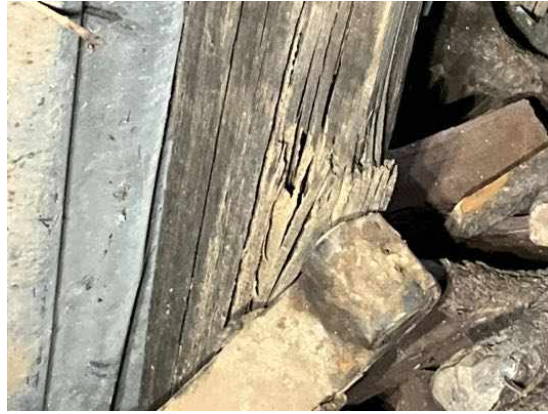
Building: Building 1
 Location: Garage 2
 Finding: Evidence of termite damage - minor
 Information: Despite no live termite or timber pest activity being indicated, previous termite damage was found to have affected this area. This damage is considered to be inactive and is minor in nature.

It is advised that the area be visually inspected frequently to ensure that the condition of affected building materials does not worsen. At the time of inspection, damage is not structural and is only considered to be superficial.

A building contractor may be appointed to provide a further invasive inspection if further damage is evident.

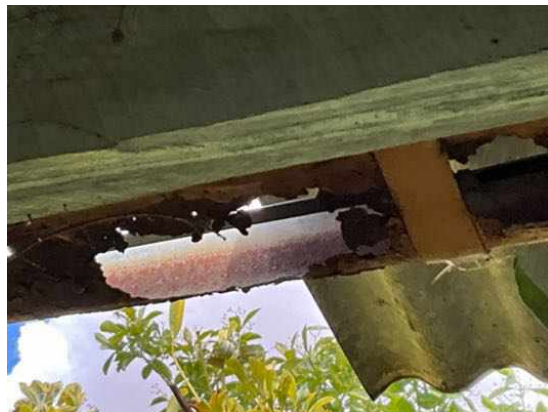
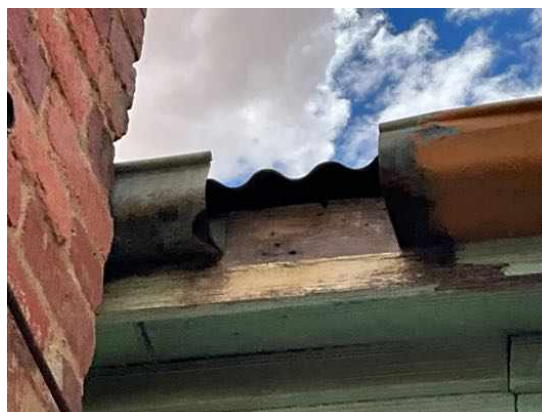
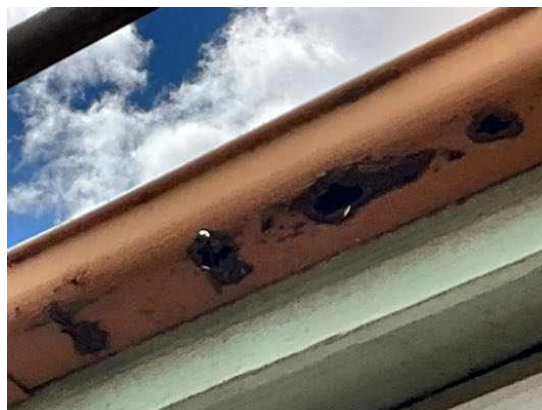
Finding 6.01

Building:	Building 1
Location:	Verandah, eaves
Finding:	Gutters- Deteriorated
Information:	The guttering and some downpipes have deteriorated.

Although not a major problem now, they will deteriorate further if left for an extended period.

Sagging can be seen in the rear gutter.

A Licensed Plumber should be engaged as soon as possible to advise on any repairs or maintenance that may be required.

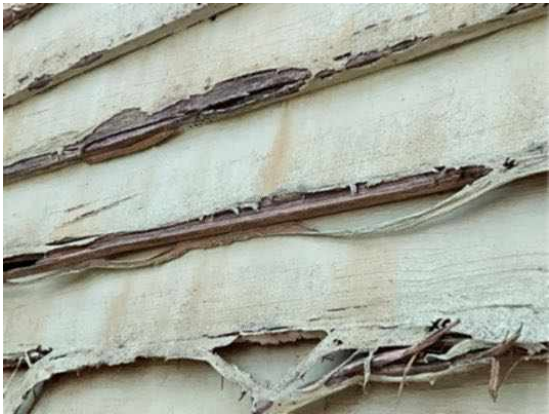
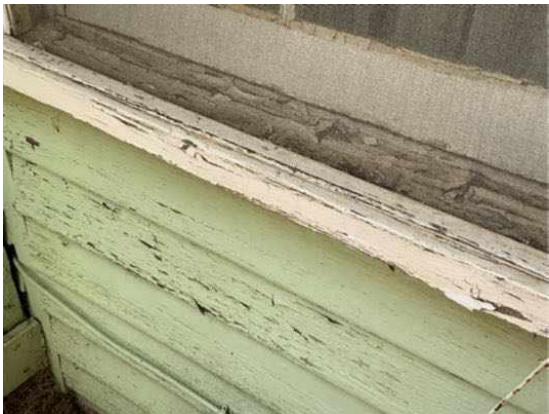
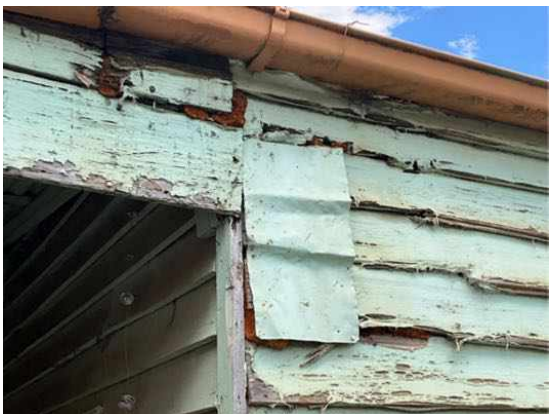
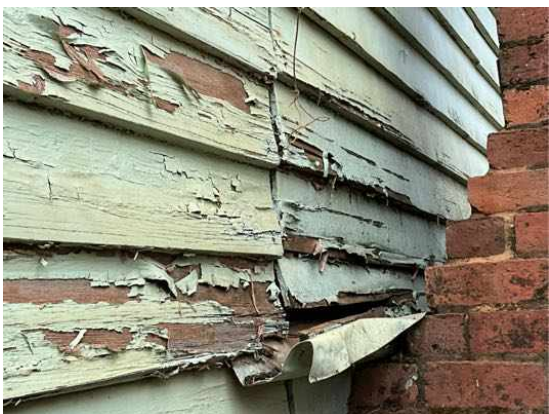
Finding 6.02

Building:	Building 1
Location:	All External Areas
Finding:	External painting deteriorated
Information:	Much of the external paintwork including but not limited to windows, fascias, guttering, veranda and other external fitments have been neglected and require attention to prepare and re-paint.

Whilst incomplete or missing paint finish is generally an appearance defect, it can also lead to the development of secondary building defects over time. Incomplete areas of paint finish expose the area to moisture, potentially accelerating the deterioration of underlying building materials.

Degraded paint finishes should be sanded back, filled, leveled and painted, as applicable. Where inadequate or missing paint protection has led to the deterioration of the associated building element, repair and/or replacement of this building element may be required.

A painting contractor should be appointed as soon as possible to perform necessary works to aid the appearance of the affected area and to ensure the area is protected against further deterioration. Alternatively, the homeowner following manufacturer instructions may perform these works.

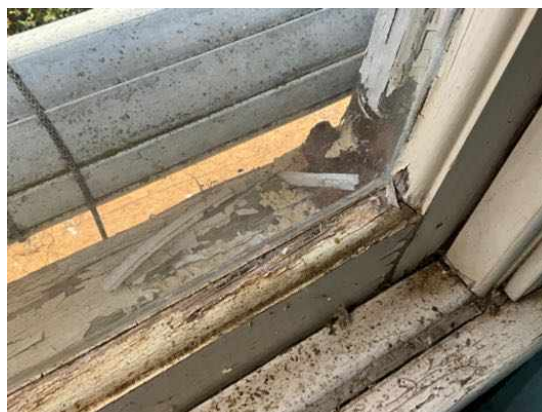
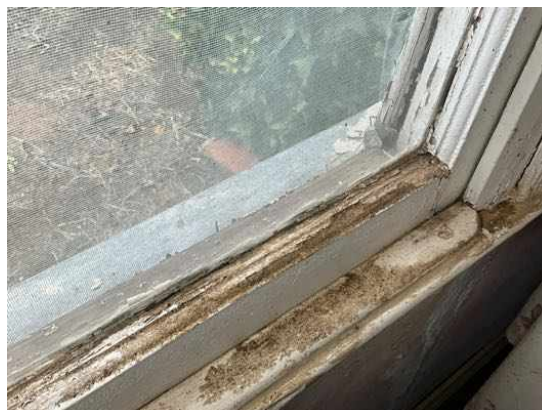
Finding 6.03

Building: Building 1
 Location: Bedroom 1,2
 Finding: Timber - exposed to weather
 Information: External timbers that are frequently exposed to harsh weather conditions require adequate protection in order to maintain their condition. Where timbers have not been painted or treated adequately, general deterioration is likely to occur at an accelerated rate.

If left unattended, replacement of these timbers is likely to be necessary in the short-term future. Adequate treatment of these timbers is required as soon as possible by a painting contractor or general handyman.

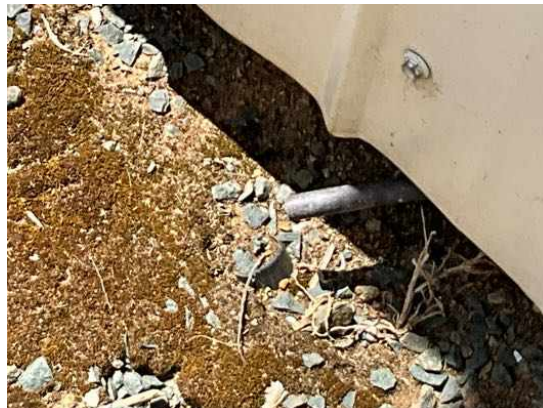
Finding 6.04

Building: Building 1
 Location: Yard - Side
 Finding: HWS Overflow - Not Connected
 Information: The Hot Water System (HWS) overflow was found to be disconnected from storm water drainage and is creating excessive moisture in the surrounding area.

These damp conditions can lead to secondary defects such as rot, rust or corrosion of associated building elements, the formation of fungal decay, or even the creation of potential slip hazards. When coupled with poor site drainage, pooling of water may

It is highly recommended that a licensed plumber be appointed to connect the HWS overflow in order to prevent such an environment from being created. These minor works should be carried out as soon as possible.

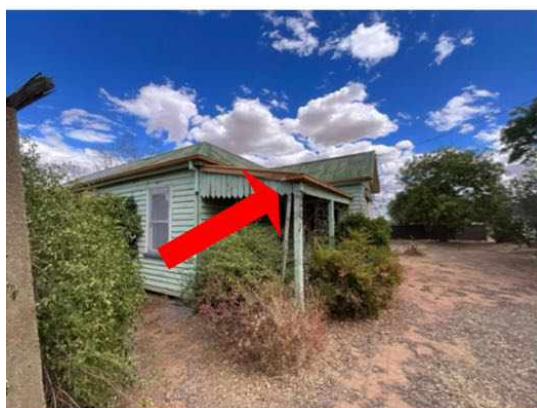
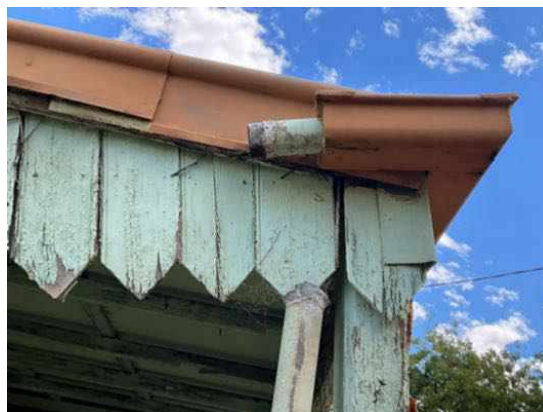
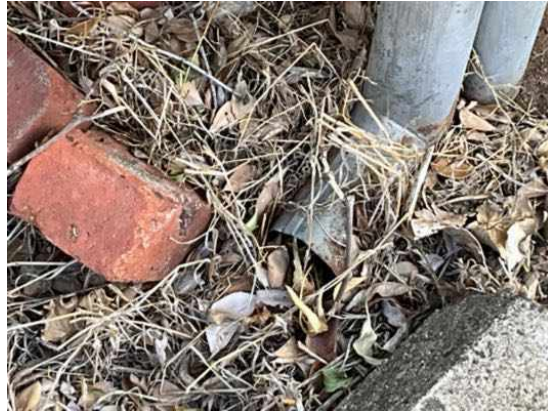
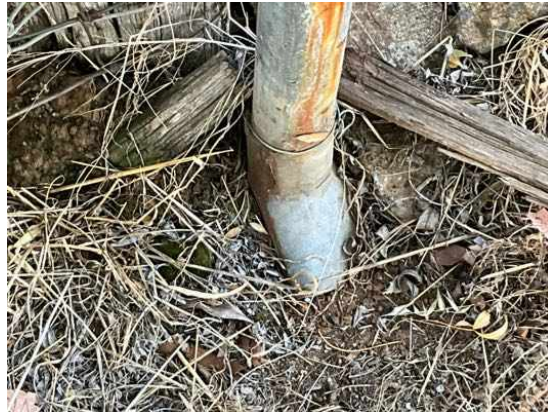
Finding 6.05

Building:	Building 1
Location:	Verandah, garage 2
Finding:	Stormwater drain - Not connected
Information:	The roof plumbing is not adequately connected to stormwater drainage on the site. This disconnection negatively impacts the functional capacity of the roof plumbing.

Where roof plumbing doesn't drain adequately, the area at the base perimeter can become excessively damp, potentially creating an environment that is susceptible to rust and corrosion of surrounding building elements, as well as attracting termites and other pests.

It is highly recommended that a plumber be appointed to further inspect the area and to install adequate drainage equipment where necessary.

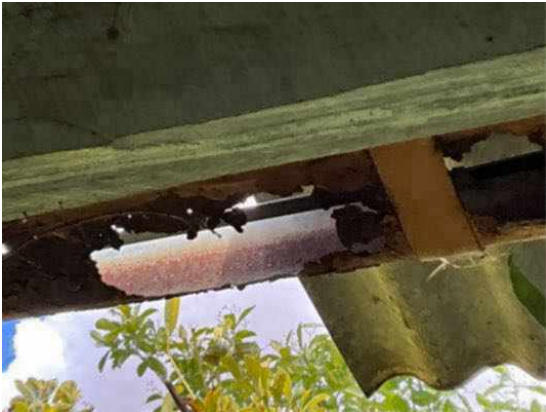
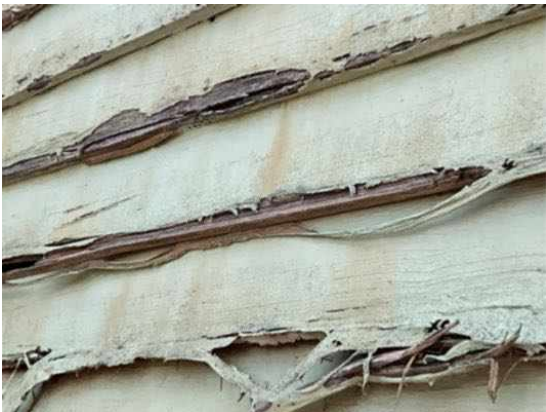
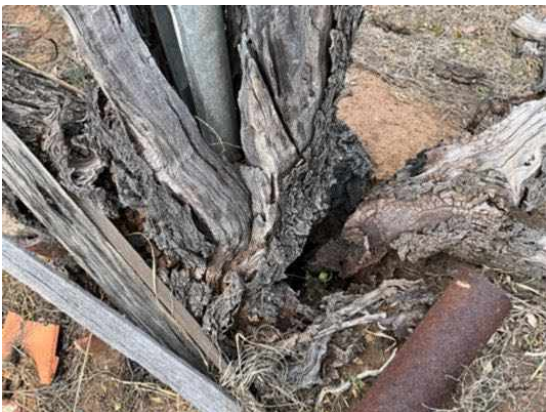
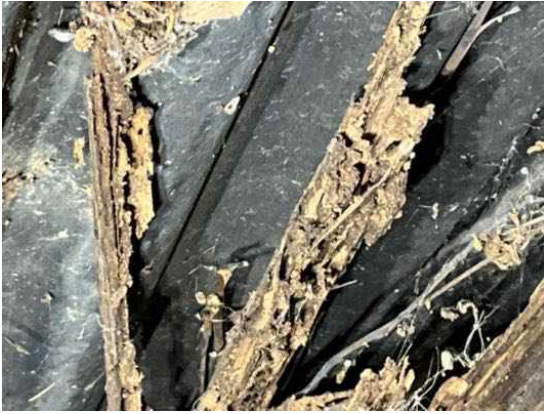
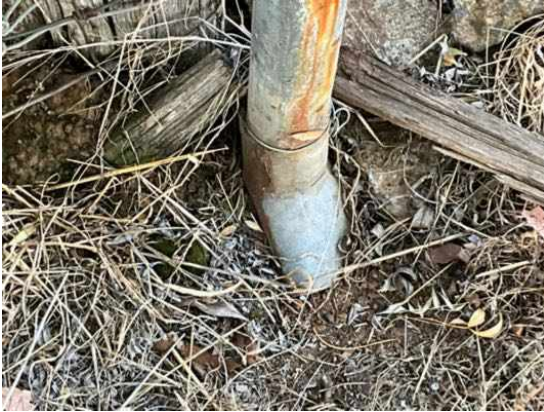
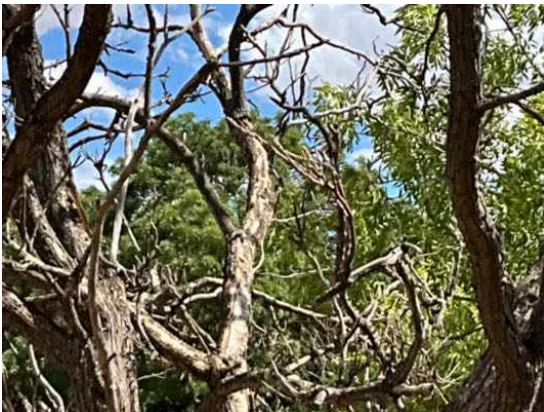
Finding 6.07

Building:	Building 1
Location:	All External Areas
Finding:	Termite Management System - no evidence of a chemical installation
Information:	The application of a post-construction chemical termite barrier is highly recommended for all properties, particularly if live termite activity has been found on the site previously. Such barriers are highly effective in preventing termite attack on any timber building elements throughout the property.

The client may consider gaining further advice from a pest controller as to the costs and procedures involved with this application. It is recommended that obtaining such advice be a short-term priority.

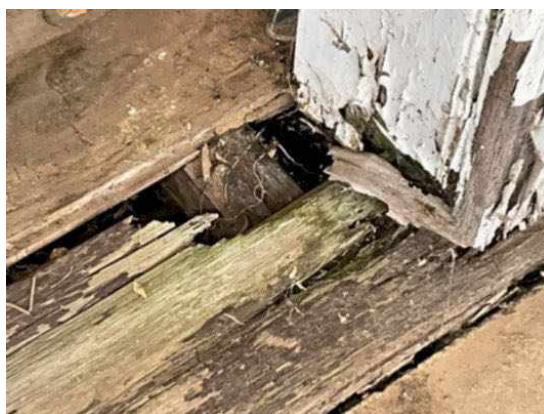
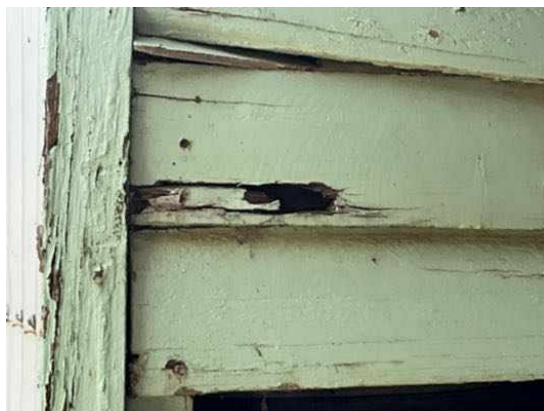
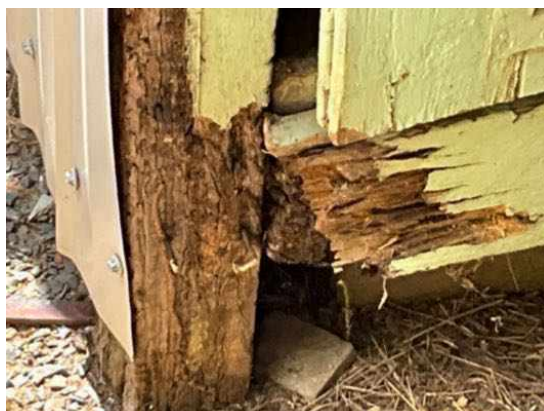
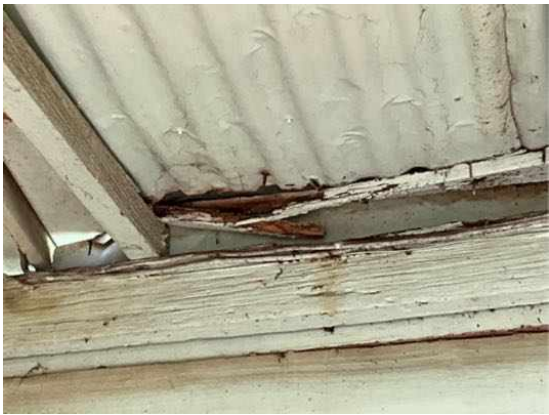
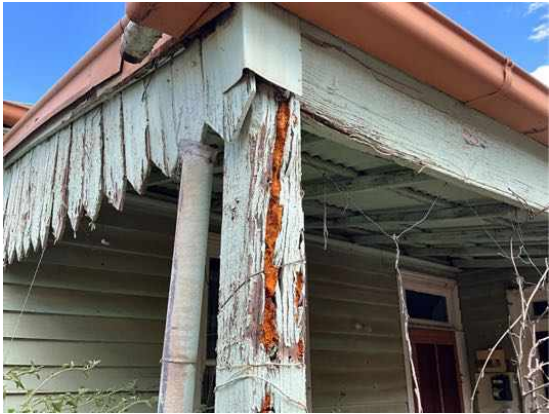
Finding 7.01

Building:	Building 1
Location:	Laundry, side yard, verandah
Finding:	Fungal decay - present (localised)
Information:	Fungal decay also known as wood decay or wood rot generally refers to the deterioration of timber elements when in contact with excessive levels of moisture for a prolonged period of time.

The development of fungal decay is accelerated by temperatures in the range of 5degreeC to 40degreeC as well as the presence of oxygen. Generally fungal decay develops on timber elements that are in use in an external environment which are exposed to rain penetration.

In this case although the affected timber element is in a decaying state the extent of any visible damage appears to be localised to a specific area and is yet to spread to other parts of the building element or affect adjoining structures. The fungal decay is therefore likely to be of a relatively superficial nature with minimal impact on the structural integrity or tensile strength of the timber element.

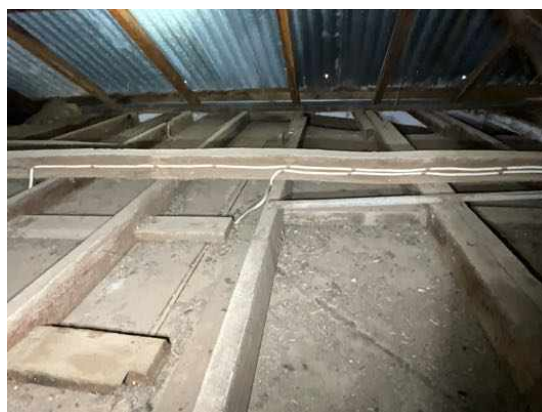
Building:	Building 1
Location:	Roof Void, rear rooms
Finding:	Insulation - Missing
Information:	Upon inspection of the roof void it was noted that insulation is not present.

Where insulation is absent, the area does not meet current Australian Standards. Installation of adequate insulation is required and should be conducted as soon as possible.

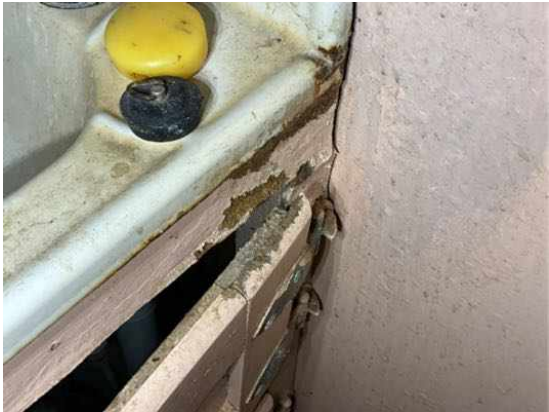
Building:	Building 1
Location:	Bathroom
Finding:	Cabinets- moisture affected.
Information:	The structure of the Cabinets in this area was found to be deteriorating due to the effects of excessive moisture. Replacement of any damaged board materials is recommended. Parts of the Cabinetry not badly damaged or swollen may be re-sealed or painted.

The source of the moisture must be identified and rectified before repairs and replacement is carried out. The services of a Cabinet maker or General Handy Person should be sought at the discretion of the owner.

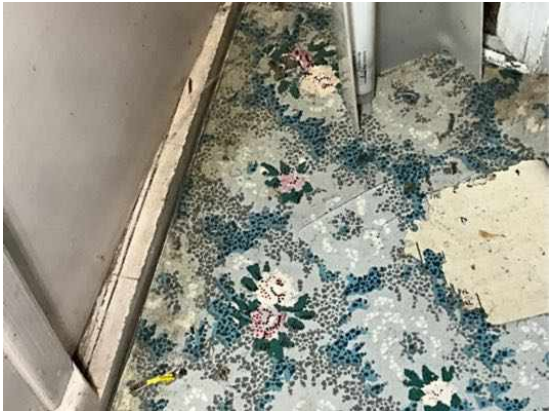
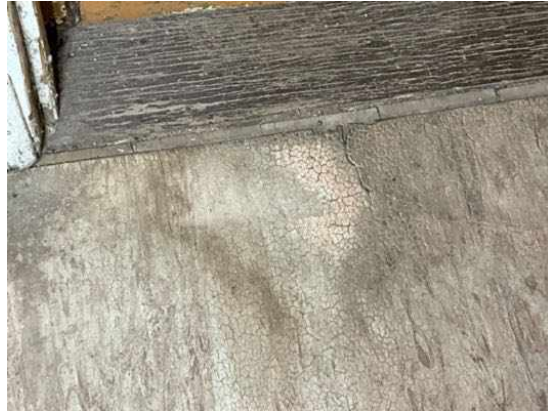
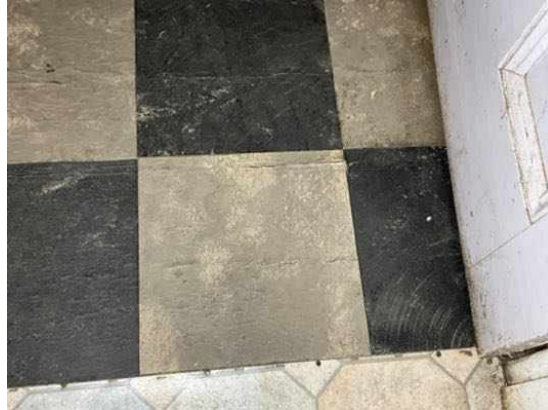
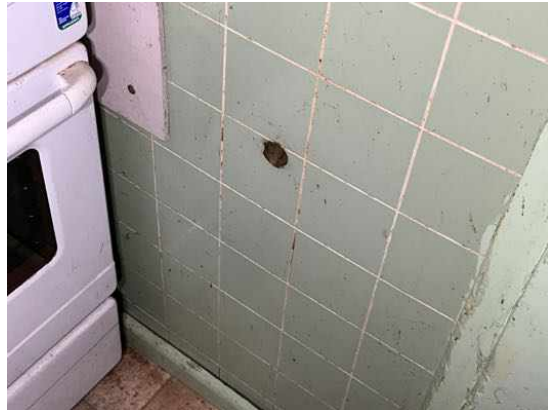
Building: Building 1
Location: Rear hall area, kitchen
Finding: Asbestos - Suspected ACM Identified on Site
Information: Reporting on Asbestos is outside the Scope of this Report. This suspected defect is highlighted as a caution only. We suspect, based on our experience in the building industry, that there is a higher risk of the identified building element containing asbestos.

As Asbestos Reporting is outside the scope of this report, we advise that you consider a separate Asbestos Inspection and Condition Audit, which can include the taking of samples for definitive confirmation of the presence of Asbestos.

In the interim, the client is advised to act with caution, especially when considering any damage to building materials general wear and tear renovations extensions demolition and general maintenance activities due to the suspected presence of Asbestos.

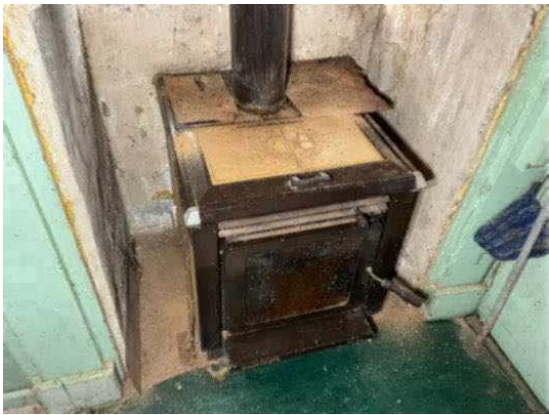
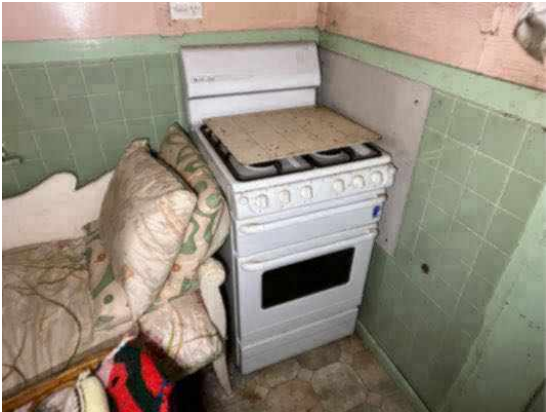
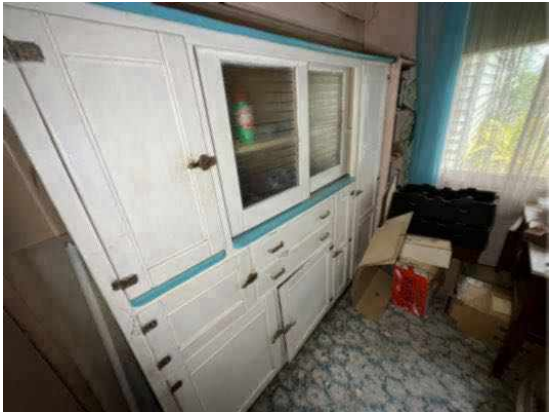
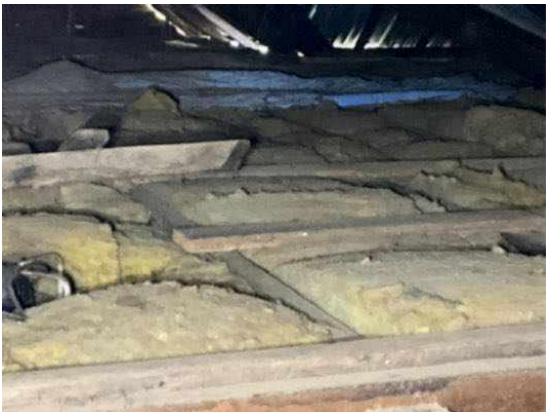
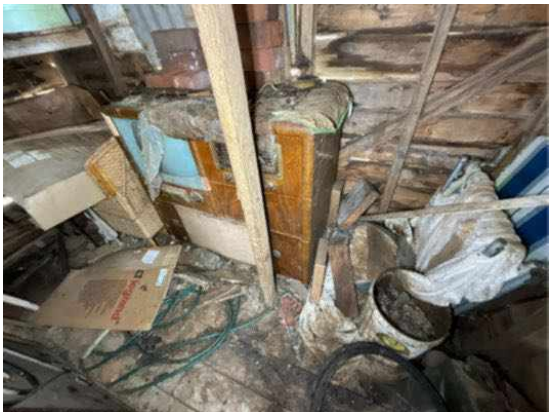
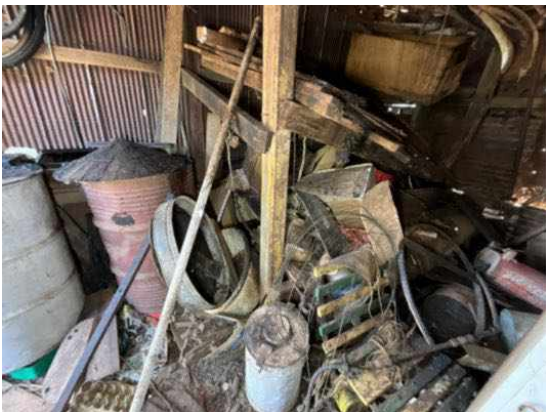
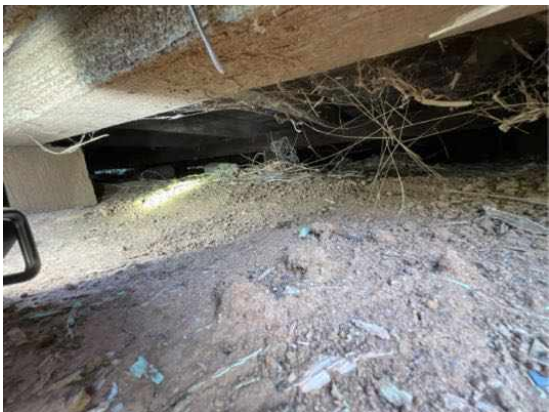
Building:	Building 1
Location:	All Areas
Finding:	Additional Photos - Obstructions and Limitations
Information:	These photographs are an indication of the obstructions and limitations which impeded full inspection of the property at the time of inspection. These obstructions can hide an array of defects and should be removed to allow full inspection to be carried out. A re-inspection is recommended once the areas are made accessible.
