# Building and Timber Pest Inspection Report

Inspection Date: Thu, 12 Mar 2026

Property Address: 4 Thackeray Cl, Wetherill Park NSW 2164,  
Australia

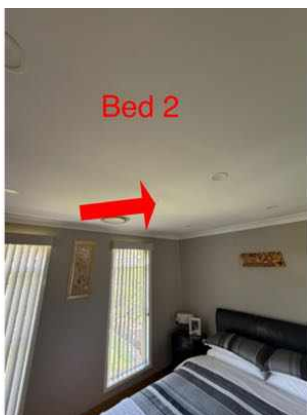
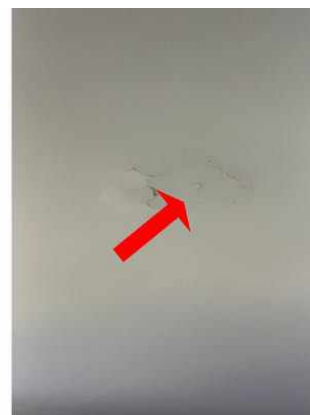
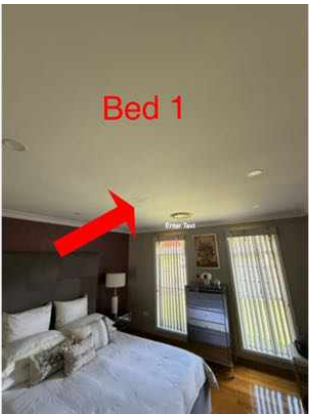
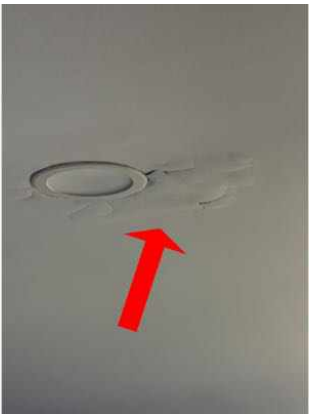
Building: Main Building  
Location: Bed 1/2  
Finding: Wall Patch Inadequate  
Information: A previously patched area to the gyprock has been completed to an inadequate standard. The repair is visibly uneven and poorly finished, resulting in an unsatisfactory appearance and inconsistent surface finish. The patched area has not been properly blended with the surrounding wall surface and requires further rectification and painting to achieve an acceptable standard of workmanship.

Poor aesthetics, potential cracking or failure of the patch over time, and reduced durability of the wall finish.

A suitably qualified plasterer or handyman should rework the patch repair to ensure a smooth, properly finished surface, followed by appropriate preparation and repainting to match the surrounding wall.

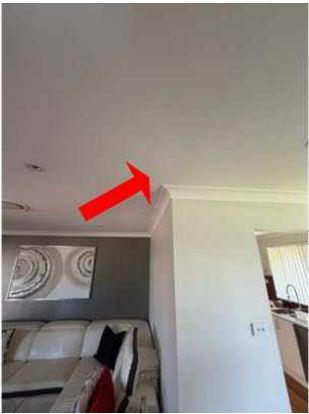
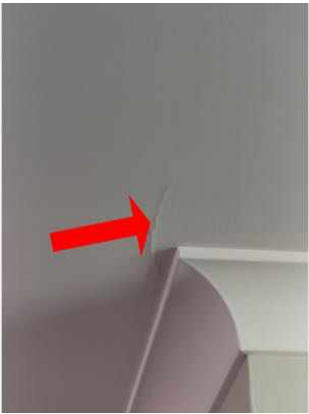
**Finding 3.02**

Building: Main Building  
 Location: Lounge  
 Finding: Cracking - Damage Category 1 - Fine (up to 1mm)  
 Information: Although fine cracks are quite noticeable, they are often only considered to be an appearance defect, and usually do not indicate any structural damage. Generally, the cause of a fine crack is indicative of a separation between building materials and finishes (e.g. paint, plaster, etc.) along joins.

Cracking of this nature can generally be repaired with minor sanding, filling and/or repainting. Such works should be performed by a qualified painter or a general handyman.

Monitoring of all cracking should be conducted frequently. Always contact a building inspector should cracks widen, lengthen, or become more numerous.

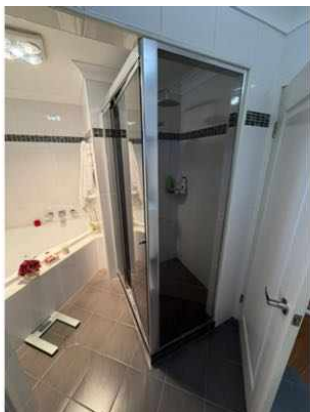
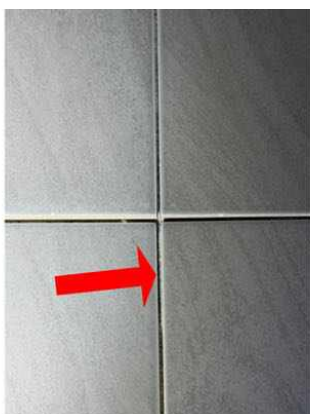
**Finding 3.03**

Building: Main Building  
 Location: Shower  
 Finding: Shower-Re Grouting/Sealing required  
 Information: The tiled shower floor was observed to have significant deterioration of the grout

between the tiles. In many areas the grout has washed away over time, leaving open joints between the tiles. This condition allows water to penetrate beneath the tiles and may lead to moisture ingress, deterioration of the substrate, and potential water damage to surrounding building elements.

The shower base requires the removal of any loose or remaining deteriorated grout, followed by regrouting and proper sealing to restore the integrity and waterproof performance of the shower floor. Repairs should be carried out by a suitably qualified tradesperson.

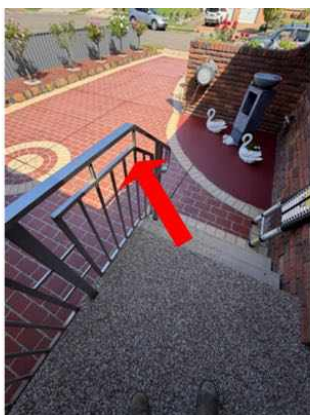
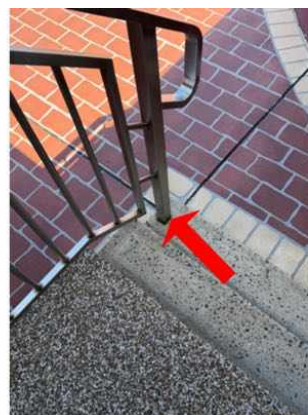
### Finding 3.04

| Finding: | Handrail-Loose |
| Information: | The stainless steel handrail installed at the front porch was found to be loose at the time of inspection. This indicates that the fixings or connections securing the handrail are not adequately tightened or secured, which may reduce the stability of the handrail when used. |

Loose handrails can present a potential safety risk and should be rectified. The handrail should be inspected and the fixings tightened or otherwise secured to ensure it is firmly fixed and compliant for safe use. Repairs should be carried out by a suitably

qualified tradesperson.

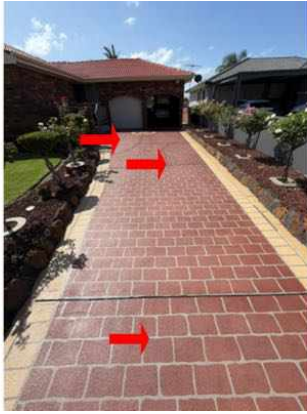
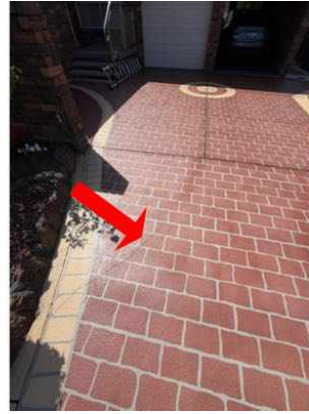
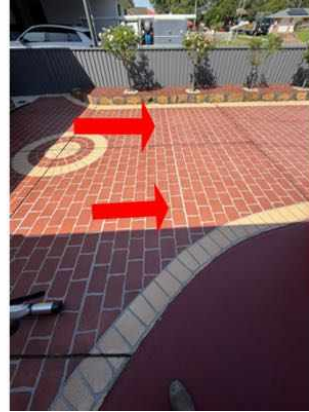
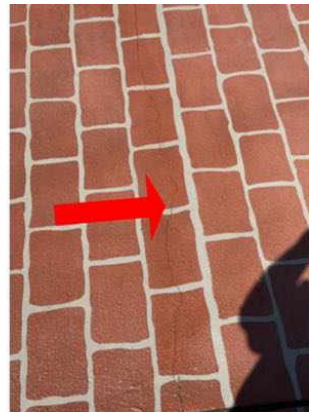
### Finding 3.05

| Finding: | Cracking - External Concrete Paving Damage Category 0 - Hairline (less than 1 mm) |
| Information: | Hairline cracks were identified in external concrete paving. Hairline cracks are very minor in nature and generally are only ever an appearance defect. To be classified as a Category 0 or hairline crack, the crack width would be less than 0.3mm. While such cracking may be noticeable in some cases, it is common and does not indicate any structural damage. |

Generally the cause of a hairline crack in existing concrete paving such as driveways and pathways is indicative of the expansion and contraction of the concrete. Such causes are generally due to environmental factors, such as moisture levels, weather conditions, root systems of nearby trees or the soil types on which they are laid.

Hairline cracks may also be due to poor original installation of the concrete. Factors such as poor compaction of the sub surface and/or inadequate reinforcing of the slab may create cracking and other secondary defects.

Monitoring of all cracking should be conducted frequently. Always contact a building inspector should cracks widen, lengthen, or become more numerous.

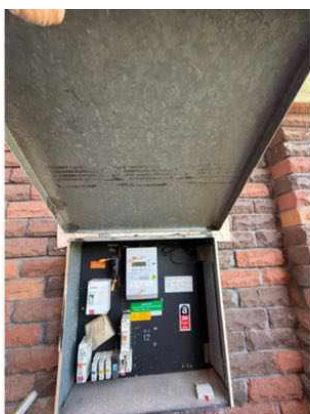
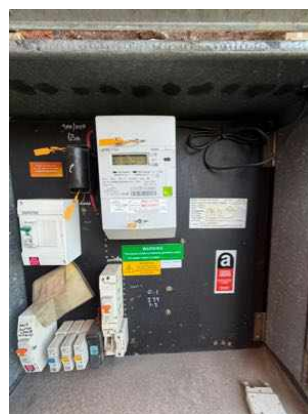
| Information: | The application of a post-construction chemical termite barrier is highly recommended for all properties, particularly if live termite activity has been found on the site previously. Such barriers are highly effective in preventing termite attack on any timber building elements throughout the property. |

A durable notice should be placed in the switchboard unit to indicate current termite barriers. At the time of inspection, it appeared as though no termite management system has been installed, with no evidence to suggest preventative works taking place.

The client may consider gaining further advice from a pest controller as to the costs and procedures involved with this application. It is recommended that obtaining such advice be a short-term priority.

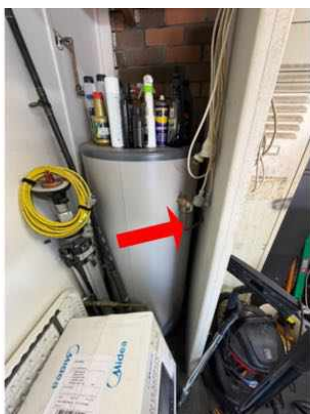
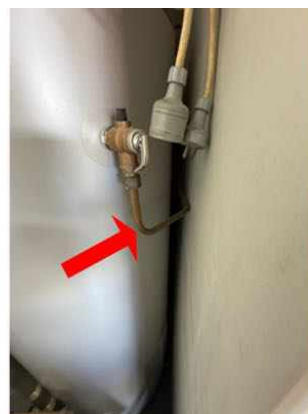
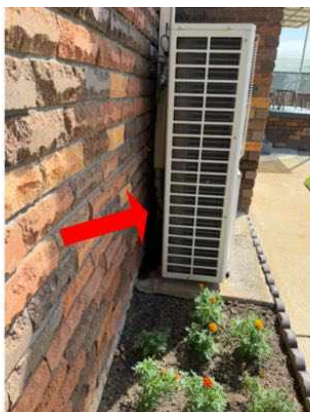
## Finding 6.02

These damp conditions can lead to secondary defects such as rot, rust or corrosion of associated building elements, the formation of fungal decay, or even the creation of potential slip hazards. When coupled with poor site drainage, pooling of water may also attract termite activity to this area.

It is highly recommended that a qualified plumber be appointed to install adequate drainage to the overflow. These works will ensure that the area remains dry and free of any secondary defects.

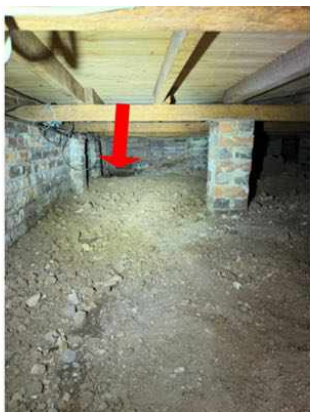
### Finding 6.03

| Finding: | Excessive subfloor moisture |
| Information: | Excessive moisture can attract termites and produce conditions that promote termite attack fungal growth and wood decay. |

Excessive moisture is generally caused by inadequate subfloor ventilation and poor site drainage.

There appear to be inadequate vents installed to the perimeter of the building and I would suggest that further solar powered fans or the like be installed to improve cross flow ventilation and aid in keeping the subfloor area relatively dry.

The installation of additional surface drainage to the property would also be beneficial to keeping the subfloor dry.

It is highly recommended that both subfloor ventilation and site drainage be improved and maintained regularly in order to prevent excessive moisture being present in the external / internal property.

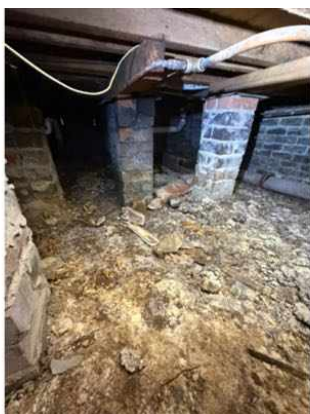
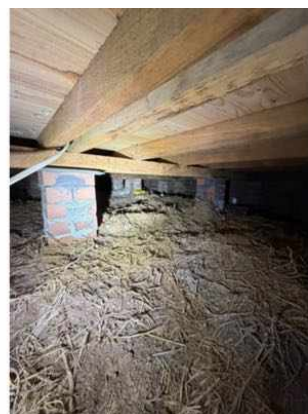
### Finding 6.04

| Information: | It was noted at the time of inspection that the subfloor area lacks adequate ventilation. Ventilation can be restricted by a variety of minor defects, including obstructions in the subfloor space, a lack of vents or a low clearance. |

A well ventilated subfloor aids in maintaining dry conditions, preventing secondary damage such as wood rot and pest activity, as well as preventing the development of mould and mildew (which can lead to respiratory safety hazards for occupants).

The initial step in improving ventilation is to ensure that the subfloor area is free of any debris or stored items. Where ventilation is still inadequate, it is advised to ensure that all vents are clear of blockages, and additional vents may be installed.

The client may also consider mechanical ventilation (powered fans) to improve subfloor airflow. Remedial works should be conducted as a matter of urgency to protect against the development of potentially harmful subfloor conditions.

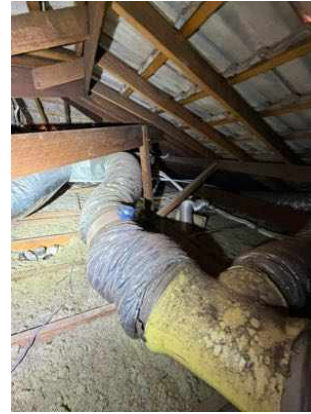
| Information: | These photographs are an indication of the obstructions and limitations that impeded the full inspection of the roof cavity at the time of inspection. Note that the insulation covered nearly all the ceiling joists, which are a major structural element of the ceiling; the inspection was also limited to areas with an allowable crawl space of 600mm x 600mm, in particular towards the external walls where the roof line diminishes, it was not accessible. These obstructions and limitations can hide an array of defects and should be removed to allow a full inspection to be carried out. A re-inspection is |

recommended once areas are made accessible.

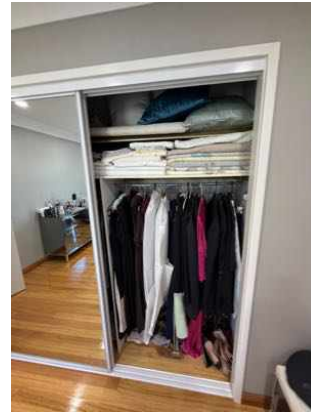
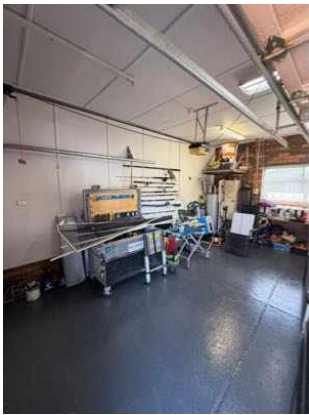
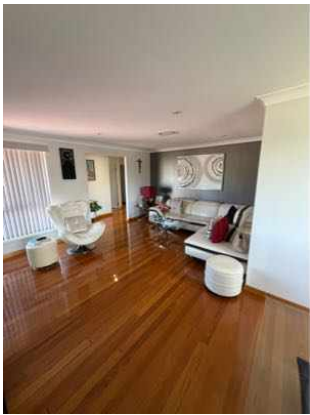
Finding: Obstructions and Limitations-Internal areas

Information: These photographs are an indication of the obstructions and limitations which impeded full inspection of the internal areas at the time of inspection. These obstructions can hide an array of defects and should be removed to allow a full inspection to be carried out. A re-inspection is recommended once the areas are made accessible.

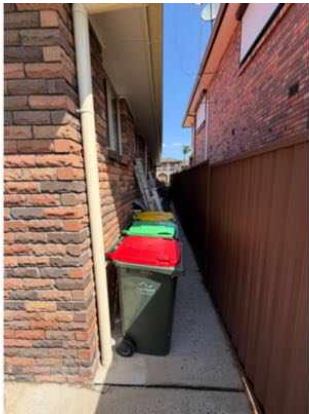
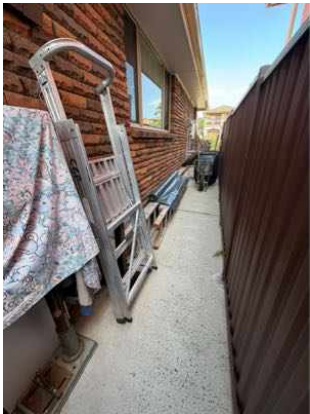
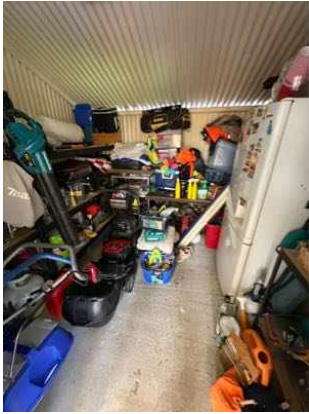
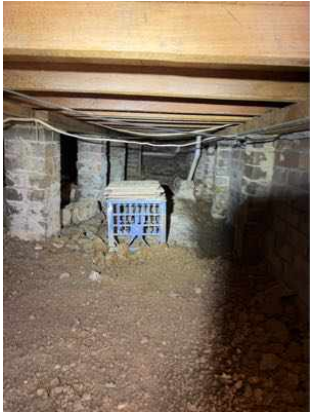
Building: Main Building  
 Location: External Areas/Sub-Floor  
 Finding: Obstructions and Limitations-External Areas/Sub-Floor  
 Information: These photographs are an indication of the obstructions and limitations which impeded full inspection of the external areas/subfloor at the time of inspection. These obstructions can hide an array of defects and should be removed to allow full inspection to be carried out. A re-inspection is recommended once the areas are made accessible.

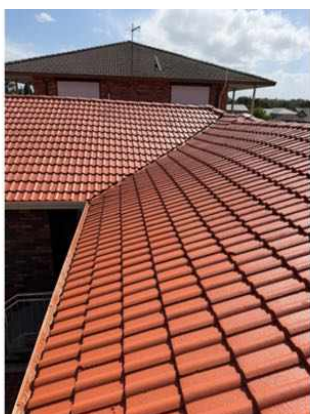
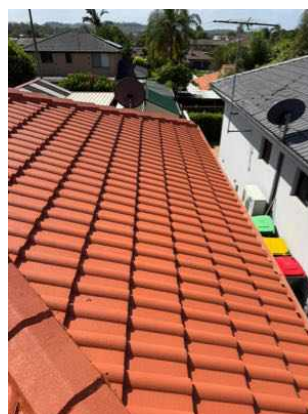
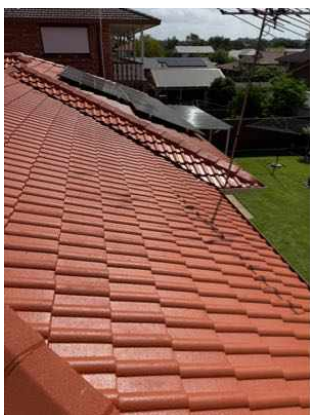
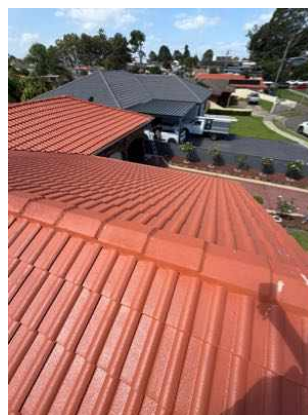
Building: Main Building  
Location: Roof Exterior  
Finding: FYI-Roof Tile Condition  
Information: At the time of inspection, the roof tiles visible from accessible areas were visually assessed and appeared to be in good condition. No significant damage, displacement, or defects were noted to the tiles that were observable during the inspection.

Based on the observations made during the inspection, the roof tiles appeared to be serviceable and performing as intended at the time of assessment. Regular maintenance and periodic roof inspections are recommended to help ensure the roof covering continues to perform effectively over time.

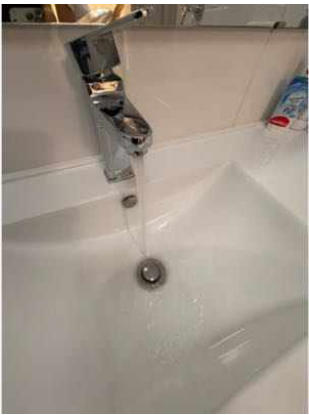
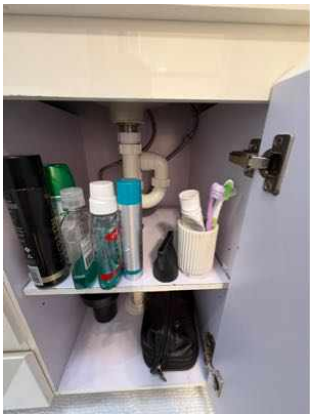
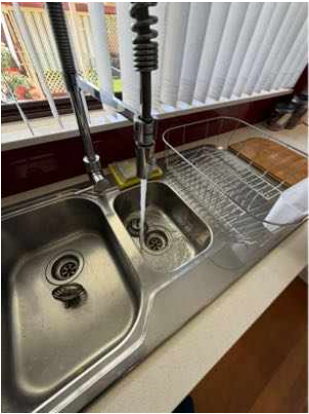
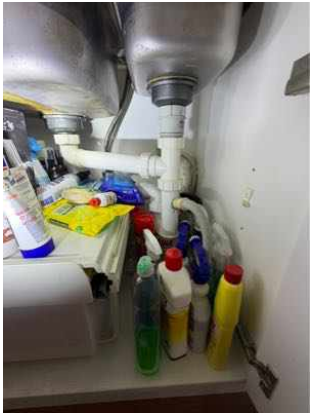
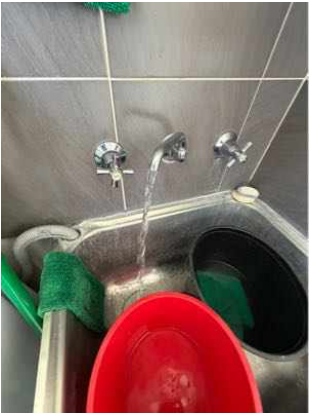
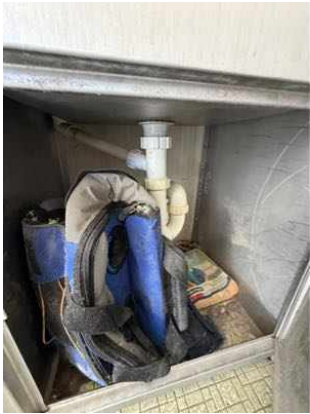
Building: Main Building  
 Location: Cabinetry Plumbing  
 Finding: FYI-Cabinetry Plumbing  
 Information: All cupboards where sinks and basins with drainage plumbing were inspected no evidence of leaks were present at the time of inspection.
