Building Inspection Report

Inspection Date: Thu, 26 Feb 2026

Property Address: 3/8 Central Ave, Boronia VIC 3155,
Australia

Company Name: Jim's Building Inspections (Croydon)

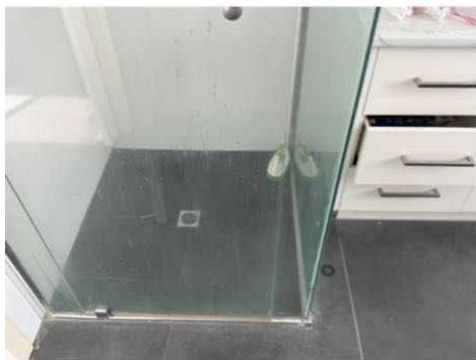
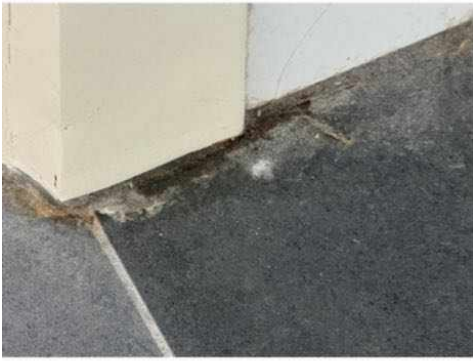
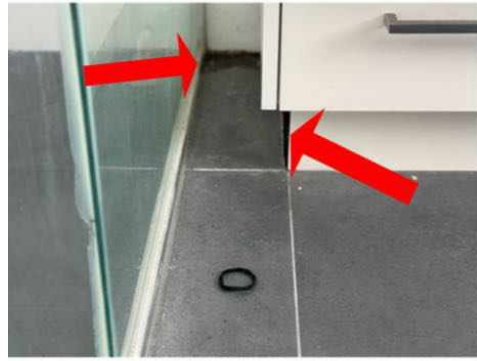
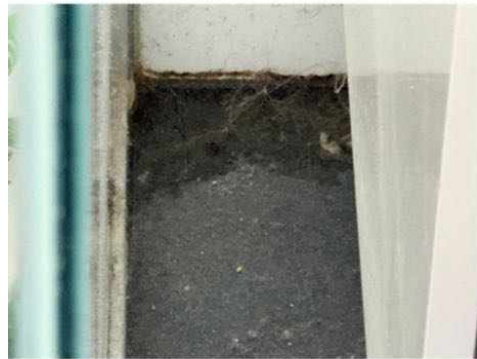
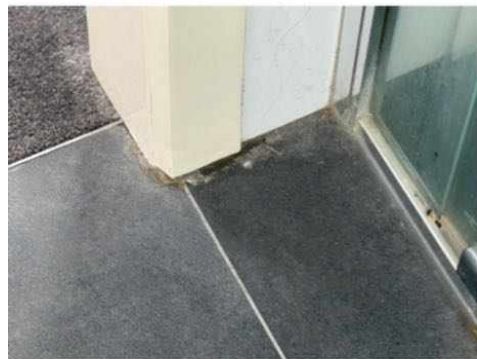
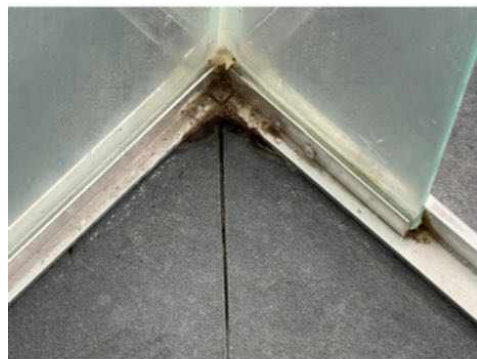
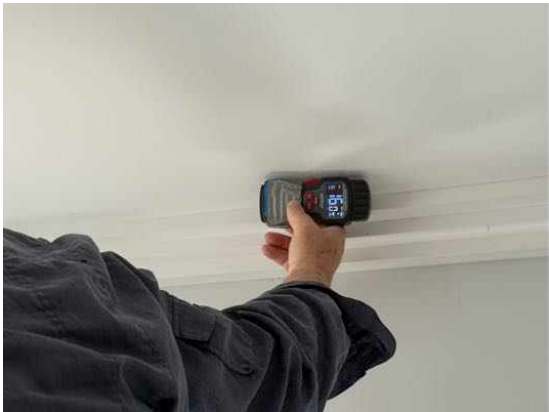
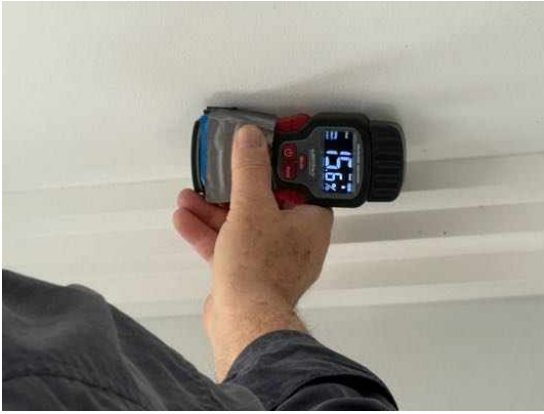
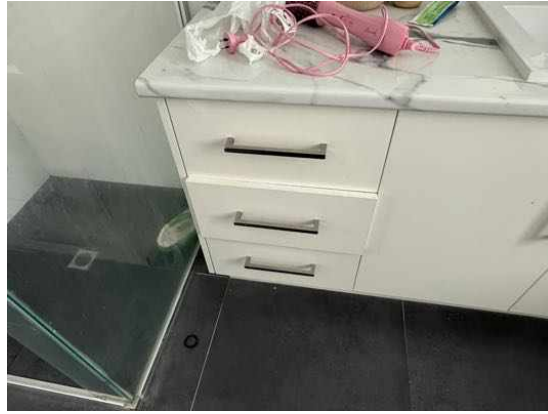
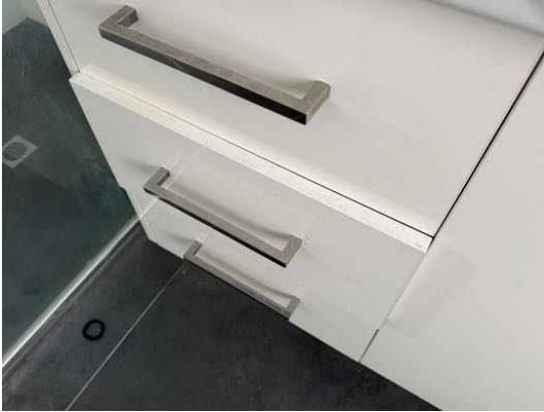
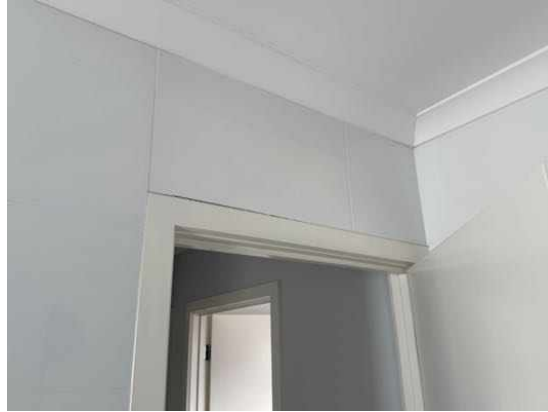
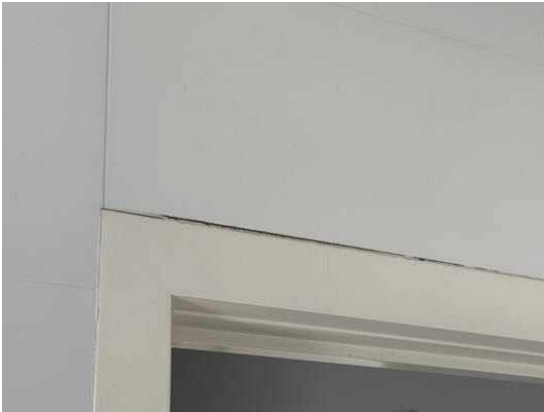
Defects 2.01

Building: Building 1
Location: Bathroom > All Areas
Finding: Suspected active moisture and water leak under the shower alcove floor tiles
Information: Active moisture and water leak was observed in and around the shower alcove. Moisture or water leaks are suspected to be entering where the grout between the tiles has been dislodged or missing. If left unmanaged water and moisture will certainly graduate further to cause secondary damage, corrosion and deterioration.

For the client's attention, the shower alcove showed areas where the grout had been dislodged frame between the shower floor tiles. It is highly suspect that moisture has penetrated below the tiles. This defect needs to be rectified immediately or in the very short future. To prevent further secondary damage, the client should not use this shower before these defects are rectified.

Where water damage is observed, the primary requirement is to identify and rectify the source of the leak immediately. A licensed builder should be appointed as soon as possible to remove the relevant shower floor tiles to identify any damage or deteriorated building elements and perform remedial works as deemed to be necessary to repair the leaks. Immediate action to rectify this problem will help ensuring the water damage is restricted and contained.

Once the shower floor tiles are repaired, consultation with relevant tradespeople, such as a cabinet maker is advised. Rectification works may include replacement of the basin cabinet and other building elements depending on the extent of the damage and how long the leak has been active.

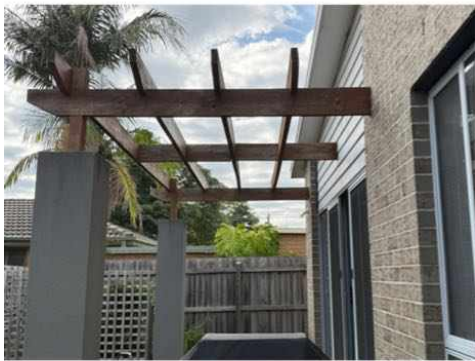
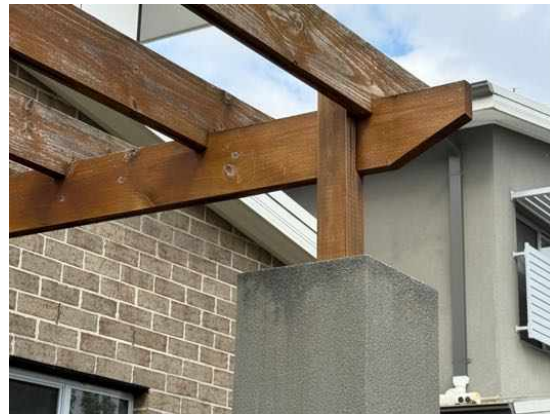
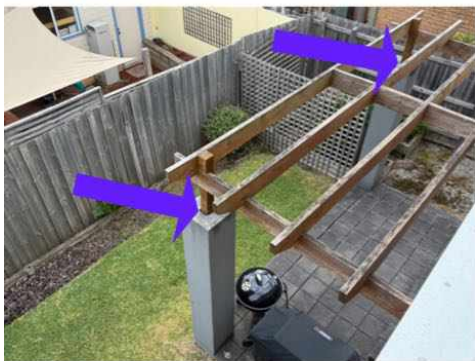
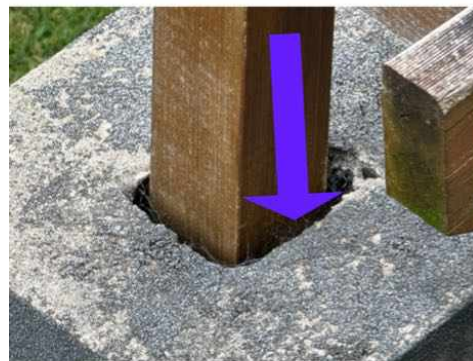
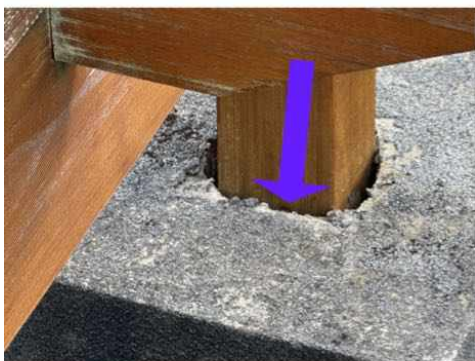
Defects 3.01

Building:	Building 1
Location:	All Areas > All Areas
Finding:	High probability of damage, deterioration or wood rot in the future
Information:	At the rear pergola where the post go into the tops of the pillars, there is a high probability of these timber posts showing accelerated moisture damage and deterioration or future wood rot. These holes around the perimeter of the posts should be filled to minimise the moisture being allowed to enter the holes around the posts.

Over time wood rot can develop due to timber exposed to extreme weather conditions over a prolonged period of time.

Always ensure exterior timbers are not exposed continuously extreme weather conditions or in contact with the ground as this will accelerate damage and deterioration to the timber. If left unmanaged further damage is highly likely to occur. Where the timber posts show deterioration due to excessive moisture, the cause of the moisture should be identified and reduced as deemed necessary. A qualified carpenter should be appointed to repair and replace rotting building elements and materials in the near future.

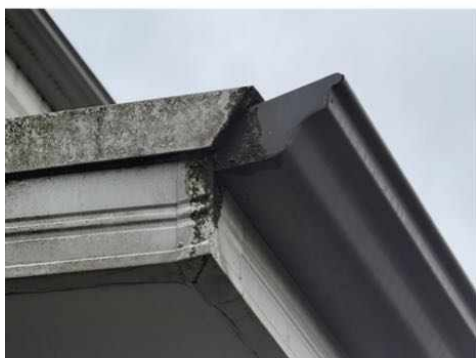
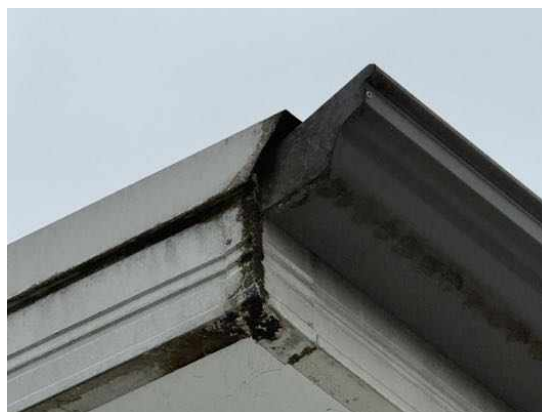
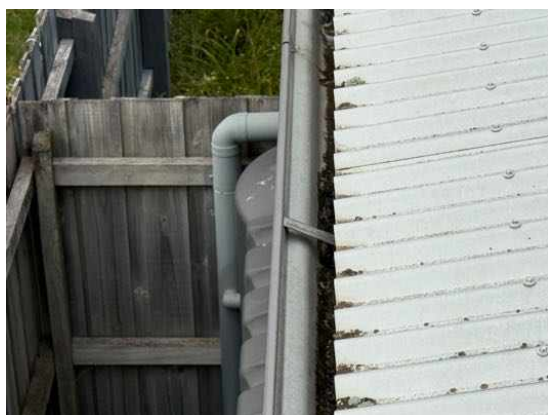
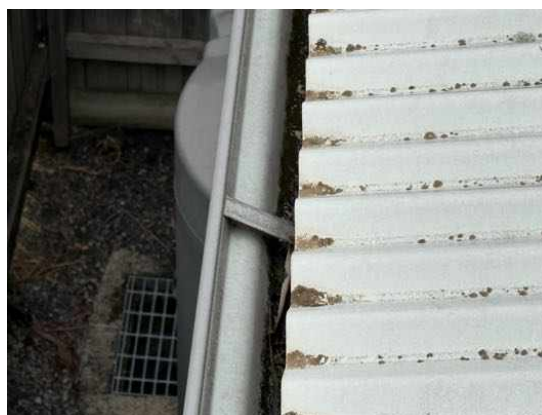
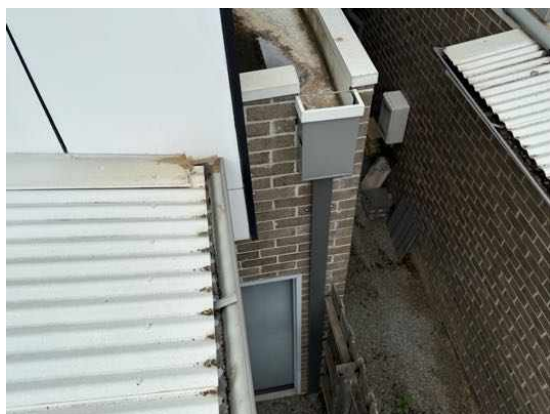
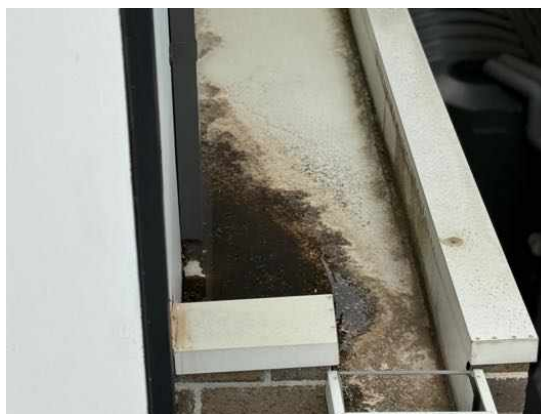
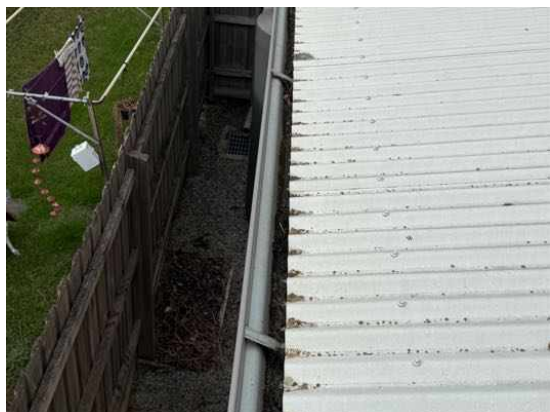
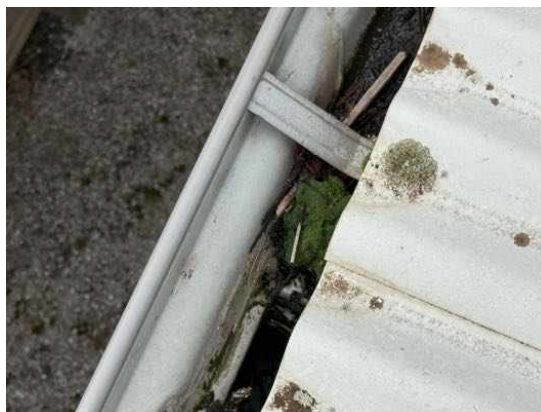
Defects 3.02

Building: Building 1
Location: All Areas > All Areas
Finding: Gutters - minor blockages
Information: Client should expect when buying a home that gutters cleaning is an essential maintenance item that's needs attention periodically. If trees are surrounding the property client should expect to clean out gutters regularly due to high amounts of leaf matter and debris from standing trees around the perimeter of the property. This maintenance and the clearing out of the gutters is considered to be very important to prevent blockages of the guttering and downpipes which will lead to water pooling and accumulated water overflows, which is likely to subsequently flood exterior walls and enter internal areas and damage building structures and other building elements. Roof plumbing structures, such as guttering and downpipes, should be free of all debris to prevent blockages.

Blocked gutters are likely to lead to high levels of moisture in the affected areas. Such moisture will not only cause rust and decay of the associated building materials, but can also provide conditions that are conducive to termite and timber pest activity. Blockages in gutters should therefore be removed immediately to ensure dry conditions are maintained. It is recommended that blocked gutters be cleaned and leaf matter and debris be removed by a relevant tradespersons regularly.

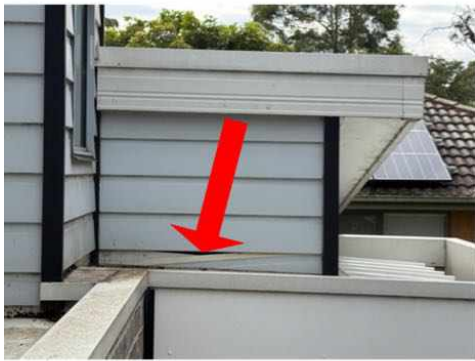
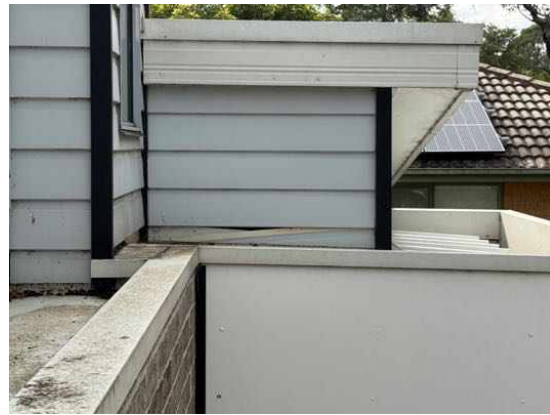
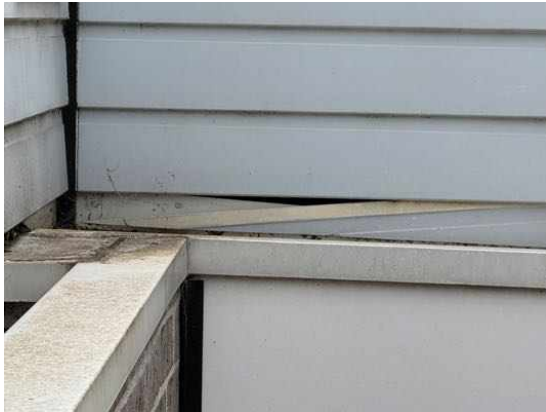
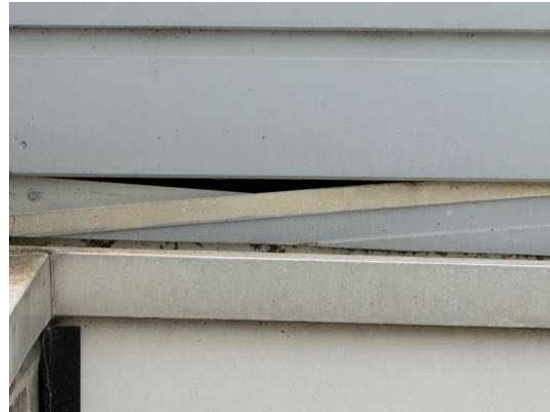
Defects 3.03

Building:	Building 1
Location:	All Areas > All Areas
Finding:	Exterior wall board has been dislodged or slipped
Information:	Upon inspection of the roof above the entry area, it was observed that the bottom wall board may have been installed poorly and has either slipped down or has been dislodged from the correct position. The wallboards is suspected to have slipped down, this can happen due to a number of minor causes, including not installed correctly at the time of installation or fixing may have failed.

The board will require some remedial work to replace and fix properly with an adhesive and nailing. Where these boards have moved from their original positions, it may allow water penetration into the wall or roof void, exposing these structures to moisture. This creates an environment that is conducive to water damage and accelerated deterioration of all associated building elements. Remedial work to rectify is highly recommended, it is recommended immediately or in the short term future to prevent the development or any possibility of secondary defects. A qualified carpenter or other relevant tradesperson should be appointed to complete such works as deemed to be necessary.

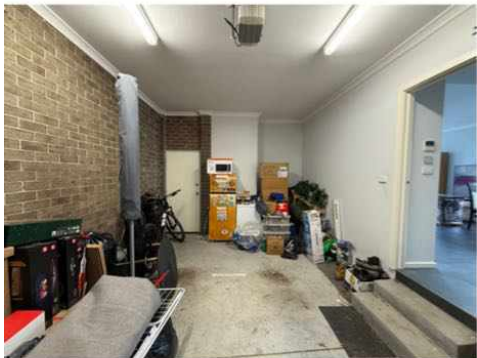
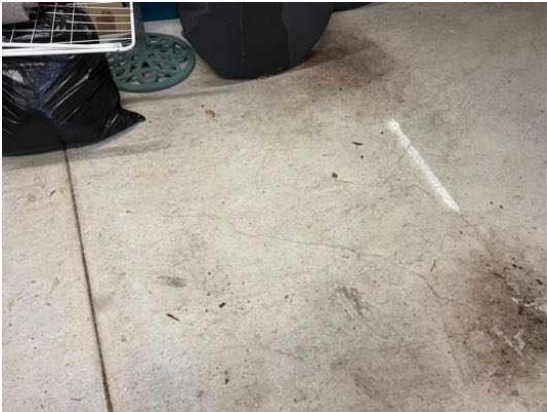
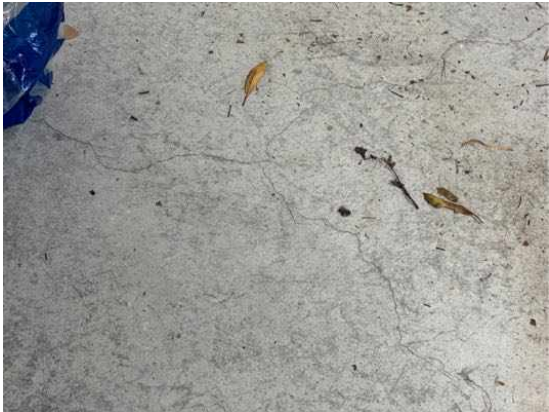
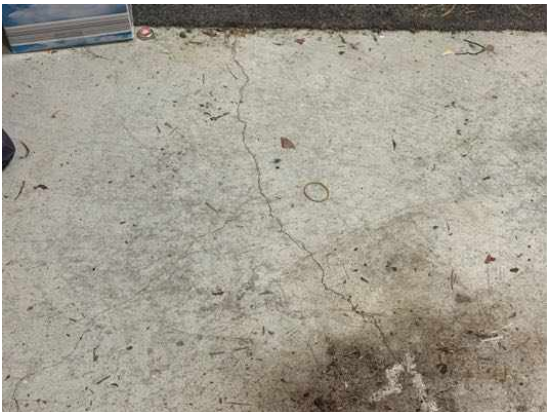
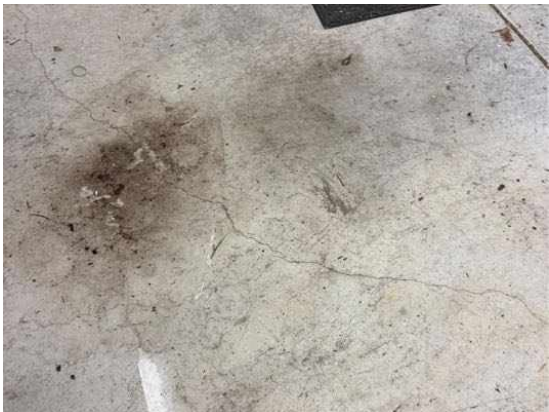
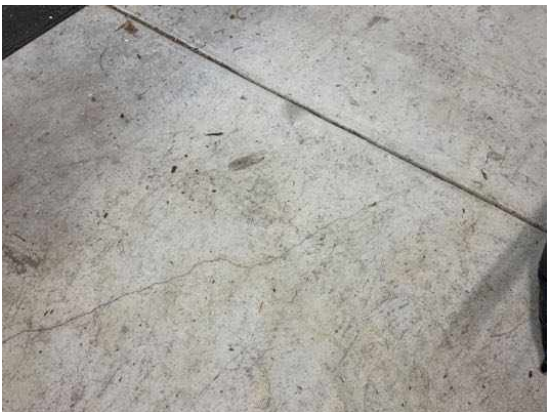
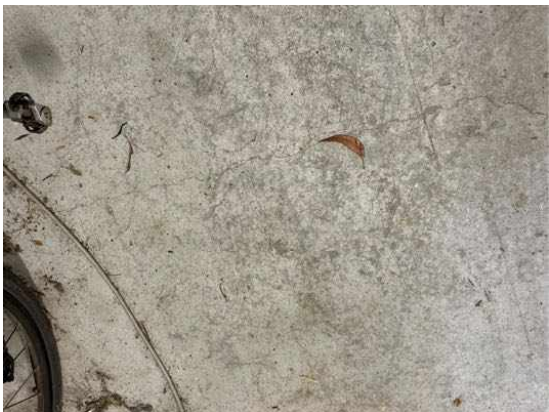
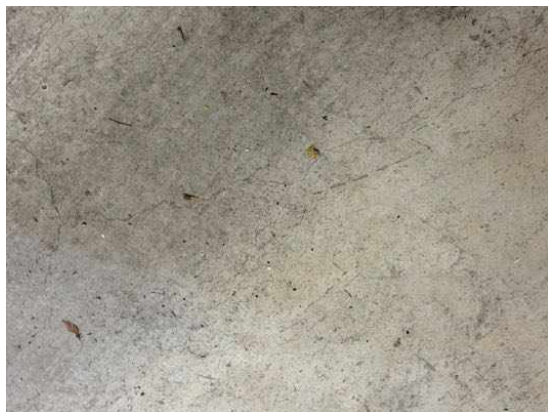
Defects 3.04

Building:	Building 1
Location:	Garage floor > All Areas
Finding:	Minor garage concrete cracks
Information:	The garage showed minor concrete cracks at the time of the inspection. Concrete cracks were considered to be minor are a common occurrence as a result of many primary defects. Such causes may include age, general wear and tear, expected building movement, general expansion/contraction of building materials in different weather conditions, and/or minor failings in the installation or application of building materials.

Monitoring of all cracking should be conducted annually. Contact a relevant tradespersons should cracks widen, lengthen, or become more numerous.

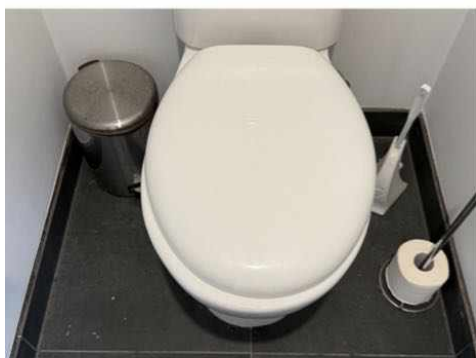
Defects 3.05

Building:	Building 1
Location:	Toilet (WC) > All Areas
Finding:	Toilet seat not fitted correctly
Information:	At the time of the inspection it was observed that toilet seat was not fitted correctly and will require refitting and adjustment. All stickers are required to be cleaned off all bathroom and toilets and fixtures.

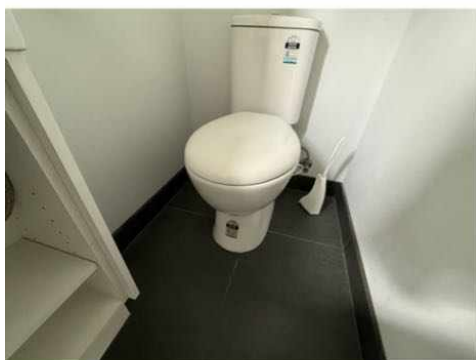
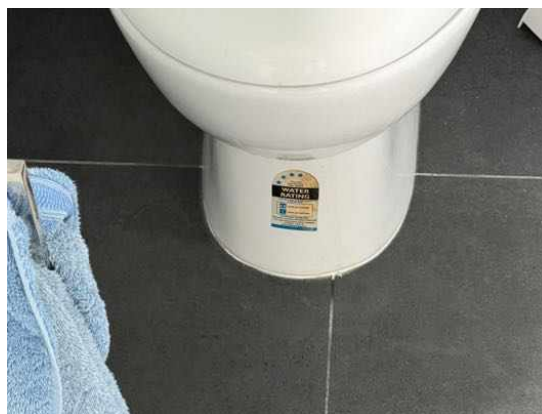
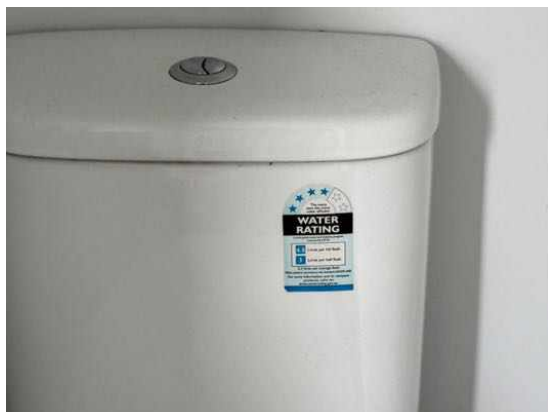
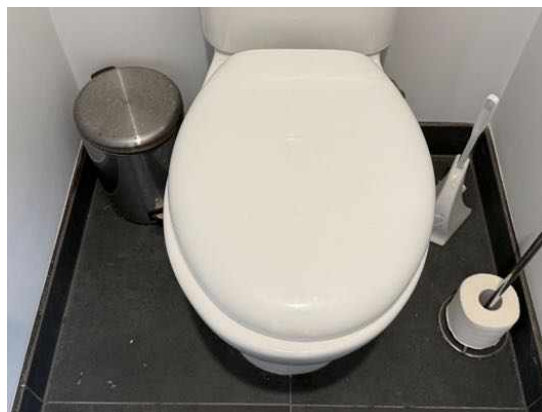
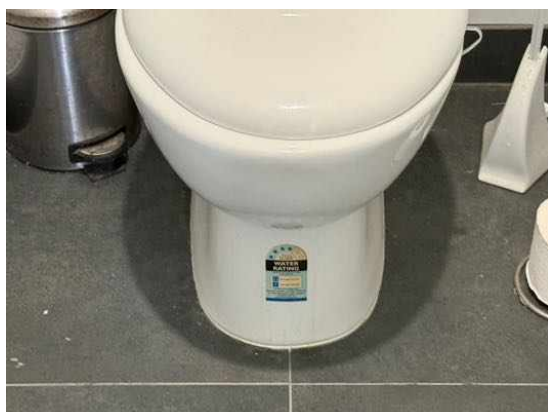
Defects 3.06

Building:	Building 1
Location:	Toilet (WC) > All Areas
Finding:	Toilet manufacturers stickers
Information:	At the time of the inspection it was observed that the toilets have manufactures stickers still on them, this is considered to detract from the overall quality and appearance of the home. These should be removed and cleaned off all bathroom and toilets, fittings and fixtures. This should be performed as part of the handover cleaning.

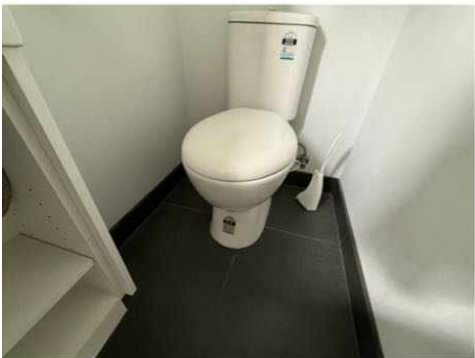
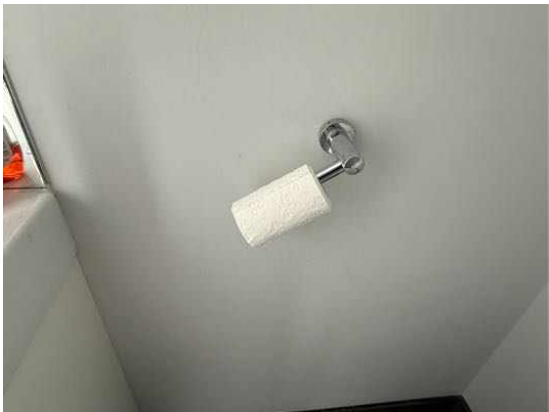
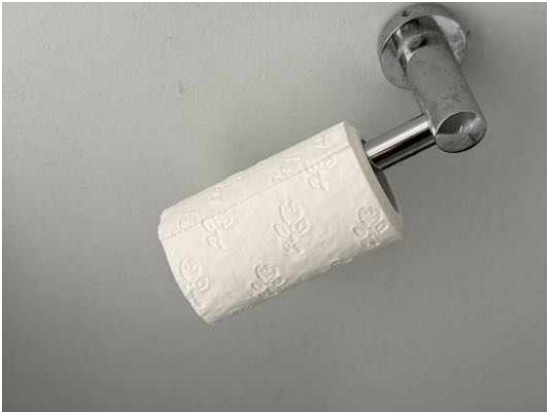
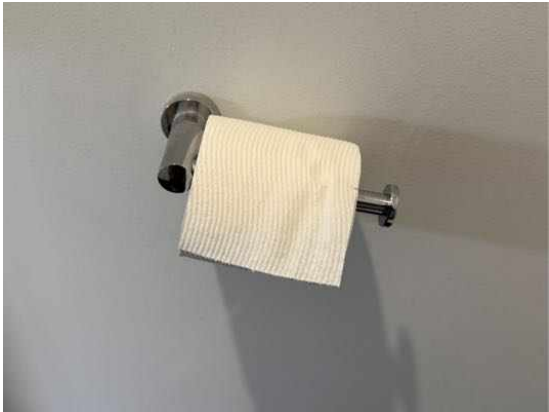
Defects 3.07

Building:	Building 1
Location:	Toilet (WC) > All Areas
Finding:	Toilet roll holders - Loose
Information:	The toilet roll holders and towel rail were found to be loose at the time of inspection. While not a major operational defect, function can deteriorate if the problem is left unmanaged. It is recommended that some remedial works to rectify the loose toilet roll holders and towel rails to its original fixing. If these cannot be be rectified to function as intended, client is recommended to renew. A qualified carpenter may be required to perform these works.

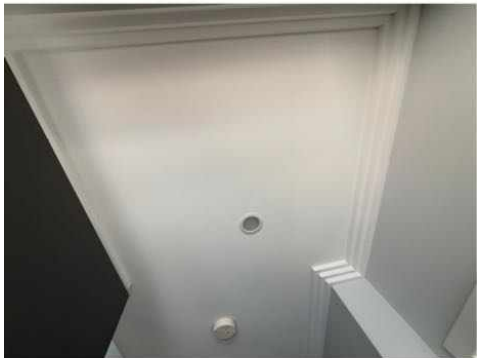
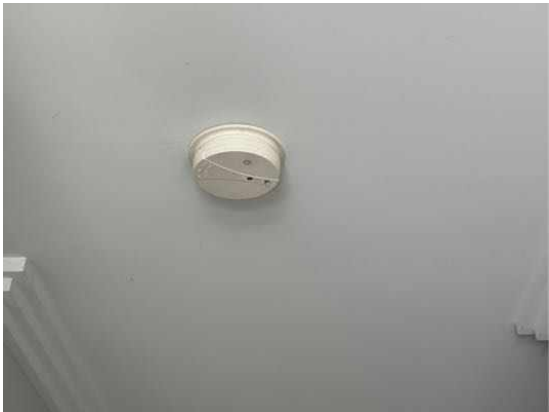
Building: Building 1
Location: All Areas > All Areas
Finding: Smoke detectors and alarms
Information: Reporting on Smoke Detectors or Alarms, including hard wired smoke detection systems and their legislative requirements, is outside the Scope of this Report. Please note that this defect is highlighted as a caution only. We suspect, based on our experience in the building industry, that smoke detectors are sometimes get over looked, or they may be in a poor condition, so we recommend that they always should be addressed prior to occupation to improve occupant safety.

Always ensure sufficient working and suitable smoke detectors are installed prior and

during to occupying any building. Additionally, it is advised that all smoke detectors be tested by the homeowner on a monthly basis.

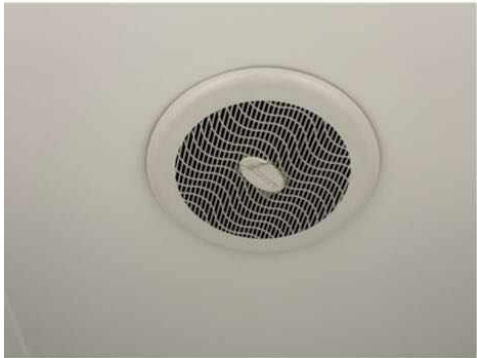
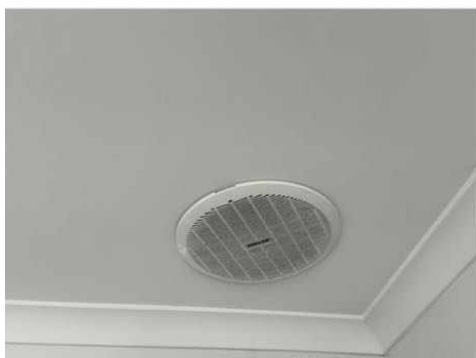
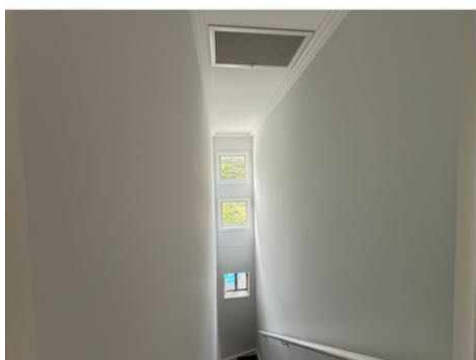
Building: Building 1
Location: All Areas > All Areas
Finding: Air filters, grilles and fans - require maintenance and cleaning
Information: Air grilles and fan covers need regular maintenance and cleaning. Dust, debris and dirt accumulated on the grill mesh will obstruct the normal air flow, these should be cleaned to prevent impairment of their intended functions. This includes such grilles and air filters from rangehoods, ducted heating / cooling units, ceiling and bathroom fans.

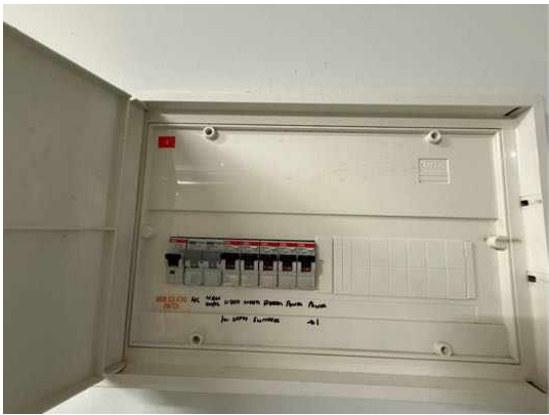
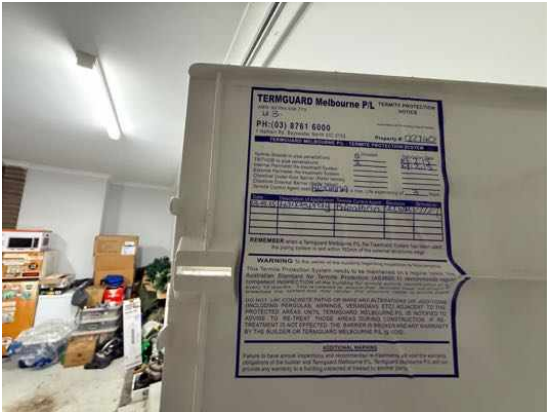
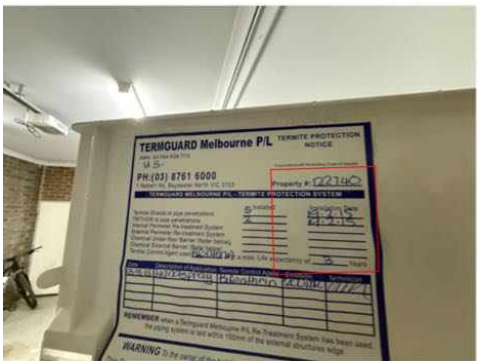
Building:	Building 1
Location:	All Areas > All Areas
Finding:	Termite Management System - out dated
Information:	At the time of the inspection, an old application of a chemical termite barrier was observed which is suspected to be from when the home was constructed. Such barriers are highly effective in preventing termite attack on any timber building elements throughout the property. A durable notice was observed to be placed in the in the meter box that indicated an old and out of date termite barrier, it appeared as though no termite management system has been installed recently, with no evidence to suggest preventative works taking place.

The client may consider gaining further advice from a pest controller as to the costs and procedures involved with this application. It is recommended that obtaining such advice be a short-term priority.
