Building and Timber Pest Inspection Report

Inspection Date: Fri, 6 Mar 2026

Property Address: 38 Graham St, Auburn NSW 2144, Australia

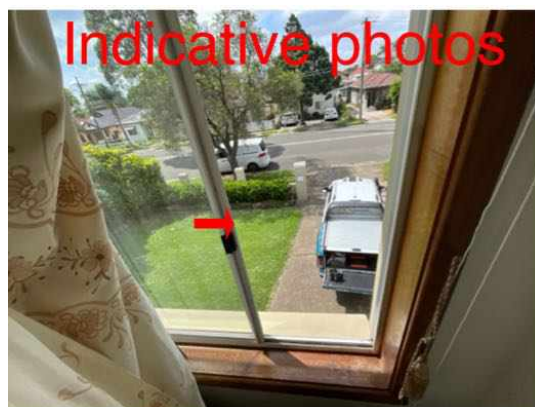
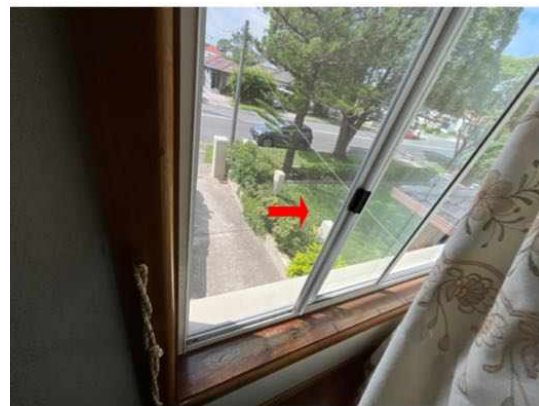
Building:	Main Building
Location:	Upstairs Windows
Finding:	Window restrictions - Missing
Information:	Window restrictors were found to be missing.

The National Construction Code (NCC) requirements apply to all openable bedroom windows in residential buildings, including hotels, motels and for all windows in early childhood centres.

Windows need to be locked at 12.5cm when the devices are engaged. The safety devices must be robust and child proof. The alternative is security screens such as bars or grills on the windows so long as they have gaps no bigger than 12.5cm. Flyscreens do not comply unless they are the reinforced security type and capable of resisting the very strong outward pressure which would prevent a child falling through. The laws apply to openable windows in a building within 1700mm of the internal floor and if the internal floor is more than 2m above the ground floor outside.

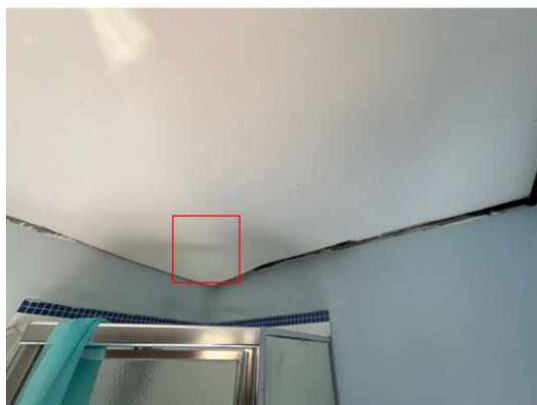
Finding: Ceiling - Sagging
Information: Sections of the ceiling were found to be sagging at the time of inspection. Sagging to the fixed ceiling structure generally indicates that the building materials have swollen, due to contact with water, or that fixings (e.g. nails or glue) have become loose and require reattachment.

In some cases, sagging ceiling linings may also indicate that there are structural issues, causing surfaces to warp, twist or sag. Where sagging appears to be major, appointment of a structural engineer is advised to further inspect the property and identify the source and rectification works required.

Where minor sagging is evident, comparatively minor works, such as re-gluing of ceiling sheets, may be required. Such works may be performed by relevant tradespeople, such as plasterers and painters. Where excessive moisture has caused the roofing structure to swell and sag, the source of the water leak should primarily be identified prior to any remedial works being performed.

The appropriate action should be taken by the client as soon as possible to ensure that any potential further damage is limited.

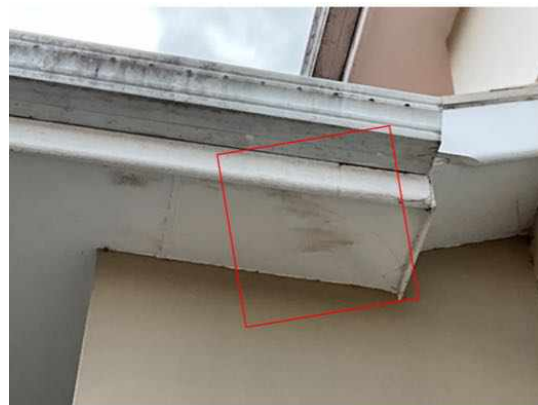
Finding: Eaves/Roof plumping -- water damages

Information: Water damage is generally an indication of excessive moisture being present, usually via a leak. It is suspected that gutter blockages causing stormwater to backflow into the eaves causing water damages. This is additionally conducive to termite activity due to the damp conditions.

Where water damage is evident, the primary requirement is to identify and rectify the source of the leak. Gutters must be kept clear of any blockages moving forward. A roofing plumber should be appointed for further assessment if the problem persists.

Once the leak is repaired, consultation with relevant tradespeople, including carpenters, plasterers and painters, is advised.

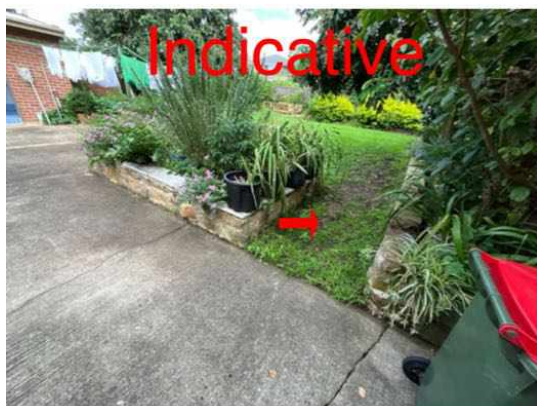
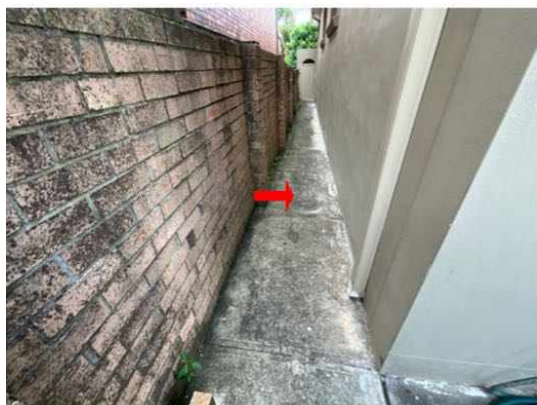
Finding 3.04

Finding: Site drainage— Inadequate

Information: The site drainage in this area was found to be inadequate at the time of inspection, creating potential for subsequent water damage to associated building elements. This is additionally conducive to termite activity.

It is important that water does not lie against the base of walls; surrounding paths and ground levels should be sloped to drain water away from walls. Downpipes should not discharge stormwater onto lower walls or plinths. Stormwater should be carried away by large, regularly cleaned drains. Ground levels may need to be lowered to expose a buried DPC.

Where site drainage is inadequate, installation of an Agricultural (Aggie) Drain may be required. A licensed plumber should be appointed to further inspect the property and perform any remedial works as necessary. Water damage and secondary defects are likely to occur if left unmanaged.

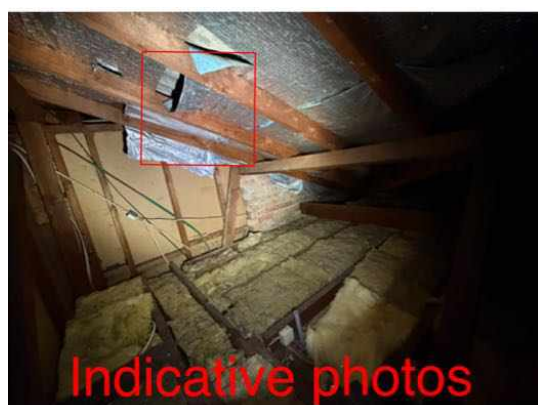
Building:	Main Building
Location:	Roof Void
Finding:	Sarking - Damaged
Information:	Sarking, a laminated aluminium foil applied to the interior of the roof covering, assists in insulating the property and acting as a vapour-barrier to the roof void and, subsequently, to the household.

Where sarking is damaged, both insulation and moisture protection of the property are inhibited. This creates a loss of energy and thus negatively impacts the energy efficiency of the property, allowing potential for moisture ingress from condensation or leaking roof tiles.

It is important to repair any holes or damaged sections of sarking to ensure that the building material is fully functional. A registered builder or qualified carpenter should be consulted to provide further advice on this defect and to perform rectification works at client discretion.

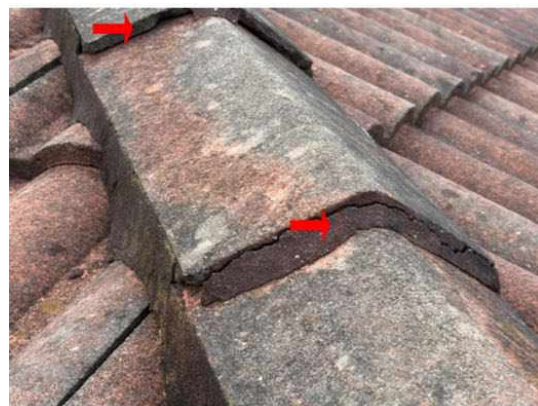
Finding 3.09

Building: Main Building
 Location: Roof Exterior
 Finding: Roof tiles - Weathered
 Information:

Upon inspection of the exterior roofing, the majority of roof tiles were considered to be in a fair condition. While weathering of the tiles is consistent with the age of the property, maintenance works are required.

Isolated areas of mortar have come loose and minor cracking is also present. Re-pointing and re-sealing the may be considered as an interim solution by the client to help preserve and extend the life span of the tiles.

Where left unmanaged, deteriorating roof tiles are likely to lead to a number of secondary defects, including minor water leaks and weather exposure to internal roofing structures.

Consultation with a licensed roofing contractor is highly advised to gain advice on cost of remedial works that may be required in the short to medium term. Remedial works are likely to increase the longevity of the exterior roofing structure.

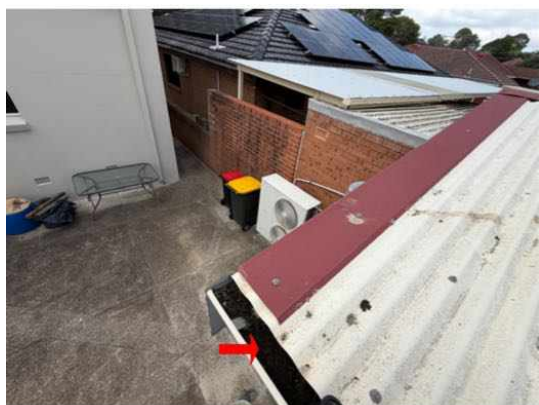
Finding 3.10

Blocked gutters are likely to lead to high levels of moisture in the affected areas. Such moisture will not only cause rust and decay of the associated building materials, but can also provide conditions that are conducive to termite and timber pest activity. Blockages in gutters should therefore be removed immediately to ensure dry conditions are maintained.

Consult a Licensed Plumber for further specific advice on remedial works that may be required. In the interim, it is highly advised that blocked gutters be removed by the homeowner or a general handyperson as a matter of urgency.

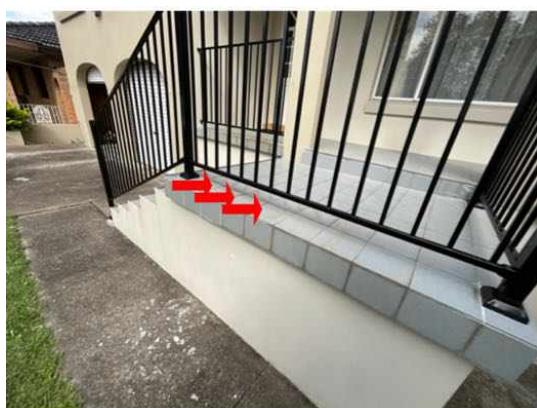
Finding 3.11

Building: Main Building
 Location: Porch
 Finding: Tiles - Drummy
 Information: Drummy tiled areas were identified at the time of inspection. The term 'drummy' refers to tiles that have become detached from their fixing, despite otherwise being in relatively good condition. Such defects are generally caused by physical or moisture damage to the area. Drummy tiled areas may also be a direct result of poor workmanship during the construction process.

Tiled areas may swell and shrink with changes in air humidity if the area has sustained moisture damage. Any exposure to moisture is capable of causing tiled areas to become drummy and/or cracked over a prolonged period of time. Drummy tiled areas generally require removal and replacement of affected tiles, with adequate sealant and grouting.

Specialist trades are available for these types of services. A licensed tiling contractor may be appointed to perform works as necessary.

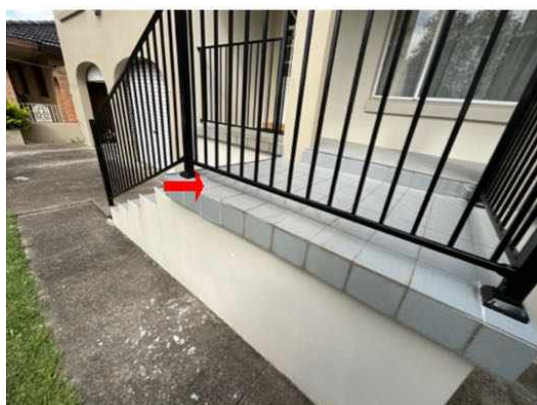
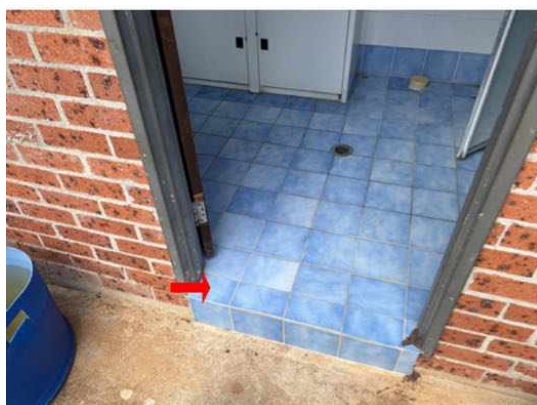
Finding 3.12

Building: Main Building
 Location: Porch, Outbounding
 Finding: Cracked floor tiles
 Information:

Cracking in the floor tiles was evident in this area at the time of inspection. It is suspected that this cracking has occurred as a result of minor settlement or shrinkage.

Cracked tiles throughout the household detract from the overall appearance of the affected areas however it is unlikely to create or lead to any secondary defects.

While not considered a matter of urgency, replacement of cracked floor tiles is recommended at the clients discretion. A licensed tiling contractor may be appointed to perform these works. Where cracks become more numerous, contact a licensed

building inspector for further investigation.

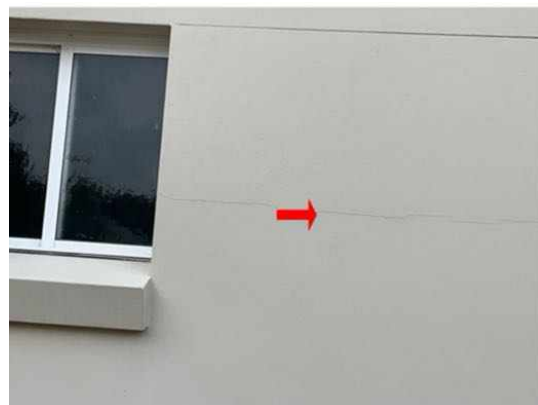
Building:	Main Building
Location:	Exterior walls - rear
Finding:	External render — Cracked (minor)
Information:	Rendered surfaces were identified to be cracked at the time of inspection. The width of these cracks are under 1mm and are not significant.

This generally does not indicate a structural defect and may be due to poor workmanship during construction. Other causes include age, general wear and tear, expected building movement, general expansion/contraction of building materials in different weather conditions, and/or minor failings in the installation or application of building materials.

Any exposure to moisture is capable of causing rendered areas to become drummy and/or crack further. A licensed renderer or painter should be appointed for rectification works in short term.

Always contact your building inspector should cracks widen, lengthen, or become more numerous.

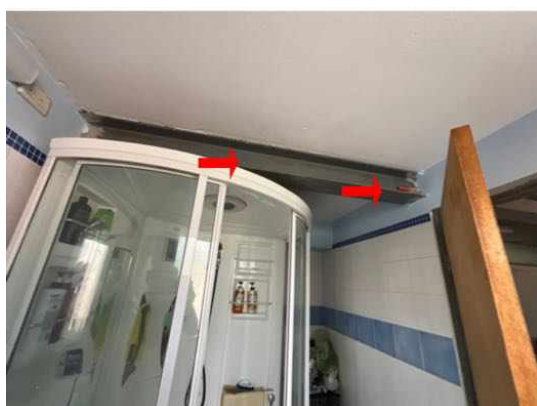
Finding 3.15

Building:	Main Building
Location:	Garage Bathroom
Finding:	Building element - Rusted or corroded
Information:	This building element shows evidence of rusting and corrosion, which is likely to have developed as a result of excessive exposure to moisture and or inadequate coatings.

As surface rust provides no protection to the underlying iron, the deteriorating condition is likely to worsen if not addressed in the short-term future.

Where possible, the use of galvanized (treated) metals or aluminium coated metals aid in rust prevention, as does regular general maintenance. Rust formation can be controlled with coatings, such as paint, that isolate the iron from the environment.

Rusting and corrosion should be managed by ideally removing or limiting the affected surface from exposure to moisture. A licensed painter must be appointed for an adequate level of paint work.

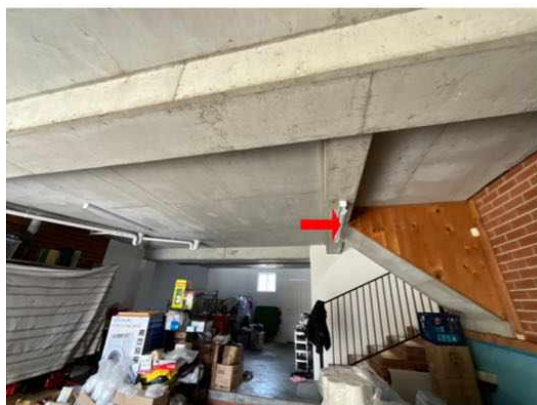
Finding 3.16

Building:	Main Building
Location:	Garage
Finding:	Fitting or fixture - Loose

Information: The fitting in this area is loose and requires adjustment to tighten.

If left unmanaged, the fitting may further deteriorate, causing potential for the development of other minor secondary defects.

A relevant tradesperson should be appointed to perform these rectification works at discretion of the client.

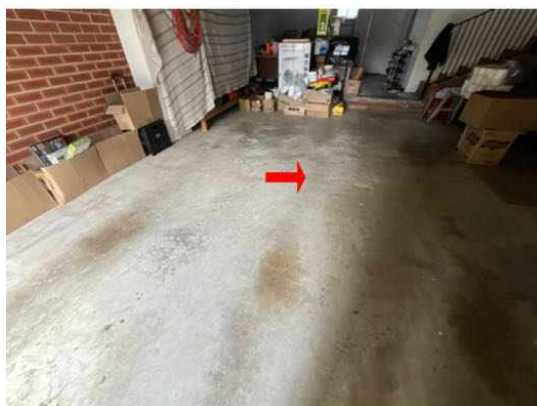
Finding 3.17

Finding: Crack in concrete slab - Category 1

Information: A crack coded as Category 1 was identified in the slab. A Category 1 crack is described as a fine but noticeable crack, with the slab at an otherwise reasonable level.

To be considered Category 1, the approximate width of the crack is less than 1.0mm, or a less than 10mm change in offset when a 3m straight edge is placed over the defect.

Category 1 cracks should be monitored for a period of 12 months. At the end of the monitoring period, identified cracks that are rated greater than Category 2 are considered defects, and require rectification.

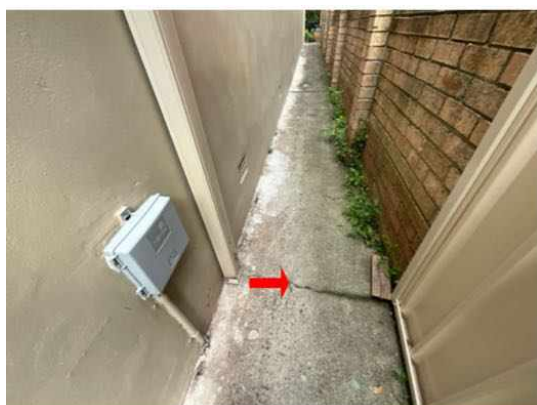
Finding 3.18

Building: Main Building
 Location: Multiple areas
 Finding: Crack in concrete slab - Category 2
 Information: A crack coded as Category 2 was identified in the slab. A Category 2 crack is described as a distinct crack, with the slab being noticeably curved or changed in level.

Category 2 cracks to slabs should be monitored for a period of 12 months. At the end of the monitoring period, cracks rated greater than Category 2 are considered defects that require rectification.

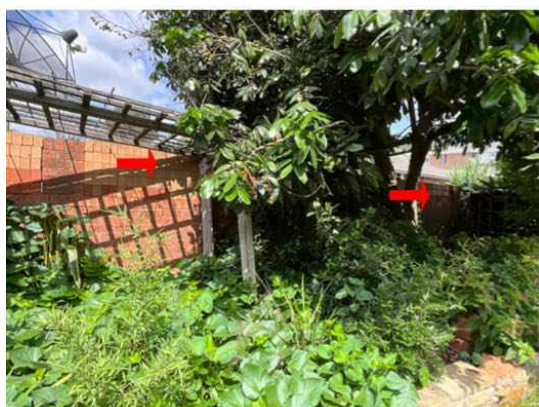
Finding 3.19

Building: Main Building
 Location: Brick fencing
 Finding: Unconventional handyman work
 Information: This handyman work appears to have been completed to a substandard level and

The client should exercise care when coming into the immediate vicinity of the substandard works. Rectification works are advised as soon as possible by the appropriate trades.

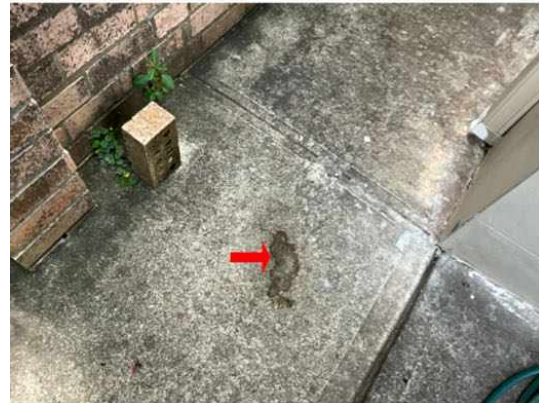
Finding 6.02

Building:	Main Building
Location:	Rear left corner
Finding:	Water leak - External
Information:	Water leaks were found to be present to exterior plumbing work. Leaks are generally caused by deterioration of the plumbing elements over time, due to exposure to weather conditions, but may have also been caused by minor impact damage.

may be present. Areas of repair and replacement of plumbing fittings and fixtures may be required and, as such, a quotation should be sought.

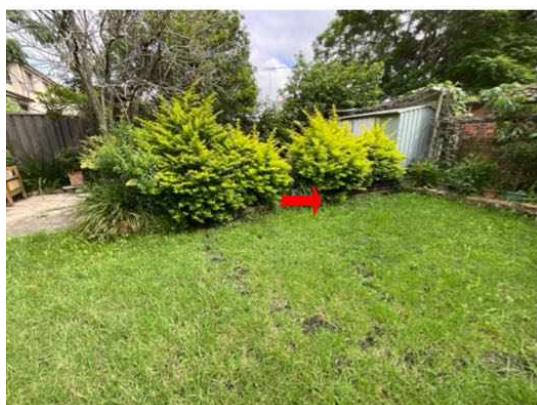
Finding 6.06

Building:	Main Building
Location:	Fencing & Landscaping
Finding:	Building materials in direct ground contact - conducive to termites
Information:	Where timber elements are in direct contact with the ground and consequently moisture or dampness they become conducive to termite activity. Whether timber is used as a building element part of a fencing structure or stored as an unused item they can provide an environment that is attractive to termite infestation.

The removal of any such materials that may be conducive to termite activity should be removed as soon as possible to minimise the risk of termite attack.

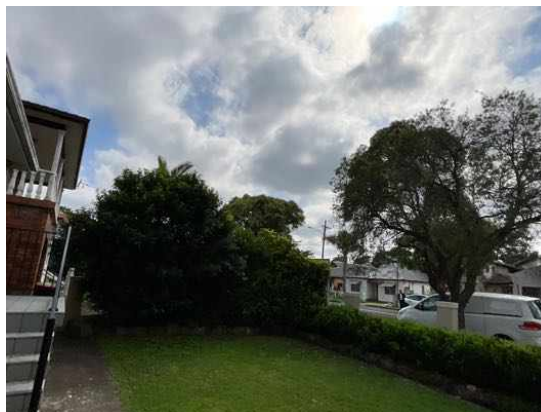
Finding 6.08

Building:	Main Building
Location:	
Finding:	Surrounding bushland - Conducive
Information:	Home and or building is situated in a high risk area for termite activity, due to close proximity to surrounding bushland.

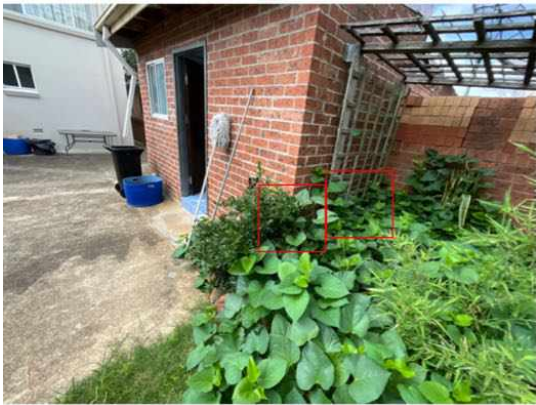
Finding 6.09

Building:	Main Building
Location:	Outbounding
Finding:	Bridging - Vegetation
Information:	Where vegetation obstructs inspection of building elements, also known as bridging as it provides a bridging point for the access of termites, full inspection can not be achieved. Consequently moisture or dampness may be present and the areas becomes conducive to termite activity. Plants against or very close to buildings provide cover, shade and can provide an environment that is attractive to termite infestation.

The removal of any such materials that may be conducive to termite activity should be carried out as soon as possible and arrange re inspection to minimize the risk of termite attack.

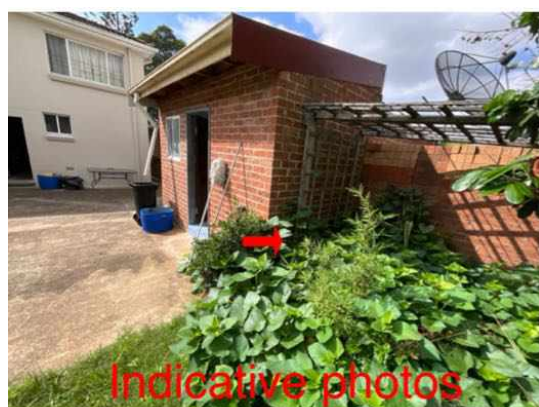
Not able to comment. A very high proportion of termite attacks are over the edge of both Infill and other concrete slabs types. Covering the edge of a concrete slab makes concealed termite entry easy. Infill slab type construction has an even higher risk of concealed termite ingress as the slab edge is concealed due to the construction design and cannot be exposed. The type of slab may only be determined by assessment of the construction plans by a qualified person e.g. Builder, Architect. Construction Plans may be obtainable by your local Council or Builder. Termite activity and or damage may be present in concealed timbers of the building. We strongly recommend frequent regular inspections in accordance with AS 3660.2. Where the slab edge is not fully exposed or the slab is an infill slab or the slab type cannot be determined then we strongly recommend inspections every 3 to 6 months in accordance with AS 3660.2 or AS 4349.3.
