Building and Timber Pest Inspection Report

Inspection Date: Fri, 20 Feb 2026

Property Address: 56 Clara St, Tumbarumba NSW 2653,
Australia

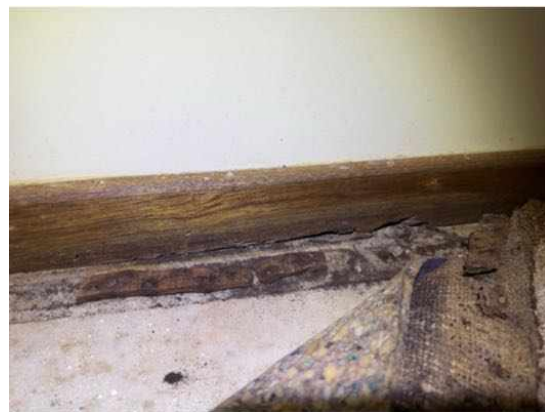
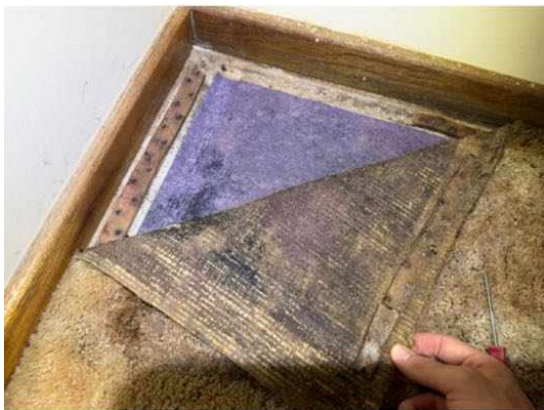
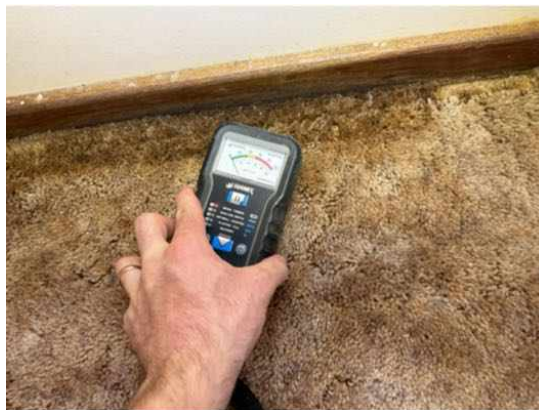
Finding 3.01

Building: Main Building
Location: Lounge room carpet
Finding: Mould - Present
Information: It appears mould growth was identified at, but not limited to, the lounge room carpet. A musty/mouldy smell was also present in this area at the time of inspection. The client is advised to ensure that the general environment has sufficient airflow and light penetration to aid in the prevention of mould formation and development.

It appears mould was present at, but not limited to the lounge room carpet. No high moisture was identified in this area at the time of inspection. A musty/mouldy smell was also present in this area. Recommend engaging a cleaning contractor to remove & clean the mould growth.

Mould growth should be cleaned/removed promptly, by a cleaning contractor. No high moisture was identified in the area, at the time of inspection.

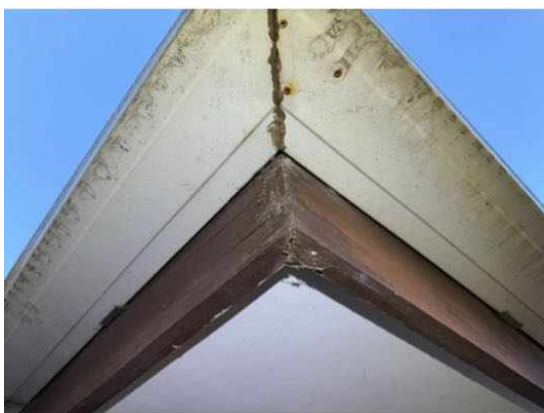
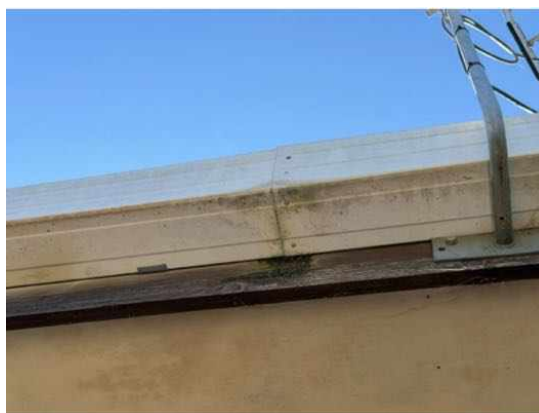
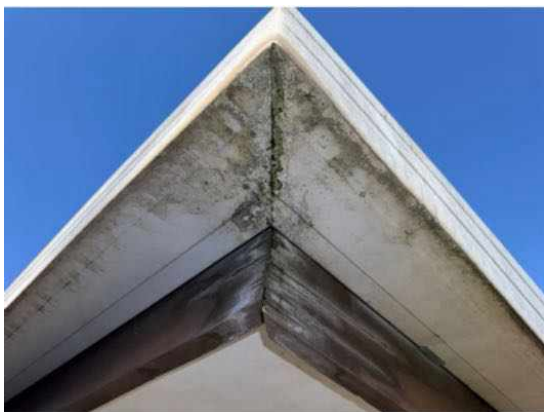
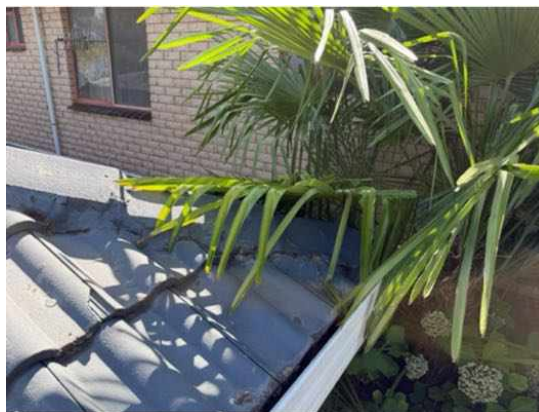
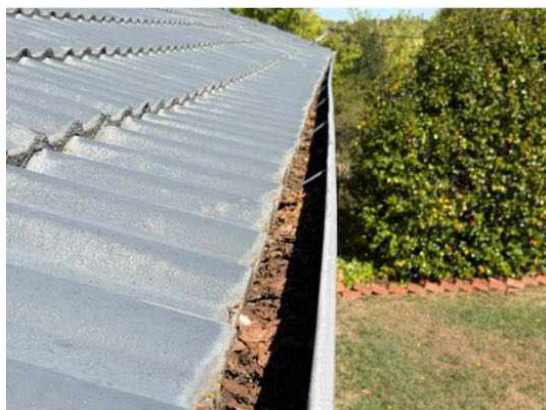
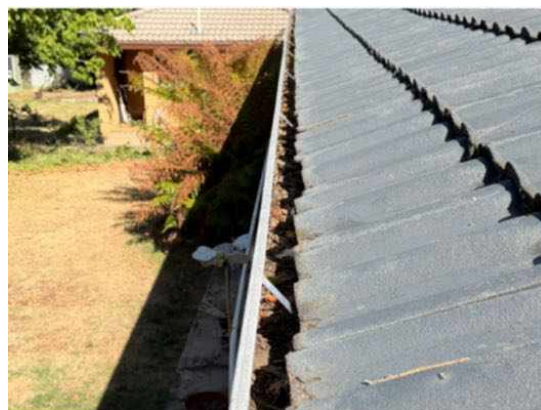
Finding 3.02

Building: Main Building

Location: Gutters

Finding: Gutters - Debris & Corrosion/Leaking

Information: It appears that there is debris present in the guttering in some areas. Some areas of corrosion / leaking were also noted, a common finding in buildings of a similar age.

Recommend engaging a licensed roof plumber in the short term, to provide further advice on maintenance works needed, to avoid further deterioration. All debris should be removed from the gutters promptly, to prevent blockages and overflows.

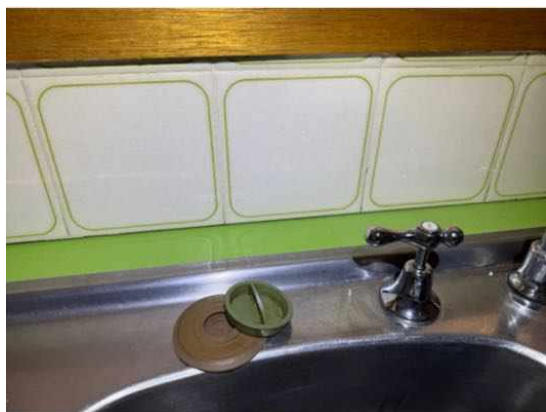
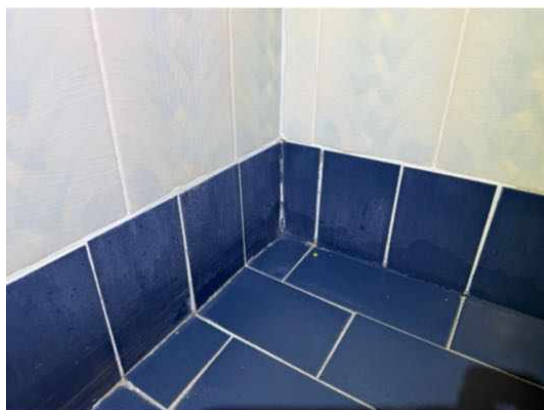
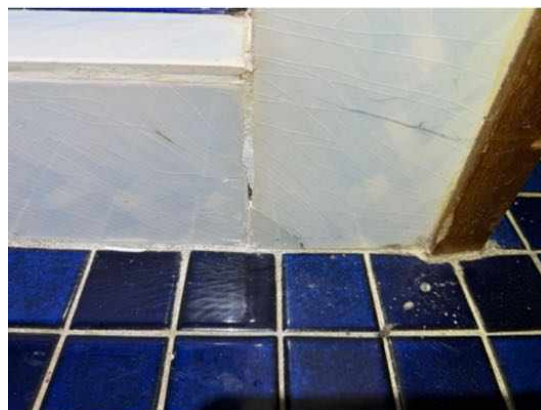
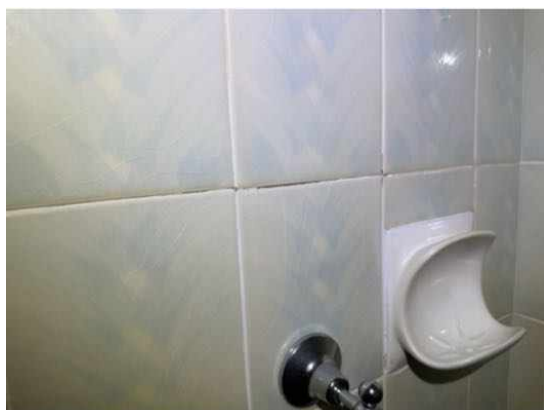
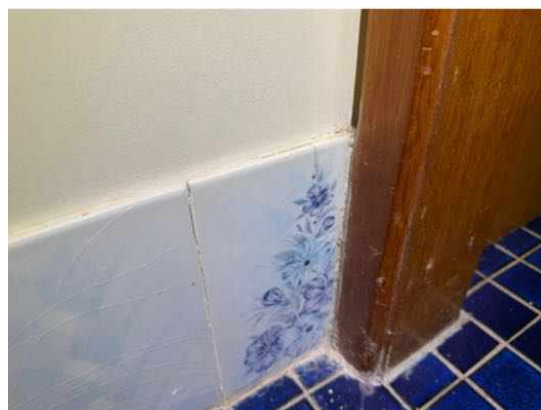
Finding 3.03

Building: Main Building

Location: Tiled Areas

Finding: Sealant / grouting - deteriorated or missing & Cracked Tiles

Information: It appears that the sealant and grout has deteriorated in some tiled areas, a common defect in buildings of a similar age. Areas of cracked tiles were also noted, which can allow for moisture ingress behind the tiles, if neglected.

Sealant and grouting in areas that come into regular contact with water should be maintained for the long term care of your property.

Recommend engaging a licensed tiling contractor in the short term, to provide maintenance works where necessary.

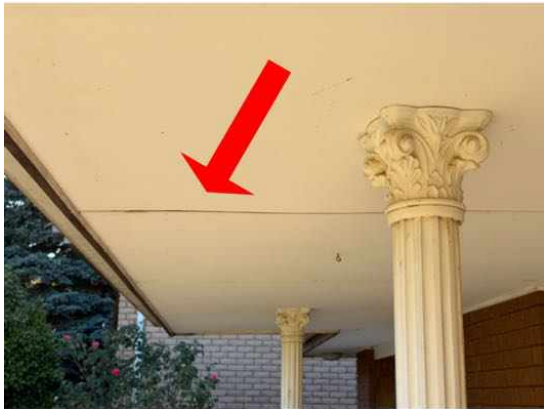
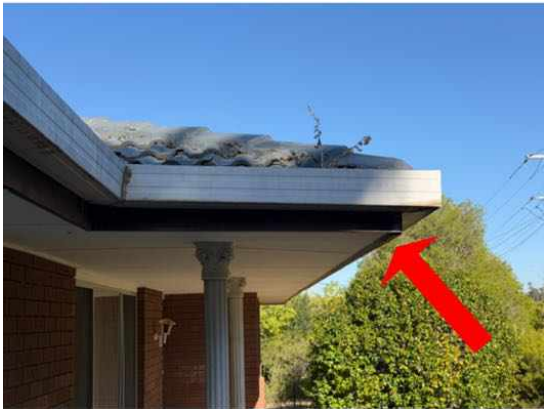
Finding 3.04

Building:	Main Building
Location:	Front Elevation
Finding:	Eaves - Sagging
Information:	<p>It appears that the eaves at but not limited to the front elevation, were found to be sagging at the time of inspection. Sagging of eaves generally indicates that the fixings (e.g. nails or glue) have become loose and require refixing, or the associated framing has sagged overtime.</p> <p>It is recommended that the client monitor the sagging. Should the sagging worsen, a licensed carpenter should be engaged to provide further advice & remedial works where necessary.</p>

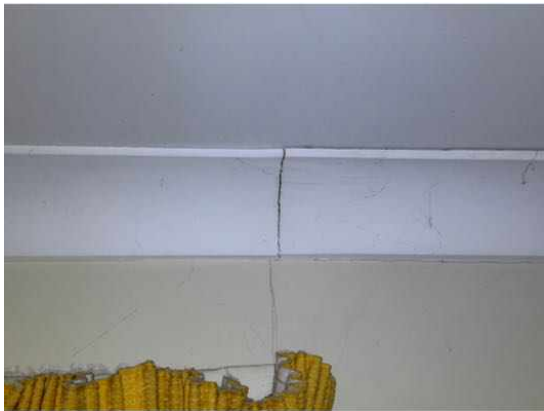
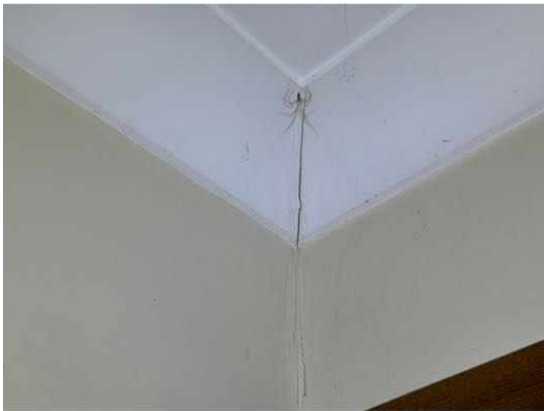
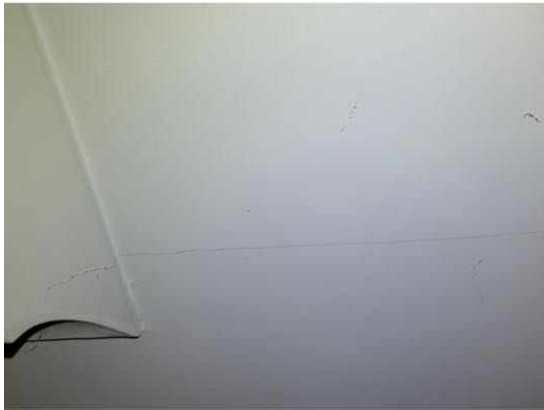
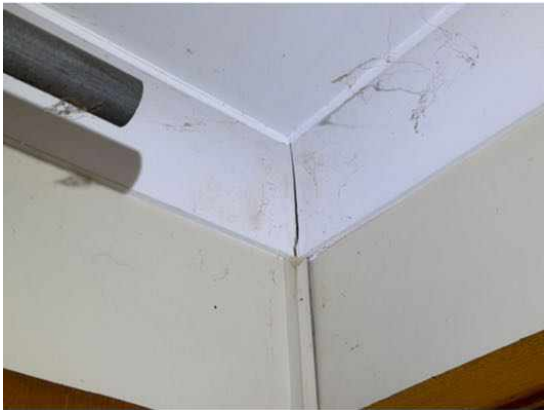
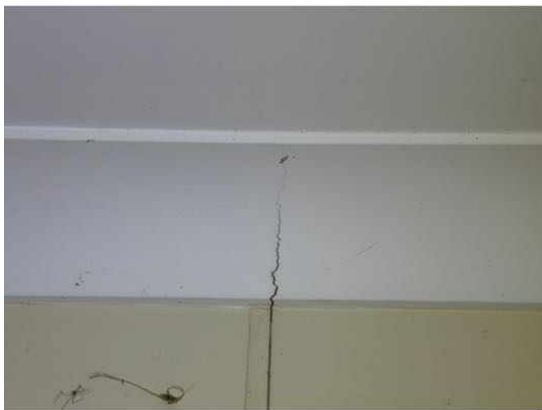
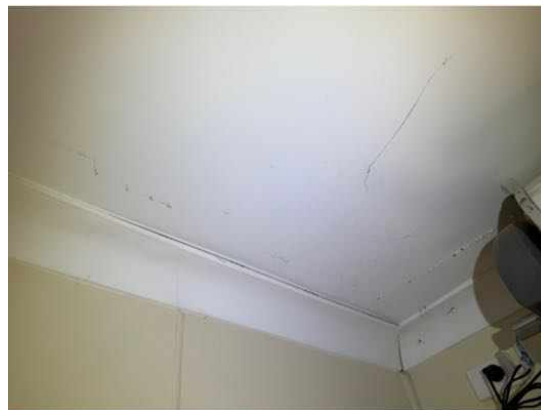
Finding 3.05

Building: Main Building
Location: All Internal Areas
Finding: Plaster - Cracking
Information: There appears to be minor cracking in some areas of the ceiling and wall linings throughout the building. Cracking of this type is common in buildings of a similar age.

Although this is mostly a visual defect, it is advised that the client monitor these areas. Should cracking widen, lengthen, or become more numerous, the client should consult with a structural engineer promptly, for further evaluation.

All areas of cracking should be monitored to identify any further movement. Should cracking lengthen, widen, or become more numerous, a structural engineer should be engaged for further evaluation.

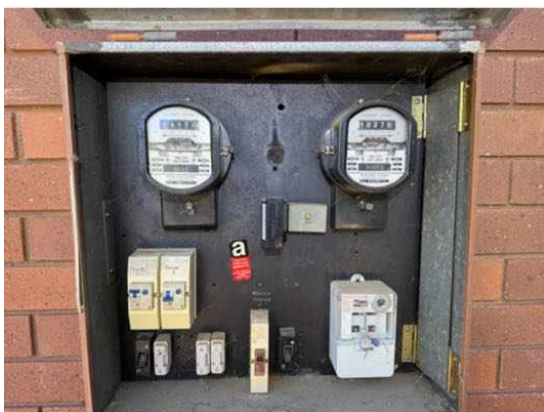
Finding 6.01

Building: Main Building
 Location: Switchboard
 Finding: Termite Management System - no evidence of a chemical installation
 Information: The application of a termite barrier is recommended, as it appears no termite management system has been installed, with no evidence or durable notice to suggest works taking place. Generally, a durable notice is placed in the meter box to indicate current termite barriers.

Installation of a termite barrier is recommended as there was no evidence of installation of a previous termite management system. 12 monthly termite inspections, conducted by a qualified termite inspector are also advised. Recommend engaging a licensed pest controller, to provide further advice.

Such barriers are highly effective in preventing termite attack on the building and therefore should be installed.

Recommend seeking further advice from a licensed pest controller.

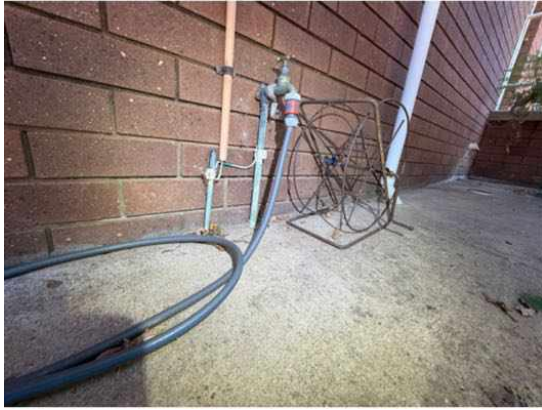
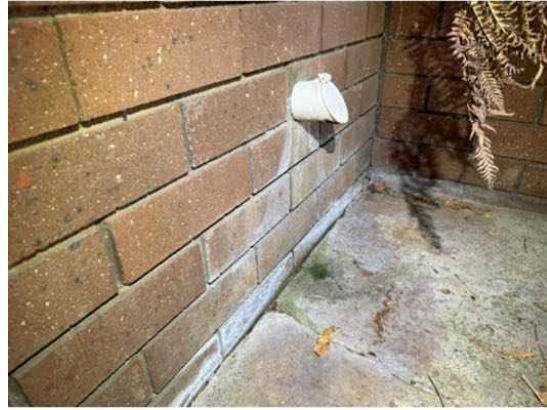
Finding 6.03

Building:	Main Building
Location:	Rear elevation
Finding:	Potential Water pooling - against property
Information:	Potential areas of water pooling around the perimeter of the property were identified. Where insufficient drainage of taps, and drains are present, water pooling is likely to occur, and can create areas conducive to timber pests. Recommend consulting with a licensed plumber to provide further advice.

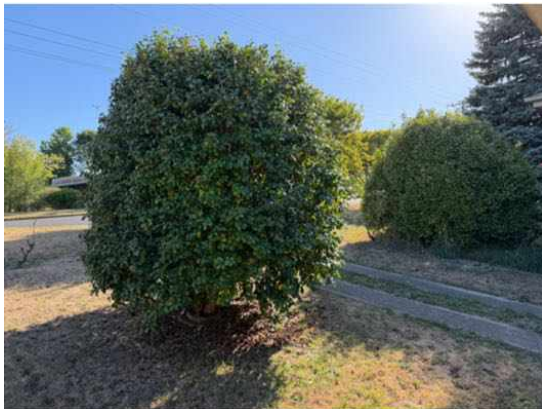
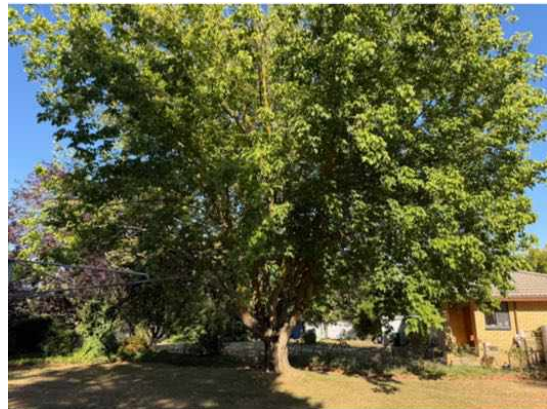
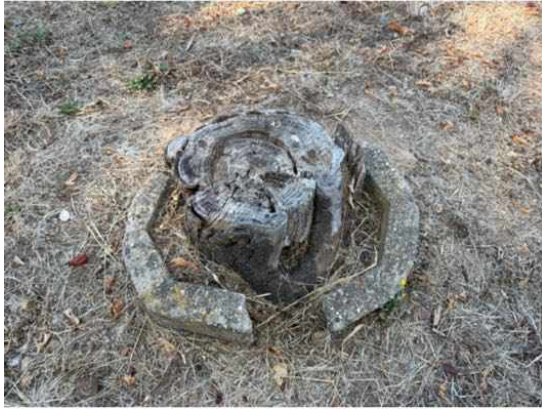
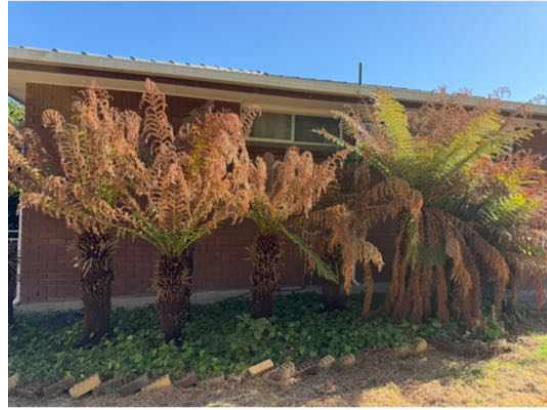
Finding 6.04

Building:	Main Building
Location:	All External Areas
Finding:	Timber in direct ground contact & trees - conducive to termites
Information:	Where timber materials are in direct contact with the ground and consequently moisture, they become conducive to termite activity. The tree stumps, and trees surrounding the building create an environment conducive to termite infestation.

Where feasible, any timbers in direct contact with the ground should be removed and any trees in close proximity to the building should be removed or test drilled (inspected) at least annually to reduce the risk of termite infestation & detect any early signs of termite activity.

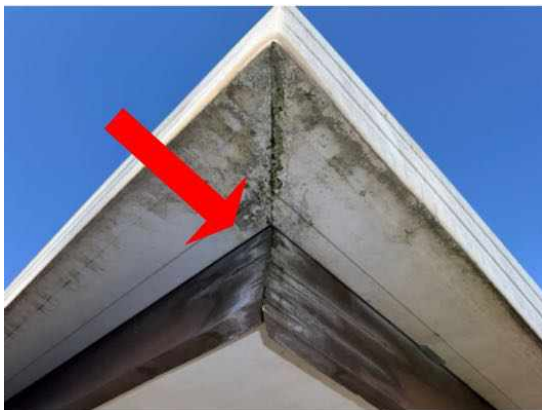
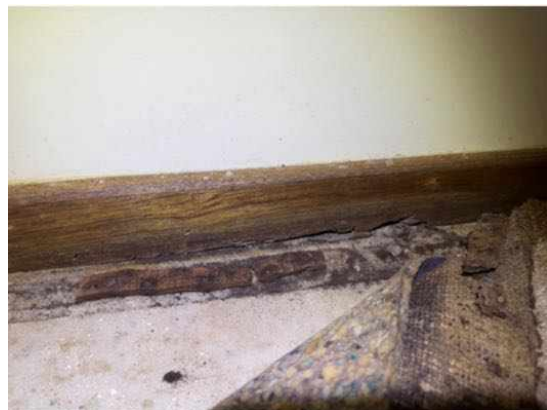
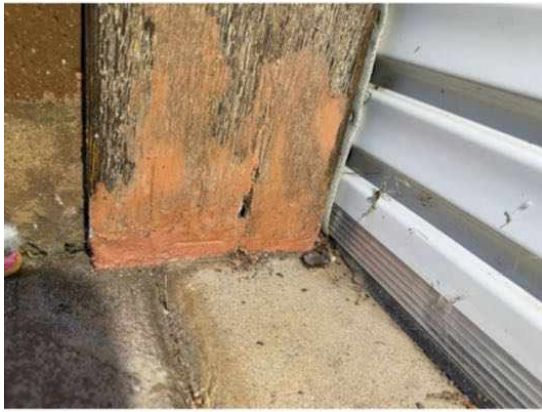
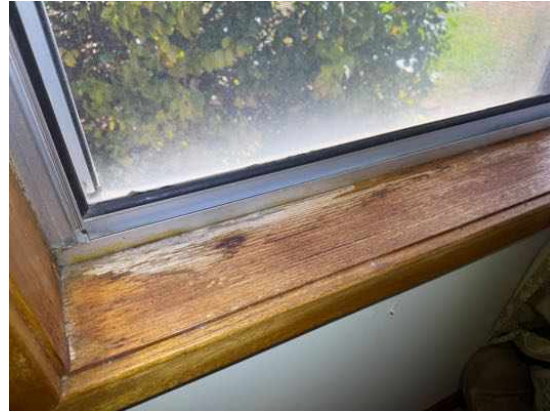
Finding 7.01

Building:	Main Building
Location:	Garage door jamb, skirting, fascia, window frames
Finding:	Fungal decay & weathering
Information:	Areas of fungal decay (wood rot) & weathering were identified at but not limited to garage door jamb, skirting board, fascias, and some window frames

For areas of fungal decay, the client can engage a licensed carpenter at their discretion to replace affected materials. For areas of general weathering, it is advised the client engage a licensed painter to apply protective sealant or coating to areas of weathered timbers.

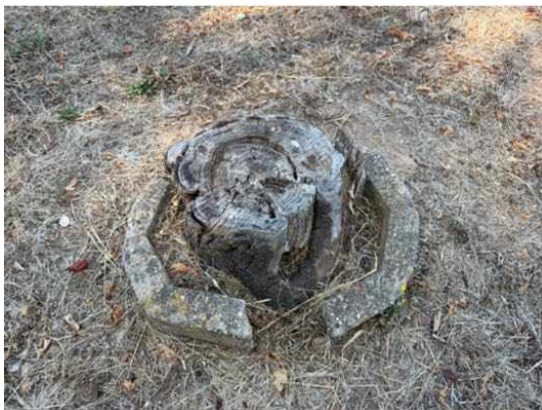
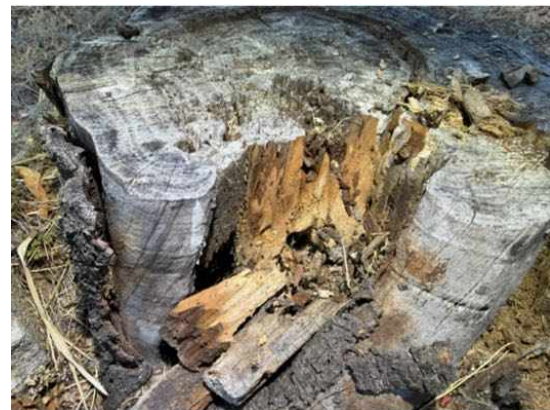
Finding 8.01

Building: Main Building
Location: Tree Stump
Finding: Evidence of wood borer damage identified (powder-post)
Information: Evidence of previous Lyctus Borer (powder-post beetle) damage was identified at, but not limited to a rear tree stump.

As no live wood borer activity was identified treatment is not required.

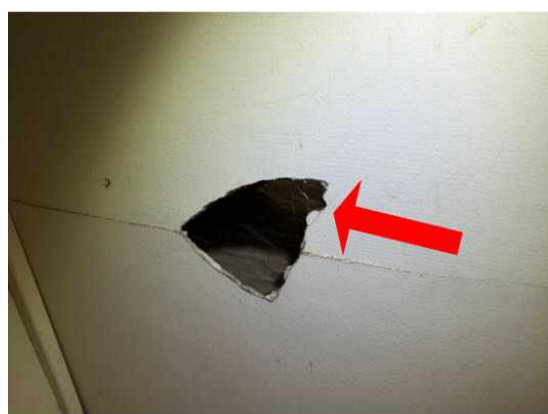
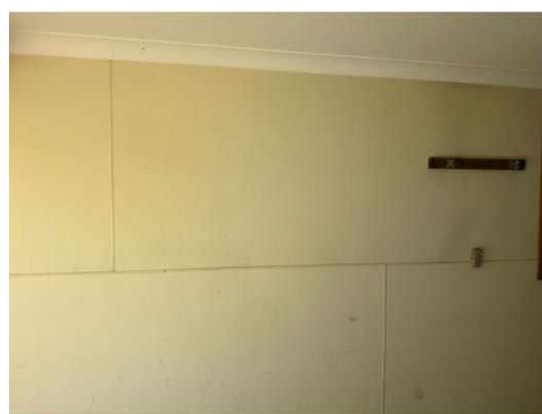
Building: Main Building
Location: Garage Walls
Finding: Asbestos - Suspected ACM Identified on Site
Information: This suspected defect is highlighted as a caution only as reporting on asbestos is outside the scope of this report. It is suspected that the materials including but not limited to the garage wall linings may be an ACM (Asbestos containing material)

Damage was identified to a sheet, therefore it is advised that the client consider a separate Asbestos Inspection and Condition Audit, which can include the taking of samples for definitive confirmation of the presence of Asbestos, carried out by a licensed Asbestos Inspector.

In the interim, no works should be conducted to these areas without further specialist advice.

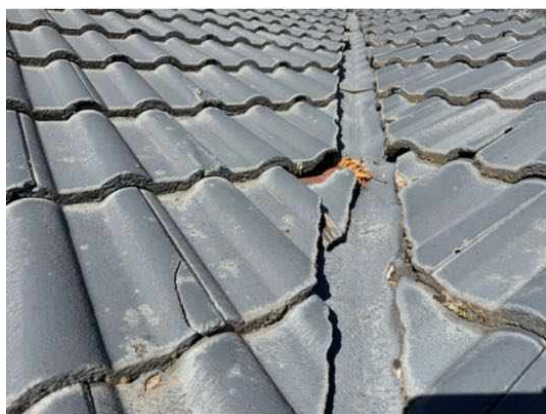
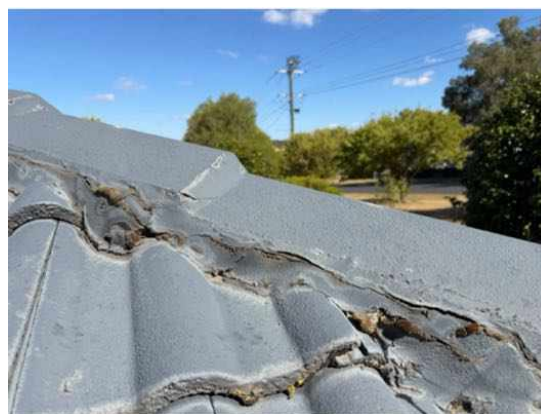
Building: Main Building
Location: Roof Exterior
Finding: Roof Exterior - Minor Cracking / Chipping
Information: Although the overall condition of the roof exterior appeared to be in fairly good

condition, some areas of minor cracking/chipping were noted. While weathering of the tiles is consistent with the age of the property, maintenance works are advised, to ensure the longevity of the roof exterior.

Recommend monitoring the condition of the roof exterior. Maintenance works can be conducted by a licensed roofing contractor, at clients discretion.

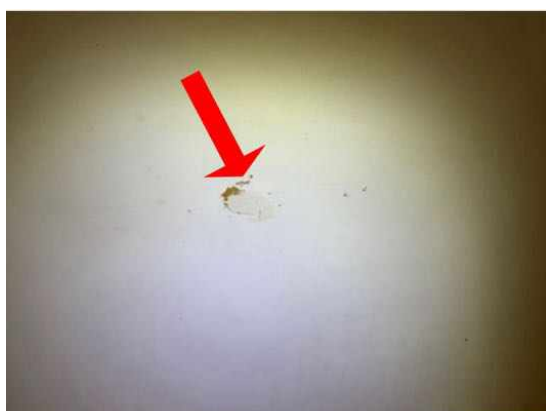
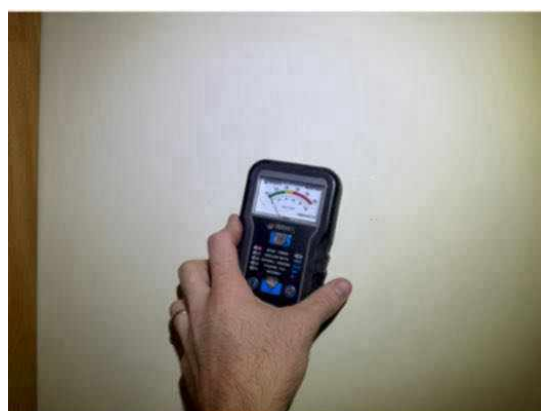
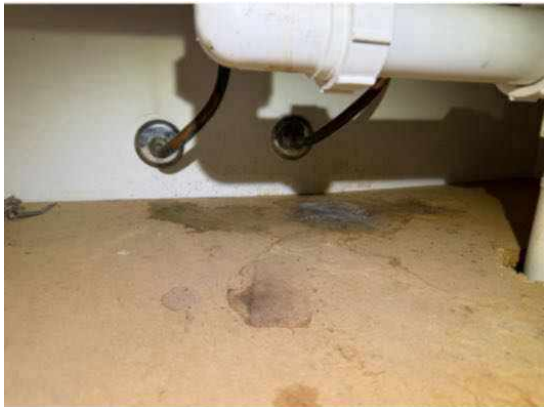
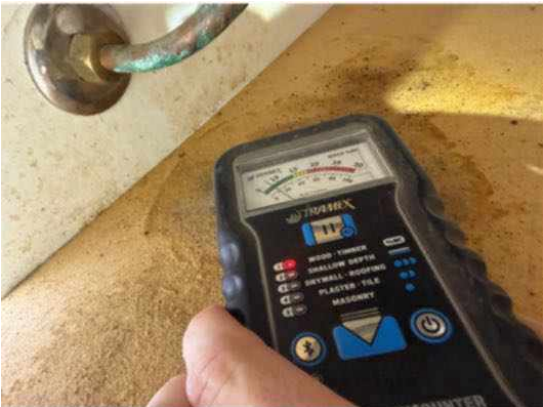
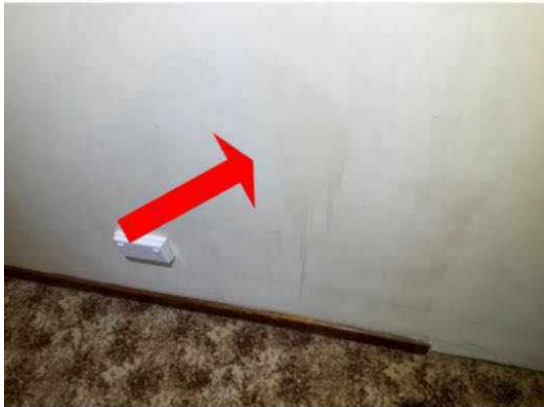
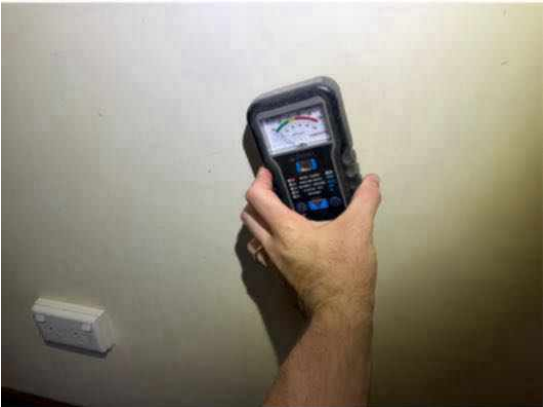
Building: Main Building
 Location: Kitchen, Garage & Bedroom Ceiling, Kitchen Sink, Carpet
 Finding: Staining / Marks Present
 Information: It appears that staining and marks were present at but not limited to, the kitchen, garage & bedroom ceiling, beneath the kitchen sink and lounge room carpet. Potential causes of leaking include deteriorated roof cladding or damaged plumbing fittings and fixtures. No high moisture was evident in these areas at the time of inspection.

Recommend that the client monitor these areas and engage a licensed plumber, should the leak persist or return.

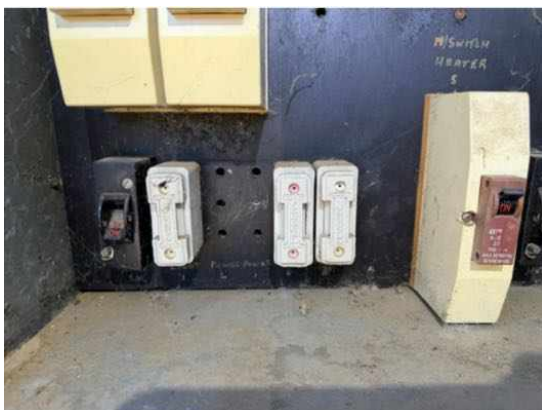
Building:	Main Building
Location:	Switchboard
Finding:	Electrical switchboard - Old ceramic fuses
Information:	It was noted that the electrical switchboard has old ceramic fuses in place. It is noted for the clients consideration that a switchboard upgrade may be required. Recommend consulting with a licensed electrician to provide further advice.

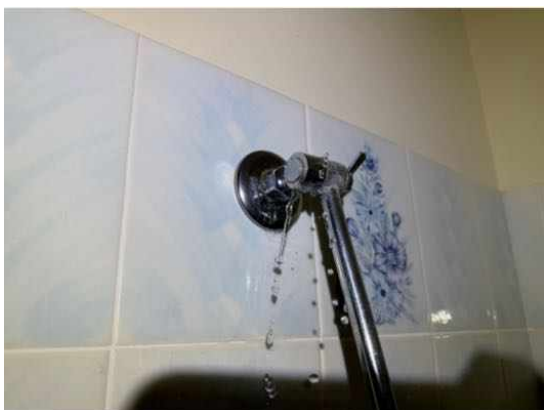
Building:	Main Building
Location:	Shower
Finding:	Shower Head - Leaking
Information:	Leaking was identified at, but not limited to the shower head of the main bathroom. Recommend engaging a licensed plumber at clients discretion, to provide minor remedial works.

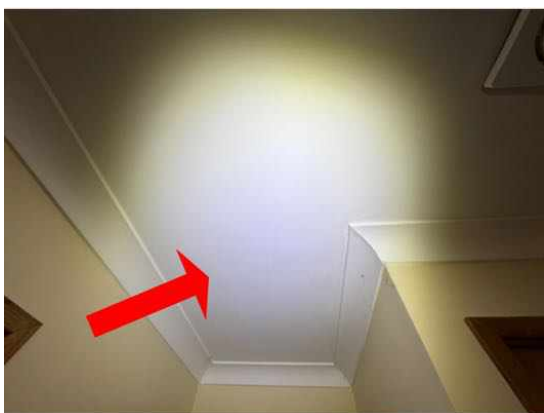
Building: Main Building
 Location: Shower
 Finding: Exhaust fan - Missing
 Information: Although there was an exhaust fan installed to the main bathroom area, there was no exhaust fan installed directly above the shower. It is advised that an exhaust fan be installed above the shower area, to ensure adequate ventilation is achieved.

Recommend consulting with a licensed electrician to provide further advice, at clients discretion.

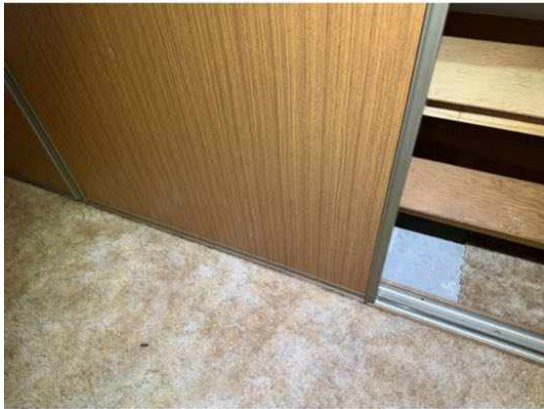
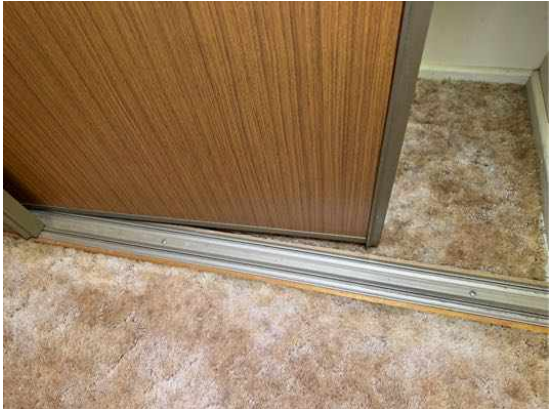
Building: Main Building
 Location: Wardrobes
 Finding: Sliding Doors - Stiff to slide
 Information: It is noted for the clients information that some sliding wardrobe doors were found to be stiff to slide at the time of inspection. The client can engage a general handyman, at their discretion to provide maintenance works where necessary.
