Building and Timber Pest Inspection Report

Inspection Date: Wed, 18 Feb 2026

Property Address: 57/15 Beech Street Port Melbourne

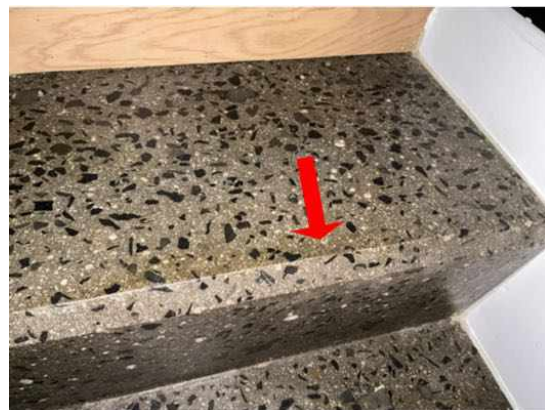
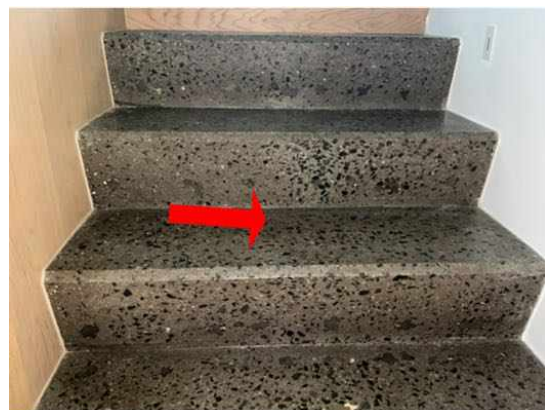
Building:	Main Building
Location:	Concrete stair treads and landing
Finding:	Stairs slippery finish
Information:	It was observed that the polished concrete stairs were finished in a coating that has no slip index rating and appears to be quite smooth

Polished stairs should be finished in an appropriate non-nonslip coating with a rough surface finish. Alternatively the stairs should be fitted with nonslip nosing to the treads or a non-slip tape to the stair treads

A general handyman or surface sealing contractor should review as soon as possible.

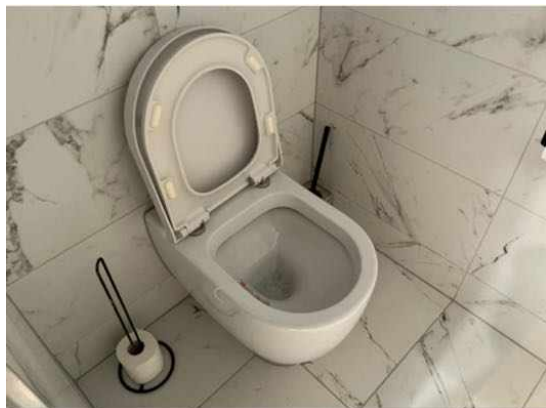
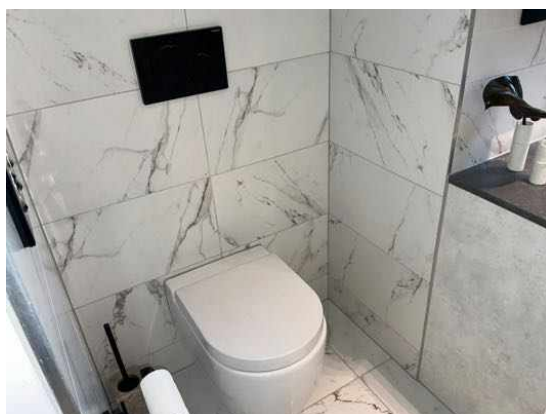
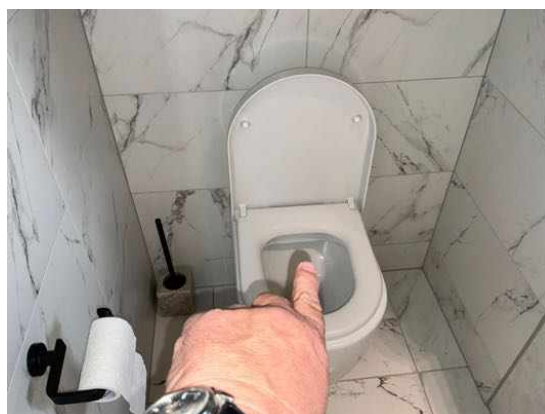
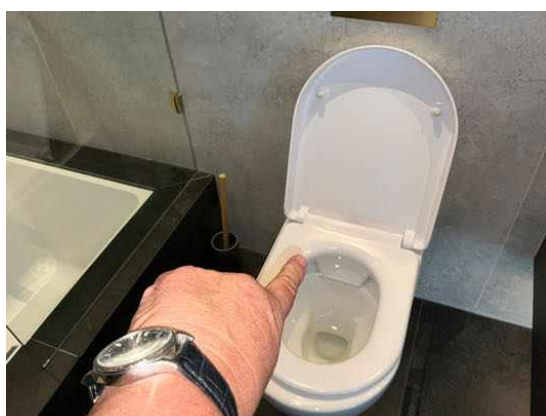
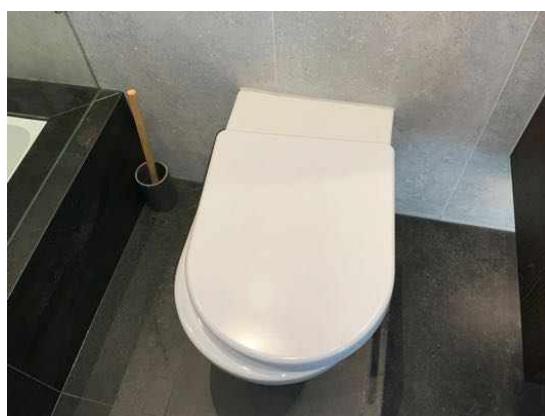
Finding 1.02

Building:	Main Building
Location:	All bathrooms
Finding:	Toilet seat loose

Information: It was observed that the toilet seats was loose and unstable.

Loose seats can cause fall injury to persons while in use and lead to serious injury

A licensed sanitary plumber should be engaged to review prior to use

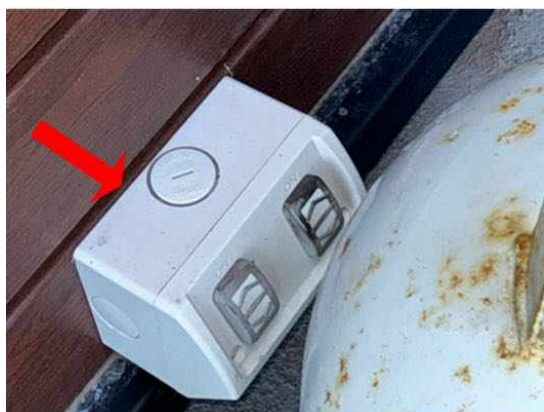
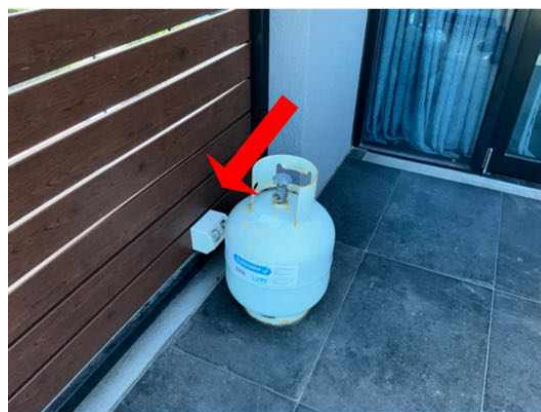
Finding 1.03

Information: It was observed that the external power point to balcony was not adequately sealed

from moisture ingress.

Moisture inside a fitting can caused earth leakage,power cut out and could cause injury to persons

All external power points are to be sealed (generally at the top) to prevent moisture ingress to the fitting.

A licensed electrician should review immediatly

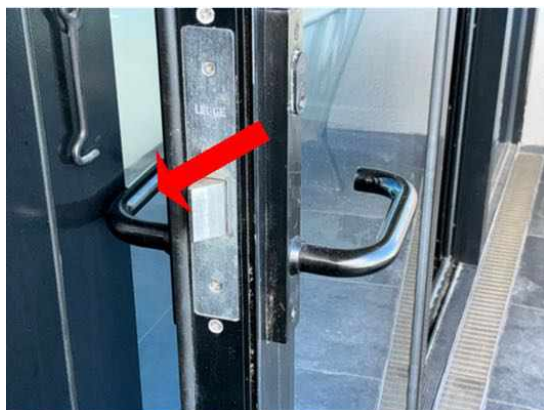
Finding 1.04

Information: It was observed at the time of the inspection that the French door to the master balcony does not have a door closing restraint mechanism four door cushion to stop the door and window colliding when operation. Unattended to the door and window could prematurely deteriorate.

If the door is opened. aggressively the glass could break.or shatter.

A window specialist or qualified carpenter should be engaged by the owner to review as soon as possible. Should the building still be under a builders warranty,The builder should make good immediately.

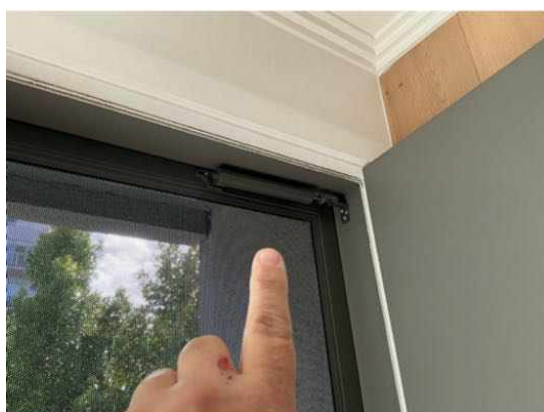
Finding: Security door closure defective

Information: It was observed that the door closure to the security door was not operating correctly and appears to require adjustment.

This is a minor defect and would be considered general wear and tear

A general handyman should be engaged to review at the clients discretion.

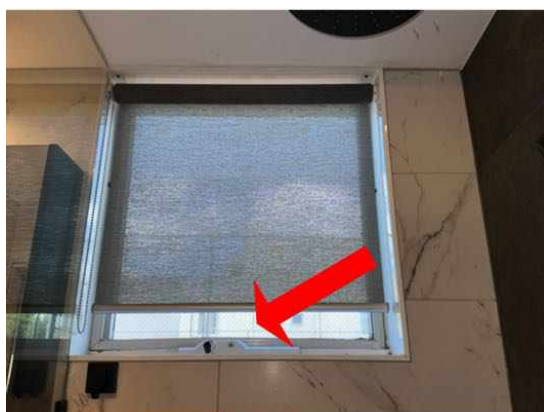
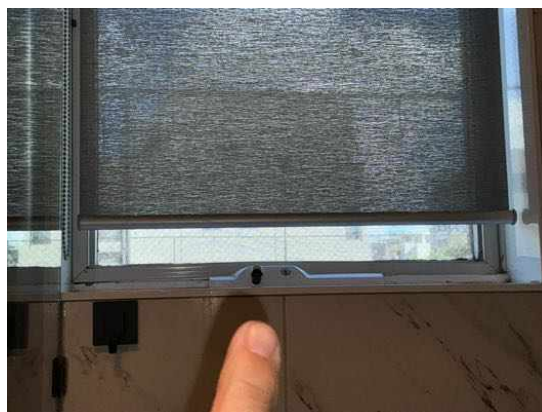
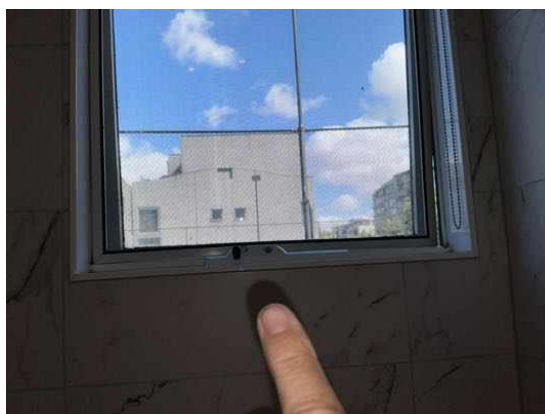
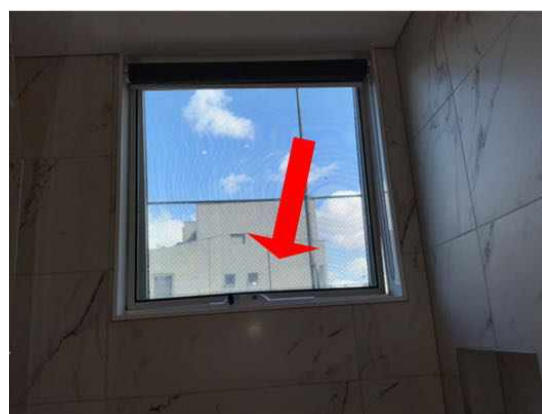
Finding 3.02

Finding: Windows - inoperable
 Information: The awning windows to the first floor bathrooms in the shower closet were jammed and inoperable at the time of the inspection. Windows provide ventilation to the adjoining area and should be at a fully operational level to ensure user comfort. Restricted function of the window may also pose as a potential safety hazard if required for emergency egress from the building.

Generally, factors such as general age of the building element and a lack of maintenance are the usual causes for this type of defect.

Replacement of window hardware or frame may be required, as well as minor repairs and cleaning. A registered builder or general handy person will be required to repair the window.

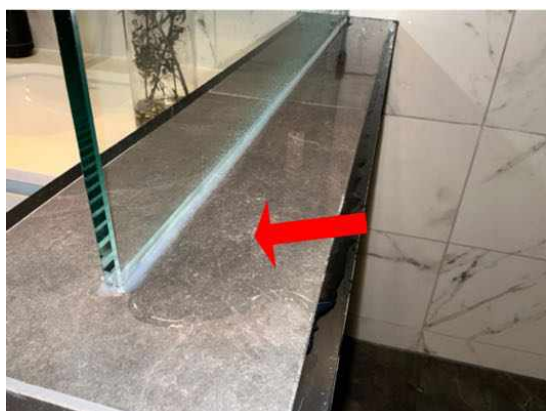
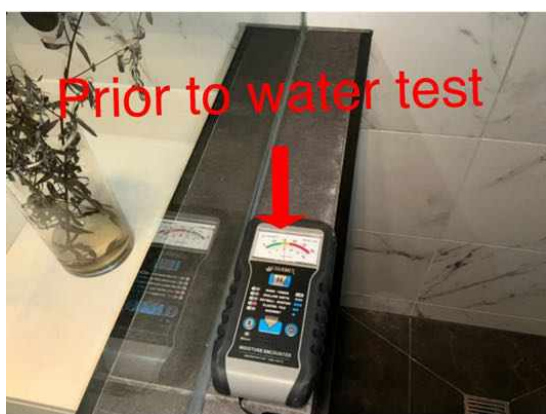
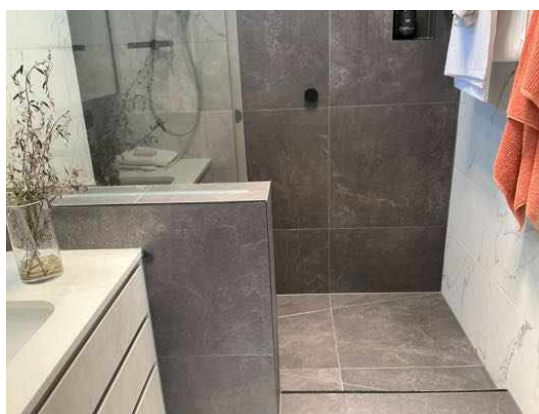
Finding 3.03

Building: Main Building
 Location: Bathroom 2
 Finding: Water pooling/shower closet
 Information: It was observed at the time of the inspection that there was water pooling on the top of the wall to the shower closet. It appeared that the top of the wall was constructed level and no consideration was made for water to run off back into the shower floor.

Given time the pooling water has a potential to cause premature deterioration to other building elements which could eventually cause water leaking.

A wall and floor tile should be engaged to review at the owners discretion

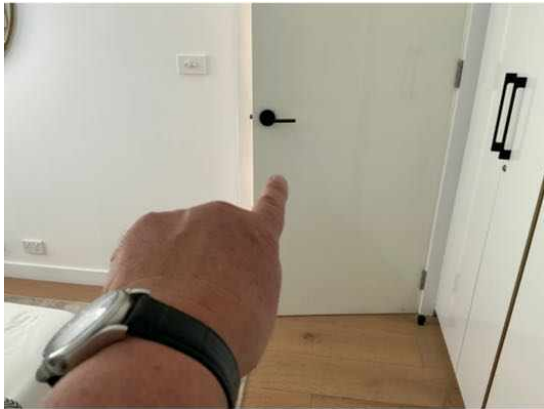
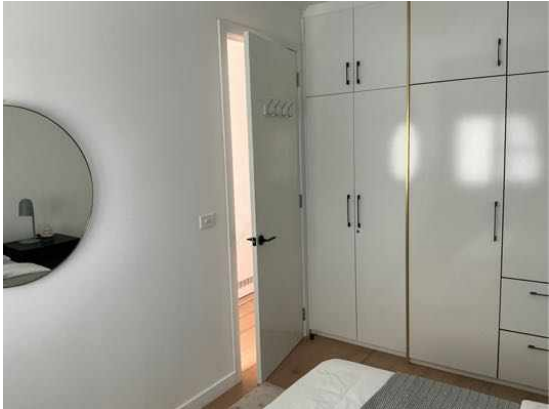
Finding 3.04

Building: Main Building
 Location: Bedroom 3
 Finding: Doors rattling
 Information: It was observed that the bed 3 internal door was rattling when closed at the latch.

Unadjusted, the rattling should can be noisy and irritating. Door movement also can cause cracking paintwork to the door frame and architraves.

A qualified carpenter or handyman should be engaged to adjust at the owners convenience

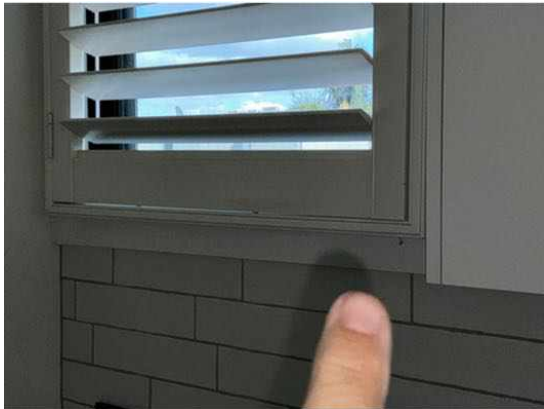
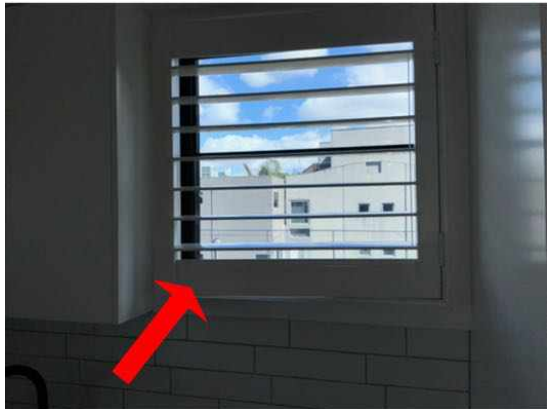
Finding 3.05

Building: Main Building
Location: All Internal Areas
Finding: Window shutters jamming
Information: It was observed at the time of the inspection that many window shutters throughout the property were binding and catching.

Unattended to the binding could cause premature deterioration to the shutter and other building elements

An experienced window installation contractor should be engaged to review at the owners discretion.

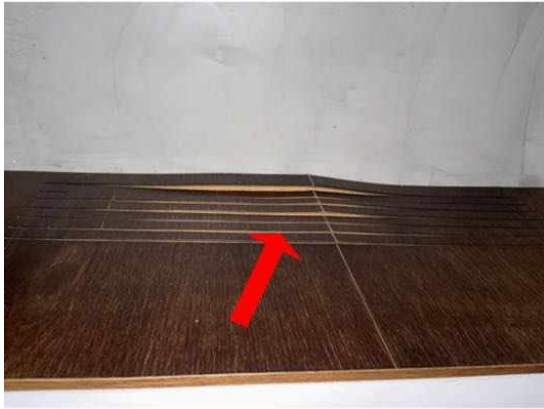
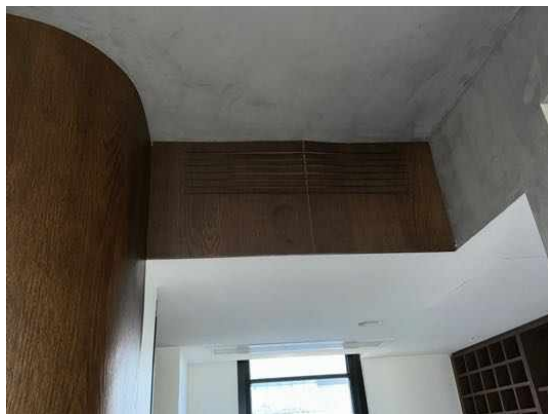
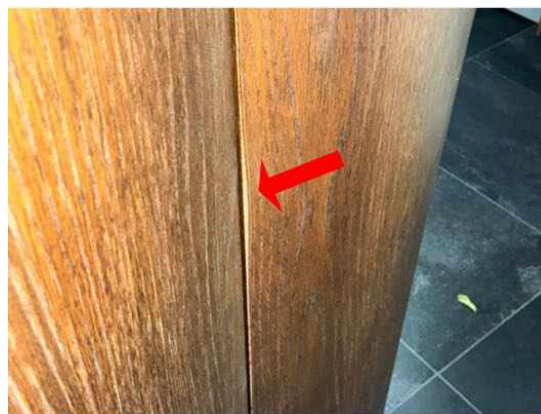
Finding 3.07

Building: Main Building
Location: Bedroom - Master
Finding: Cabinet veneer peeling and deteriorating
Information: It was noted at the time of the inspection that the veneer to the cabinet works in the master bedroom was peeling away from the chipboard substrate.

This is an aesthetic defect. However, it deteriorate from the overall appearance of the building. Unattended to the vineyard could further deteriorate.

A qualified cabinet maker should be engaged to review at the owners discretion.

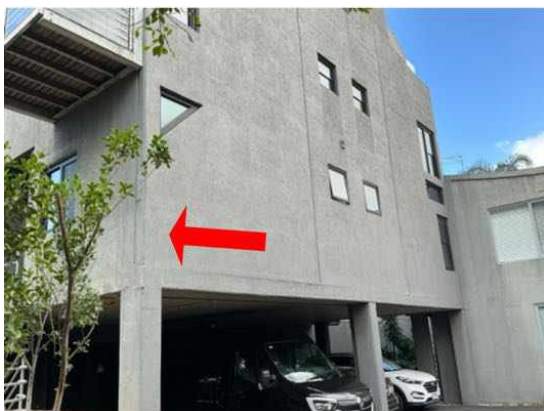
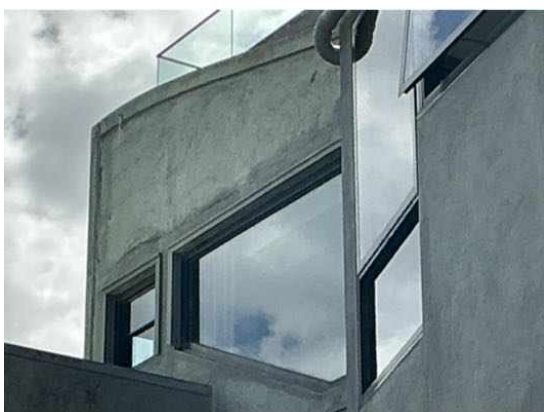
Finding 3.09

Building:	Main Building
Location:	Exterior walls - right side and front
Finding:	Minor cracking to rendering
Information:	At the time of the inspection, it was noted that there was some minor cracking and deterioration of the rendering coating to the building external walls.

Although this is a minor and aesthetic defect it detracts from the overall appeal of the building.

Unattended to the cracking could further deteriorate and eventually cause damage to other building elements

A qualified render should review at the owners discretionk

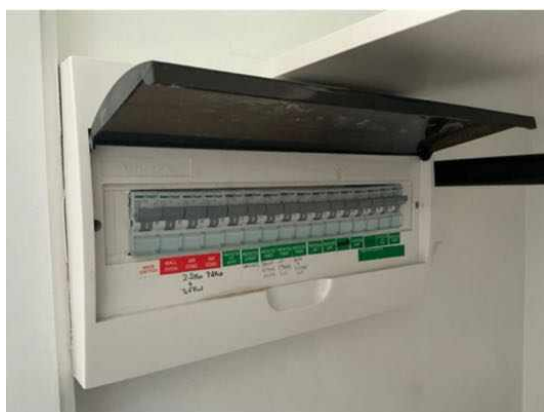
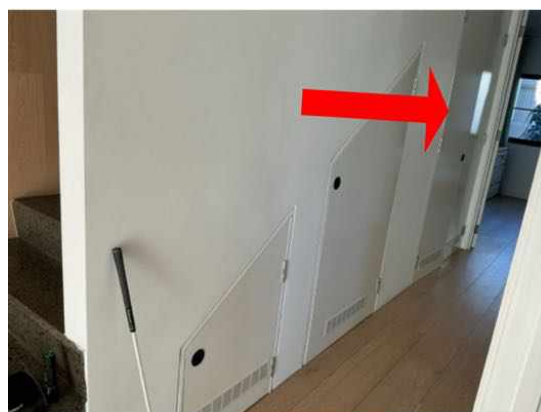
Building:	Main Building
Location:	Meter Box
Finding:	Termite Management System - no evidence of a chemical installation
Information:	The application of a post-construction chemical termite barrier is highly recommended for all properties, particularly if live termite activity has been found on the site

A durable notice should be placed in the switchboard unit to indicate current termite barriers. At the time of inspection, it appeared as though no termite management system has been installed, with no evidence to suggest preventative works taking place.

The client may consider gaining further advice from a pest controller as to the costs and procedures involved with this application. It is recommended that obtaining such advice be a short-term priority.

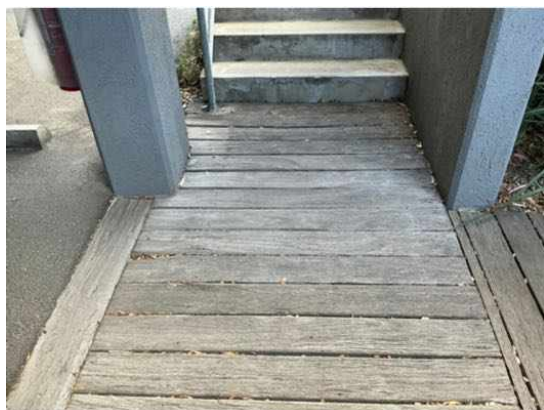
Finding 6.02

Building:	Main Building
Location:	Yard - Front
Finding:	Untreated or non-durable timbers/ sleeper foot path
Information:	To reduce the risk of timber pest attack it is essential that timber used in a hazardous environment (e.g. in direct contact with the ground or frequently exposed to damp conditions) is of sufficient durability and/or is adequately preservative treated.

Untreated timbers in direct contact with the ground are likely to develop severe wood rot and/or fungal decay if left unattended creating attraction for subterranean termites to infest the timbers from surrounding areas.

If untreated or non-durable timbers are found to be in a hazardous environment it is highly advised that replacement of these building elements be performed as soon as possible to aid the protection of the property against termite / timber pest attack.

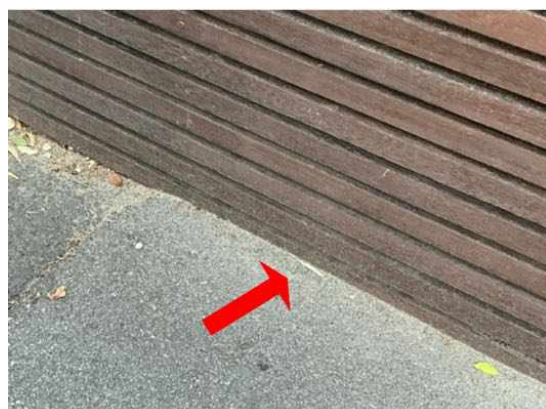
Finding 6.03

Building:	Main Building
Location:	Front Elevation
Finding:	Untreated or non-durable timbers / fence
Information:	To reduce the risk of timber pest attack it is essential that timber used in a hazardous environment (e.g. in direct contact with the ground or frequently exposed to damp conditions) is of sufficient durability and/or is adequately preservative treated. The timber for inground use should be rated H5 as stated in AS1604

Untreated timbers in direct contact with the ground are likely to develop severe wood rot and/or fungal decay if left unattended creating attraction for subterranean termites to infest the timbers from surrounding areas.

If untreated or non-durable timbers are found to be in a hazardous environment it is highly advised that replacement of these building elements be performed as soon as possible to aid the protection of the property against termite / timber pest attack.

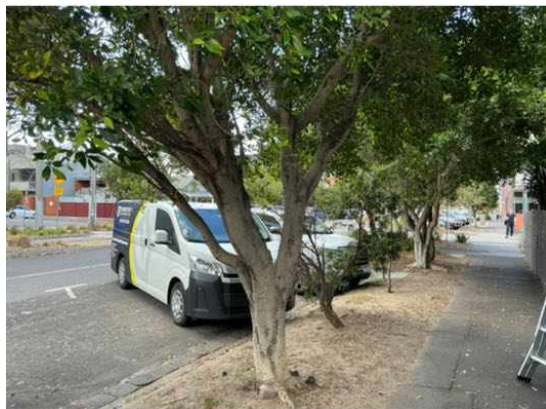
Finding 6.04

Building:	Main Building
Location:	All External Areas
Finding:	Trees/large/termite

Information: It was observed that there were several large trees next to or nearby the building.

The trees have the potential to provide conducive conditions for termite infestation

It is recommended that periodic 12 monthly inspections by a registered pest control contractor be undertaken and further reinstatement of outdated termite barriers as soon as possible.

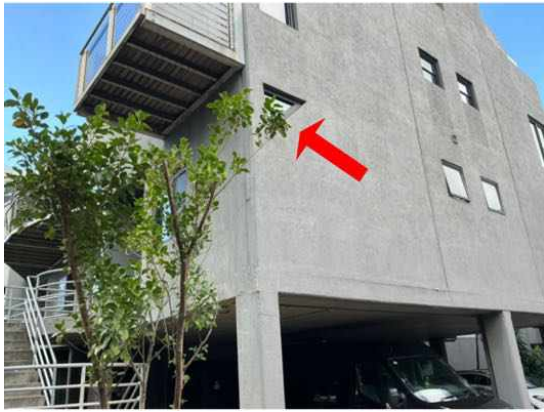
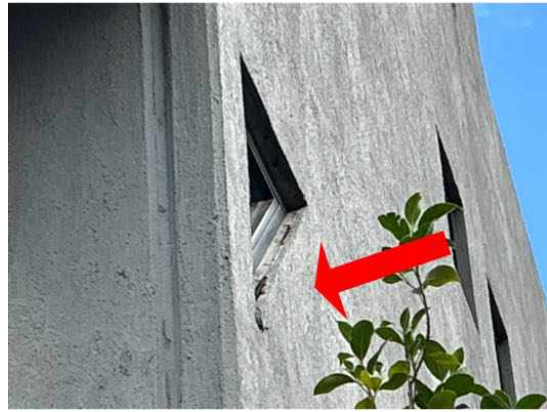
Finding 7.01

Finding: Window and surrounds deteriorated

Information: It was observed at the time of the inspection that the small window on the right hand side of the building appears to be affected by wood rot and fungal decay. The render is also cracked and damaged around this area.

When tested internally using a moisture meter, the recordings were dry.

Unattended to the window and surrounding rendering could further deteriorate and eventually cause further damage to other building elements

A qualified carpenter should be engaged to review the window and an experienced renderer should review the required rendering repairs
