# Building and Timber Pest Inspection Report

Inspection Date: Mon, 22 Dec 2025

Property Address: 7 Sotterra Walk Fraser rise

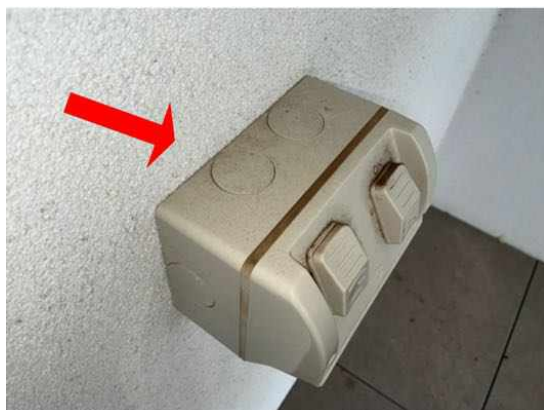
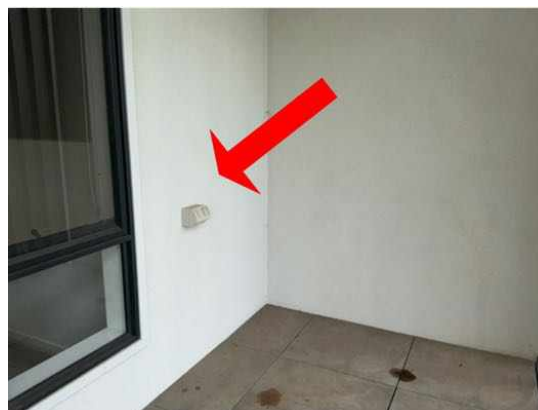
Building:	Main Building
Location:	Balcony
Finding:	External power point not sealed
Information:	It was observed that the external power point to external wall was not adequately sealed from moisture ingress.

Moisture inside a fitting can cause earth leakage, power cut out and could cause injury to persons

All external power points are to be sealed (generally at the top) to prevent moisture ingress to the fitting.

A licensed electrician should review immediately

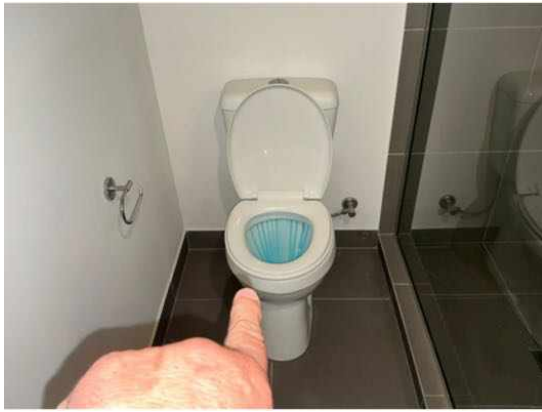
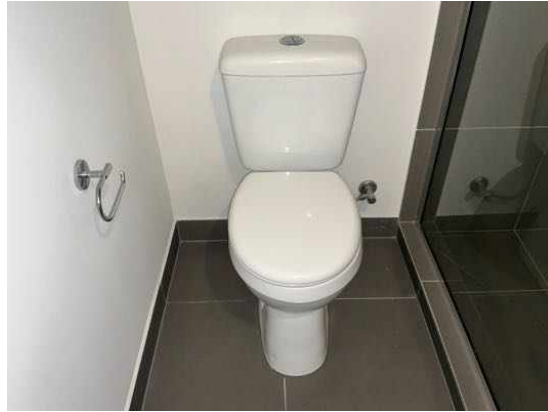
#### Finding 1.02

Building:	Main Building
Location:	Ensuite
Finding:	Toilet seat loose
Information:	It was observed that the toilet seat was loose and unstable.

Loose seats can cause fall injury to persons while in use and lead to serious injury

A licensed sanitary plumber should be engaged to review prior to use

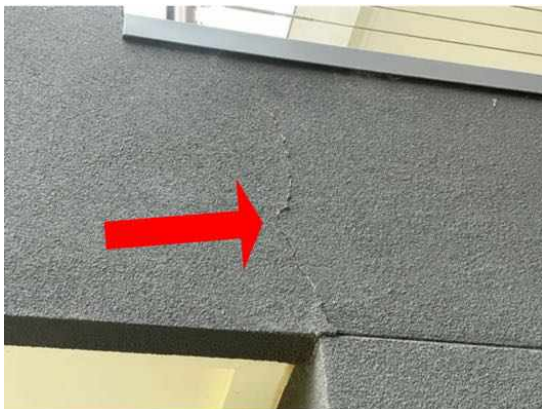
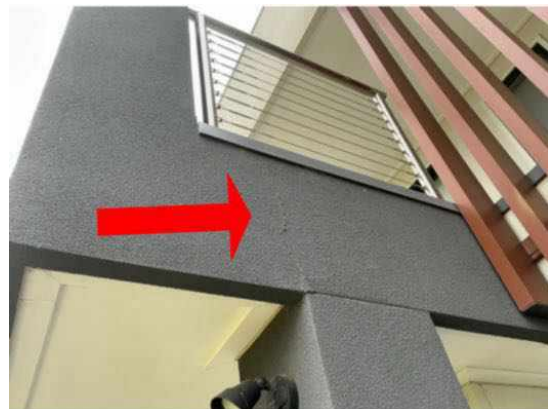
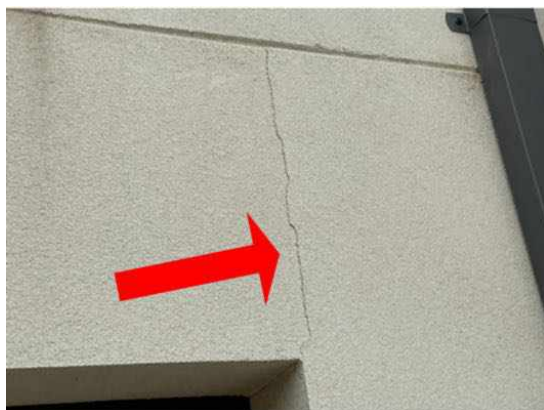
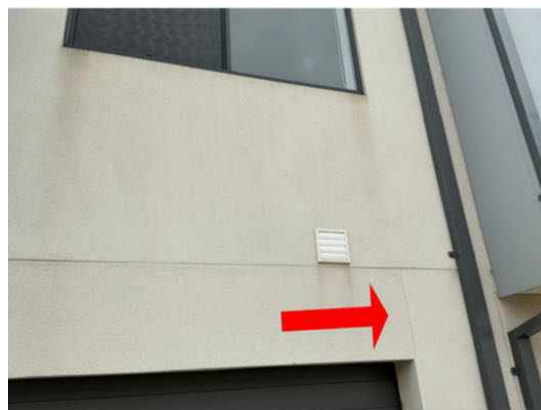
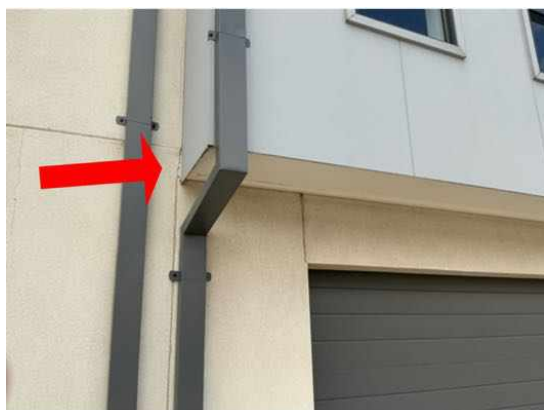
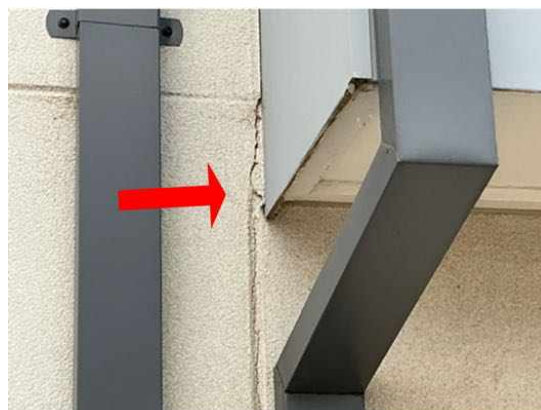
Building: Main Building  
 Location: All External Areas  
 Finding: Cracks to external render - Category 1  
 Information: It has been observed that cracking to external rendered surfaces has occurred. The degree of damage falls within Category 1, described as fine cracks that do not need repair and which are less than 1.0mm in width limit.

Damage of this category is not considered a defect for rectification, however to maintain the aesthetic appeal of the building the building owner may wish to undertake repairs. An experienced rendering contractor should be engaged to review at the owners discretion Always contact your building inspector should cracks widen, lengthen, or become more numerous.

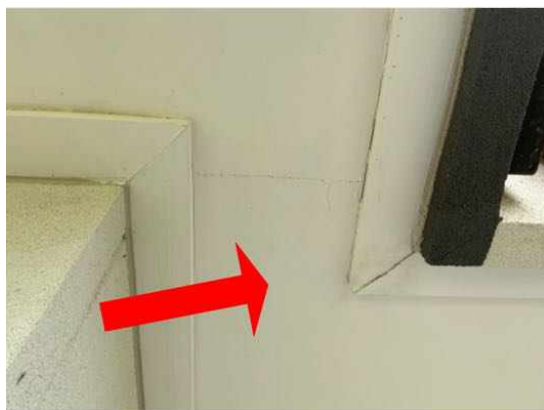
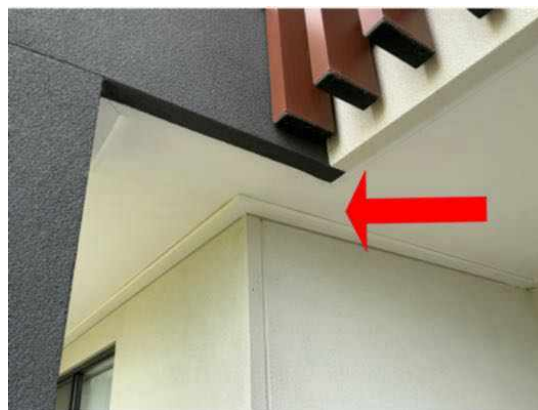
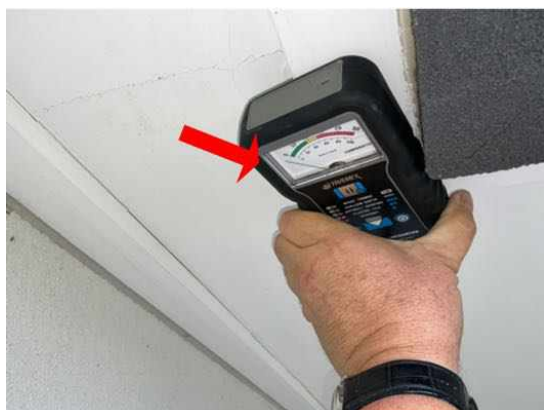
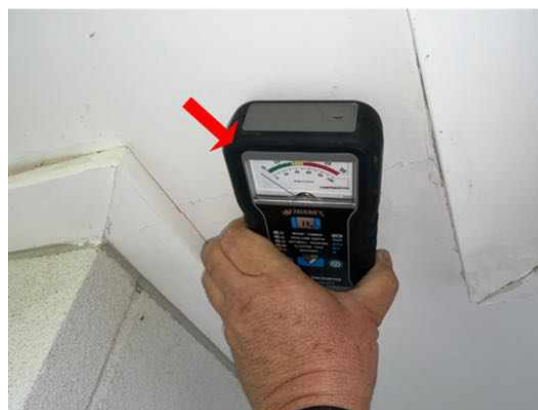
### Finding 3.02

Building:	Main Building
Location:	Porch
Finding:	Water leak - Inactive at the time of the inspection
Information:	Water leaks generally occur when a particular area of the property is not weather- or water-tight. While the damage in this area appears to be from an old inactive water leak, the area should be monitored frequently for the recurrence of any dampness.

Repair and / or replacement of previously affected building elements is at client discretion. Consider a further invasive inspection: removal of obstructions around the damaged area may reveal further damage which has been concealed. A more significant or major defect may be identified at this time.

Where recurrence of an active water leak is identified, a qualified plumber should be appointed immediately to rectify the leak and advise on any further preventative works as necessary.

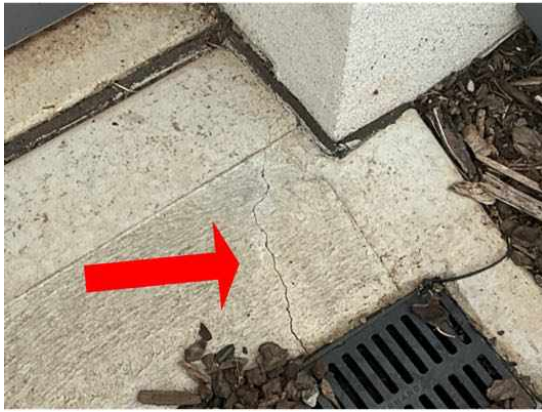
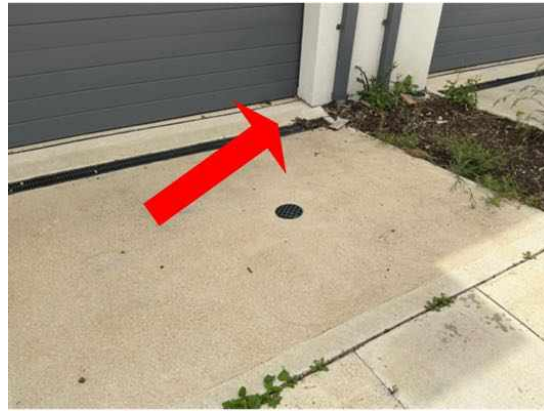
### Finding 3.03

Building:	Main Building
Location:	Garage entry paving
Finding:	Cracking - External Concrete Paving Damage Category 0 - Hairline (less than 1mm)
Information:	Hairline cracks were identified in external concrete paving. Hairline cracks are very minor in nature and generally are only ever an appearance defect. To be classified as a Category 0 or hairline crack, the crack width would be less than 0.3mm. While such cracking may be noticeable in some cases, it is common and does not indicate any structural damage.

Generally the cause of a hairline crack in existing concrete paving such as driveways and pathways is indicative of the expansion and contraction of the concrete. Such causes are generally due to environmental factors, such as moisture levels, weather conditions, root systems of nearby trees or the soil types on which they are laid.

Hairline cracks may also be due to poor original installation of the concrete. Factors such as poor compaction of the sub surface and/or inadequate reinforcing of the slab may create cracking and other secondary defects.

Monitoring of all cracking should be conducted frequently. Always contact a building inspector should cracks widen, lengthen, or become more numerous.

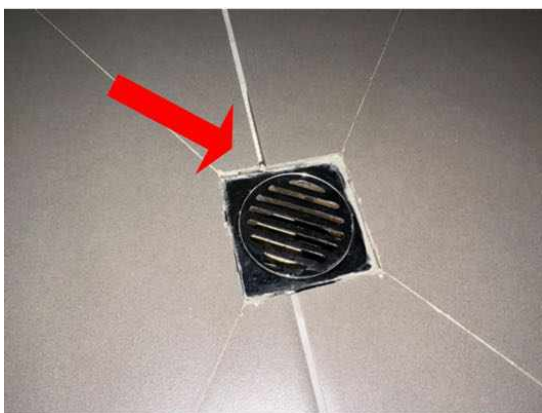
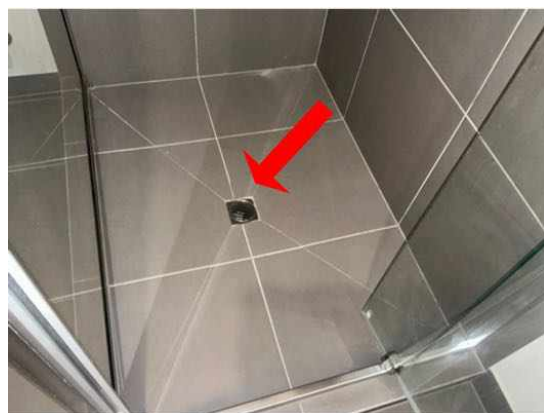
### Finding 3.04

Building:	Main Building
Location:	Ensuite
Finding:	grouting - Missing or damaged
Information:	It was noted on inspection that sealant or grout is degraded to the tiled shower base.

Different materials and floor areas move at different rates, generally causing cracking to grout or sealant at this point. A flexible sealant is required to allow for expected expansion and contraction, while keeping the joint water tight and protective of all associated building materials.

Flexible and mould resistant materials should be applied to affected areas to prevent any subsequent water damage that is likely to occur. Regular maintenance and replacement of damage or missing or damaged sealant and grout is highly recommended to the wet areas, as this is a regular wear and tear defect. Sealant and grouting in areas that come into regular contact with water should be maintained for the long term care of your property.

A sealant specialist or tiling contractor should be appointed to complete these works as soon as possible

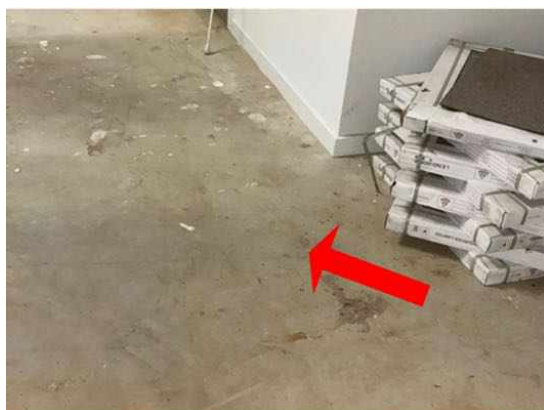
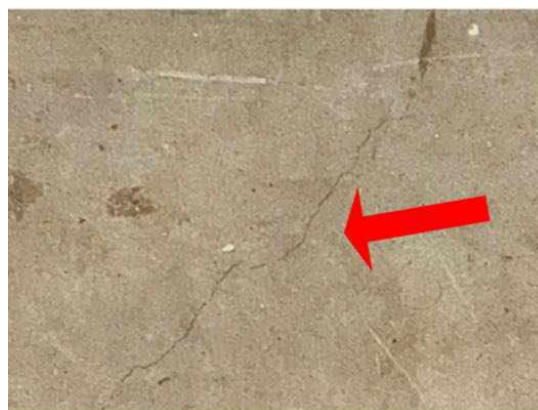
### Finding 3.05

Building: Main Building  
 Location: Garage  
 Finding: Crack in concrete slab - Category 0  
 Information: A crack coded as Category 0 was identified in the slab. A Category 0 crack is described as a hairline crack, representing insignificant movement of slab from level.

The approximate width of the crack to be considered Category 0 is 0.3mm, or change in offset of less than 8mm when a 3m straight edge is placed over the defect.

No rectification is required at this time. However, all cracking should be monitored over a 12 month period to identify any further damage in the area.

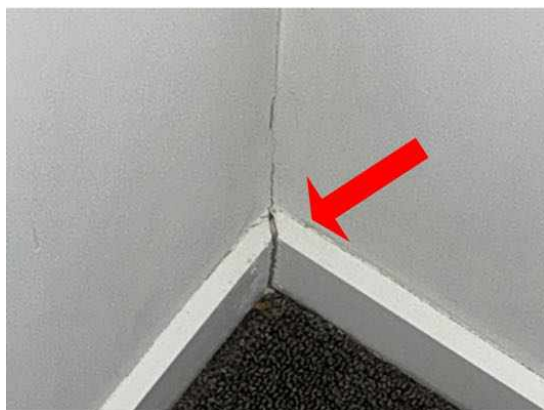
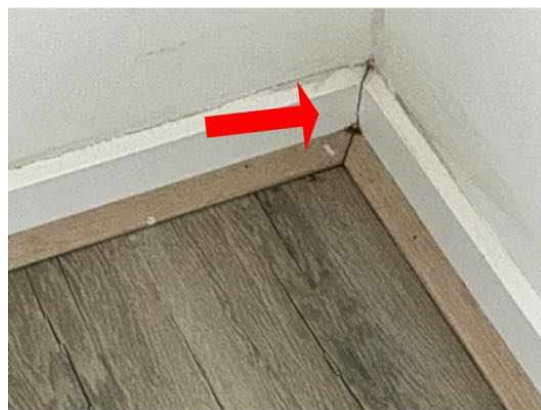
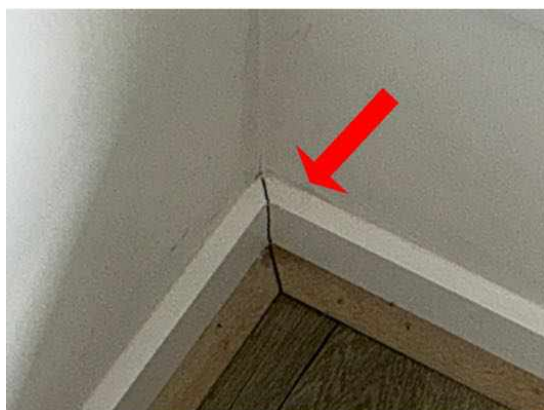
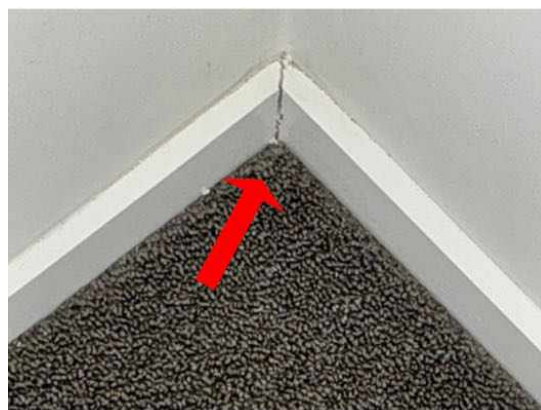
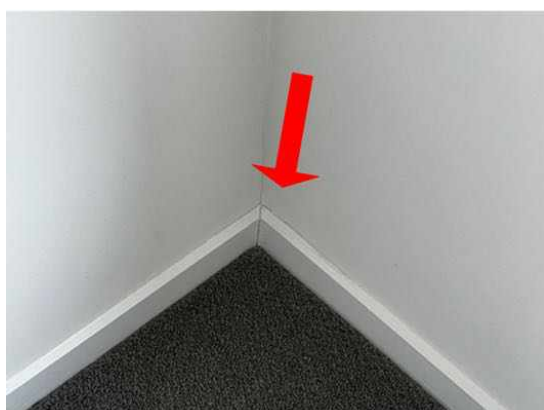
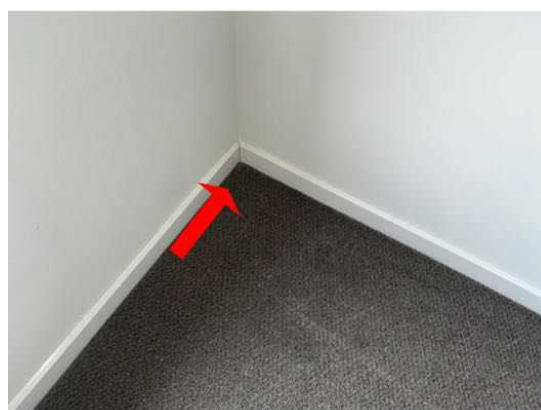
### Finding 3.06

Building: Main Building  
 Location: All Internal Areas  
 Finding: Minor shrinkage cracking  
 Information: It was observed that there was minor shrinkage and building movement cracking throughout the building especially at skirting board level.

This cracking would not be considered non defective on a house that is of this age however it is an aesthetic defect and it detracts from the overall appearance of the building.

The owner may wish to engage a qualified painter or general handyman to review this minor cracking at the owner's convenience

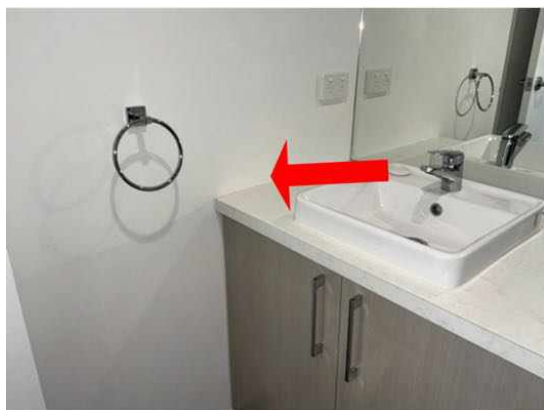
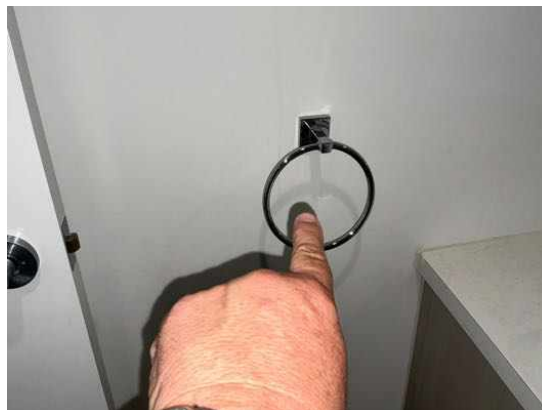
### Finding 3.07

Building: Main Building  
 Location: Bathroom  
 Finding: Towel ring - Loose  
 Information: The towel ring was found to be loose at the time of inspection. While not a major operational defect, function can deteriorate if the problem is left unmanaged.

It is advised that the homeowner performs remedial works to re-attach the towel ring to its original fixing. A general handyman may be required to perform these works.

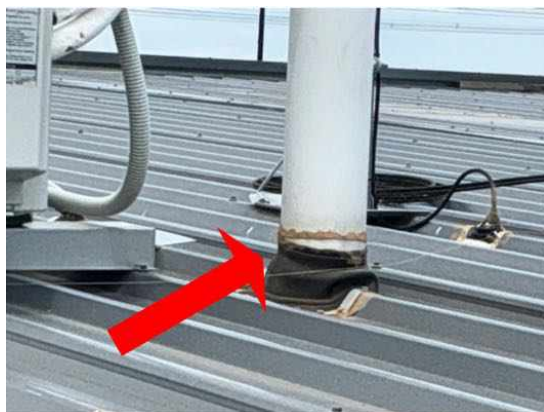
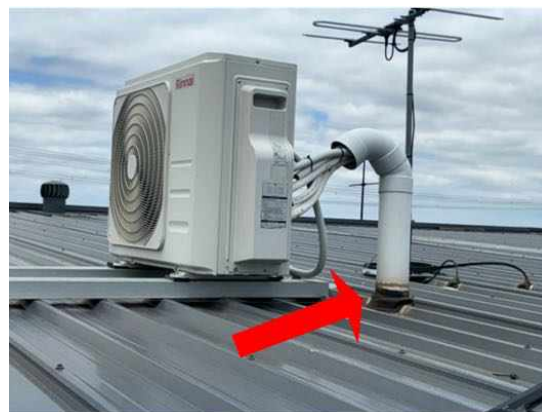
### Finding 3.08

Building:	Main Building
Location:	Roof Exterior
Finding:	Deteriorated silicon sealant
Information:	It was observed at the time of the inspection that the silicon ceiling around the air conditioning surface dog has deteriorated and the rubber deck tight flashing has moved.

The silicone sealant should be reapplied as soon as possible possible by a licensed plumber or general handyman to prevent any possible future water ingress to the roof space

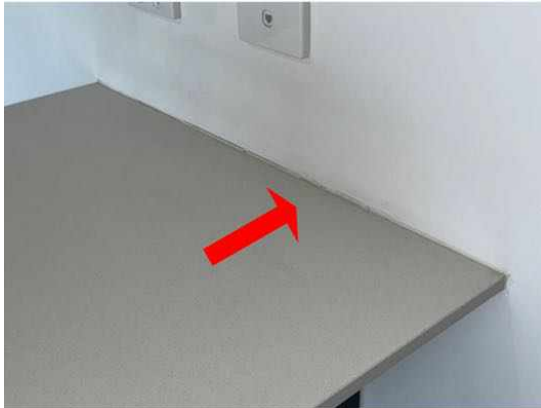
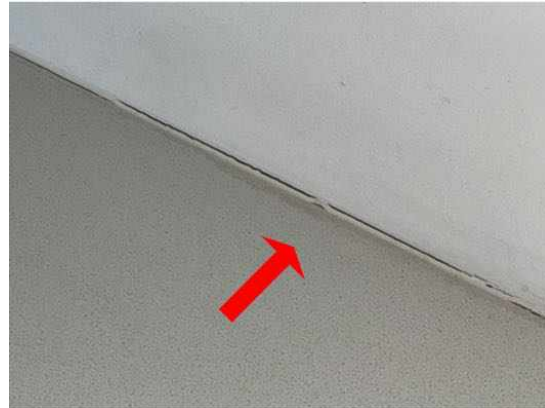
### Finding 3.09

Building:	Main Building
Location:	Kitchen
Finding:	Bench top sealant deteriorated and cracked
Information:	It was observed at the time of the inspection that the silicon sealant to the kitchen bench top has deteriorated and cracked. The sealant is to prevent water ingress penetrating between the wall and bench top when the kitchen is in use.

A general handyman should be engaged to review at the owners discretion.

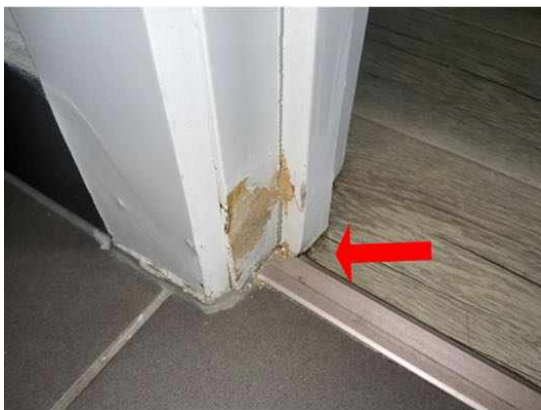
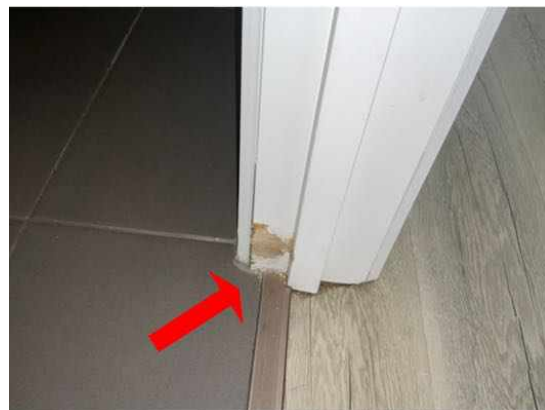
### Finding 3.10

Finding: Water damage to bathroom door frame

Information: It was observed at the time of the inspection that there was some water damage and swelling which has occurred to the bathroom door frame at floor level. After testing the shower, it was observed that the water damage is unlikely to have been caused by leaks within the shower closet. It may be caused by water being left on the surface of the floor tiles after using the shower and eventually the custom wood door frame has soaked up the moisture and caused some deterioration of the door frame.

A waterproof specialist should be engaged to ensure there is no leakage from the shower closet and a qualified carpenter or handyman should be engaged to review the deteriorated door frame as soon as possible

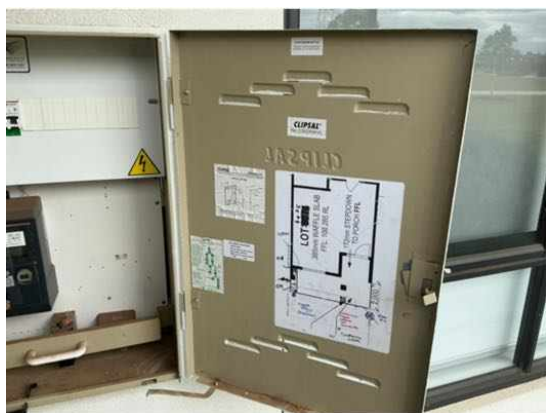
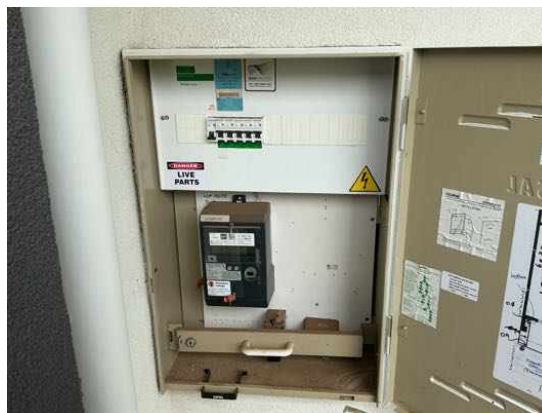
Building:	Main Building
Location:	Meter Box
Finding:	Termite Management System - no evidence of a chemical installation
Information:	The application of a post-construction chemical termite barrier is highly recommended for all properties, particularly if live termite activity has been found on the site previously. Such barriers are highly effective in preventing termite attack on any timber building elements throughout the property.

A durable notice should be placed in the switchboard unit to indicate current termite barriers. At the time of inspection, it appeared as though no termite management system has been installed, with no evidence to suggest preventative works taking place.

The client may consider gaining further advice from a pest controller as to the costs and procedures involved with this application. It is recommended that obtaining such advice be a short-term priority.

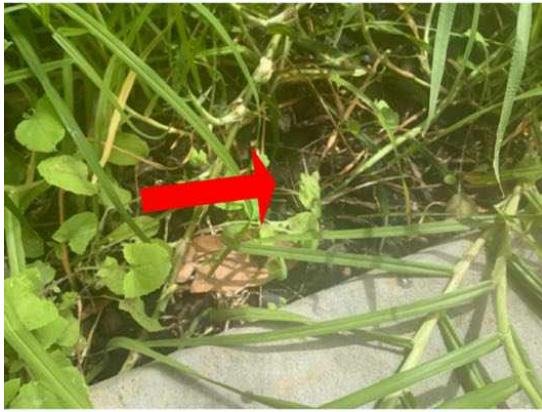
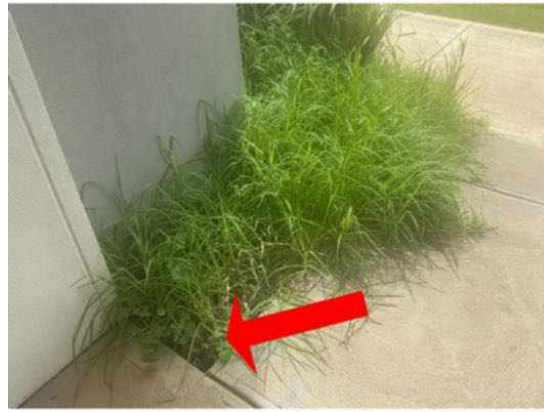
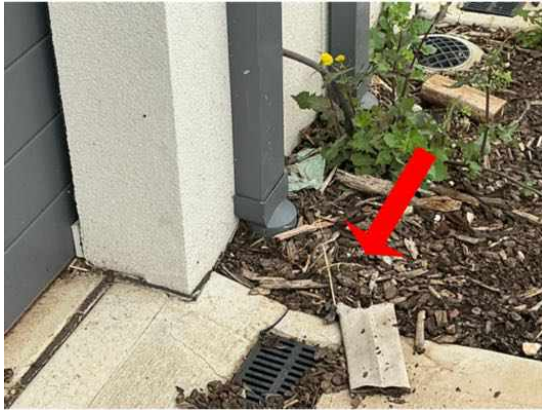
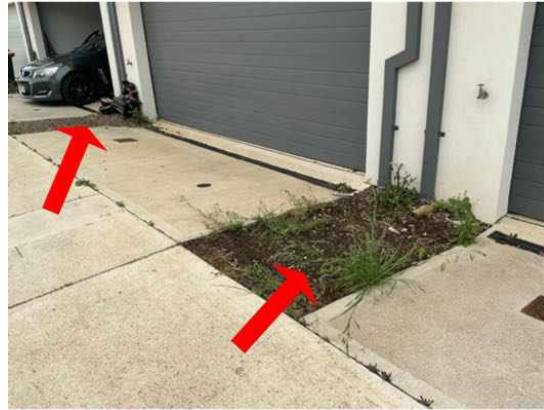
### Finding 6.02

Building:	Main Building
Location:	Yard - Front
Finding:	Garden Beds - Conditions Conducive to Termites
Information:	Garden beds were found to be evident in the garden area. These garden beds can include untreated timber, and with a combination of moisture from watering hosing can make conditions conducive to termite activity and termite ingress.

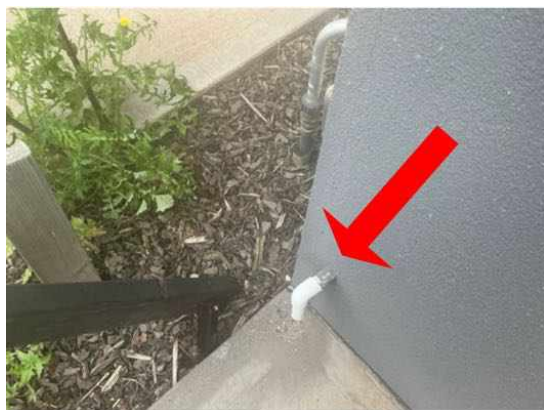
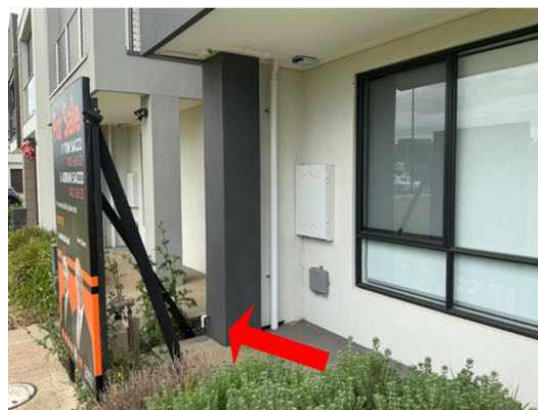
### Finding 6.03

Building: Main Building  
Location: Porch  
Finding: Air conditioner condenser pipe not connected  
Information: The A/C Condenser overflows were found to be disconnected from the stormwater system and is creating excessive moisture to the surrounding area.

Such leaking creates an environment which is conducive to an array of defects including water damage to associated building materials and the attraction of termites or timber pest infestation.

A Licensed plumber should be engaged to review as soon as possible

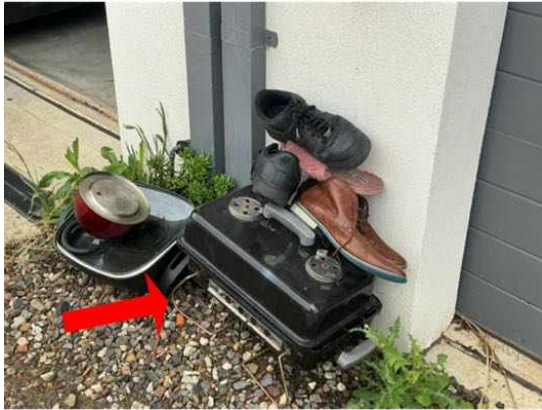
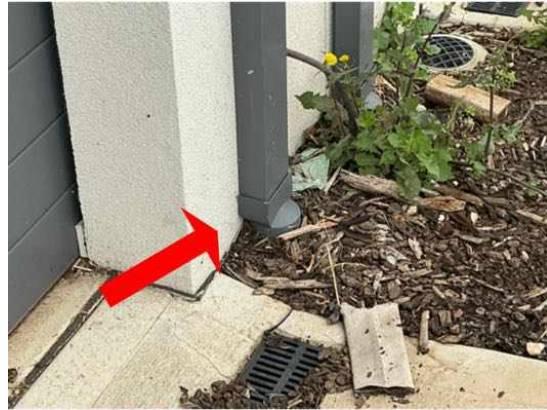
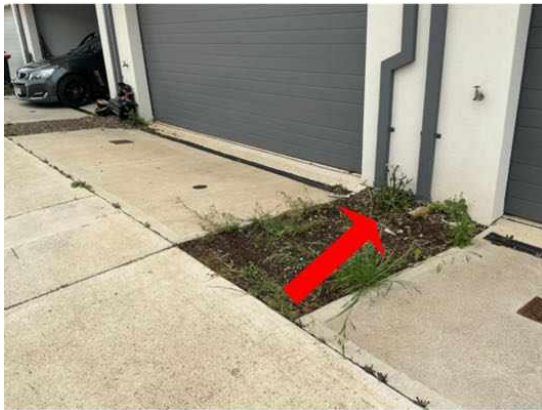
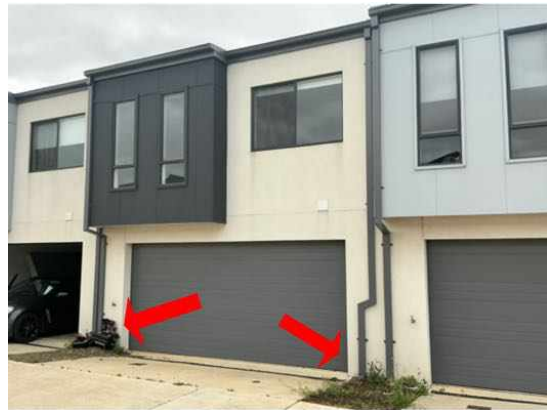
It is important for internal flooring to be raised above adjacent external ground levels. Where external ground levels are above internal flooring water pooling and subsequent internal flooding is likely to occur which may attract termite activity to the internal area.

It is highly advised that a landscaper or paver be appointed to lower external grounds that are raised above adjacent internal flooring. Alternatively if external grounds and internal flooring is level installation of a raised door sill may be appropriate in preventing any water pooling in the area.

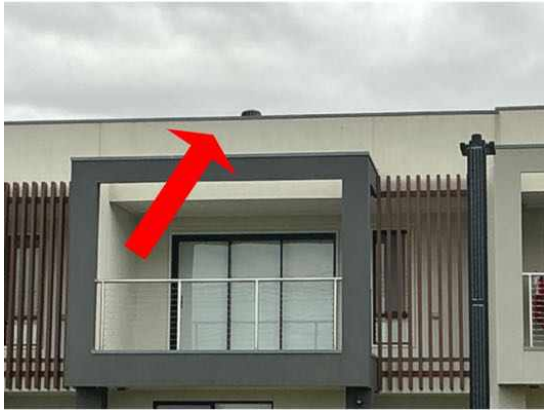
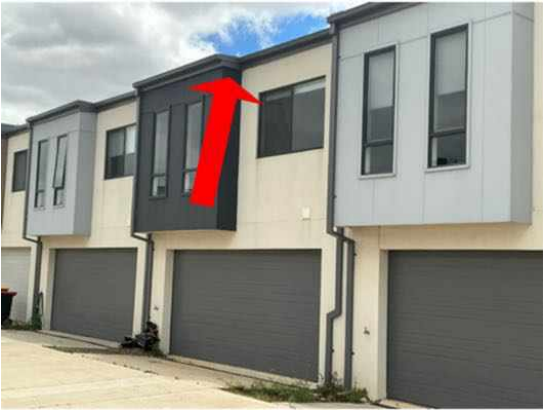
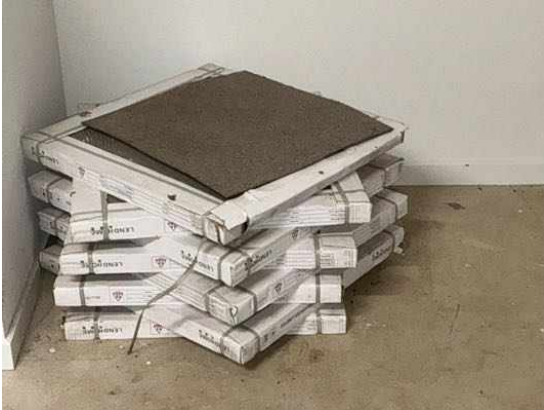
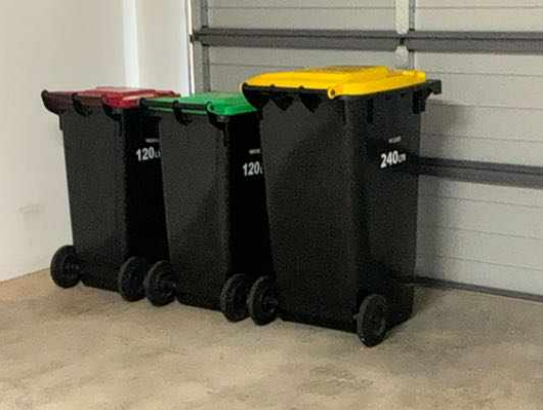
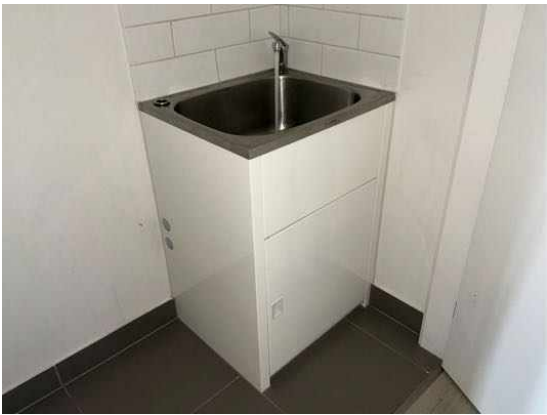
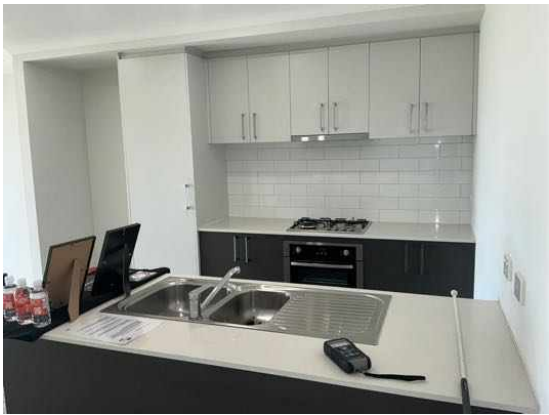
Building: Main Building  
Location: All Areas  
Finding: Additional Photos - Obstructions and Limitations  
Information: These photographs are an indication of the obstructions and limitations which impeded full inspection of the property at the time of inspection. These obstructions can hide an array of defects and should be removed to allow full inspection to be carried out. A re-inspection is recommended once the areas are made accessible.
