Building and Timber Pest Inspection Report

Inspection Date: Fri, 20 Mar 2026

Property Address: 232 Bourke St, Glen Innes NSW 2370,
Australia

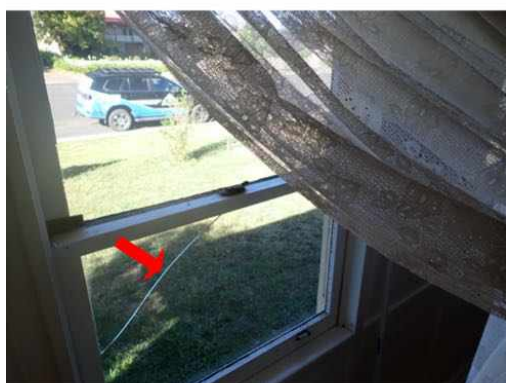
Finding 1.01

Building:	Main Building
Location:	Dining room
Finding:	Cracked Window Glass Pane to Dining Room
Information:	A crack was identified to the window glass pane in the dining room. Cracked glazing can worsen over time and may allow moisture ingress and further deterioration of the window assembly. Possible causes include impact damage or general age-related deterioration. This is a relatively common defect. It is recommended that a licensed glazier replace the damaged glass pane and inspect the surrounding frame for any associated damage. Preventative maintenance includes avoiding impact to glazing and ensuring window frames are well maintained. Repairs should be carried out as required.

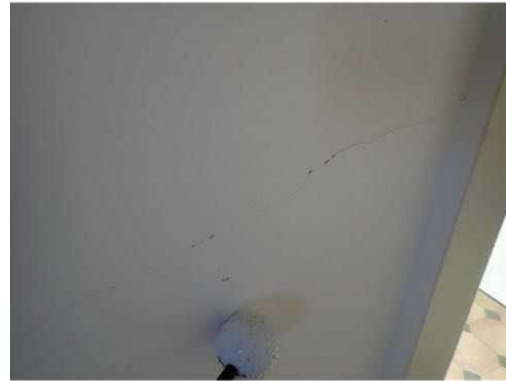
Finding 1.02

Building:	Main Building
Location:	Dining room
Finding:	Crack to Internal Lining – Dining Room (Possible Asbestos Containing Material)
Information:	A crack was identified to the internal lining in the dining room. The lining may contain asbestos, which was common in materials used in properties of this age. Cracking may allow further deterioration of the material and potential disturbance risks if not managed appropriately. Possible causes include structural movement, impact damage, or general age-related deterioration. This is a common defect in properties of this age. It is recommended that a licensed asbestos professional or suitably qualified contractor assess the material and confirm whether asbestos is present prior to any disturbance. Any repairs or removal should be carried out in accordance with relevant regulations and safe handling procedures. Preventative measures include avoiding disturbance to the material until it has been properly assessed. Assessment and any

required works should be carried out prior to any renovation or disturbance of the material.

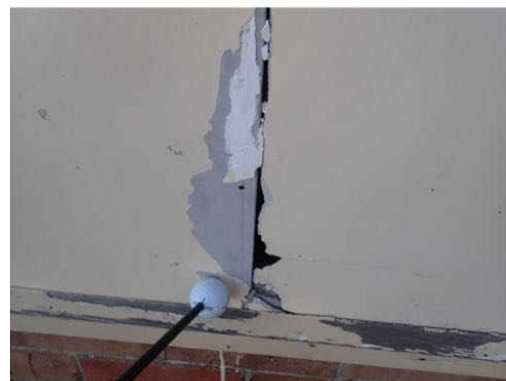
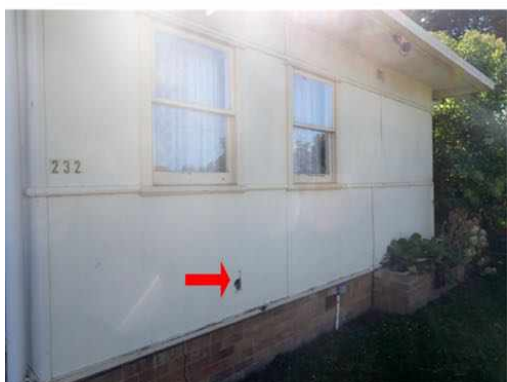
Finding 1.03

Building:	Main Building
Location:	External cladding
Finding:	Damaged External Cladding (Possible Asbestos Containing Material)
Information:	Damage was identified to the external cladding at several locations. The cladding may contain asbestos, which was commonly used in materials of this age. Deterioration or damage to this material may pose risks if disturbed and can lead to further degradation of the cladding if not managed appropriately. Possible causes include impact damage, weathering, and general age-related deterioration. It is recommended that a licensed asbestos professional or suitably qualified contractor assess the material to confirm the presence of asbestos prior to any disturbance, and carry out repairs or removal in accordance with relevant regulations. Preventative measures include avoiding disturbance of the material until it has been properly assessed. Assessment and any required works should be carried out prior to any repair, renovation, or disturbance of the material.

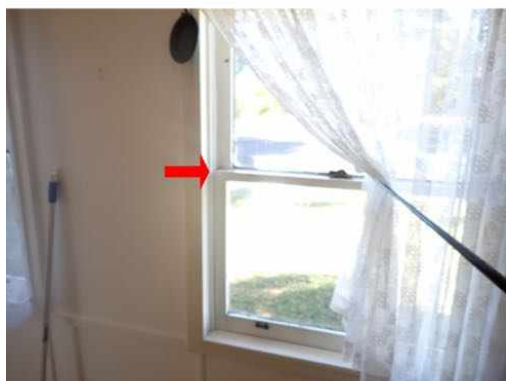
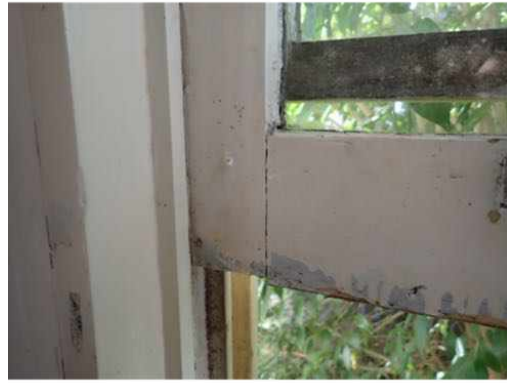
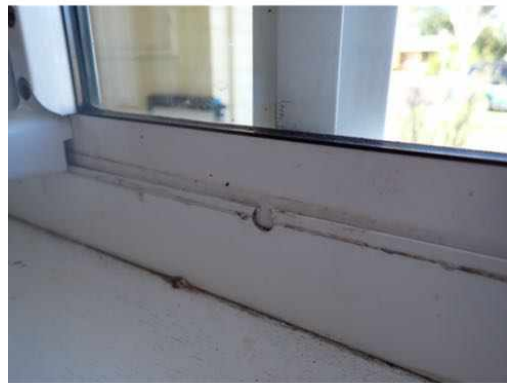
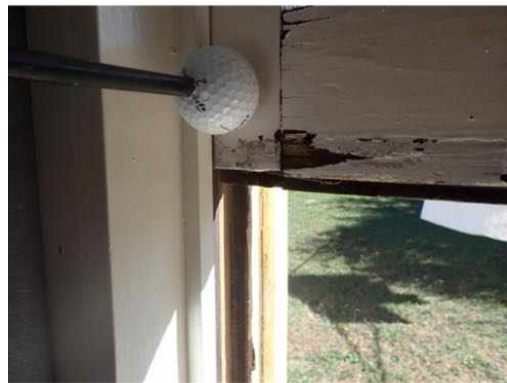
Finding 2.01

Building:	Main Building
Location:	Windows
Finding:	Windows Difficult to Operate and Deteriorated Condition
Information:	<p>The majority of the windows were either unable to be opened or were difficult to operate at the time of inspection. Some windows also showed signs of deterioration including wood rot. This condition may lead to reduced functionality and ongoing deterioration of associated building elements if left unaddressed. Possible causes include lack of maintenance, paint build-up, moisture ingress, structural movement, or general age-related wear and tear. This is a common defect in properties of this age. It is recommended that a licensed carpenter assess all affected windows, carry out repairs to ensure they are fully operational, and replace any components affected by wood rot as required. Preventative maintenance includes regular servicing, painting, and sealing of window frames to protect against moisture ingress. Repairs should be carried out as required.</p>

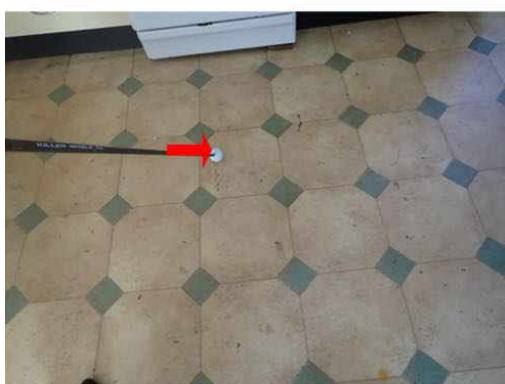
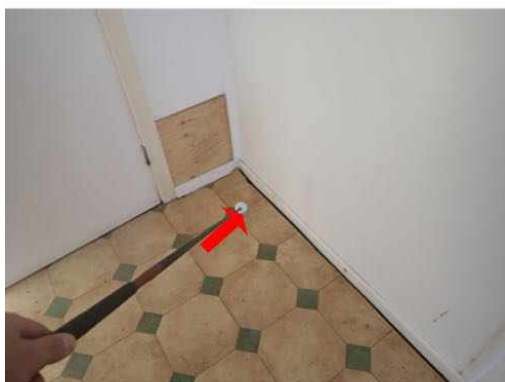
Finding 2.02

Building:	Main Building
Location:	Vinyl floored areas
Finding:	Vinyl Flooring in Poor Condition
Information:	The vinyl flooring was observed to be in poor condition with signs of wear and deterioration. This may lead to further degradation of the flooring surface and underlying materials if not addressed. Possible causes include general age-related wear and tear, moisture exposure, or inadequate maintenance. This is a common defect in properties of this age. It is recommended that a licensed flooring contractor assess the condition of the flooring and carry out repairs or replacement as required. Preventative maintenance includes regular cleaning and ensuring moisture is kept to a

minimum. Repairs should be carried out in the short term to prevent further deterioration.

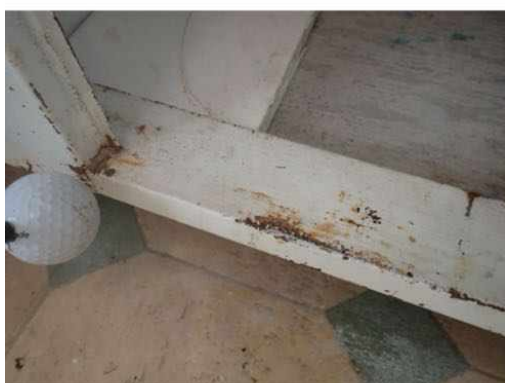
Finding 2.03

Building:	Main Building
Location:	Laundry
Finding:	Laundry Tub Cabinet Not Secured and Deteriorated Condition
Information:	The laundry tub cabinet was observed to be not secured to the wall, with surface rust present, a missing door, and damaged and missing tiles to the splashback. This condition may lead to instability of the cabinet and allow moisture ingress, resulting in further deterioration of the unit and surrounding building materials if not addressed.

Possible causes include poor installation, moisture exposure, and general age-related wear and tear. It is recommended that a licensed plumber or carpenter, in conjunction with a tiler, assess the cabinet, secure it appropriately to the wall, replace or repair the unit as required, and rectify the damaged splashback tiles with appropriate sealing. Preventative maintenance includes ensuring fixtures are properly fixed and limiting moisture exposure to cabinetry and wall linings. Repairs should be carried out in the short term to prevent further deterioration.

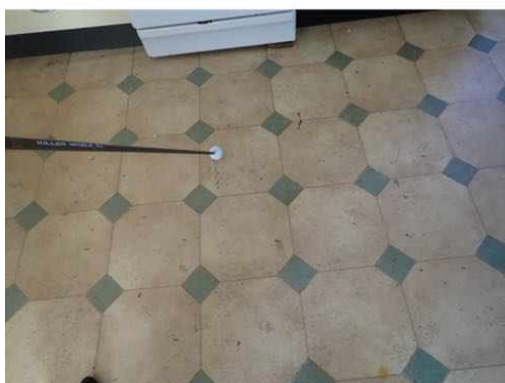
Finding 2.04

Building:	Main Building
Location:	Floor all areas
Finding:	Floor Uneven and Out of Level
Information:	The floor was observed to be generally wavy and out of level throughout the building. This condition may indicate movement or deterioration of the subfloor structure and can affect the performance of floor coverings and fixtures if not addressed. Possible causes include subfloor movement, settlement, inadequate support, moisture-related issues, or general age-related deterioration. This is a common defect in properties of this age. It is recommended that a licensed builder assess the subfloor and structural supports, and carry out further investigation and rectification works as required. Preventative maintenance includes maintaining adequate subfloor ventilation and ensuring moisture is controlled. Repairs should be carried out in the short term to prevent further deterioration.

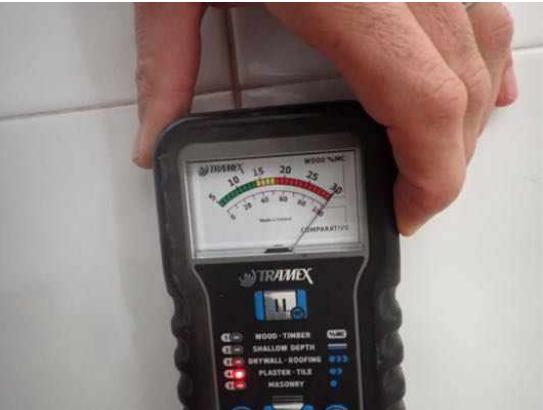
Finding 2.05

Building:	Main Building
Location:	Bathroom
Finding:	Bathroom Water Damage and Deteriorated Finishes
Information:	Water damage was identified to the bathroom, with missing tiles, deteriorated silicone and grout, and high moisture meter readings recorded to the walls. The bathroom entry door was also noted to be affected. This condition has led to deterioration of underlying building materials and may continue to deteriorate further if not addressed. Possible causes include failed waterproofing, deteriorated sealants and grout, and general age-related wear and tear. It is recommended that a licensed builder, in conjunction with a tiler and plumber, assess the extent of moisture damage, carry out further investigation to underlying materials, and complete repairs including replacement of tiles, re-grouting, and re-sealing as required. Preventative maintenance includes maintaining effective waterproofing, sealants, and grout to wet areas. Repairs should be carried out as soon as possible.

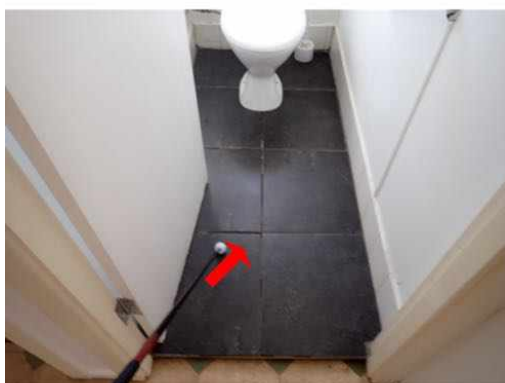
Finding 2.06

Building:	Main Building
Location:	Toilet (WC)
Finding:	Toilet Floor Tiles in Poor Condition and Poorly Laid
Information:	The toilet floor tiles were observed to be in poor condition and poorly laid. This may result in uneven surfaces, loose or drummy tiles, and potential moisture ingress if not addressed. Possible causes include poor workmanship, inadequate substrate preparation, or general wear and tear. It is recommended that a licensed tiler assess the area, remove and re-lay the tiles with appropriate preparation and sealing as required. Preventative maintenance includes ensuring tiles are properly installed and maintaining grout and sealants. Repairs should be carried out in the short term to prevent further deterioration.

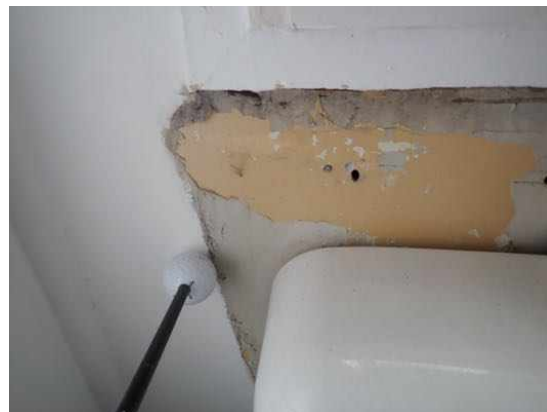
Finding 2.07

Building:	Main Building
Location:	Toilet (WC)
Finding:	Toilet Loose with Minor Leak and Wall Damage
Information:	The toilet was observed to be loose with a minor leak present, and damage was noted to the wall where a previous toilet installation had been carried out. This condition may lead to ongoing water leakage and further deterioration of surrounding building materials if not addressed. Possible causes include poor installation, failed seals, or

movement of the fixture over time. It is recommended that a licensed plumber assess the toilet, secure it correctly, repair the leak, and make good any associated wall damage as required. Preventative maintenance includes ensuring fixtures are properly installed and promptly addressing any leaks. Repairs should be carried out as soon as possible.

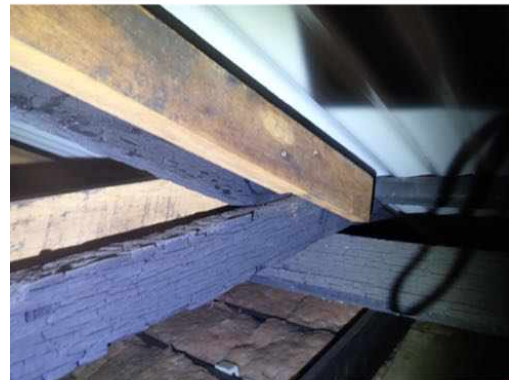
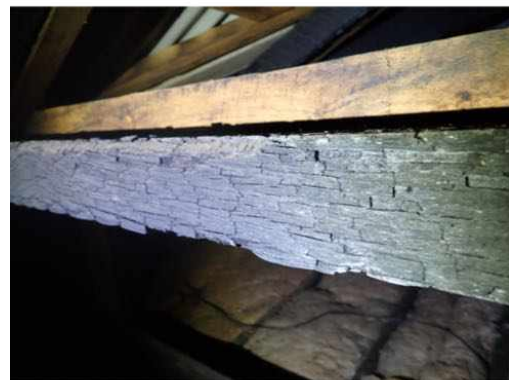
Finding 2.08

Building:	Main Building
Location:	Ceiling space
Finding:	Fire Damage to Roof Timbers (Partial Replacement Noted)
Information:	Evidence was observed that a fire has previously affected the roof timbers, with

sections having been replaced. This condition may indicate potential concealed damage to remaining structural elements and variations in the integrity of the roof framing if not fully assessed. Possible causes relate to a past fire event and subsequent partial rectification works. It is recommended that a licensed builder or structural engineer assess the roof structure to determine the extent of any remaining damage and confirm that repairs have been carried out appropriately. Preventative measures include ensuring all fire-affected materials have been fully removed and replaced where required. Further assessment should be carried out in the short term to confirm structural integrity.

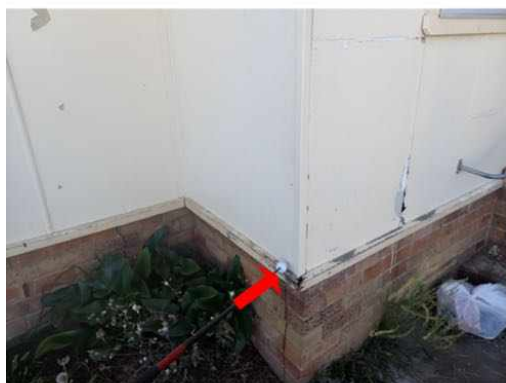
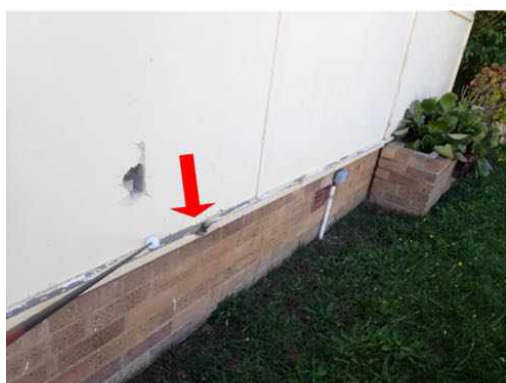
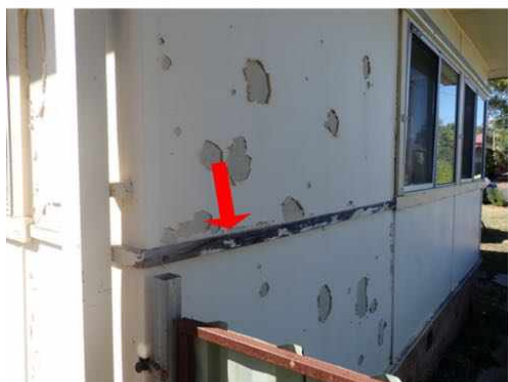
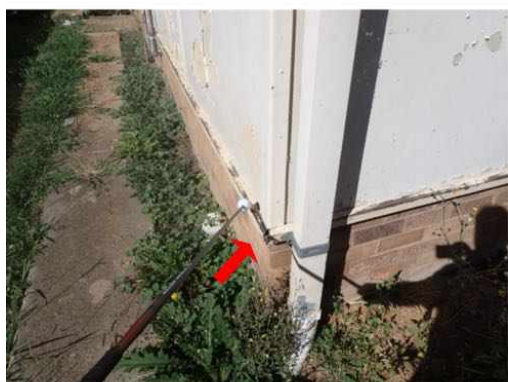
Finding 2.09

Building:	Main Building
Location:	External timber trims
Finding:	Wood Rot and Deteriorated Paintwork to External Timber Trims
Information:	Wood rot and deteriorated paintwork were identified to the external timber trims around the building. This condition may allow moisture ingress and lead to further deterioration of the timber elements if not addressed. Wood rot is also conducive to termite attack. Possible causes include prolonged exposure to weather, lack of maintenance, and general age-related wear and tear. This is a common defect in properties of this age. It is recommended that a licensed carpenter assess the affected timber trims, carry out repairs or replacement of any rotted sections, and repaint/seal the surfaces as required. Preventative maintenance includes regular painting and sealing of external timber elements to protect against moisture. Repairs should be carried out in the short term to prevent further deterioration.

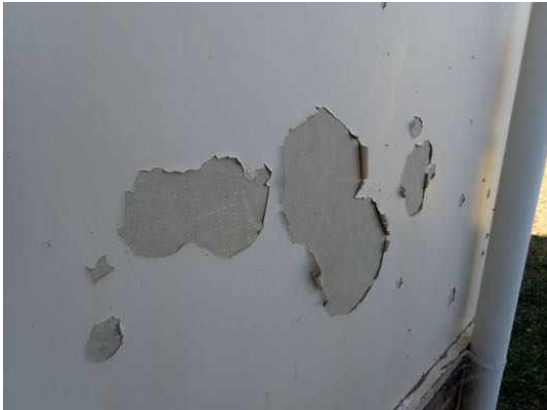
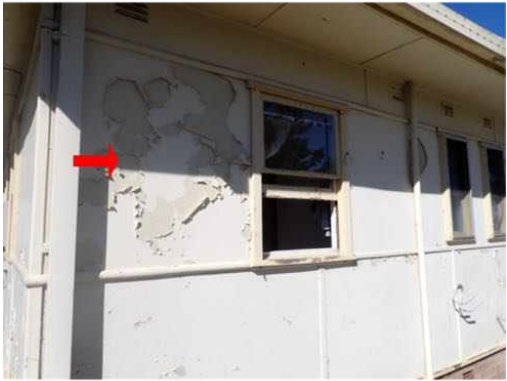
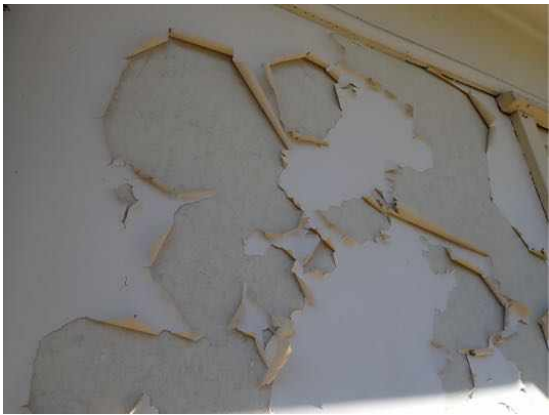
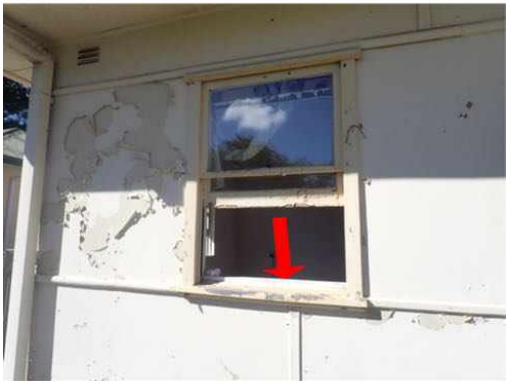
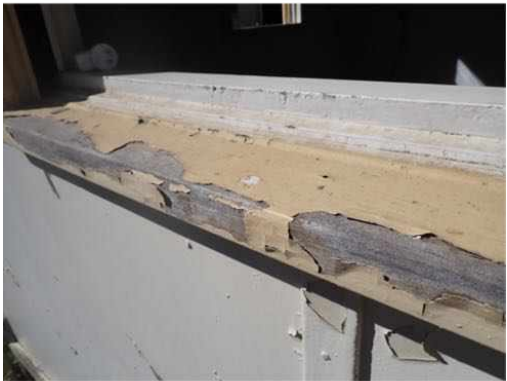
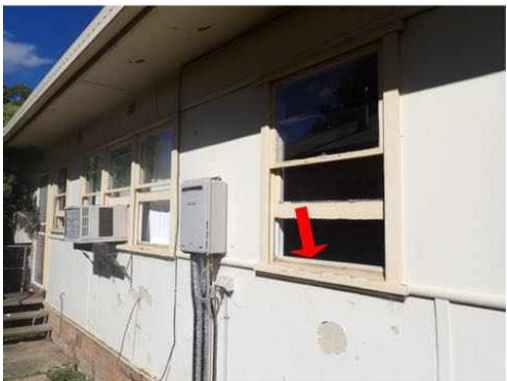
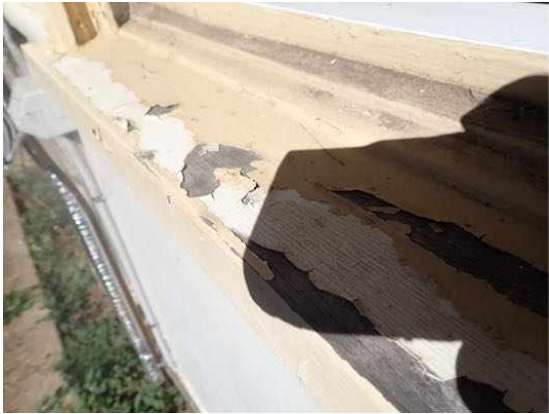
Finding 2.10

Building:	Main Building
Location:	External timber trims
Finding:	External Painting Required to Entire Dwelling
Information:	The external surfaces of the house, including timber windows and doors, were observed to be in need of painting. Deteriorated and unprotected surfaces may allow moisture ingress and lead to ongoing deterioration of timber elements if not addressed. Possible causes include weather exposure, lack of maintenance, and general age-related wear and tear. This is a common condition in properties of this age. It is recommended that a licensed painter assess all external surfaces, prepare the areas appropriately, and carry out full repainting including timber windows and doors. Preventative maintenance includes regular painting and sealing of external surfaces to protect against weathering. Works should be carried out in the short term to prevent further deterioration.

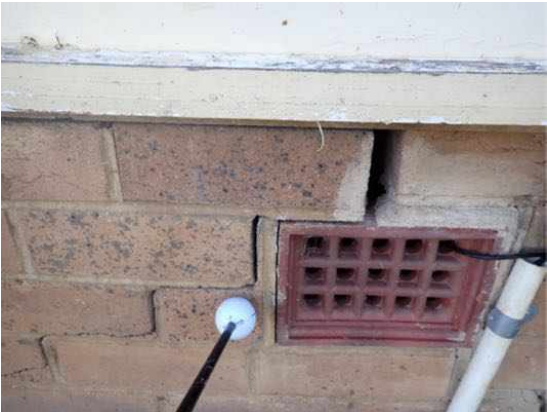
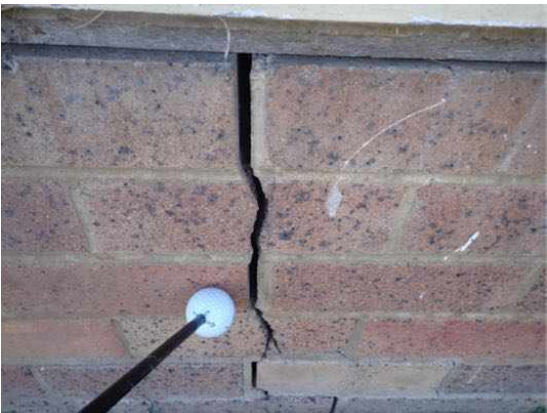
Finding 2.11

Building: Main Building
Location: Perimeter of building
Finding: Significant Cracking to Brick Base of Building
Information: Multiple significant cracks were identified to the brick base of the building. This condition indicates movement or possible structural issues and may lead to further structural deterioration if not addressed. Possible causes include foundation movement, reactive soils, moisture variation, or long-term settlement. It is recommended that a licensed structural engineer, in conjunction with a licensed builder, carry out a detailed assessment to determine the cause and extent of movement and specify appropriate rectification works. Preventative measures include

managing site drainage and controlling moisture levels around the building. Repairs and further assessment should be carried out as soon as possible.

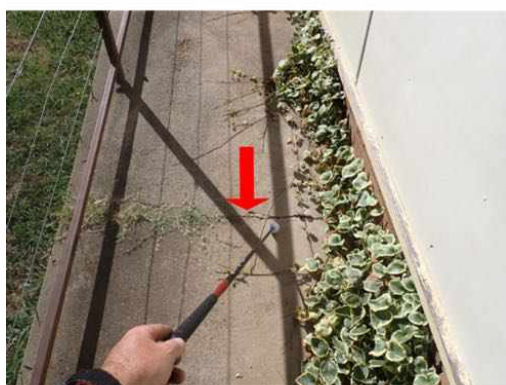
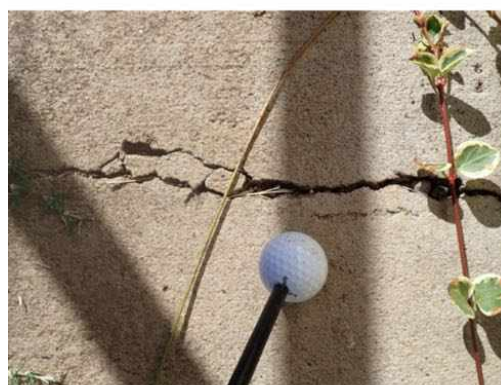
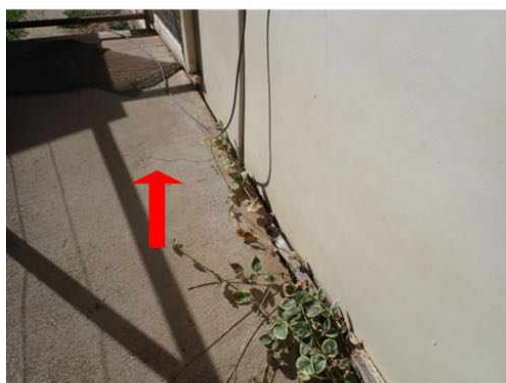
Finding 2.12

Building:	Main Building
Location:	Rear concrete ramp
Finding:	Cracking to Rear Concrete Ramp
Information:	A small and a large crack were identified to the rear concrete ramp. This condition may indicate movement or deterioration of the concrete and can lead to further cracking and surface degradation if not addressed. Possible causes include ground movement, shrinkage, inadequate reinforcement, or general age-related wear and tear. It is recommended that a licensed concreter or builder assess the extent of the cracking and carry out repairs as required, which may include sealing, patching, or replacement of affected sections. Preventative maintenance includes monitoring cracks and maintaining proper drainage to minimise movement. Repairs should be carried out in the short term to prevent further deterioration.

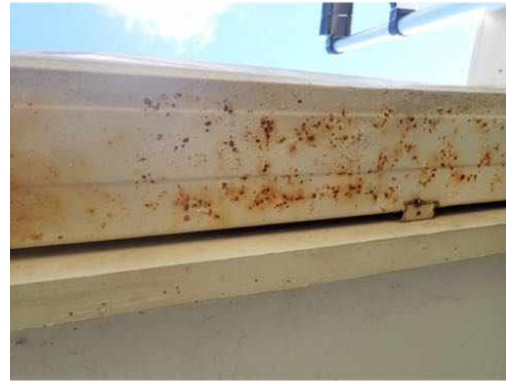
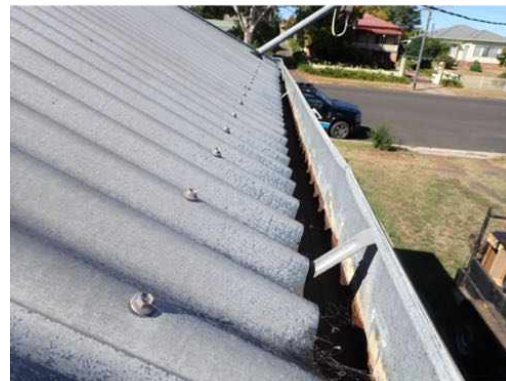
Finding 2.13

Building:	Main Building
Location:	Gutters
Finding:	Rust to Gutters at Multiple Locations
Information:	Rust was identified to the gutters at multiple locations. This condition may lead to perforation, leaking, and reduced effectiveness of the drainage system if not addressed. Possible causes include prolonged exposure to weather, debris build-up, and general age-related deterioration. This is a common defect in properties of this age. It is recommended that a licensed roofer or plumber assess the gutters, carry out

rust treatment, and repair or replace affected sections as required. Preventative maintenance includes regular cleaning of gutters and maintaining protective coatings. Repairs should be carried out in the short term to prevent further deterioration.

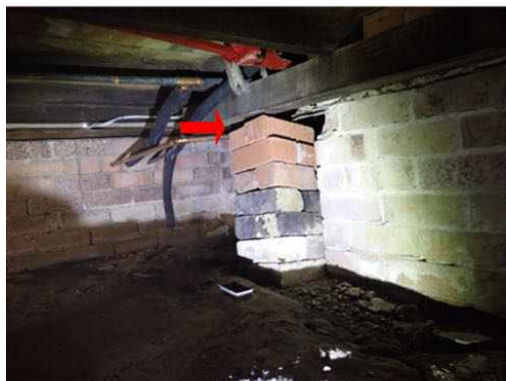
Finding 2.14

Building:	Main Building
Location:	Subfloor
Finding:	Leaning Brick Pier Not Engaged to Timber Bearers
Information:	A brick pier was observed to be leaning and not properly engaged with the timber bearers. This condition may compromise the structural support to the subfloor and can lead to movement or failure of supported elements if not addressed. Possible

causes include ground movement, inadequate installation, deterioration of materials, or loss of bearing over time. It is recommended that a licensed builder assess the affected pier, re-establish proper support and engagement to the timber bearers, and carry out any necessary rectification works. Preventative measures include ensuring adequate footing support and regular inspection of subfloor structural elements. Repairs should be carried out as soon as possible.

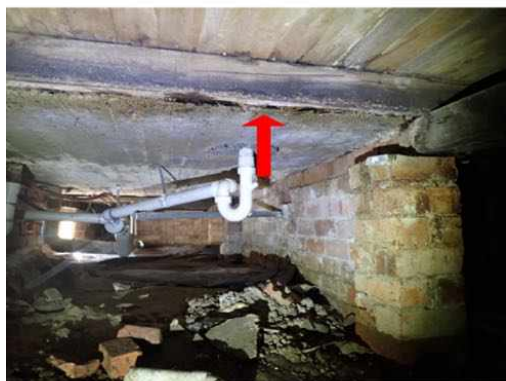
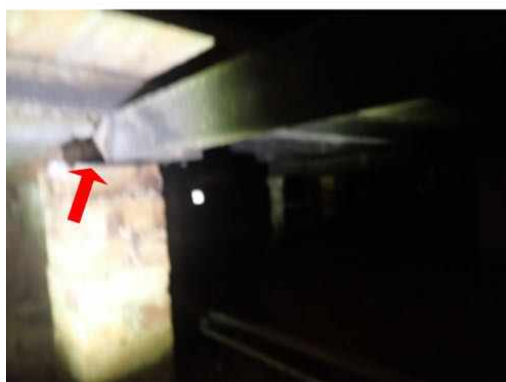
Finding 2.15

Building:	Main Building
Location:	Subfloor
Finding:	Active Leak and Wood Rot to Bathroom Subfloor Timbers
Information:	An active leak was identified to the bathroom subfloor area, with wood rot present to associated timbers. This condition indicates ongoing moisture ingress and may lead to further deterioration of structural timbers if not addressed. Wood rot is also conducive to termite attack. Possible causes include leaking plumbing, failed waterproofing, or damaged pipework. It is recommended that a licensed plumber locate and repair the source of the leak, and a licensed builder assess and repair or replace any affected structural timbers as required. Preventative maintenance includes regular inspection of plumbing and ensuring leaks are addressed promptly. Repairs should be carried out as soon as possible.

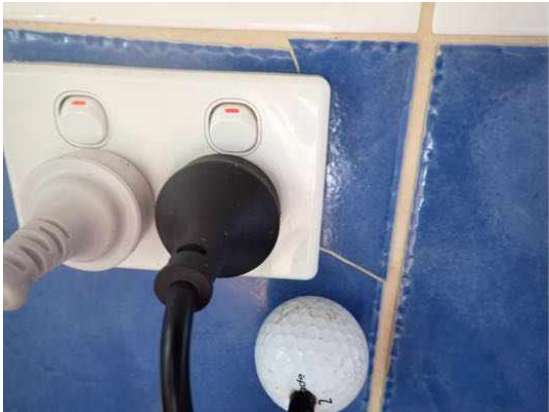
Building:	Main Building
Location:	Kitchen
Finding:	Kitchen in Fair Condition with Minor Defects Identified

The kitchen was observed to be in fair condition for its age, with defects noted including deteriorated silicone to junctions and cracked tiles to the splashback. These conditions may allow moisture ingress and lead to further deterioration of associated building materials if not addressed. Possible causes include general age-related wear and tear and ongoing use. This is a common condition in kitchens of this age. It is recommended that a licensed builder or tiler assess the affected areas, replace cracked tiles, and re-apply silicone sealant as required. Preventative maintenance includes maintaining effective seals and promptly addressing any damaged tiles. Repairs should be carried out in the short term to prevent further deterioration.

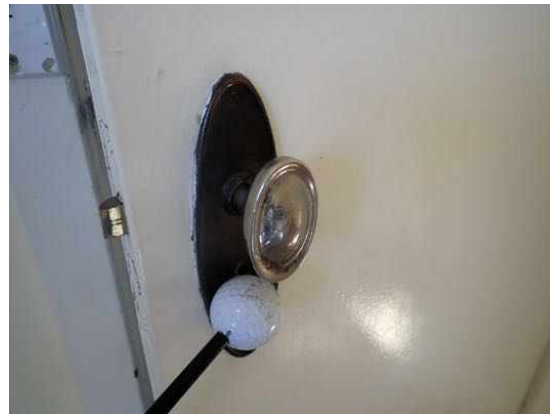
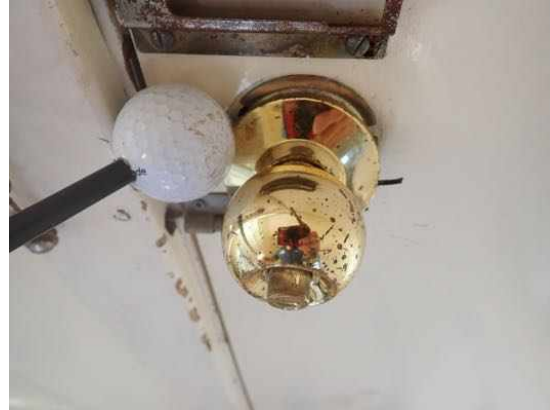
Finding 3.03

Finding: Doors and Hardware in Poor Condition

Information: The doors and associated hardware were observed to be in poor condition, although generally operational at the time of inspection. Defects may include wear, damage, misalignment, and deteriorated hardware components. This condition may lead to reduced functionality and ongoing deterioration if not addressed. Possible causes include general age-related wear and tear, lack of maintenance, and repeated use. This is a common defect in properties of this age. It is recommended that a licensed carpenter assess all affected doors and hardware, carry out adjustments, and repair or replace components as required to ensure proper operation. Preventative maintenance includes regular adjustment, lubrication, and timely replacement of worn hardware. Repairs should be carried out in the short term to prevent further deterioration.

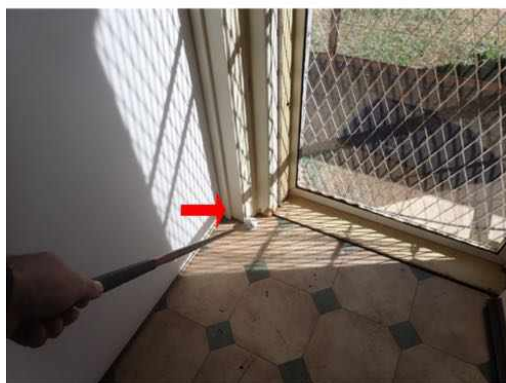
Finding 3.05

Building:	Main Building
Location:	Rear exit door
Finding:	Rear Exit Door Catching and Swollen Architrave
Information:	The rear exit door was observed to be catching on the floor covering, and the door architrave was noted to be swollen and made from MDF. This condition may lead to reduced functionality and ongoing deterioration, particularly where MDF has been affected by moisture. Possible causes include moisture ingress, material swelling, poor installation, or general wear and tear. It is recommended that a licensed carpenter assess the door and architrave, carry out adjustments to ensure proper clearance, and repair or replace the affected MDF components with more suitable materials as required. Preventative maintenance includes managing moisture levels and ensuring appropriate materials are used in areas prone to moisture. Repairs should be carried out in the short term to prevent further deterioration.

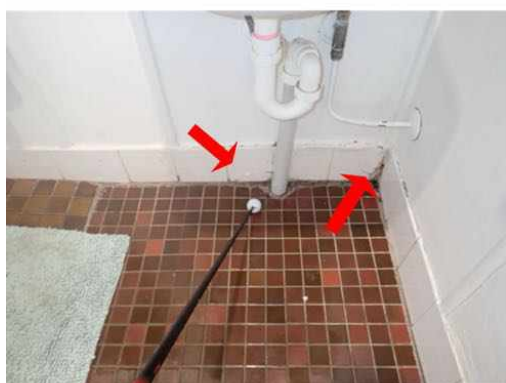
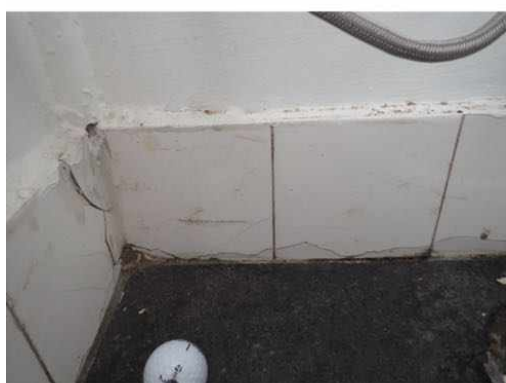
Finding 3.06

Building:	Main Building
Location:	Bathroom
Finding:	Cracked Tiles to Bathroom and Toilet Skirting
Information:	Cracked tiles were identified to the bathroom and toilet skirting. This condition may allow moisture ingress and lead to deterioration of adjacent building materials if not addressed. Possible causes include movement in the structure, impact damage, poor installation, or general age-related wear and tear. It is recommended that a licensed

tiler assess the affected area, replace the damaged tiles, and ensure appropriate sealing and waterproofing is in place. Preventative maintenance includes maintaining grout and sealants and addressing damaged tiles promptly. Repairs should be carried out in the short term to prevent further deterioration.

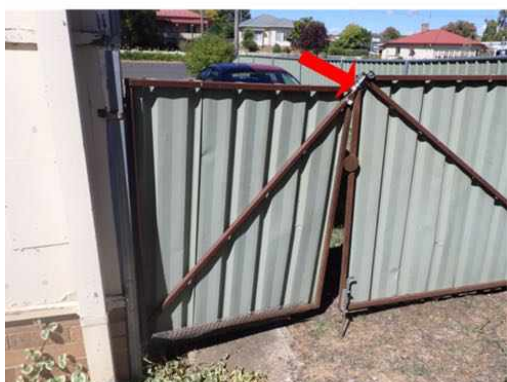
Building: Main Building
Location: Bounty fencing
Finding: Boundary Fencing in Deteriorated Condition
Information: The boundary fencing was observed to be in deteriorated condition overall, with signs of wear, weathering, and reduced structural integrity in sections. This condition may lead to further deterioration and potential failure of fencing components if not addressed. Possible causes include prolonged exposure to weather, age-related deterioration, and lack of maintenance. It is recommended that a licensed carpenter or fencing contractor assess the fencing and carry out repairs or replacement of affected sections as required. Preventative maintenance includes regular inspection and upkeep of fencing components. Repairs should be carried out in the short term to prevent further deterioration.

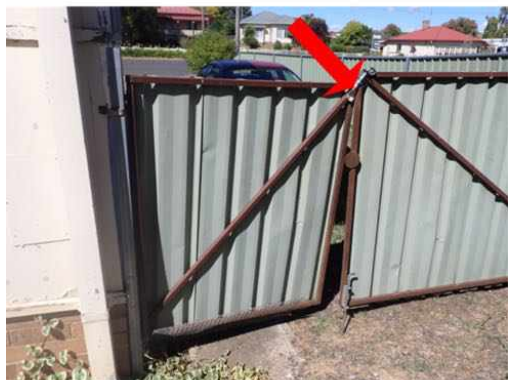
Finding 3.09

Building:	Main Building
Location:	Side gate
Finding:	Side Gate in Poor Condition
Information:	The side gate was observed to be in poor condition with signs of wear, damage, and deterioration. This condition may affect functionality and security and can lead to further deterioration if not addressed. Possible causes include general age-related wear and tear, weather exposure, and lack of maintenance. It is recommended that a licensed carpenter or fencing contractor assess the gate and carry out repairs or replacement as required. Preventative maintenance includes regular inspection and upkeep of gate components. Repairs should be carried out in the short term to prevent further deterioration.

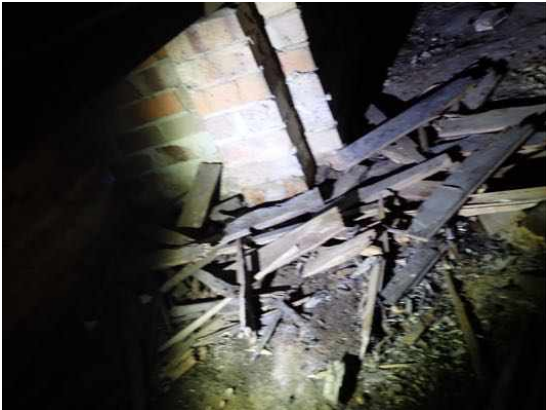
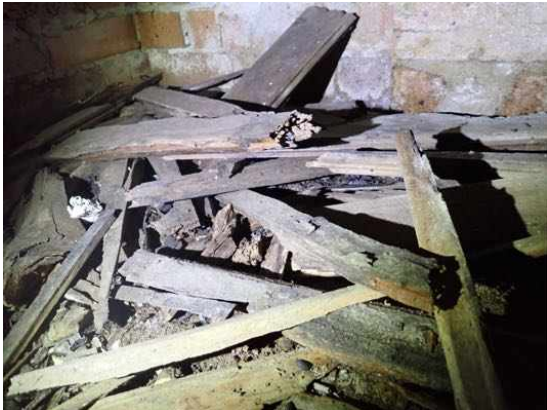
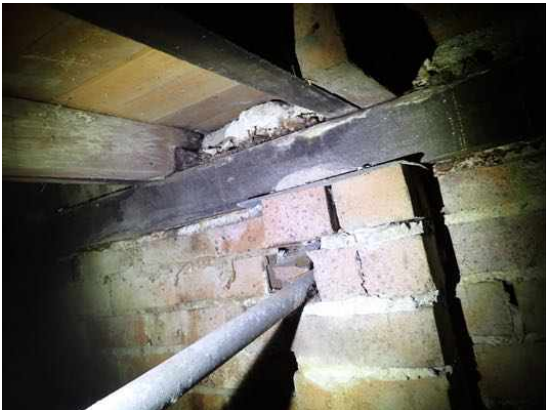
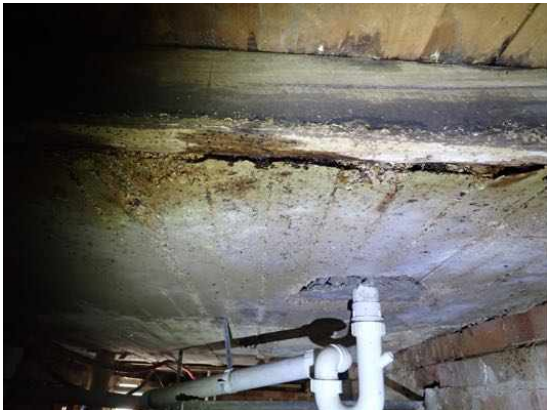
Finding 6.01

Building:	Main Building
Location:	Perimeter of building
Finding:	Conditions Conducive to Termite Attack – Concealed Entry Points
Information:	<p>Conditions conducive to termite attack were identified around the building and with in the subfloor, including areas that may allow concealed entry. Such conditions can increase the risk of termite activity and potential damage to timber elements if not addressed. Possible causes include timber in contact with the ground, inadequate clearance, poor maintenance, and obstructed inspection zones. This is a common issue in properties of this age. It is recommended that a licensed timber pest inspector assess the property, identify all risk areas, and implement appropriate termite management and protection measures. Preventative maintenance includes maintaining clear inspection zones, ensuring adequate clearances, and removing or isolating timber from ground contact. Works should be carried out in the short term to reduce the risk of termite attack.</p>

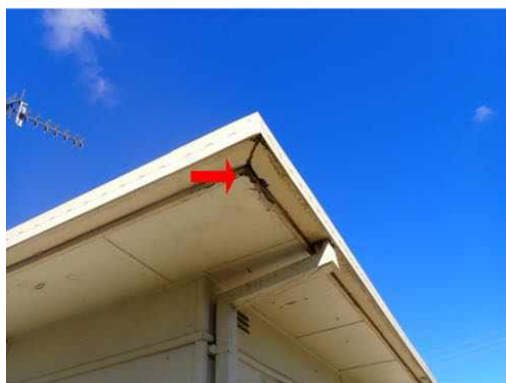
Finding 6.02

Building:	Main Building
Location:	Fascia boards
Finding:	Wood Rot to Fascia Board Ends
Information:	Wood rot was identified to the ends of the fascia boards. This condition may allow moisture ingress and lead to further deterioration of the timber elements if not addressed. Wood rot is also conducive to termite attack. Possible causes include prolonged exposure to weather, failed paint coatings, and general age-related wear and tear. This is a common defect in properties of this age. It is recommended that a licensed carpenter assess the affected fascia boards, carry out repairs or replacement of rotted sections, and repaint/seal the surfaces as required. Preventative maintenance includes regular painting and sealing of external timber elements to protect against moisture. Repairs should be carried out in the short term to prevent further deterioration.

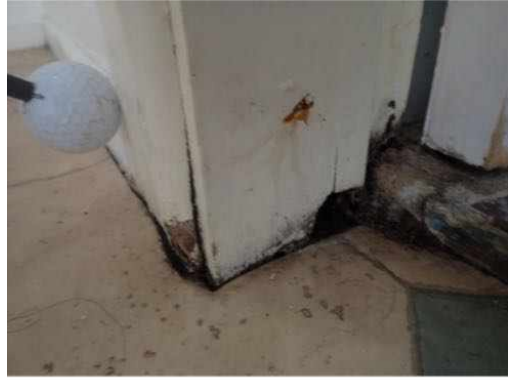
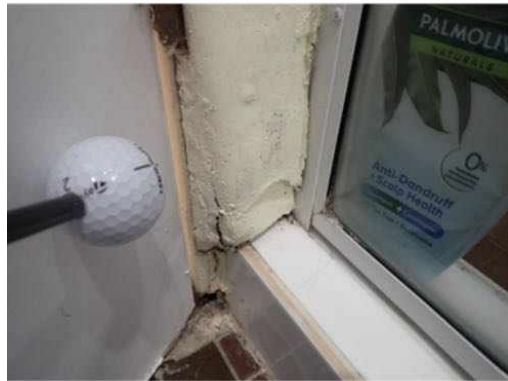
Finding 7.01

Building:	Main Building
Location:	Bathroom
Finding:	Wood Rot to Bathroom Door Jamb and Architraves
Information:	Wood rot was identified to the bathroom door jamb and architraves, likely resulting from moisture associated with a leaking shower. This condition indicates prolonged moisture exposure and may lead to further deterioration of surrounding building materials if not addressed. Possible causes include failed waterproofing, leaking shower components, and ongoing moisture ingress. It is recommended that a licensed builder, in conjunction with a plumber, assess the source of the leak, rectify the moisture issue, and repair or replace the affected timber elements as required. Preventative maintenance includes ensuring shower waterproofing and seals are maintained and promptly addressing any leaks. Repairs should be carried out as soon as possible.
