Building and Timber Pest Inspection Report

Inspection Date: Fri, 6 Mar 2026

Property Address: 10 Glenairne St, Wodonga VIC 3690,
Australia

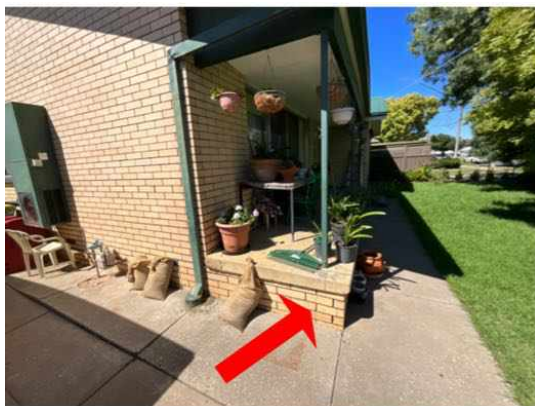
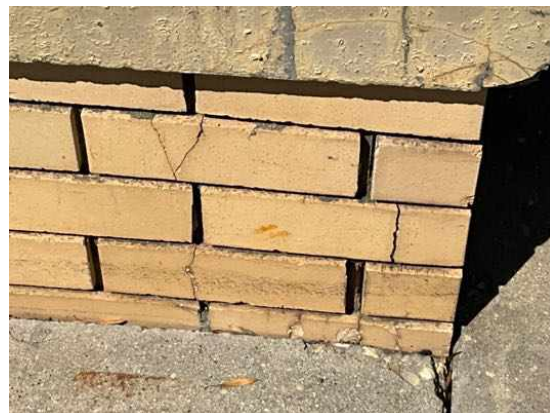
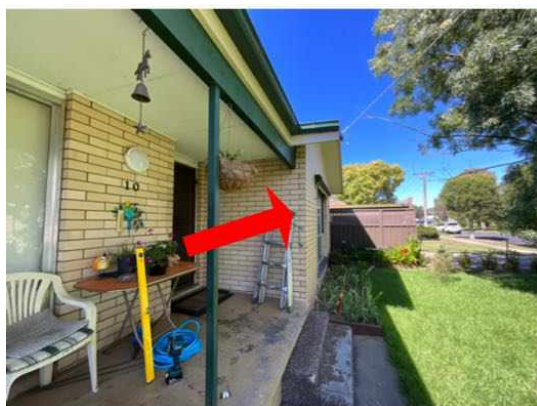
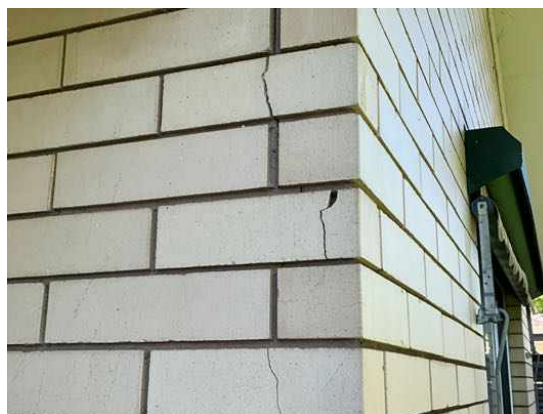
Finding 3.01

Building: Building 1
Location: Exterior walls - front
Finding: Brickwork - Cracking noticeable
Information: There were several cracks and or crack repairs evident to external brickwork.

Noticeable cracks are a common occurrence in external brickwork and are a likely result of age expected building movement, general expansion, and/or contraction of building materials in different weather conditions. Noticeable cracks in brickwork may develop if left unattended, with potential for necessitating major remedial works or replacement of the brickwork.

It is highly advised that a qualified bricklayer be appointed to provide necessary works to cracked brickwork to prevent any further damage. Such works should be conducted as soon as possible.

Always monitor these cracks and contact a building inspector should cracks widen, lengthen, or become more numerous.

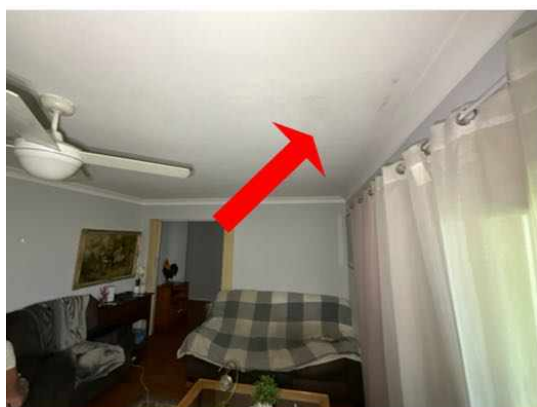
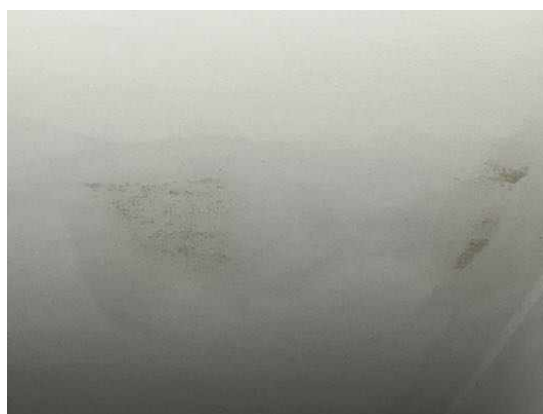
Finding 3.02

Building:	Building 1
Location:	Living Room
Finding:	Ceiling - Water stained
Information:	Water staining to ceiling linings in this area was evident at the time of inspection. Water staining indicates that surfaces have been exposed to excessive moisture over time. The minerals and other elements in the water lead to staining, which may graduate to corrosion and deterioration if left unmanaged.

While mostly an appearance defect, water staining can be indicative of more serious defects, which may be currently concealed by interior ceilings.

Where water staining is active, a licensed plumber must be consulted to identify the cause of the staining and to provide advice on any reparation works that may be required. Replacement of any damaged structures is advised.

Conversely, where water staining is old and inactive, affected building materials may be repaired or replaced at client discretion.

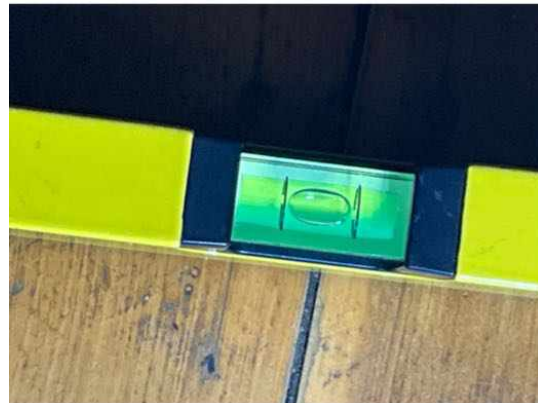
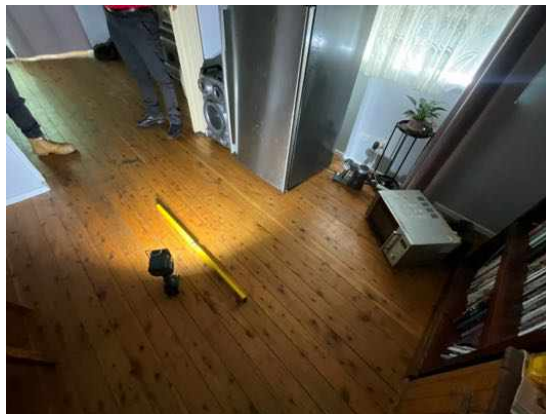
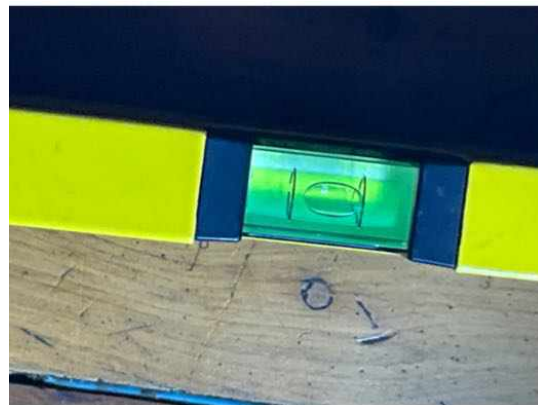
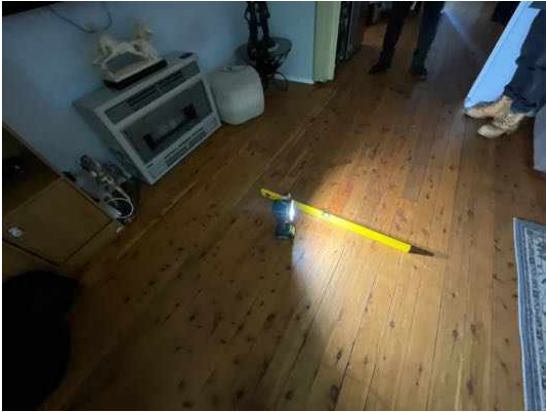
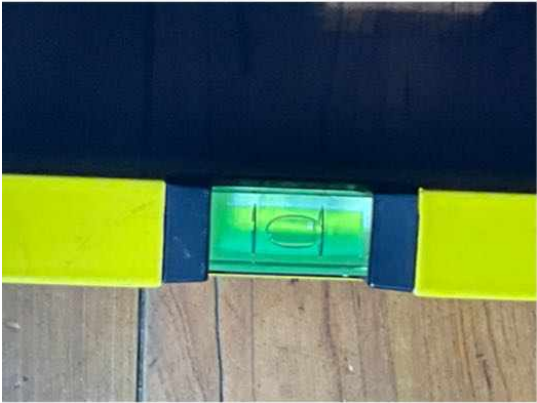
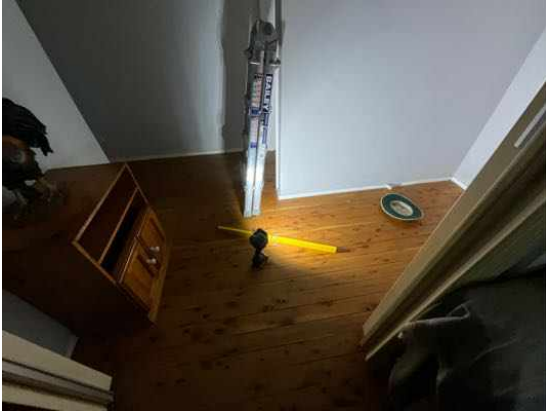
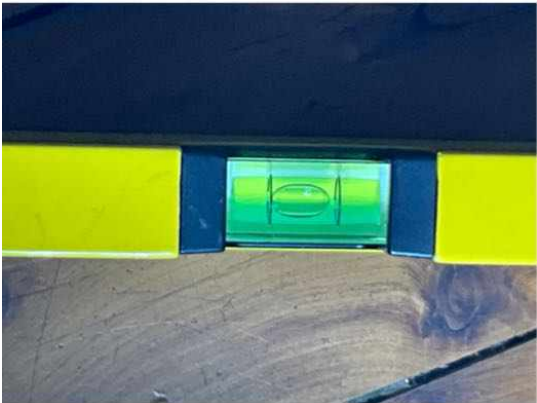
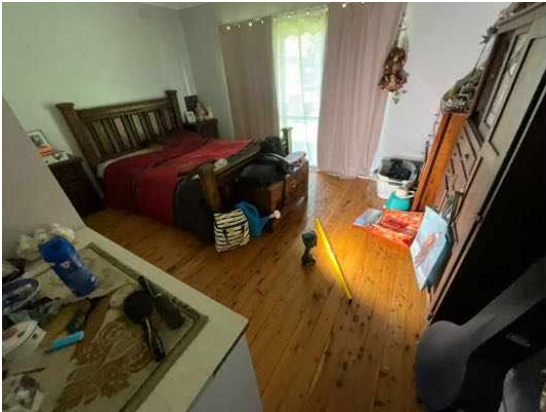
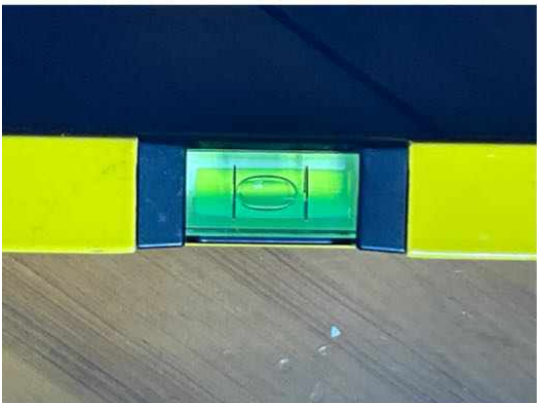
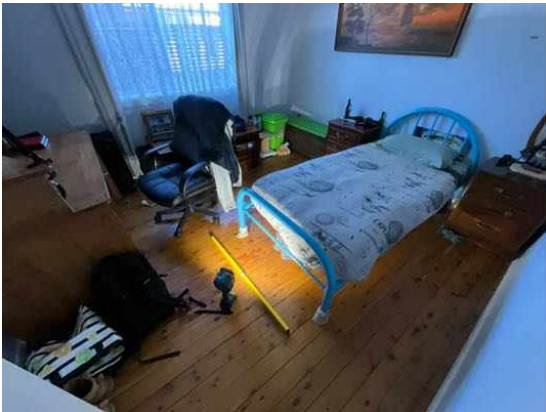
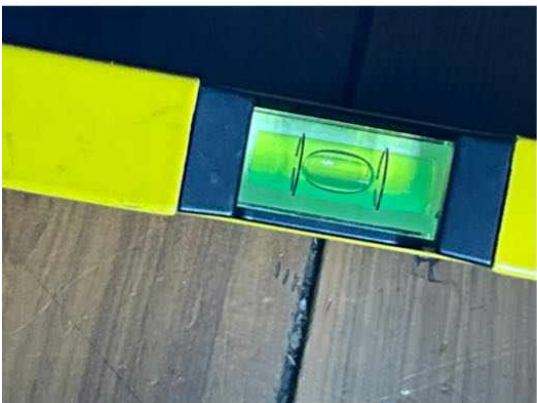
Finding 3.03

Building:	Building 1
Location:	All Internal Areas

Information: The internal flooring in this area is out of level and uneven. Uneven flooring is likely to indicate minor defects such as expected movement of the foundations of the property, but may also indicate subsidence of the associated subfloor stumps.

It is advised that the flooring be closely monitored to identify any further movement. Where flooring remains relatively unchanged for an extended period of time (i.e. several months), it is likely that this defect has been caused by expected movement of the foundations of the property.

However, where flooring is uneven further, potentially invasive inspection of the subfloor structures and stumps in this area is required. In this case, works to repair are likely to be required, and would be carried out by a registered builder specialising in re-stumping.

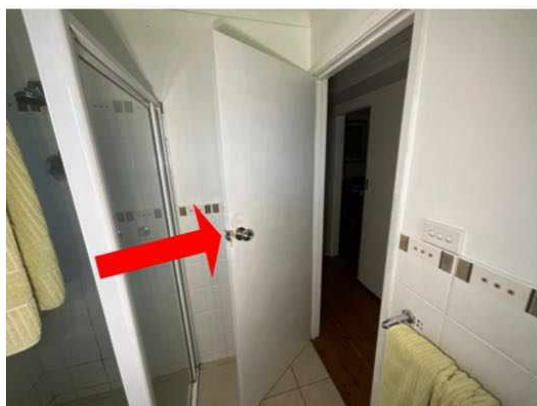
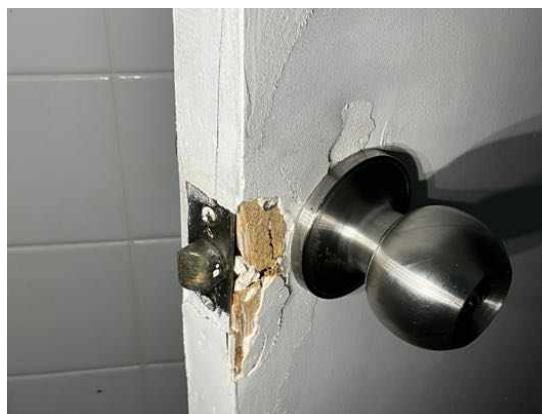
Finding 3.04

Building: Building 1
 Location: Bathroom
 Finding: Door handle- Poor operation
 Information: The door handle/ catch in this area was found to be faulty during the visual inspection. This is most probably because of a lack of maintenance or wear and tear over time.

A general Handy person or lock specialist should be contacted to make needed repairs at the discretion of the owner and restore full function.

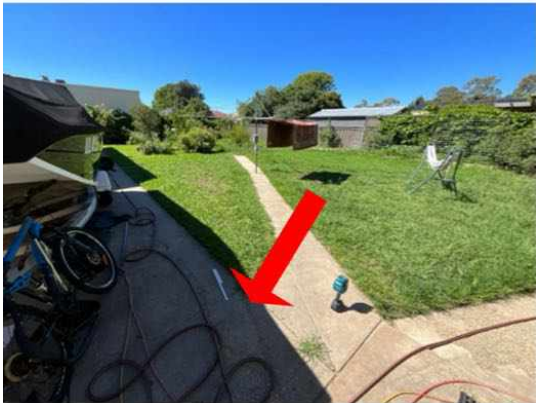
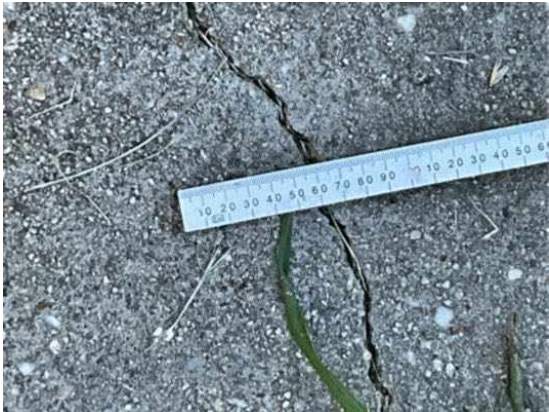
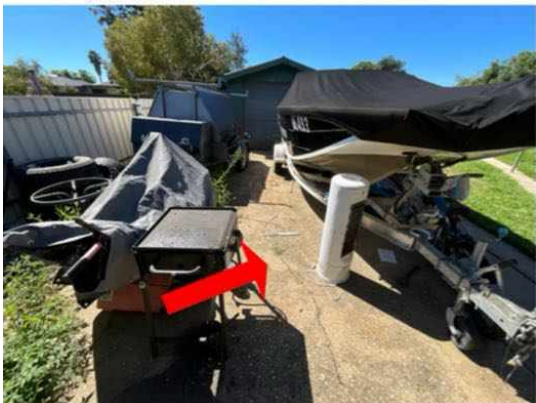
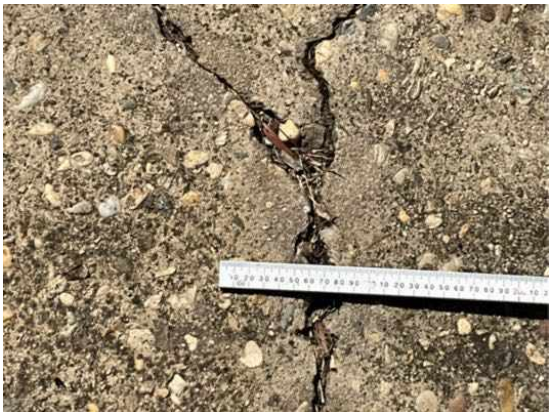
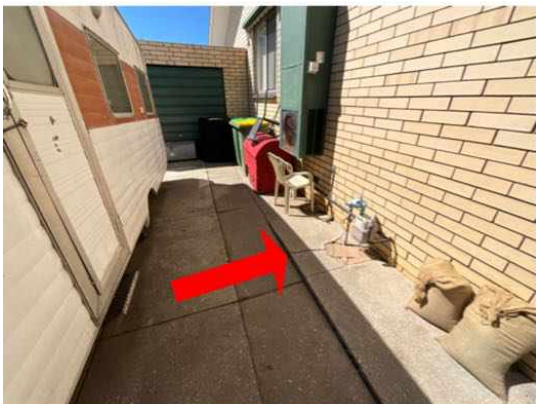
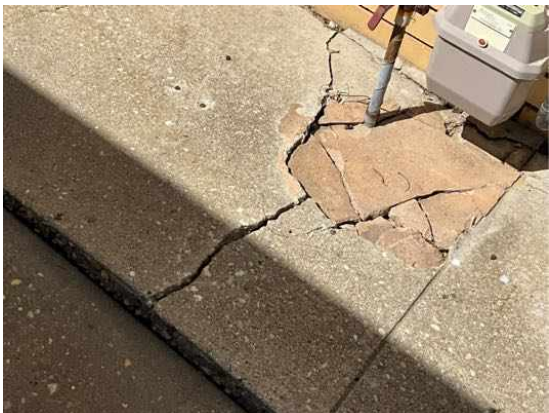
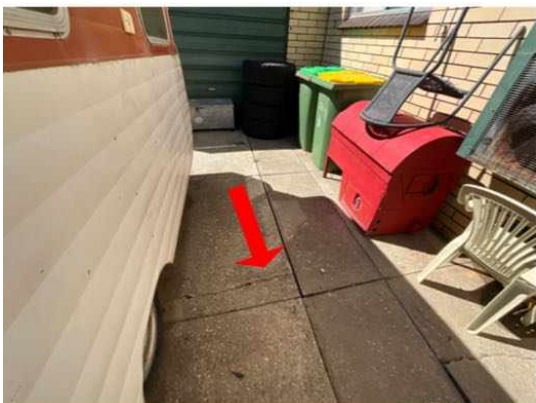
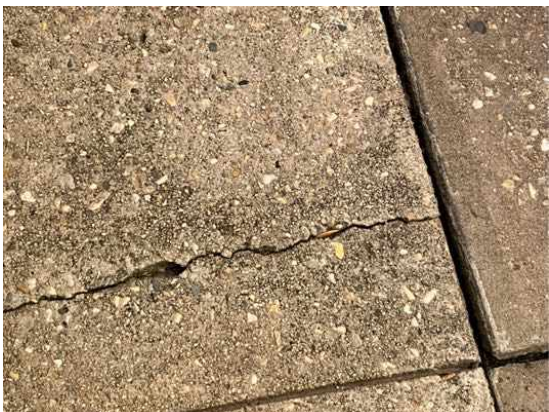
Finding 3.05

Building: Building 1
 Location: Yard - Back, driveway
 Finding: Cracking - External Concrete Paving Damage Category 4 - Gaps in Slab (4mm - 10mm +)
 Information: Gaps in the slab were identified in external concrete paving. Gaps in the slab are significant and are likely to lead to the development of safety hazards and secondary defects if left unmanaged, such as the creation of a trip hazard.

General age and expected deterioration of the paved areas is a common cause of this type of cracking. However, expansion and contraction of the slab may also have occurred due to environmental factors. Such factors include variable moisture and weather conditions, the presence of trees and their roots having a settling or lifting affect on the soil, or the effect of load bearing, e.g. heavy vehicles over a sustained period of time.

Cracking to this degree may also be due to poor original installation of the concrete. Factors such as poor compaction of the sub surface and/or inadequate reinforcing of the slab may create cracking and other secondary defects. Gaps in the concrete paving may also have a more significant structural cause, such as subsidence of soils.

Where gaps in the concrete paving are adjacent to structural elements of the building, the advice of a Structural Engineer is advisable before undertaking repairs. Significant repair and likely replacement of the concrete paving is probable.

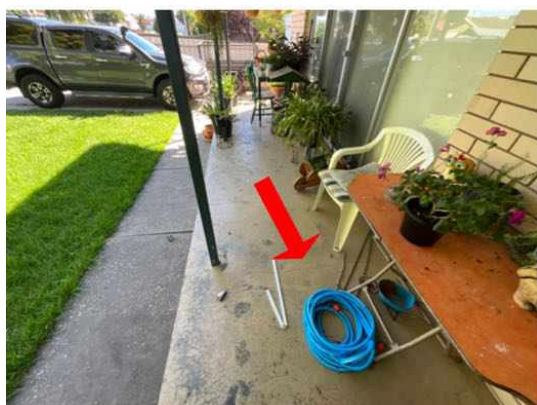
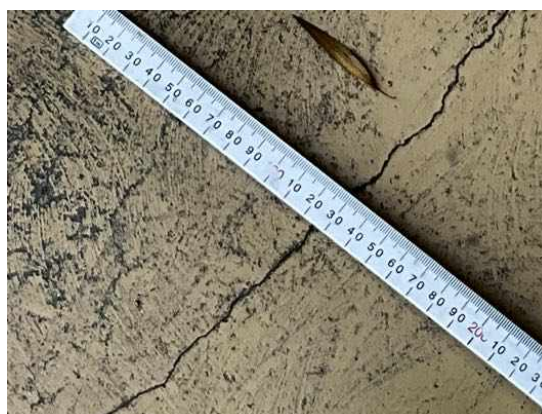
Finding 3.06

Building:	Building 1
Location:	Yard - Front
Finding:	Cracking - External Concrete Paving Damage Category 1 - Fine (less than 2mm)
Information:	Fine cracks were identified in external concrete paving. Although fine cracks are quite noticeable, they are often only considered to be an appearance defect, and usually do not indicate any structural damage. To be considered a Category 1 or fine crack, the crack is found to be less than 2mm in width.

Generally the cause of a hairline crack in existing concrete paving such as driveways and pathways is indicative of the expansion and contraction of the concrete. Such causes are generally due to environmental factors, such as moisture levels, weather conditions, root systems of nearby trees or the soil types on which they are laid.

Fine cracks may also be due to poor original installation of the concrete. Factors such as poor compaction of the sub surface and/or inadequate reinforcing of the slab may create cracking and other secondary defects.

Monitoring of all cracking should be conducted frequently. Always contact a building inspector should cracks widen, lengthen, or become more numerous.

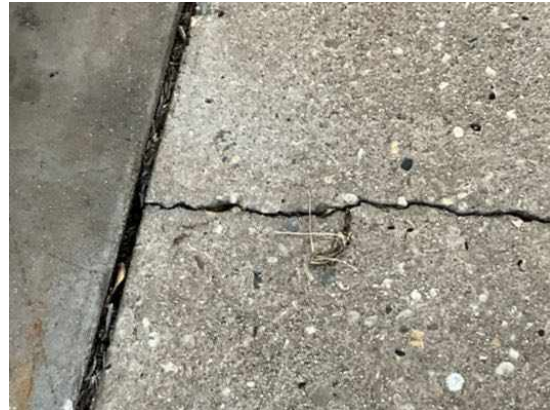
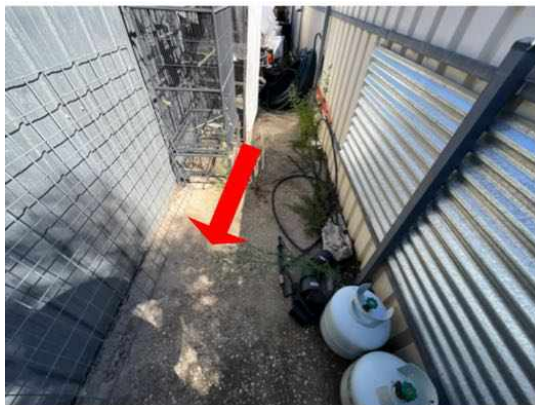
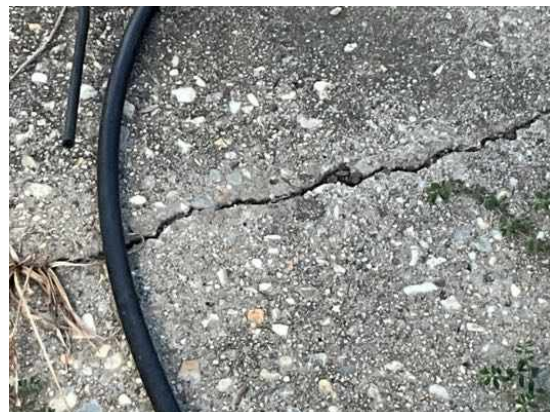
Finding 3.07

Building:	Building 1
Location:	Yard - Back
Finding:	Cracking - External Concrete Paving Damage Category 1 - Fine (less than 2mm)
Information:	Fine cracks were identified in external concrete paving. Although fine cracks are quite noticeable, they are often only considered to be an appearance defect, and usually do not indicate any structural damage. To be considered a Category 1 or fine crack, the crack is found to be less than 2mm in width.

Generally the cause of a hairline crack in existing concrete paving such as driveways and pathways is indicative of the expansion and contraction of the concrete. Such

causes are generally due to environmental factors, such as moisture levels, weather conditions, root systems of nearby trees or the soil types on which they are laid.

Fine cracks may also be due to poor original installation of the concrete. Factors such as poor compaction of the sub surface and/or inadequate reinforcing of the slab may create cracking and other secondary defects.

Monitoring of all cracking should be conducted frequently. Always contact a building inspector should cracks widen, lengthen, or become more numerous.

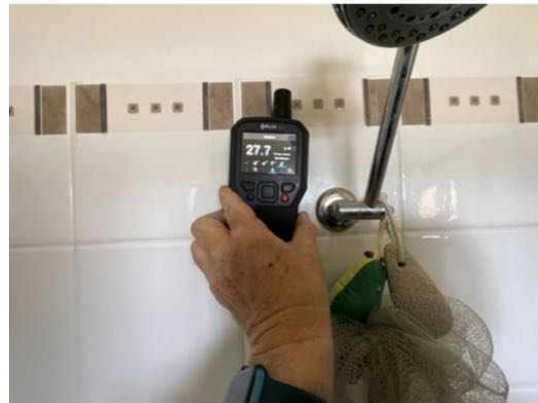
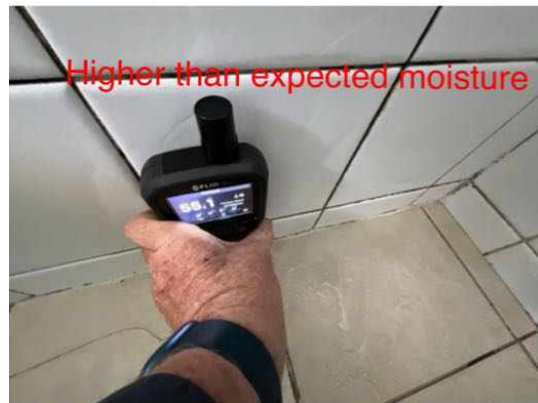
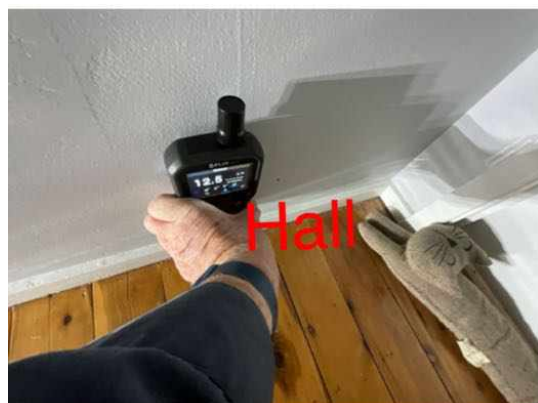
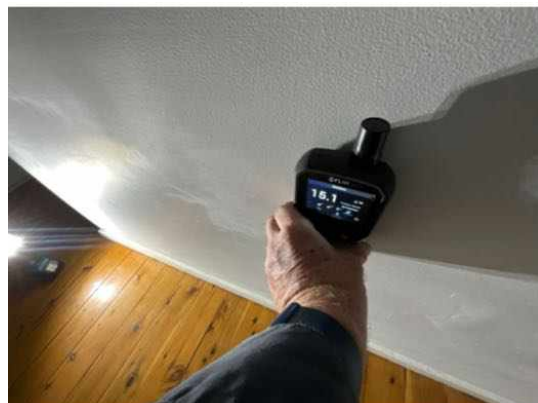
This defect is quite common, and is suspected to have been caused by moisture permeating or leaching through the grouting and perhaps gaps in the sealant prior to repair.

Damp (or structural damp) refers to the presence of unwanted moisture in the structure of a building, either as the result of intrusion from outside, or condensation from within the structure. In the shower area, internal water leaks or other sources of excessive moisture are generally the cause of damp.

Monitoring the area is advised and if any visual signs of excessive moisture appear (peeling paint, mould) then consultation with a qualified plumber or bathroom specialist would be advised to identify the cause of damp and to perform remedial works as required.

Always ensure that sealant and grout is in good condition to prevent any moisture issues occurring in the future.

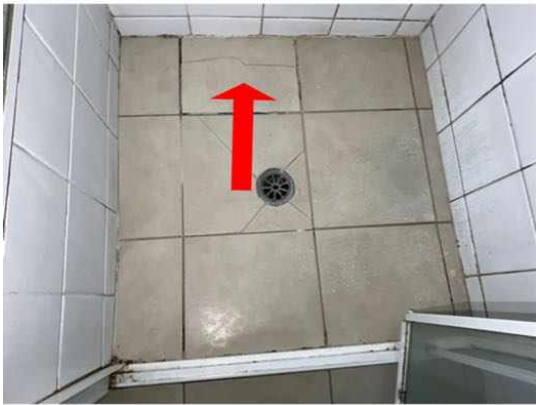
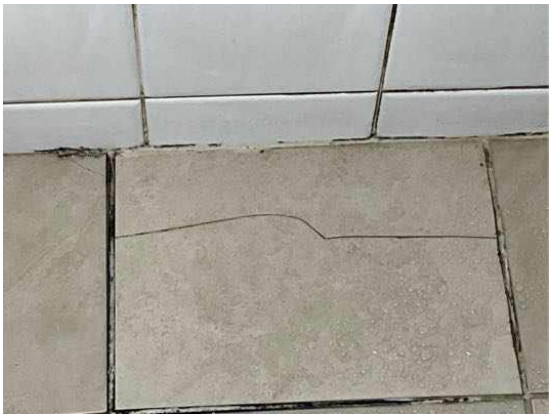
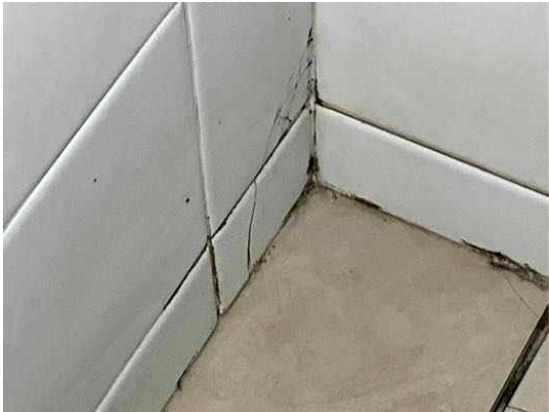
Finding 6.02

Building:	Building 1
Location:	Bathroom
Finding:	Cracked floor tiles
Information:	Cracking in the floor tiles was evident in this area at the time of inspection. It is suspected that this cracking has occurred as a result of minor settlement or impact damage.

Cracked tiles throughout the household detract from the overall appearance of the affected areas however it is unlikely to create or lead to any secondary defects.

While not considered a matter of urgency, replacement of cracked floor tiles is recommended at the clients discretion. A tiling contractor may be appointed to perform these works. Where cracks become more numerous, contact a licensed building inspector for further investigation.

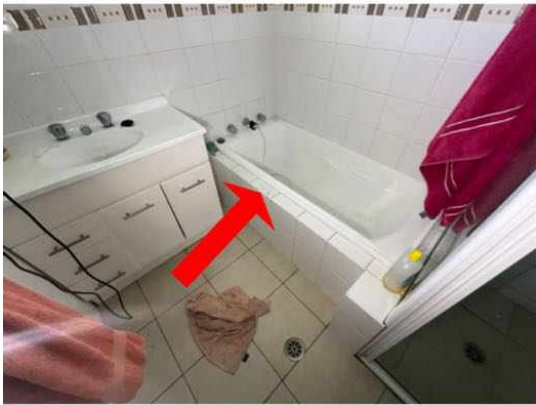
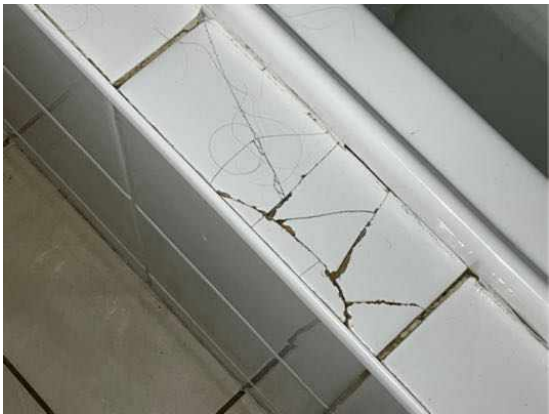
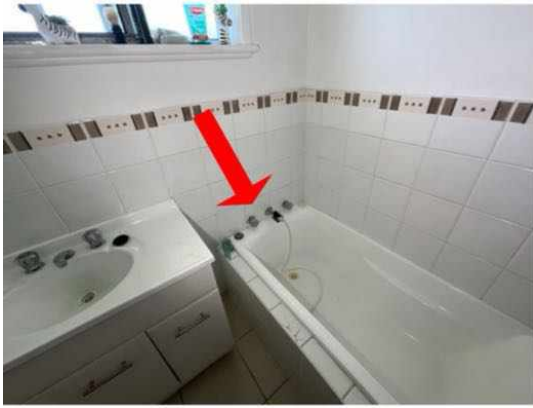
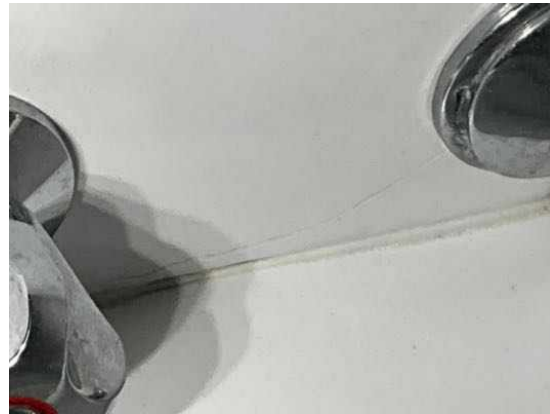
Finding 6.03

Building: Building 1
Location: Bathroom
Finding: Wall Tiles- Cracked
Information: Cracked tiles within the household detract from the overall appearance of the affected areas, as well as creating potential for water penetration to adjoining building elements. If left unmanaged, water damage may occur as a result of constant water penetration over a prolonged period of time.

While not considered a matter of urgency, replacement of tiles is advised as a solution. A Tiling Contractor may be appointed to perform these works at client discretion.

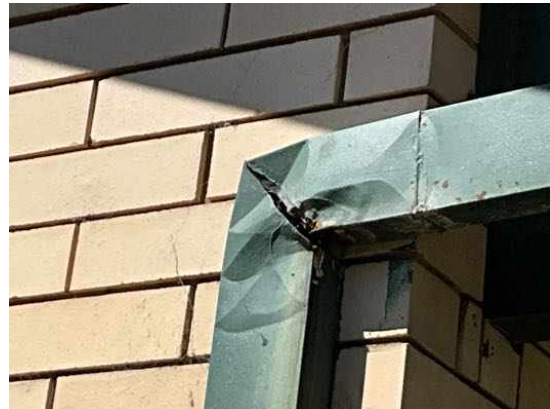
Finding 6.04

Building:	Building 1
Location:	Driveway
Finding:	Downpipe- Damaged
Information:	The Downpipe was found to be damaged at the time of inspection. This damage has occurred because of impact from a foreign object.

Downpipes ensure excess water is directed away from the structure to prevent damage. This damage includes Fungal timber decay, Termite attack and sinking of the stumps that support the floor. All of this type of damage may lead to costly repairs.

A Plumber should be contacted to make repairs as soon as possible to prevent deterioration of the Structure.

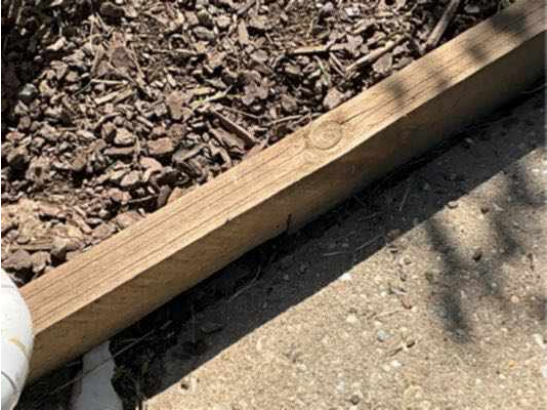
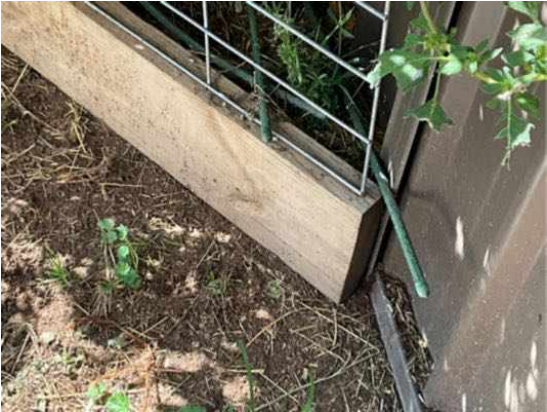
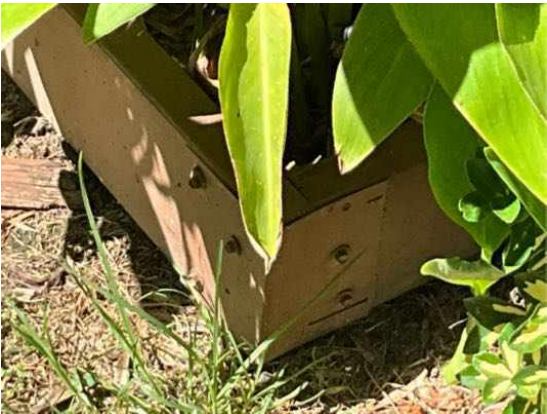
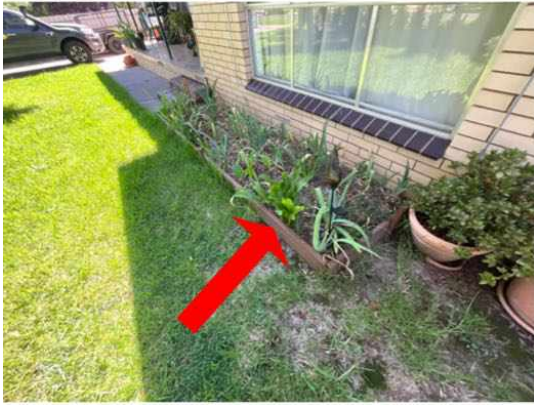
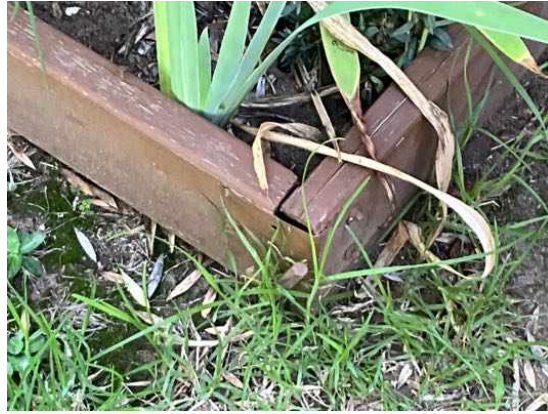
Finding 6.05

Building:	Building 1
Location:	Yard - Back, front
Finding:	Untreated or non-durable timbers in a hazardous environment
Information:	To reduce the risk of timber pest attack it is essential that timber used in a hazardous environment (e.g. in direct contact with the ground or frequently exposed to damp conditions) is of sufficient durability and/or is adequately preservative treated.

Untreated timbers in direct contact with the ground are likely to develop severe wood rot and/or fungal decay if left unattended creating attraction for subterranean termites to infest the timbers from surrounding areas.

If untreated or non-durable timbers are found to be in a hazardous environment it is highly advised that replacement of these building elements be performed as soon as possible to aid the protection of the property against termite / timber pest attack.

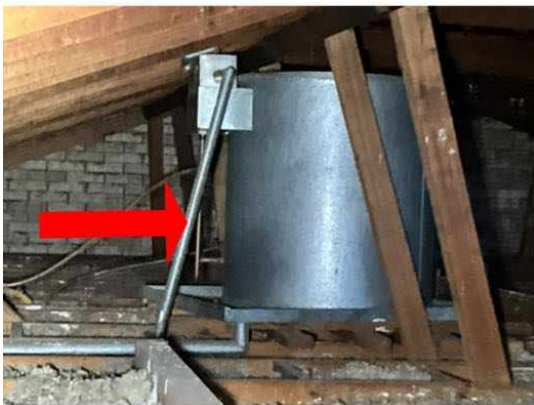
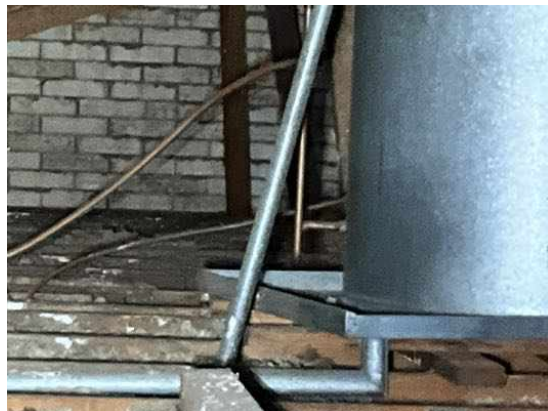
Finding 6.06

Building:	Building 1
Location:	Roof Void
Finding:	Gravity-Fed HWS - Disconnected
Information:	It was noted at the time of inspection that a disconnected gravity-fed hot water system (HWS) remains in this area.

Despite this plumbing structure being unused, it is likely to be storing residual water, and is therefore susceptible to rust and corrosion. If allowed to continue, rust and corrosion is likely to lead to damage to adjoining building elements, and may also make the area susceptible to termite or timber pest activity.

While it is a costly exercise to remove the disused gravity-fed HWS, it is advisable in the short-term future to prevent any further damage to the area. Further consultation with a licensed plumber is required to gain further advice on removal of the structure.

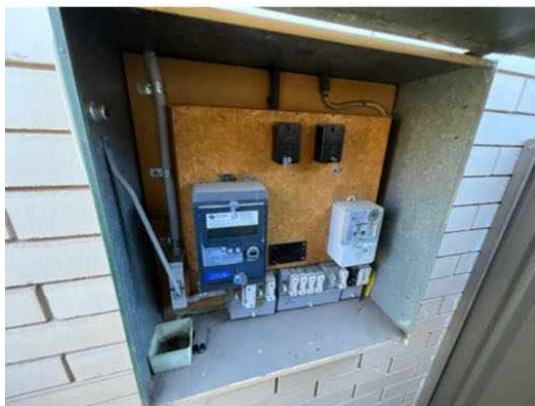
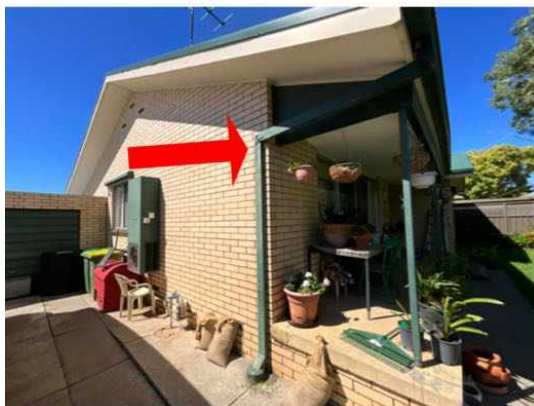
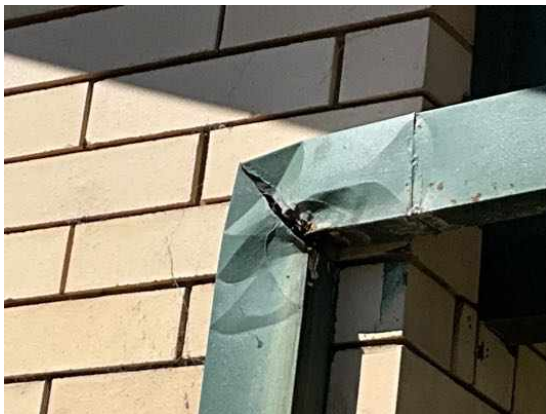
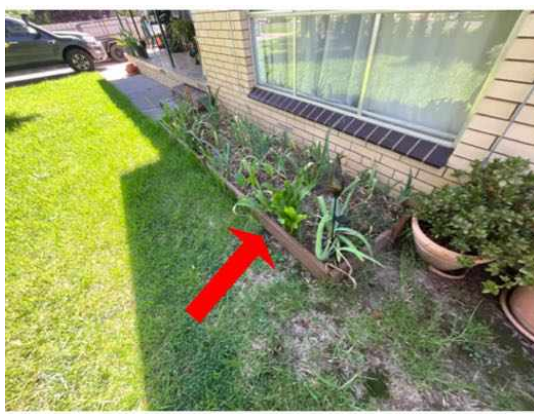
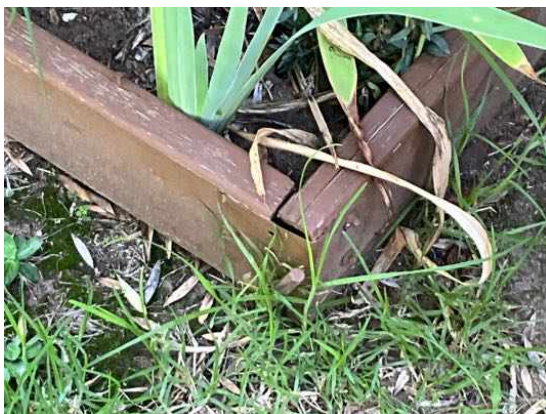
Finding 6.07

Building:	Building 1
Location:	All External Areas
Finding:	Termite Management System - no evidence of a chemical installation
Information:	The application of a post-construction chemical termite barrier is highly recommended

for all properties, particularly if live termite activity has been found on the site previously. Such barriers are highly effective in preventing termite attack on any timber building elements throughout the property.

A durable notice should be placed in the switchboard unit to indicate current termite barriers. At the time of inspection, it appeared as though no termite management system has been installed, with no evidence to suggest preventative works taking place.

The client may consider gaining further advice from a pest controller as to the costs and procedures involved with this application. It is recommended that obtaining such advice be a short-term priority.

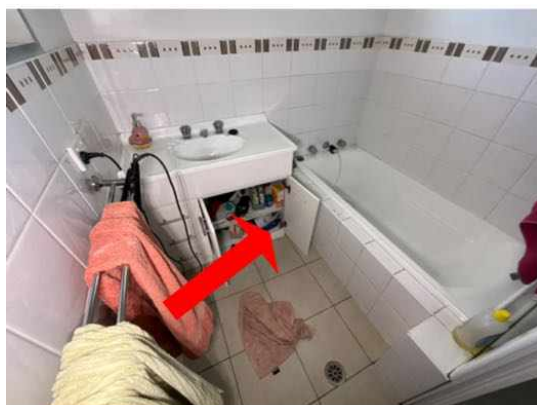
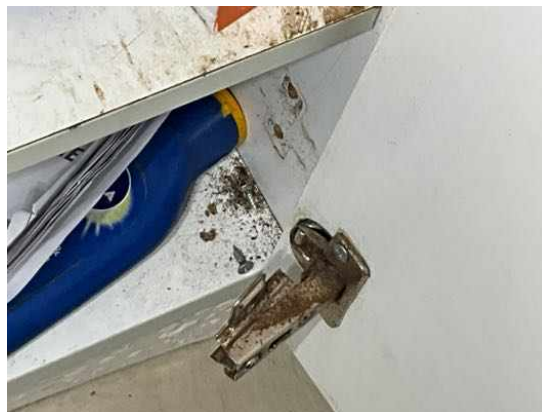
Building:	Building 1
Location:	Bathroom
Finding:	Door, hinge loose
Information:	The hinge in this area is loose. This may lead to decreased operation of the door and further deterioration.

To improve operation of the affected door, a general handyman may be appointed to replace the faulty hinges. Such works should be completed at discretion of the client.

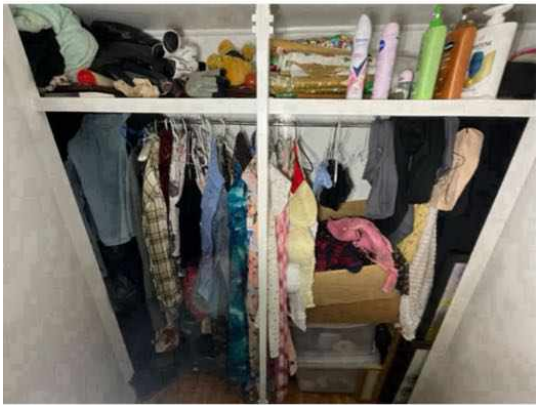
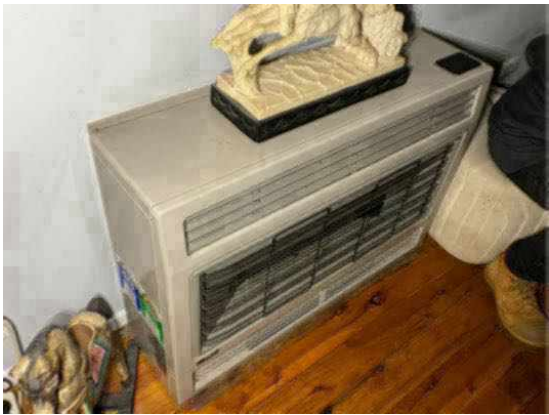
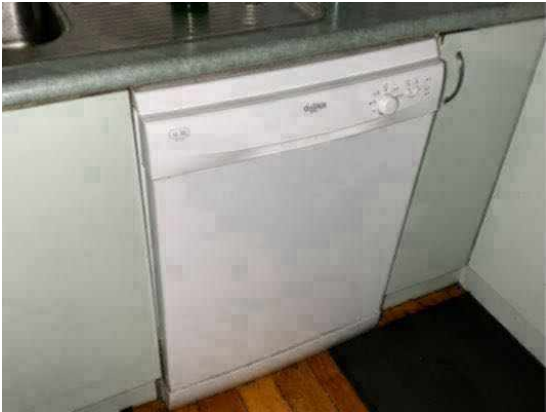
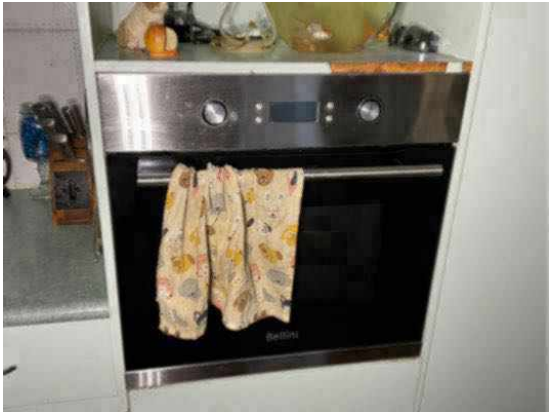
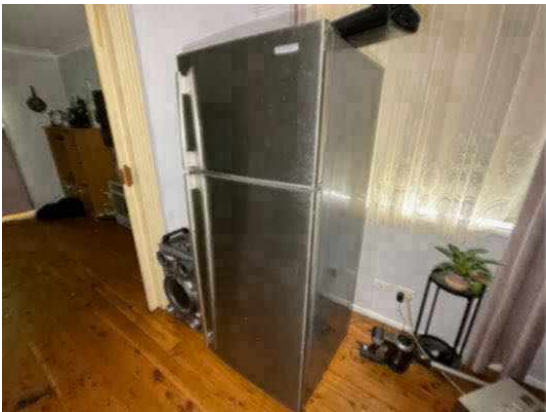
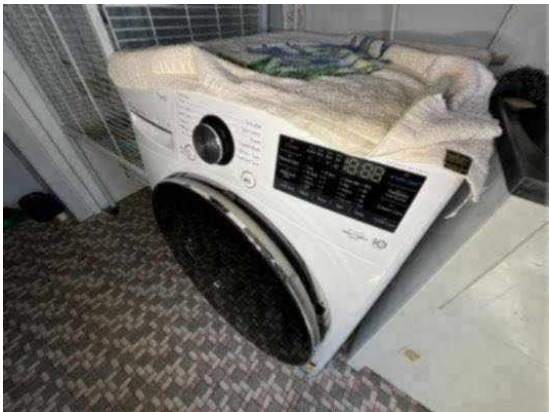
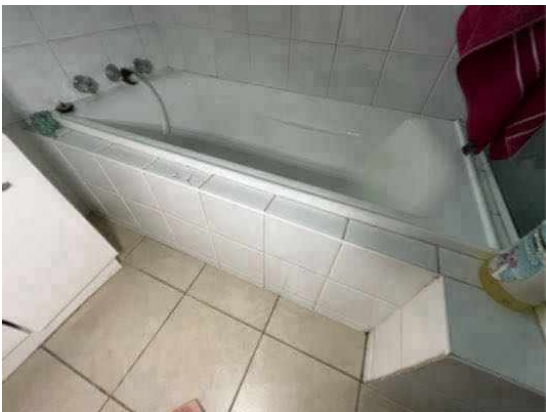
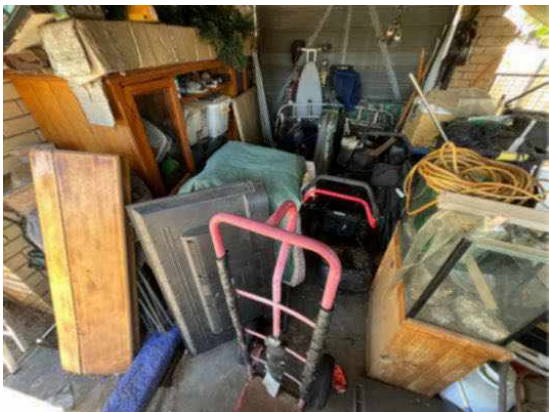
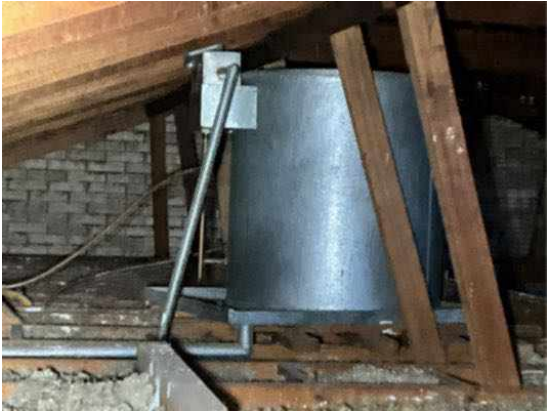
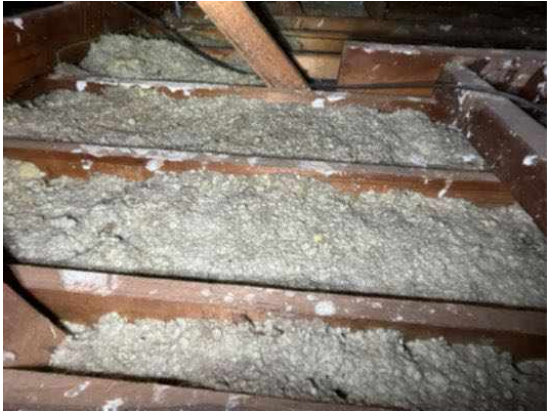
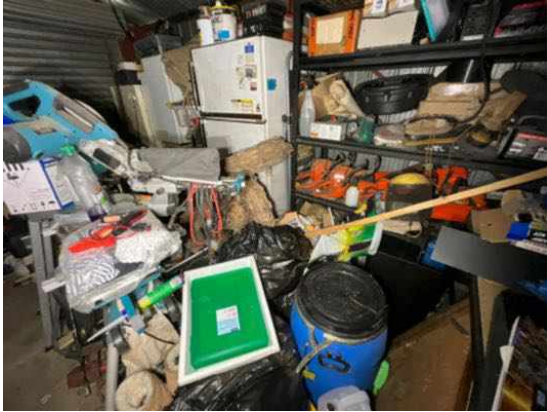
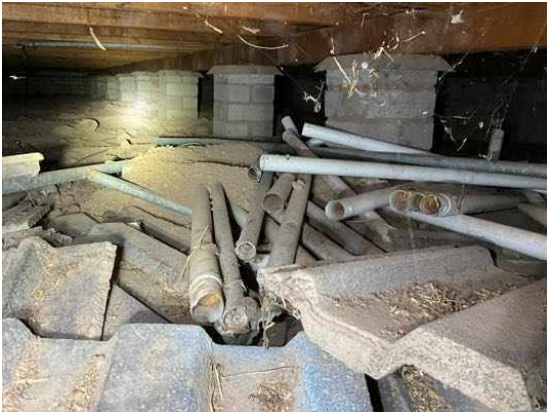
Building:	Building 1
Location:	All Areas
Finding:	Additional Photos - Obstructions and Limitations
Information:	These photographs are an indication of the obstructions and limitations which impeded full inspection of the property at the time of inspection. These obstructions can hide an array of defects and should be removed to allow full inspection to be carried out. A re-inspection is recommended once the areas are made accessible.
