Building Inspection Report

Inspection Date: Mon, 16 Mar 2026

Property Address: 37 Armstrong Way, Highland Park QLD
4211, Australia

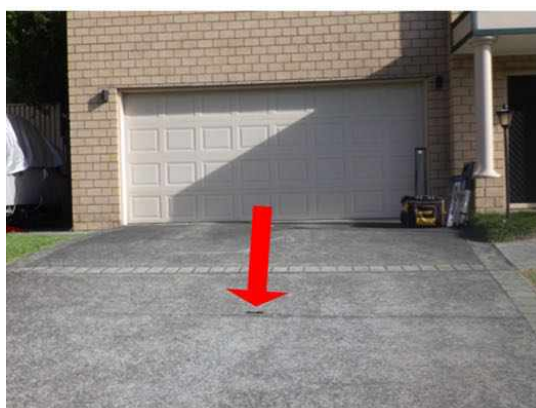
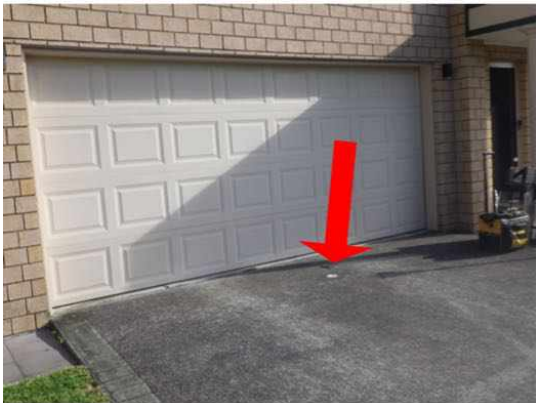
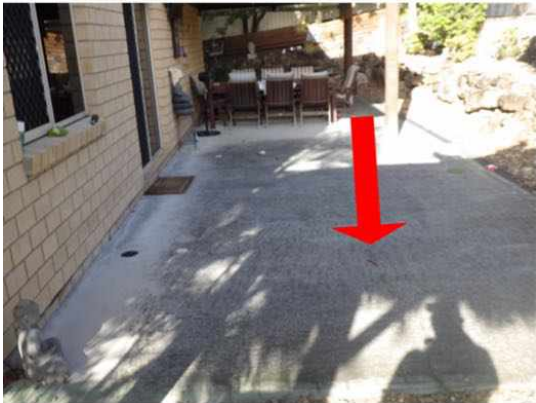
Defects 3.01

Building: Main Building
Location: Driveway > Ground Level
Finding: Cracking in concrete slab - Category 1
Information: Cracking coded as Category 1 was identified in the driveway and footpaths concrete slabs (as per example photos). A Category 1 crack is described as a fine but noticeable crack, with the slab at an otherwise reasonable level.

To be considered Category 1, the approximate width of the crack is less than 1.0mm, or a less than 10mm change in offset when a 3m straight edge is placed over the defect.

Category 1 cracks should be monitored for a period of 12 months. At the end of the monitoring period, identified cracks that are rated greater than Category 2 are considered defects, and require rectification.

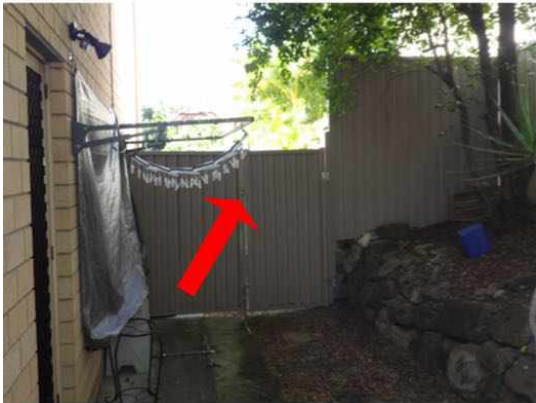
Defects 3.02

Building: Main Building
 Location: Exterior walls - left side > Existing
 Finding: Gate - Sticking/ jamming
 Information: At the time of inspection the gate to the left side of the property was sticking or jamming during standard operation.

A fencing contractor or general handyman could be engaged to adjust or repair the gate as required.

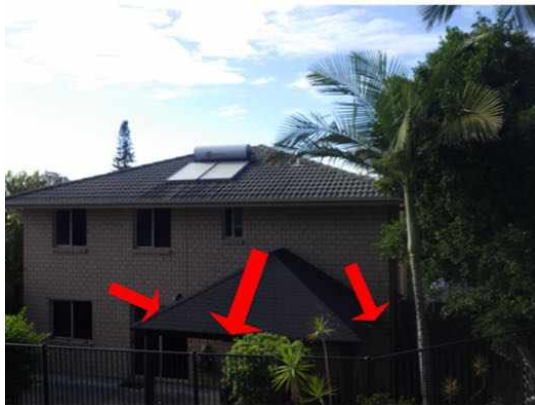
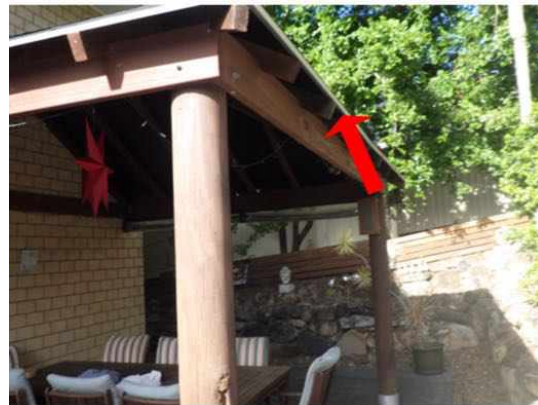
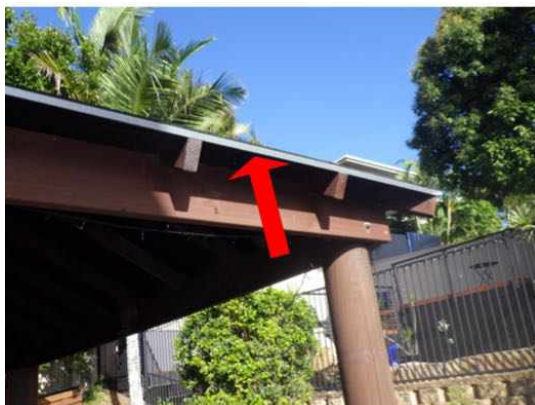
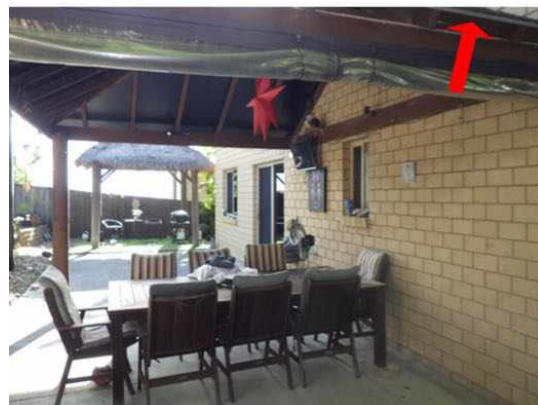
Defects 3.03

| Finding: | Roof Guttering Missing |

Although some building elements may seem irrelevant or unnecessary, all building elements play a key role in the operation and function of the overall structure and its performance. Roof areas missing gutters are likely to lead to high levels of moisture in the ground areas directly below. Such moisture will not only cause rust and decay of the associated building materials, but can also provide conditions that are conducive to termite and timber pest activity.

Installation of roof guttering and stormwater downpipes should be conducted to ensure that no damage or functional issues occur to associated building materials.

A qualified roof plumber should be appointed to replace the missing guttering.

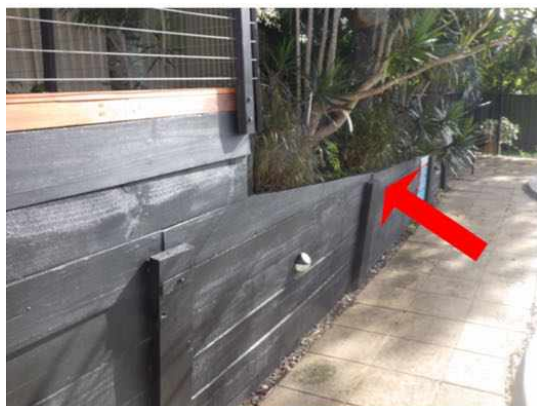
Defects 3.04

Information: The timber retaining wall to the rear of the property showed signs of minor movement or deterioration at the time of inspection. Generally, deteriorated retaining walls are caused by poor material use or continuous exposure to weather conditions. However, deteriorated retaining walls may also be a result of substandard construction, poor site drainage or unmanaged stormwater flows.

In this instance it appears the timber retaining wall movement is the result of plant or vegetation growth in the area.

A landscaper or retaining wall installer could be appointed to repair the wall, at the discretion of the client.

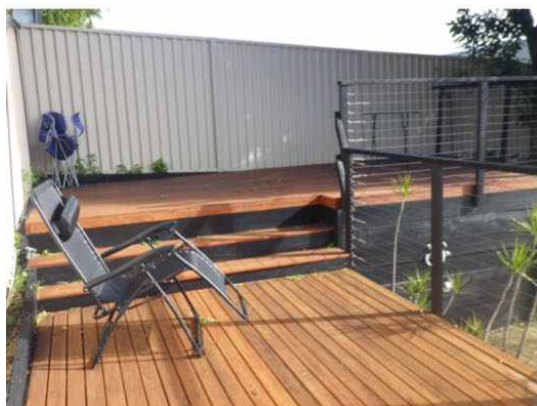
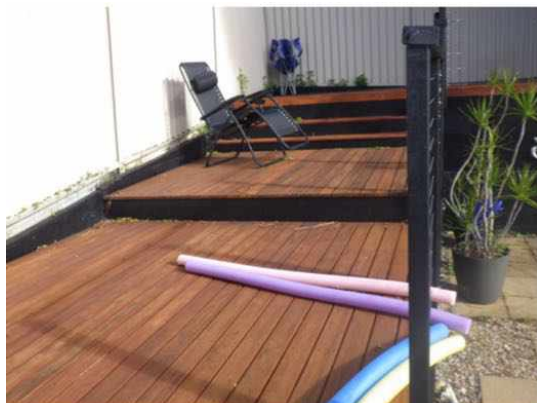
Defects 3.05

Building: Main Building
 Location: Deck > Existing
 Finding: Deck - In ground contact
 Information: At the time of inspection it was noted the timber deck area to the rear of the property is in direct contact with the finished ground level.

Any timbers in direct ground contact provide opportunity for concealed termite activity and are likely to be subject to premature rot and decay as the soil retains moisture or damp conditions against the timbers.

Frequent pest inspections are advised to readily identify any termite activity in these areas.

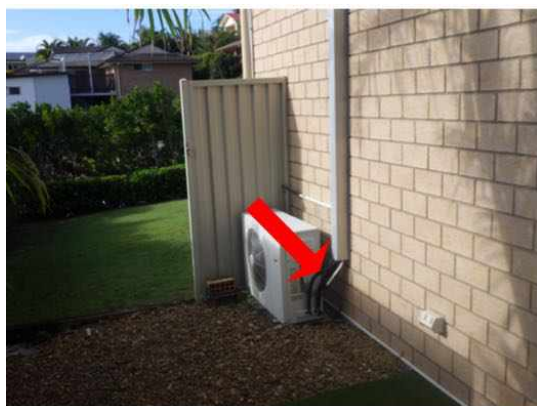
Defects 3.06

| Finding: | Pipework - Insulation deteriorated |
| Information: | <p>At the time of inspection sections of the air conditioning unit pipe work insulation showed evidence of damage and deterioration. It is suspected that this deterioration has developed as a result of excessive exposure to weather, including UV exposure in daylight. Deteriorated insulation reduces the effectiveness of the material in helping to maintain the desired temperature and work most efficiently.</p> <p>If left in an exposed position, it is likely that the deterioration will continue and worsen over time, potentially resulting in secondary building defects as well as a further loss in insulating properties.</p> <p>Some areas of replacement of pipe insulation is likely to be required. Further preventative measures to remove or protect the material from future exposure are also advisable. Consultation with a licensed air conditioning installer is advised to gain quotes for the repair and/or replacement of deteriorated insulation.</p> |

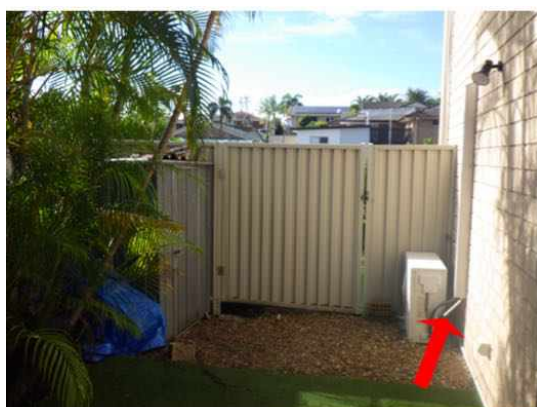
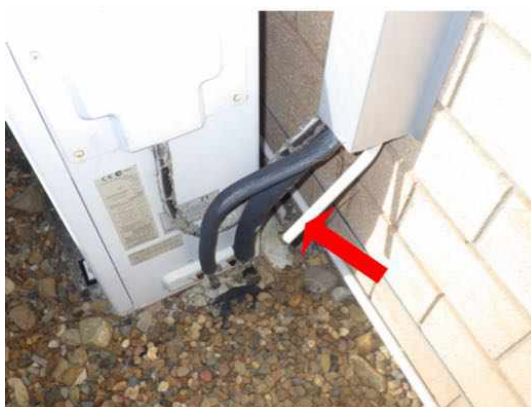
Defects 3.07

| Finding: | Overflow - Not plumbed for drainage |
| Information: | The air conditioning unit overflow is not plumbed or connected to suitable drainage, which can result in the surrounding area becoming excessively damp. These damp conditions can lead to secondary defects such as rot, rust or corrosion of associated building elements, the formation of fungal decay, or even the creation of potential slip hazards. When coupled with poor site drainage, pooling of water may also attract termite activity to this area. It is highly recommended that a qualified plumber be appointed to install adequate drainage to the overflow. These works will ensure that the area remains dry and free of any secondary defects. |

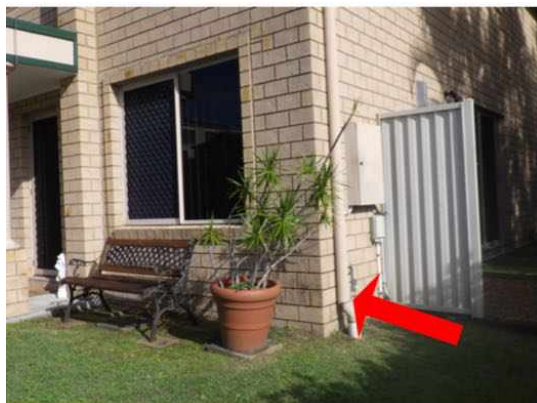
Defects 3.08

| Finding: | Stormwater pipe - Damaged |
| Information: | The down pipe to the right side exterior wall of the building has suffered damage to the top of the down pipe adaptor. |

become excessively damp, potentially creating an environment that is susceptible to rust and corrosion of surrounding building elements, as well as attracting termites and other pests.

It is recommended that a plumber or handyman be appointed to repair the down pipe as necessary.

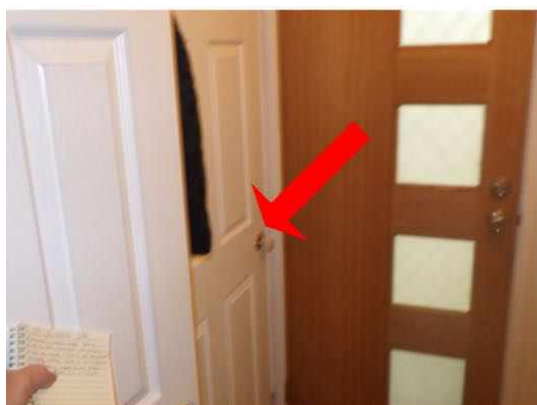
Defects 3.09

Building: Main Building
 Location: Under Stair Void or Storeroom > Front
 Finding: Door - Not latching
 Information: The door to the under stair storage room was found to be not latching at the time of inspection. Breakage occurs generally when the building materials have aged and decayed.

A qualified carpenter or general handyman could be appointed to adjust the door handle striker plate at the client's discretion.

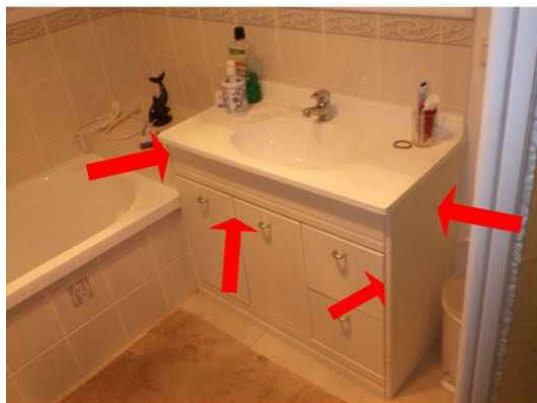
Defects 3.10

Building: Main Building
 Location: Bathroom > Centre Right

Finding: Cabinetry - Deterioration
 Information: At the time of inspection the bathroom cabinetry showed signs of minor deterioration. The level of damage appears consistent with exposure to moisture or general wear and tear.

A qualified cabinet maker or general handyman could be engaged to undertake repair works at the clients discretion.

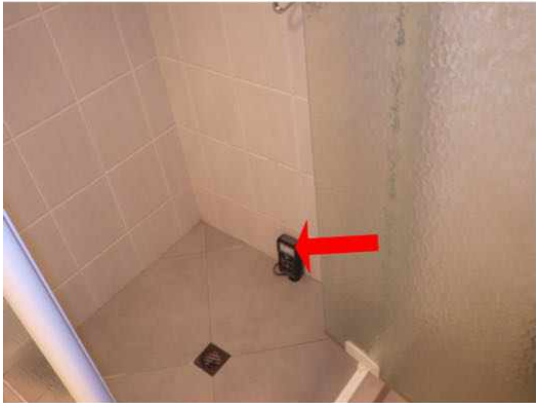
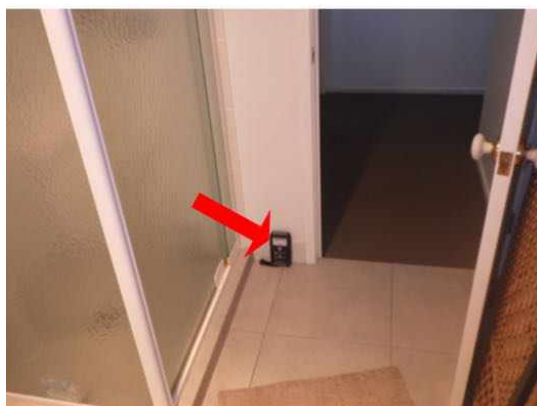
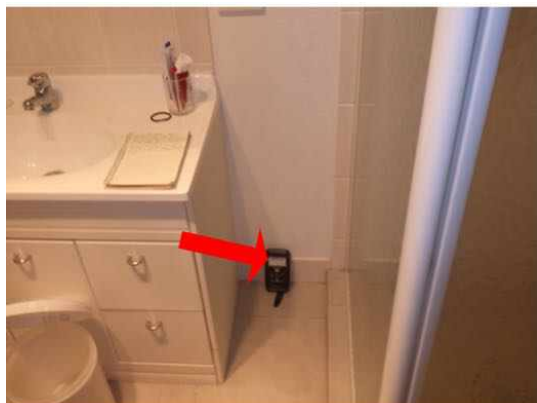
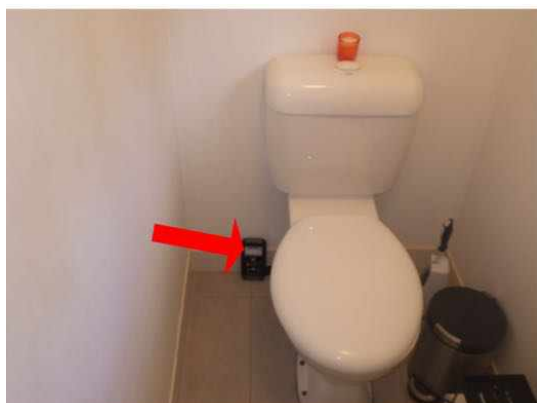
Defects 3.11

Building: Main Building
 Location: Bathroom > Front Right
 Finding: Shower - Monitor
 Information: Elevated moisture level readings were recorded to the lower 200mm of wall to the bathroom shower alcove at the time of inspection. There was no elevated moisture level readings around the tap area, and no elevated readings transferring outside the shower cubicle or to the other side of the wall in the areas where moisture readings were able to be obtained. Both sealant and grout appear in good condition at present.

This defect is quite common, and is suspected to have been caused by moisture permeating or leaching through the grouting and perhaps gaps in the sealant.

Monitoring the area is advised and if any visual signs of excessive moisture appear

(peeling paint, mould) then consultation with a bathroom specialist would be advised.

Always ensure that sealant and grout is in good condition to prevent any moisture issues occurring in the future.

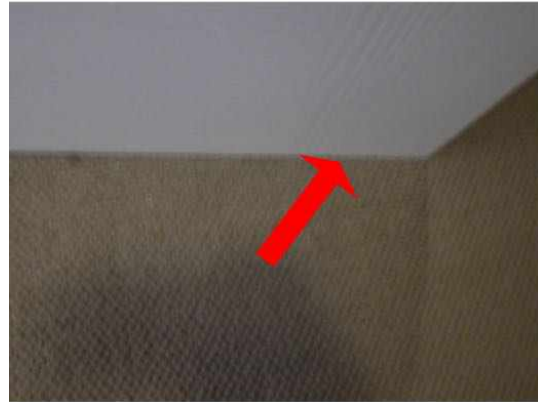
Defects 3.14

Building: Main Building
 Location: Walk In Robe > Front
 Finding: Door Rubbing
 Information: It was noted that the bottom edge of the walk in robe door is rubbing on the carpet making the door stiff to open and close at the time of inspection.

This is noted as a minor defect that you need to be aware of.

A licensed carpenter or general handyman could be engaged to ease the door at the clients discretion.

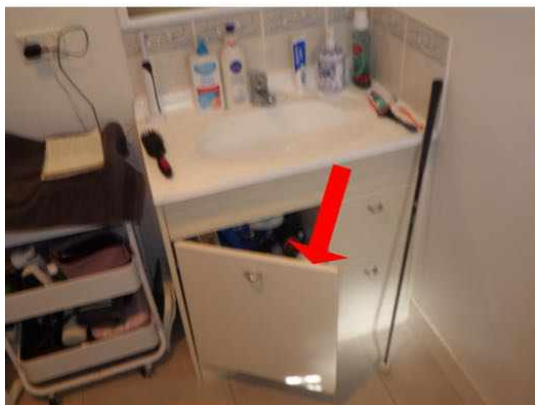
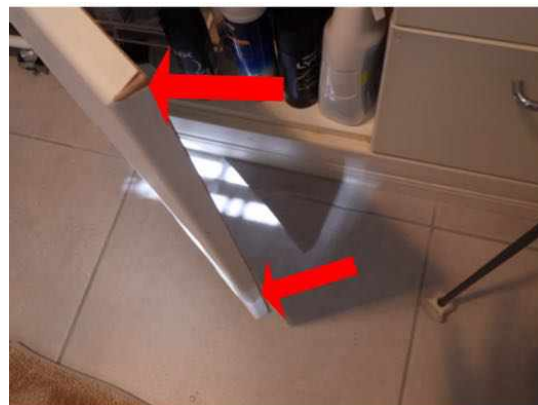
Defects 3.15

Building: Main Building
 Location: Ensuite > Rear Left
 Finding: Cabinetry - Deterioration
 Information: At the time of inspection the ensuite cabinetry showed signs of deterioration. The level of damage appears consistent with exposure to moisture or general wear and tear.

A qualified cabinet maker or general handyman could be engaged to undertake repair works at the clients discretion.

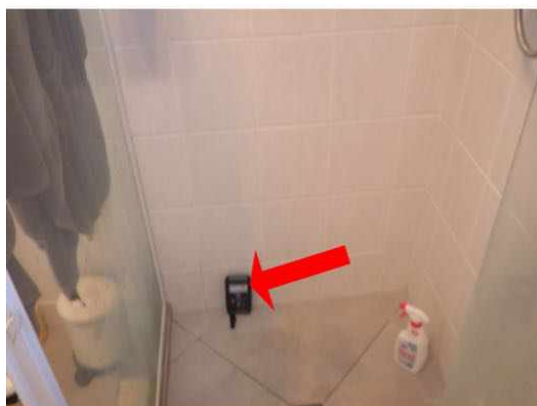
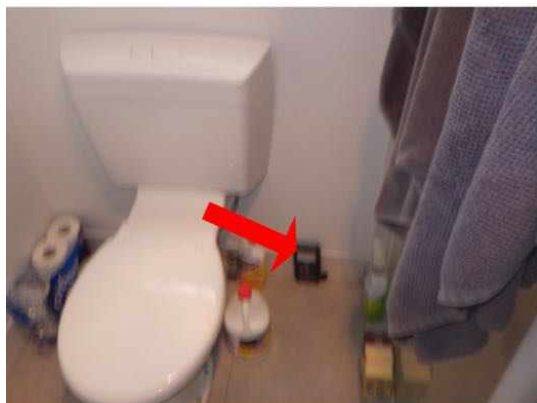
Defects 3.16

Building: Main Building
 Location: Ensuite > Front Right
 Finding: Shower - Monitor
 Information: Elevated moisture level readings were recorded to the rear lower 200mm of wall to the ensuite shower alcove at the time of inspection. There was no elevated moisture level

readings around the tap area, and no elevated readings transferring outside of the shower cubicle in the areas where moisture readings were able to be obtained. Both sealant and grout appear in good condition at present.

This defect is quite common, and is suspected to have been caused by moisture permeating or leaching through the grouting and perhaps gaps in the sealant.

Monitoring the area is advised and if any visual signs of excessive moisture appear (peeling paint, mould) then consultation with a bathroom specialist would be recommended.

Always ensure that sealant and grout is in good condition to prevent any moisture issues occurring in the future.
